THE IMPACT OF HURRICANE GEORGES ON THE CARBONATE BEACHES OF THE FLORIDA KEYS

November 1998

**Bureau of Beaches and Coastal Systems
Florida Department of Environmental Protection**

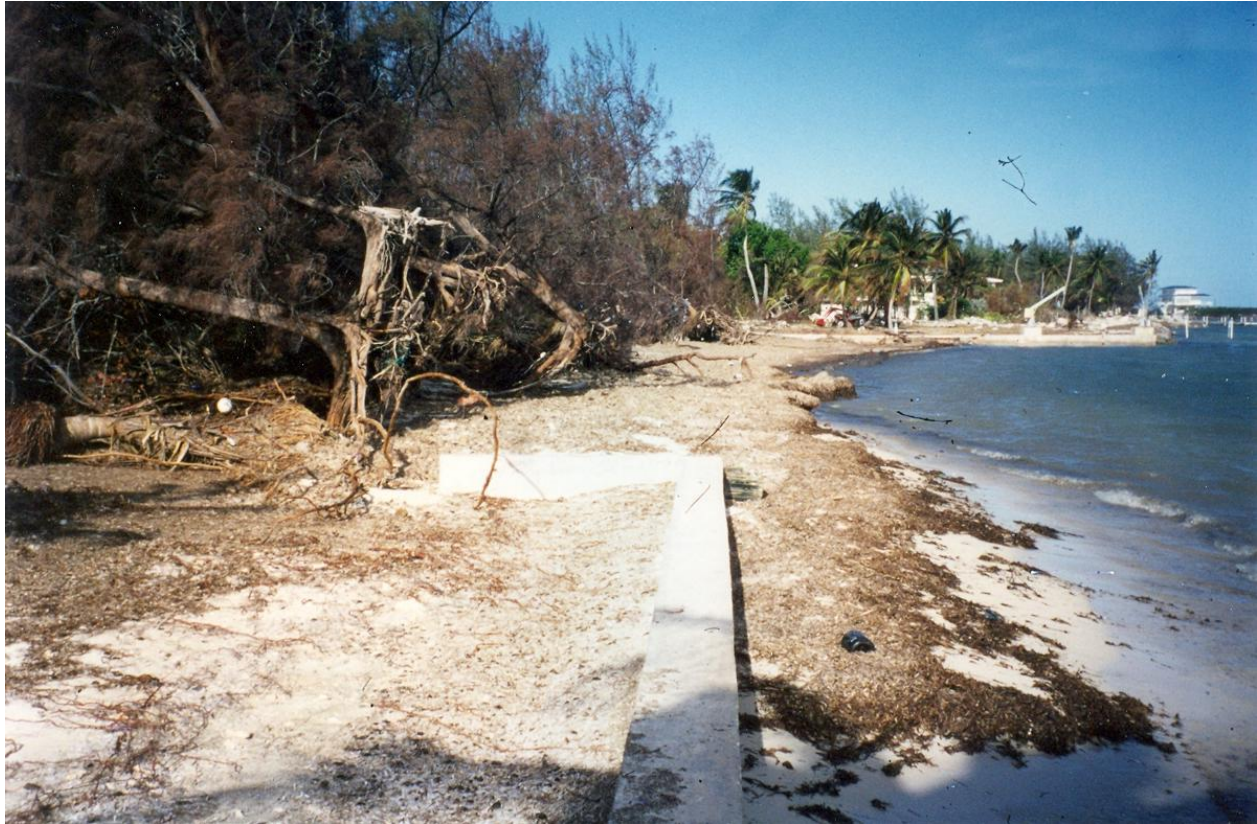
shoreline. Minor to moderate erosion was sustained along the beaches and numerous walls and piers were damaged or destroyed. Along 4,200 feet of sandy and rocky shoreline fronting on U.S. Highway 1 at the western end of the island, the beach (in places 50 feet wide) was eroded and sand was transported across the road. A substantial seaweed rack has been deposited along the shore. Anne's Beach sustained minor beach erosion.

Damage at Lower Matecumbe Key.

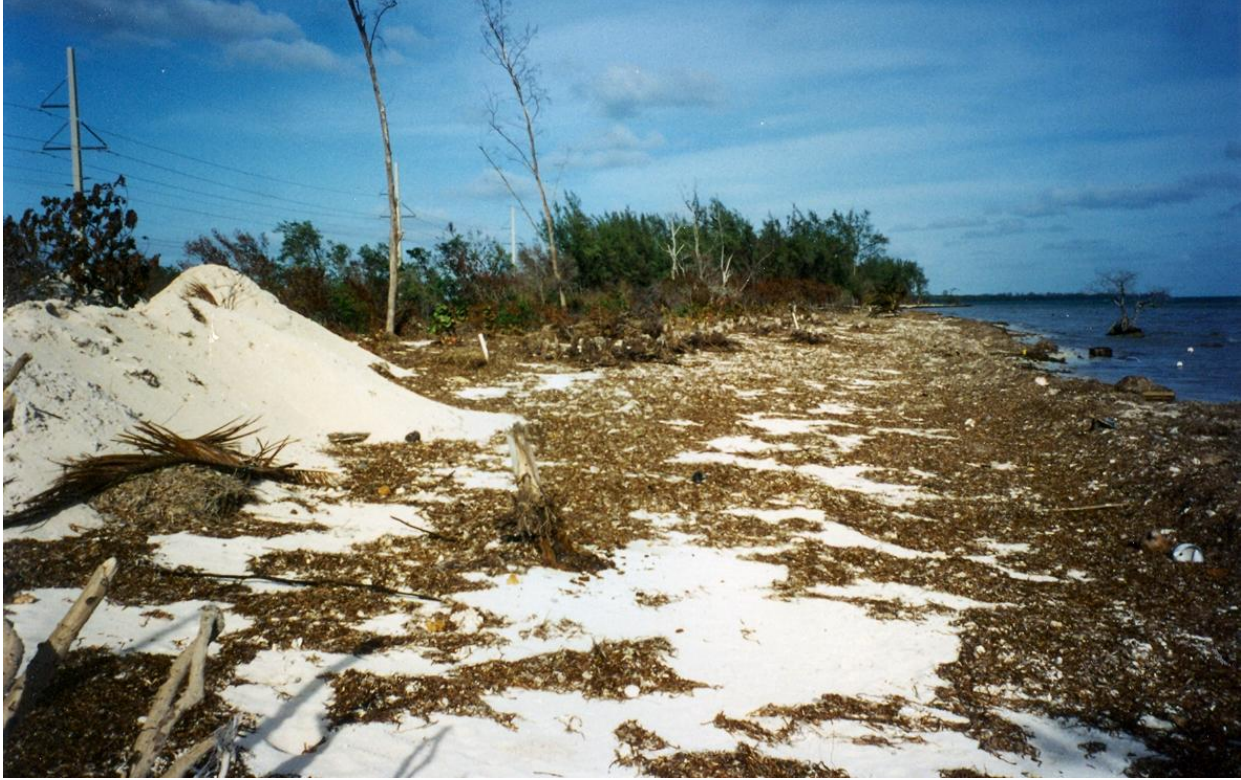
The 4.2-mile long island of Long Key has a predominately coarse-grained sand beach with a couple of short segments of mangrove shoreline fronting on the Straits of Florida. Roughly one half of the island is within the Long Key State Recreation Area. With the longest sandy shoreline in the Keys, the State Recreation Area has approximately 15,800 feet of beach averaging 25 feet in width. A 2,950-foot segment of shoreline along the Park's camping and swimming areas is a designated critical erosion area where shoreline recession between 1970 and 1990 was estimated to be about -3 feet per year. Notwithstanding extensive damage within the park and to most all facilities, the beach sustained relatively minor erosion losses. The dune or upland areas actually gained sand as the 4 to 5-foot storm tide transported a substantial quantity of sand inland from the offshore areas. An average of 6 inches of sand blanketed the park. However, given the degree of threat to recreational interests which exists within the park, the stretch of shoreline designated as critical erosion should be doubled.

Damage at Long Key.

- (1) Long Key State Recreation Area – plant dune vegetation.
- (2) Key Colony Beach – beach nourishment and plant vegetation.
- (3) Sombrero Beach – plant vegetation and possible nourishment; terminal groin recommended.

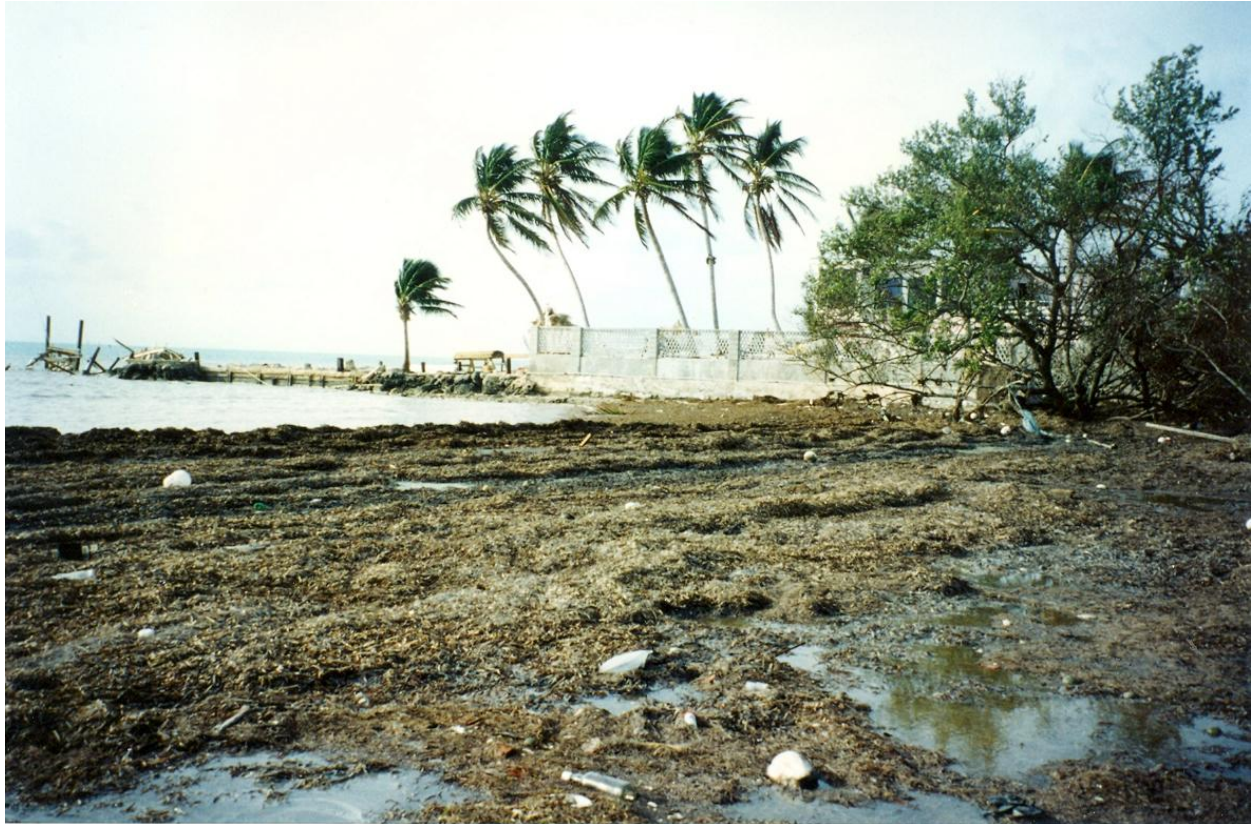
On the 3-mile long island of Grassy Key, a mangrove shoreline exists at the east end due to the sheltering effect of the islands to the southeast, but 6,800 feet of coarse grained sand beach exists along numerous private pocket beaches which average 15 feet in width. Along this moderately developed shoreline exist six groins and three shore normal breakwaters. Actual erosion appeared to be relatively minor from the hurricane; however, storm tides and waves damaged and destroyed numerous piers and walls and flooded many buildings. The most objectionable effect on the Grassy Key shoreline was the addition of more dead seagrass, which in addition to that which already existed, has created a very large seagrass wrack accumulation.

Damage at Grassy Key.

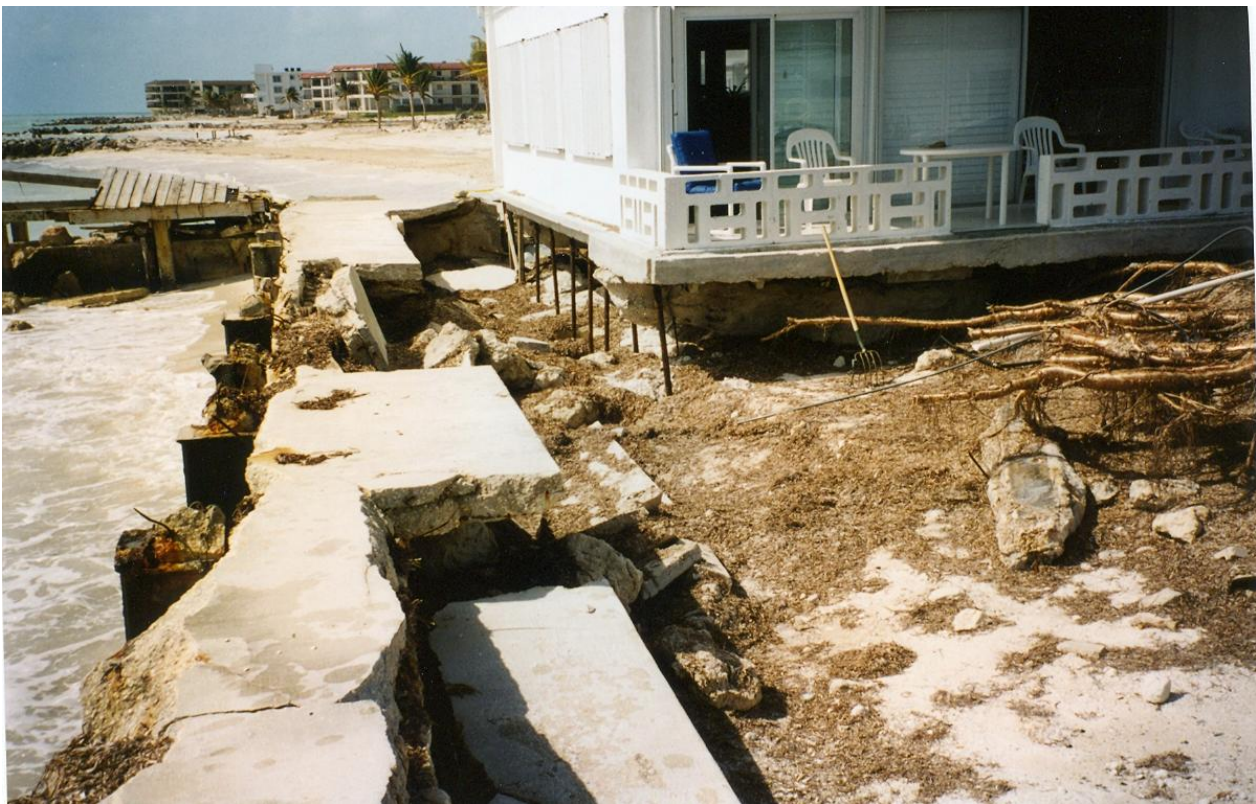
West of Coco Plum Beach is Key Colony Beach, which is substantially developed and is incorporated as the City of Key Colony Beach. This 4,550-foot long private beach averages 50 feet wide and is stabilized by 15 limerock groins, which were constructed in 1958. The longshore transport direction is to the southwest. The hurricane inflicted substantial flooding and structural damage along these beaches along with minor to moderate beach erosion. A number of piers were destroyed or severely damaged. Buildings and walls also sustained major damage. For example: the seawall and pool at the Key Colony Beach Motel was destroyed, buildings were damaged at the Ocean Beach Club, the Beach House Restaurant was destroyed or sustained major damage, the seaward two units of the Ocean Front Condominium were undermined, damaged, and condemned, and a 30-foot wall section was destroyed at the Sunset Beach Club. Overall, erosion conditions have now become critical for this community.

Damage at Key Colony Beach.

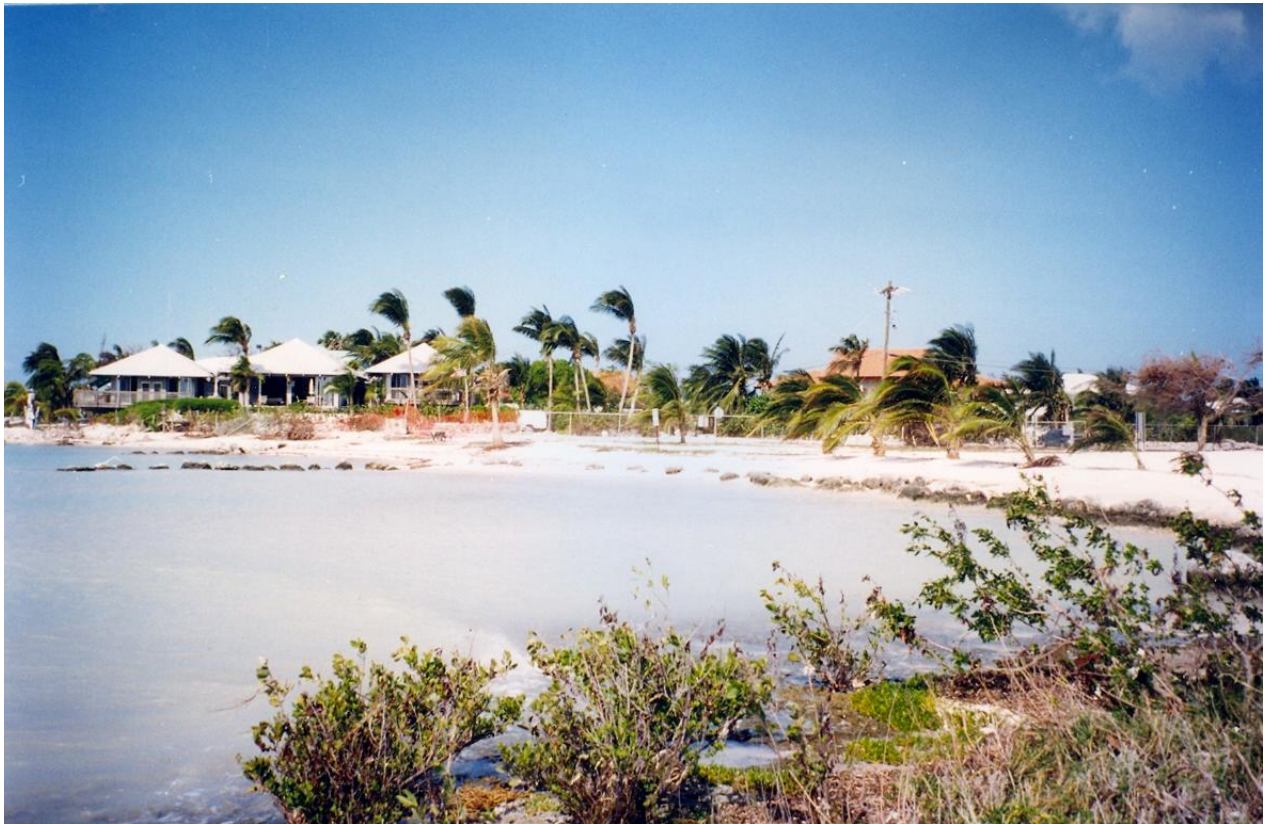
The small Tingle Island at the southern tip of Vaca Key is armored with bulkheads and riprap. To the west, and sheltered from east and southeast wave activity, is the Monroe County Park at Sombrero Beach. This fine-grained sandy beach is 1,600 feet long. The eastward transport of beach sediment off Sombrero Beach and into the adjoining canal to the east has resulted in critical erosion. The entire park and facilities sustained major damage from the storm tide flooding and landward sediment transport during Georges. Sand was transported inland across the park burying nearly all existing ground vegetation. Longshore stabilization remains critically needed now, as it did when recommended in 1990.

Damage at Sombrero Beach.

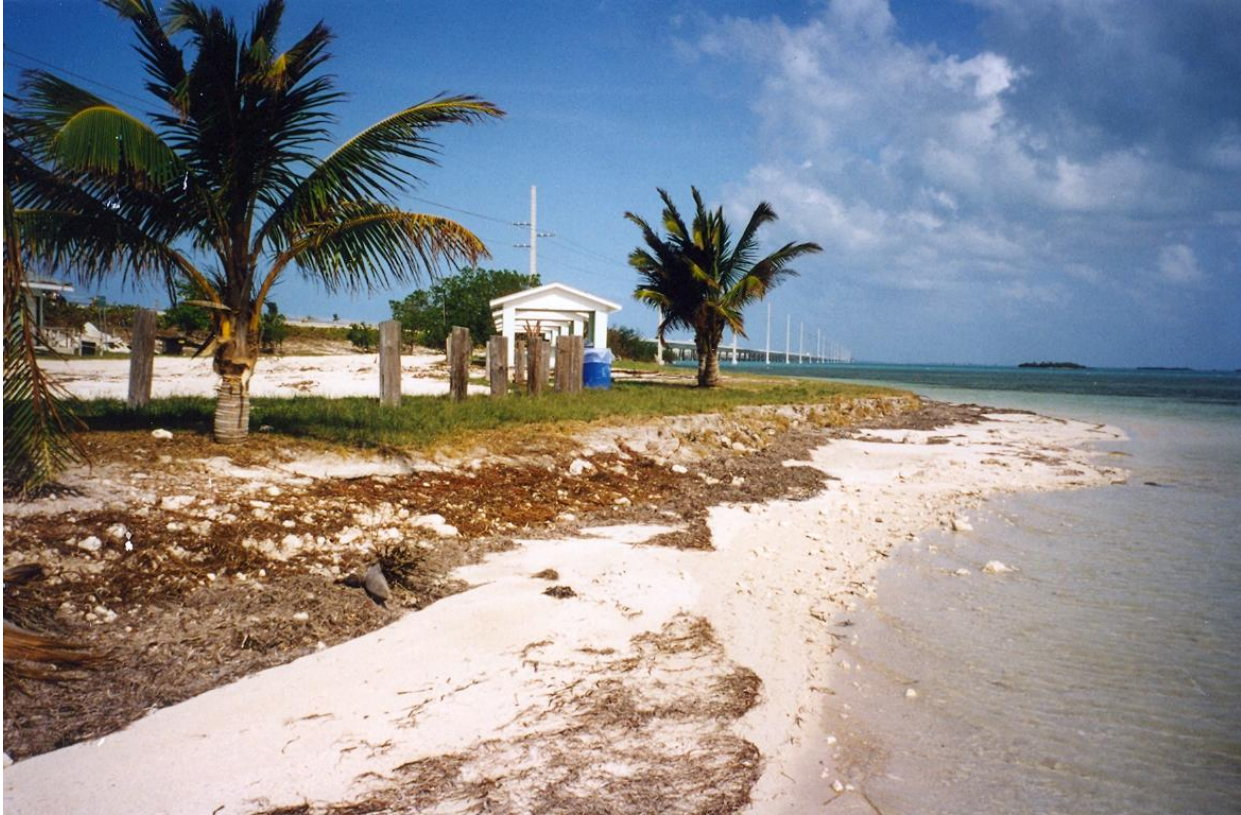
West of the Seven Mile Bridge, Little Duck Key has a 25-foot wide, 825-foot long public beach maintained by Monroe County. Missouri Key has a couple of narrow pocket beaches of 500 feet at its west end. The larger Ohio Key has 1,600 feet of narrow beach along the eastern half of its shoreline and mangrove along the western half. These islands sustained only minor beach and dune erosion but extensive flooding damage. Many mobile homes were damaged on Ohio Key from the flooding and the hurricane winds.

Conditions at Little Duck Key.

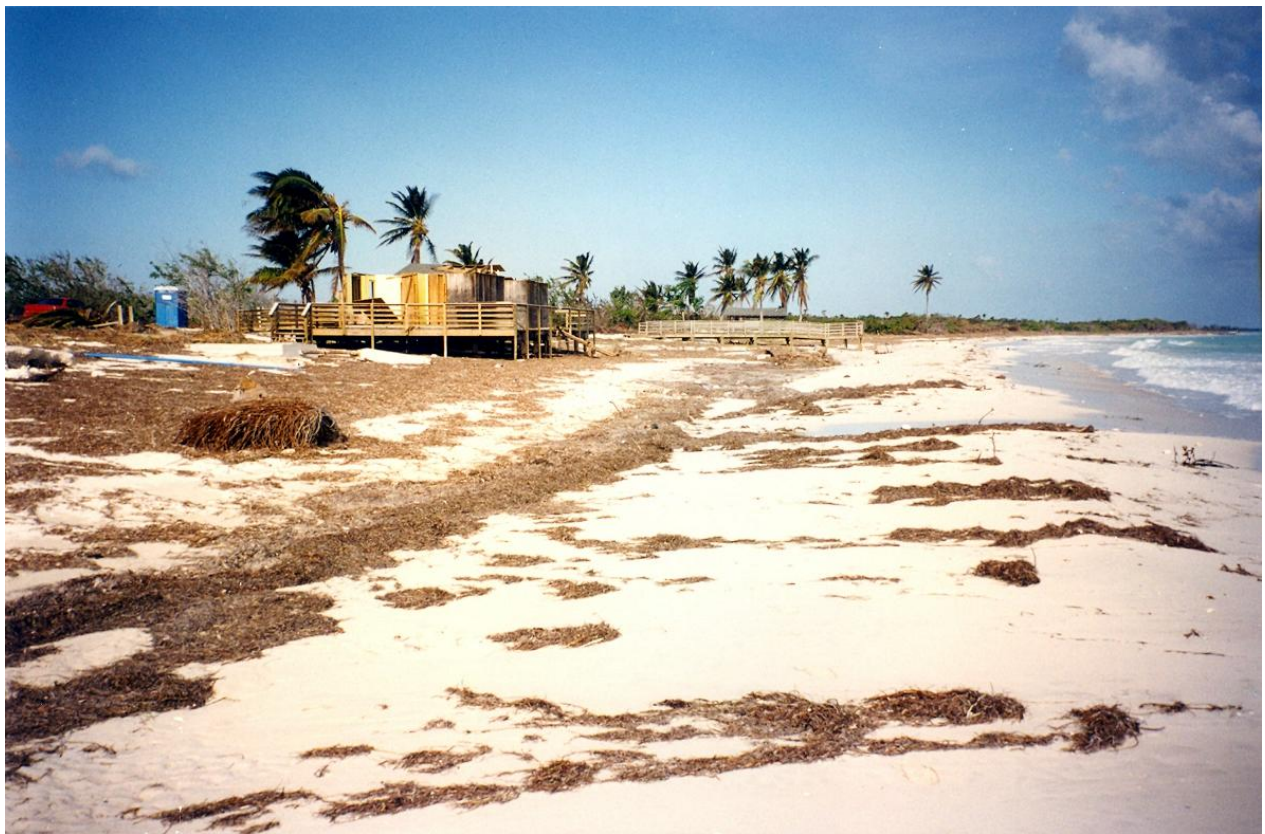
The eastern 7,400 feet of beach of Bahia Honda Key is known as Sandspur Beach, which, with prominent vegetated barrier dunes and a beach width averaging 60 feet, had previously appeared stable for most of its length. Only a 650-foot eastern segment was designated as noncritical erosion. Historically the park staff has planted sea oats and constructed beach access structures on this well managed beach, previously designated as the number one best beach in America in a nationwide study conducted by the University of Maryland. Hurricane Georges has had a devastating impact throughout Sandspur Beach. Camping sites have been destroyed, the parking area, restrooms and bathhouse have been destroyed, and all beach access walkways have been destroyed. Condition IV erosion (major beach and dune erosion) was sustained and 1.4 miles of shoreline should now be added to the existing designated critical erosion area.

Conditions and damage at Sandspur Beach.

- (6) Bahia Honda State Recreation Area, Sandspur Beach – dune restoration with planted vegetation.
- (7) Key West, Smathers Beach - a major beach restoration project has already been approved, permitted and funded.

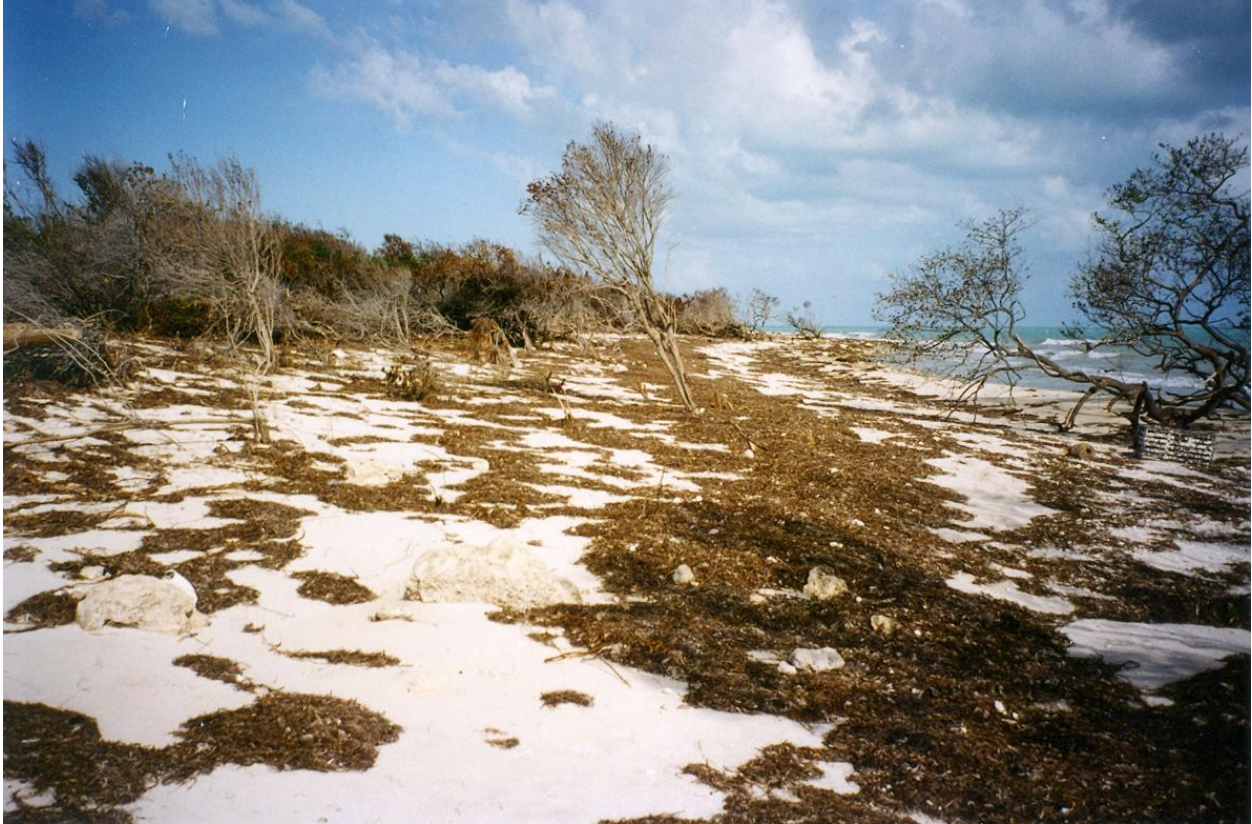
The 600-foot long public recreation beach (Caloosa Beach) between the Flagler Bridge and the U.S. Highway 1 Bridge is a designated critical erosion area. Caloosa Beach sustained moderate beach and dune erosion from the hurricane despite the stabilization of a 100-foot terminal groin that was constructed in 1989. Renourishment is critically needed on this beach.

The western 3,500 feet of beach fronting directly on the Straits is also a designated critical erosion area. Between 1971 and 1986 the west beach eroded about -5 feet per year. Past erosion control efforts have included the placement of 24-inch by 36-inch concrete bridge piles near the west end of the island, riprap placed along 400 to 500 feet of erosion threatened roadway in the early 1970's, the 1988/89 construction of a 1,200-foot long limerock revetment, and substantial sea oats plantings during the 1980's and 1990's. The hurricane caused major beach and dune erosion and severe damage along this entire stretch of critical erosion. The roadway and bridge were also damaged. A major coastal engineering and planning investigation is now needed for

Conditions and damage at Bahia Honda State Park.

this segment to evaluate sediment transport conditions, erosion rates, and storm damage protection measures.

- (4) Bahia Honda State Recreation Area, Caloosa Beach – beach nourishment.
- (5) Bahia Honda State Recreation Area, Loggerhead Beach – beach nourishment, plant vegetation, and possible armoring to protect the road.

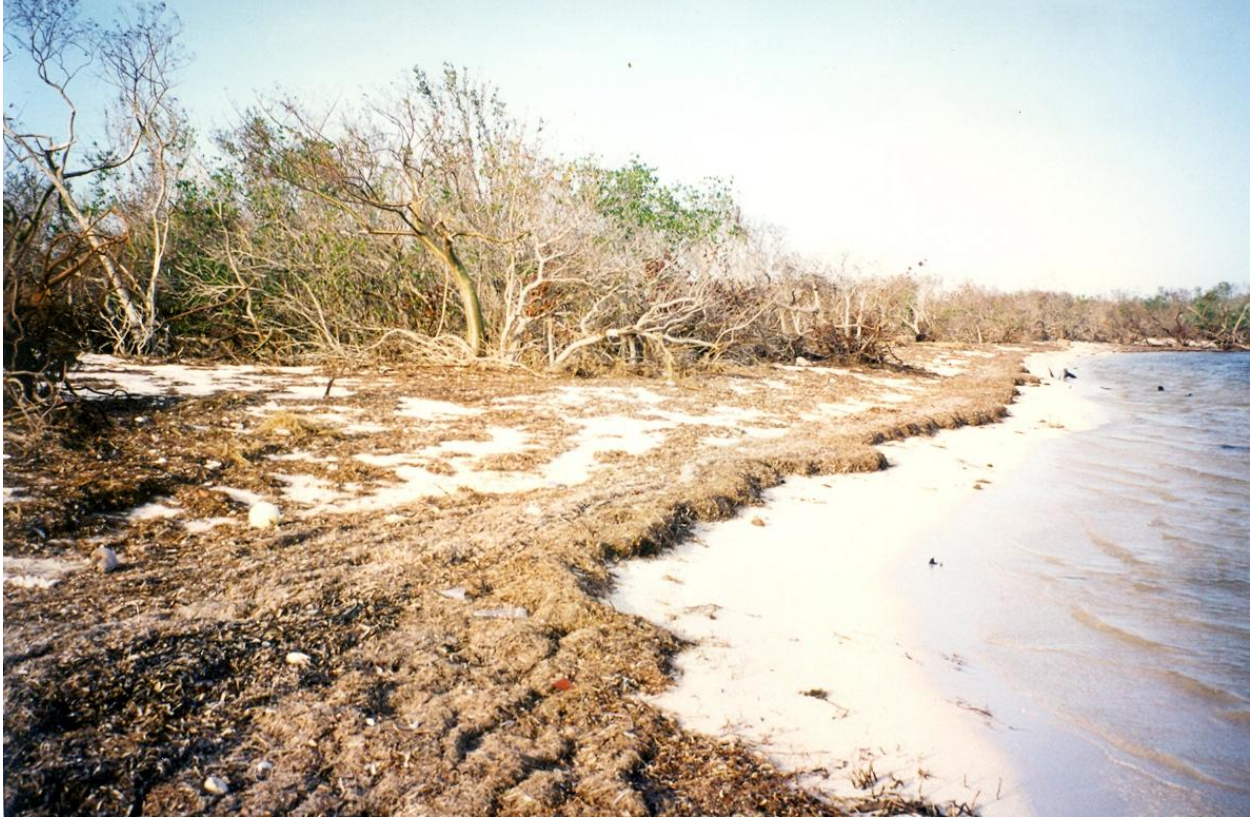
The easternmost lower Keys Island with the exposed Miami oolite limestone is Big Pine Key. Much of the Strait's shoreline of Big Pine Key is a coarse-grained sand, perched beach. Although mollusks and coral fragments provide an available source for natural renourishment and although a prominent barrier dune backed much of the shoreline, erosion had substantially reduced the width and quality of the beach and a 1.0 mile length known as Long Beach has been designated a noncritical erosion area. Continued development pressures have substantially impacted the barrier dune. Hurricane Georges inflicted minor to moderate erosion along Long Beach and caused substantial damage to single-family dwellings, especially to first floors and understructures.

Conditions at Big Pine Key.

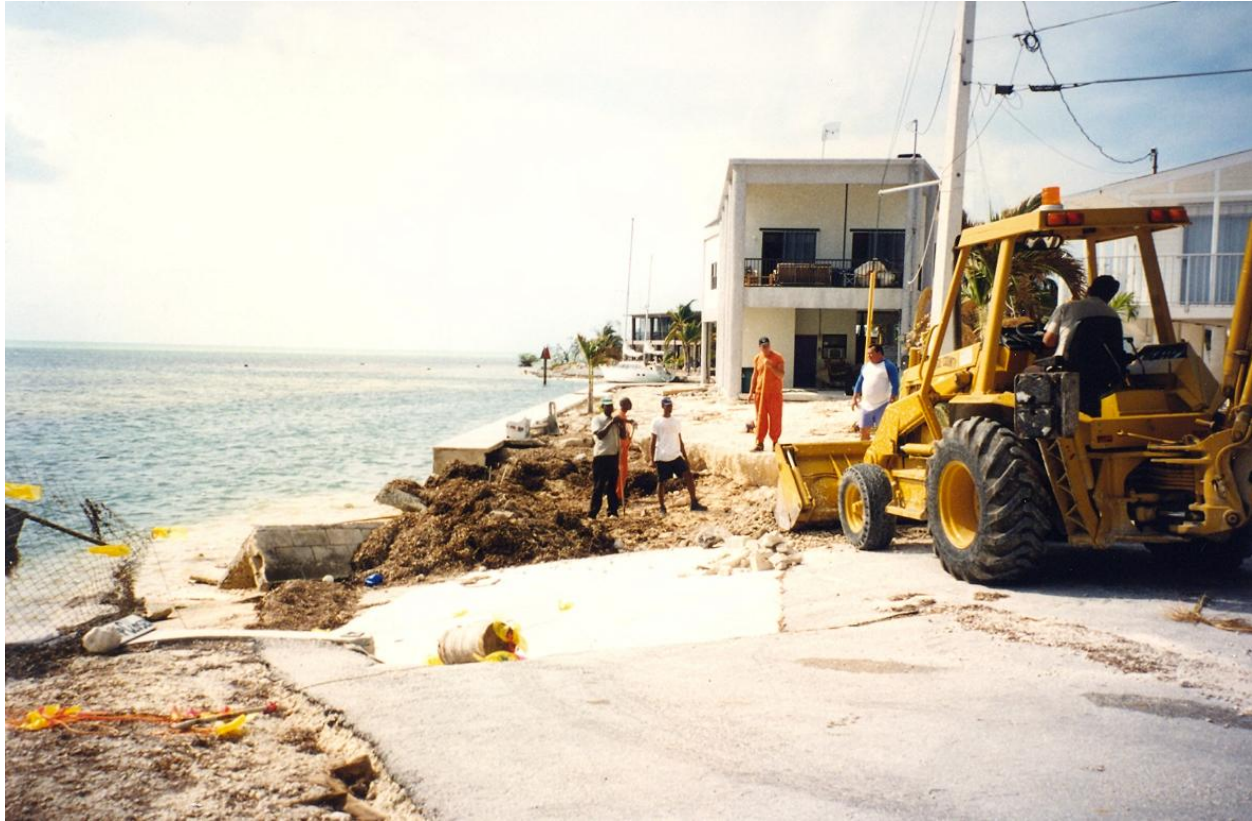
Along US Highway 1 at Shark Key over 300 feet of seawall was destroyed. Numerous other walls were damaged or destroyed on Big Coppitt Key and Geiger Key. On Geiger Key a 60-foot section of street-end seawall was destroyed and an adjacent single-family dwelling damaged. Other single-family homes were damaged by the flooding and many mobile homes were damaged or destroyed.

Damage at Geiger Key.

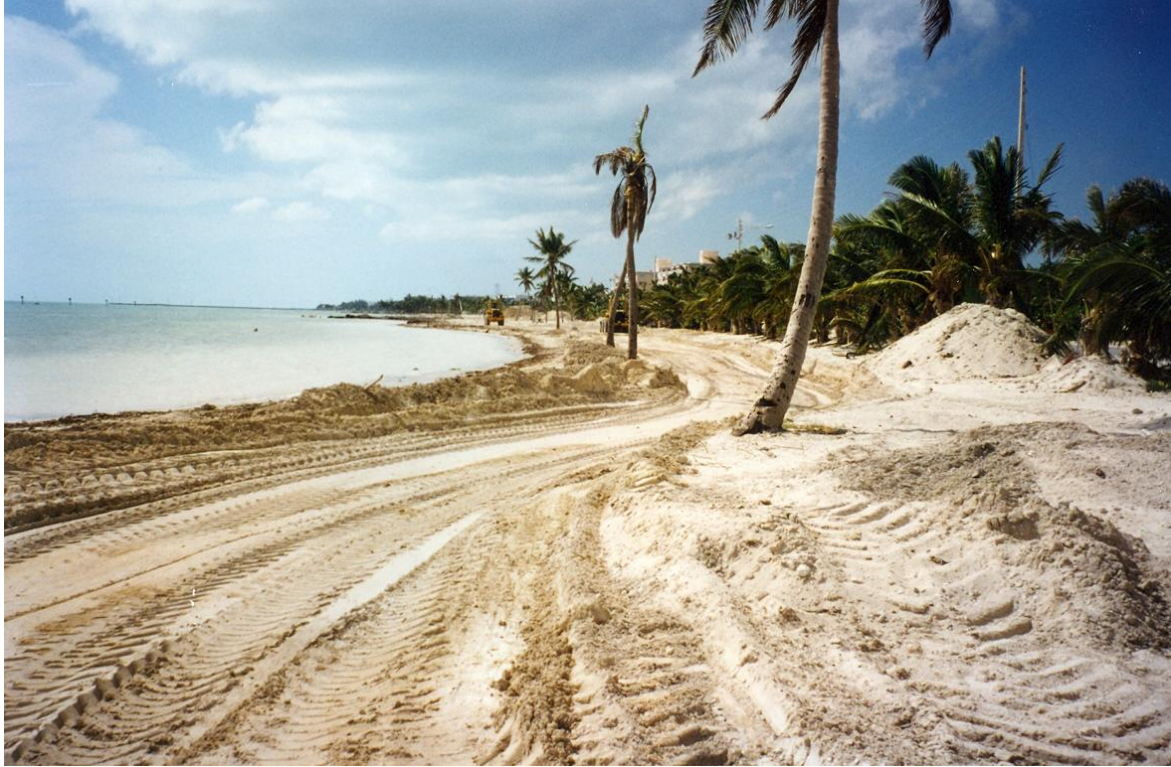
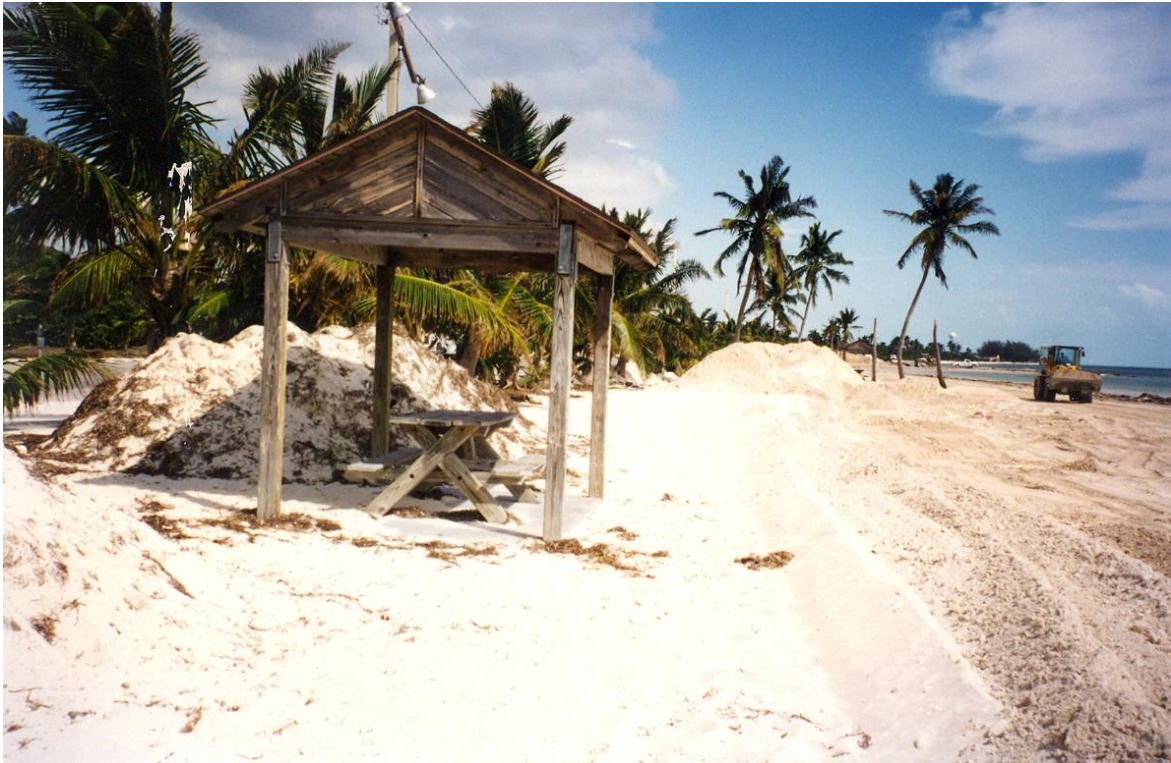
To the west is the 3,300-foot segment of shoreline named George Smathers Beach which was originally constructed in 1960 and consisted of the construction of four limestone rock groins (200 to 300 feet long) and of beach restoration with 30,000 cubic yards of sand. Smathers Beach was subject to erosion from several storms and was renourished once in 1989. Hurricane Georges inflicted moderate beach and dune erosion throughout Smathers Beach as the storm tides transported sand across Roosevelt Boulevard as well as offshore. The City of Key West has removed sand from the street and spread it back on the beach. A pending beach restoration project will compensate for any beach losses from Georges and past storms.

Photos both above and below showing damage and repair work being done at Smathers Beach.

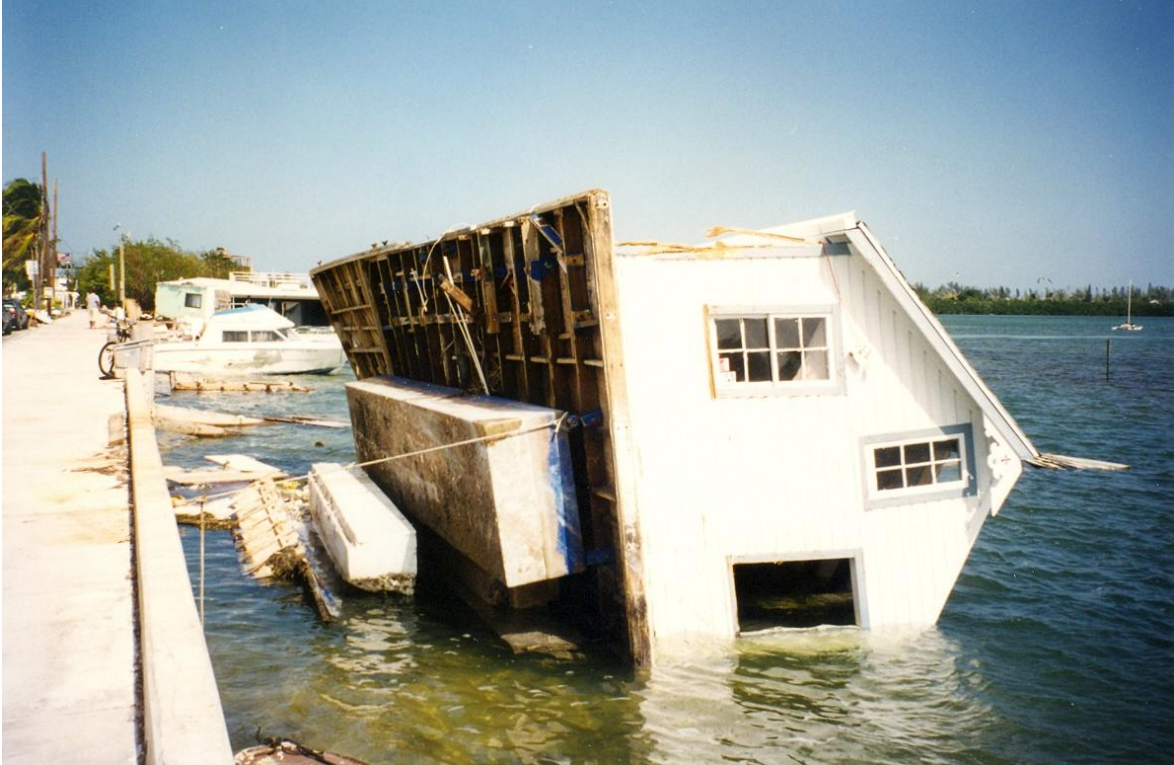
The South Roosevelt Boulevard seawall was constructed in 1926 and was repaired in 1951 after the hurricane of October, 1944 destroyed 4,000 feet of the wall and road. Hurricane Georges destroyed one-tenth of that previously destroyed or about 400 feet in five separate sections of damage.

Damage along South Roosevelt Boulevard, Key West.

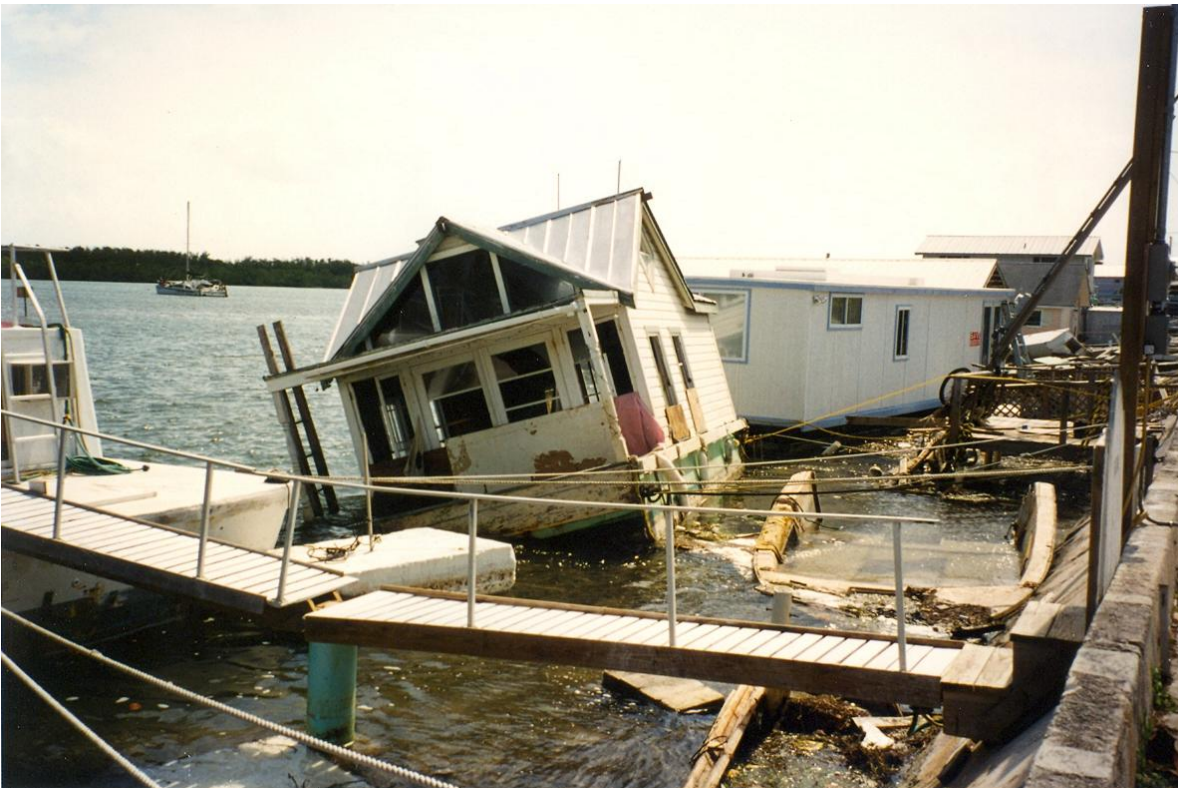
Damage along South Roosevelt Boulevard, Key West.

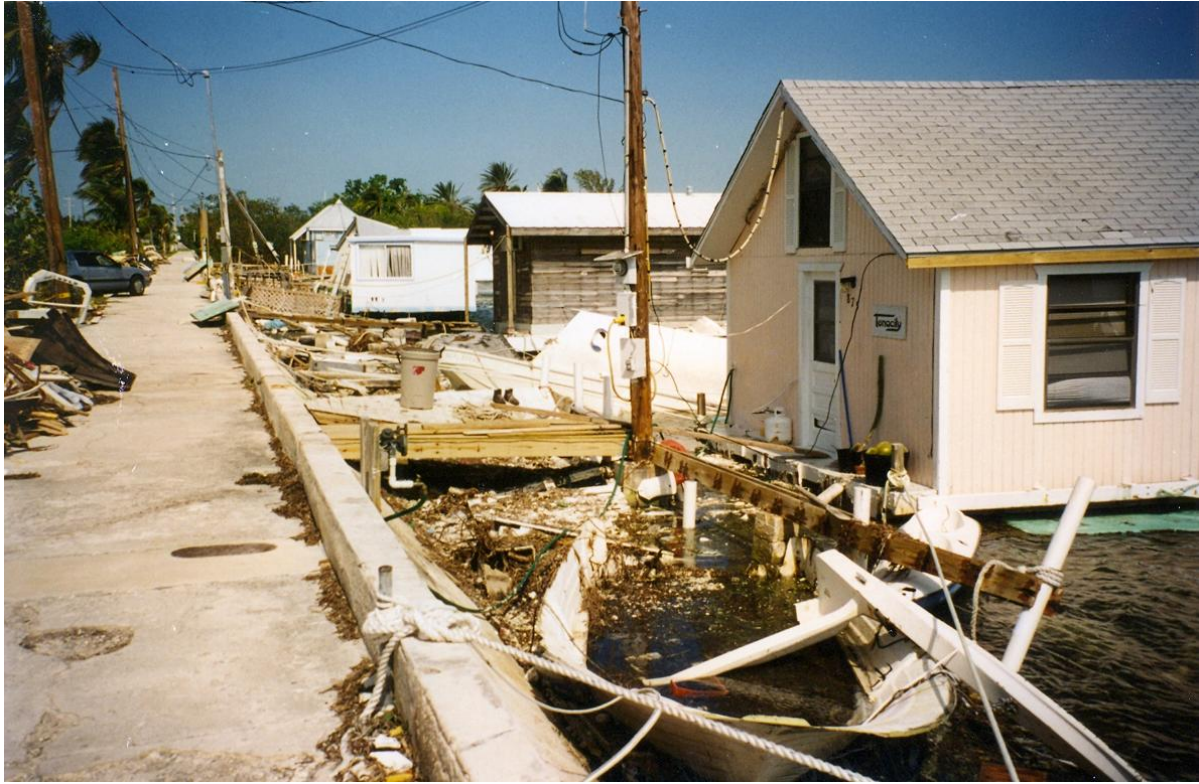
Damage along South Roosevelt Boulevard, Key West.

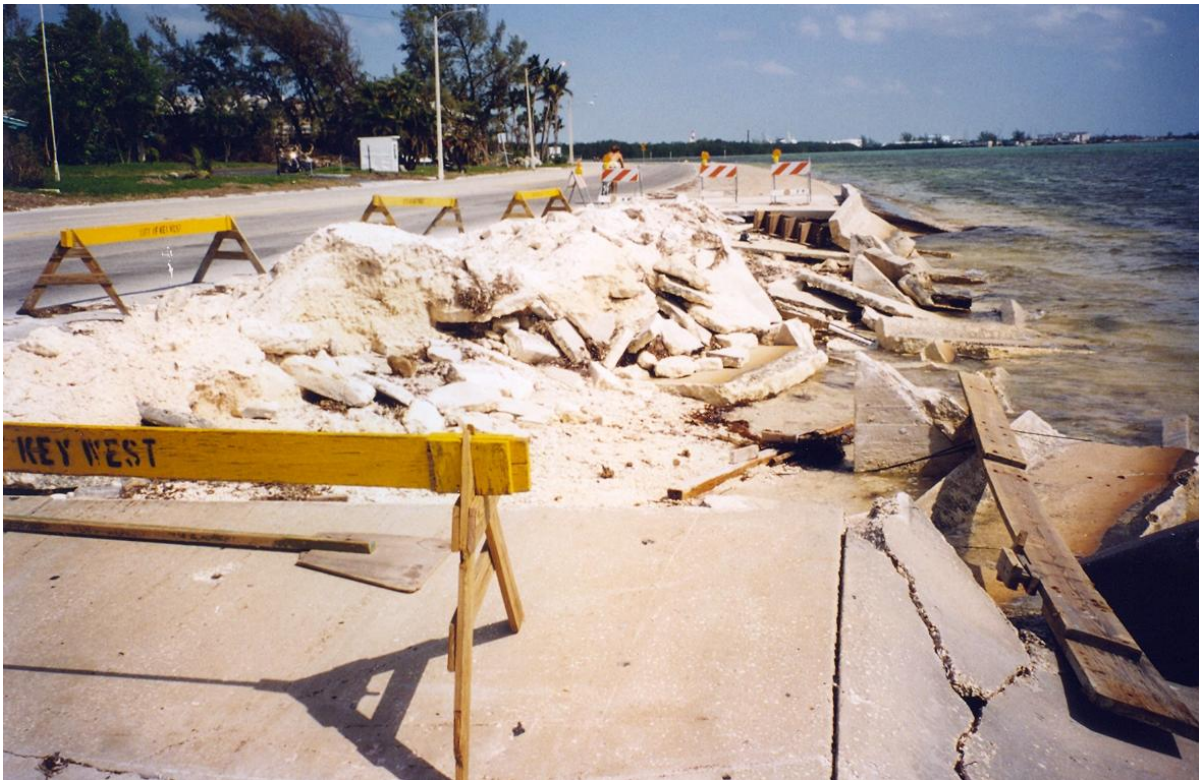
Key West east of Smathers Beach along South Roosevelt Boulevard.

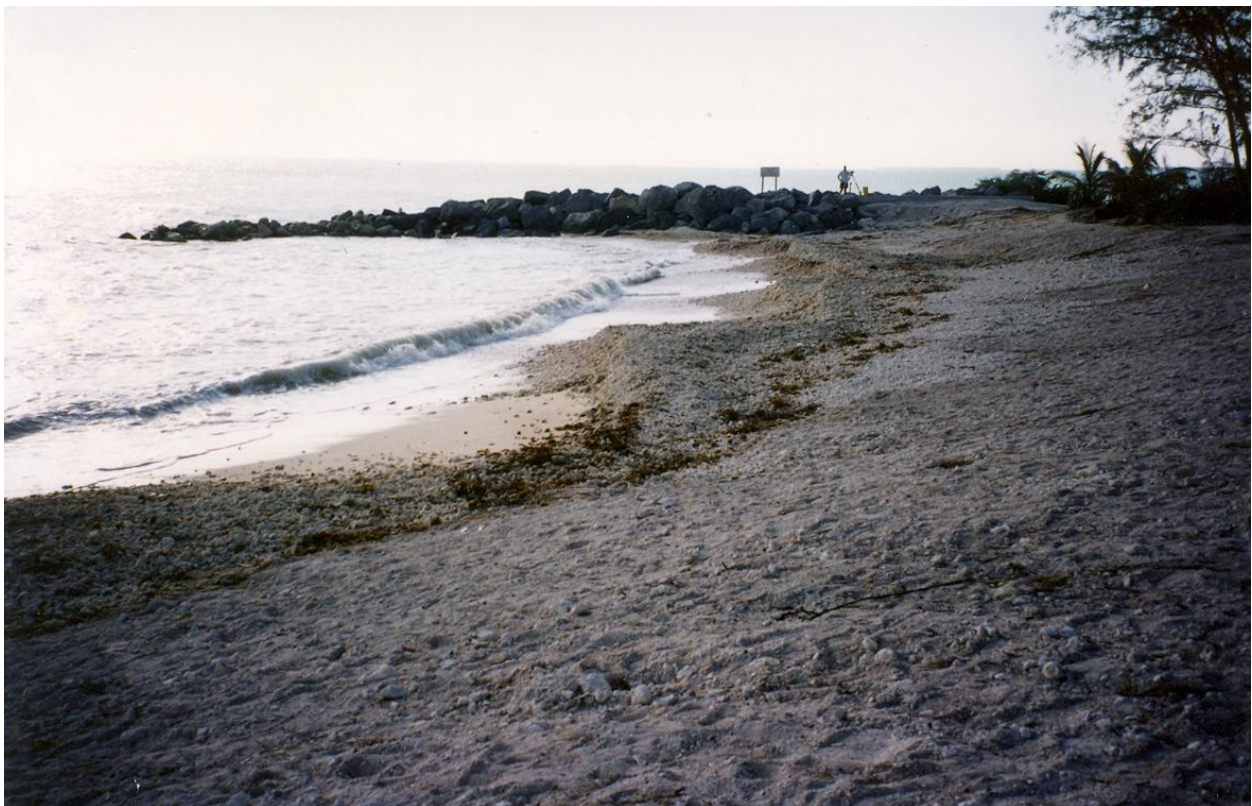
On the southwest tip of Key West is an area which was built by dredge spoil from the ship channel dredging project. The fill site includes the nearly 150-year old fort and a 1,500-foot artificial recreational beach. Erosion has been ongoing at this beach since the initial filling. Between 1971 and 1985 the shoreline receded as much as 160 feet. The state constructed a 100-foot detached offshore breakwater and a 110-foot long terminal groin and placed additional sand fill in 1989. Another breakwater was constructed in the mid-1990's. Hurricane Georges inflicted major beach and dune erosion along this beach leaving an 8 to 9 foot vertical escarpment along the dune line between the west breakwater and the terminal groin. Many trees were toppled and park facilities damaged. Extending north from the terminal groin along the ship channel shoreline the rock revetment experienced major settlement and the perimeter access road was destroyed.

Conditions at Ft. Zachary Taylor State Historic Site.

- (10) Key West, Zachary Taylor State Historical Site – beach nourishment to cover small rocks and dune restoration is needed; repair to the west of the shore armoring may be needed.
