# THE IMPACT OF HURRICANE ELENA AND TROPICAL STORM JUAN ON COASTAL CONSTRUCTION IN FLORIDA

Beaches and Shores Post-Storm Report No. 85-3

March, 1986

Bureau of Coastal Engineering and Regulation  
Division of Beaches and Shores  
FLORIDA DEPARTMENT OF NATURAL RESOURCES

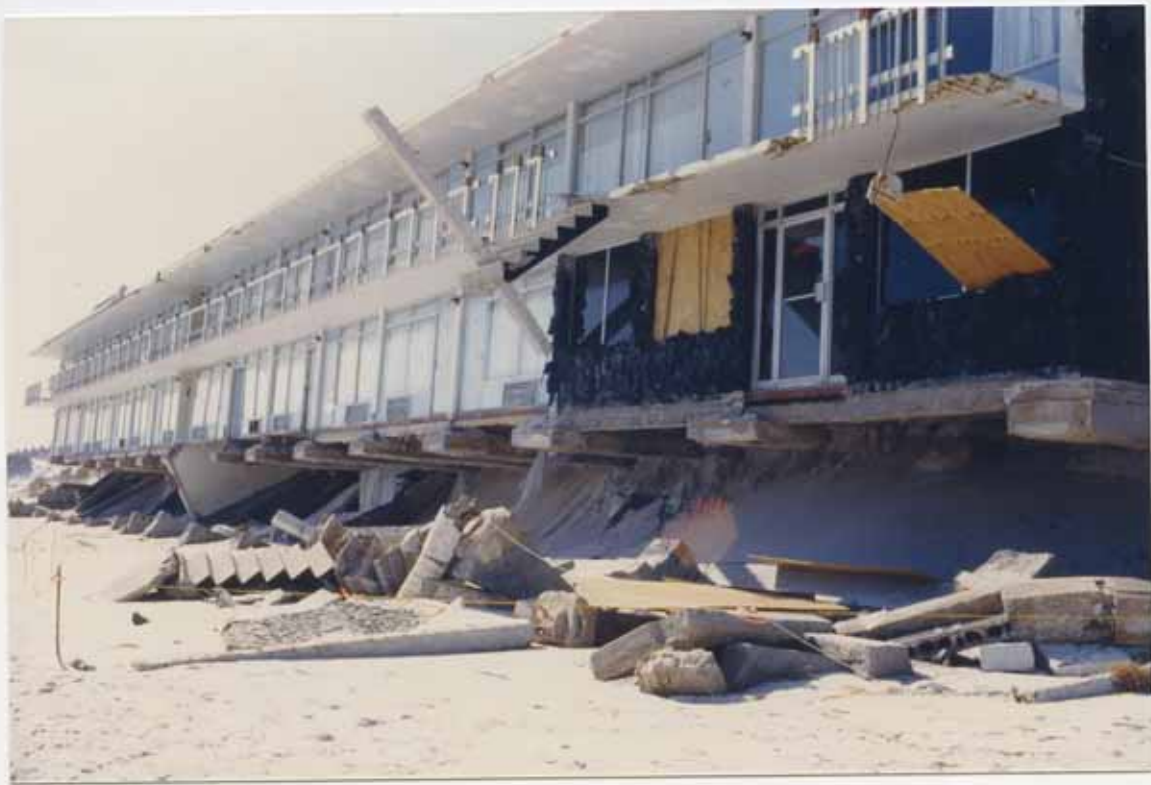
units as it experienced substantial undermining following the failure of its 200 foot long concrete retaining wall during Elena on August 30 (Figure 2). Approximately 8,000 cubic yards of sand fill were placed under the building on an emergency basis in 1979 after hurricane Frederic; however, the storm tide and wave uprush from Elena and Juan removed all the fill that was placed. On October 31, the building was substantially undermined by Juan and destroyed by wave action (Figure 3). The Gulf front 27 units were completely destroyed and the road front 29 units were damaged beyond repair.

FIGURE 2. Dunes Motel damaged by Elena's erosion, Pensacola Beach (D. Dodder)

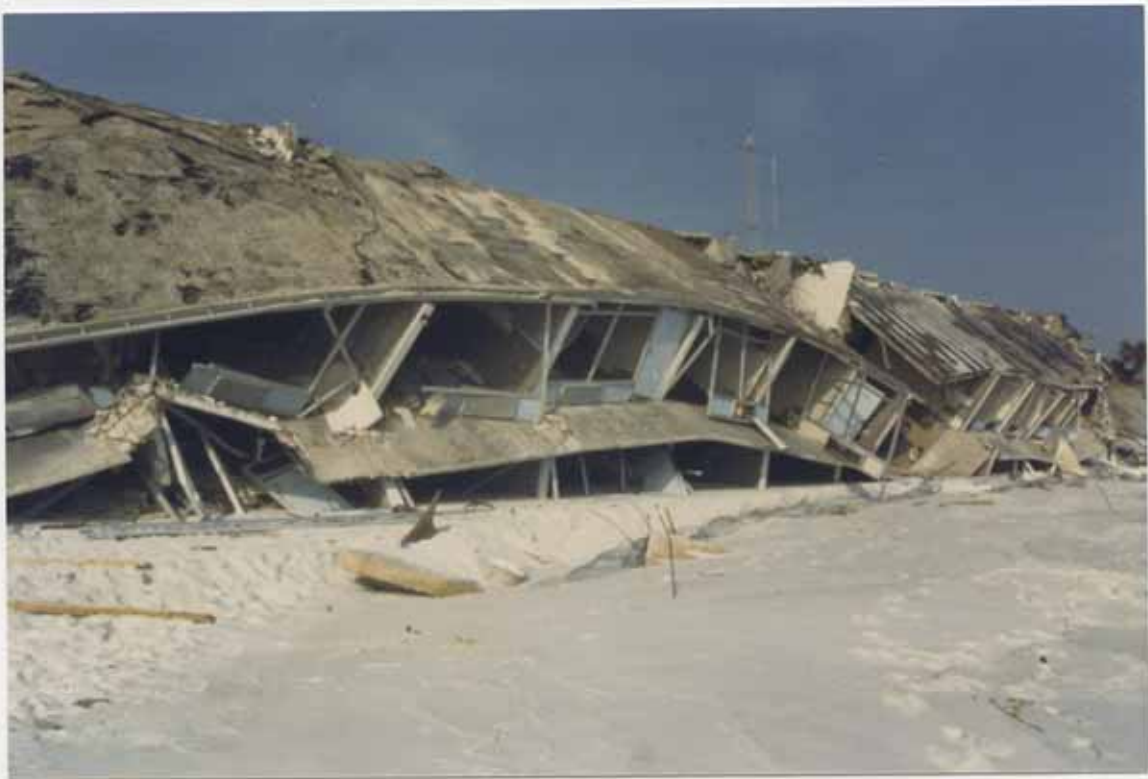
FIGURE 3. Dunes Motel destroyed by Juan, Pensacola Beach (G. L. Hill)

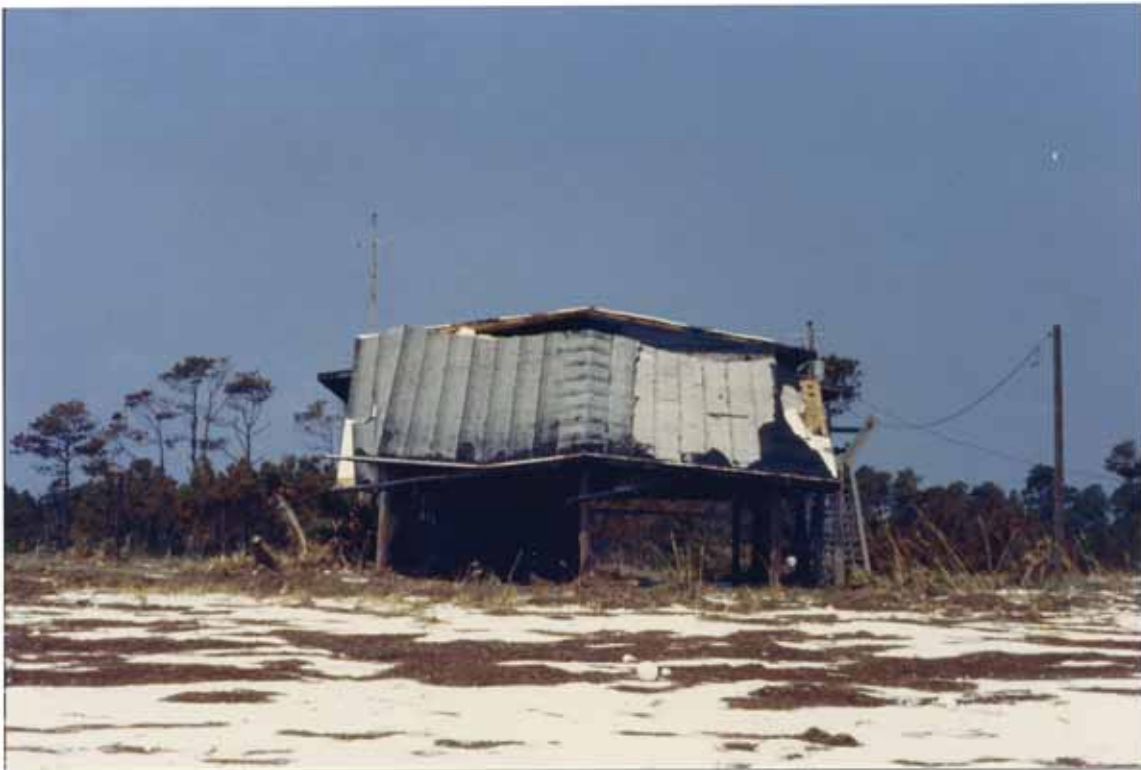
FIGURE 11. Dwelling damaged by Elena's wind, Dog Island  
(G. L. Hill)

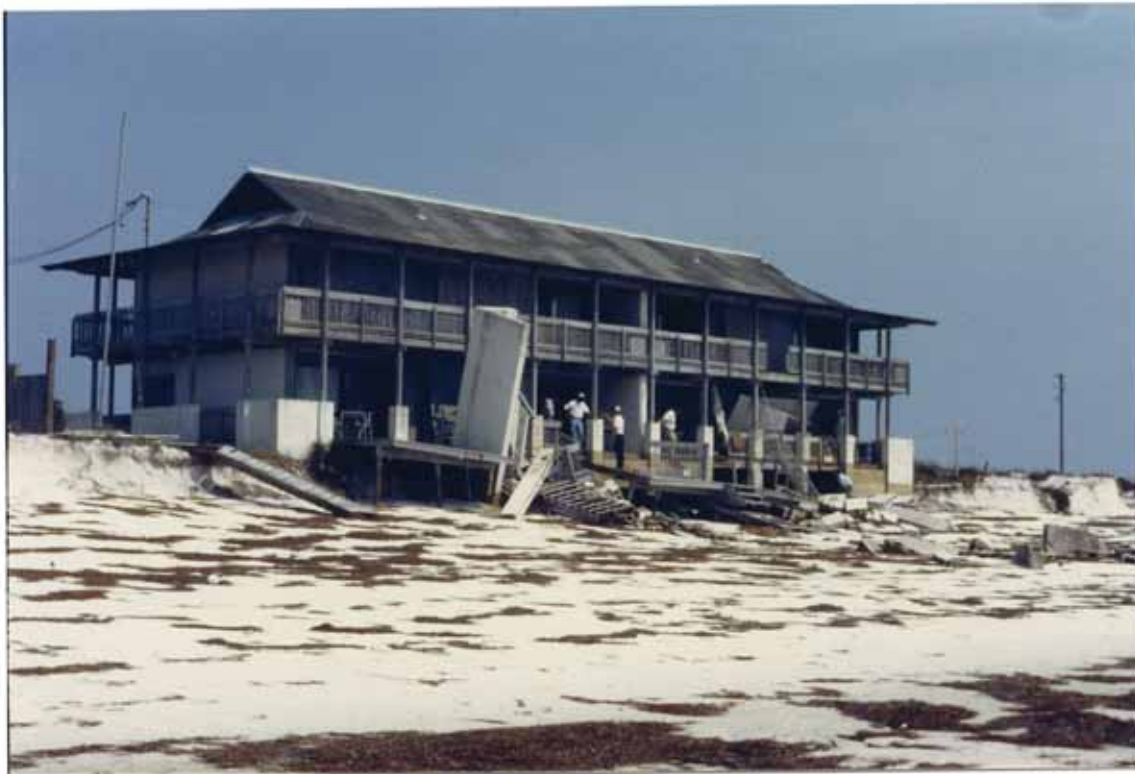
beach (Figure 12). It is not known whether the structure was damaged on August 30 when Elena initially passed offshore; however, following the erosion event of August 30 the building was certainly placed in imminent danger of collapse from further erosion which did occur on September 1 during the second and most devastating of offshore passes. Nearby, the multi-unit Pelican Inn sustained major deck and walkway damage and the concrete block stairwells on the front of the building were destroyed (Figure 13).

FIGURE 13. Pelican Inn damaged by Elena, Dog Island (G. L. Hill)

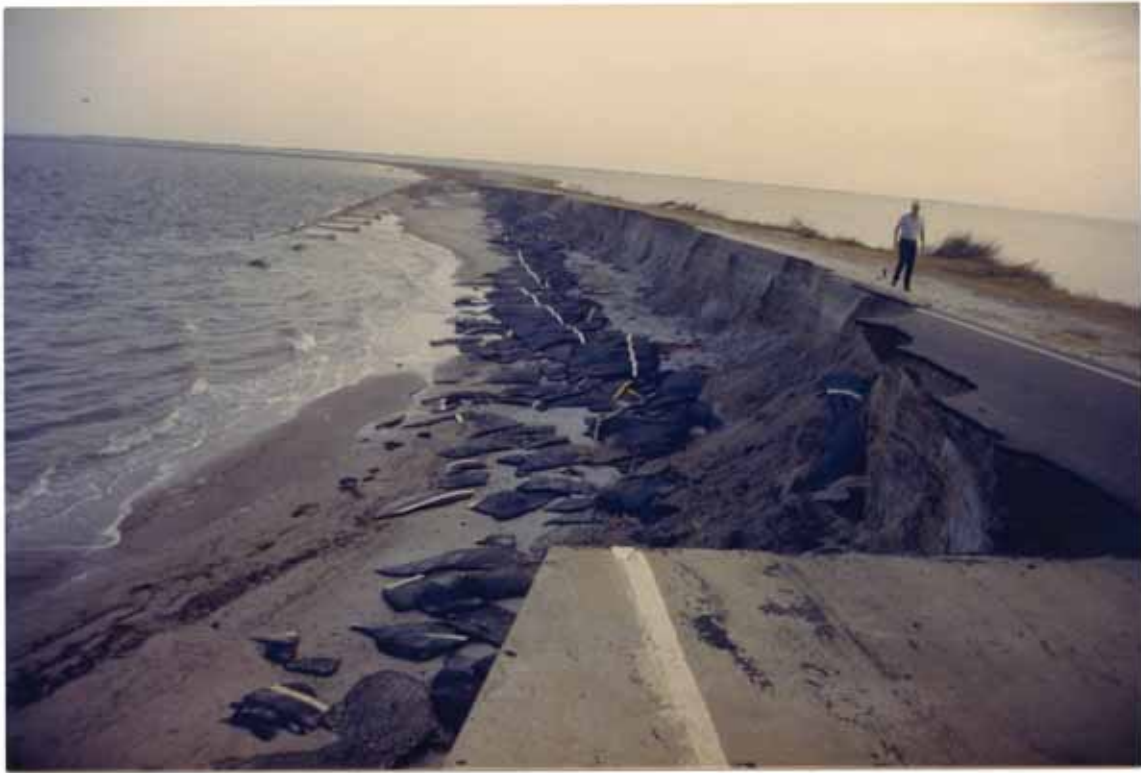
Because of the strong east to southeast winds associated with Elena's west-northwestward track on September 1, a significant setup of the storm tide occurred along the east shoreline of the causeway to St. George Island. Because of this storm tide and the incident storm wave activity which grew over a long fetch length of St. George Sound, major damage to 1,600 feet of the causeway was sustained (Figures 14 and 15). Approximately 830 feet of the concrete bulkhead was destroyed by wave activity and the Intracoastal Waterway bridge abutment sustained major damage due to hydraulic forces of the storm tide. Although the concrete bridges appear to have sustained no major damage, three bridge approaches were destroyed. The erosion loss to the causeway requiring replacement totaled approximately 58,000 cubic yards of fill (Florida Department of Transportation).

FIGURE 14. St. George Island causeway damaged by Elena's waves

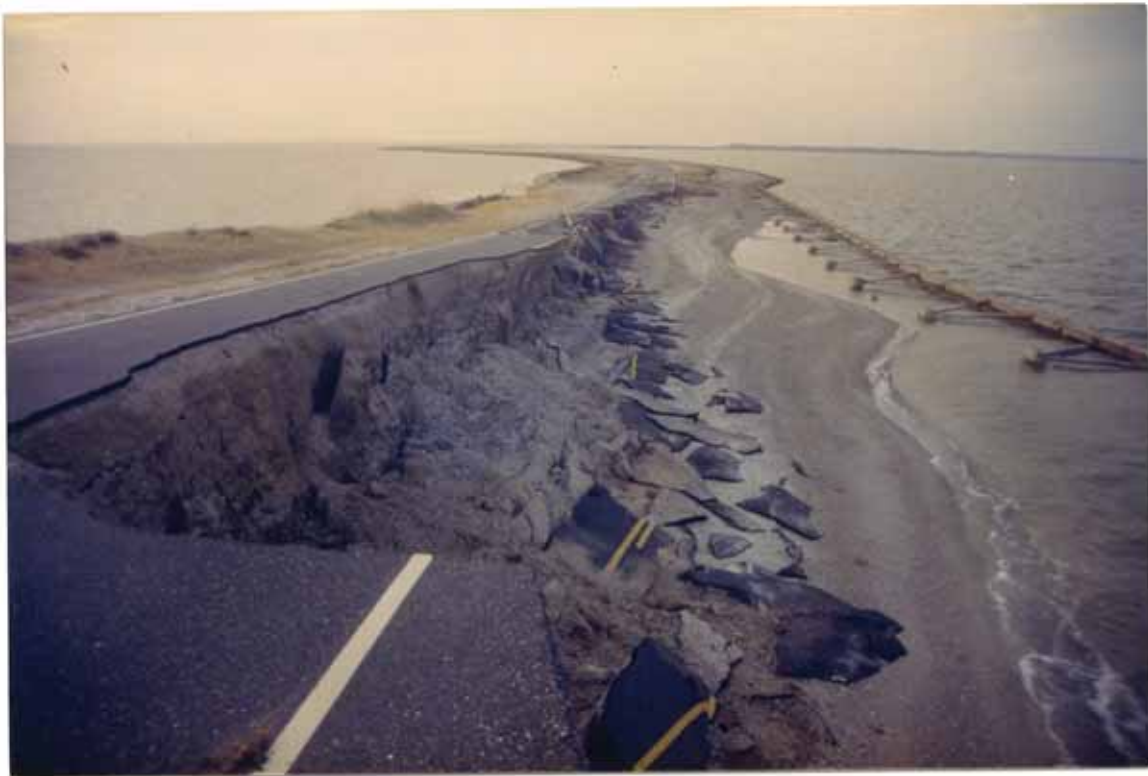
FIGURE 15. St. George Island causeway damaged by Elena's waves

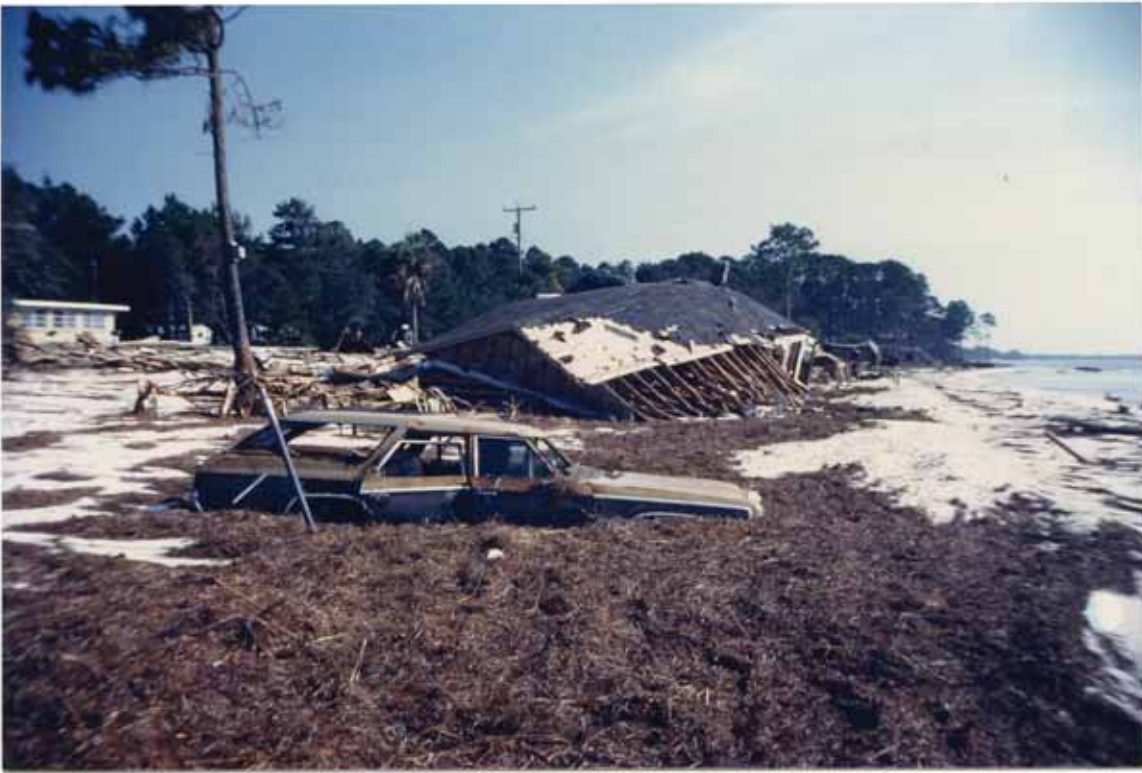
FIGURE 18. Carrabelle Beach after Elena

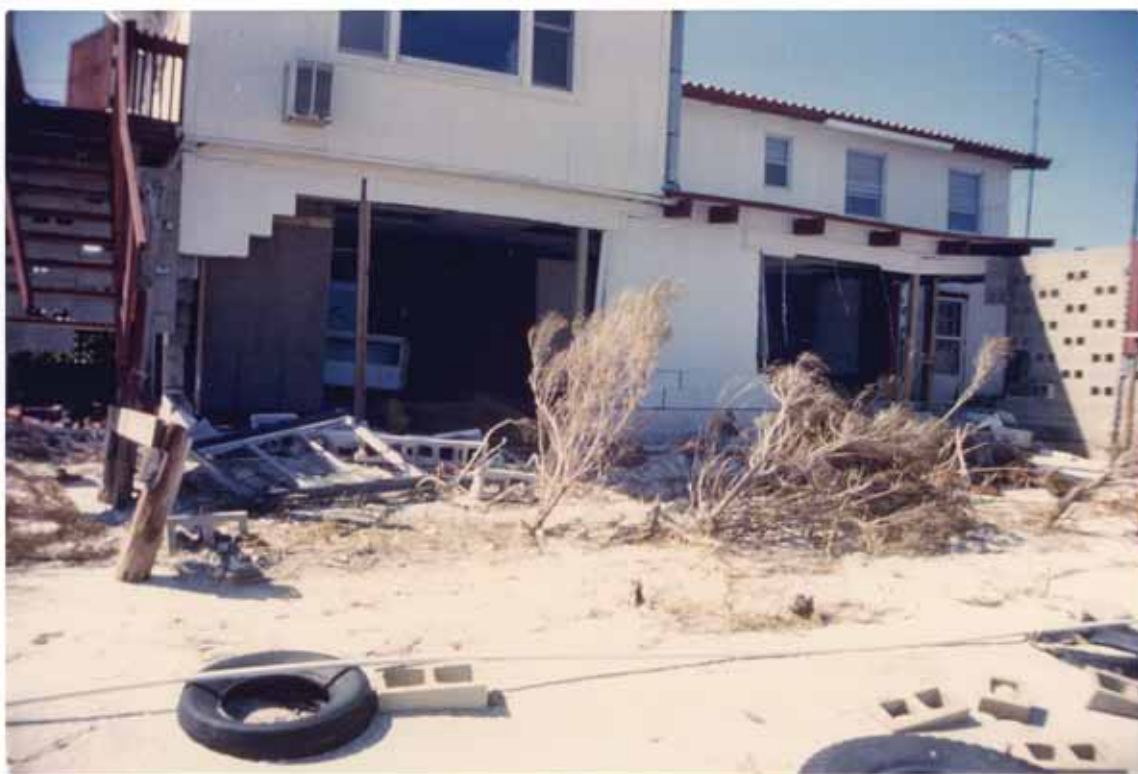
FIGURE 24. Alligator Harbor shoreline dwelling damaged by Elena

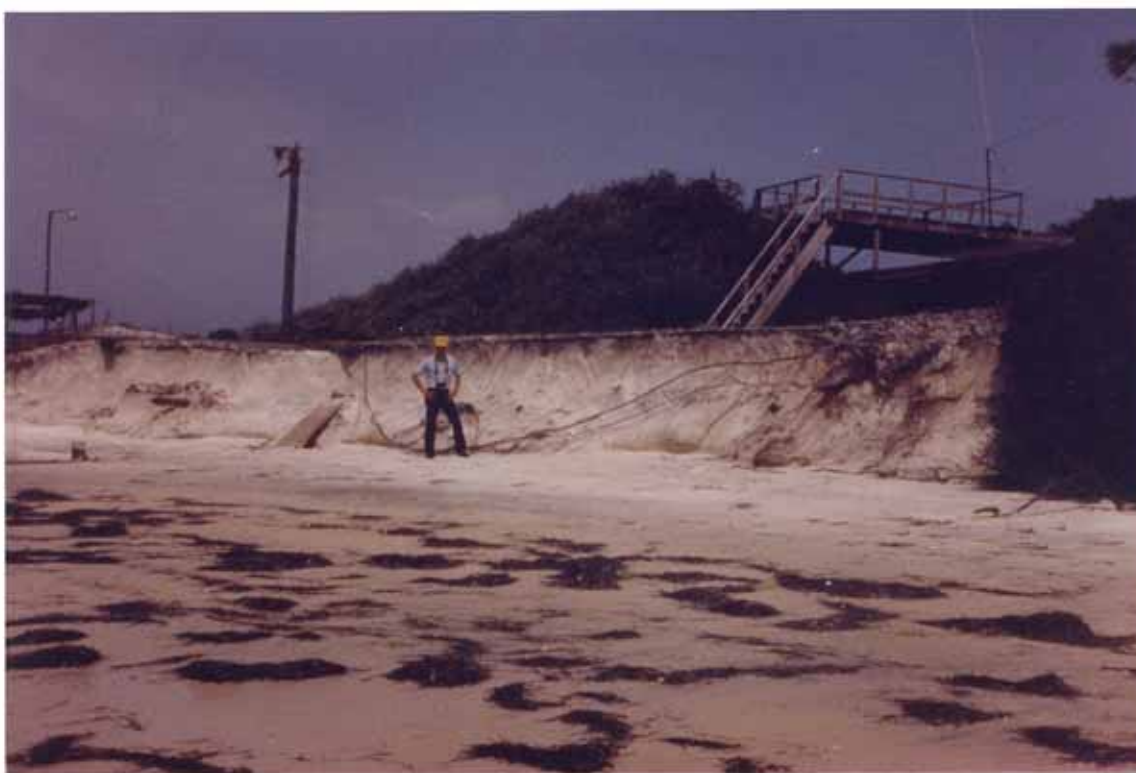
FIGURE 25. Dune erosion by Elena at the Southwest Cape

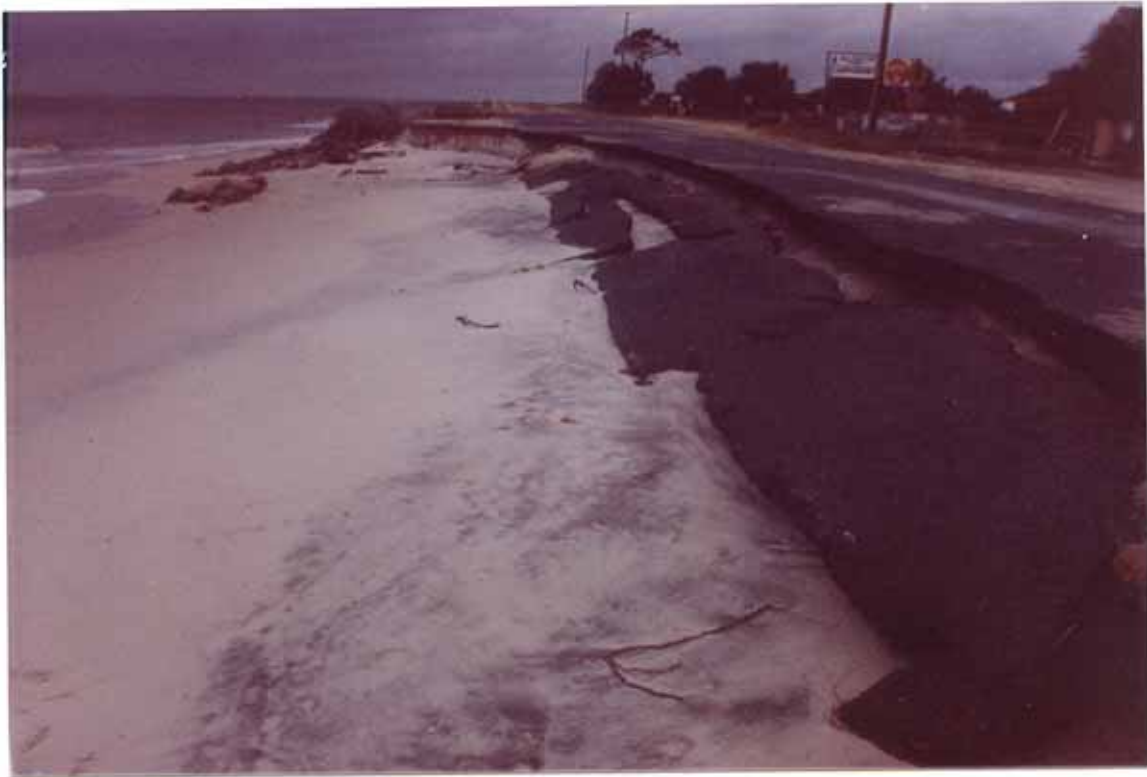
FIGURE 30. Elena's first pass damaged County Road C370 on August 30

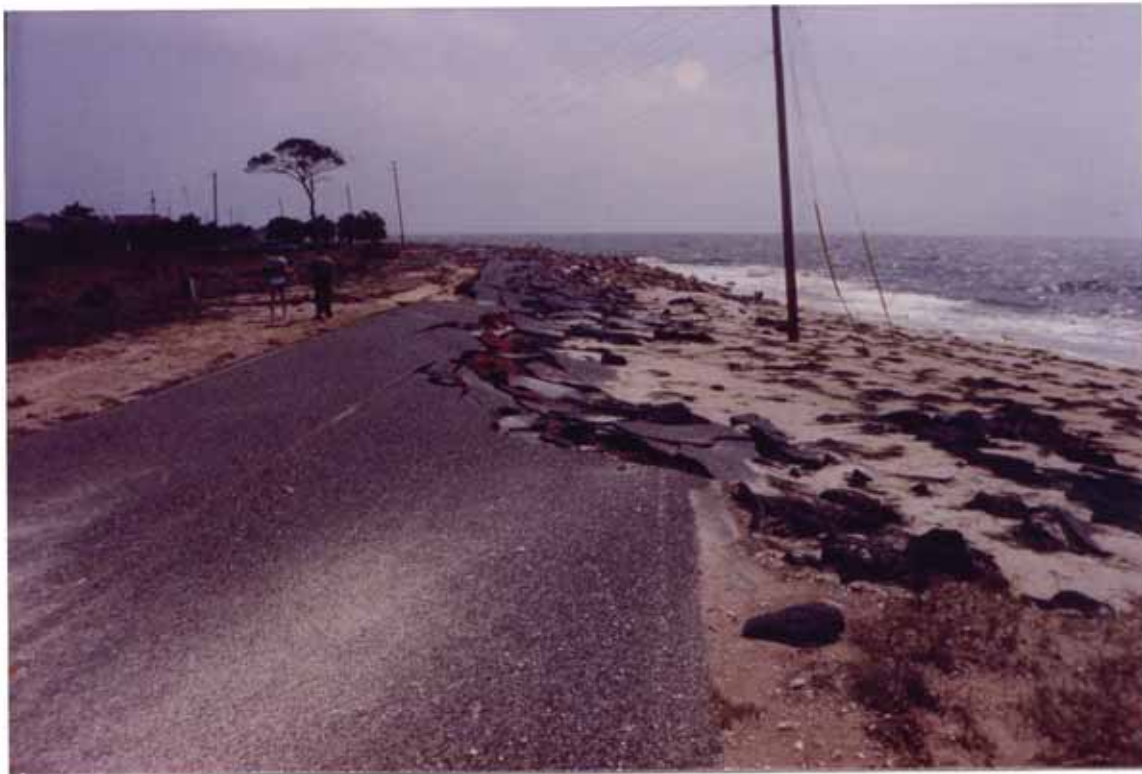
FIGURE 31. Elena's second pass destroyed County Road C370 on September 1

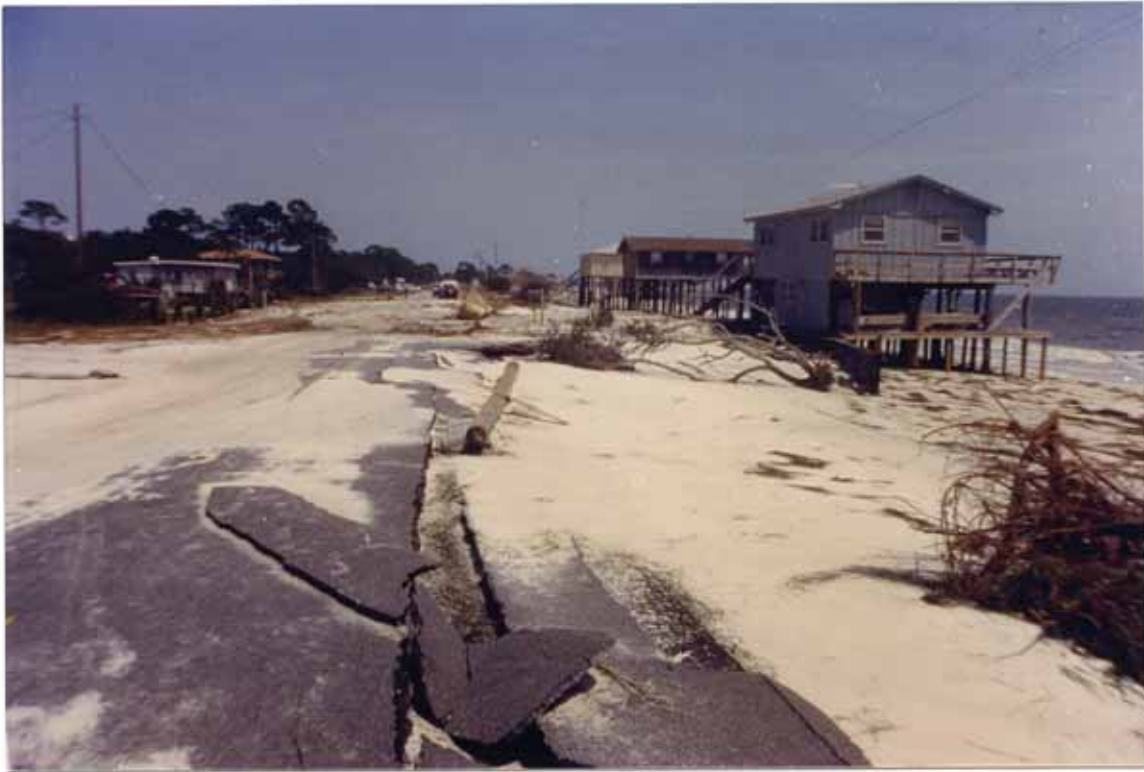
East of the KOA Campgrounds, four pile supported single-family dwellings sustained only light damages as their septic systems, stairways, and utilities were substantially damaged (Figures 32 and 33). One dwelling's fiberglass septic tank was transported approximately 250 feet westward before being deposited along the

FIGURE 32. Elena erosion and damage

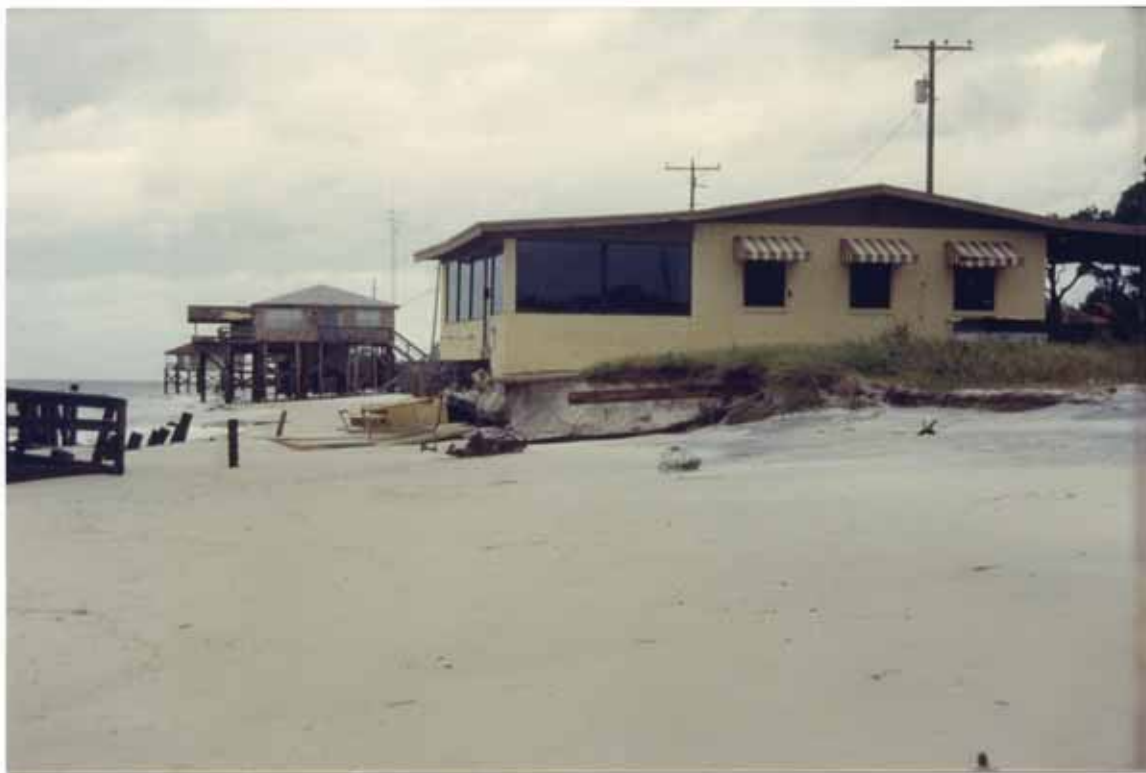
On August 30, at a location 350 feet east of the four pile supported dwellings, a 100 foot long wood bulkhead fronting a dwelling was destroyed and the entire yard seaward of the house was lost to erosion (Figure 34). An inspection of the dwelling on August 31 revealed initial major damage to the front of the structure as the slab had been undermined by several feet. On September 1, the house and its detached garage structure were completely destroyed (Figure 35).

FIGURE 34. Wood bulkhead destroyed and dwelling undermined on August 30 (H. N. Bean)

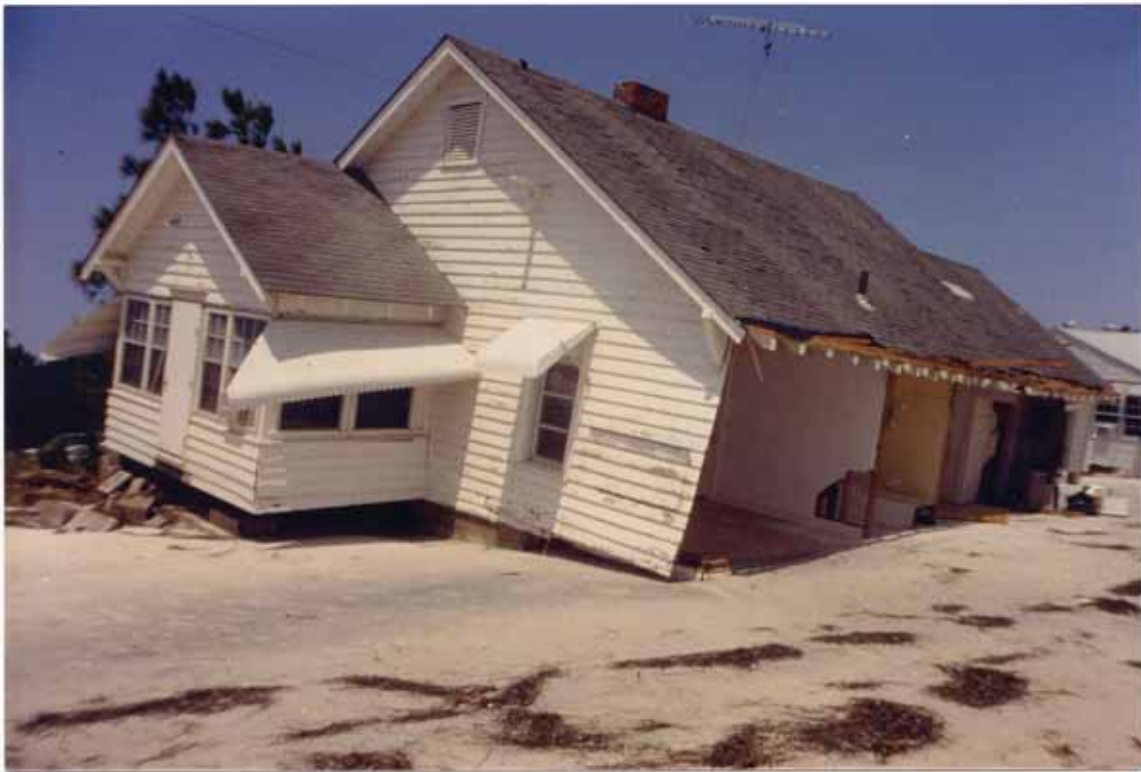
FIGURE 38. Frame dwelling substantially damaged on September 1

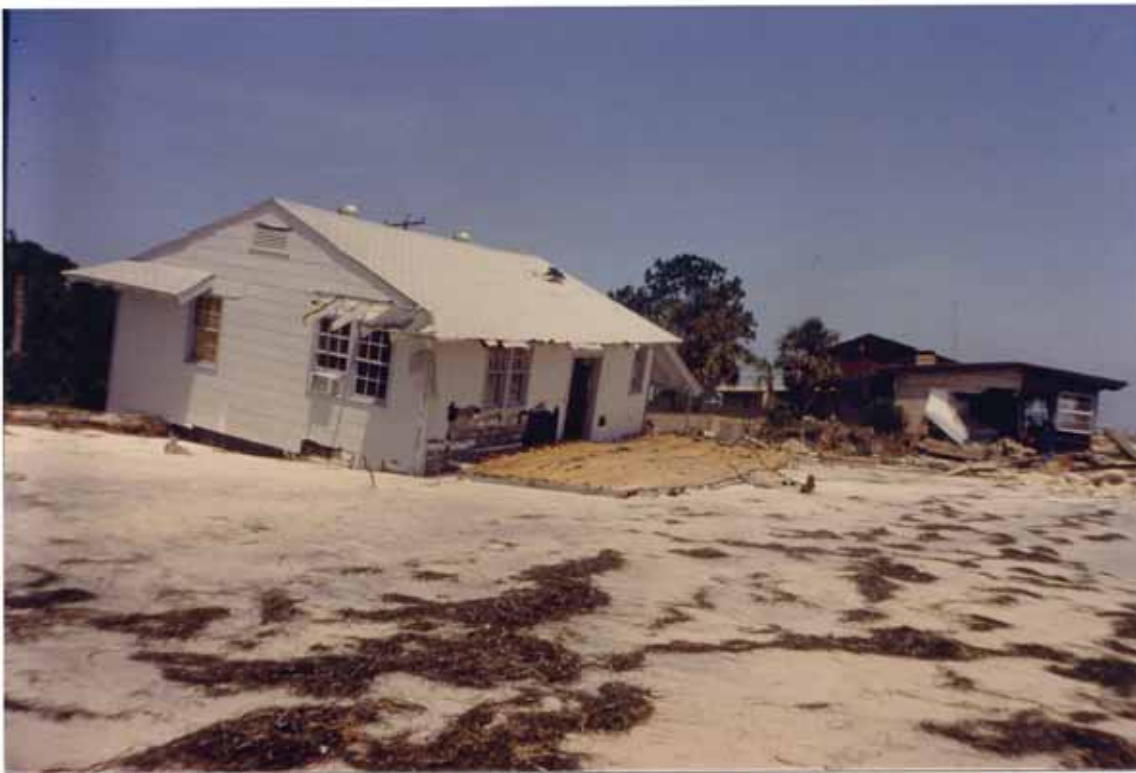
FIGURE 39. Frame dwelling damaged on September 1

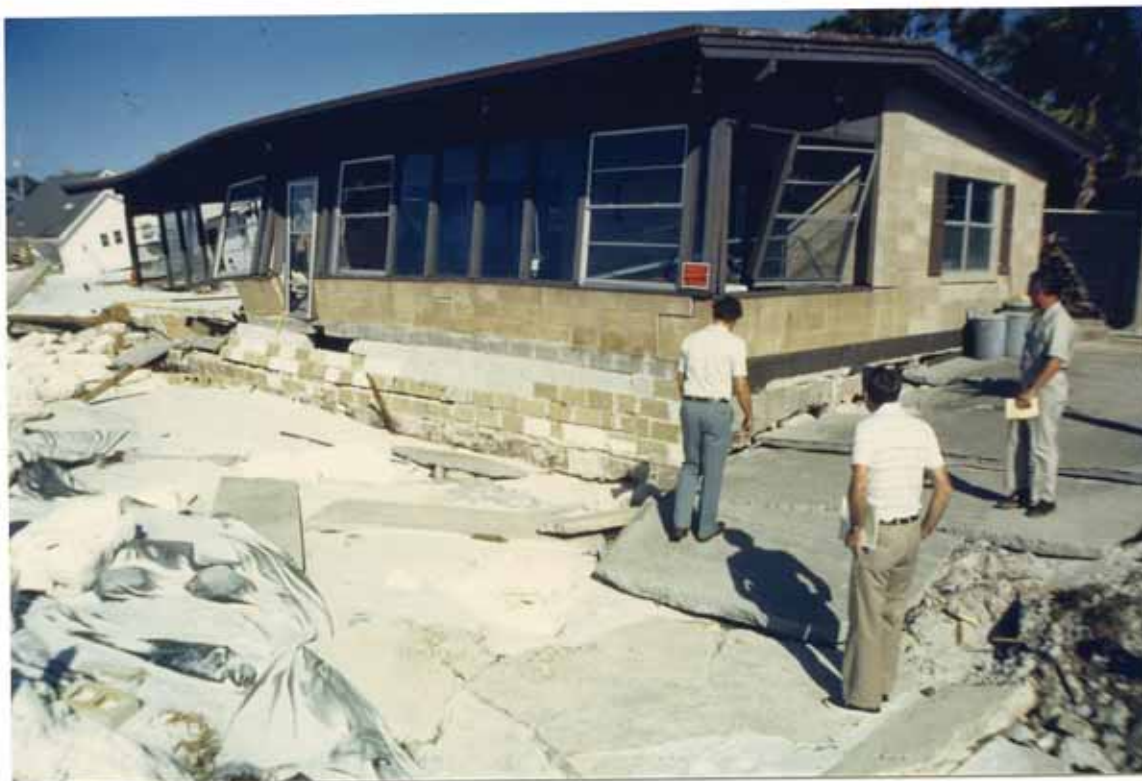
FIGURE 40. Concrete block dwelling damaged by Elena

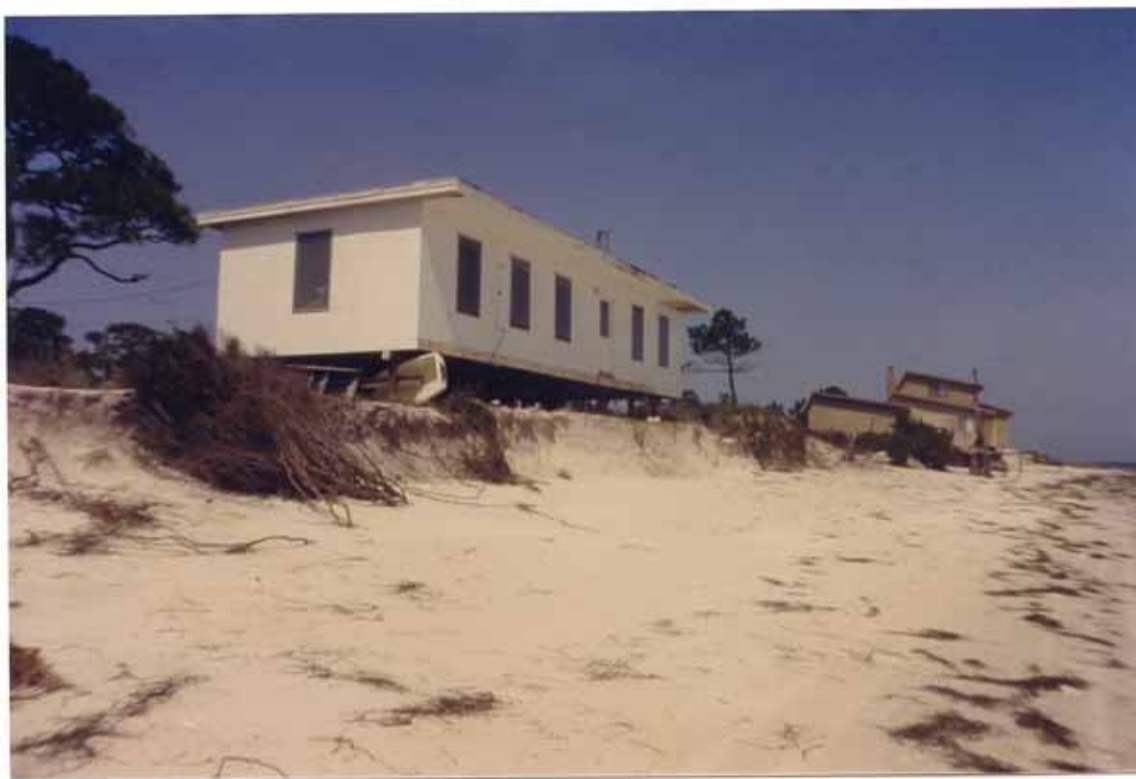
Moderate to heavy dune erosion was sustained eastward to Lighthouse Point. Immediately west of Lighthouse Point the dune recession nearly undermined one dwelling which should have been relocated inland (Figure 41). To its east, a wood frame dwelling on short wood piles and concrete footings, was undermined and sustained major damage to the foundation and floor slab (Figure 42). An inspection of the structure on August 31 revealed the dune recession had reached to within a couple feet of the dwelling overnight, and on September 1 the continued dune recession caused the eventual damage.

FIGURE 41. Lighthouse Point dwelling threatened by Elena's erosion

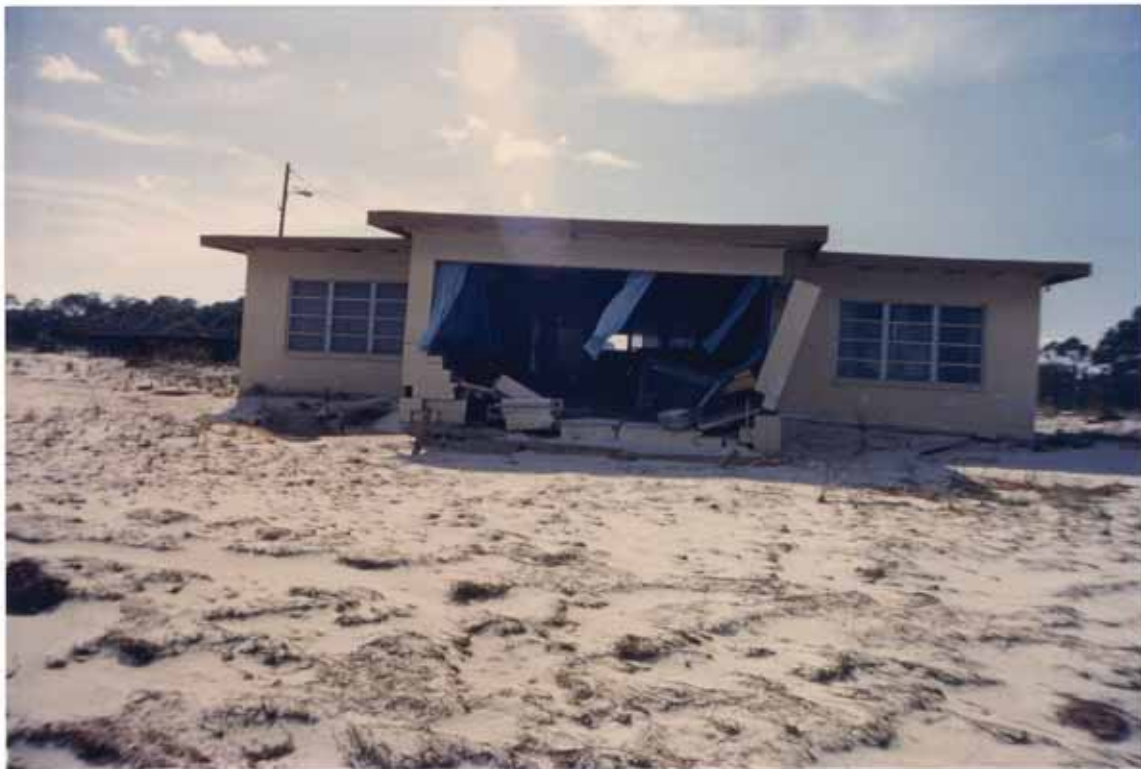
FIGURE 43. Elena's waves damaged dwelling near Bald Point

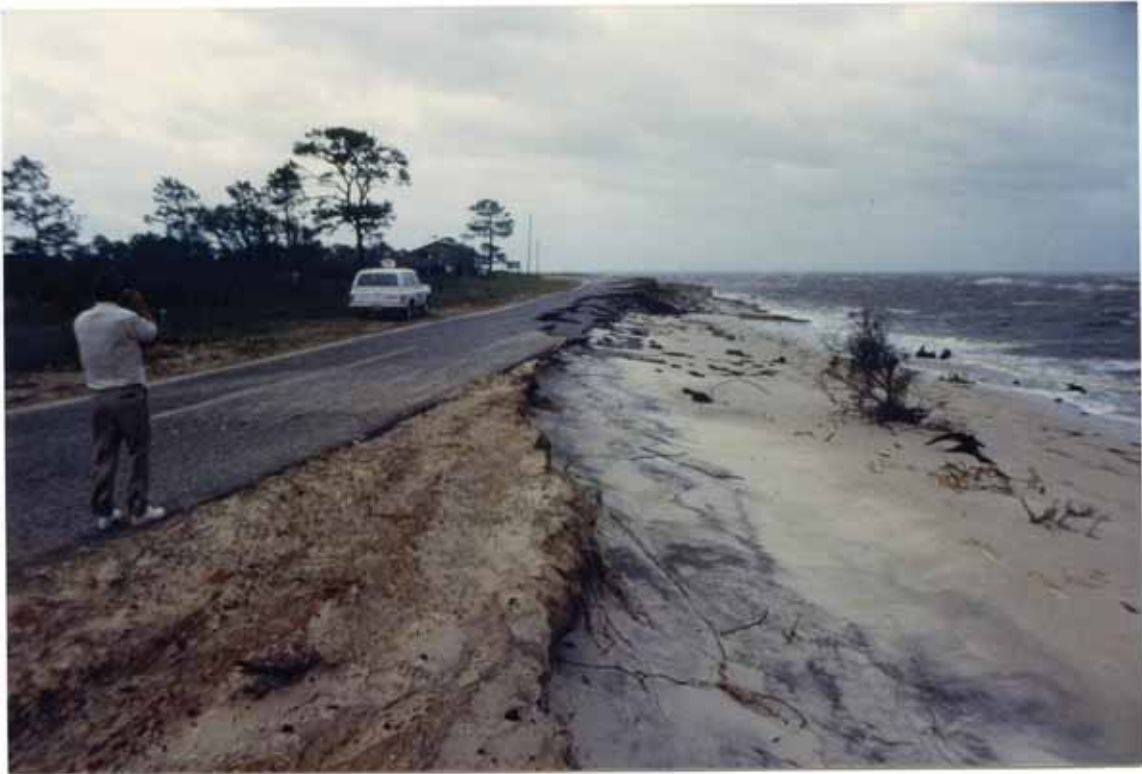
damaged, with the seaward lane and road shoulder being destroyed (Figures 44 and 46). A few hundred feet of concrete bulkhead had also been destroyed by Elena's first pass. On September 1, approximately 2,250 feet of the road was totally destroyed along with 1,400 feet of concrete bulkhead (Figures 45 and 47).

FIGURE 44. Lighthouse Point road damaged on August 30

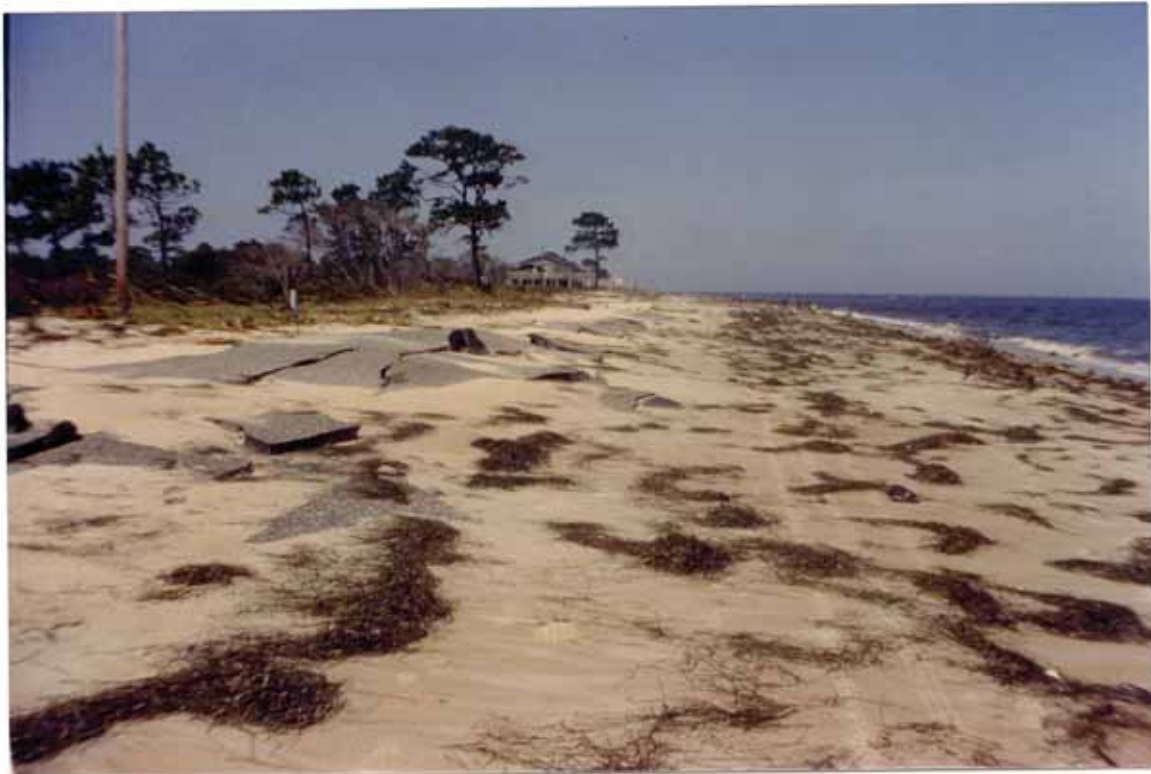
FIGURE 45. Lighthouse Point road destroyed on September 1

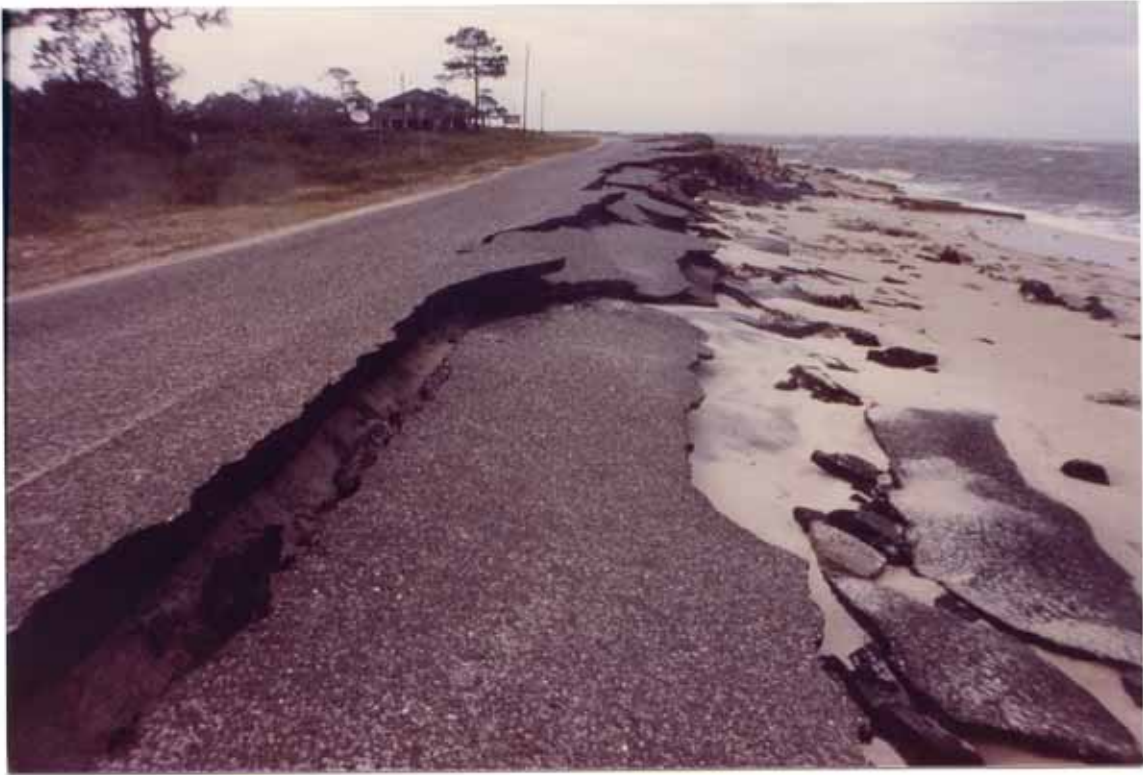
FIGURE 46. Lighthouse Point road damaged on August 30

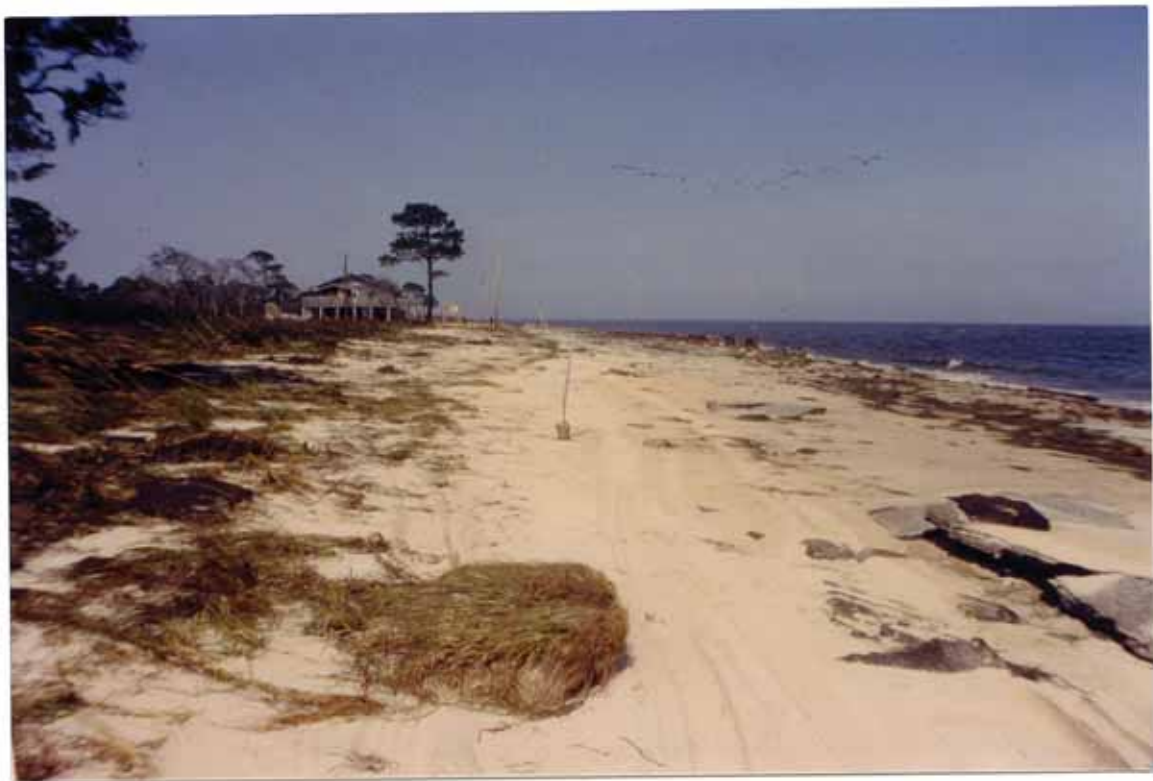
FIGURE 47. Lighthouse Point road destroyed on September 1

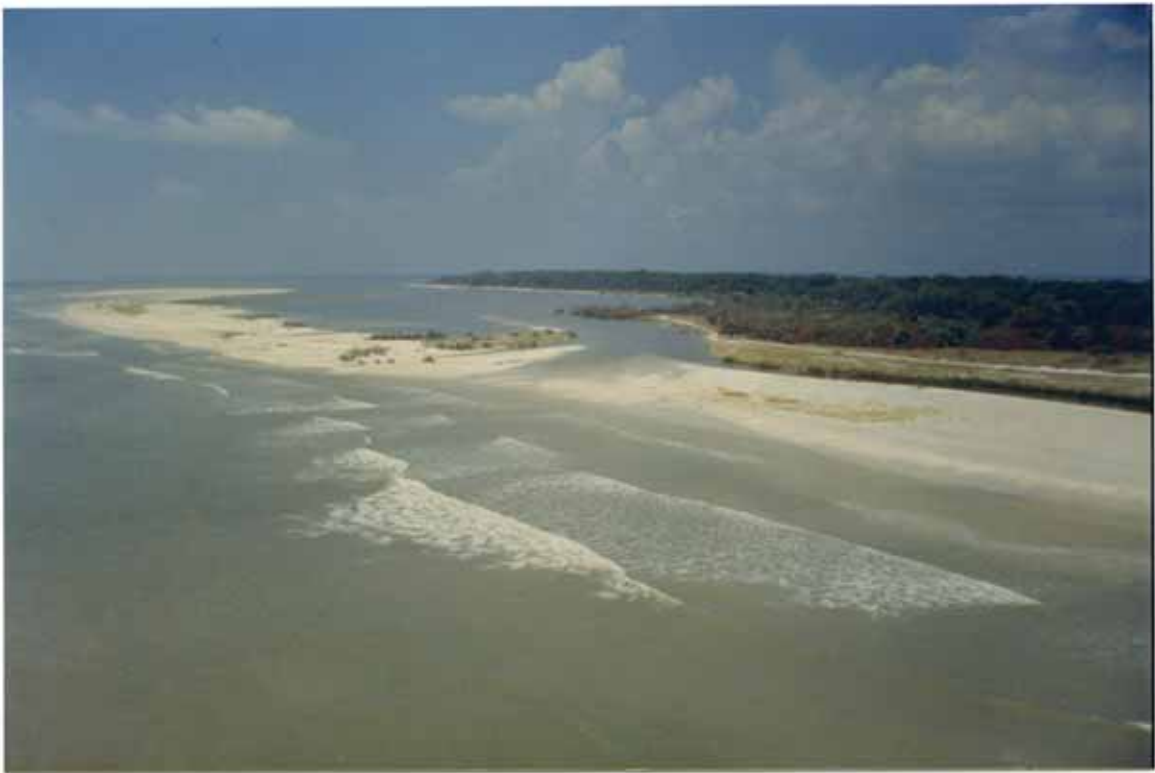
FIGURE 48. Inlet breach on Honeymoon Island

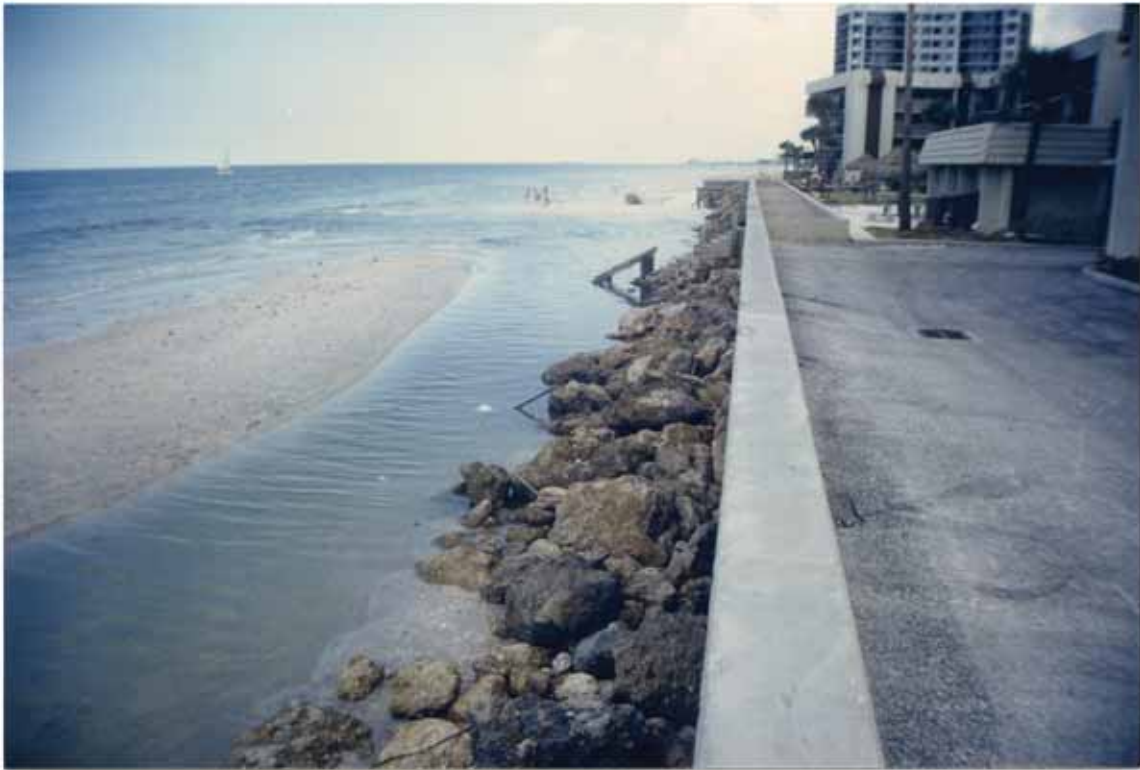
FIGURE 52. Beach erosion due to Elena at Montmarte Apartments
