# THE IMPACT OF HURRICANE ELENA AND TROPICAL STORM JUAN ON COASTAL CONSTRUCTION IN FLORIDA

Beaches and Shores Post-Storm Report No. 85-3

March, 1986

Bureau of Coastal Engineering and Regulation  
Division of Beaches and Shores  
FLORIDA DEPARTMENT OF NATURAL RESOURCES

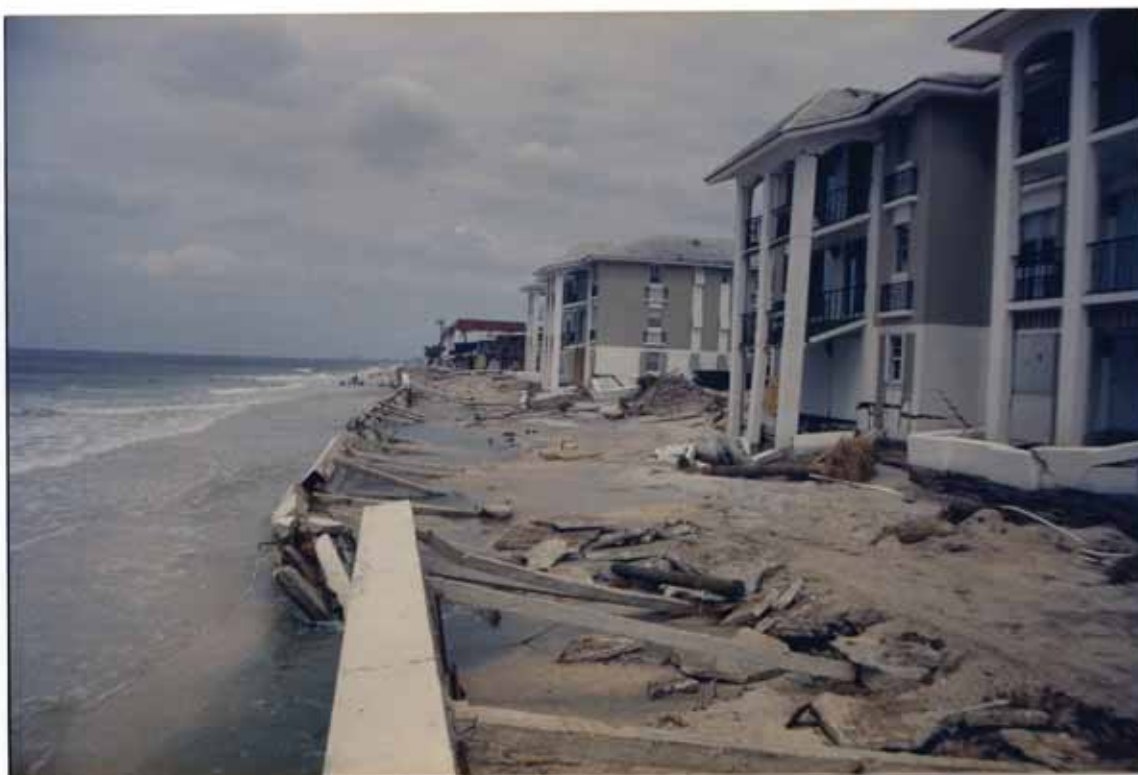
FIGURE 58. Tortugas Condominium bulkhead destroyed and buildings damaged

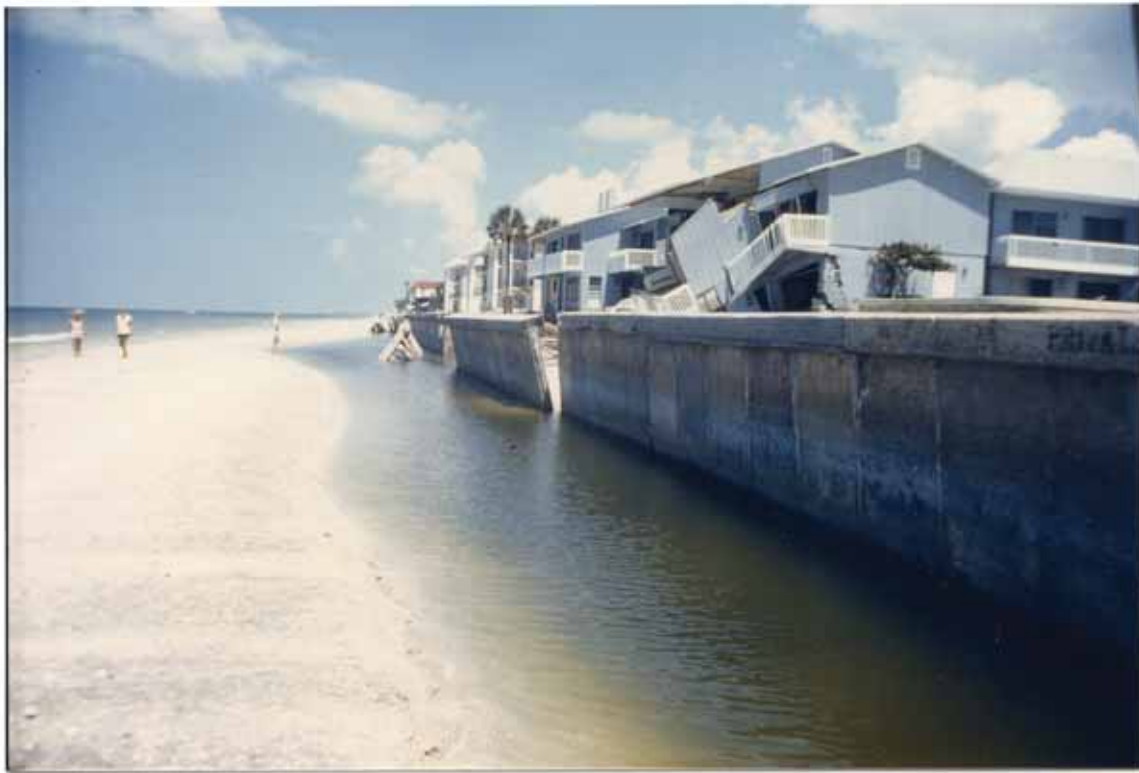
FIGURE 60. Bulkhead damage, La Casa de los Caracoles, Belleair Beach

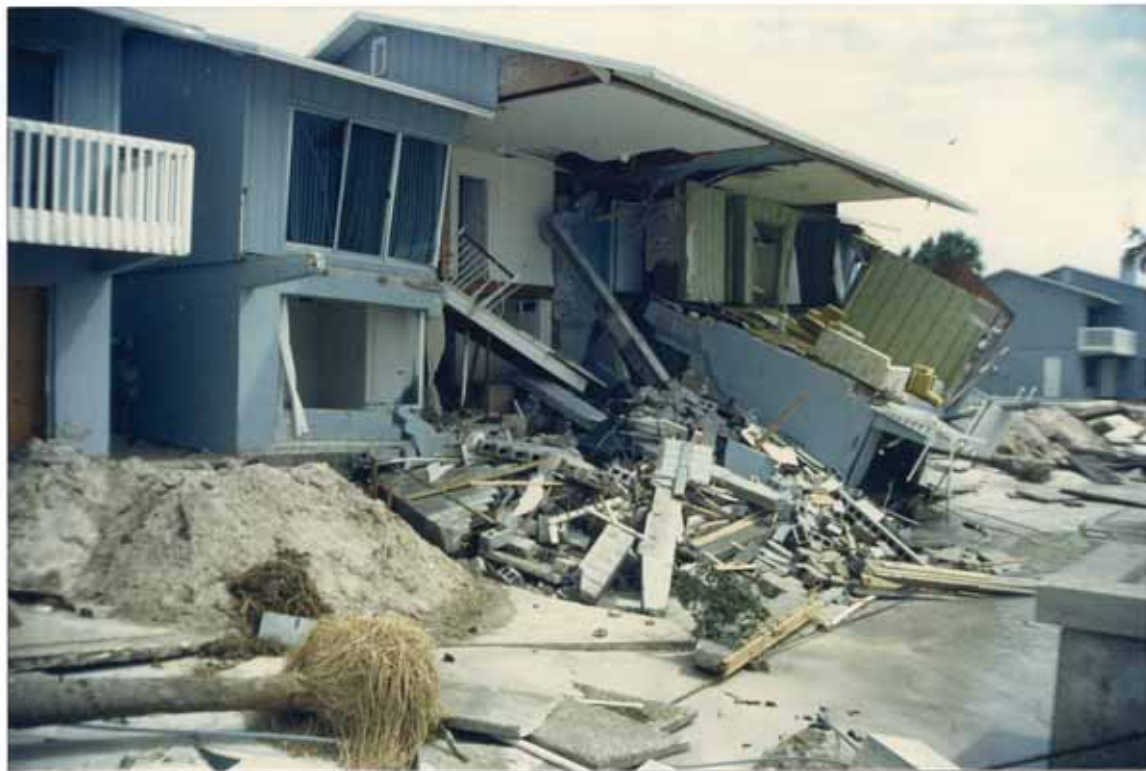
FIGURE 61. Two-unit building destroyed by Elena's waves

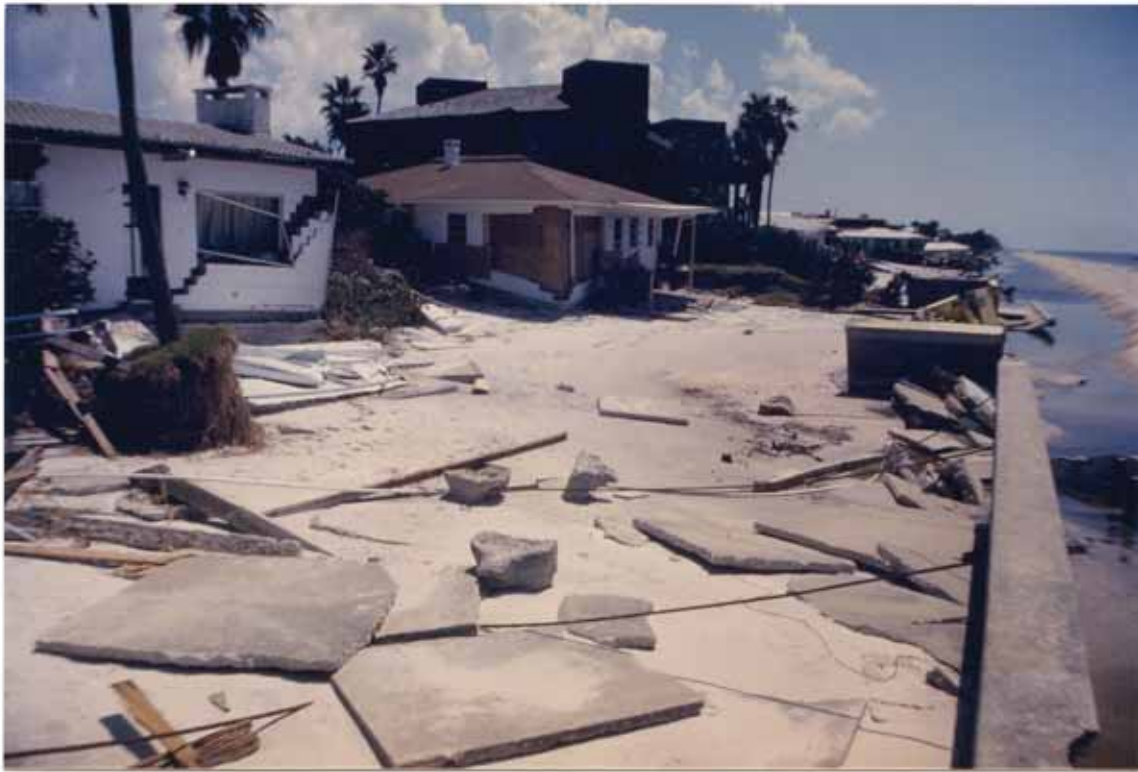
North of 18th Street a 150 foot segment of wall was completely destroyed and two residences were damaged (Figure 62). Between 18th Street and 17th Street the seaward end of a large residence was destroyed (Figure 63). South of 18th Street, with the exception of a damaged 100 foot segment still standing, a 650 foot stretch of wall was destroyed (Figure 64). With the lowering of the profile seaward of the walls and the loss of material from behind the walls, the structures could not withstand the direct wave impact loads. South of 16th Street a swimming pool structure also was destroyed by direct wave impact loads (Figure 65). A 160 foot segment of wall was completely destroyed south of 15th Street and another 160 foot segment was destroyed south of the 12th Street beach access (Figure 66). An 80 foot wall and seaward portion of a house was substantially destroyed adjacent to the Belleair Causeway and a 140 foot segment of wall was destroyed/damaged, a pool damaged, and the seaward portion of a house destroyed between the Belleair Causeway and 9th Street (Figure 67).

FIGURE 62. North Belleair Shore damage

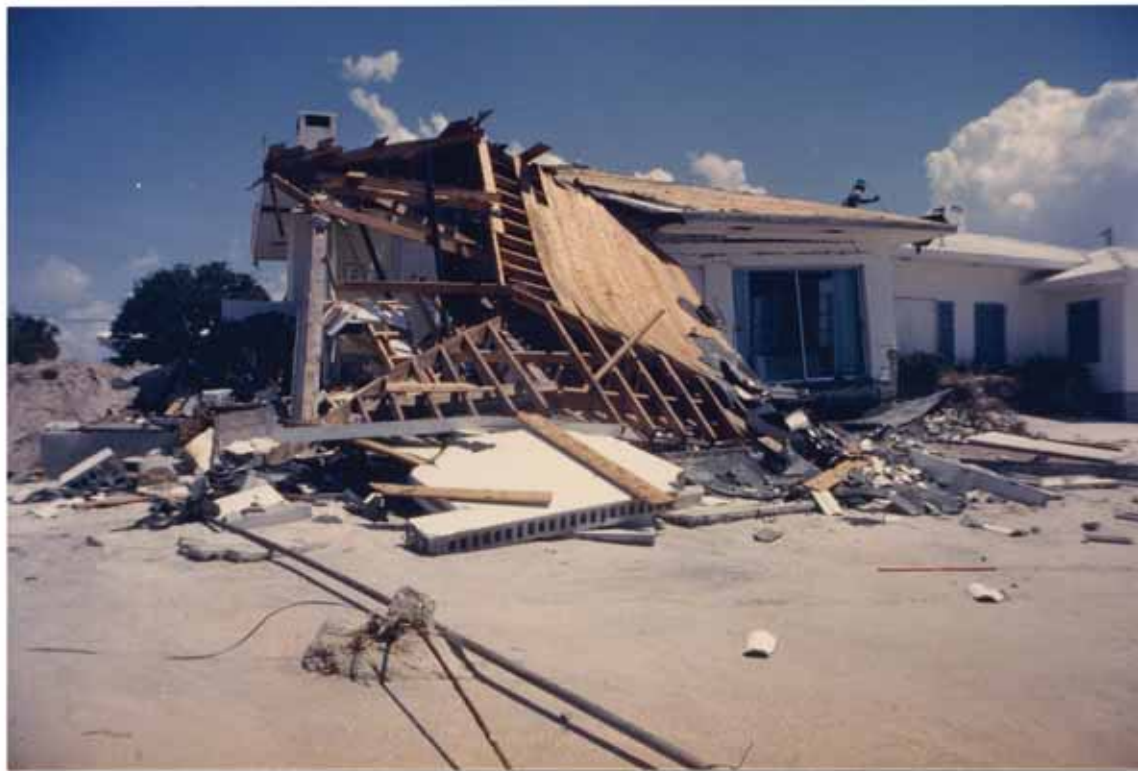
FIGURE 63. Belleair Shore dwelling damaged

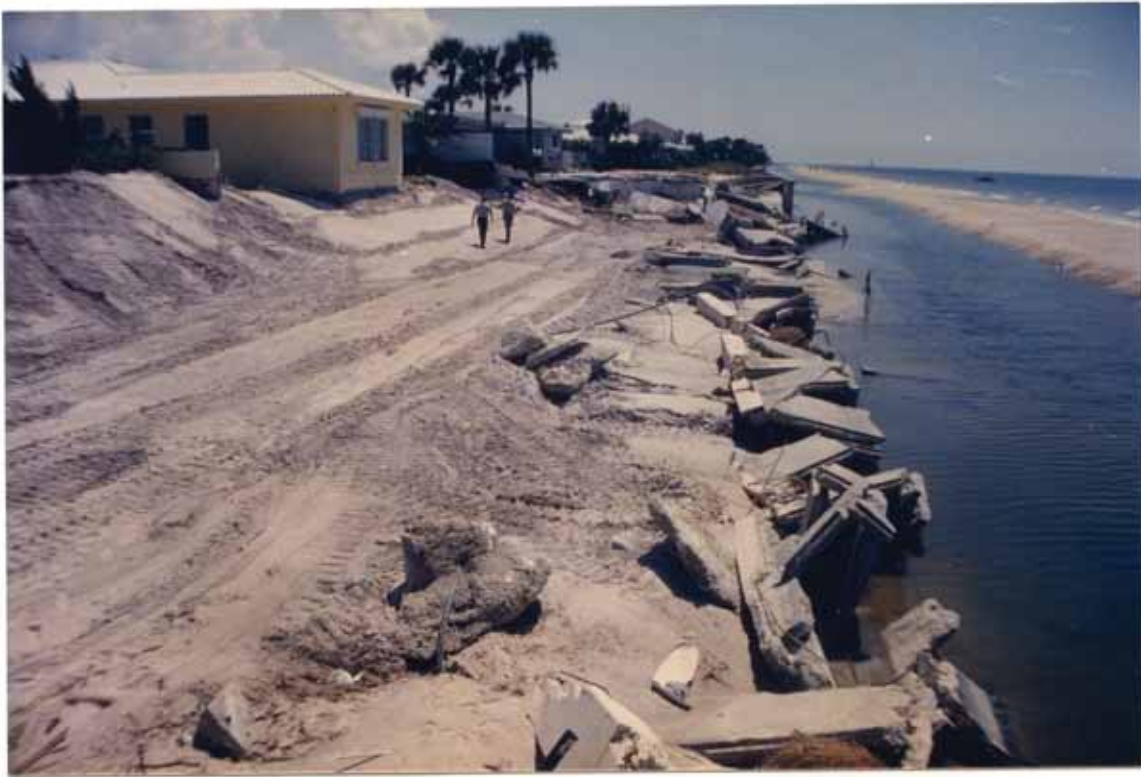
FIGURE 64. Concrete bulkhead destroyed, 650 feet

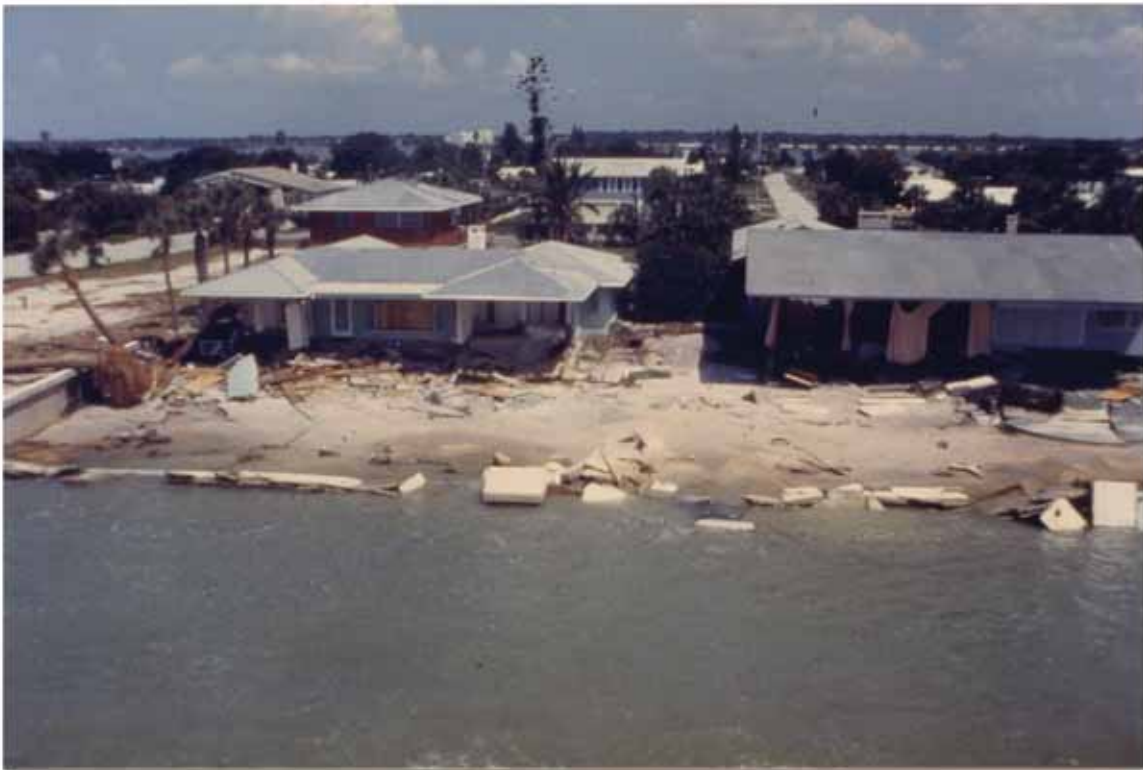
Adjacent 9th Street, two residences sustained heavy damage from undermining (Figure 68). A 400 foot length of bulkhead fronting these two residences and continuing south to 8th Street was destroyed along with another residence (Figure 69). Between 7th Street and the 6th Street beach access a 120 foot segment of wall was destroyed and a pool and residence damaged. A 40 foot section of wall was destroyed at 5th Street and a 160 foot segment was destroyed north of 3rd Street. Adjacent 2nd Street an 80 foot wall segment was destroyed and the seaward portion of a residence destroyed. The south end of the Town's walls sustained substantial cap damage.

FIGURE 68. Wall destroyed and dwellings damaged

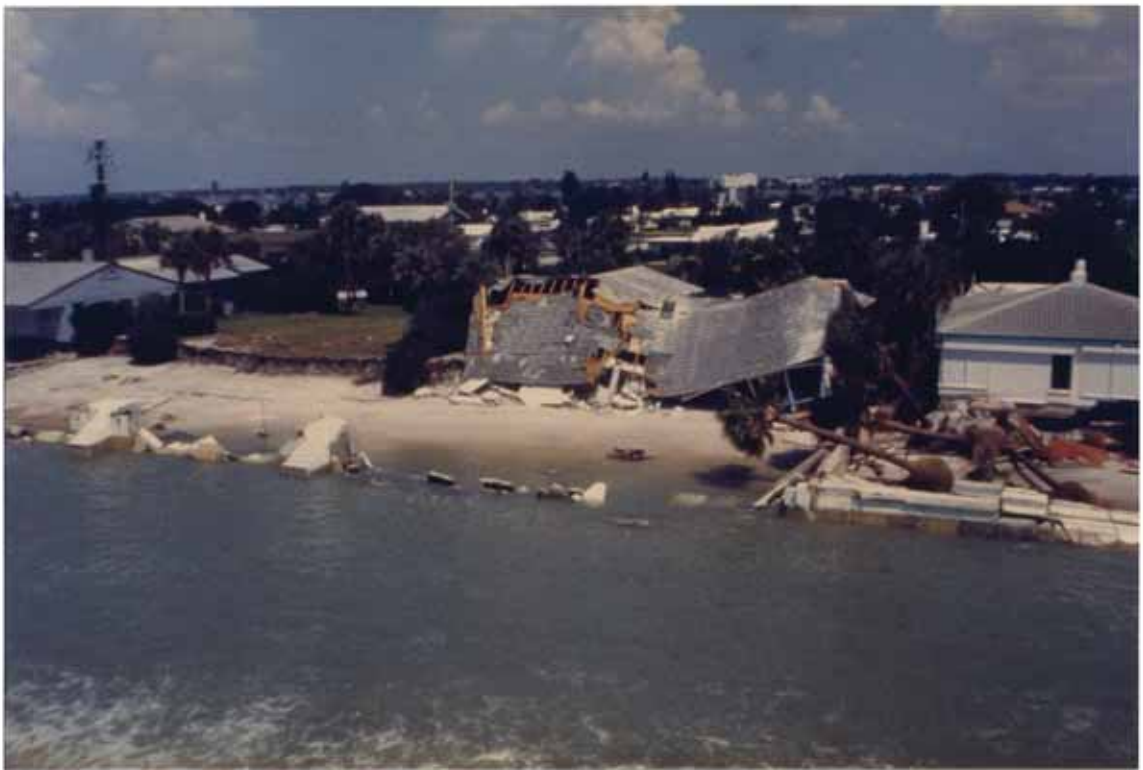
FIGURE 69. Wall and dwelling destroyed

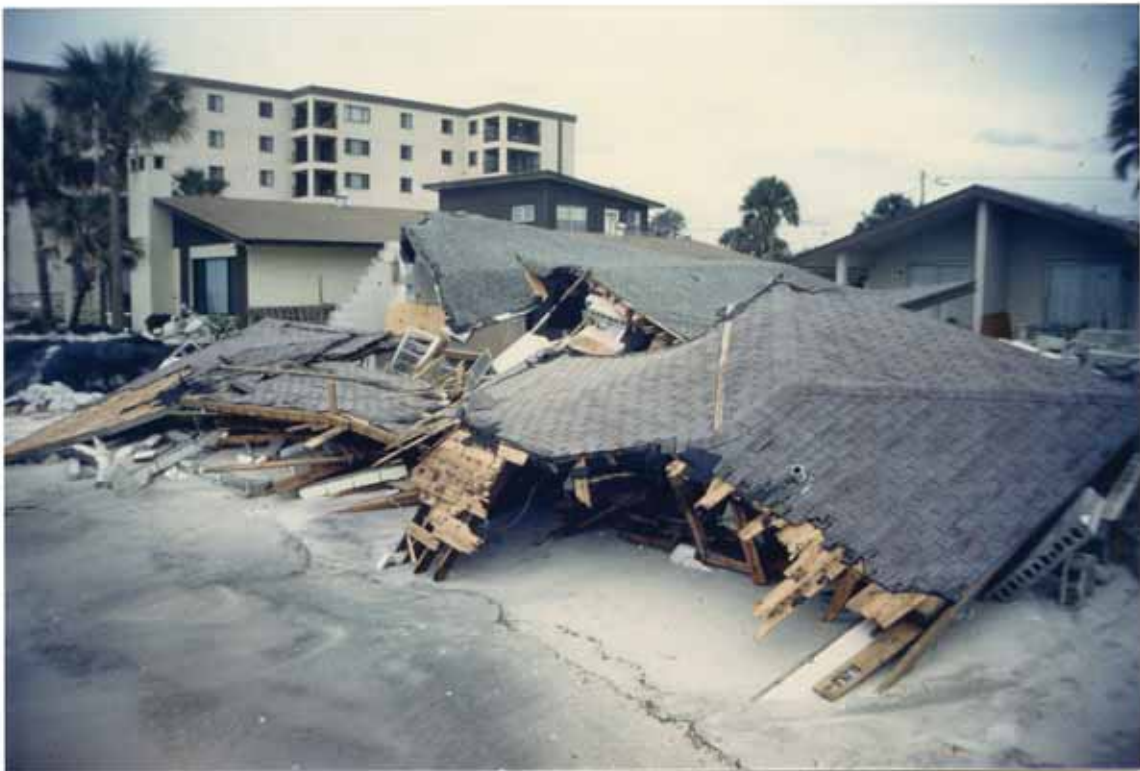
FIGURE 71. Dwelling destroyed by Juan

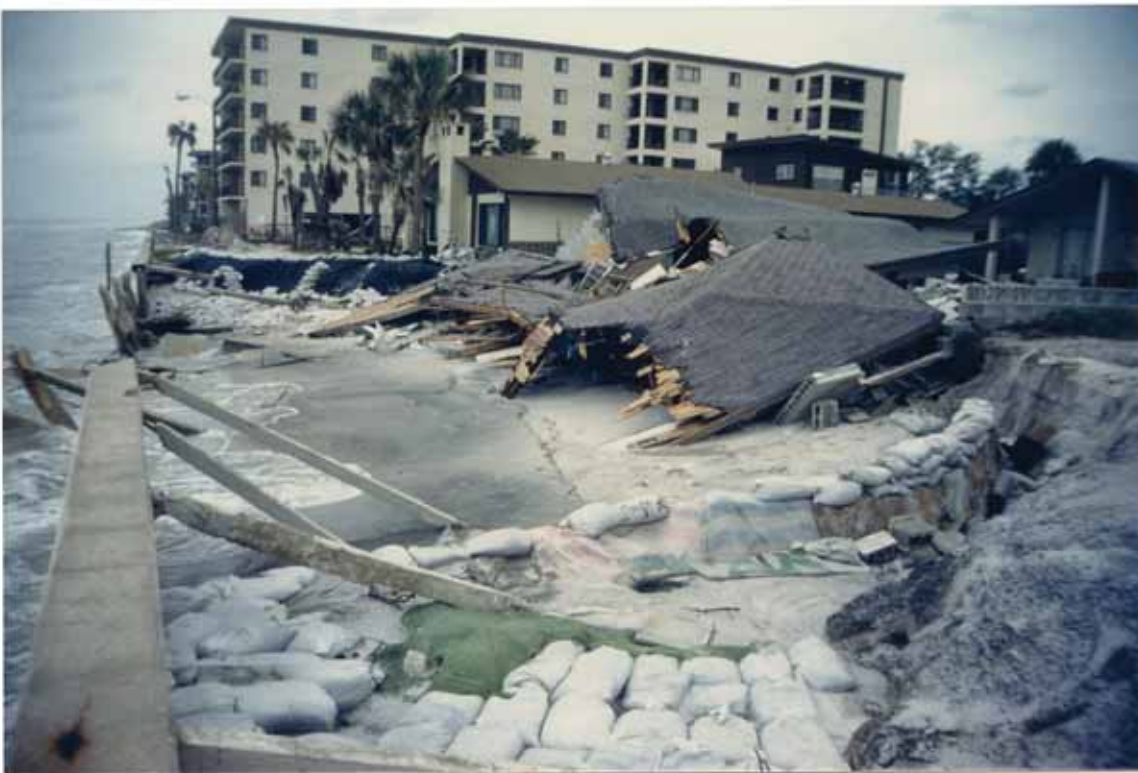
FIGURE 73. Same dwelling destroyed by Juan

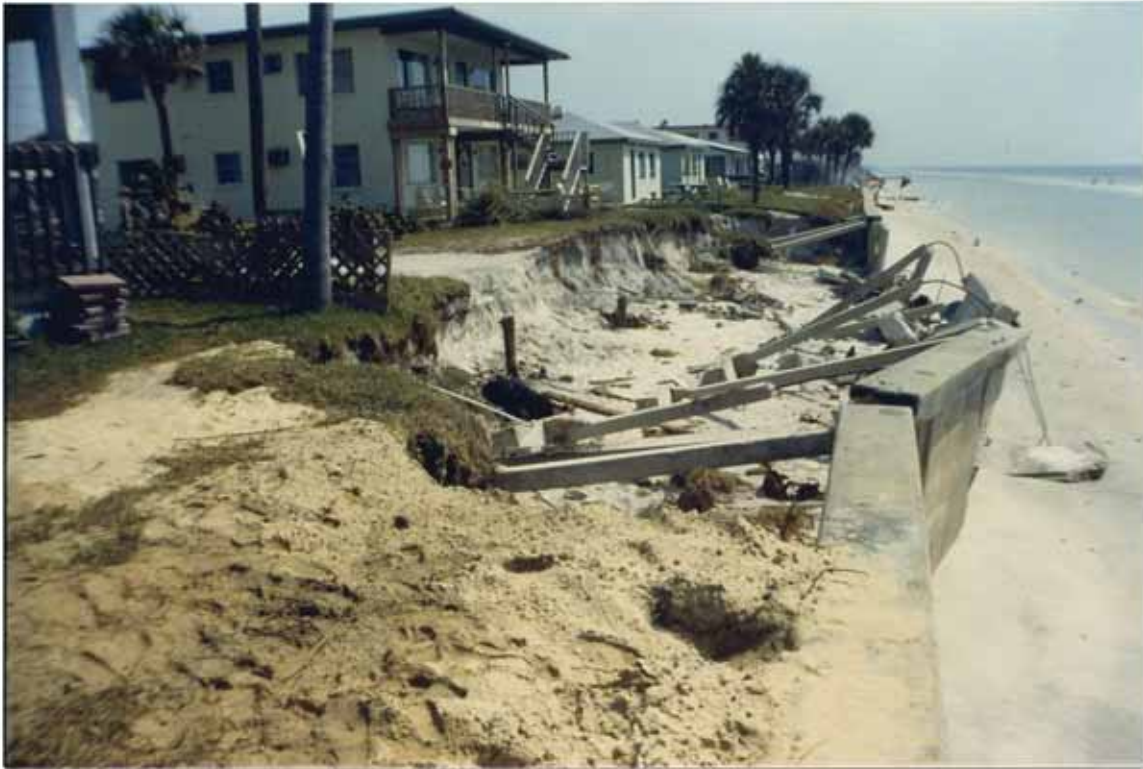
FIGURE 74. Elena damaged 23rd Avenue

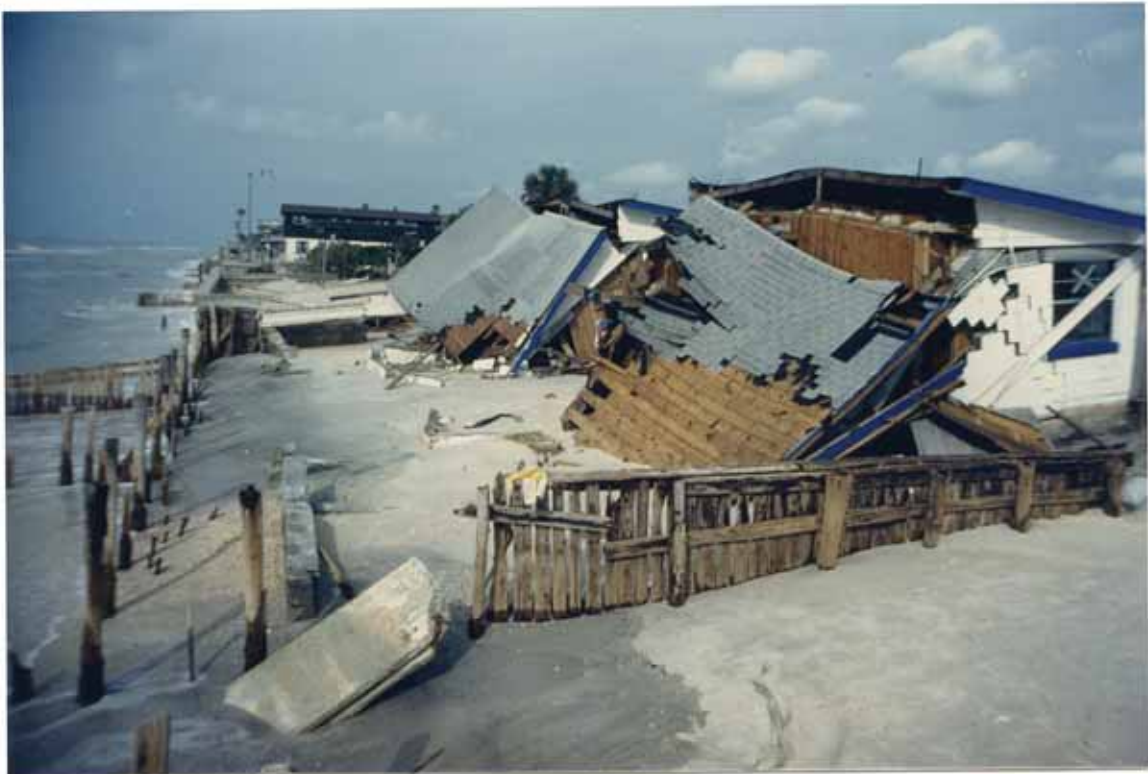
FIGURE 79. Juan's additional damage at 18th Avenue

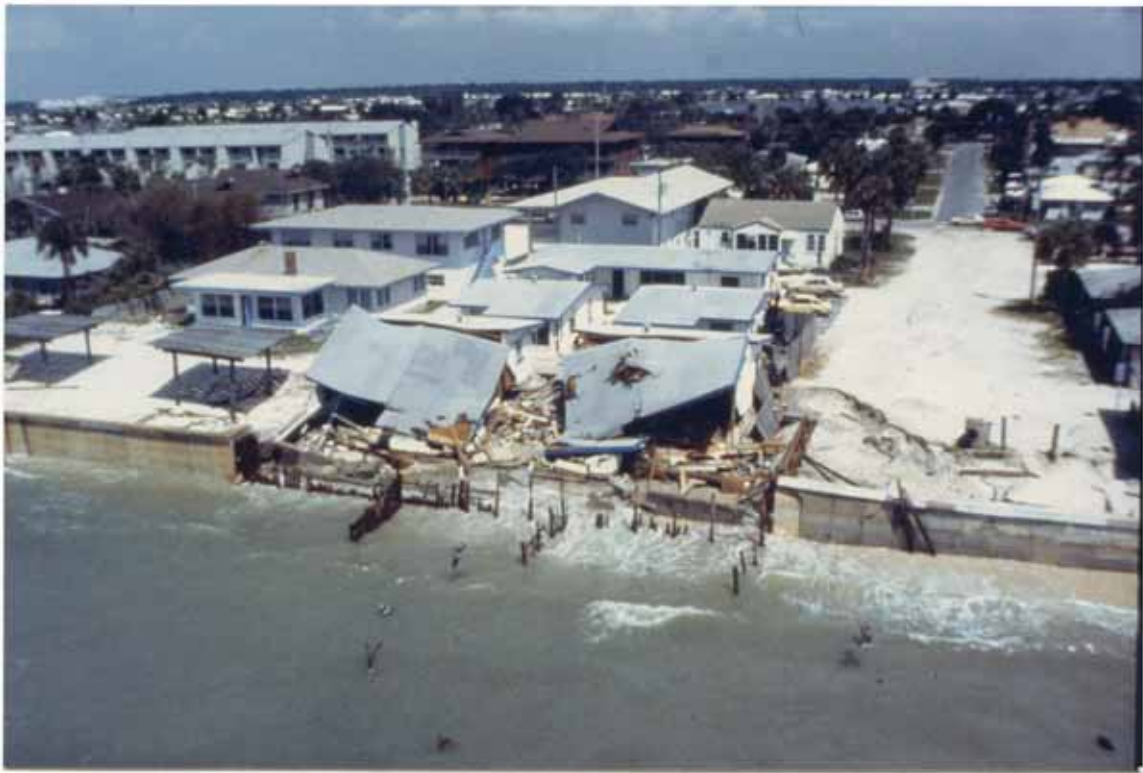
FIGURE 80. Wall and dwellings destroyed by Elena

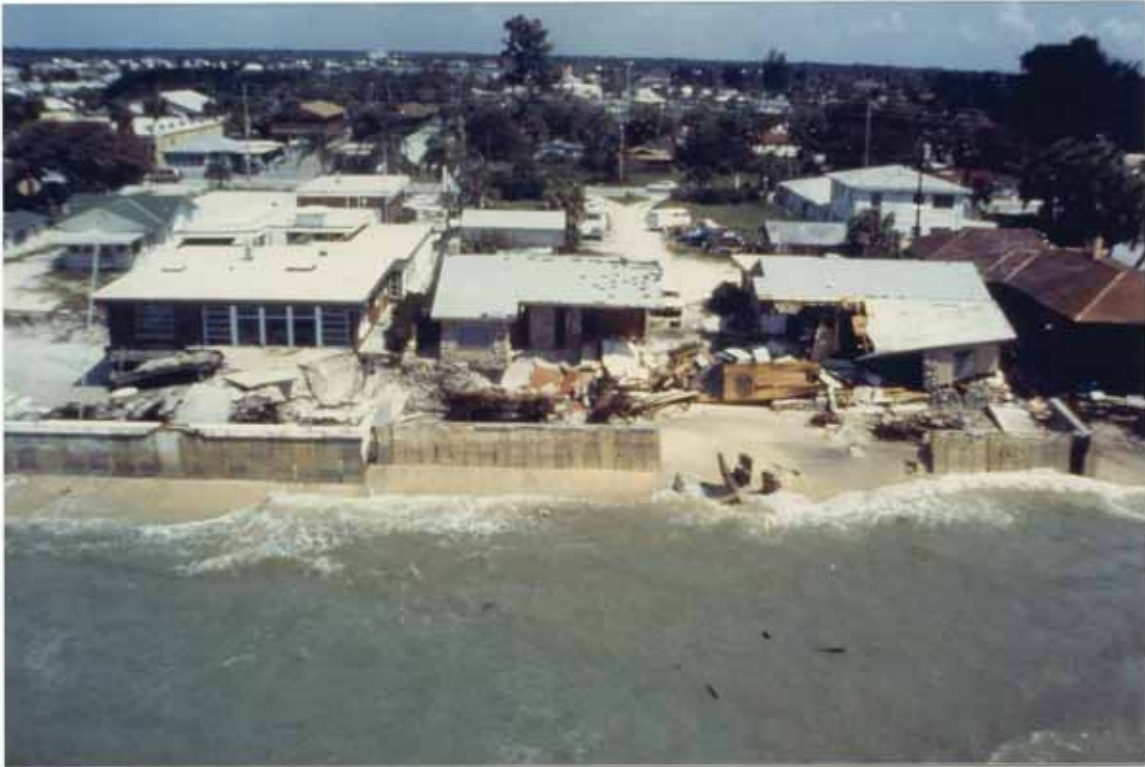
FIGURE 84. Bulkhead and dwellings damaged

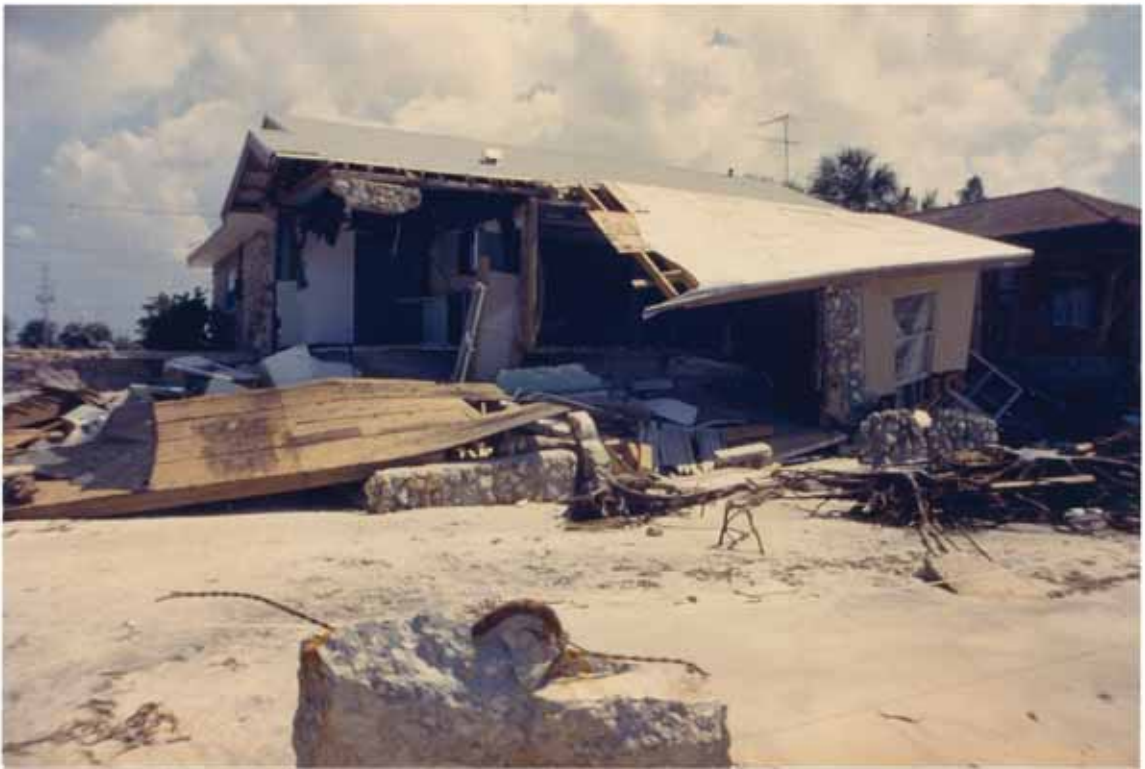
FIGURE 85. Dwelling damaged by Elena

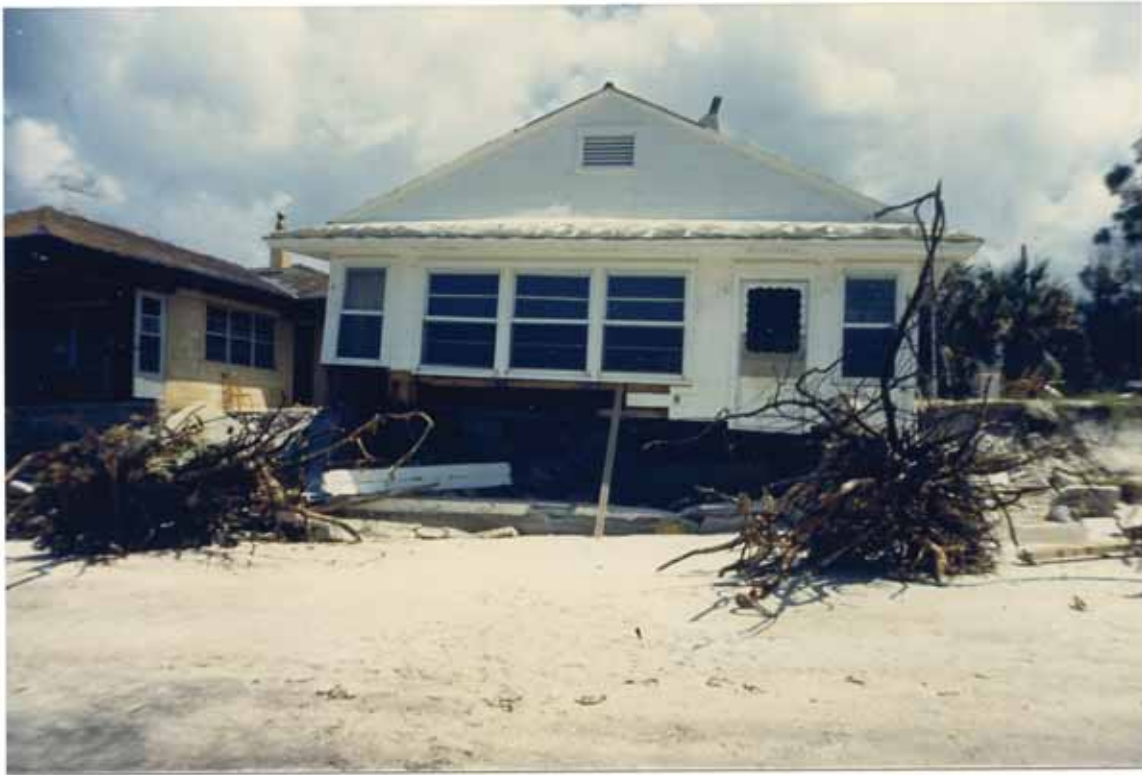
frame dwelling located 150 feet north of 15th Avenue was substantially damaged by Elena (Figure 86) and destroyed by Juan (Figure 87).

FIGURE 86. Dwelling damaged by Elena

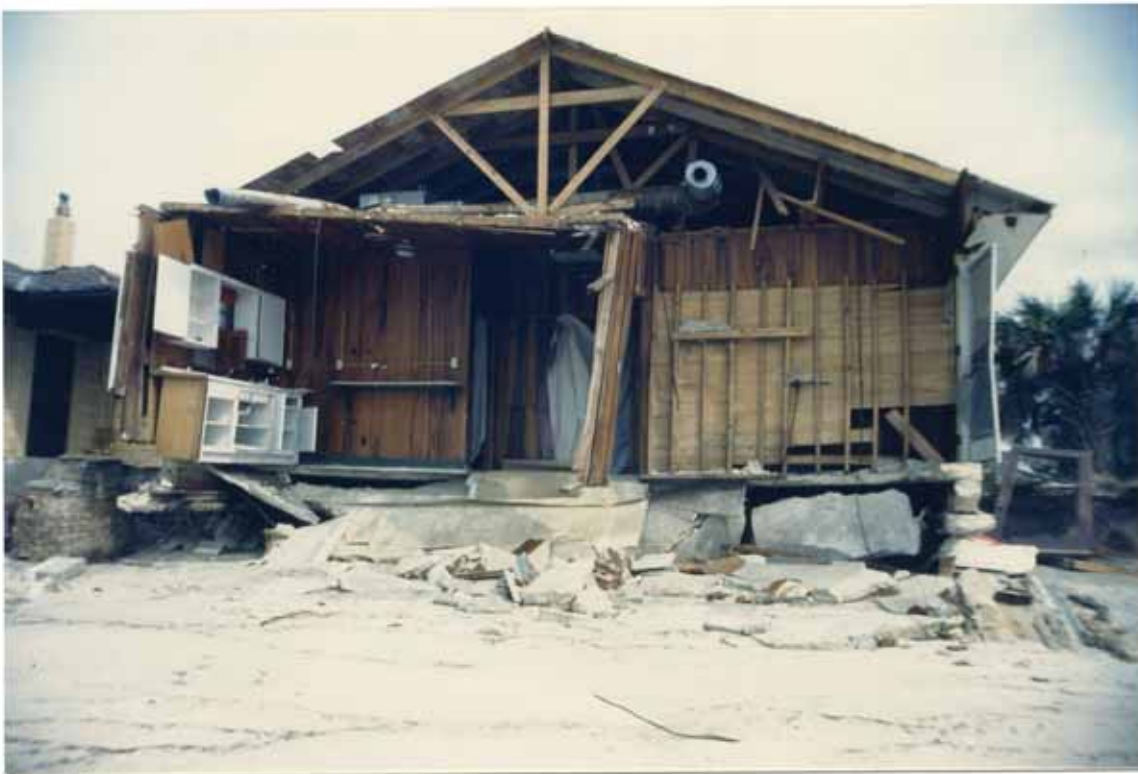
FIGURE 87. Same dwelling damaged by Juan

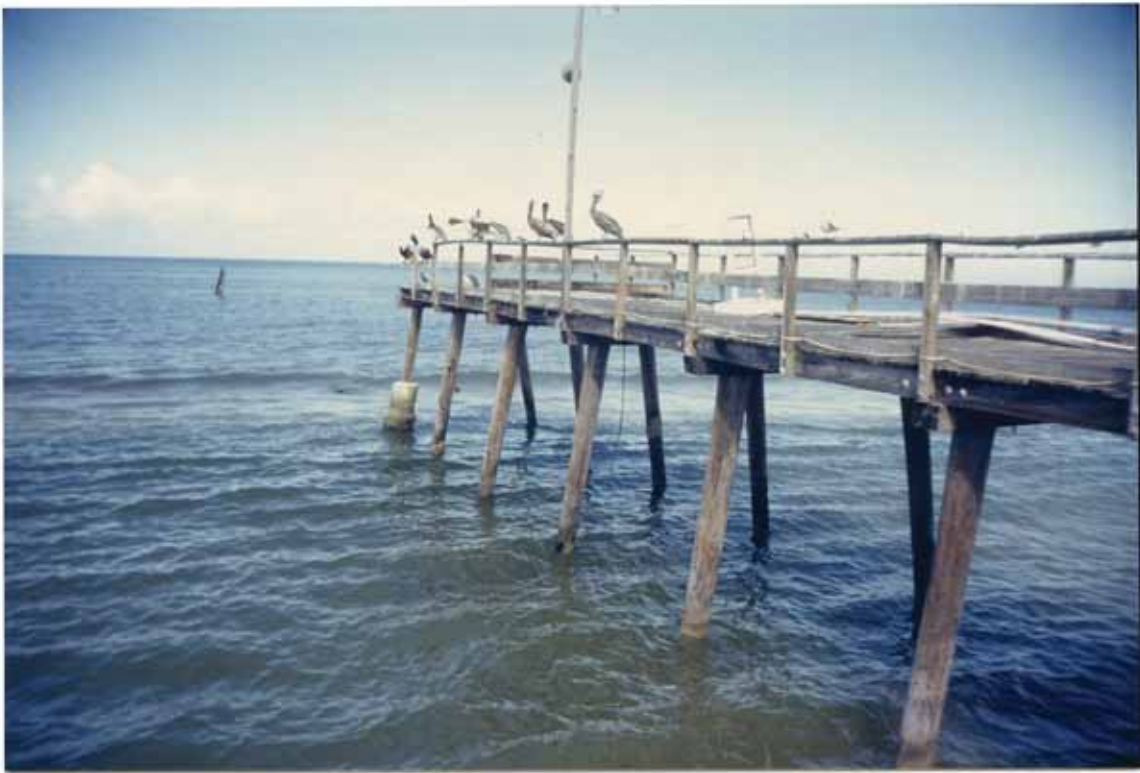
FIGURE 88. Big Indian Rocks Fishing Pier destroyed

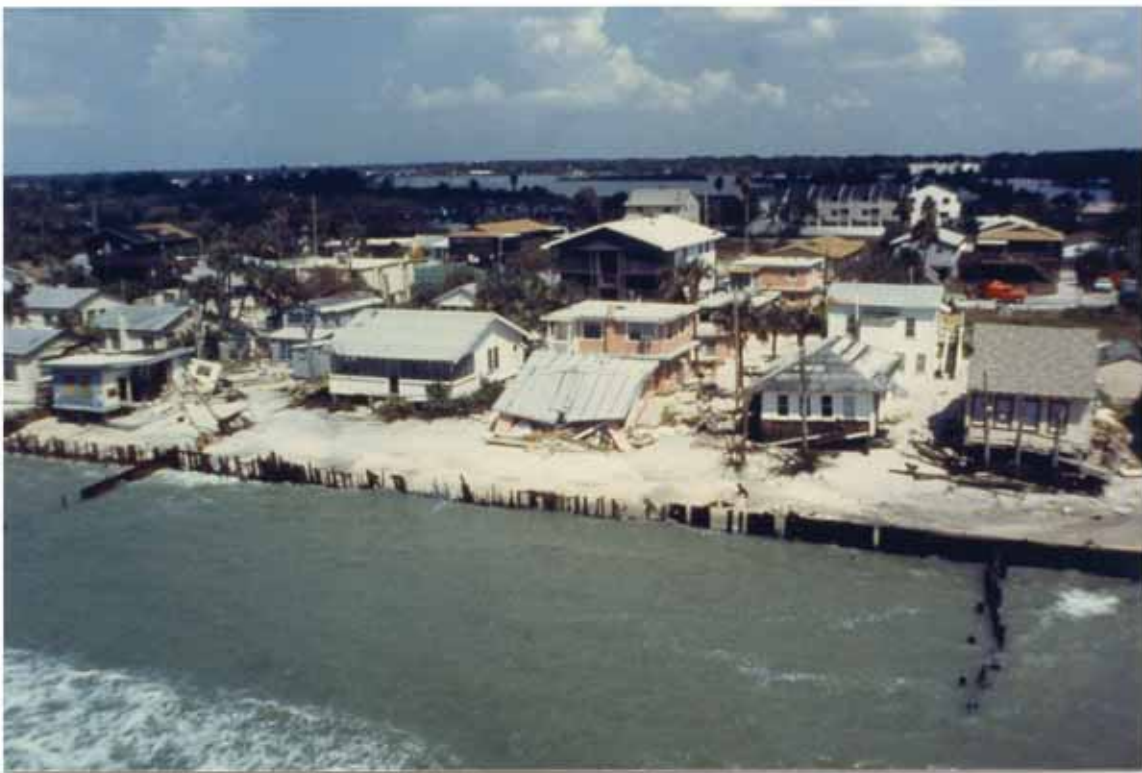
FIGURE 89. Bulkheads and dwellings destroyed and damaged

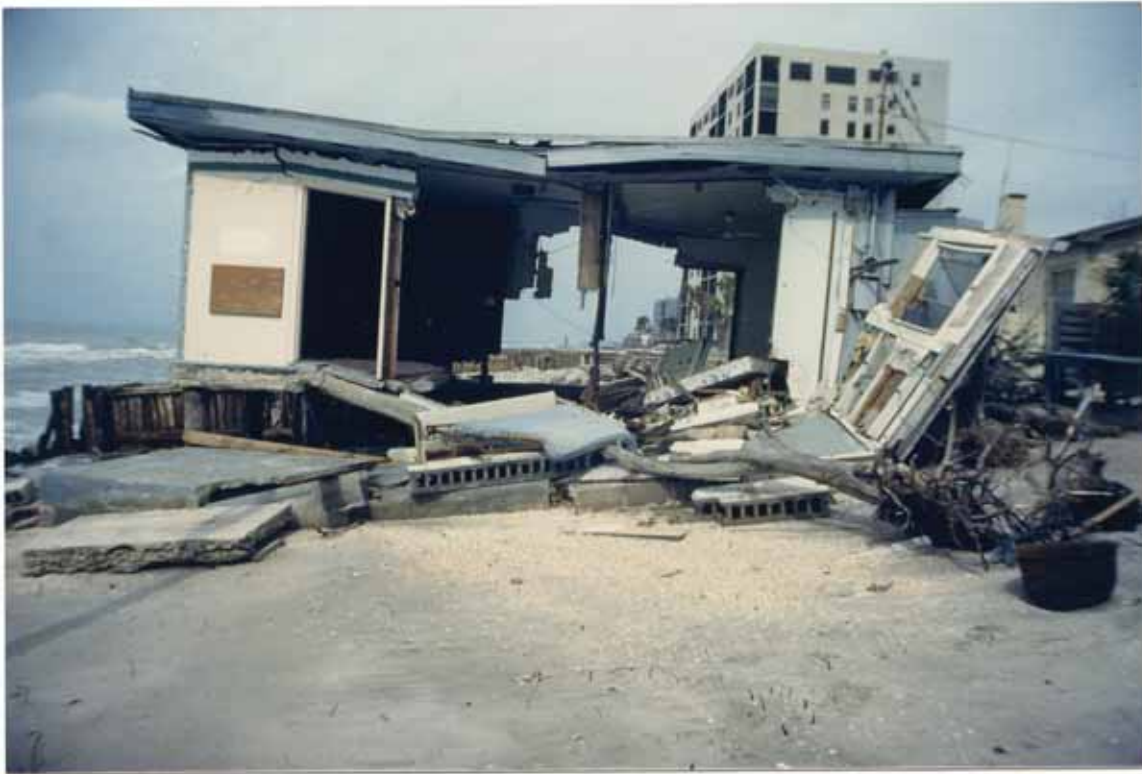
FIGURE 90. Dwelling destroyed by Elena

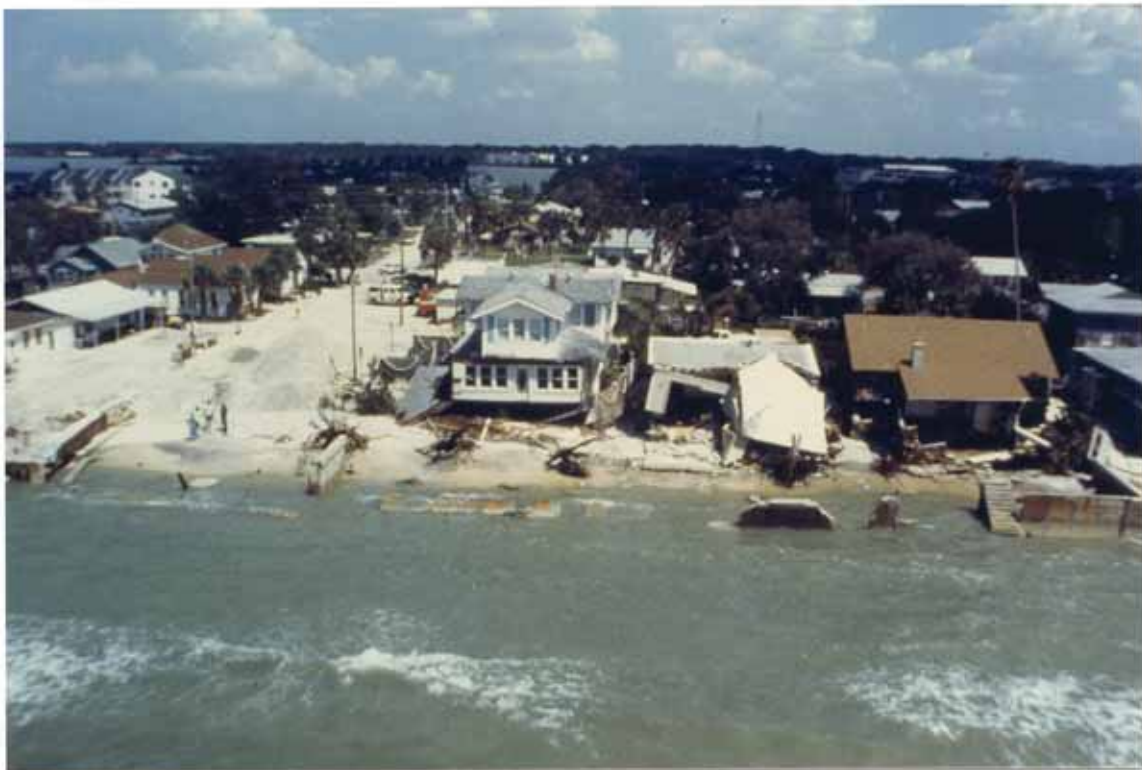
FIGURE 91. Bulkheads and dwellings destroyed and damaged

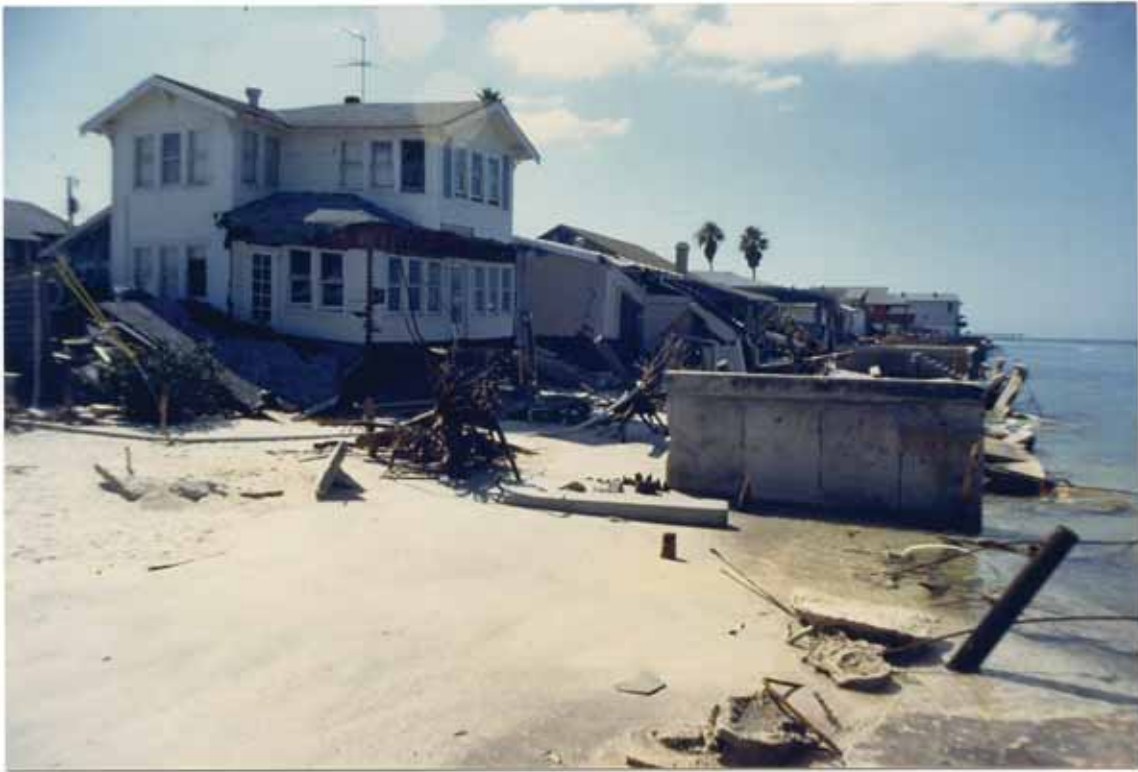
FIGURE 92. Elena destroyed 8th Avenue

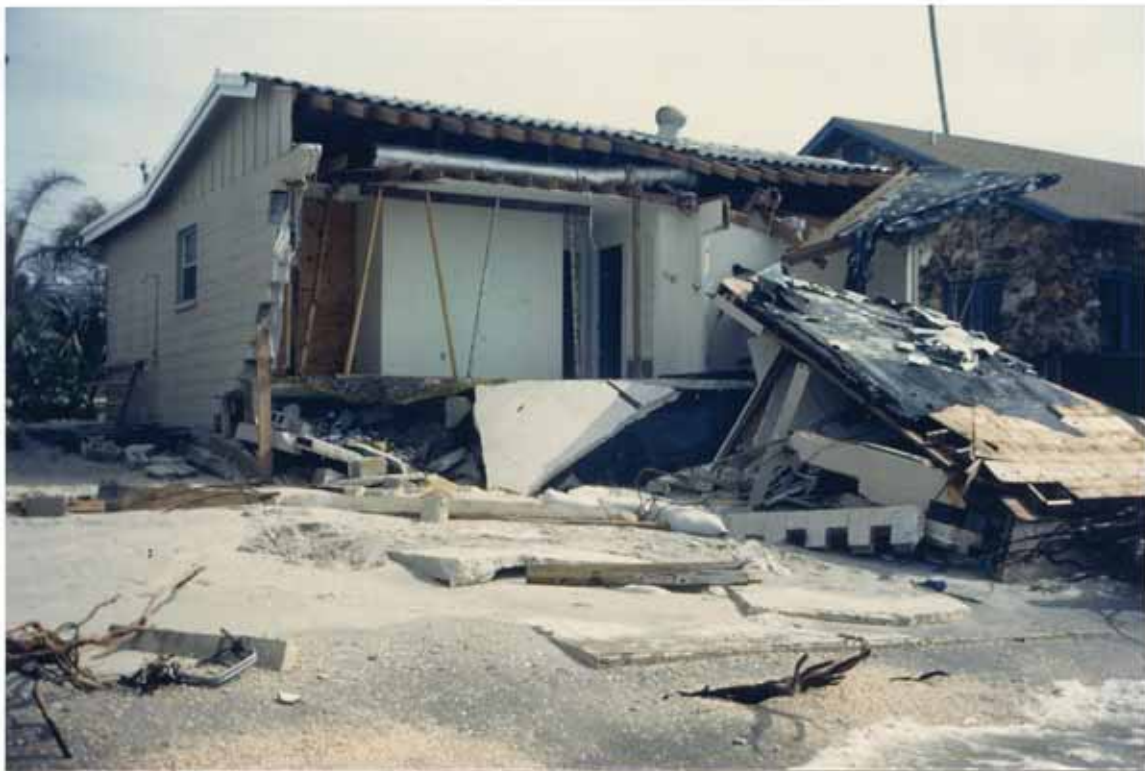
FIGURE 93. Dwelling damage by Juan

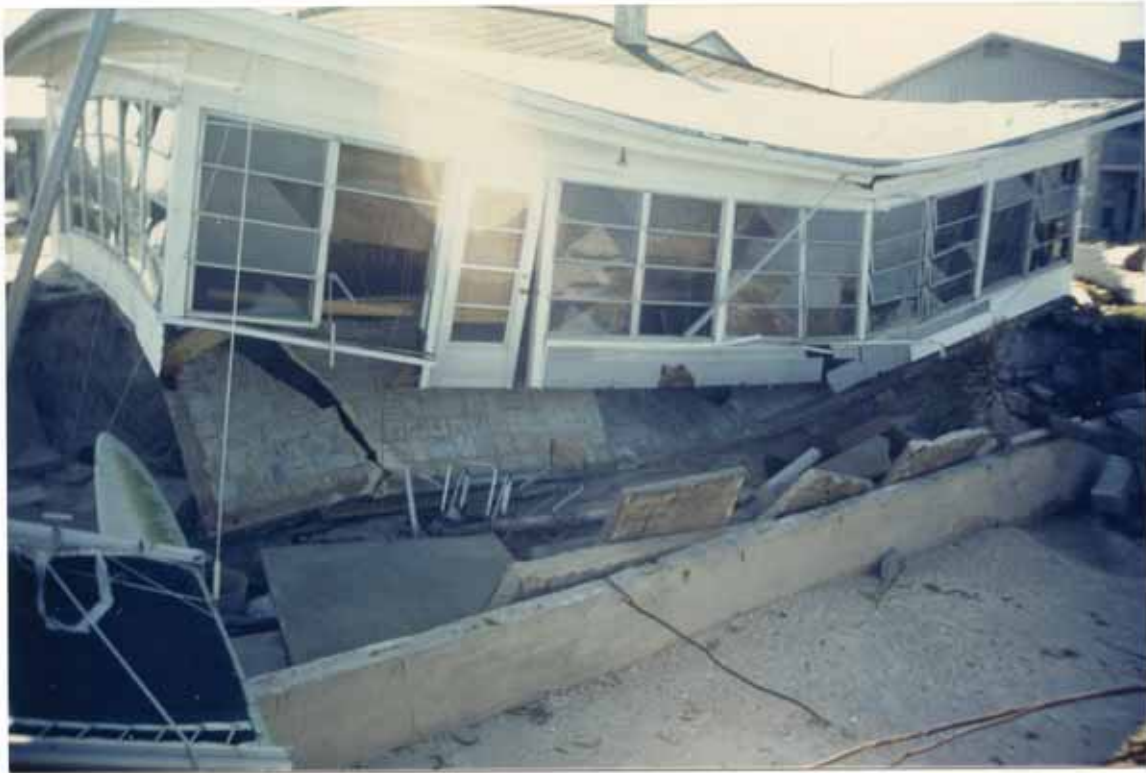
FIGURE 103. Indian Shores dwelling destroyed by Elena

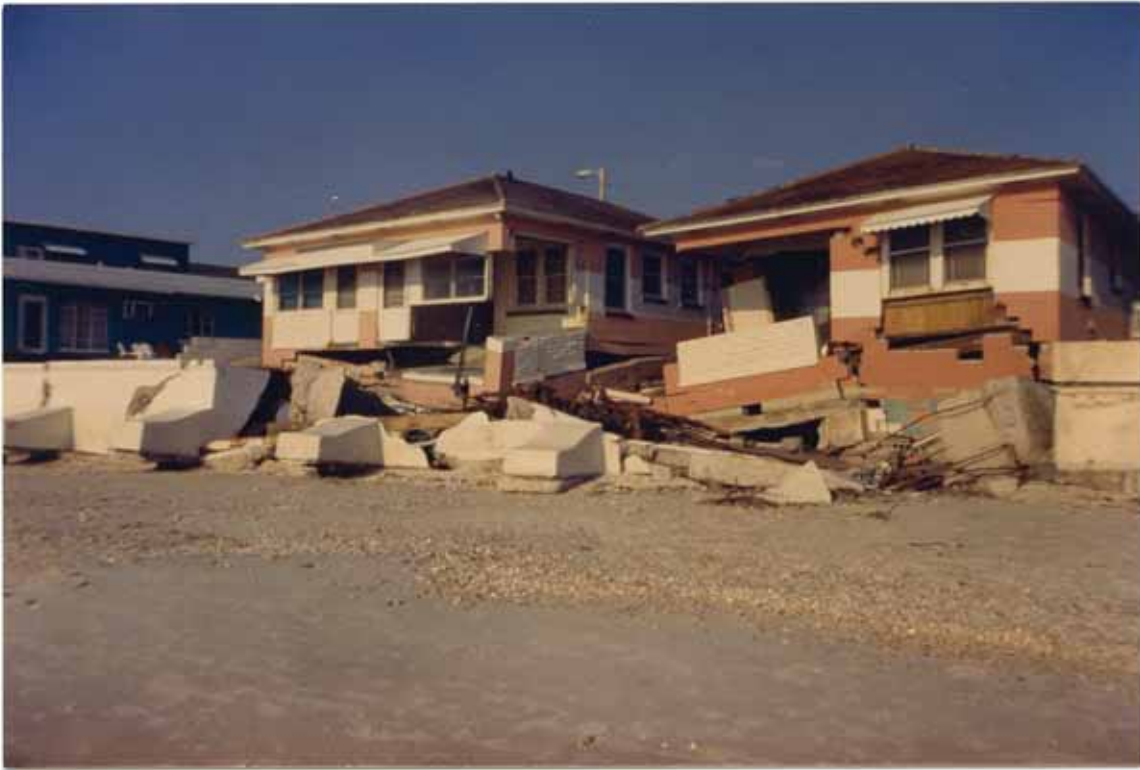
FIGURE 107. Wall destroyed and dwellings damaged
