# THE IMPACT OF HURRICANE ELENA AND TROPICAL STORM JUAN ON COASTAL CONSTRUCTION IN FLORIDA

Beaches and Shores Post-Storm Report No. 85-3

March, 1986

Bureau of Coastal Engineering and Regulation  
Division of Beaches and Shores  
FLORIDA DEPARTMENT OF NATURAL RESOURCES

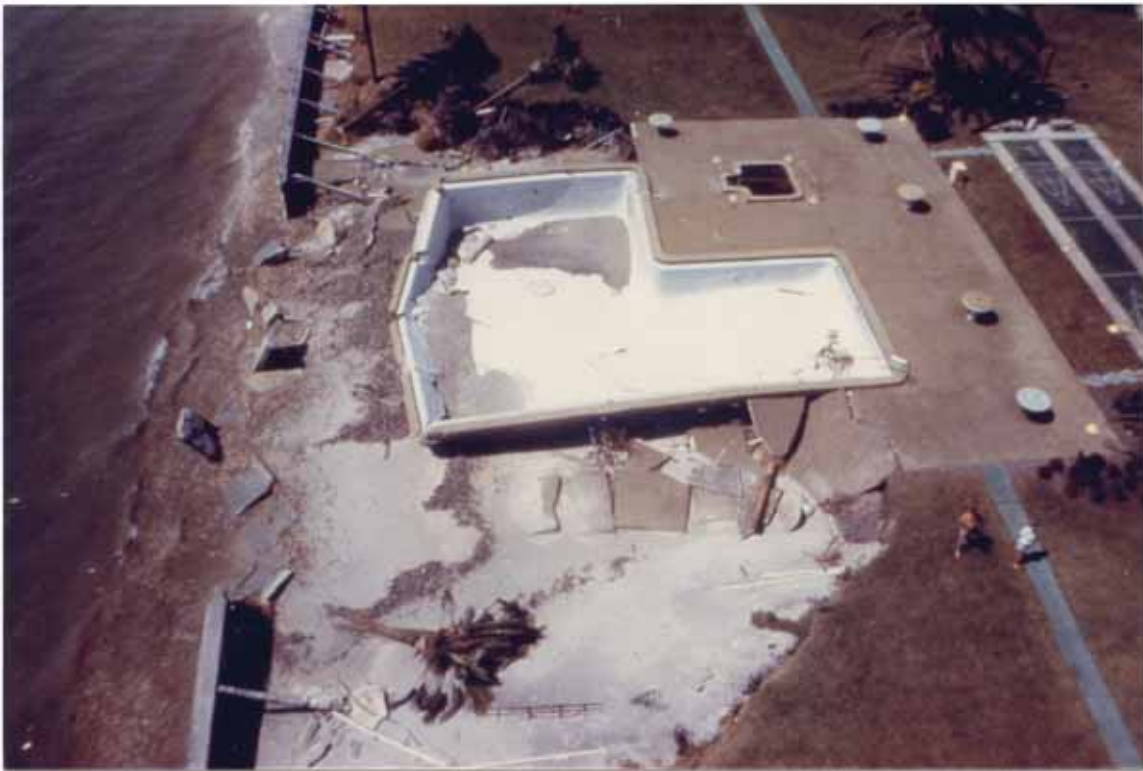
FIGURE 115. Wall and pool destroyed, Shore Mariner Condominium

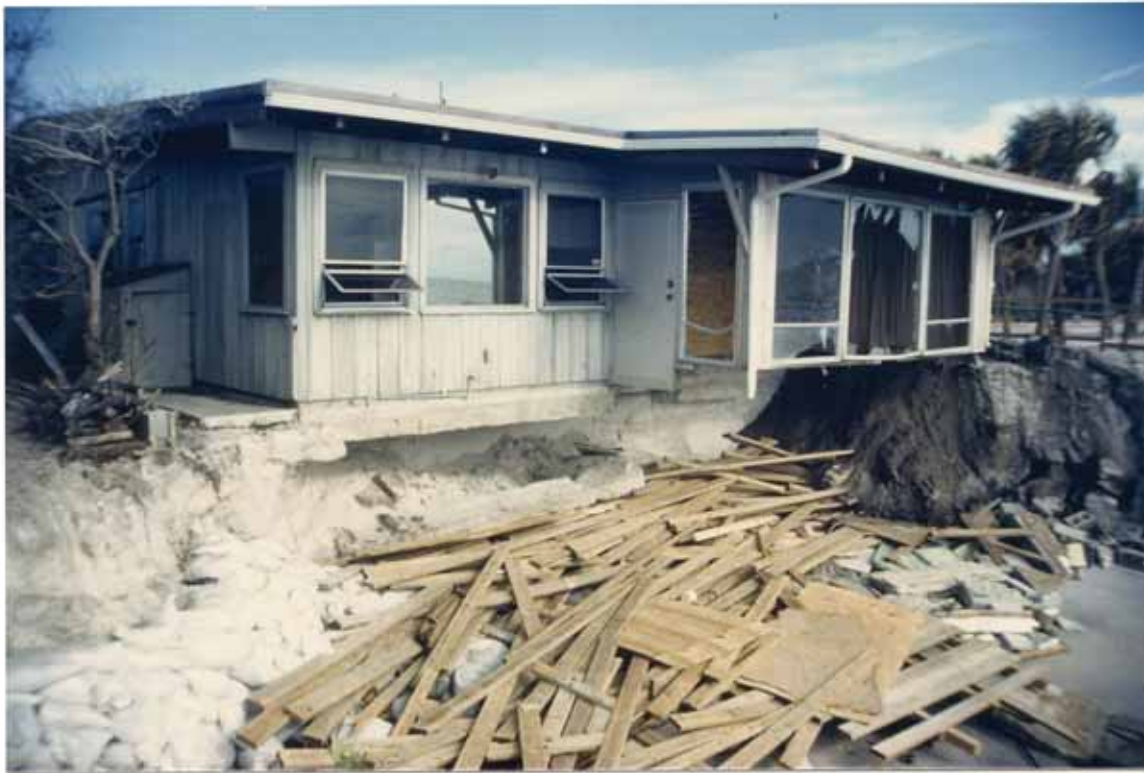
FIGURE 117. Redington Shores dwelling damaged by Juan

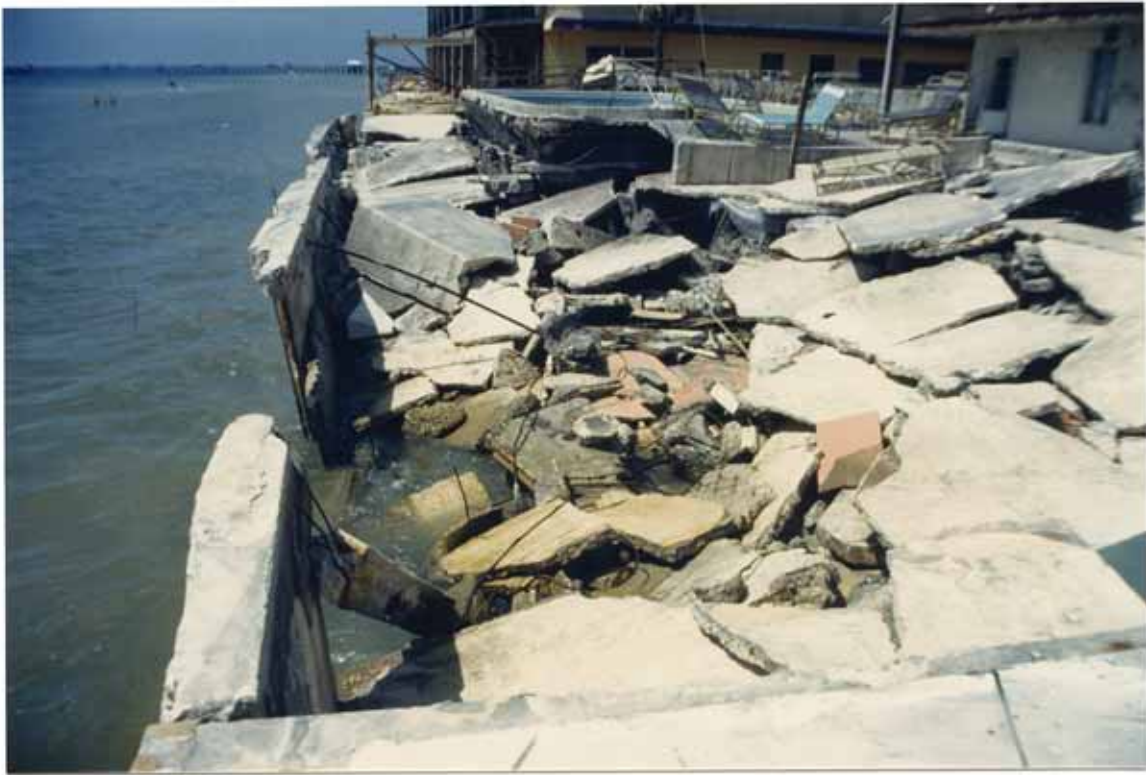
FIGURE 119. Flagship property damage after Elena

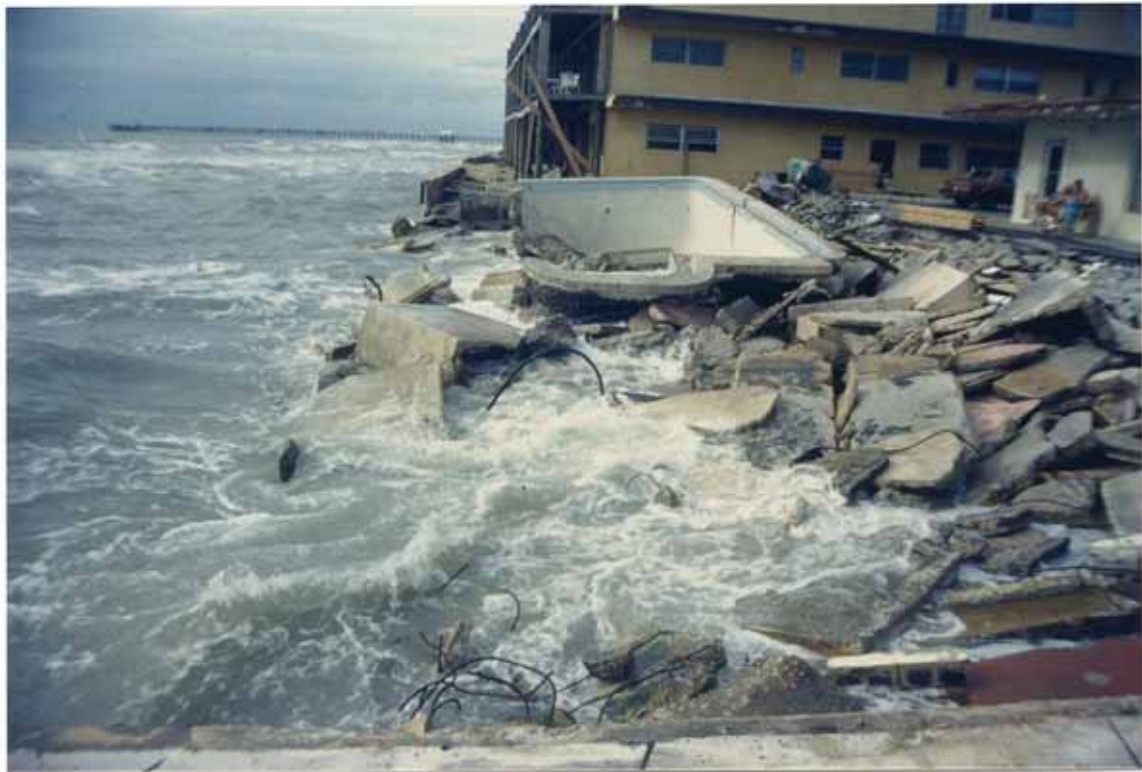
FIGURE 120. Additional damage and pool destroyed by Juan

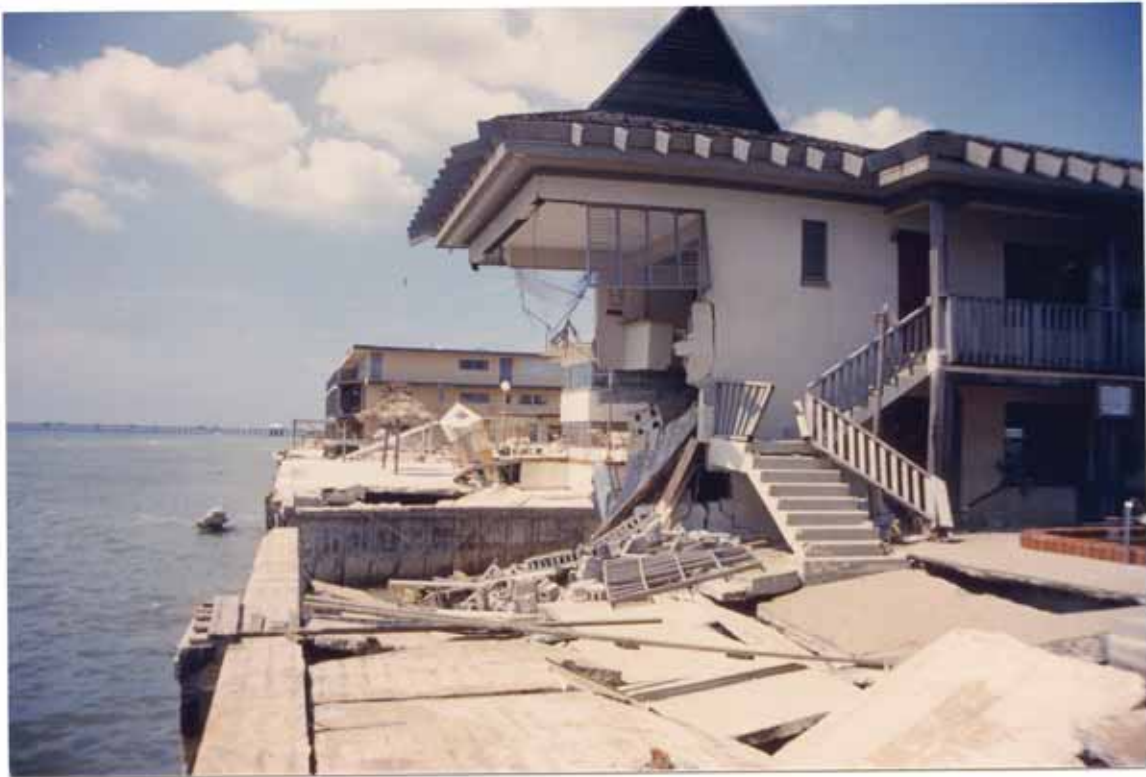
FIGURE 121. The Islander after Elena's damage

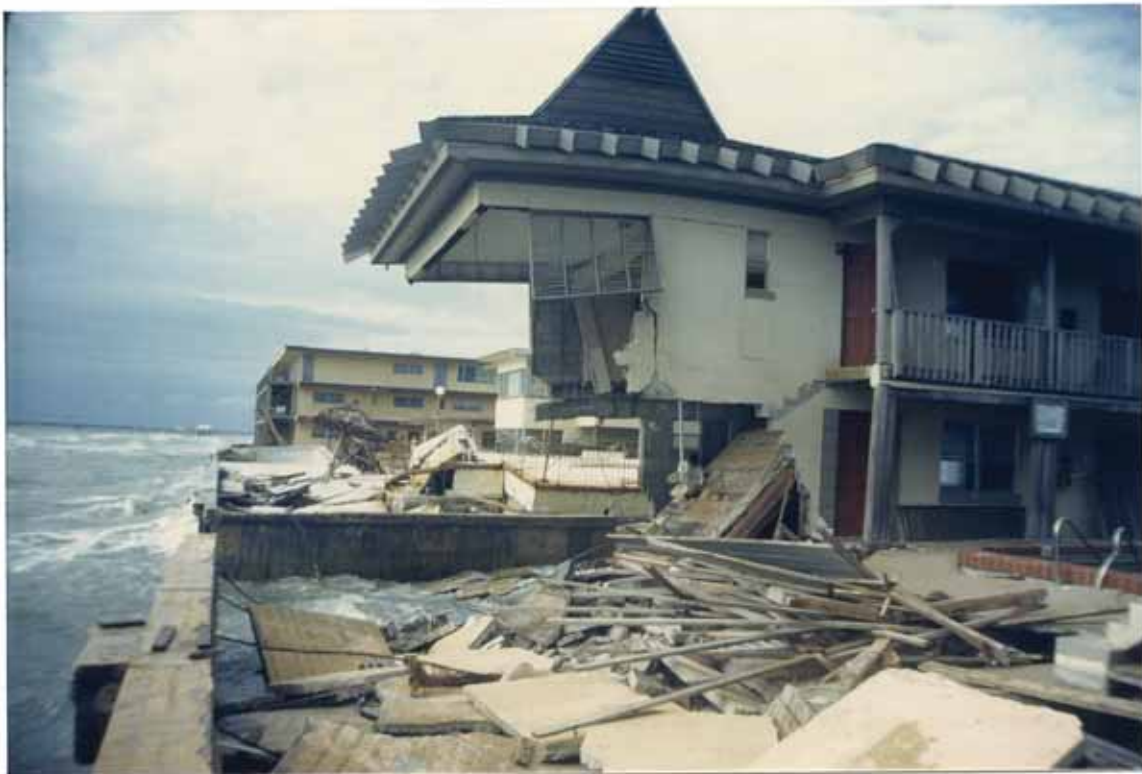
FIGURE 122. The Islander after Juan's additional damage

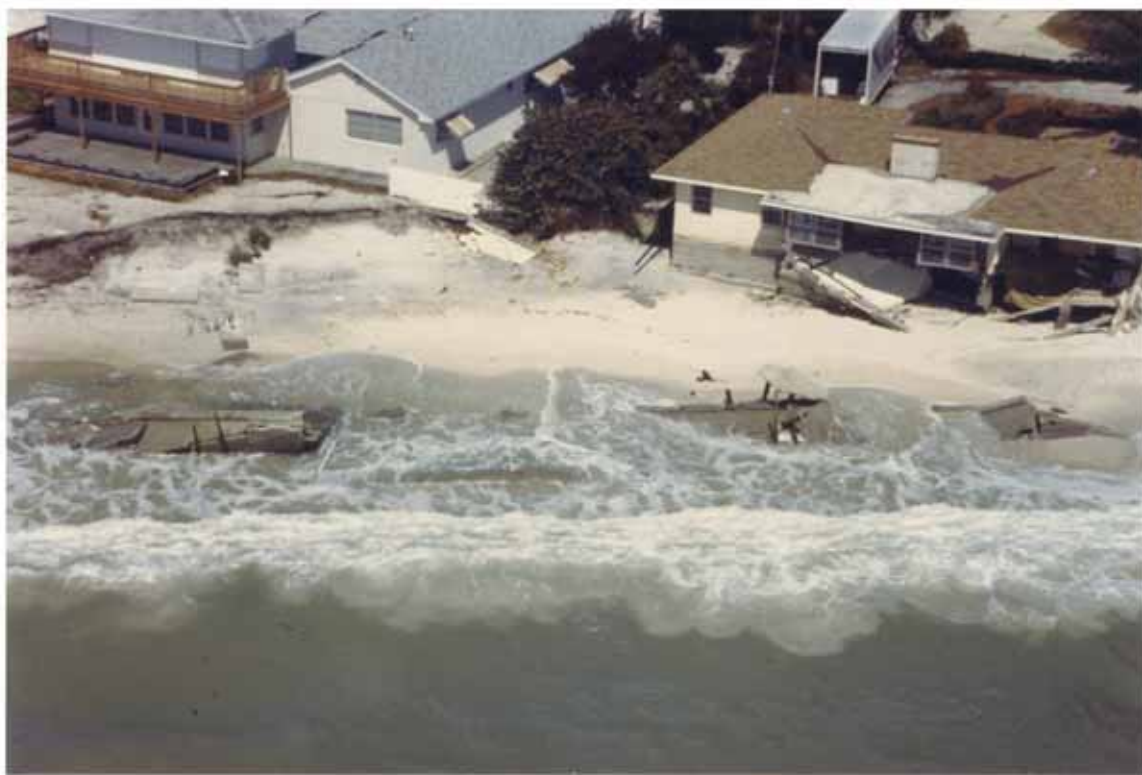
FIGURE 128. Dwelling damaged by Elena

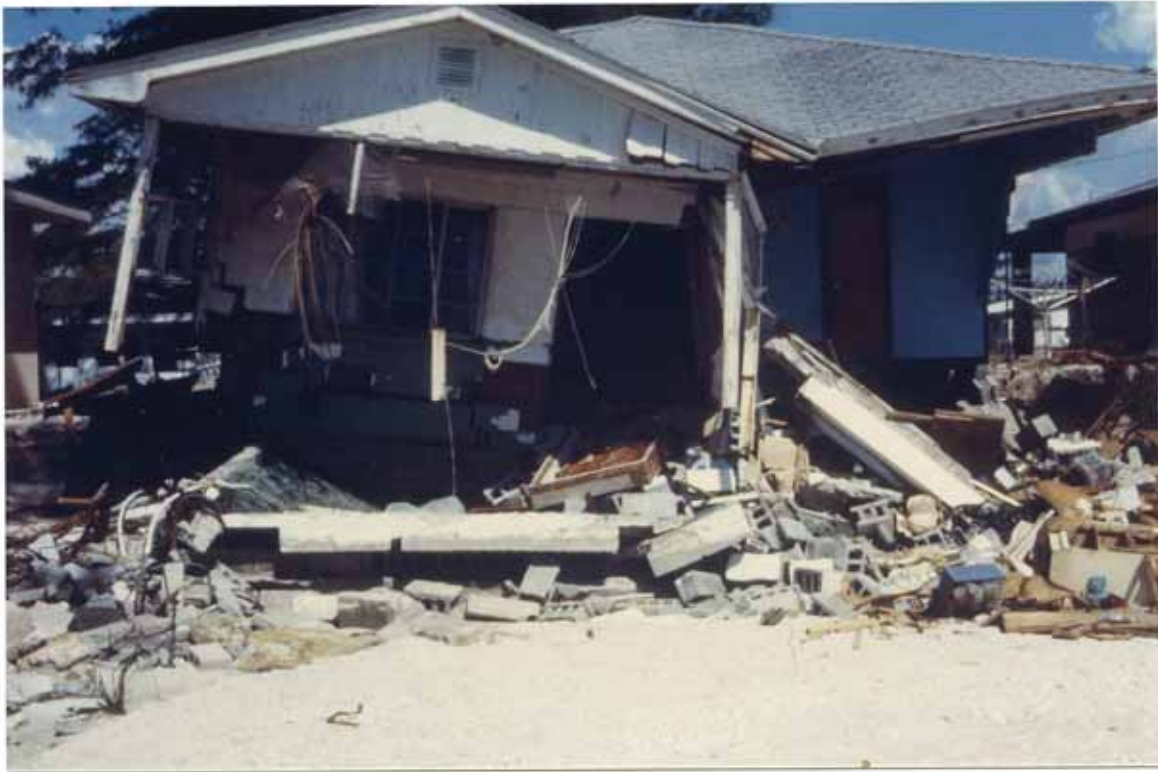
FIGURE 131. Holmes Beach dwelling destroyed by Elena (S. West)

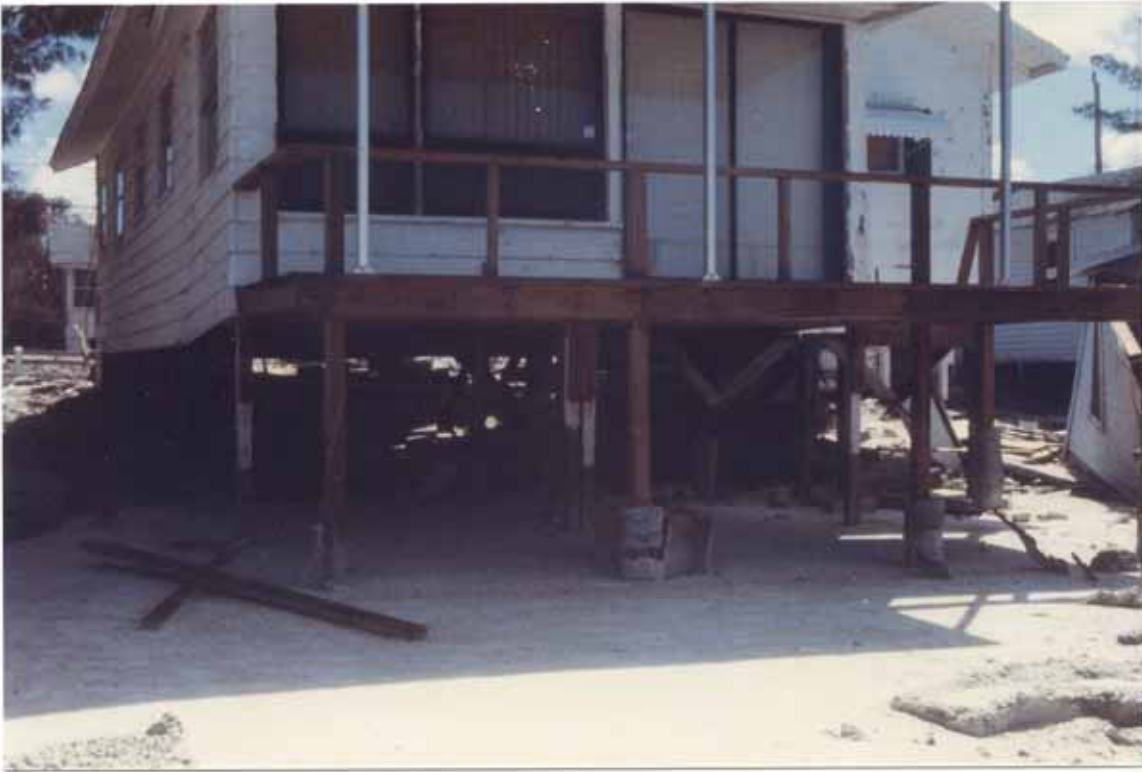
FIGURE 137. Bradenton Beach dwelling damaged by Elena (S. West)

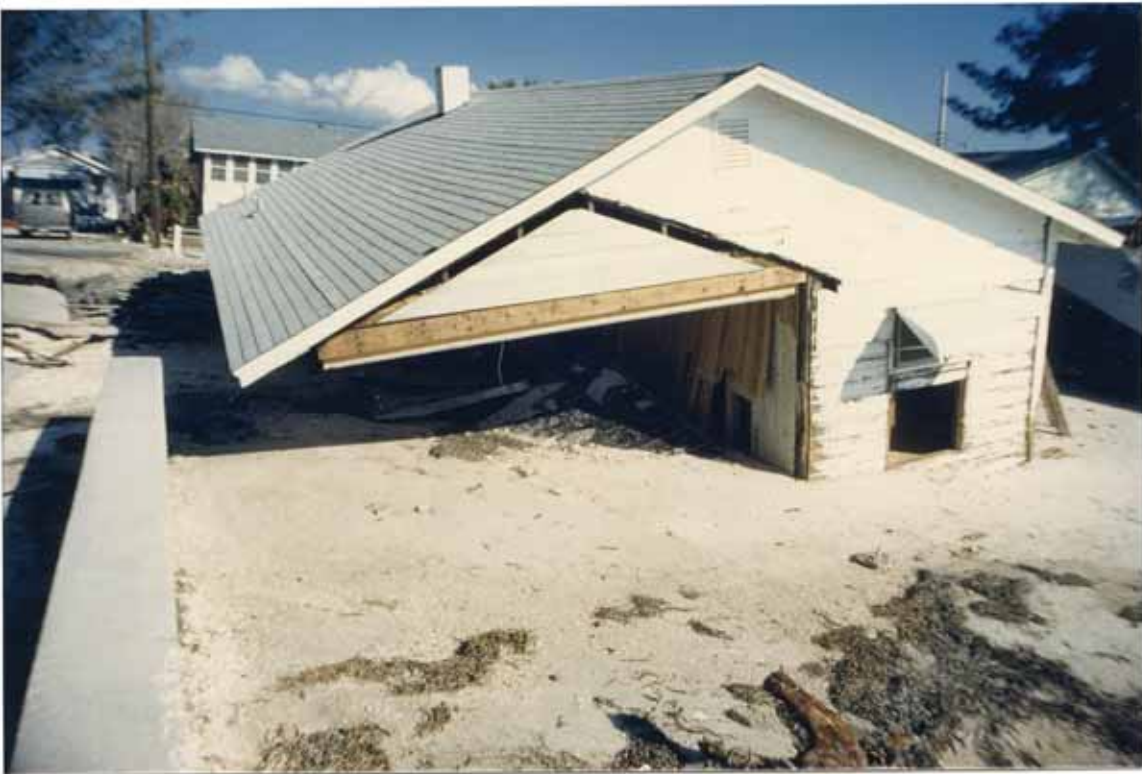
FIGURE 138. Same dwelling destroyed by Juan

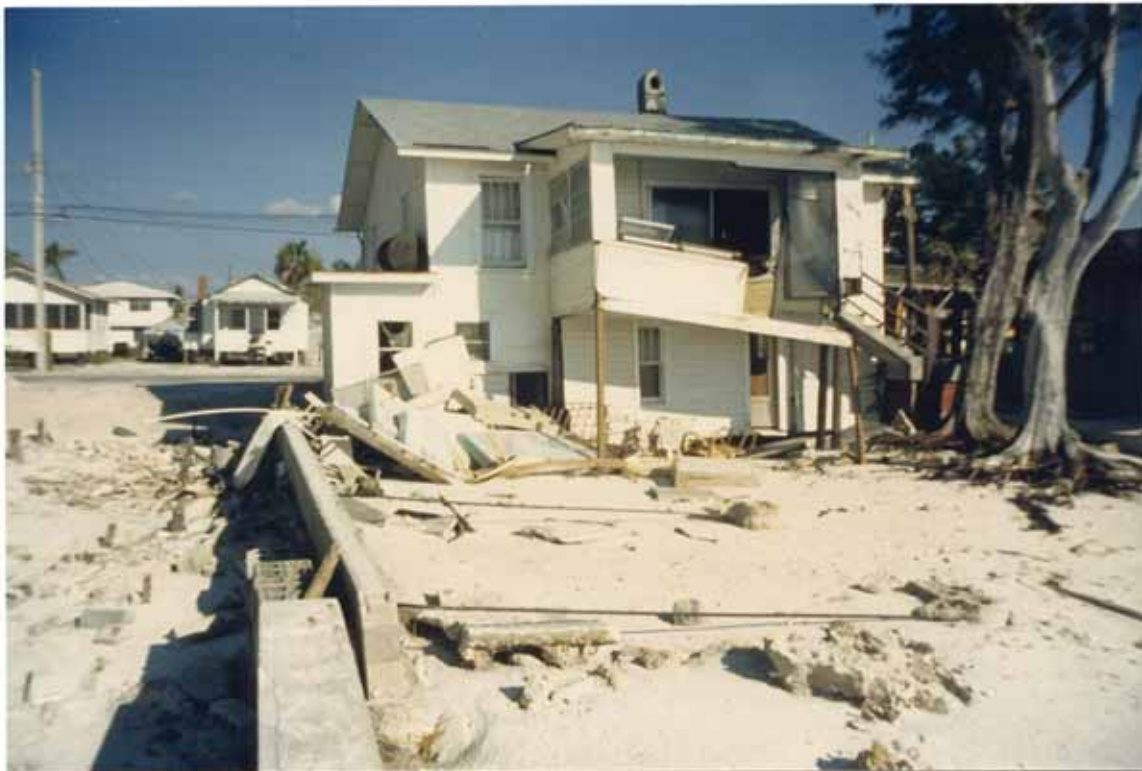
FIGURE 140. Dwelling damaged and settled

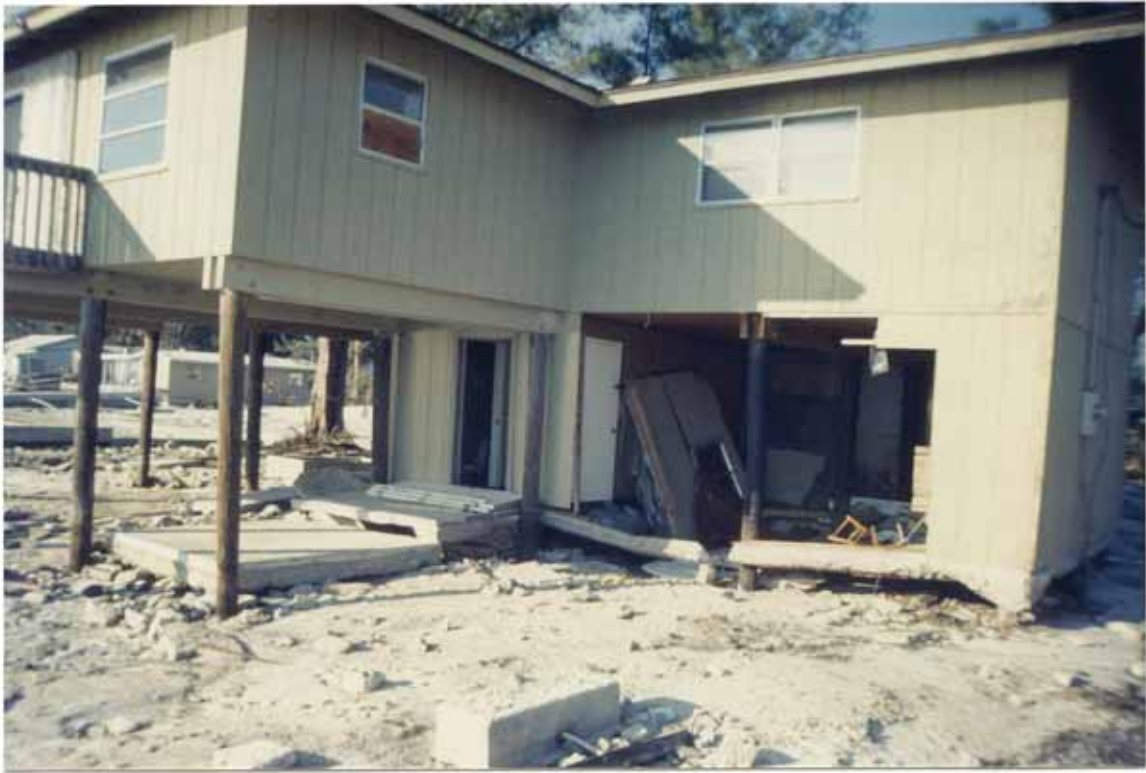
FIGURE 141. Subfloor damage to Longboat Key dwelling

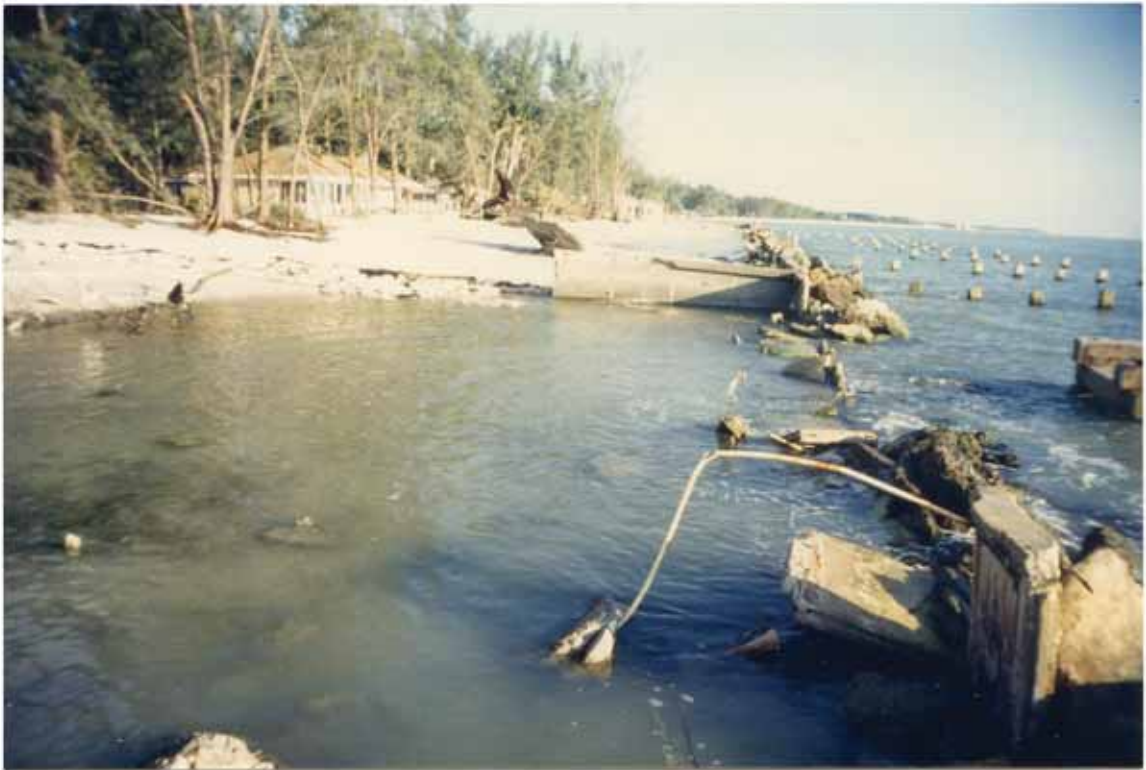
FIGURE 142. Juan destroyed 700 feet of bulkheads

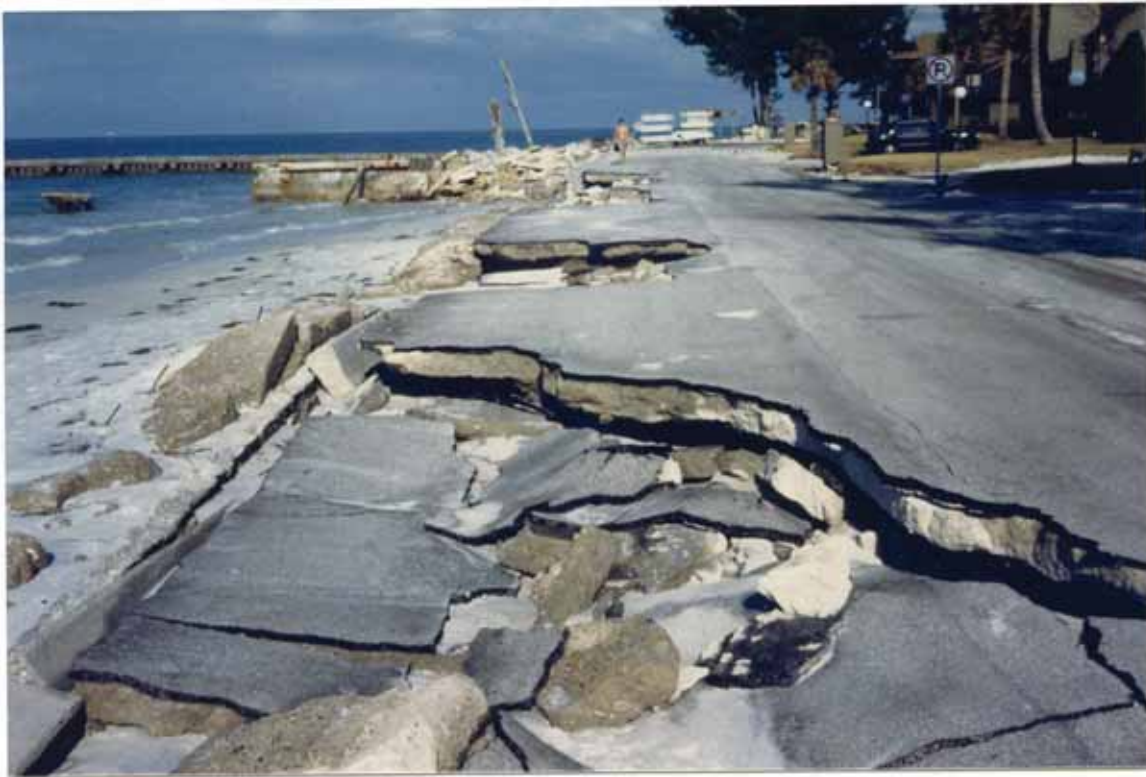
FIGURE 151. Beach Road damaged on Siesta Key (S. West)

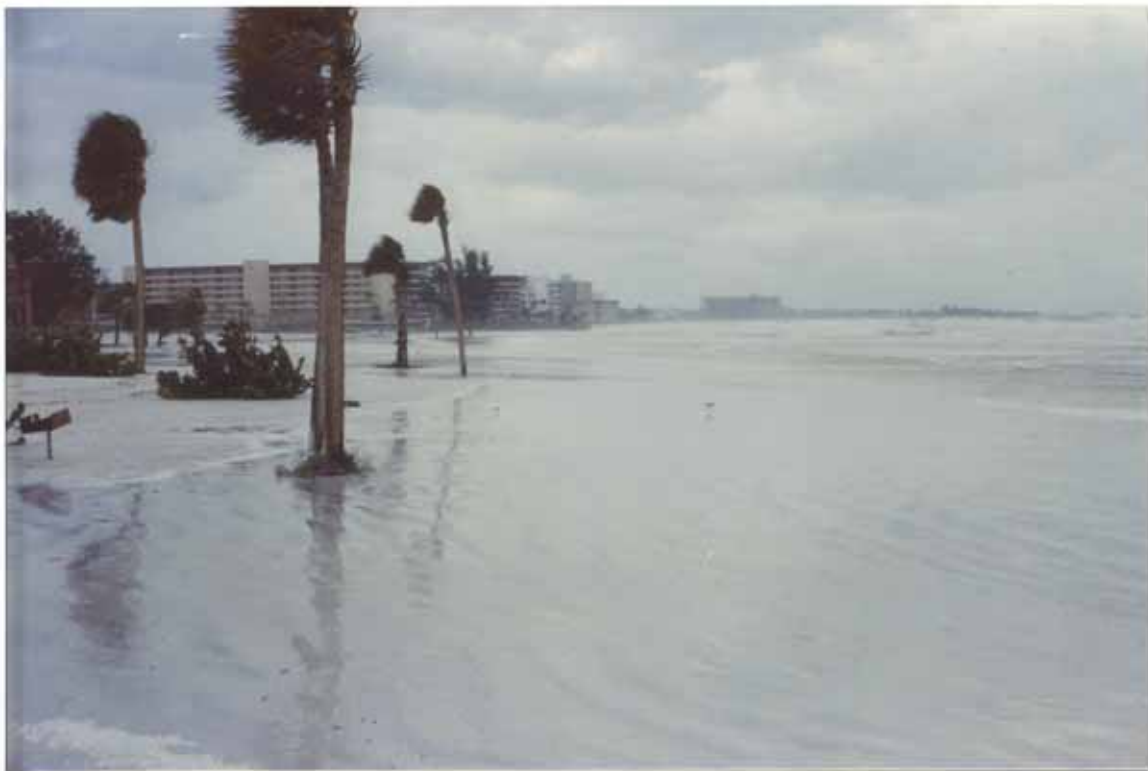
FIGURE 152. Siesta Key flooding during Elena (S. West)

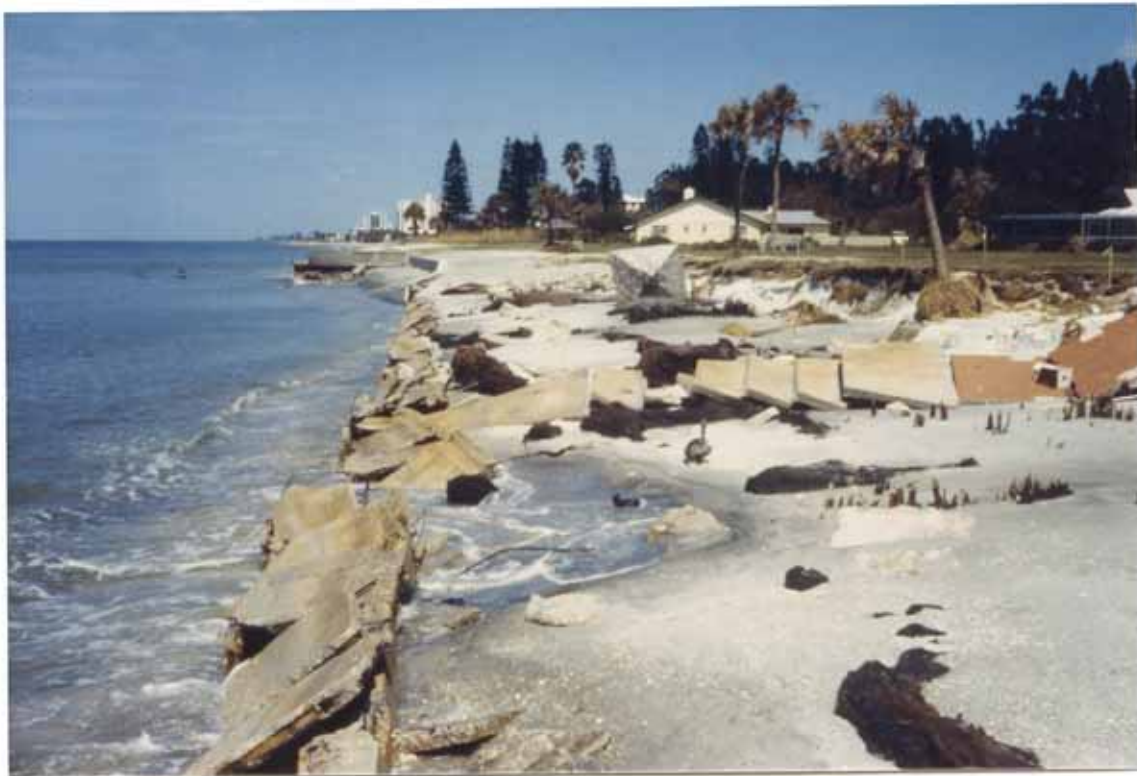
FIGURE 154. Elena destroyed Venice bulkhead (S. West)
