# ***HURRICANE IVAN***

## **BEACH AND DUNE EROSION AND STRUCTURAL DAMAGE ASSESSMENT AND POST-STORM RECOVERY PLAN FOR THE PANHANDLE COAST OF FLORIDA**

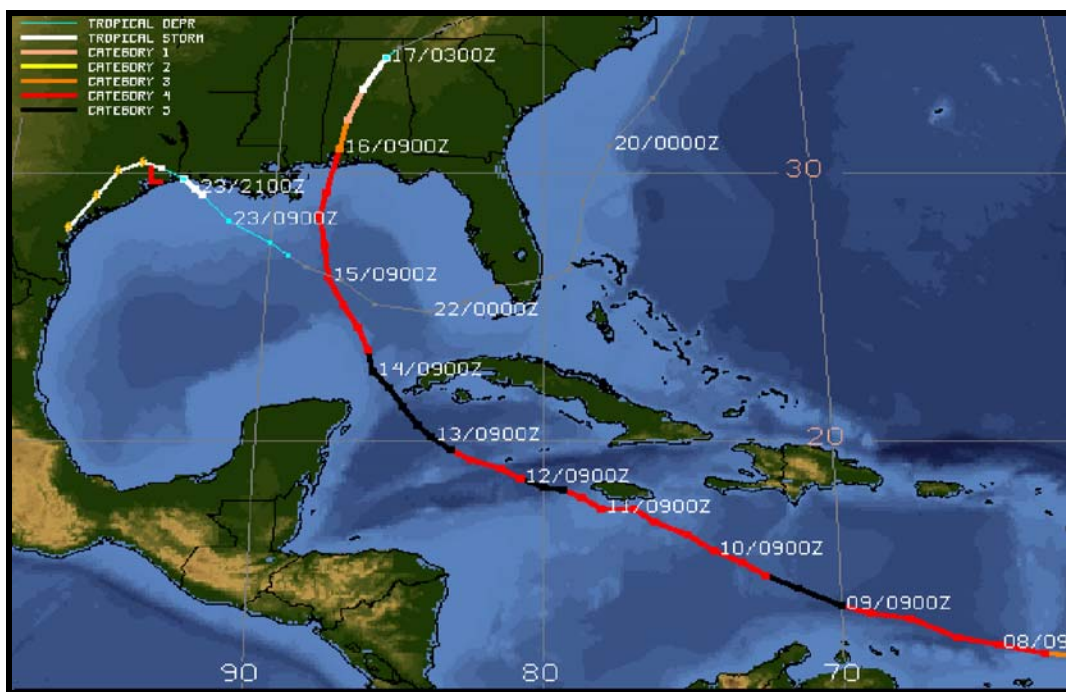
Figure 1. Hurricane Ivan made initial landfall just west of the Florida Panhandle Coast (Source: NOAA / NCEP / Tropical Prediction Center).

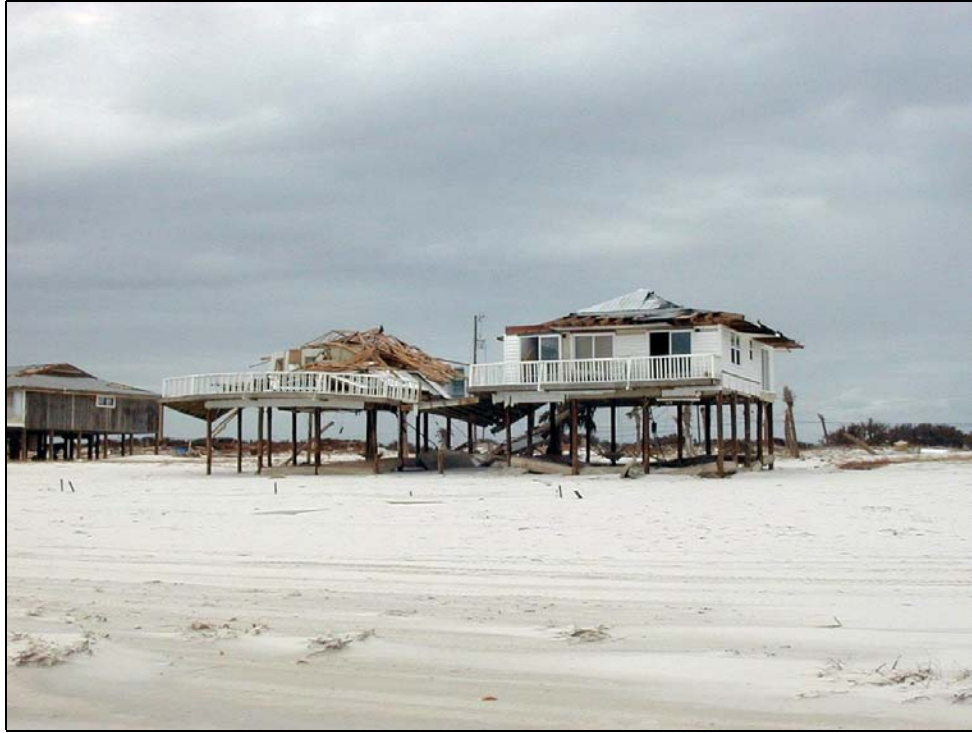
Photo ES-1. Destroyed single-family dwelling at R9 (-200') on Perdido Key.

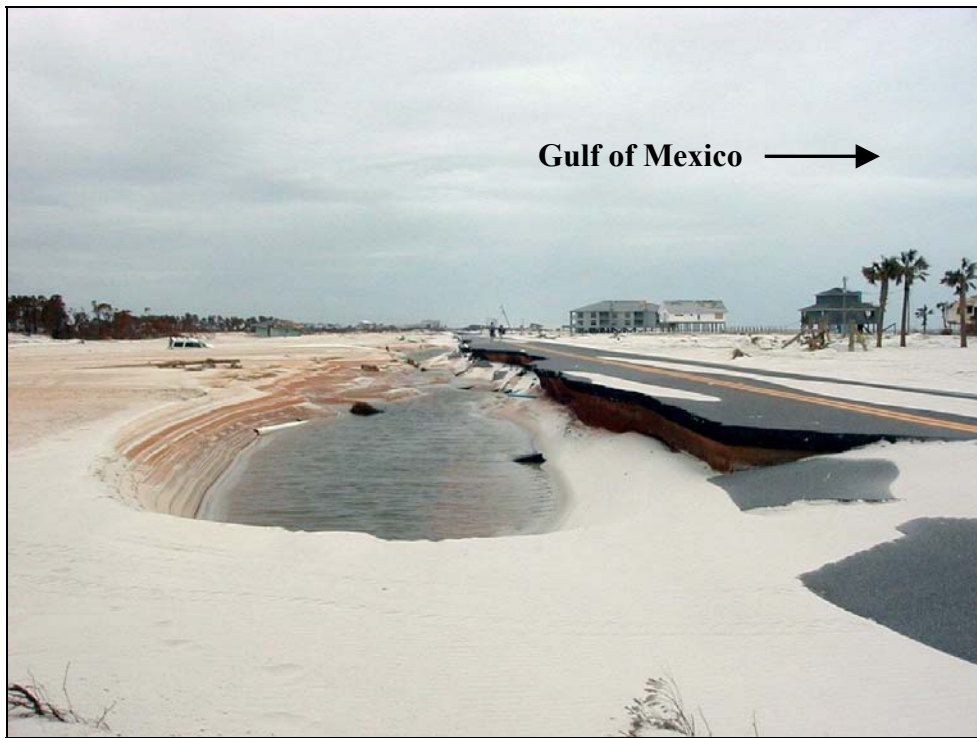
Photo ES-2. Damage to Perdido Key Dr. (C.R. 292) between R11 and R13 on Perdido Key.

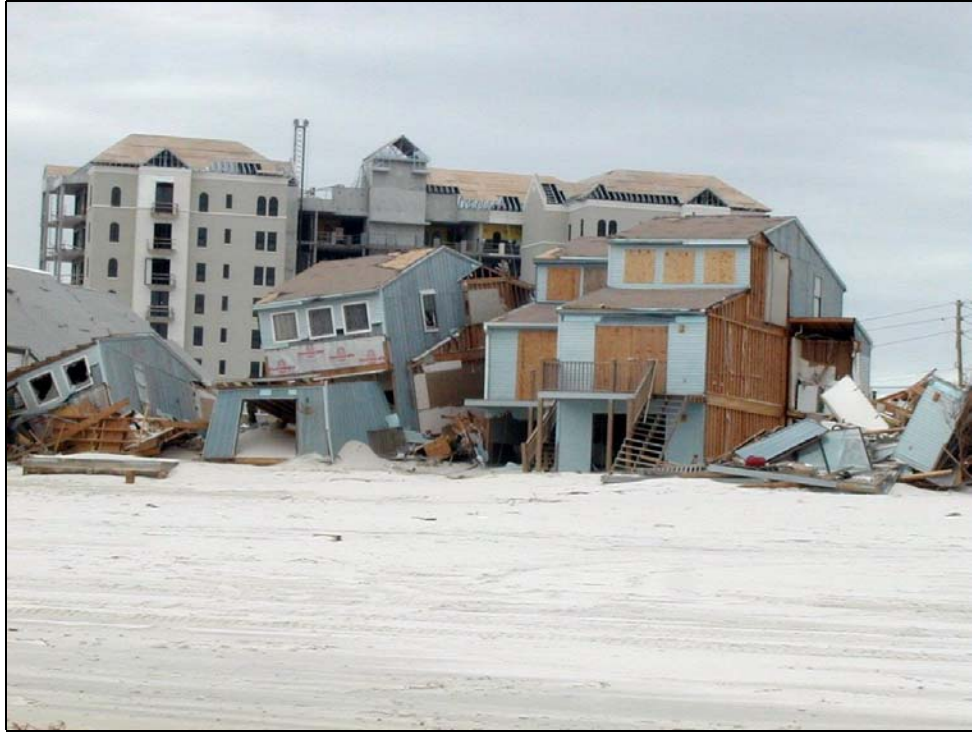
Photo ES-3. Destroyed multi-family dwellings at R22 (+450') on Perdido Key.

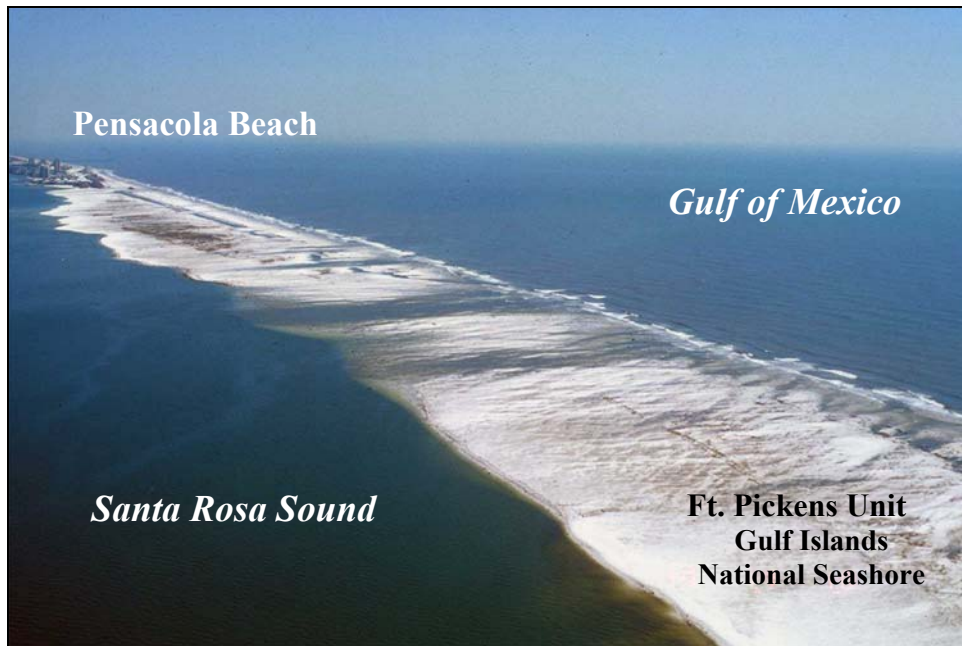
ES-5. Extensive overwash and barrier island breaching at Gulf Islands National Seashore. (photo obtained by U.S.G.S.; provided to FDEP courtesy of Olsen Associates, Inc.)

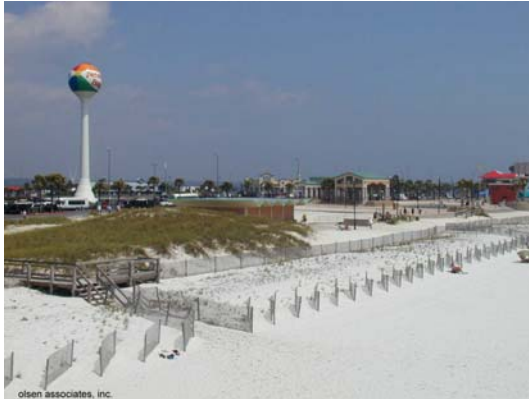
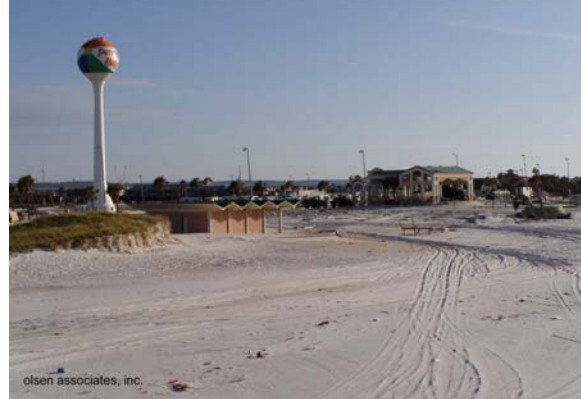
Photos ES-6 and ES-7. Pre-Ivan view (left; 04/06/04) vs. post-Ivan view (right; 09/21/04) depict beach and dune erosional losses in Pensacola Beach (courtesy, Olsen Associates, Inc.)

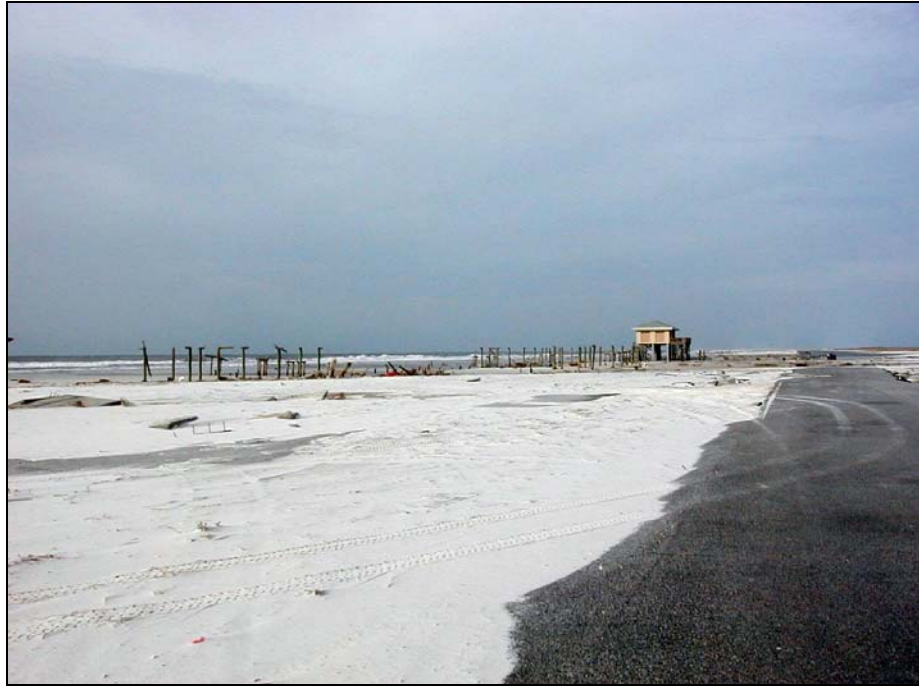
Photo ES-8. Remnants of destroyed public picnic shelters at R108 in Pensacola Beach.

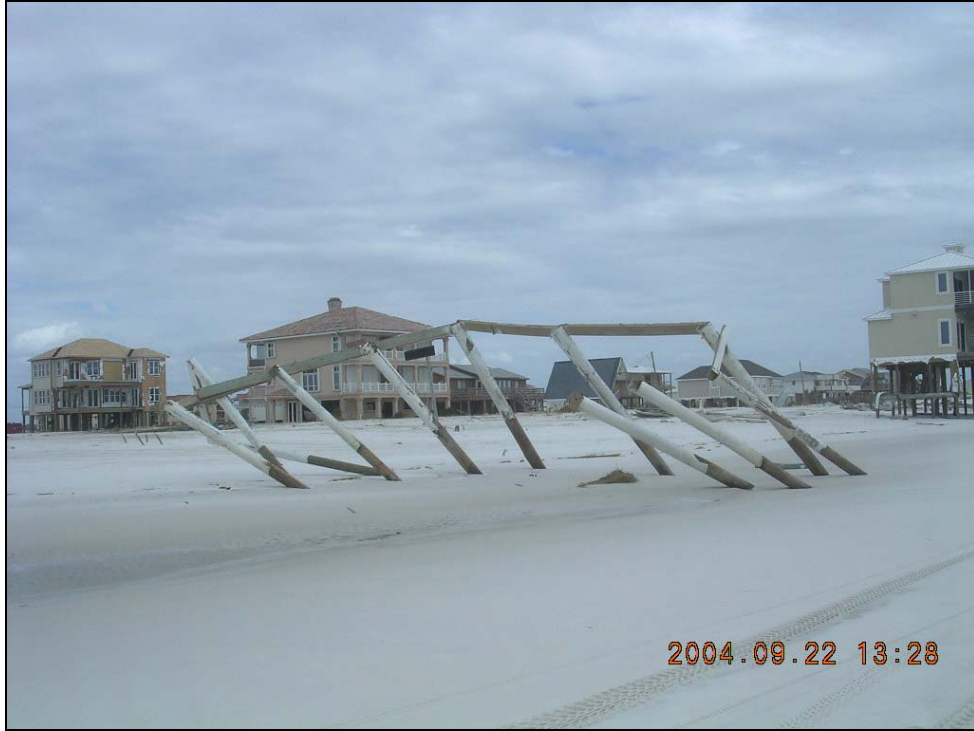
Photo SR-1. Remains of destroyed single-family dwelling at R194 (-100') in Navarre Beach.

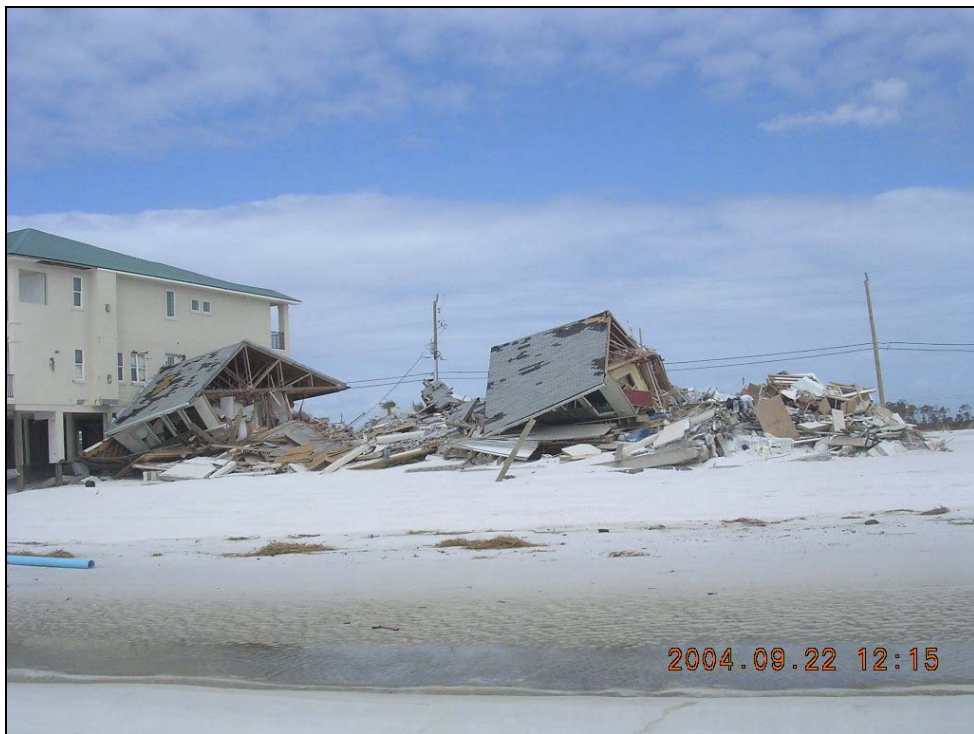
Photo SR-2. Destroyed single-family dwellings near R200 (+700') in Navarre Beach adjacent to better designed dwelling that survived major damage from Ivan.

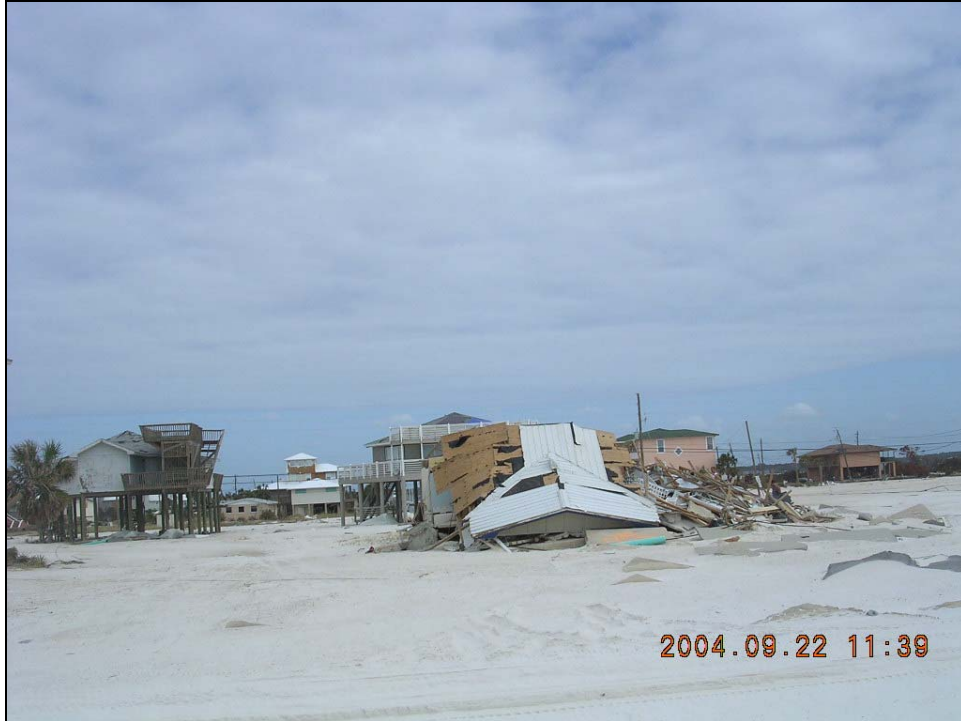
Photo SR-3. Destroyed single-family dwelling at R204 (+500') in Navarre Beach.

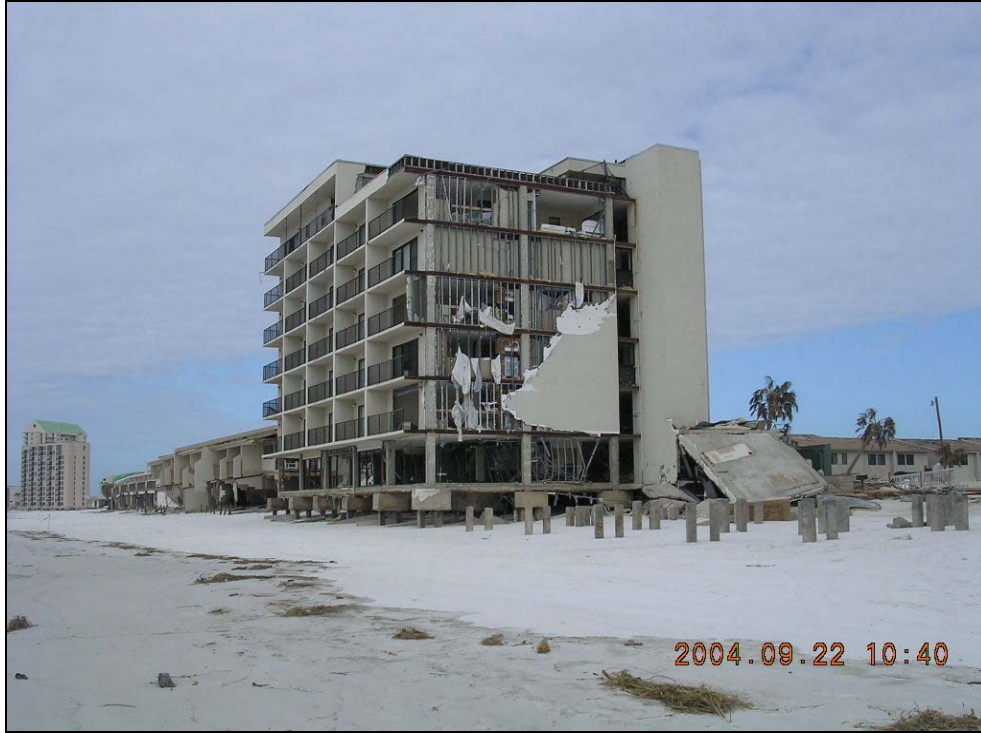
Photo SR-5. Multi-family dwelling with major damage near R208 in Navarre Beach.

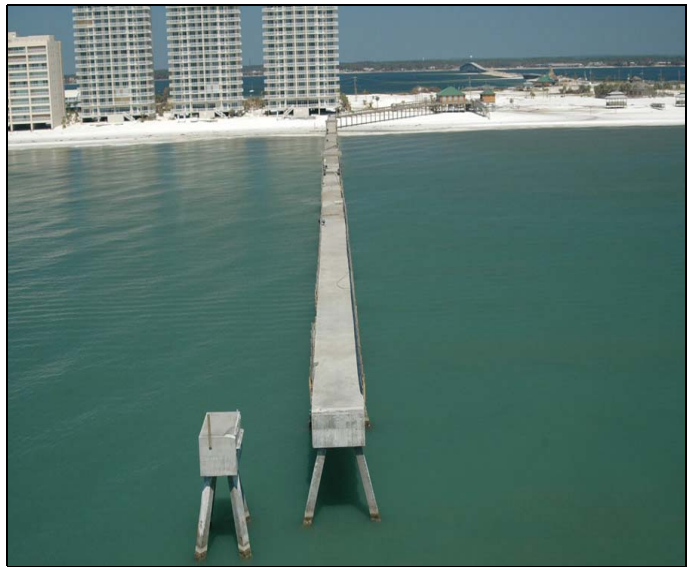
Post-Ivan (09-18-04)

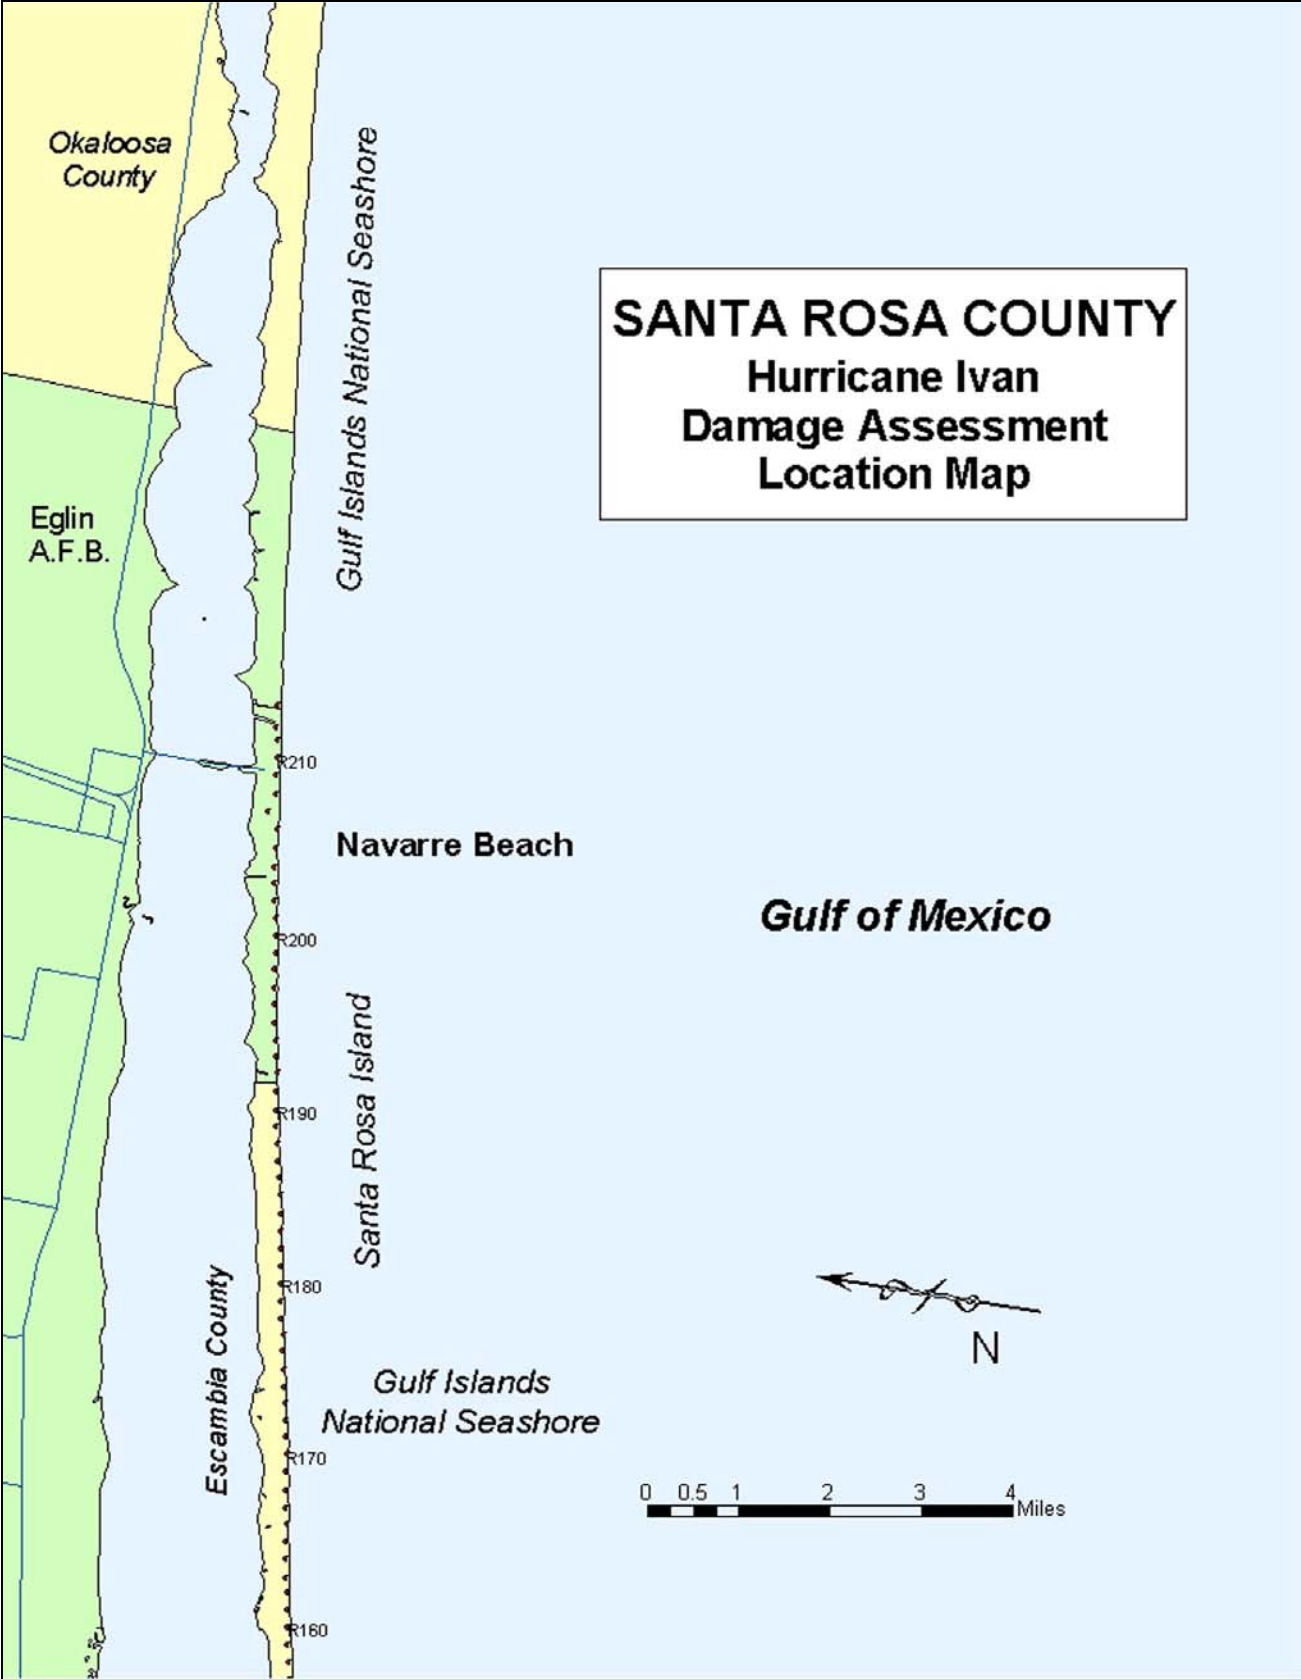
## **Okaloosa County**

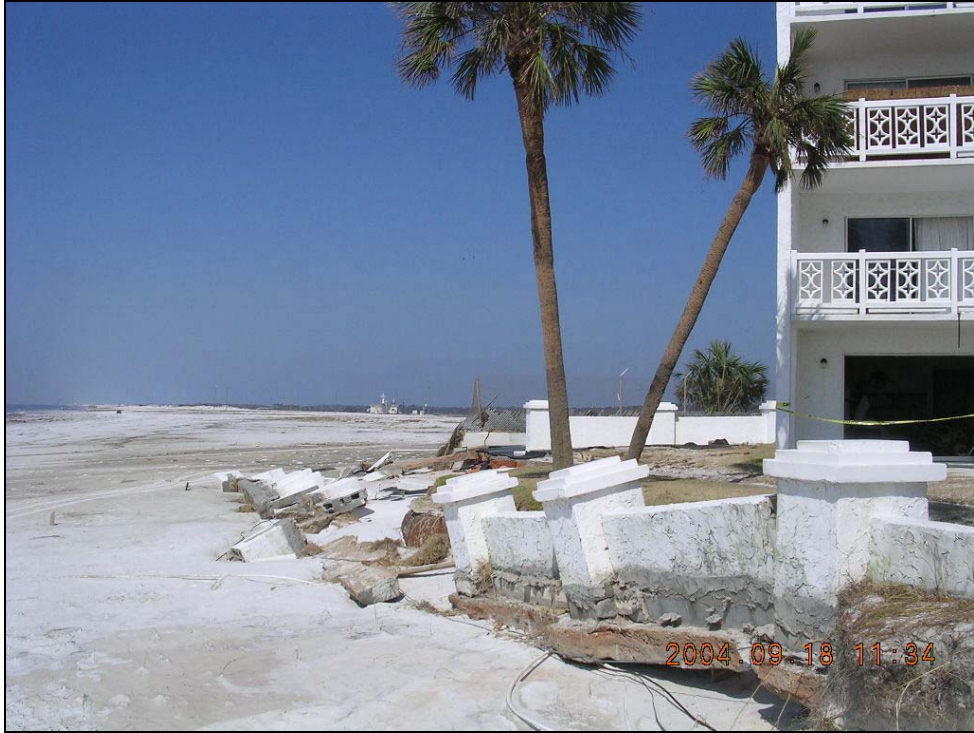
Photo OK-1. Damage to decorative wall and lower floor on Okaloosa Island near R1.

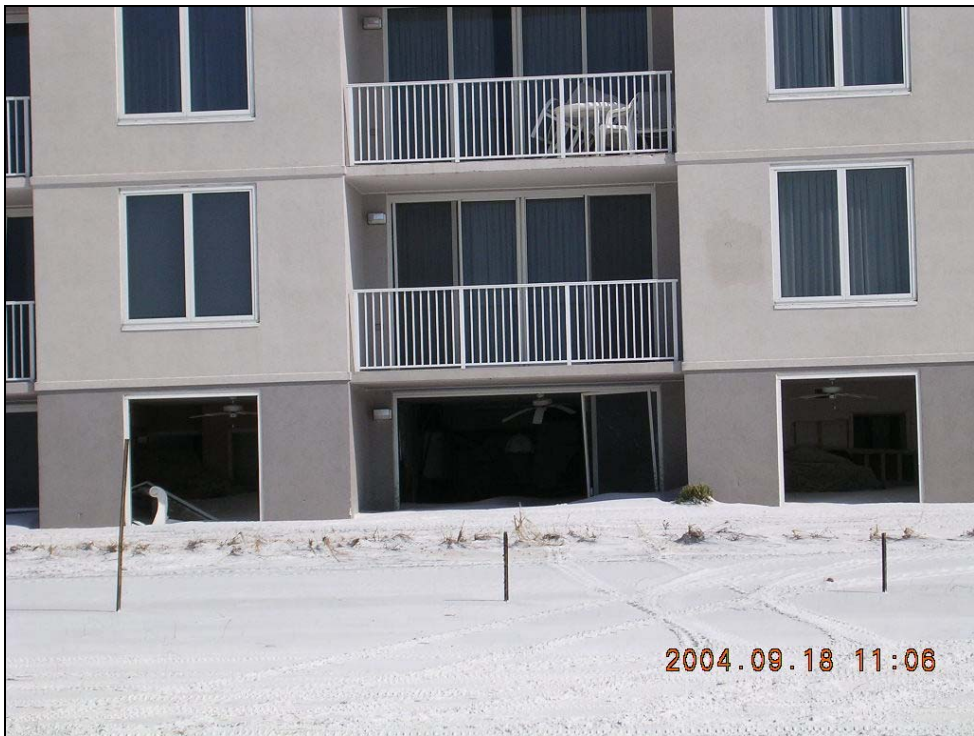
Photo OK-2. Overwash sand deposition and flooding damage in bottom floor areas near R1.

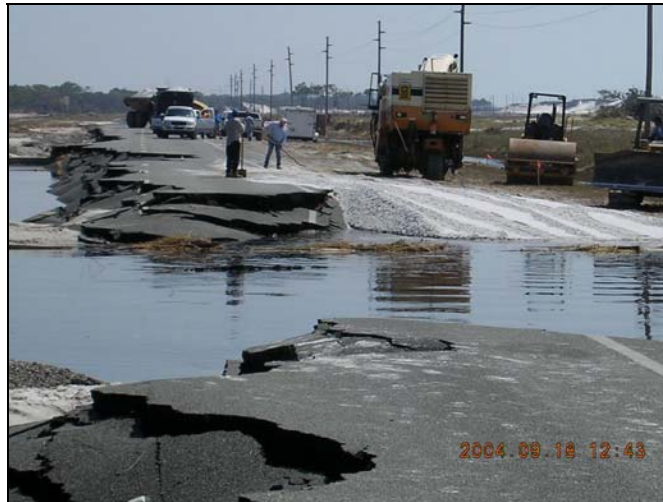
Photo OK-3. Damage to Highway 98 between Destin and Ft. Walton Beach.

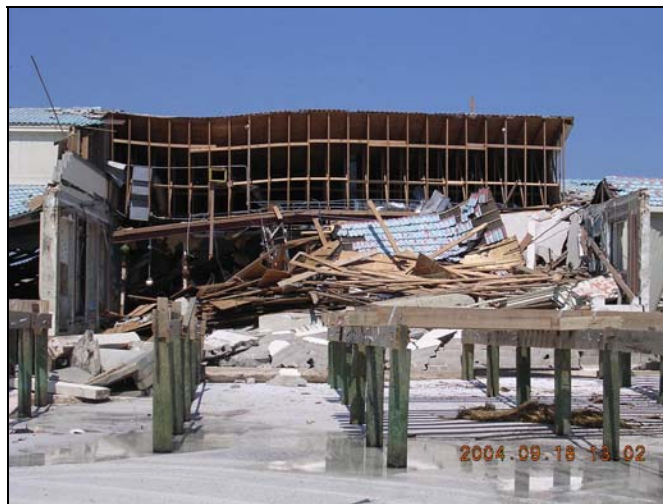
Photo OK-4. Destroyed beach club building; Eglin Air Force Base; east Santa Rosa Island

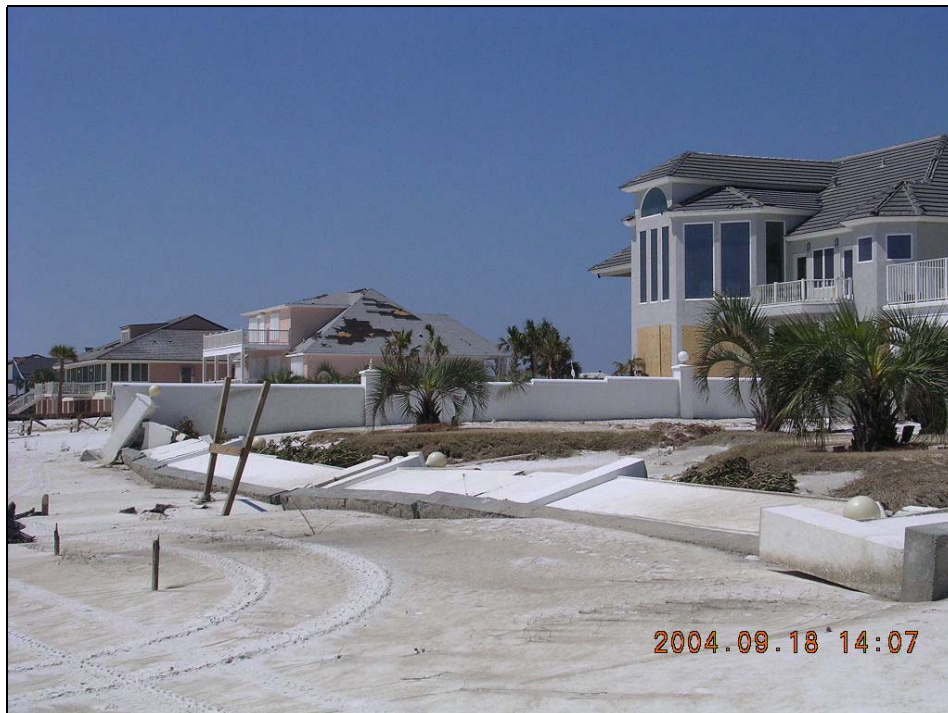
Photo OK-7. Overwash and decorative wall damage near R22 in Destin.

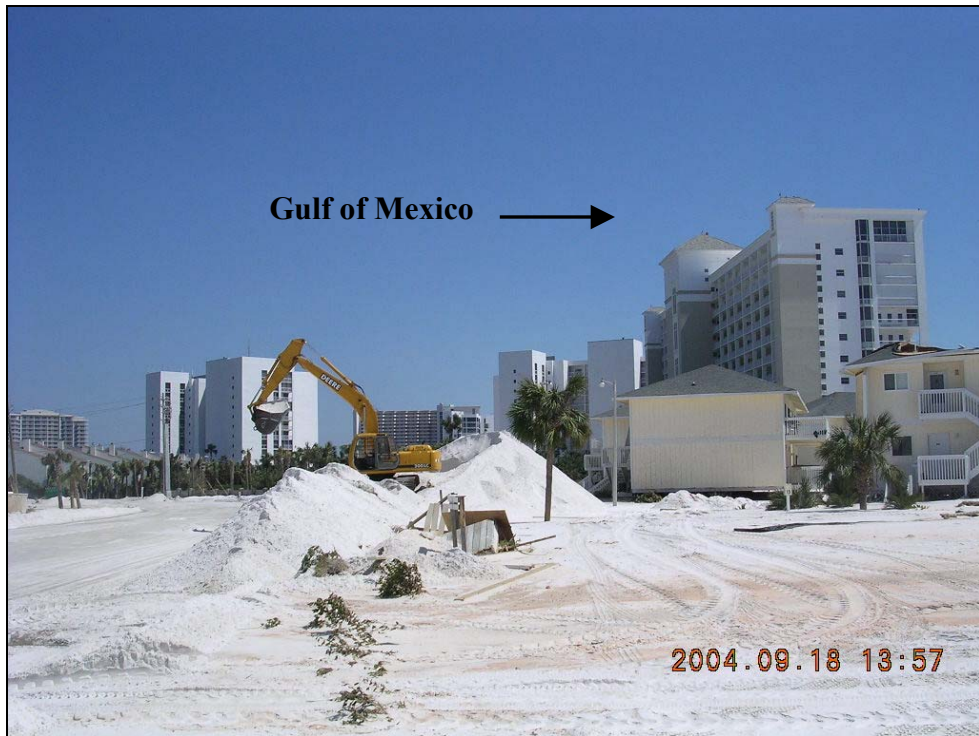
Photo OK-8. Extensive overflow of beach sand and road clearing in Destin at R24-25.

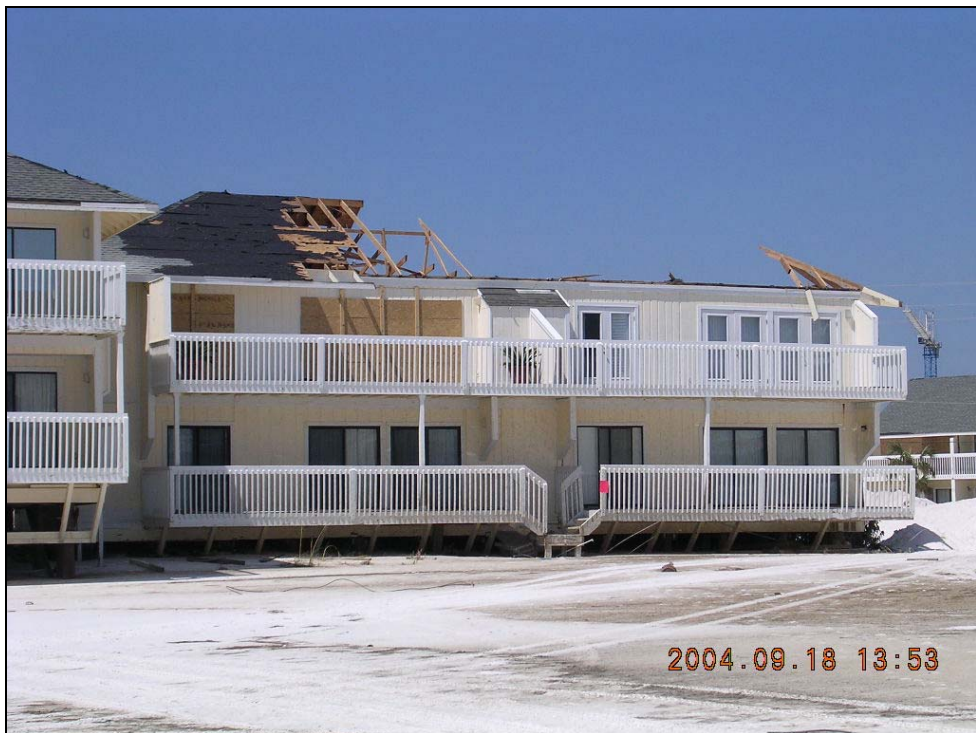
Photo OK-9. Major habitable structure damage in Destin between R24-25.

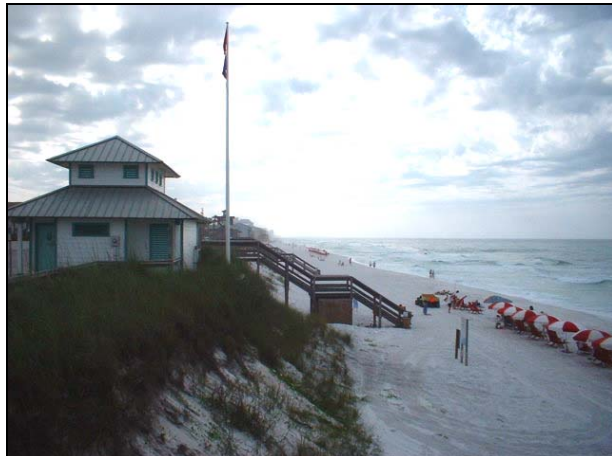
For the areas seaward of the CCCL, a total of 7 habitable structures, all multi-family structures, and a total of 4 non-habitable structures were destroyed or sustained major damage. In addition, a total of 49 habitable structures sustained moderate to minor damage to understructure areas and/or sustained moderate to minor roof damage. A total of six (6) wooden retaining wall structures were destroyed or sustained major damage. Examples by referenced location of damages in this area are shown on the photographs below and on the following pages.

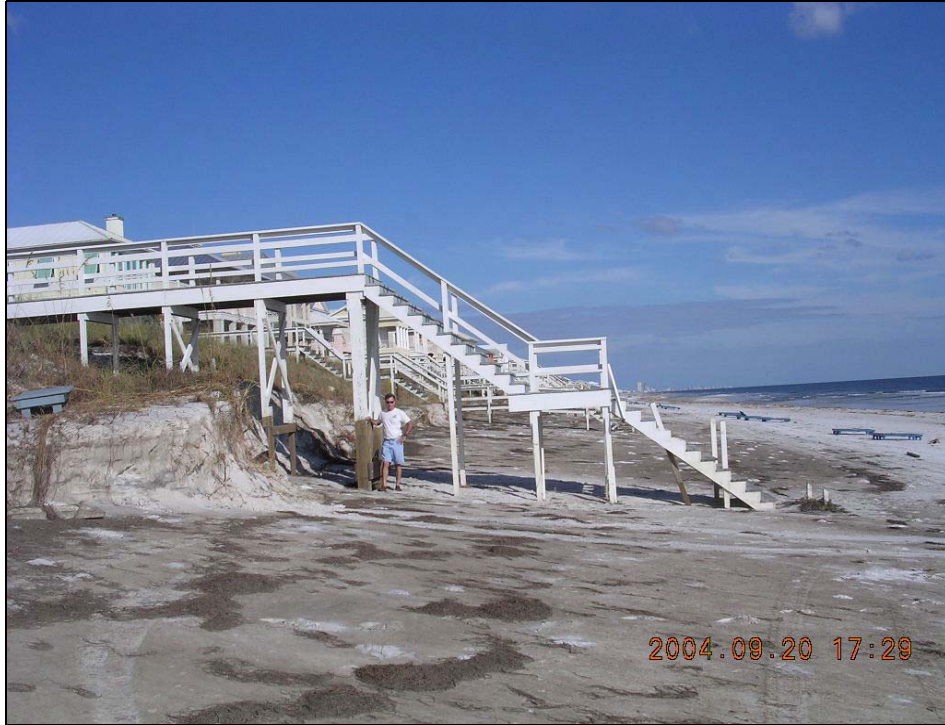
Photo BA-1. Demonstration of Condition III erosion in west Bay County at R3.

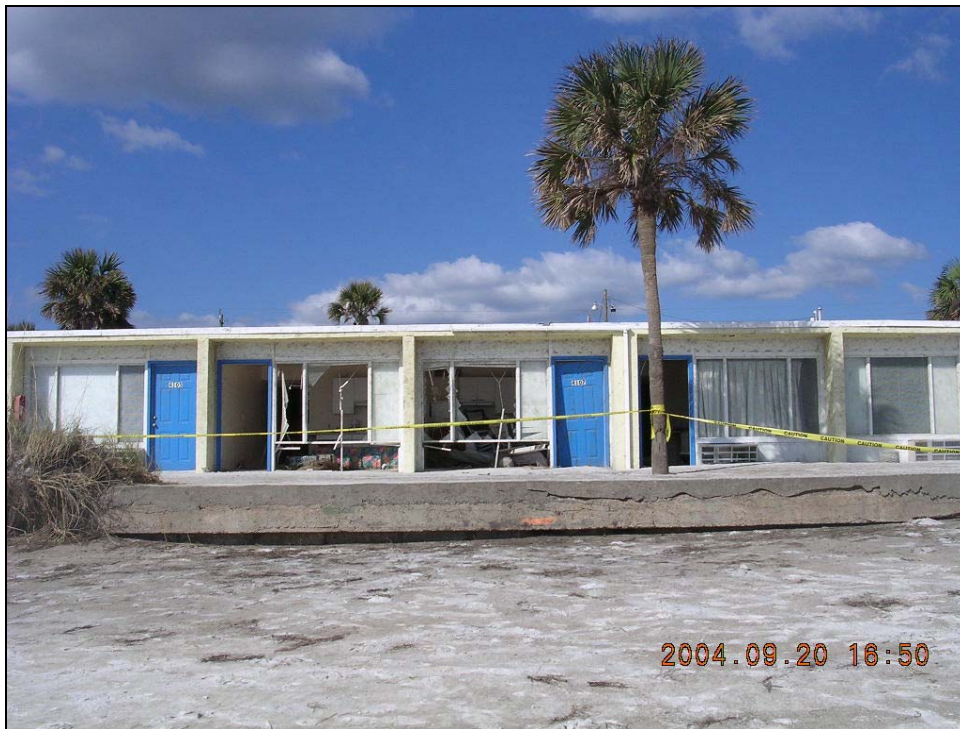
Photo BA-2. Major damage to motel structure at R22 (-400') in Bay County.

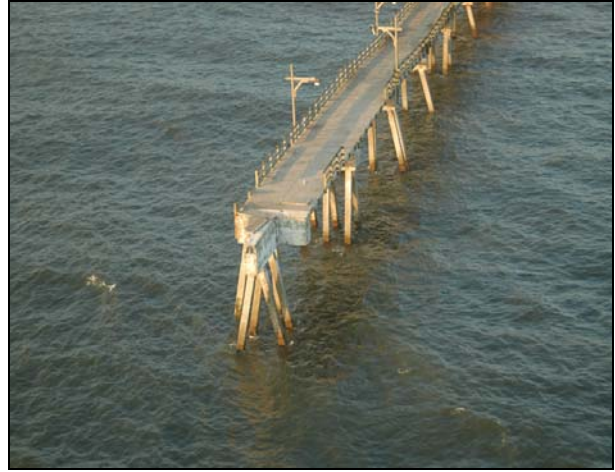
Post-Ivan (09-18-04)

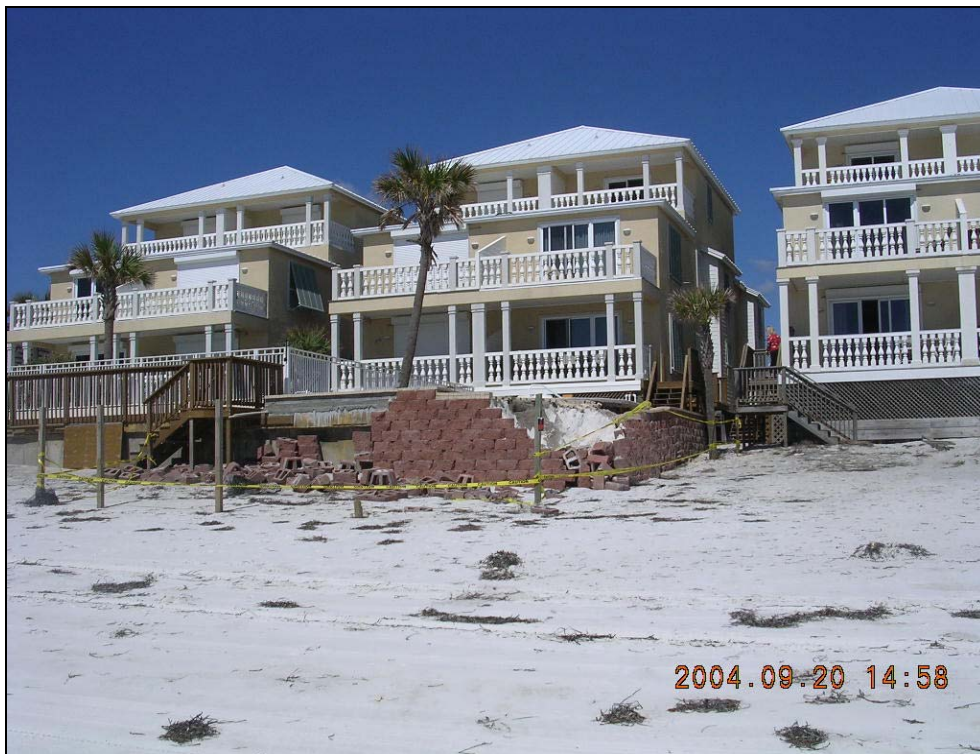
Photo BA-4. Damage to block retaining wall at R76 (+200) in Panama City Beach.

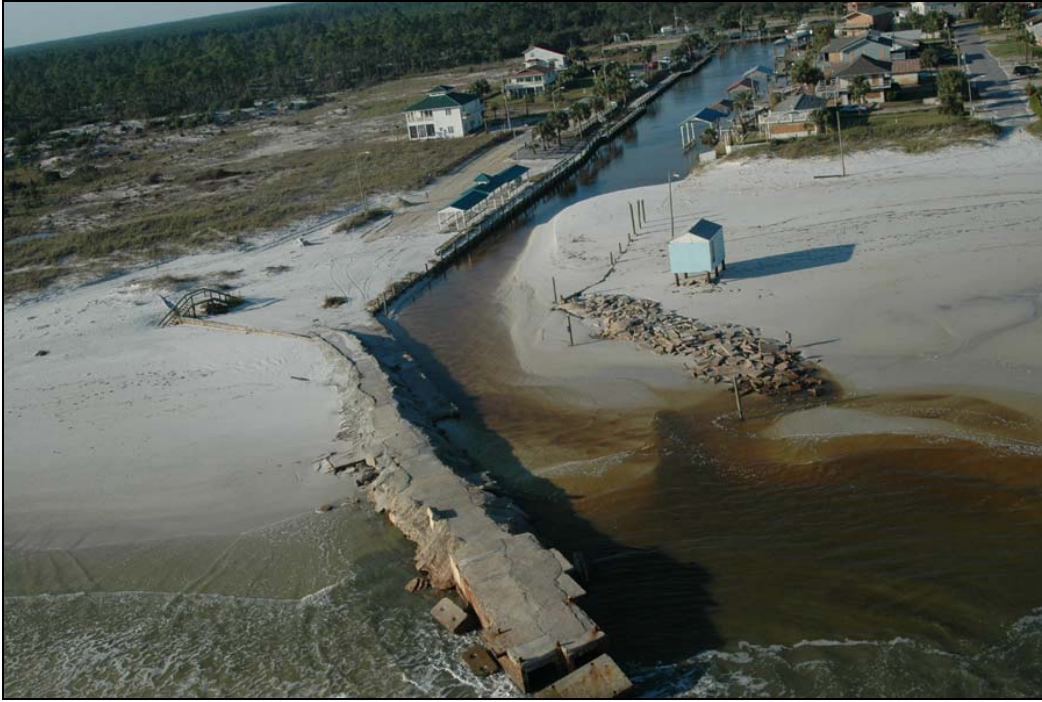
Photo BA-5. Mexico Beach Inlet impacts following Hurricane Ivan at R128 (-700').

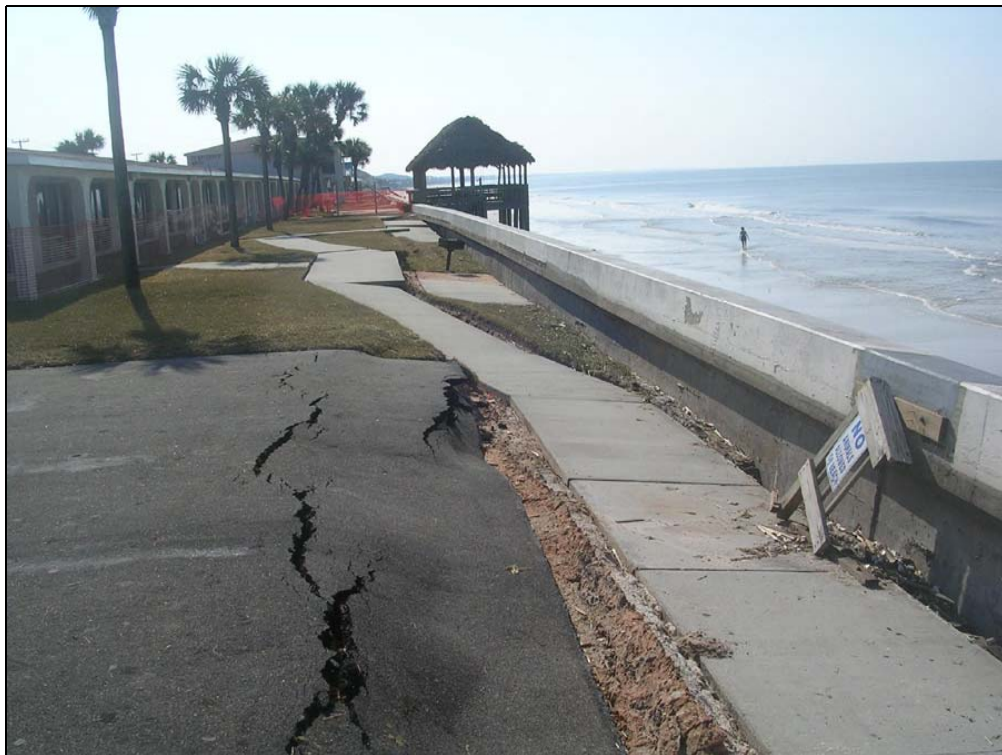
Photo BA-6. Damage to the El Governor seawall in Mexico Beach at R135 (-300').

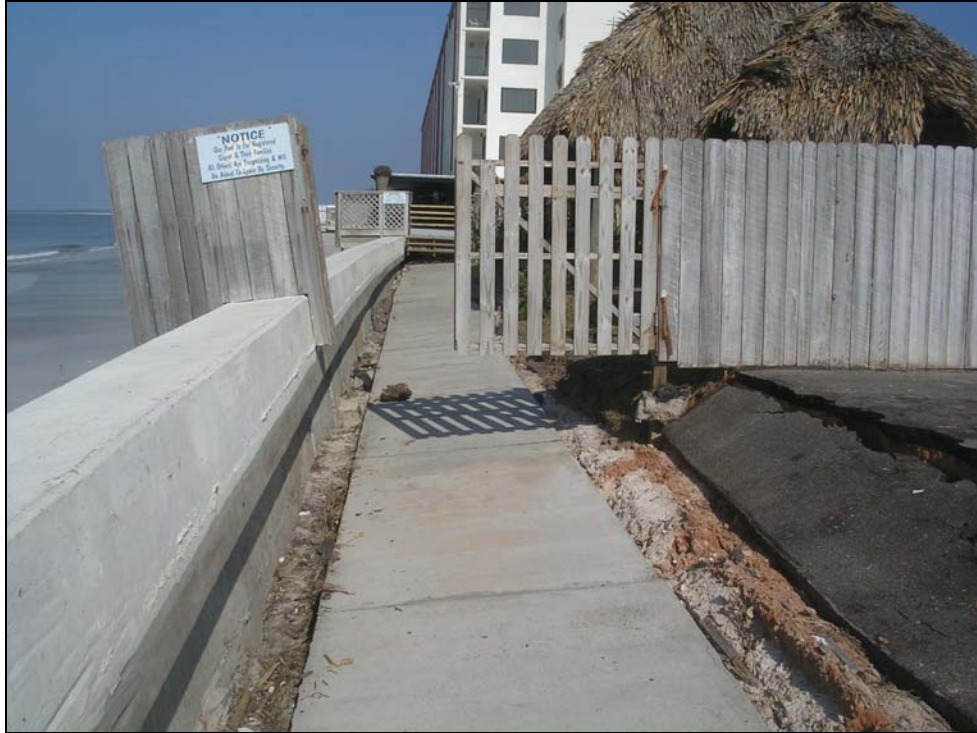
Photo BA-7. Damage to the El Governor seawall in Mexico Beach at R135 (-300').

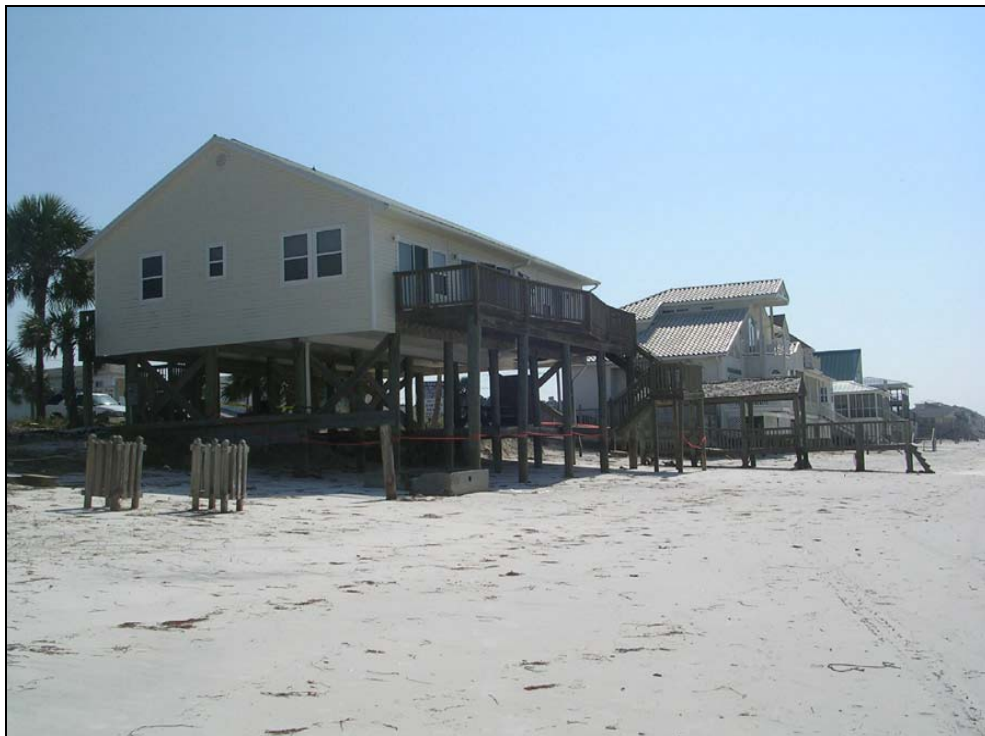
Photo BA-8. Loss of sand elevation and volume in Mexico Beach at R135 (+200').

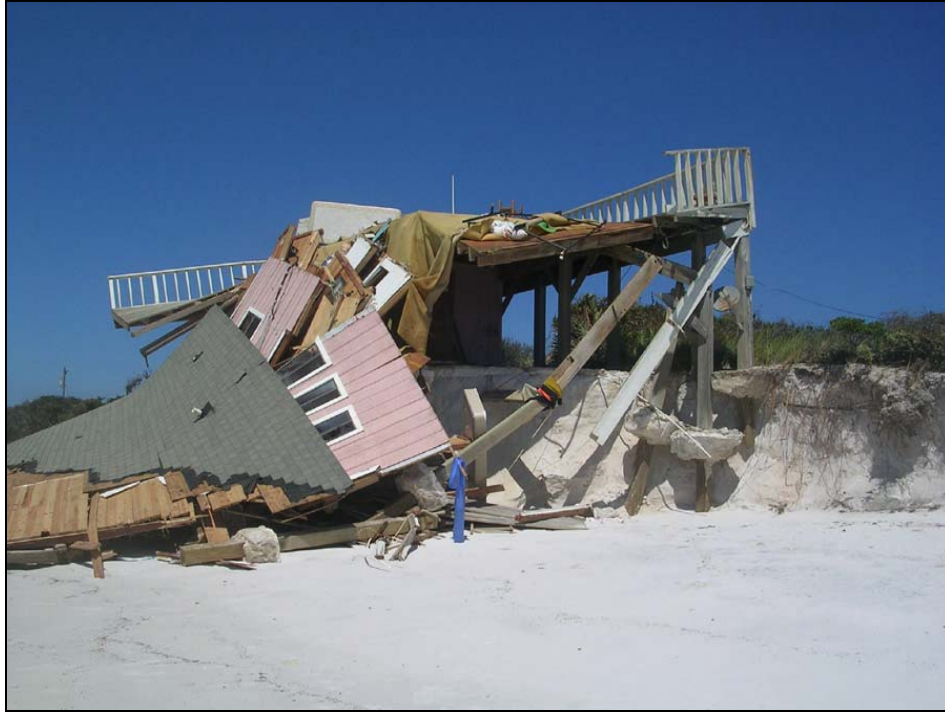
Photo GU-1. Destroyed single-family dwelling on St. Joseph Peninsula at R100 (+450')

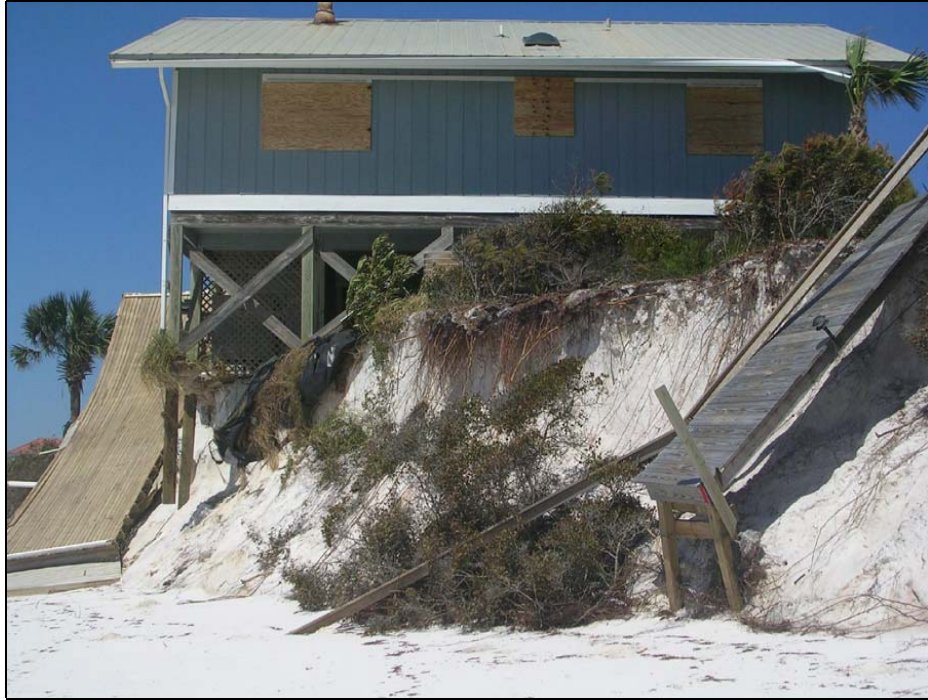
Photo GU-5. Eroded dune bluff; structural damage at R99; St. Joseph Peninsula

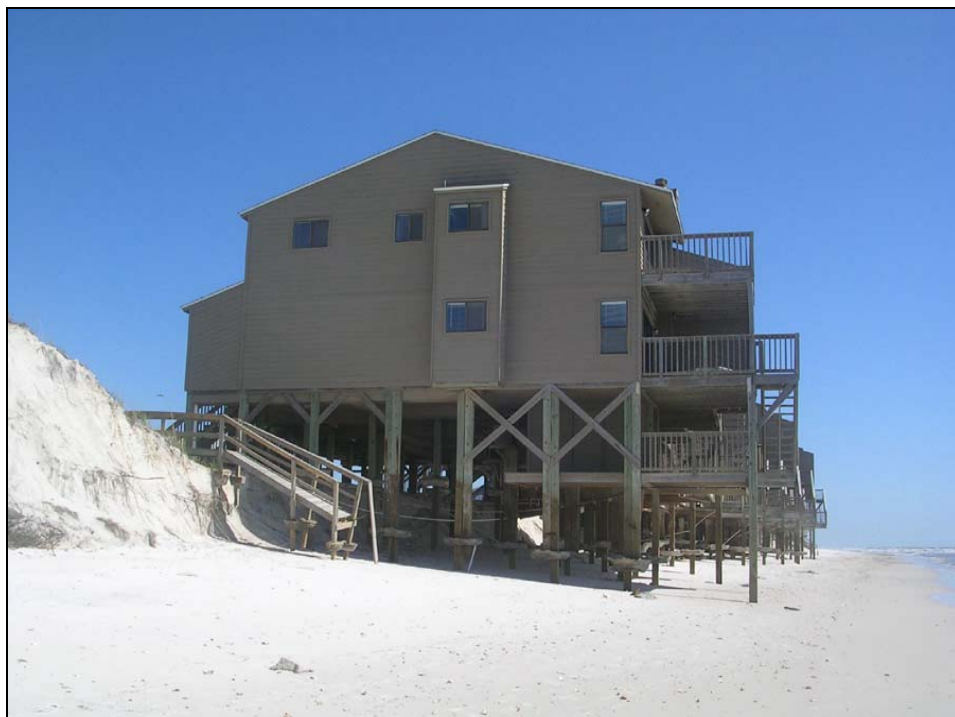
Photo GU-6. Major dune erosion at habitable structures on the beach on St. Joseph Peninsula at R90 (+300').

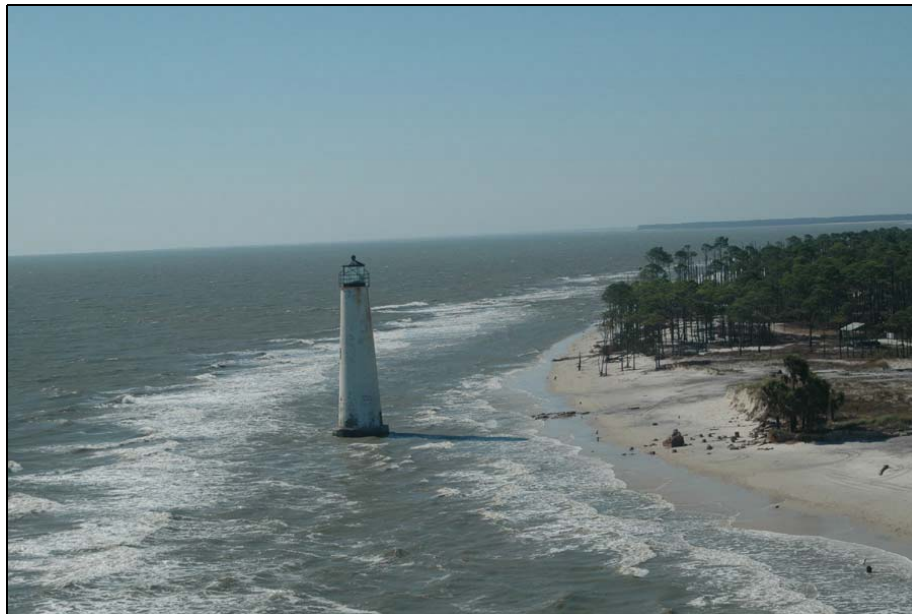
Photo FR-1. View of Cape St. George lighthouse after Ivan (note: the lighthouse was substantially seaward of the shoreline into Gulf waters prior to Ivan).
