# ***HURRICANE IVAN***

## **BEACH AND DUNE EROSION AND STRUCTURAL DAMAGE ASSESSMENT AND POST-STORM RECOVERY PLAN FOR THE PANHANDLE COAST OF FLORIDA**

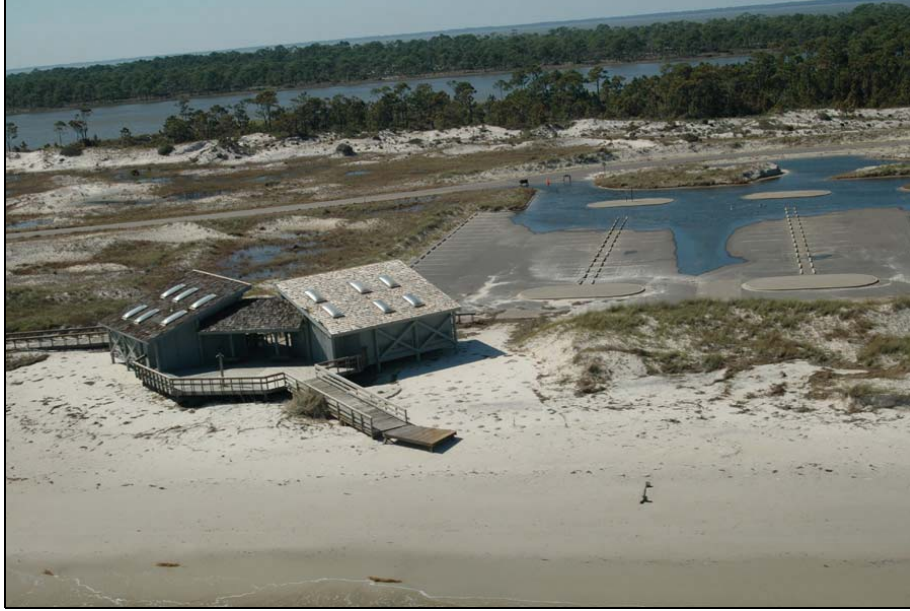
Photo FR-2. Flooding from Hurricane Ivan at St. George Island State Park.

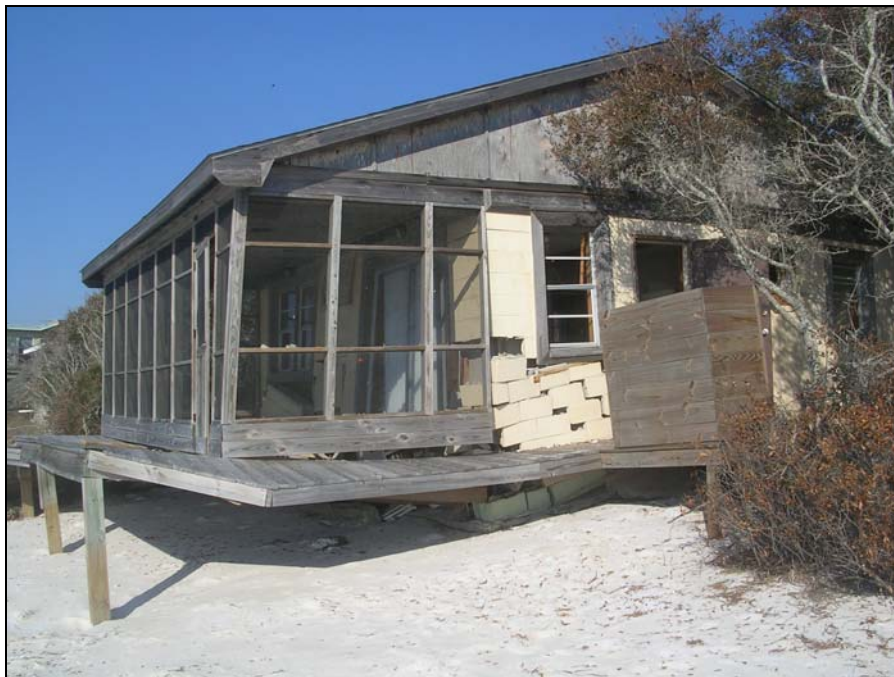
Photo FR-3. Destroyed single-family structure at Lighthouse Point at R221 (+50').

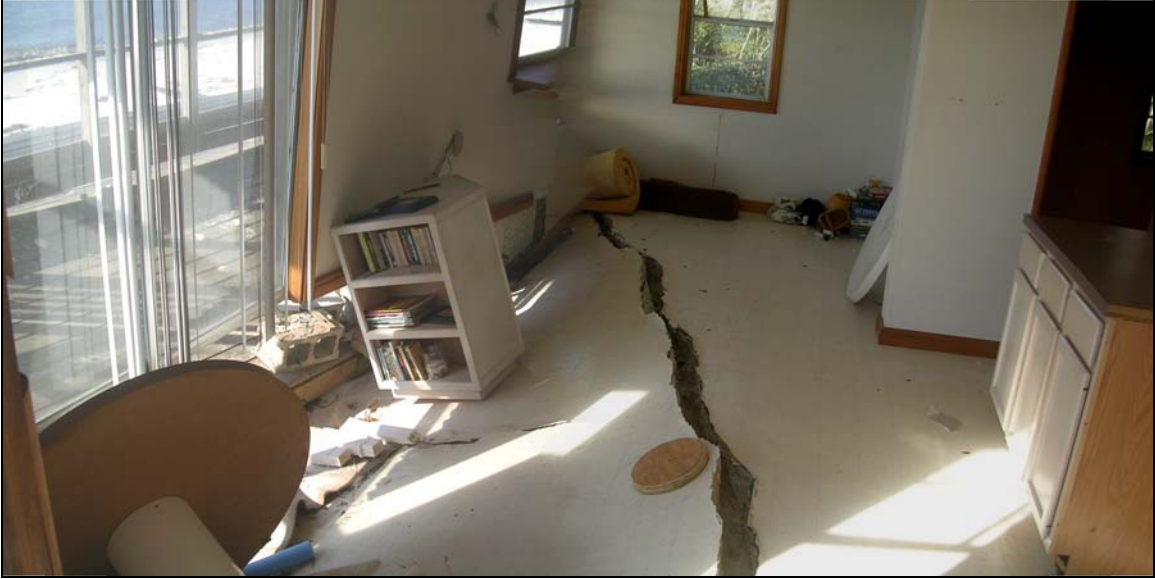
Photo FR-4. Major damage to single-family structure at Lighthouse Point at R221 (+50').

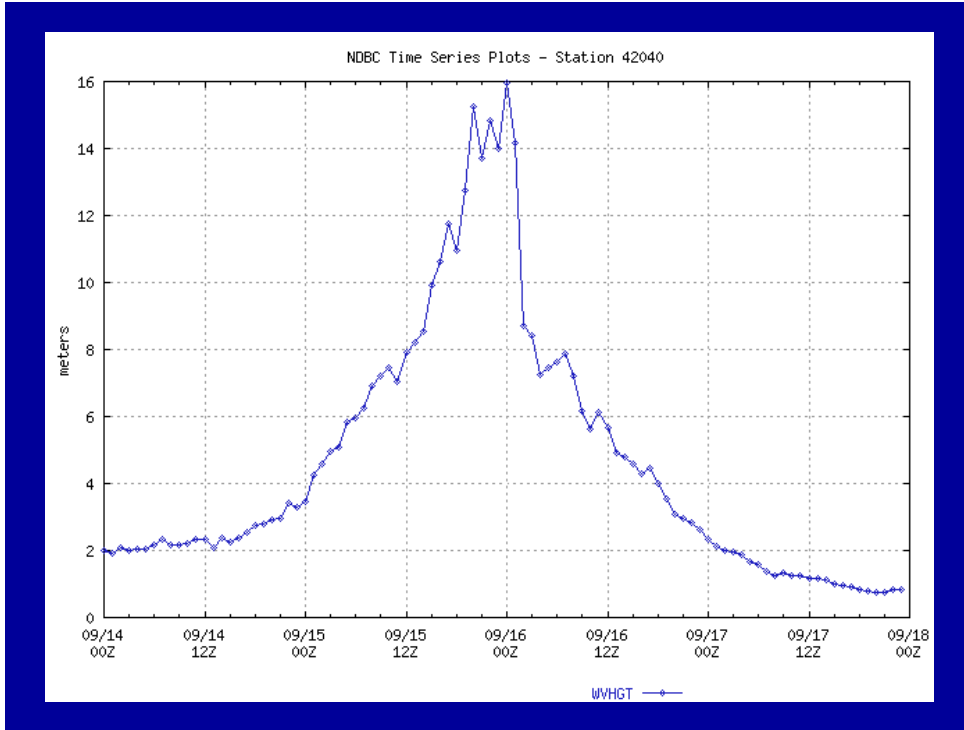
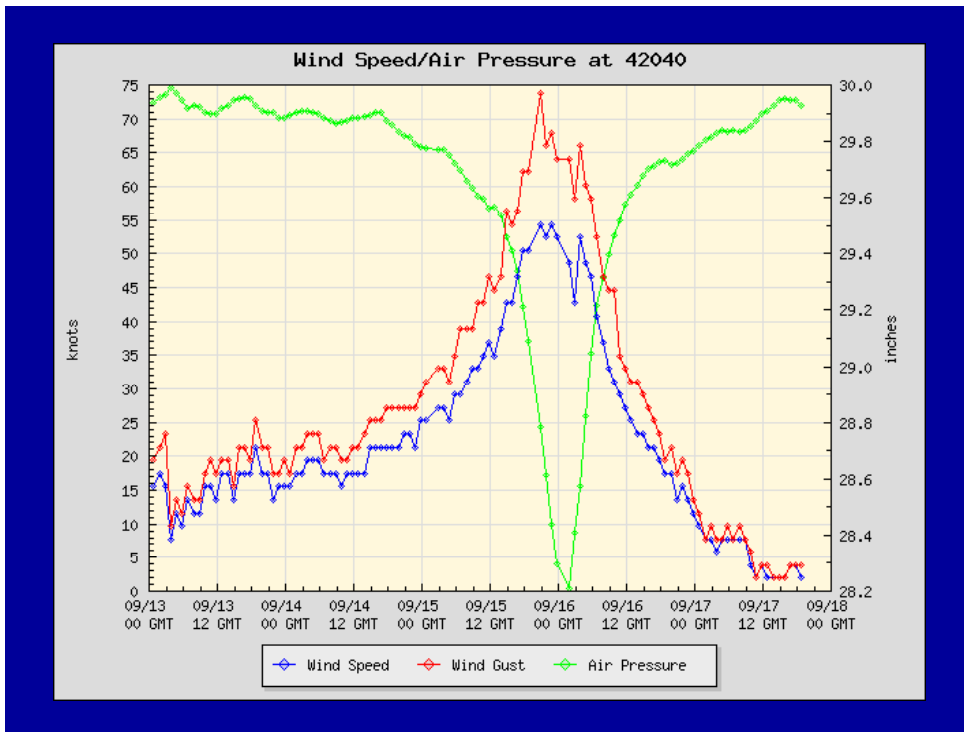
**Appendix A**  
**NOAA-NDBC Buoy Station # 42040**  
**Ivan Wave Heights and Wind Speed/Air Pressure**

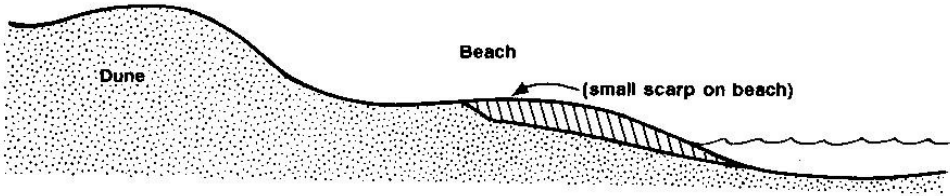
### CONDITION II: MINOR DUNE AND BEACH EROSION

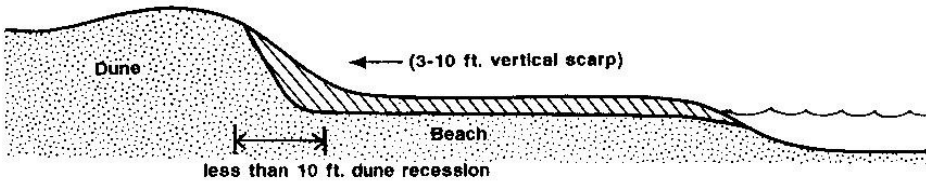
### CONDITION IV: MAJOR DUNE EROSION
