# THE IMPACT OF HURRICANE ELENA AND TROPICAL STORM JUAN ON COASTAL CONSTRUCTION IN FLORIDA

Beaches and Shores Post-Storm Report No. 85-3

March, 1986

Bureau of Coastal Engineering and Regulation  
Division of Beaches and Shores  
FLORIDA DEPARTMENT OF NATURAL RESOURCES

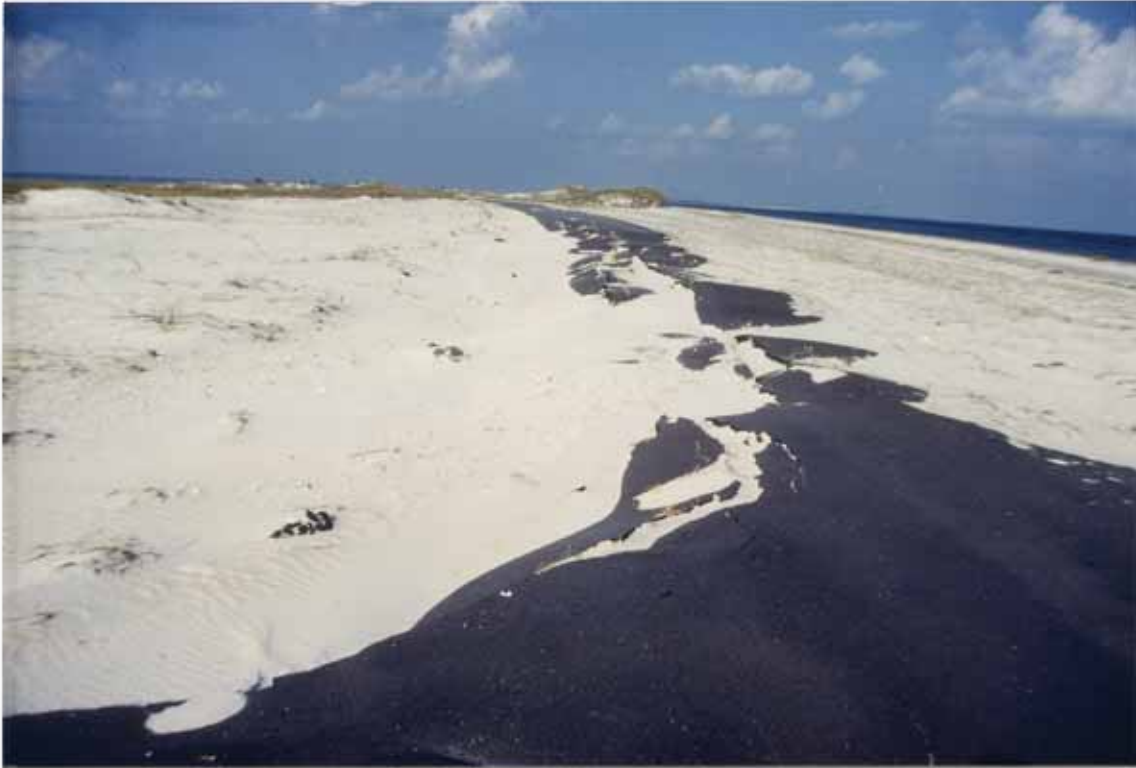
The park road was destroyed along much of its length in 1972 by hurricane Agnes. Reconstructed by the Florida Department of Transportation in the mid-1970's, the road has performed well for the past decade. Elena totally destroyed approximately 400 feet of the road at its eastern end (Figure 10). An additional 350 feet of the south pavement edge was damaged due to direct wave attack and undermining. Along approximately 20,650 feet or 3.91 miles of the road, the north pavement edge was damaged due to the hydraulic scour by storm surge overtopping. The pavement edge damage rendered this narrow two lane asphalt road unsuitable for safe driving conditions.

FIGURE 10. Park road segment destroyed by Elena,  
St. George Island

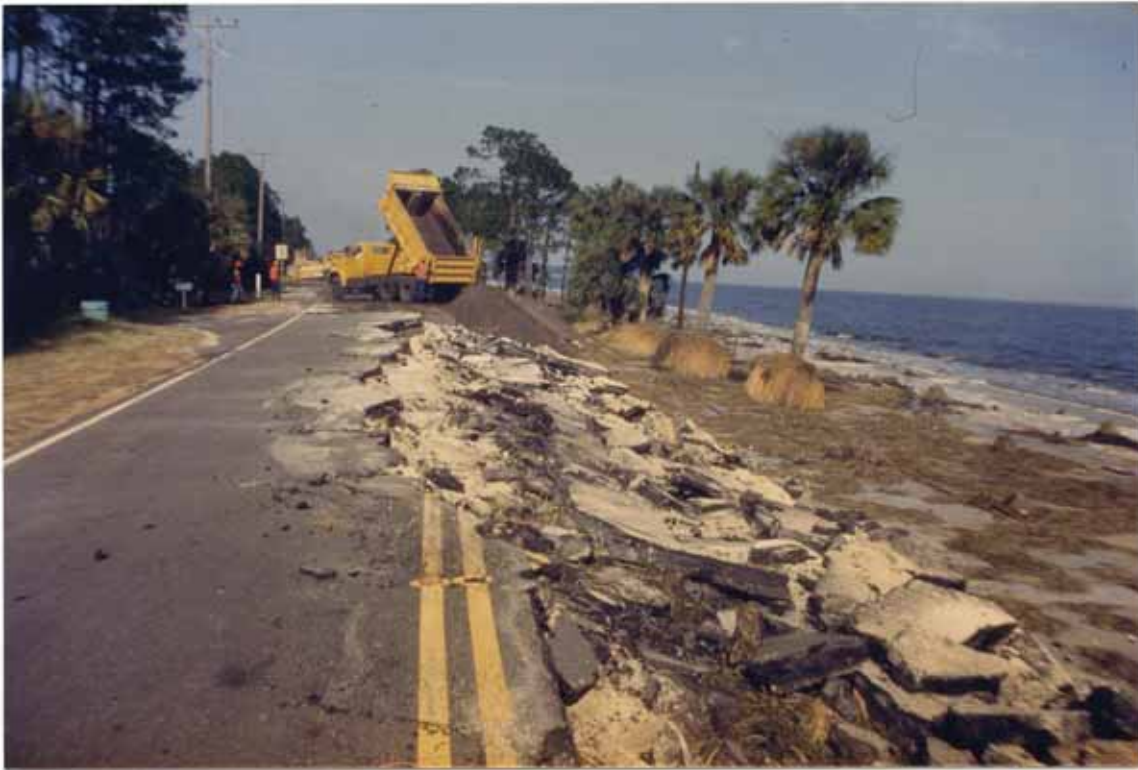
Much of the sandy mainland shoreline along St. George Sound typifies a barrier beach and dune system. There is a high degree of exposure to storm tides and wave activity along the shoreline stretch opposite the open water gap between Alligator Point and Dog Island and adjacent to East Pass between Dog Island and St. George Island. Along a 10 to 12 mile stretch of U. S. Highway 98, the two lane asphalt road is located in close proximity to the shoreline along a considerable distance. Although the shoreline length of damaged road was not determined, after Elena the Florida Department of Transportation measured 123,000 square feet of pavement destroyed and 130,000 cubic yards of fill lost from U.S. Highway 98 (Figures 16 and 17).

FIGURE 16. U.S. Highway 98 damaged by Elena, Carrabelle Beach

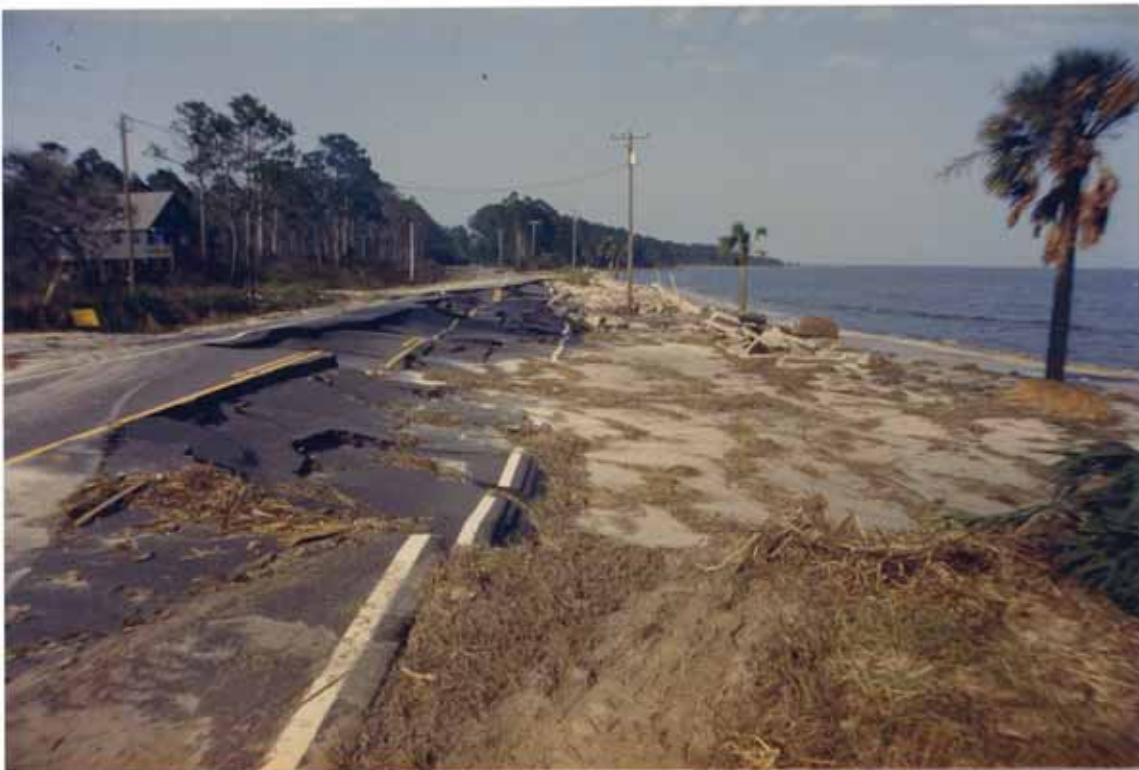
FIGURE 17. U.S. Highway 98 damaged by Elena

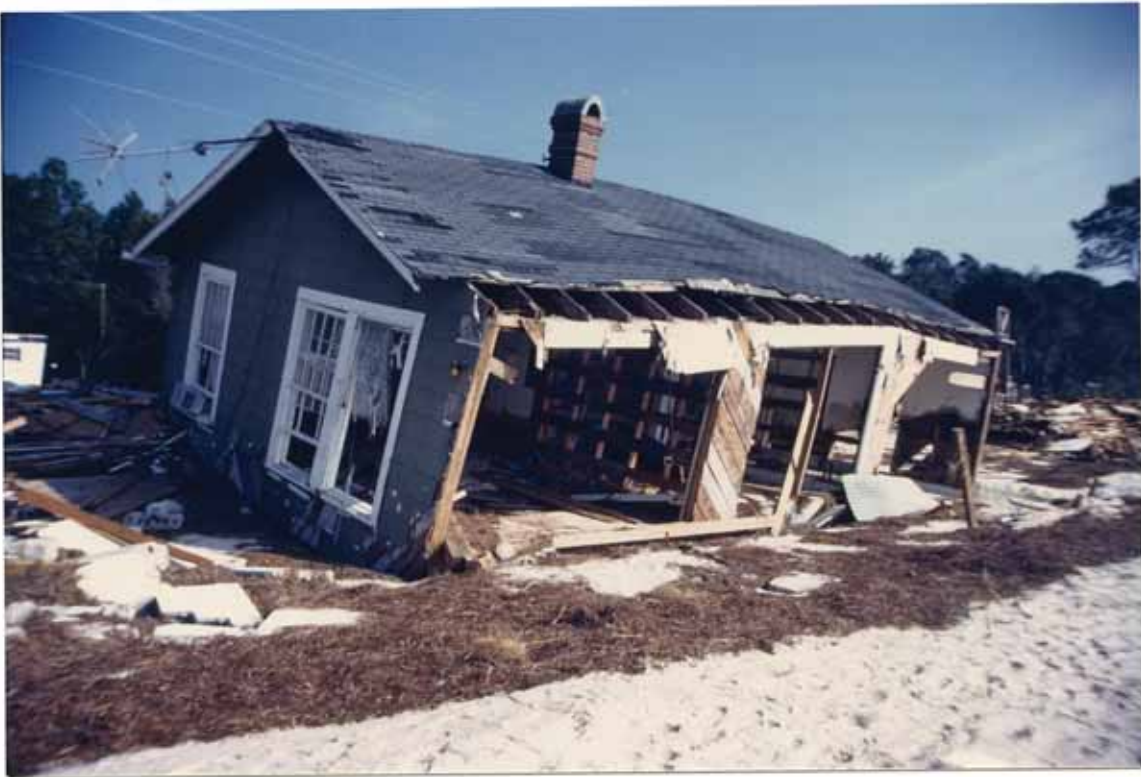
The Carrabelle Beach area west of Carrabelle is directly exposed to the storm tide and wave activity through East Pass between Dog Island and St. George Island. East Pass is approximately two miles wide and the four miles of shoreline immediately adjacent to East Pass sustained moderate to heavy beach and dune erosion. Along this stretch of shoreline seven single-family dwellings were destroyed and two more single-family dwellings sustained major damage due to the storm tide, erosion, and wave activity (Figures 18 through 21). Inadequate foundation design and inappropriate siting were the primary reasons for the damage to these structures.

FIGURE 19. Carrabelle Beach dwelling destroyed by Elena

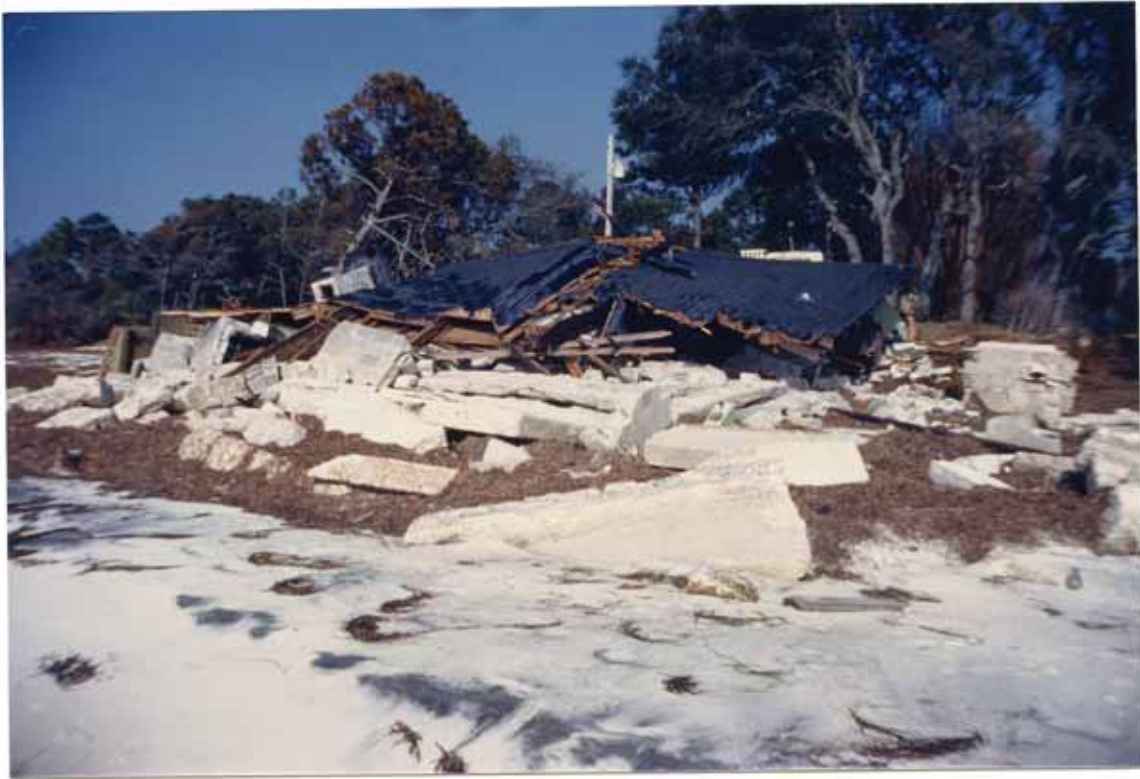
FIGURE 20. Carrabelle Beach dwelling destroyed by Elena

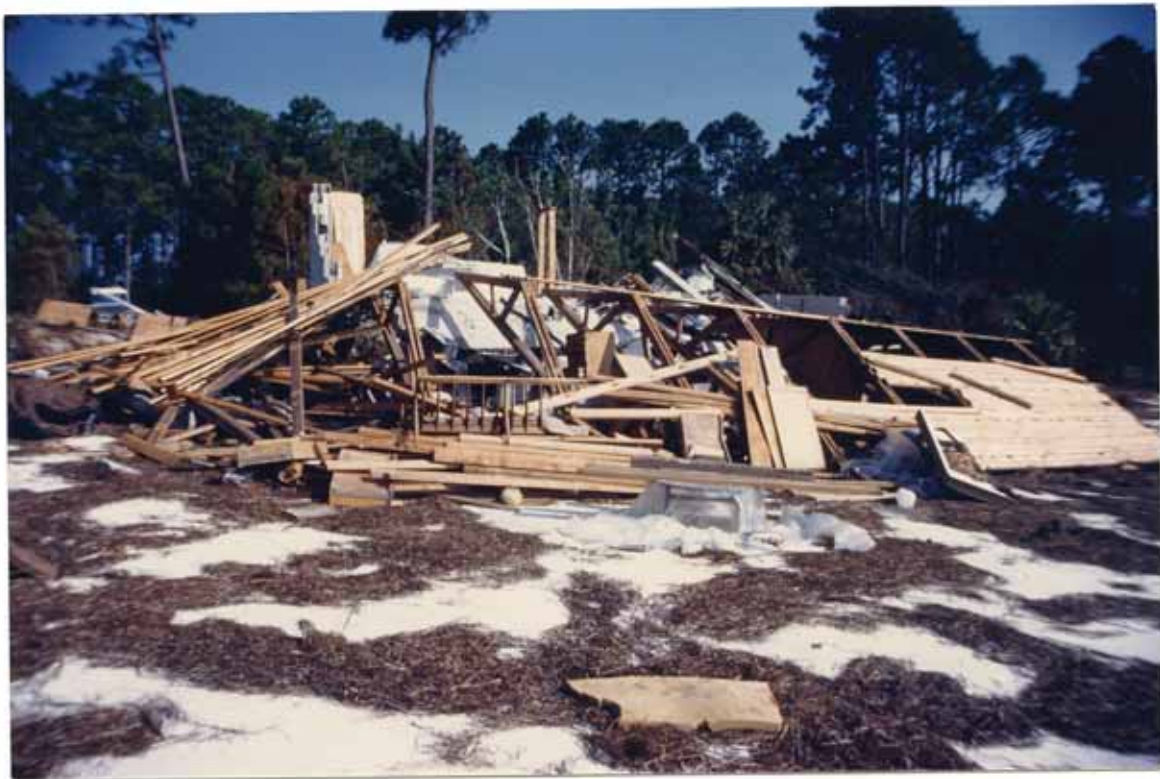
FIGURE 21. Carrabelle Beach dwelling destroyed by Elena

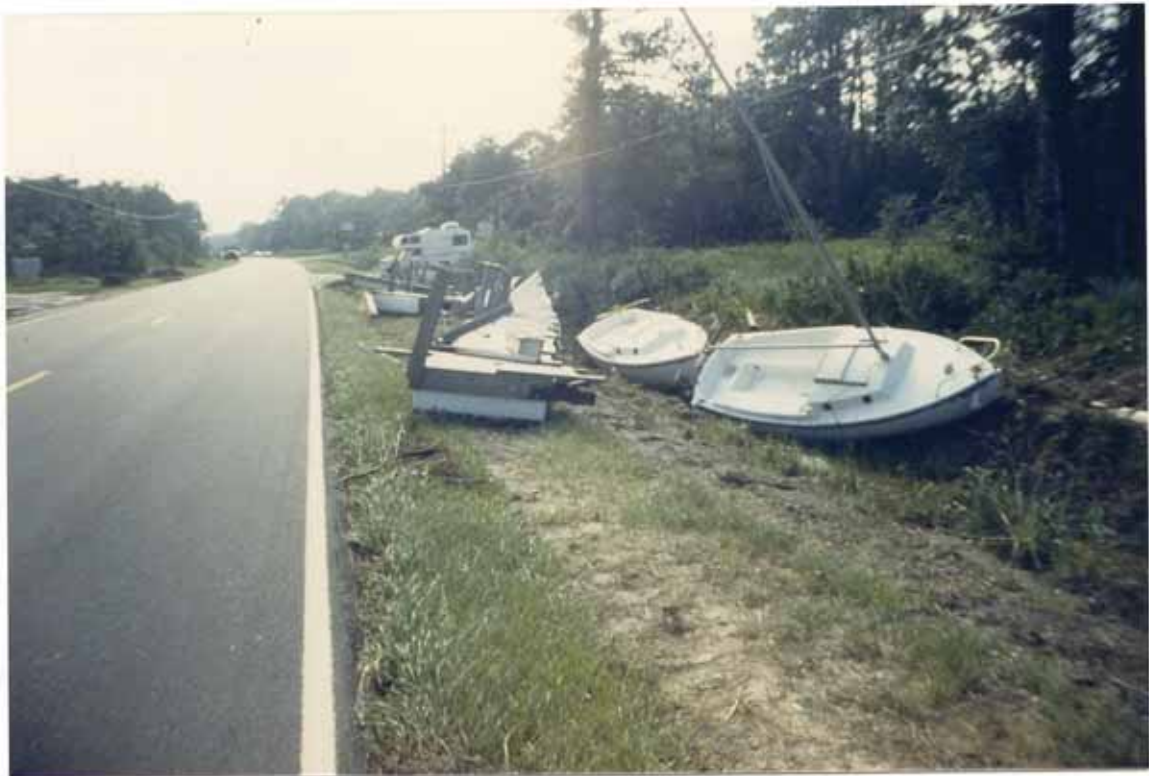
At the Lanark Marina, the storm tide and wave activity from Elena carried the floating docks and a few boats across the crown of U.S. Highway 98 and placed them in the ditch along the north right-of-way (Figure 23). The crown elevation of the road was measured at +7.487 feet NVGD by the survey team of the Bureau of Coastal Data Acquisition, Division of Beaches and Shores.

FIGURE 23. Elena's flooding at Lanark Marina, U.S. 98

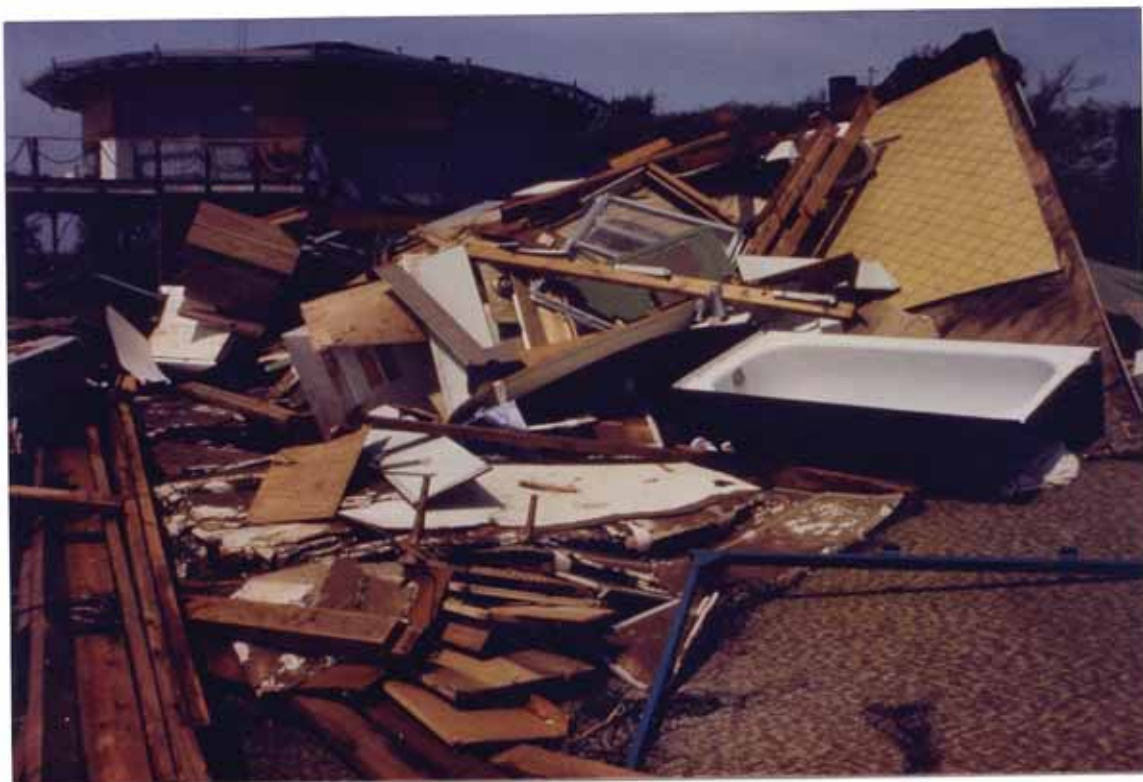
FIGURE 27. Southwest Cape dwelling destroyed by Elena

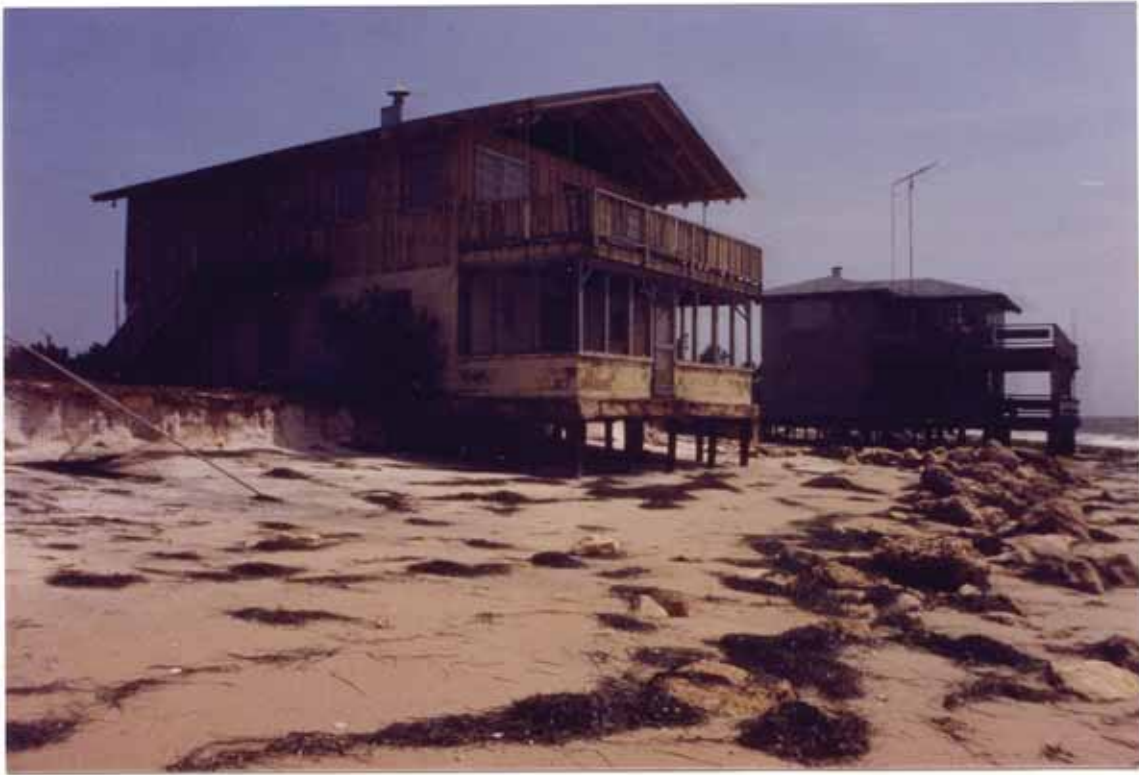
FIGURE 28. Southwest Cape revetment destroyed and dwelling undermined

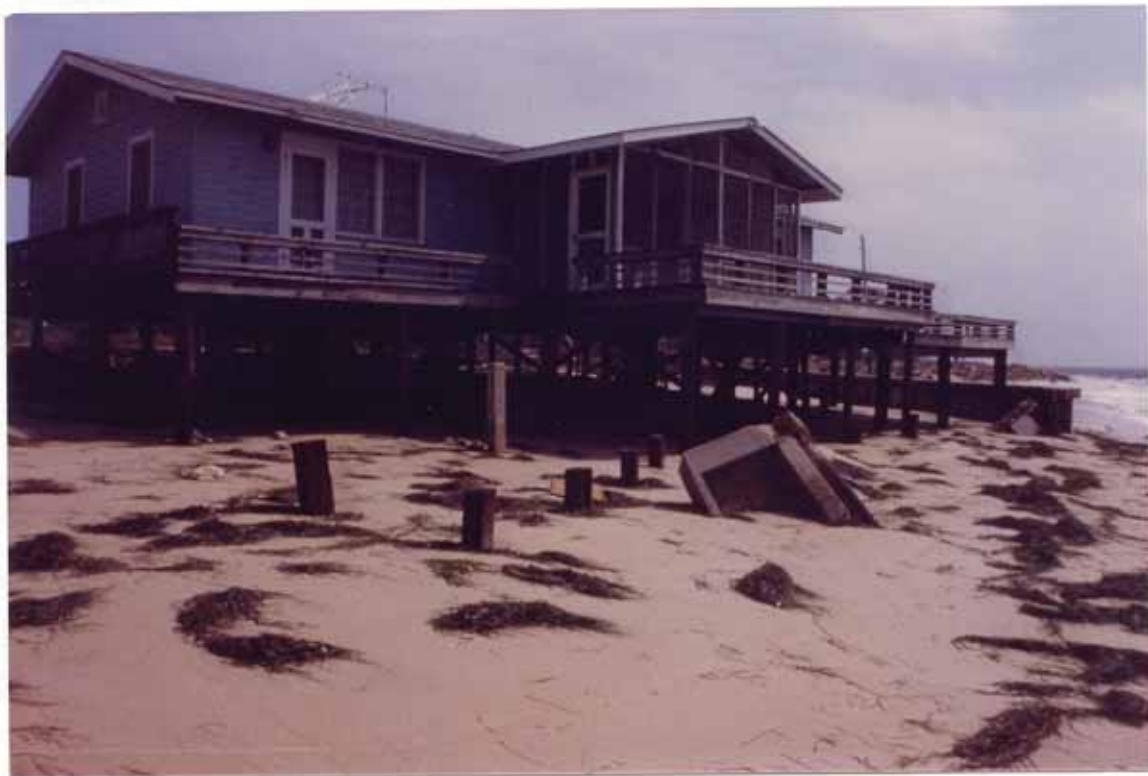
FIGURE 29. Southwest Cape bulkhead destroyed by Elena's waves

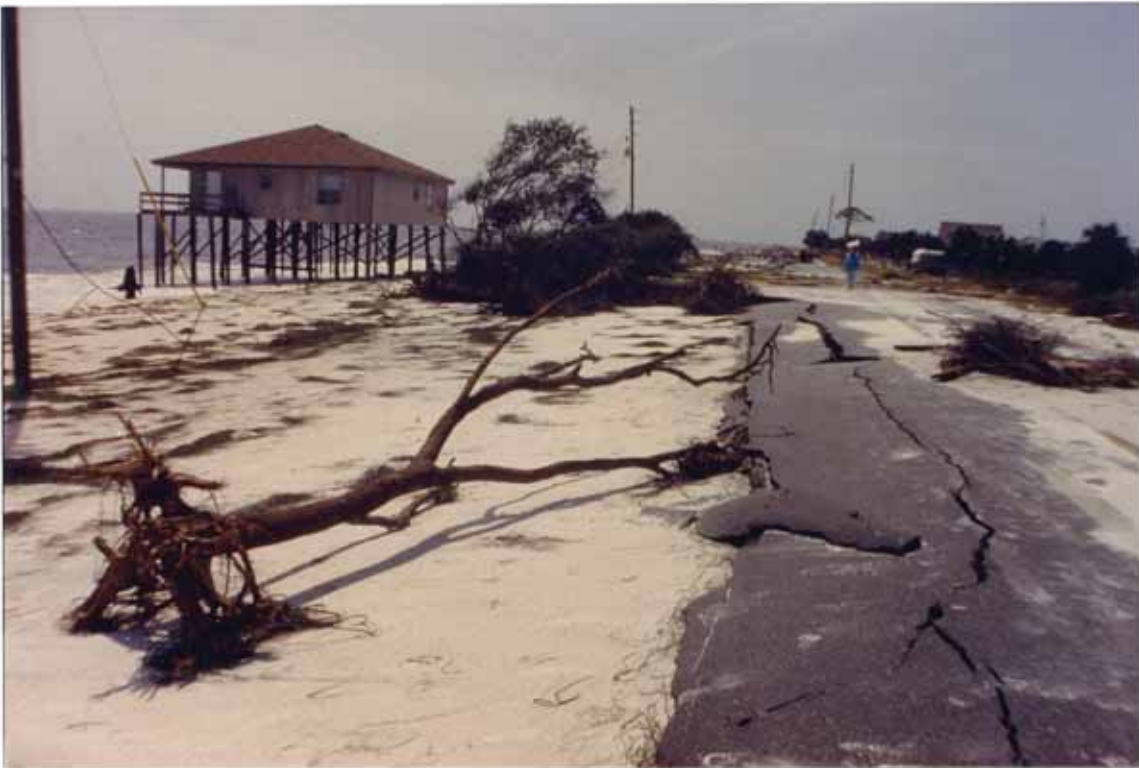
FIGURE 33. Elena erosion and damage

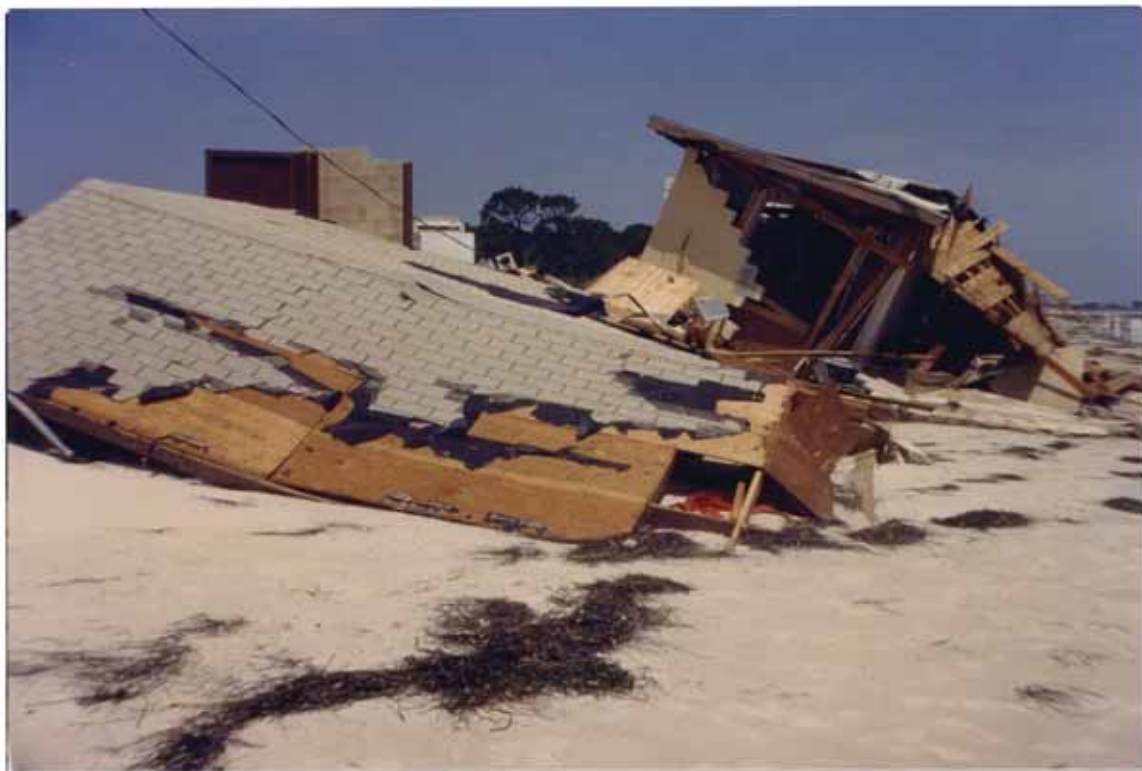
FIGURE 35. Same dwelling destroyed by Elena's erosion and waves on September 1

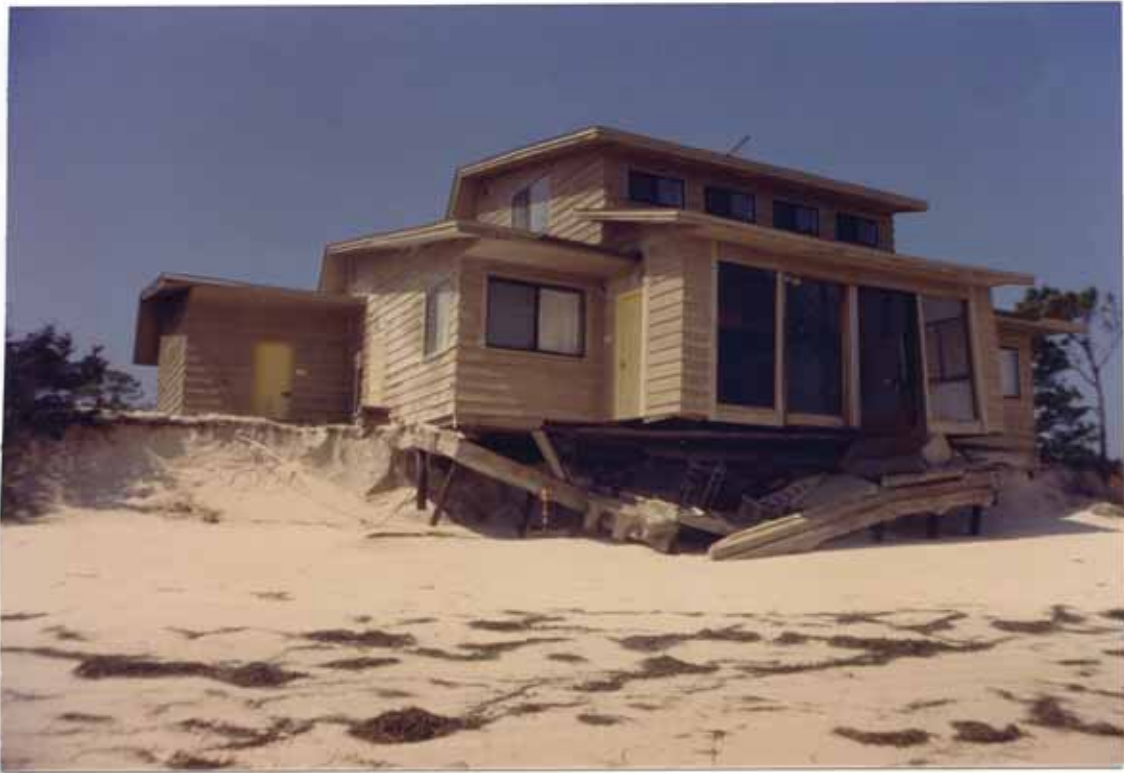
FIGURE 42. Lighthouse Point dwelling damaged by Elena's erosion

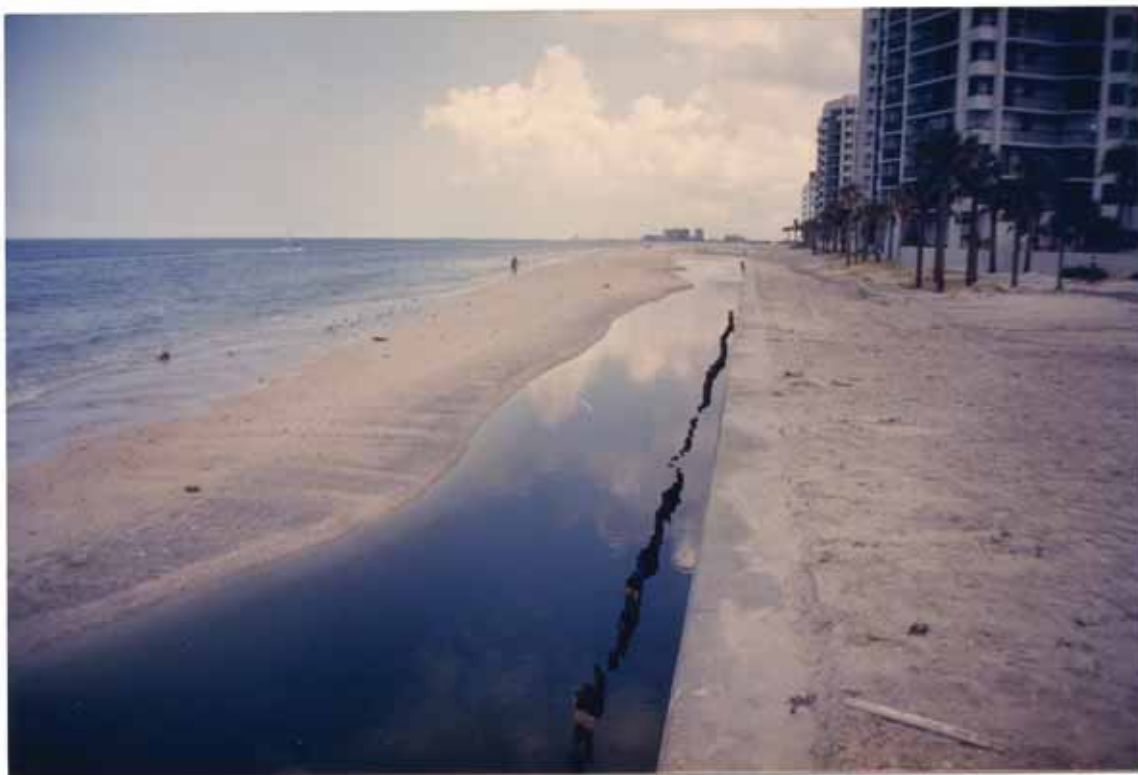
FIGURE 51. Scoured beach adjacent vertical bulkhead

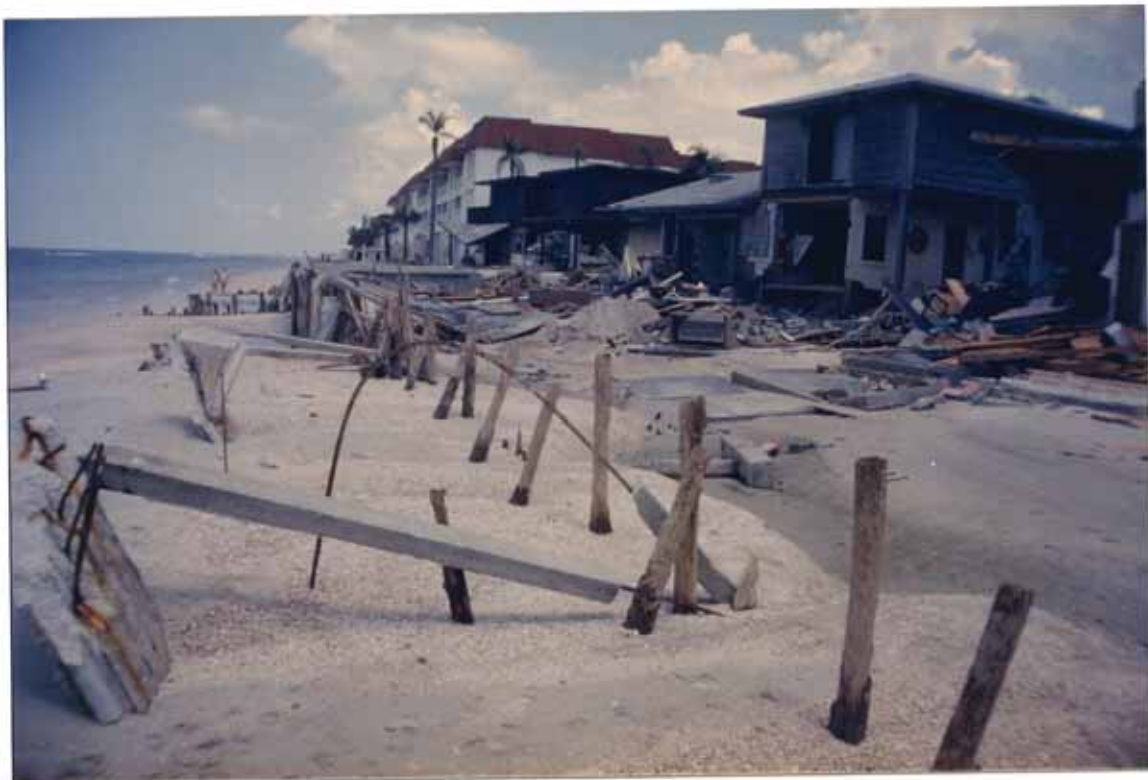
FIGURE 55. Concrete bulkhead destroyed by Elena, Belleair Beach

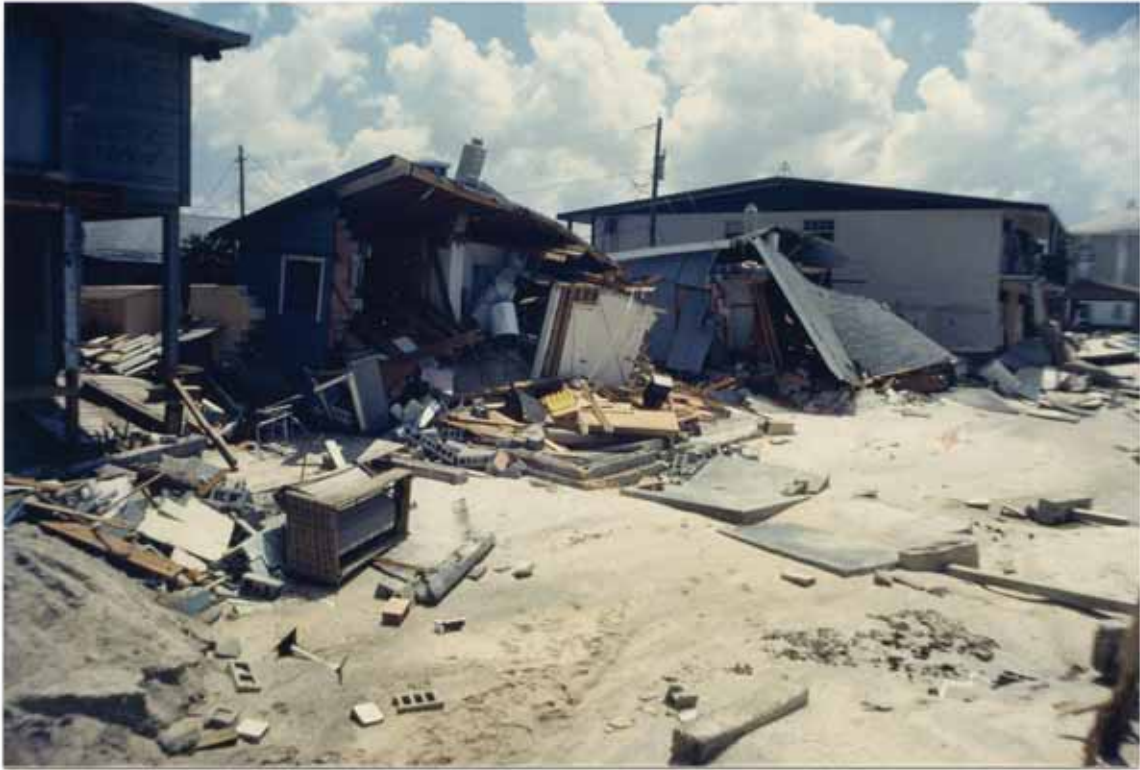
FIGURE 56. Belleair Beach dwellings destroyed by Elena

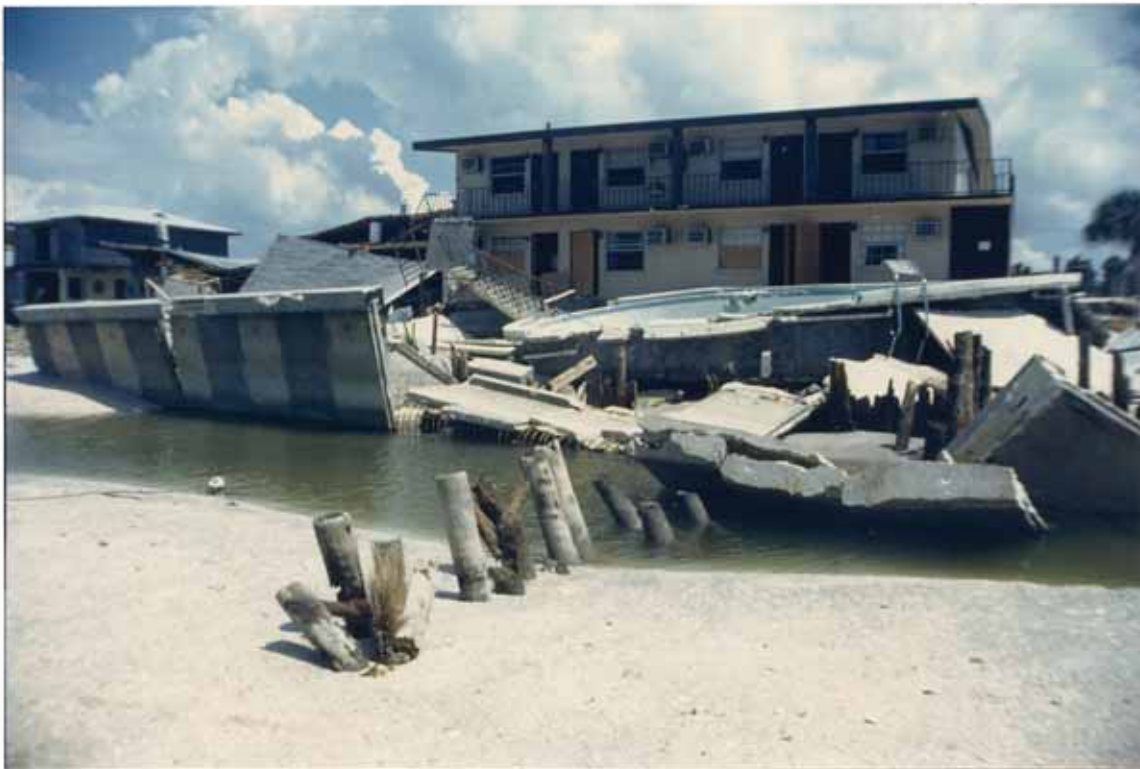
FIGURE 57. Bulkhead and swimming pool destroyed Chateau Motel, Belleair Beach

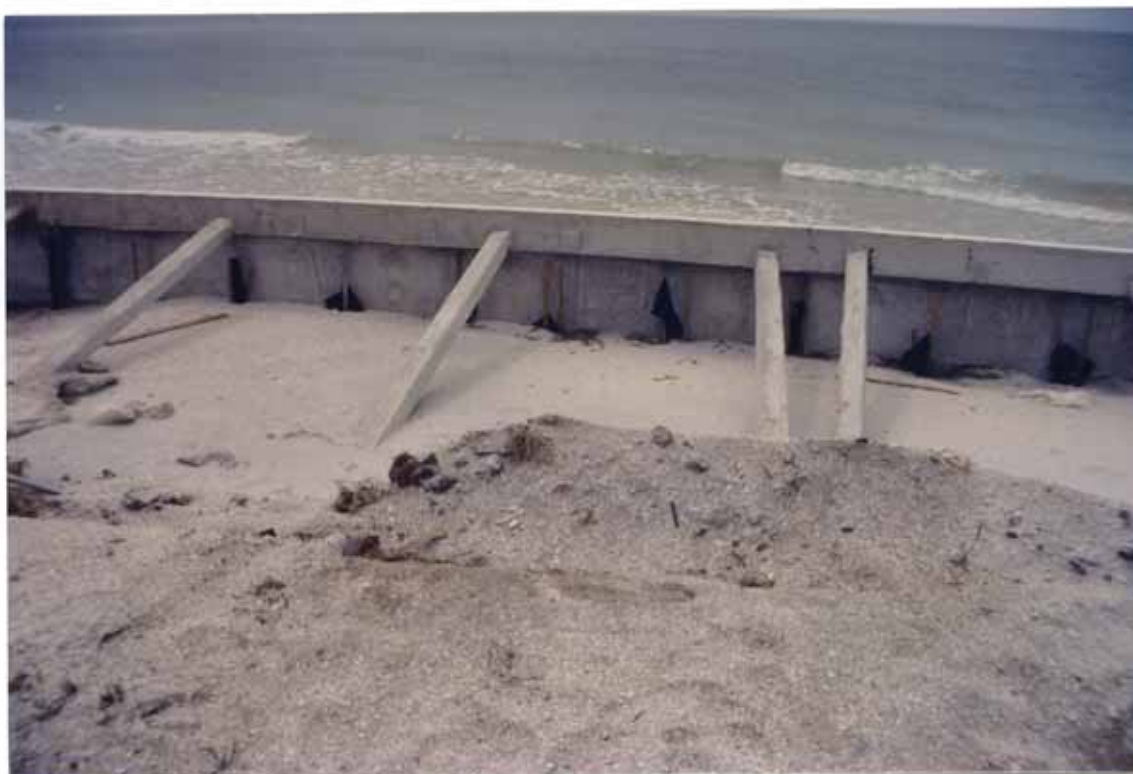
FIGURE 59. Inadequate fill containment with strips of filter fabric

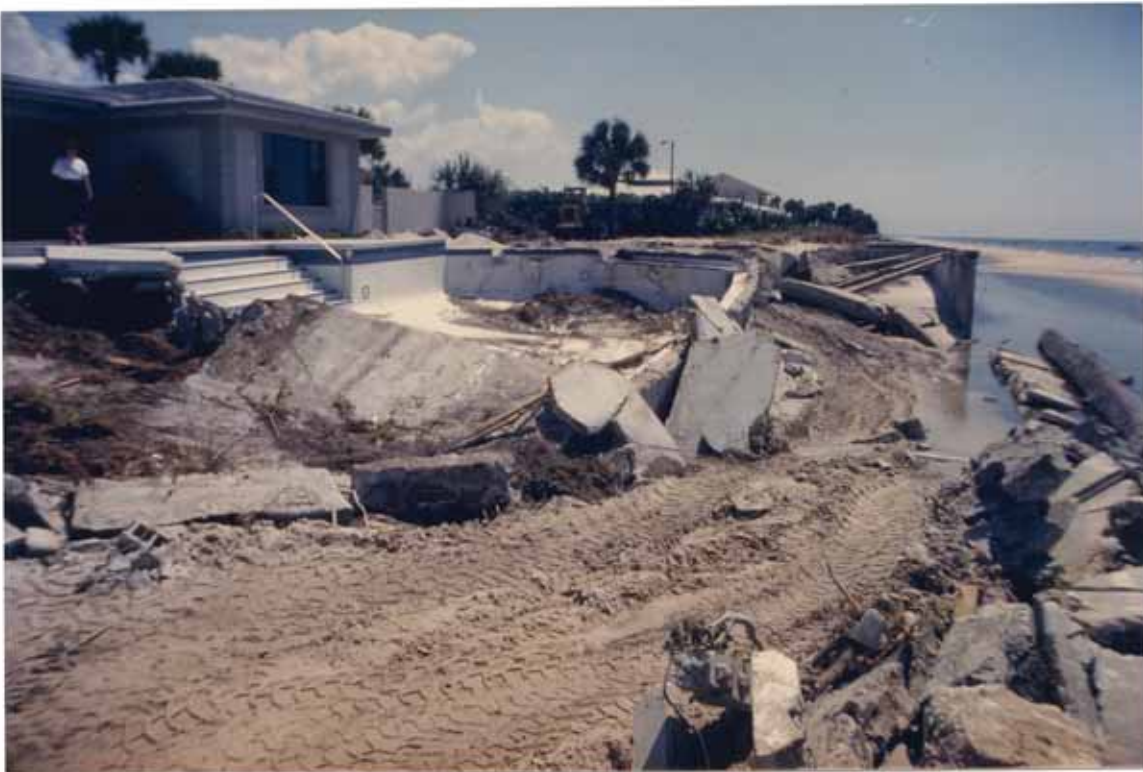
FIGURE 65. Wall and pool destroyed

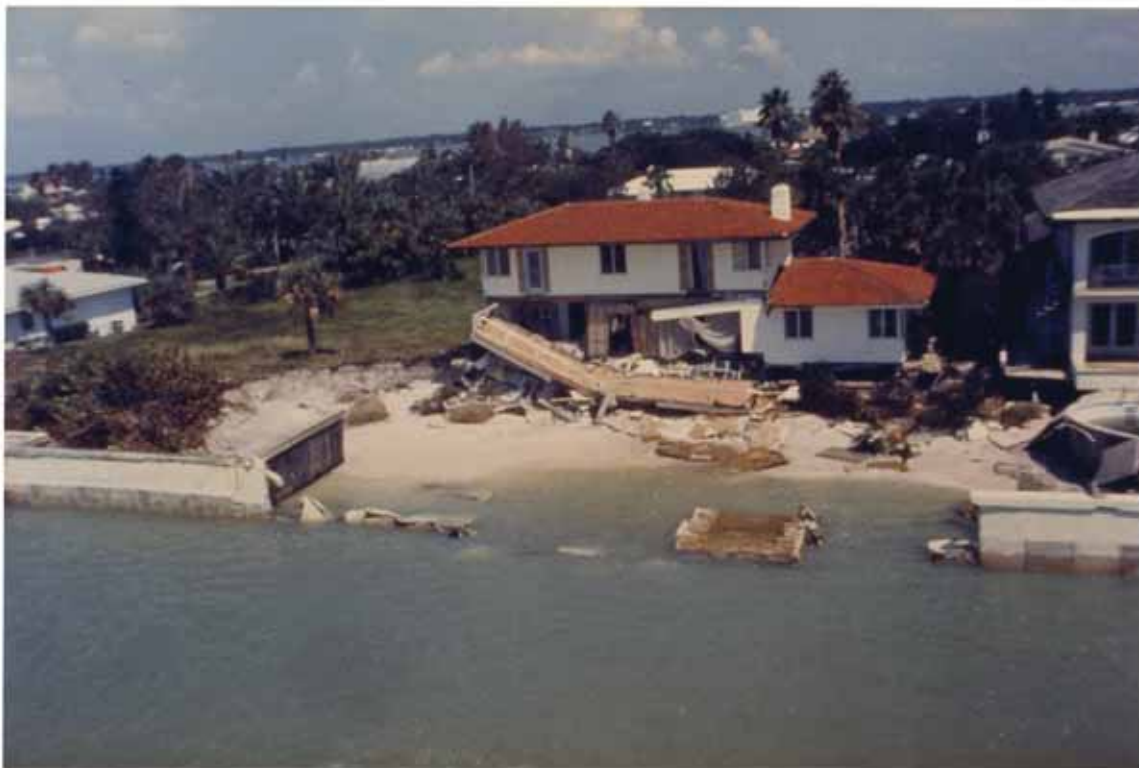
FIGURE 67. Wall destroyed and dwelling damaged

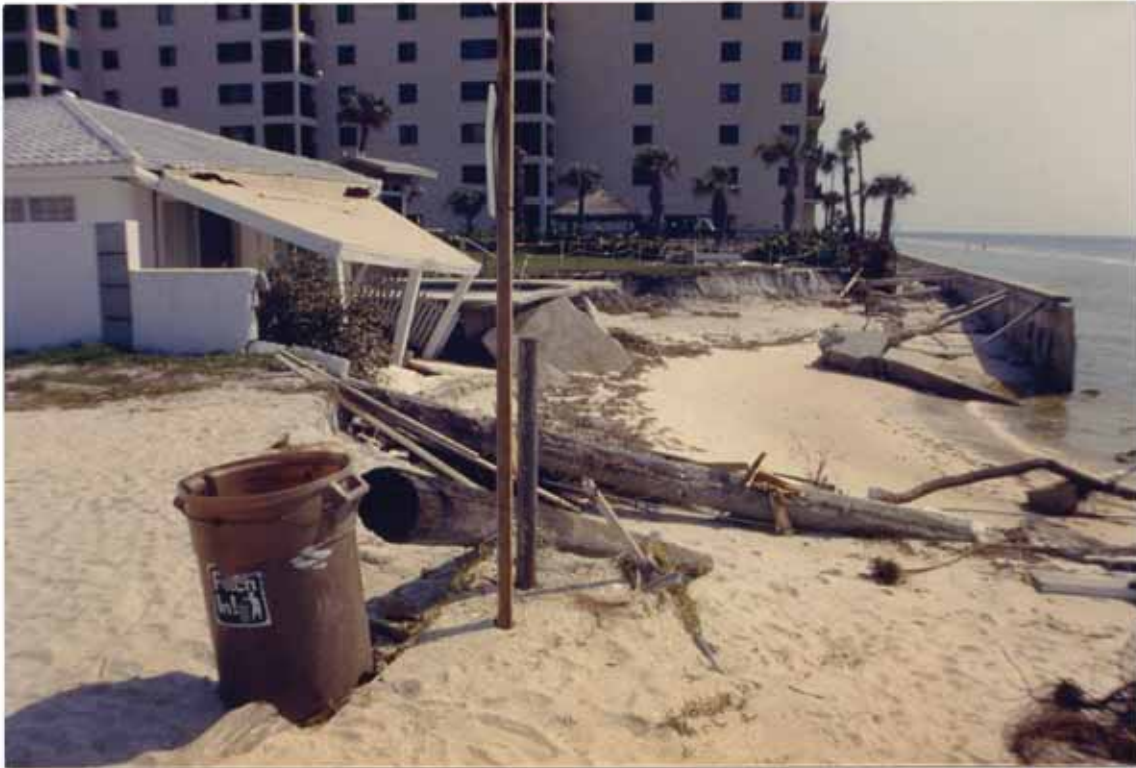
FIGURE 70. Damage at 25th Avenue, Indian Rocks Beach

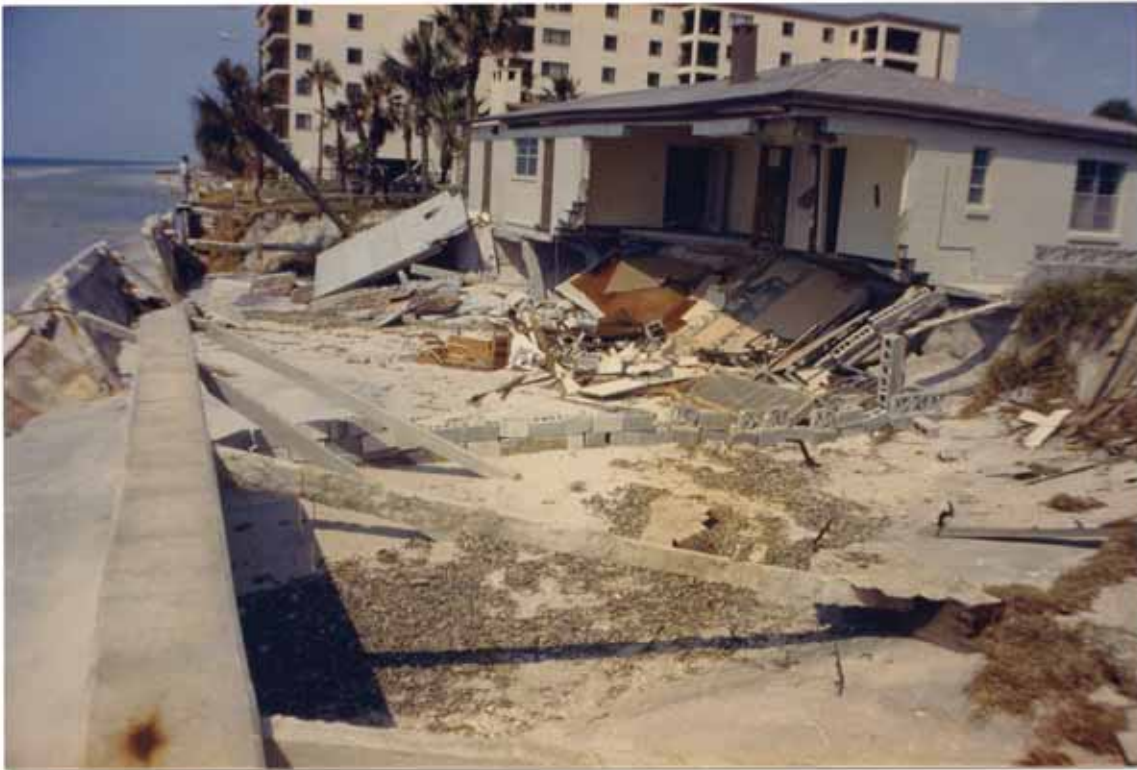
FIGURE 72. Dwelling damaged by Elena

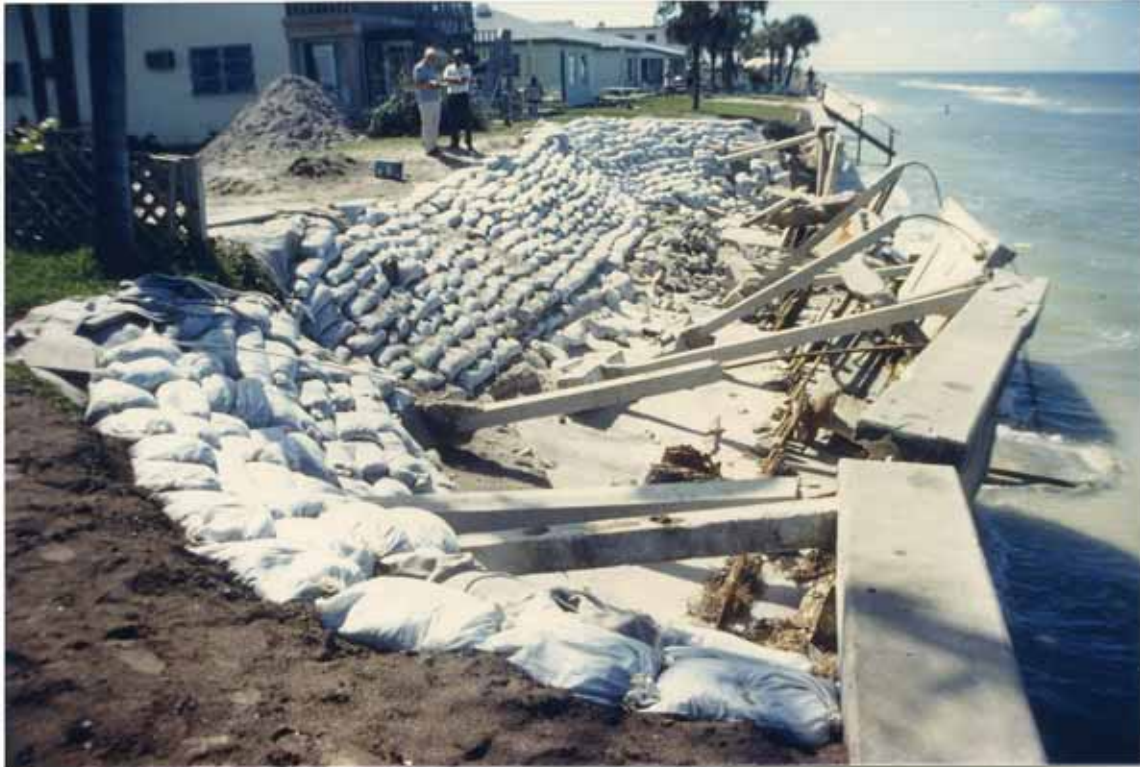
FIGURE 75. Post-Elena emergency protection, 23rd Avenue

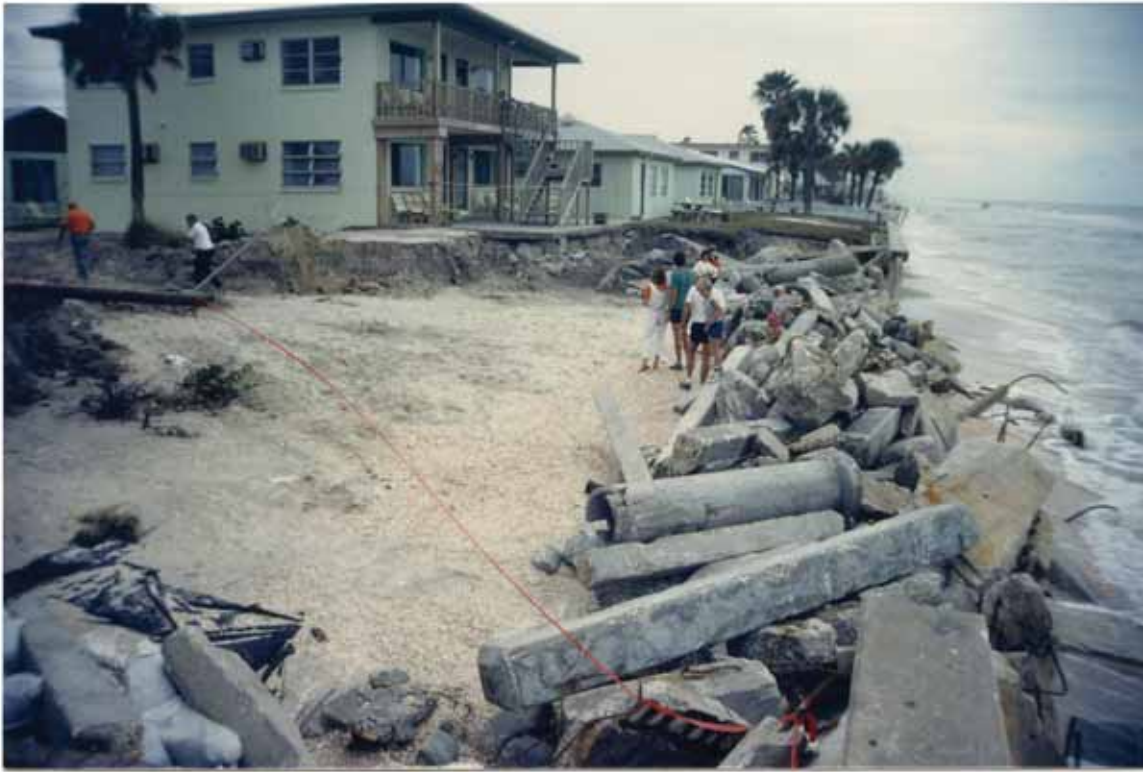
FIGURE 76. Juan destroyed 23rd Avenue

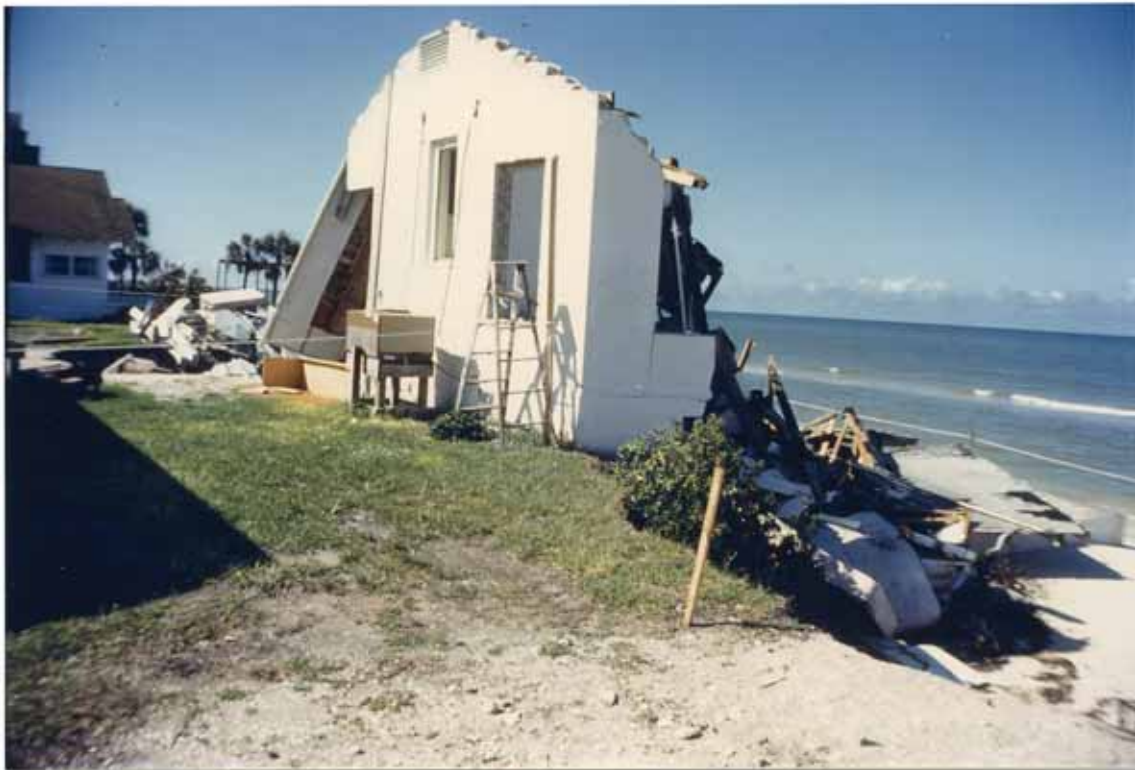
FIGURE 81. Dwellings destroyed at 17th Avenue
