# THE IMPACT OF HURRICANE ELENA AND TROPICAL STORM JUAN ON COASTAL CONSTRUCTION IN FLORIDA

Beaches and Shores Post-Storm Report No. 85-3

March, 1986

Bureau of Coastal Engineering and Regulation  
Division of Beaches and Shores  
FLORIDA DEPARTMENT OF NATURAL RESOURCES

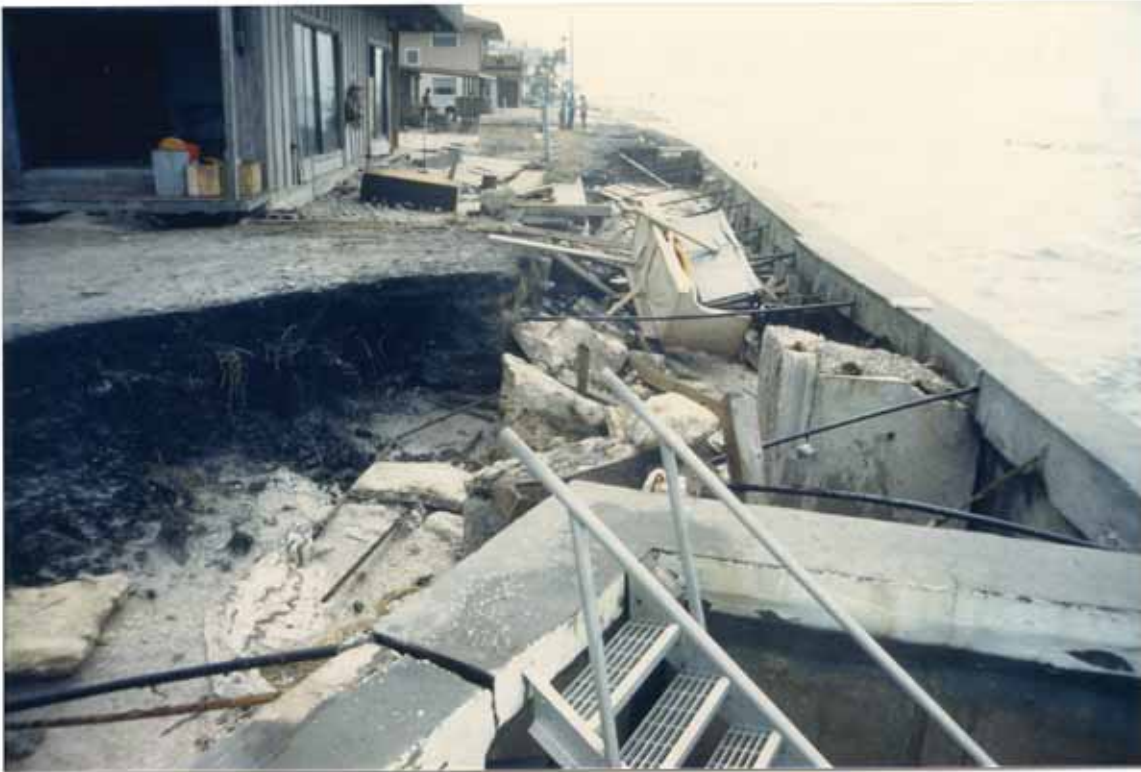
FIGURE 95. Juan eroded street-end fill, 7th Avenue

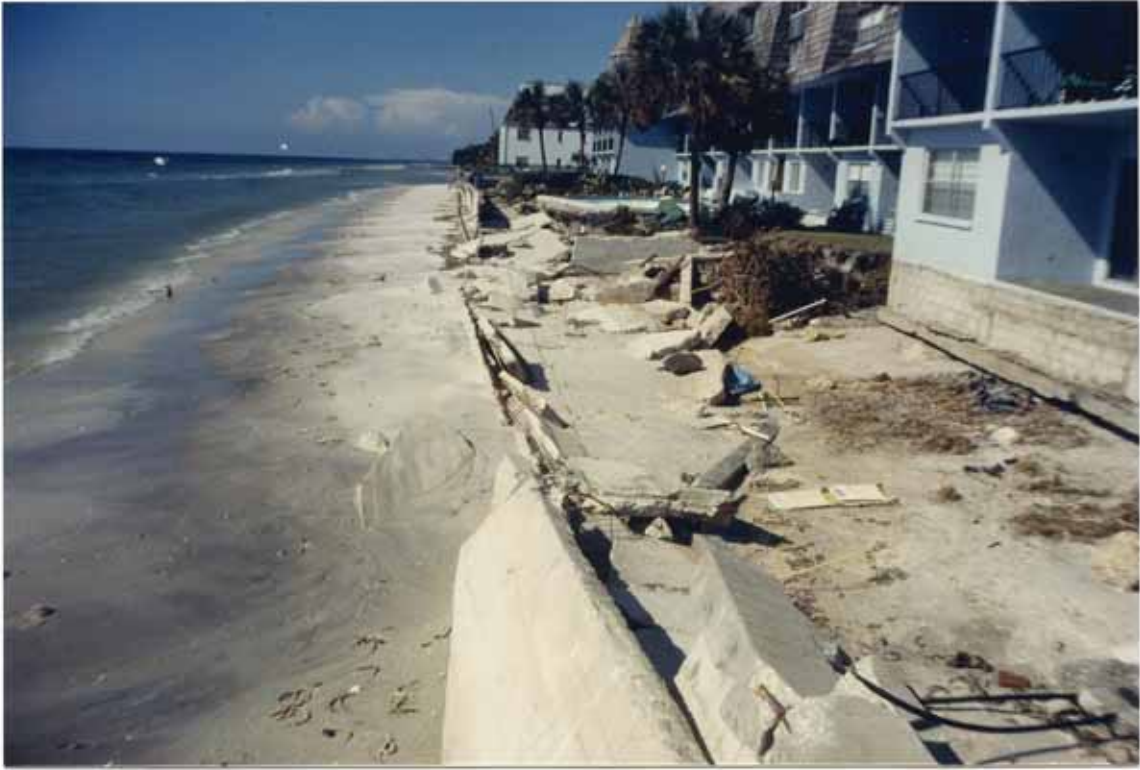
FIGURE 97. Happy Fiddler Condominium bulkhead after Elena

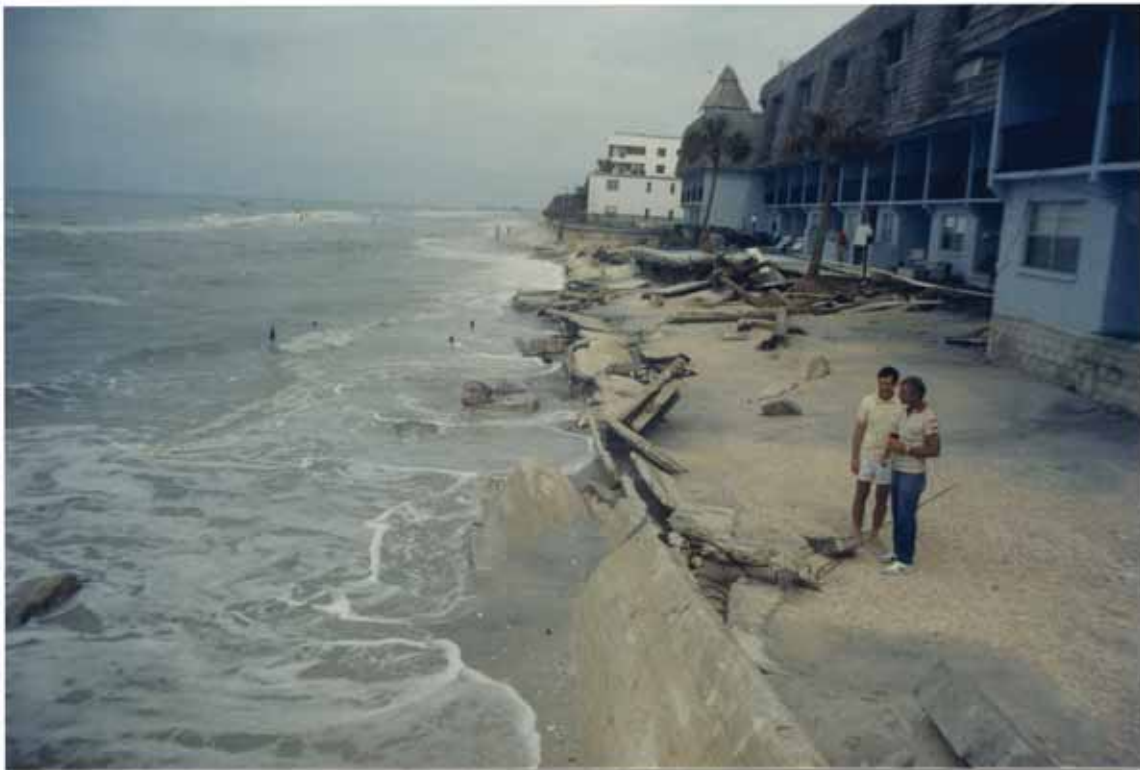
FIGURE 98. Happy Fiddler Condominium bulkhead after Juan

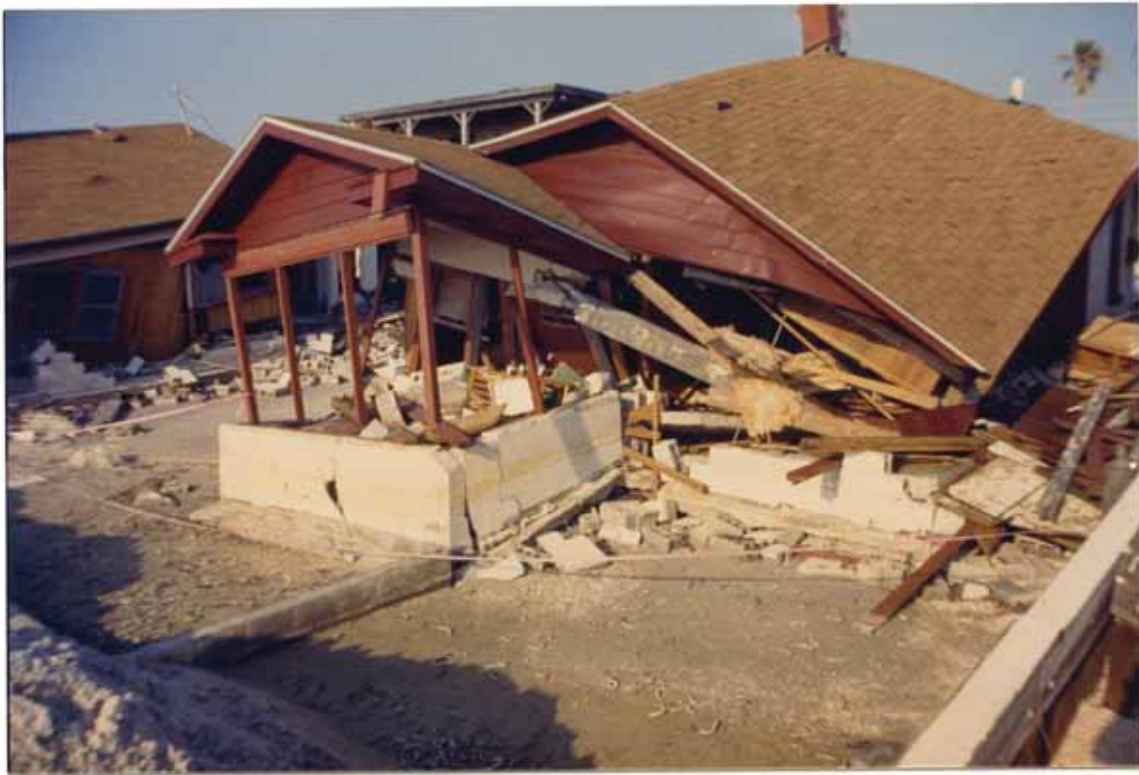
FIGURE 105. Dwelling destroyed by Elena

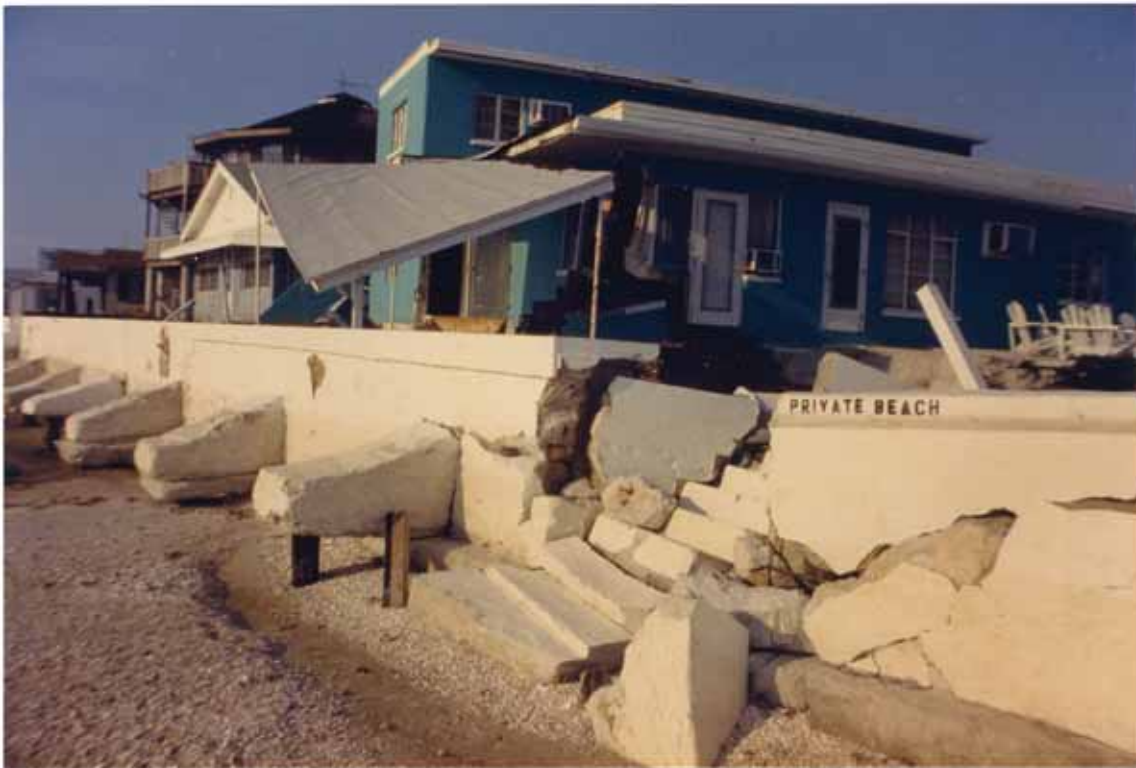
In the area of the Sand Castle Condominiums little damage was observed. Much of the beach lost to Elena returned during Juan. In the block to the south, three single-family dwellings were undermined and threatened by Elena. The beach was approximately 50 feet wide after the storms at 199th Avenue. South of 199th Avenue, 265 feet of wall and a single-family dwelling were destroyed and three townhouse structures and a single-family dwelling were undermined and threatened from any further erosion. Between 198th Avenue and 197th Avenue, seven single-family dwellings were destroyed or substantially damaged and the other dwellings were undermined and threatened from further erosion (Figure 105). A 160 foot wood bulkhead was destroyed by Elena and another 15 foot segment was destroyed by Juan. Three of the damaged dwellings were behind a 115 foot segment of concrete wall which was destroyed by Elena (Figures 106 and 107). South of

FIGURE 106. Wall damaged by wave impact loads

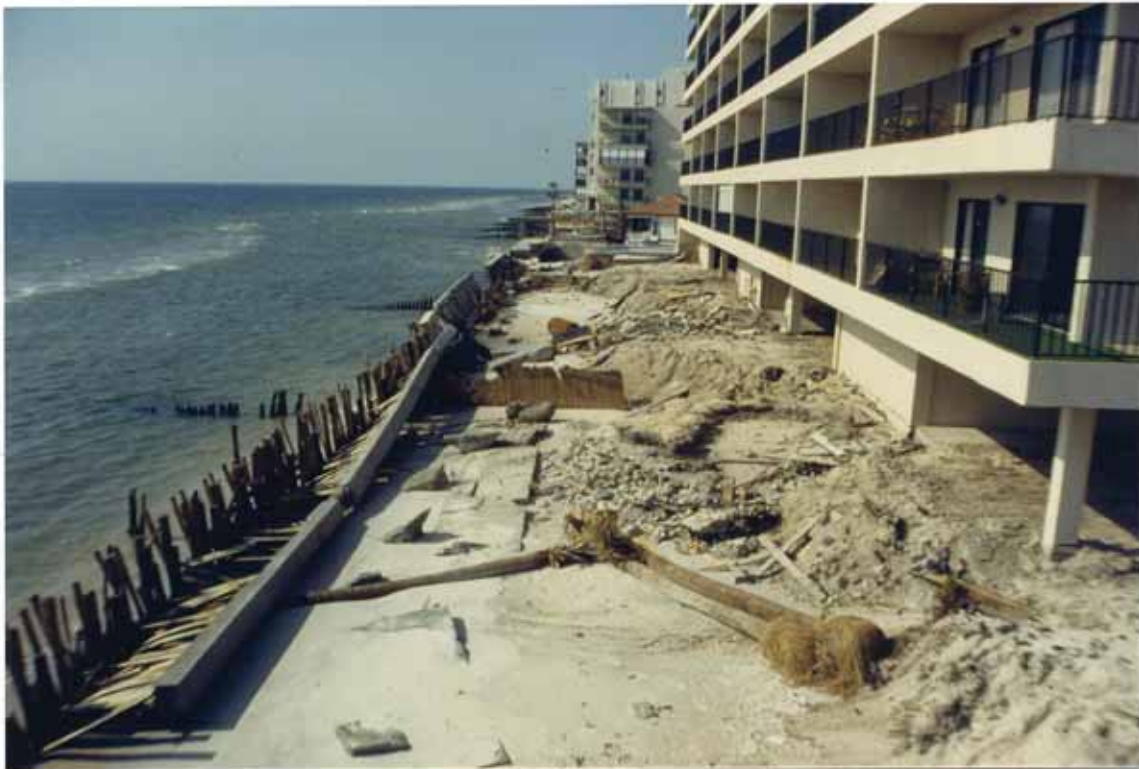
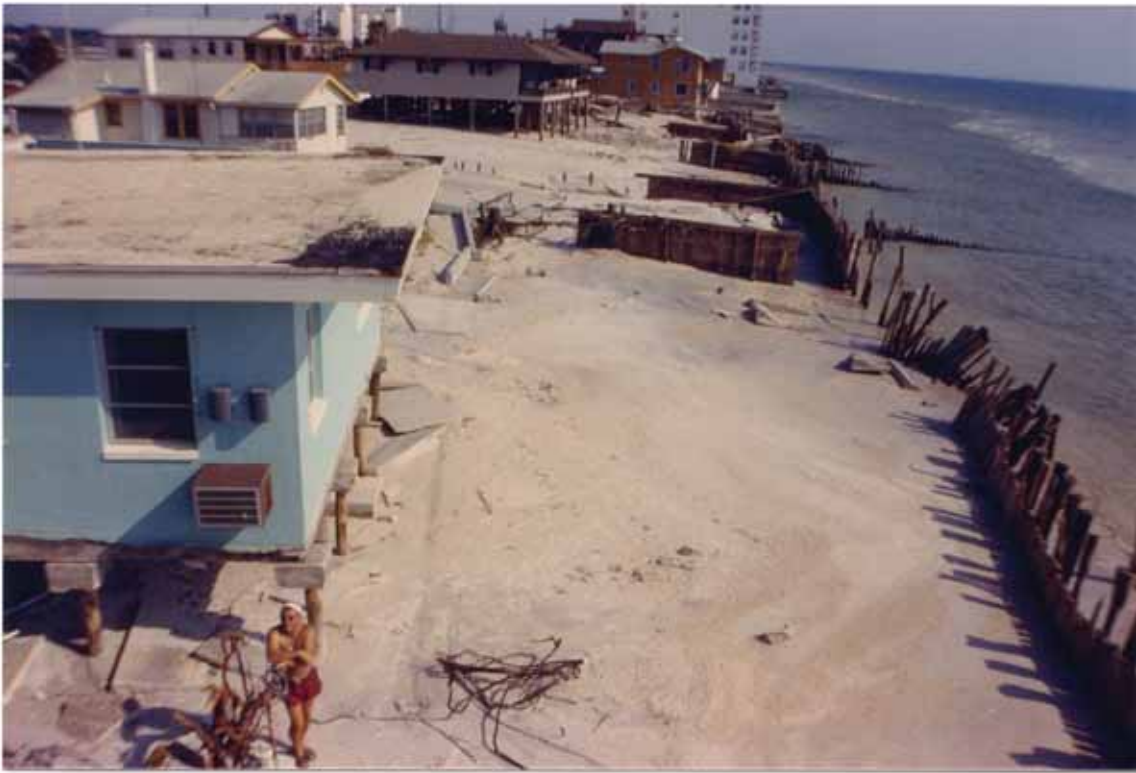
From 196th Avenue to the south, 400 feet of wood bulkhead was destroyed. Further south another 100 foot bulkhead segment was destroyed. To the north of the Indian Shores Town Hall, 820 feet of concrete and wood bulkheads were destroyed or substantially damaged (Figures 108 and 109). This area also had a swimming pool destroyed at the Sea Gate Condominium and a single-family dwelling and motel unit were damaged. Over 3,000 cubic yards of barrier dune sediment was eroded from behind this stretch of bulkhead.

FIGURE 108. Indian Shores bulkheads destroyed, 820 feet

FIGURE 109. Indian Shores bulkheads destroyed, 820 feet

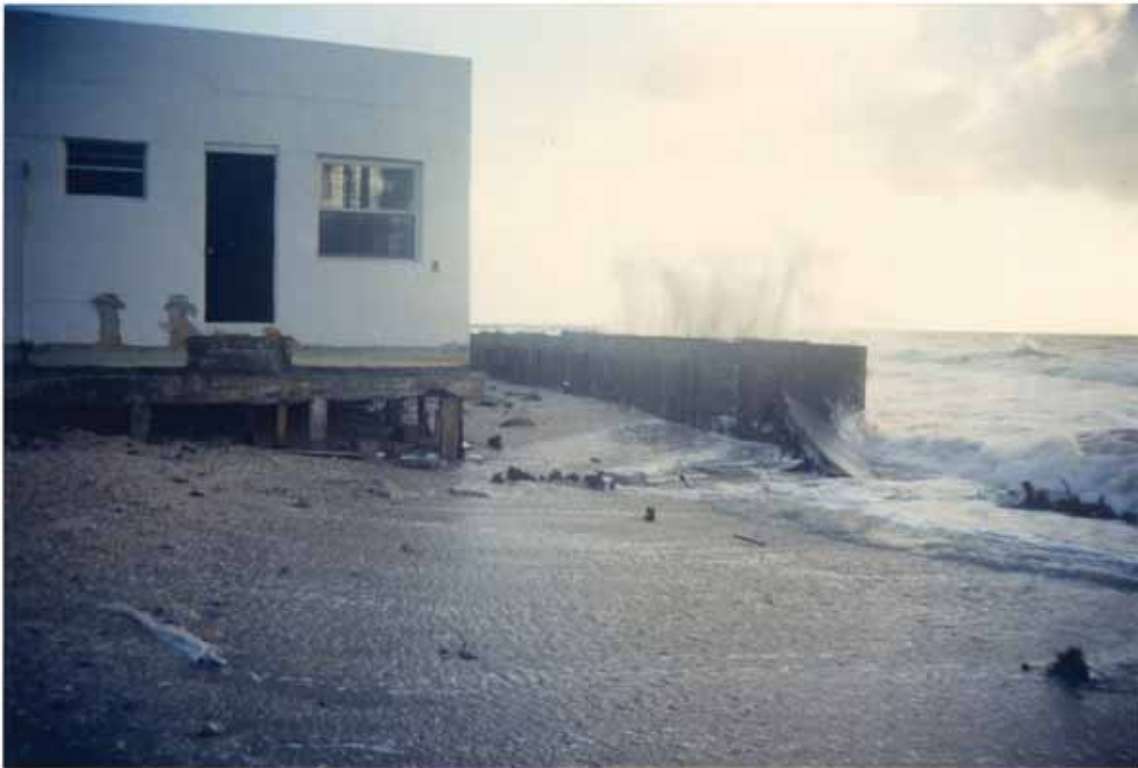
FIGURE 110. New bulkhead damaged without toe-scour protection

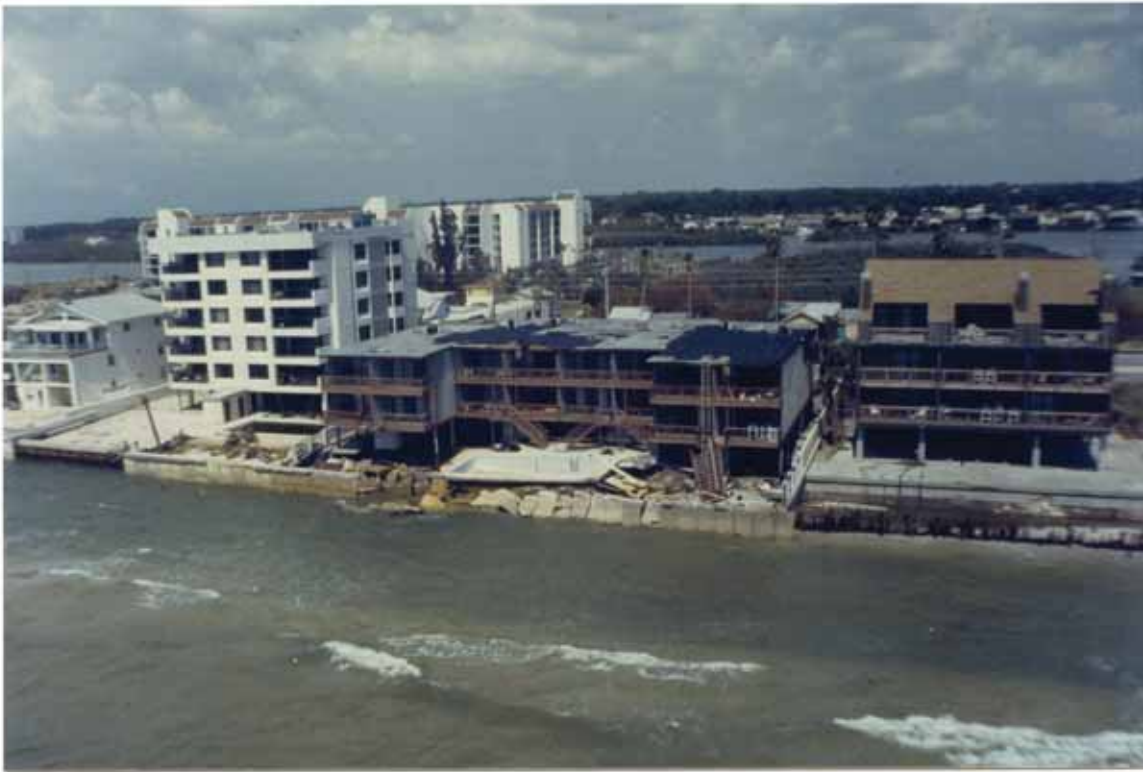
South of 190th Avenue, 100 feet of concrete bulkhead and 100 feet of wood bulkhead was destroyed by Elena (Figure 113). The concrete bulkhead was completely leveled and the swimming pool

FIGURE 113. Bulkhead destroyed by Elena

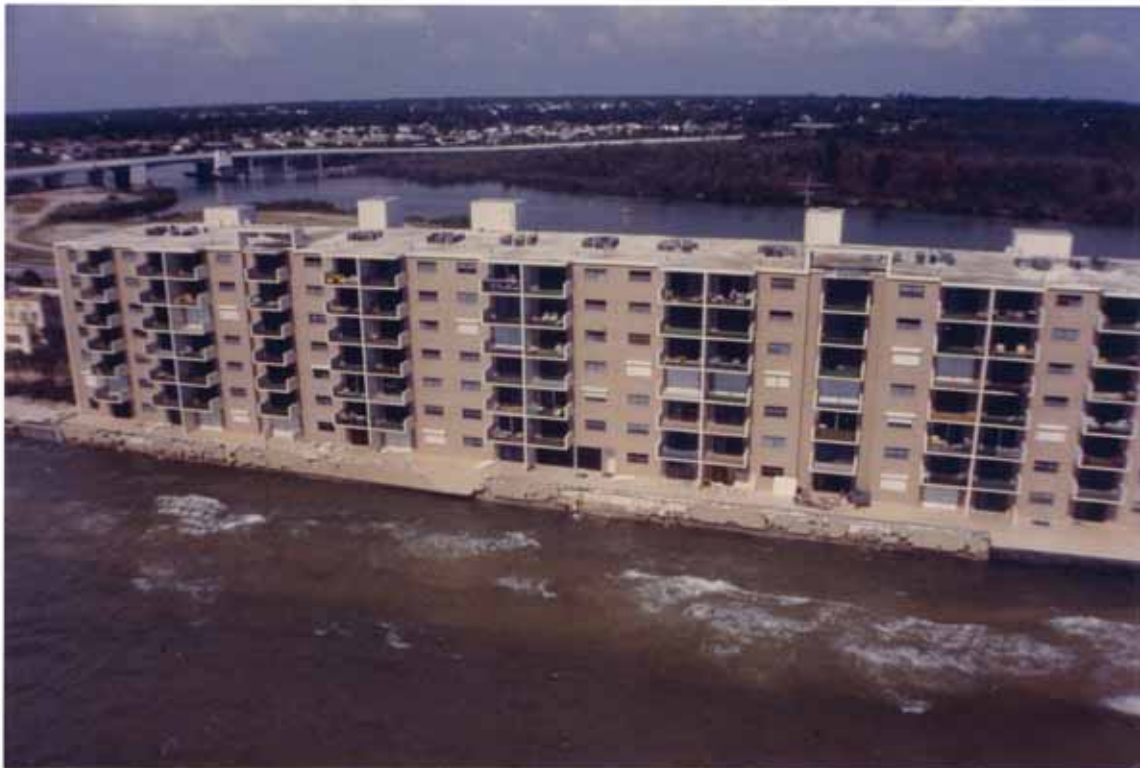
destroyed by Juan. There was no major wall damage between 189th Avenue and 186th Avenue. At the Gulf Shores Condominium which characterizes the worst of coastal planning and development in Florida, no beach remains after the storms. An inappropriately designed cantilevered concrete deck was destroyed by the uplift forces of Elena's storm waves (Figure 114).

FIGURE 114. Gulf Shores Condominium after Elena

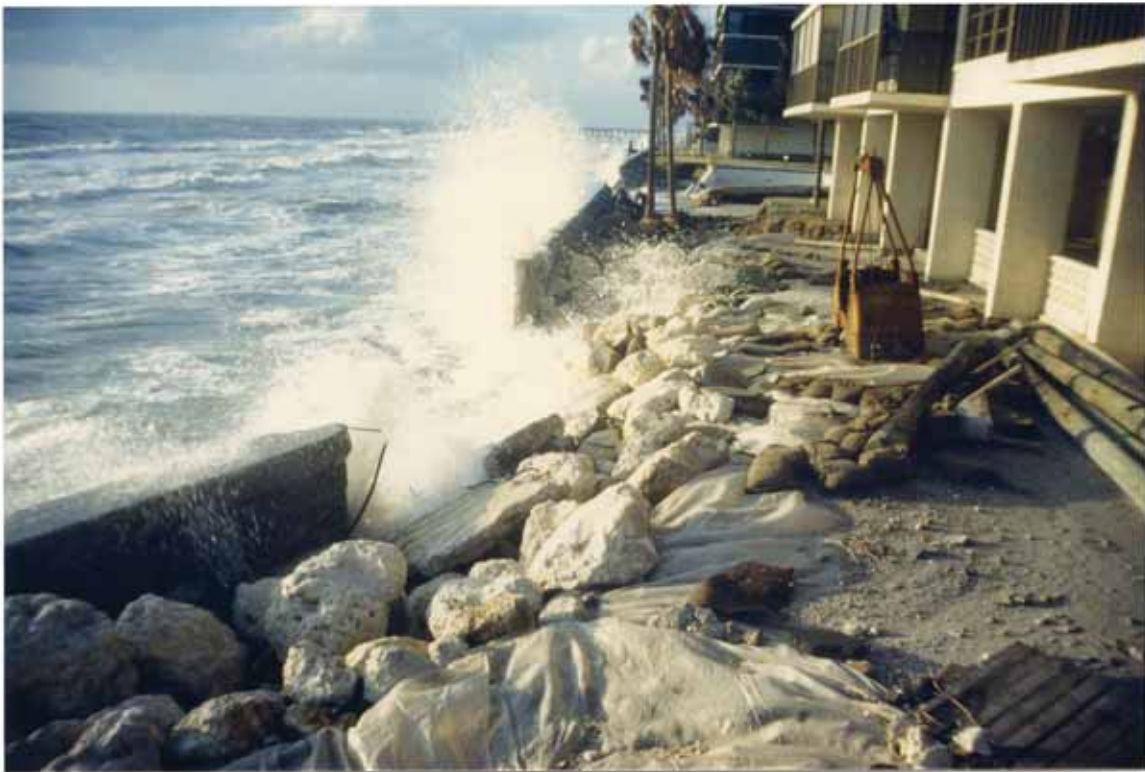
At the Shore Mariner Condominium, Elena destroyed 150 feet of concrete bulkhead and a large swimming pool (Figure 115). Additional segments of the wall, although standing, were damaged. An additional segment of wall was destroyed by Juan; however, the property owners had taken emergency measures with temporary revetment construction and prevented any building damage (Figure 116). South of the Shore Mariner a 70 foot segment of concrete wall was destroyed by Elena.

FIGURE 116. Emergency revetment protection from Juan

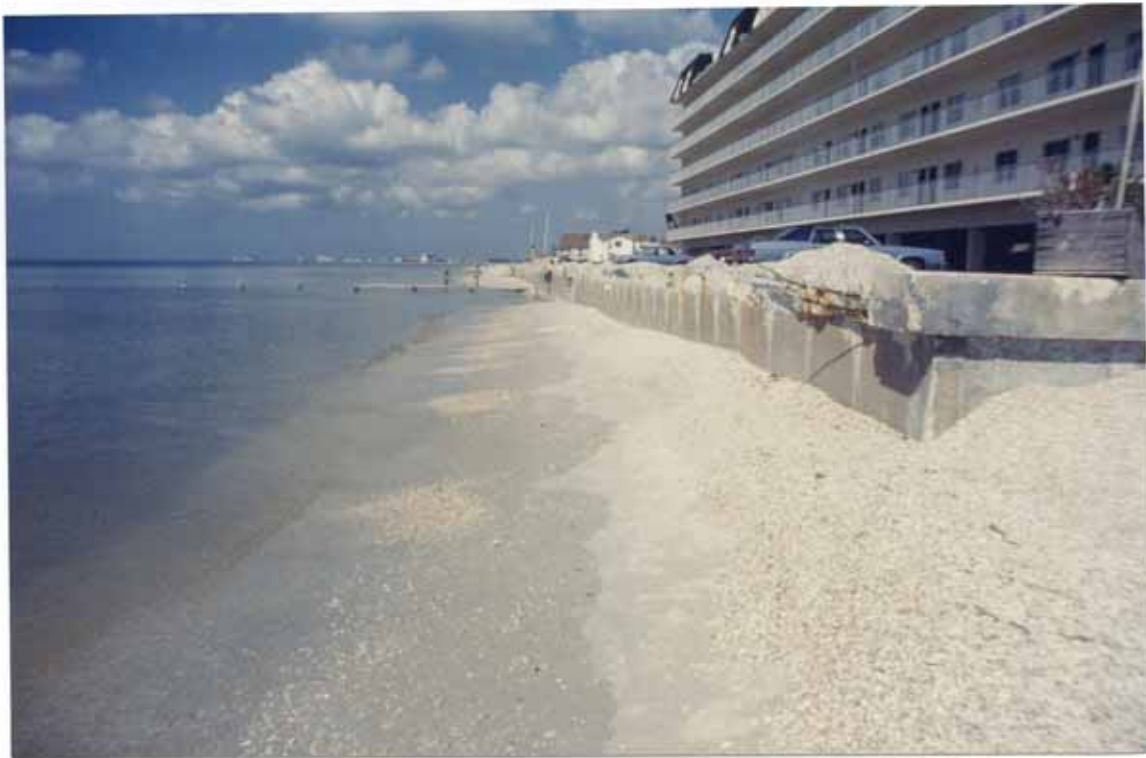
FIGURE 123. Juan damaged Sunset Chateau Condominium's bulkhead, Treasure Island

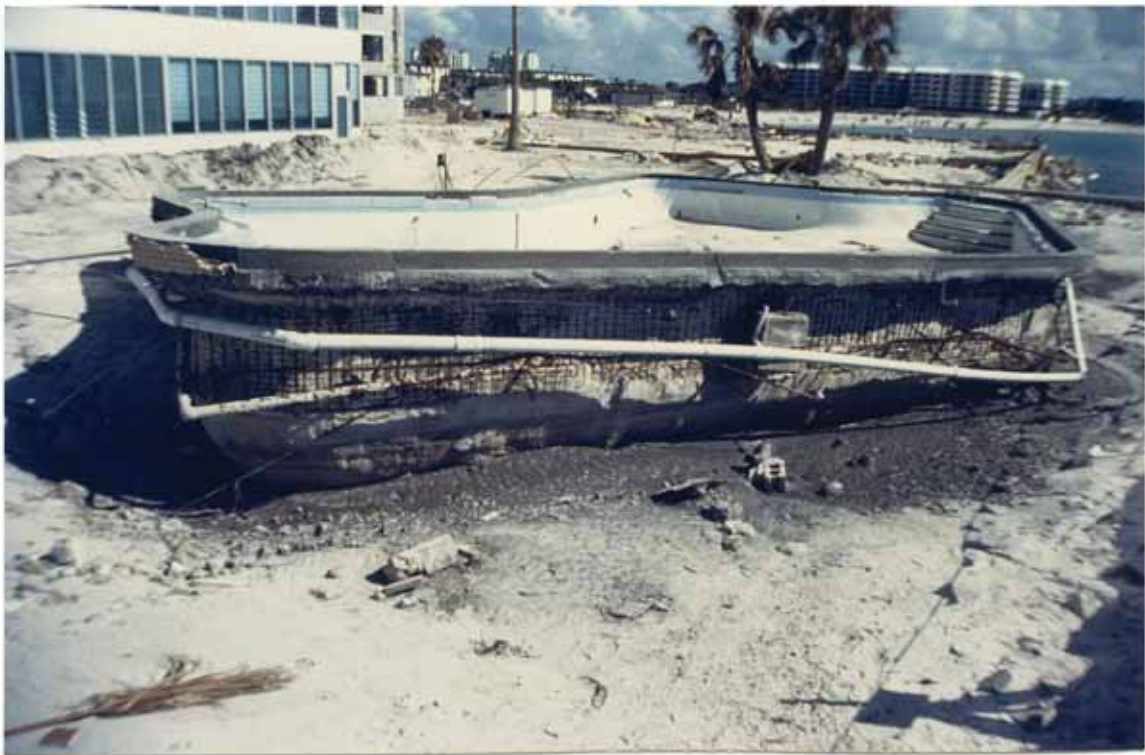
FIGURE 124. Pool at Starlight Tower Condominium floated above grade during Juan's flooding, St. Petersburg Beach

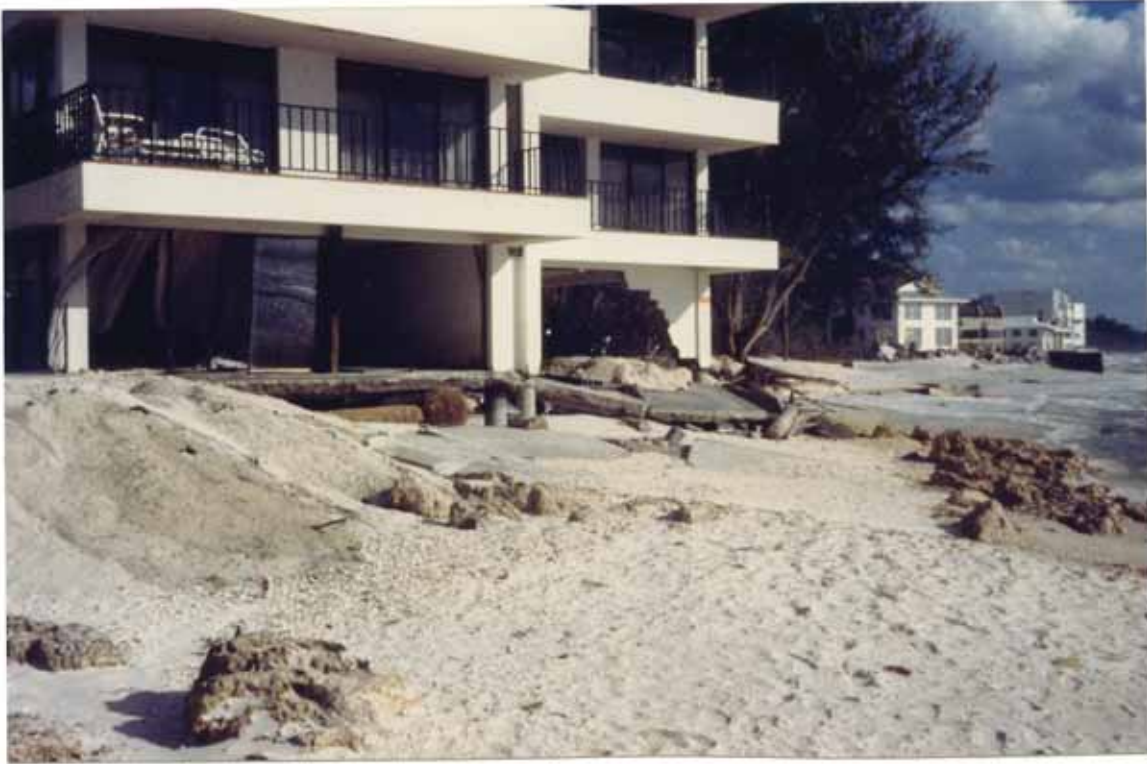
Immediately south of the end of 67th Street in Holmes Beach, a 70 foot concrete wall was damaged by Juan. At the Waters Edge Condominium major wave damage was sustained to the lower floor area of the building during Elena (Figure 125). South of the Waters Edge a 50 foot concrete wall was destroyed by Juan and a 150 foot concrete bulkhead was destroyed by Elena. South of 56th Street a single-family dwelling was undermined and sustained wave damage by Elena and its deck roof collapsed. To its south, the Sun Plaza West Condominium sustained damage to the understructure area.

FIGURE 125. Waters Edge Condominium damaged by Elena (S. West)

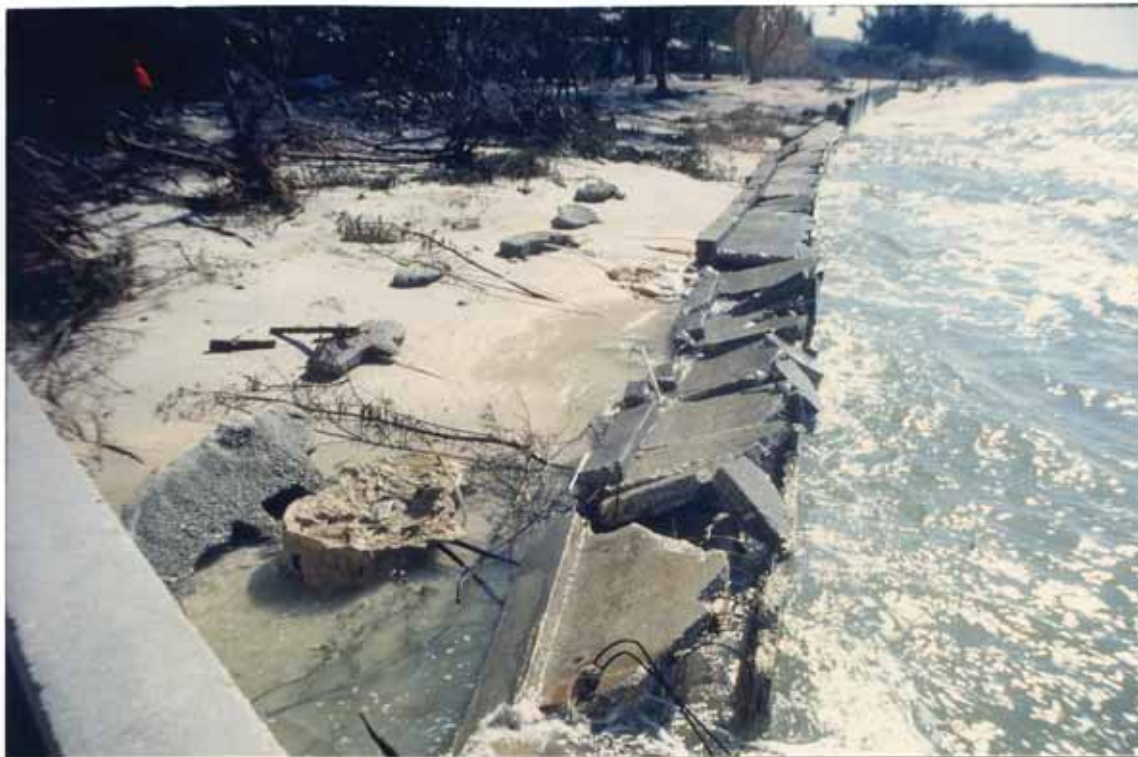
FIGURE 127. Elena and Juan destroyed 920 feet of bulkhead

Lack of fill containment was also a problem in Manatee County where there was substantial wall damage from Elena and Juan (Figure 127). In most cases boulder-mounds and revetments provided adequate protection; however, a few such structures

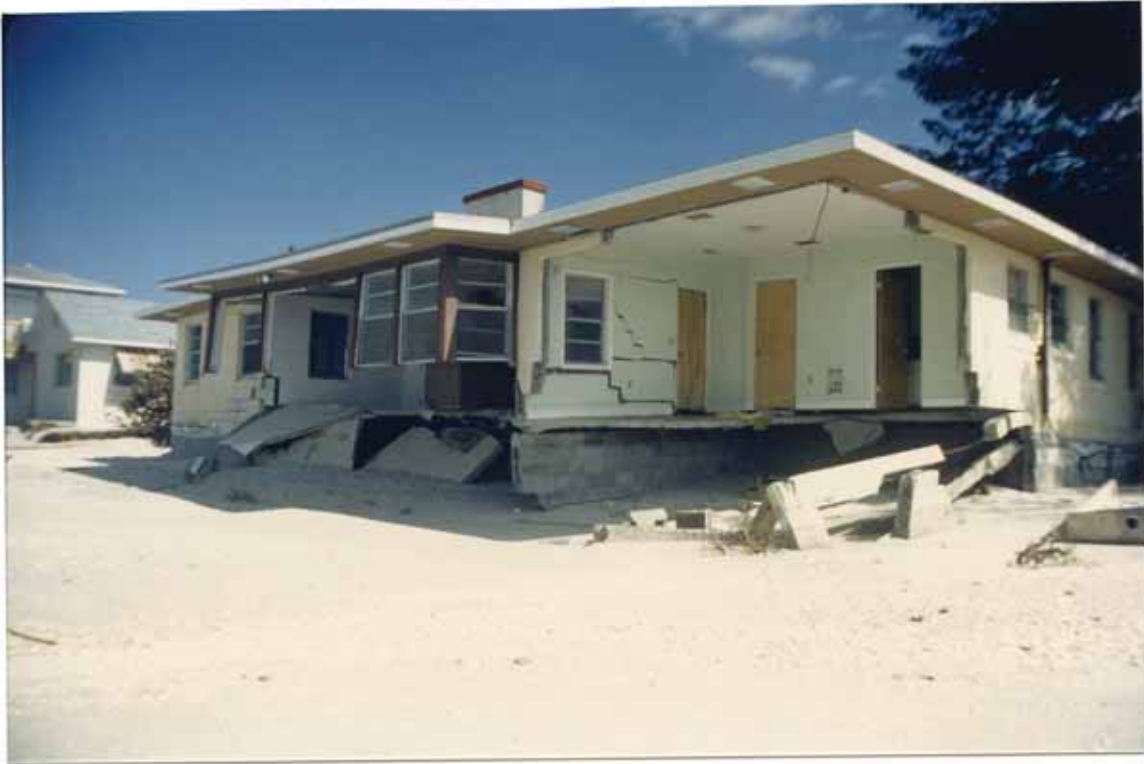
FIGURE 129. Juan's beach accretion at damaged dwelling

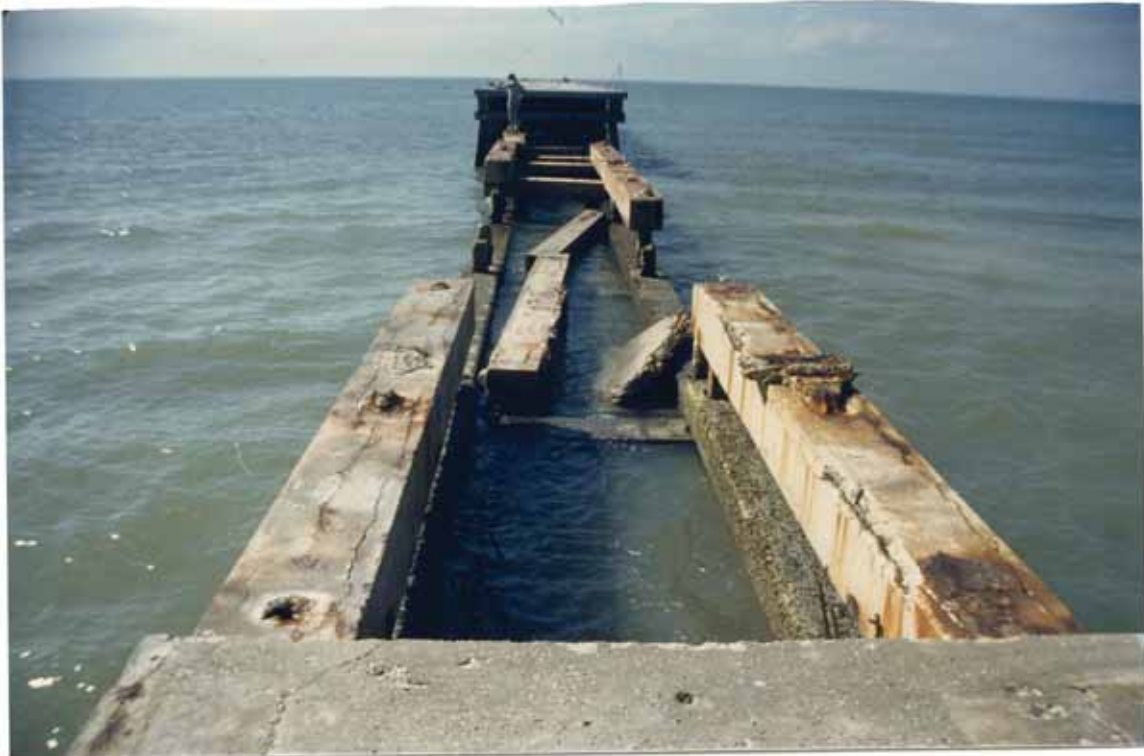
FIGURE 130. Juan damaged pier-groin at County park

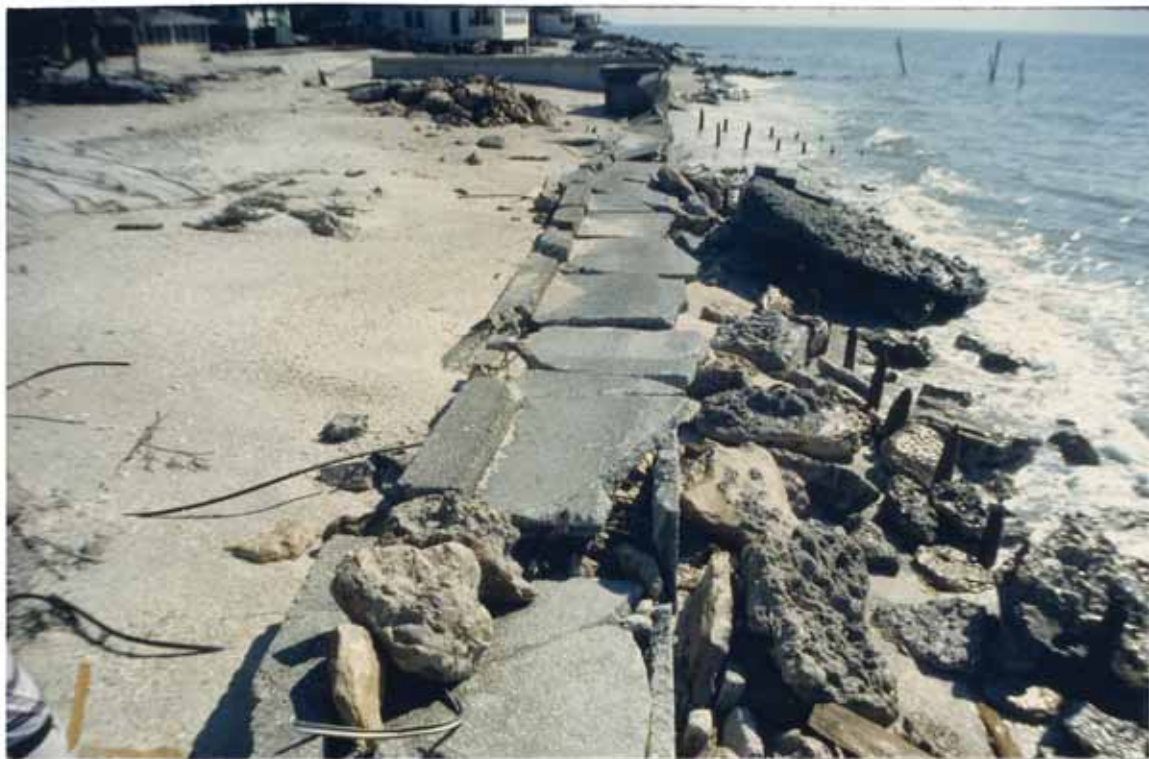
FIGURE 132. Bulkhead destroyed by wave impact loads

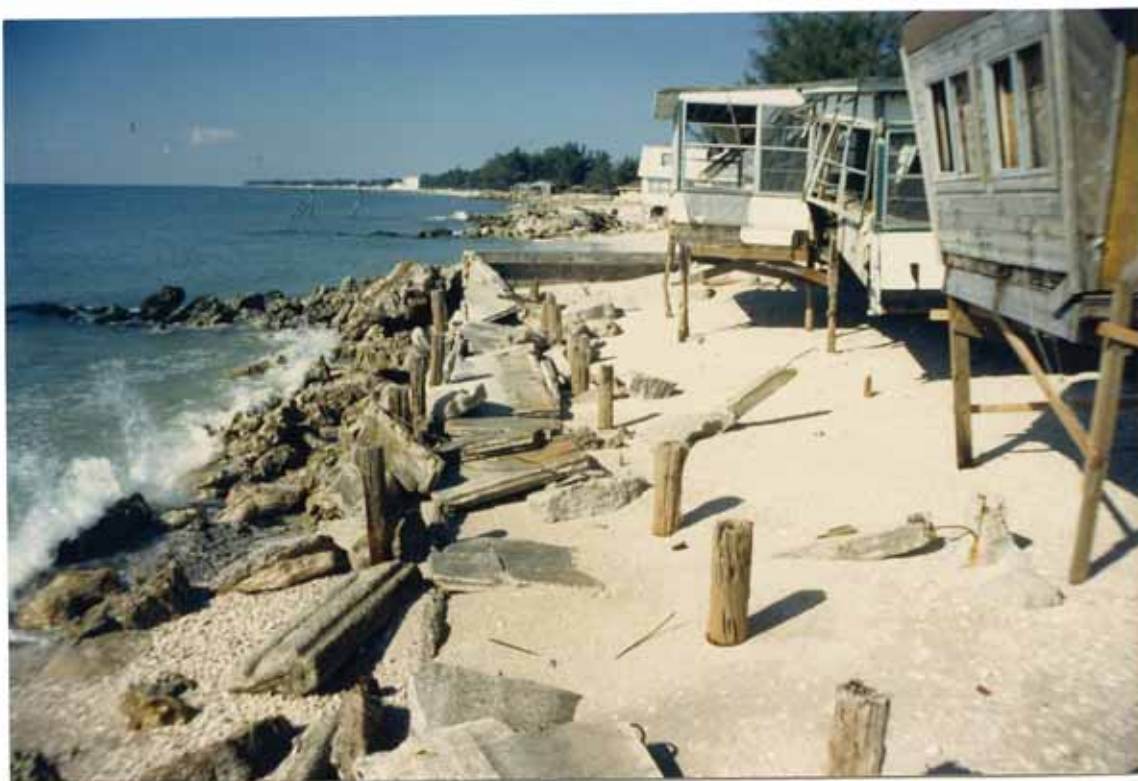
FIGURE 134. Bulkhead with toe-scour protection destroyed

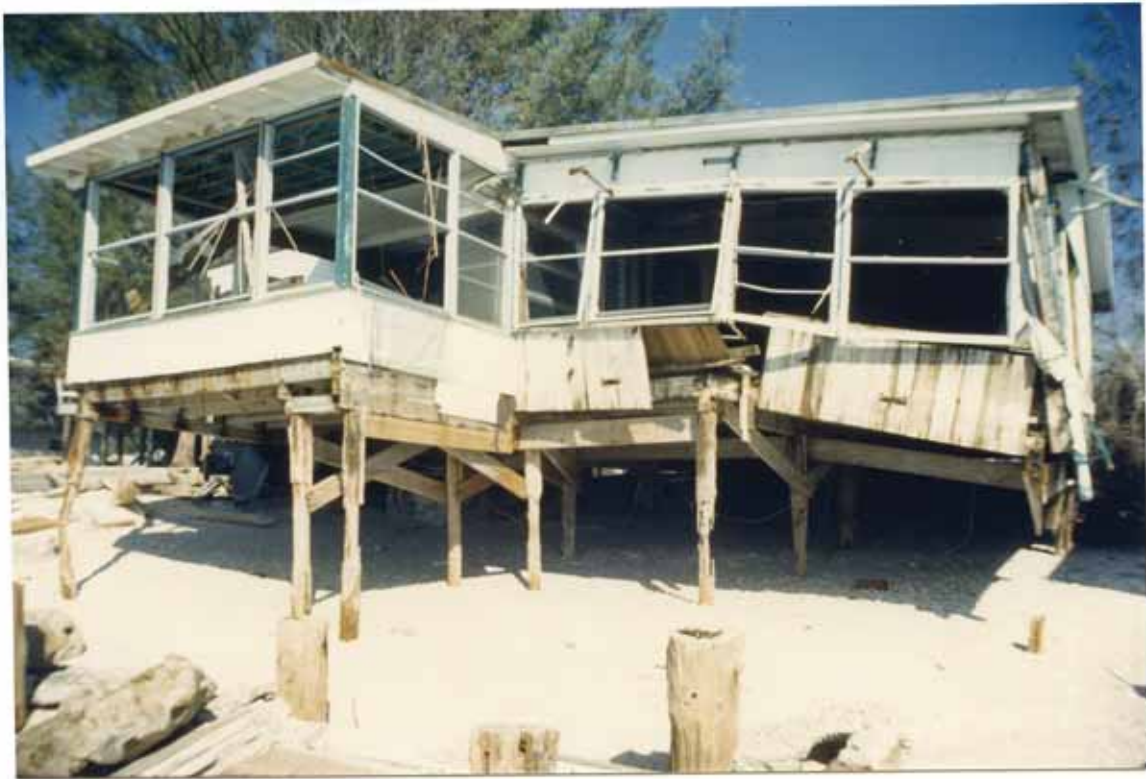
FIGURE 135. Holmes Beach dwelling destroyed by Elena

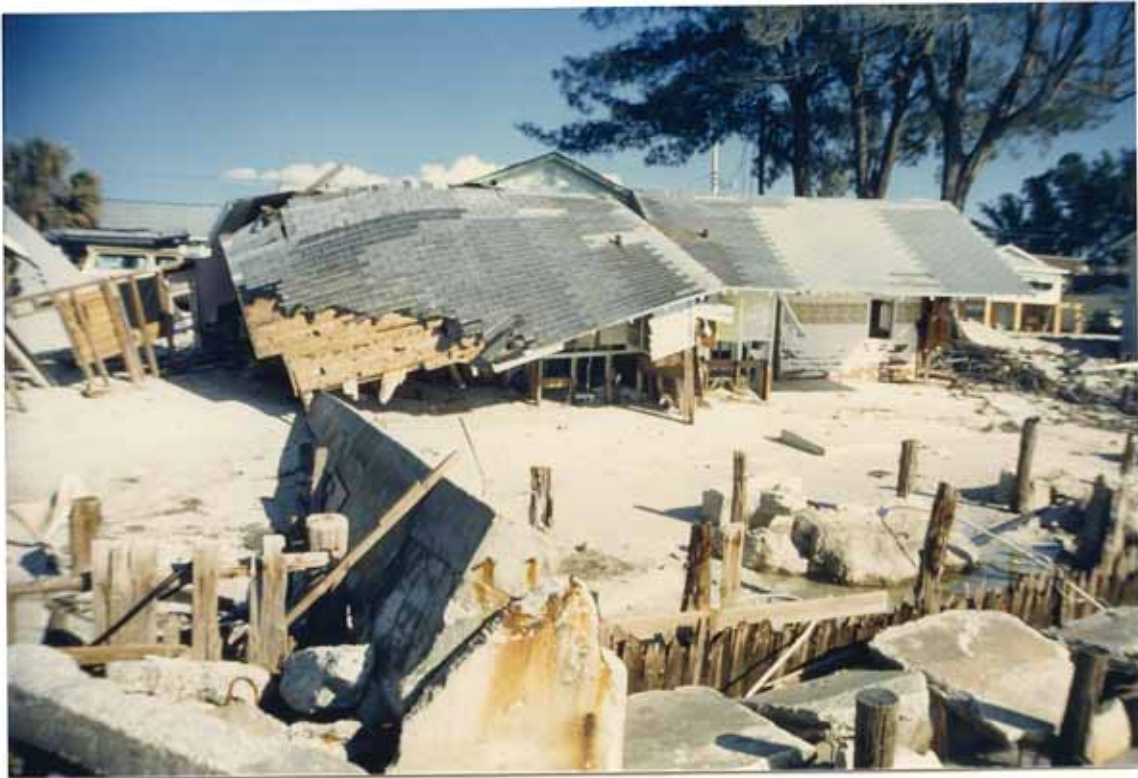
FIGURE 136. Bradenton Beach dwelling destroyed by Elena

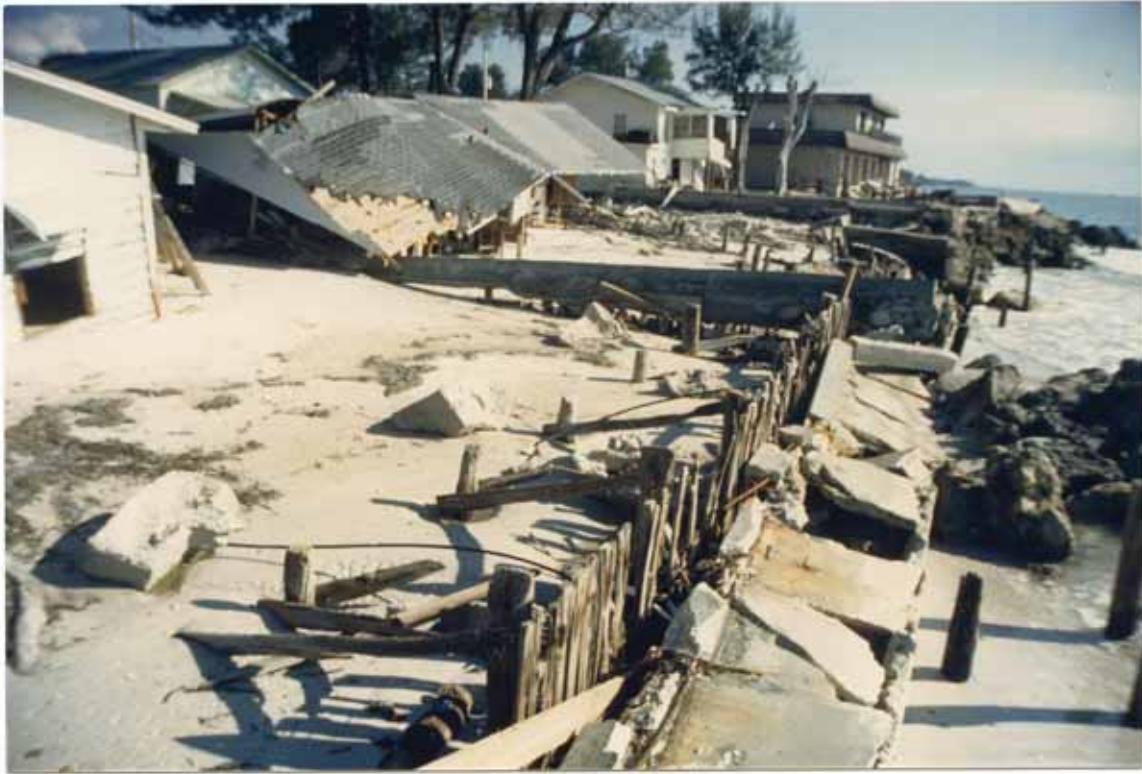
FIGURE 139. Bulkheads destroyed by wave loads

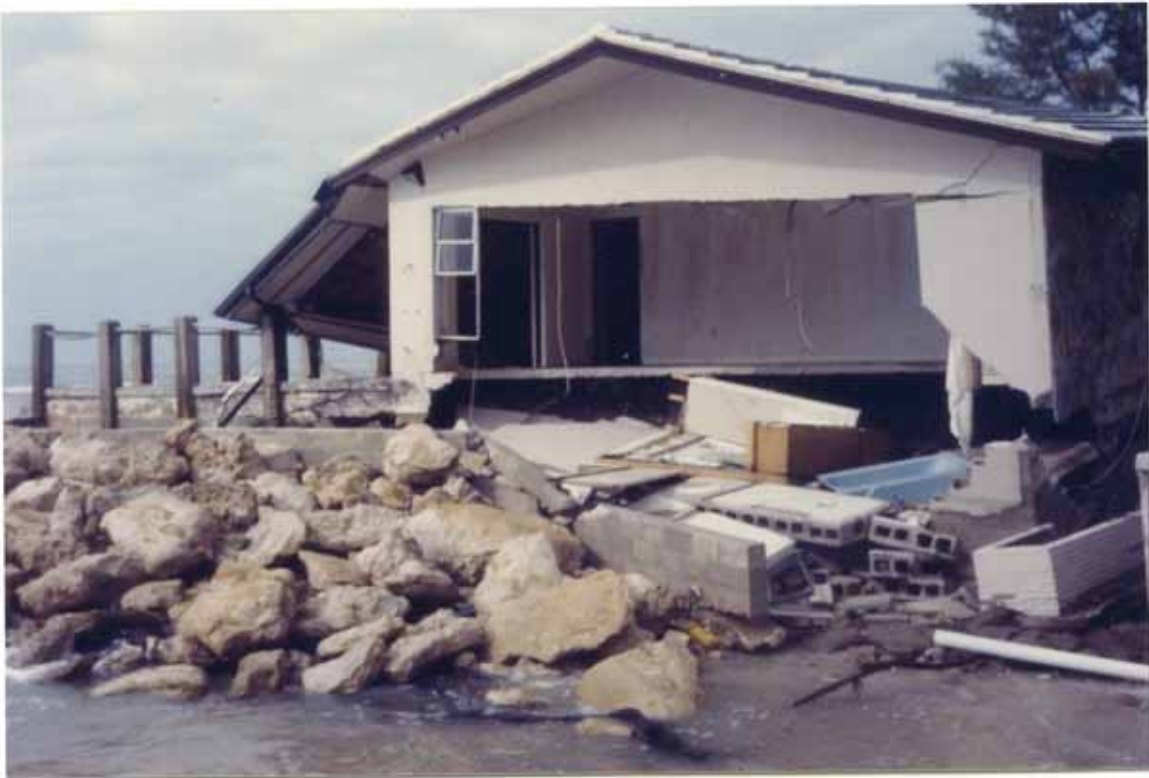
Approximately one mile south of Longboat Pass considerable structural damage occurred along Gulfside Drive. At one property, 100 feet of concrete bulkhead was destroyed, 40 feet by Elena and 60 feet by Juan, and the front deck and decorative wall seaward of the dwelling were destroyed by Juan. At the dwellings immediately to the south a patio and a deck and spa were destroyed by Juan. Further south, two single-family dwellings and a groin sustained major damage by Elena and Juan. One dwelling sustained wave damage to its lower floor (Figure 141). The other dwelling experienced roof collapse from the constant impact of Juan's storm waves (Figure 143). This dwelling was also substantially damaged from flanking wave attack around its south side (Figure 144).

FIGURE 144. Same dwelling destroyed by wave flanking  
(M. Joity)

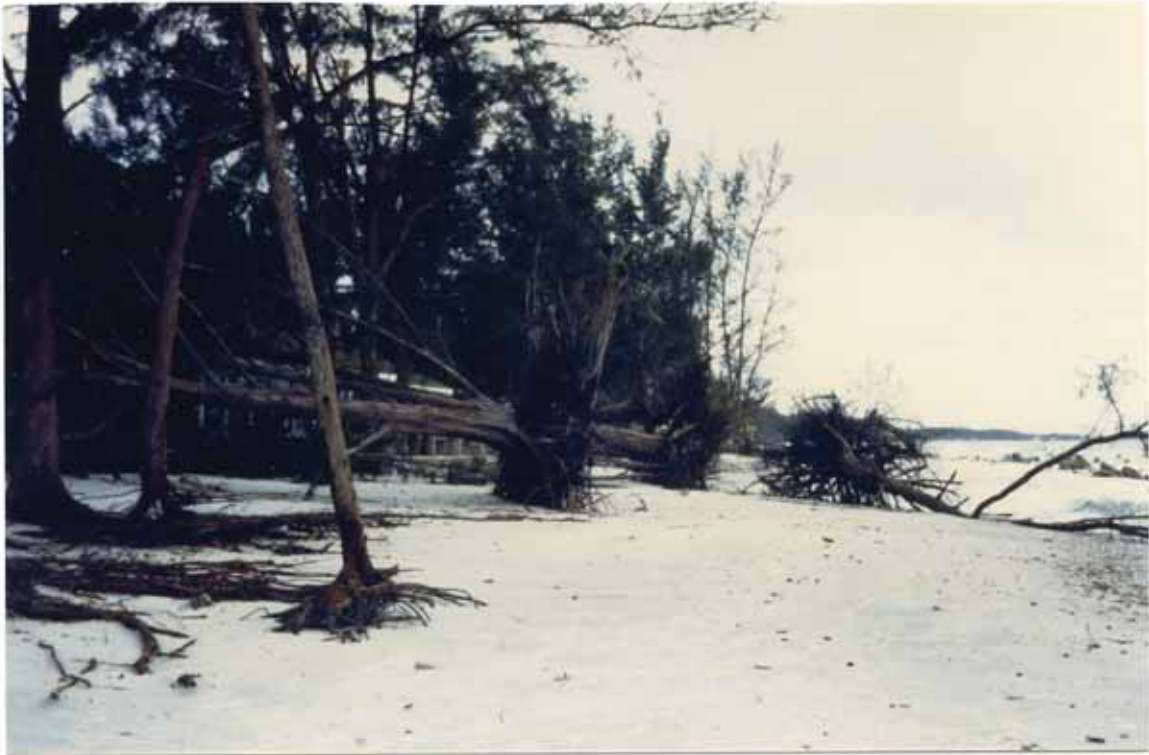
Further south a continuous 700 foot stretch of concrete bulkhead was destroyed by Juan (Figure 142). Considerable erosion took place landward of the bulkhead resulting in a number of large Australian pine trees being toppled (Figures 145 and 146). Notwithstanding the two beach profile computations at DNR reference monument numbers 51 and 54 as reported in Post-Storm Report Number 85-2, moderate to heavy beach erosion took place along the two mile stretch south of this area of heavy structural damage. This area experienced wave overtopping and one swimming pool was damaged by Juan beyond repair.

FIGURE 145. Severe erosion on Longboat Key (S. West)
