# THE IMPACT OF HURRICANE ELENA AND TROPICAL STORM JUAN ON COASTAL CONSTRUCTION IN FLORIDA

Beaches and Shores Post-Storm Report No. 85-3

March, 1986

Bureau of Coastal Engineering and Regulation  
Division of Beaches and Shores  
FLORIDA DEPARTMENT OF NATURAL RESOURCES

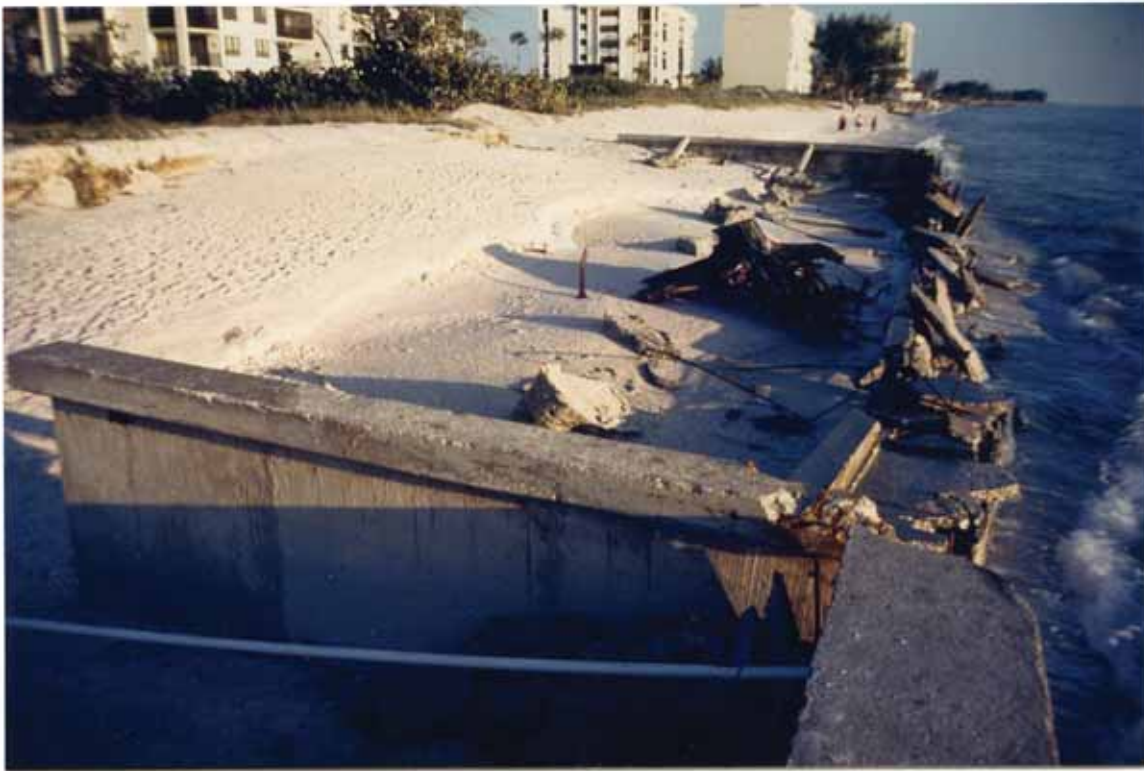
Near the south end of Manatee County, a 100 foot concrete bulkhead was destroyed by Juan adjacent a dwelling south of the Casa del Mar Condominiums (Figure 147). The Longboat Harbor Towers lost 90 feet of concrete bulkhead during Elena and an additional 120 feet of wall and the swimming pool during Juan (Figure 148).

FIGURE 147. Juan destroyed concrete bulkhead

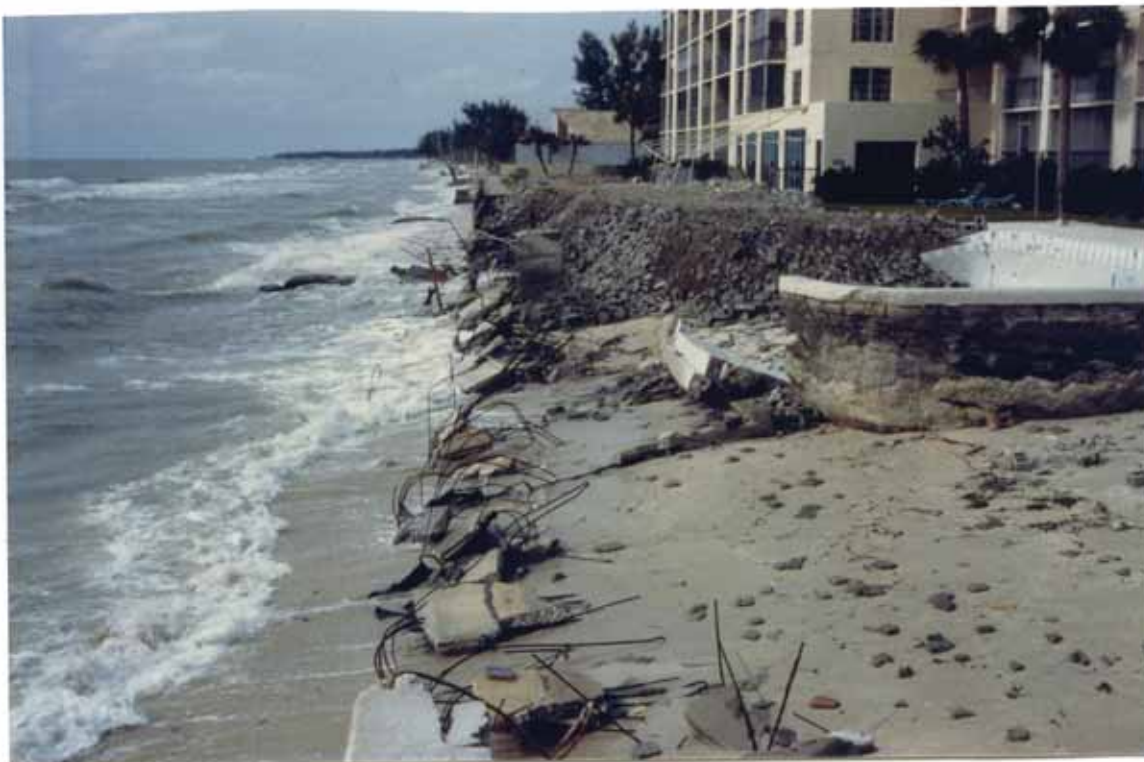
FIGURE 148. Juan destroyed pool and bulkhead, Longboat Harbor Towers (S. West)
