Appendix VIII

SBEACH 15 and 25 yr. Storm Erosion Profiles

St. Johns County

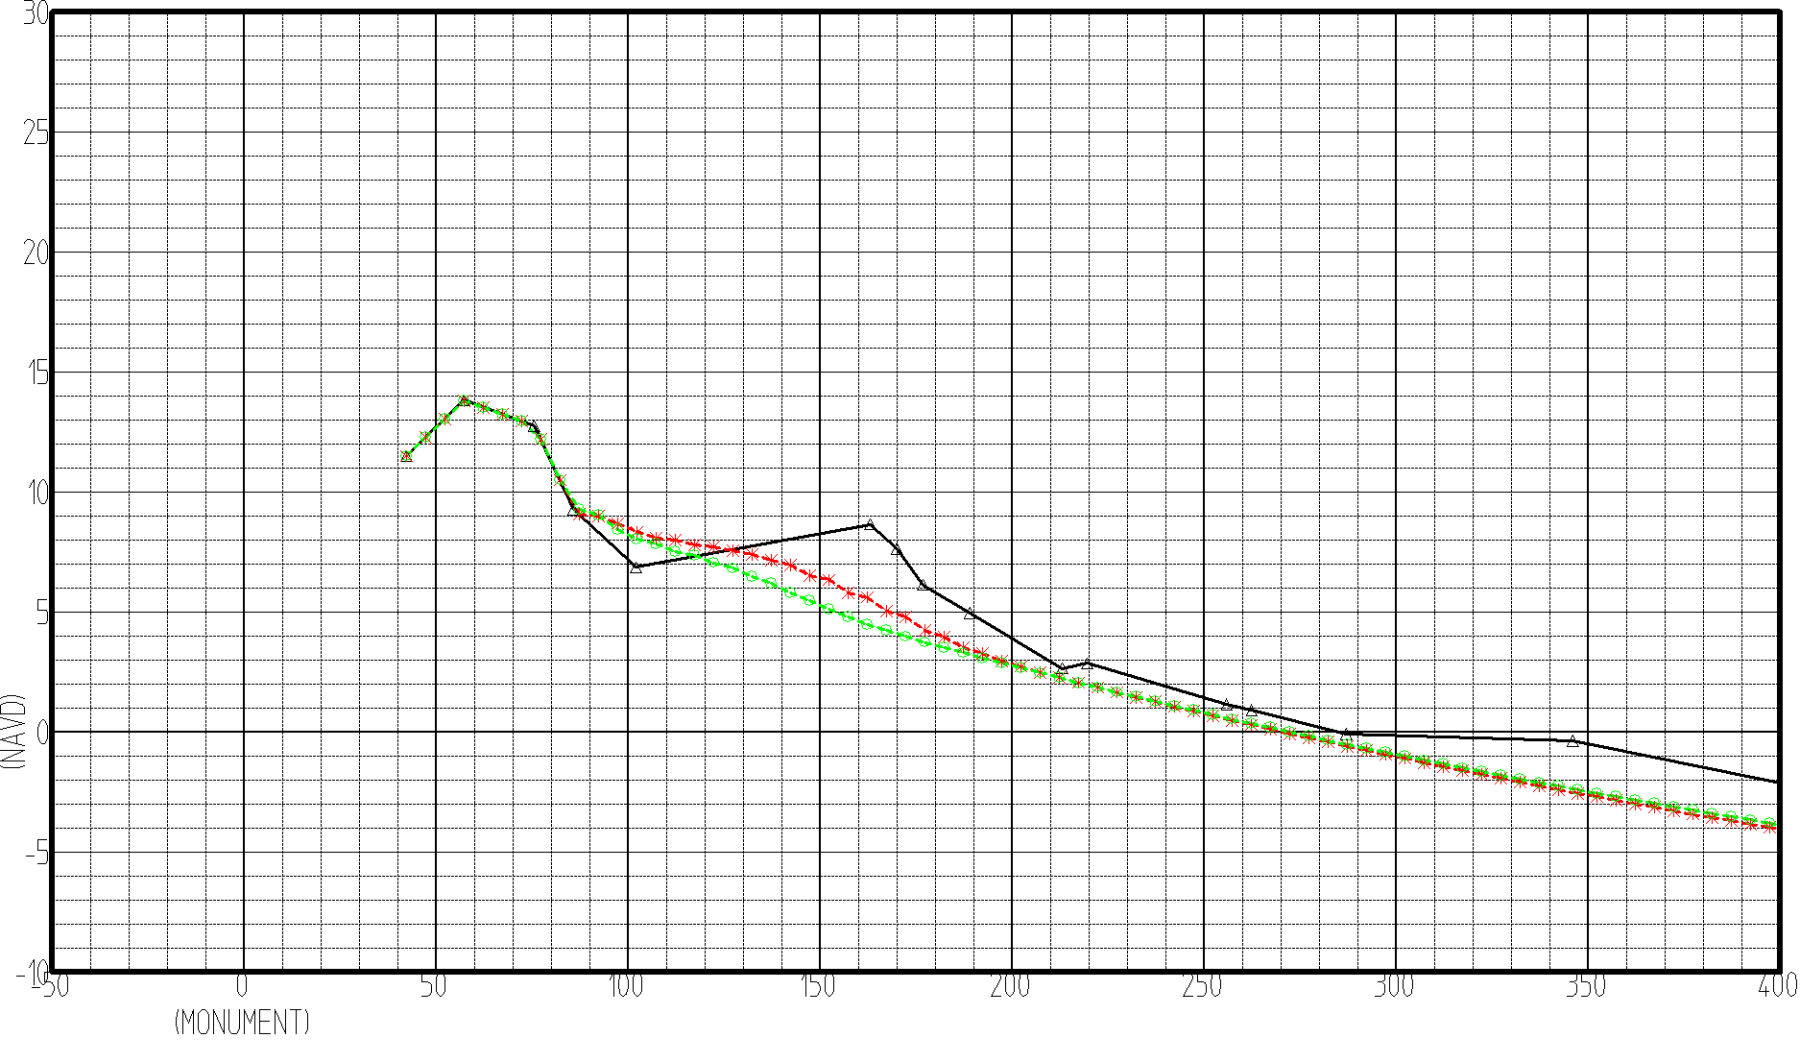
Range: R-1
 BEARING: 75.00
 1/2

BEACH PROFILE
 —△—△— ST. JOHNS 2007-2008 COMBI
 - - * - - 15YR SBCH ERODED
 - - o - - 25YR SBCH ERODED

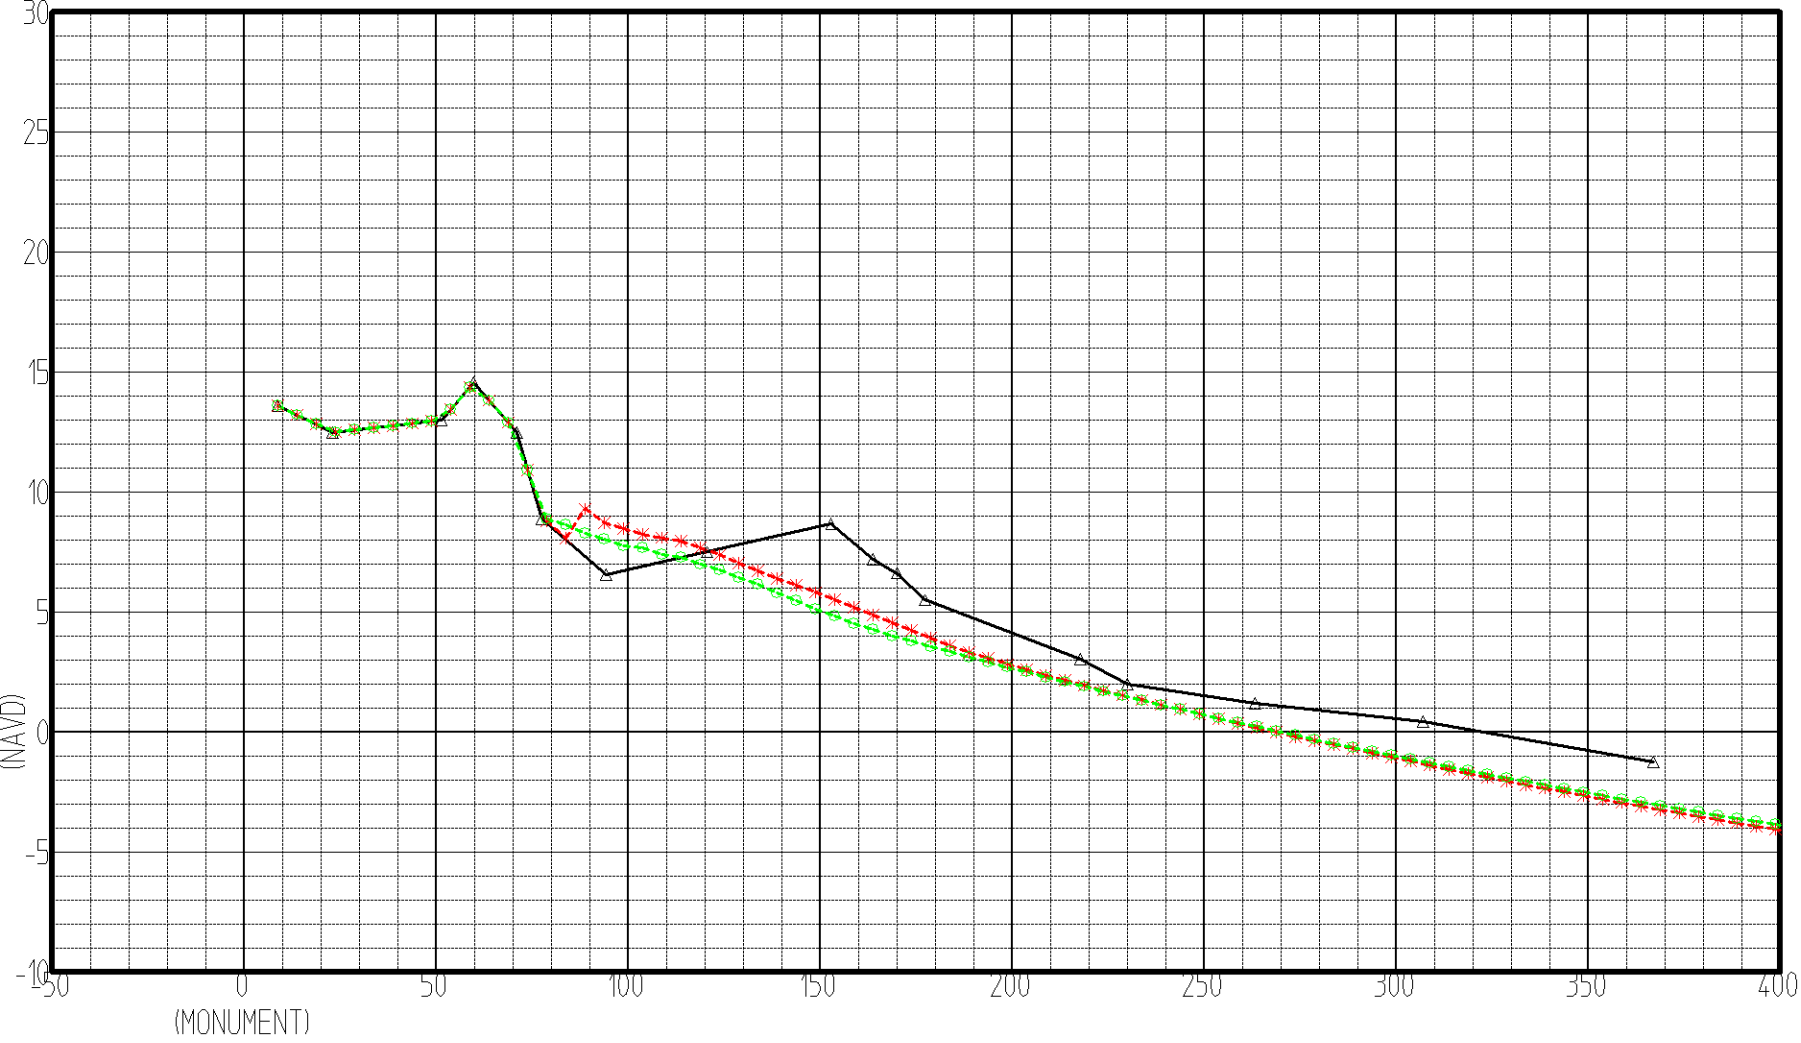
Range: R-2
 BEARING: 75.00
 1/2

BEACH PROFILE
 —△—△— ST. JOHNS 2007-2008 COMBI
 - - * - - - 15YR SBEACH ERODED
 - - o - - - 25YR SBCH ERODED

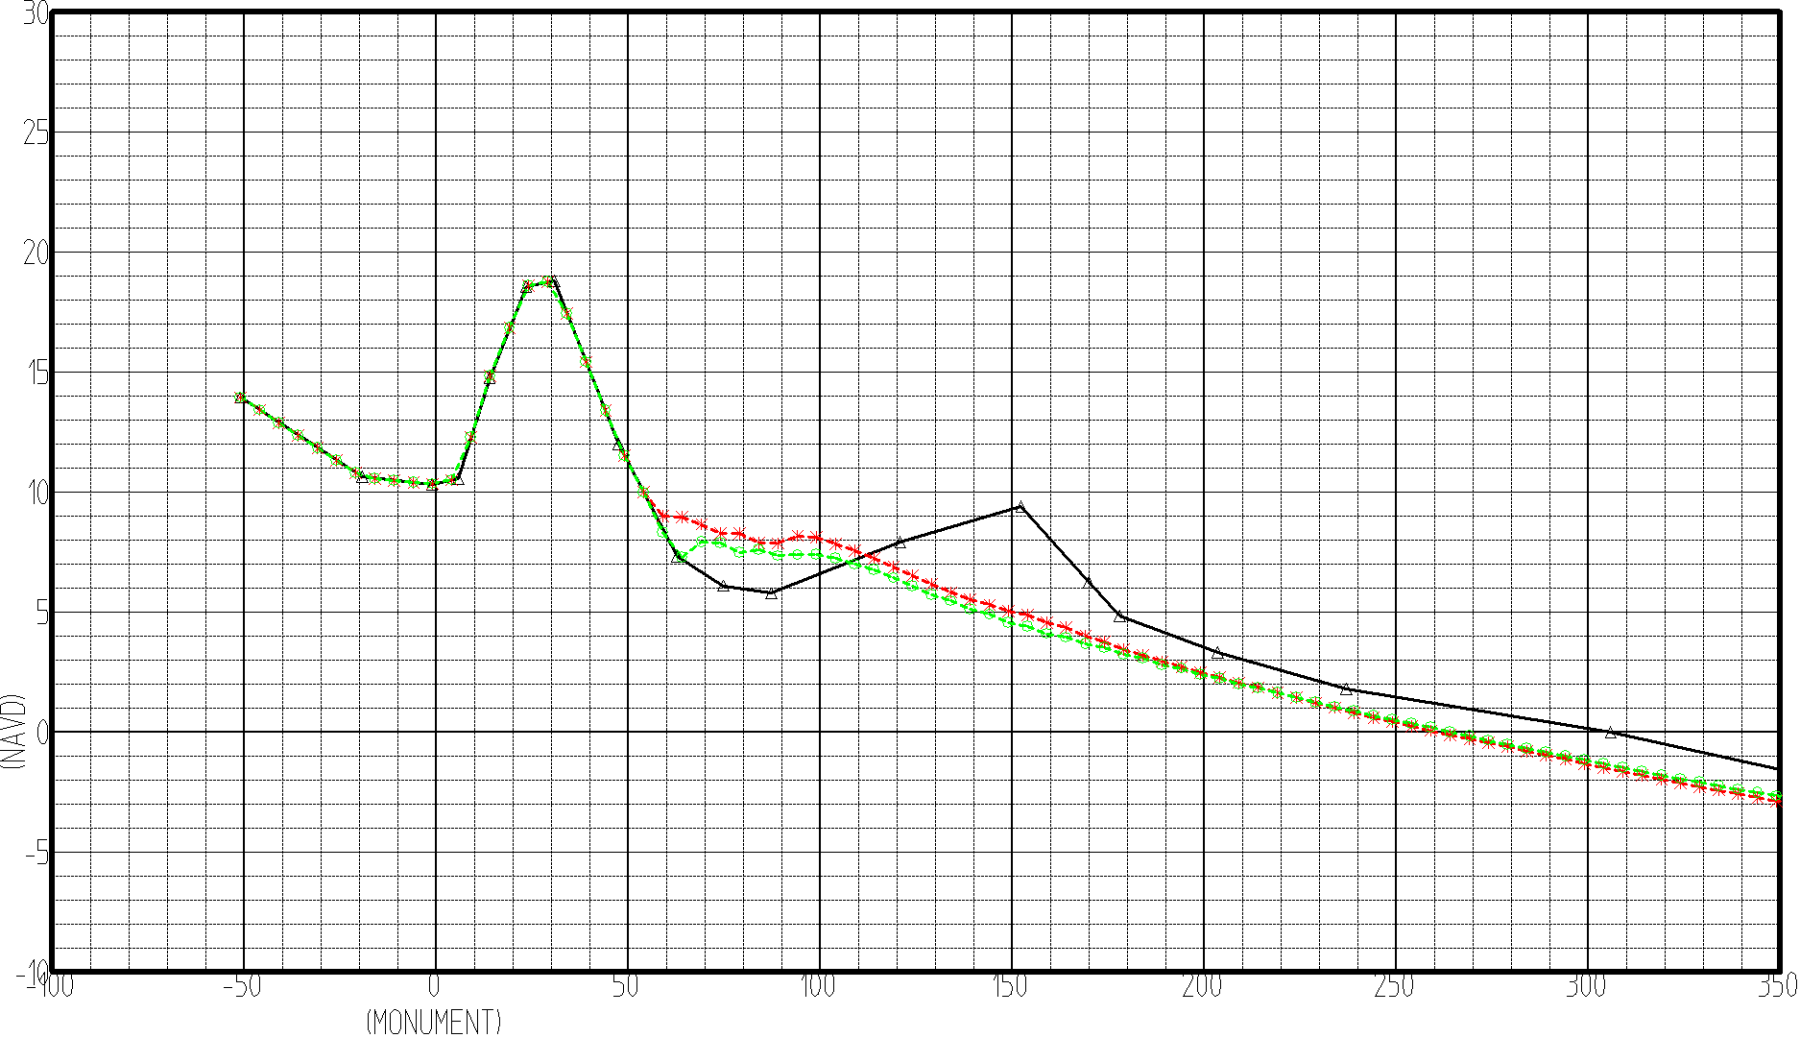
Range: R-3
 BEARING: 75.00
 1/2

BEACH PROFILE
 —△—△— ST. JOHNS 2007-2008 COMBI
 - - * - - - 15YR SBEACH ERODED
 - - o - - - 25YR SBCH ERODED

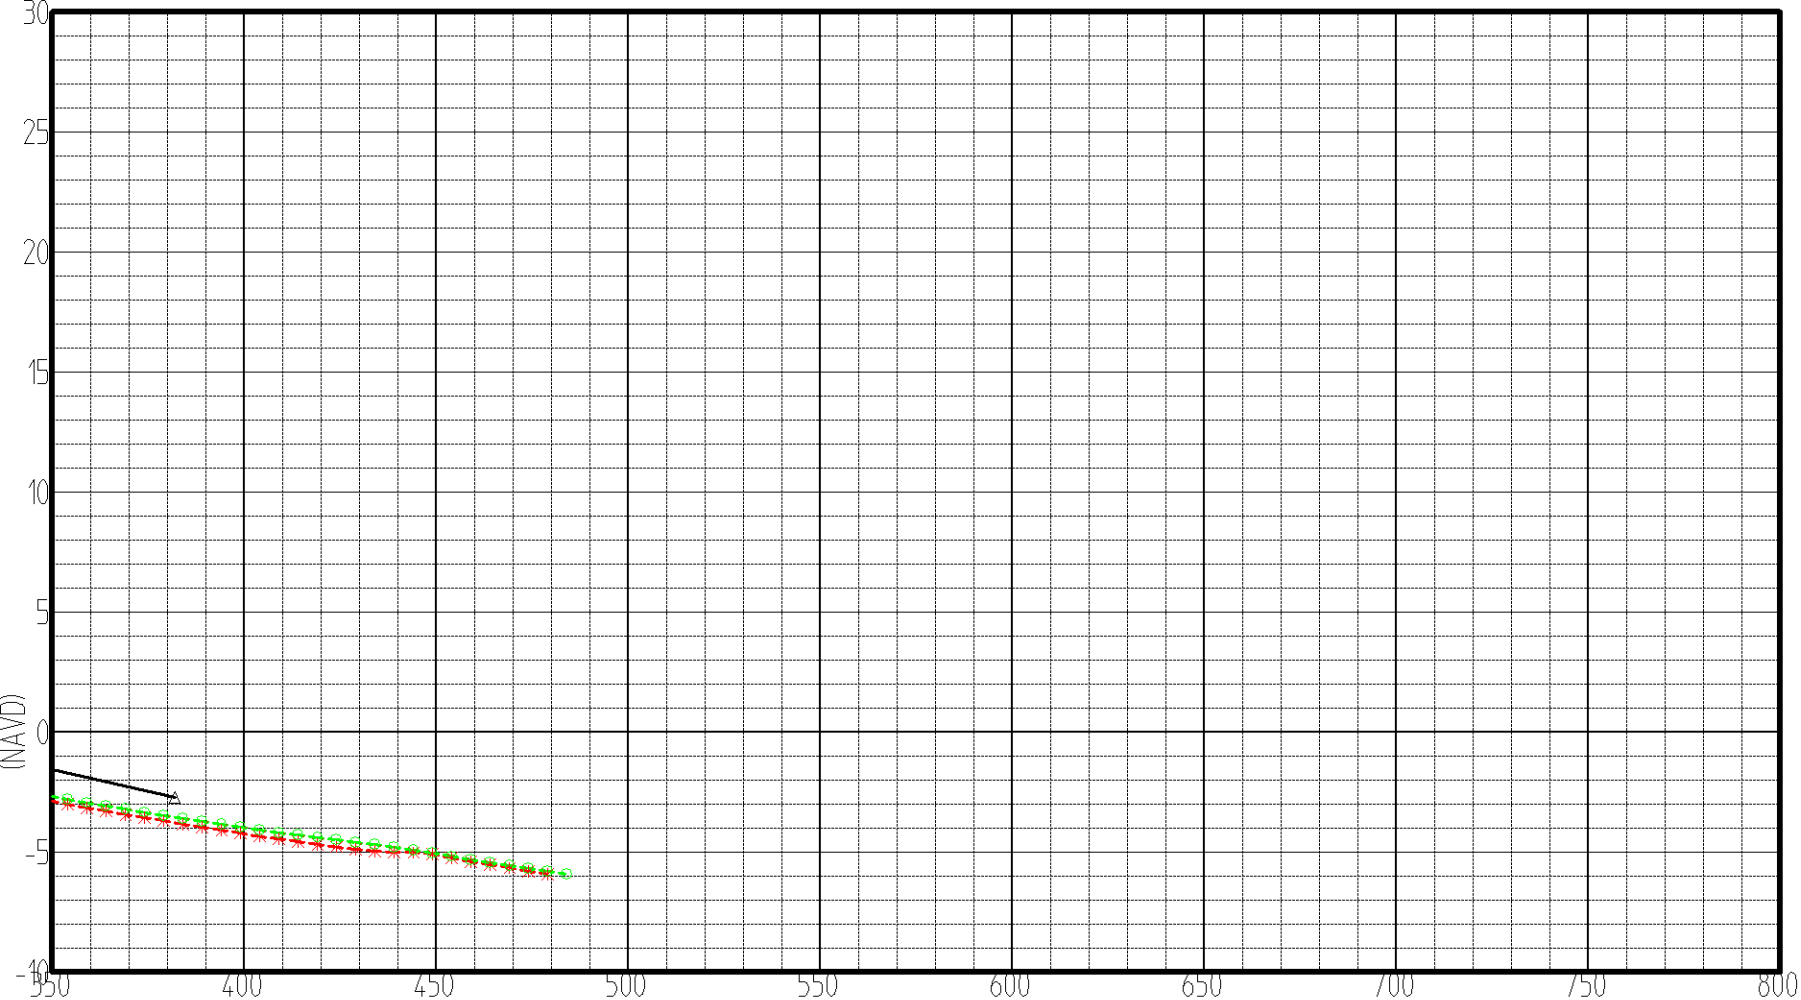
Range: R-3

BEACH PROFILE

—△—△— ST. JOHNS 2007-2008 COMBI

- - * - - - 15YR SBEACH ERODED

- - o - - - 25YR SBCH ERODED

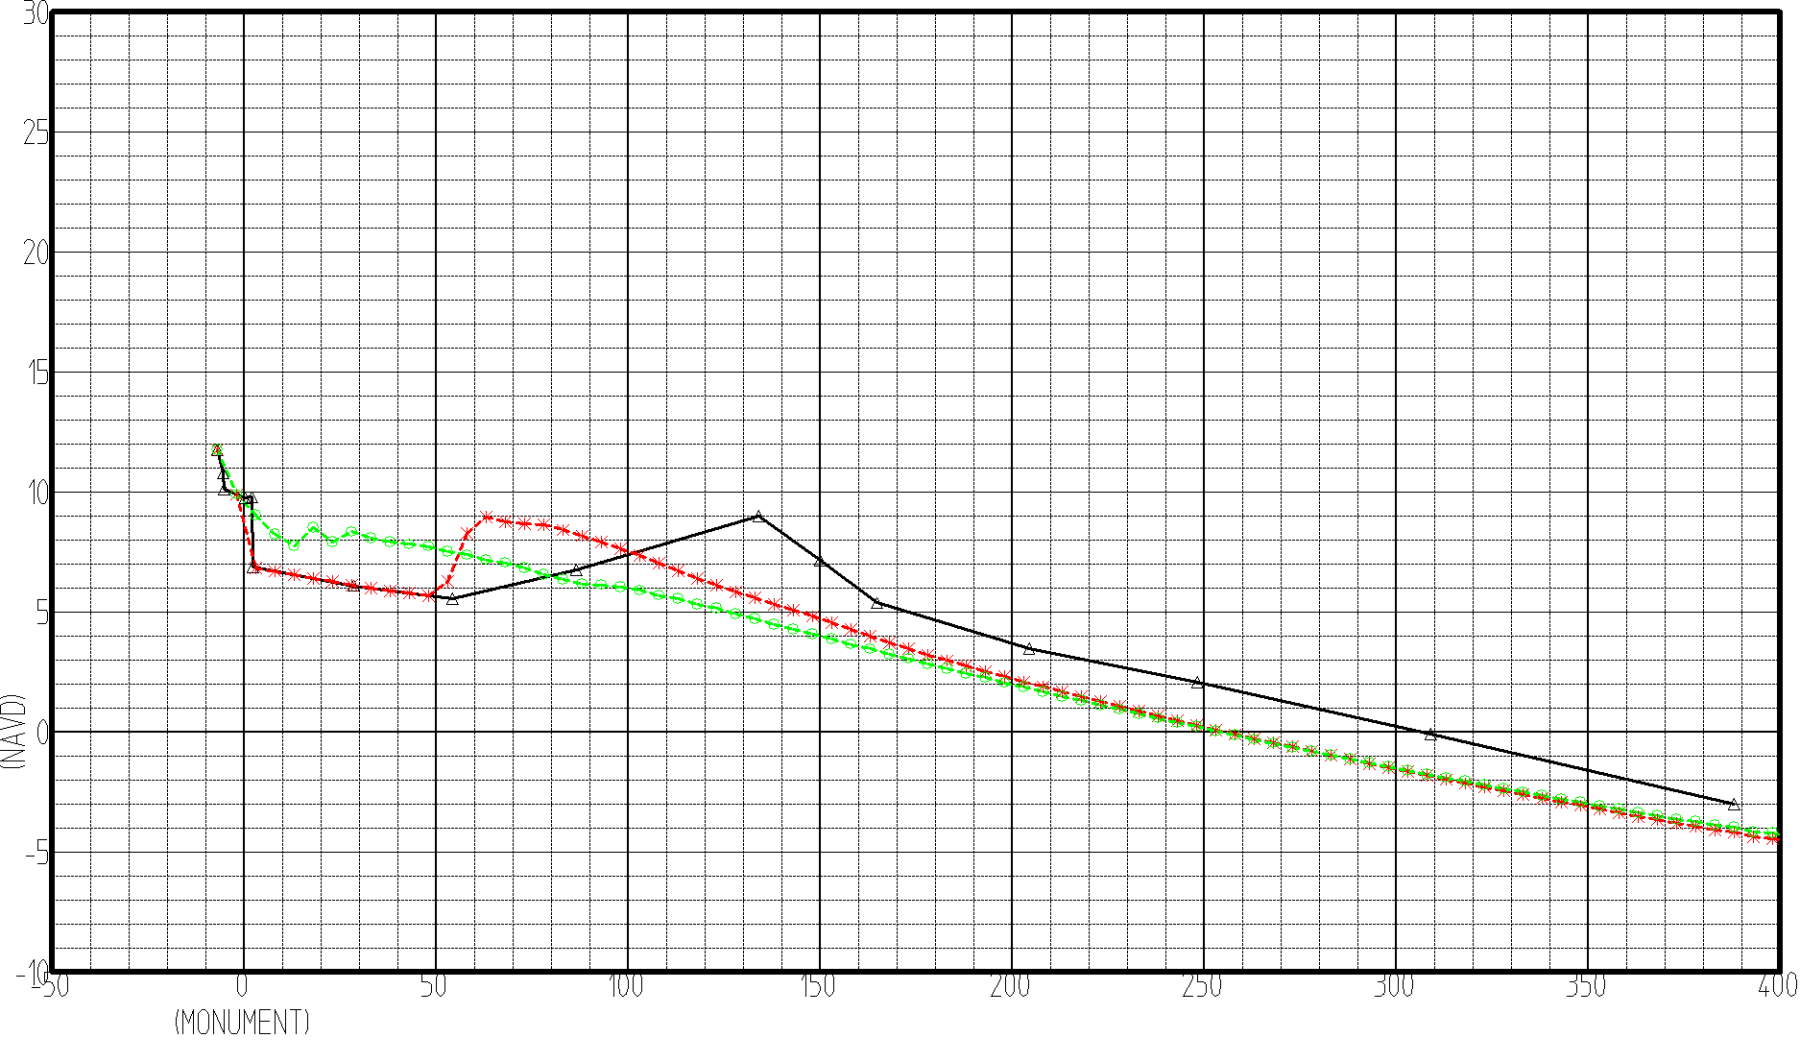
Range: R-4
 BEARING: 75.00
 1/2

BEACH PROFILE
 —△—△— ST. JOHNS 2007-2008 COMBI
 - - * - - - 15YR SBEACH ERODED
 - - o - - - 25YR SBCH ERODED

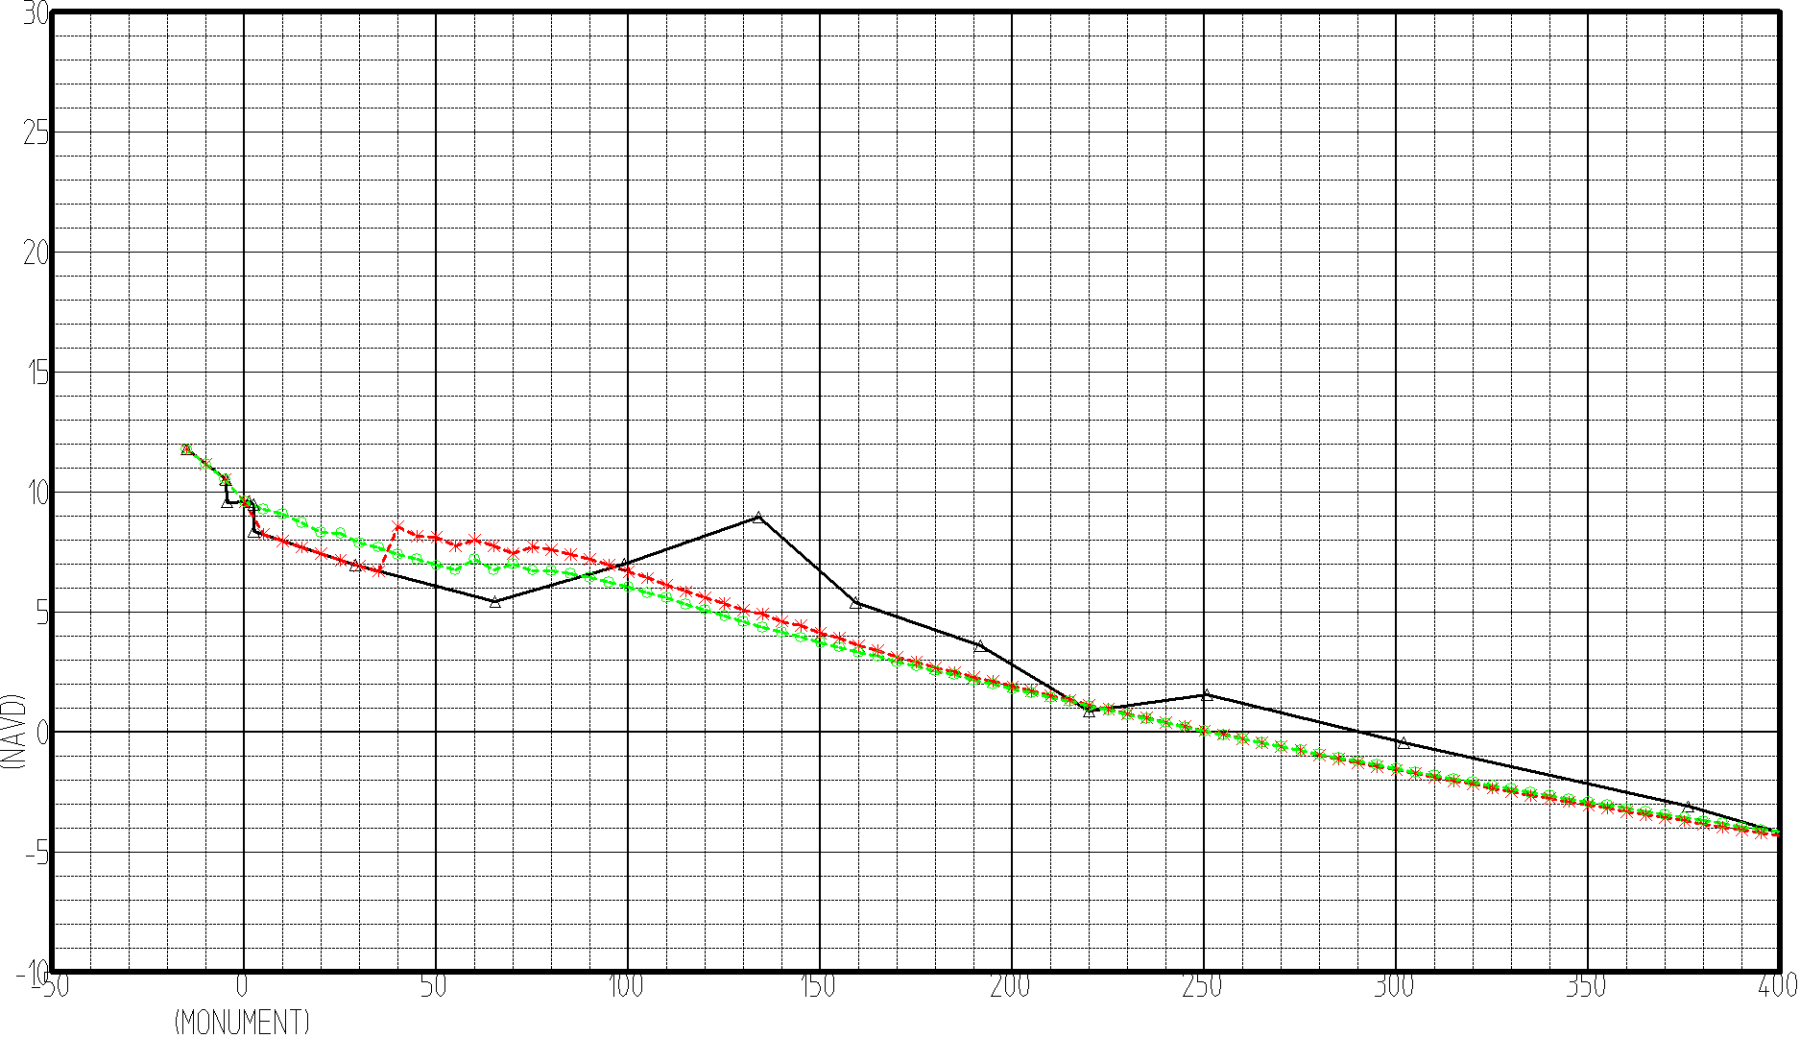
Range: T-5
 BEARING: 75.00
 1/2

BEACH PROFILE
 —△—△— ST. JOHNS 2007-2008 COMBI
 - - * - - 15YR SBACH ERODED
 - - o - - 25YR SBCH ERODED

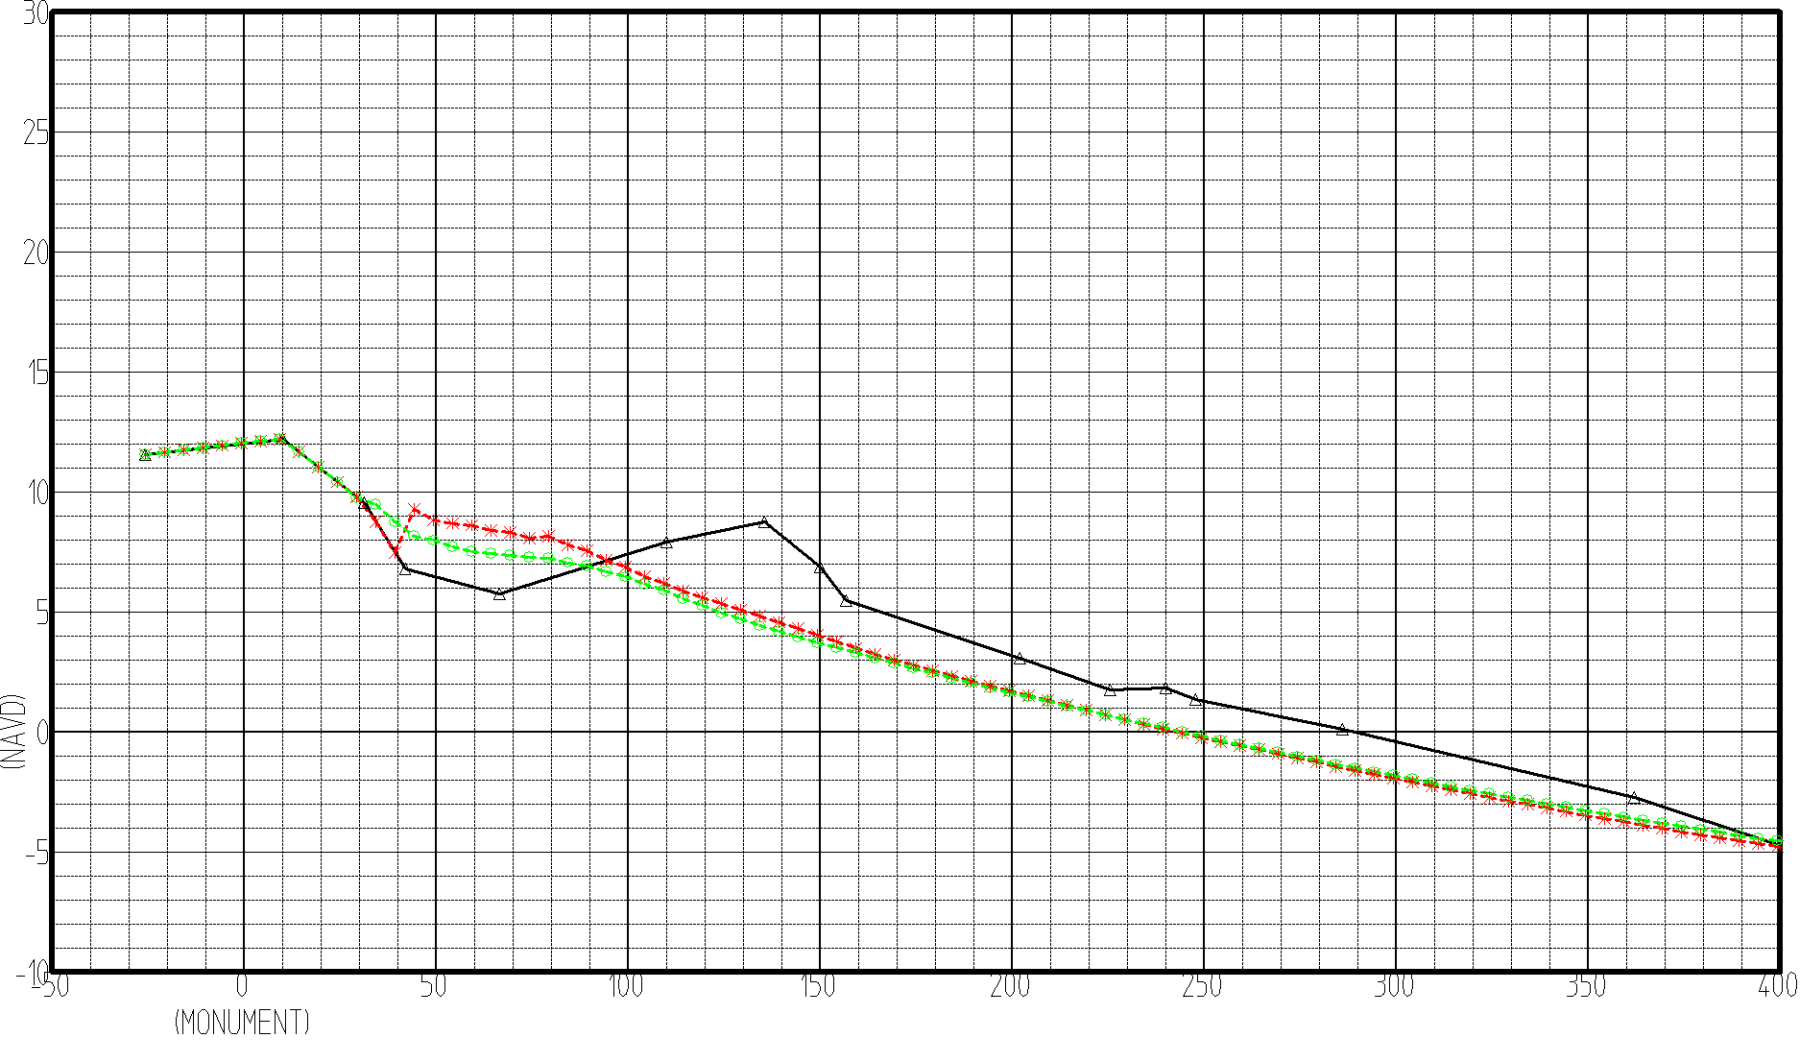
Range: R-6
 BEARING: 75.00
 1/2

BEACH PROFILE
 —△—△— ST. JOHNS 2007-2008 COMBI
 - - * - - - 15YR SBACH ERODED
 - - o - - - 25YR SBCH ERODED

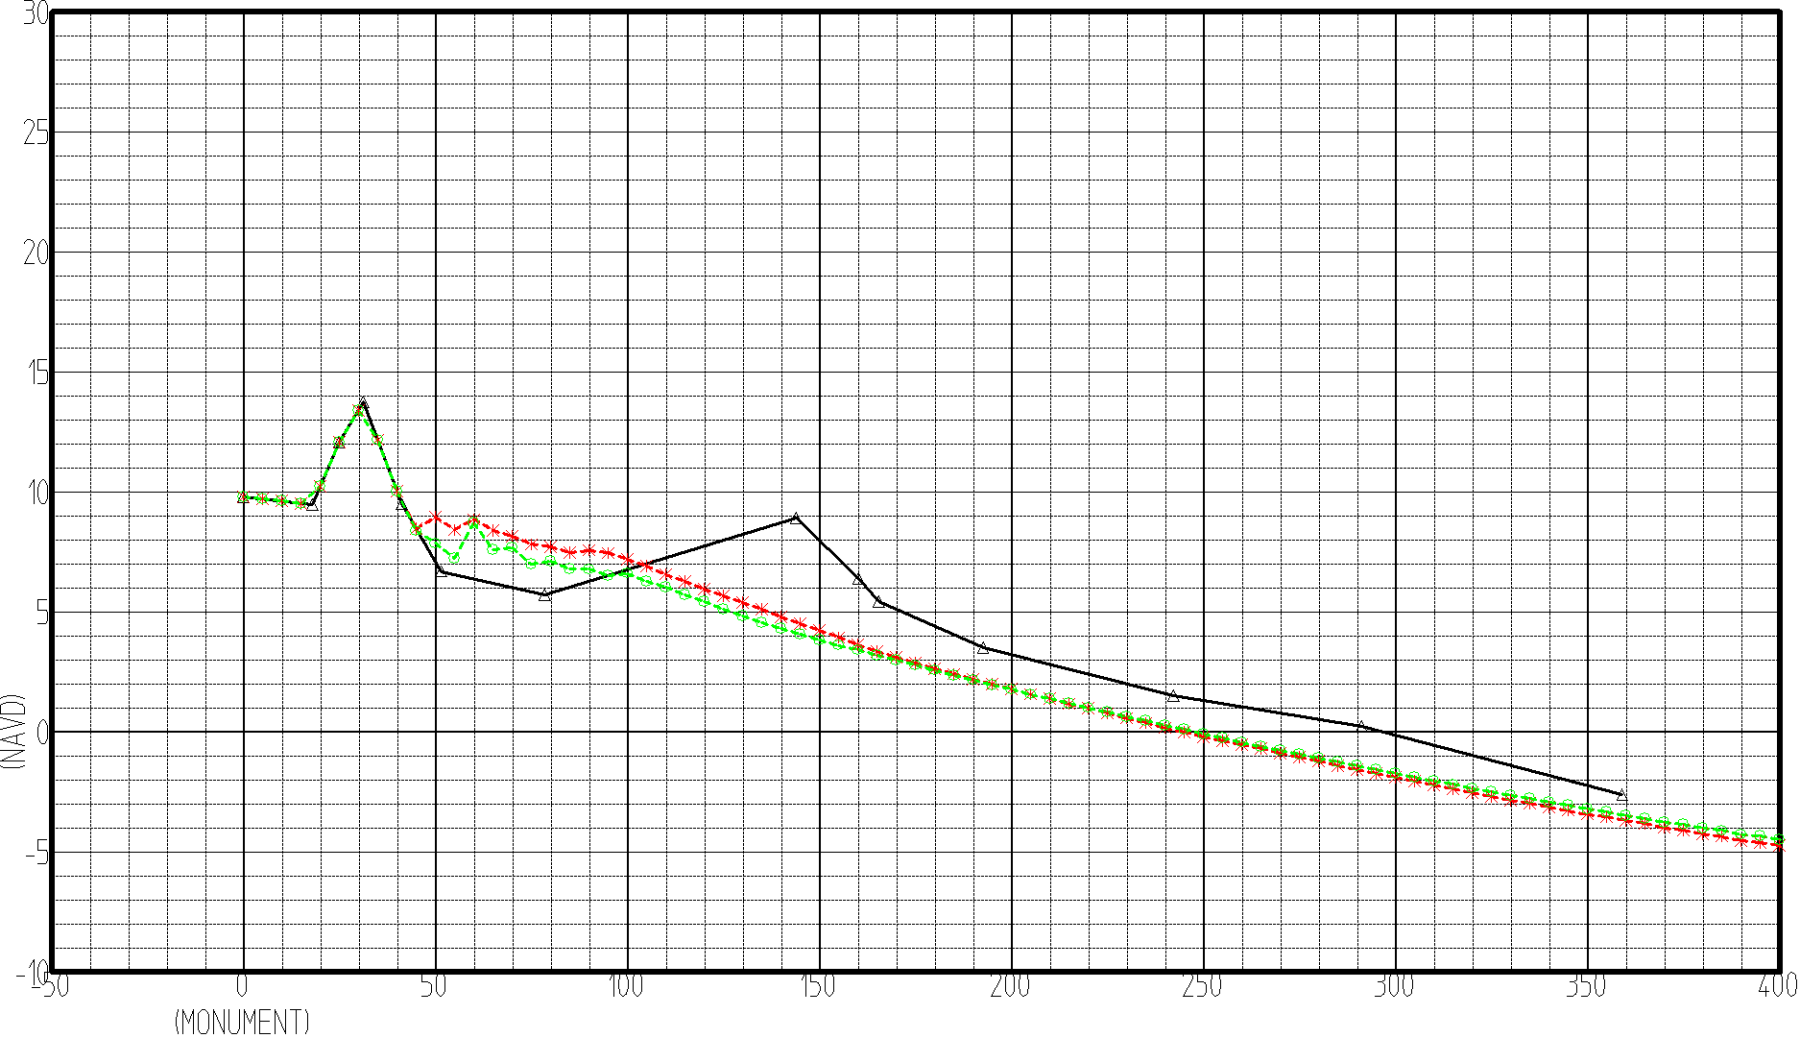
Range: R-7
 BEARING: 75.00
 1/2

BEACH PROFILE
 —△—△— ST. JOHNS 2007-2008 COMBI
 - - * - - 15YR SBCH ERODED
 - - o - - 25YR SBCH ERODED

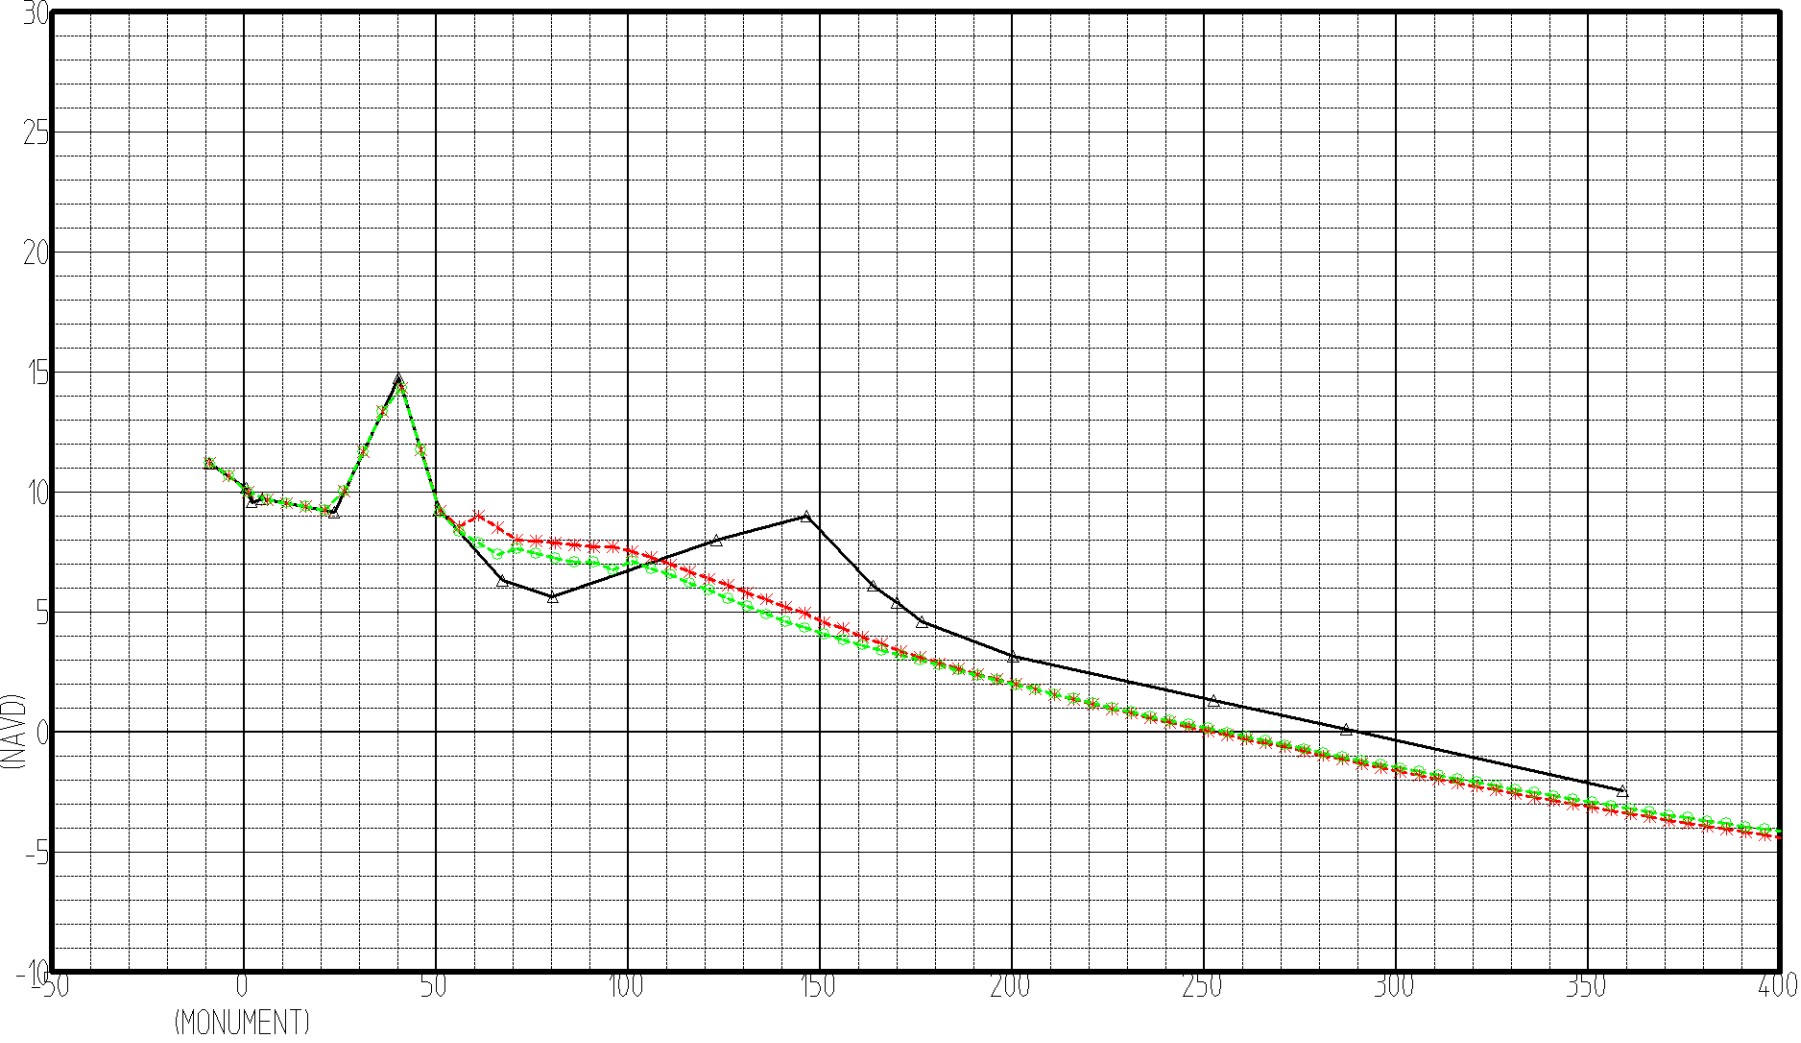
Range: R-8
 BEARING: 75.00
 1/2

BEACH PROFILE
 —△—△— ST. JOHNS 2007-2008 COMBI
 - - * - - 15YR SBEACH ERODED
 - - o - - 25YR SBCH ERODED

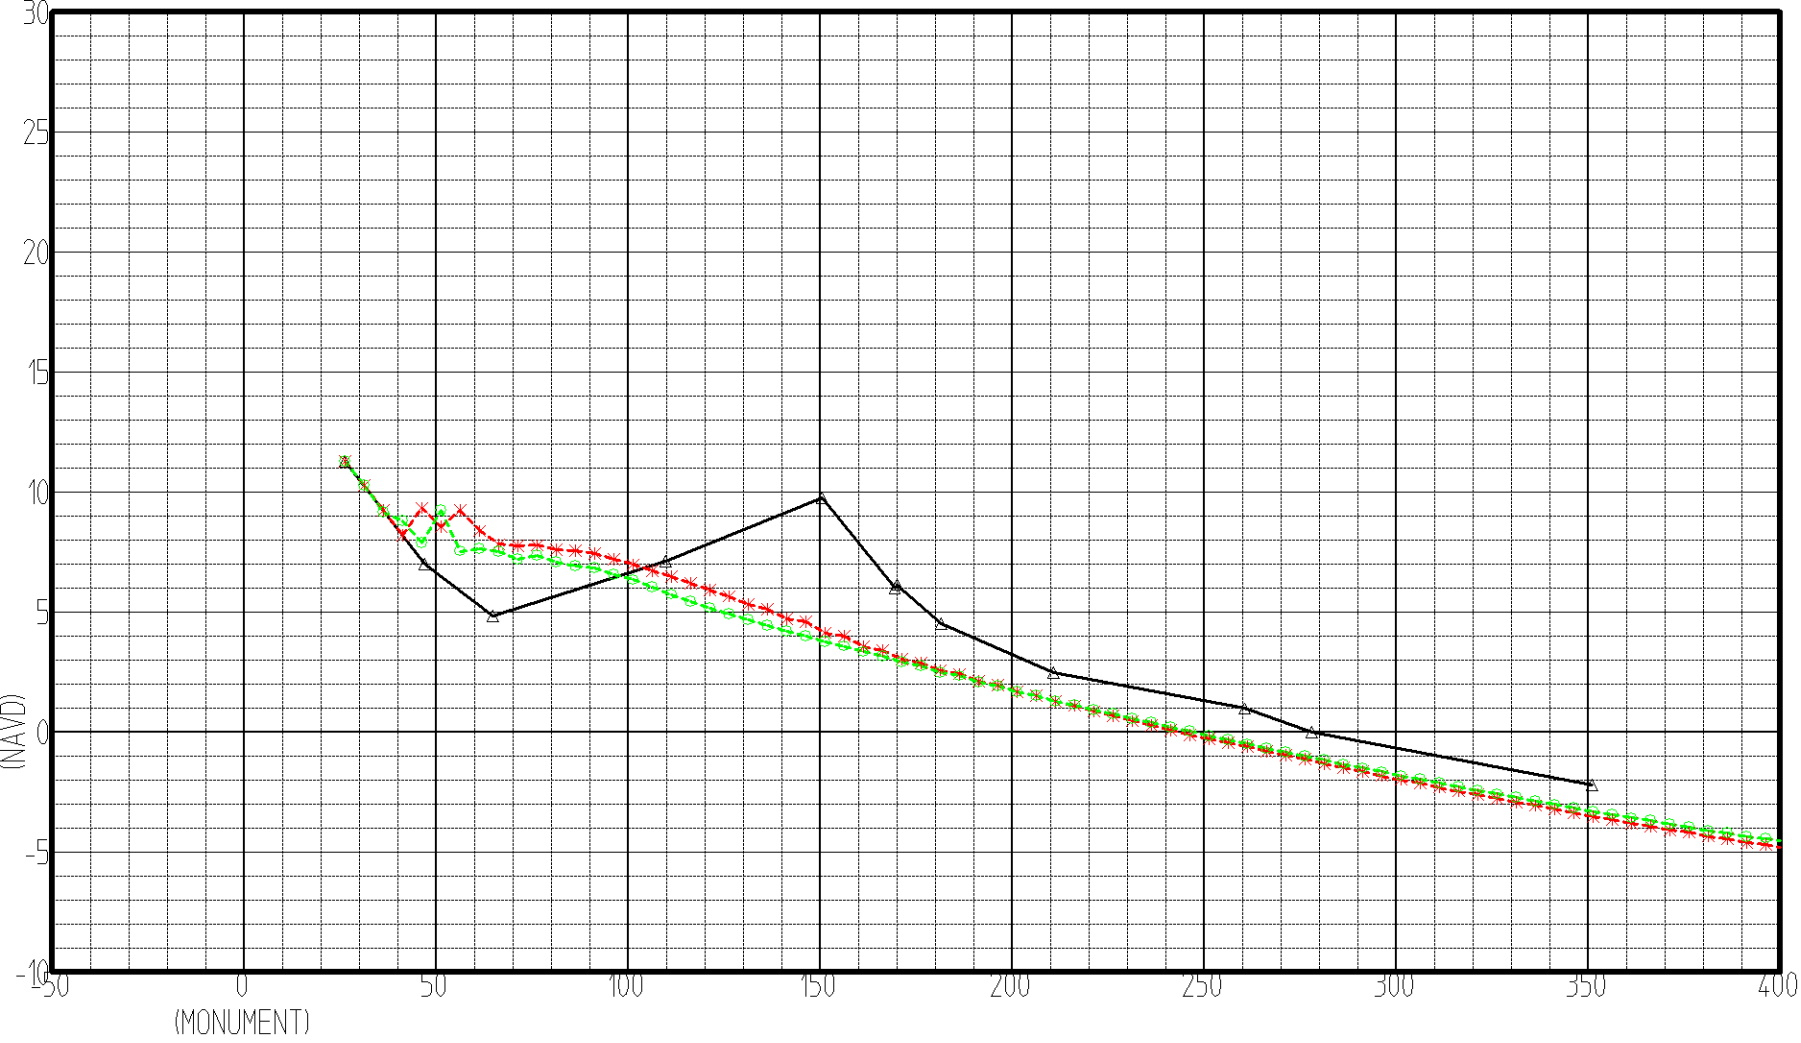
Range: R-9
 BEARING: 75.00
 1/2

BEACH PROFILE
 —△—△— ST. JOHNS 2007-2008 COMBI
 - - * - - 15YR SBCH ERODED
 - - o - - 25YR SBCH ERODED

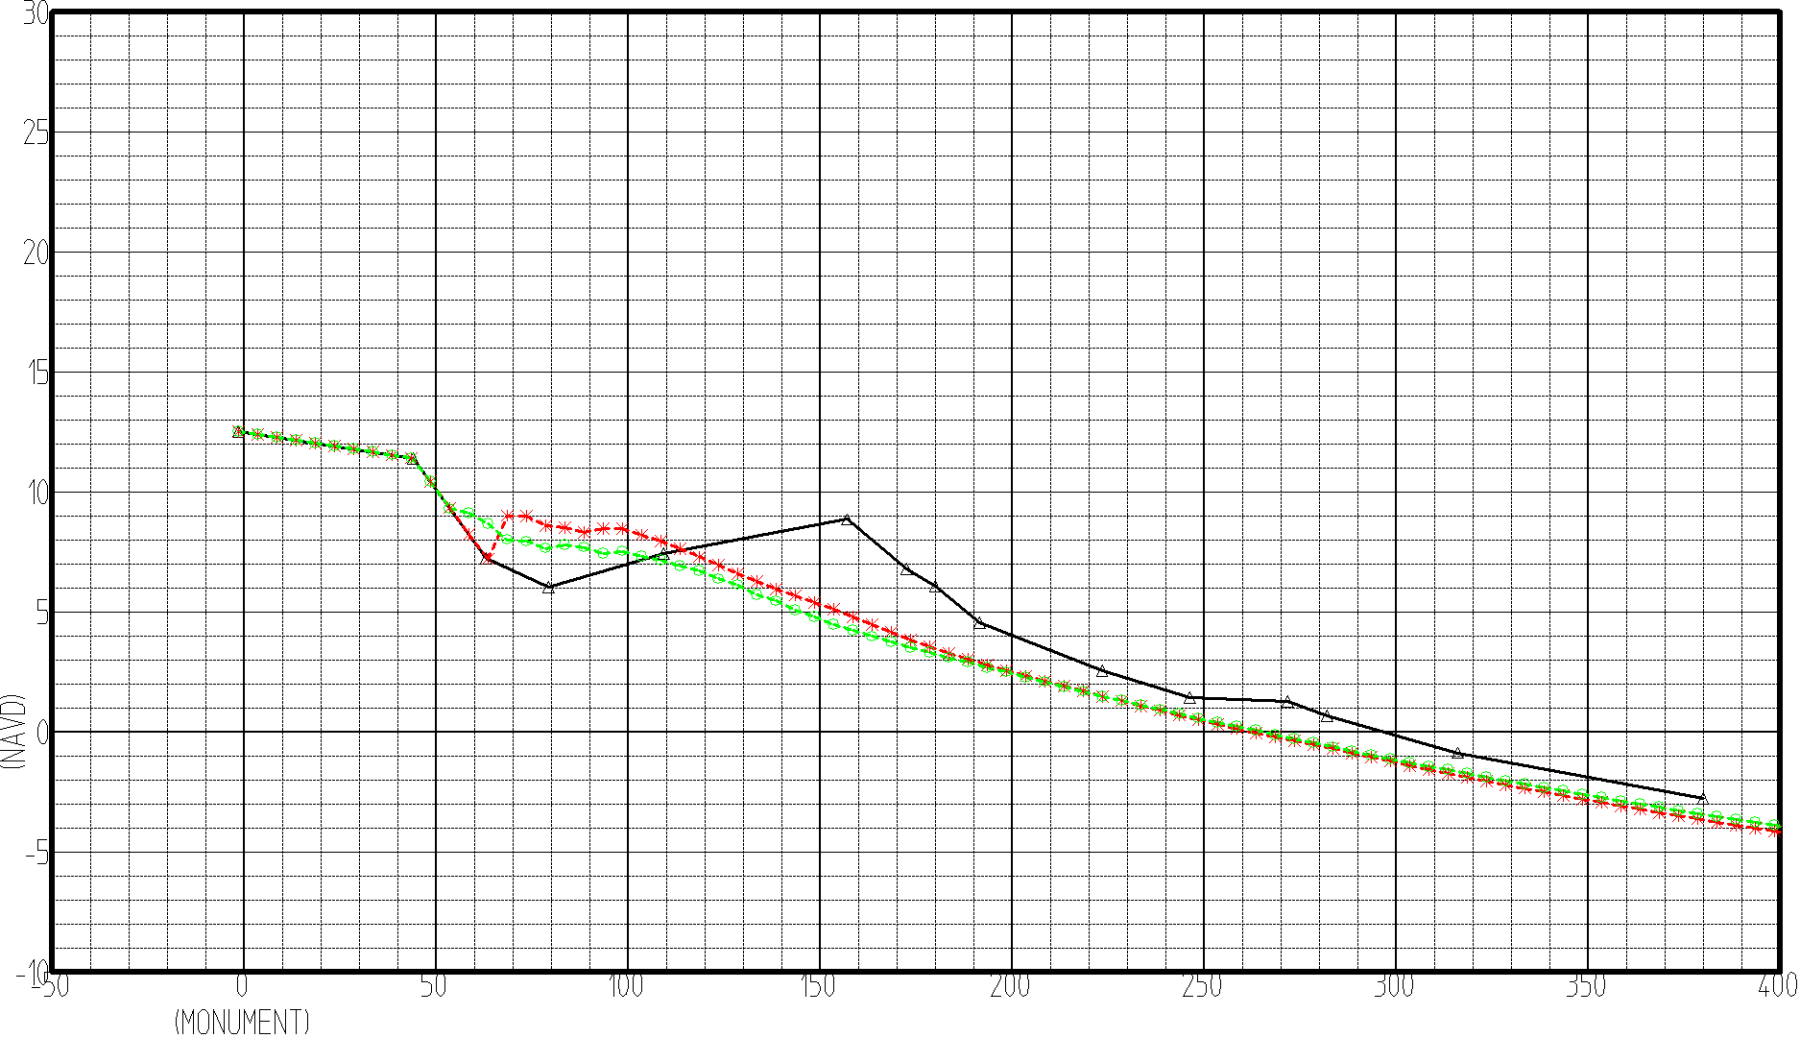
Range: R-10
 BEARING: 75.00
 1/2

BEACH PROFILE
 —△—△— ST. JOHNS 2007-2008 COMBI
 - - * - - - 15YR SBCH ERODED
 - - o - - - 25YR SBCH ERODED

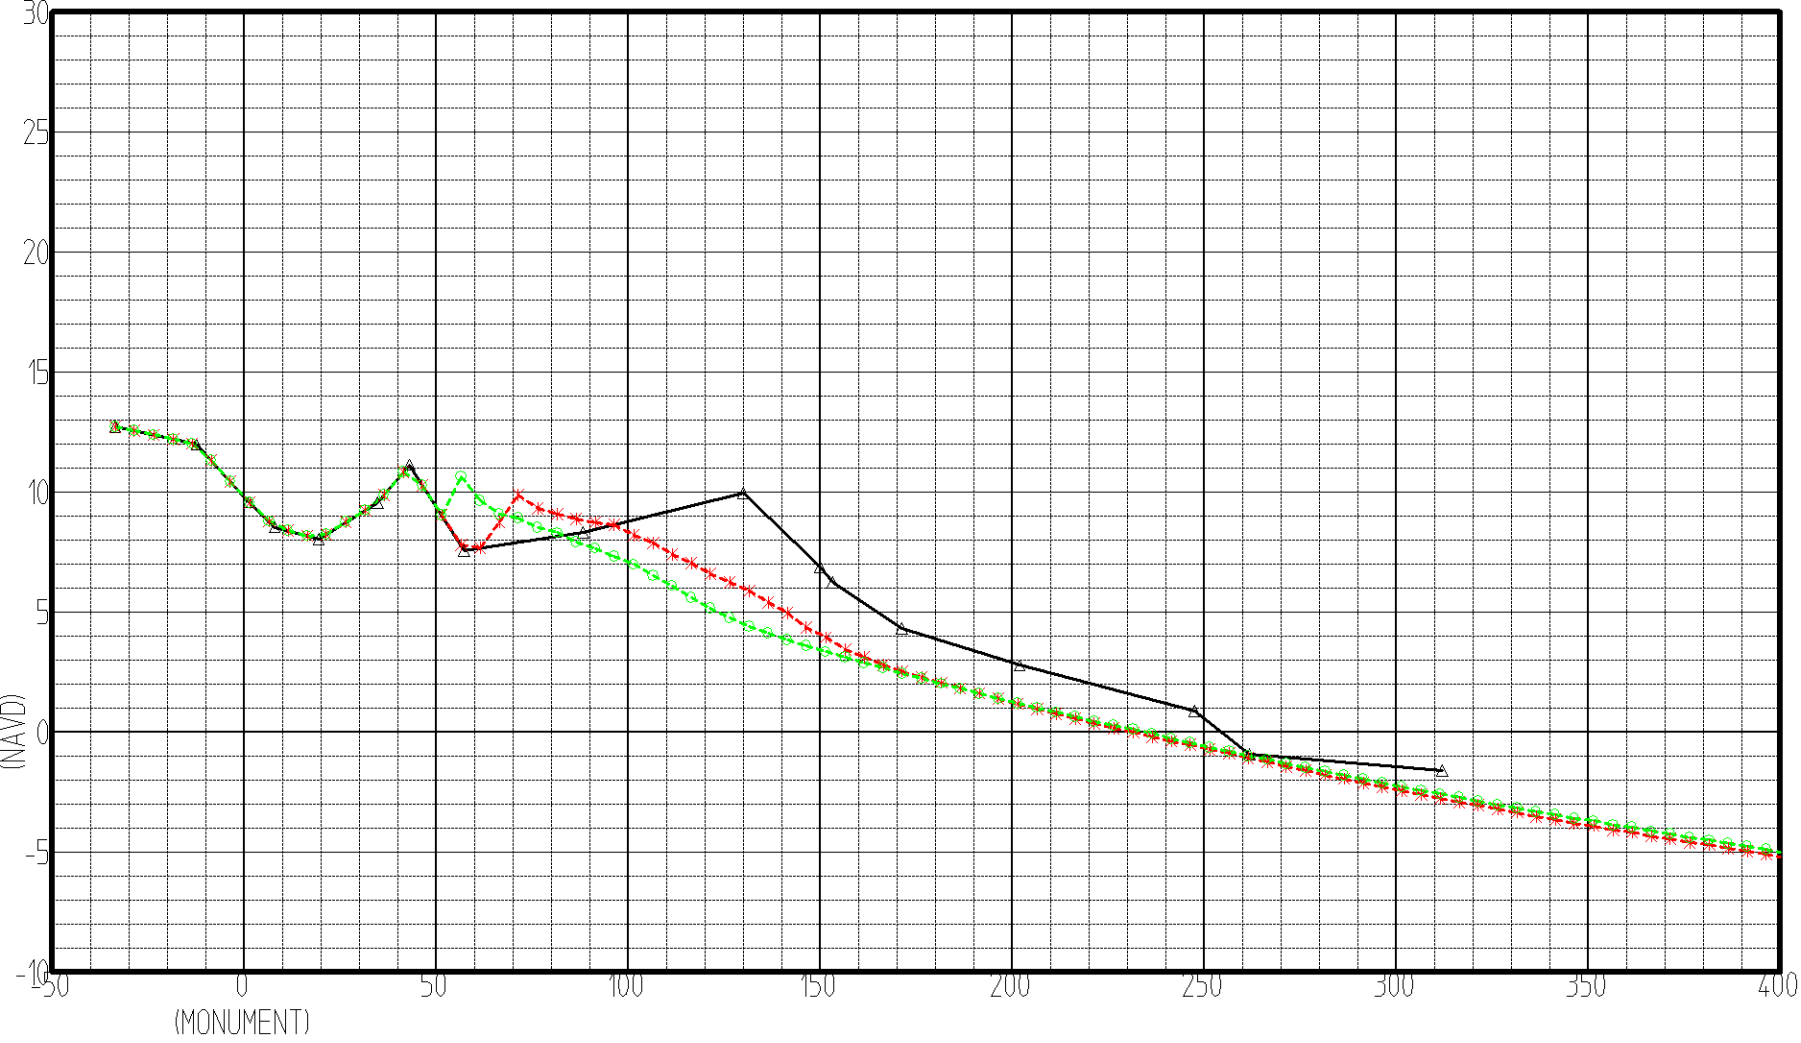
Range: R-11
 BEARING: 75.00
 1/2

BEACH PROFILE
 —△—△— ST. JOHNS 2007-2008 COMBI
 - - * - - * - - 15YR SBCH ERODED
 - - o - - o - - 25YR SBCH ERODED
