Appendix VIII

SBEACH 15 and 25 yr. Storm Erosion Profiles

St. Johns County

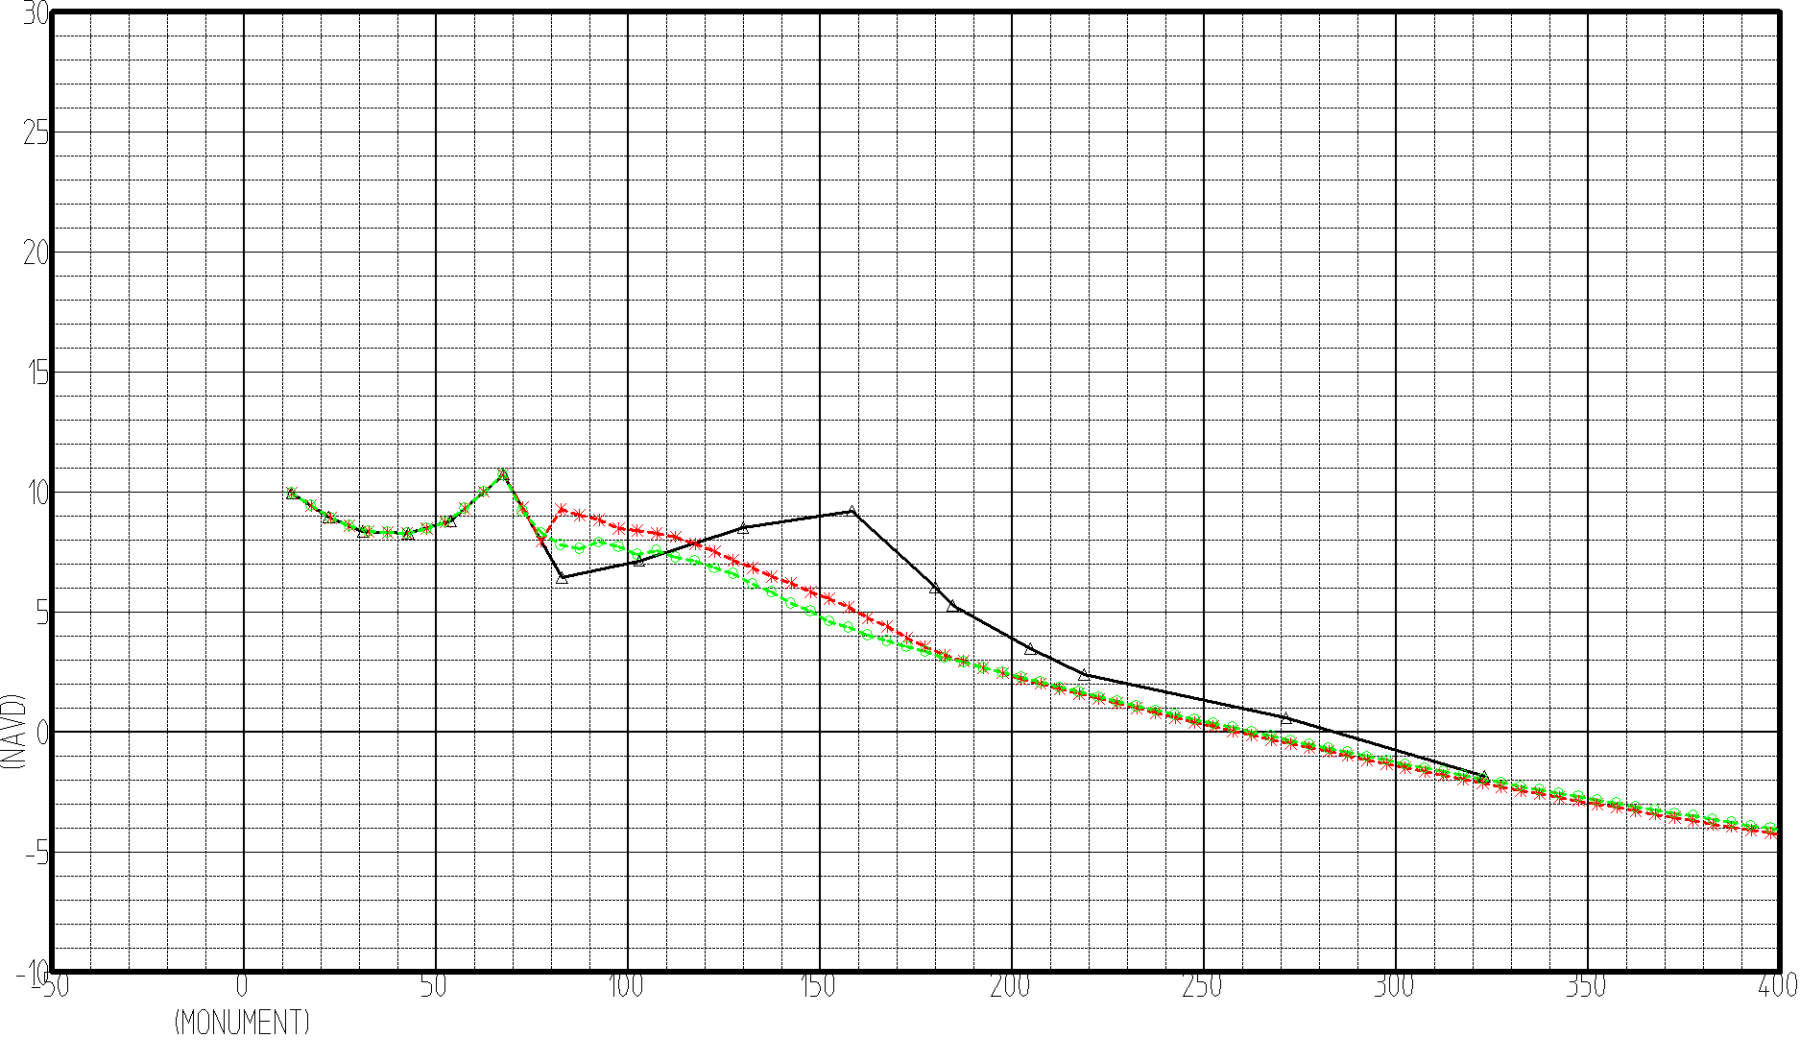
Range: R-12
 BEARING: 75.00
 1/2

BEACH PROFILE
 —△—△— ST. JOHNS 2007-2008 COMBI
 - - * - - 15YR SBCH ERODED
 - - o - - 25YR SBCH ERODED

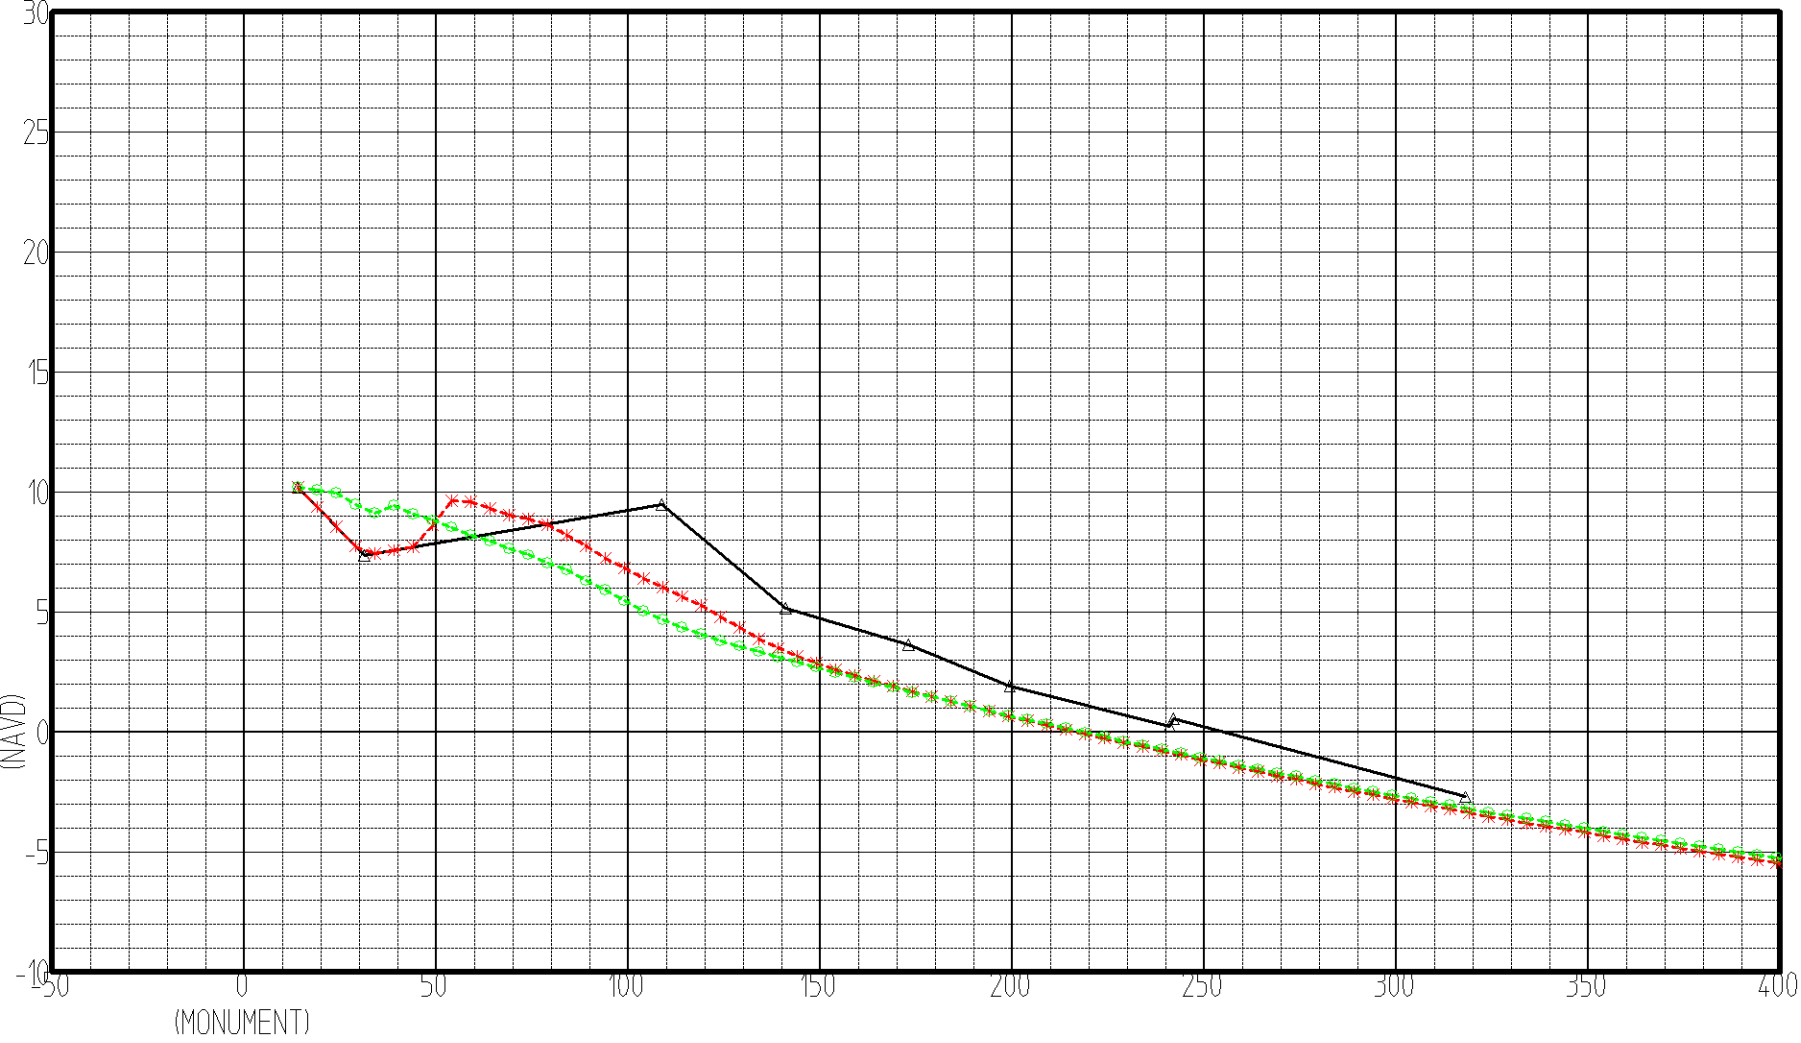
Range: R-13
 BEARING: 75.00
 1/2

BEACH PROFILE
 —△—△— ST. JOHNS 2007-2008 COMBI
 - - * - - - 15YR SBACH ERODED
 - - o - - - 25YR SBCH ERODED

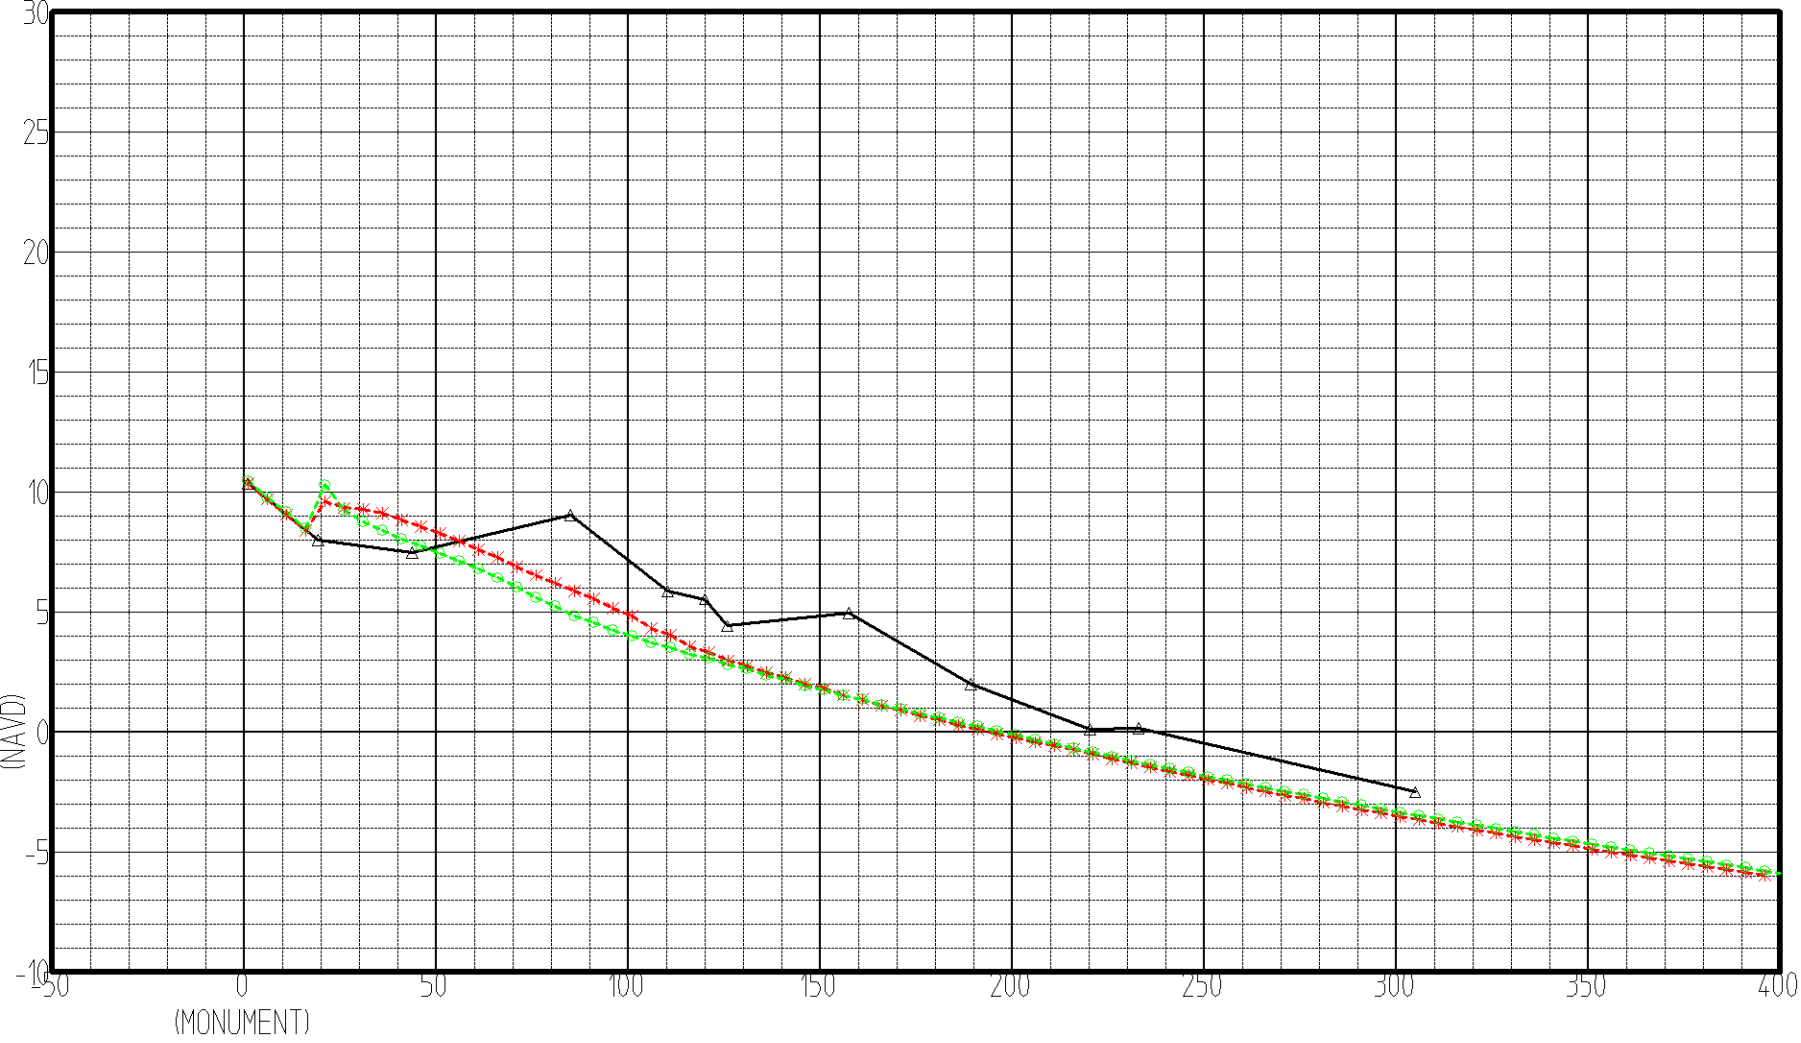
Range: R-14A
 BEARING: 75.00
 1/2

BEACH PROFILE
 —△—△— ST. JOHNS 2007-2008 COMBI
 - - * - - 15YR SBCH ERODED
 - - o - - 25YR SBCH ERODED

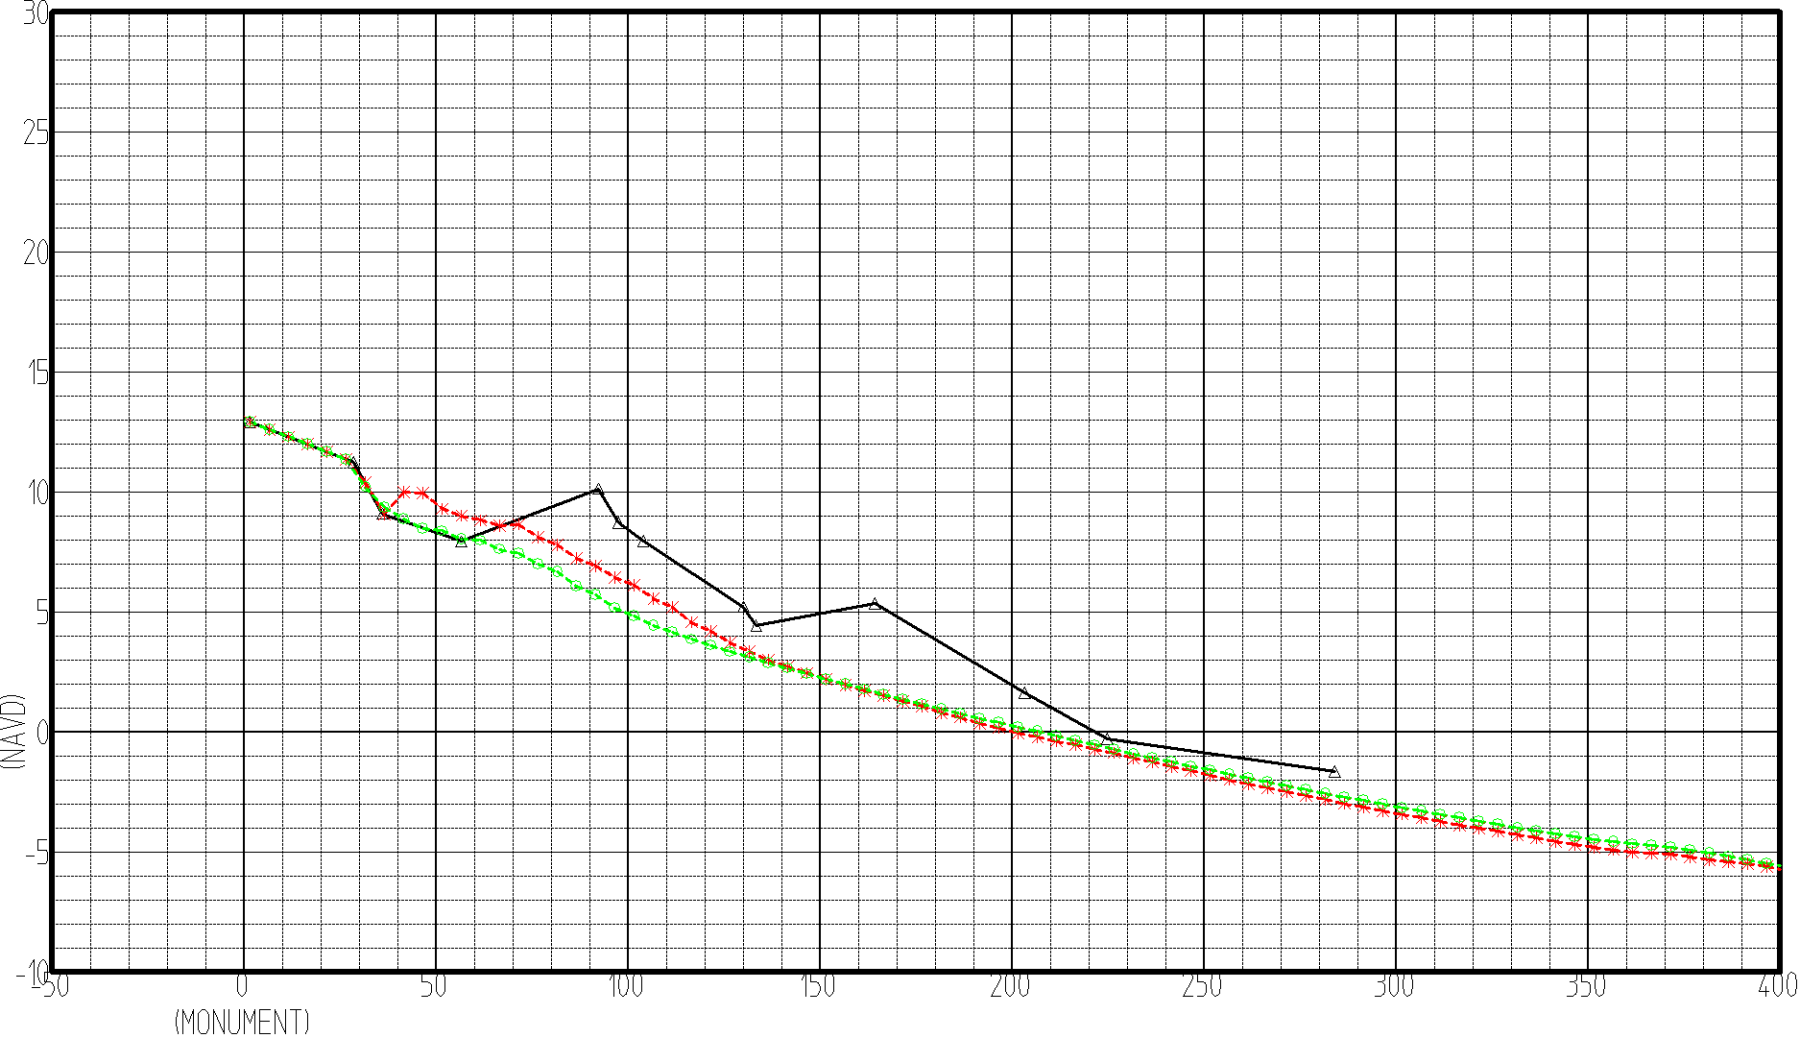
Range: R-15

BEACH PROFILE

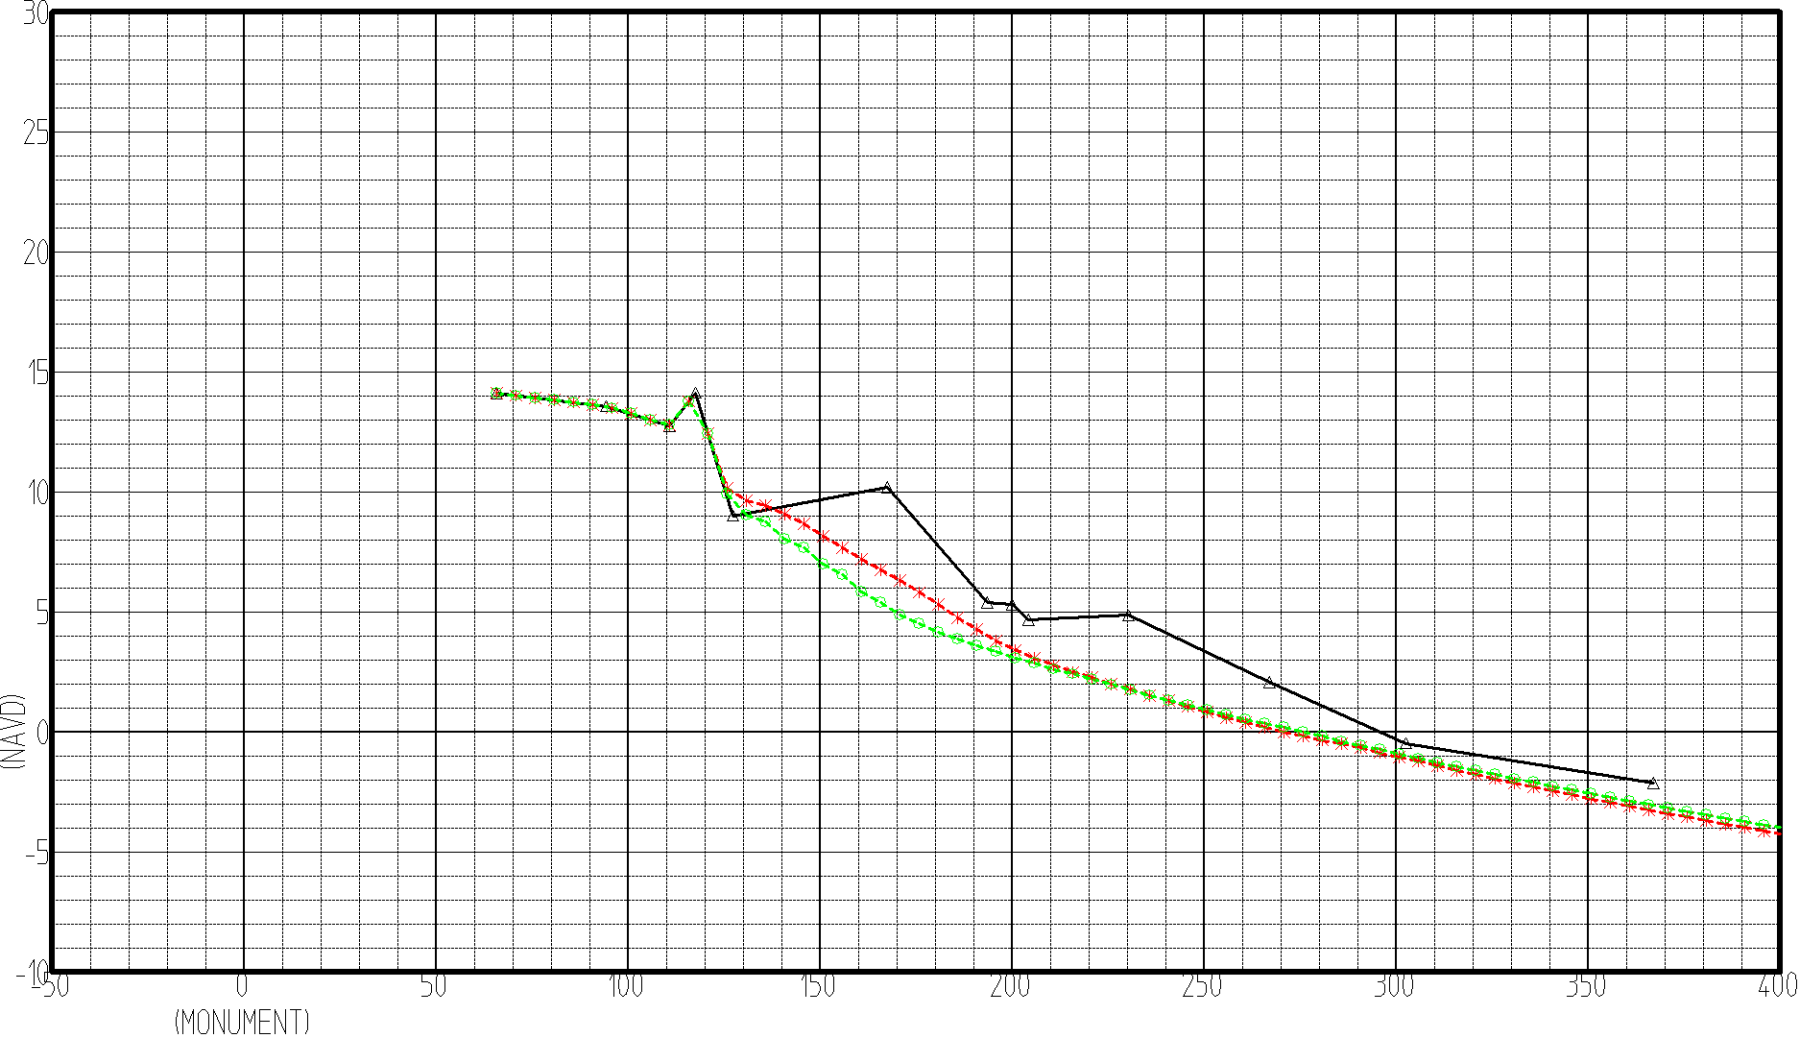
Range: R-16
 BEARING: 75.00
 1/2

BEACH PROFILE
 —△—△— ST. JOHNS 2007-2008 COMBI
 - - * - - - 15YR SBACH ERODED
 - - o - - - 25YR SBCH ERODED

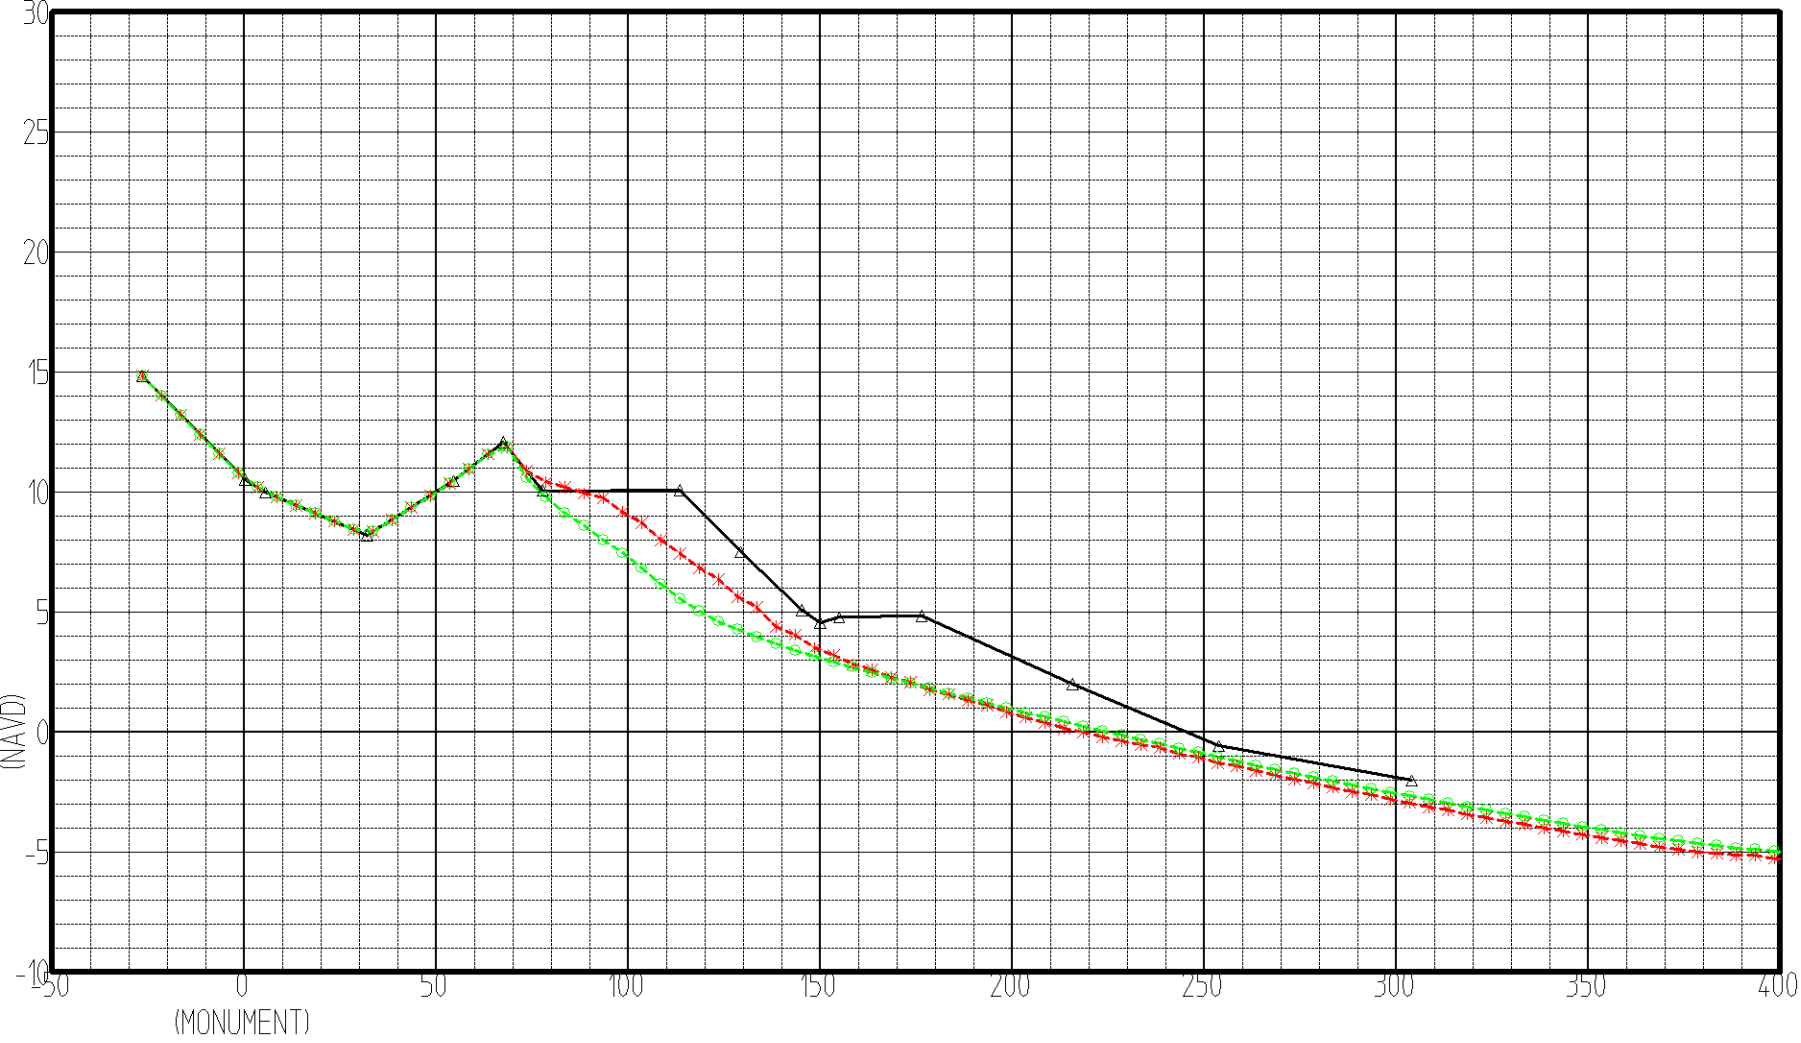
Range: R-17
 BEARING: 75.00
 1/2

BEACH PROFILE
 —△—△— ST. JOHNS 2007-2008 COMBI
 - - * - - 15YR SBACH ERODED
 - - o - - 25YR SBCH ERODED

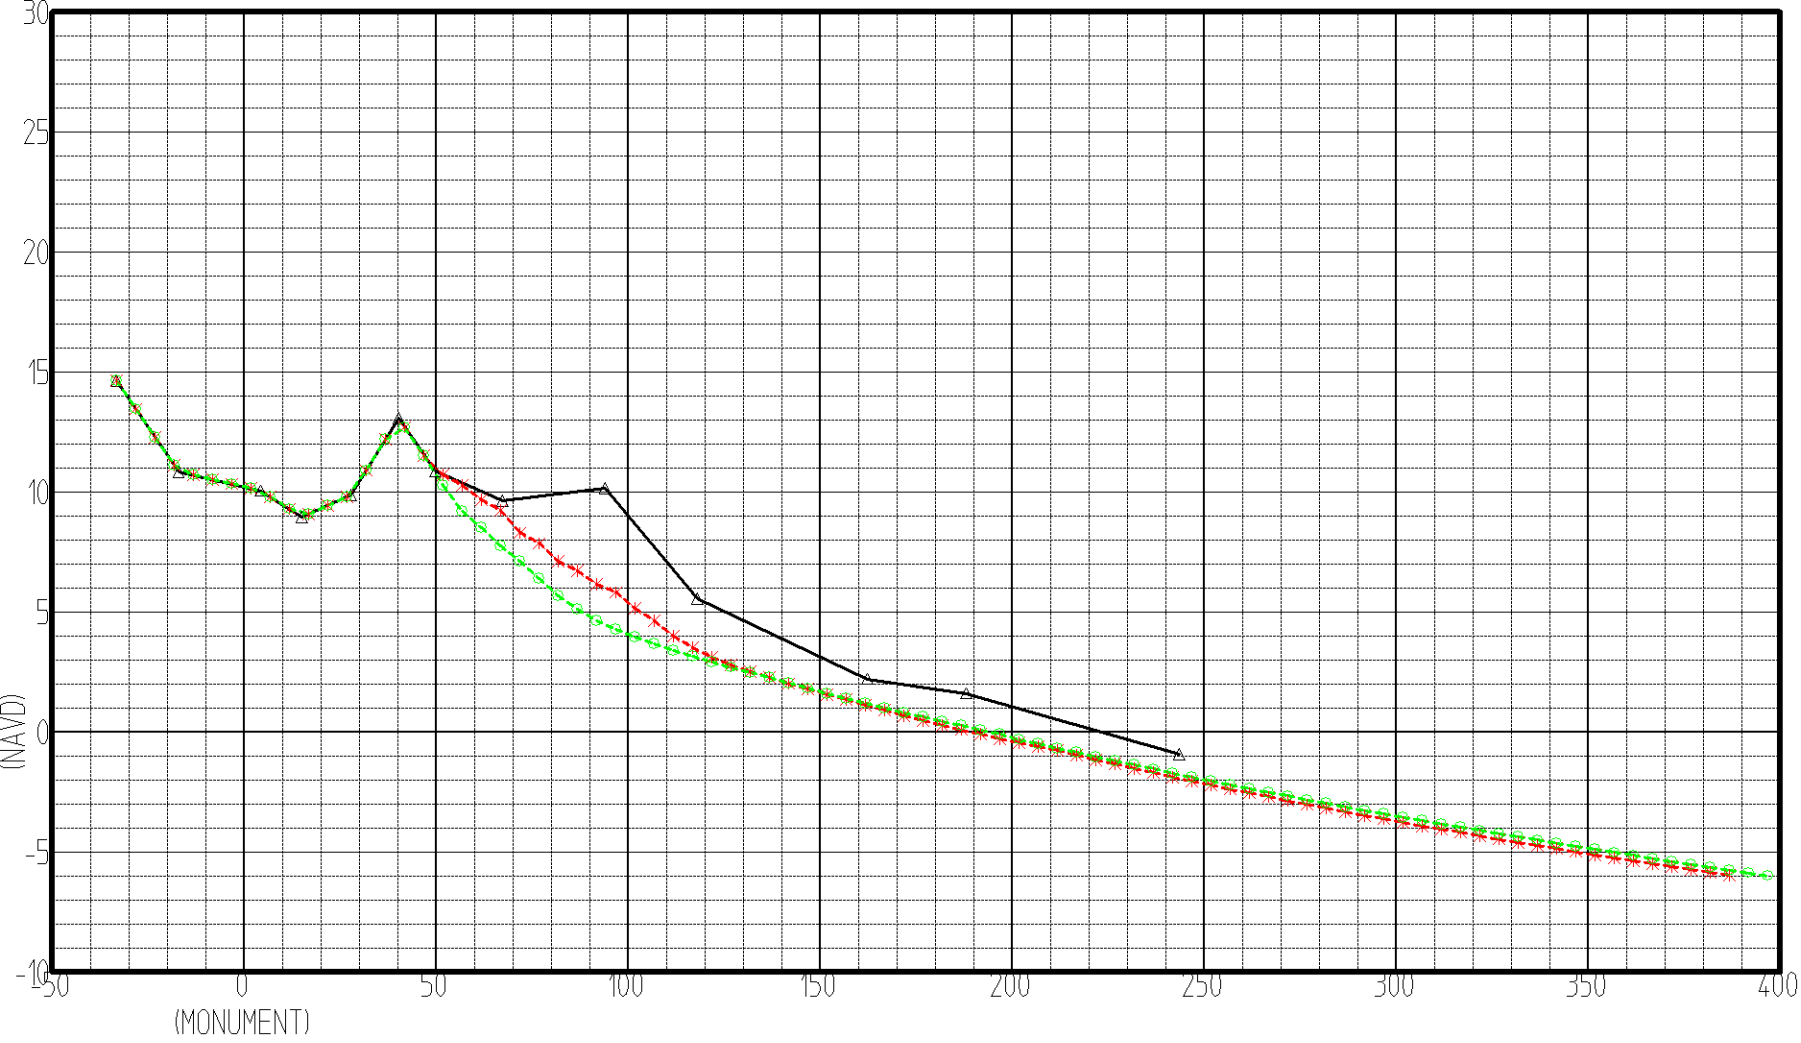
Range: R-18
 BEARING: 75.00
 1/1

BEACH PROFILE
 —△—△— ST. JOHNS 2007-2008 COMBI
 - - * - - 15YR SBEACH ERODED
 - - o - - 25YR SBCH ERODED

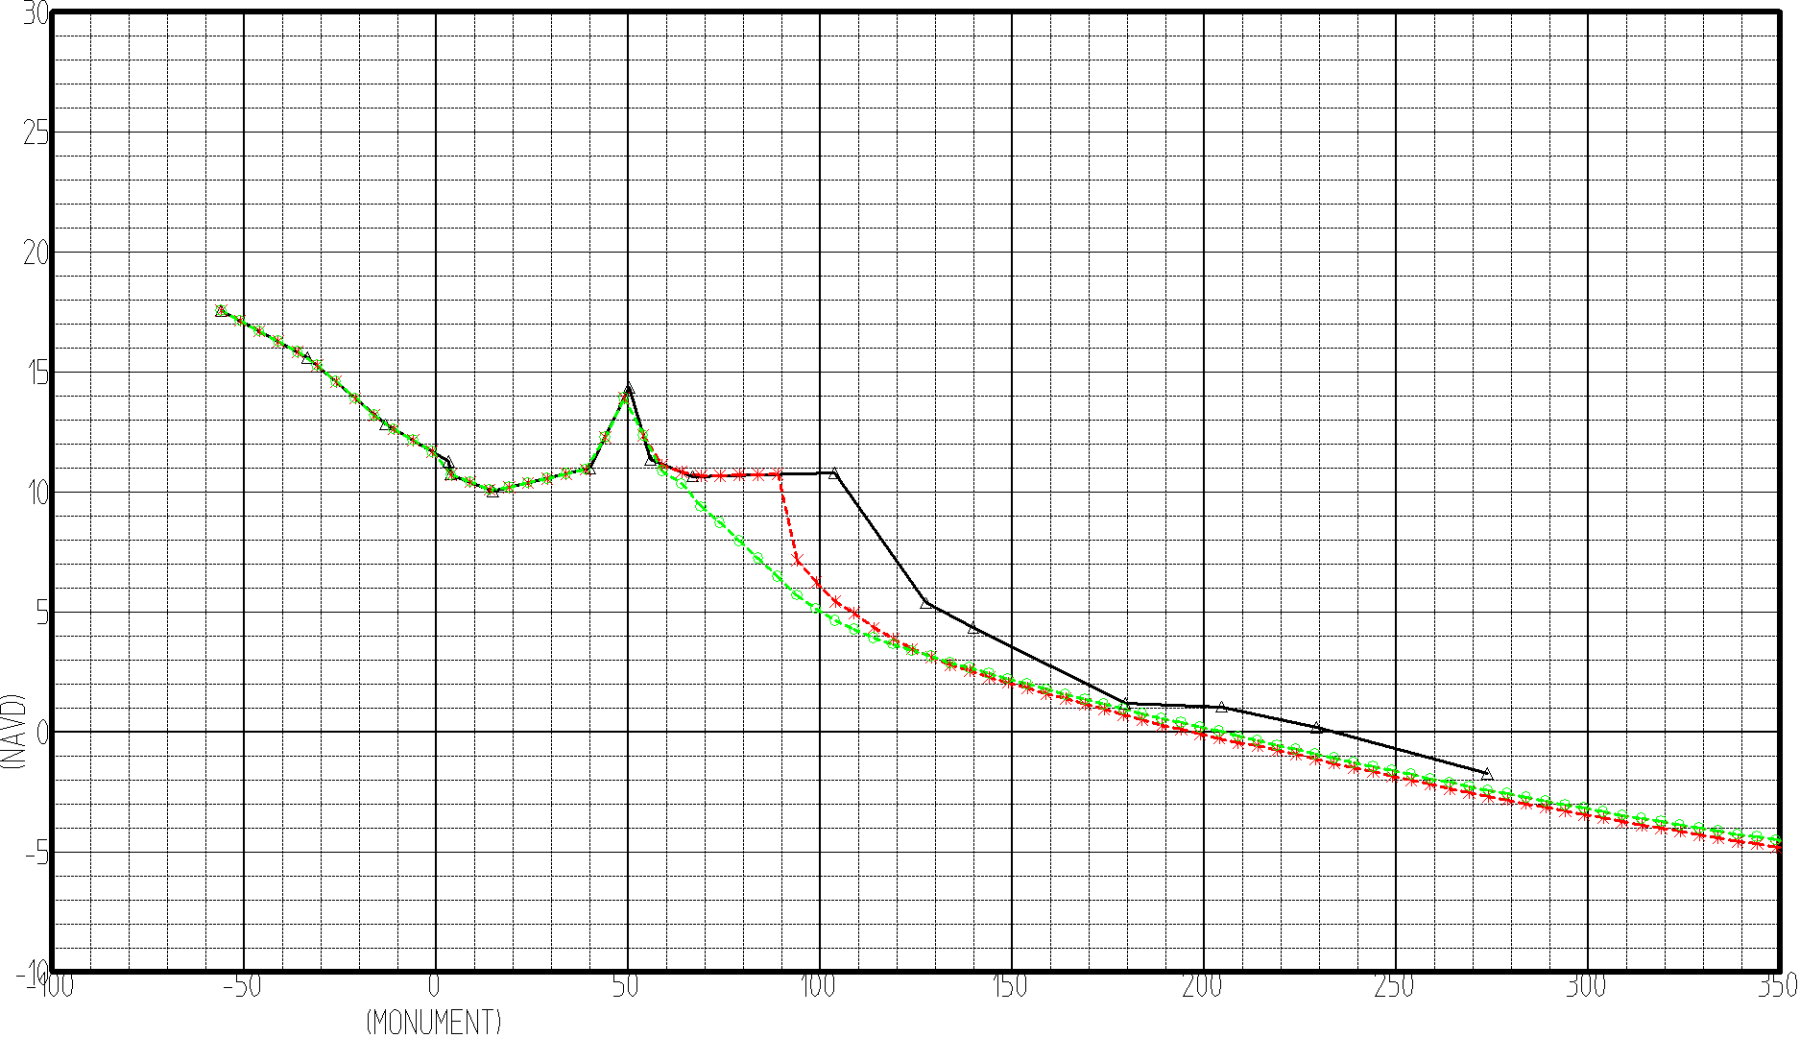
Range: R-20
 BEARING: 75.00
 1/2

BEACH PROFILE
 —△—△— ST. JOHNS 2007-2008 COMBI
 - - * - - - 15YR SBEACH ERODED
 - - o - - - 25YR SBCH ERODED

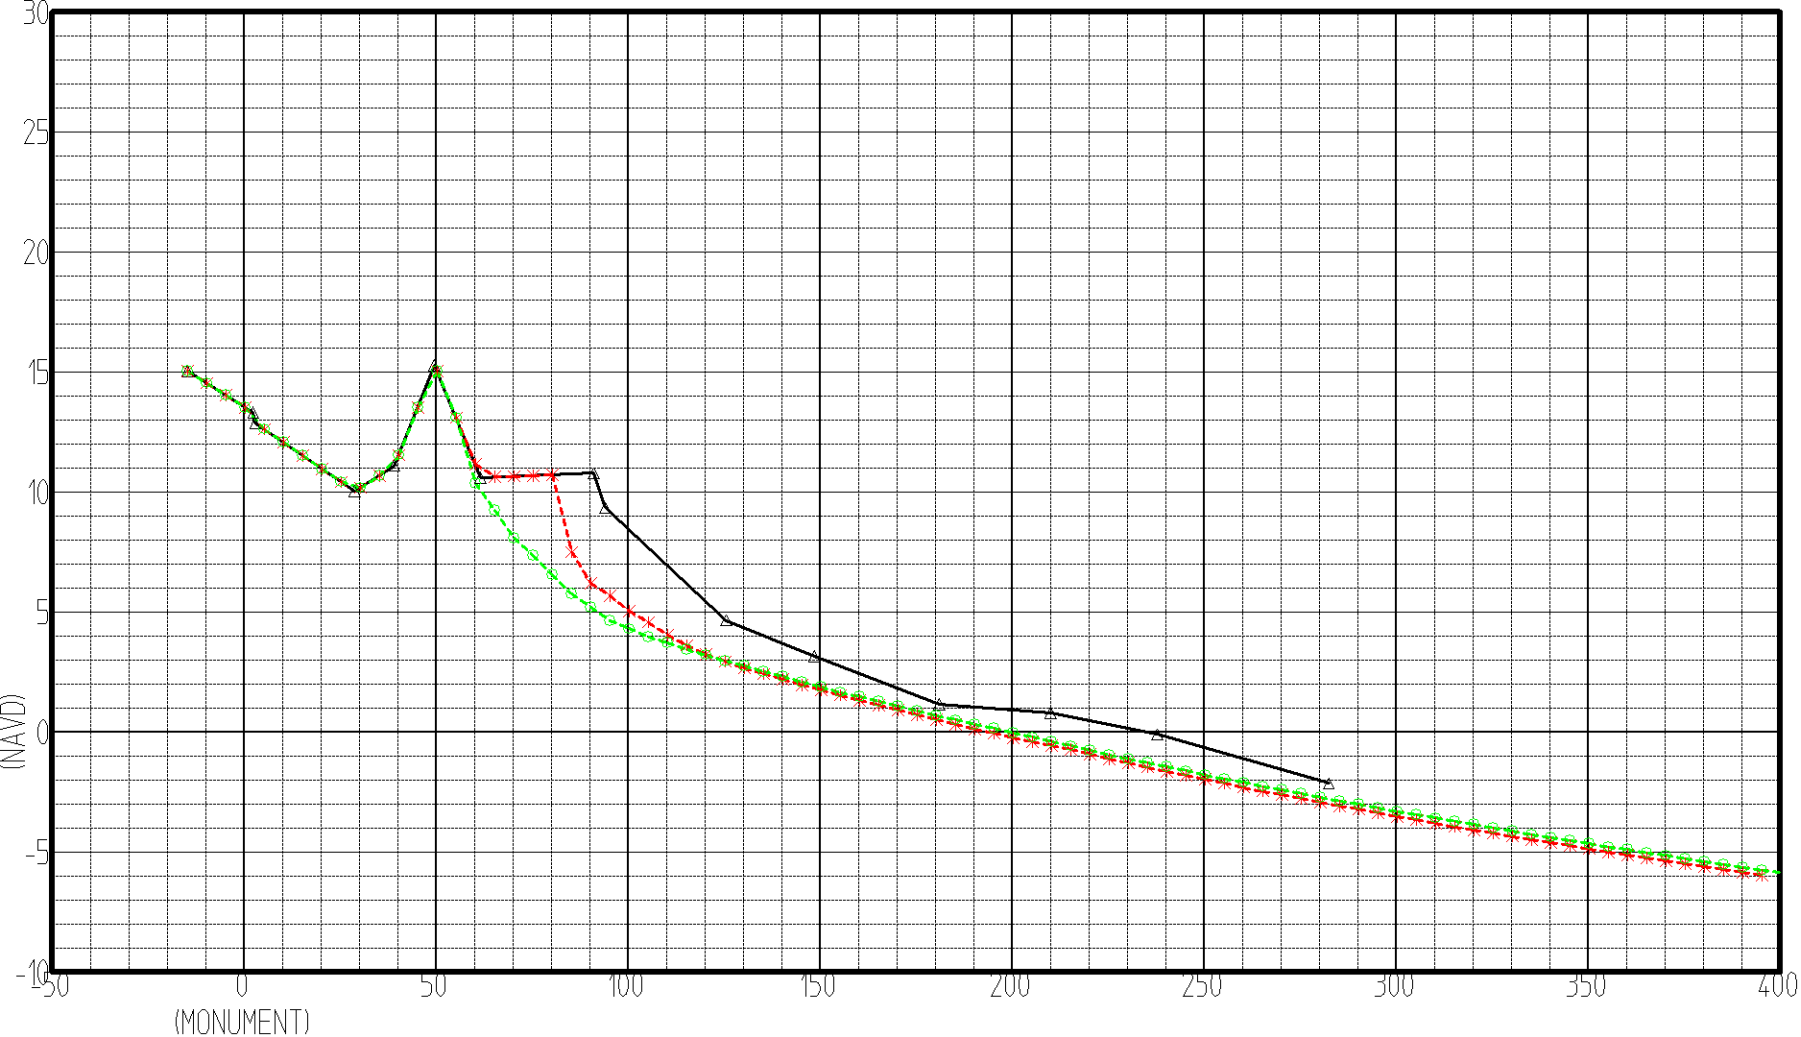
Range: R-21
 BEARING: 75.00
 1/2

BEACH PROFILE
 —△—△— ST. JOHNS 2007-2008 COMBI
 - - * - - - 15YR SBCH ERODED
 - - o - - - 25YR SBCH ERODED

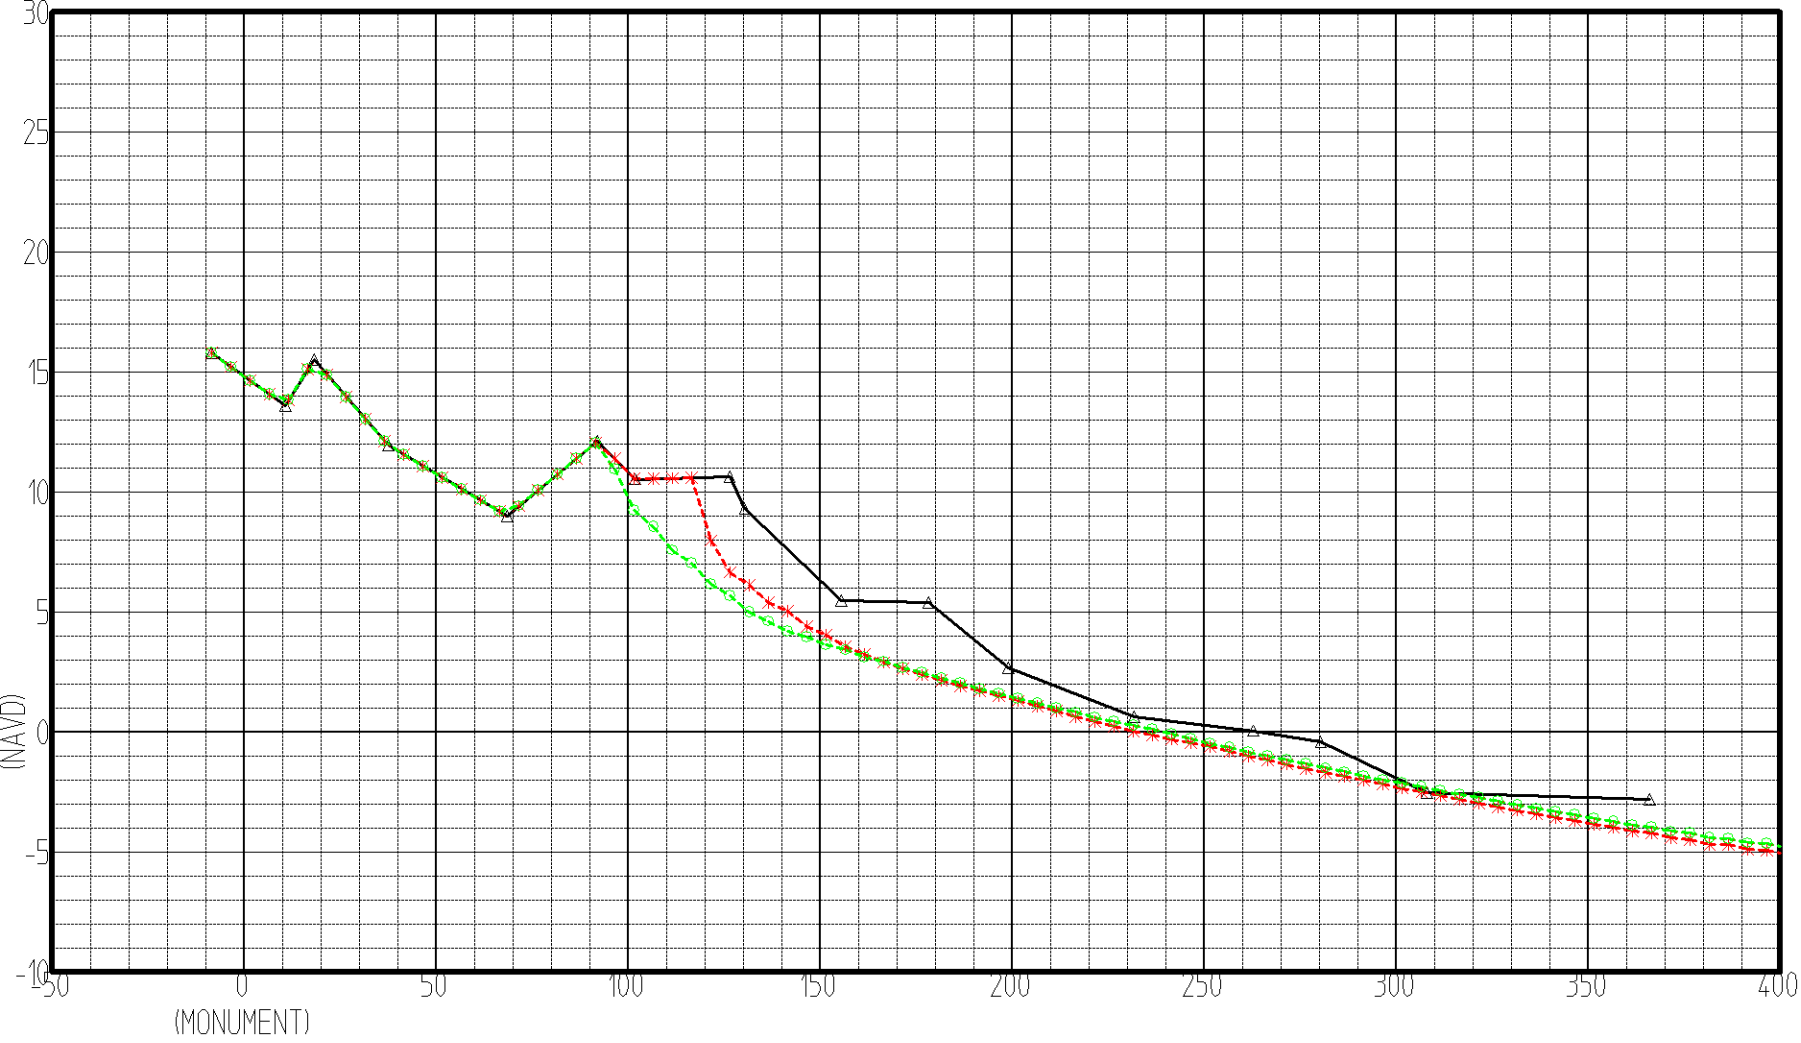
Range: R-22
 BEARING: 75.00
 1/2

BEACH PROFILE
 —△—△— ST. JOHNS 2007-2008 COMBI
 - - * - - 15YR SBCH ERODED
 - - o - - 25YR SBCH ERODED

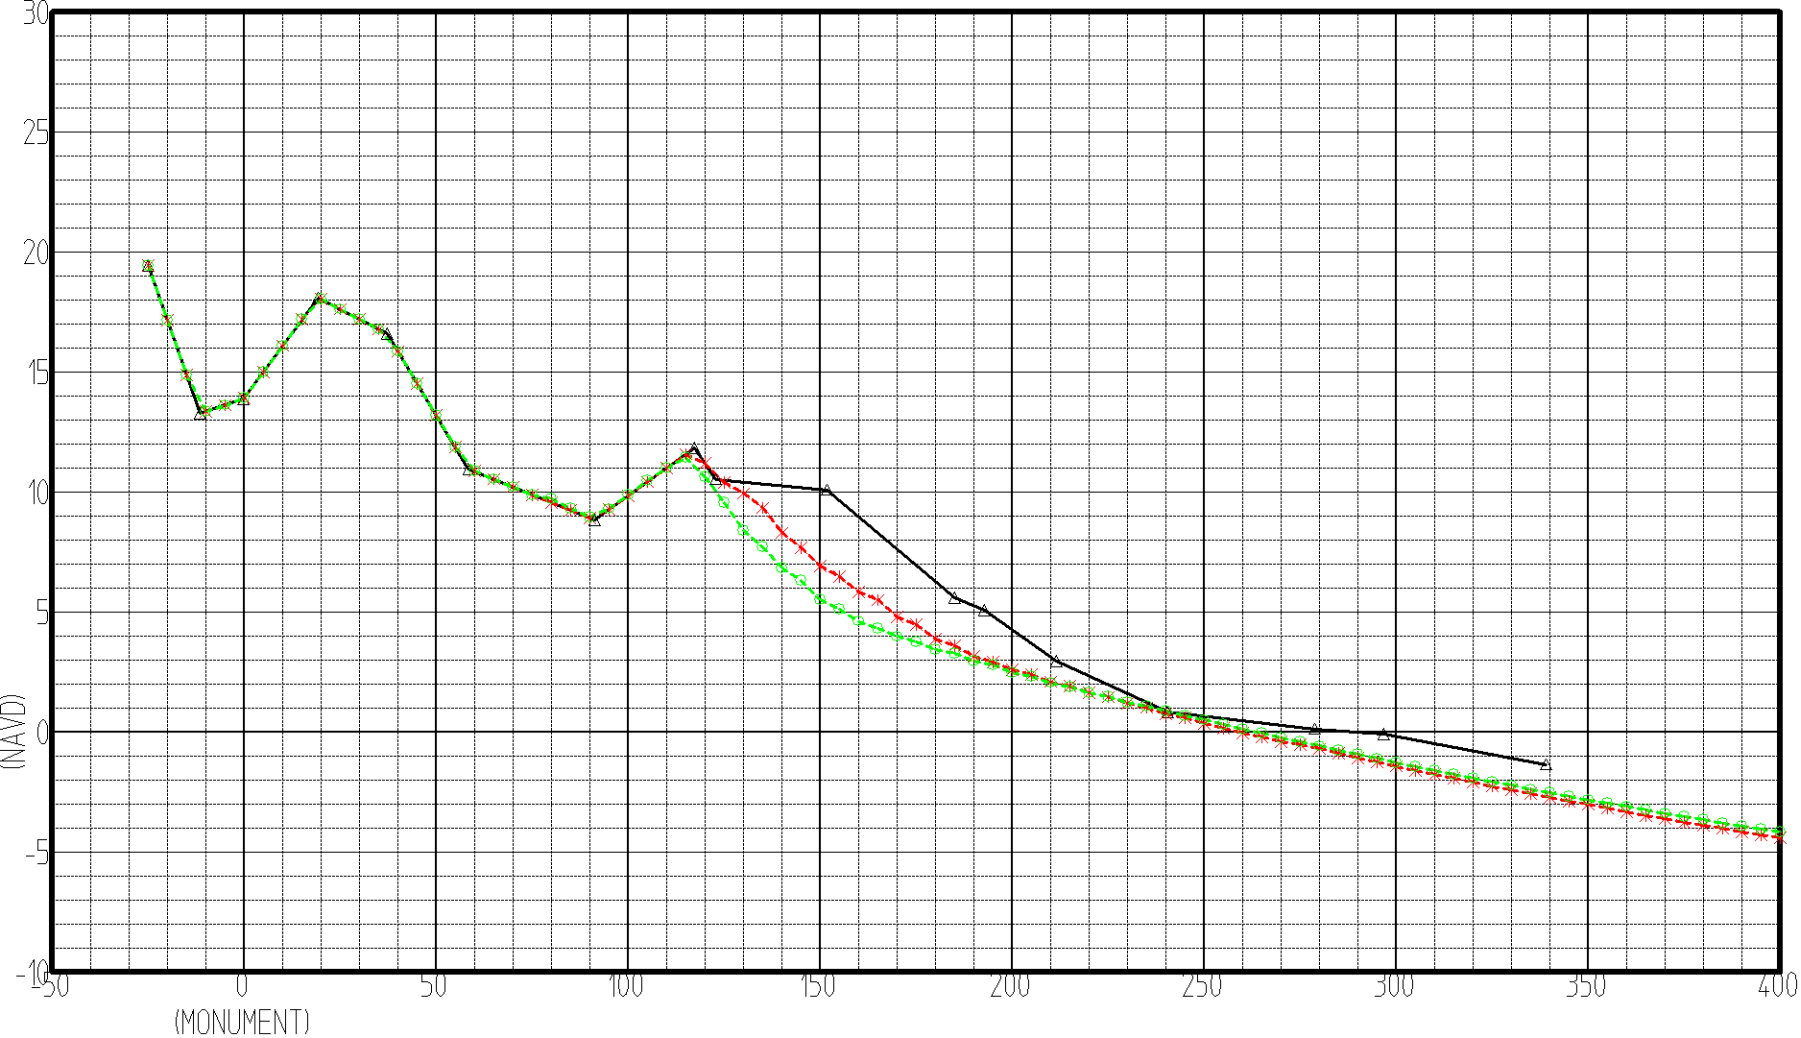
Range: R-23 1/2
 BEARING: 75.00

BEACH PROFILE
 —△—△— ST. JOHNS 2007-2008 COMBI
 - - * - - 15YR SBEACH ERODED
 - - o - - 25YR SBCH ERODED

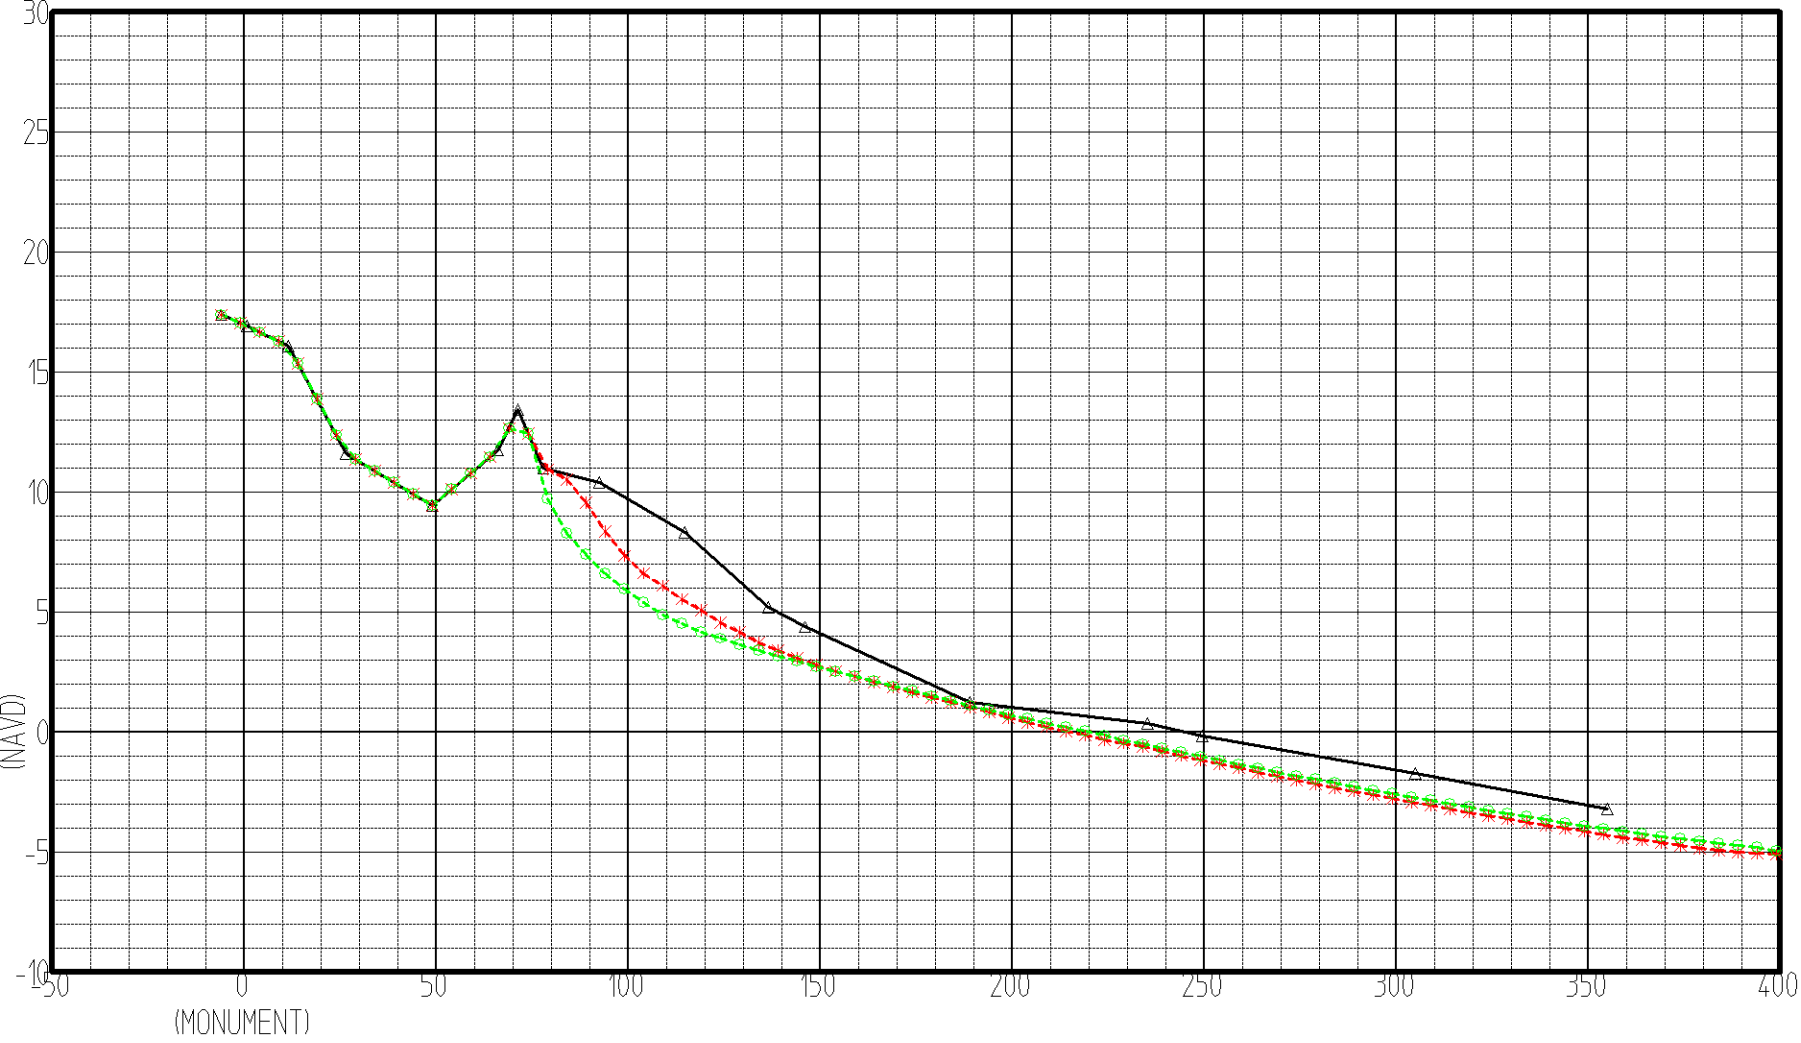
Range: R-24

BEACH PROFILE
