Appendix VIII

SBEACH 15 and 25 yr. Storm Erosion Profiles

St. Johns County

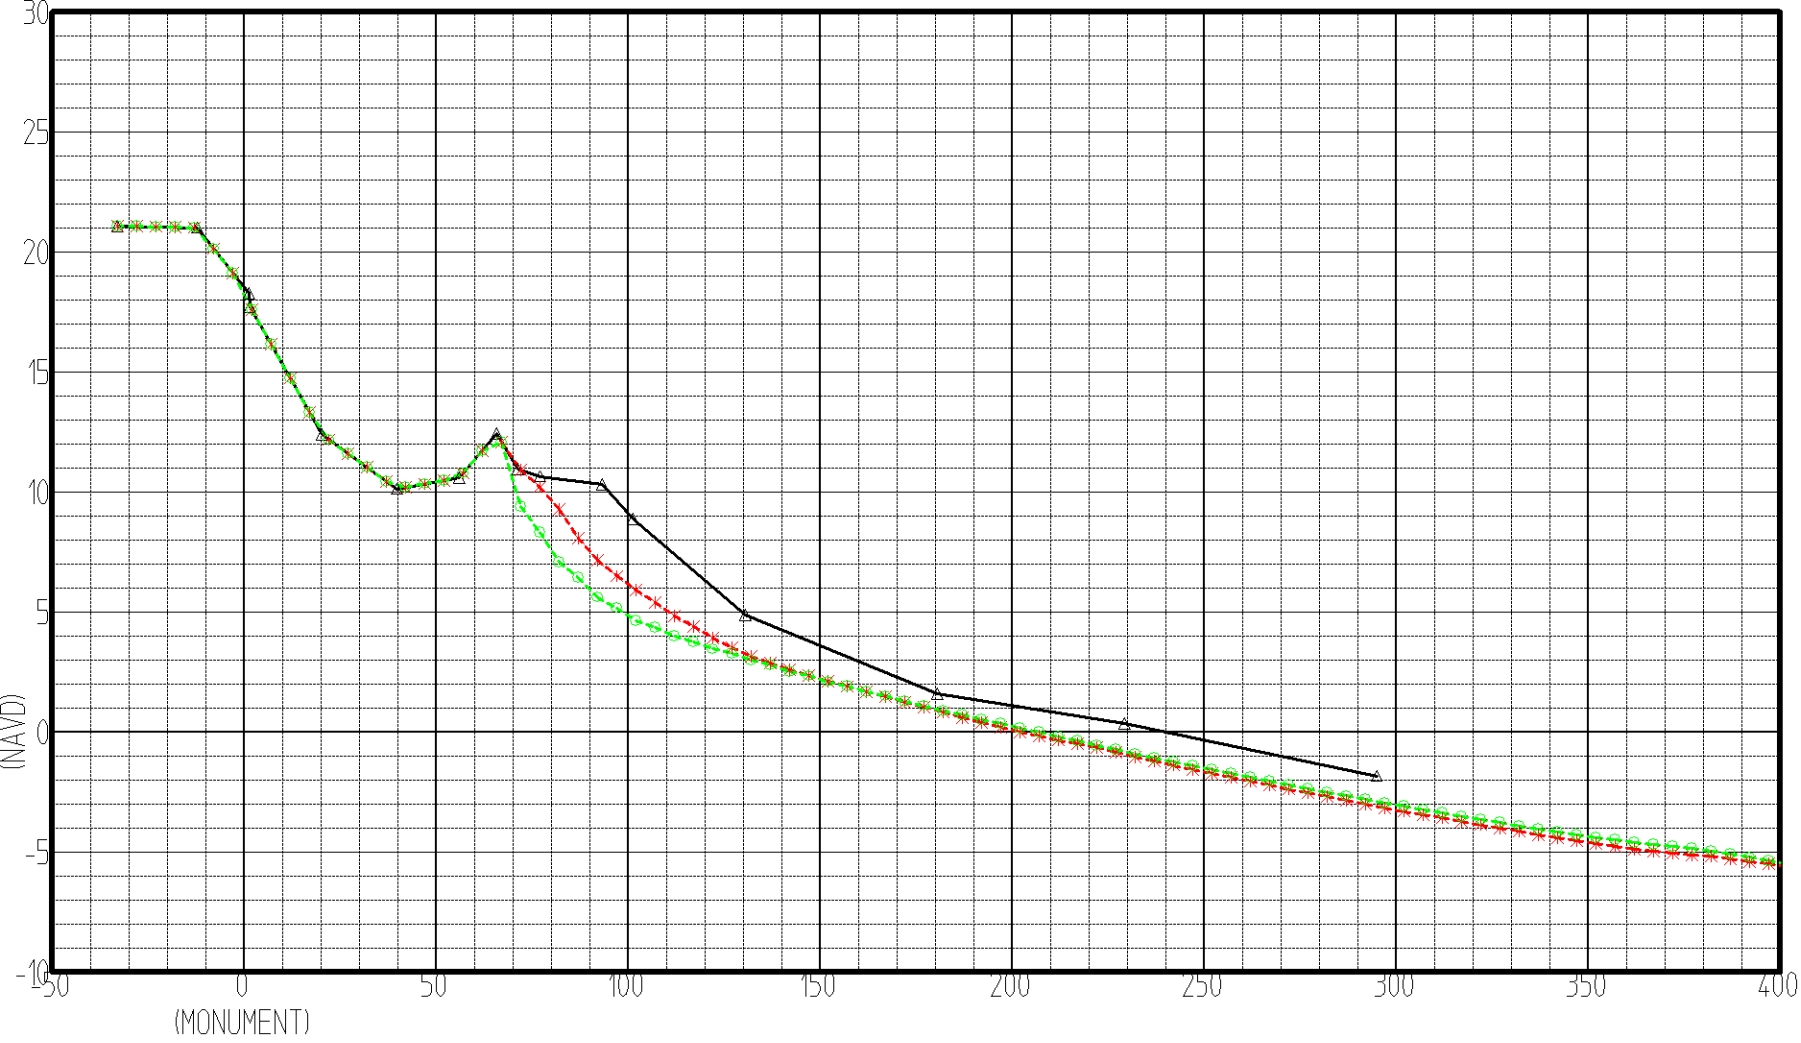
Range: R-25
 BEARING: 75.00
 1/2

BEACH PROFILE
 —△—△— ST. JOHNS 2007-2008 COMBI
 - - * - - - 15YR SBEACH ERODED
 - - o - - - 25YR SBCH ERODED

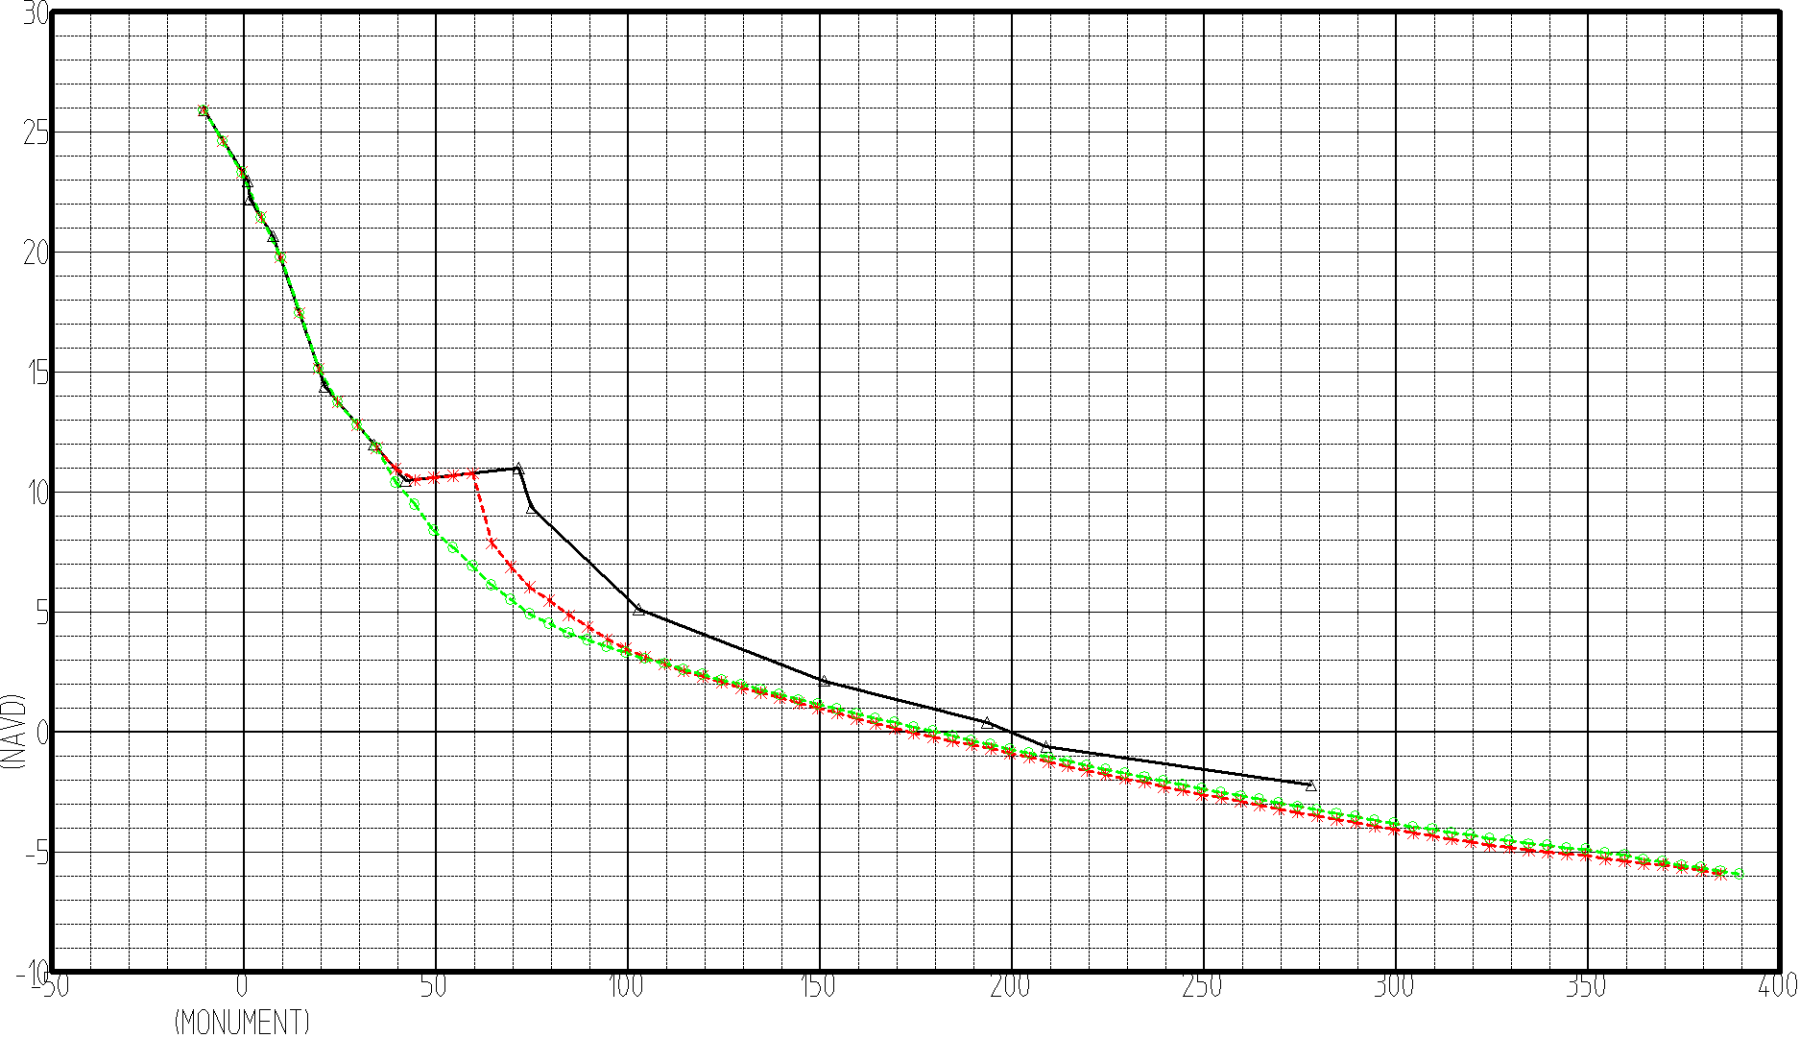
Range: R-26
 BEARING: 75.00
 1/1

BEACH PROFILE
 —△—△— ST. JOHNS 2007-2008 COMBI
 - - * - - - 15YR SBCH ERODED
 - - o - - - 25YR SBCH ERODED

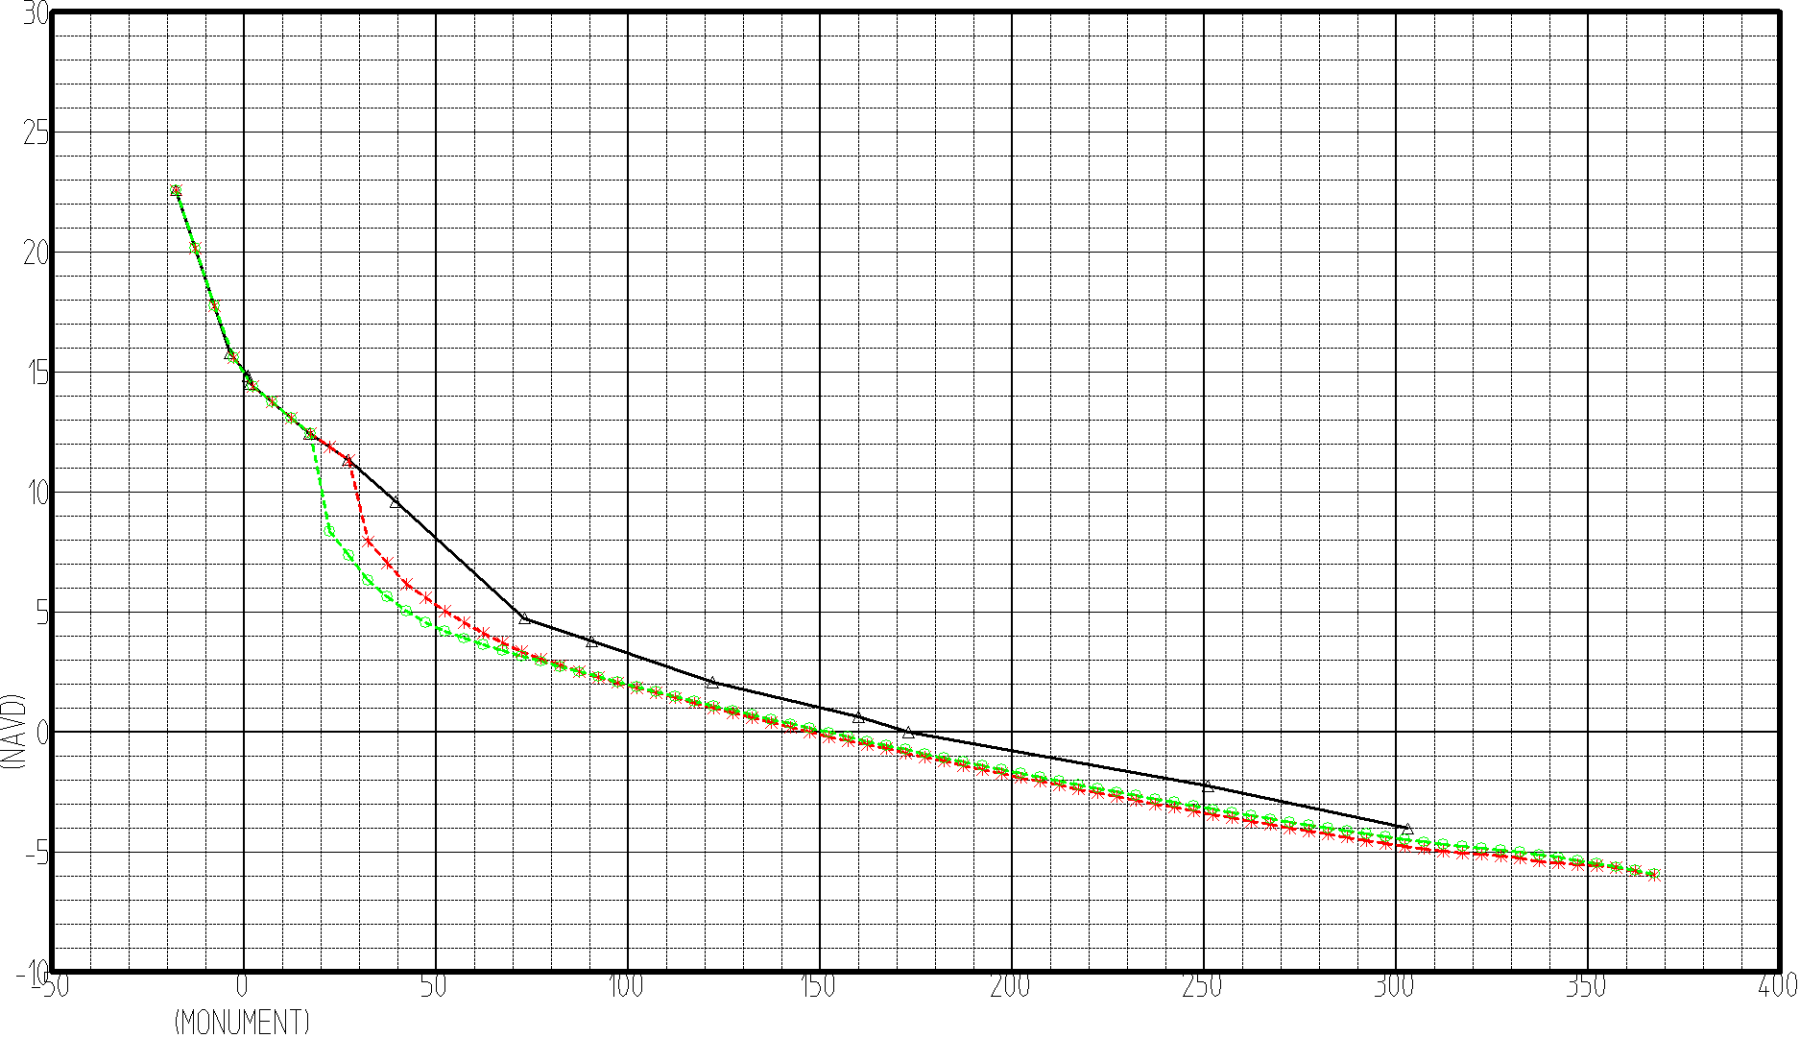
Range: R-27
 BEARING: 75.00
 1/1

BEACH PROFILE
 —△—△— ST. JOHNS 2007-2008 COMBI
 - - * - - 15YR SBCH ERODED
 - - o - - 25YR SBCH ERODED

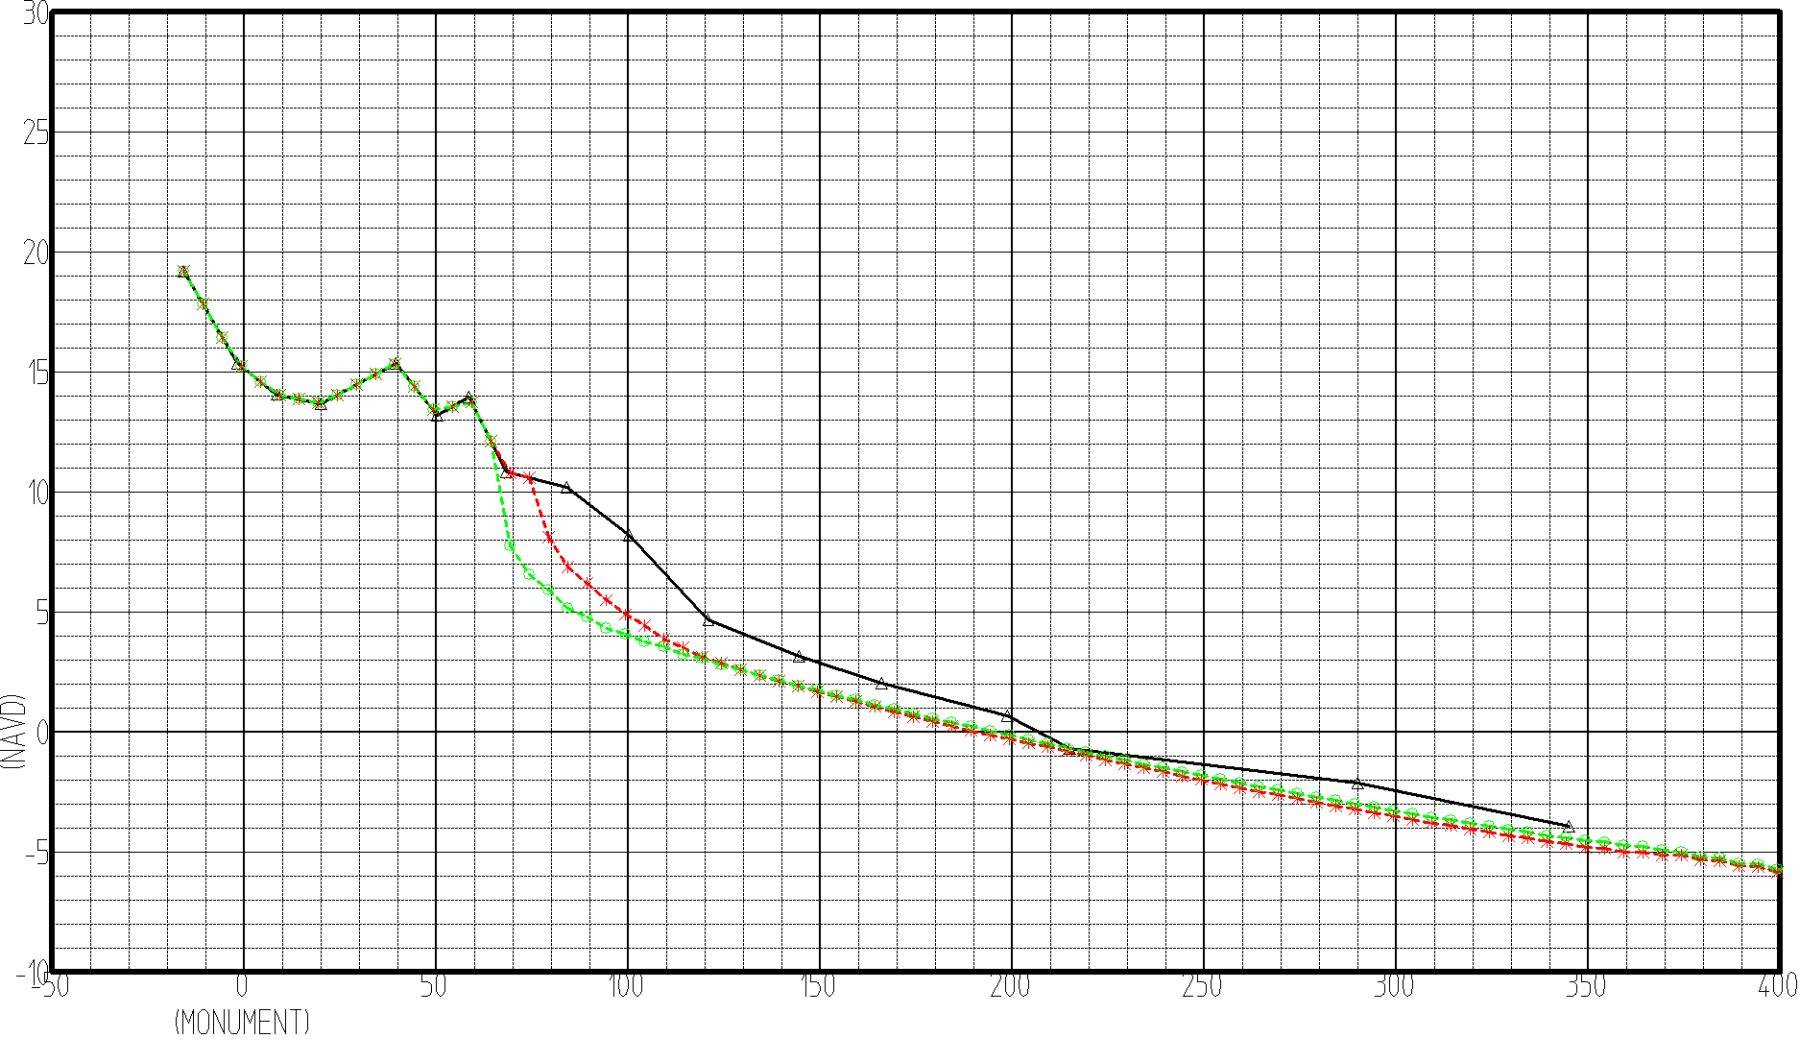
Range: R-28
 BEARING: 75.00
 1/2

BEACH PROFILE
 —△—△— ST. JOHNS 2007-2008 COMBI
 - - * - - * - - 15YR SBCH ERODED
 - - o - - o - - 25YR SBCH ERODED

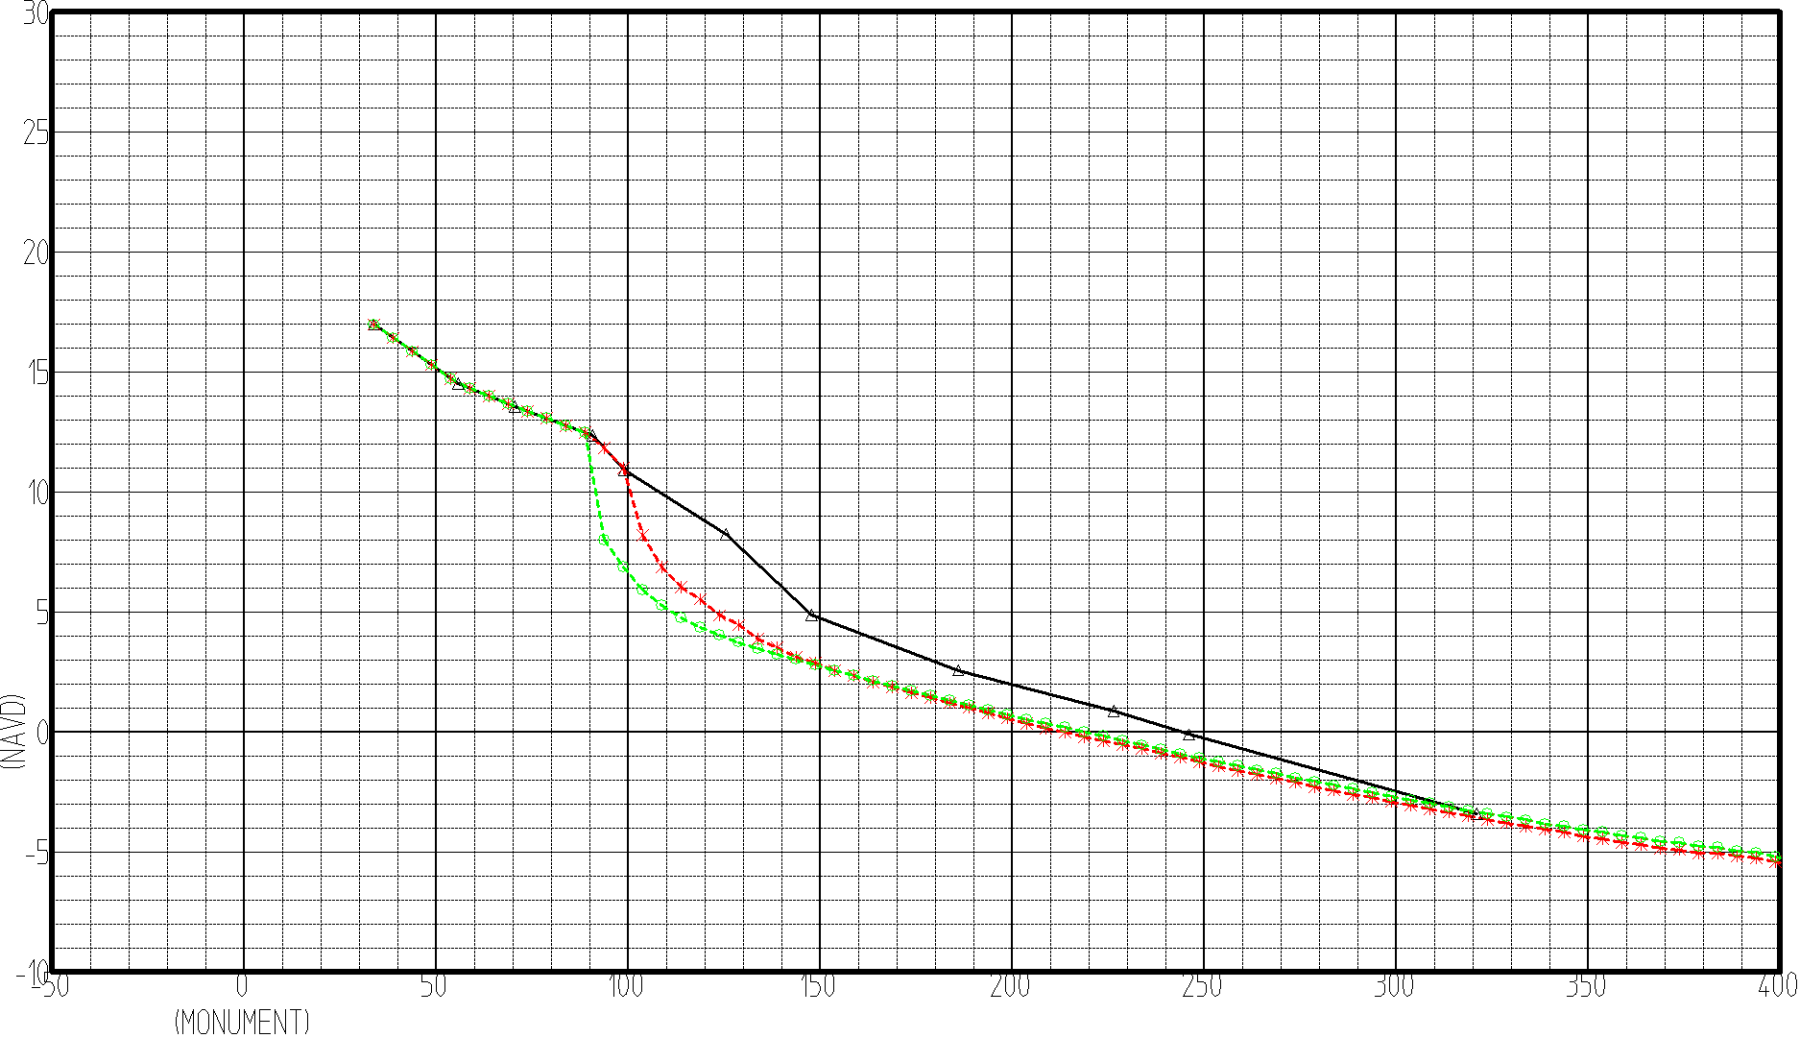
Range: R-30
 BEARING: 75.00
 1/2

BEACH PROFILE
 —△—△— ST. JOHNS 2007-2008 COMBI
 - - * - - 15YR SBEACH ERODED
 - - o - - 25YR SBCH ERODED

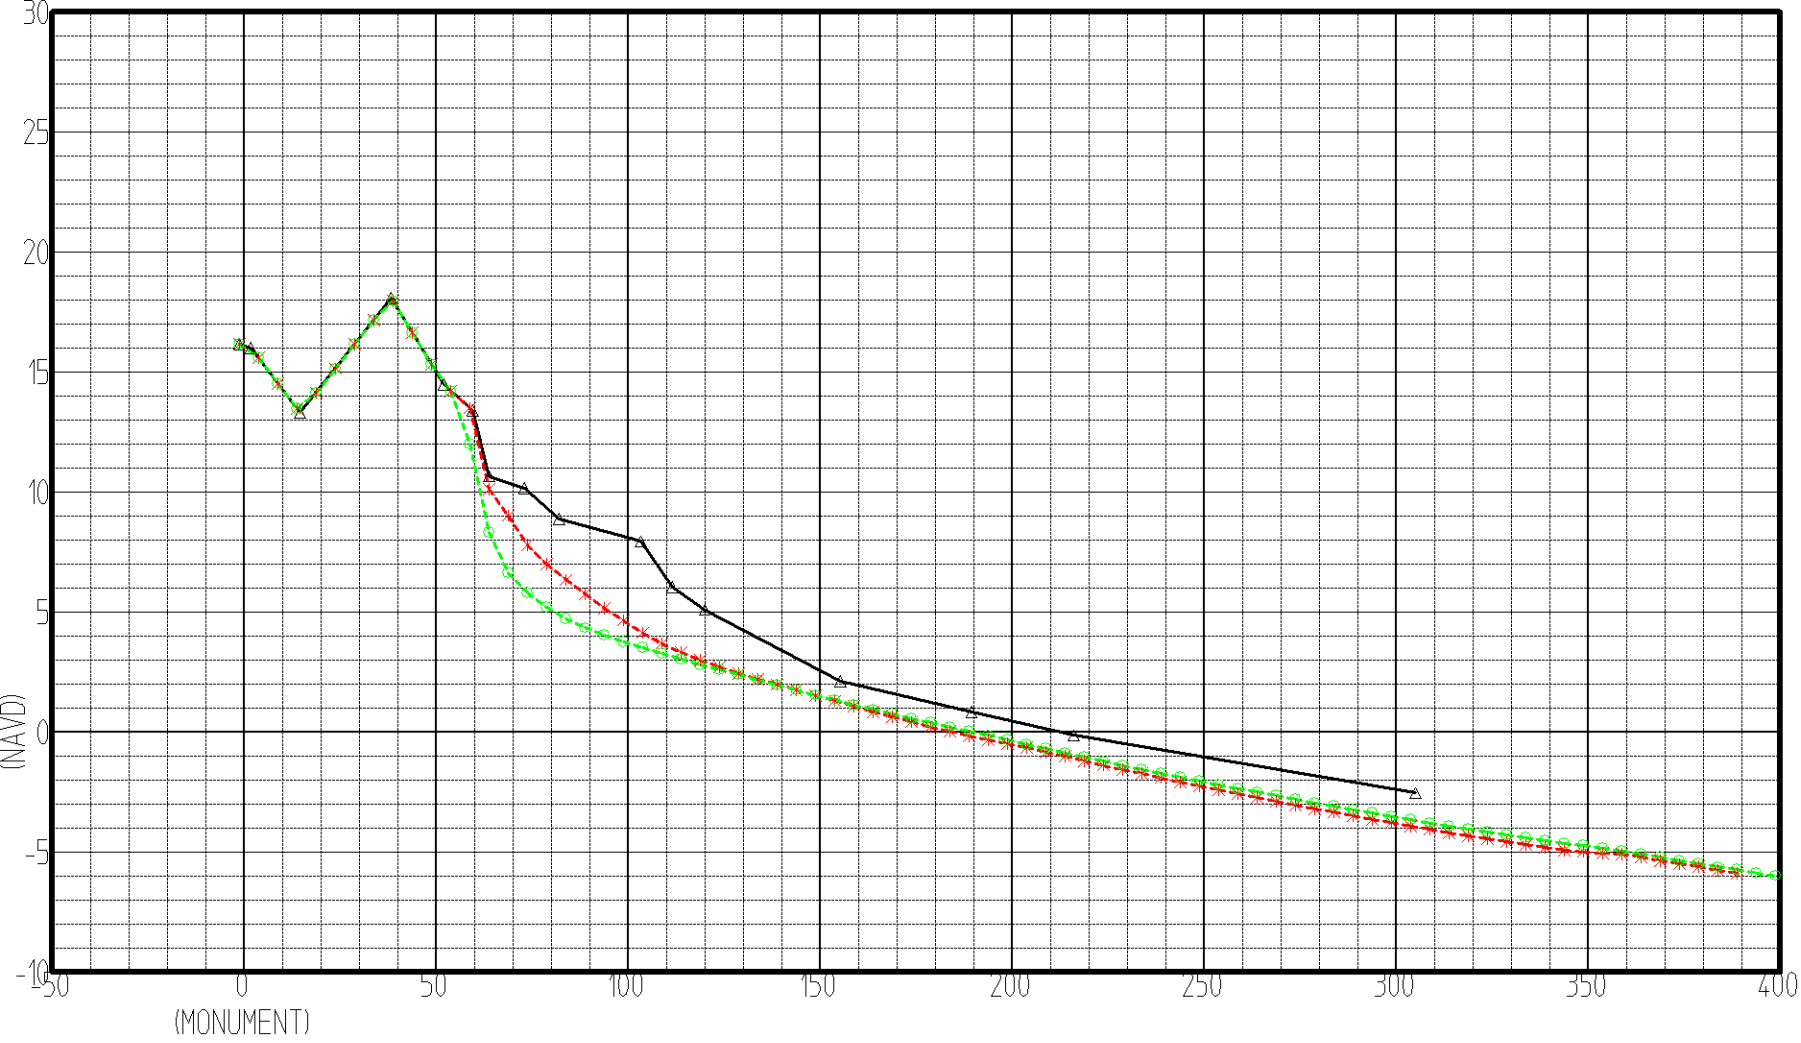
Range: R-31
 BEARING: 75.00
 1/1

BEACH PROFILE
 —△—△— ST. JOHNS 2007-2008 COMBI
 - - * - - - 15YR SBEACH ERODED
 - - o - - - 25YR SBCH ERODED

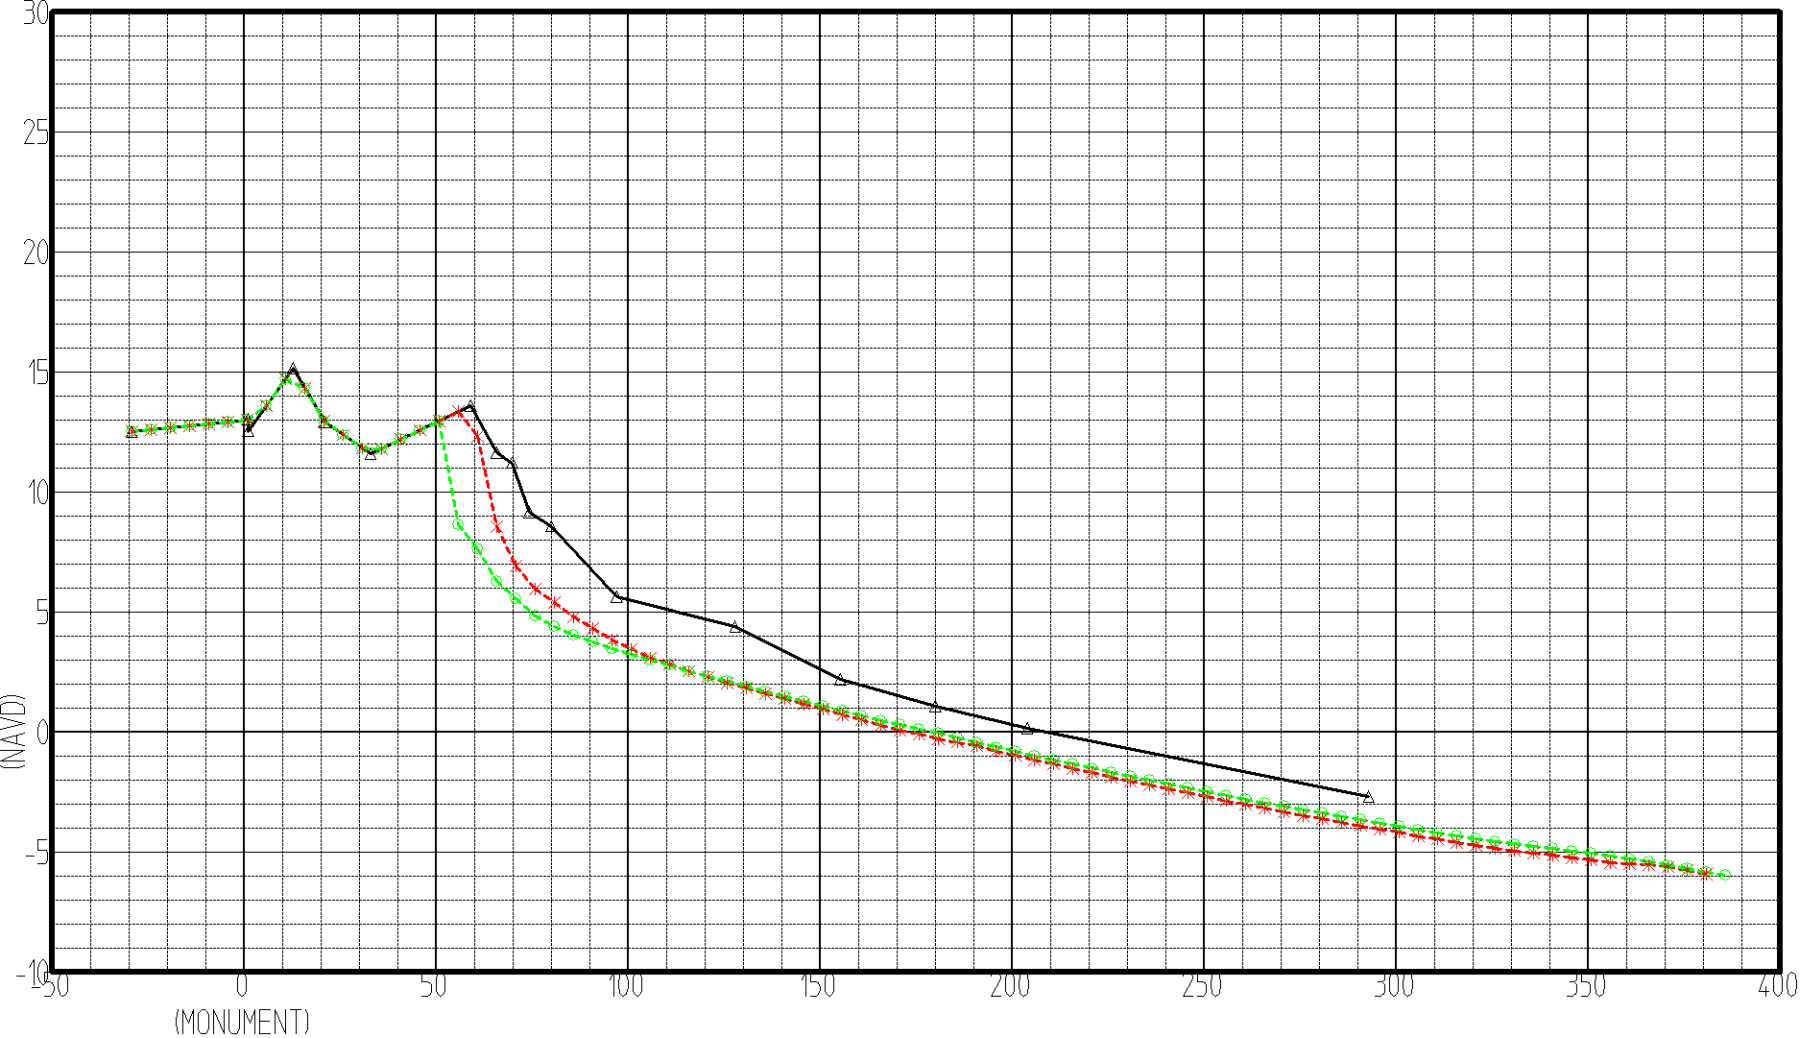
Range: R-33A 1/1
 BEARING: 75.00

BEACH PROFILE
 —△—△— ST. JOHNS 2007-2008 COMBI
 - - * - - 15YR SBEACH ERODED
 - - o - - 25YR SBCH ERODED

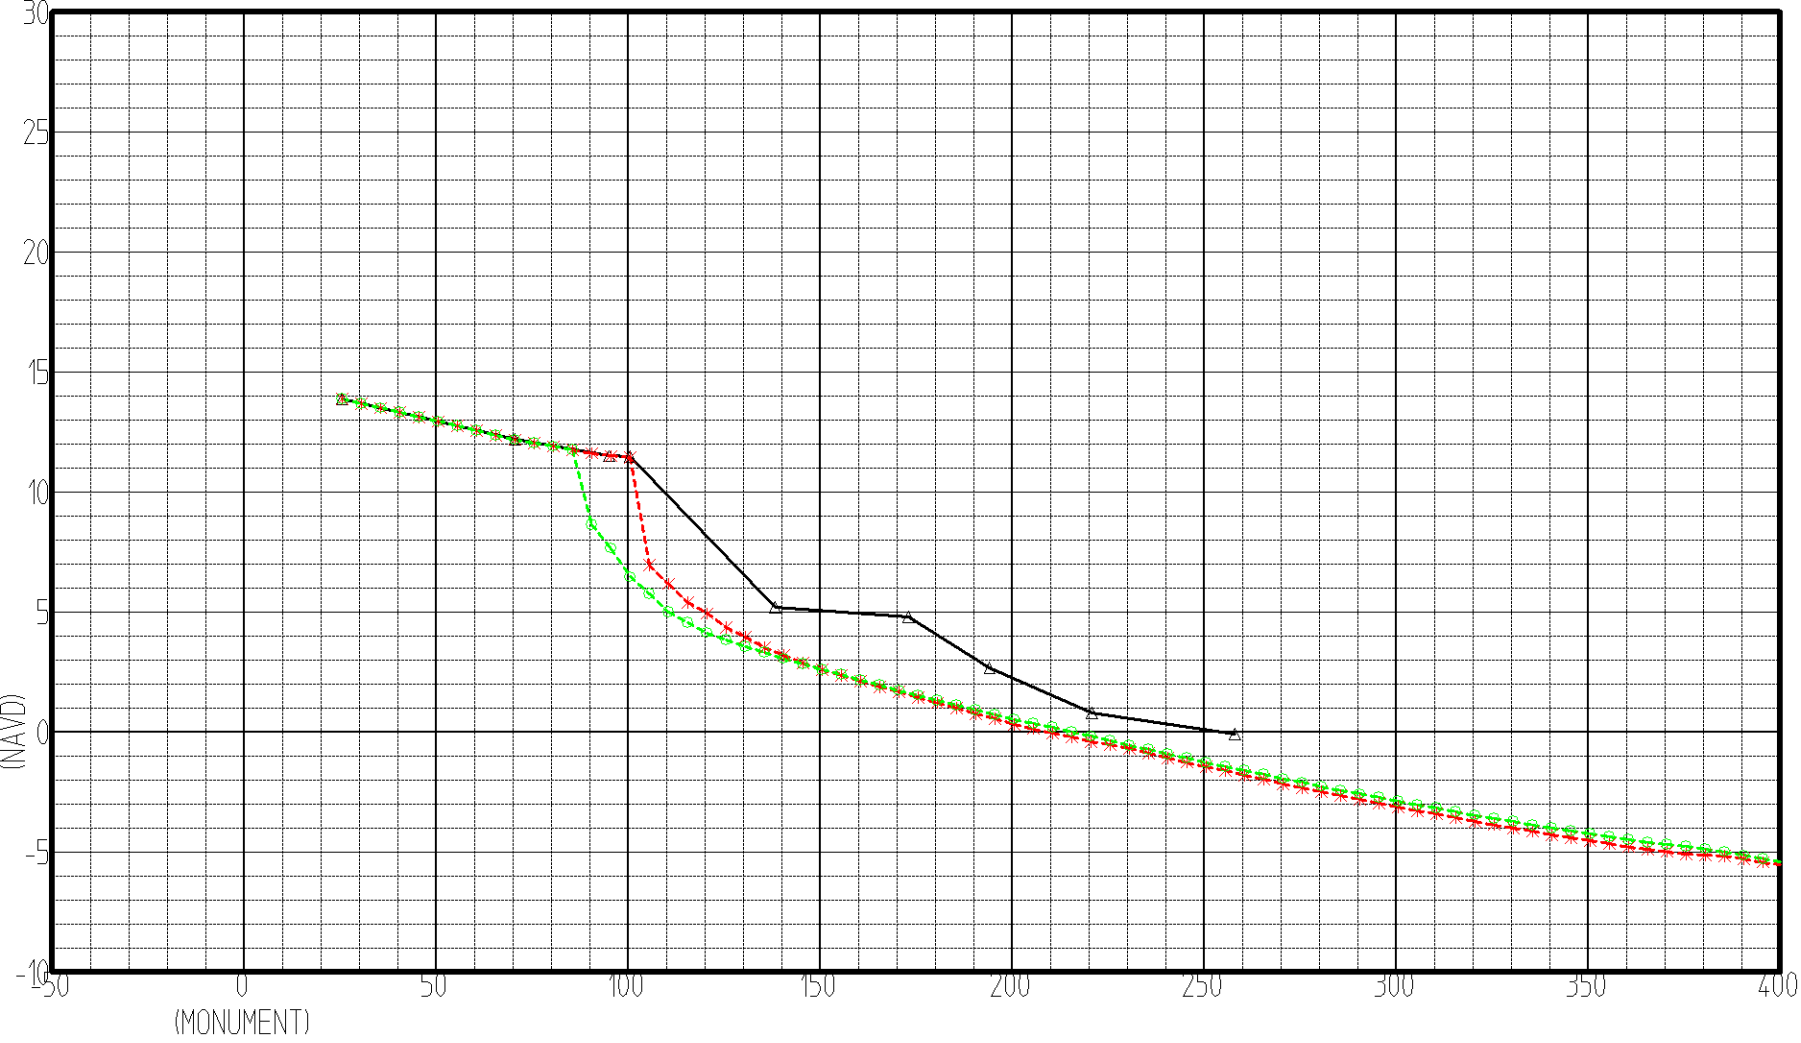
Range: R-34
 BEARING: 75.00
 1/2

BEACH PROFILE
 —△—△— ST. JOHNS 2007-2008 COMBI
 - - * - - - 15YR SBEACH ERODED
 - - o - - - 25YR SBCH ERODED

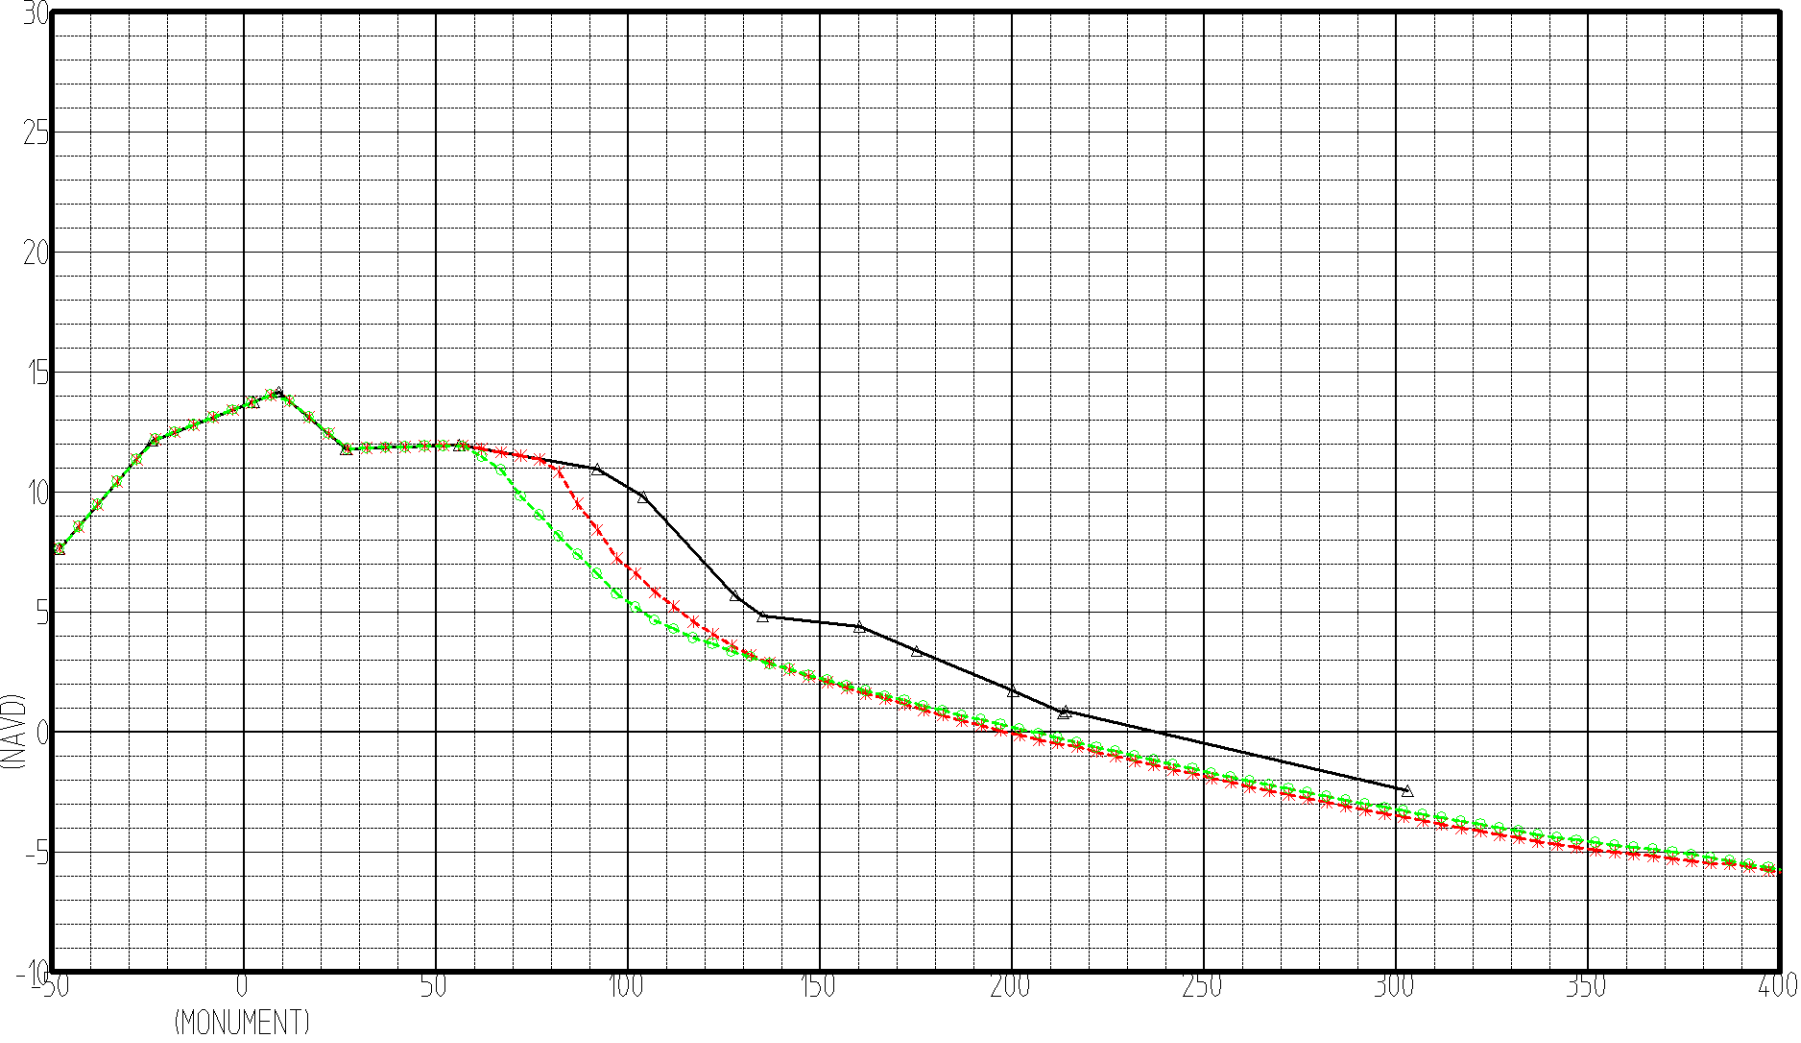
Range: T-35
 BEARING: 75.00
 1/2

BEACH PROFILE
 —△—△— ST. JOHNS 2007-2008 COMBI
 - - * - - 15YR SBCH ERODED
 - - o - - 25YR SBCH ERODED

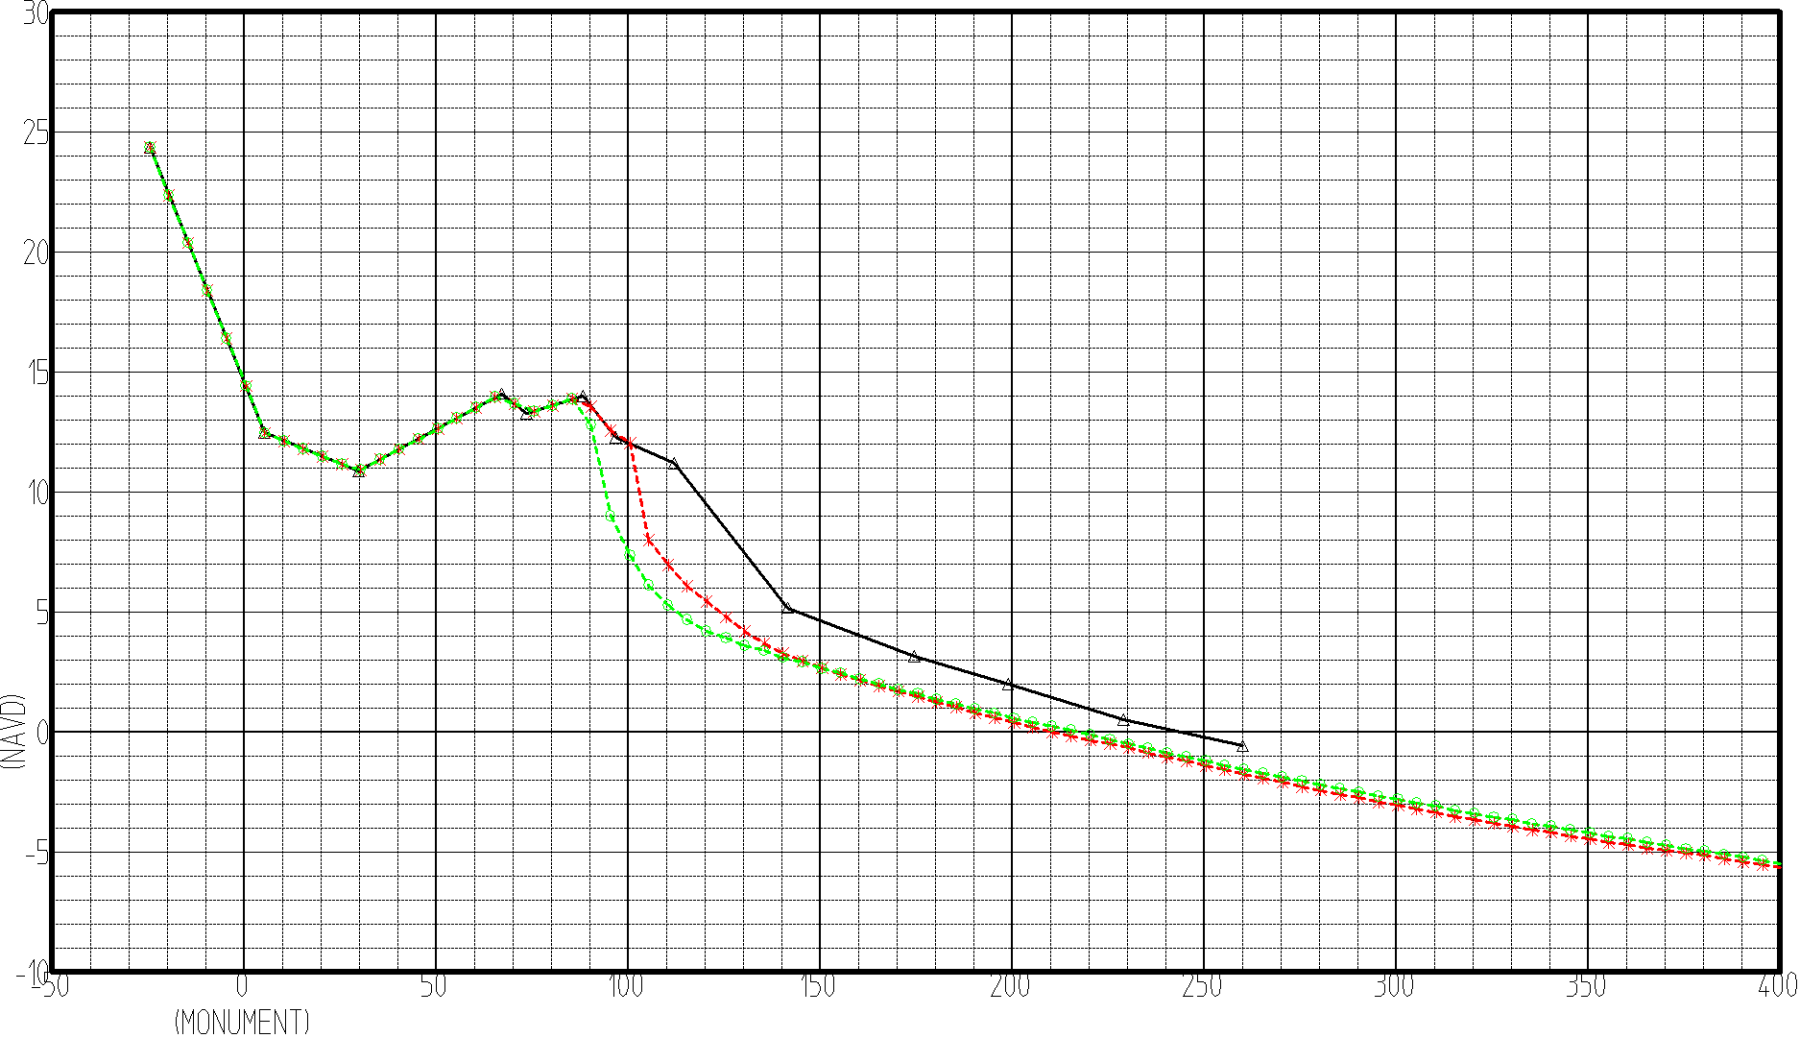
Range: R-36
 BEARING: 75.00
 1/2

BEACH PROFILE
 —△—△— ST. JOHNS 2007-2008 COMBI
 - - * - - - 15YR SBCH ERODED
 - - o - - - 25YR SBCH ERODED

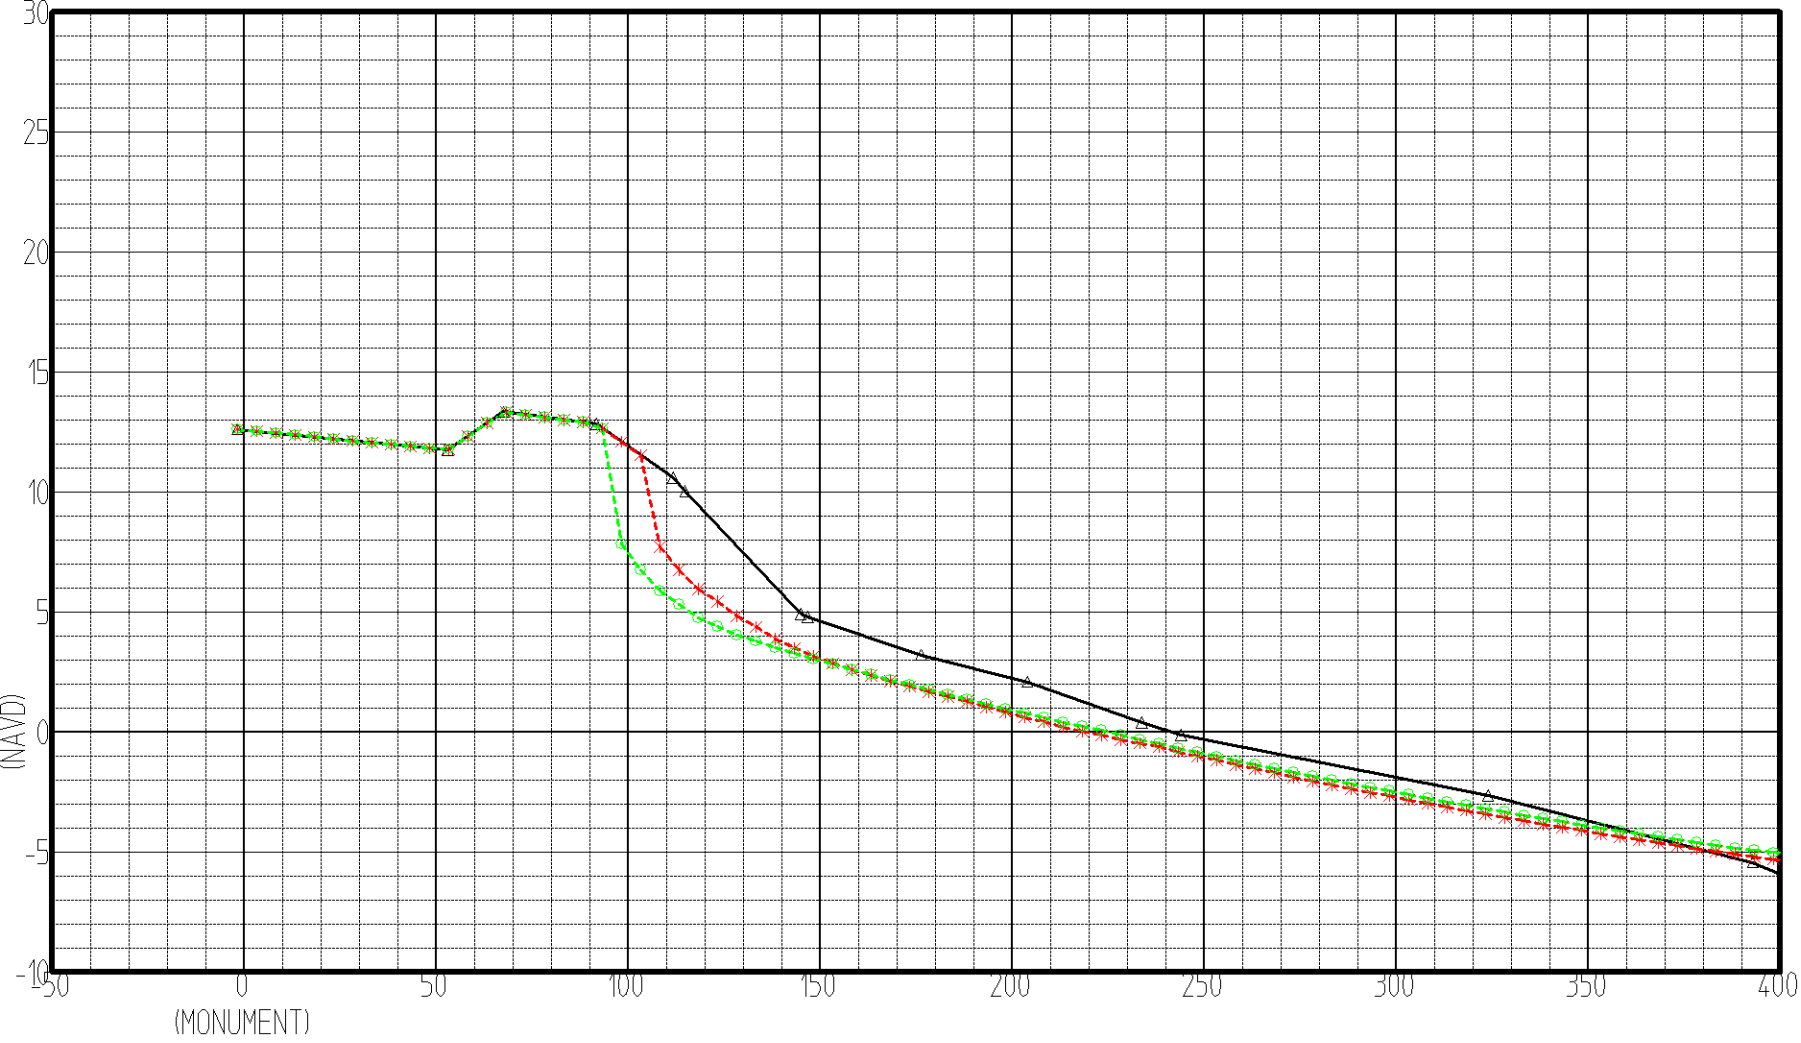
Range: R-37
 BEARING: 75.00
 1/2

BEACH PROFILE
 —△—△— ST. JOHNS 2007-2008 COMBI
 - - * - - * - - 15YR SBCH ERODED
 - - o - - o - - 25YR SBCH ERODED

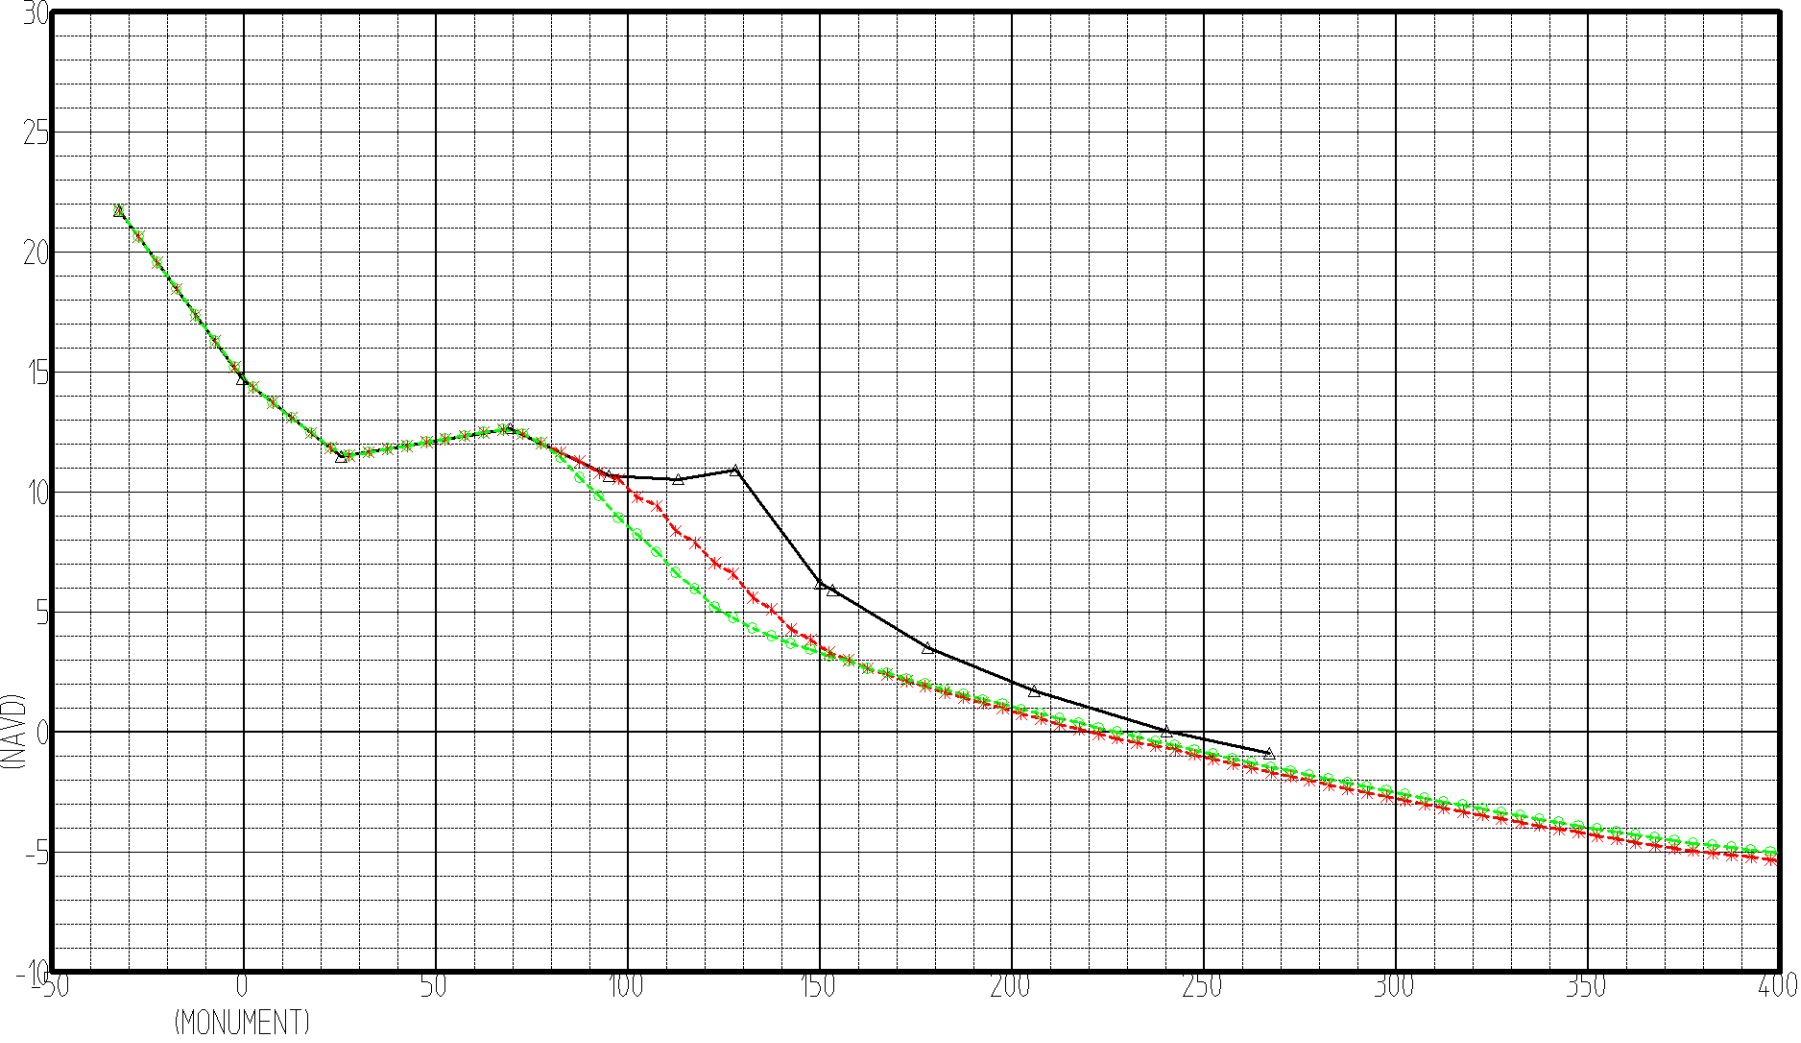
Range: R-38
 BEARING: 75.00
 1/2

BEACH PROFILE
 —△— ST. JOHNS 2007-2008 COMBI
 - - * - - 15YR SBEACH ERODED
 - - o - - 25YR SBCH ERODED
