Appendix VIII

SBEACH 15 and 25 yr. Storm Erosion Profiles

St. Johns County

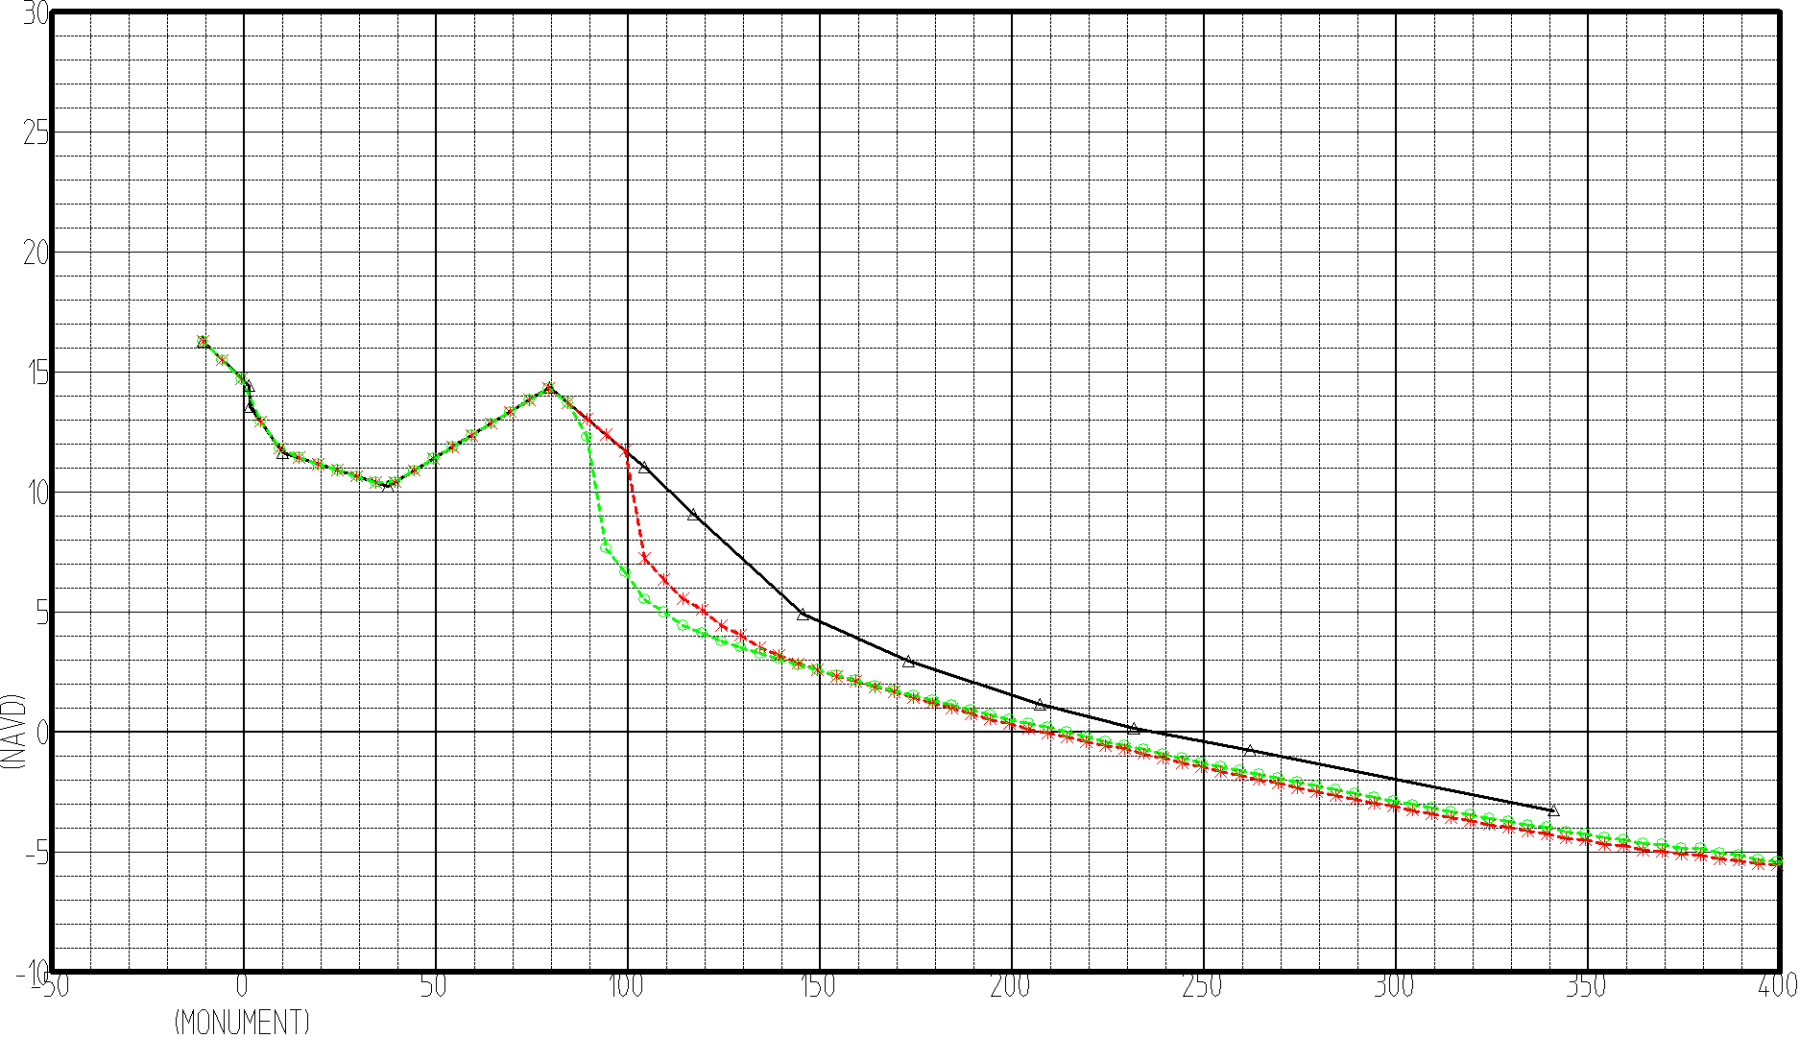
Range: R-39
 BEARING: 75.00
 1/2

BEACH PROFILE
 —△—△— ST. JOHNS 2007-2008 COMBI
 - - * - - 15YR SBCH ERODED
 - - o - - 25YR SBCH ERODED

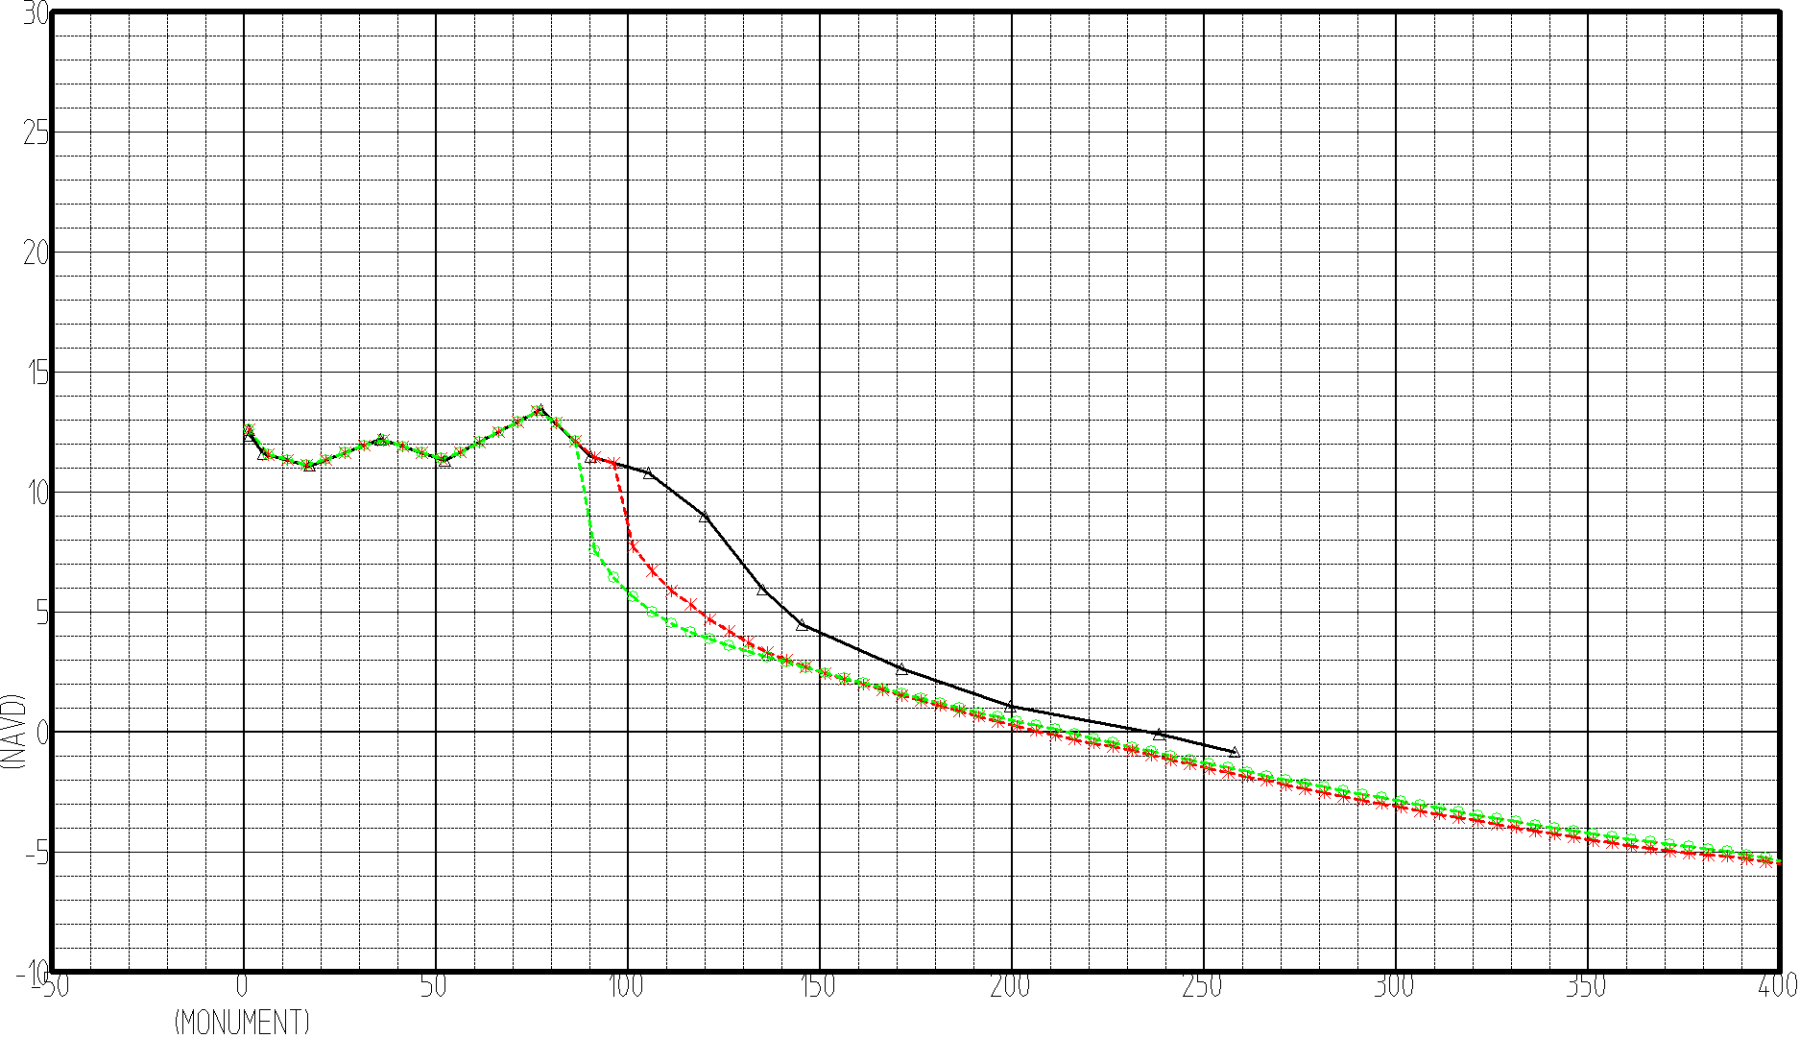
Range: T-40
 BEARING: 75.00
 1/2

BEACH PROFILE
 —△—△— ST. JOHNS 2007-2008 COMBI
 - - * - - 15YR SBCH ERODED
 - - o - - 25YR SBCH ERODED

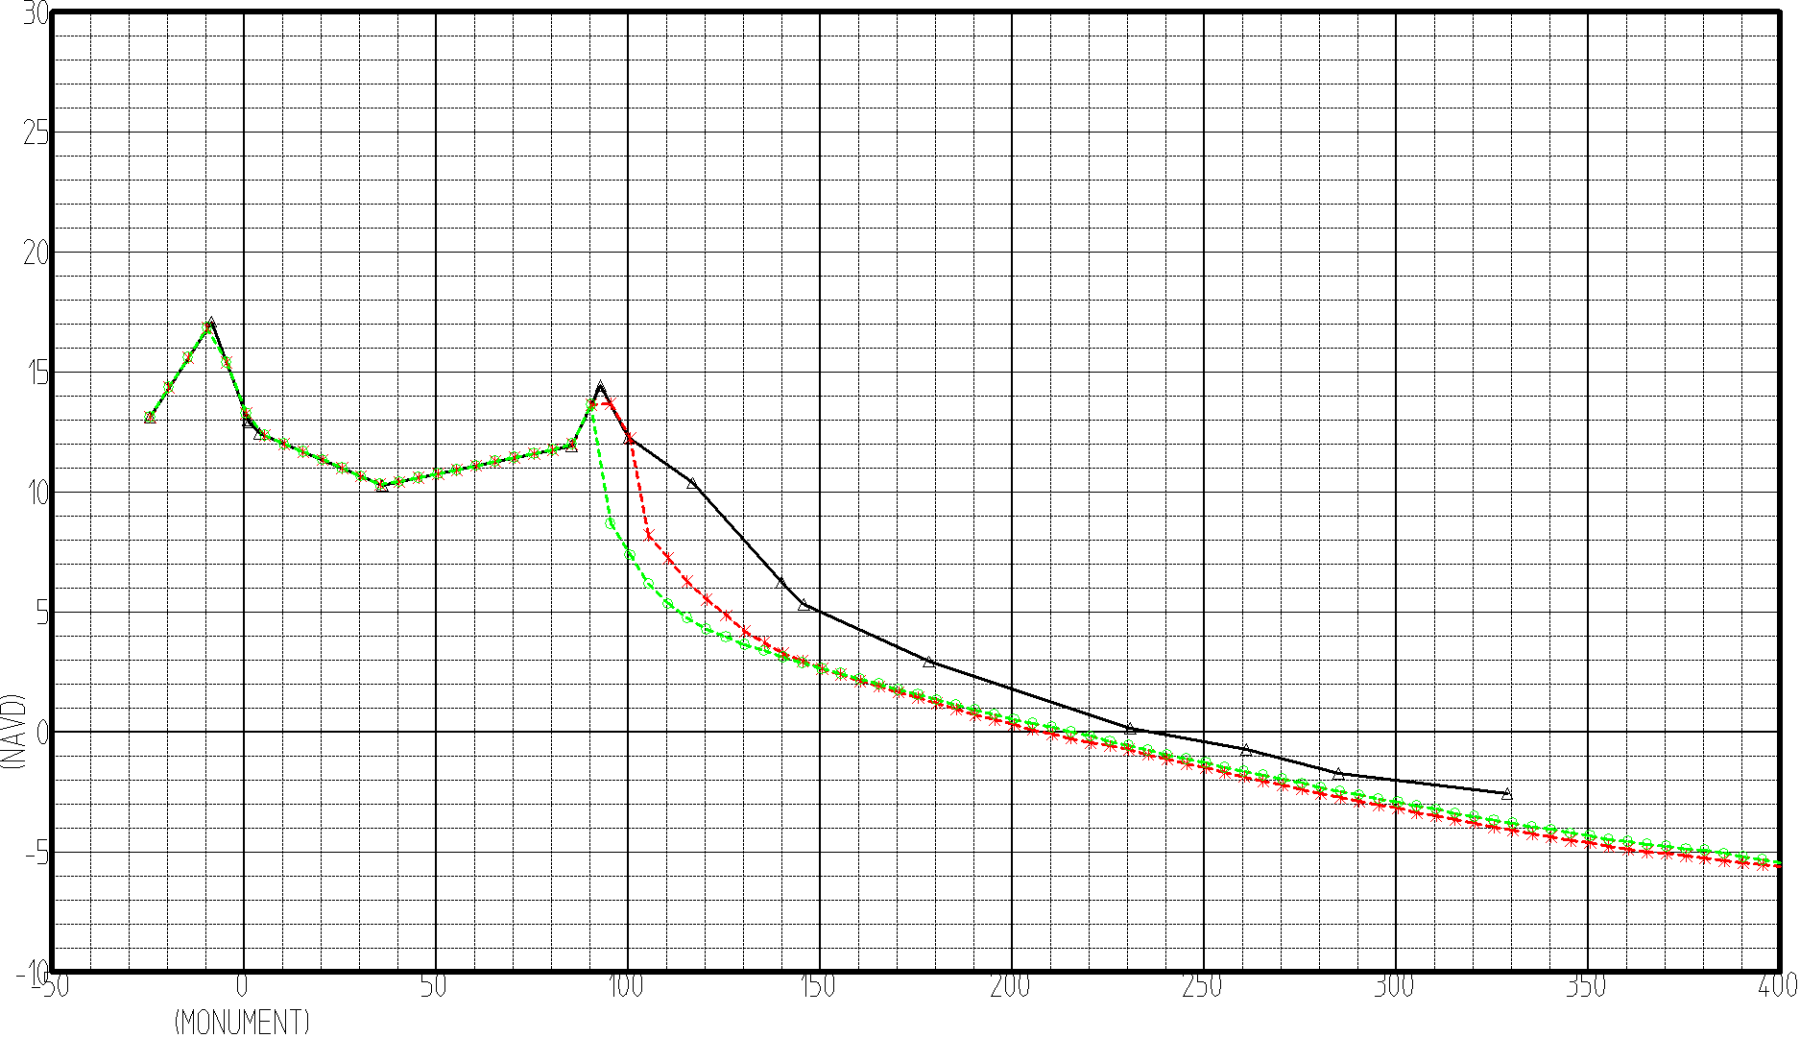
Range: T-41 1/2
 BEARING: 75.00

BEACH PROFILE
 —△—△— ST. JOHNS 2007-2008 COMBI
 - - * - - 15YR SBCH ERODED
 - - o - - 25YR SBCH ERODED

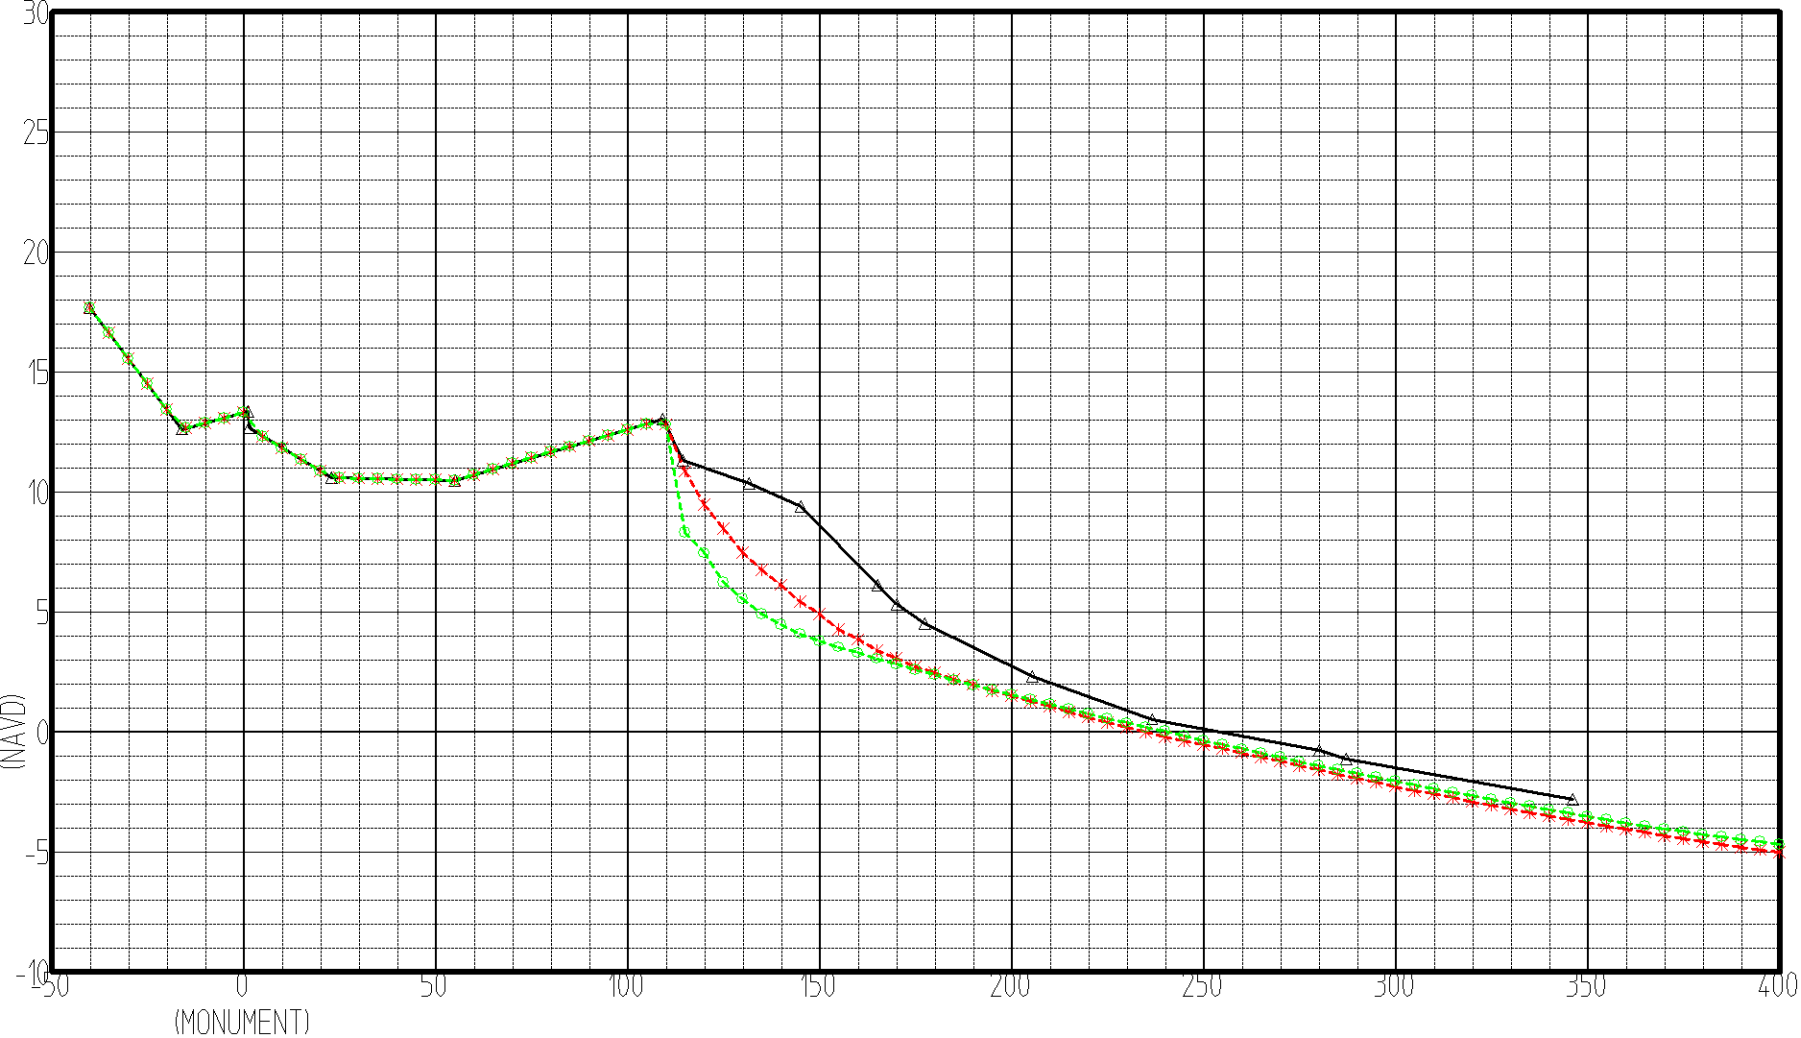
Range: R-42
 BEARING: 75.00
 1/2

BEACH PROFILE
 —△—△— ST. JOHNS 2007-2008 COMBI
 - - * - - 15YR SBCH ERODED
 - - o - - 25YR SBCH ERODED

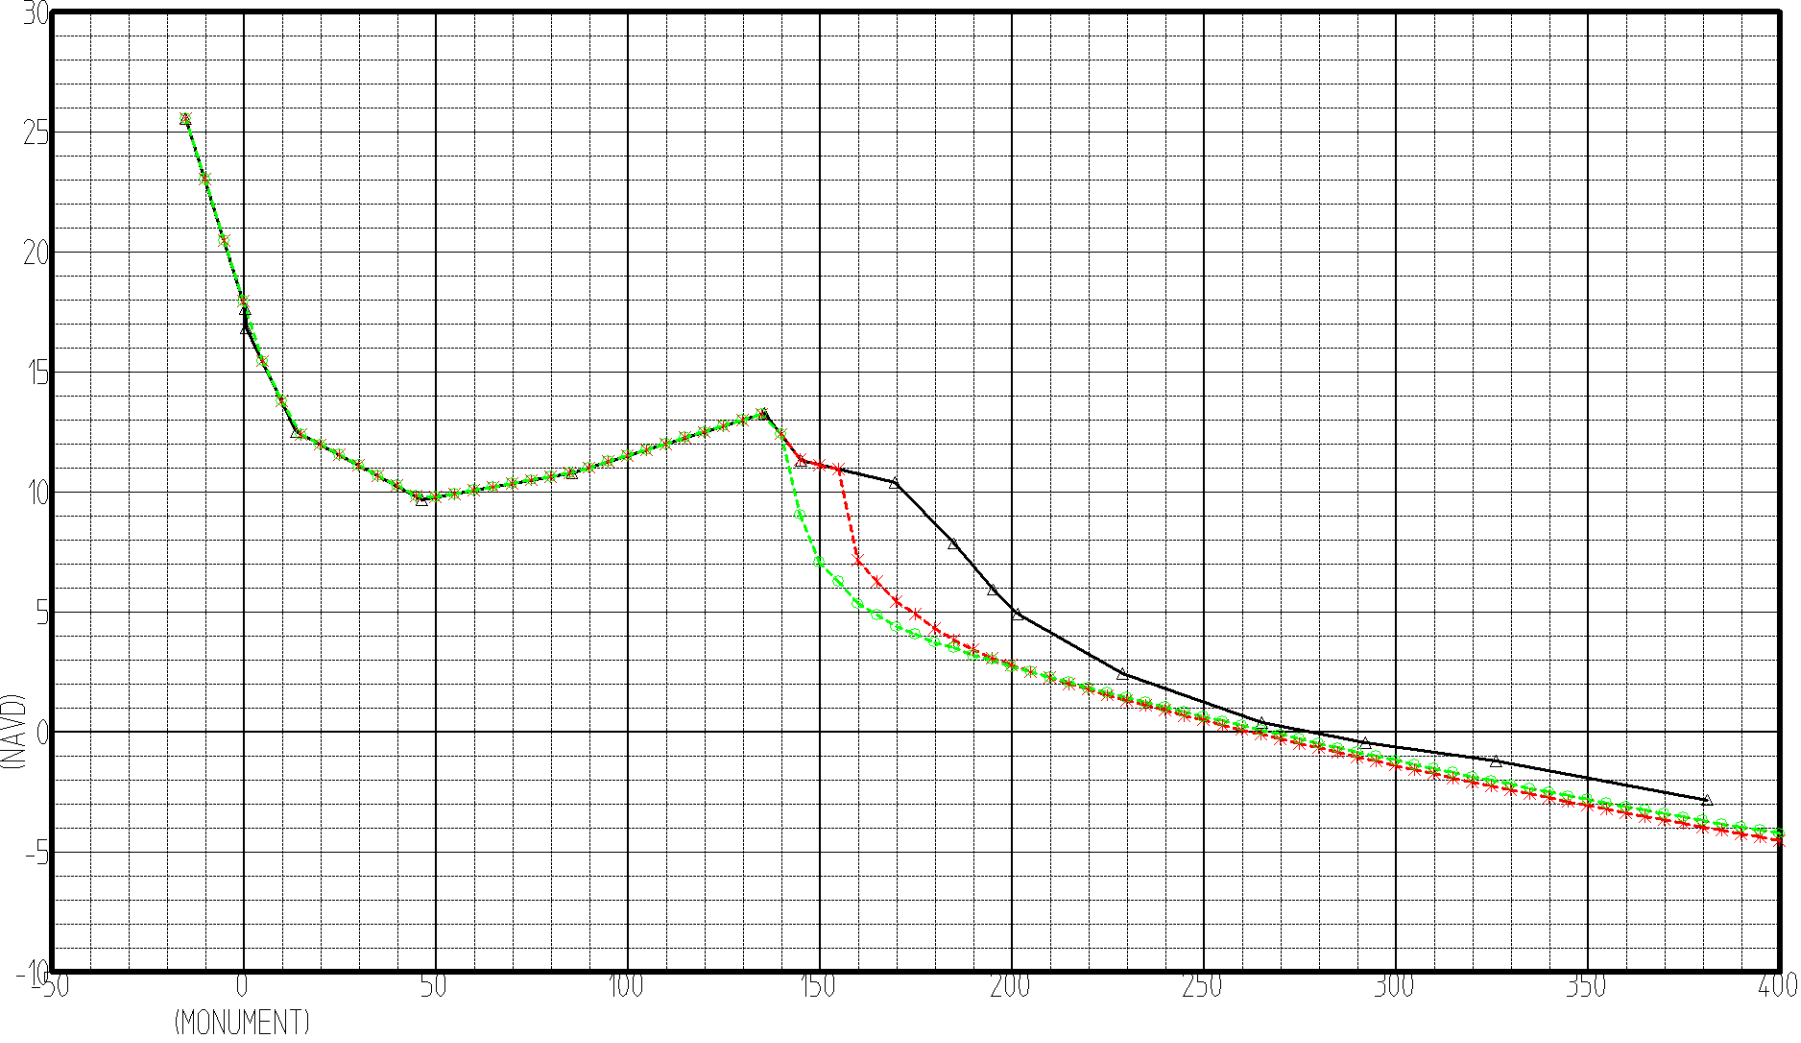
Range: R-43
 BEARING: 75.00
 1/2

BEACH PROFILE
 —△—△— ST. JOHNS 2007-2008 COMBI
 - - - * - - - 15YR SBCH ERODED
 - - - o - - - 25YR SBCH ERODED

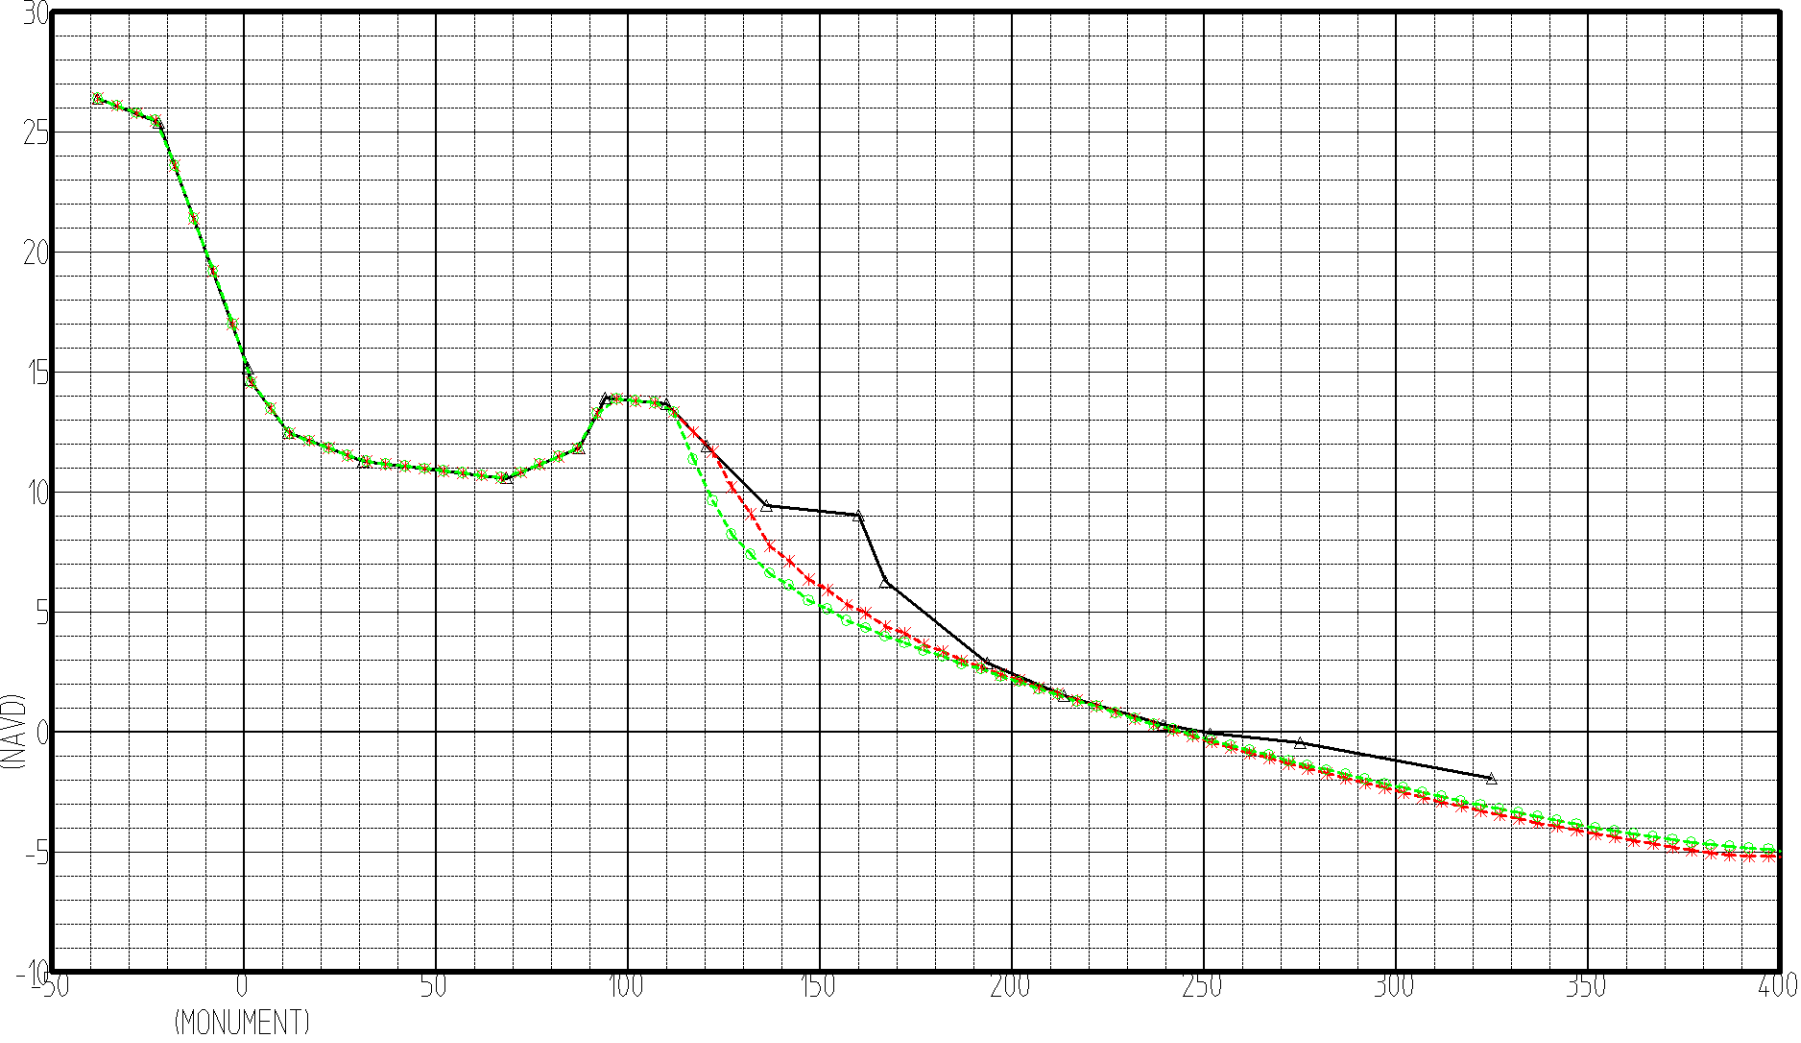
Range: R-44
 BEARING: 75.00
 1/2

BEACH PROFILE
 —△—△— ST. JOHNS 2007-2008 COMBI
 - - * - - 15YR SBCH ERODED
 - - o - - 25YR SBCH ERODED

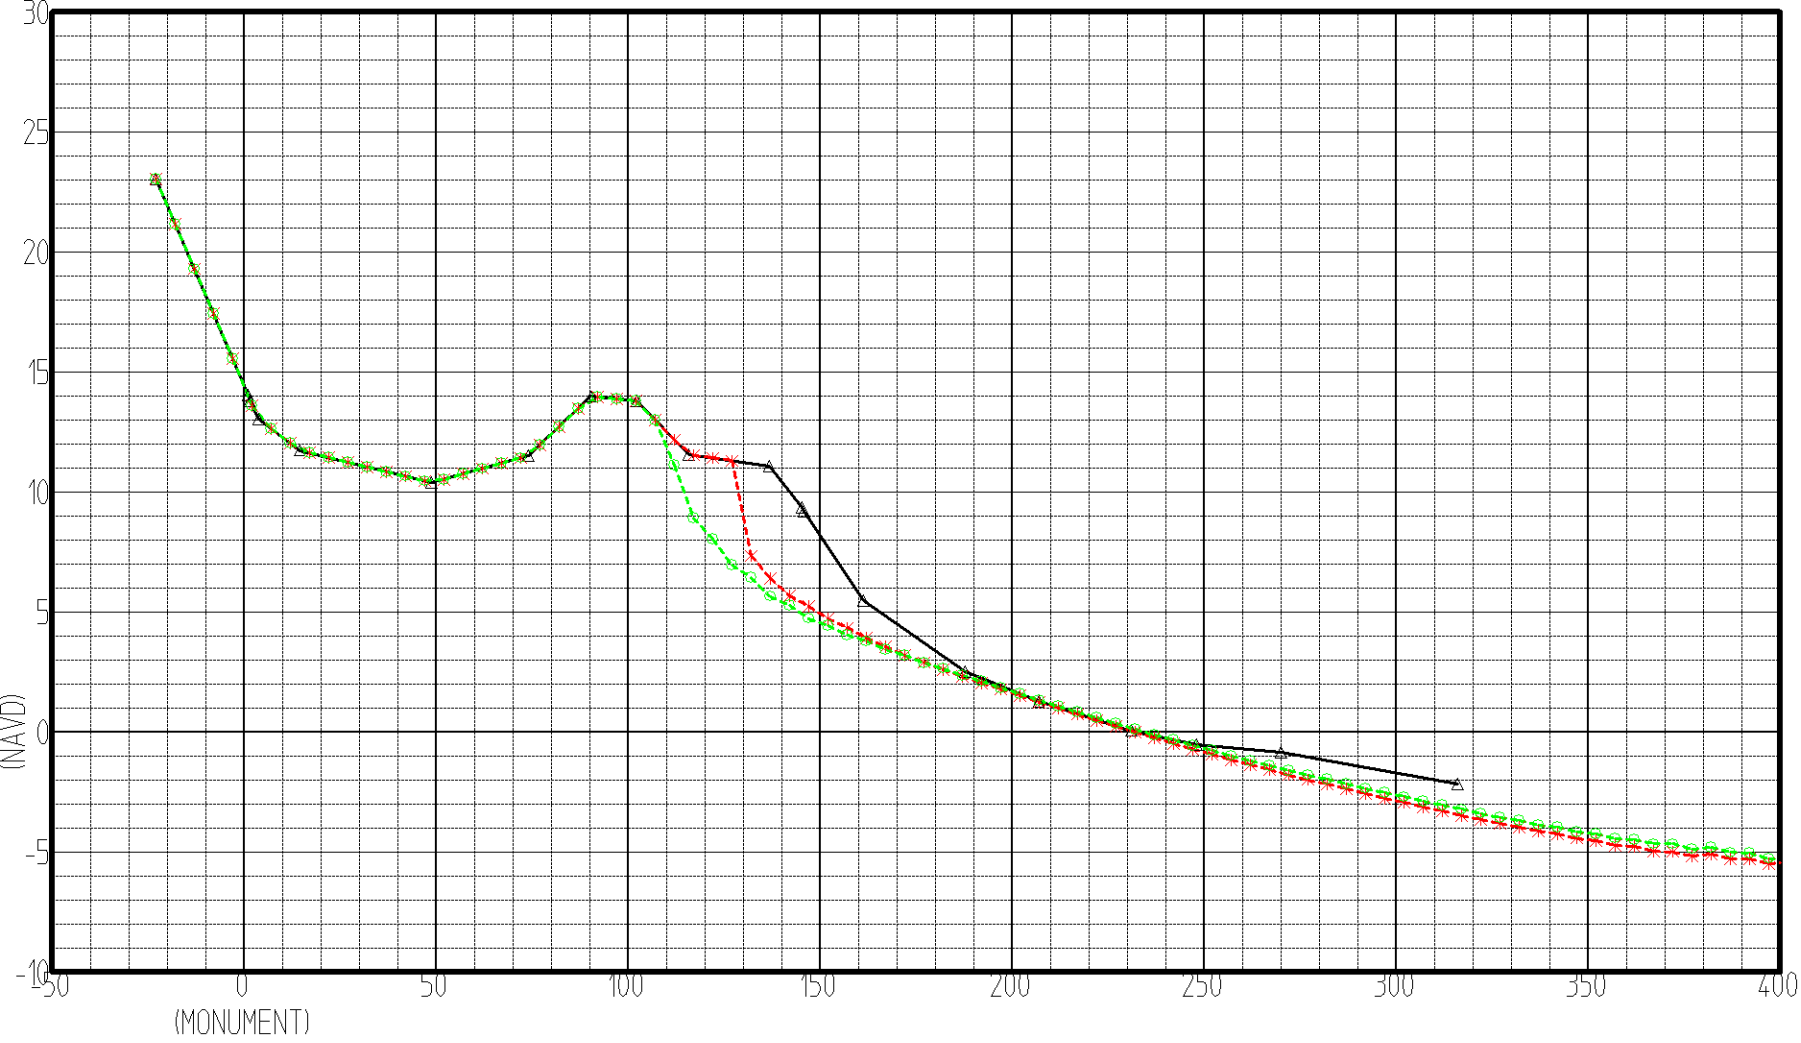
Range: R-45
 BEARING: 75.00
 1/2

BEACH PROFILE
 —△—△— ST. JOHNS 2007-2008 COMBI
 - - * - - * - - 15YR SBCH ERODED
 - - o - - o - - 25YR SBCH ERODED

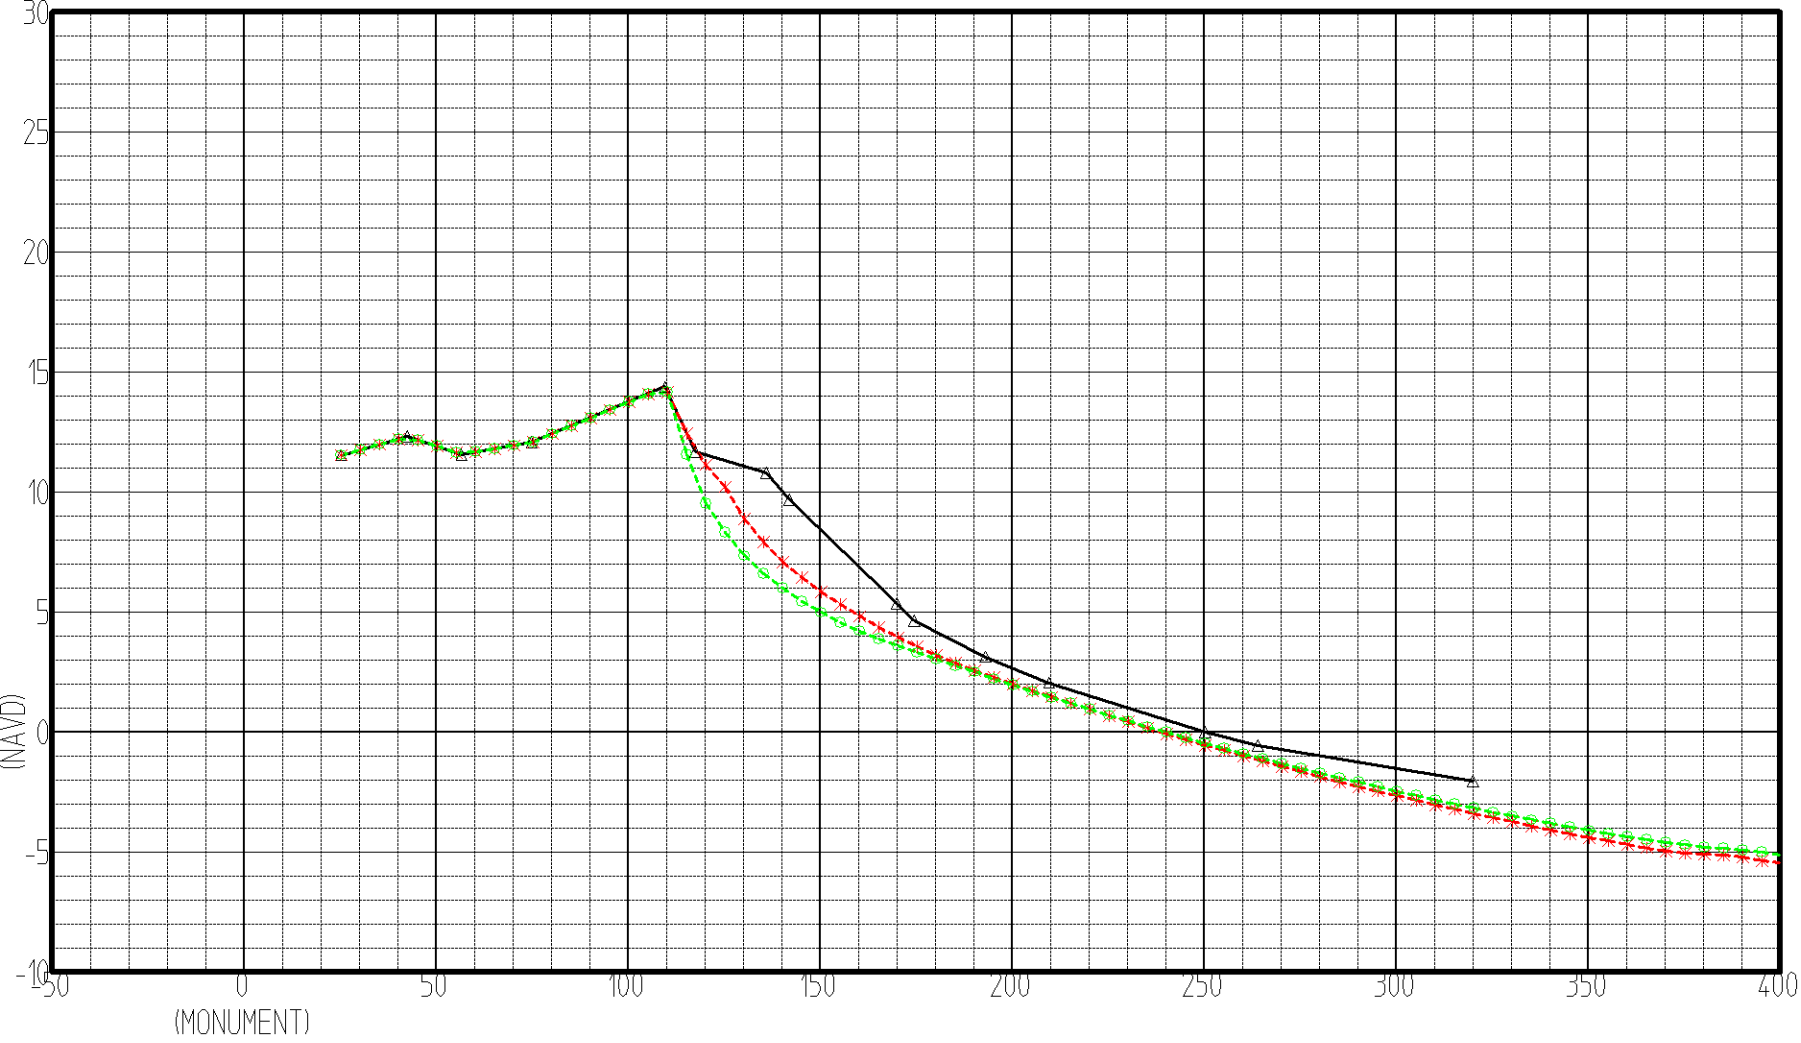
Range: R-46
 BEARING: 75.00
 1/2

BEACH PROFILE
 —△—△— ST. JOHNS 2007-2008 COMBI
 - - * - - 15YR SBCH ERODED
 - - o - - 25YR SBCH ERODED

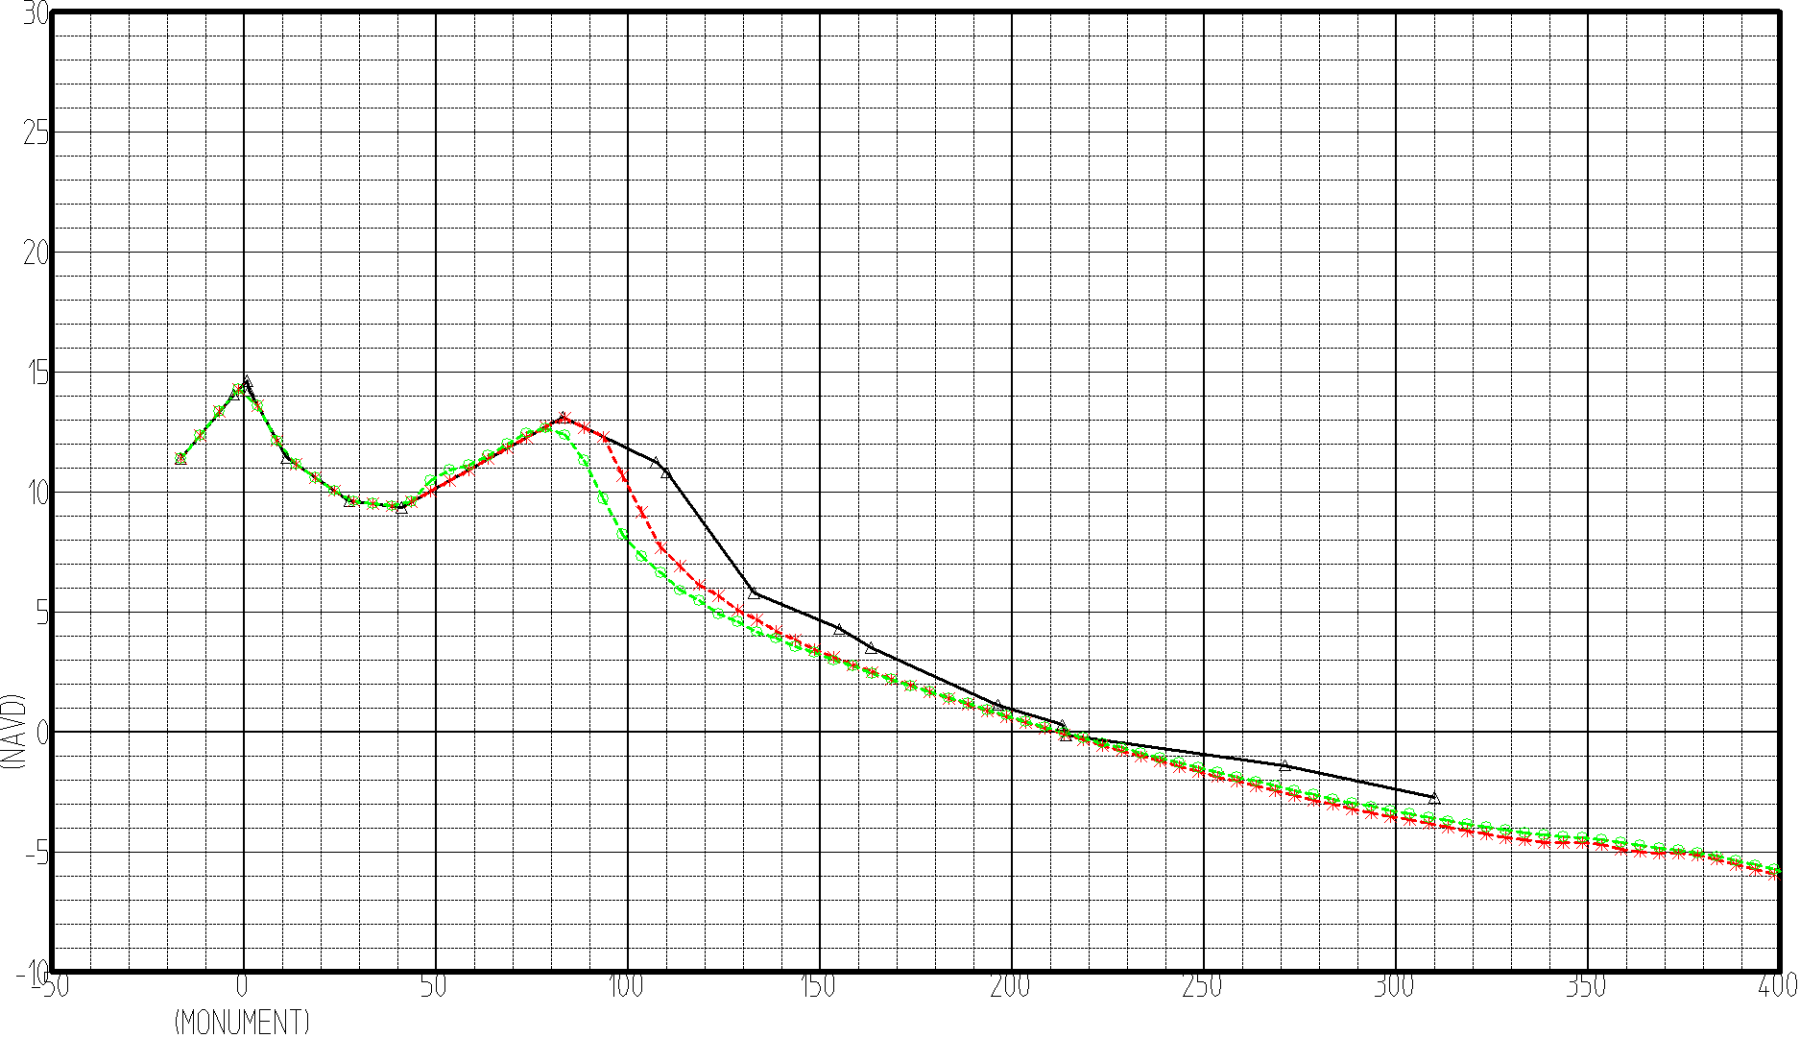
Range: T-48
 BEARING: 75.00
 1/2

BEACH PROFILE
 —△—△— ST. JOHNS 2007-2008 COMBI
 - - * - - * - - 15YR SBCH ERODED
 - - o - - o - - 25YR SBCH ERODED

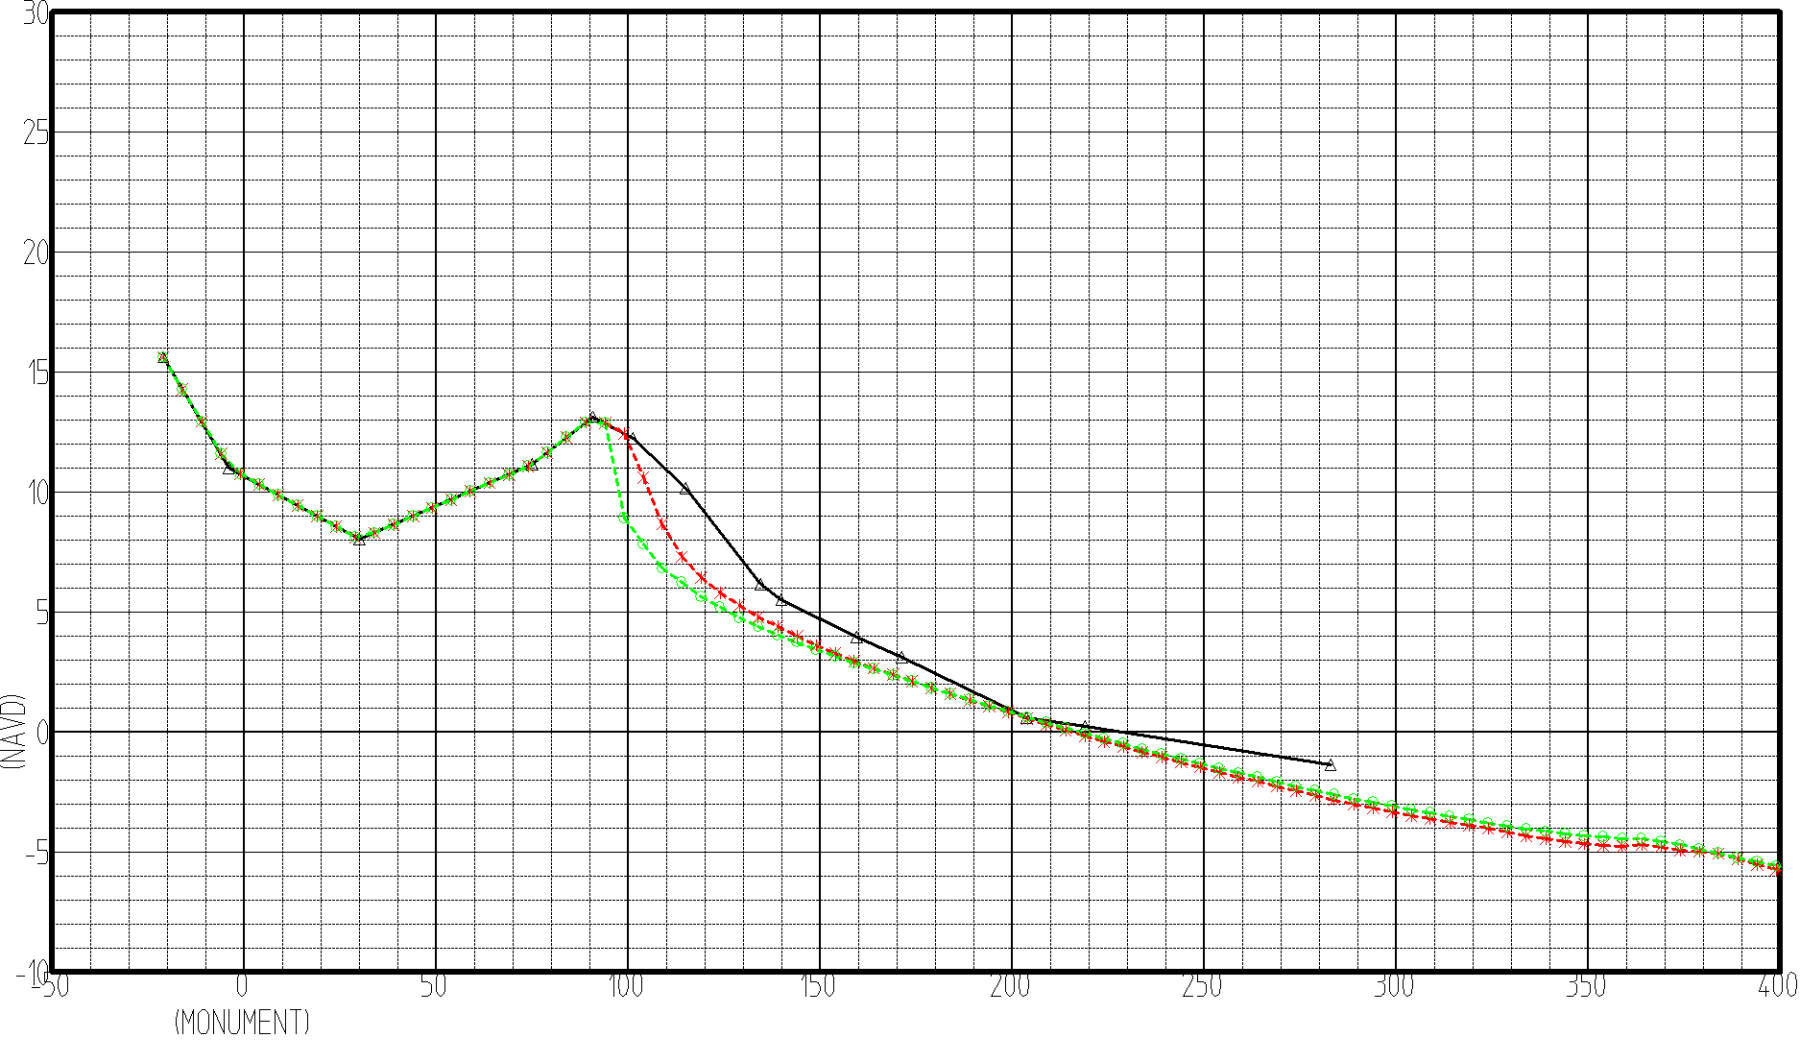
Range: R-49
 BEARING: 75.00
 1/2

BEACH PROFILE
 —△—△— ST. JOHNS 2007-2008 COMBI
 - - * - - 15YR SBEACH ERODED
 - - o - - 25YR SBCH ERODED

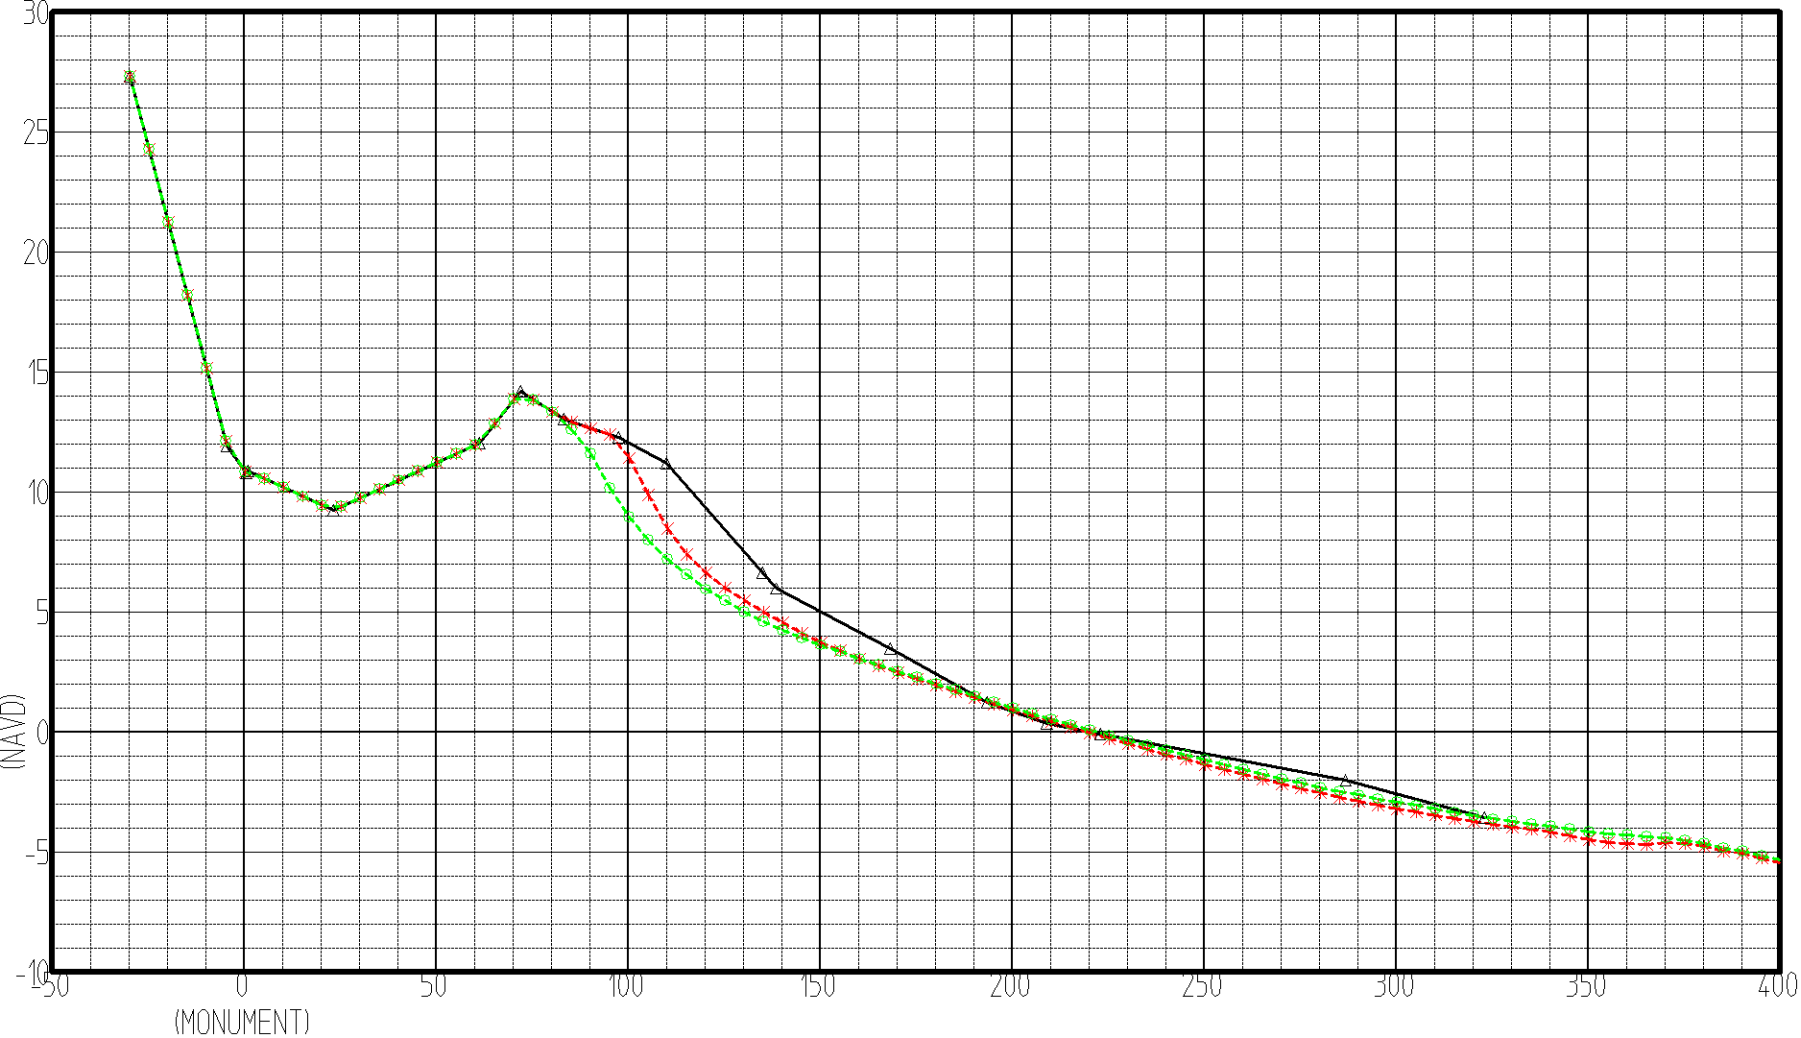
Range: R-50
 BEARING: 75.00
 1/2

BEACH PROFILE
 —△—△— ST. JOHNS 2007-2008 COMBI
 - - * - - * - - 15YR SBACH ERODED
 - - o - - o - - 25YR SBCH ERODED

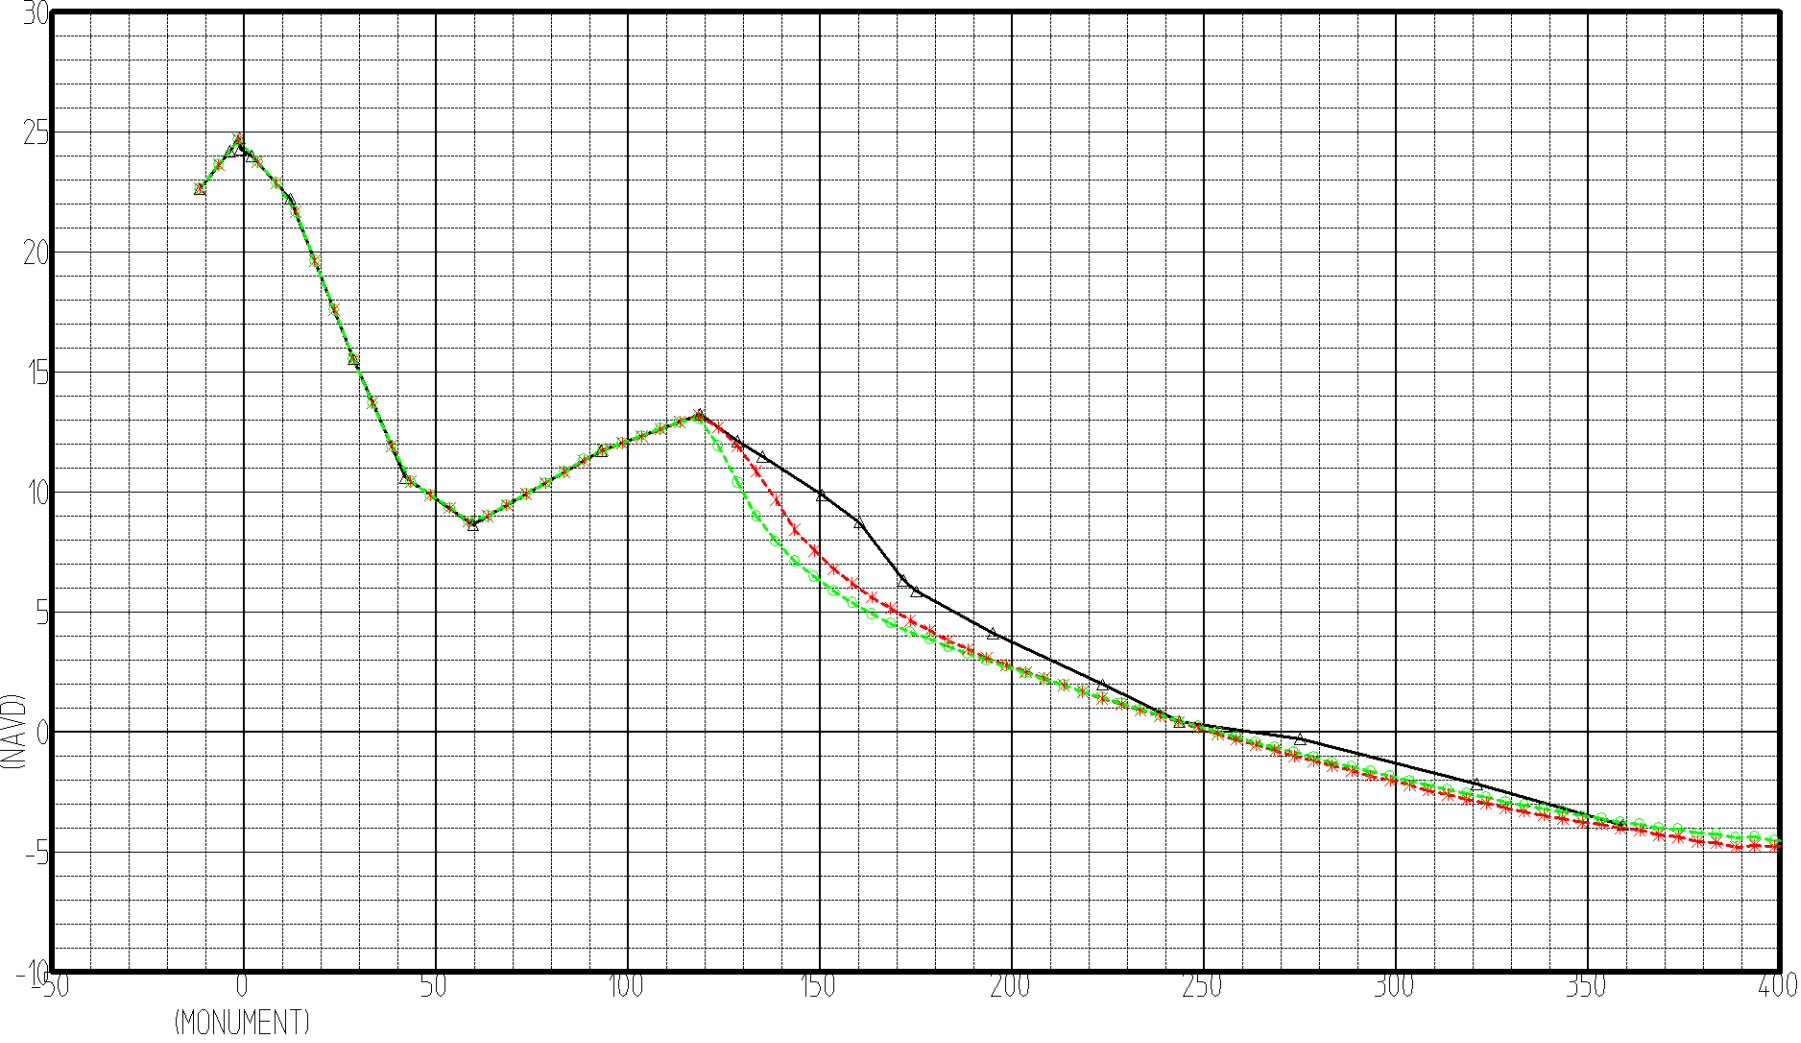
Range: T-51 1/2
 BEARING: 75.00

BEACH PROFILE
 —△—△— ST. JOHNS 2007-2008 COMBI
 - - * - - 15YR SBCH ERODED
 - - o - - 25YR SBCH ERODED
