Appendix VIII

SBEACH 15 and 25 yr. Storm Erosion Profiles

St. Johns County

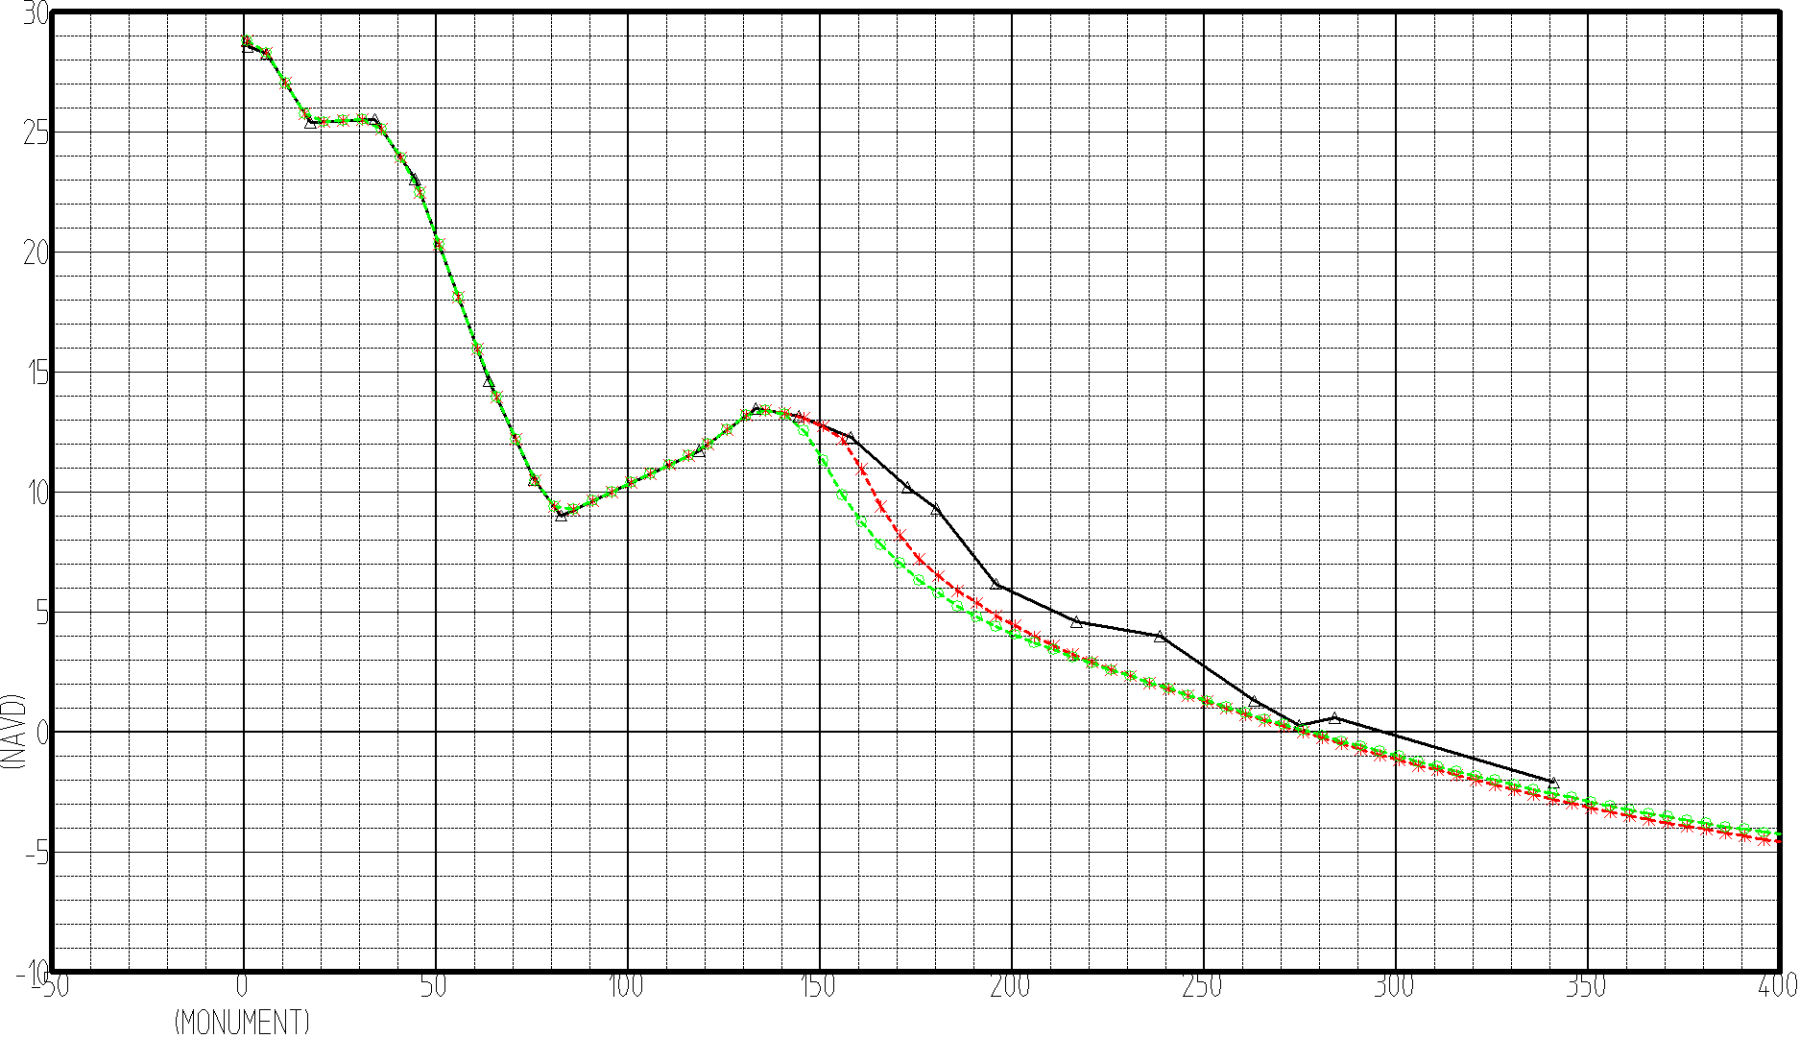
Range: R-53
 BEARING: 75.00
 1/2

BEACH PROFILE
 —△—△— ST. JOHNS 2007-2008 COMBI
 - - * - - 15YR SBEACH ERODED
 - - o - - 25YR SBCH ERODED

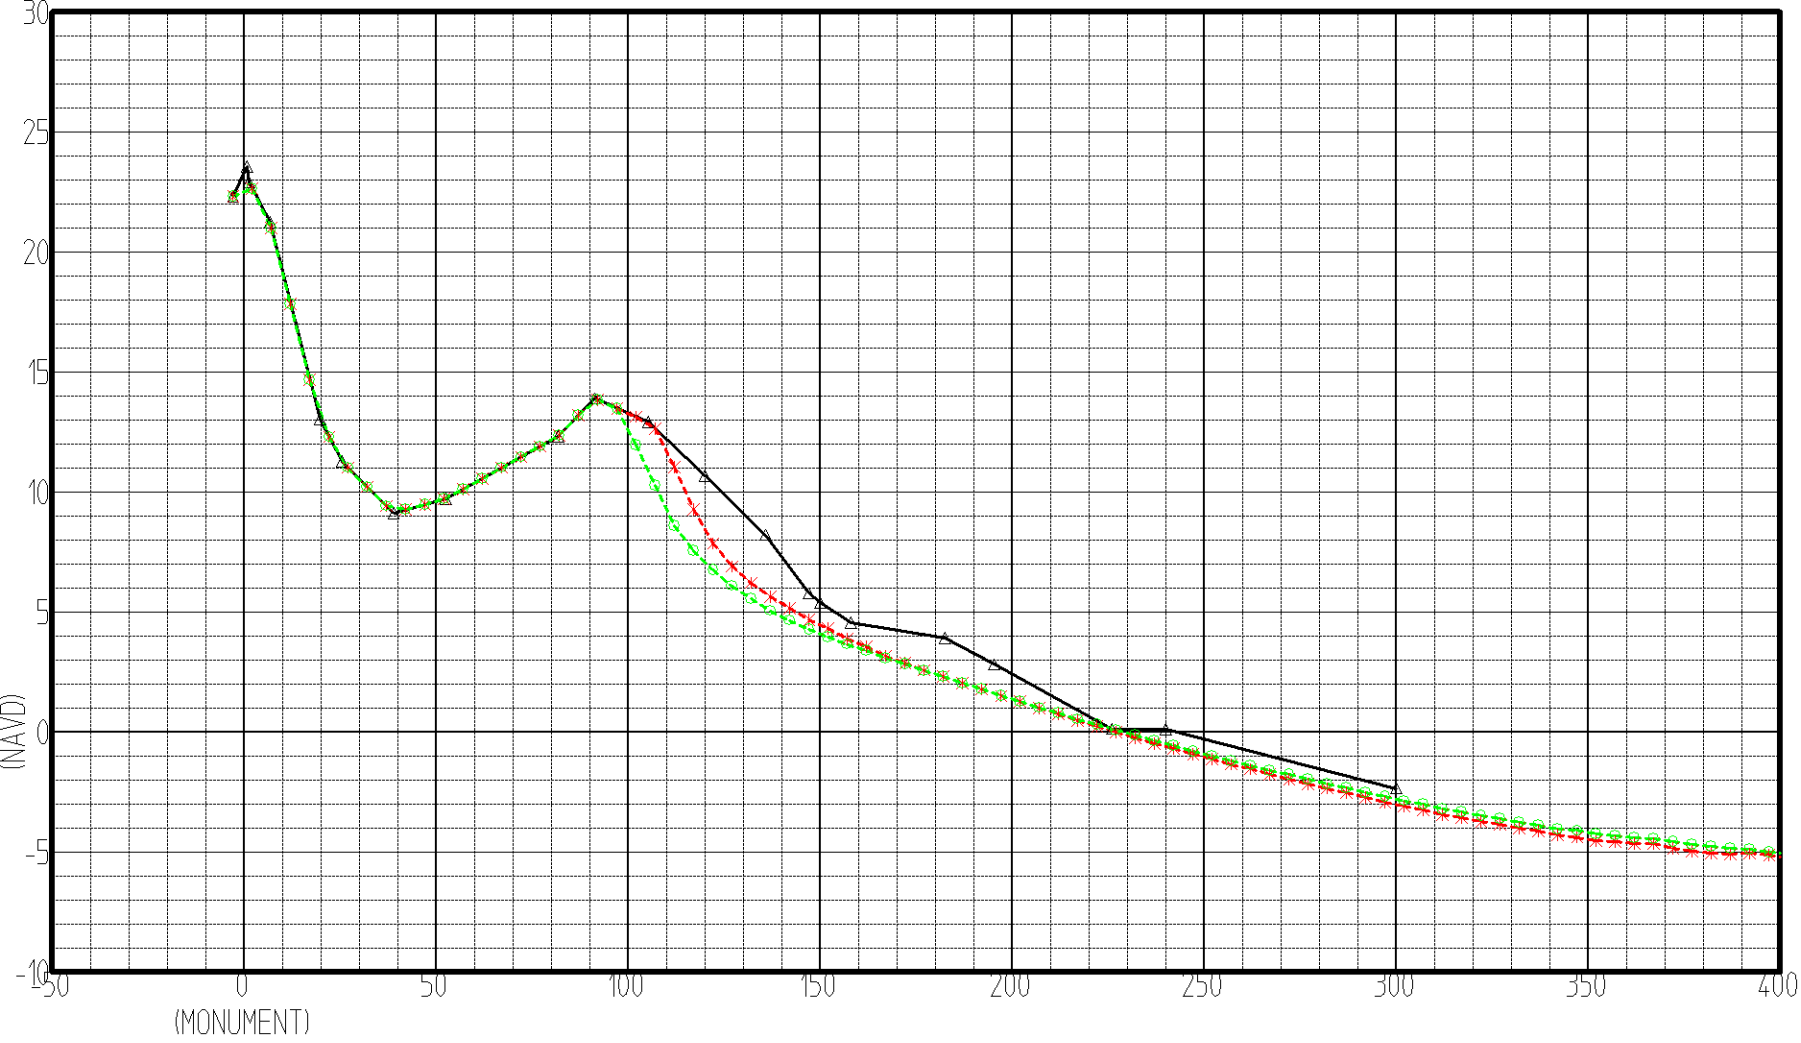
Range: R-54

BEACH PROFILE

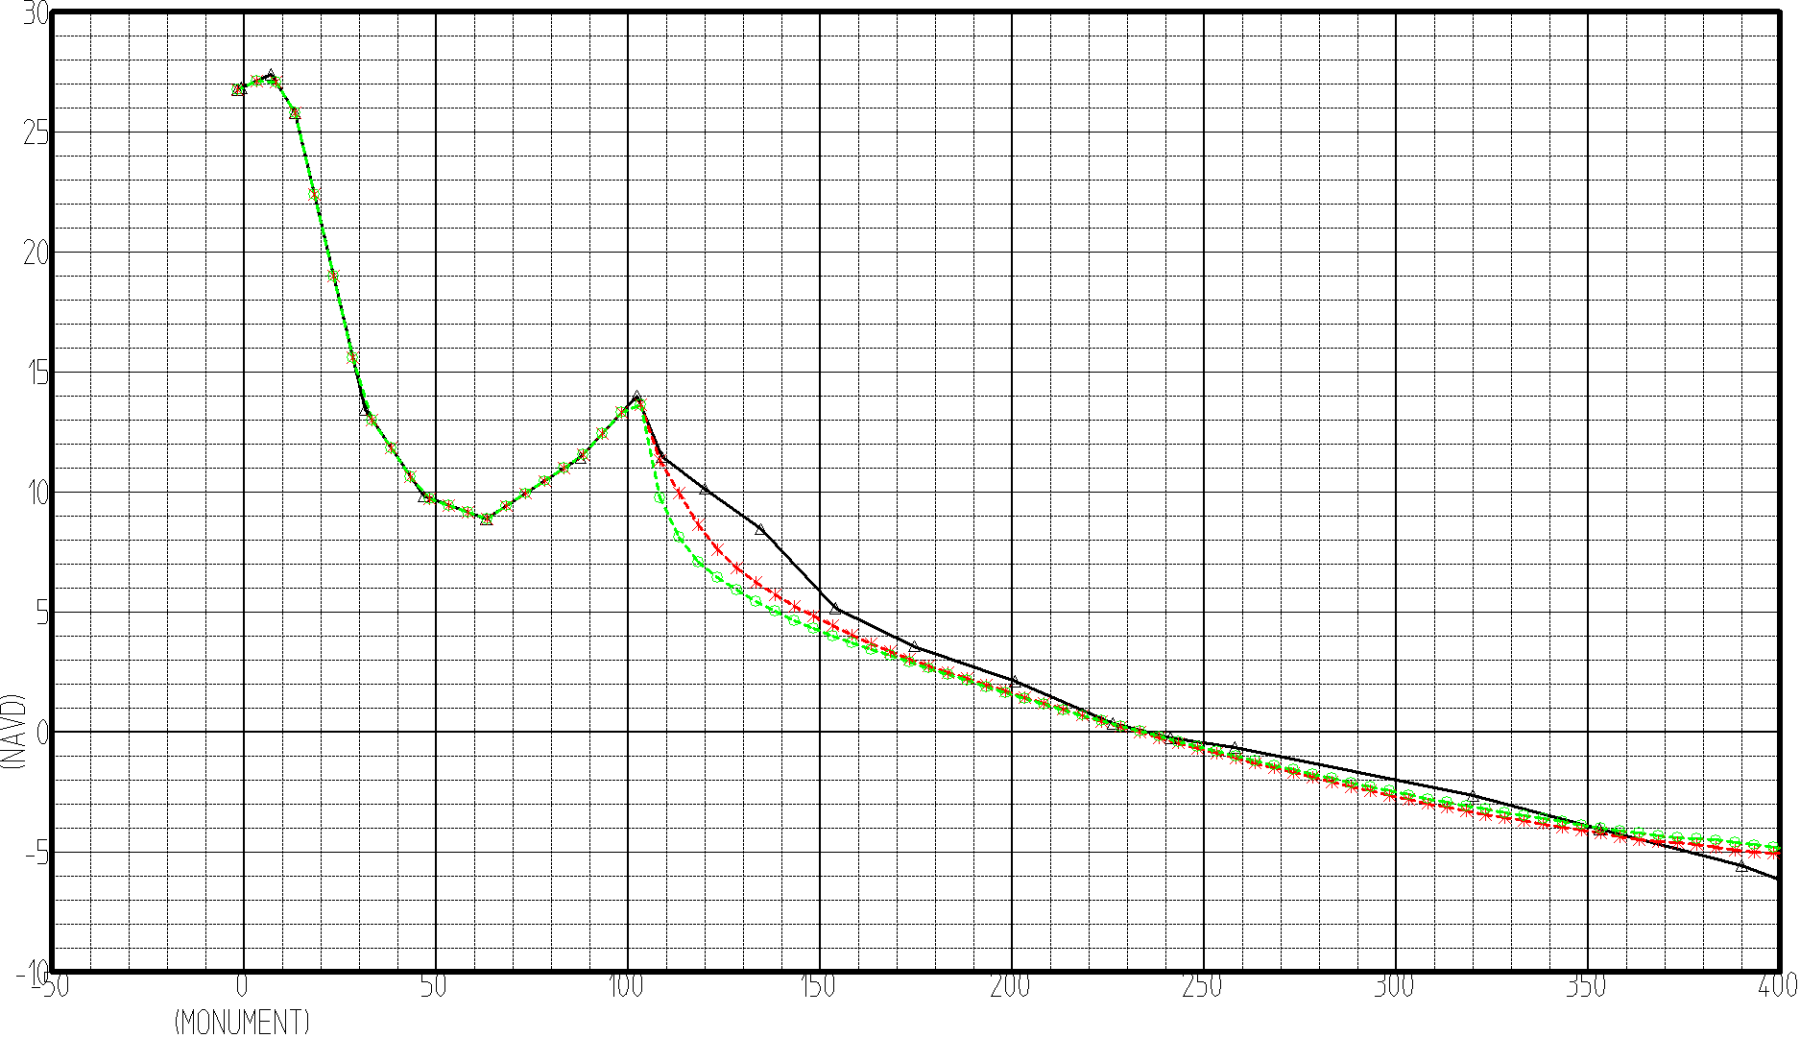
Range: R-55

BEACH PROFILE

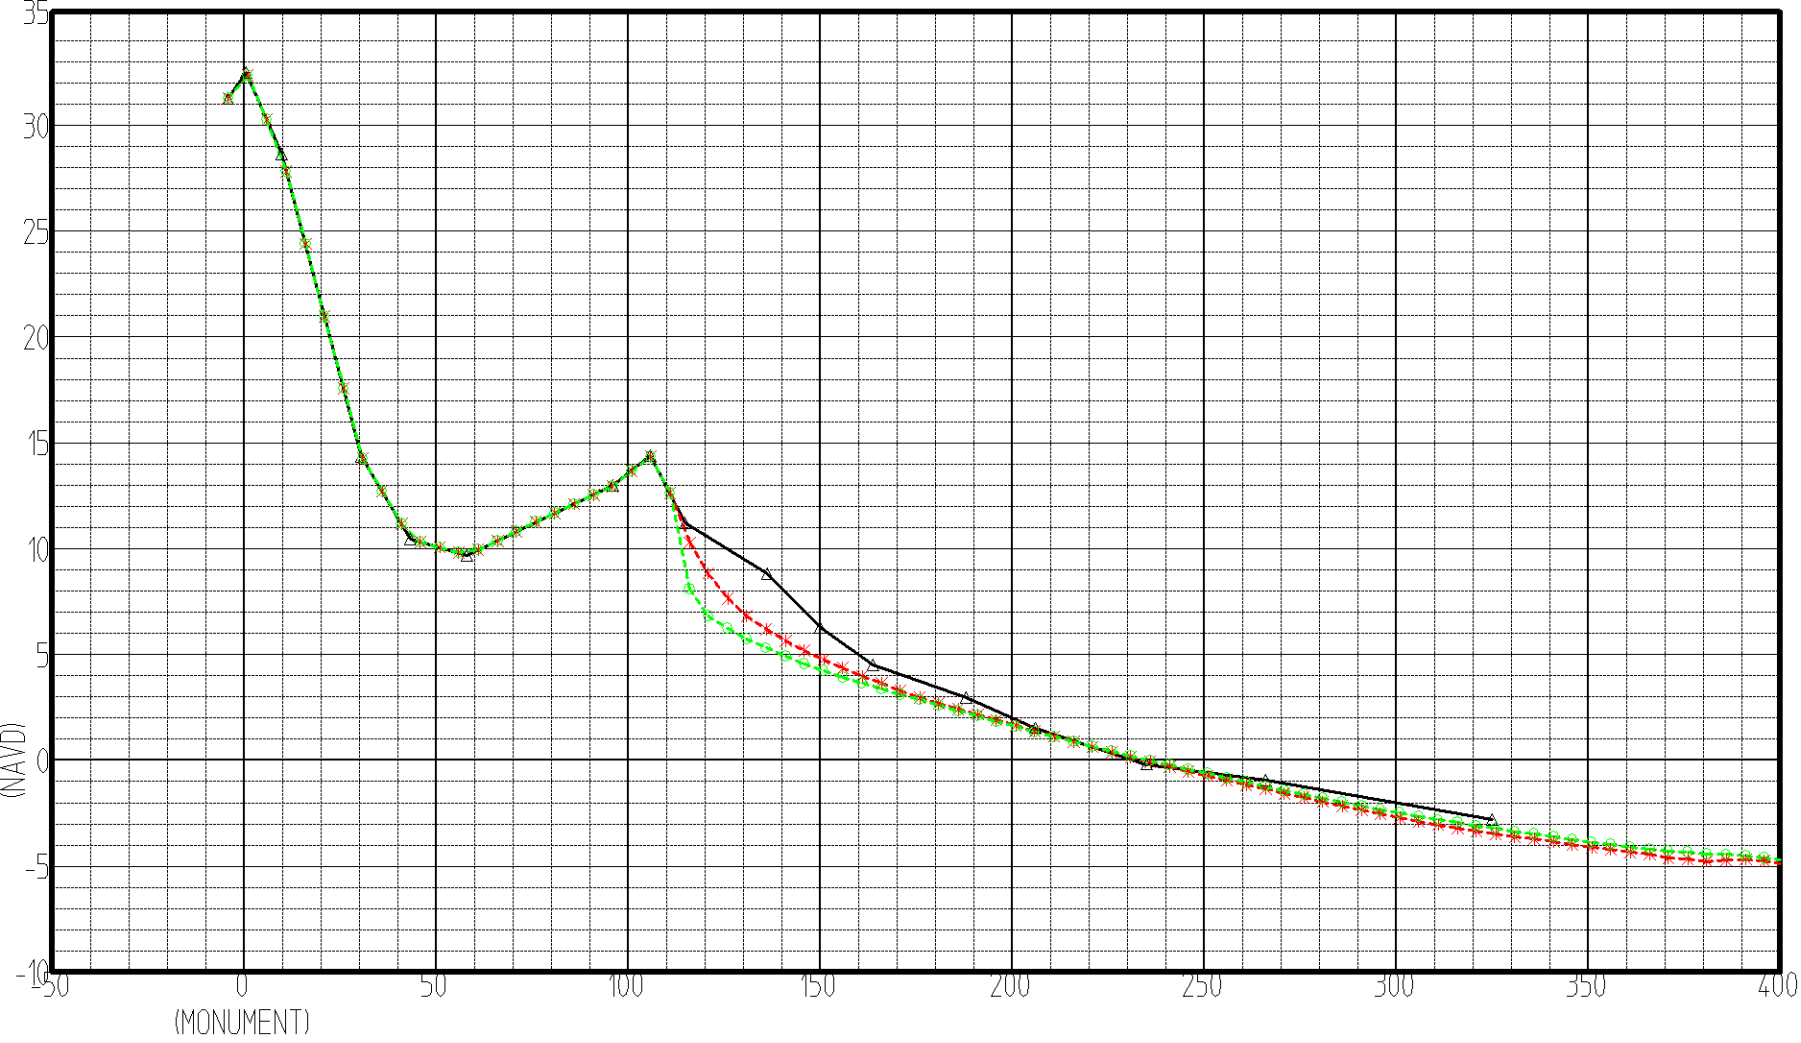
Range: R-56
 BEARING: 75.00
 1/2

BEACH PROFILE
 —△—△— ST. JOHNS 2007-2008 COMBI
 - - * - - 15YR SBCH ERODED
 - - o - - 25YR SBCH ERODED

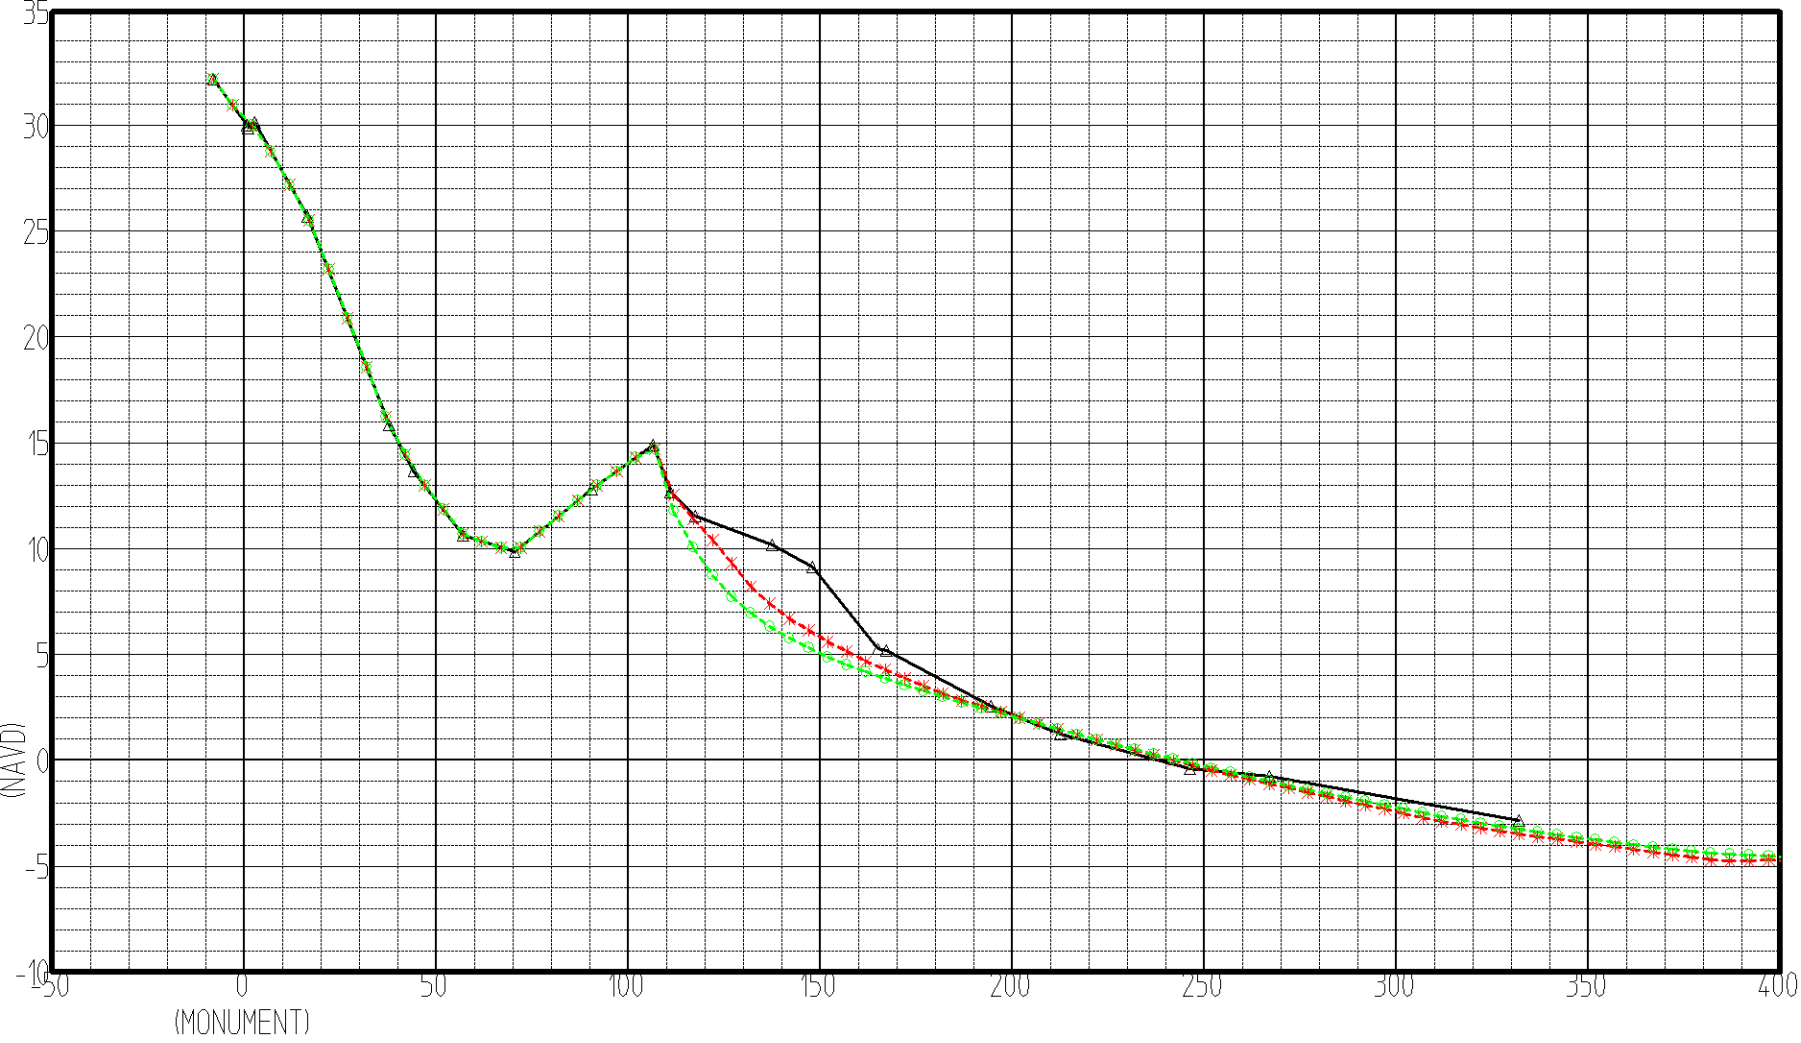
Range: R-58
 BEARING: 75.00
 1/2

BEACH PROFILE
 —△—△— ST. JOHNS 2007-2008 COMBI
 - - * - - * - - 15YR SBCH ERODED
 - - o - - o - - 25YR SBCH ERODED

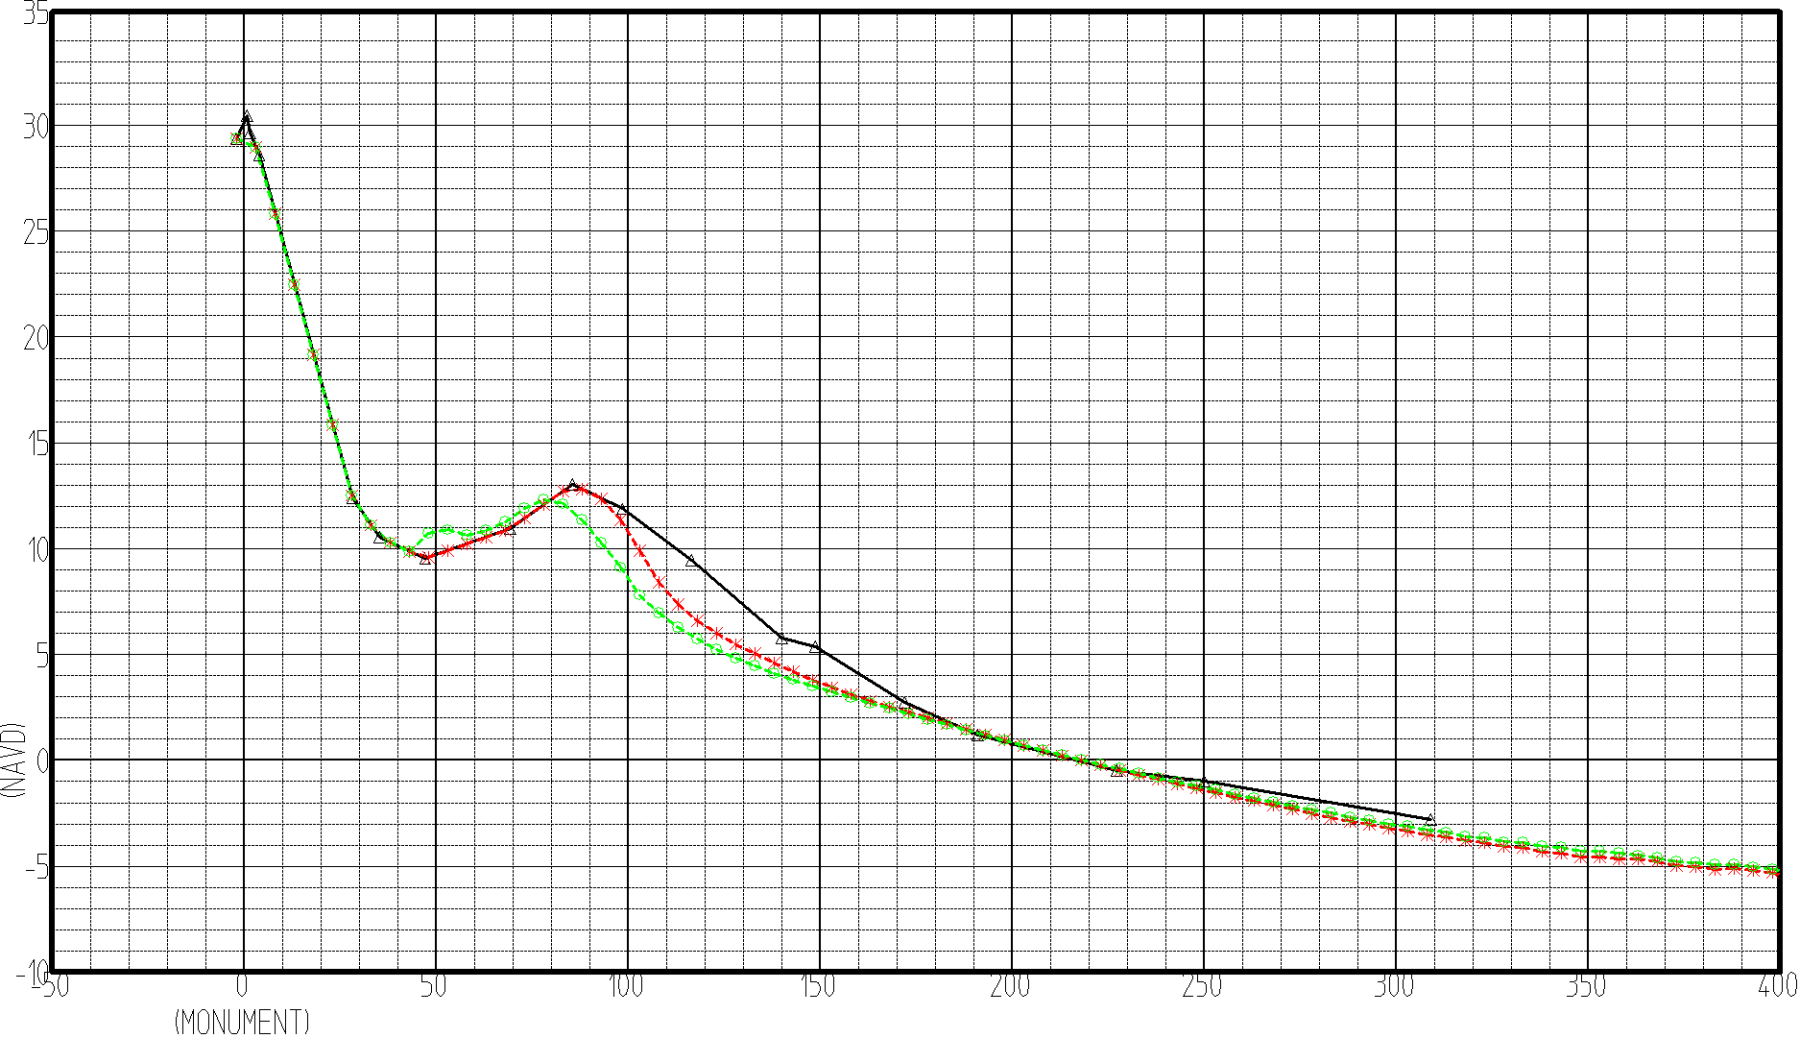
Range: R-59

BEACH PROFILE

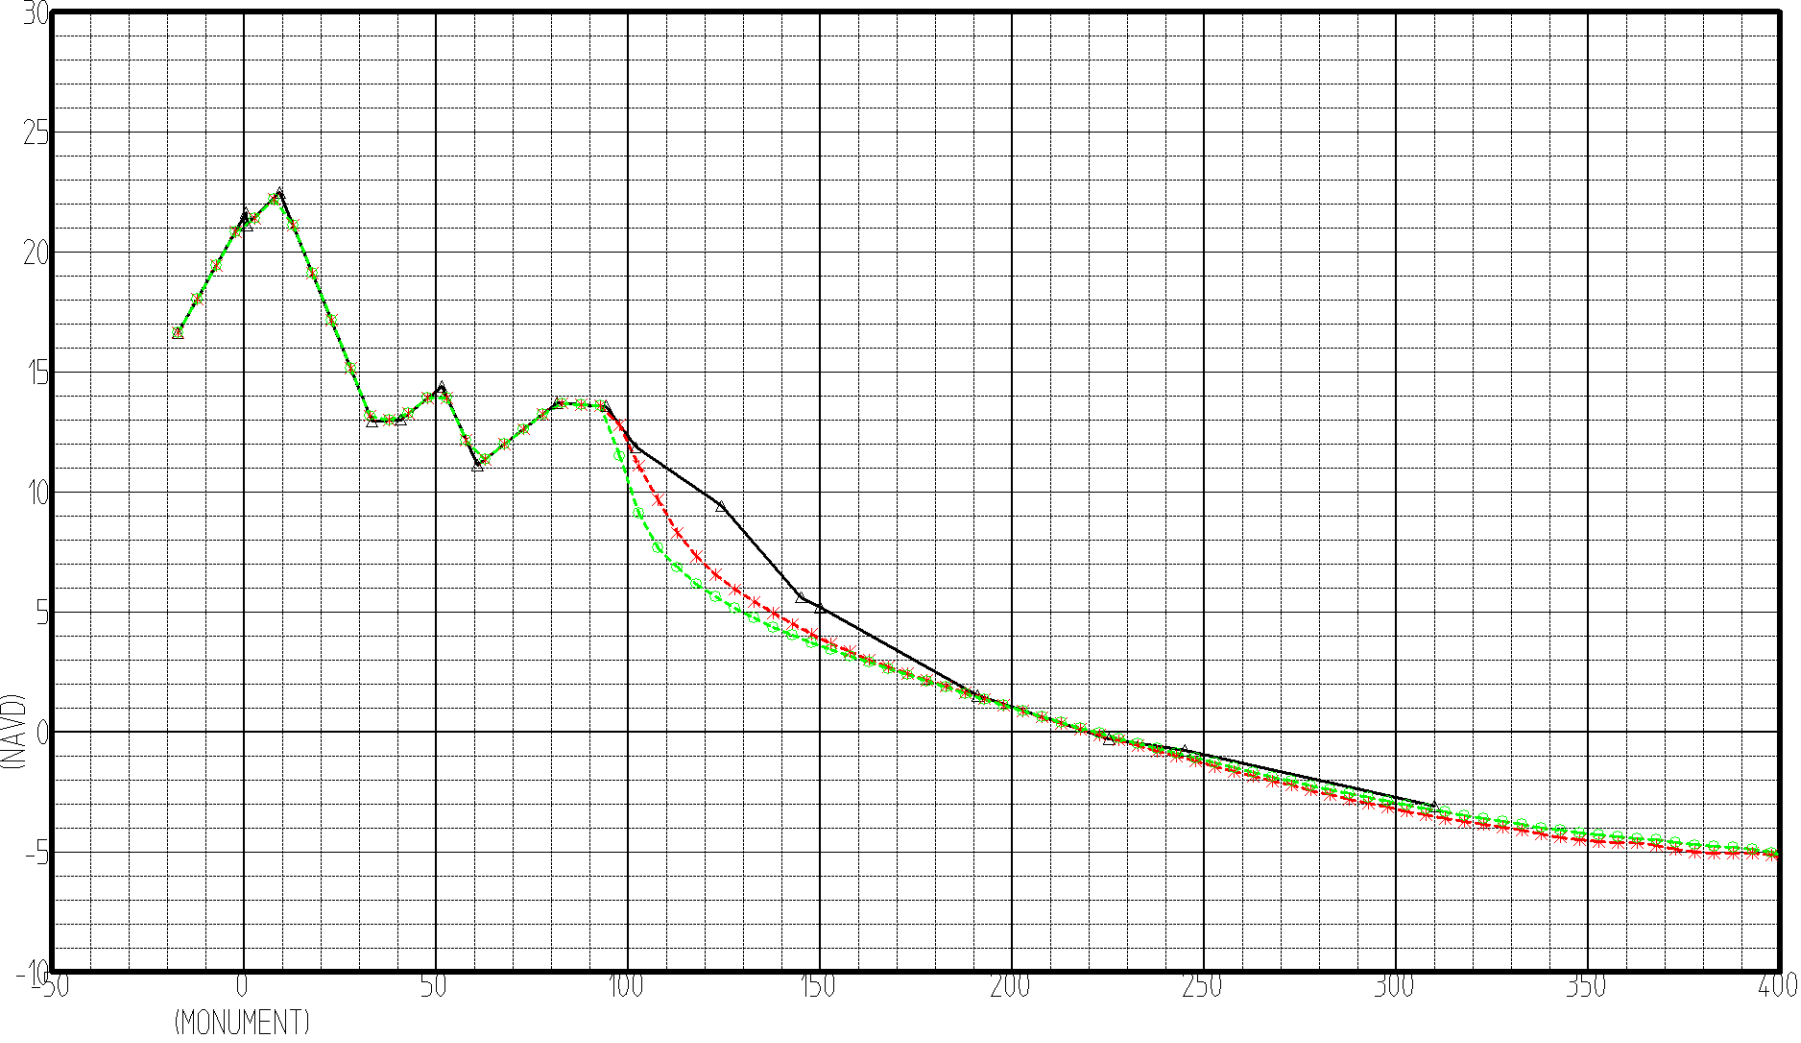
Range: R-60
 BEARING: 75.00
 1/2

BEACH PROFILE
 —△—△— ST. JOHNS 2007-2008 COMBI
 - - * - - 15YR SBEACH ERODED
 - - o - - 25YR SBCH ERODED

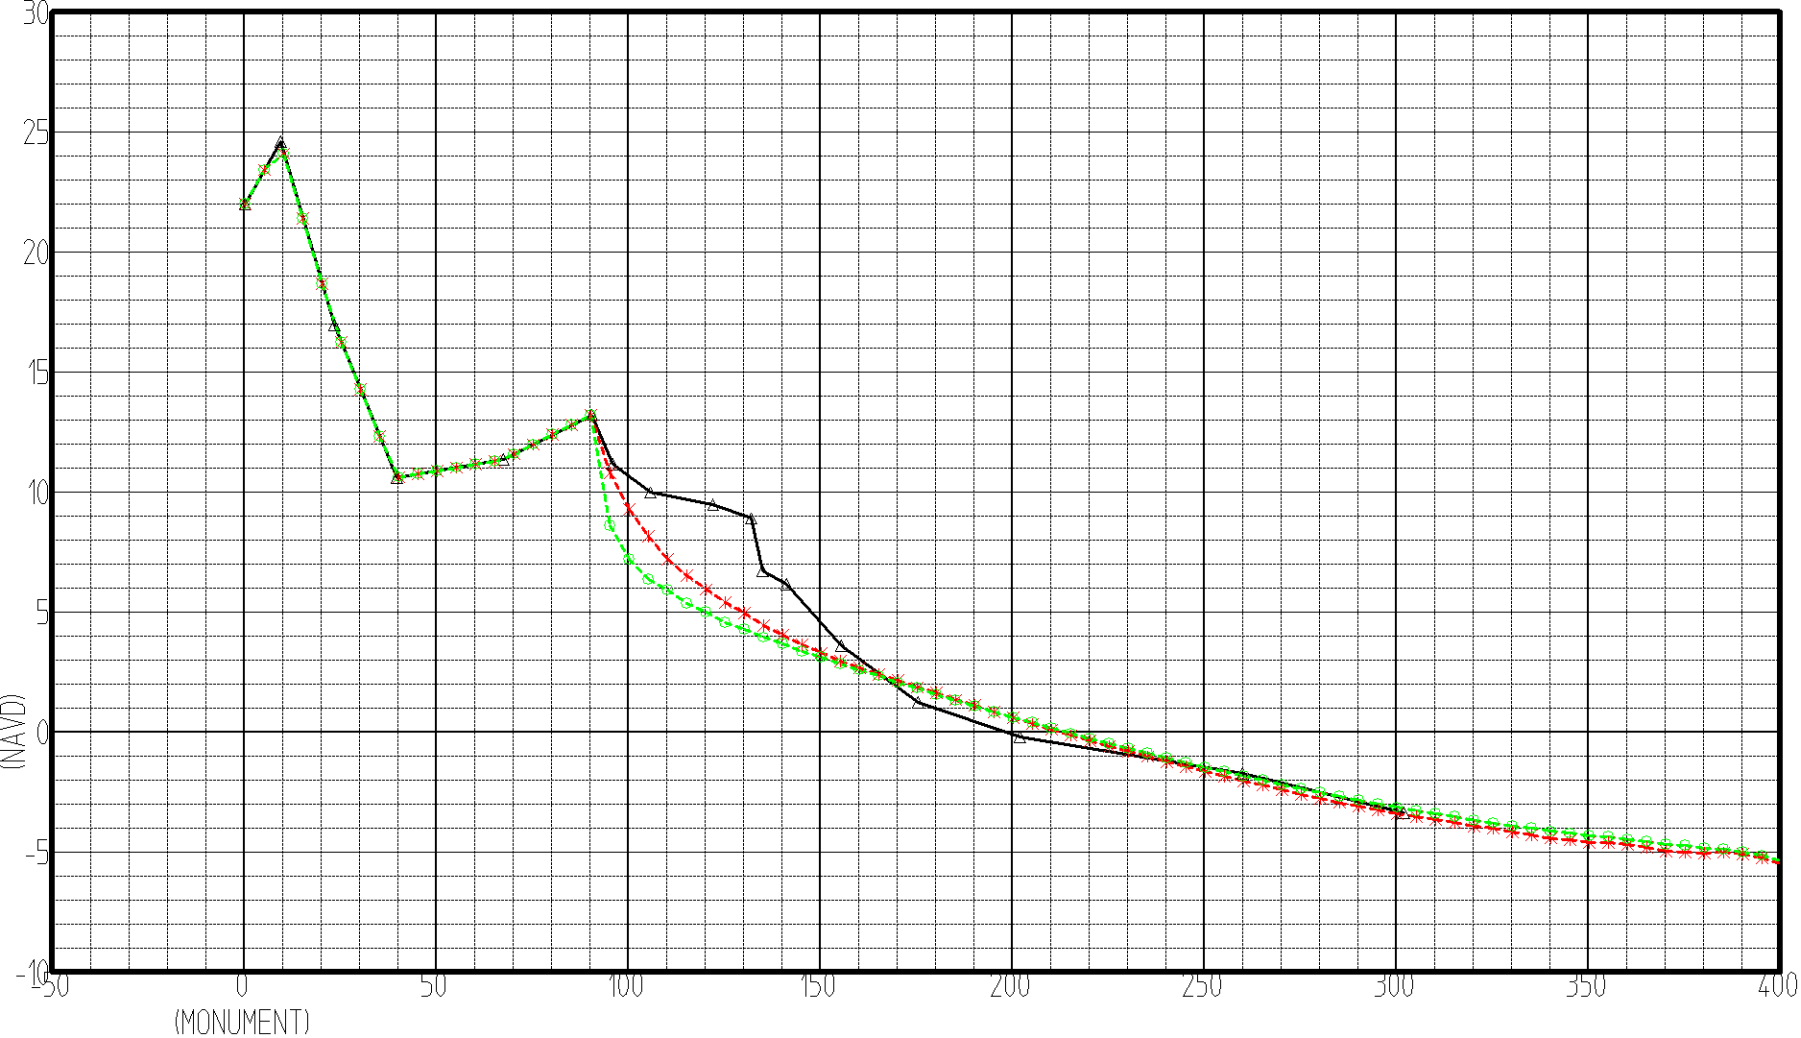
Range: R-62
 BEARING: 75.00
 1/2

BEACH PROFILE
 —△—△— ST. JOHNS 2007-2008 COMBI
 - - * - - 15YR SBCH ERODED
 - - o - - 25YR SBCH ERODED

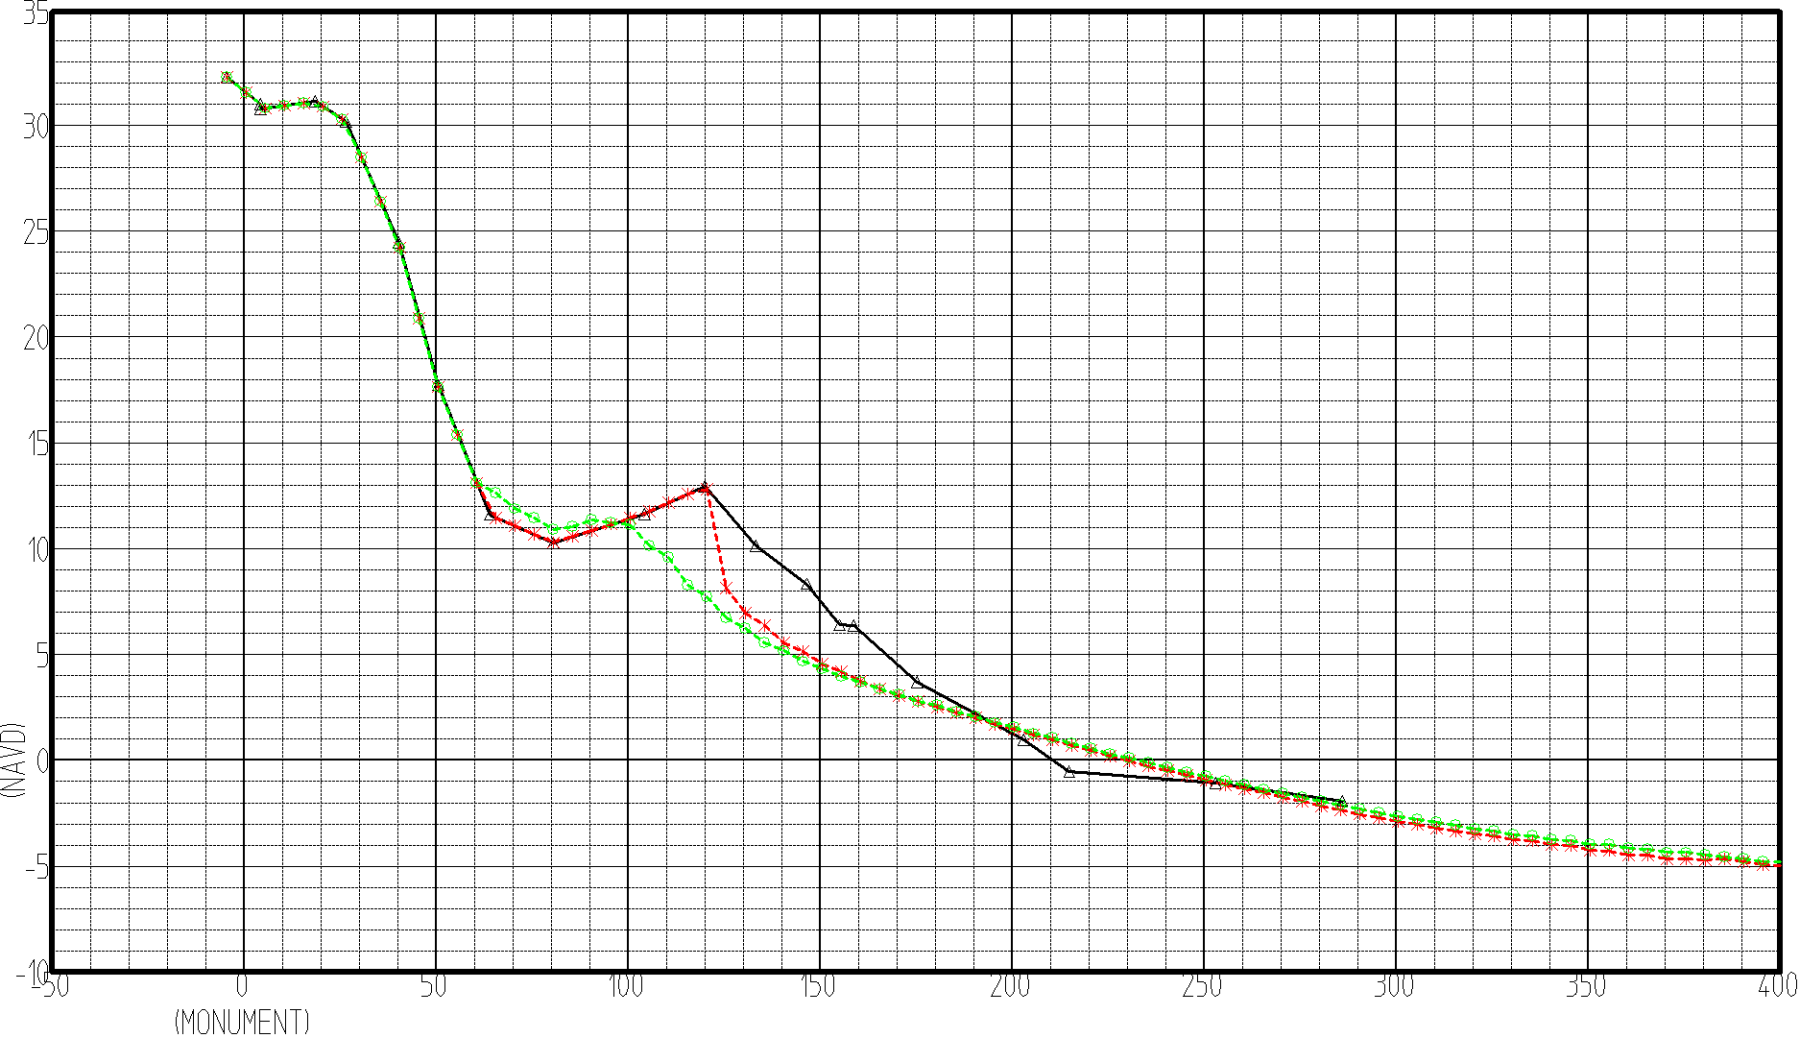
Range: R-64

BEACH PROFILE

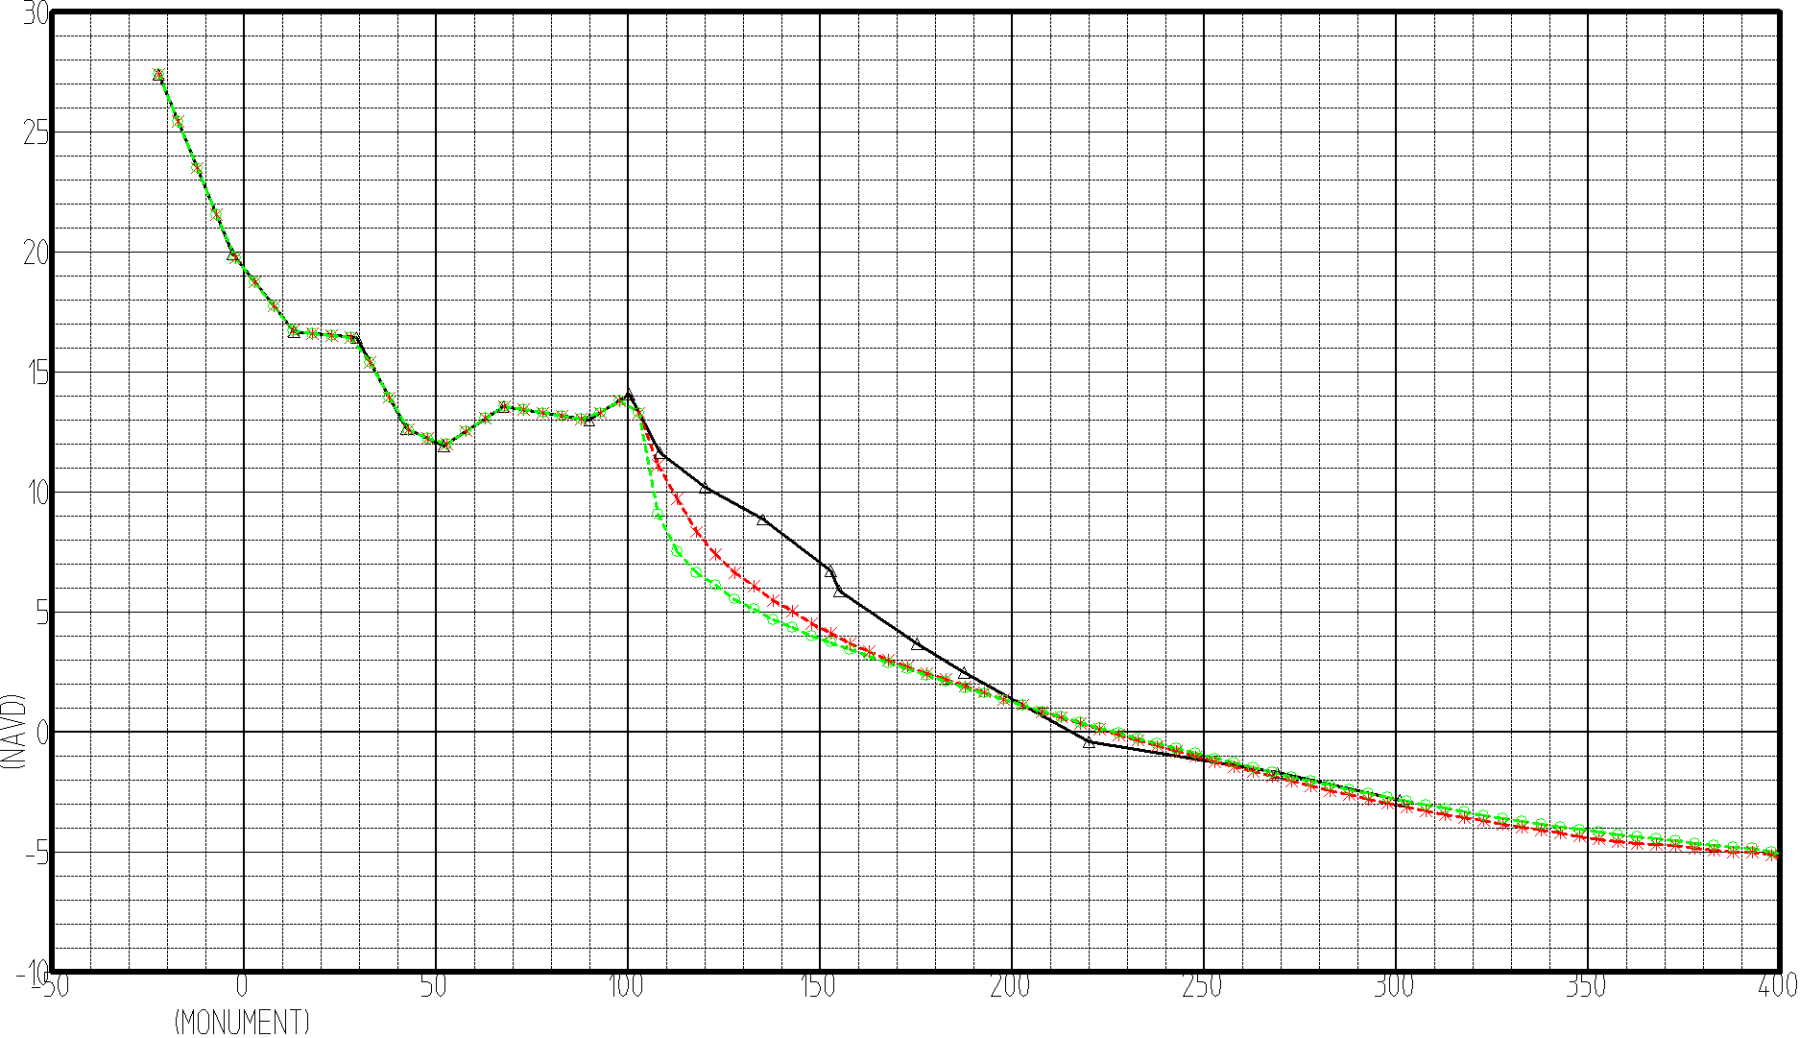
Range: R-65
 BEARING: 75.00
 1/2

BEACH PROFILE
 —△—△— ST. JOHNS 2007-2008 COMBI
 - - * - - - 15YR SBEACH ERODED
 - - o - - - 25YR SBCH ERODED

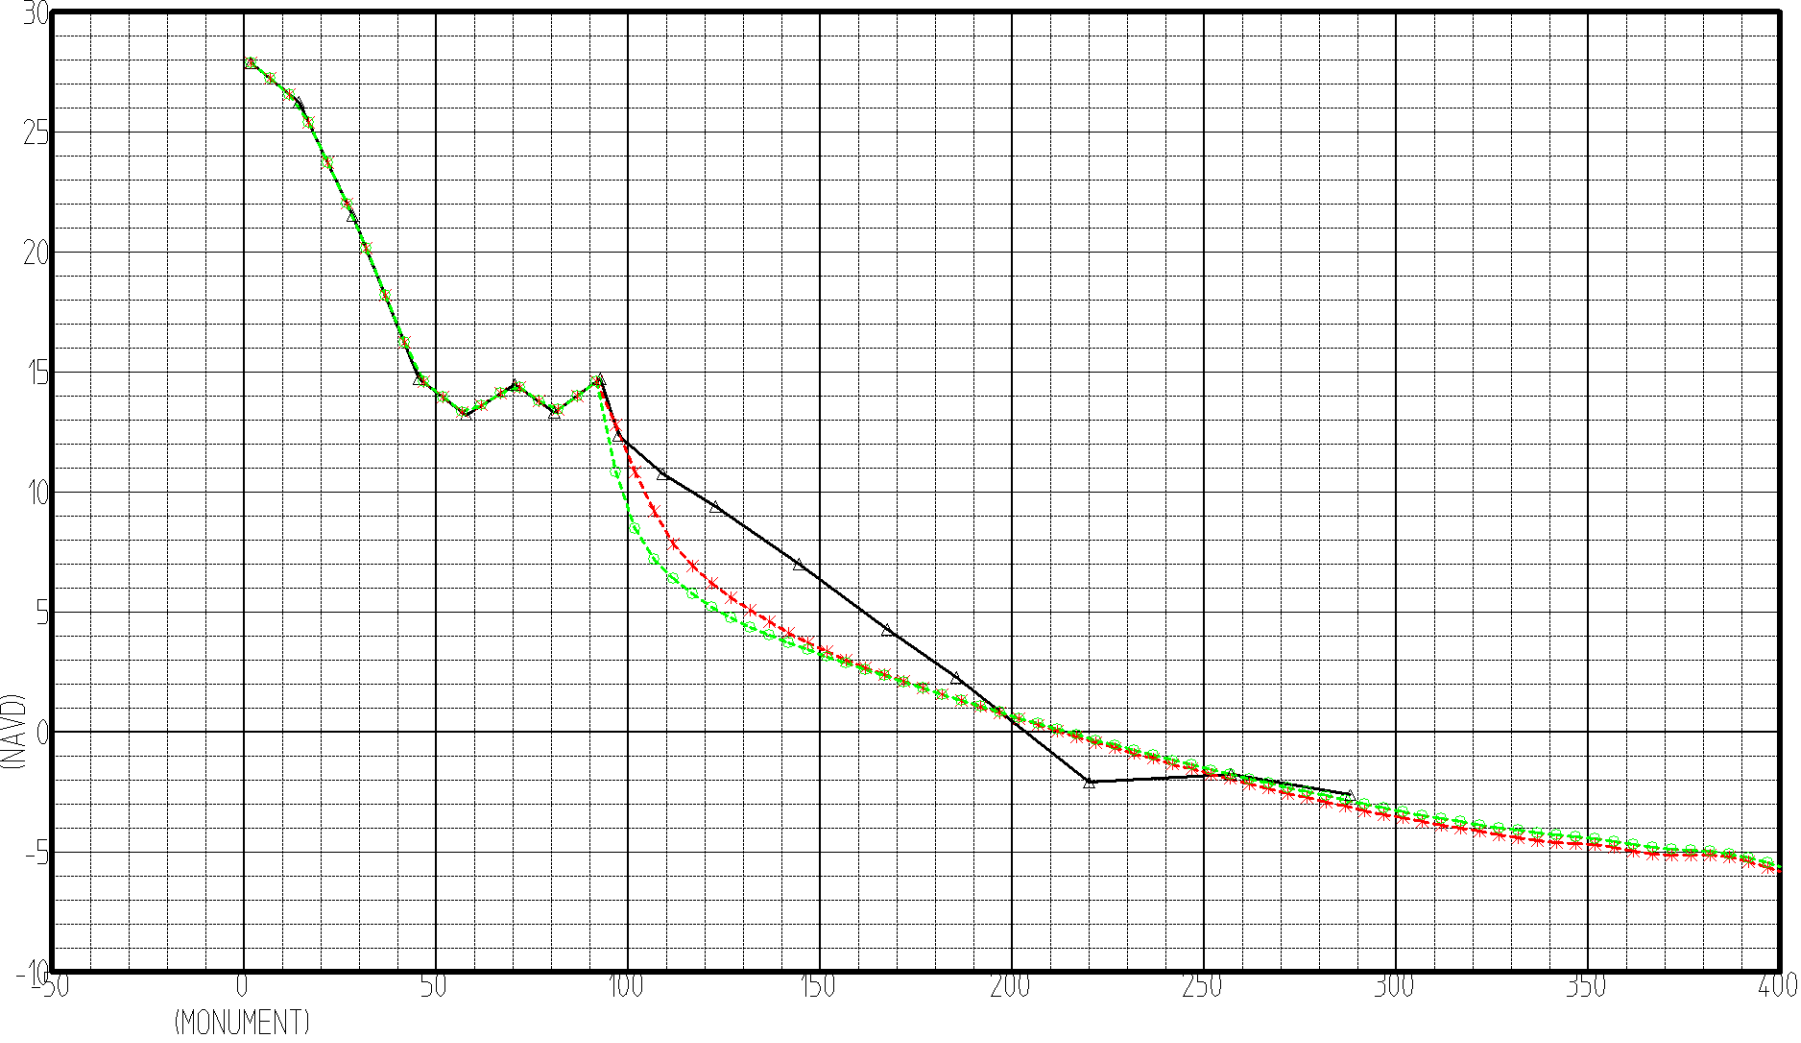
Range: R-67
 BEARING: 75.00
 1/2

BEACH PROFILE
 —△—△— ST. JOHNS 2007-2008 COMBI
 - - * - - 15YR SBEACH ERODED
 - - o - - 25YR SBCH ERODED

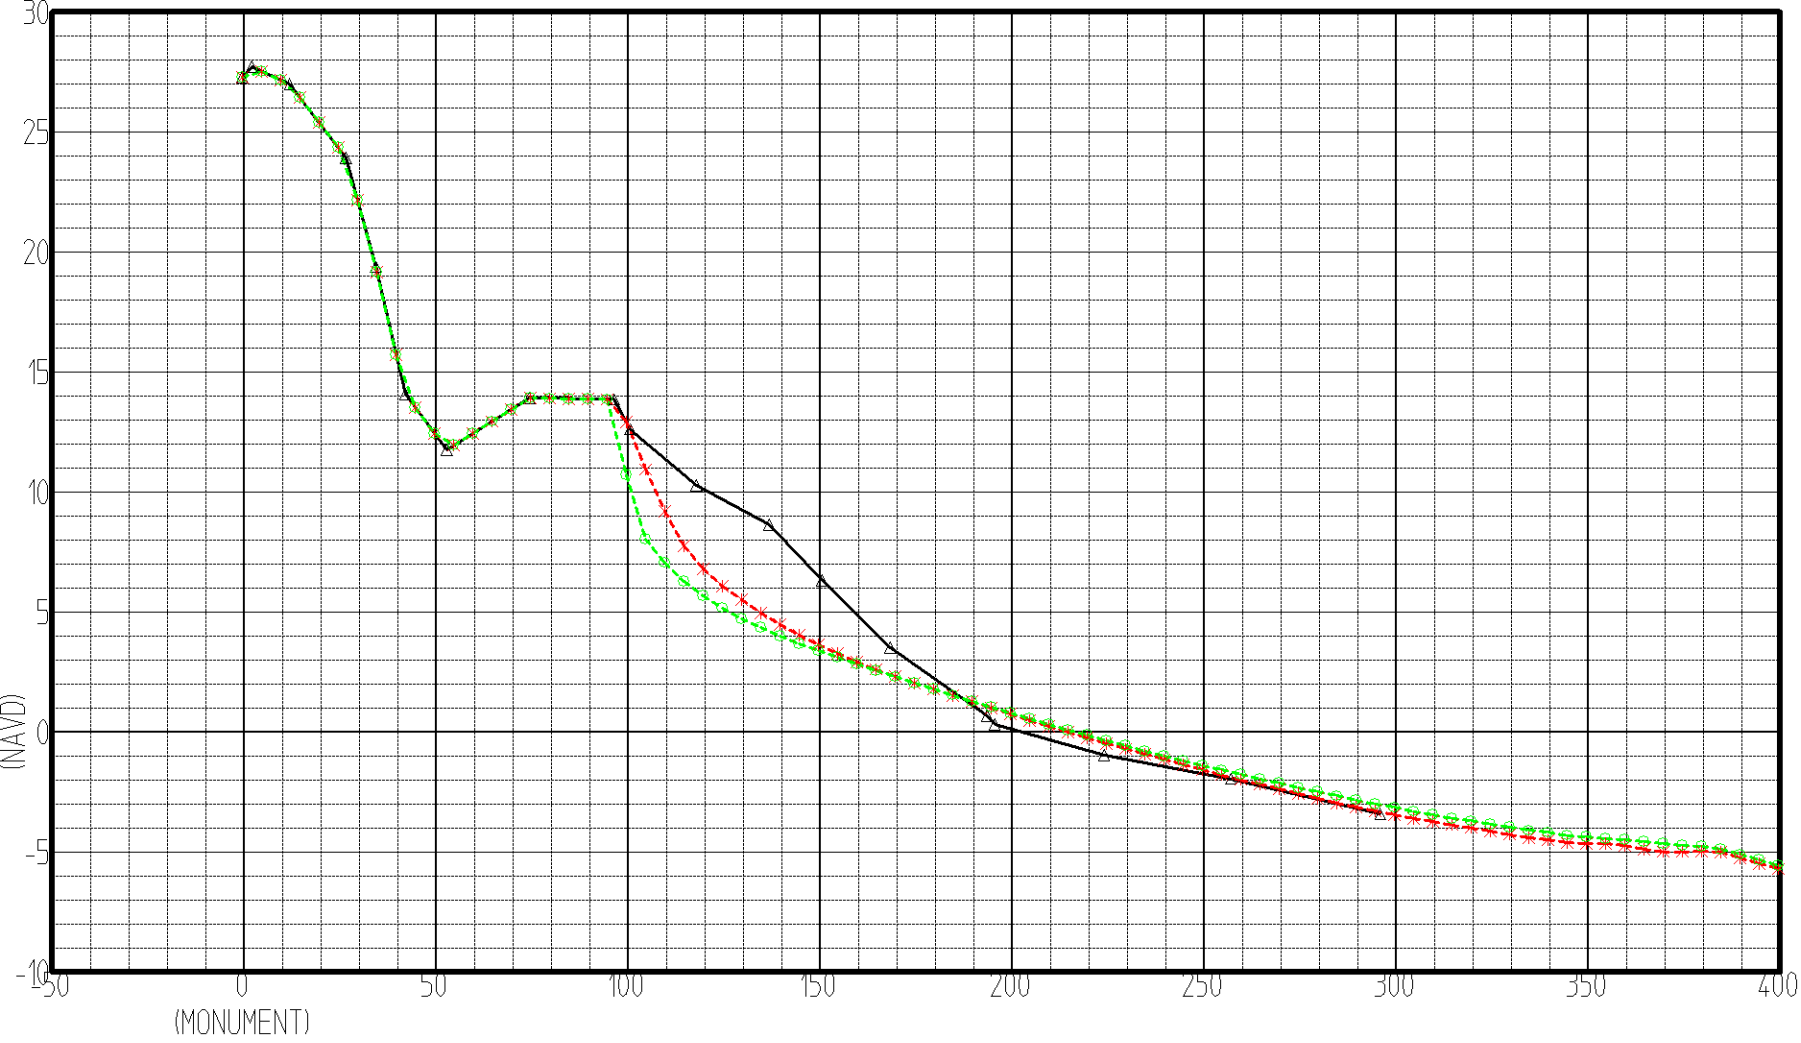
Range: R-68
 BEARING: 75.00
 1/2

BEACH PROFILE
 —△—△— ST. JOHNS 2007-2008 COMBI
 - - * - - 15YR SBCH ERODED
 - - o - - 25YR SBCH ERODED
