Appendix VIII

SBEACH 15 and 25 yr. Storm Erosion Profiles

St. Johns County

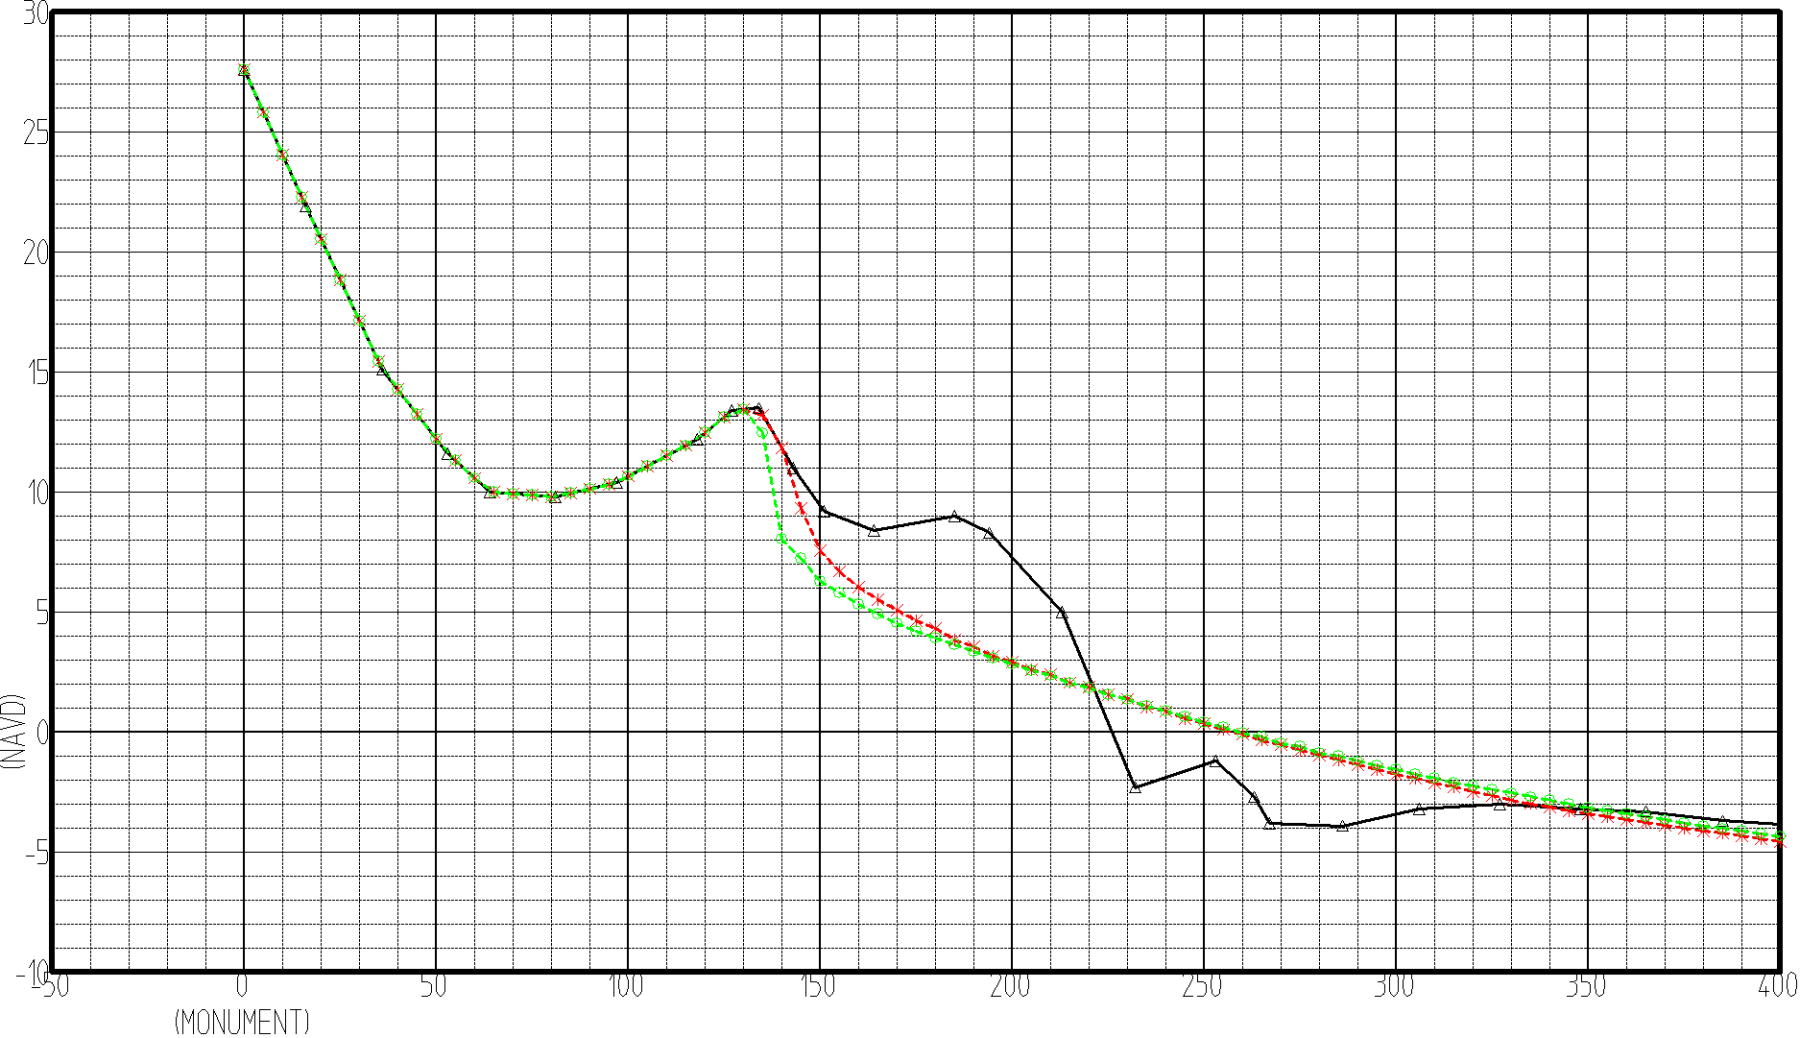
Range: T-70 1/2
 BEARING: 75.00

BEACH PROFILE
 —△—△— ST. JOHNS 2007-2008 COMBI
 - - * - - 15YR SBCH ERODED
 - - o - - 25YR SBCH ERODED

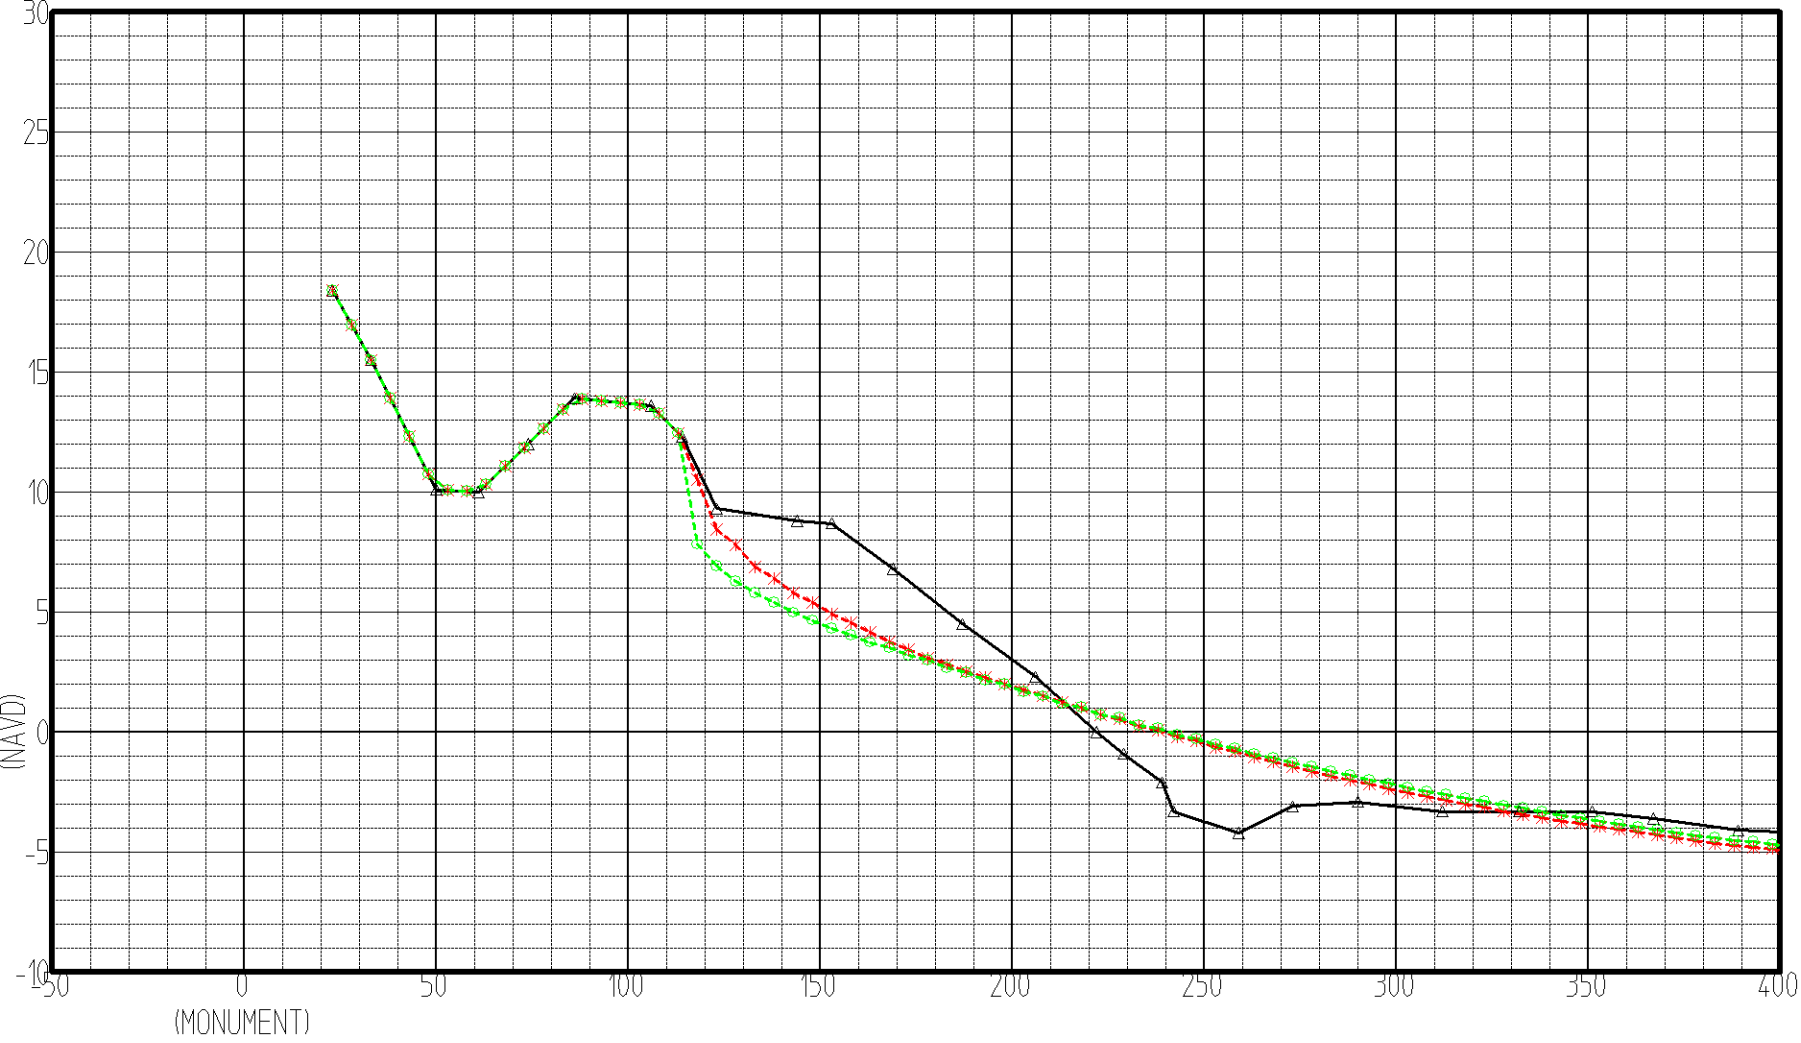
Range: R-72

BEACH PROFILE

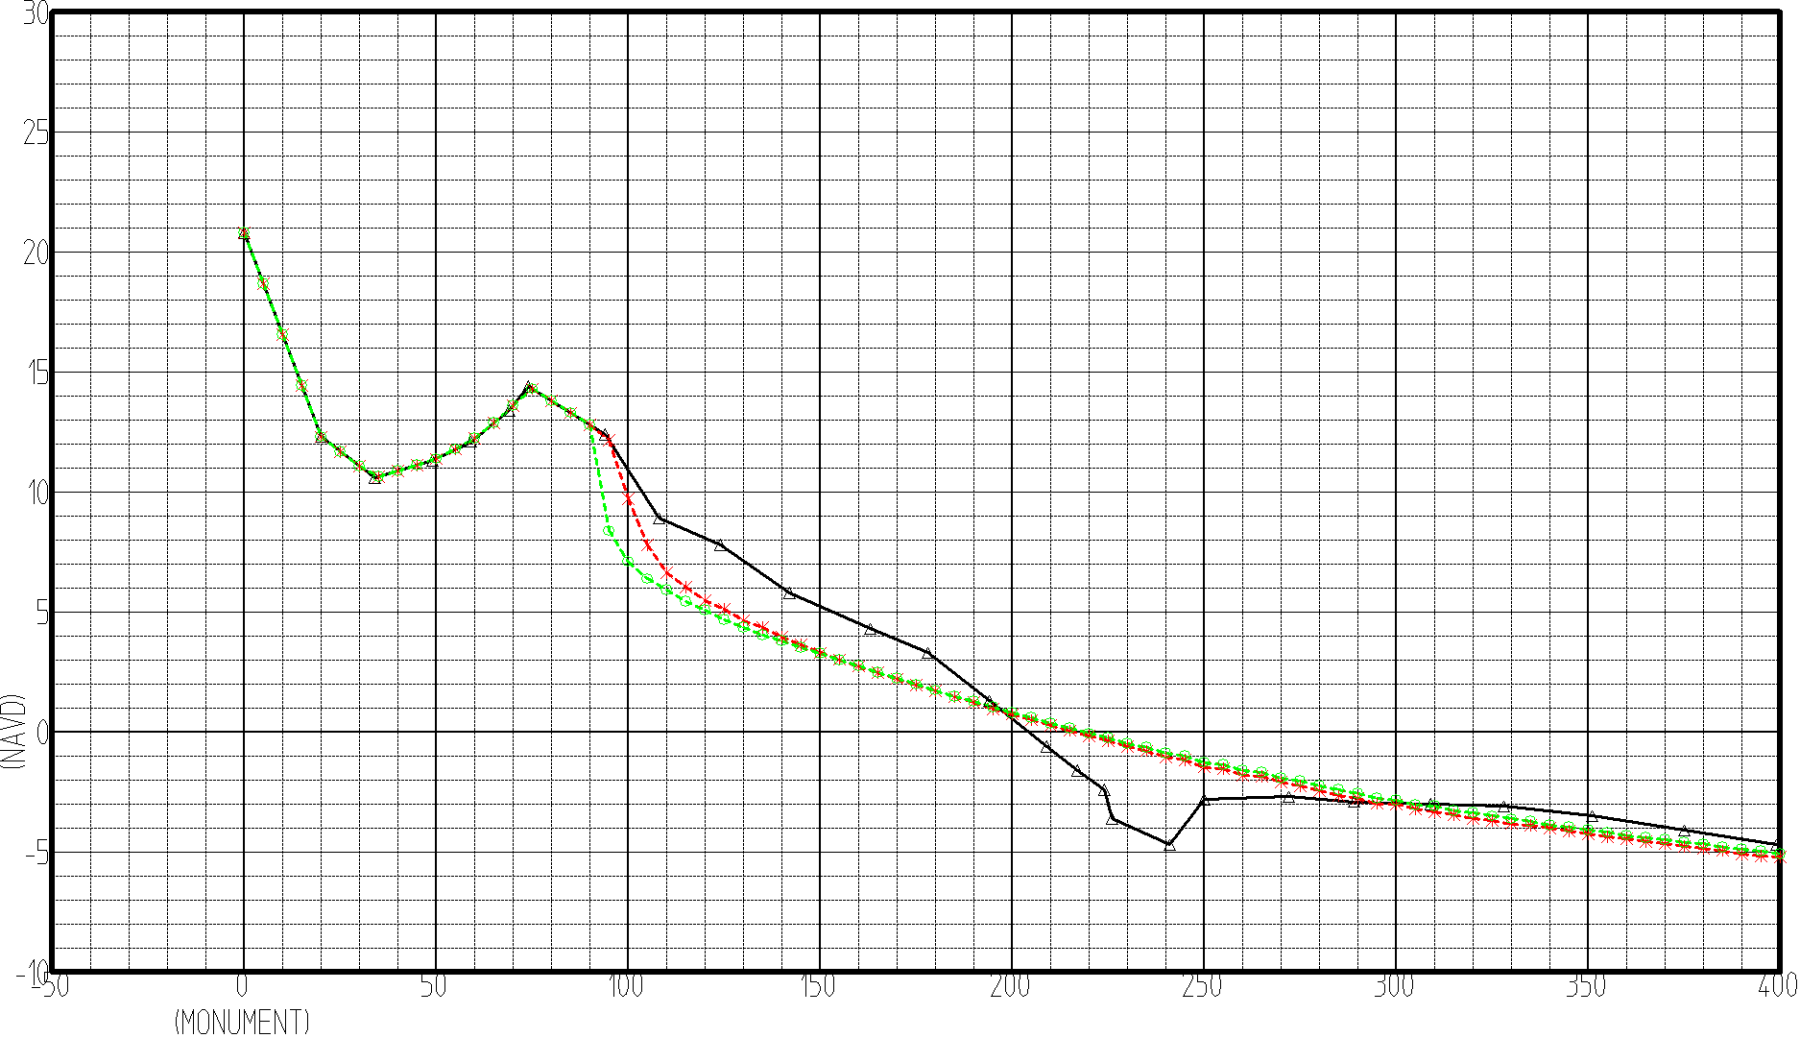
Range: R-73

BEACH PROFILE

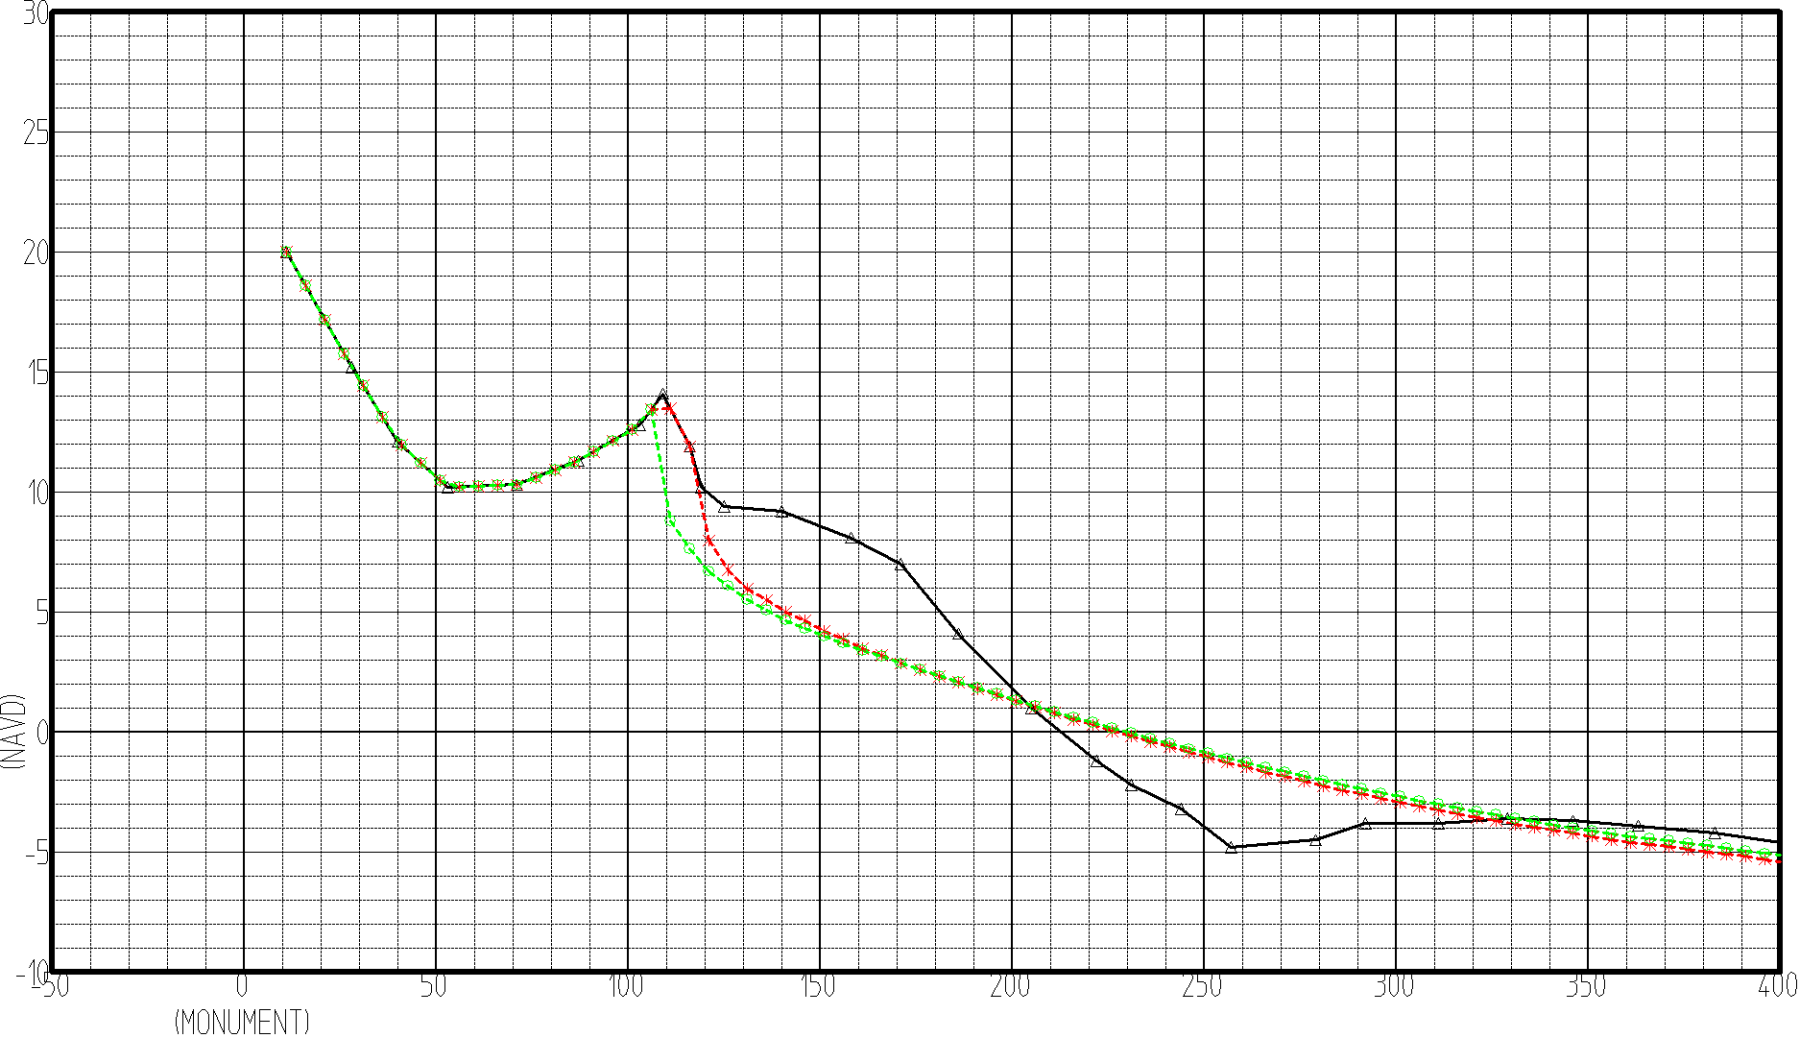
Range: R-74
 BEARING: 75.00
 1/2

BEACH PROFILE
 —△—△— ST. JOHNS 2007-2008 COMBI
 - - * - - - 15YR SBEACH ERODED
 - - o - - - 25YR SBCH ERODED

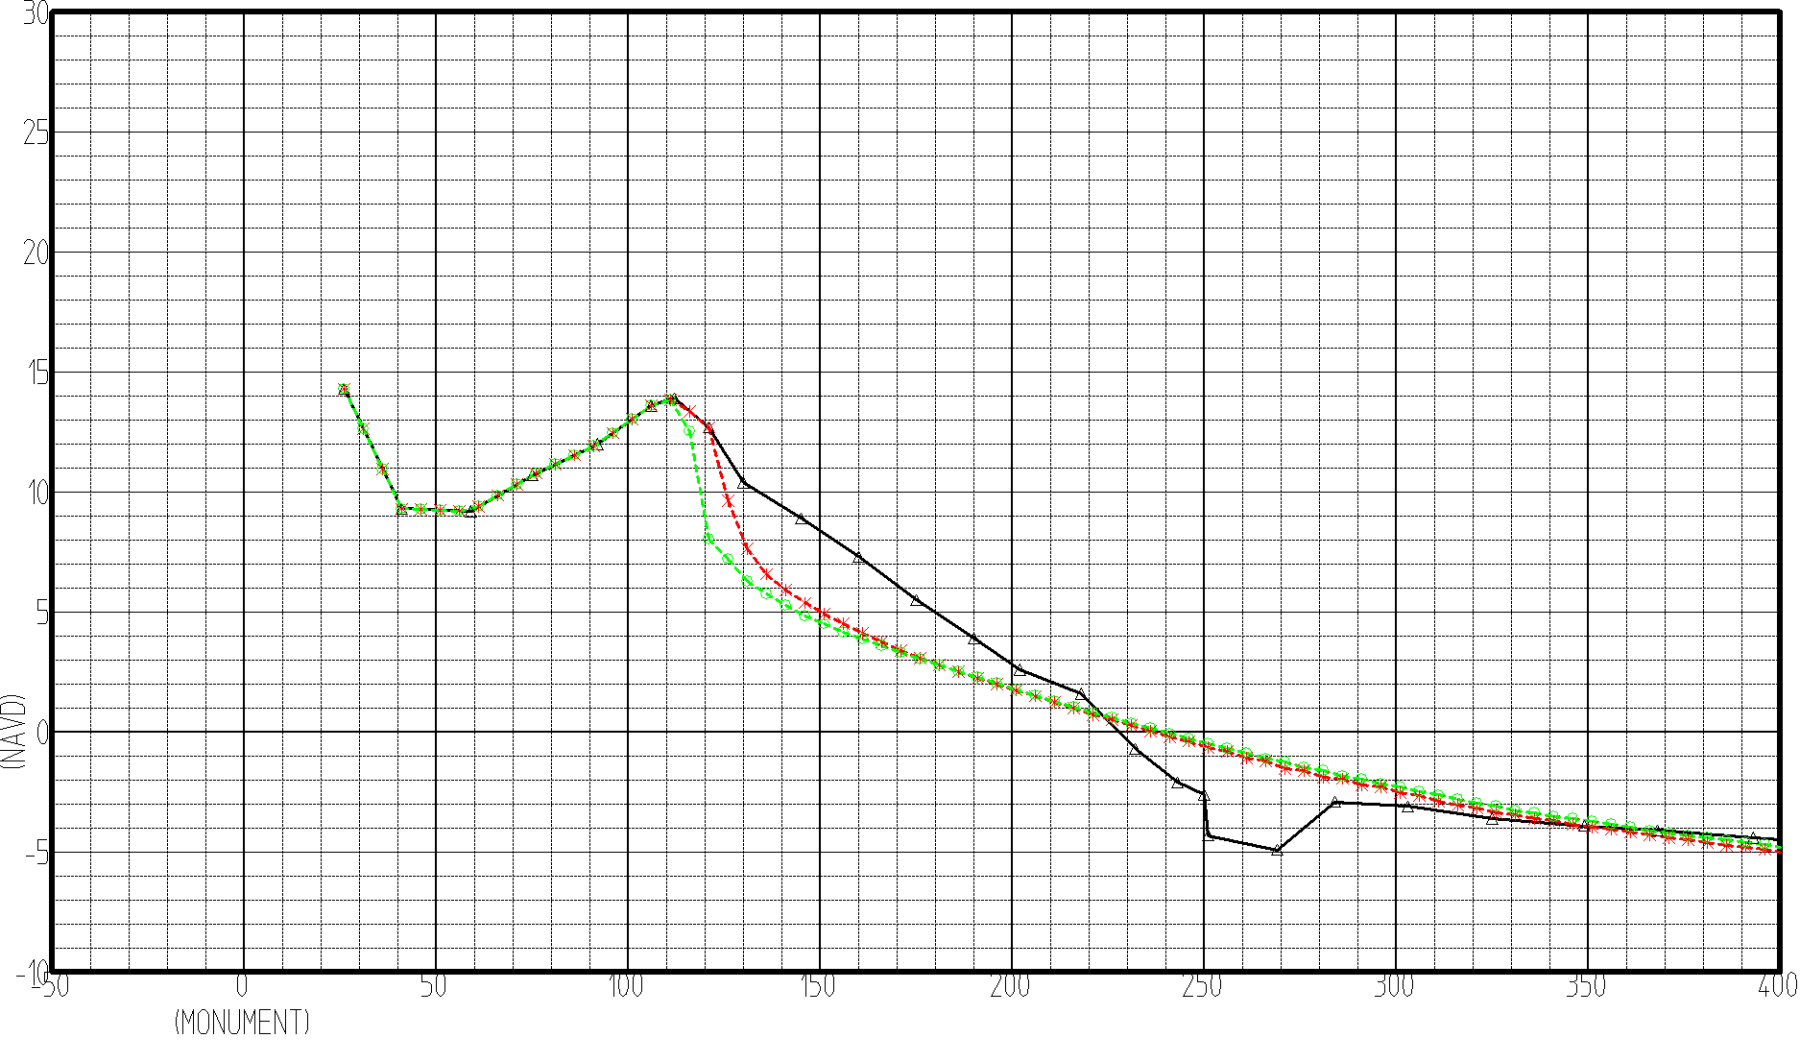
Range: R-75
 BEARING: 75.00
 1/2

BEACH PROFILE
 —△—△— ST. JOHNS 2007-2008 COMBI
 - - * - - 15YR SBCH ERODED
 - - o - - 25YR SBCH ERODED

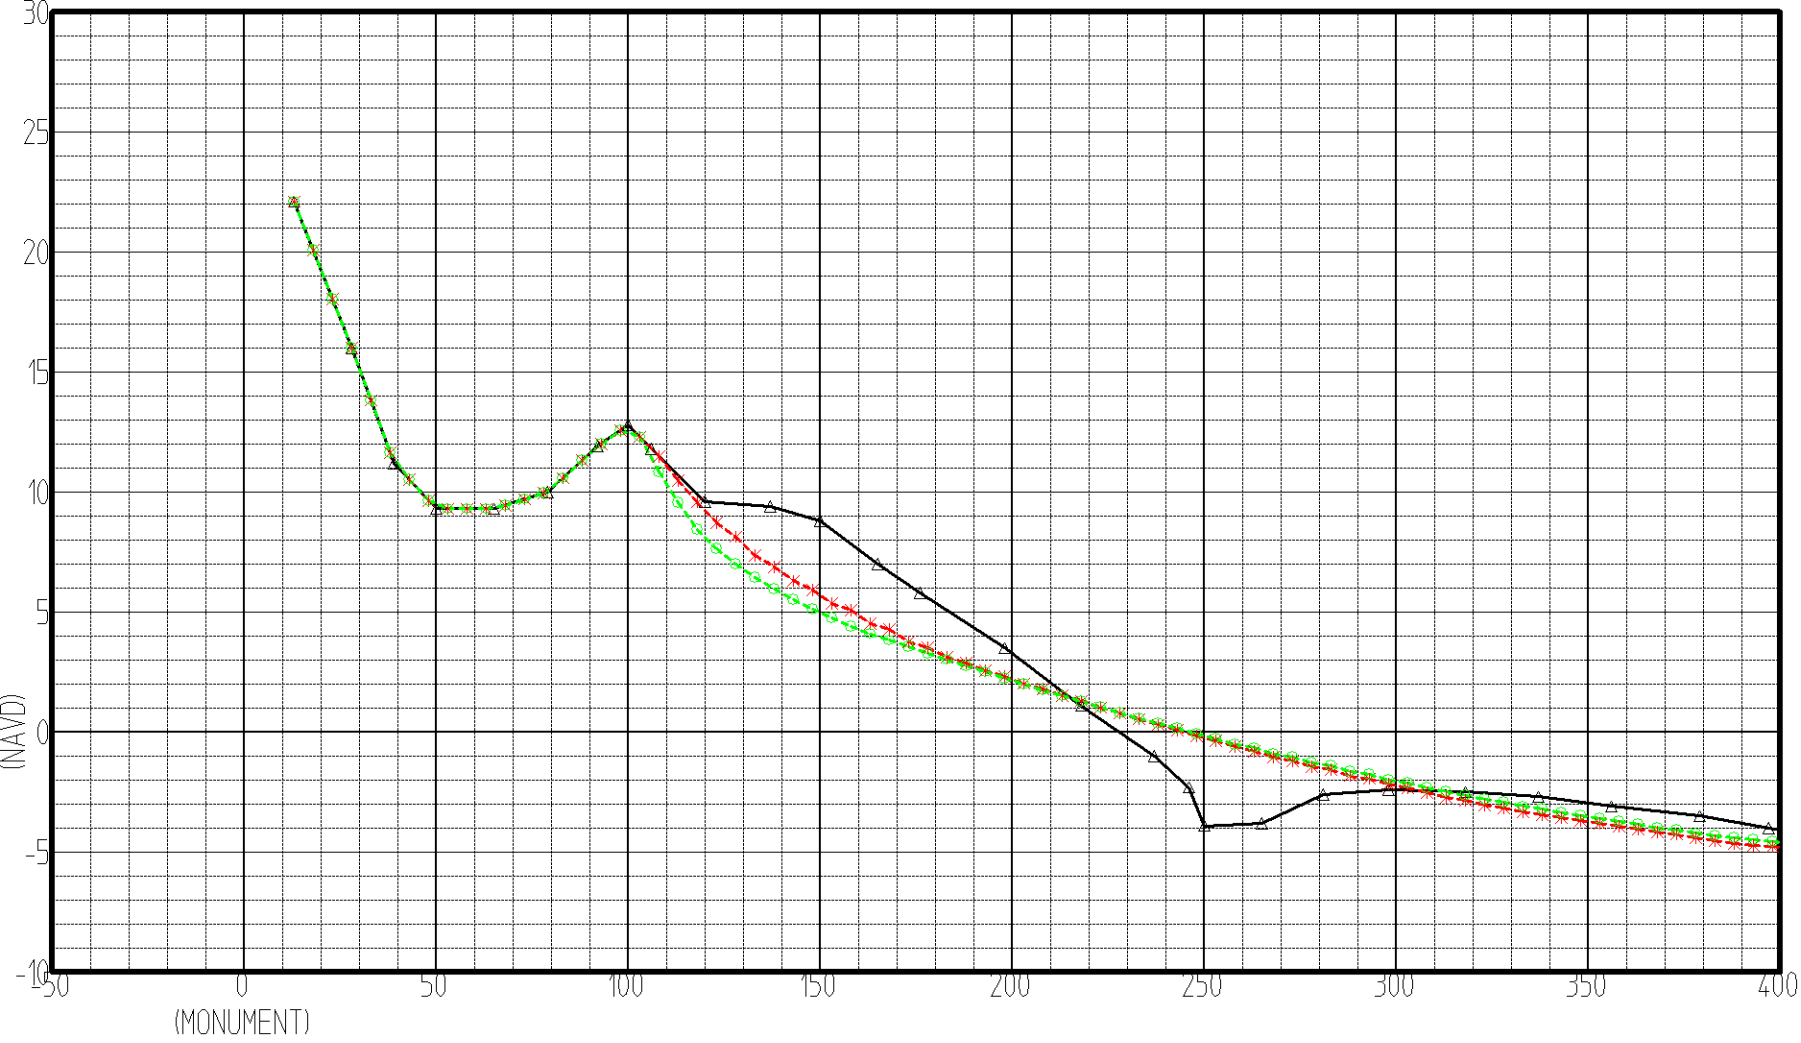
Range: R-76
 BEARING: 75.00
 1/2

BEACH PROFILE
 —△—△— ST. JOHNS 2007-2008 COMBI
 - - * - - 15YR SBCH ERODED
 - - o - - 25YR SBCH ERODED

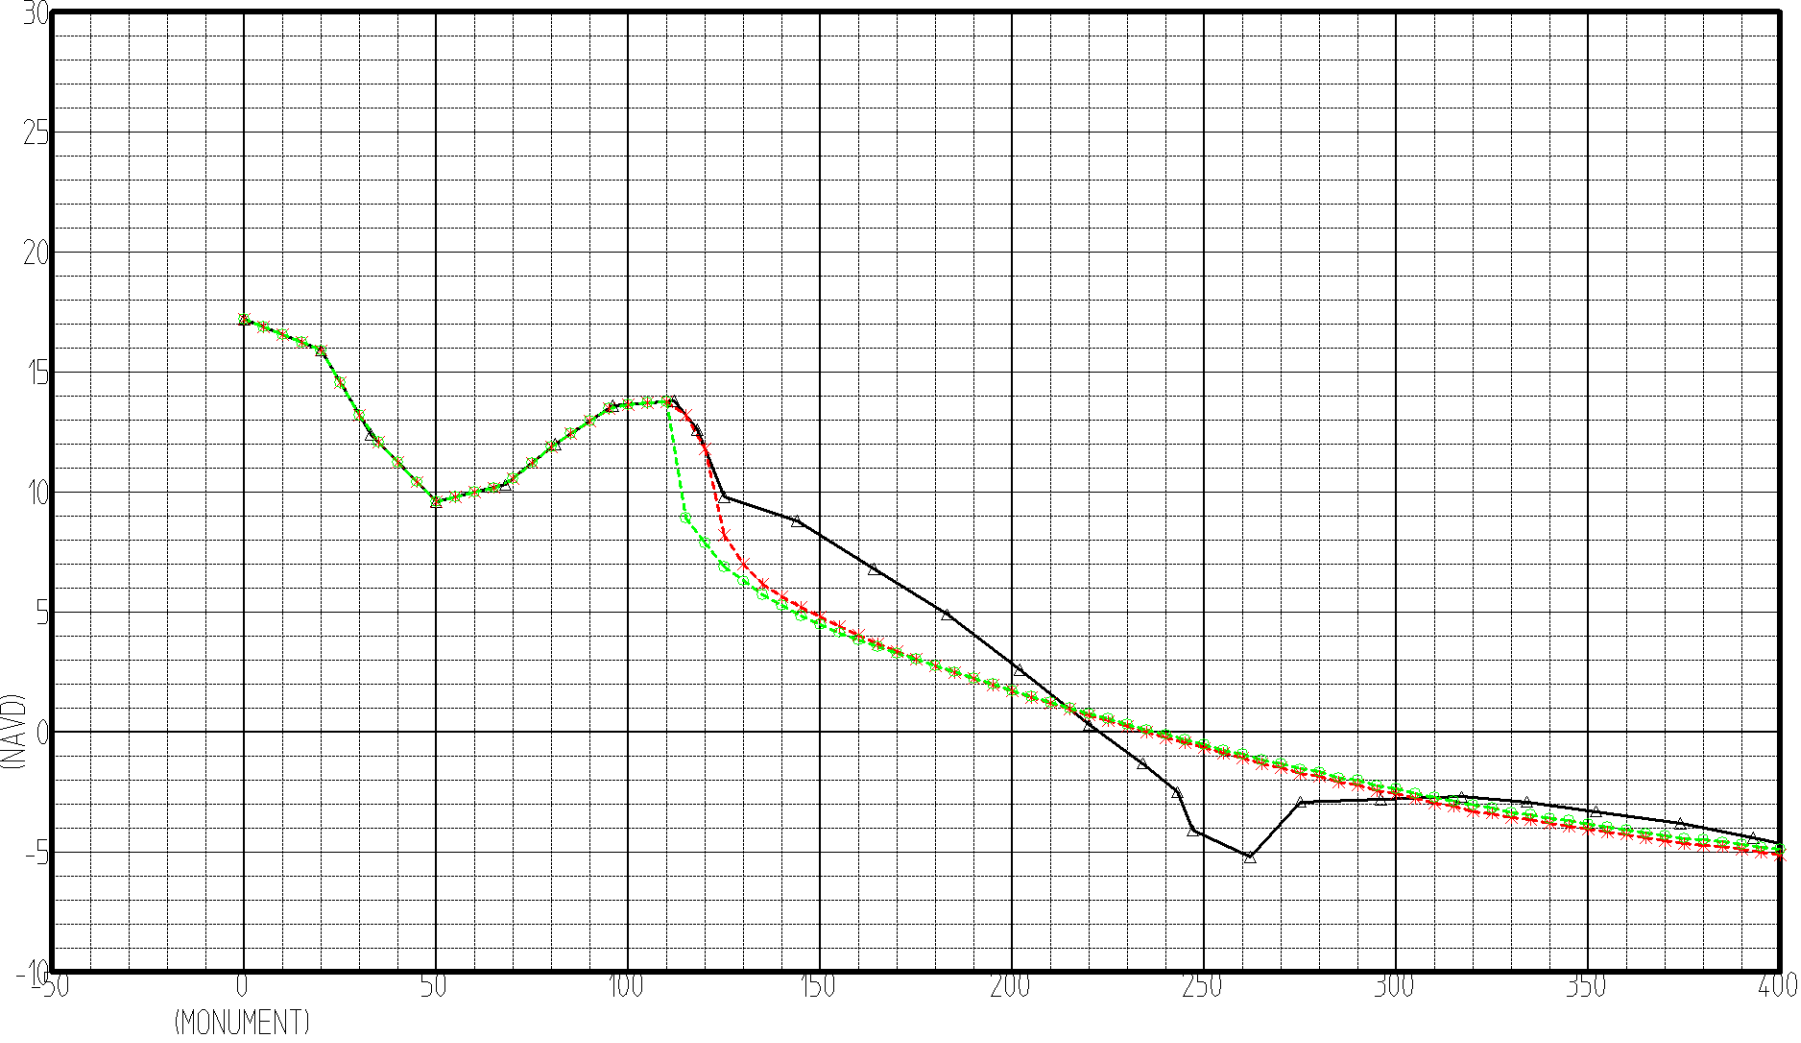
Range: R-77

BEACH PROFILE

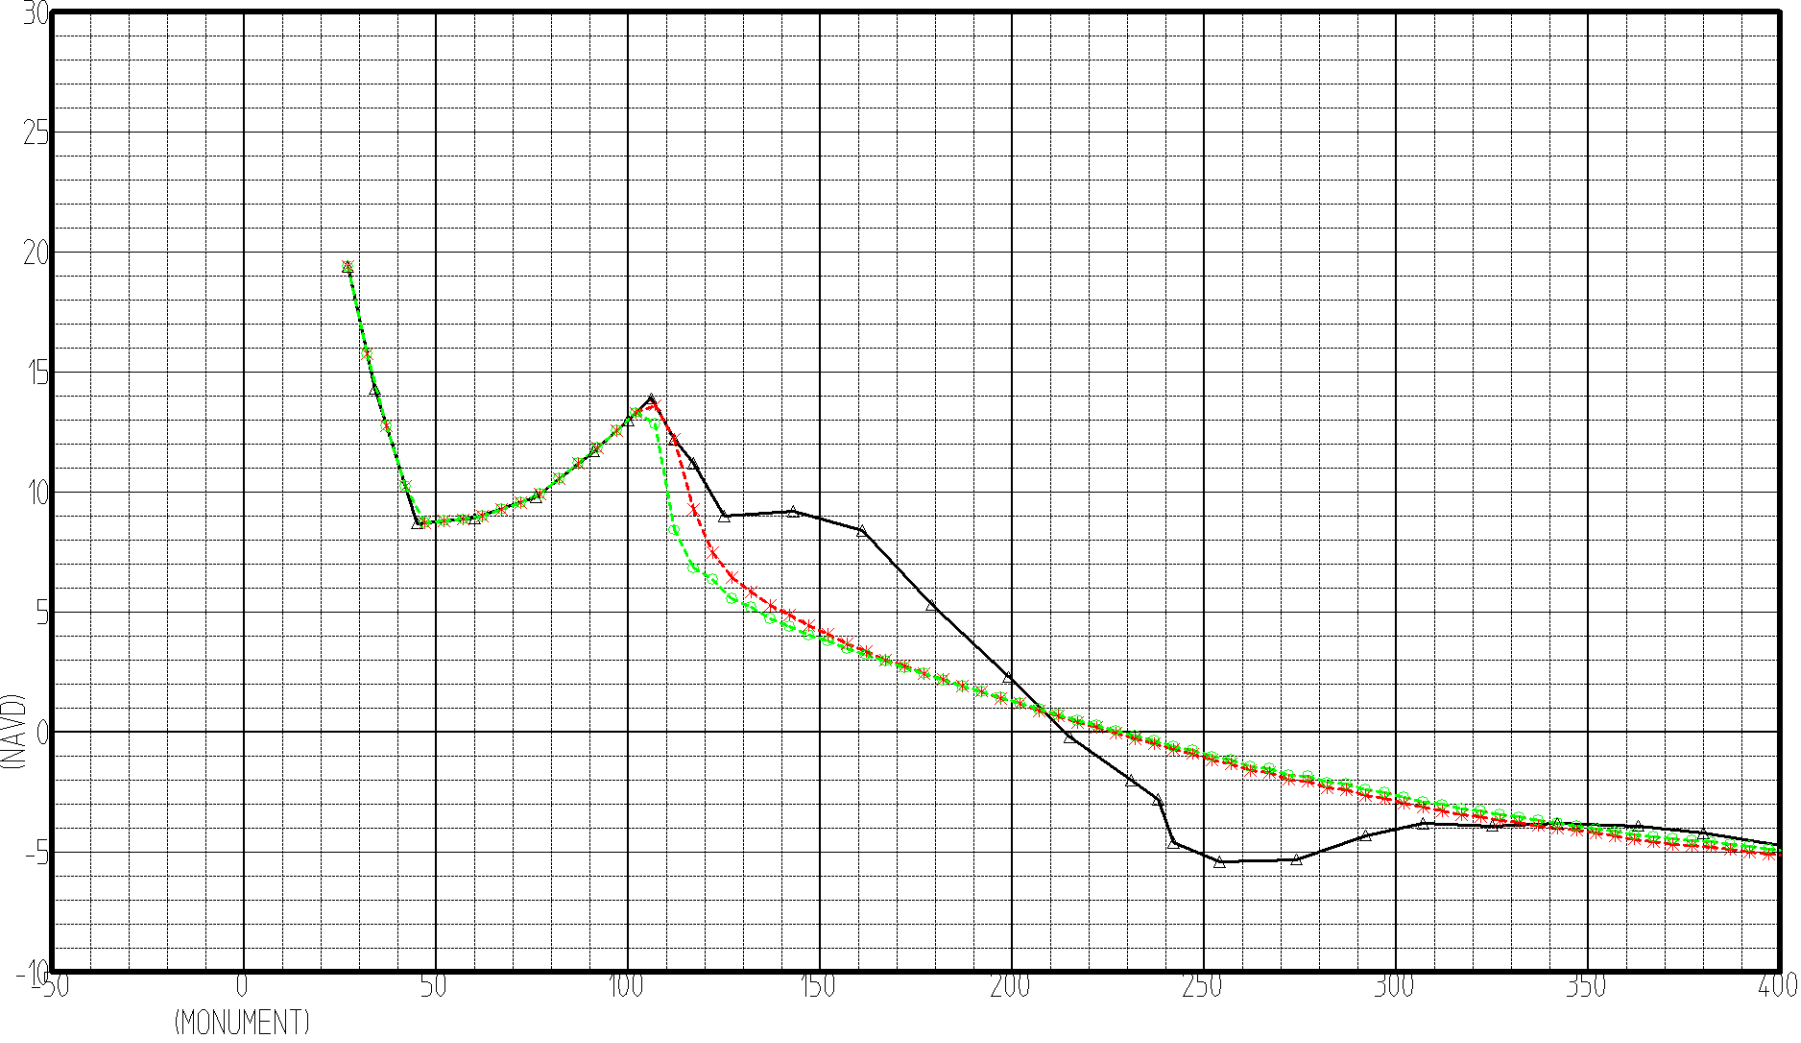
Range: T-78
 BEARING: 75.00
 1/2

BEACH PROFILE
 —△—△— ST. JOHNS 2007-2008 COMBI
 - - * - - - 15YR SBEACH ERODED
 - - o - - - 25YR SBCH ERODED

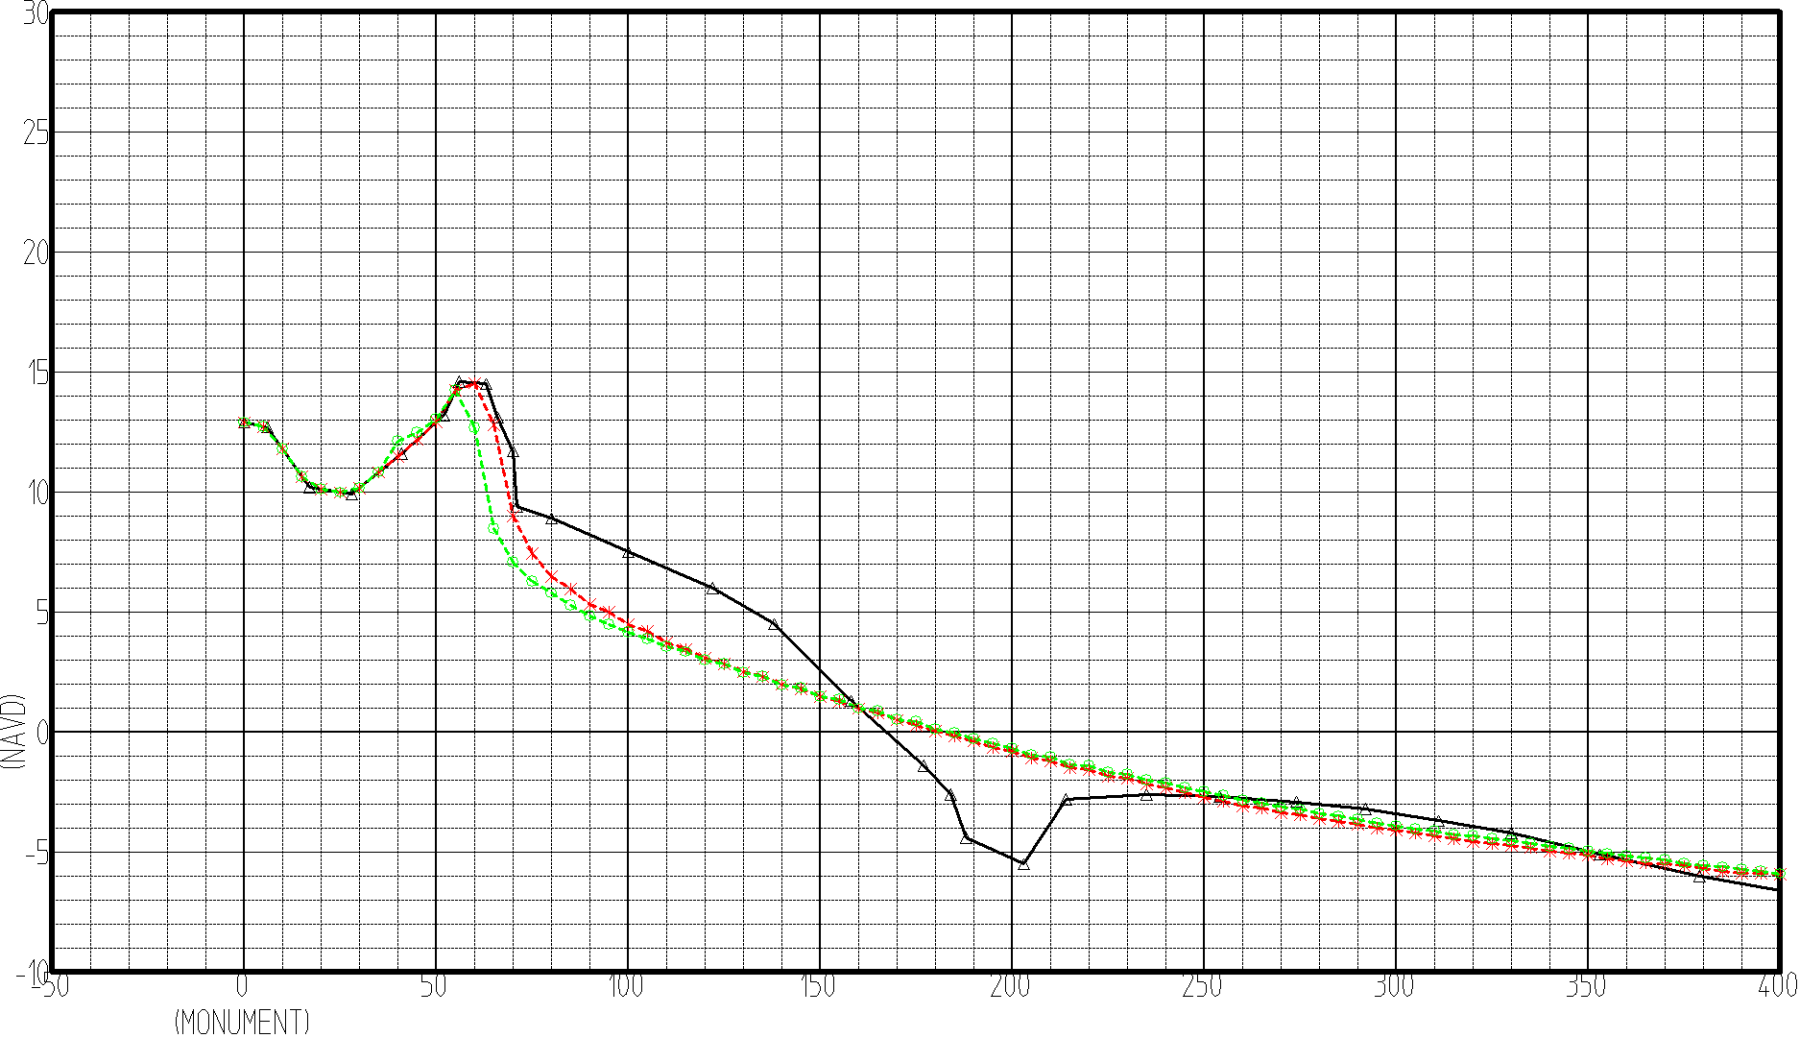
Range: R-80

BEACH PROFILE

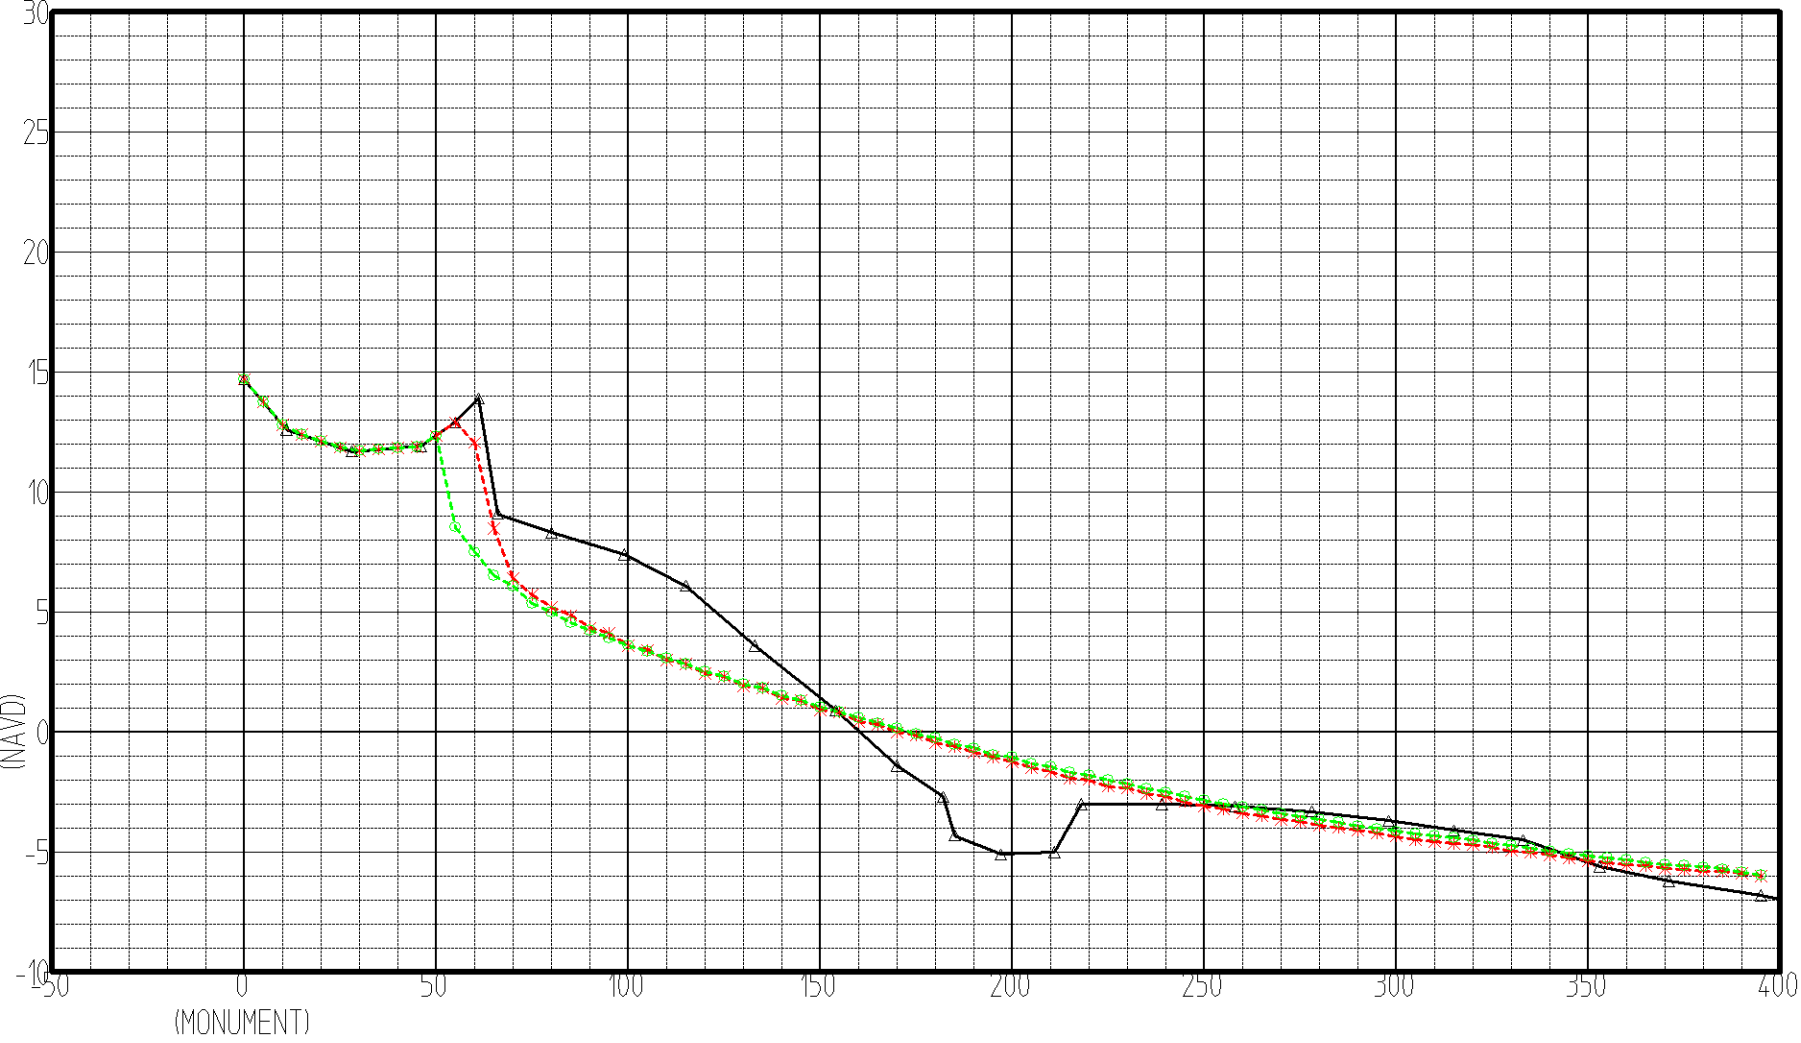
Range: R-81
 BEARING: 75.00
 1/2

BEACH PROFILE
 —△—△— ST. JOHNS 2007-2008 COMBI
 - - * - - 15YR SBACH ERODED
 - - o - - 25YR SBCH ERODED

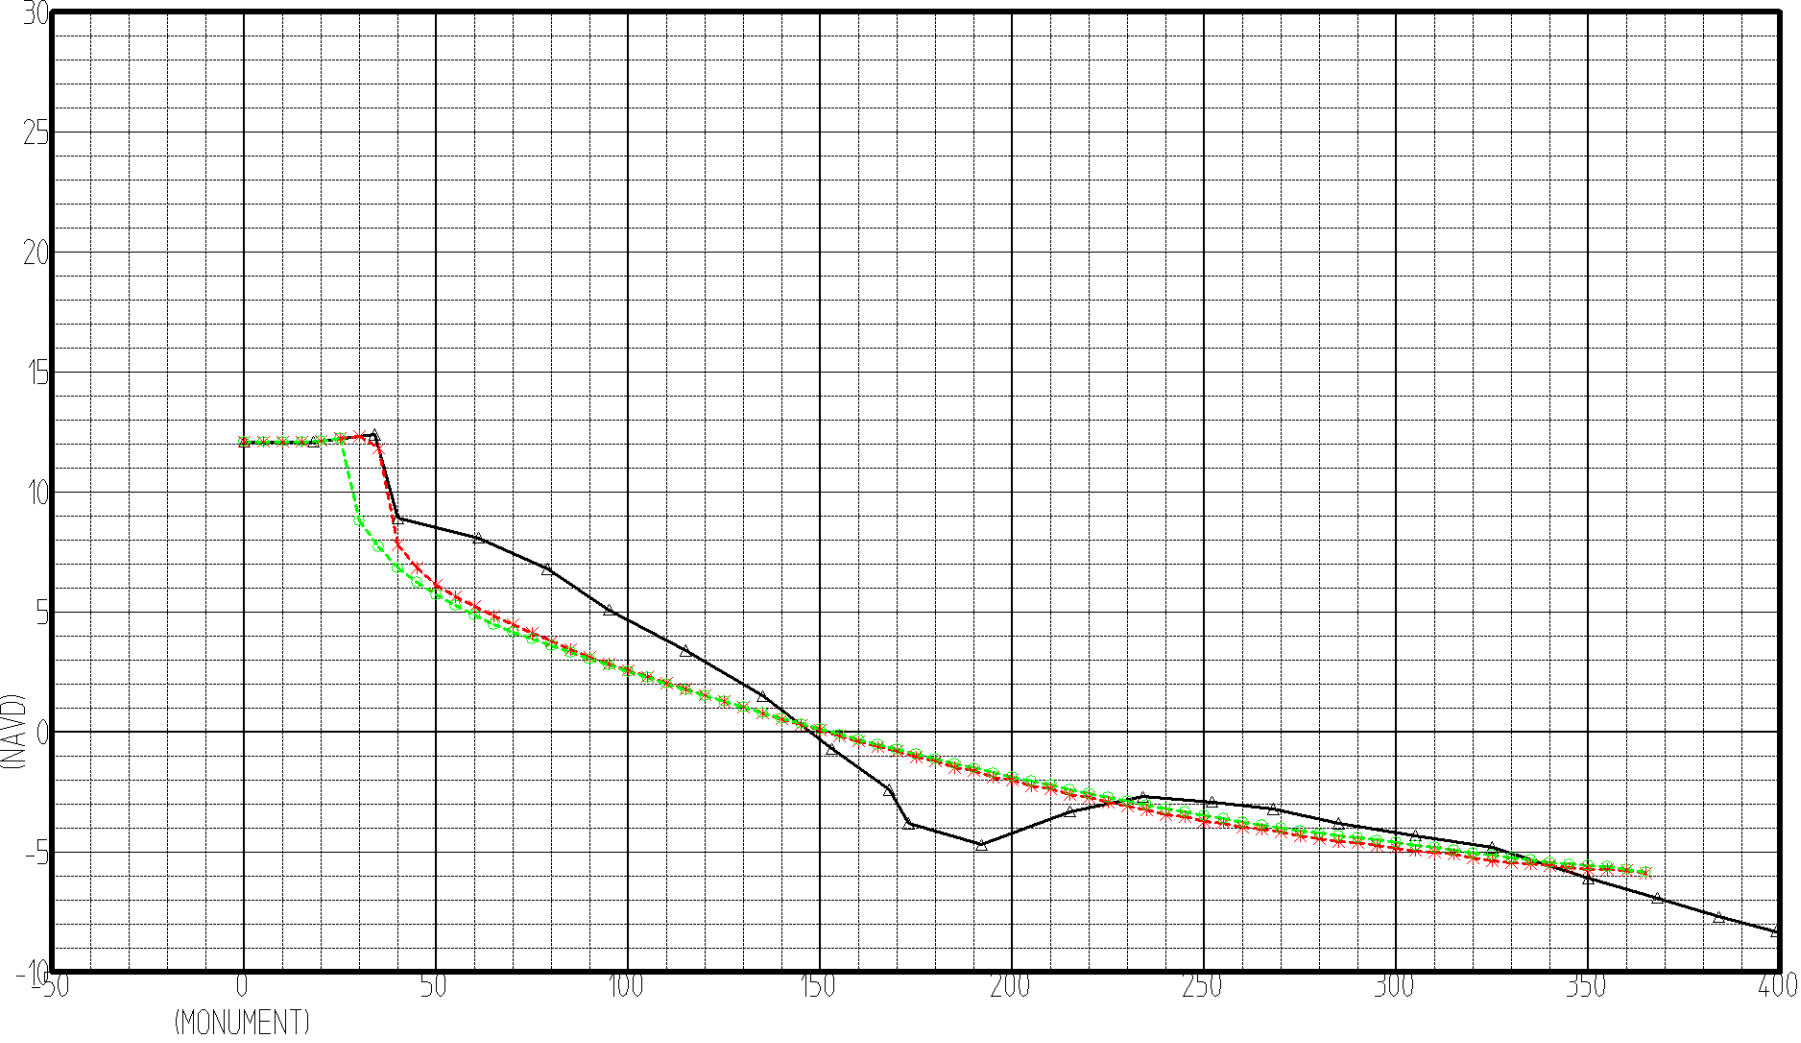
Range: R-82
 BEARING: 75.00
 1/2

BEACH PROFILE
 —△—△— ST. JOHNS 2007-2088 COMBI
 - - * - - 15YR SBACH ERODED
 - - o - - 25YR SBCH ERODED

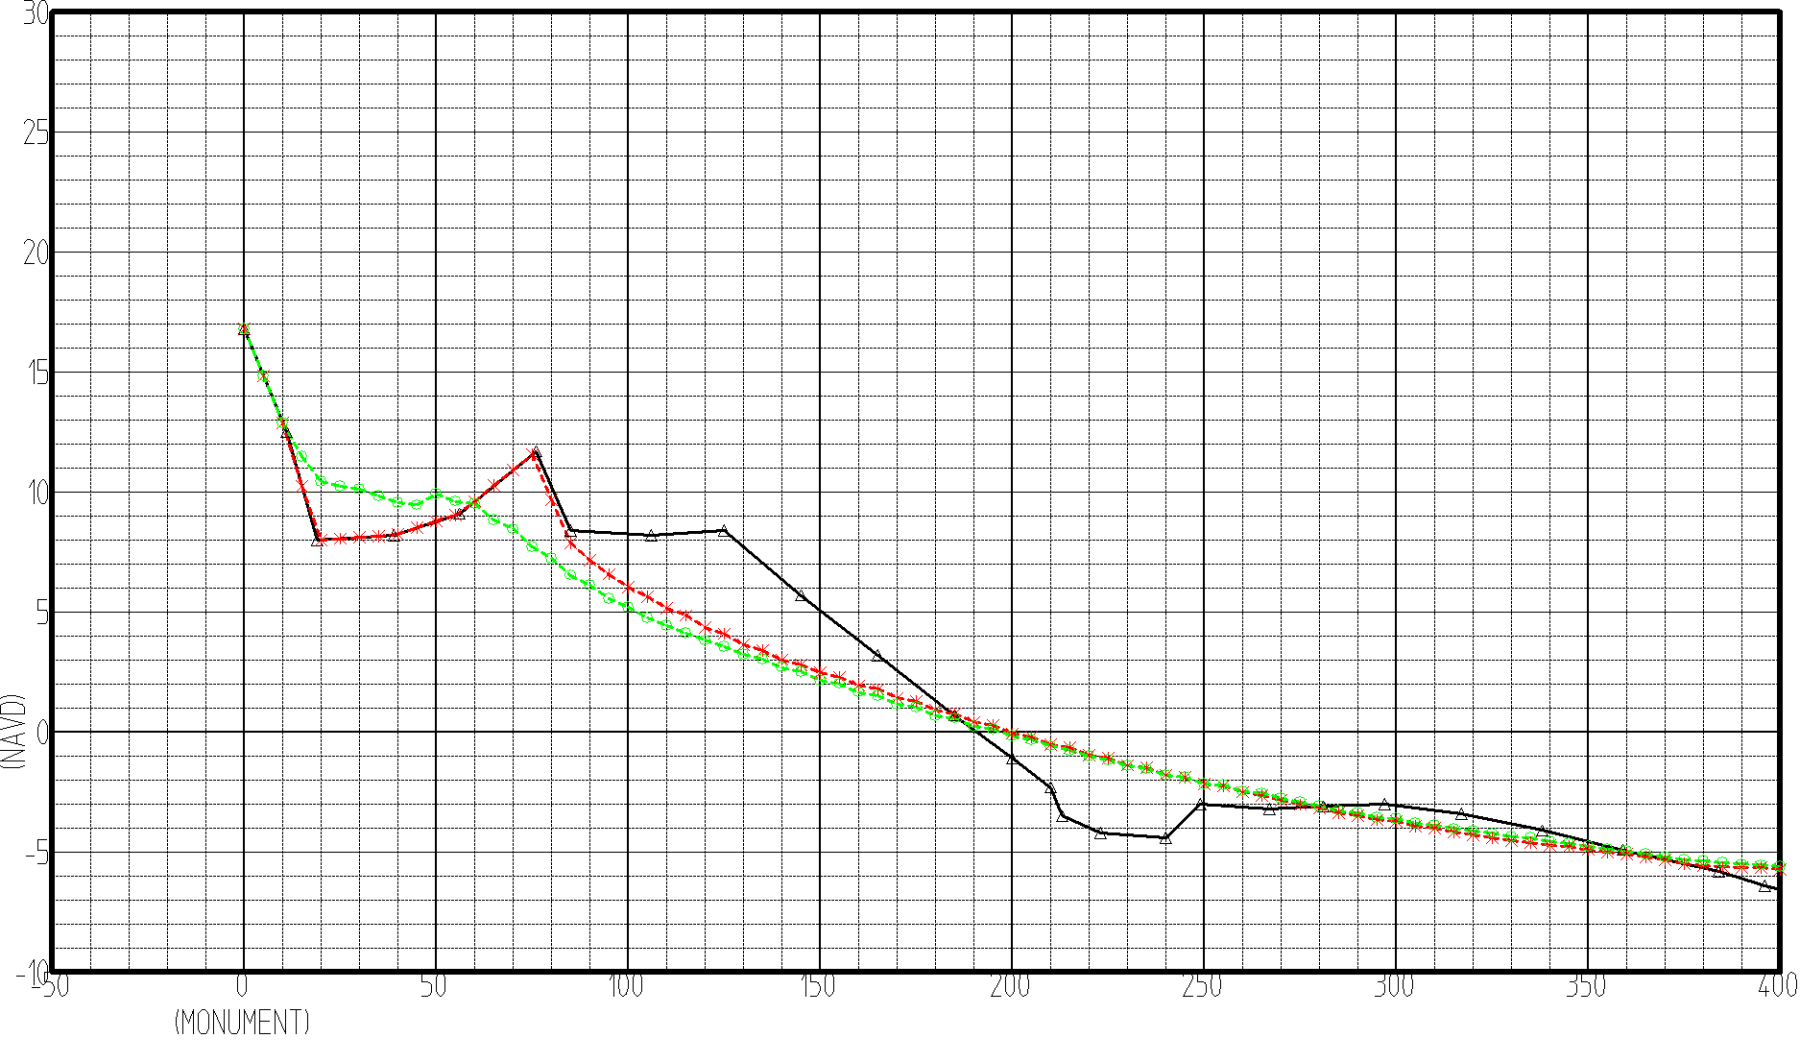
Range: R-83

BEACH PROFILE
