Appendix VIII

SBEACH 15 and 25 yr. Storm Erosion Profiles

St. Johns County

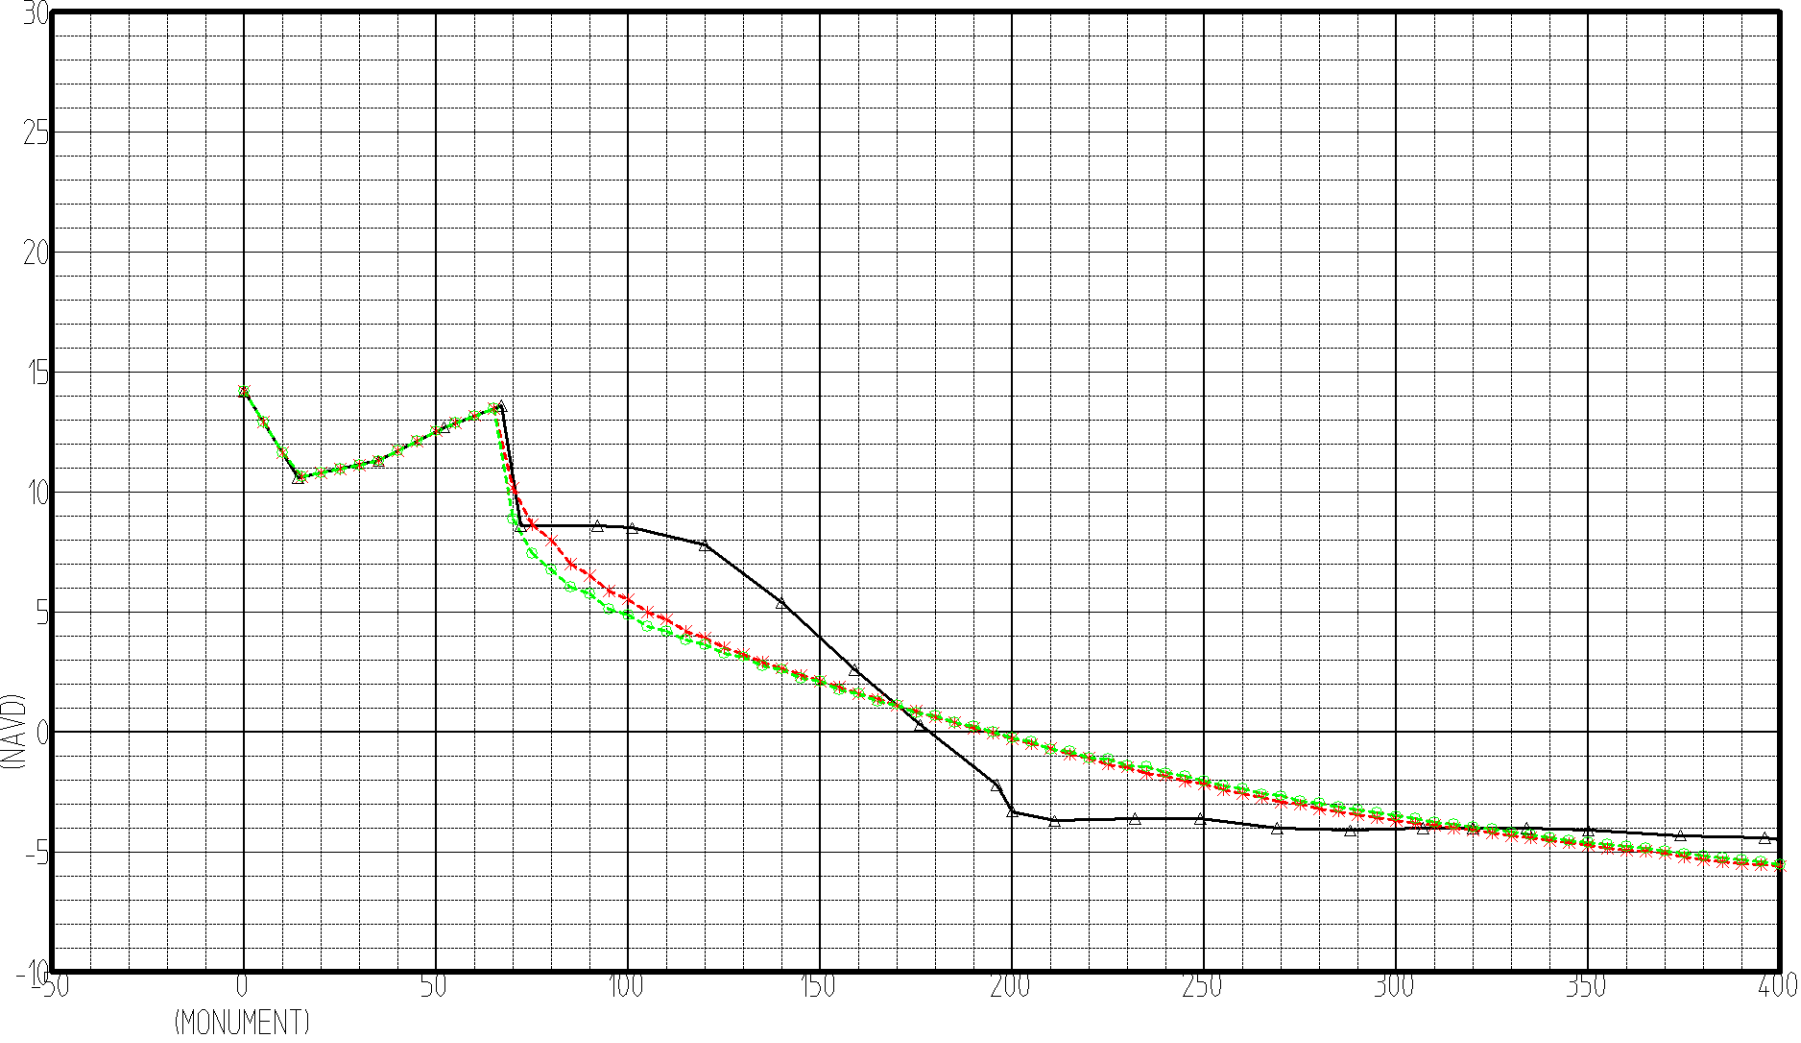
Range: R-84

BEACH PROFILE

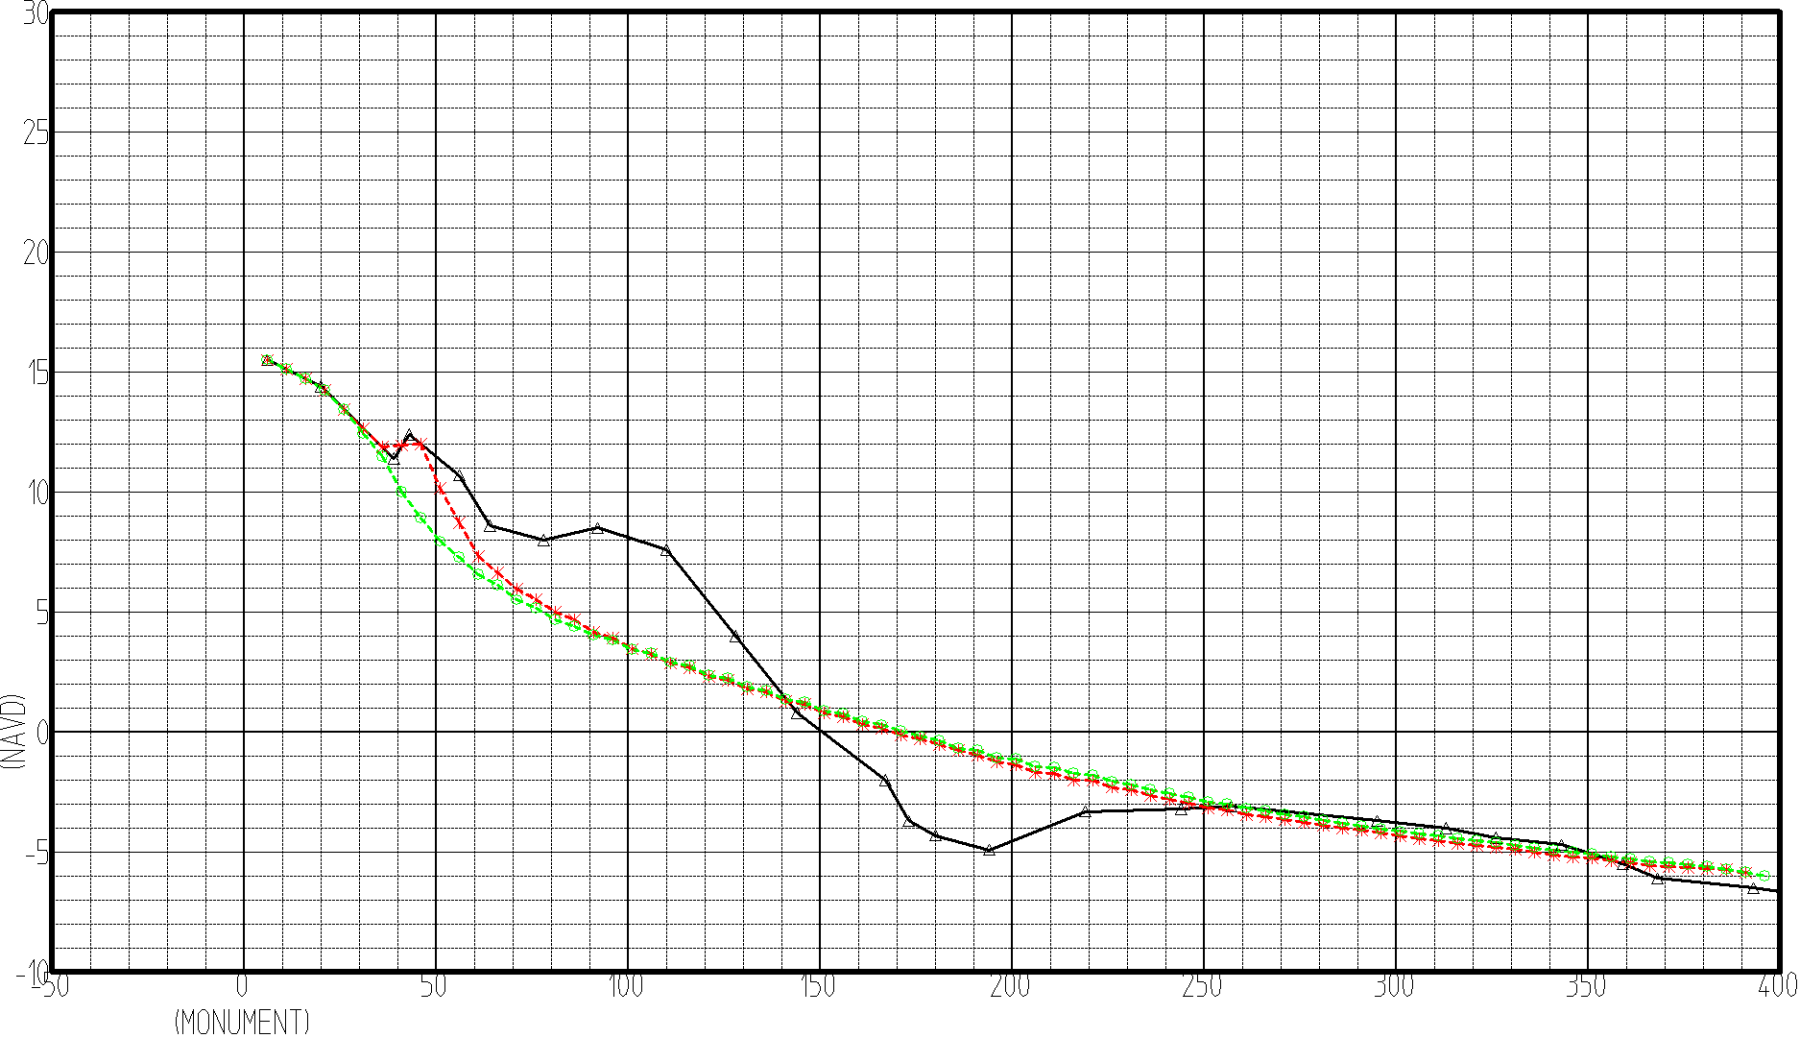
Range: R-85
 BEARING: 75.00
 1/2

BEACH PROFILE
 —△—△— ST. JOHNS 2007-2008 COMBI
 - - * - - - 15YR SBEACH ERODED
 - - o - - - 25YR SBCH ERODED

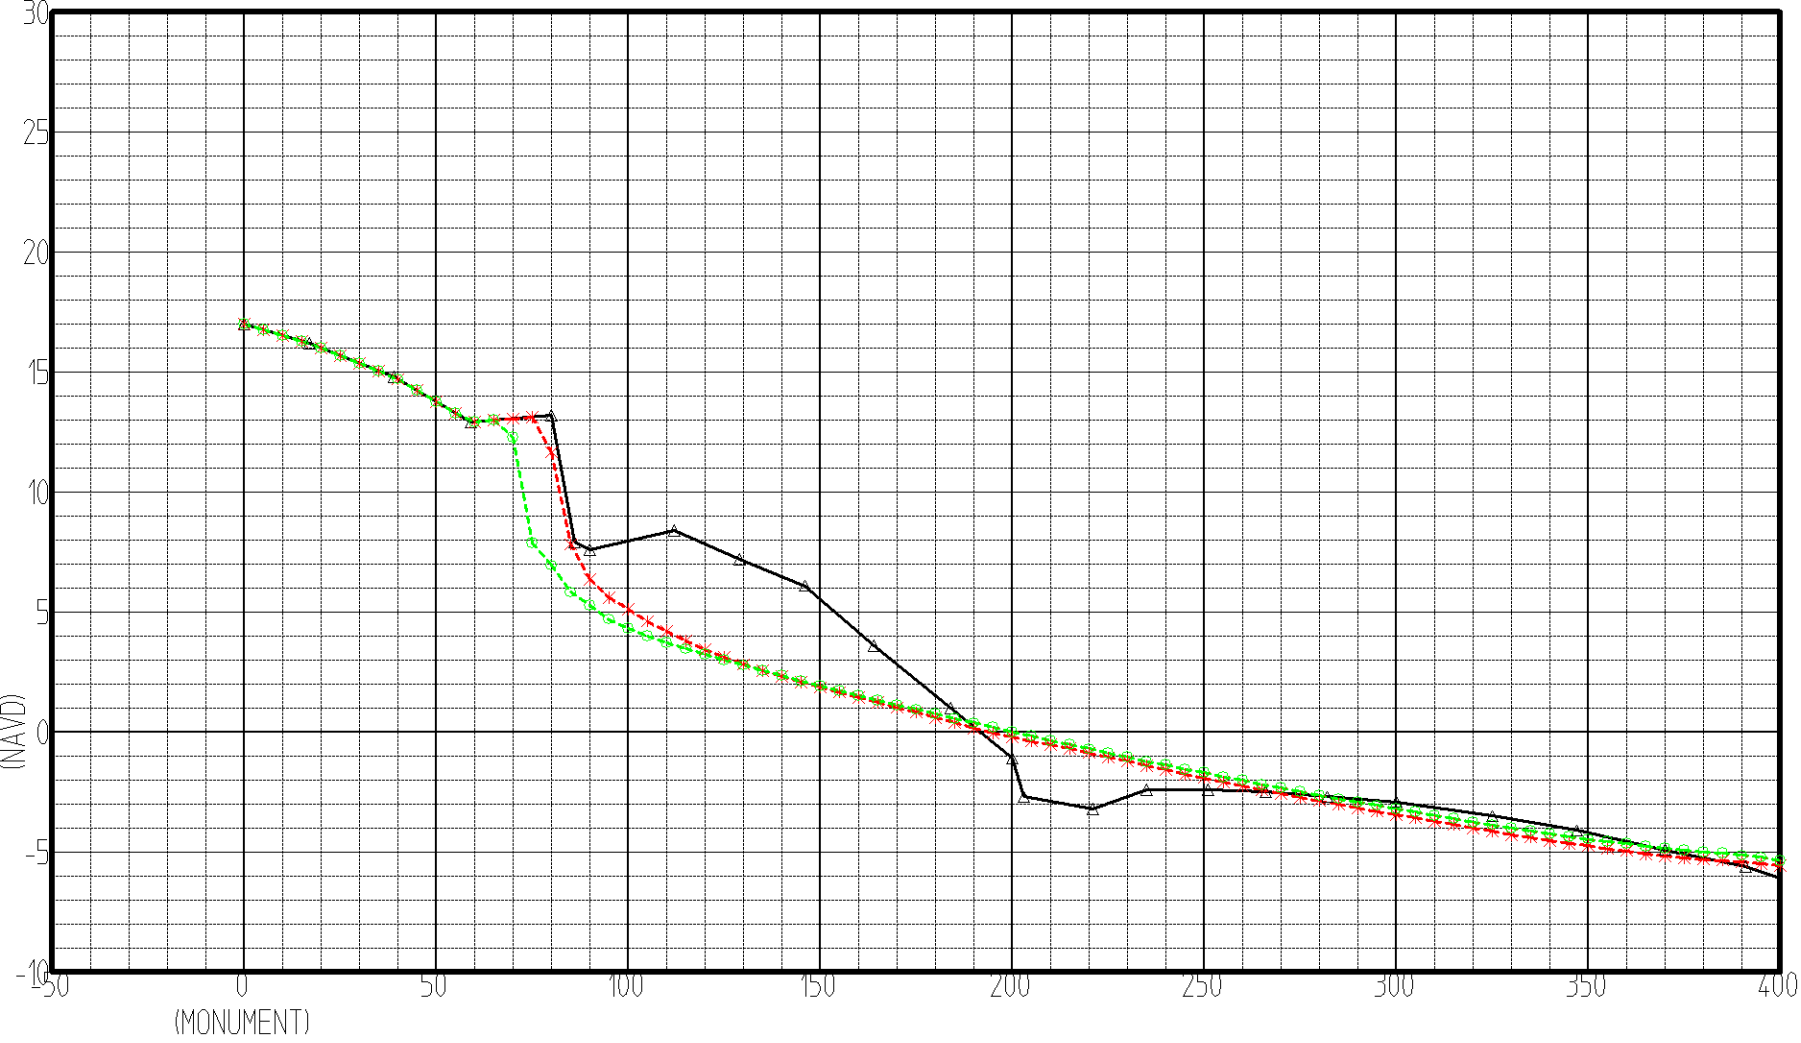
Range: R-86
 BEARING: 75.00
 1/2

BEACH PROFILE
 —△—△— ST. JOHNS 2007-2008 COMBI
 - - * - - 15YR SBCH ERODED
 - - o - - 25YR SBCH ERODED

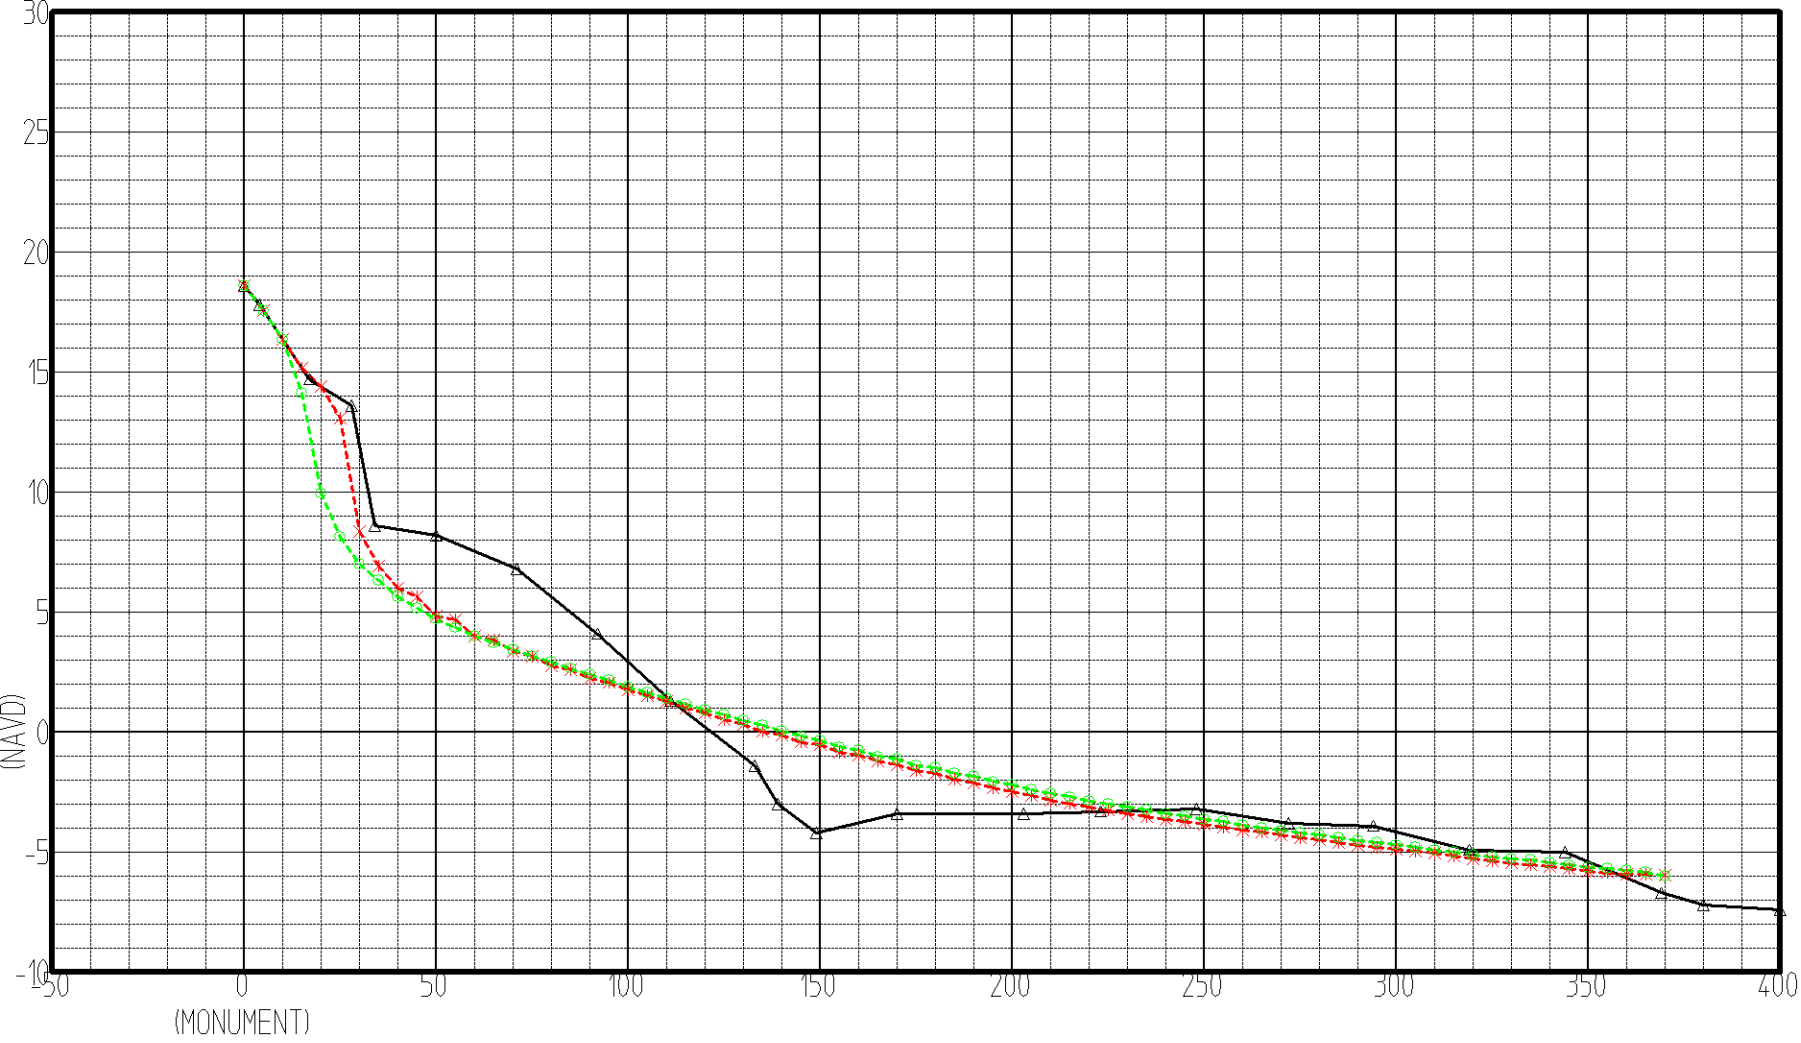
Range: R-87
 BEARING: 75.00
 1/2

BEACH PROFILE
 —△—△— ST. JOHNS 2007-2008 COMBI
 - - * - - - 15YR SBEACH ERODED
 - - o - - - 25YR SBCH ERODED

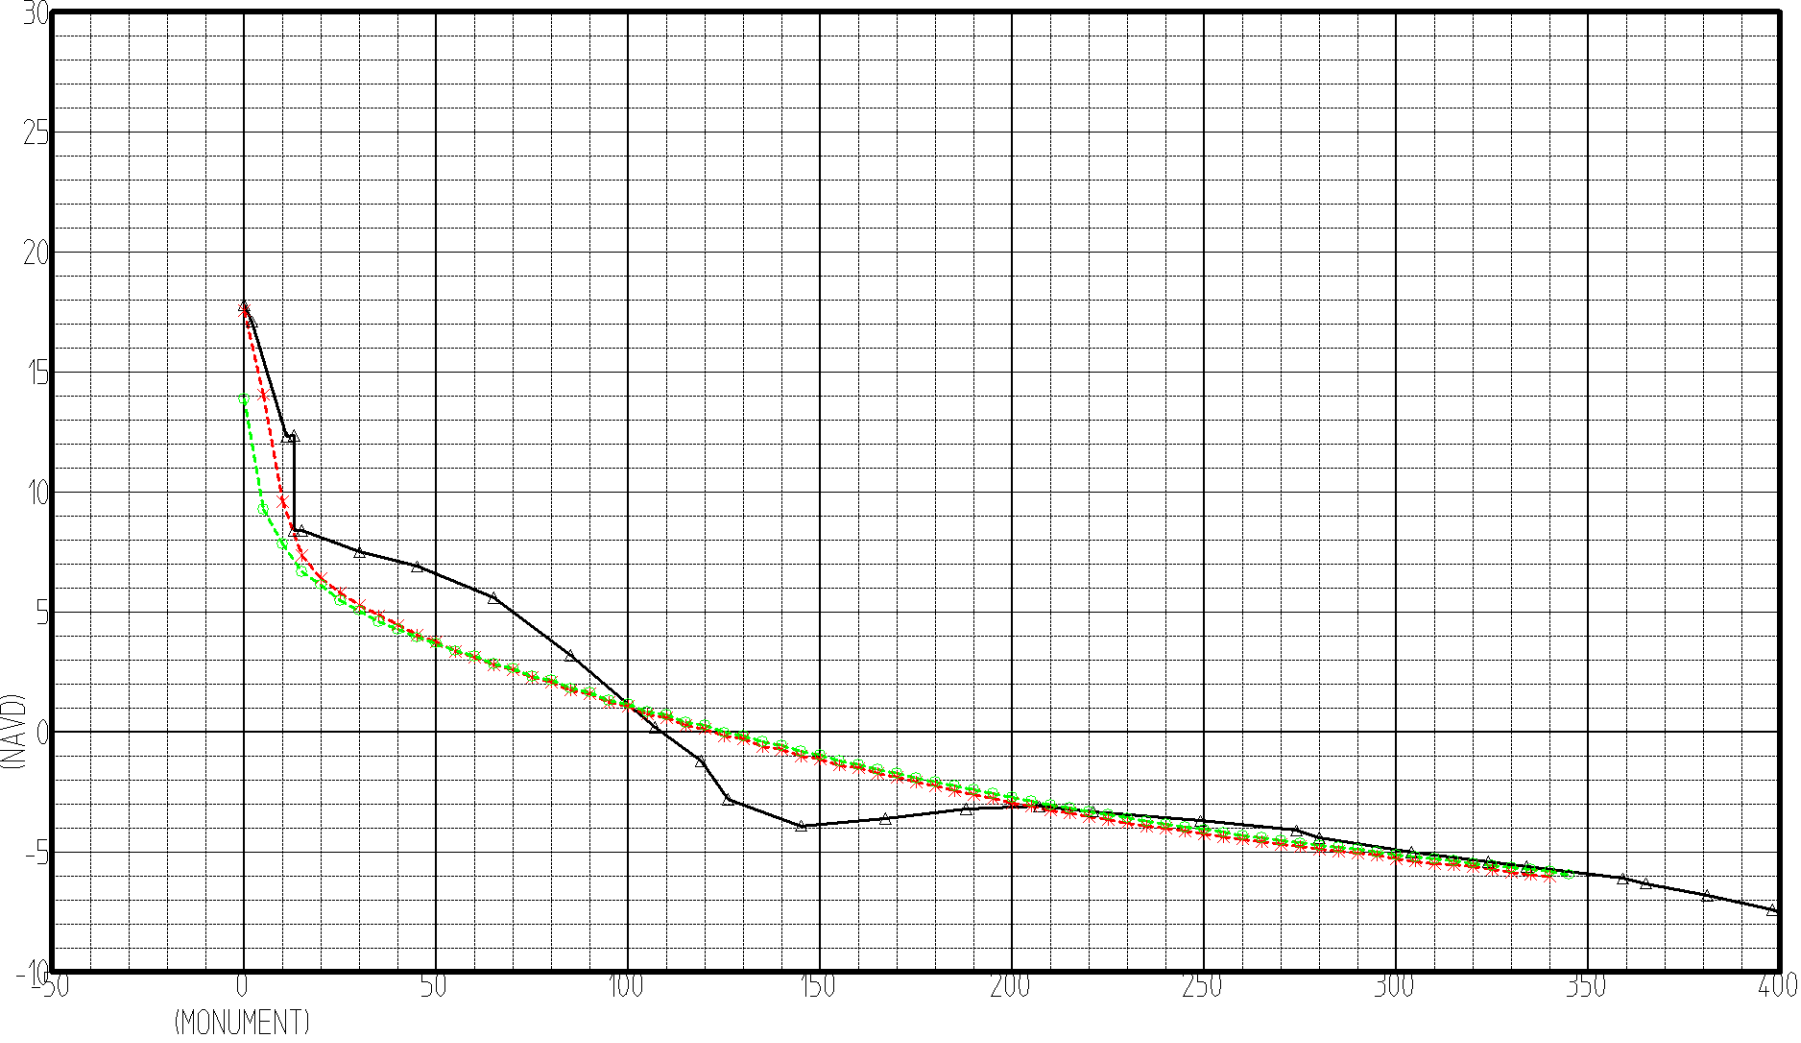
Range: R-88
 BEARING: 75.00
 1/2

BEACH PROFILE
 —△—△— ST. JOHNS 2007-2008 COMBI
 - - * - - - 15YR SBEACH ERODED
 - - o - - - 25YR SBCH ERODED

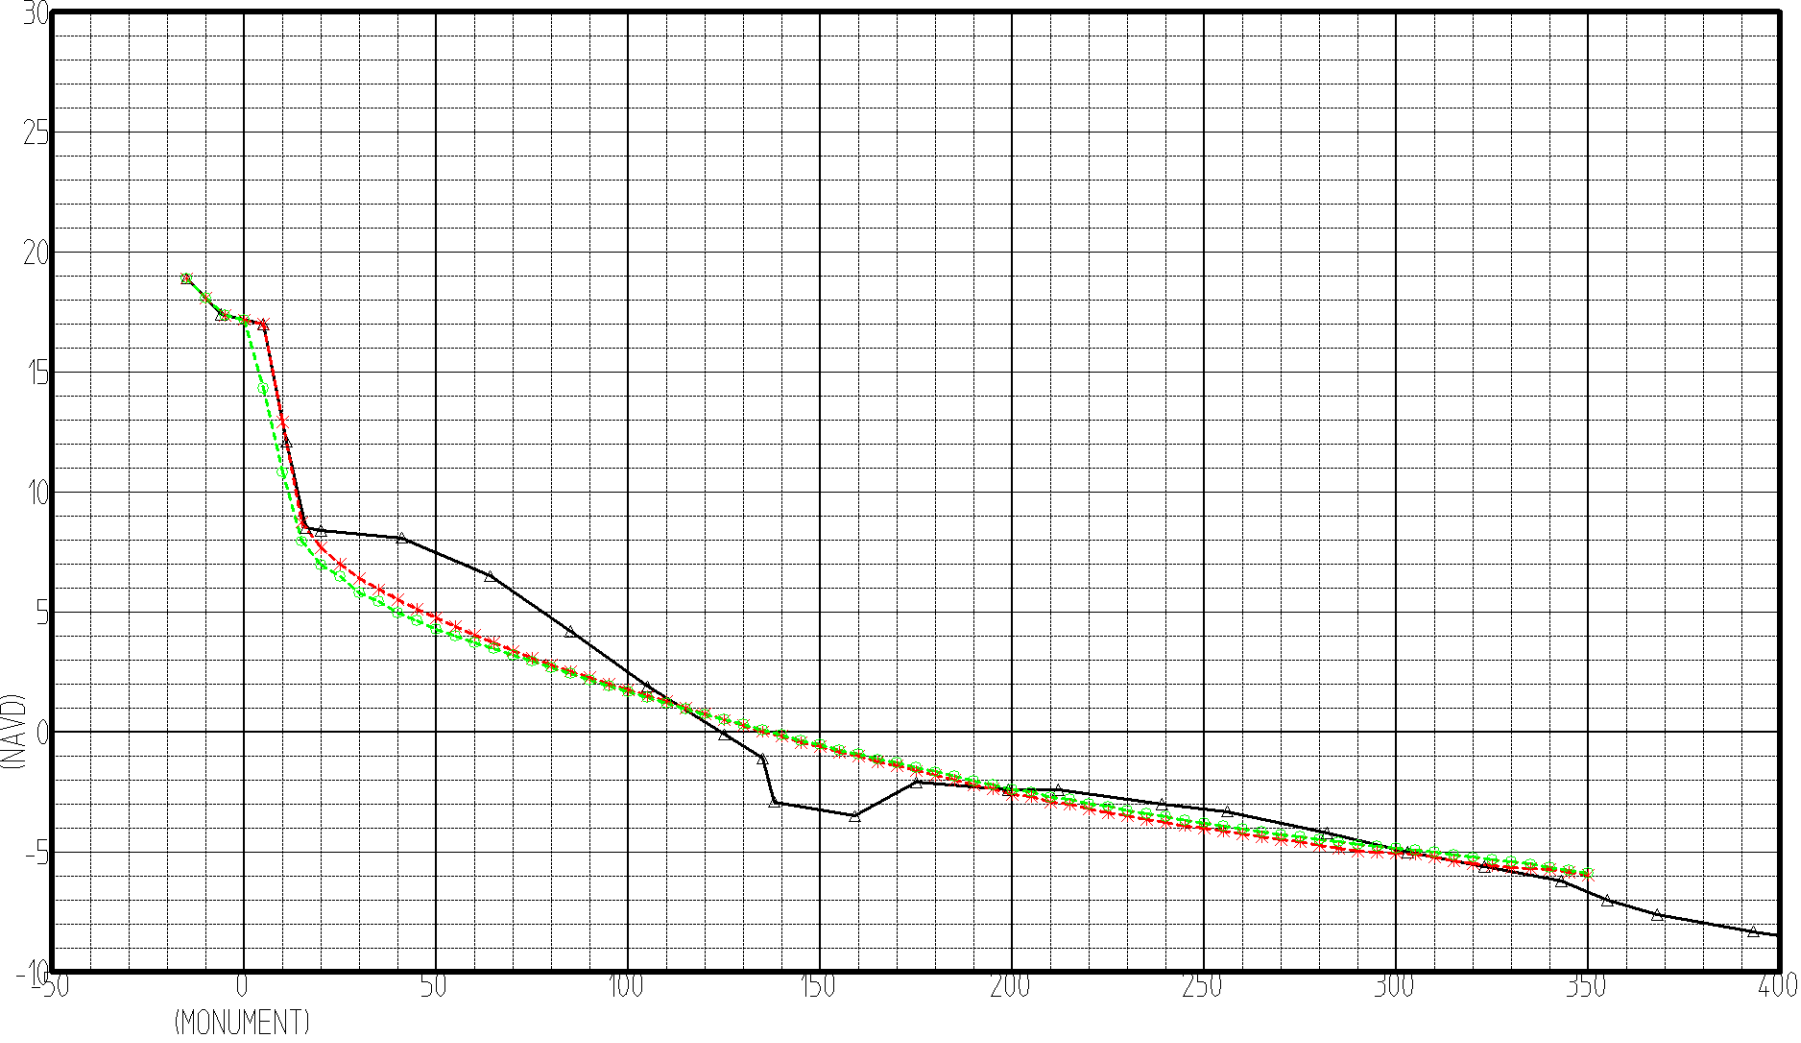
Range: R-89
 BEARING: 75.00
 1/2

BEACH PROFILE
 —△—△— ST. JOHNS 2007-2008 COMBI
 - - * - - 15YR SBCH ERODED
 - - o - - 25YR SBCH ERODED

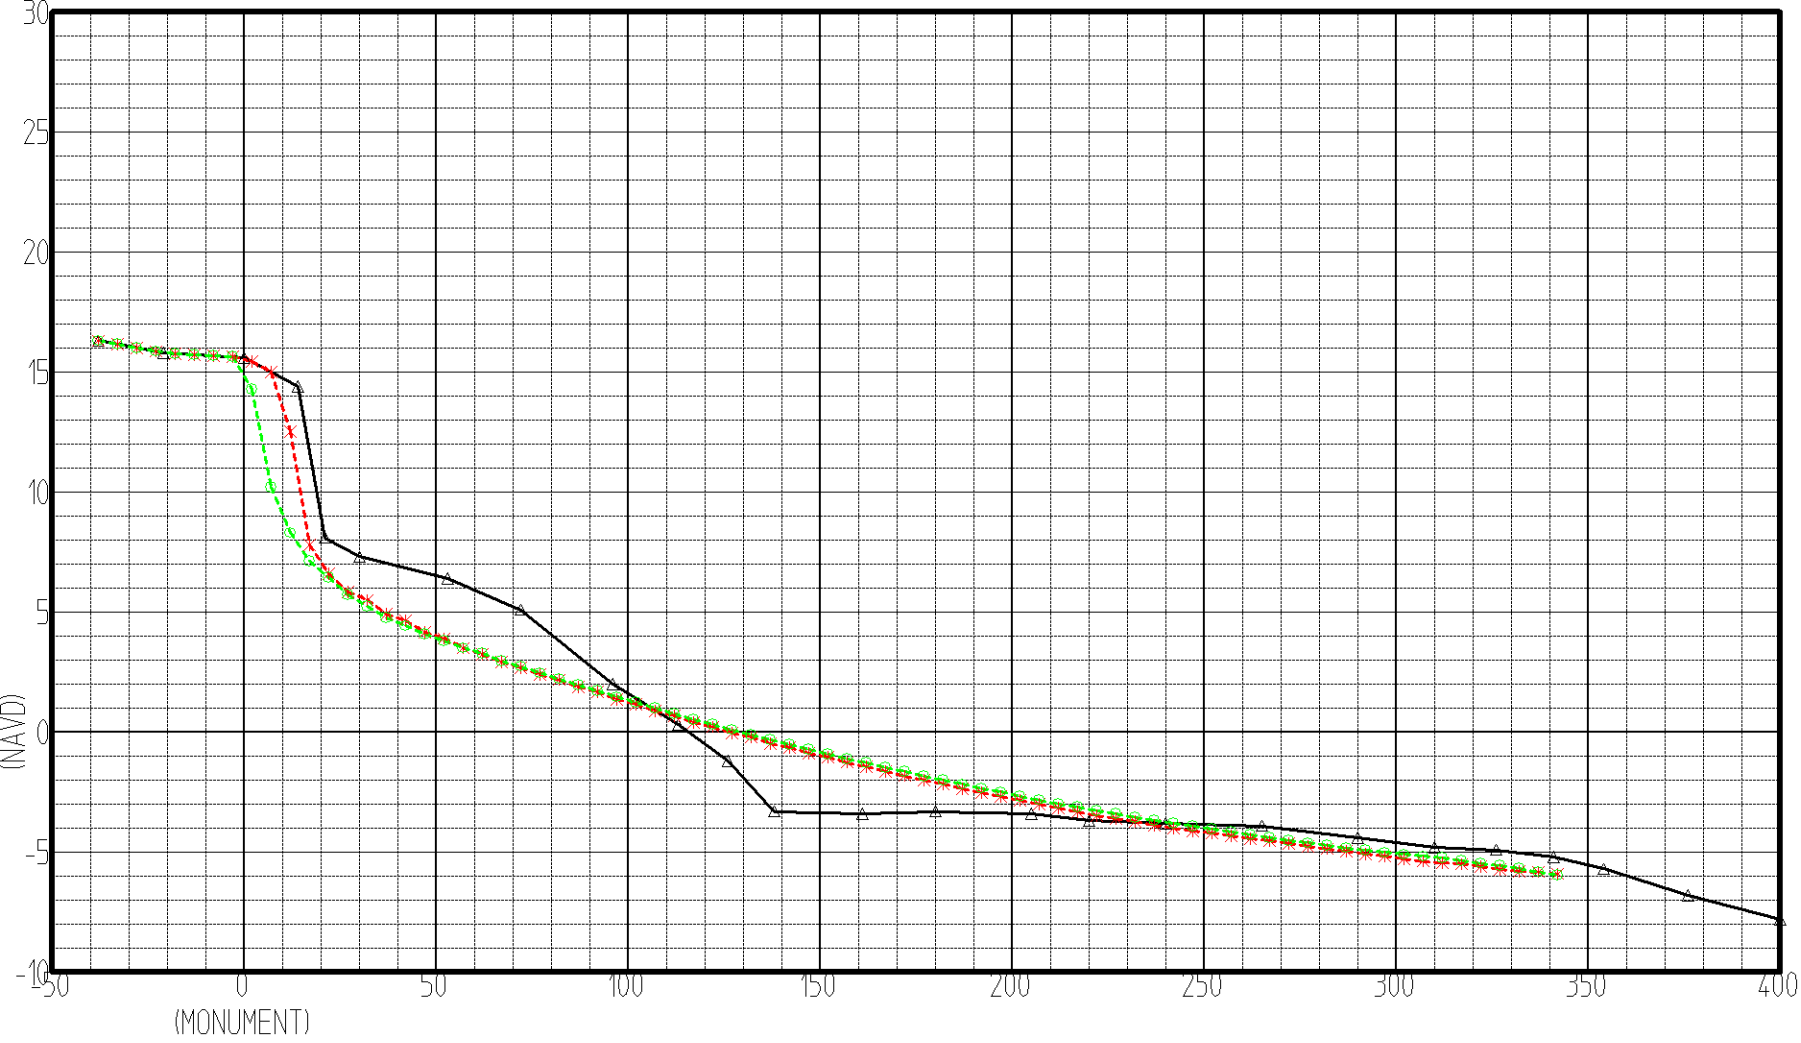
Range: R-90

BEACH PROFILE

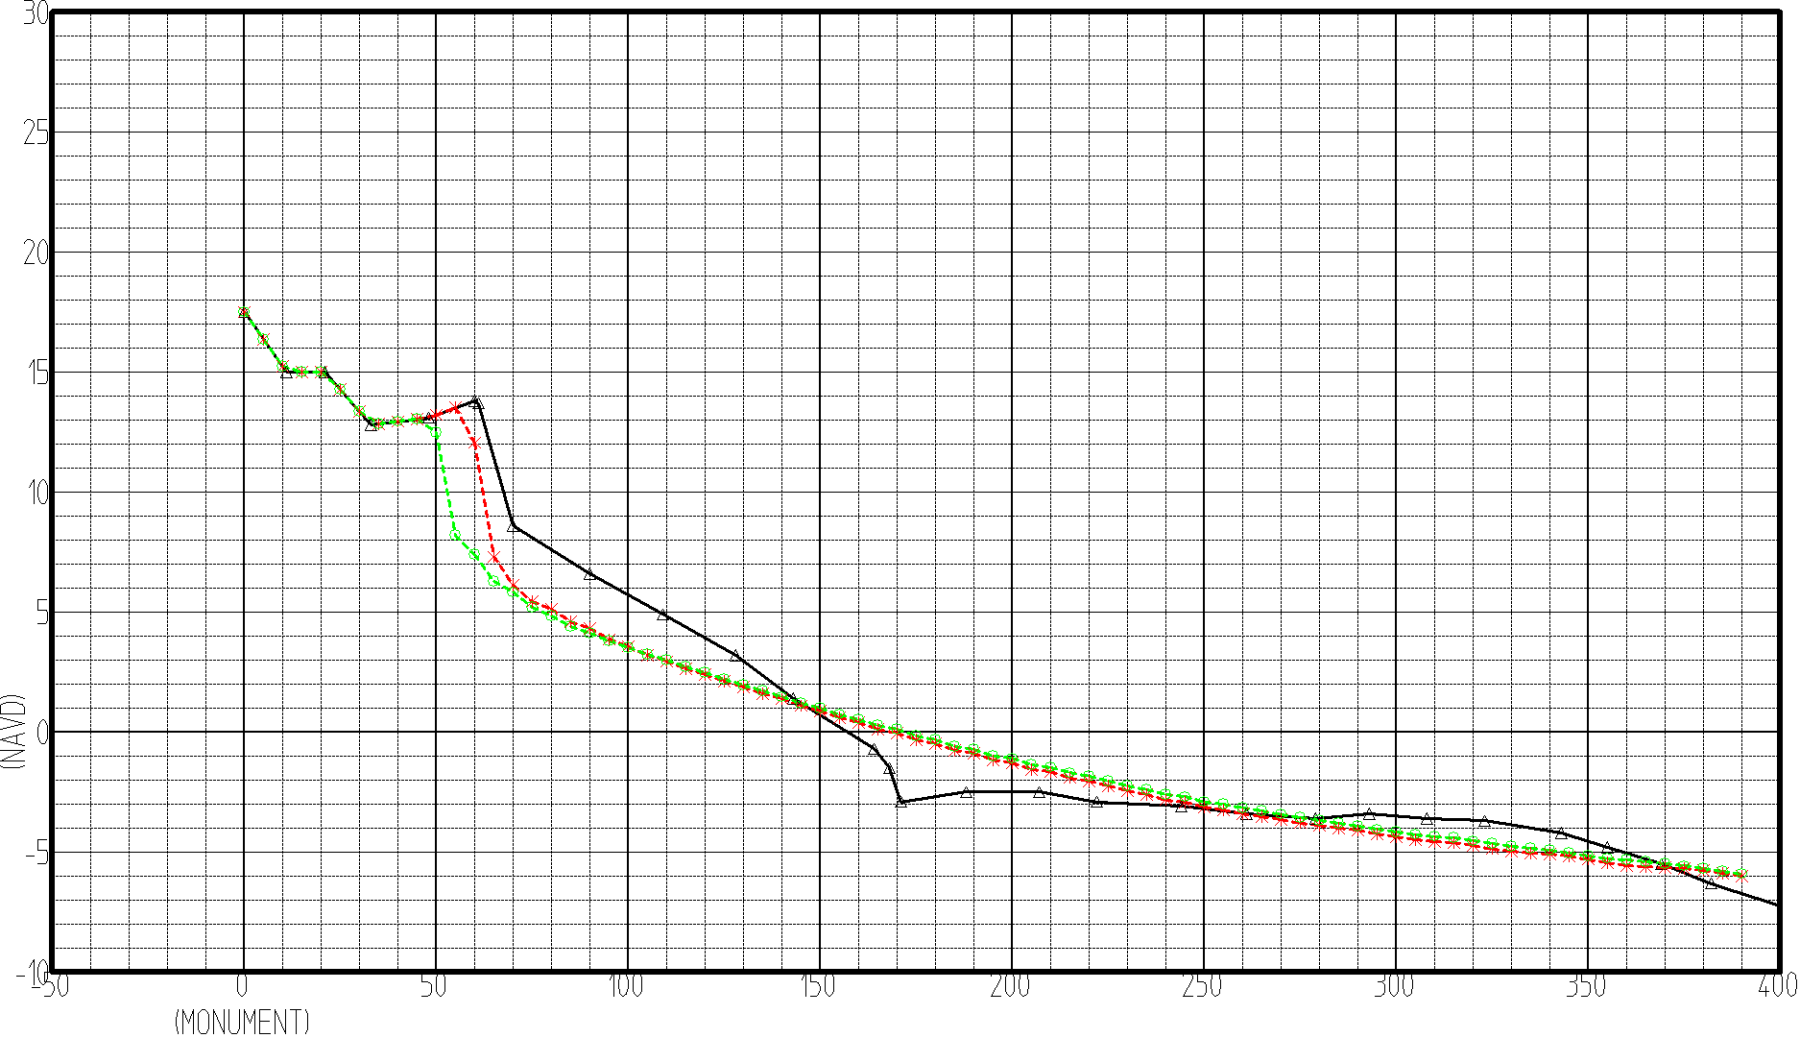
Range: R-91
 BEARING: 75.00
 1/2

BEACH PROFILE
 —△—△— ST. JOHNS 2007-2008 COMBI
 - - * - - - 15YR SBEACH ERODED
 - - o - - - 25YR SBCH ERODED

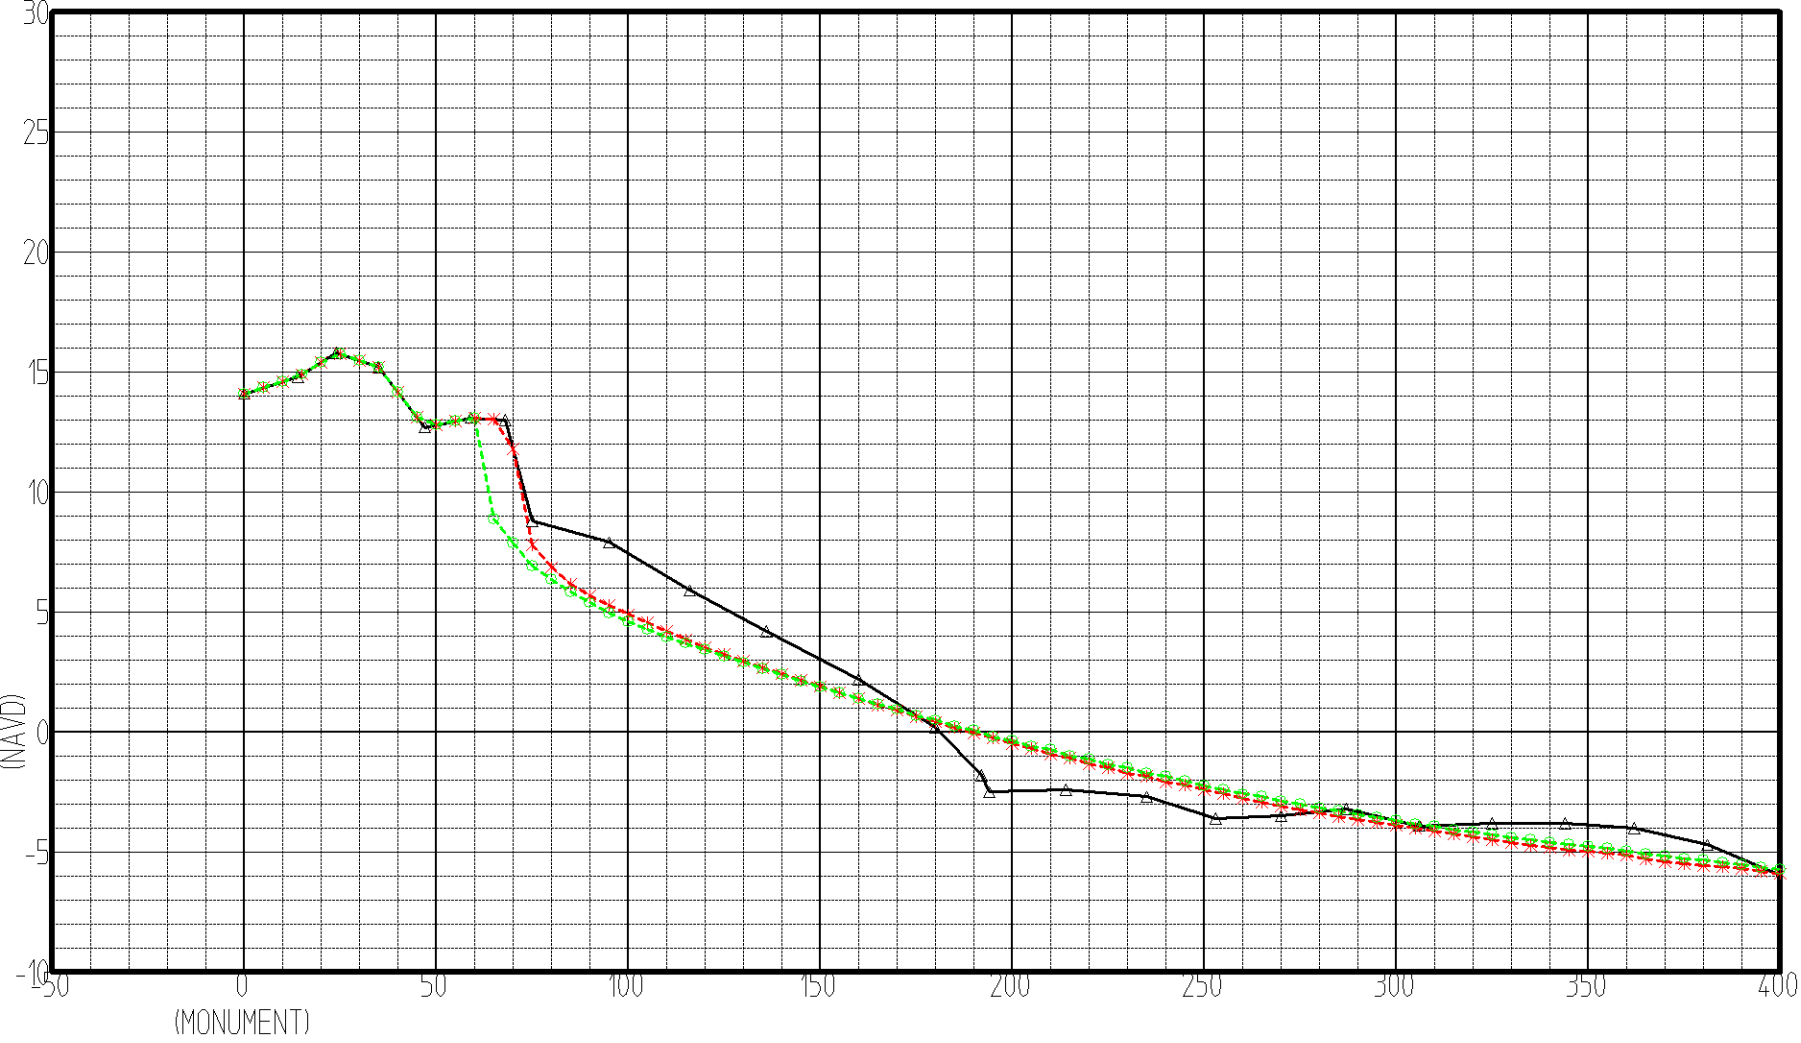
Range: R-92
 BEARING: 75.00
 1/2

BEACH PROFILE
 —△—△— ST. JOHNS 2007-2008 COMBI
 - - * - - 15YR SBEACH ERODED
 - - o - - 25YR SBCH ERODED

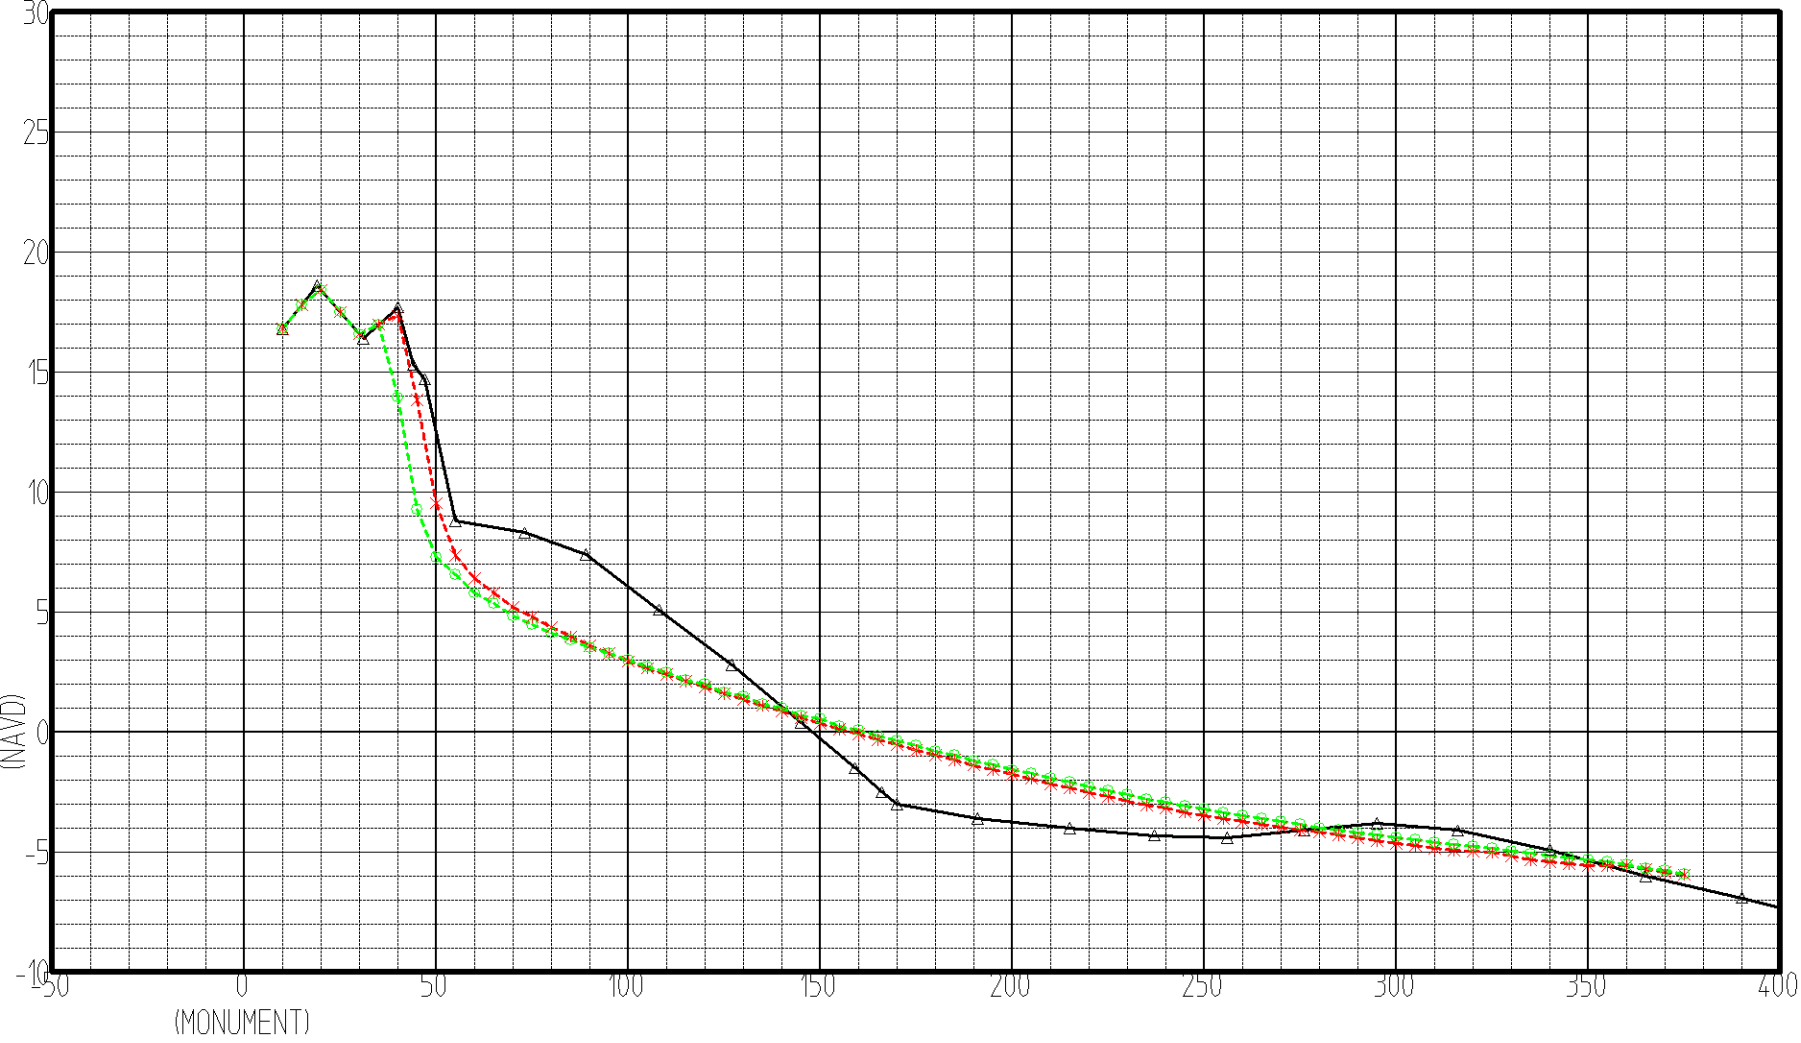
Range: R-96
 BEARING: 75.00
 1/2

BEACH PROFILE
 —△—△— ST. JOHNS 2007-2008 COMBI
 - - * - - 15YR SBEACH ERODED
 - - o - - 25YR SBCH ERODED

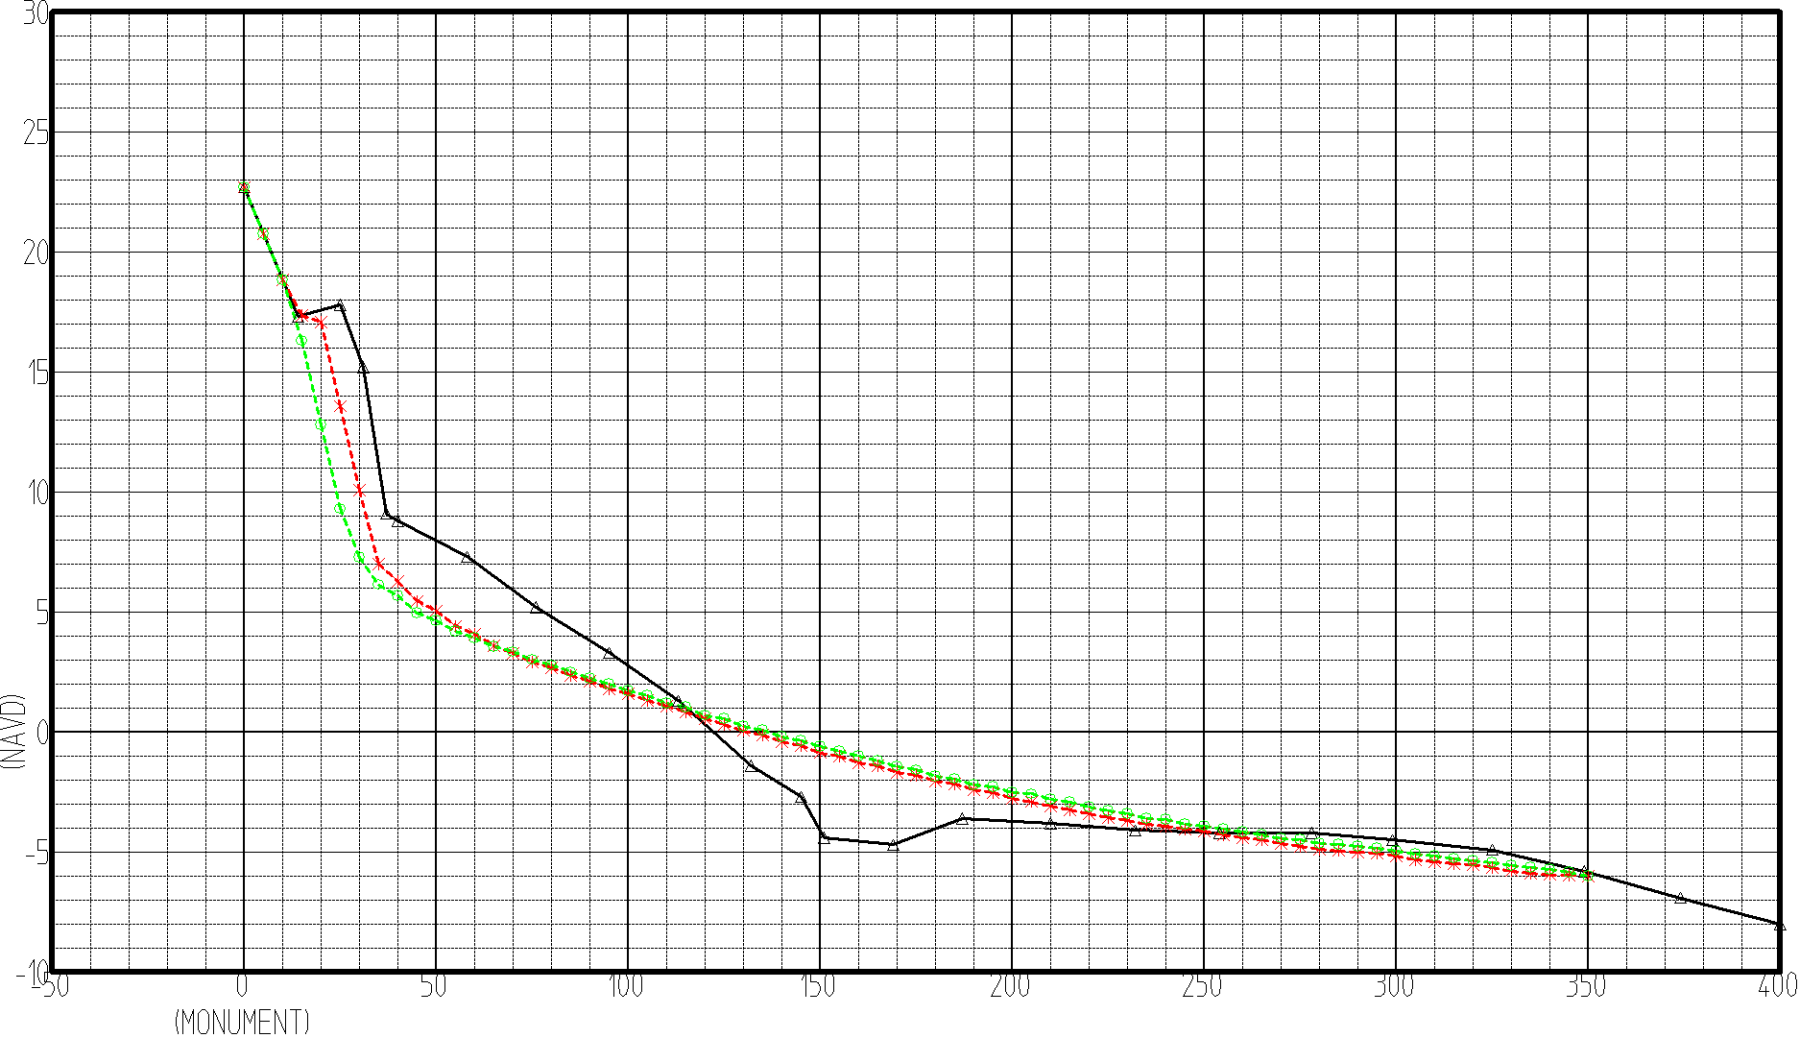
Range: R-97
 BEARING: 75.00
 1/2

BEACH PROFILE
 —△—△— ST. JOHNS 2007-2008 COMBI
 - - * - - 15YR SBEACH ERODED
 - - o - - 25YR SBCH ERODED

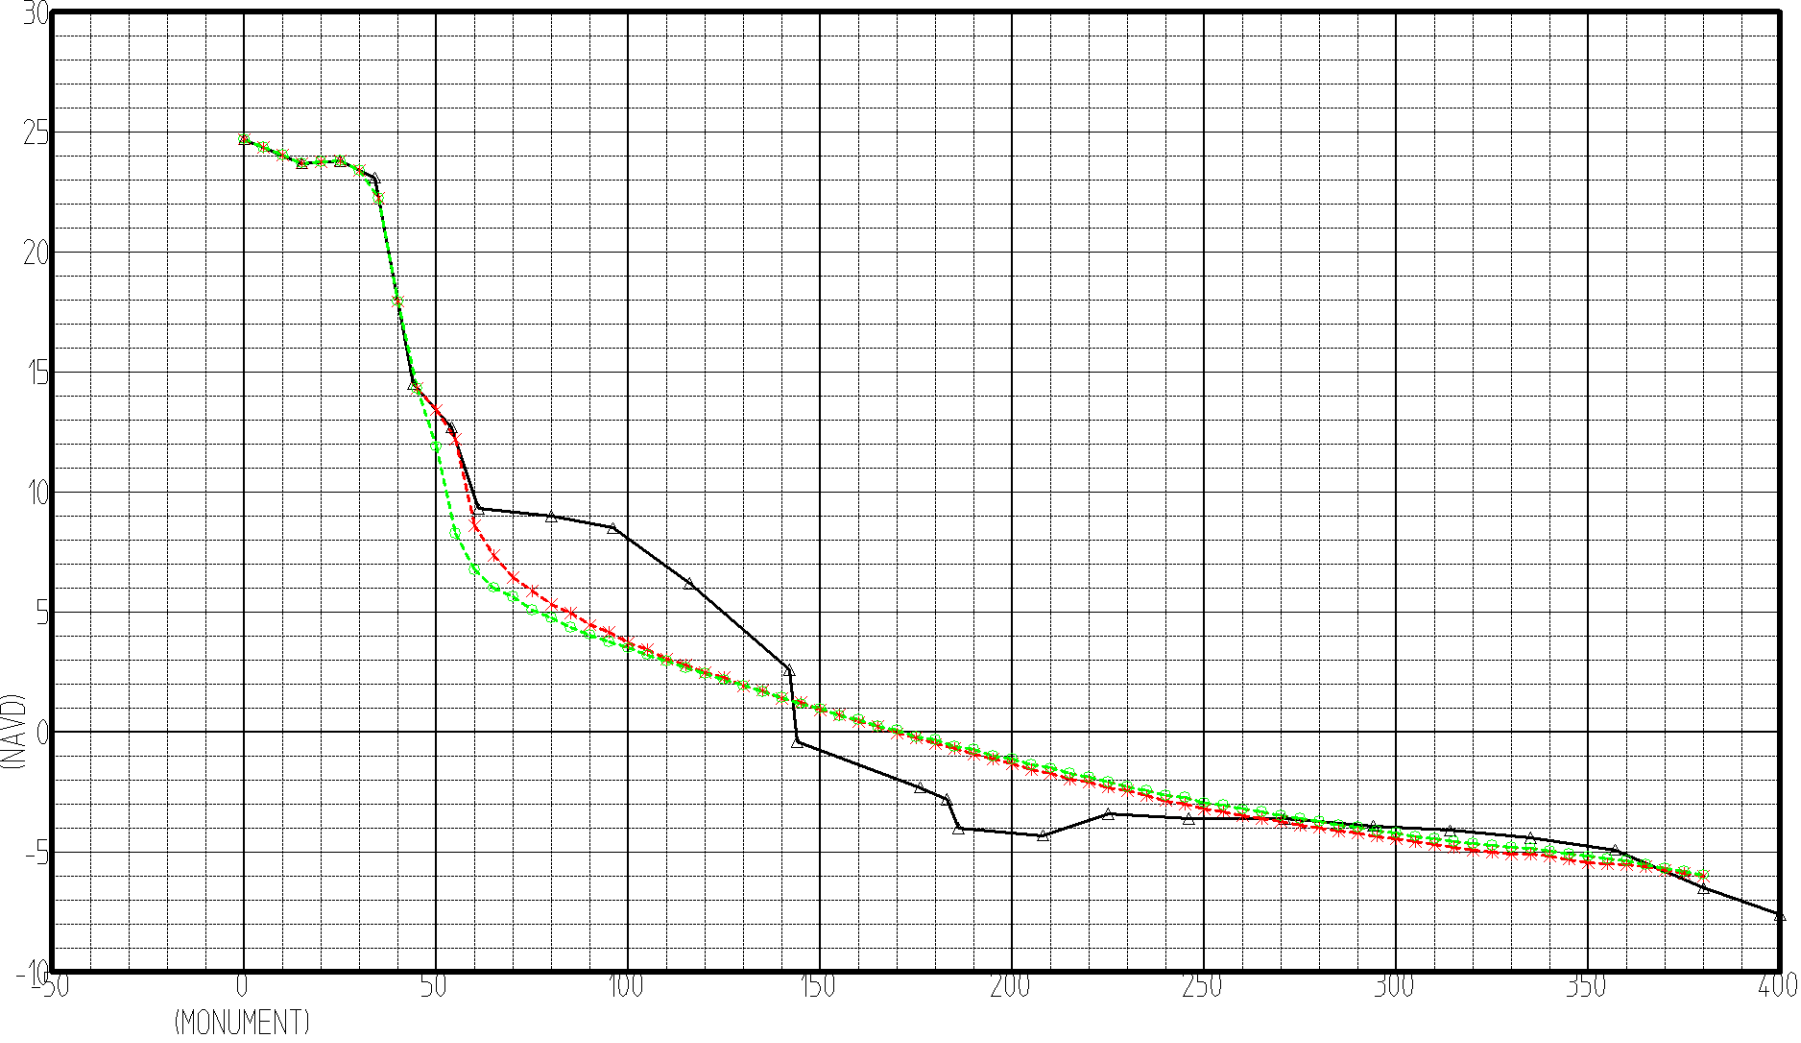
Range: R-98
 BEARING: 75.00
 1/2

BEACH PROFILE
 —△—△— ST. JOHNS 2007-2008 COMBI
 - - * - - 15YR SBCH ERODED
 - - o - - 25YR SBCH ERODED
