Appendix VIII

SBEACH 15 and 25 yr. Storm Erosion Profiles

St. Johns County

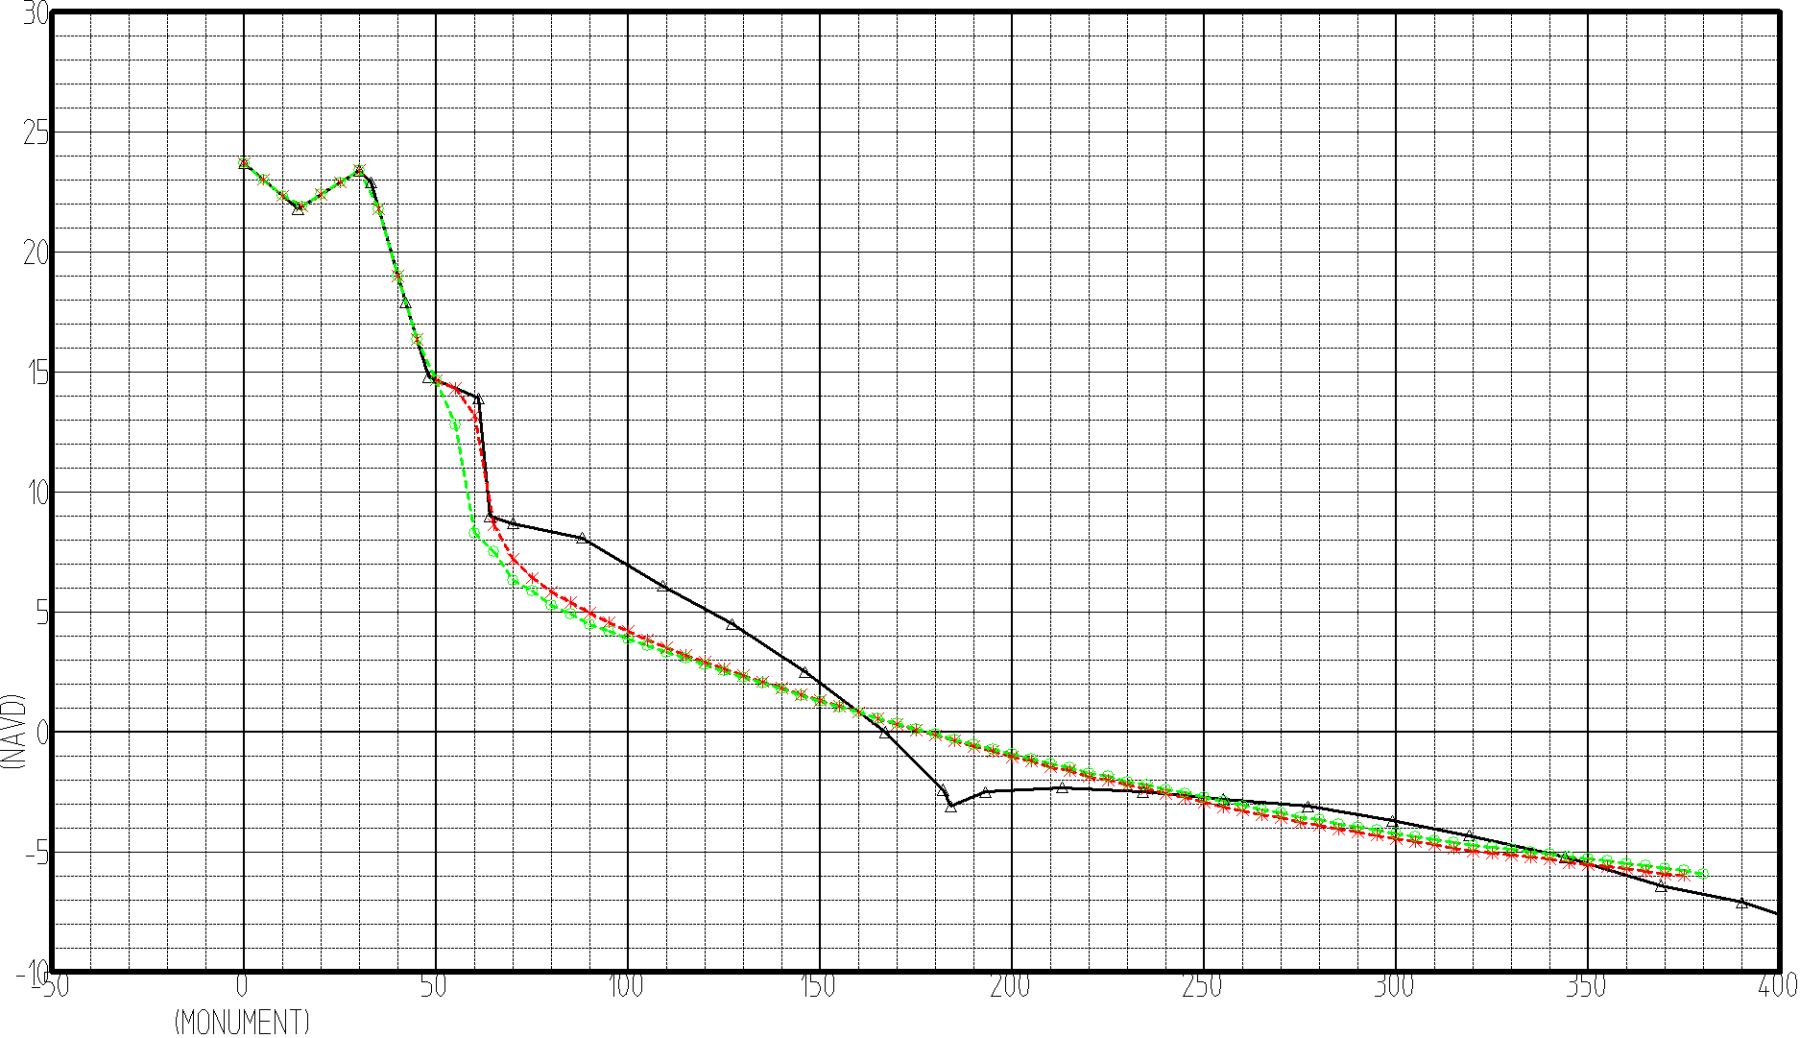
Range: R-99
 BEARING: 75.00
 1/2

BEACH PROFILE
 —△—△— ST. JOHNS 2007-2008 COMBI
 - - * - - 15YR SBEACH ERODED
 - - o - - 25YR SBCH ERODED

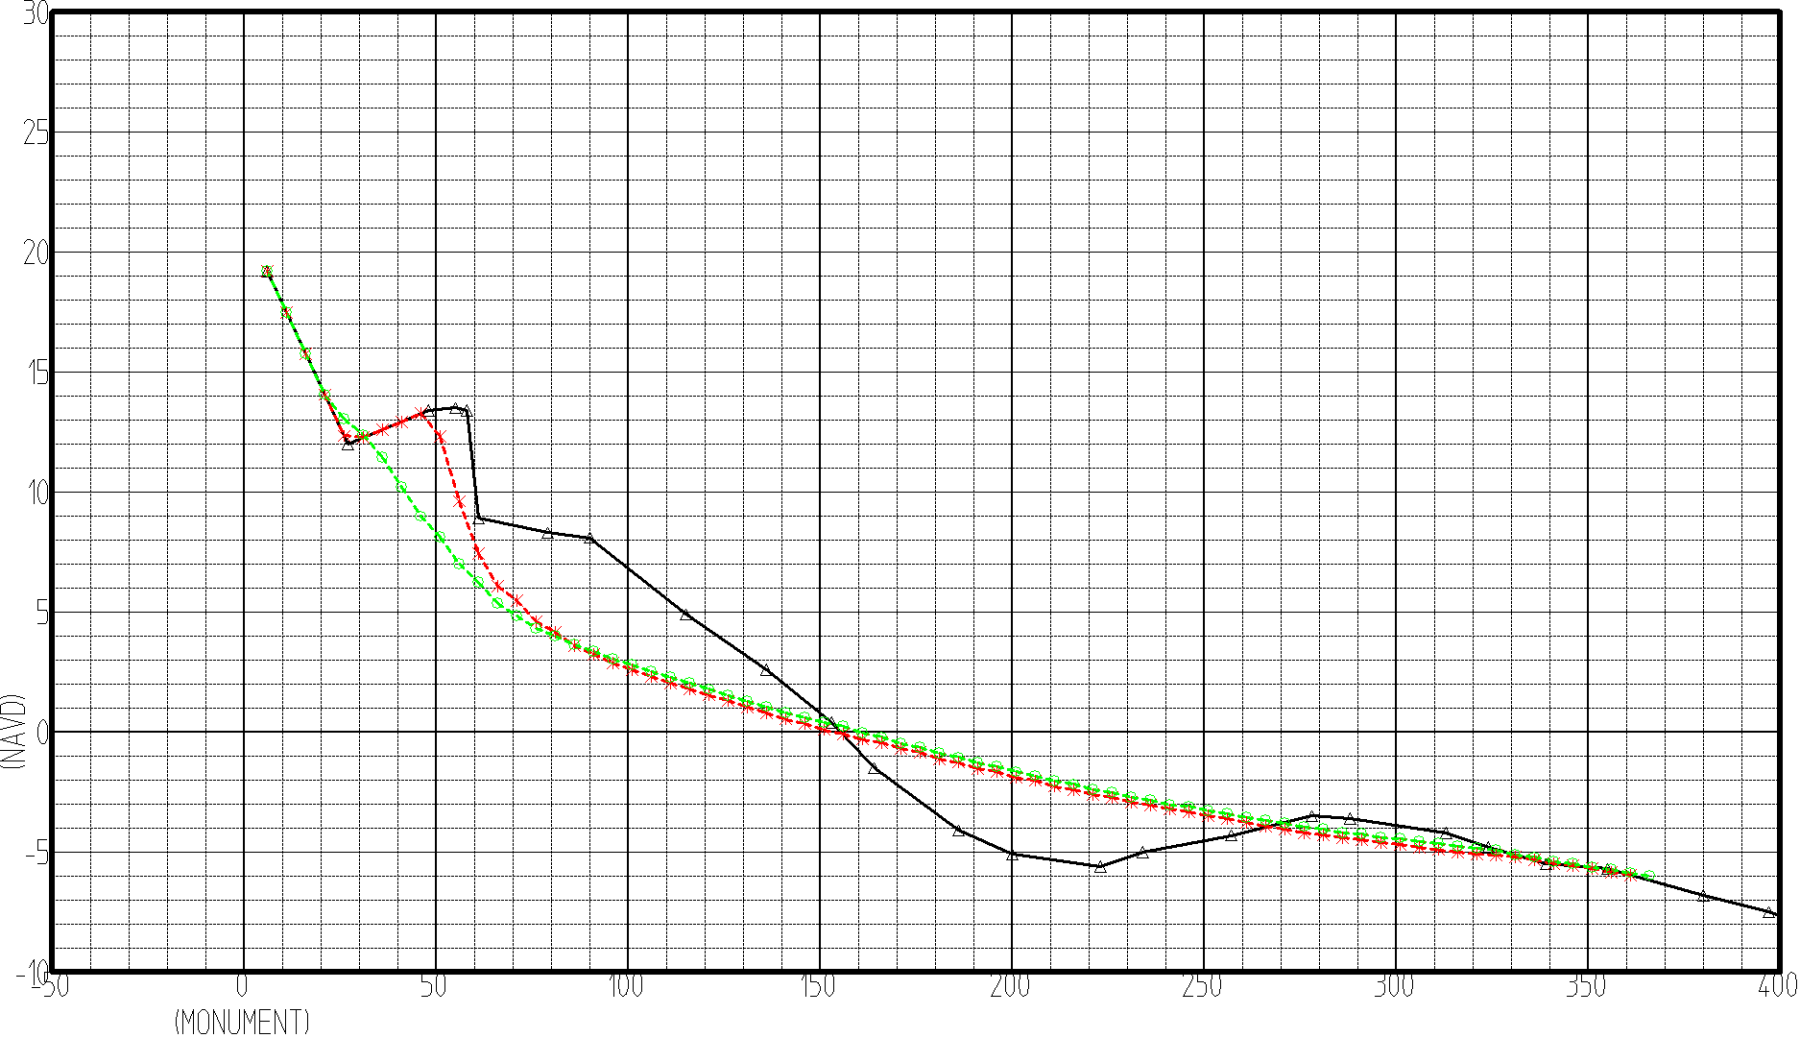
Range: R-100
 BEARING: 75.00
 1/2

BEACH PROFILE
 —△—△— ST. JOHNS 2007-2008 COMBI
 - - * - - - 15YR SBEACH ERODED
 - - o - - - 25YR SBCH ERODED

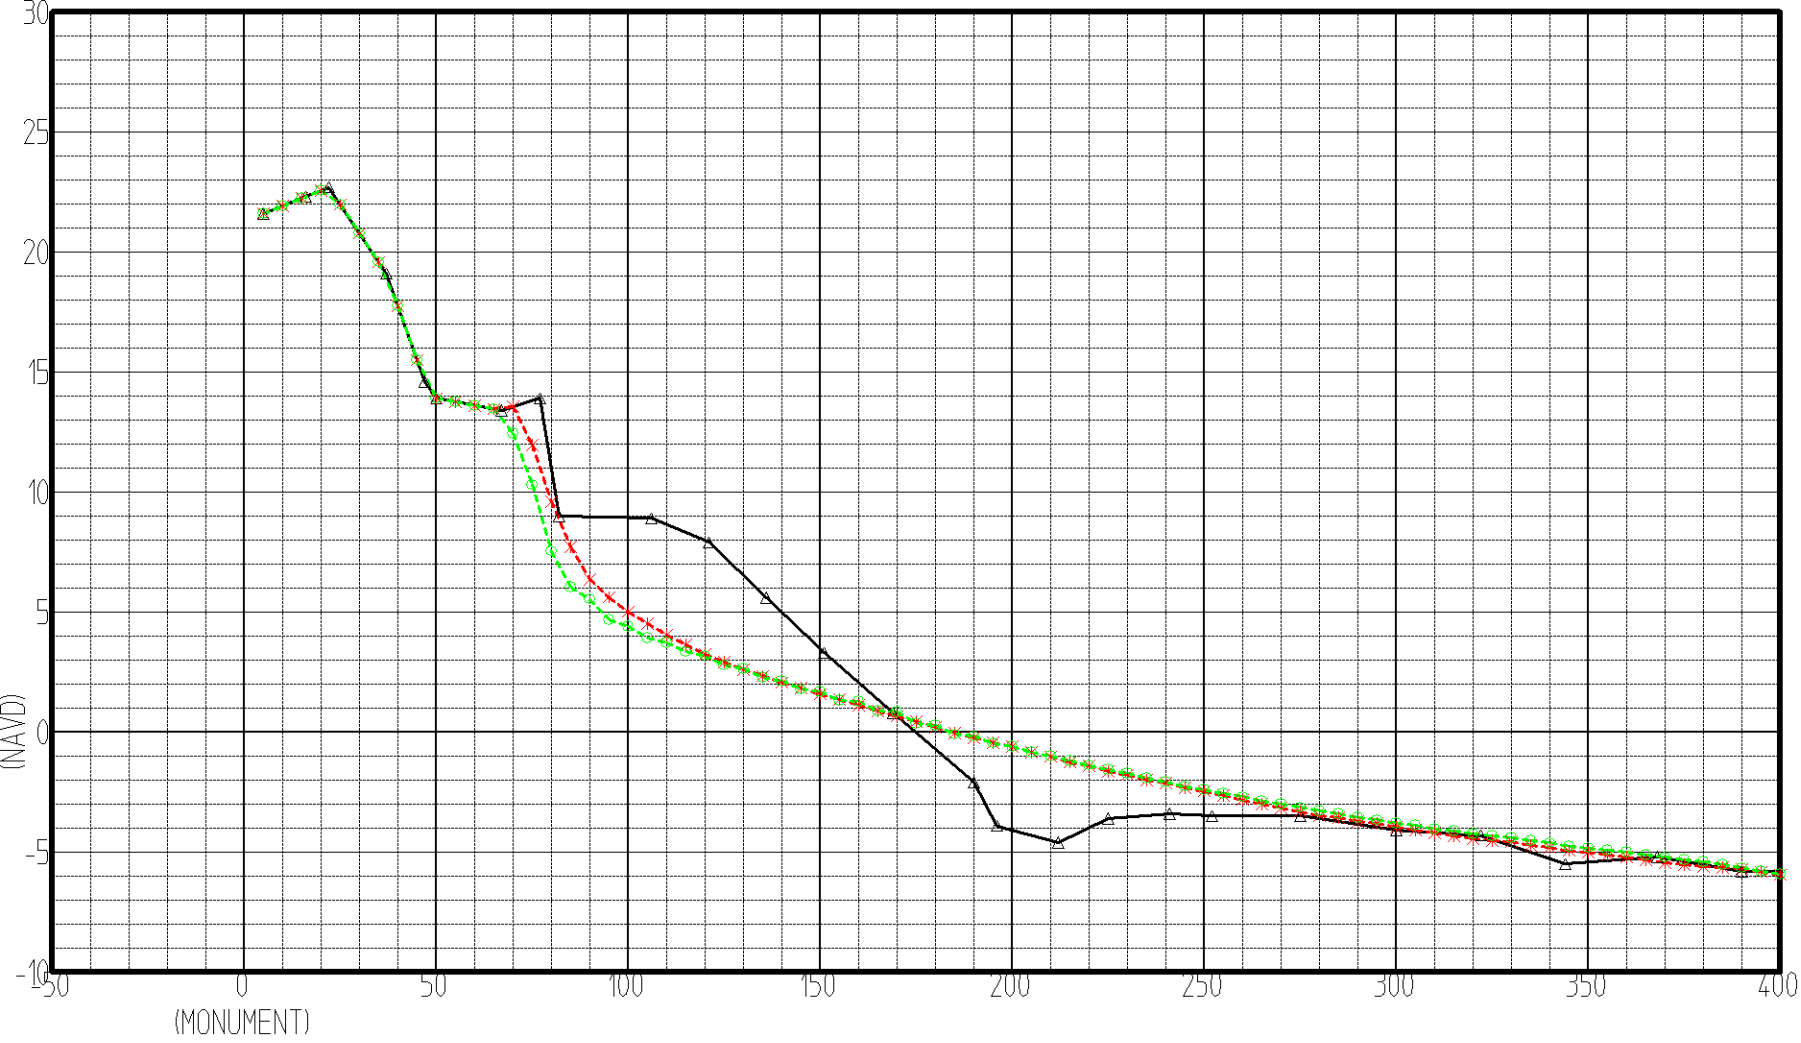
Range: R-103
 BEARING: 75.00
 1/2

BEACH PROFILE
 —△—△— ST. JOHNS 2007-2008 COMBI
 - - * - - 15YR SBEACH ERODED
 - - o - - 25YR SBCH ERODED

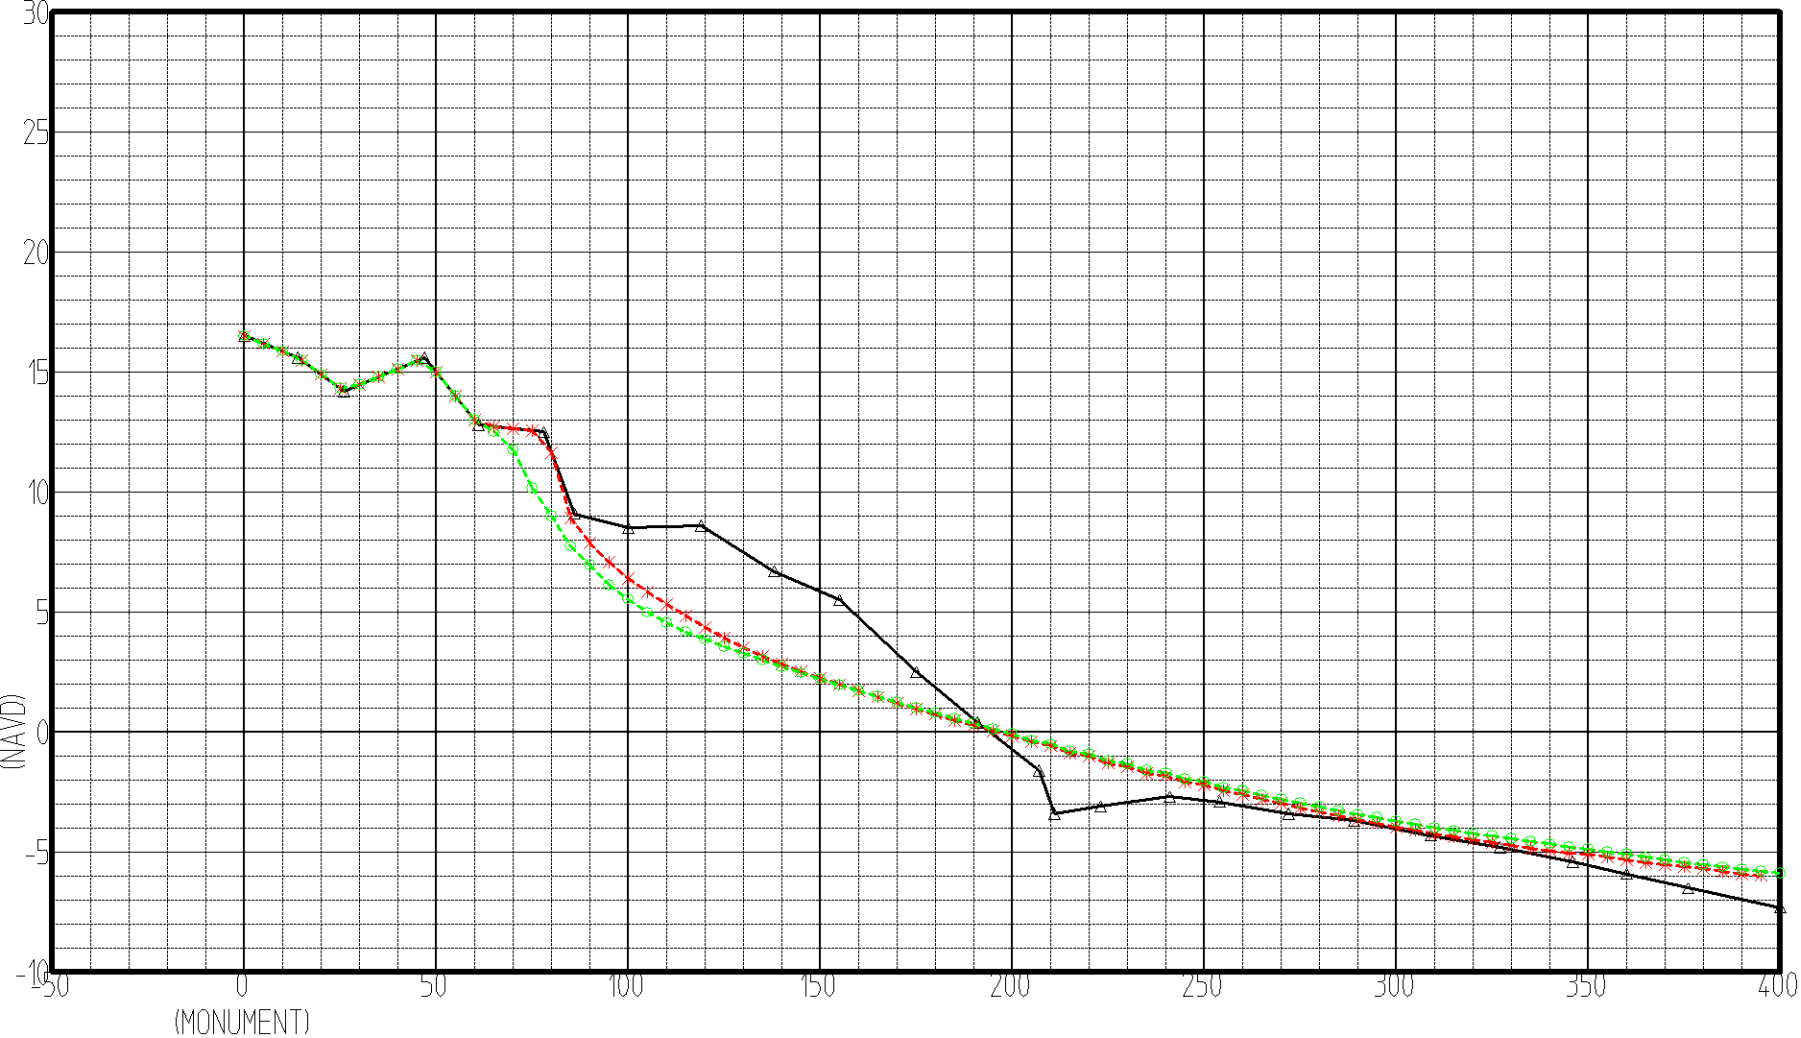
Range: R-105
 BEARING: 75.00
 1/2

BEACH PROFILE
 —△—△— ST. JOHNS 2007-2008 COMBI
 - - * - - 15YR SBCH ERODED
 - - o - - 25YR SBCH ERODED

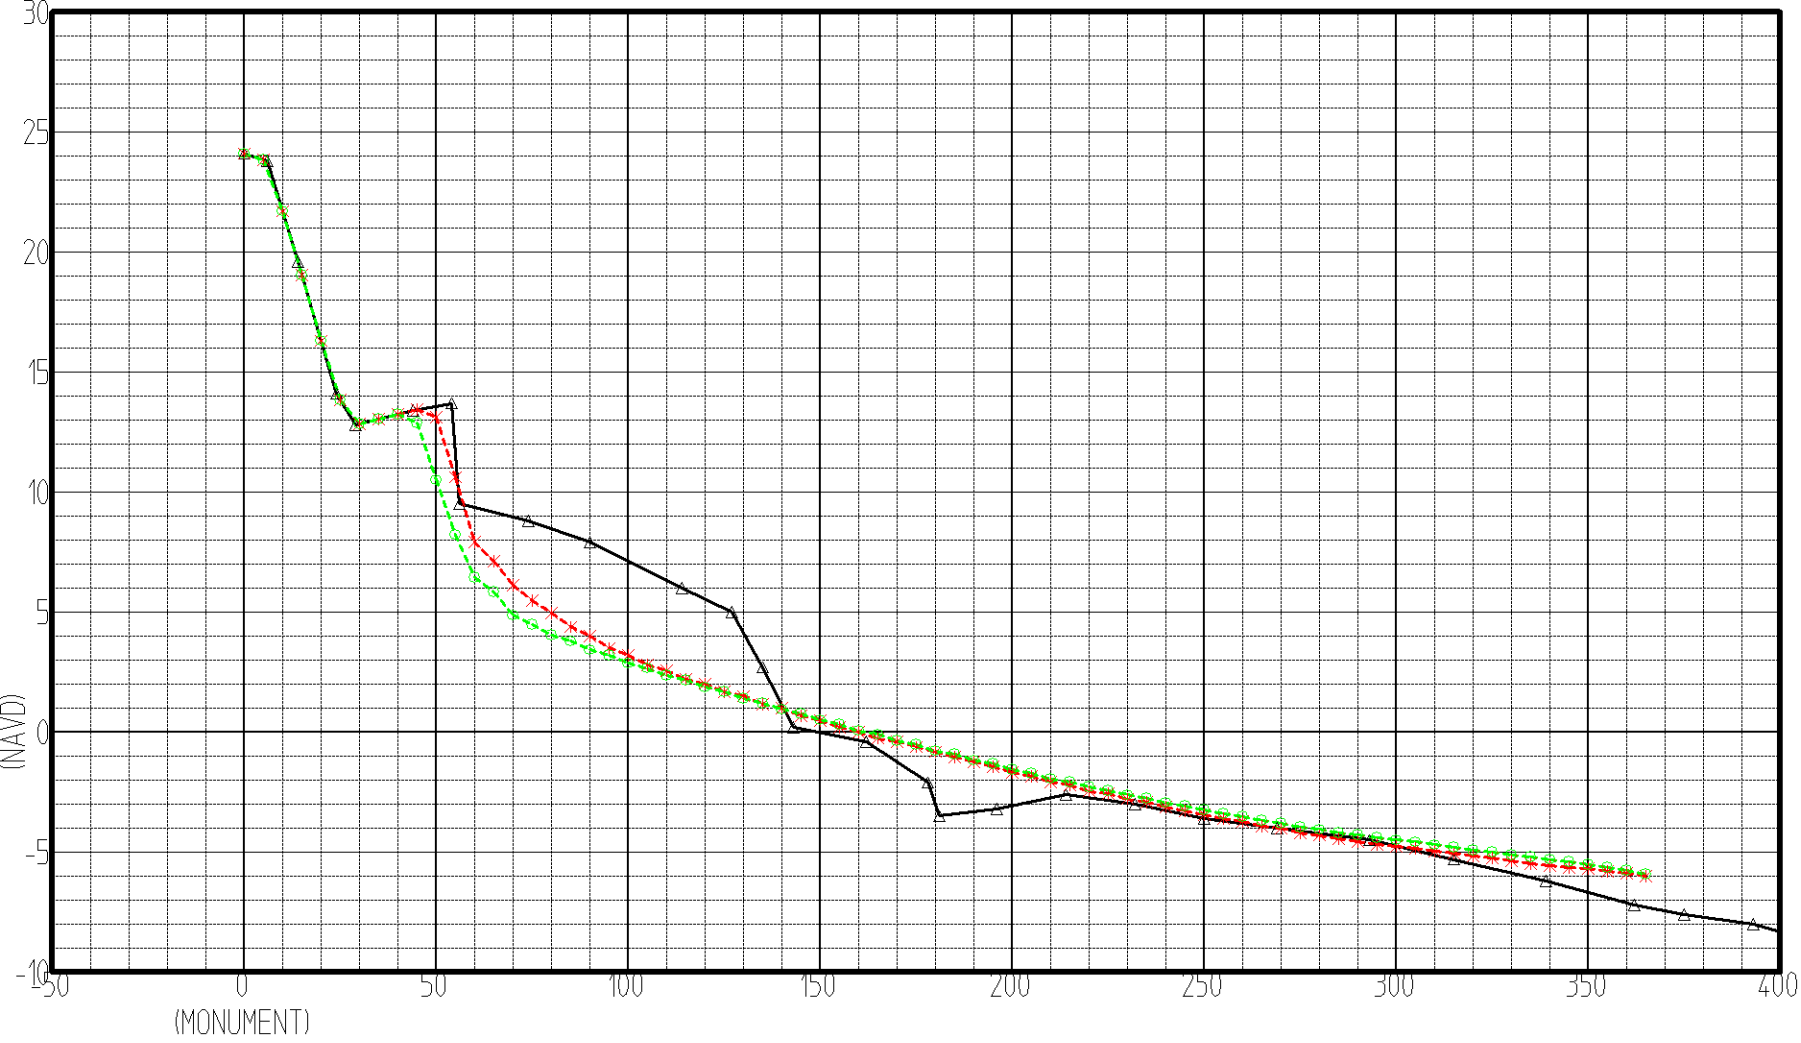
Range: R-107
 BEARING: 75.00
 1/2

BEACH PROFILE
 —△—△— ST. JOHNS 2007-2008 COMBI
 - - * - - 15YR SBEACH ERODED
 - - o - - 25YR SBCH ERODED

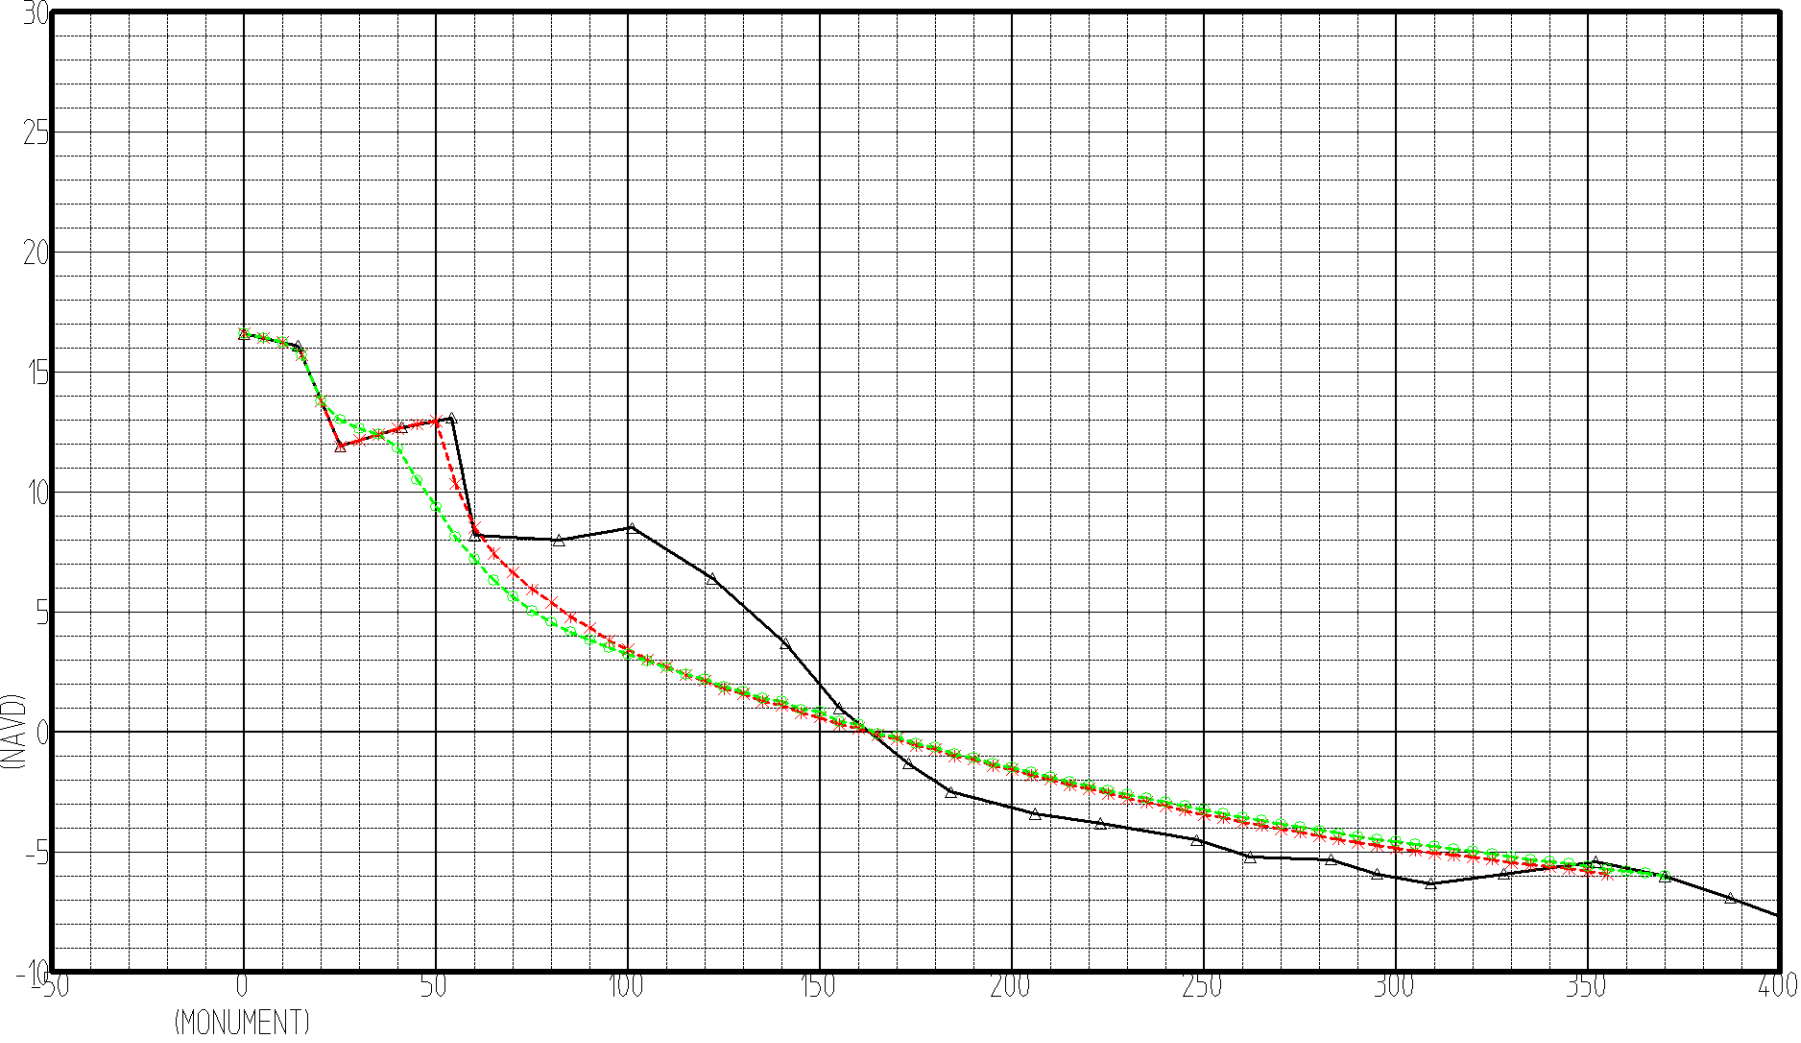
Range: R-108
 BEARING: 75.00
 1/2

BEACH PROFILE
 —△—△— ST. JOHNS 2007-2008 COMBI
 - - * - - - 15YR SBEACH ERODED
 - - o - - - 25YR SBCH ERODED

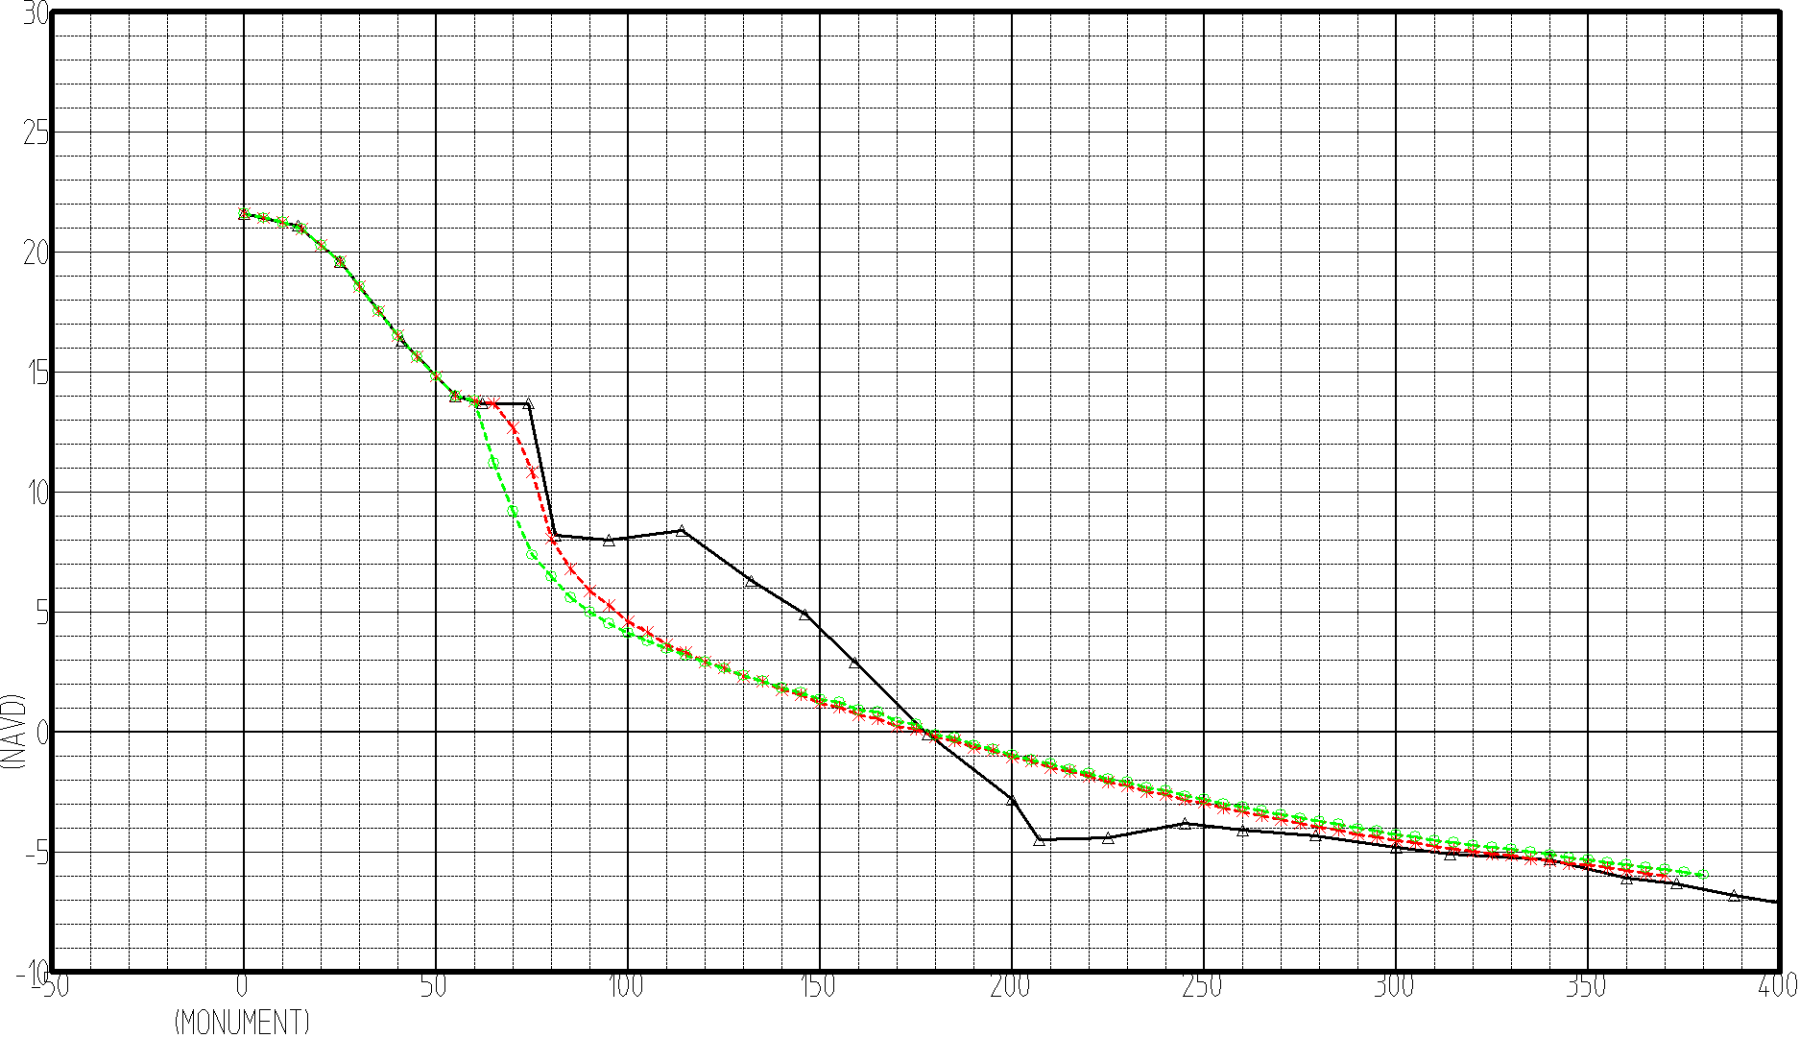
Range: R-109
 BEARING: 75.00
 1/2

BEACH PROFILE
 —△—△— ST. JOHNS 2007-2008 COMBI
 - - * - - * - - 15YR SBEACH ERODED
 - - o - - o - - 25YR SBCH ERODED

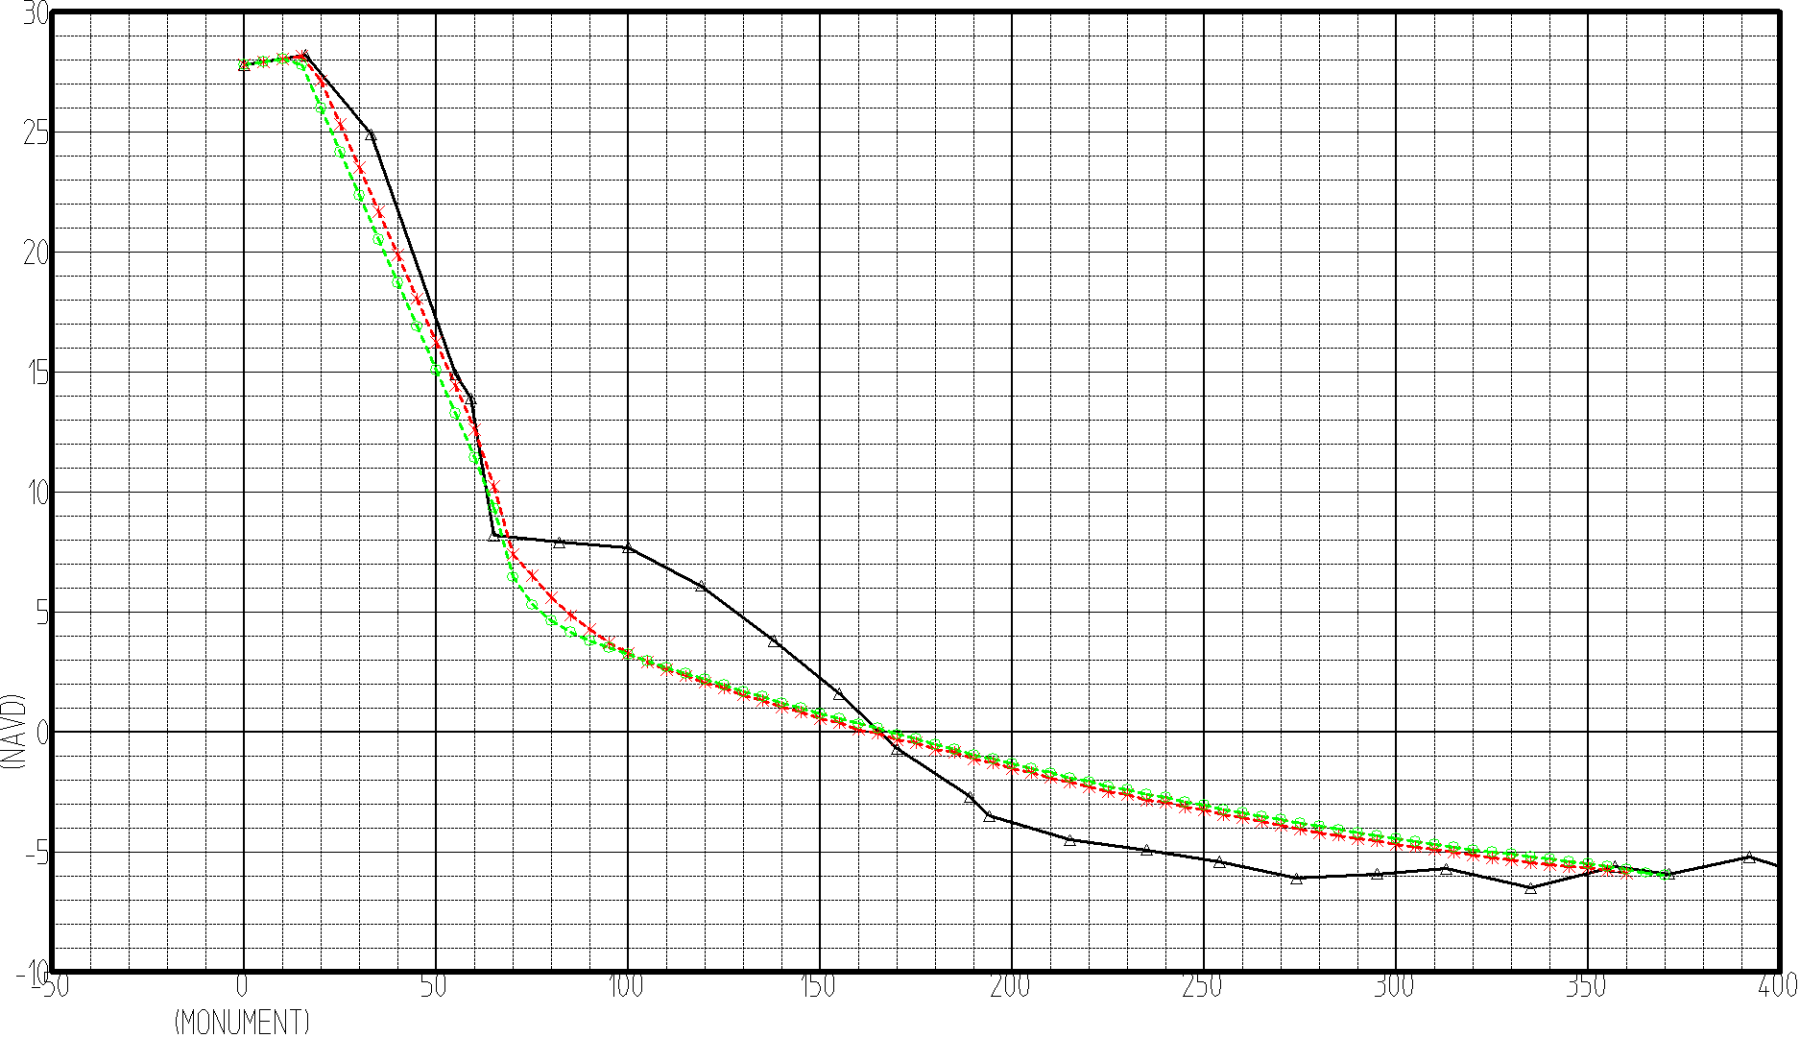
Range: R-111

BEACH PROFILE

—△—△— ST. JOHNS 2007-2008 COMBI

- - * - - - 15YR SBEACH ERODED

- - o - - - 25YR SBCH ERODED

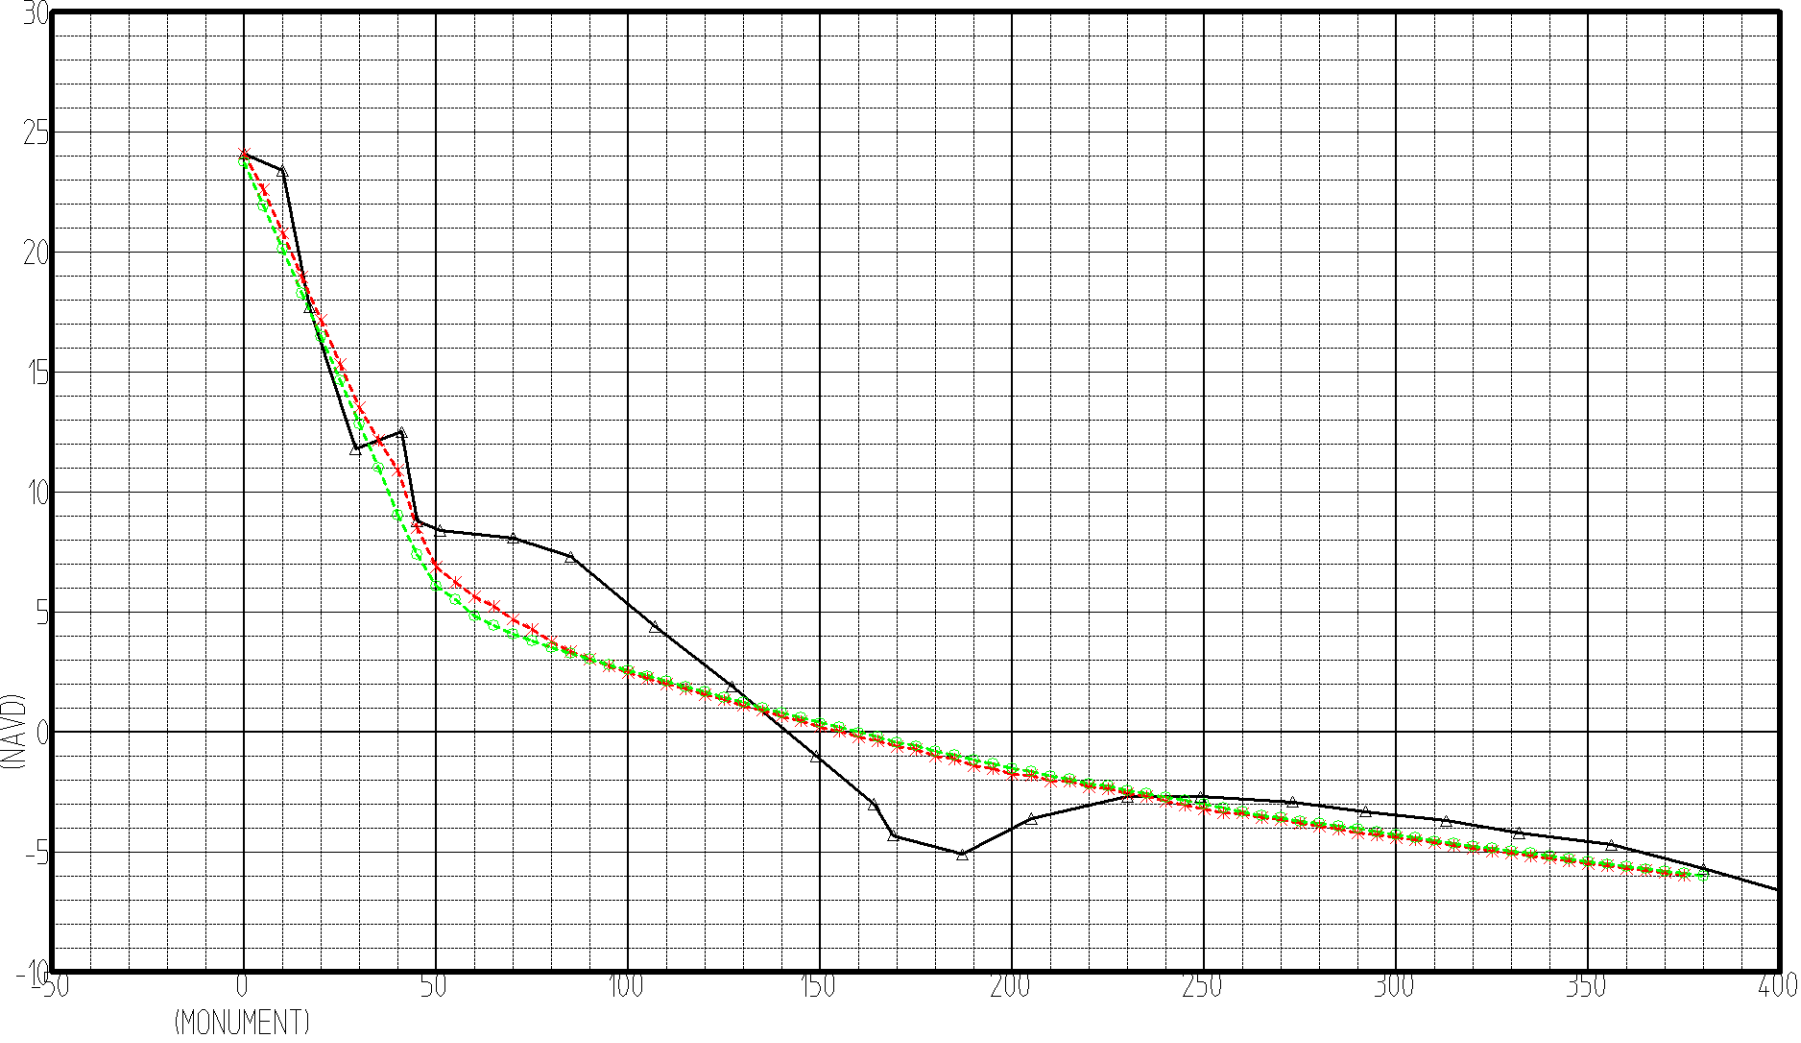
Range: T-112

BEACH PROFILE

—△—△— ST. JOHNS 2007-2008 COMBI

- - * - - 15YR SBEACH ERODED

- - o - - 25YR SBCH ERODED

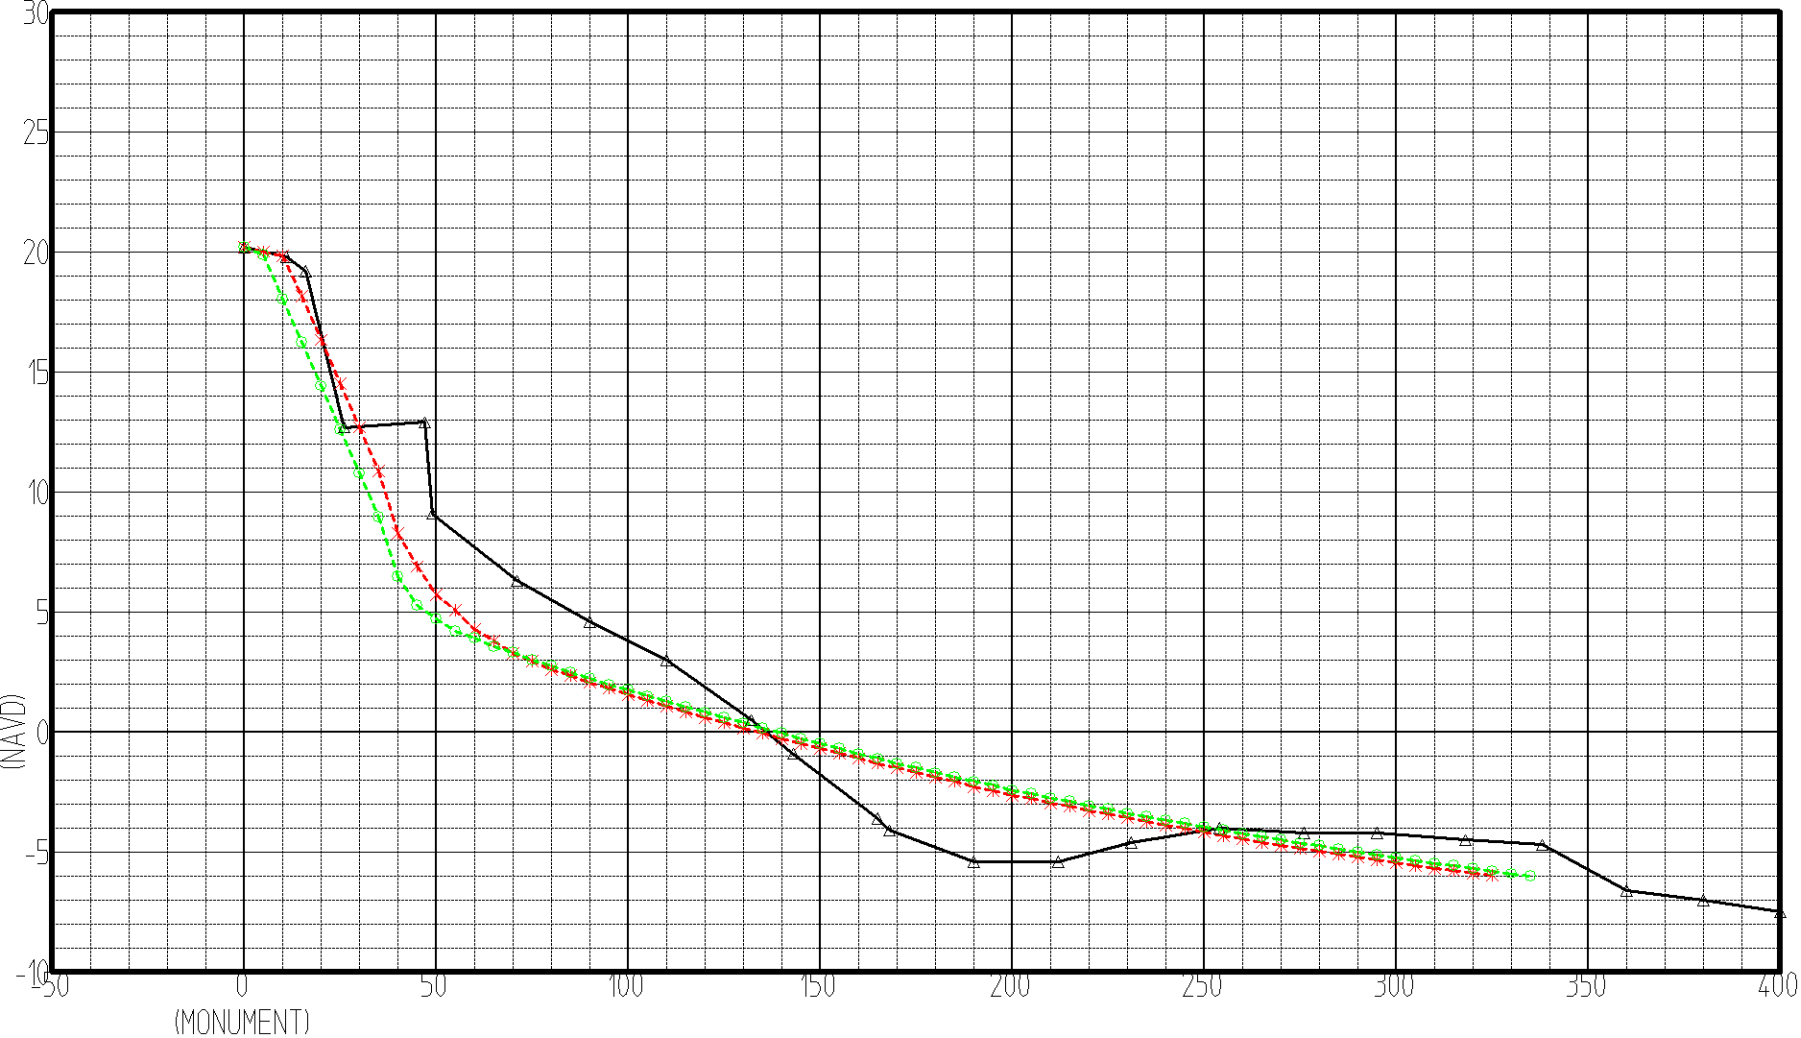
Range: R-113
 BEARING: 75.00
 1/2

BEACH PROFILE
 —△—△— ST. JOHNS 2007-2008 COMBI
 - - * - - 15YR SBEACH ERODED
 - - o - - 25YR SBCH ERODED

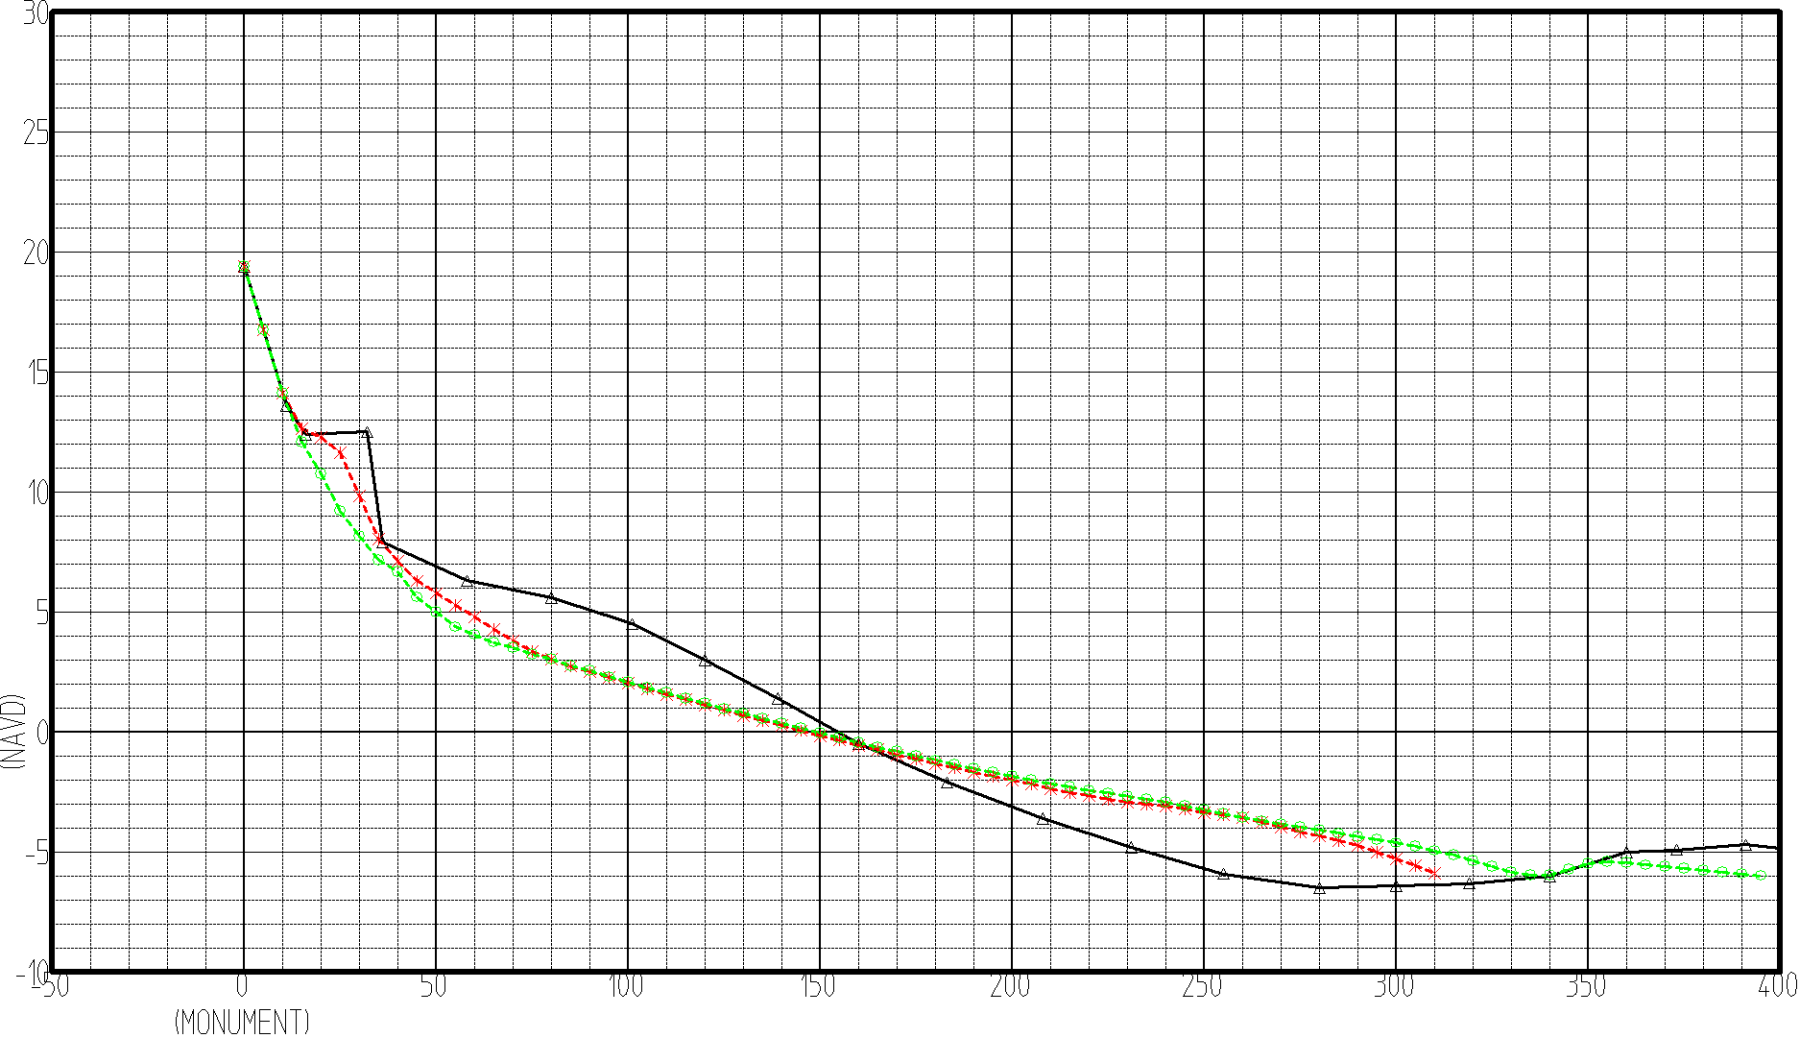
Range: T-114 1/2
 BEARING: 75.00

BEACH PROFILE
 —△— ST. JOHNS 2007-2008 COMBI
 - - * - - 15YR SBACH ERODED
 - - ○ - - 25YR SBCH ERODED

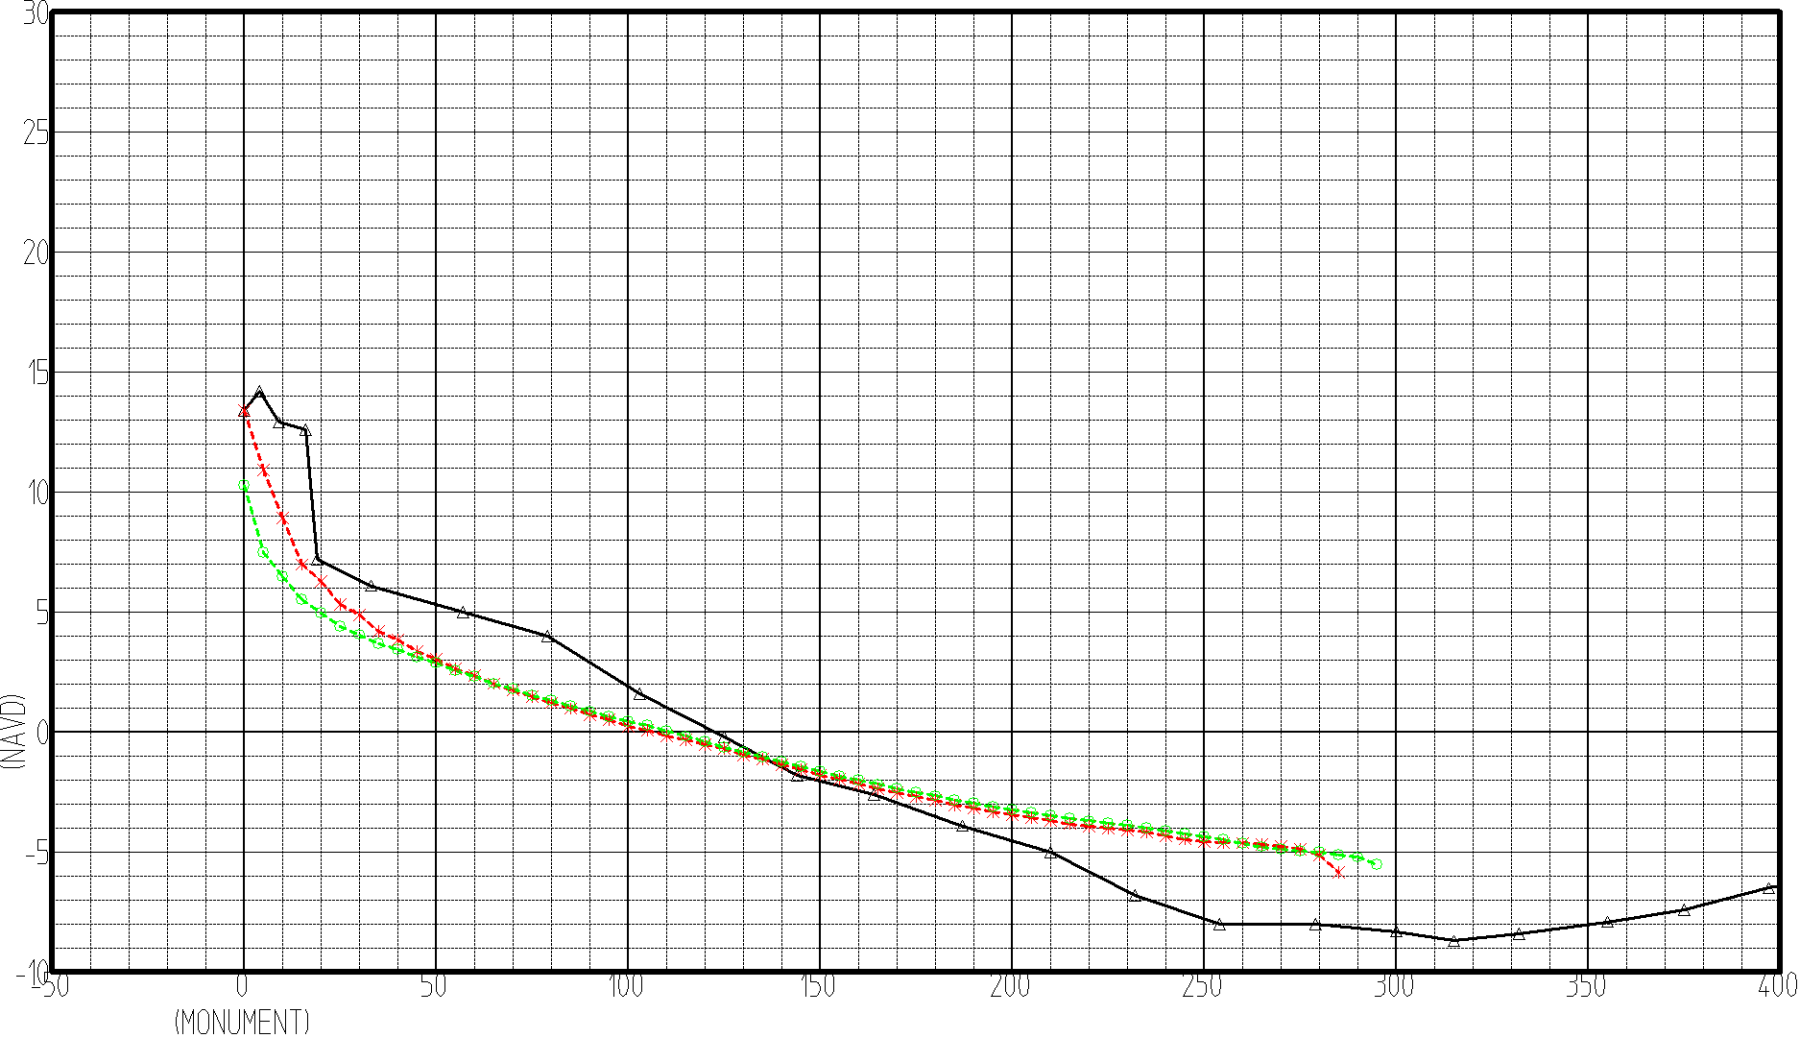
Range: R-115
 BEARING: 75.00
 1/2

BEACH PROFILE
 —△—△— ST. JOHNS 2007-2008 COMBI
 - - * - - - 15YR SBEACH ERODED
 - - o - - - 25YR SBCH ERODED
