Appendix VIII

SBEACH 15 and 25 yr. Storm Erosion Profiles

St. Johns County

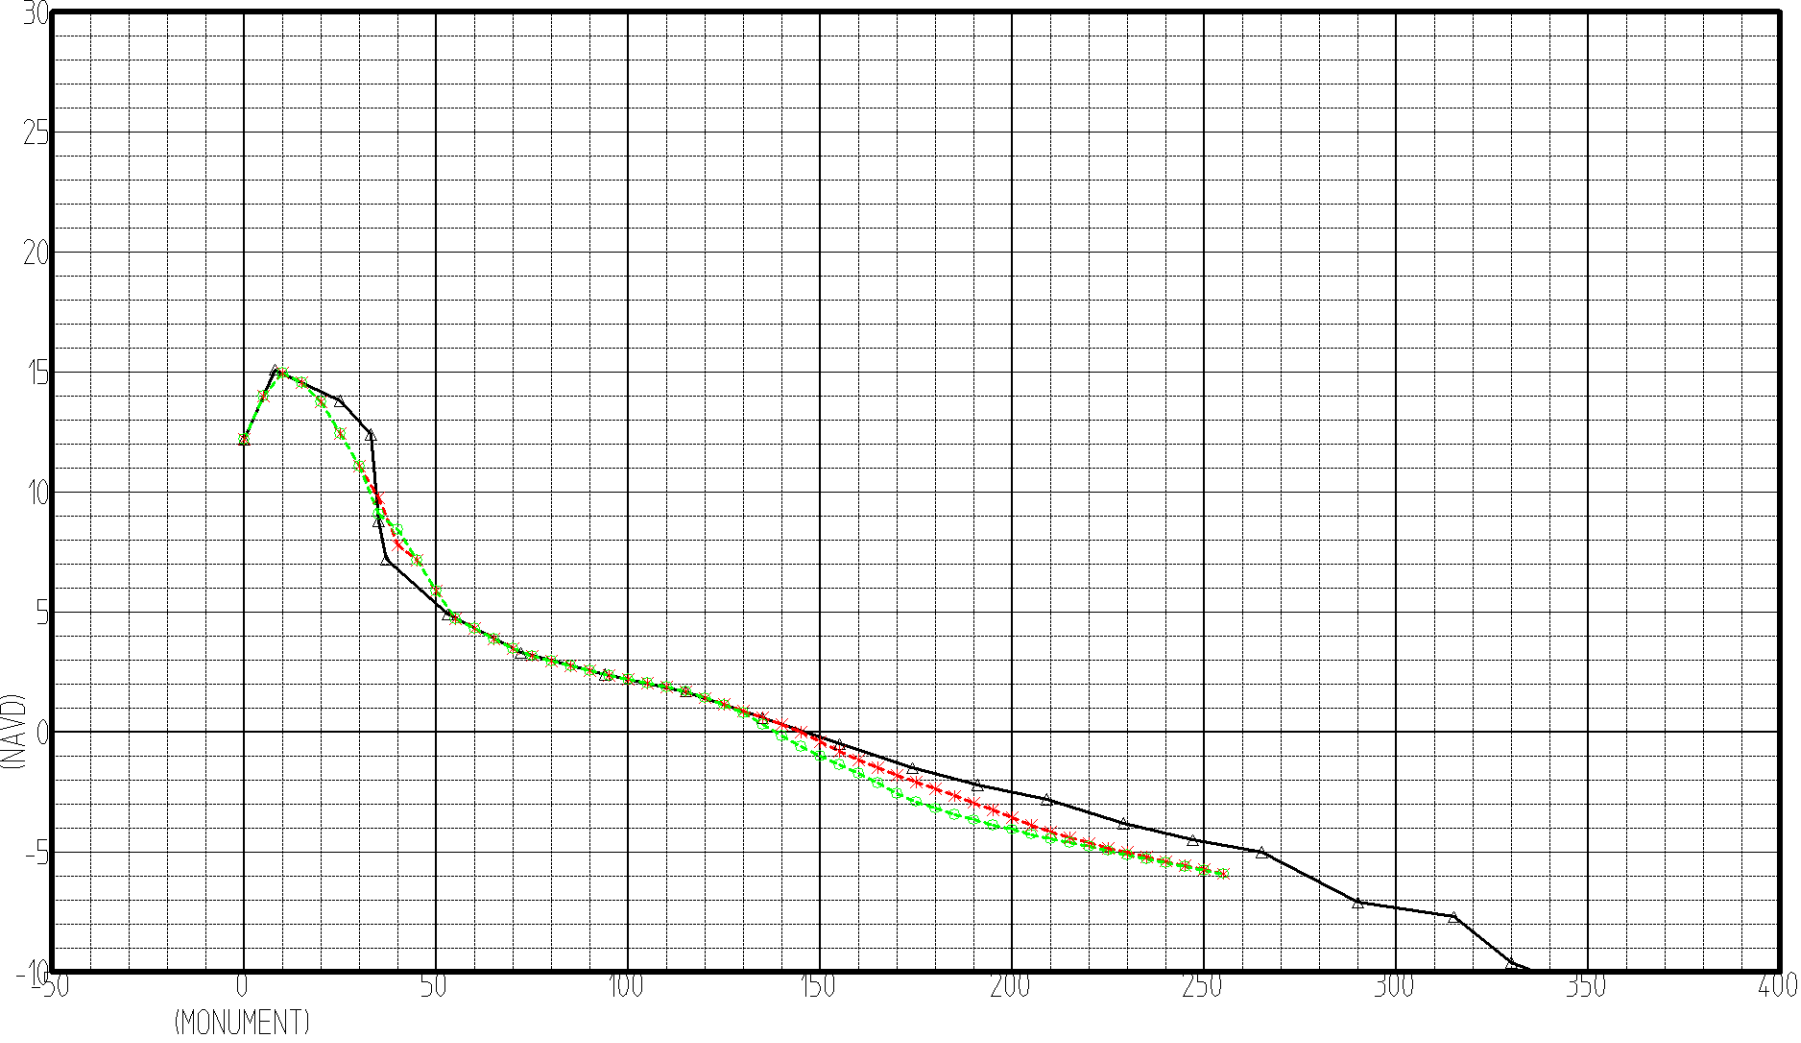
Range: R-116
 BEARING: 75.00
 1/2

BEACH PROFILE
 —△—△— ST. JOHNS 2007-2008 COMBI
 - - * - - 15YR SBEBACH ERODED
 - - o - - 25YR SBCH ERODED

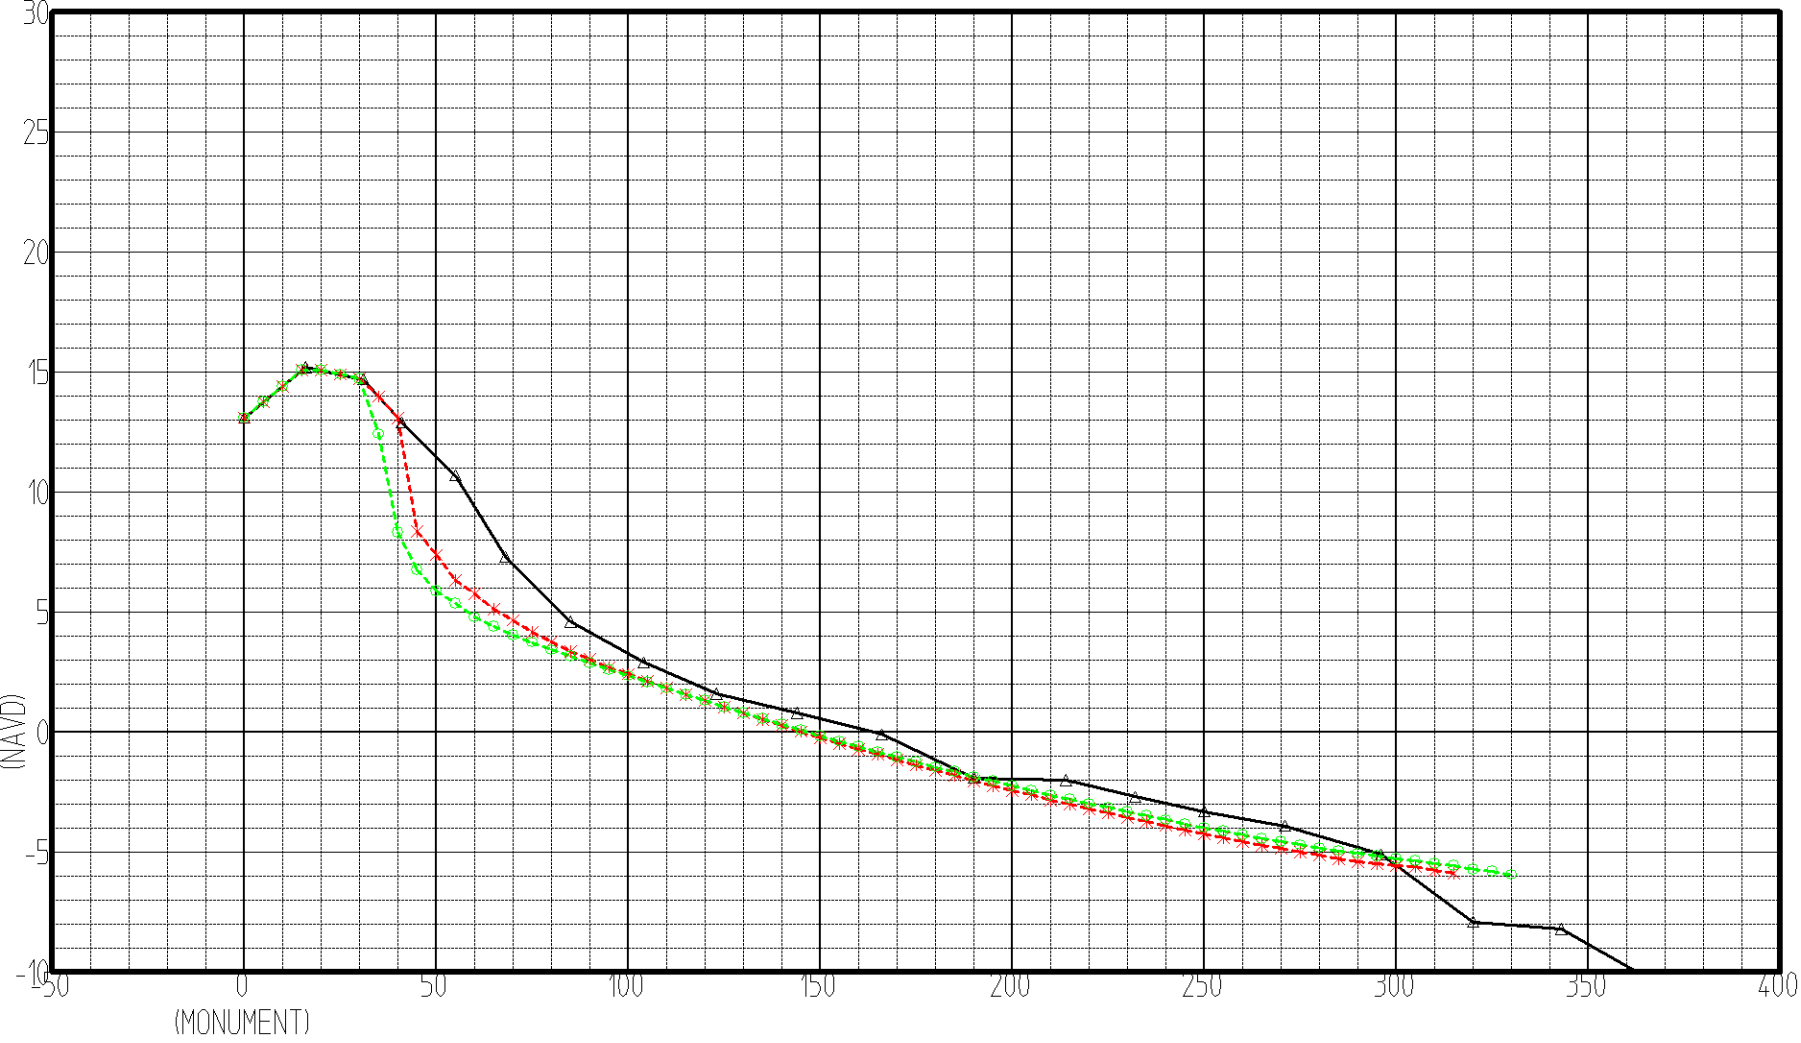
Range: R-117
 BEARING: 75.00
 1/2

BEACH PROFILE
 —△—△— ST. JOHNS 2007-2008 COMBI
 - - * - - 15YR SBCH ERODED
 - - o - - 25YR SBCH ERODED

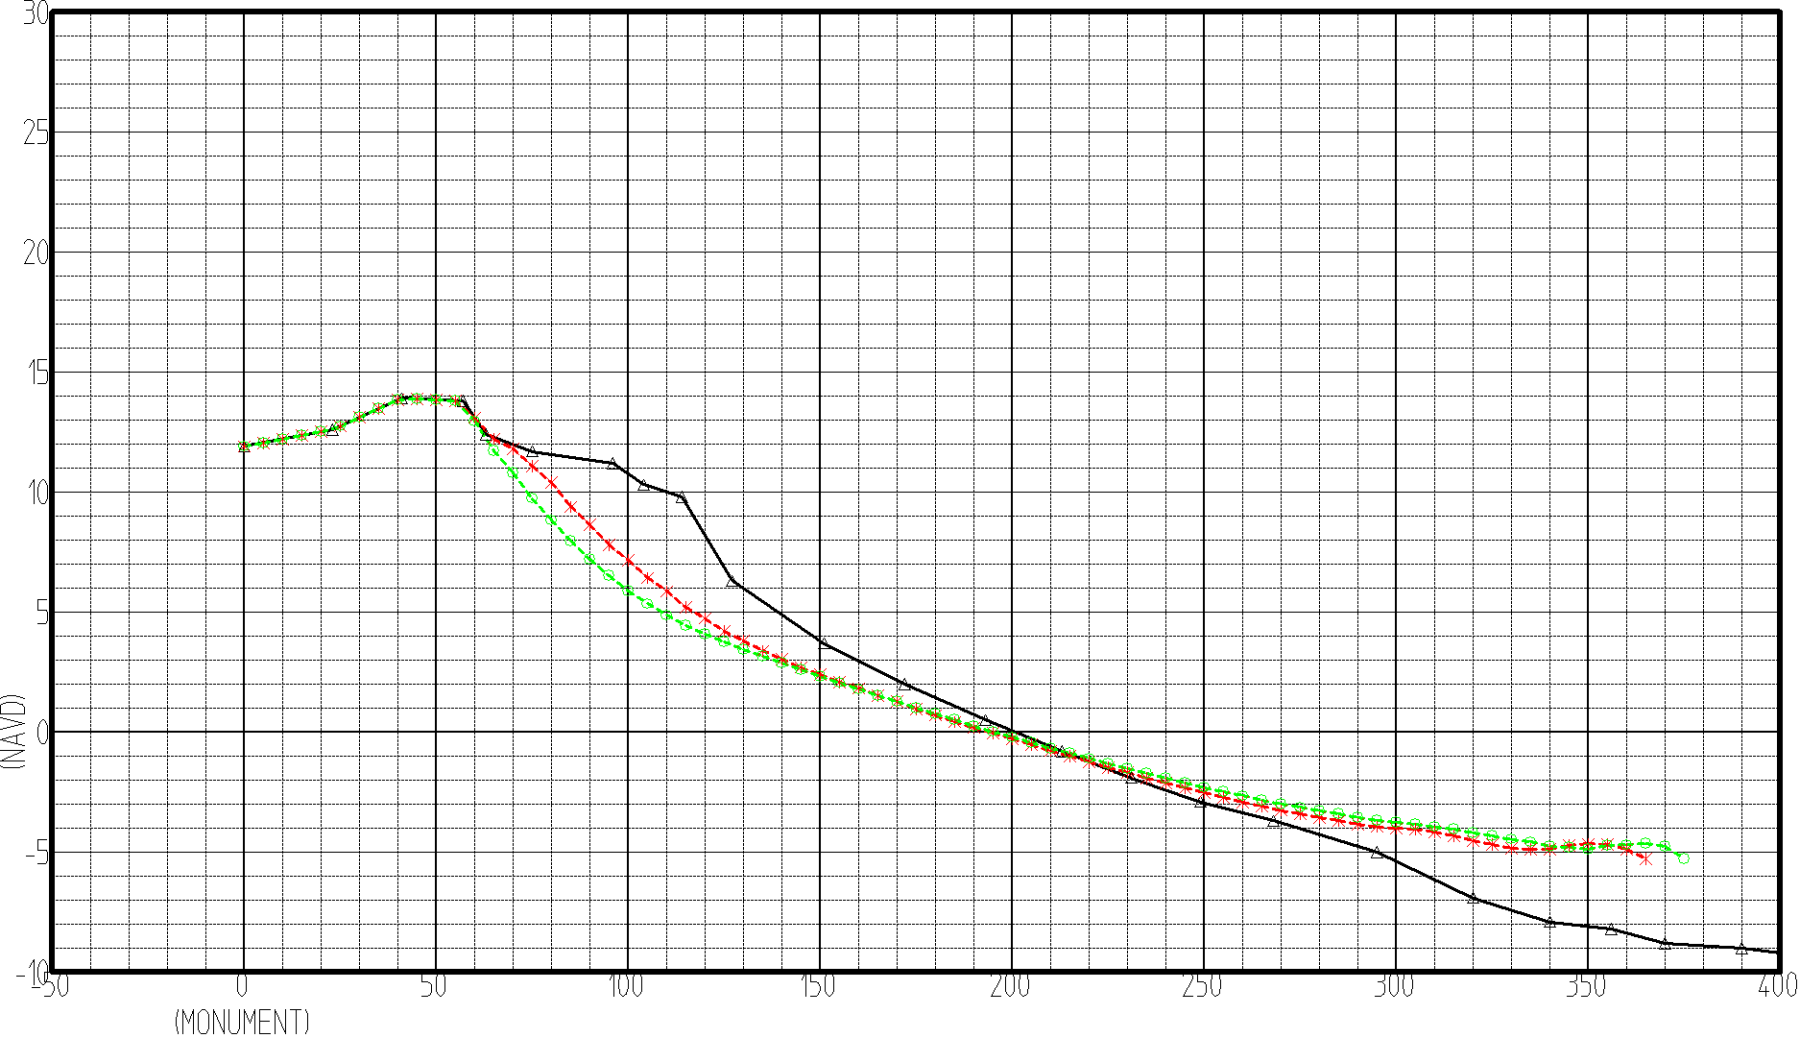
Range: R-119

BEACH PROFILE

—△—△— ST. JOHNS 2007-2008 COMBI

- - * - - 15YR SBEACH ERODED

- - o - - 25YR SBCH ERODED

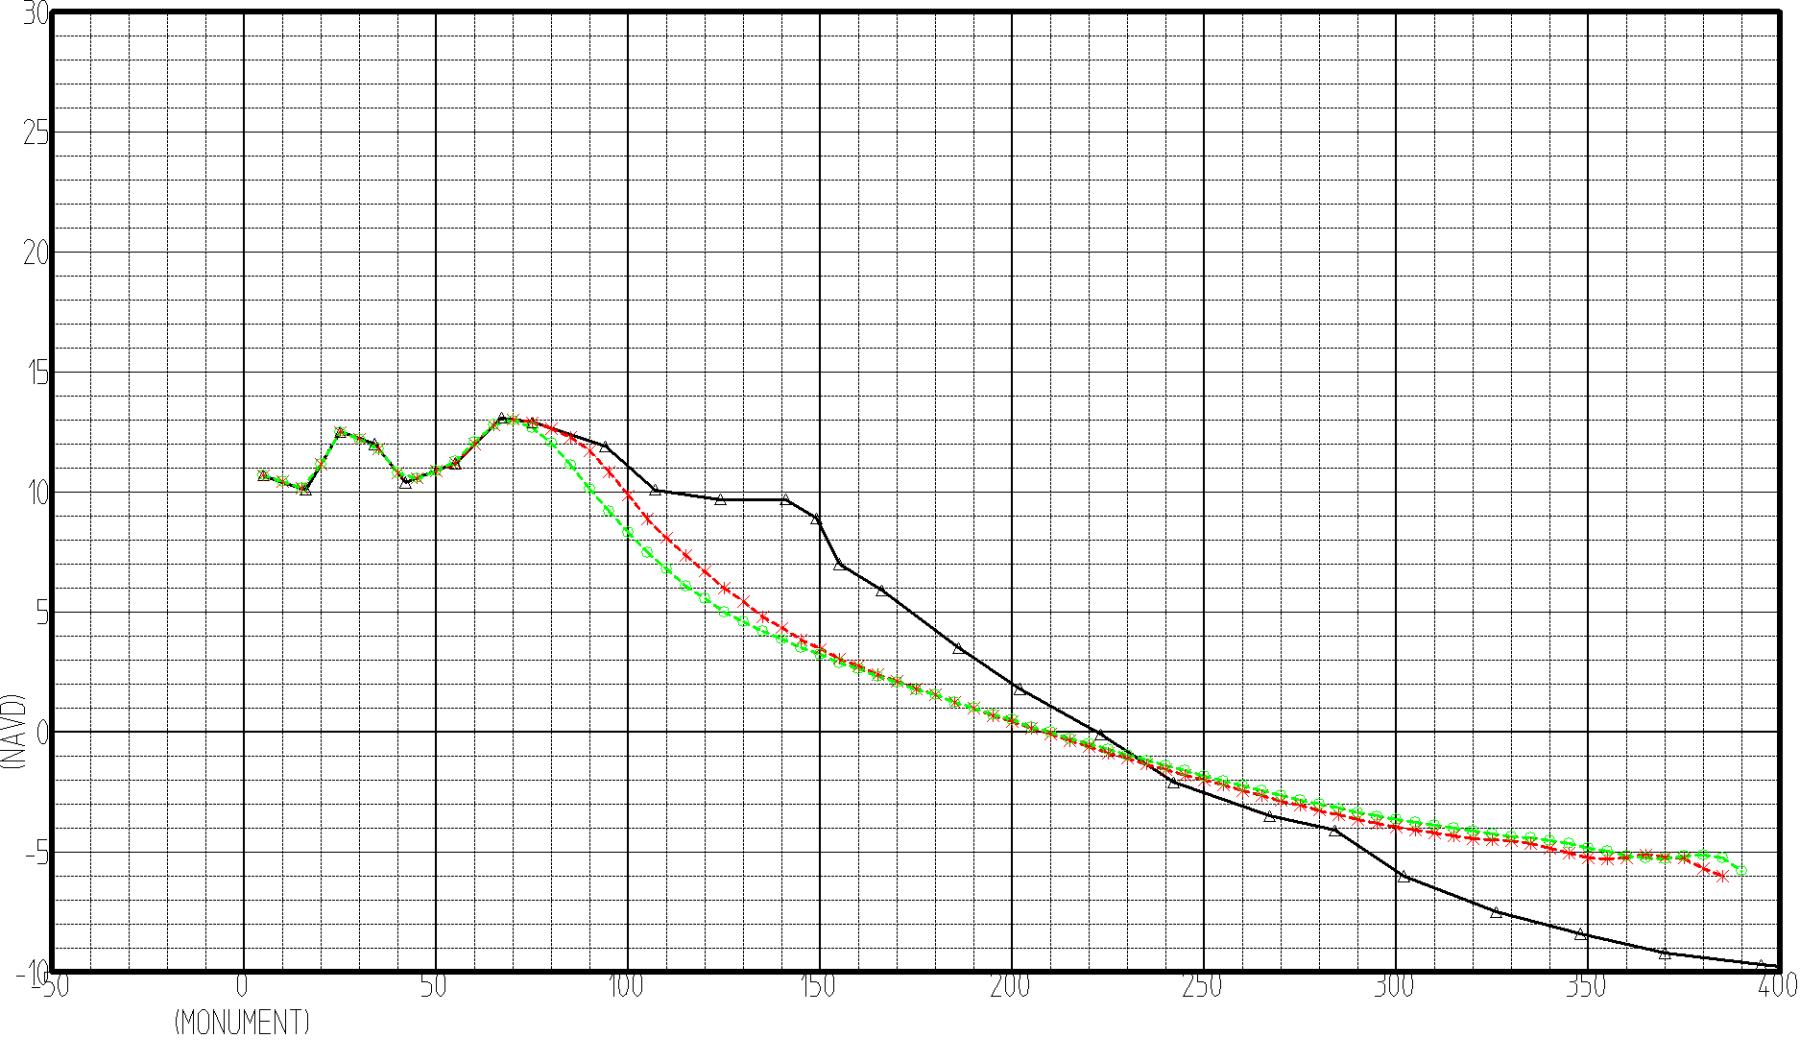
Range: R-120
 BEARING: 75.00
 1/2

BEACH PROFILE
 —△—△— ST. JOHNS 2007-2008 COMBI
 - - * - - 15YR SBEACH ERODED
 - - o - - 25YR SBCH ERODED

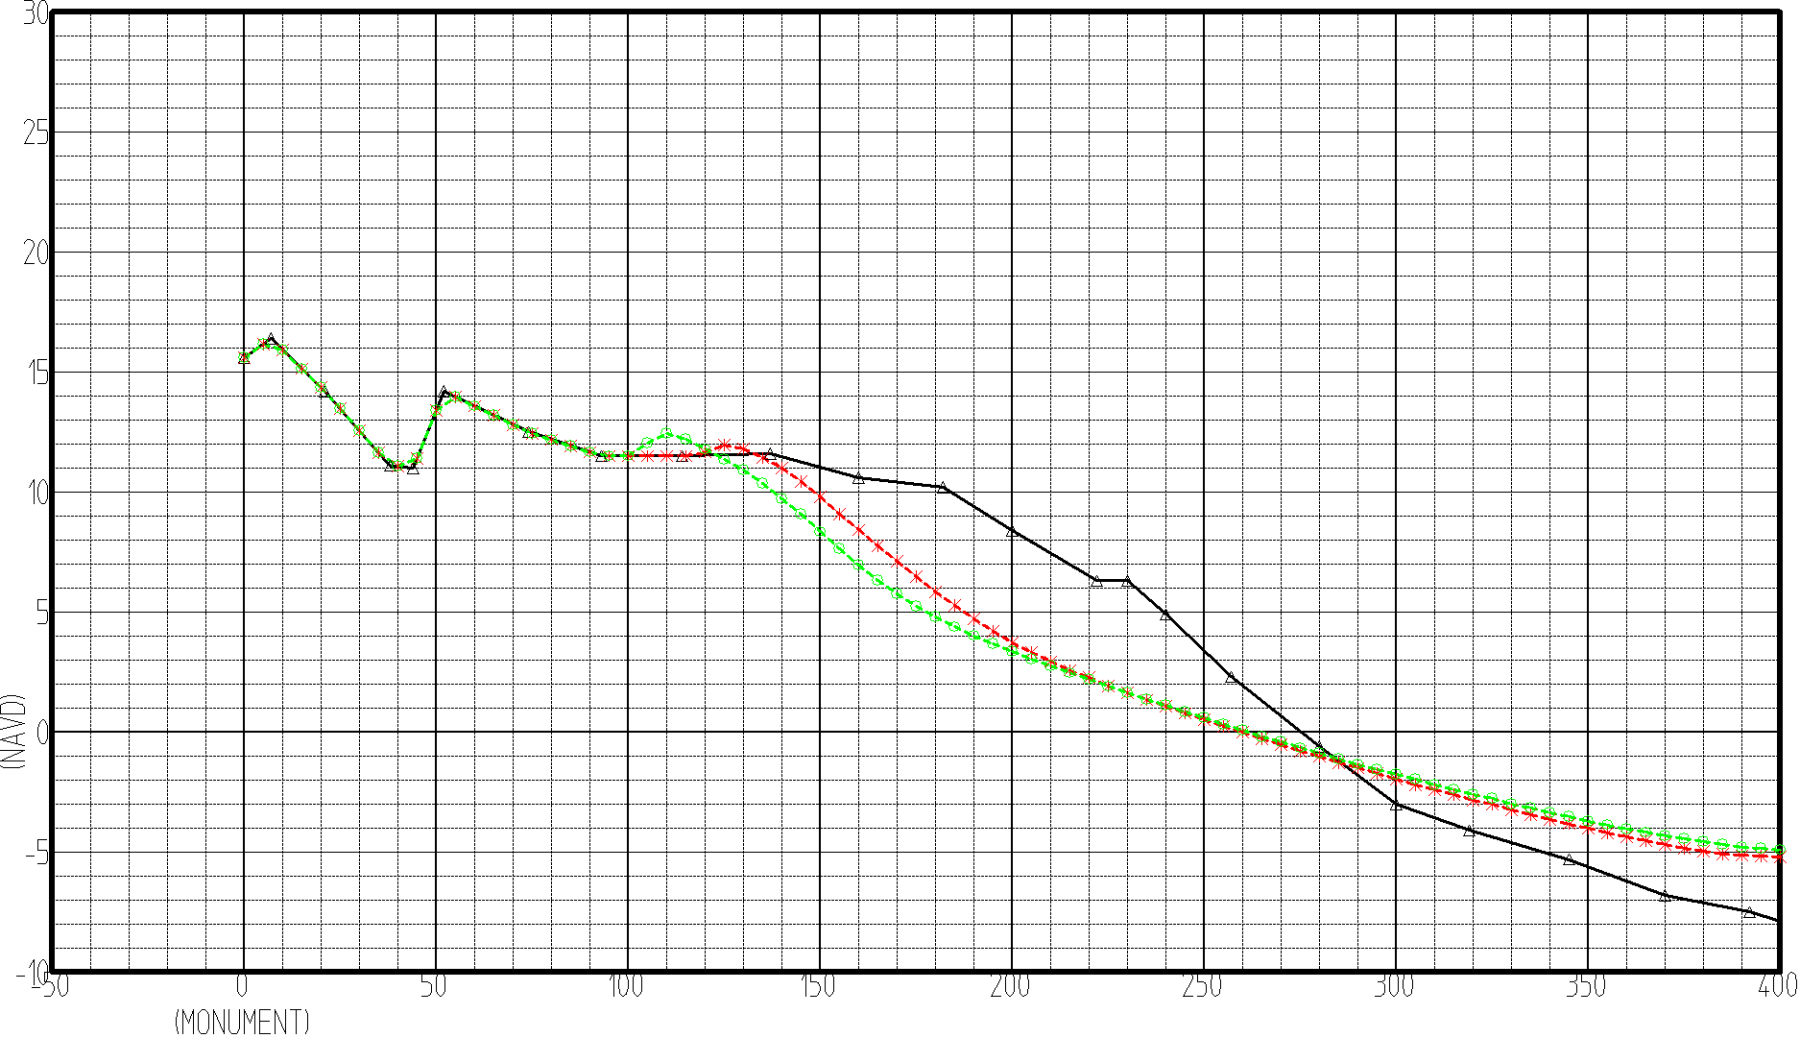
Range: R-121
 BEARING: 75.00
 1/2

BEACH PROFILE
 —△—△— ST. JOHNS 2007-2008 COMBI
 - - * - - 15YR SBEACH ERODED
 - - o - - 25YR SBCH ERODED

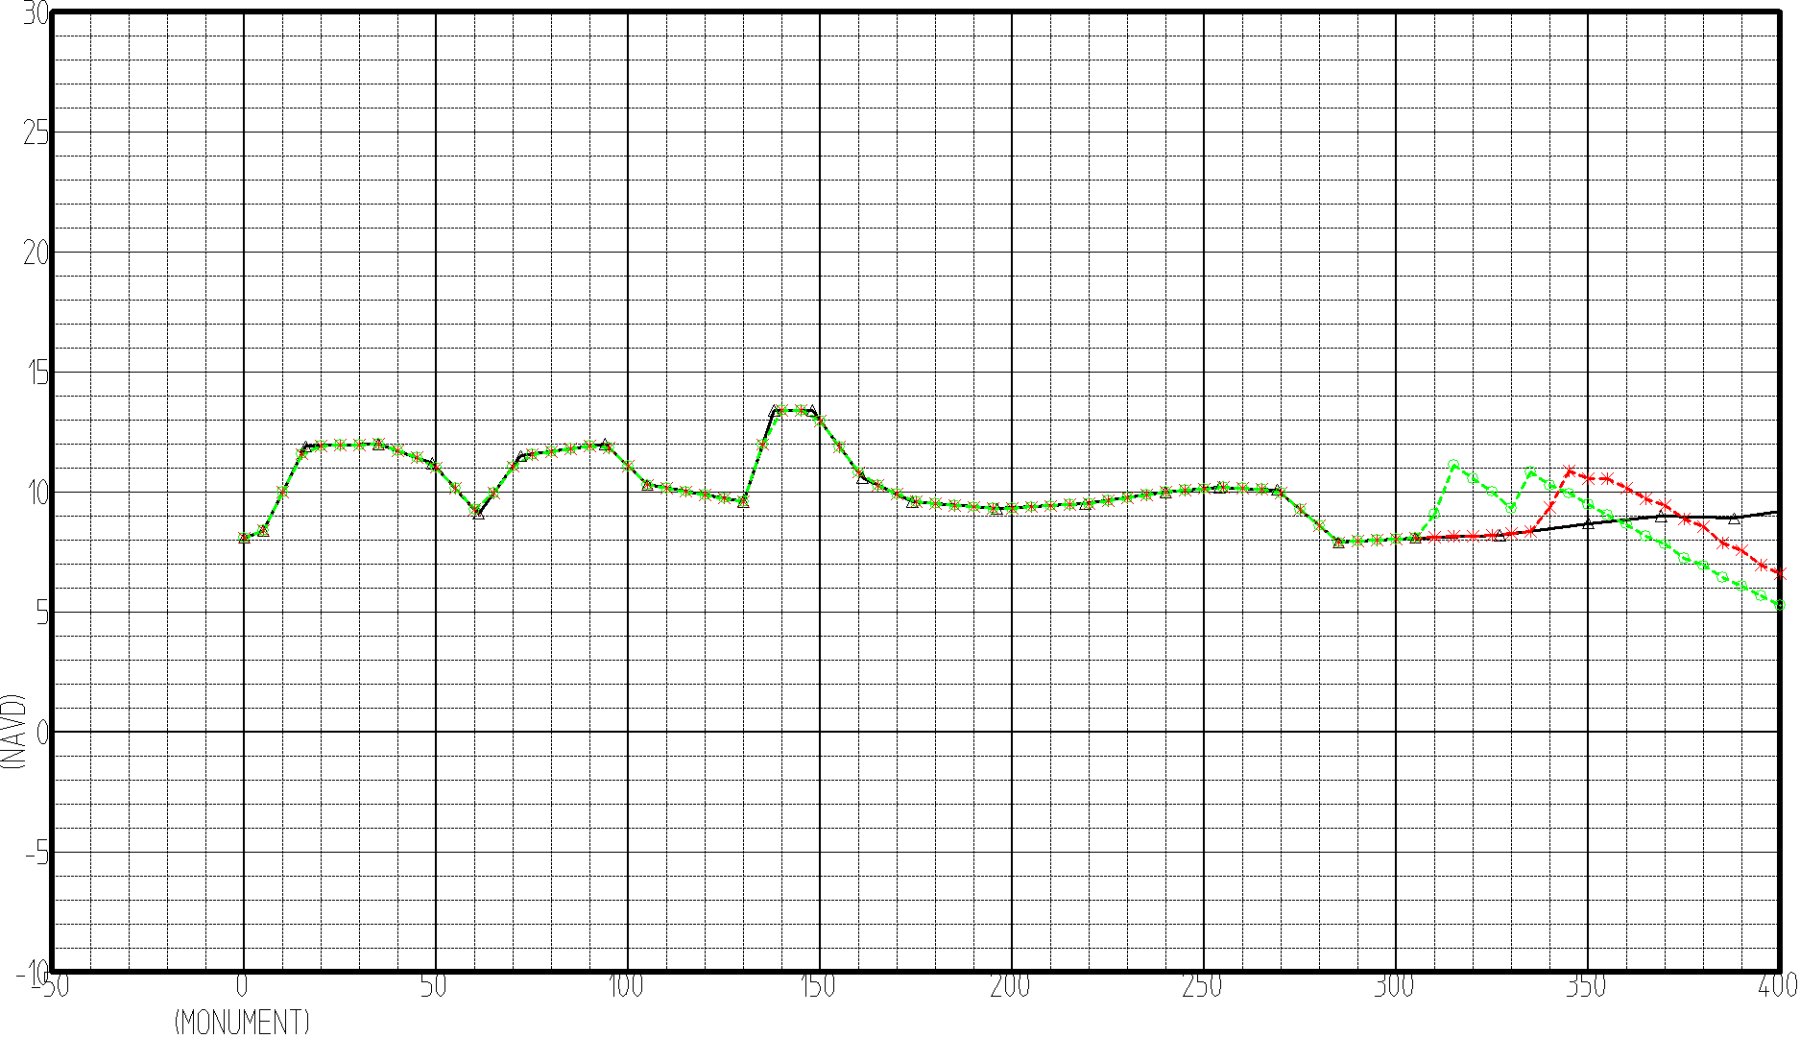
Range: R-122
 BEARING: 75.00
 1/3

BEACH PROFILE
 —△—△— ST. JOHNS 2007-2008 COMBI
 - - * - - 15YR SBCH ERODED
 - - o - - 25YR SBCH ERODED

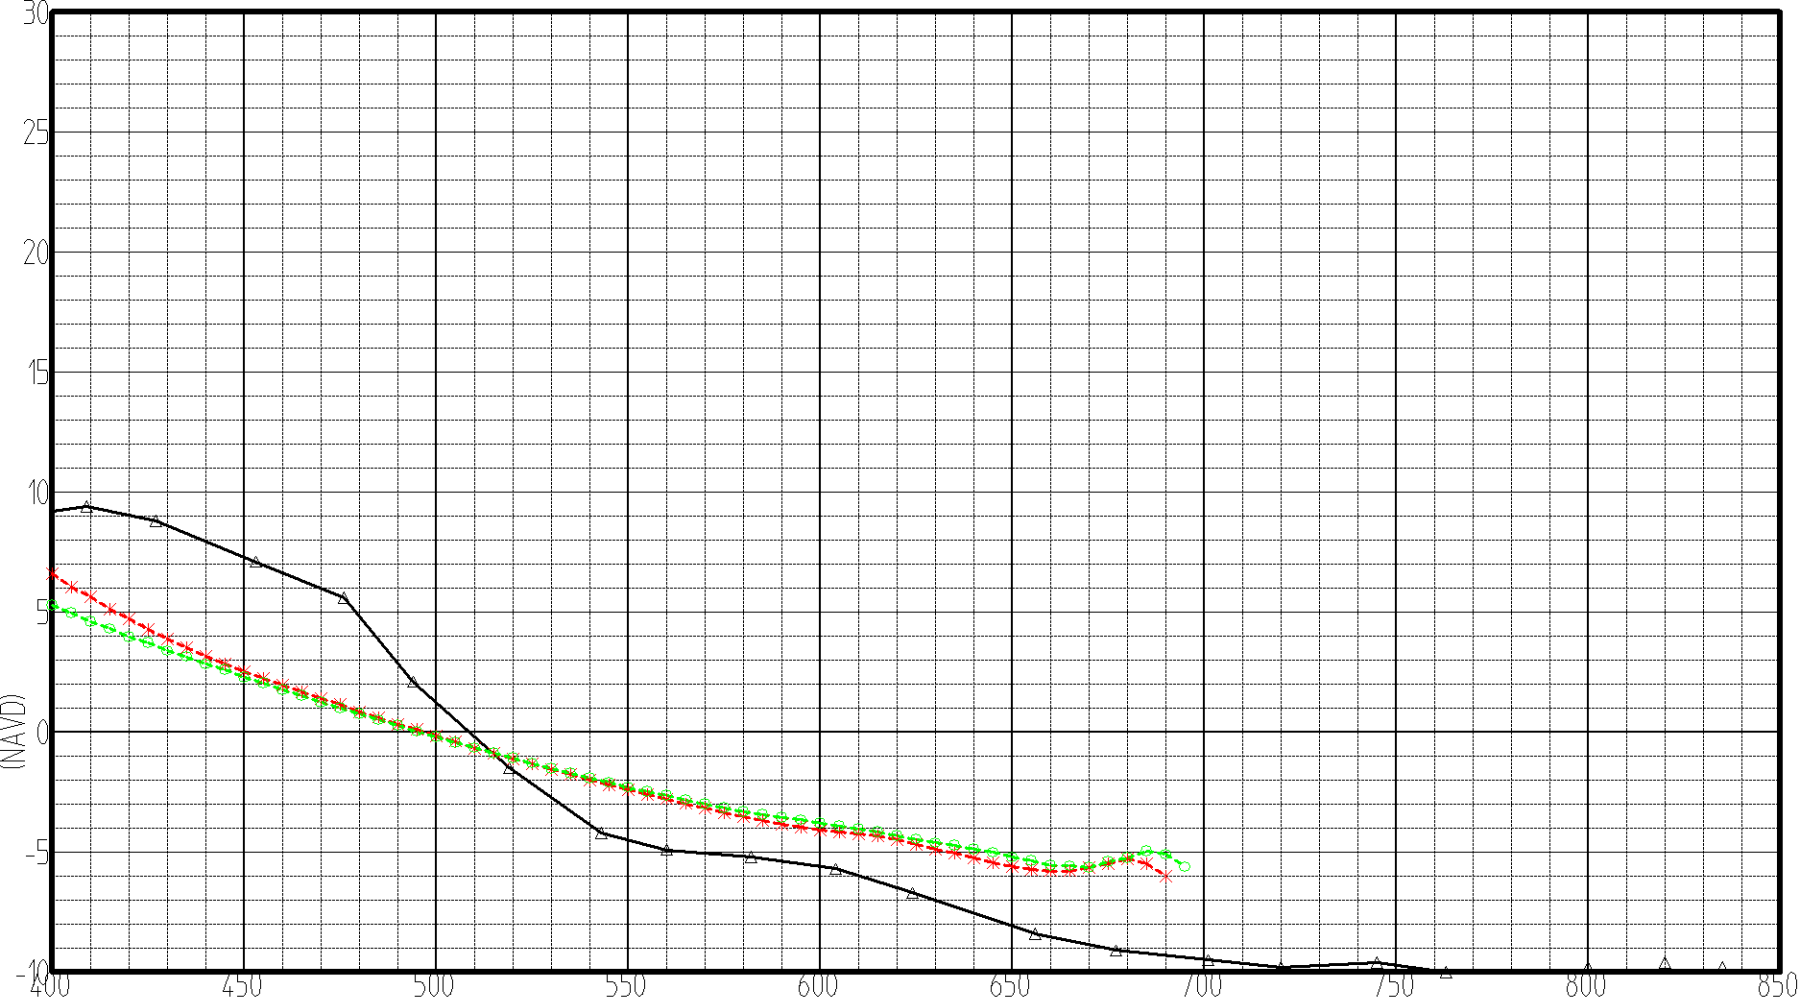
Range: R-122
 BEARING: 75.00
 2/3

BEACH PROFILE
 —△—△— ST. JOHNS 2007-2008 COMBI
 - - * - - * - - 15YR SBCH ERODED
 - - o - - o - - 25YR SBCH ERODED

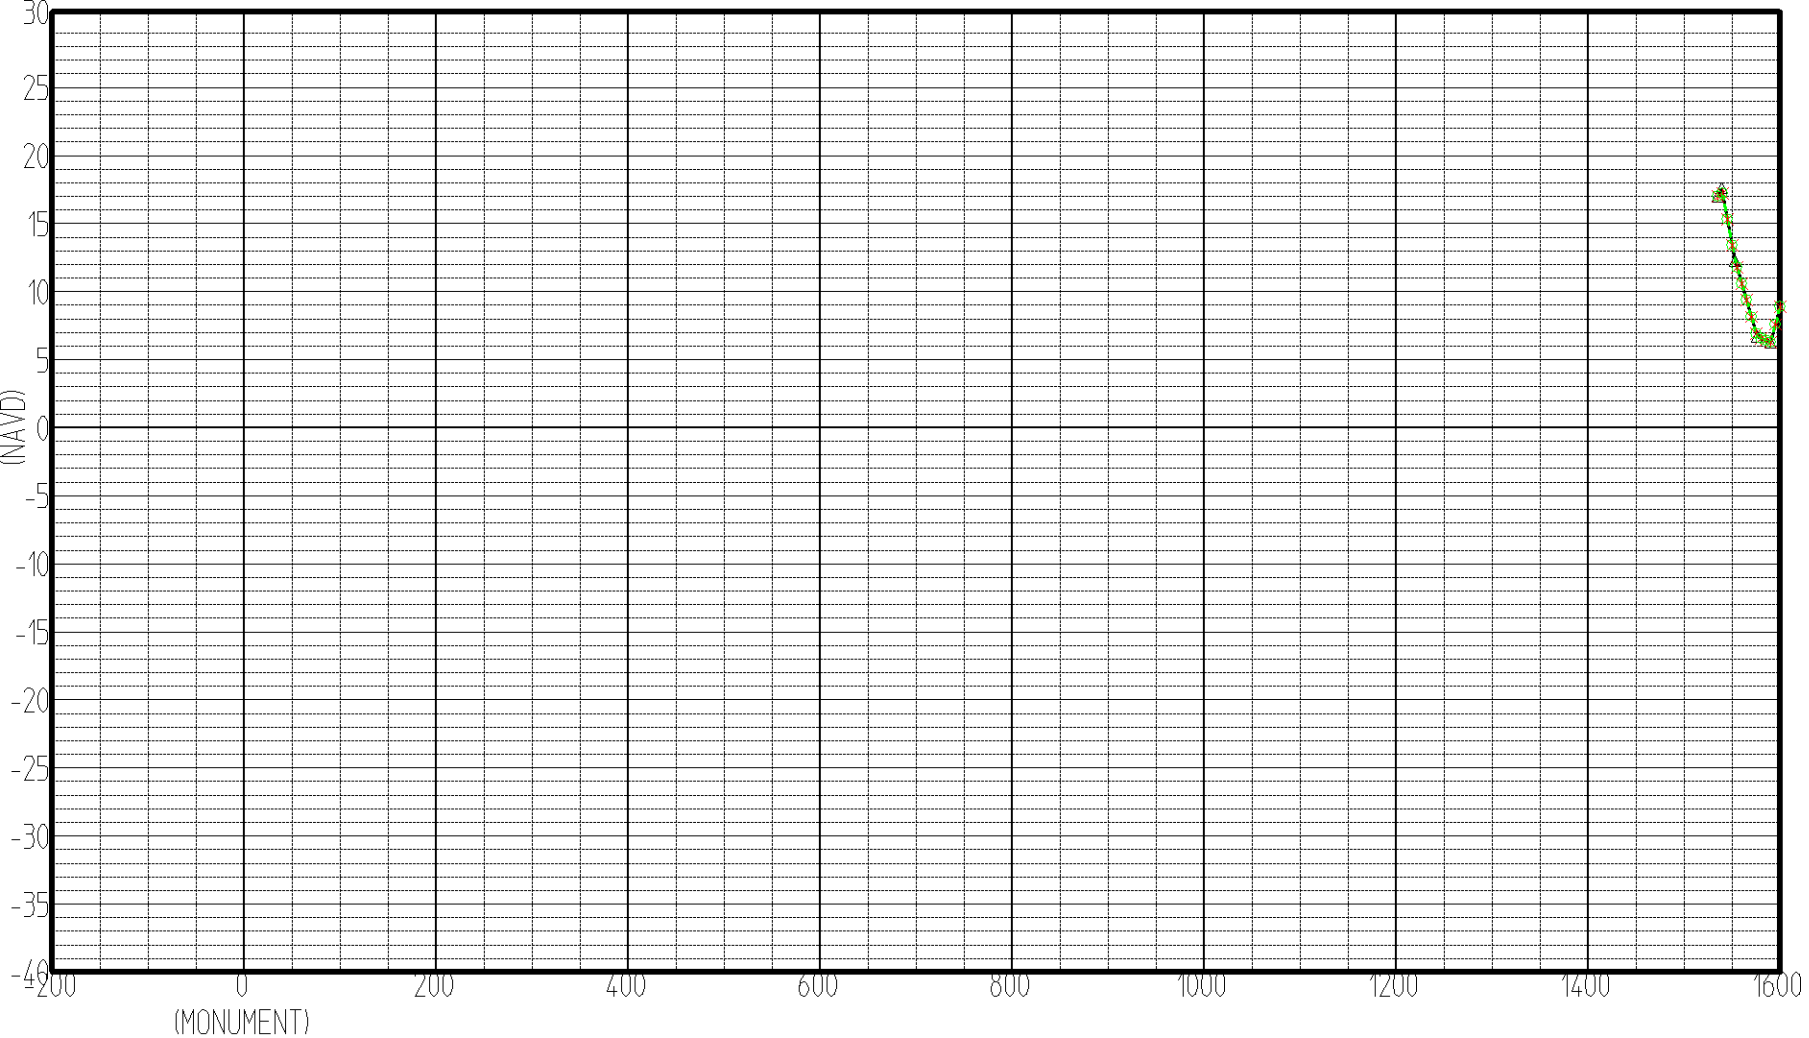
Range: T-124 1/4

OFFSHORE PROFILE

—△—△— ST. JOHNS 2007-2008 COMBI

- - - * - - - 15YR SBEACH ERODED

- - - o - - - 25YR SBCH ERODED

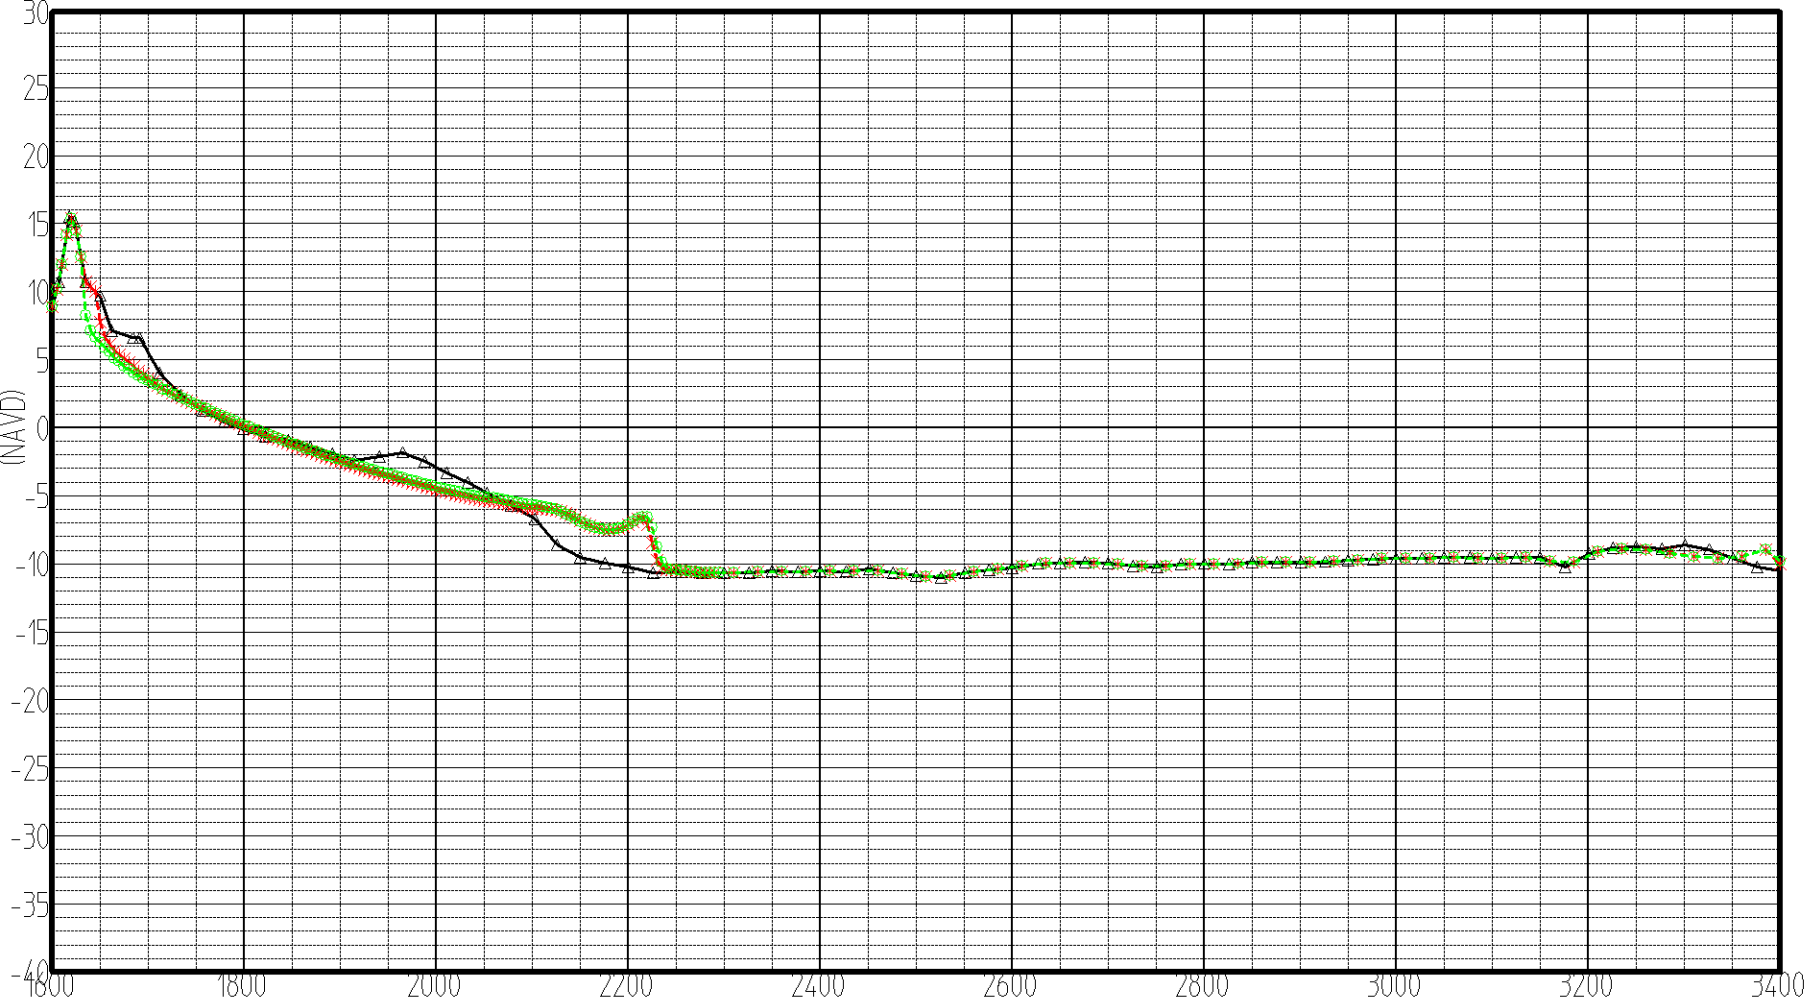
Range: T-124 2/4
 BEARING: 75.00

OFFSHORE PROFILE
 —△—△— ST. JOHNS 2007-2008 COMBI
 - - * - - 15YR SBEACH ERODED
 - - ○ - - 25YR SBCH ERODED

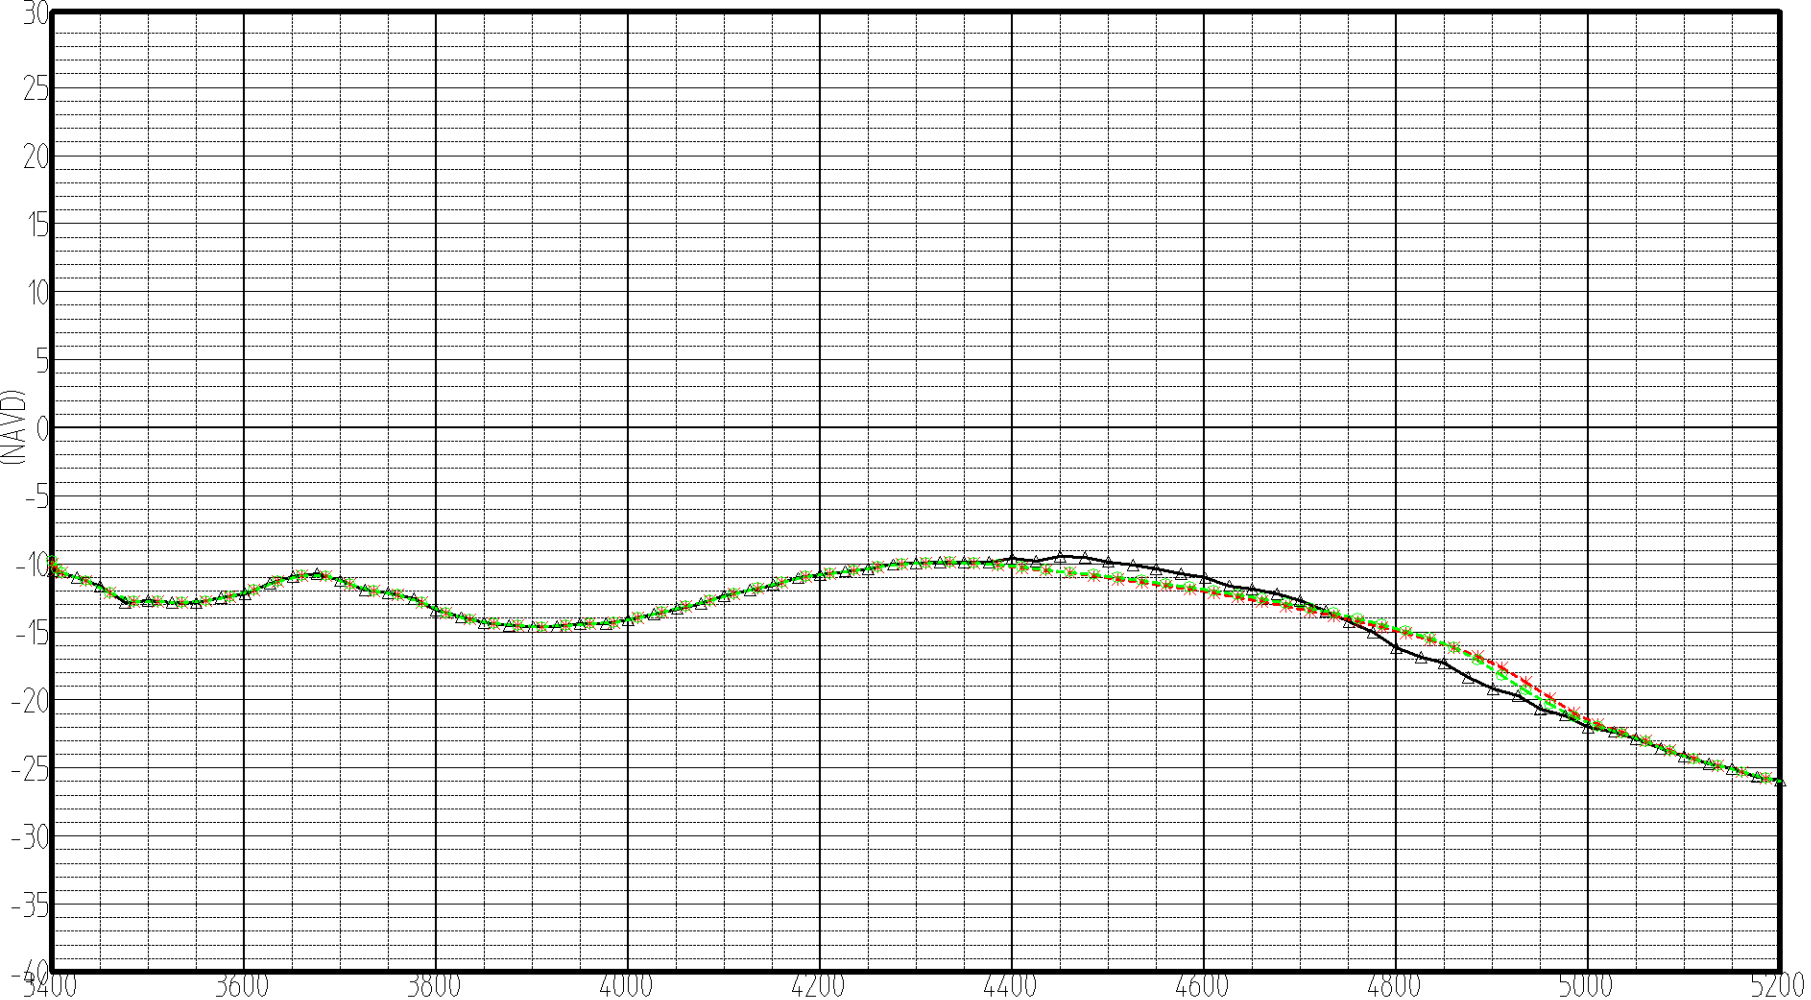
Range: T-124 3/4
 BEARING: 75.00

OFFSHORE PROFILE
 —△—△— ST. JOHNS 2007-2008 COMBI
 - - * - - 15YR SBEACH ERODED
 - - o - - 25YR SBCH ERODED

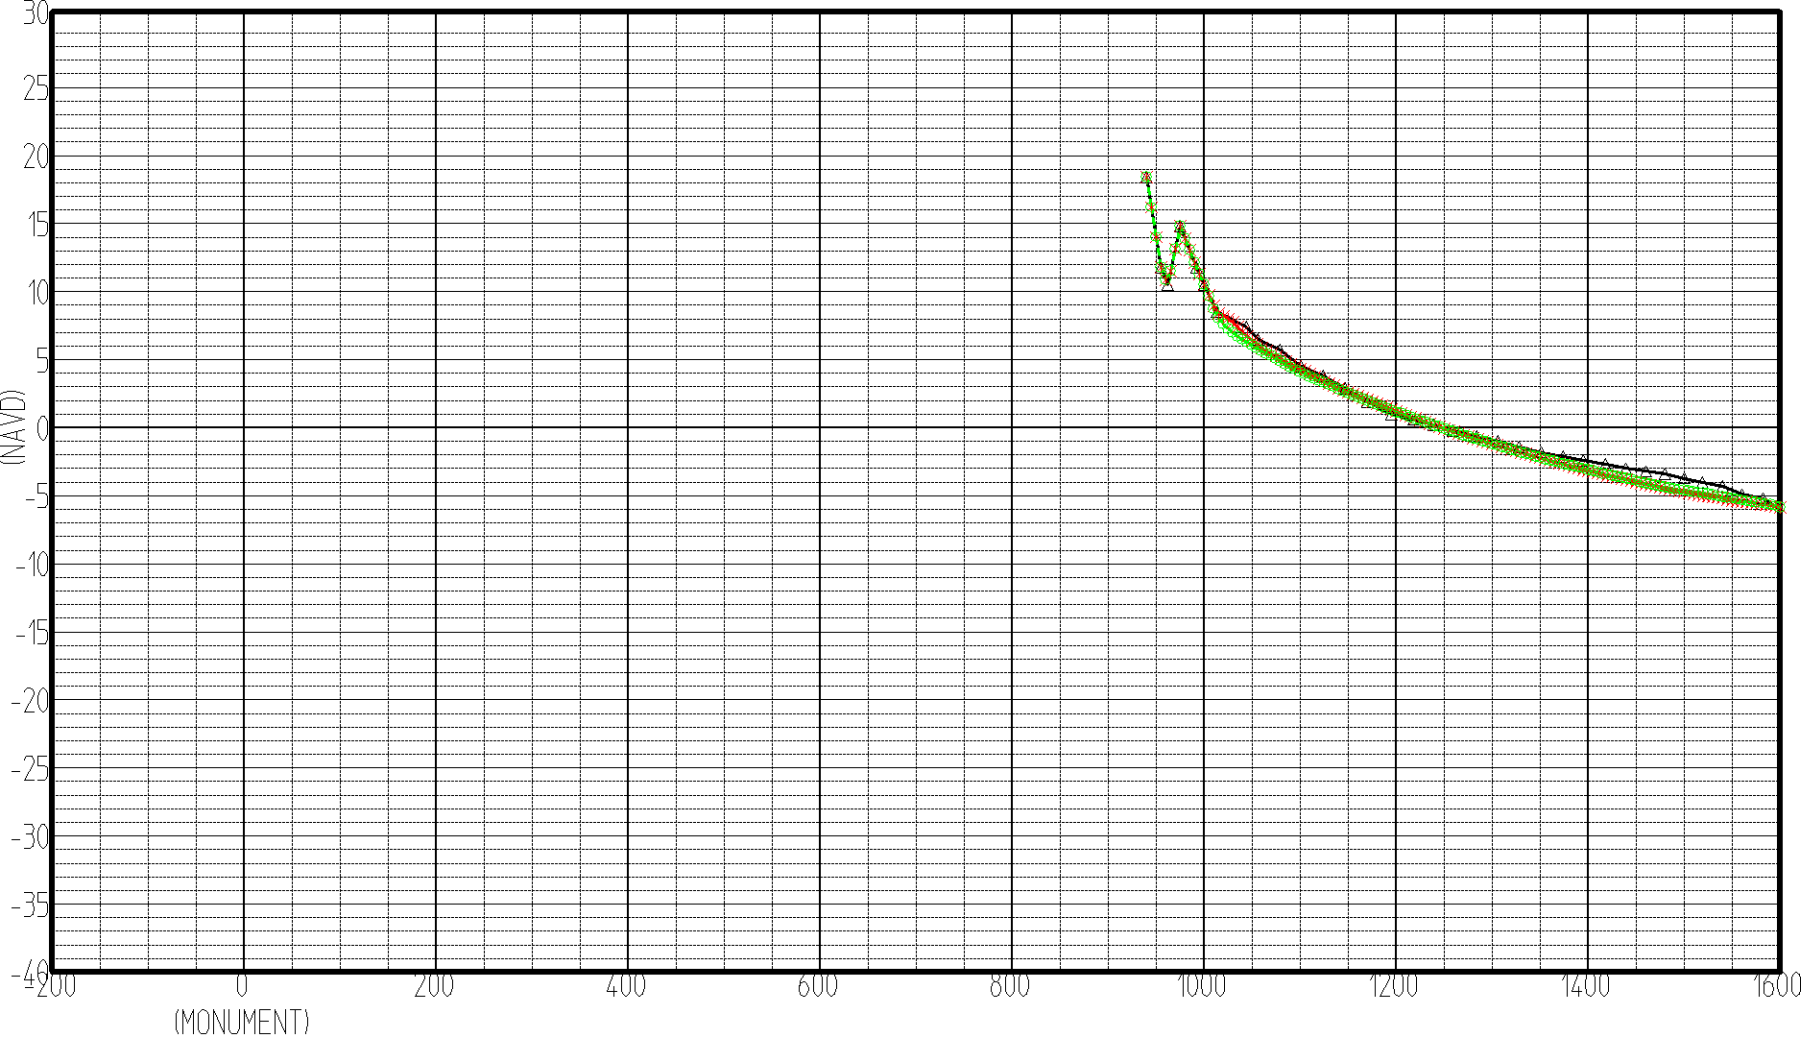
Range: T-126 1/4

OFFSHORE PROFILE

—△—△— ST. JOHNS 2007-2008 COMBI

- - * - - 15YR SBEACH ERODED

- - o - - 25YR SBCH ERODED

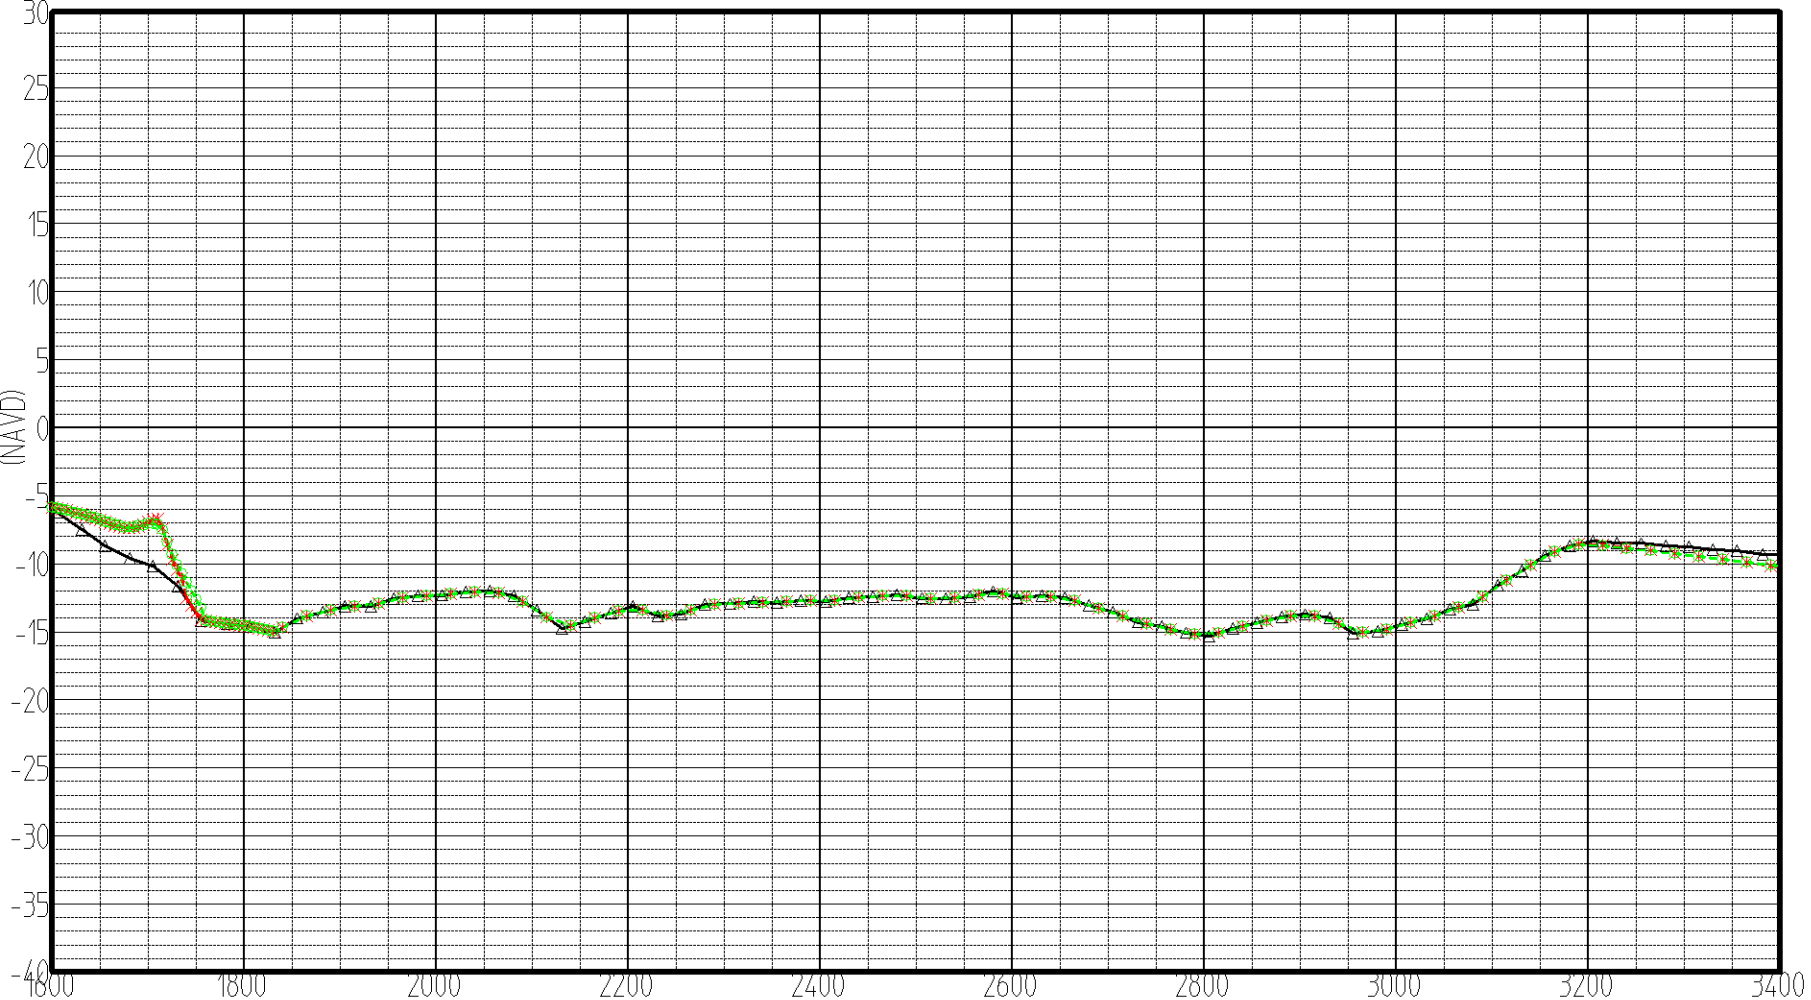
Range: T-126 2/4
 BEARING: 75.00

OFFSHORE PROFILE
 —△—△— ST. JOHNS 2007-2008 COMBI
 - - * - - 15YR SBEACH ERODED
 - - o - - 25YR SBCH ERODED
