Appendix VIII

SBEACH 15 and 25 yr. Storm Erosion Profiles

St. Johns County

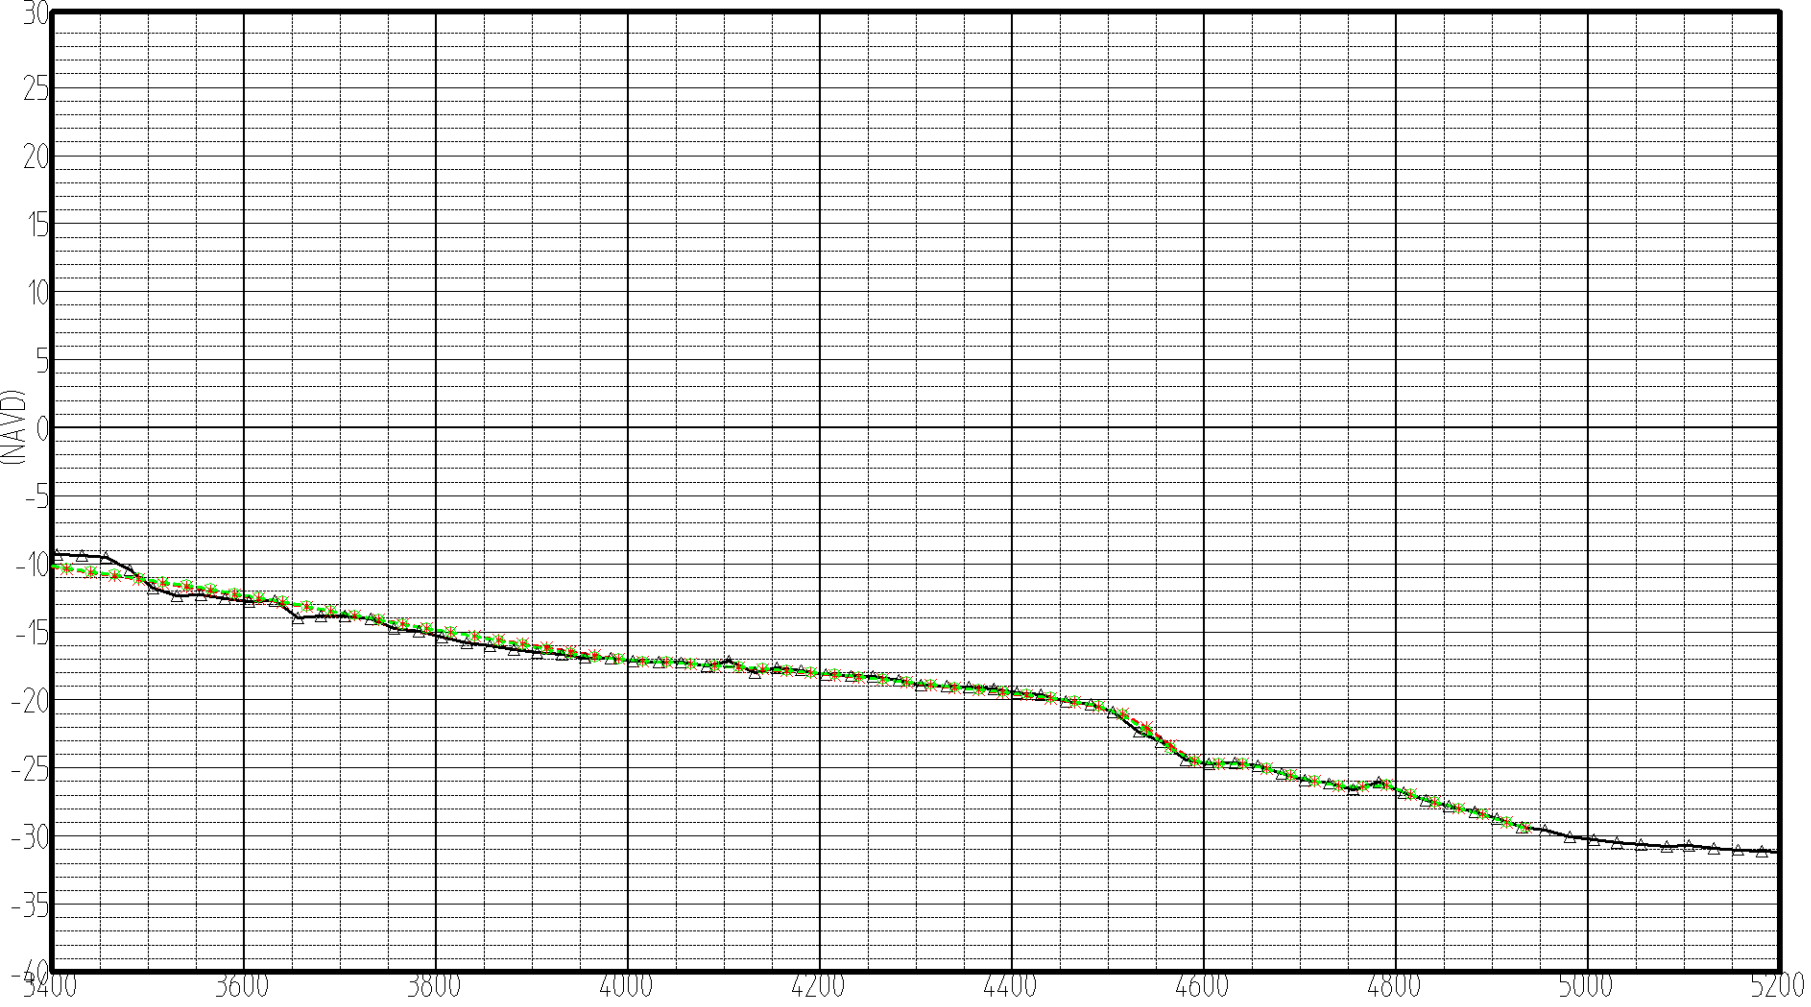
Range: T-126 3/4
 BEARING: 75.00

OFFSHORE PROFILE
 —△—△— ST. JOHNS 2007-2008 COMBI
 - - * - - 15YR SBEACH ERODED
 - - ○ - - 25YR SBCH ERODED

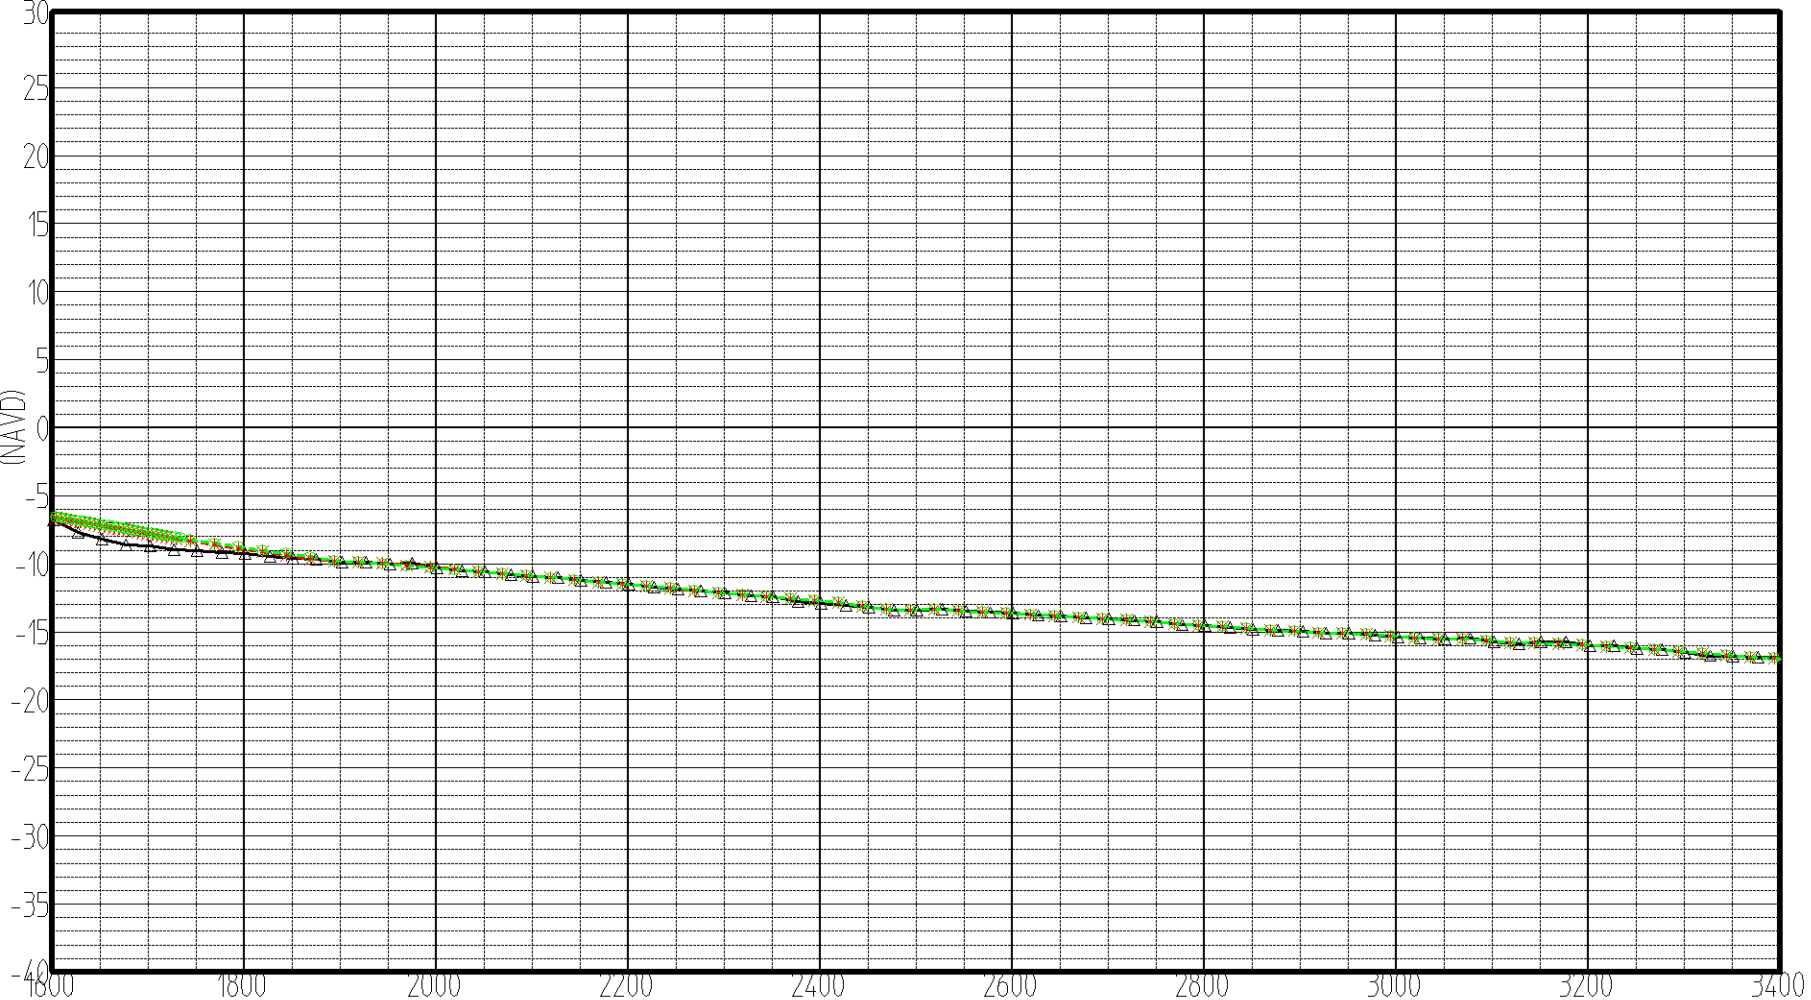
Range: R-127A 2/4

OFFSHORE PROFILE

—△—△— ST. JOHNS 2007-2008 COMBI

- - * - - 15YR SBEACH ERODED

- - o - - 25YR SBCH ERODED

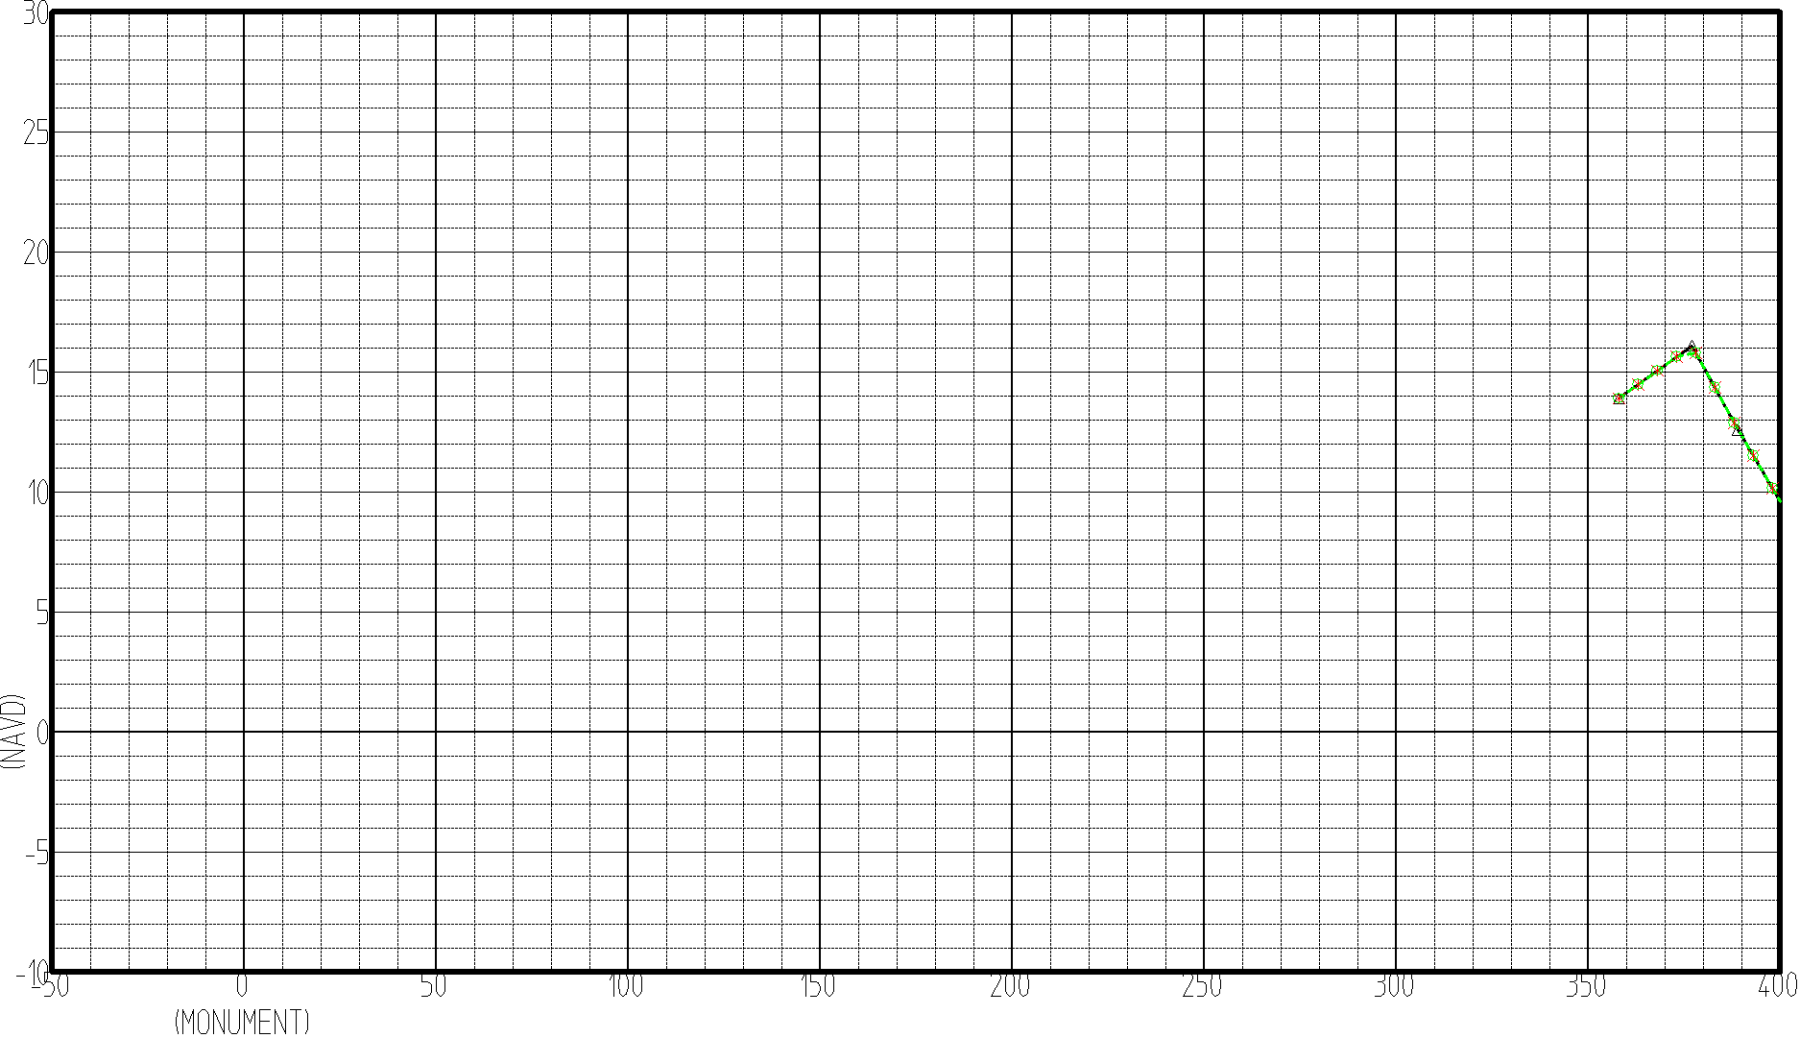
Range: T-128
 BEARING: 75.00
 1/3

BEACH PROFILE
 —△—△— ST. JOHNS 2007-2008 COMBI
 - - * - - * - - 15YR SBEACH ERODED
 - - o - - o - - 25YR SBCH ERODED

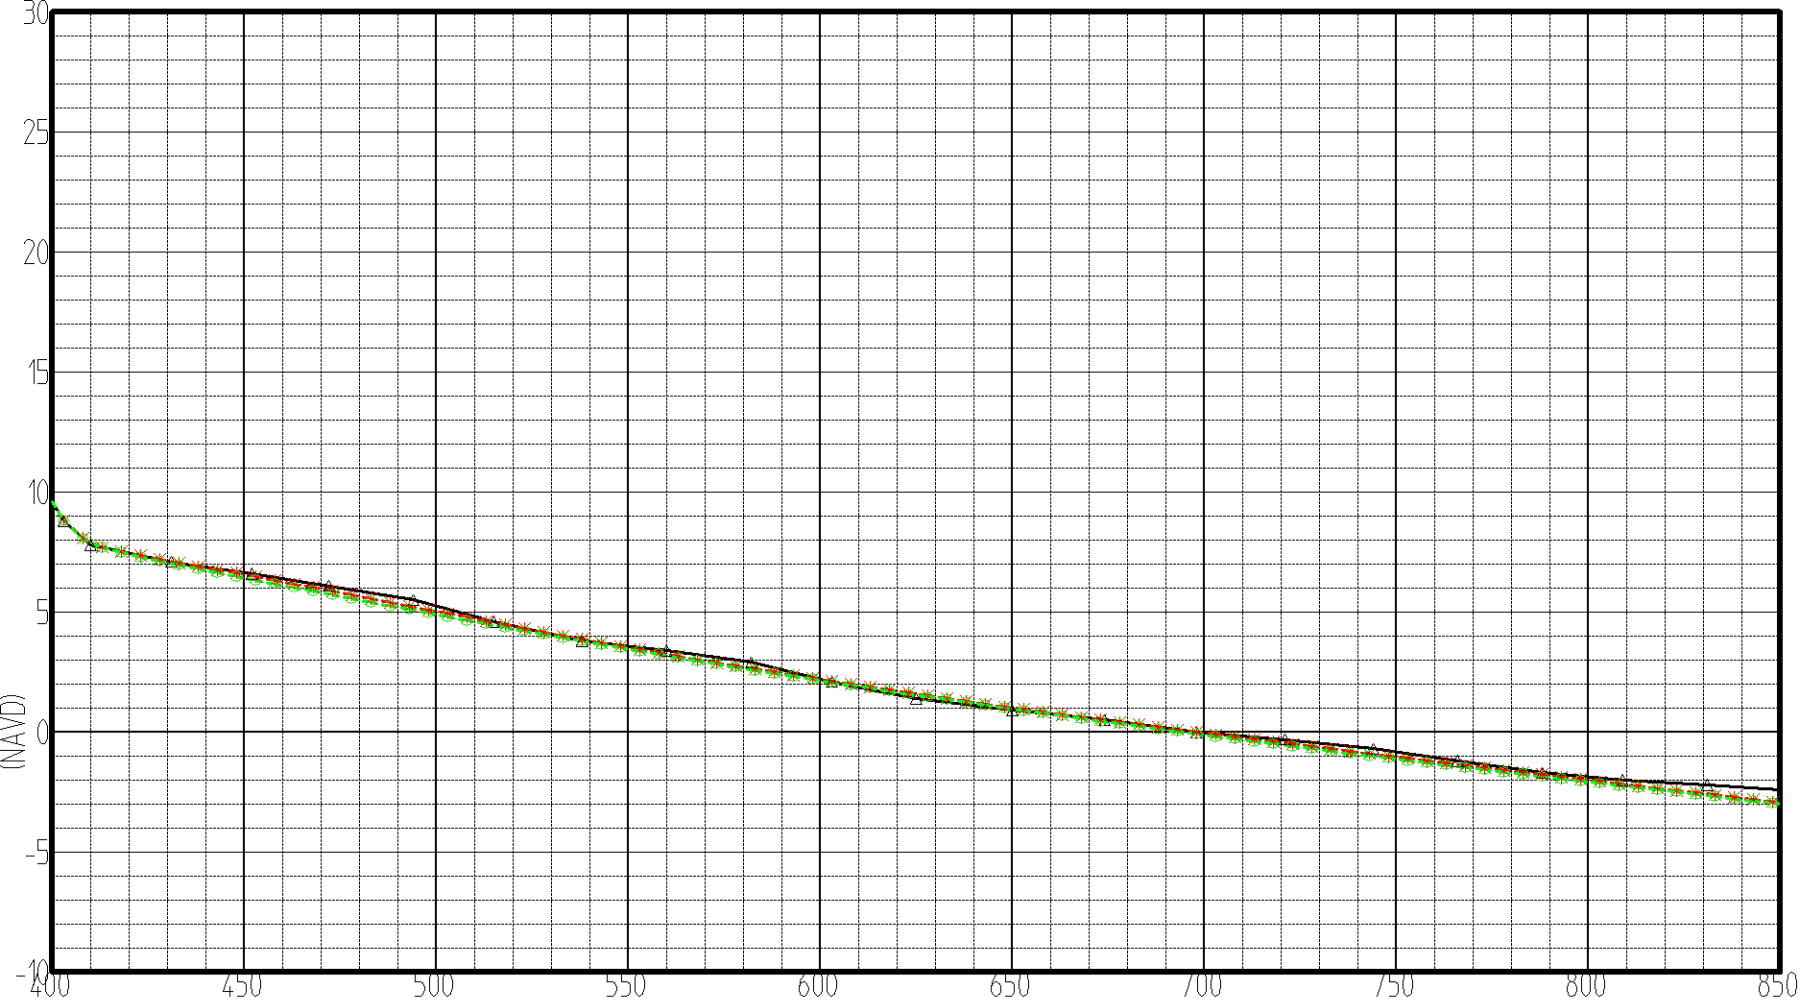
Range: T-128 2/3

BEACH PROFILE

—△—△— ST. JOHNS 2007-2008 COMBI

- - * - - * - - 15YR SBEACH ERODED

- - o - - o - - 25YR SBCH ERODED

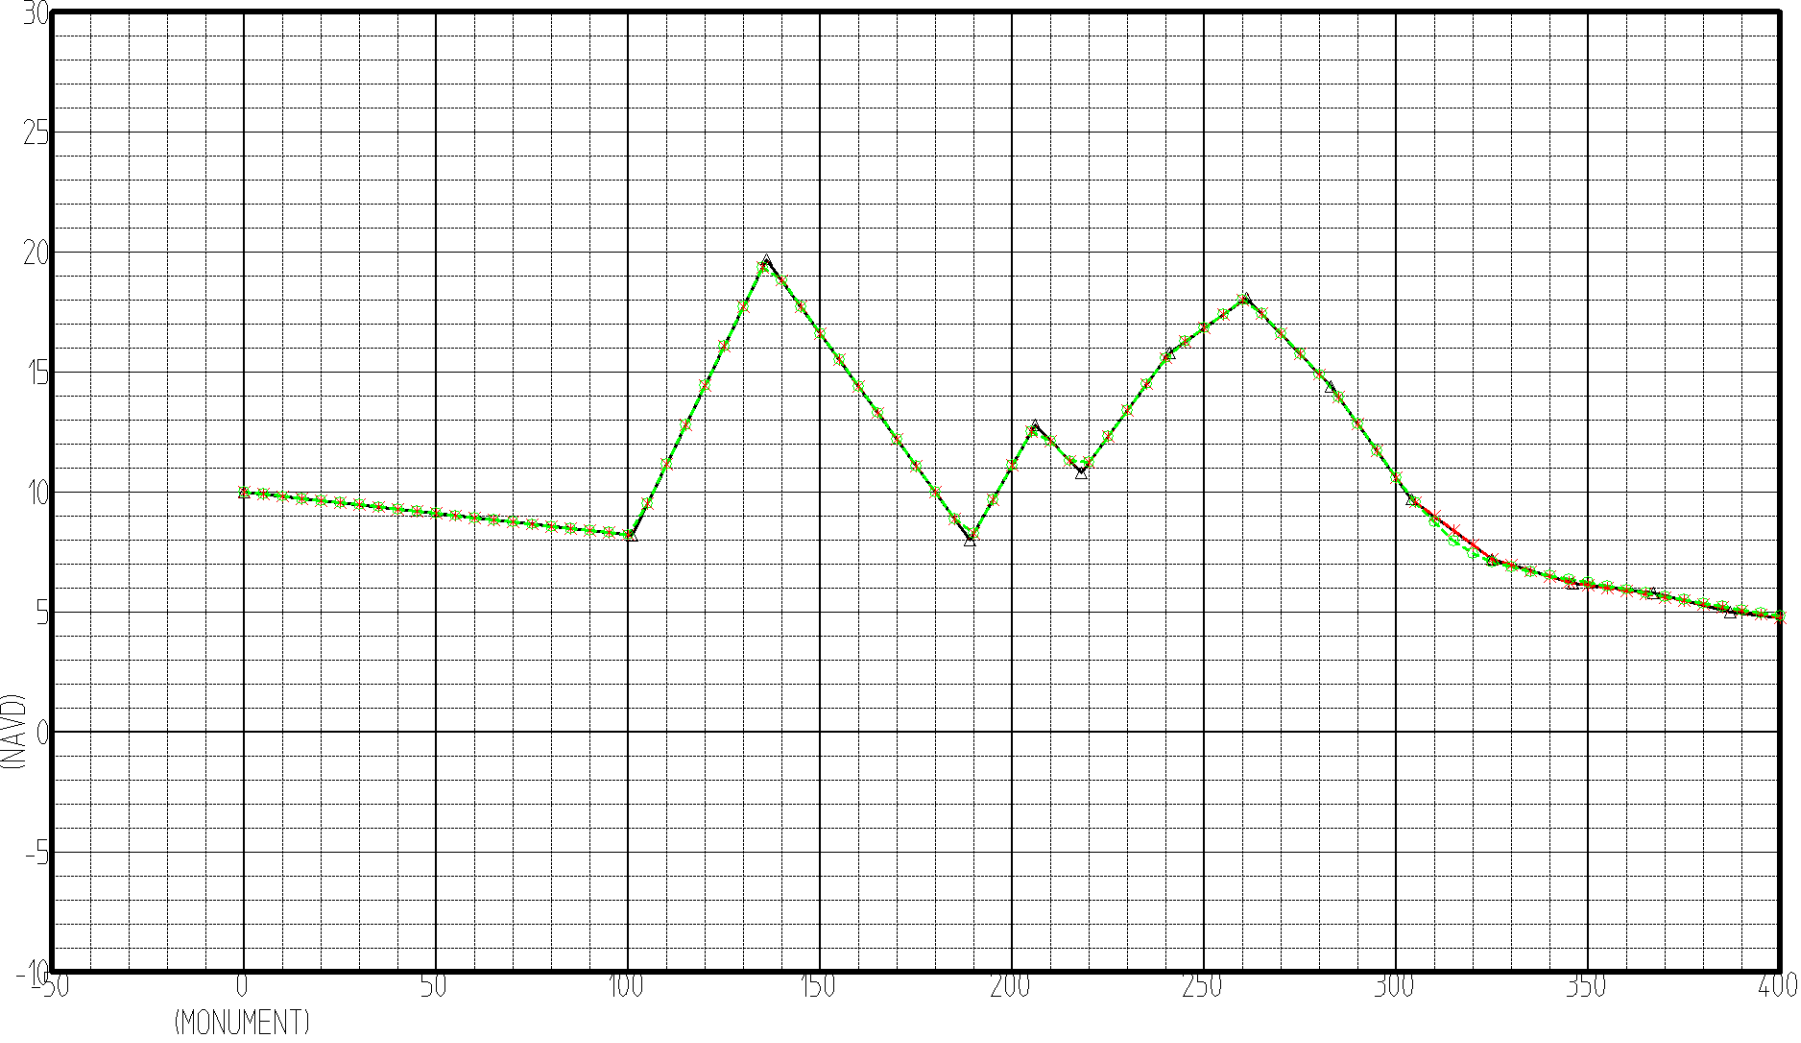
Range: T-129 1/3

BEACH PROFILE

—△—△— ST. JOHNS 2007-2008 COMBI
 - - * - - - 15YR SBEACH ERODED
 - - o - - - 25YR SBCH ERODED

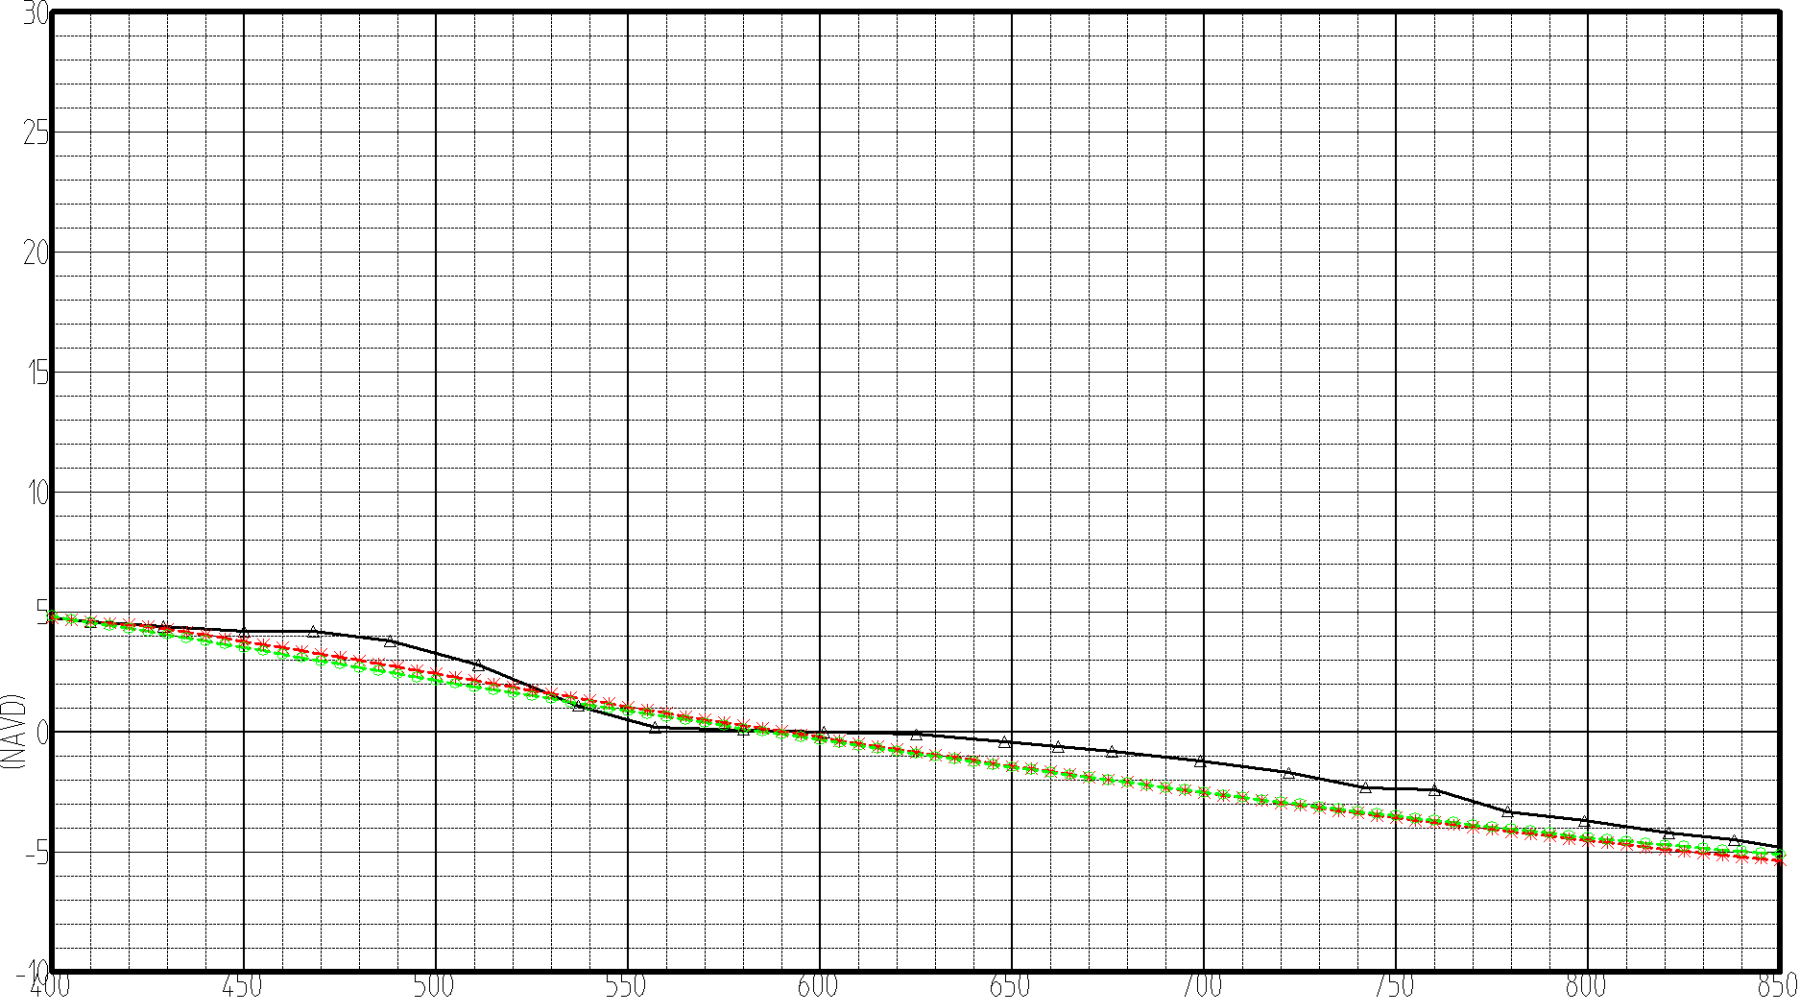
Range: T-129 2/3
 BEARING: 75.00

BEACH PROFILE
 —△—△— ST. JOHNS 2007-2008 COMBI
 - - * - - 15YR SBEACH ERODED
 - - o - - 25YR SBCH ERODED

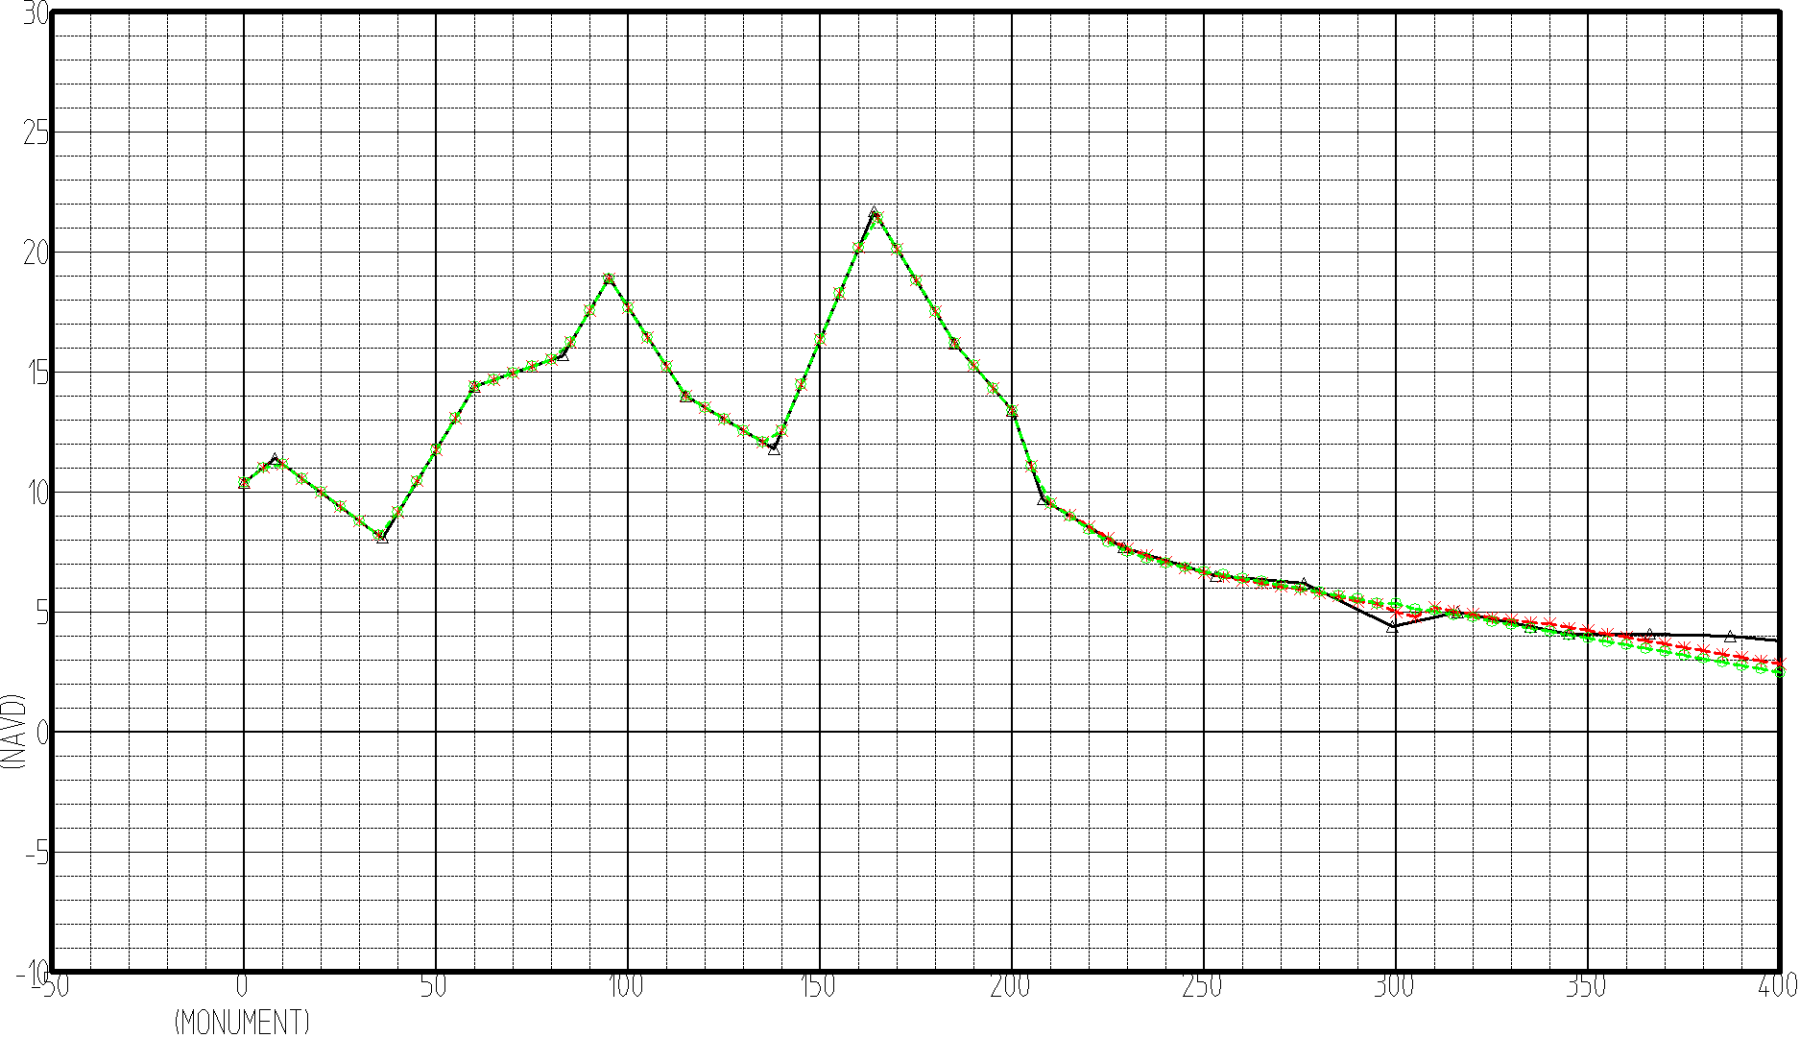
Range: T-130 1/3
 BEARING: 75.00

BEACH PROFILE
 —△—△— ST. JOHNS 2007-2008 COMBI
 - - * - - - 15YR SBEACH ERODED
 - - o - - - 25YR SBCH ERODED

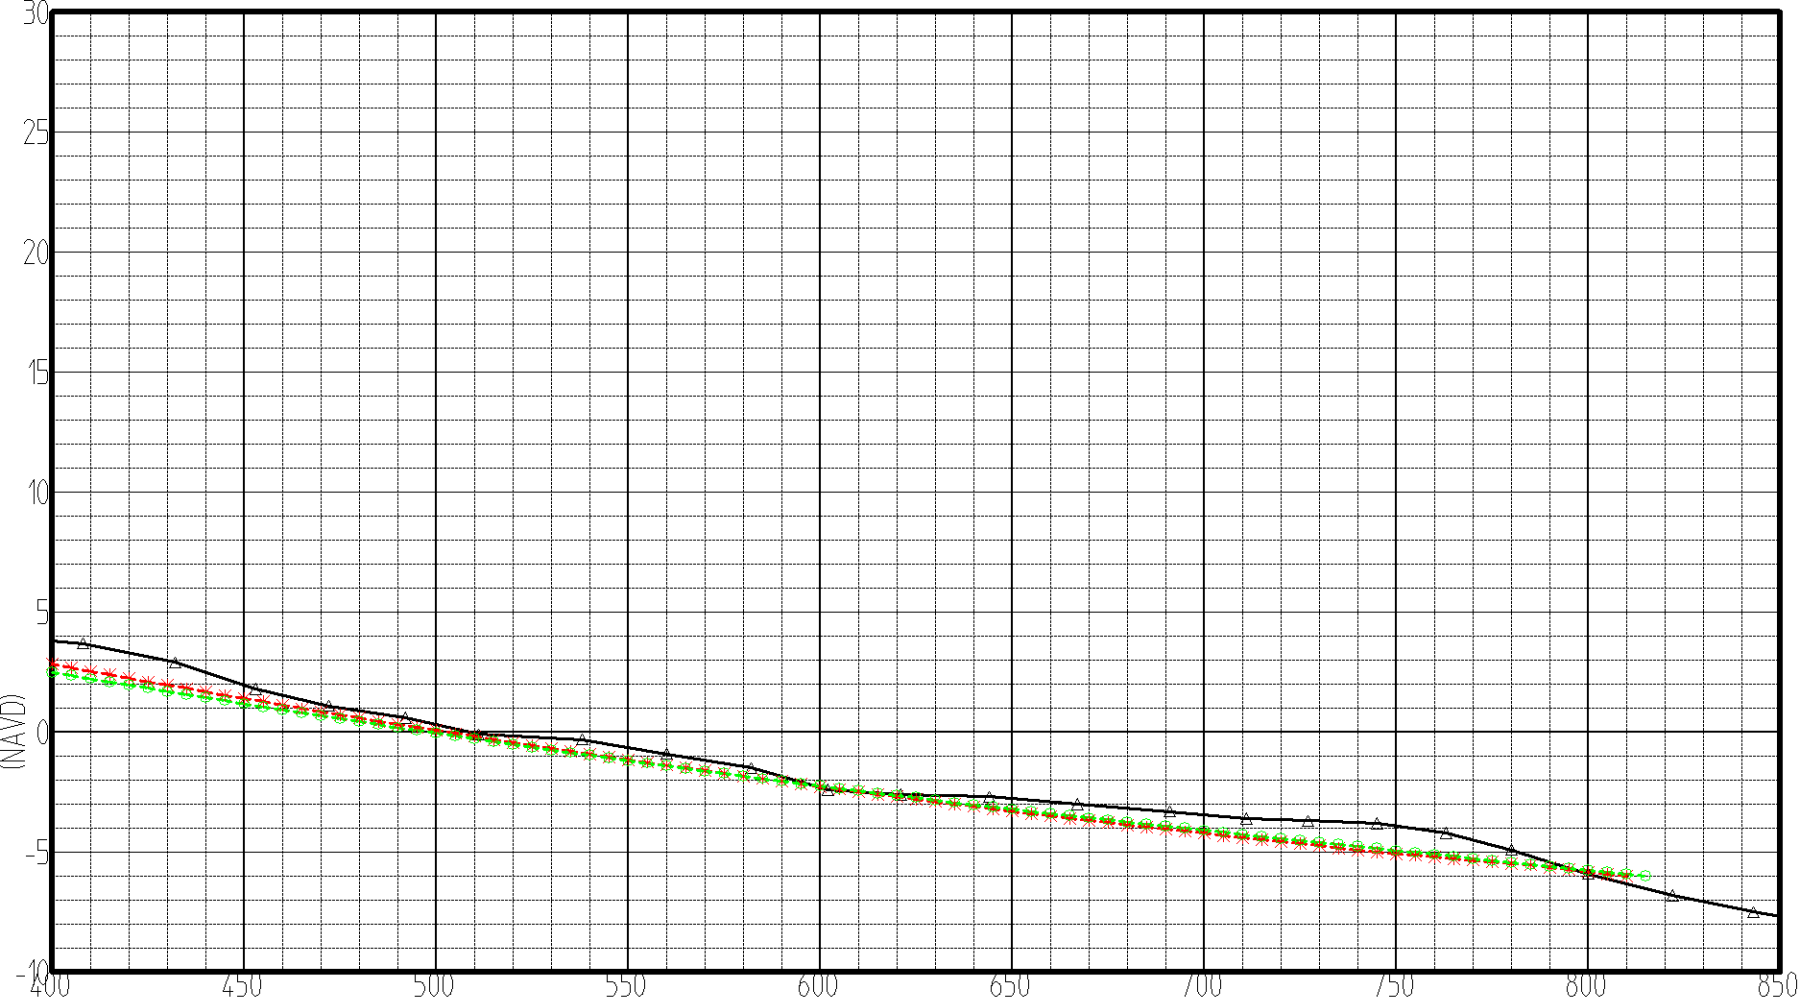
Range: T-130 2/3
 BEARING: 75.00

BEACH PROFILE
 —△—△— ST. JOHNS 2007-2008 COMBI
 - - * - - - 15YR SBEACH ERODED
 - - o - - - 25YR SBCH ERODED

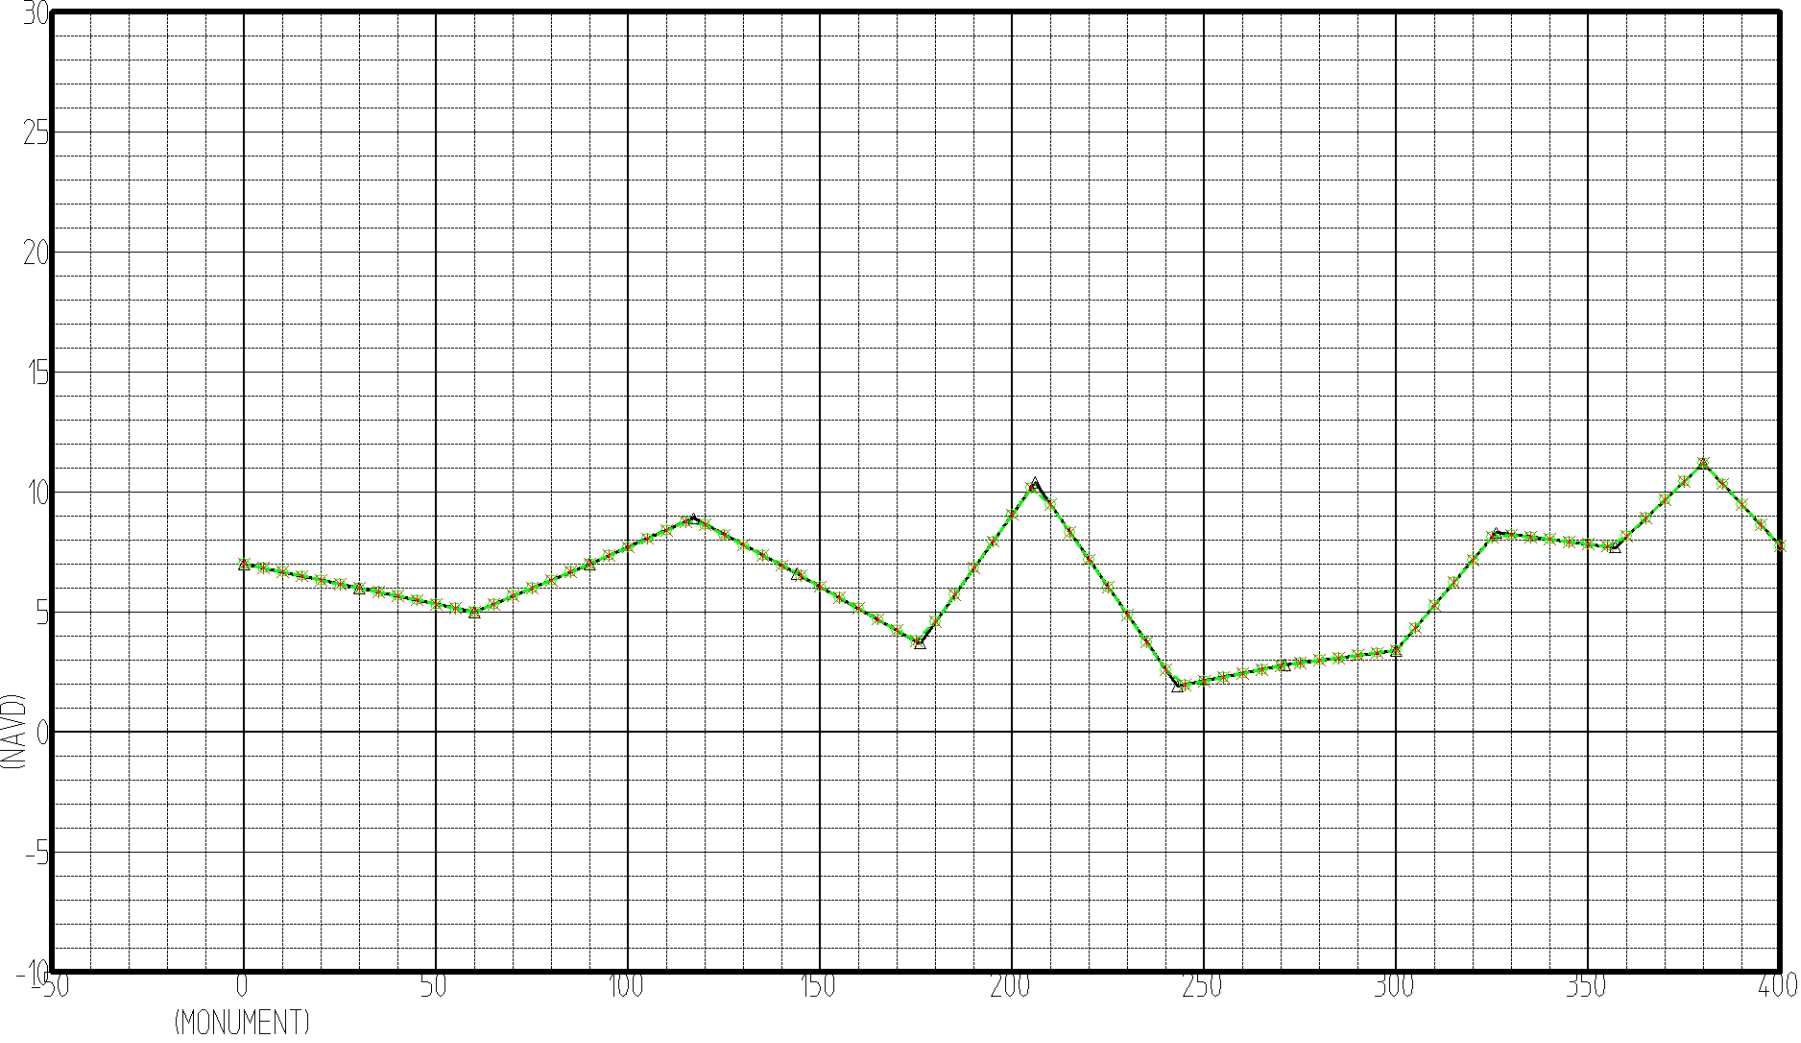
Range: R-131

BEACH PROFILE

—△—△— ST. JOHNS 2007-2008 COMBI

- - * - - * - - 15YR SBEACH ERODED

- - o - - o - - 25YR SBCH ERODED

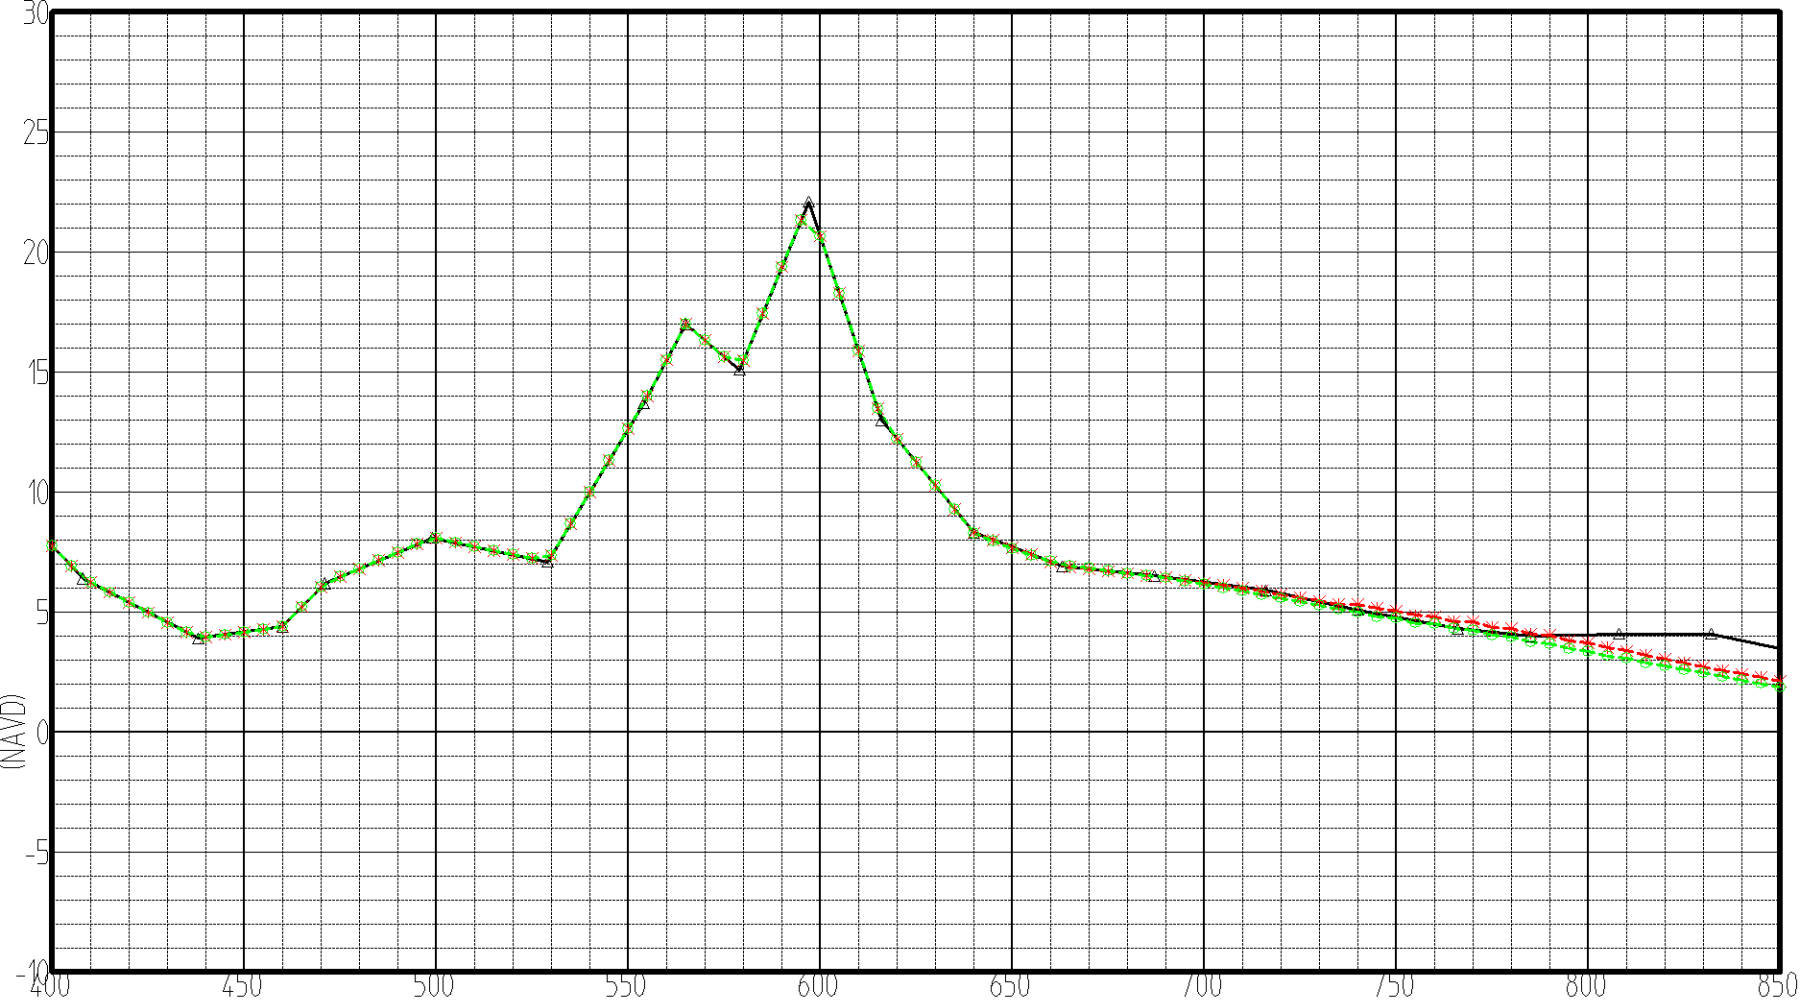
Range: R-131

BEACH PROFILE

—△—△— ST. JOHNS 2007-2008 COMBI

- - - * - - - 15YR SBEACH ERODED

- - - o - - - 25YR SBCH ERODED

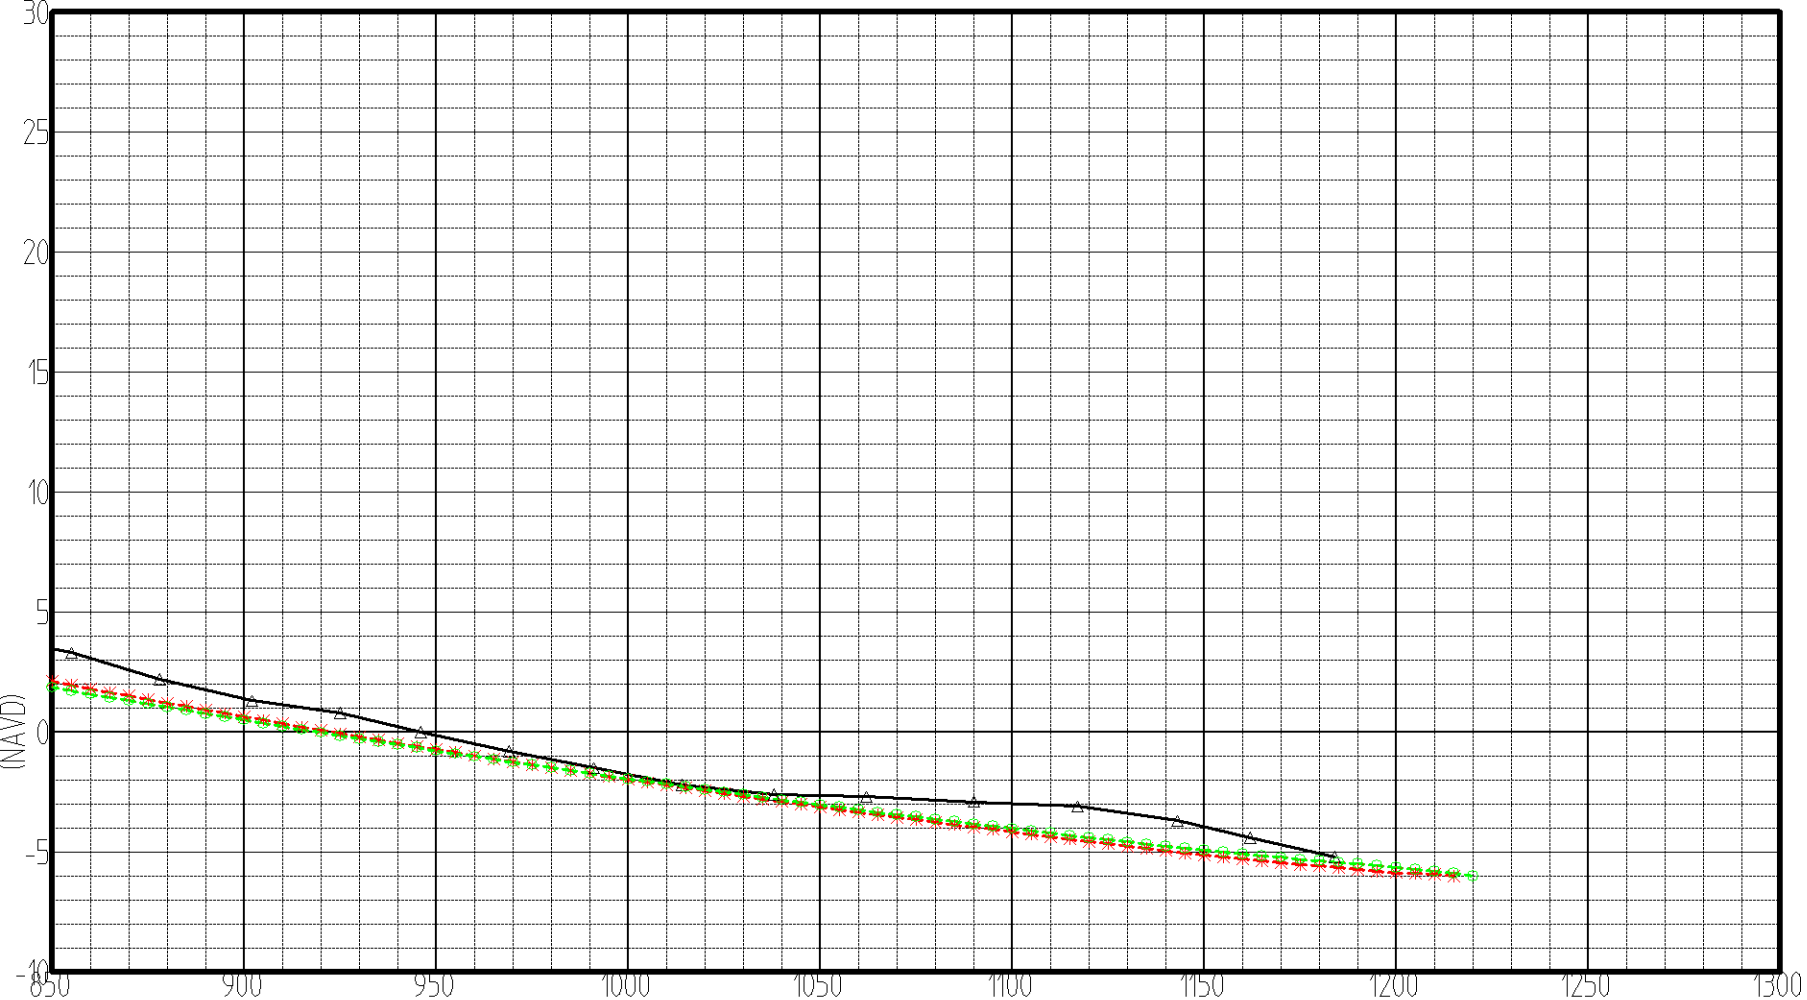
Range: R-131
 BEARING: 75.00
 3/3

BEACH PROFILE
 —△—△— ST. JOHNS 2007-2008 COMBI
 - - * - - 15YR SBEACH ERODED
 - - o - - 25YR SBCH ERODED

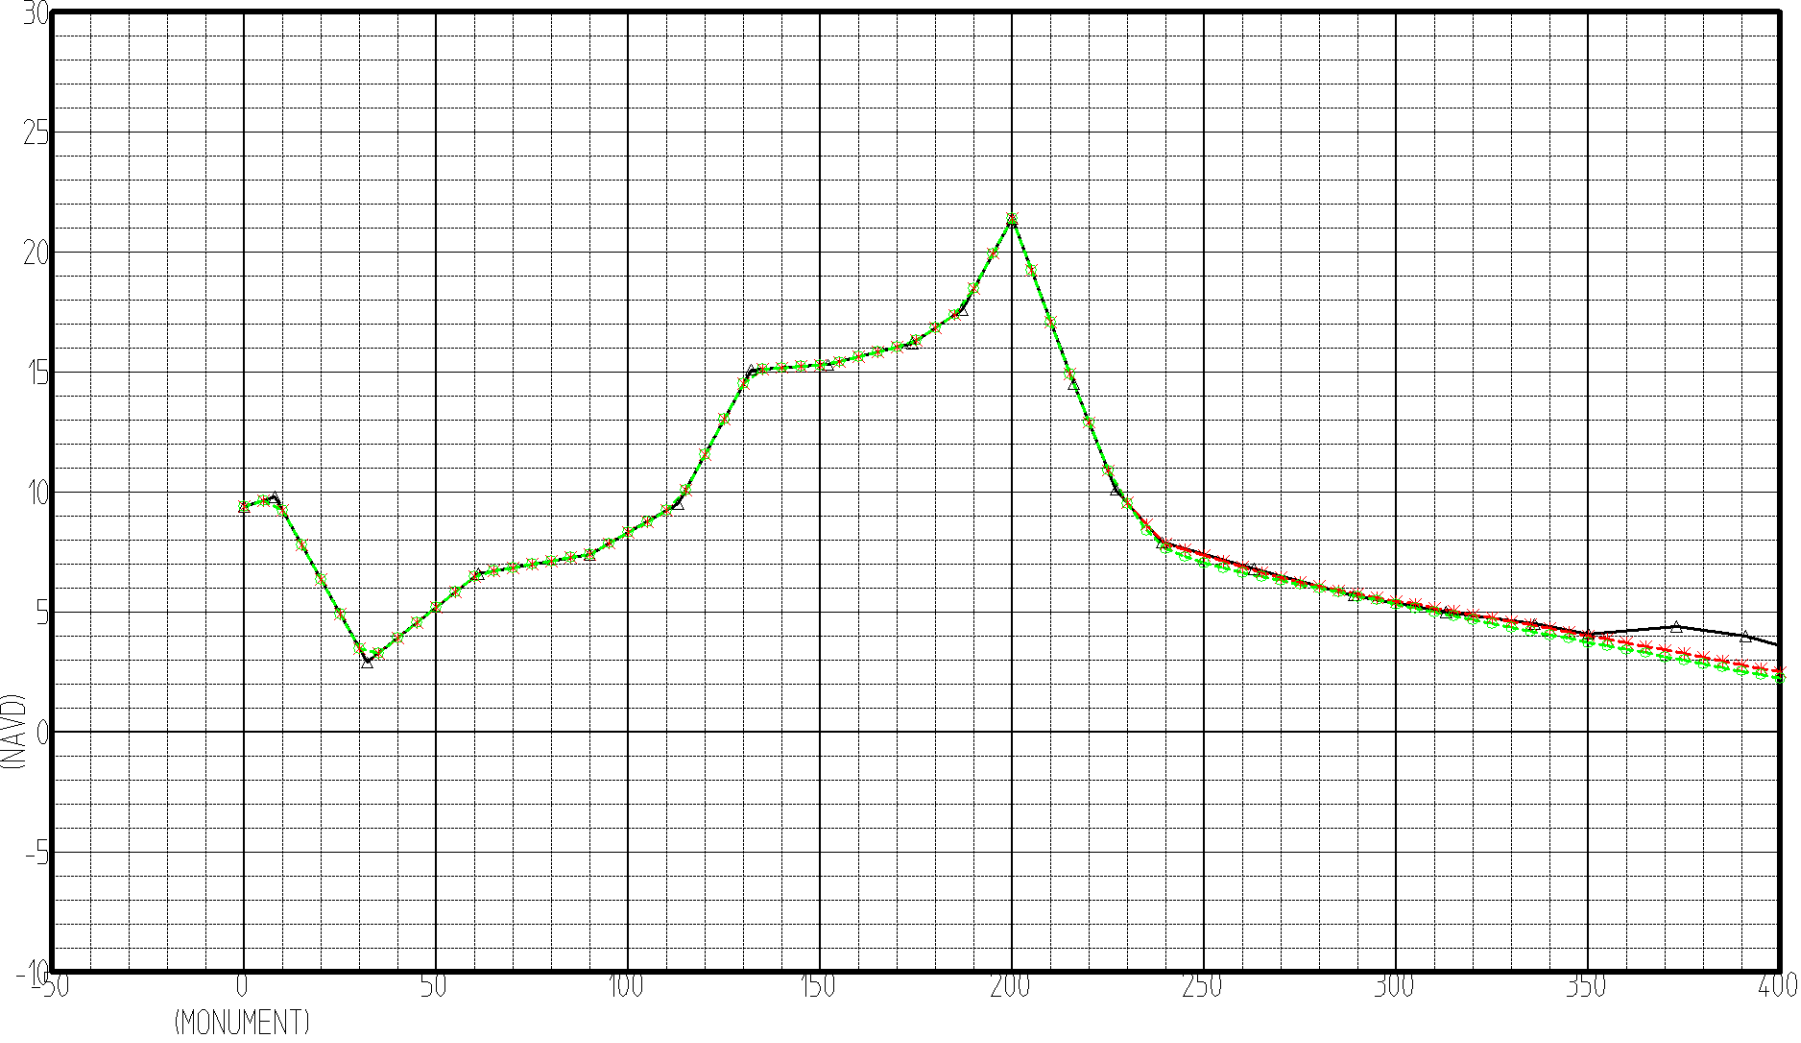
Range: T-132 1/2
 BEARING: 75.00

BEACH PROFILE
 —△—△— ST. JOHNS 2007-2008 COMBI
 - - * - - 15YR SBCH ERODED
 - - o - - 25YR SBCH ERODED
