Appendix VIII

SBEACH 15 and 25 yr. Storm Erosion Profiles

St. Johns County

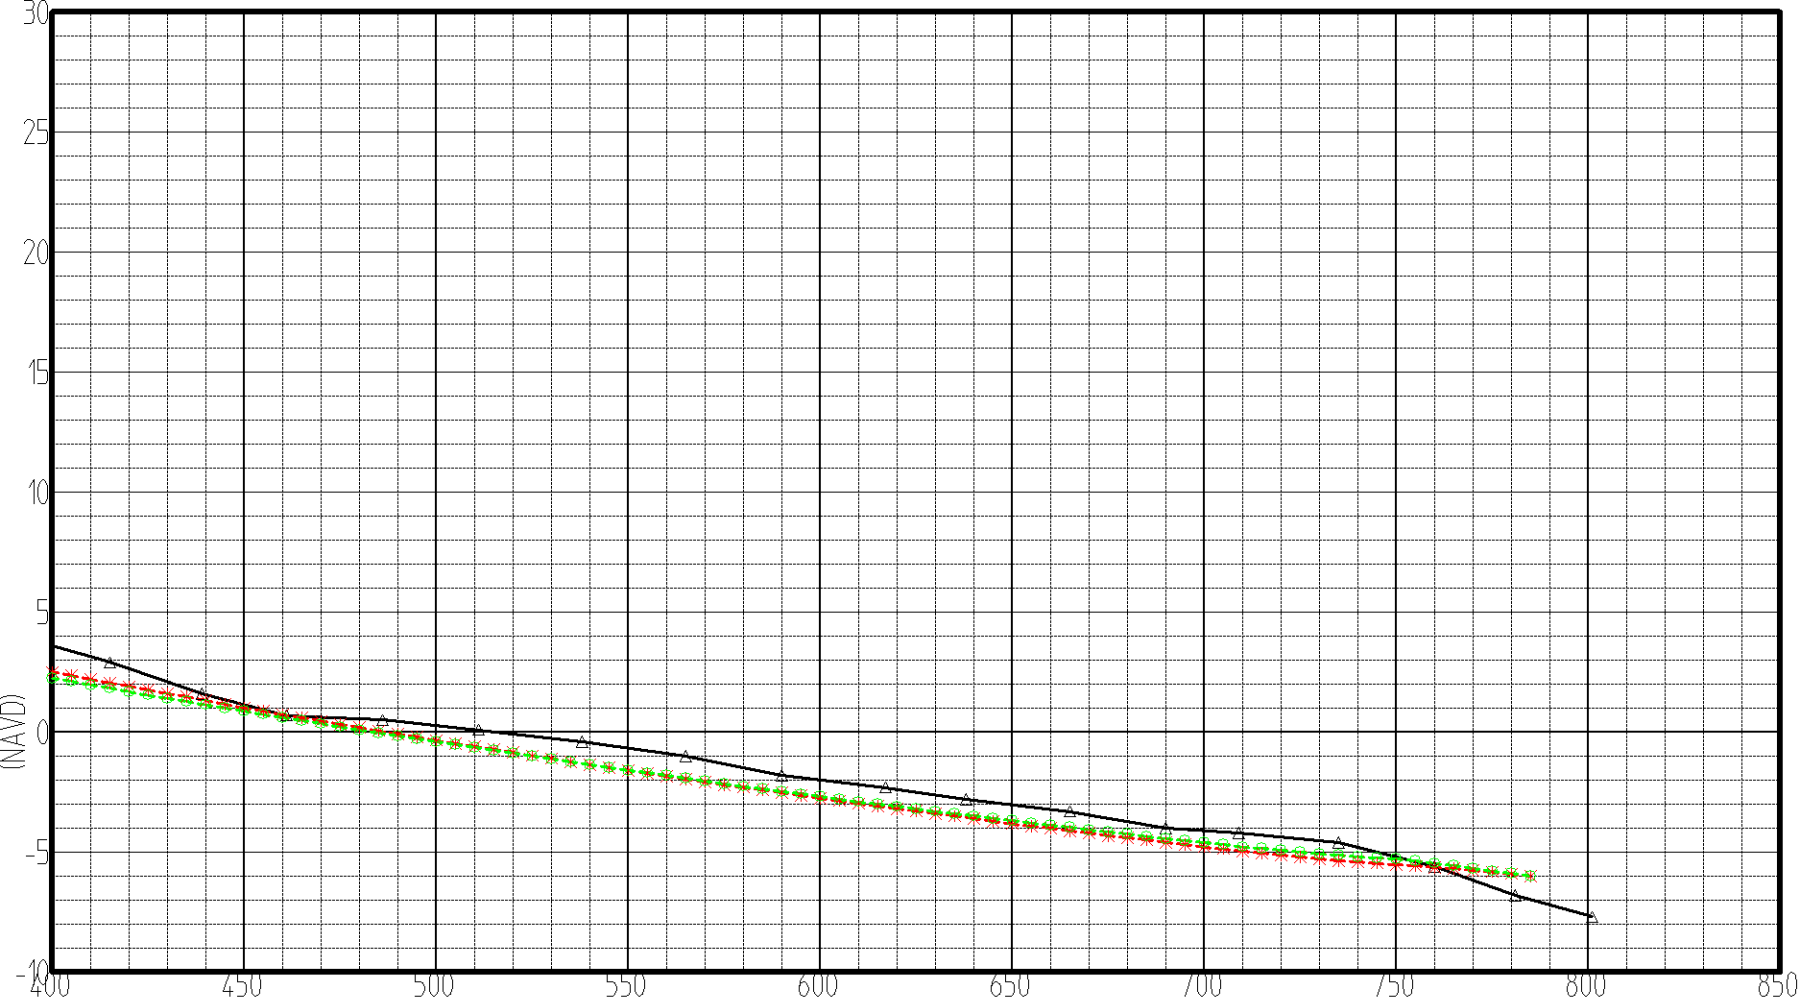
Range: T-132 2/2

BEACH PROFILE

—△—△— ST. JOHNS 2007-2008 COMBI

- - - * - - - 15YR SBEACH ERODED

- - - o - - - 25YR SBCH ERODED

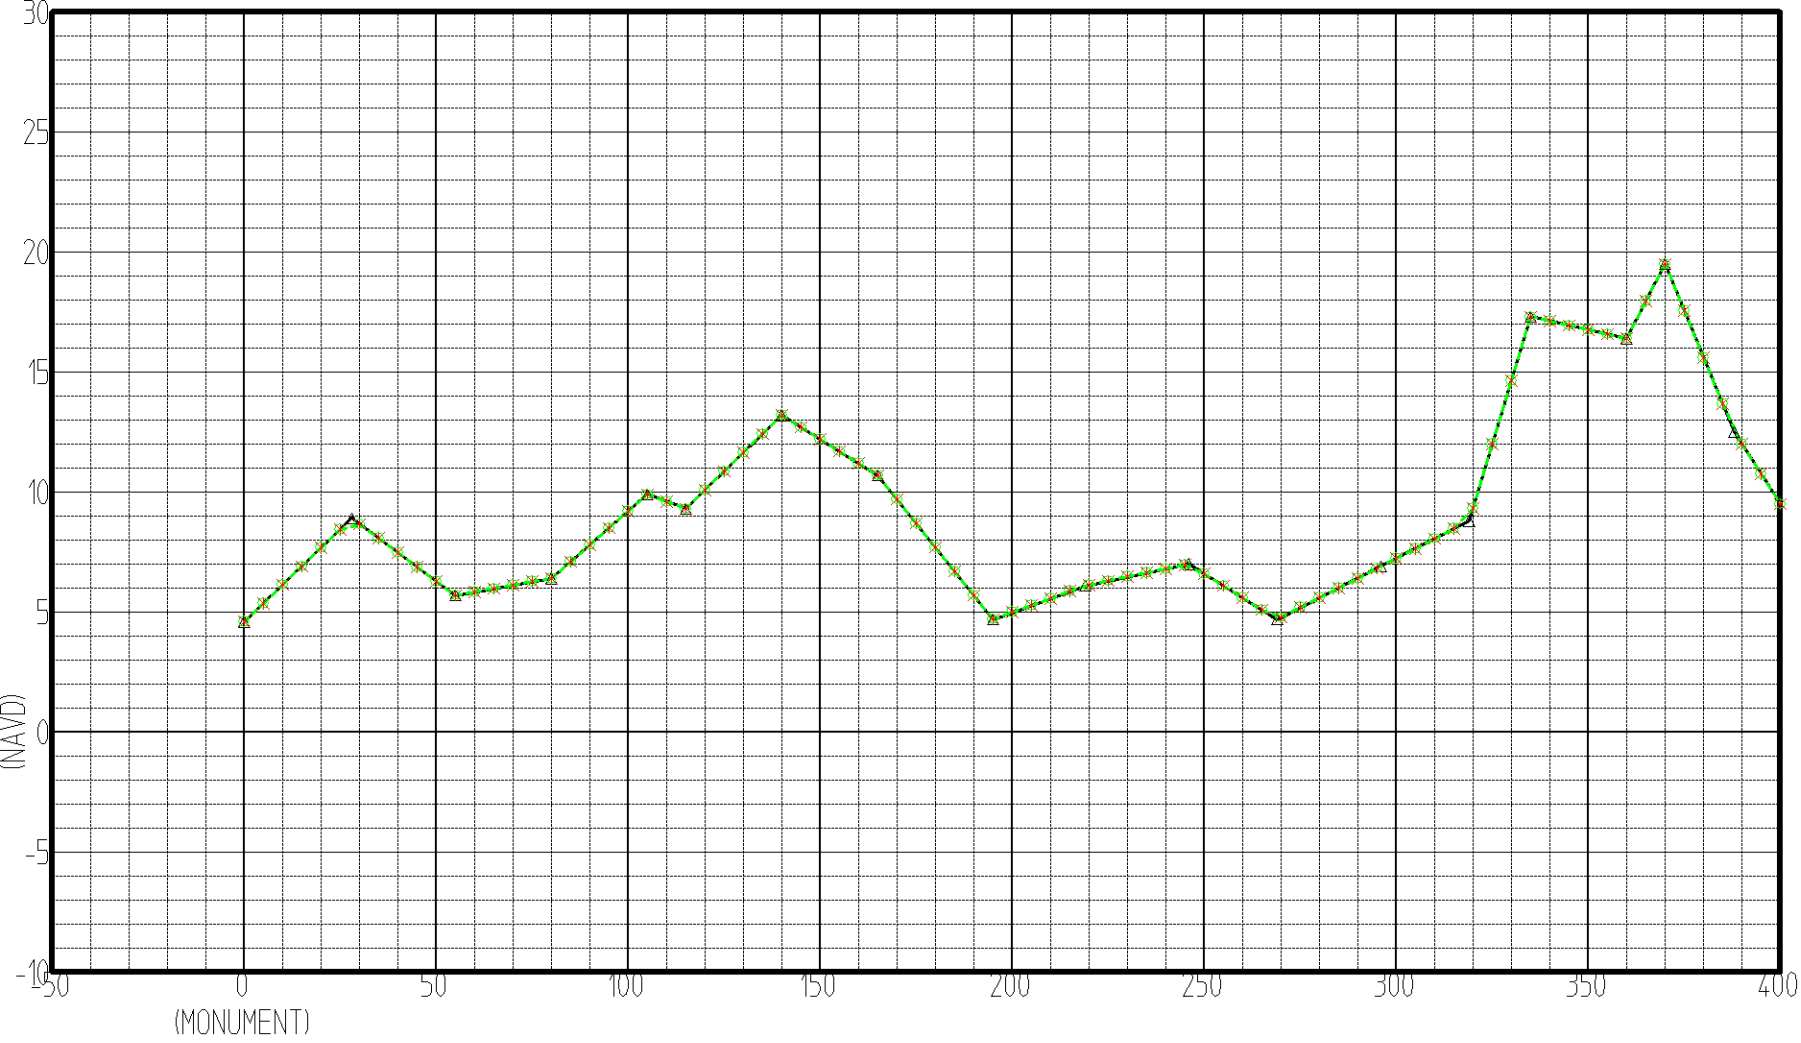
Range: R-133A 1/3
 BEARING: 75.00

BEACH PROFILE
 —△—△— ST. JOHNS 2007-2008 COMBI
 - - * - - * - - 15YR SBEACH ERODED
 - - o - - o - - 25YR SBCH ERODED

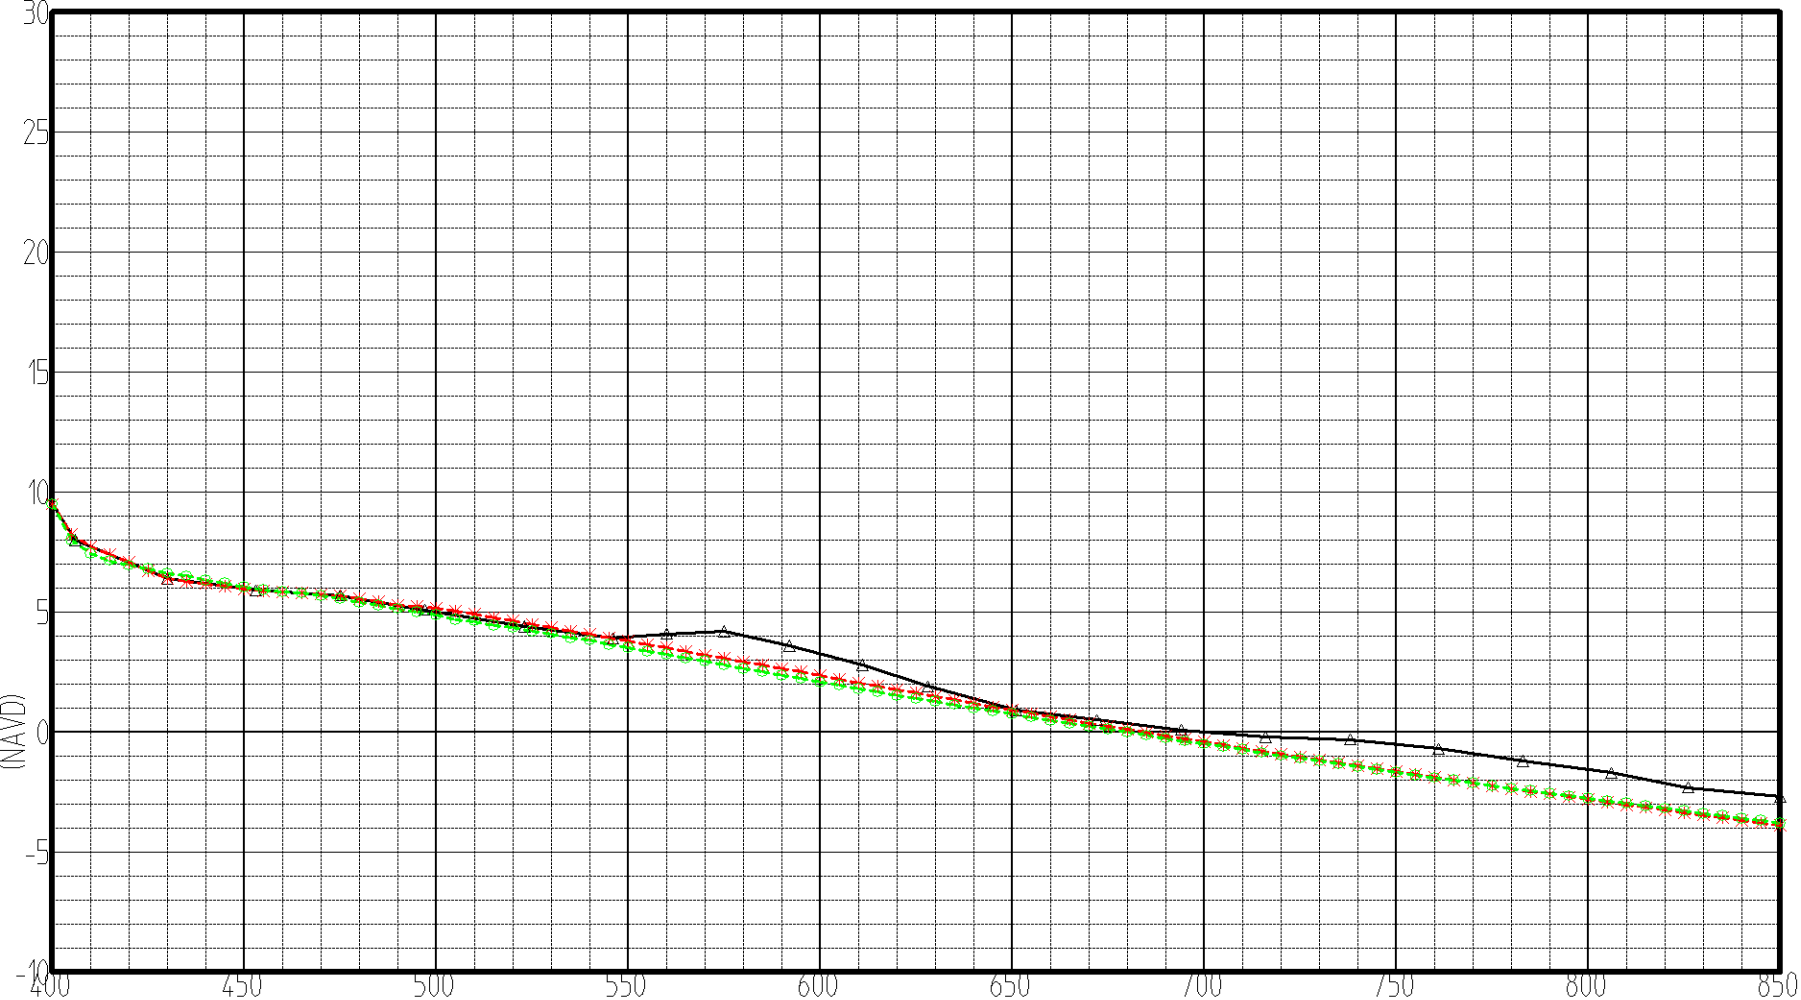
Range: R-133A 2/3
 BEARING: 75.00

BEACH PROFILE
 —△—△— ST. JOHNS 2007-2008 COMBI
 - - * - - 15YR SBEACH ERODED
 - - o - - 25YR SBCH ERODED

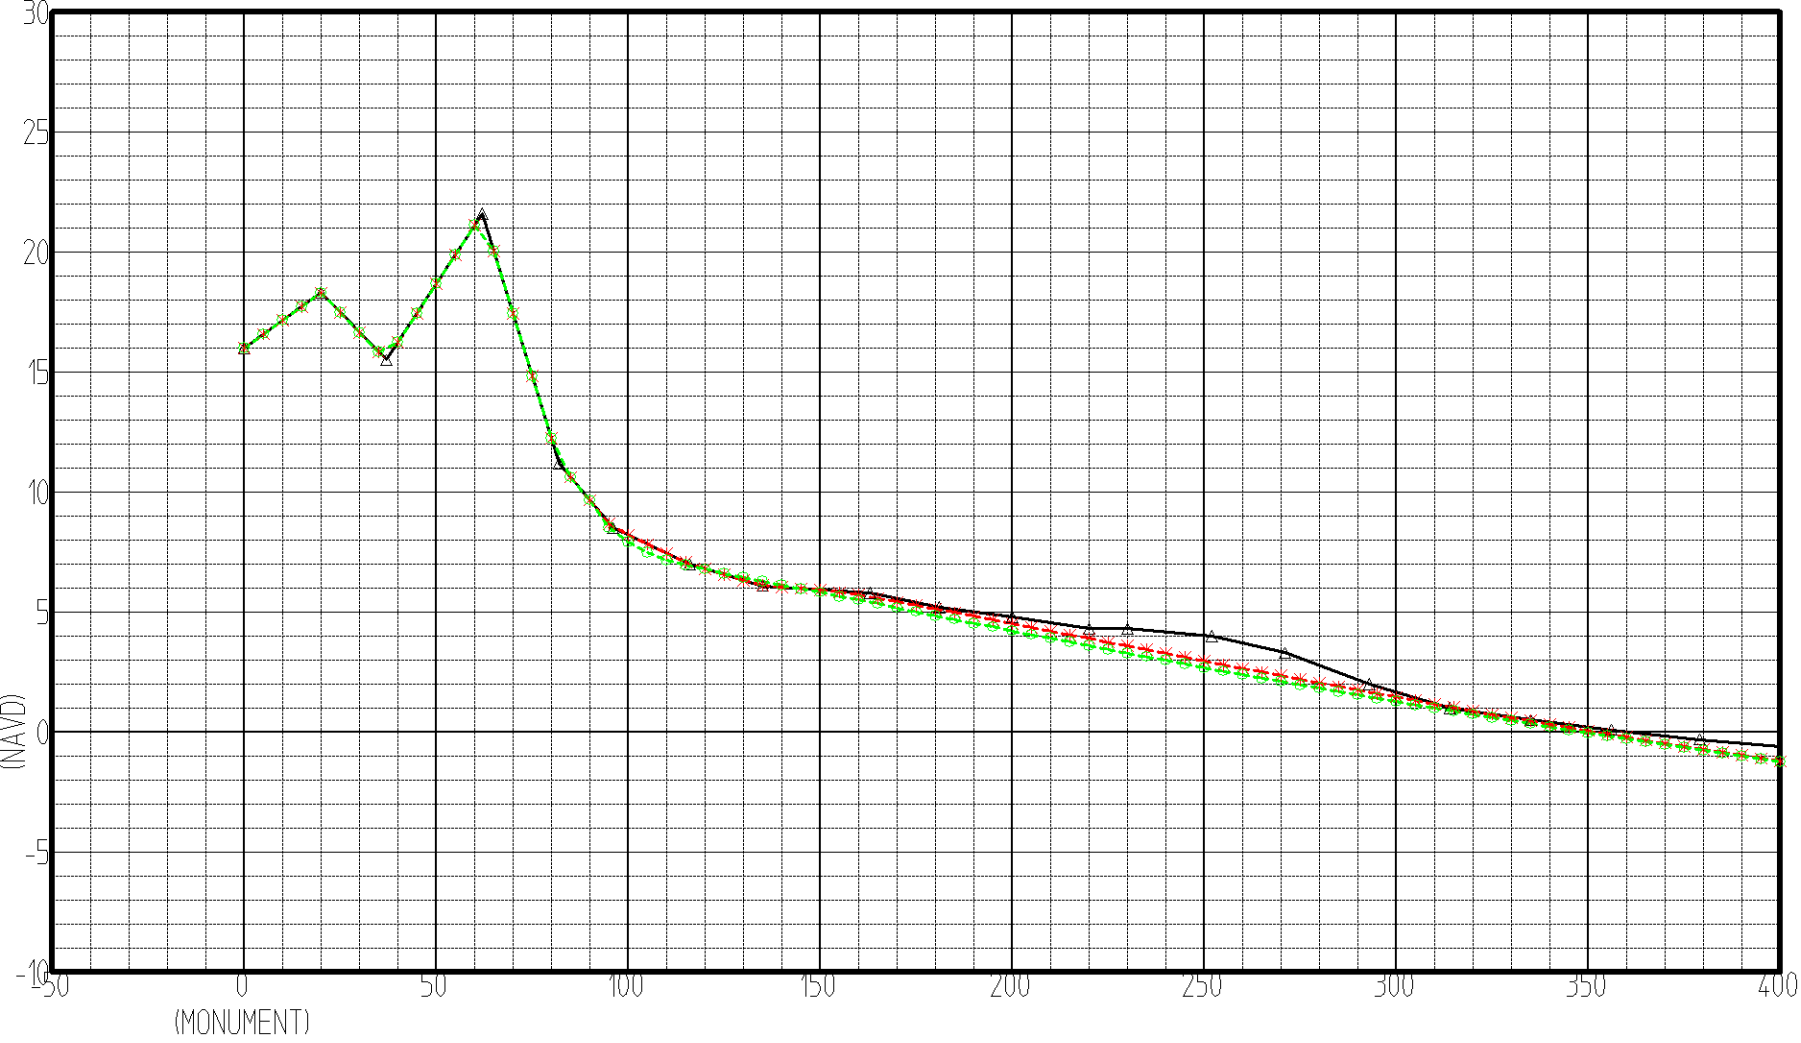
BEACH PROFILE
 —△—△— ST. JOHNS 2007-2008 COMBI
 - - * - - * - - 15YR SBEACH ERODED
 - - o - - o - - 25YR SBCH ERODED

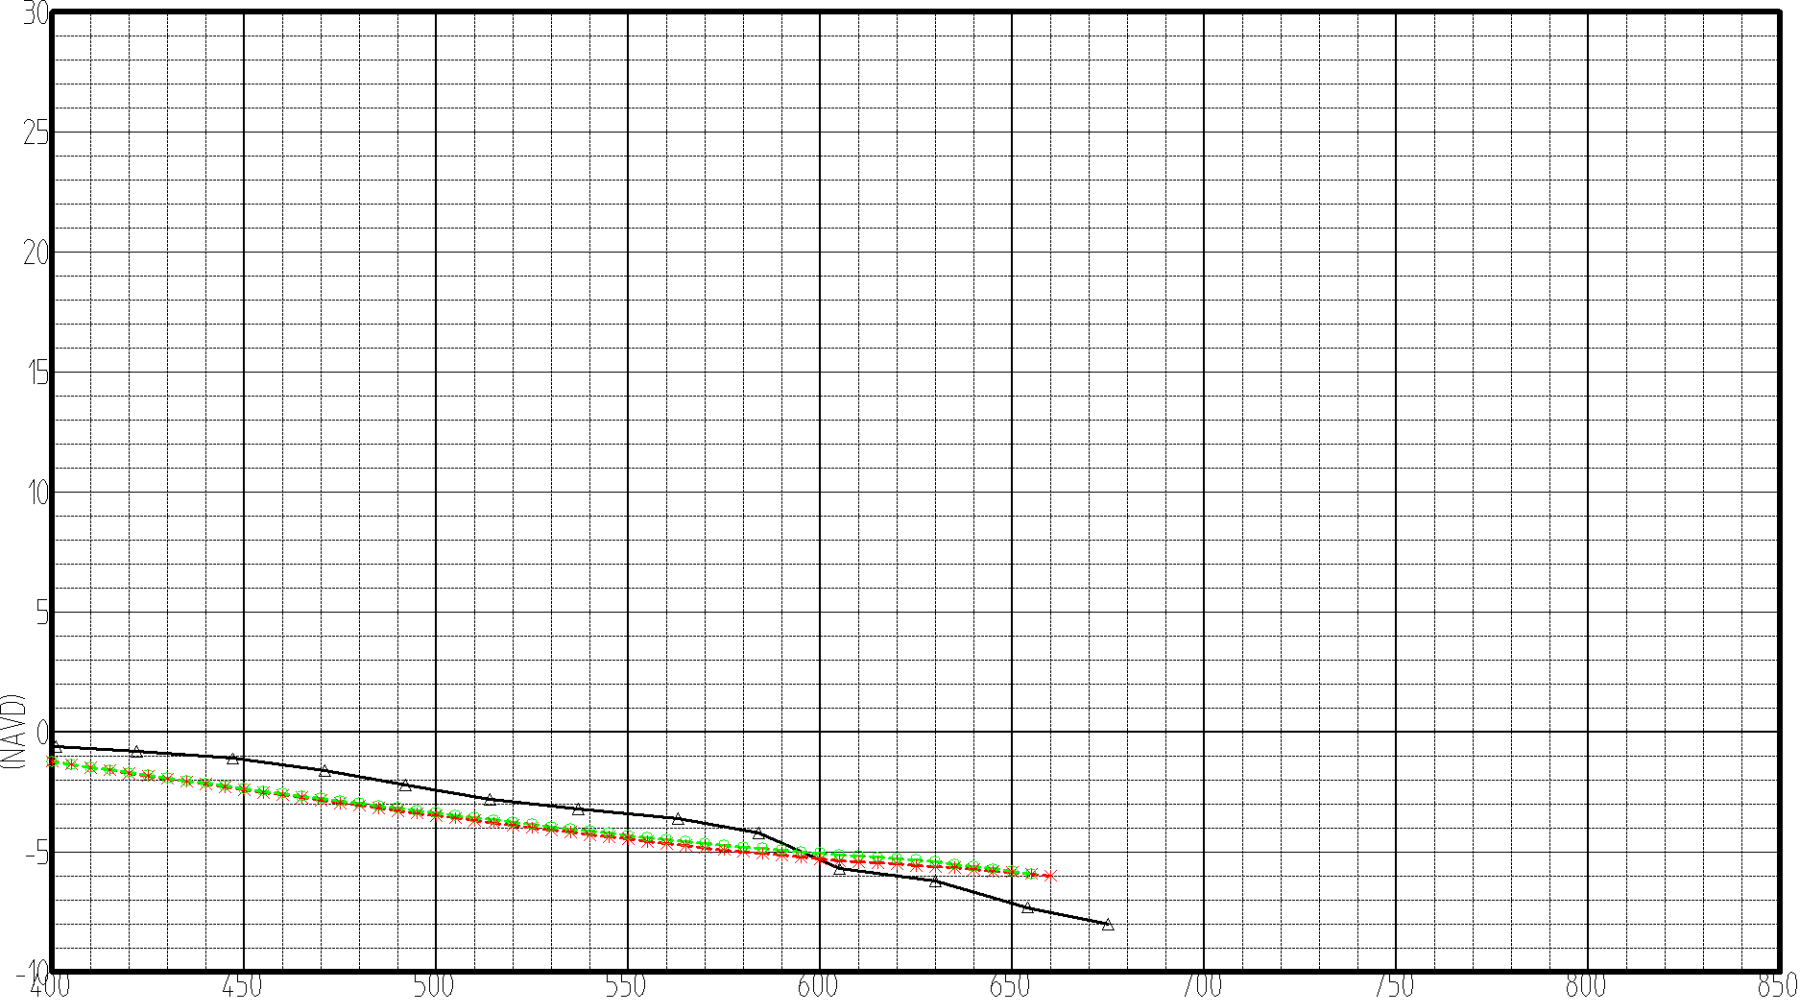
Range: R-134
 BEARING: 75.00
 2/2

BEACH PROFILE
 —△—△— ST. JOHNS 2007-2008 COMBI
 - - * - - * - - 15YR SBEACH ERODED
 - - o - - o - - 25YR SBCH ERODED

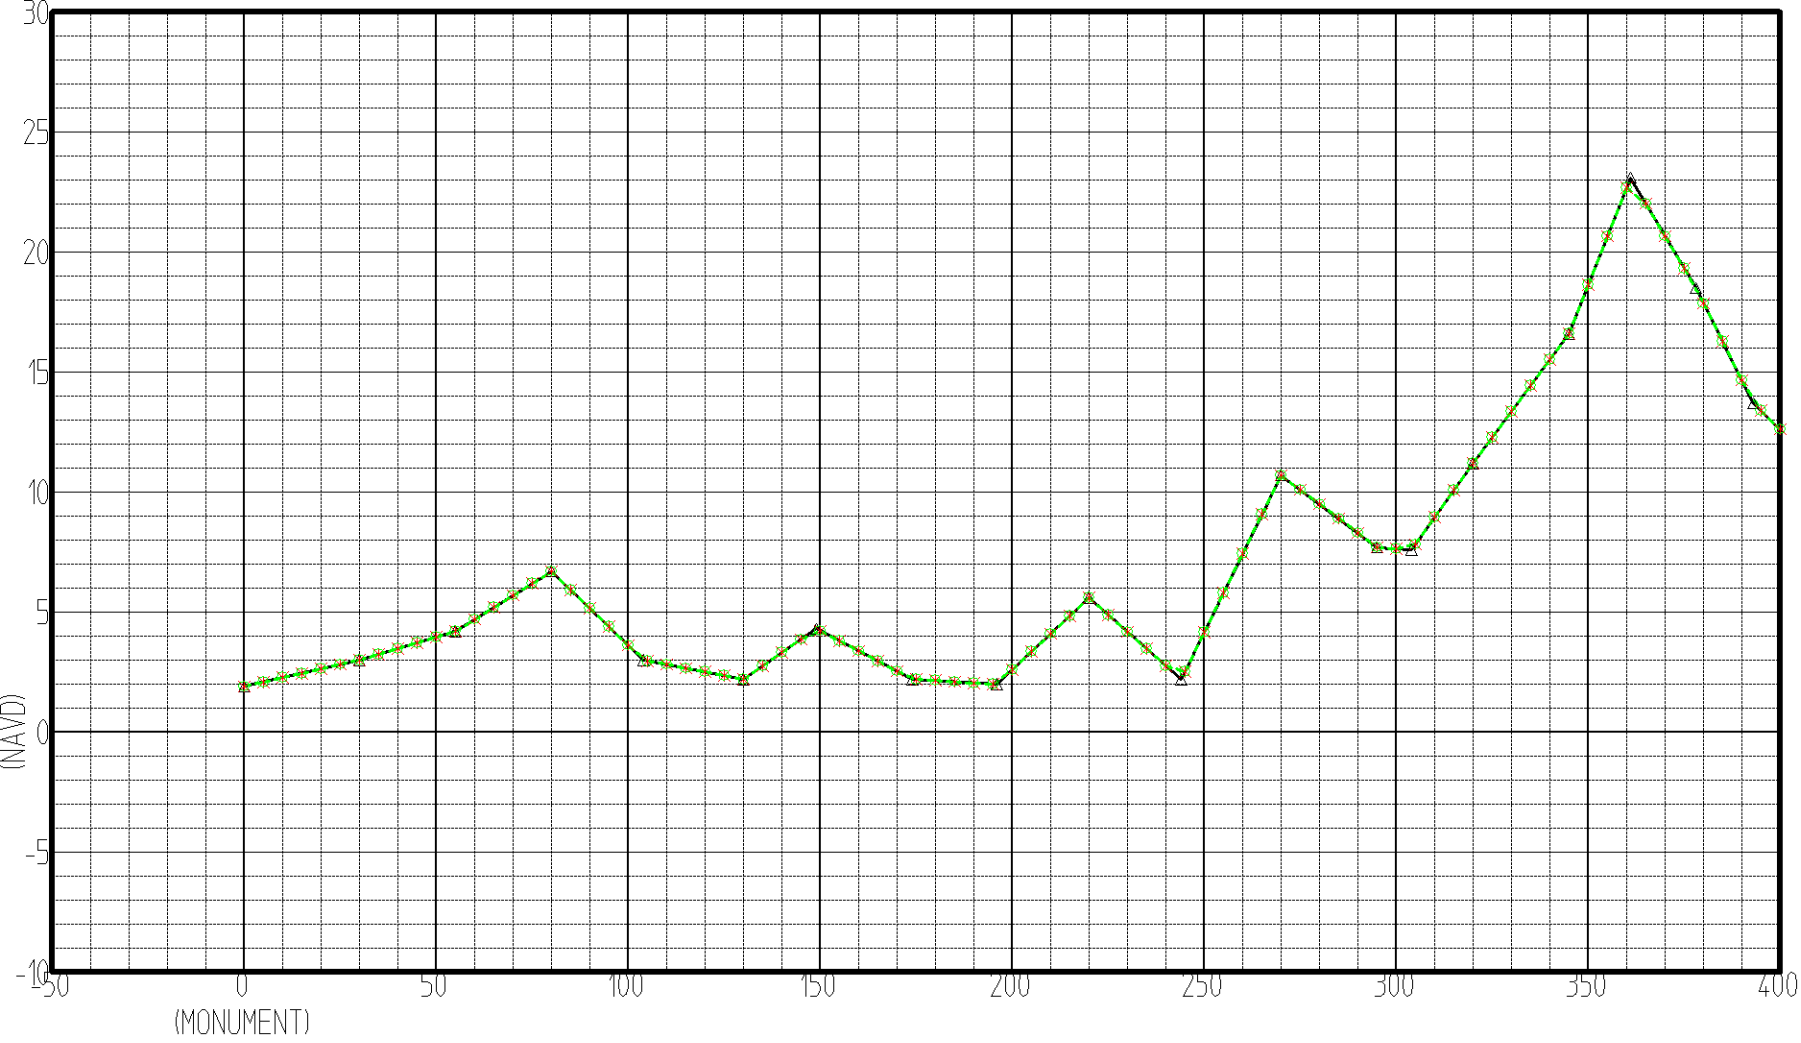
Range: R-135A

BEACH PROFILE

—△—△— ST. JOHNS 2007-2008 COMBI

- - - * - - - 15YR SBCH ERODED

- - - o - - - 25YR SBCH ERODED

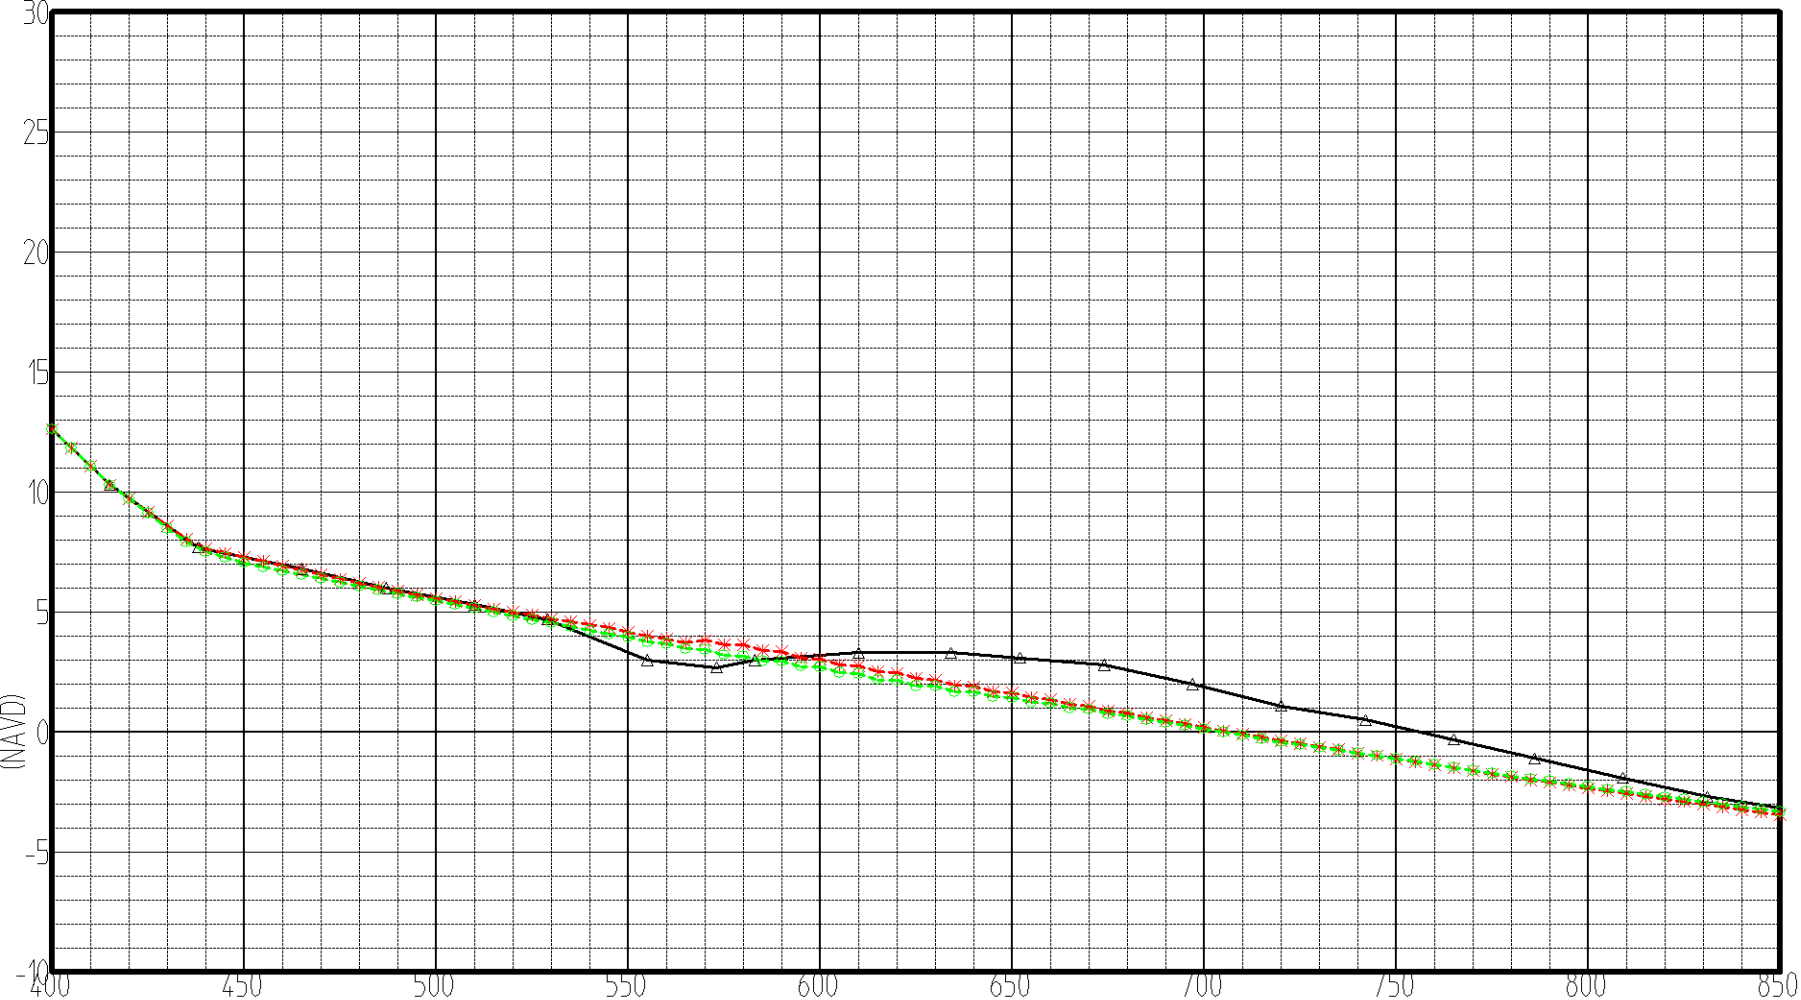
Range: R-135A 2/3
 BEARING: 75.00

BEACH PROFILE
 —△—△— ST. JOHNS 2007-2008 COMBI
 - - * - - * - - 15YR SBEACH ERODED
 - - o - - o - - 25YR SBCH ERODED

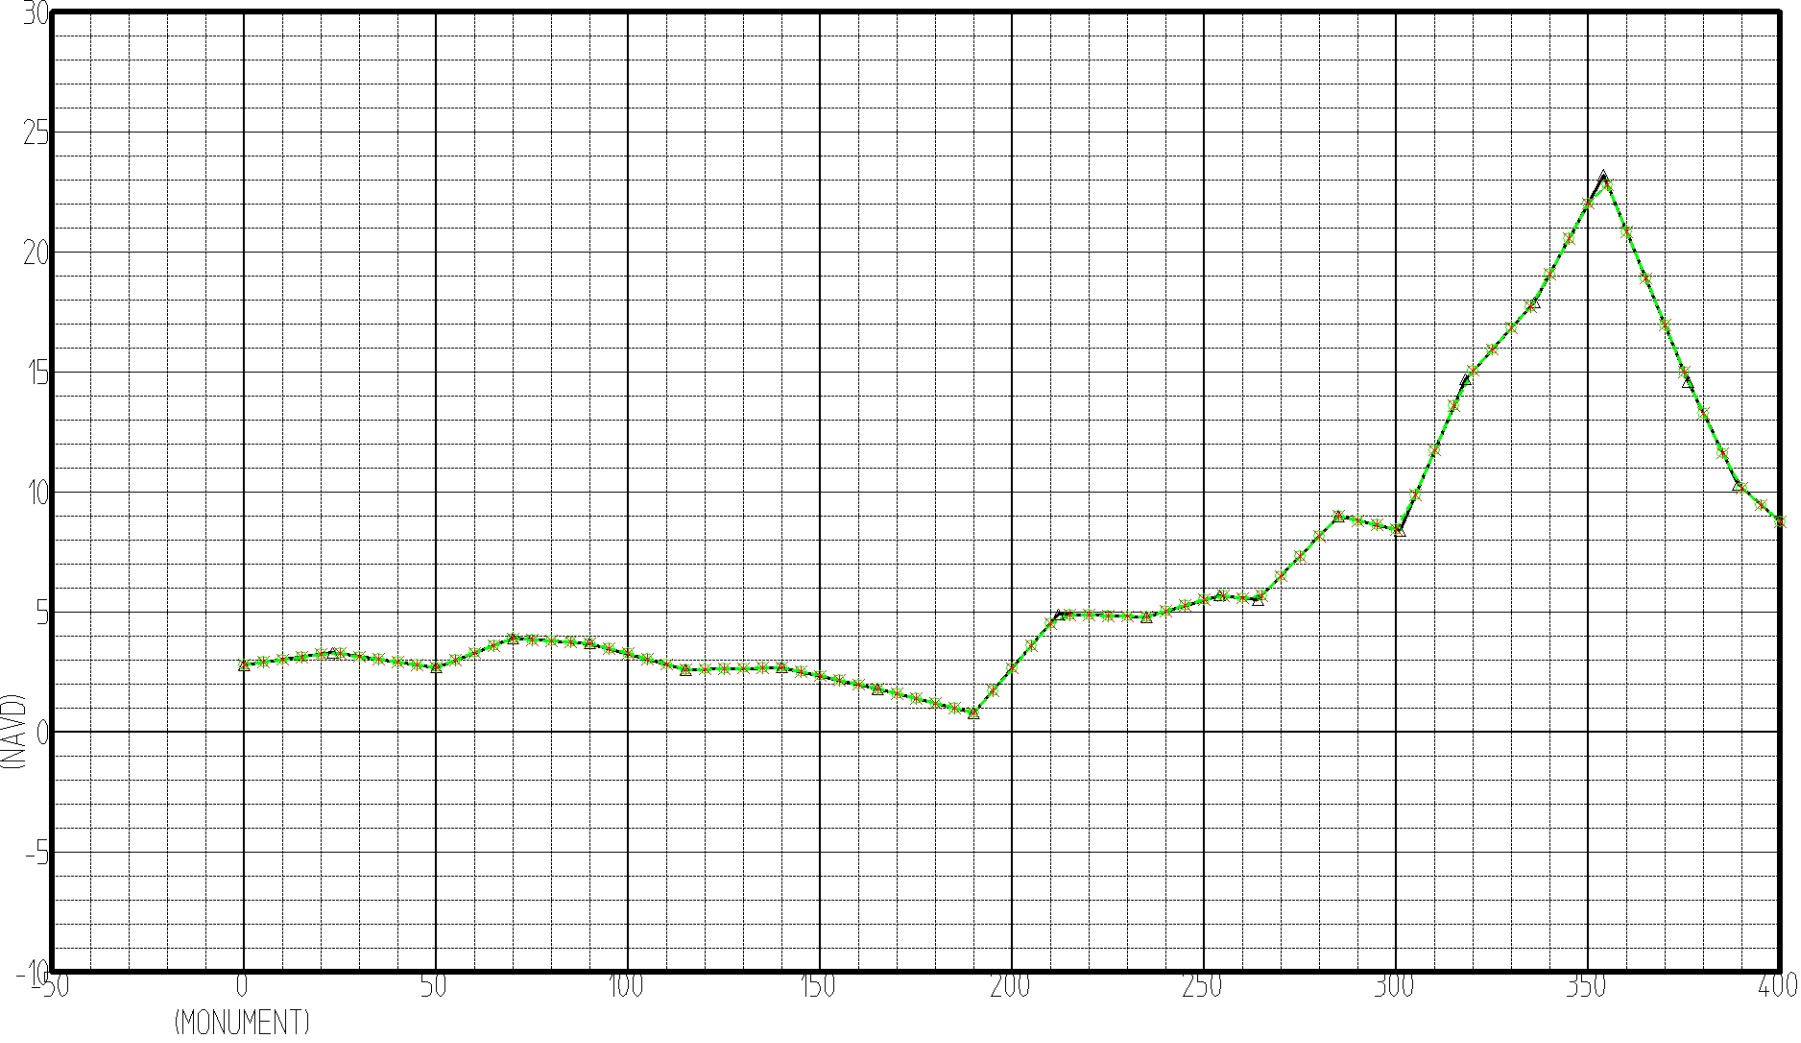
Range: R-136A
 BEARING: 75.00
 1/3

BEACH PROFILE
 —△—△— ST. JOHNS 2007-2008 COMBI
 - - * - - * - - 15YR SBCH ERODED
 - - o - - o - - 25YR SBCH ERODED

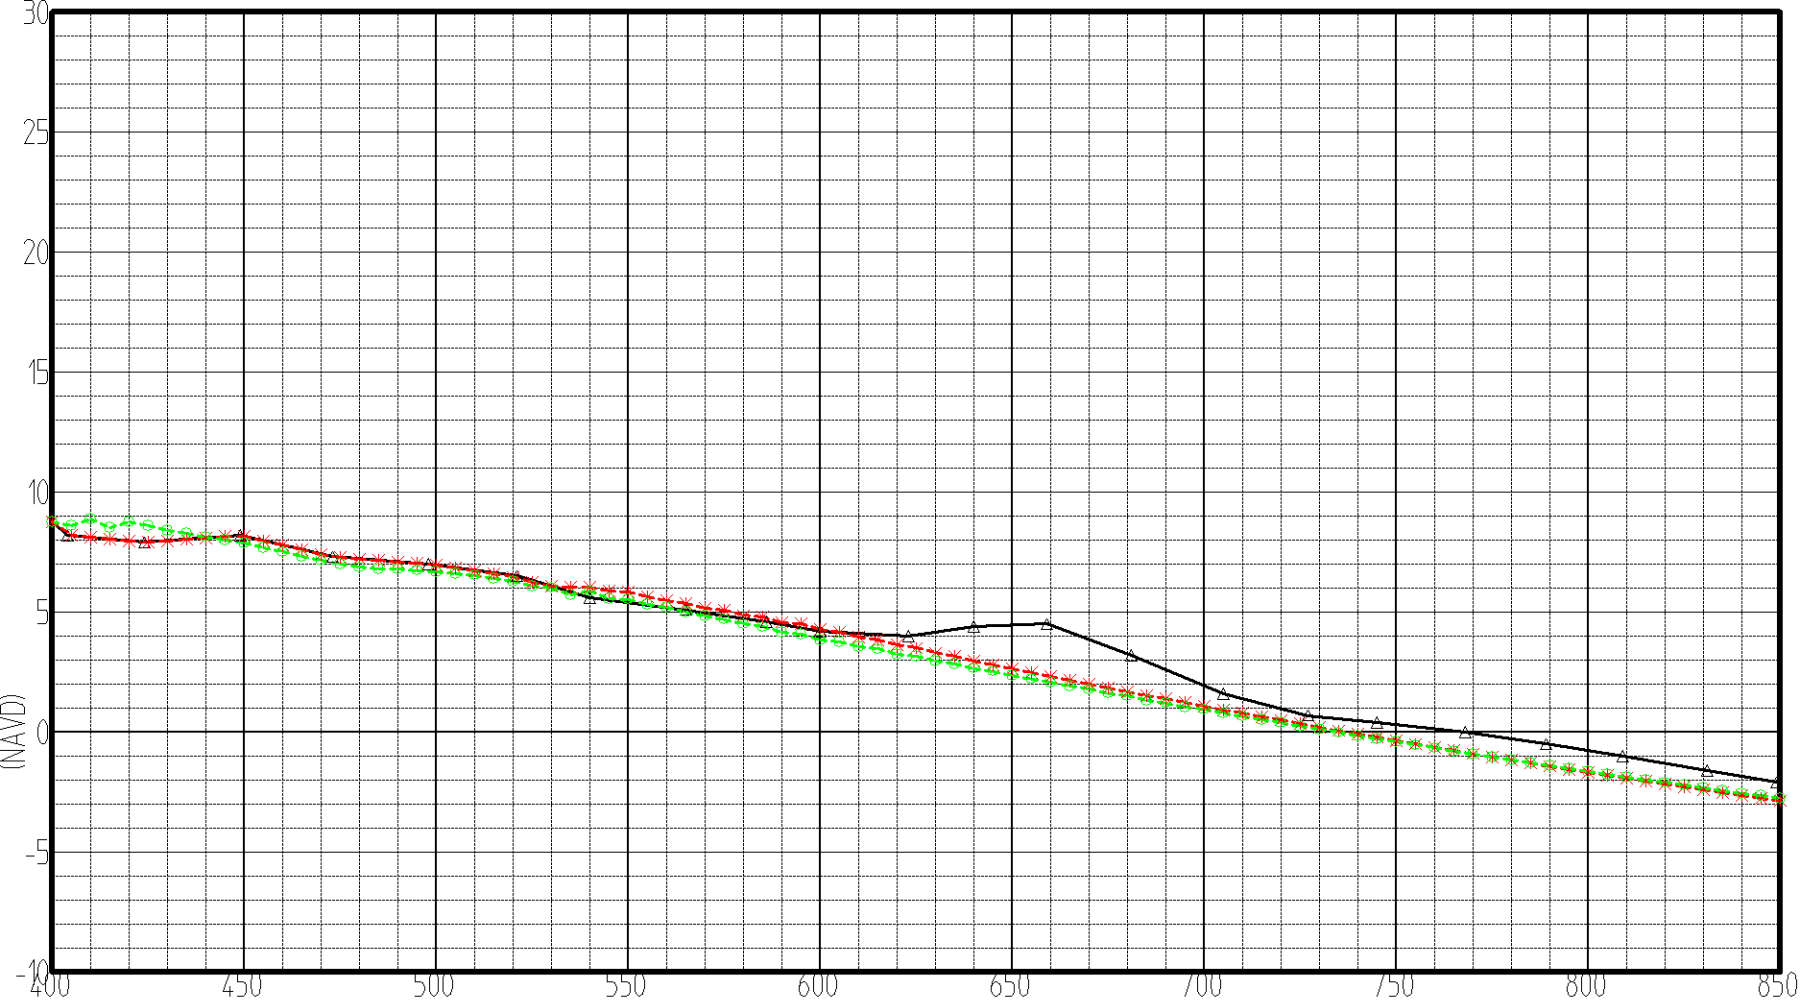
Range: R-136A 2/3
 BEARING: 75.00

BEACH PROFILE
 —△—△— ST. JOHNS 2007-2008 COMBI
 - - * - - - 15YR SBEACH ERODED
 - - o - - - 25YR SBCH ERODED

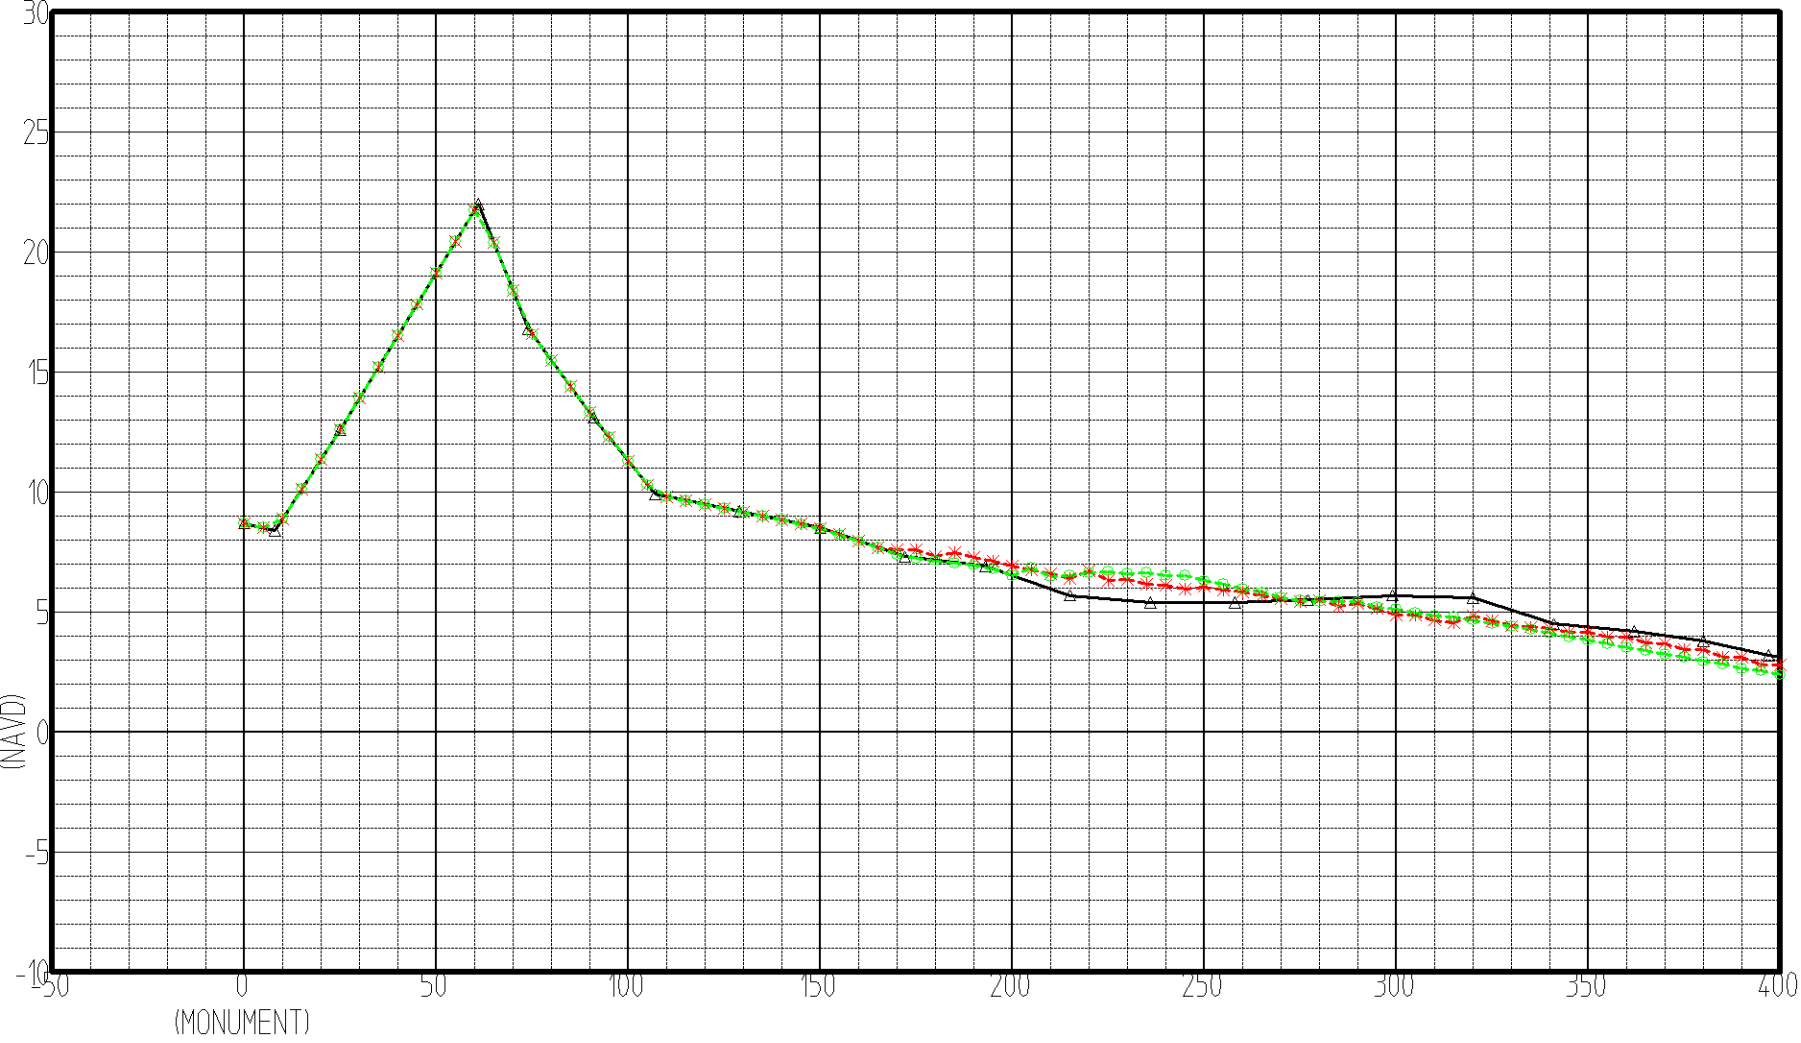
Range: R-137A 1/2
 BEARING: 75.00

BEACH PROFILE
 —△—△— ST. JOHNS 2007-208 COMBI
 - - * - - 15YR SBCH ERODED
 - - o - - 25YR SBCH ERODED

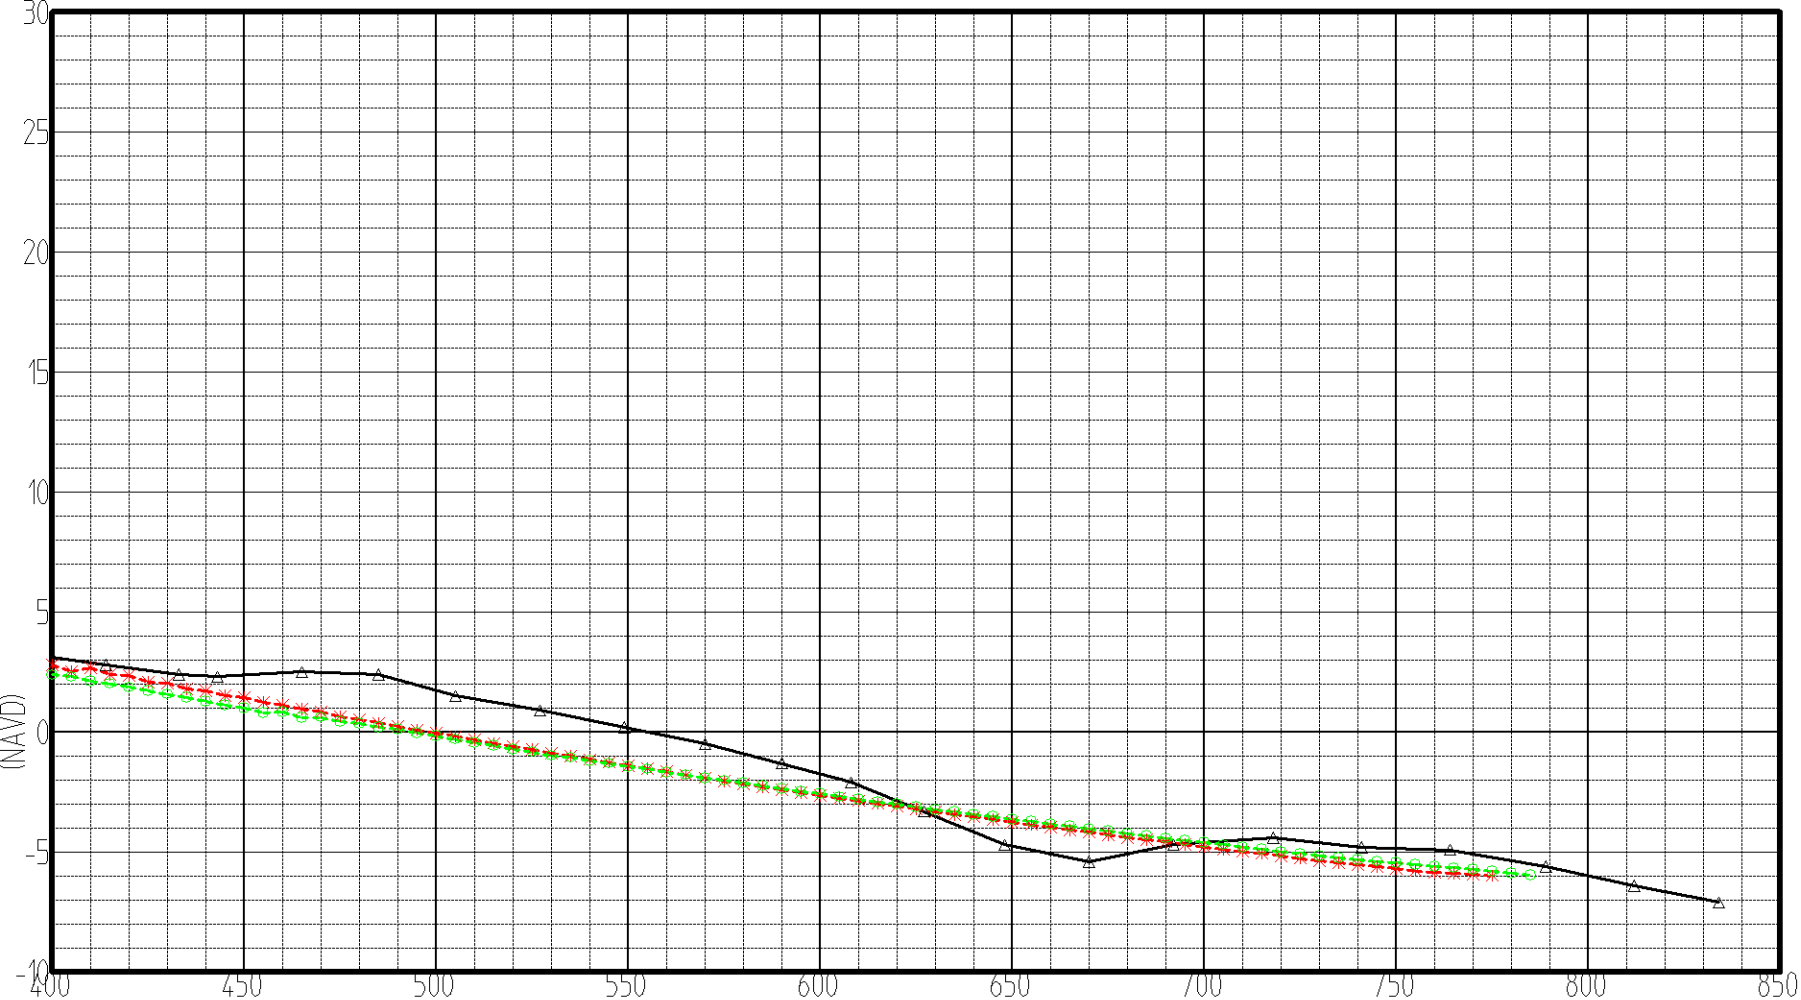
Range: R-137A 2/2
 BEARING: 75.00

BEACH PROFILE
 —△—△— ST. JOHNS 2007-2018 COMBI
 - - * - - - 15YR SBEACH ERODED
 - - o - - - 25YR SBCH ERODED

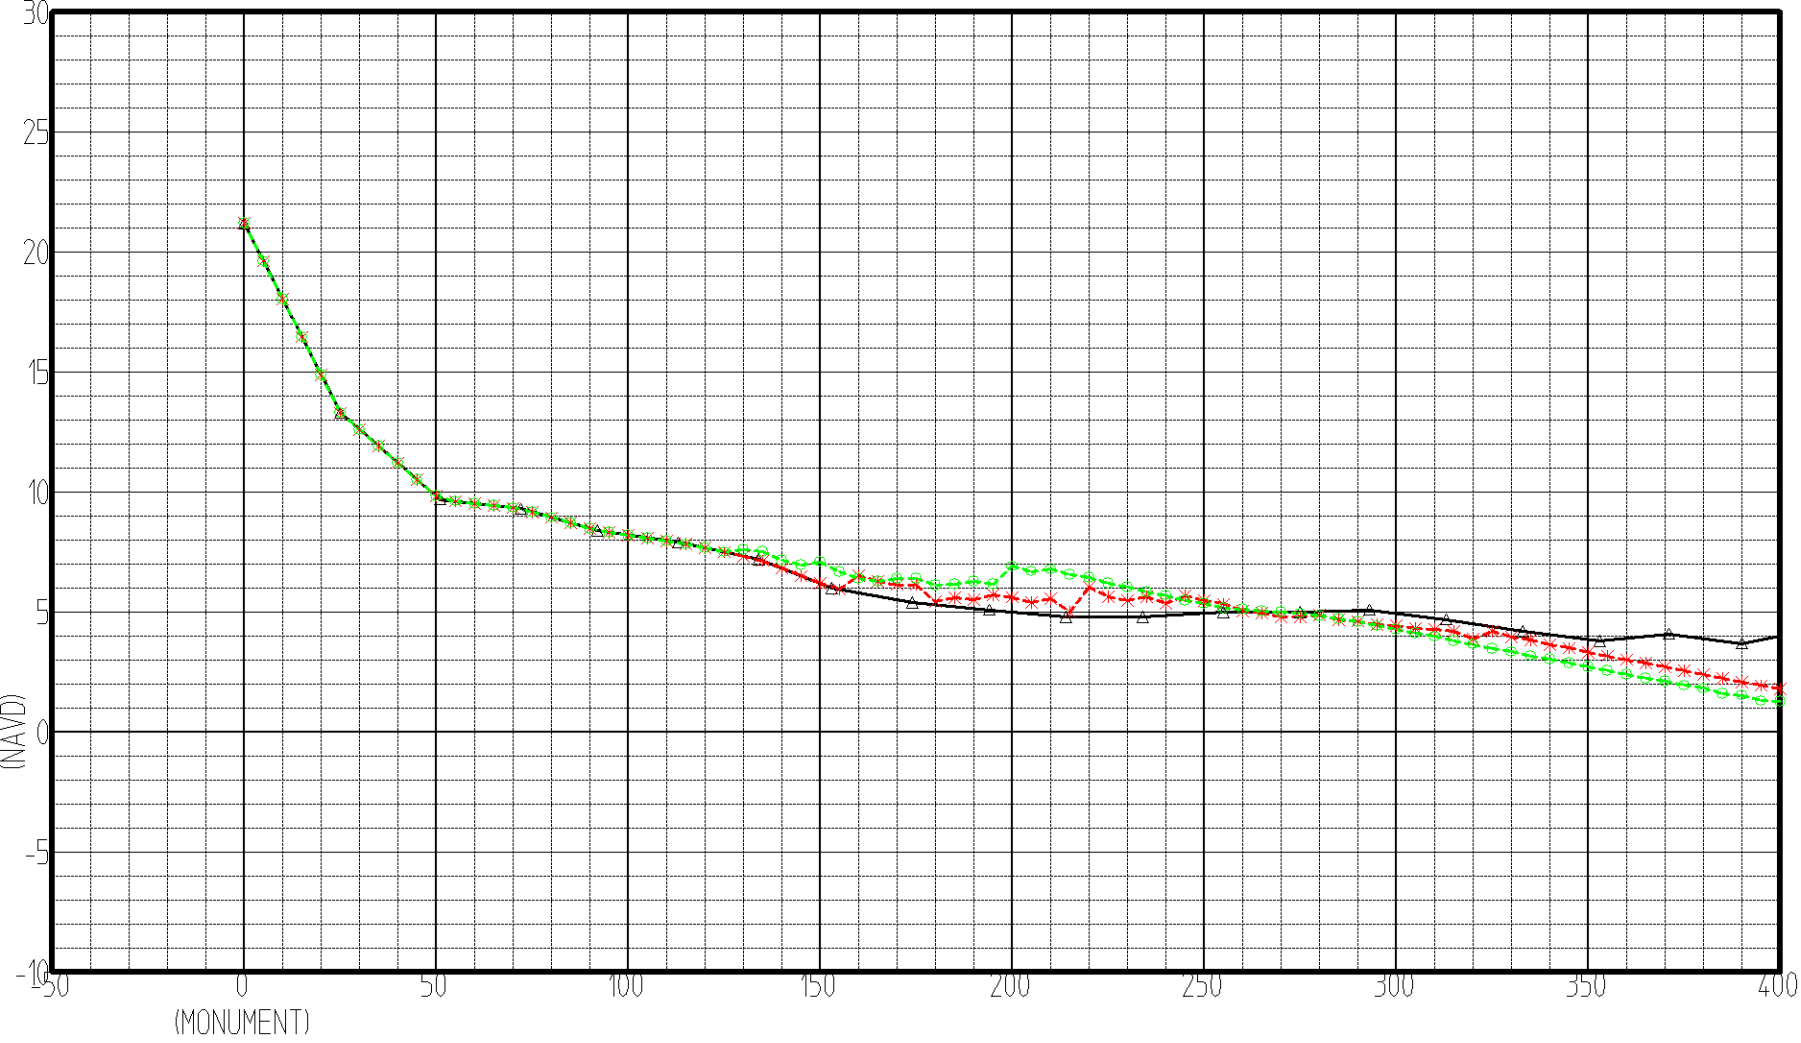
Range: R-138
 BEARING: 75.00
 1/2

BEACH PROFILE
 —△—△— ST. JOHNS 2007-2008 COMBI
 - - * - - 15YR SBCH ERODED
 - - o - - 25YR SBCH ERODED
