Appendix VIII

SBEACH 15 and 25 yr. Storm Erosion Profiles

St. Johns County

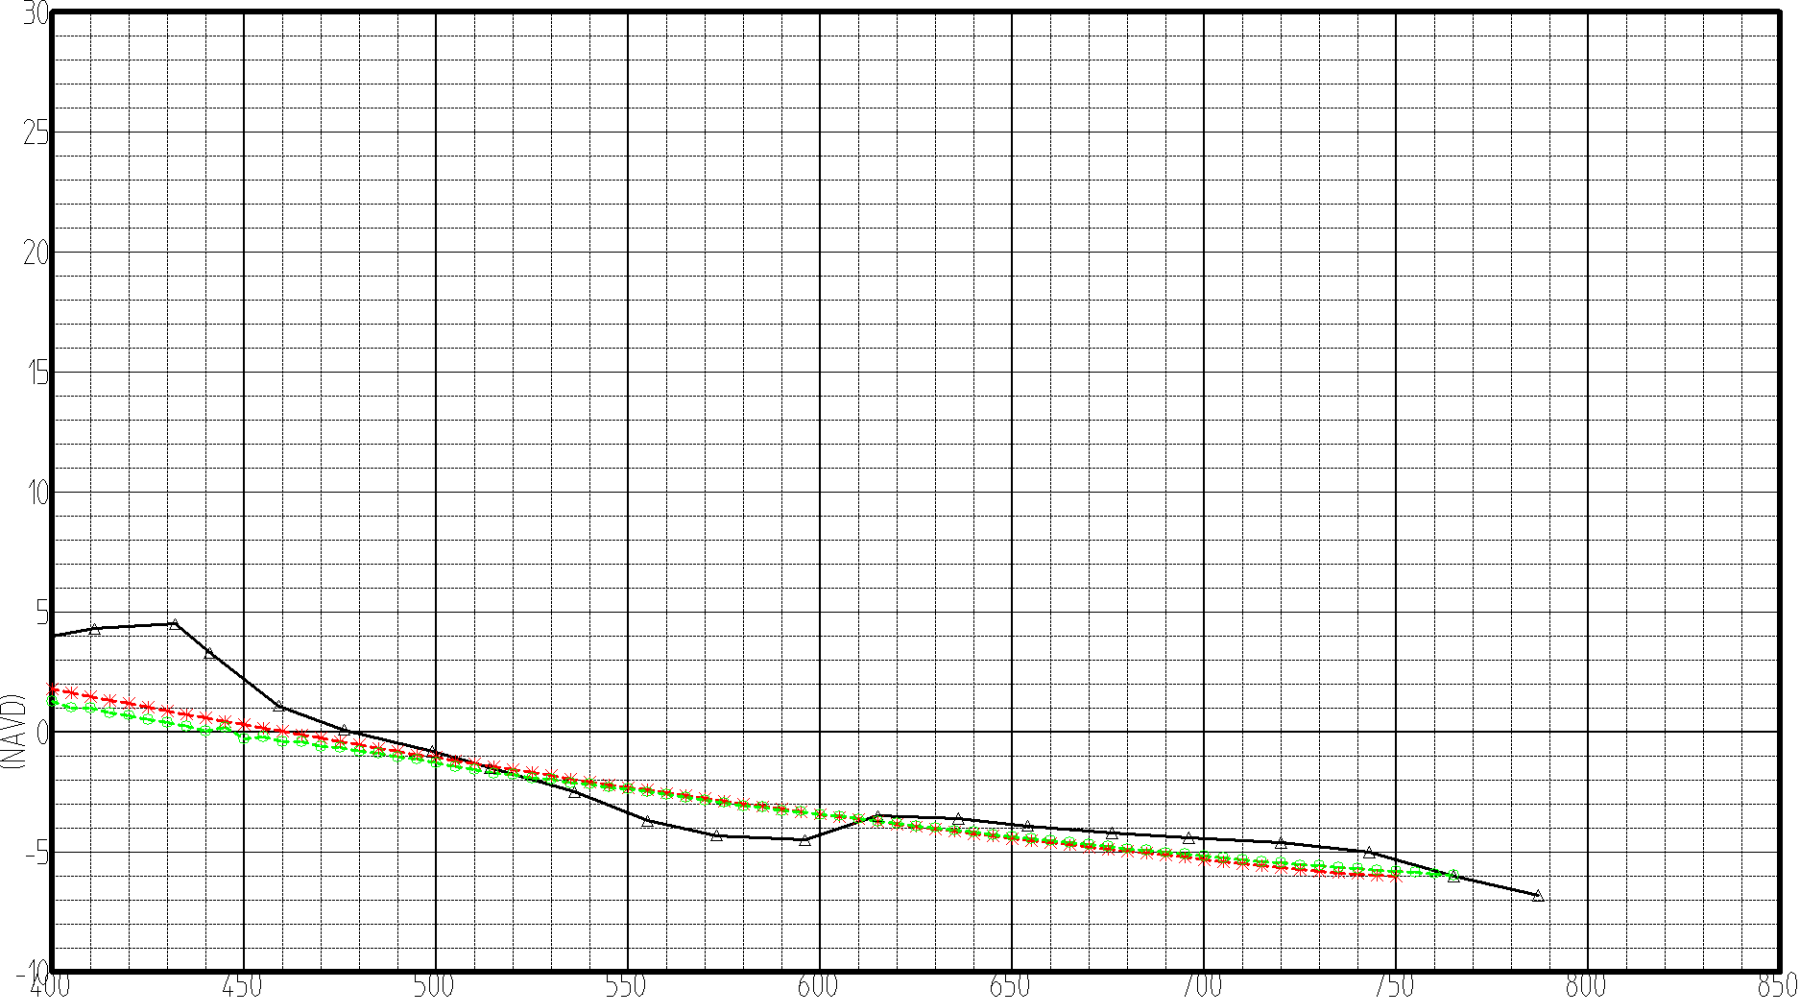
Range: R-138
 BEARING: 75.00
 2/2

BEACH PROFILE
 —△—△— ST. JOHNS 2007-2008 COMBI
 - - * - - - 15YR SBEACH ERODED
 - - o - - - 25YR SBCH ERODED

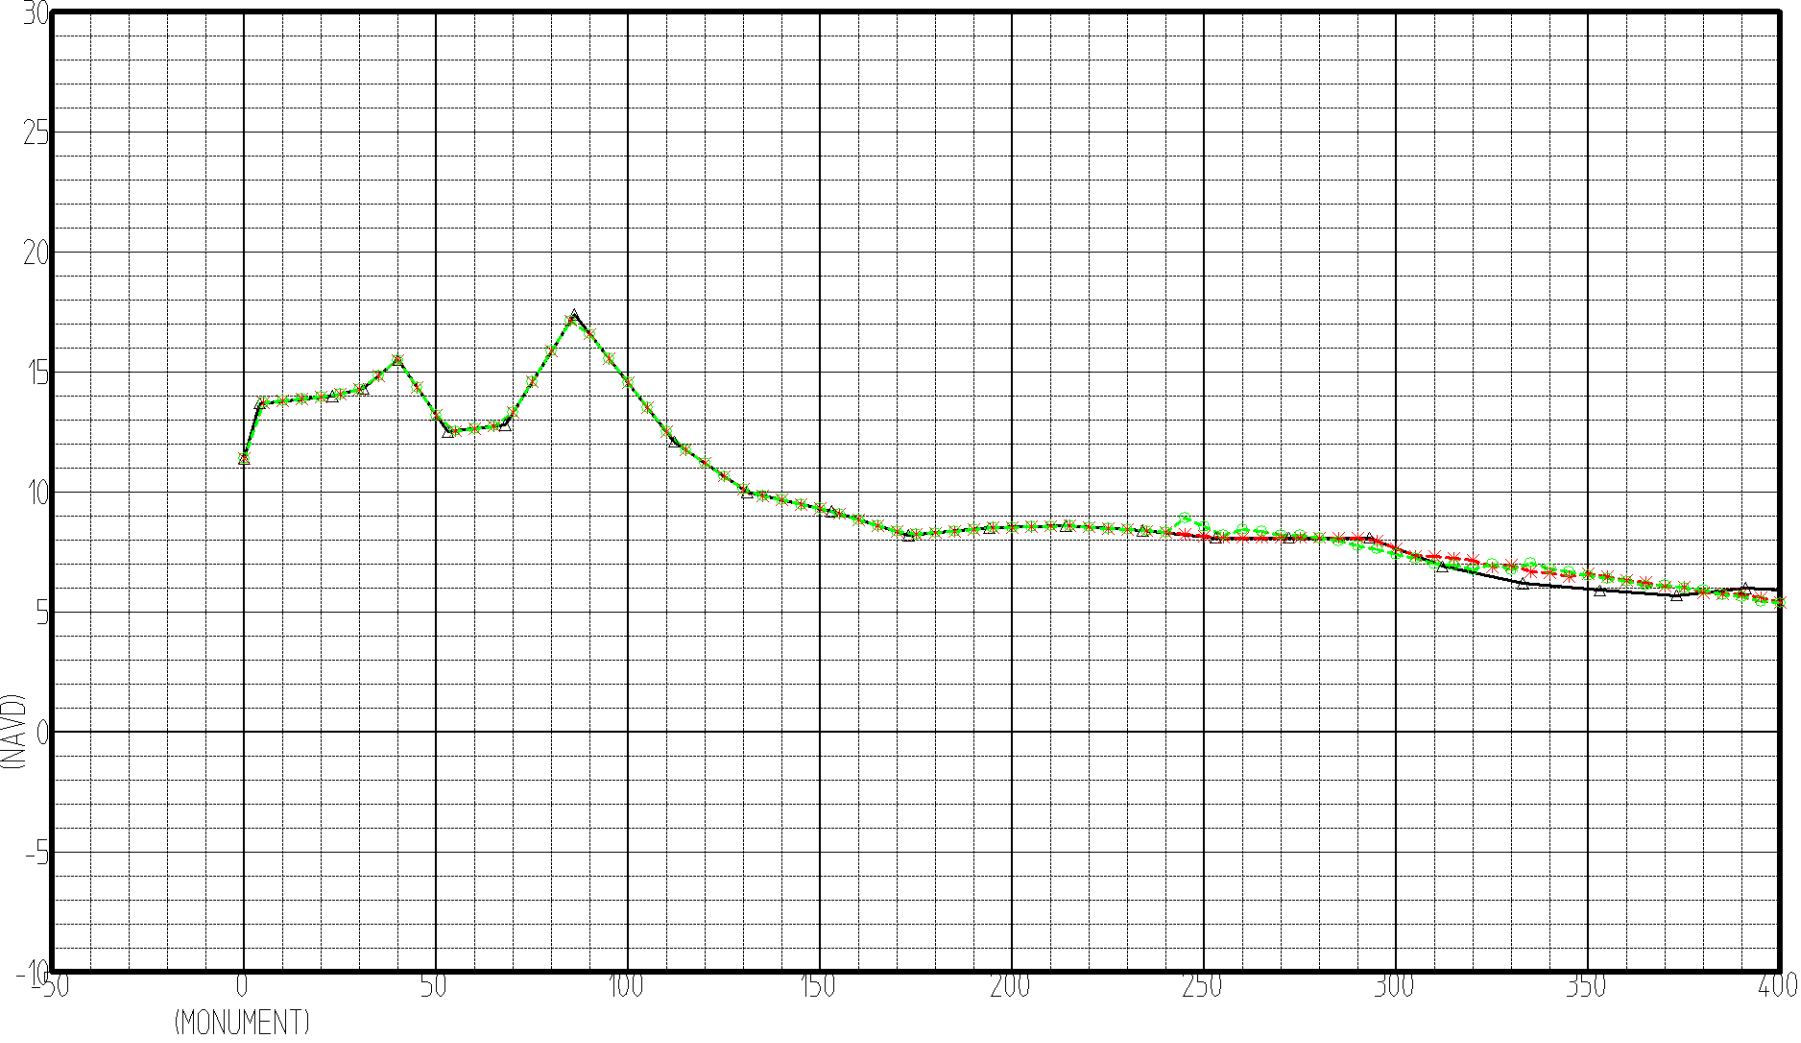
Range: R-139
 BEARING: 75.00
 1/3

BEACH PROFILE
 —△—△— ST. JOHNS 2007-2008 COMBI
 - - * - - 15YR SBEACH ERODED
 - - o - - 25YR SBCH ERODED

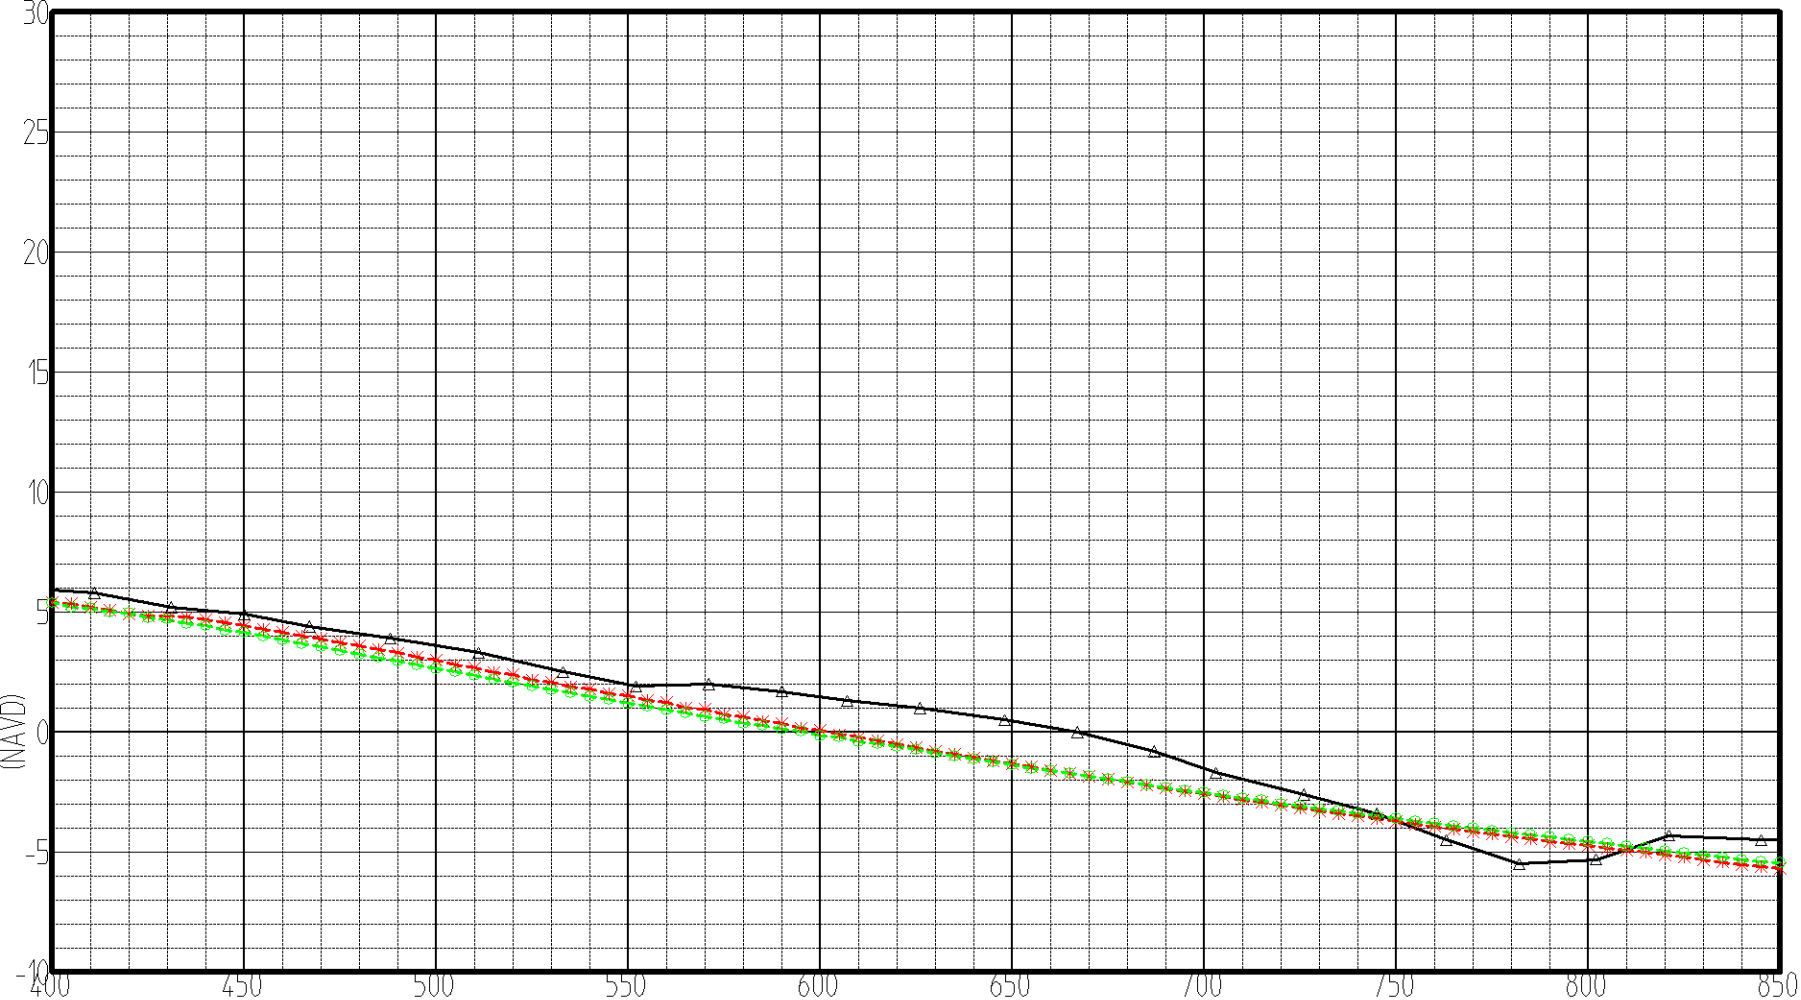
Range: R-139 2/3
 BEARING: 75.00

BEACH PROFILE
 —△—△— ST. JOHNS 2007-2008 COMBI
 - - * - - - 15YR SBACH ERODED
 - - o - - - 25YR SBCH ERODED

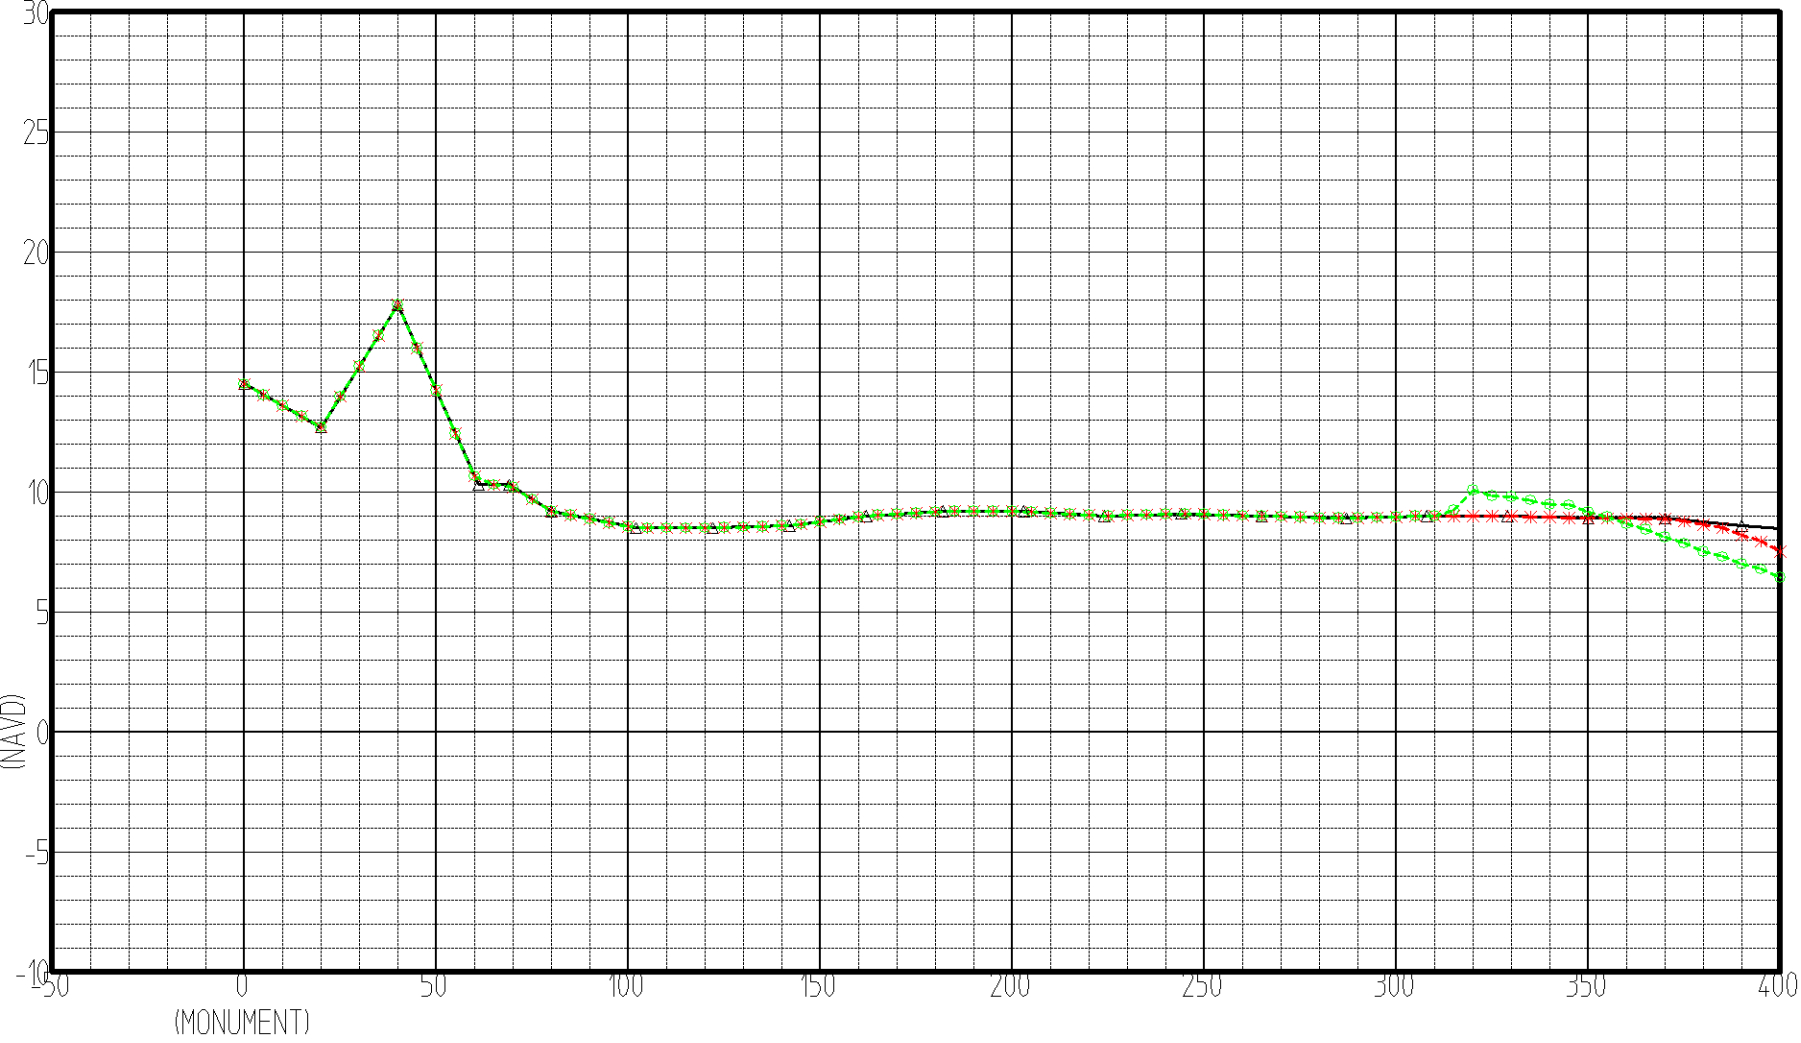
Range: R-140
 BEARING: 75.00
 1/2

BEACH PROFILE
 —△—△— ST. JOHNS 2007-2008 COMBI
 - - * - - 15YR SBEACH ERODED
 - - o - - 25YR SBCH ERODED

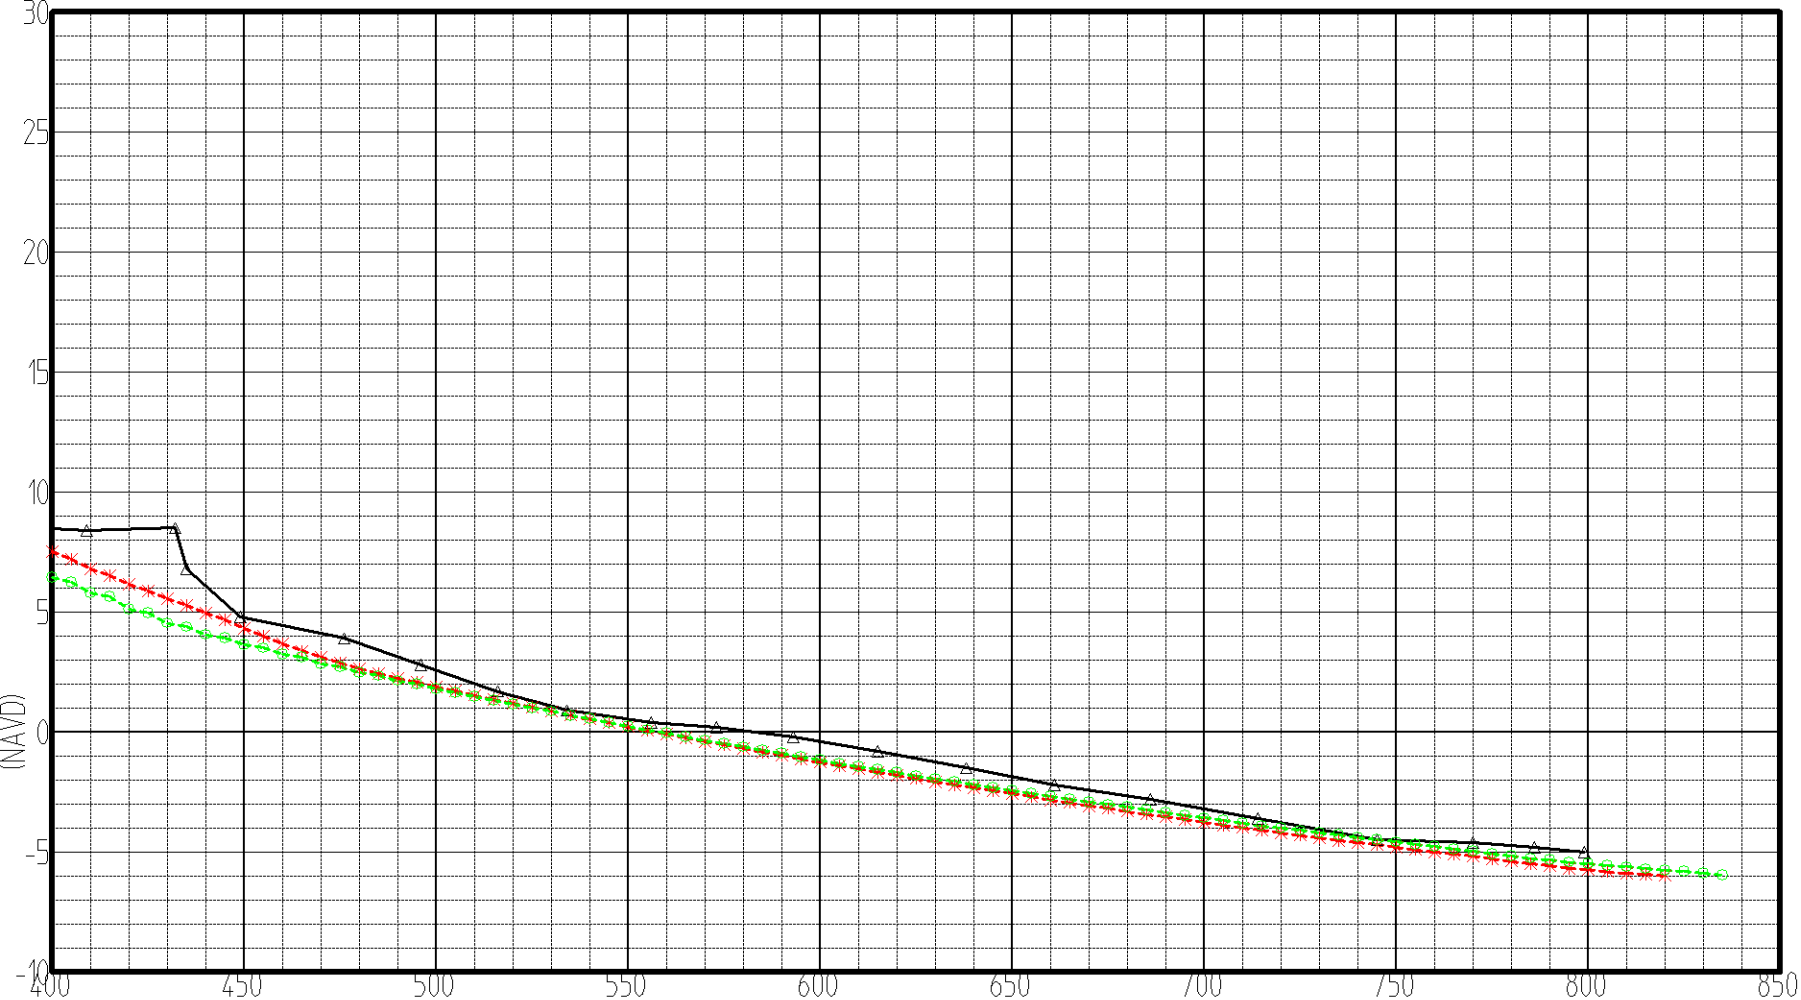
Range: R-140
 BEARING: 75.00
 2/2

BEACH PROFILE
 —△—△— ST. JOHNS 2007-2008 COMBI
 - - * - - 15YR SBEACH ERODED
 - - o - - 25YR SBCH ERODED

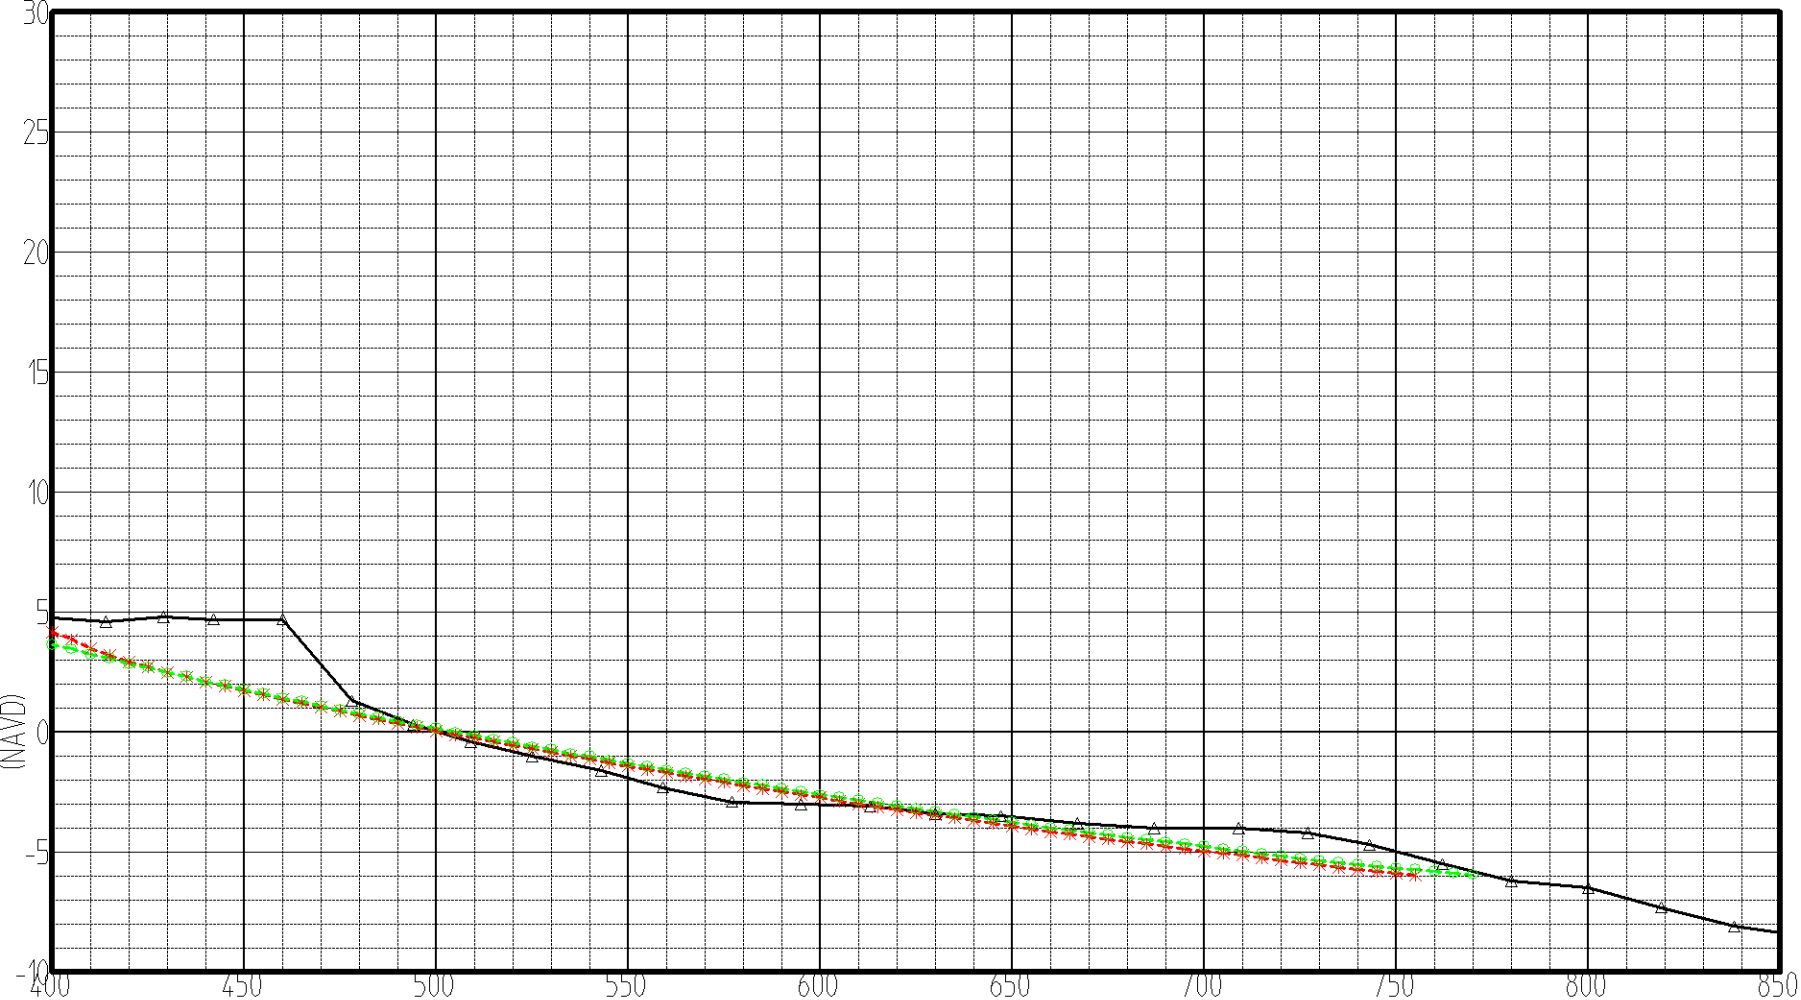
Range: R-141
 BEARING: 75.00
 2/3

BEACH PROFILE
 —△—△— ST. JOHNS 2007-2008 COMBI
 - - * - - - 15YR SBEACH ERODED
 - - o - - - 25YR SBCH ERODED

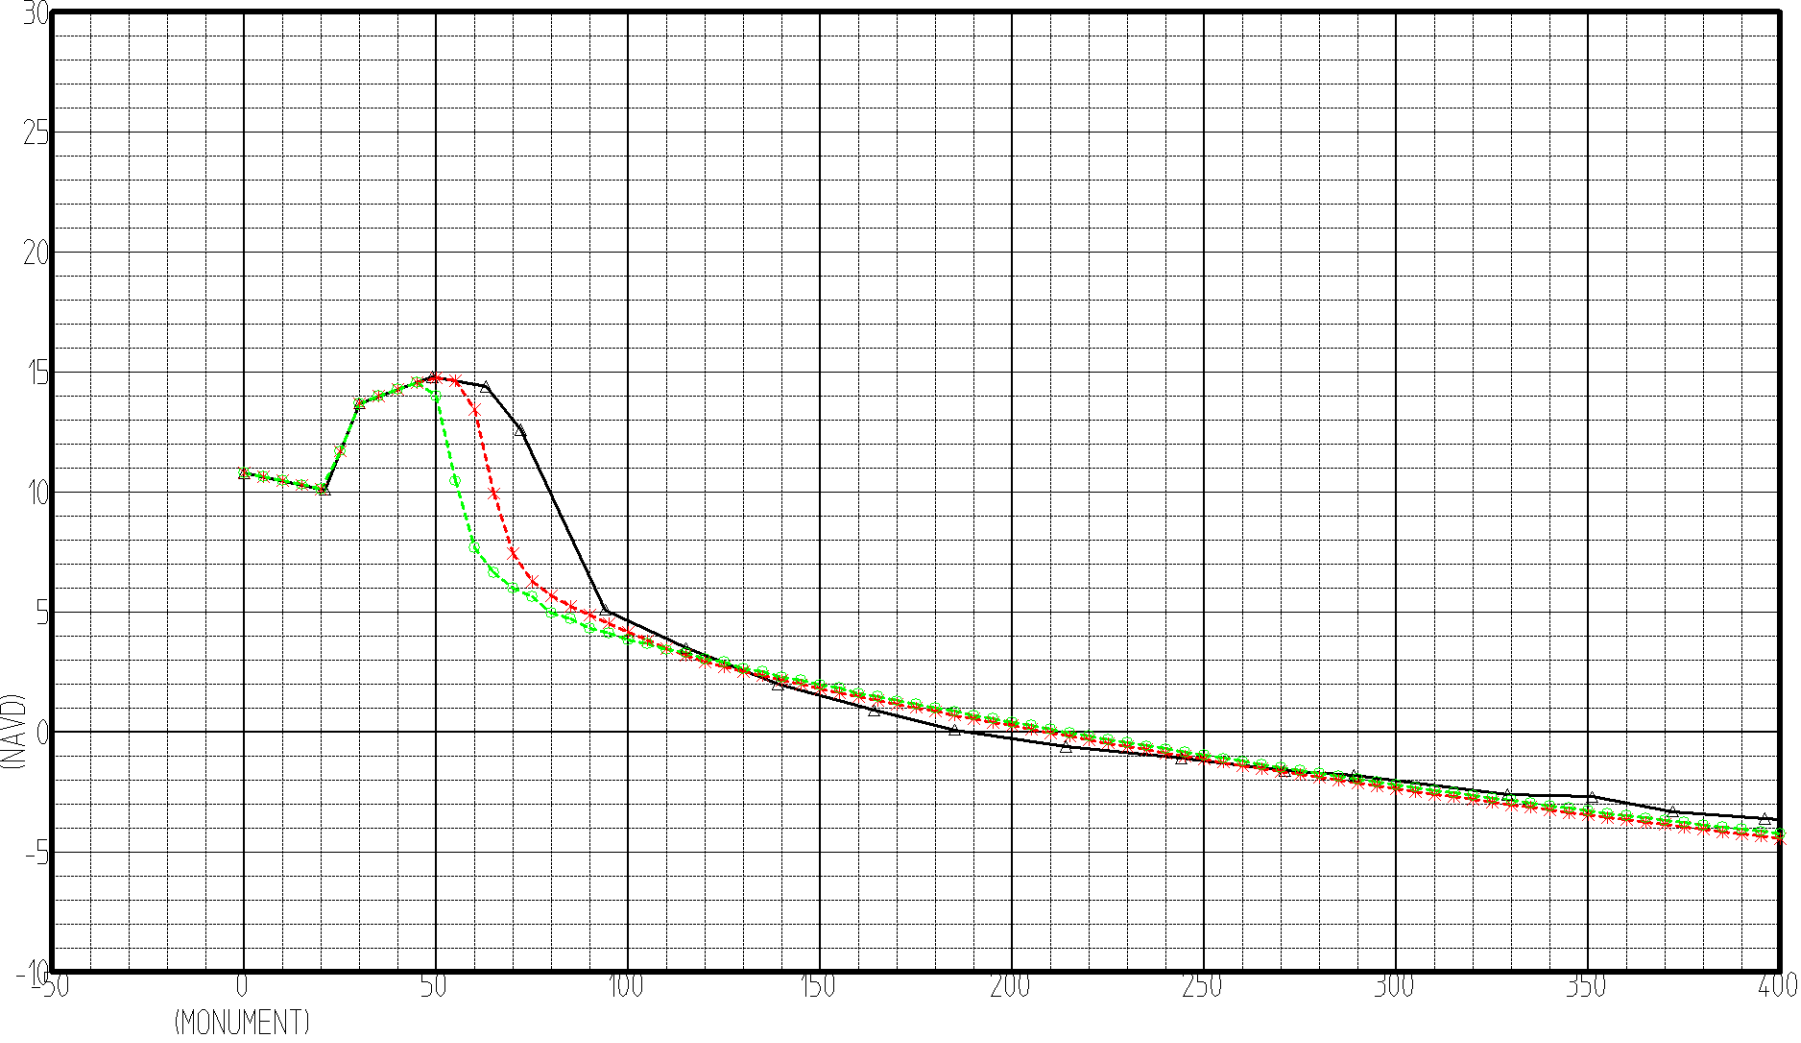
Range: R-142
 BEARING: 75.00
 1/2

BEACH PROFILE
 —△—△— ST. JOHNS 2007-2008 COMBI
 - - * - - 15YR SBEACH ERODED
 - - o - - 25YR SBCH ERODED

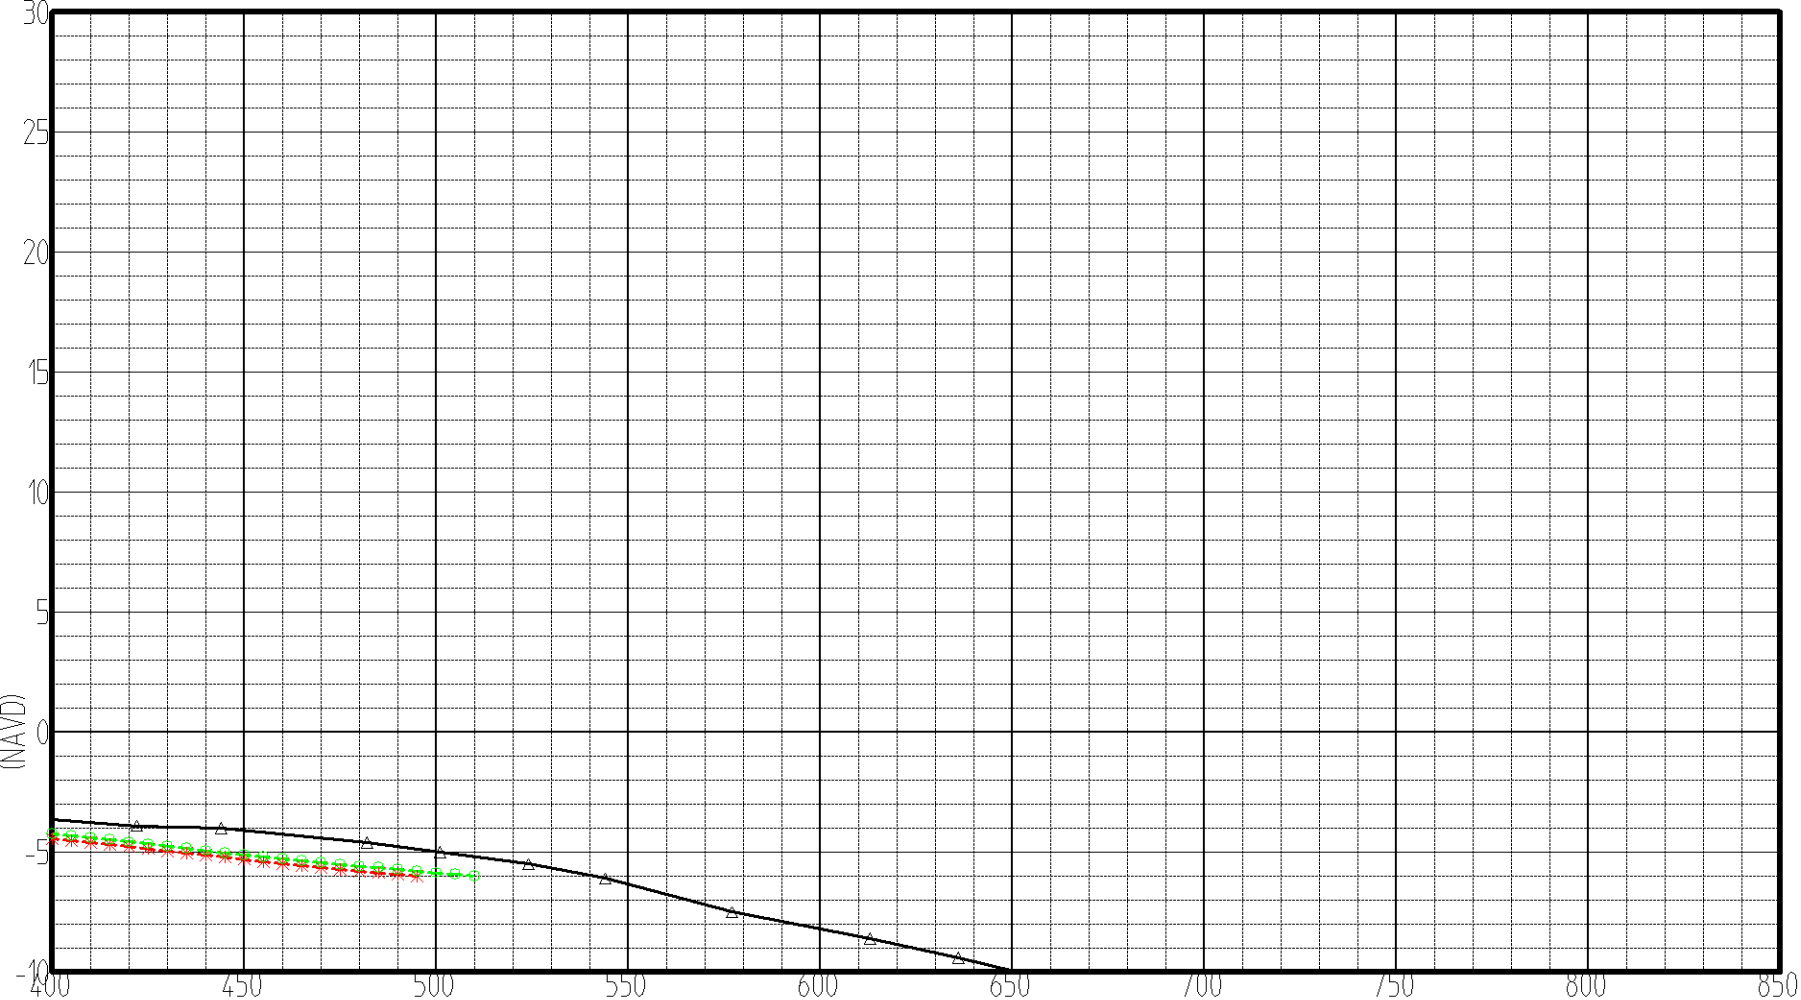
Range: R-142
 BEARING: 75.00
 2/2

BEACH PROFILE
 —△— ST. JOHNS 2007-2008 COMBI
 - - * - - 15YR SBCH ERODED
 - - ○ - - 25YR SBCH ERODED

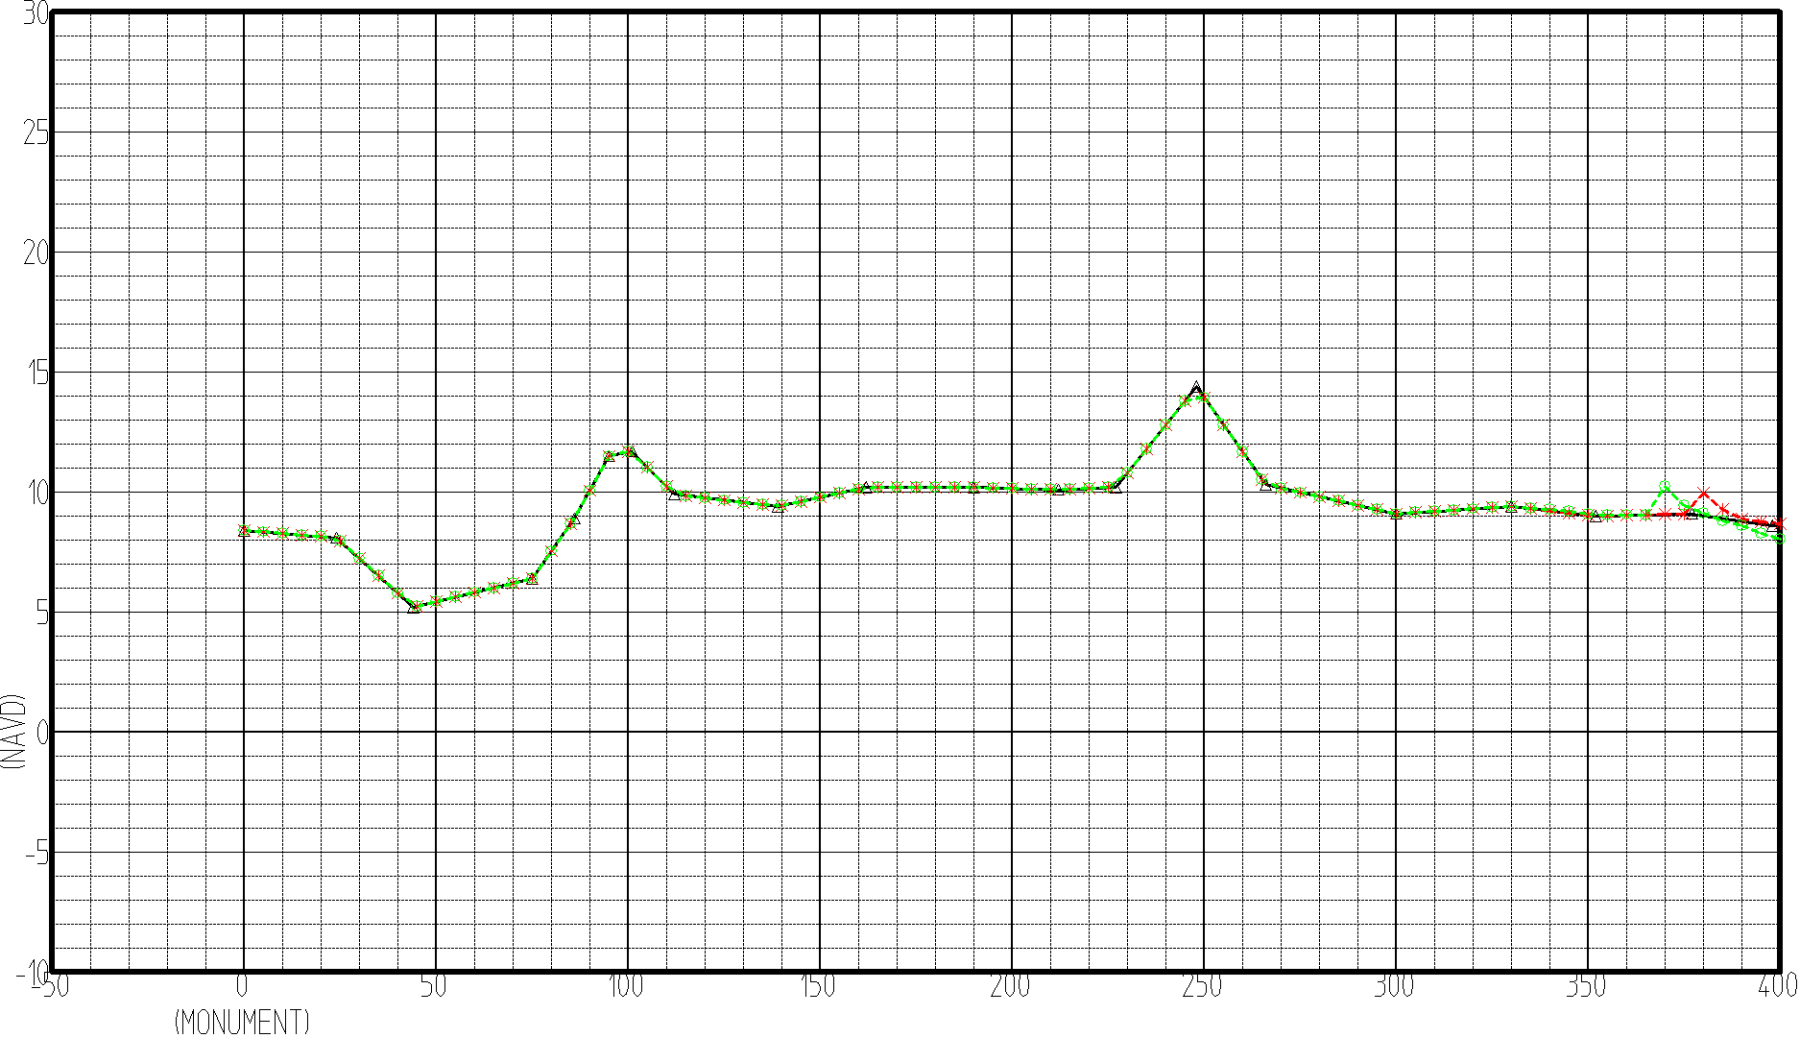
Range: R-143T 1/3
 BEARING: 75.00

BEACH PROFILE
 —△—△— ST. JOHNS 2007-2008 COMBI
 - - * - - 15YR SBEACH ERODED
 - - o - - 25YR SBCH ERODED

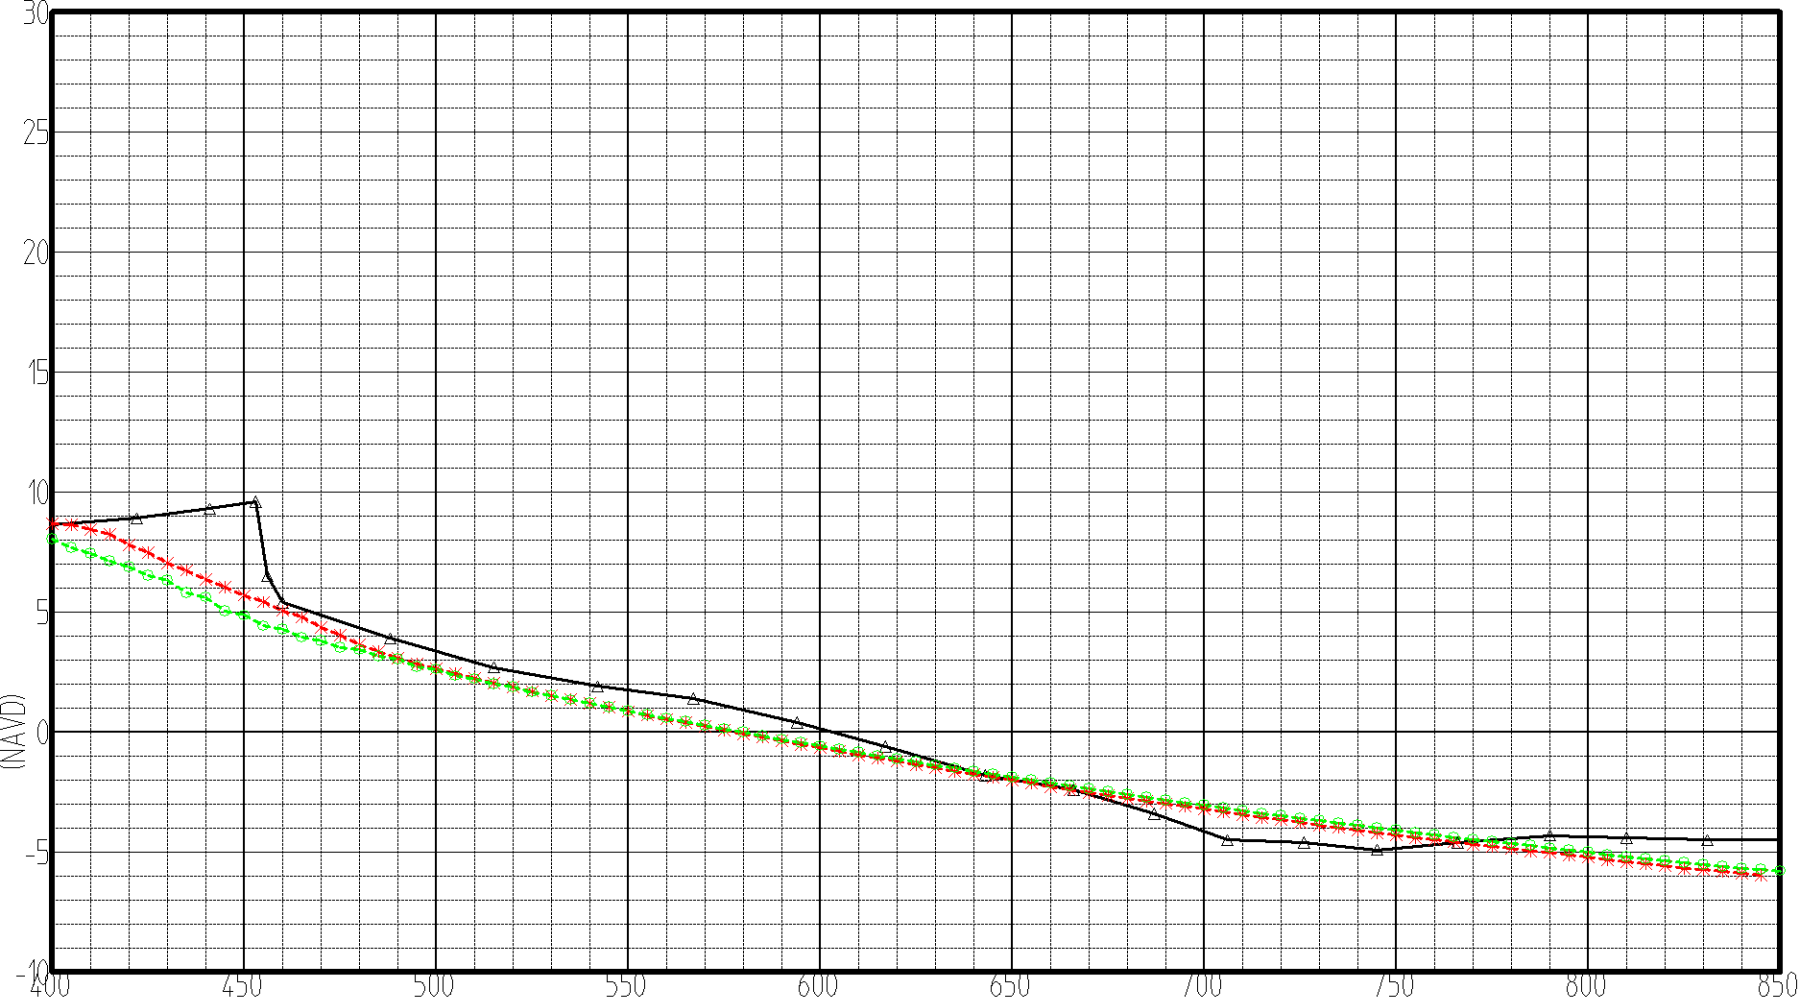
Range: R-143T 2/3
 BEARING: 75.00

BEACH PROFILE
 —△—△— ST. JOHNS 2007-2008 COMBI
 - - * - - - 15YR SBEACH ERODED
 - - o - - - 25YR SBCH ERODED

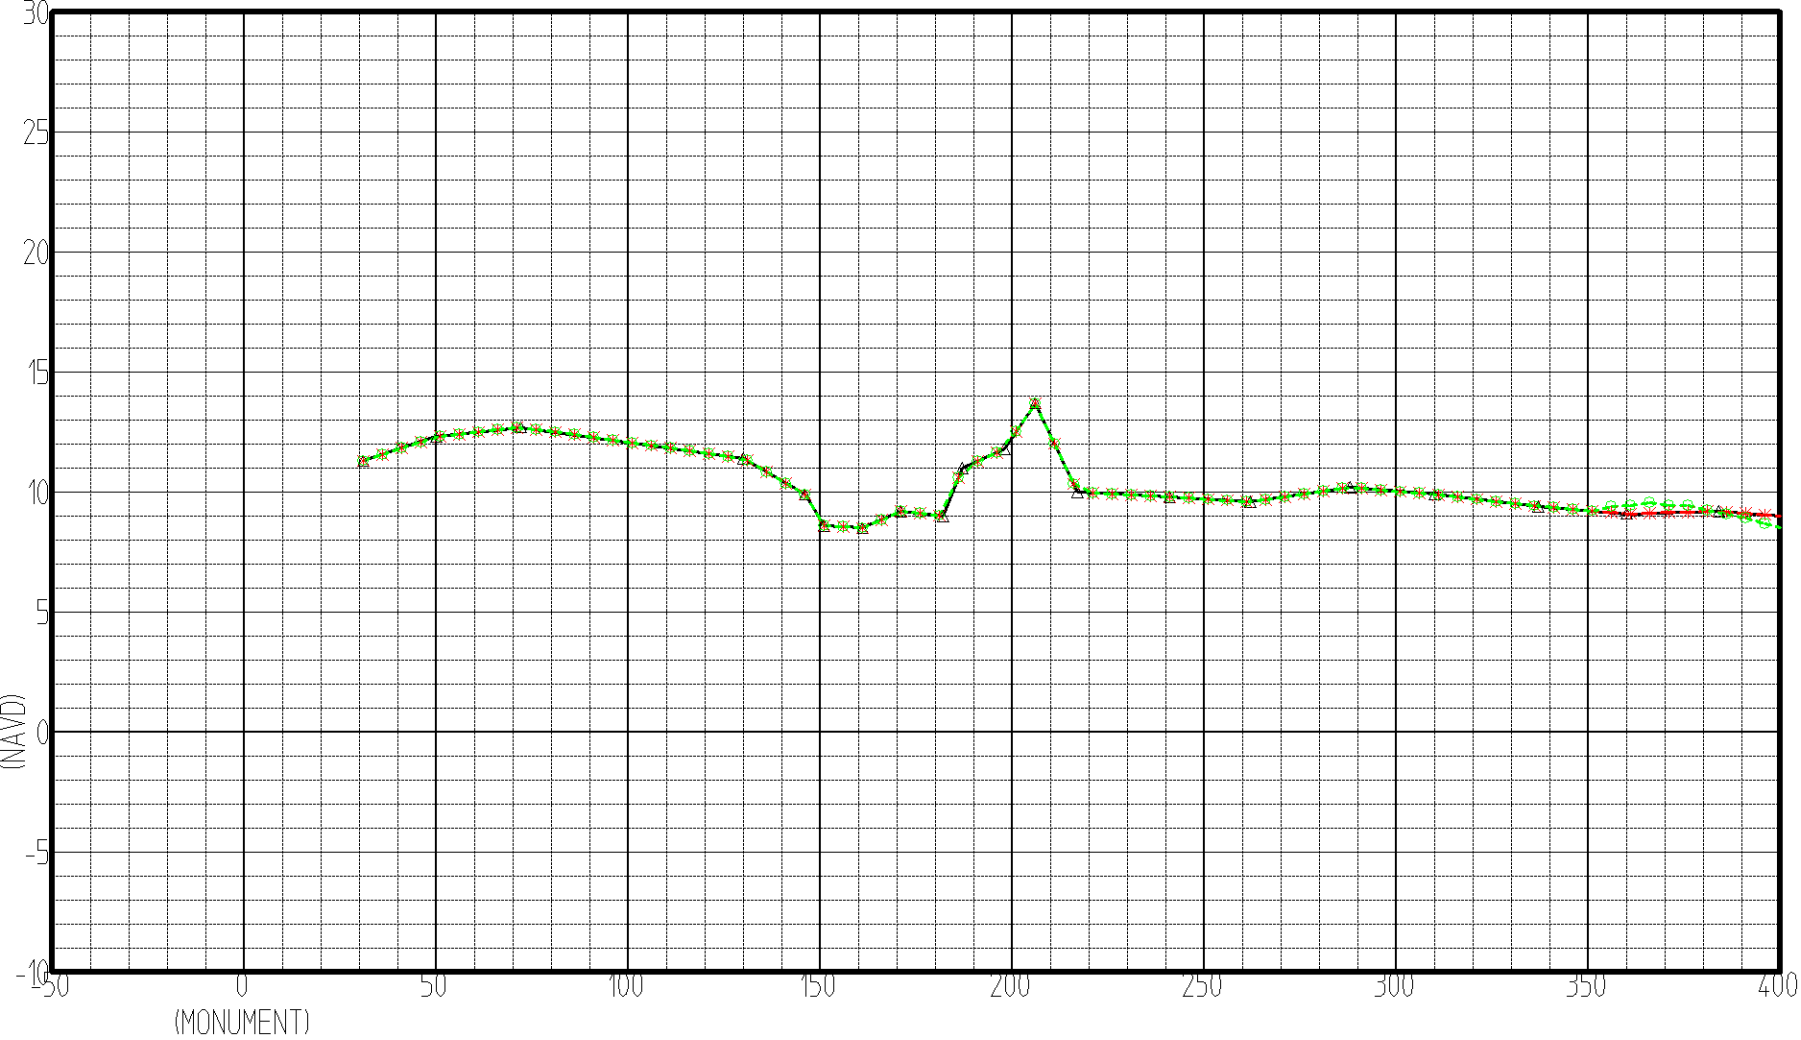
Range: R-144A

BEACH PROFILE

—△—△— ST. JOHNS 2007-2008 COMBI

- - - * - - - 15YR SBCH ERODED

- - - o - - - 25YR SBCH ERODED

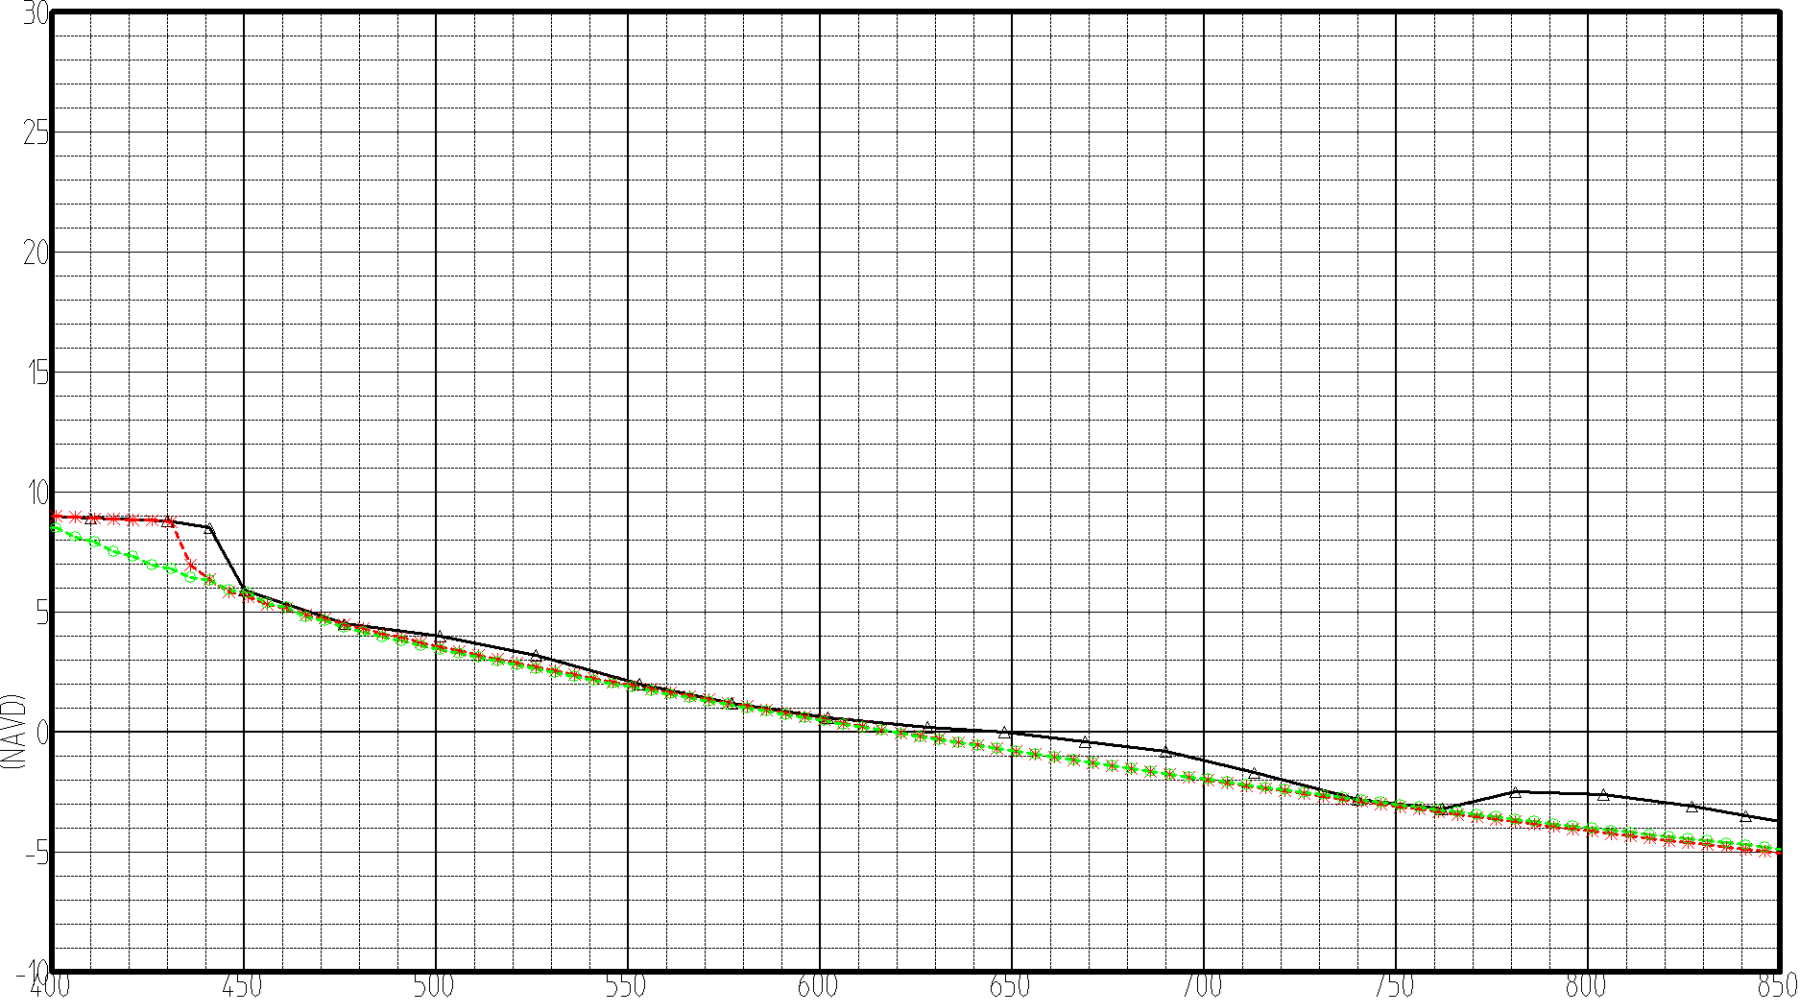
Range: R-144A 2/3
 BEARING: 75.00

BEACH PROFILE
 —△—△— ST. JOHNS 2007-2018 COMBI
 - - * - - 15YR SBEACH ERODED
 - - o - - 25YR SBCH ERODED
