Appendix VIII

SBEACH 15 and 25 yr. Storm Erosion Profiles

St. Johns County

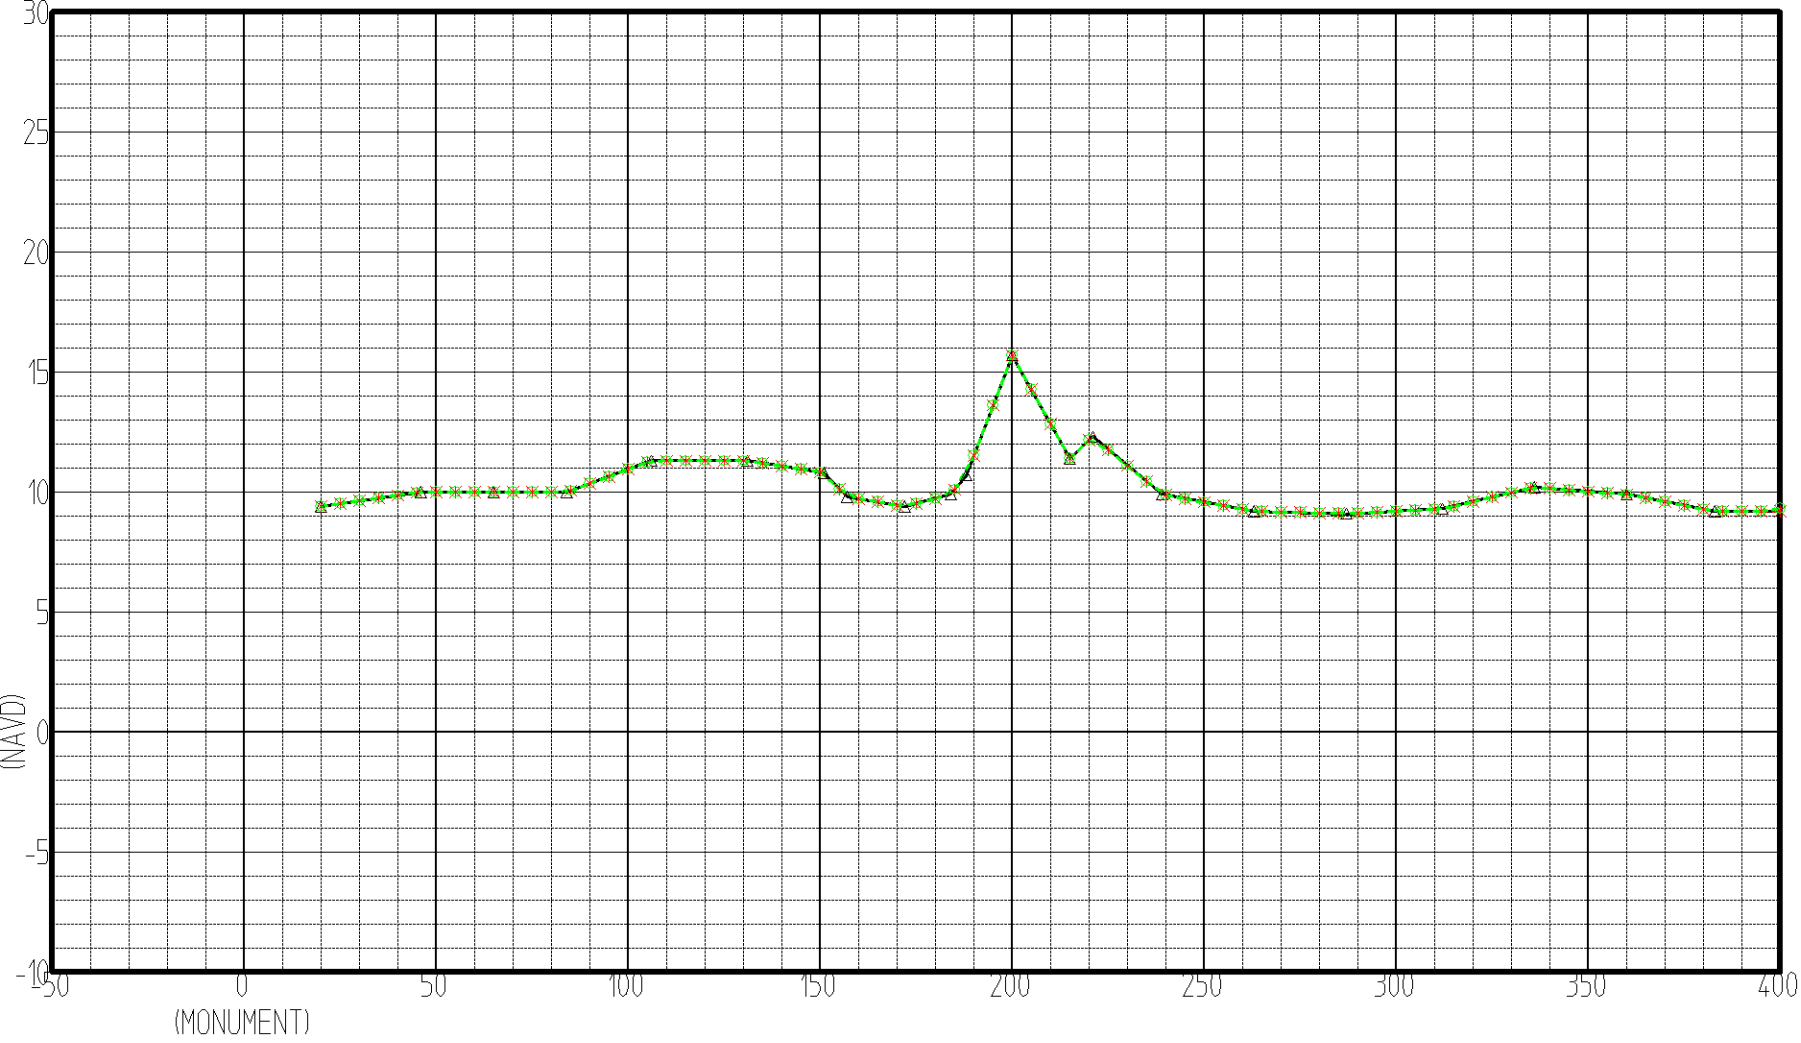
Range: R-145

BEACH PROFILE

—△—△— ST. JOHNS 2007-2008 COMBI
 - - * - - * - - 15YR SBCH ERODED
 - - o - - o - - 25YR SBCH ERODED

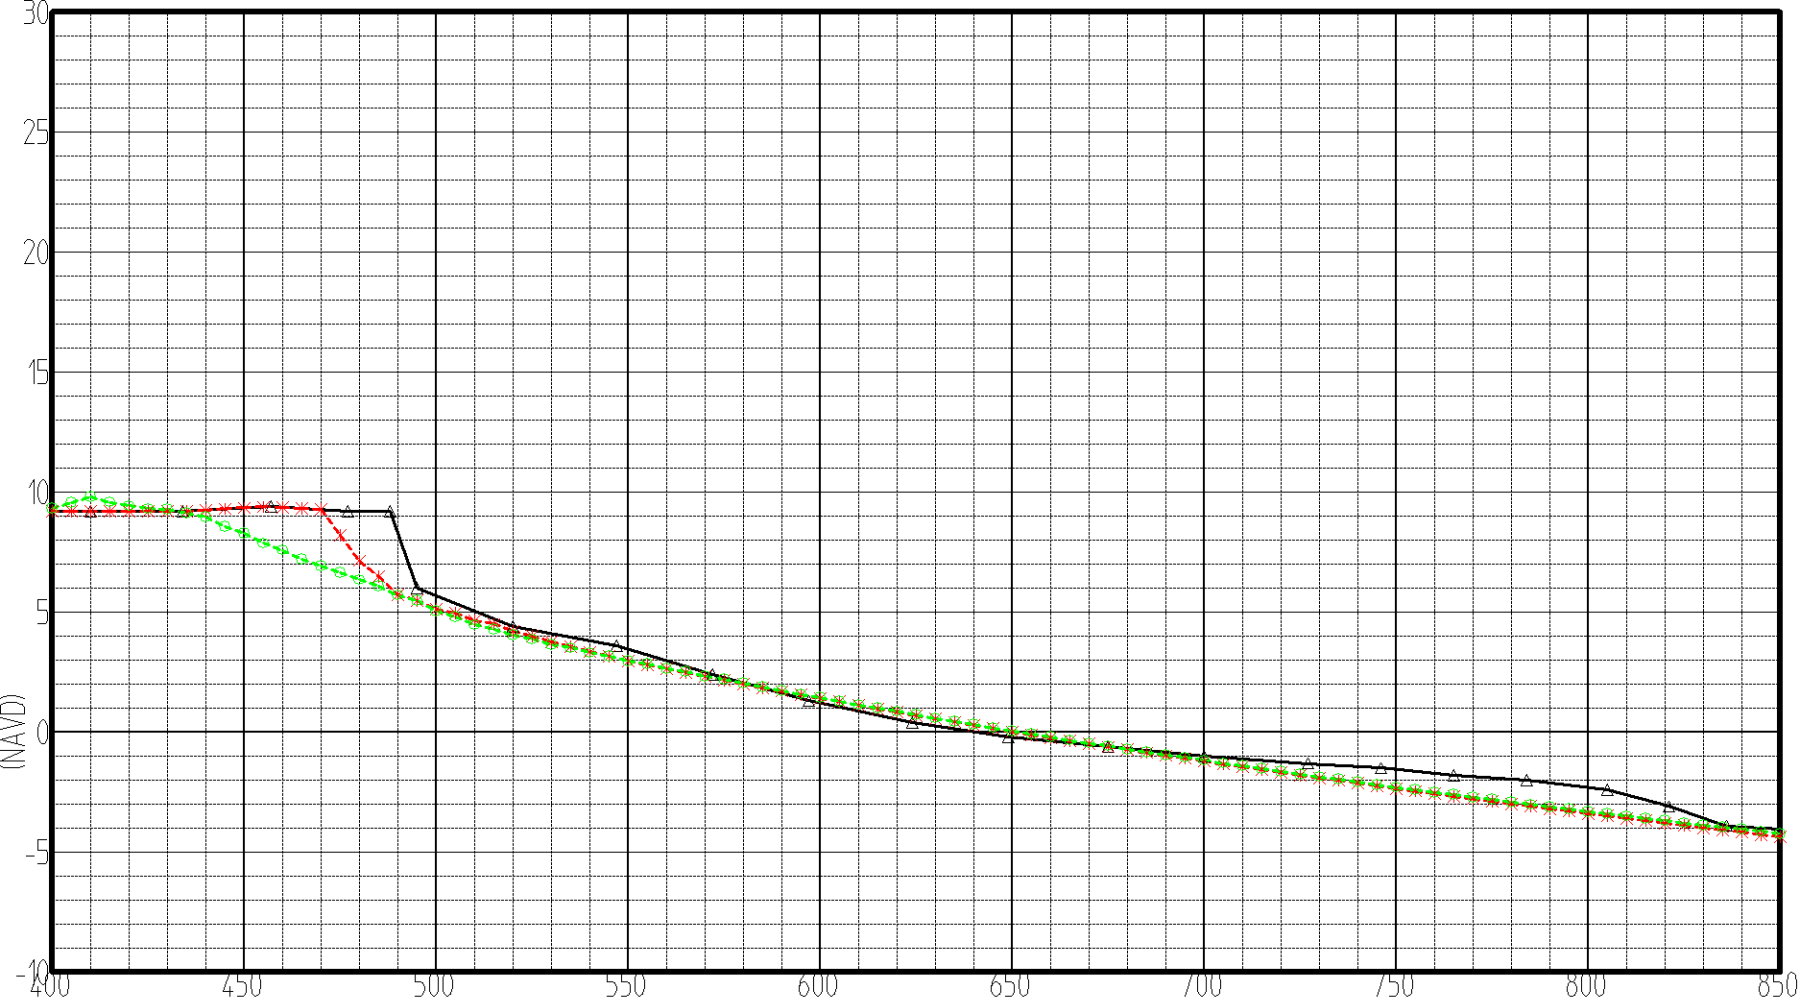
Range: R-145
 BEARING: 75.00
 2/3

BEACH PROFILE
 —△—△— ST. JOHNS 2007-2008 COMBI
 - - * - - - 15YR SBEACH ERODED
 - - o - - - 25YR SBCH ERODED

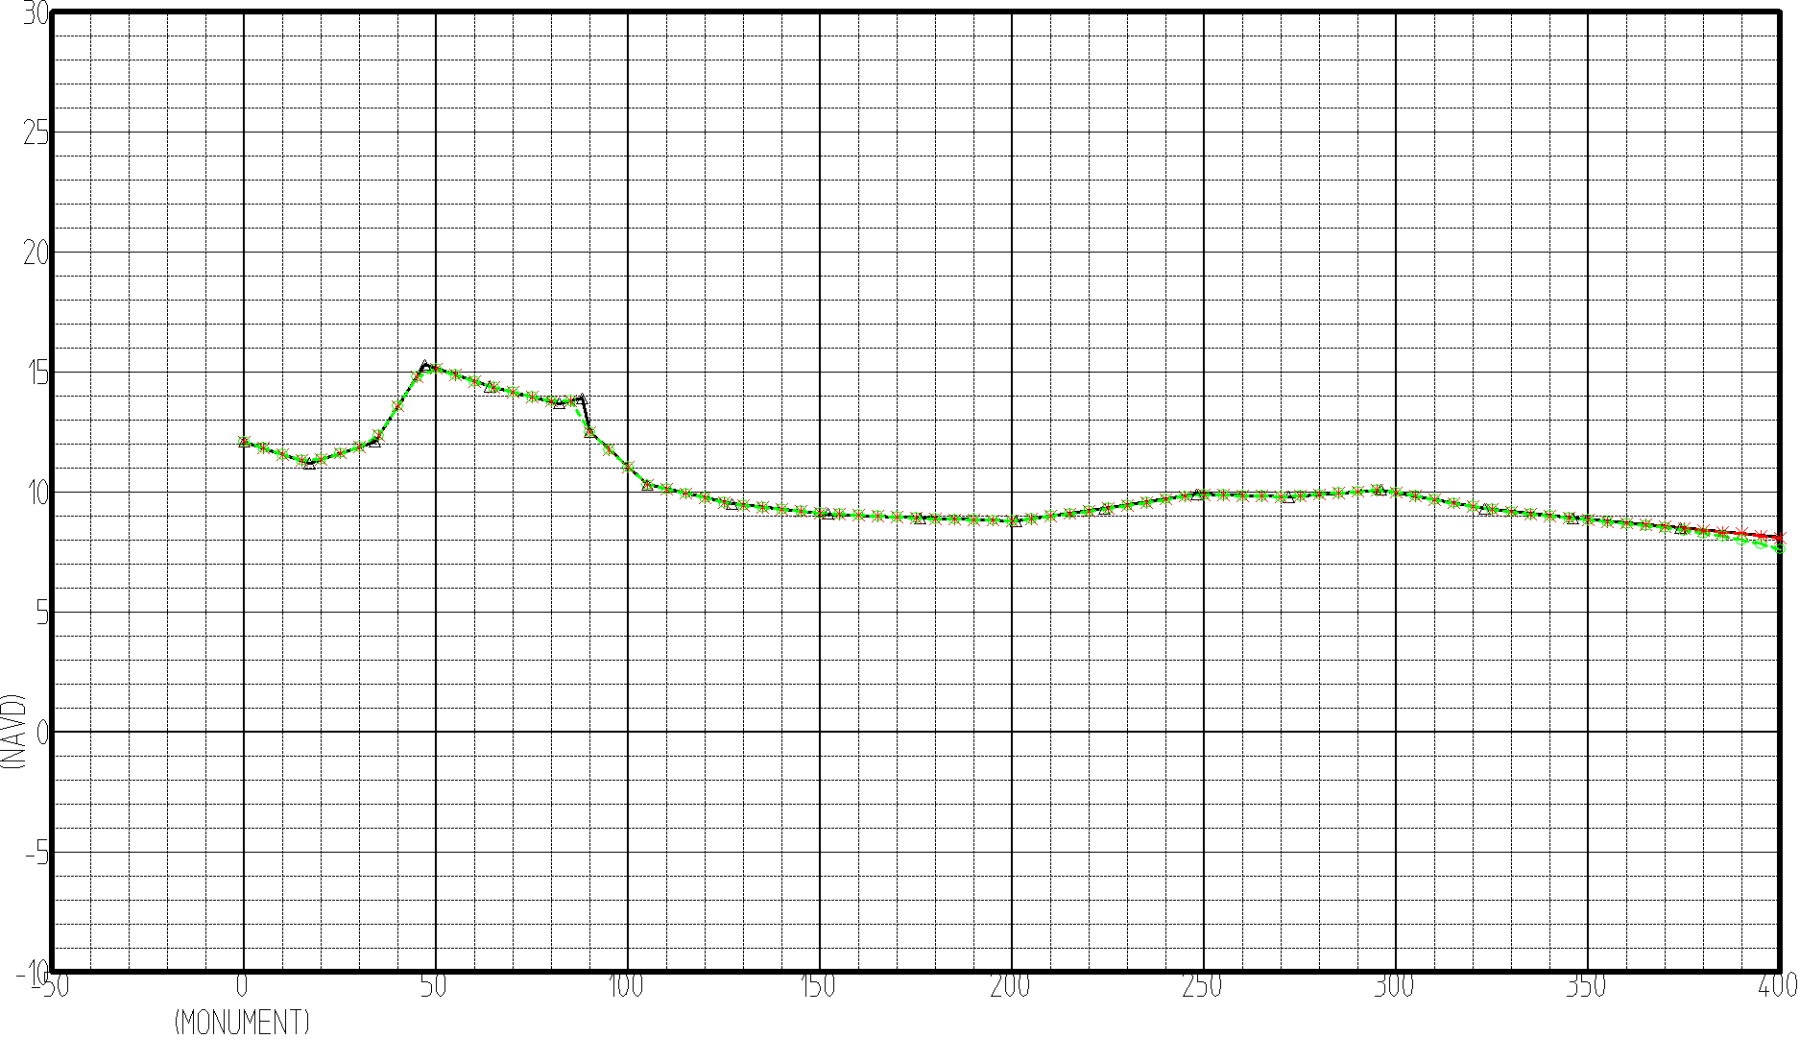
Range: R-146

BEACH PROFILE

—△—△— ST. JOHNS 2007-2008 COMBI

- - * - - * - - 15YR SBEACH ERODED

- - o - - o - - 25YR SBCH ERODED

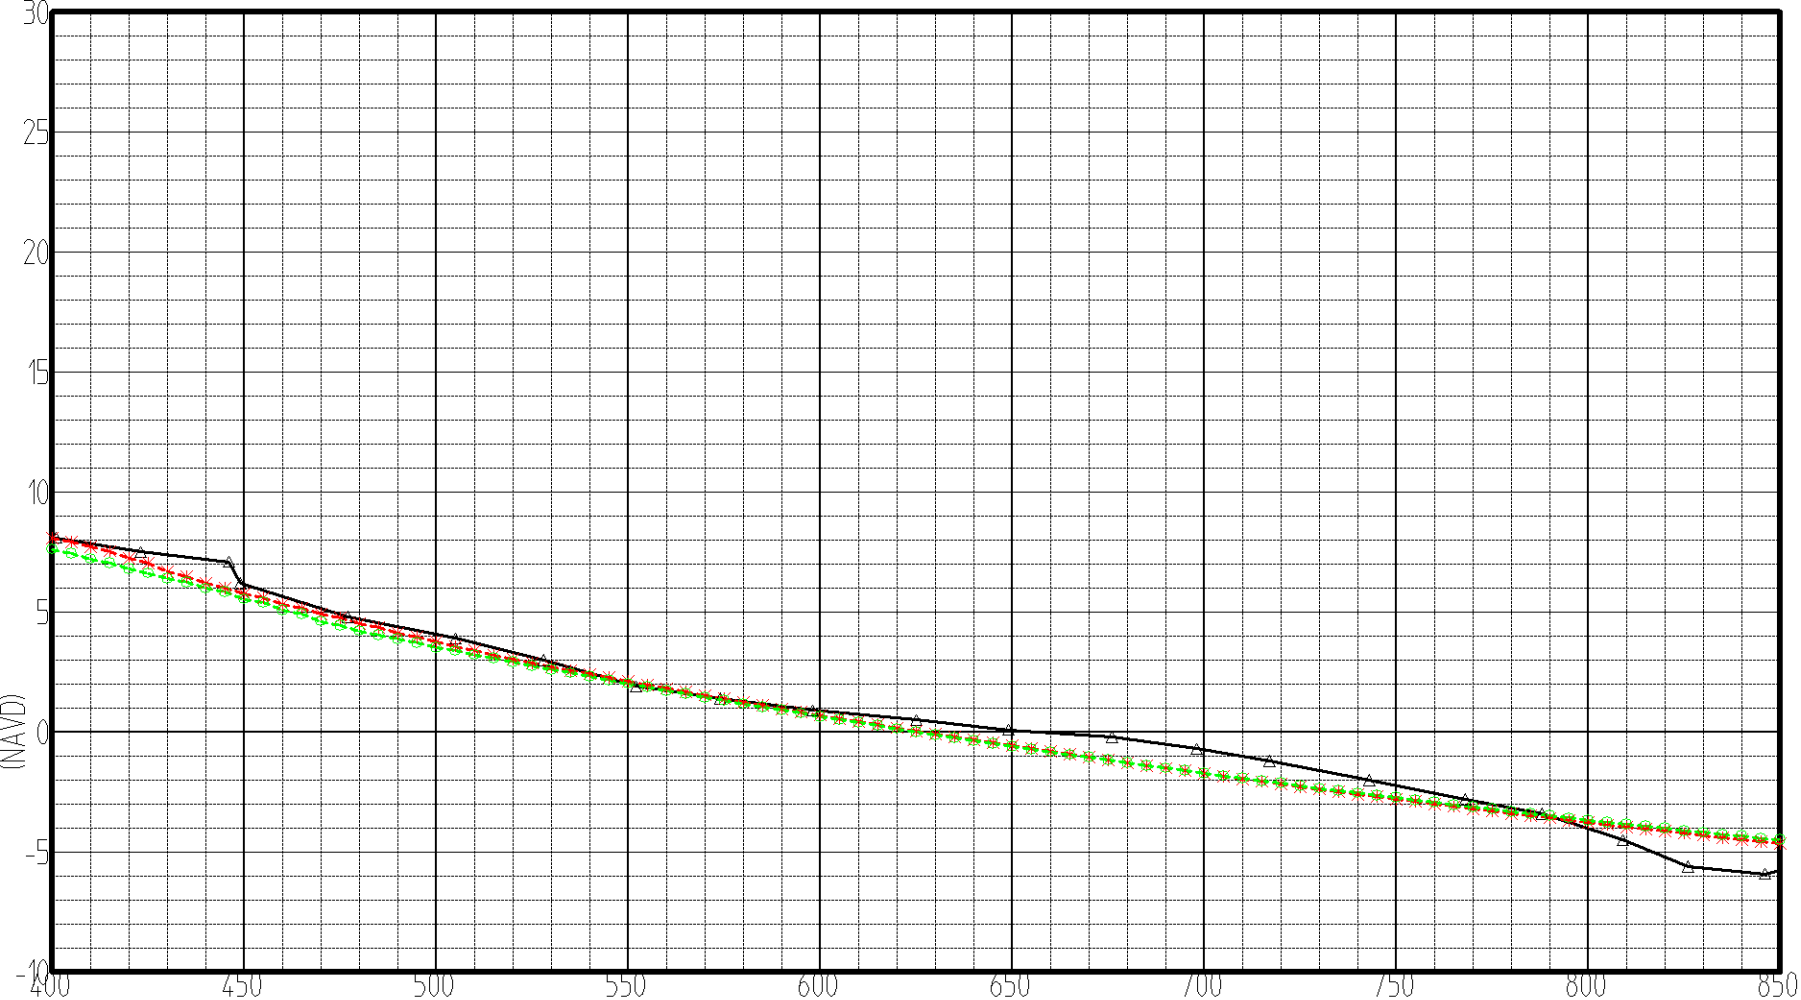
Range: R-146 2/3
 BEARING: 75.00

BEACH PROFILE
 —△—△— ST. JOHNS 2007-2008 COMBI
 - - * - - 15YR SBCH ERODED
 - - o - - 25YR SBCH ERODED

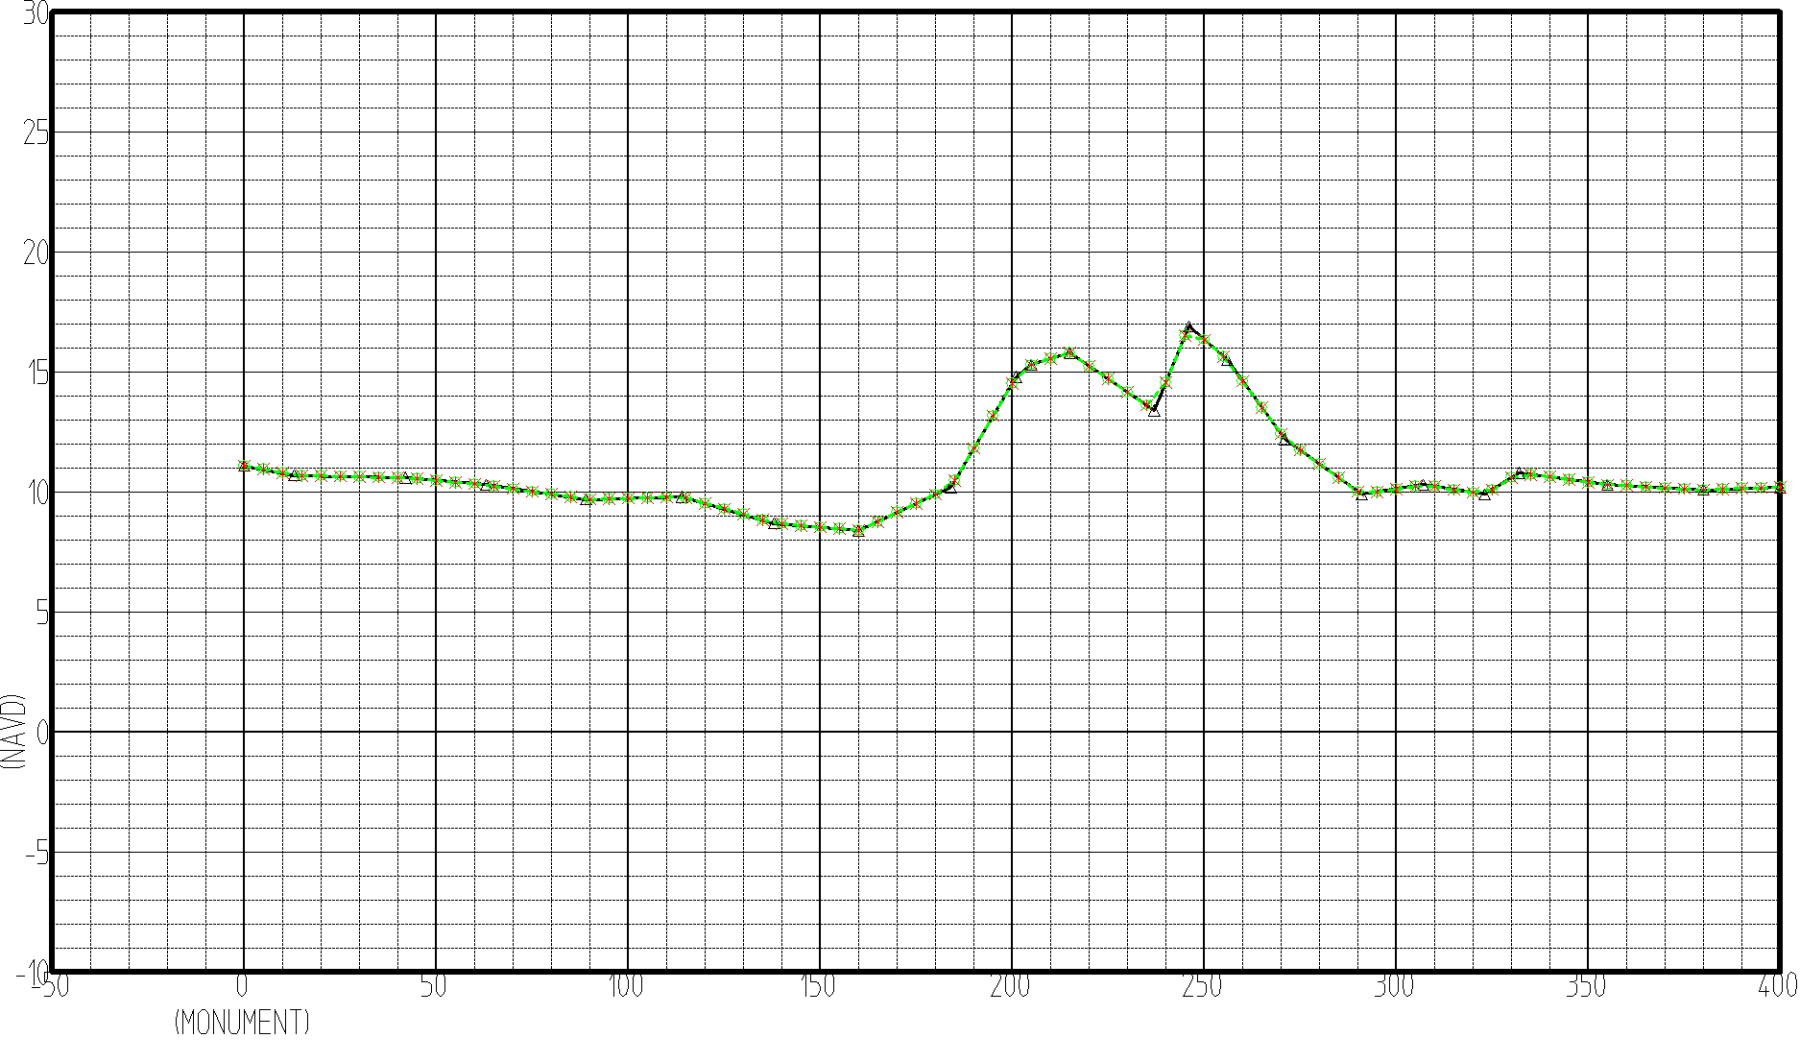
Range: R-147A

BEACH PROFILE

—△—△— ST. JOHNS 2007-2008 COMBI
 - - * - - * - - 15YR SBEACH ERODED
 - - o - - o - - 25YR SBCH ERODED

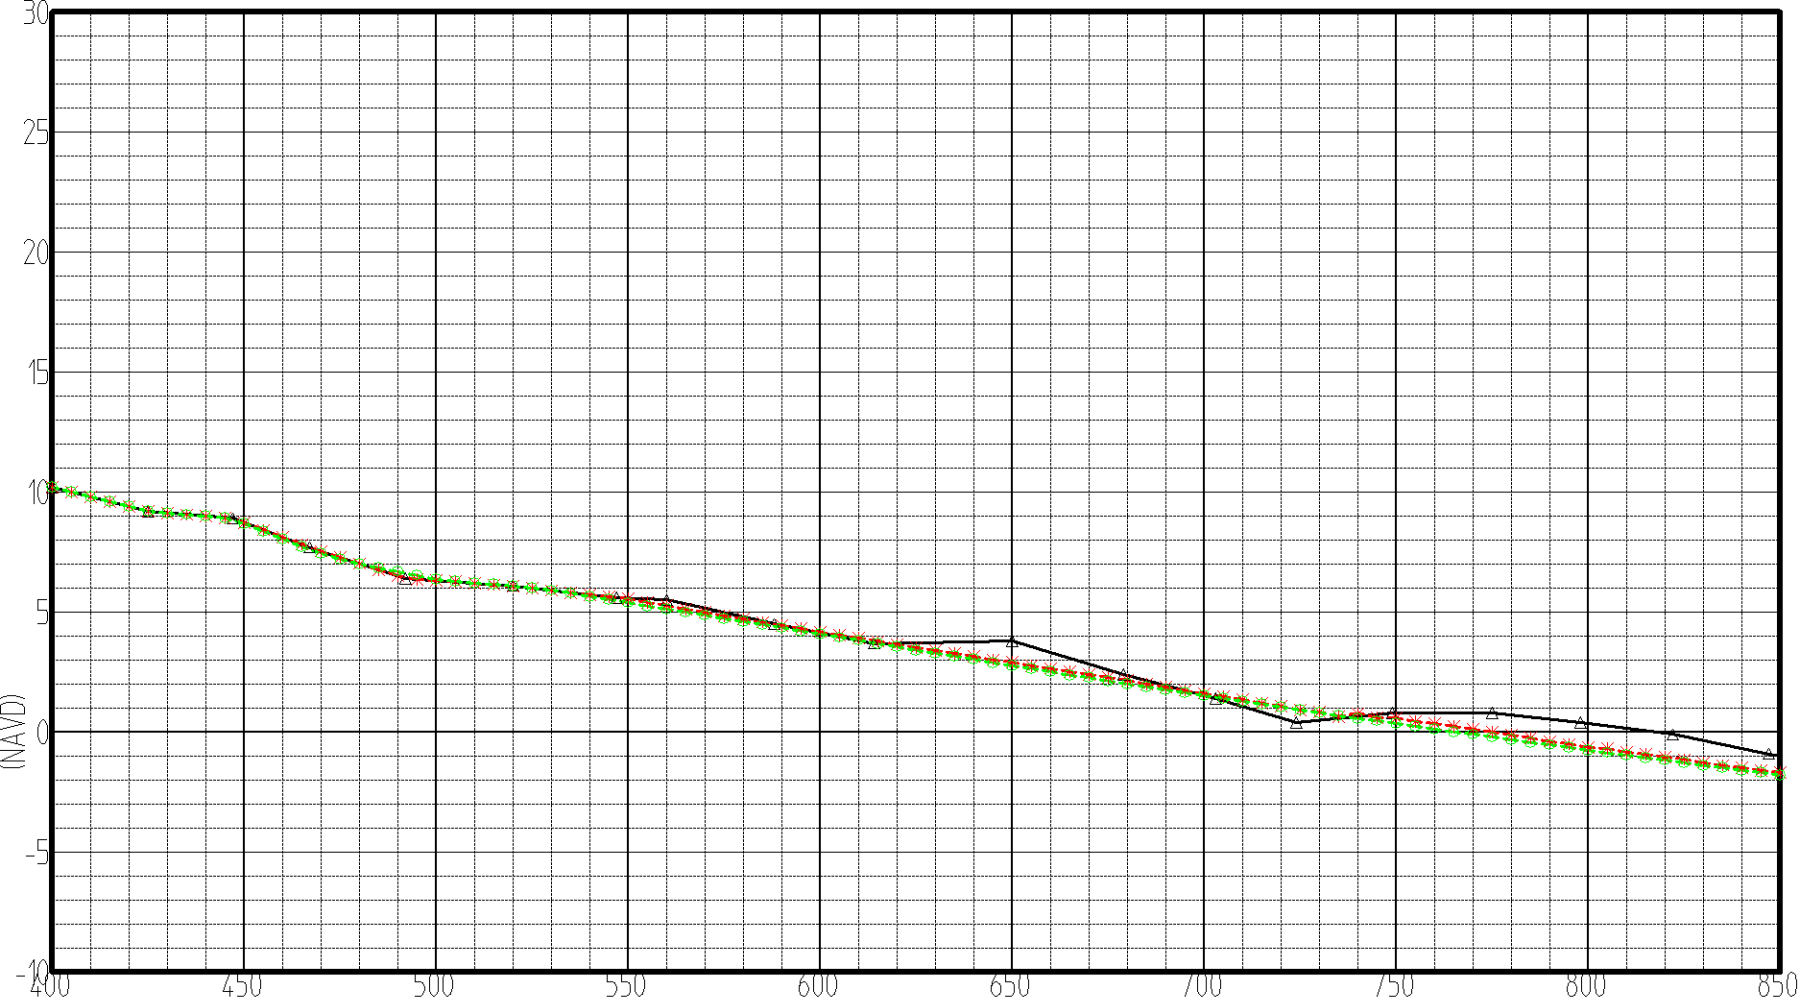
Range: R-147A 2/4
 BEARING: 75.00

BEACH PROFILE
 —△—△— ST. JOHNS 2007-2008 COMBI
 - - * - - 15YR SBEACH ERODED
 - - o - - 25YR SBCH ERODED

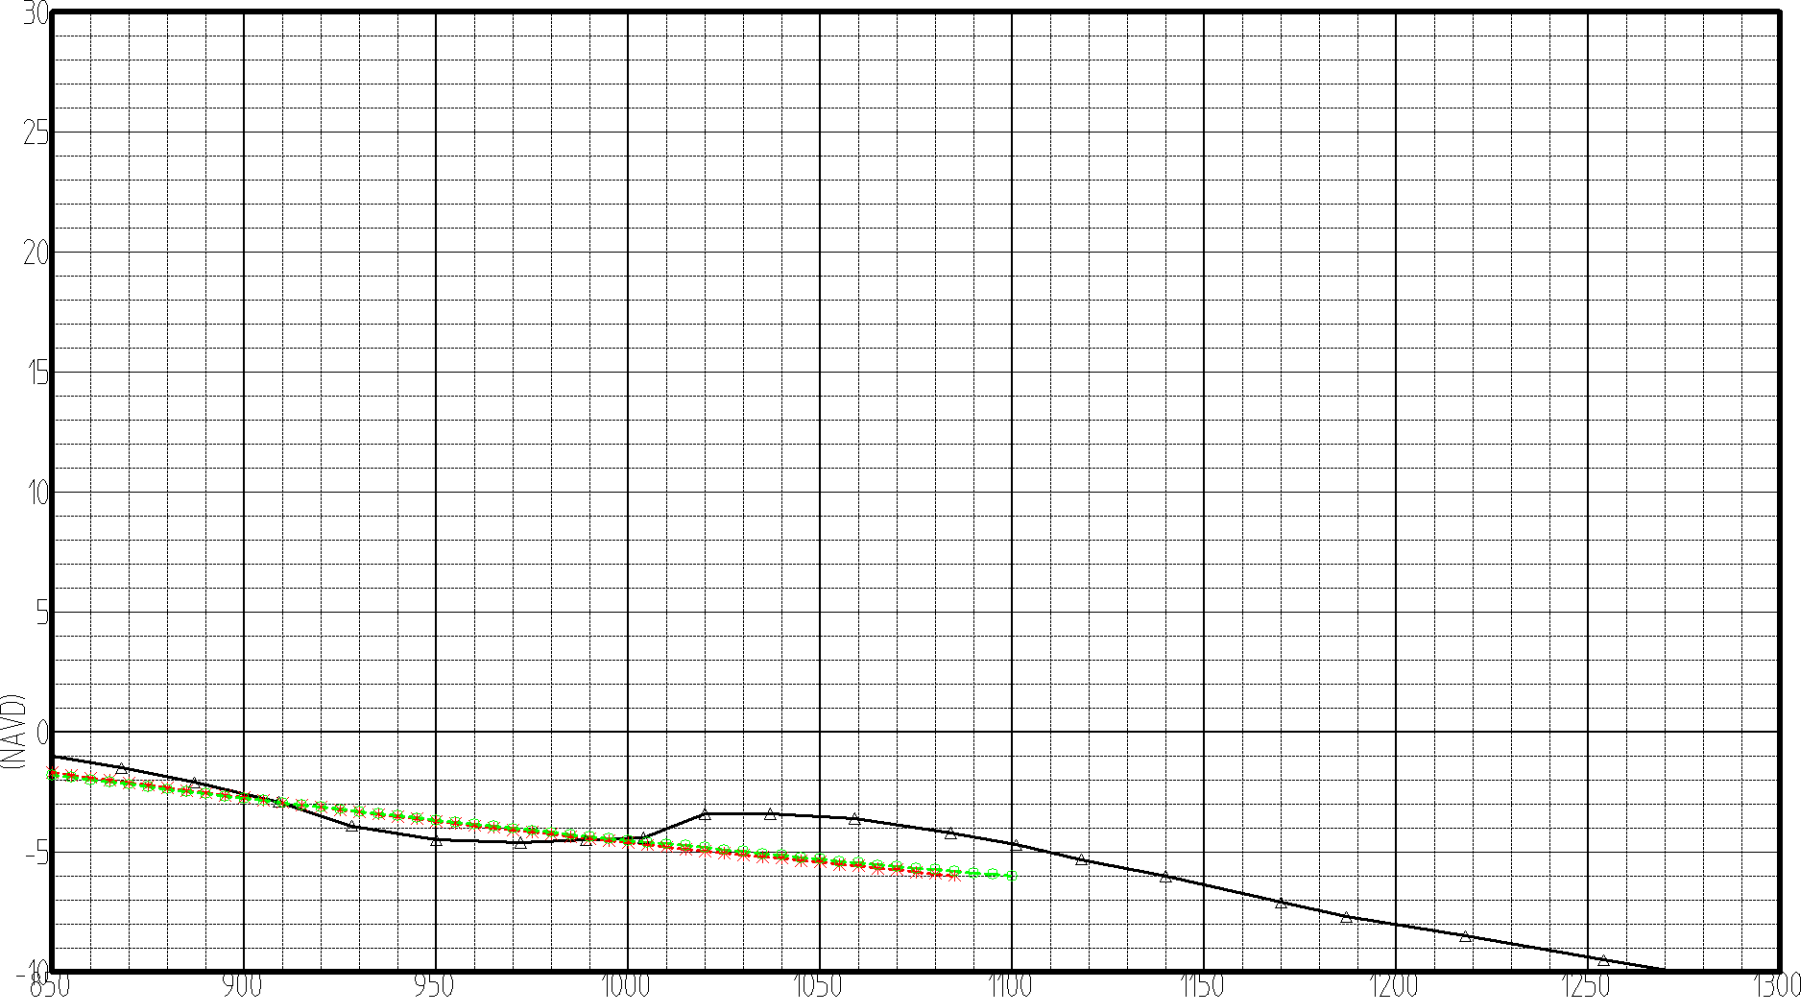
Range: R-147A 3/4
 BEARING: 75.00

BEACH PROFILE
 —△—△— ST. JOHNS 2007-2008 COMBI
 - - * - - 15YR SBACH ERODED
 - - o - - 25YR SBCH ERODED

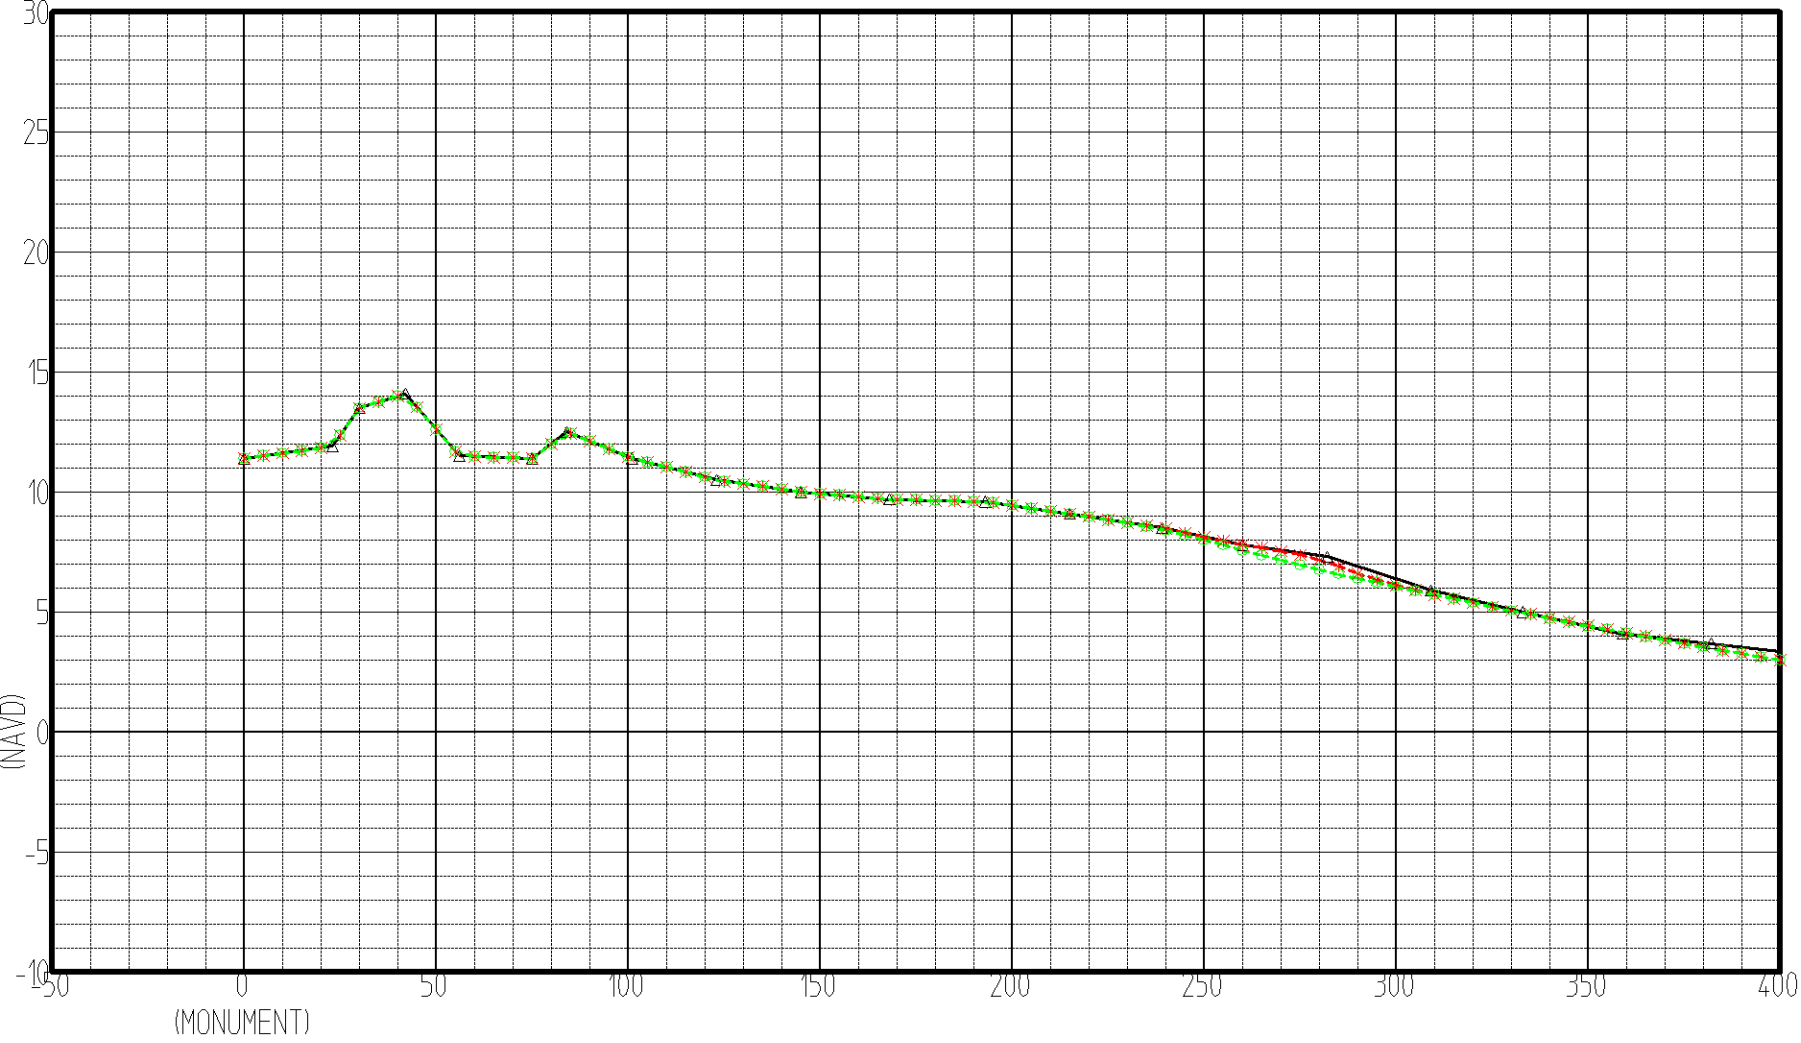
Range: R-148
 BEARING: 75.00
 1/3

BEACH PROFILE
 —△—△— ST. JOHNS 2007-2008 COMBI
 - - * - - * - - 15YR SBEACH ERODED
 - - o - - o - - 25YR SBCH ERODED

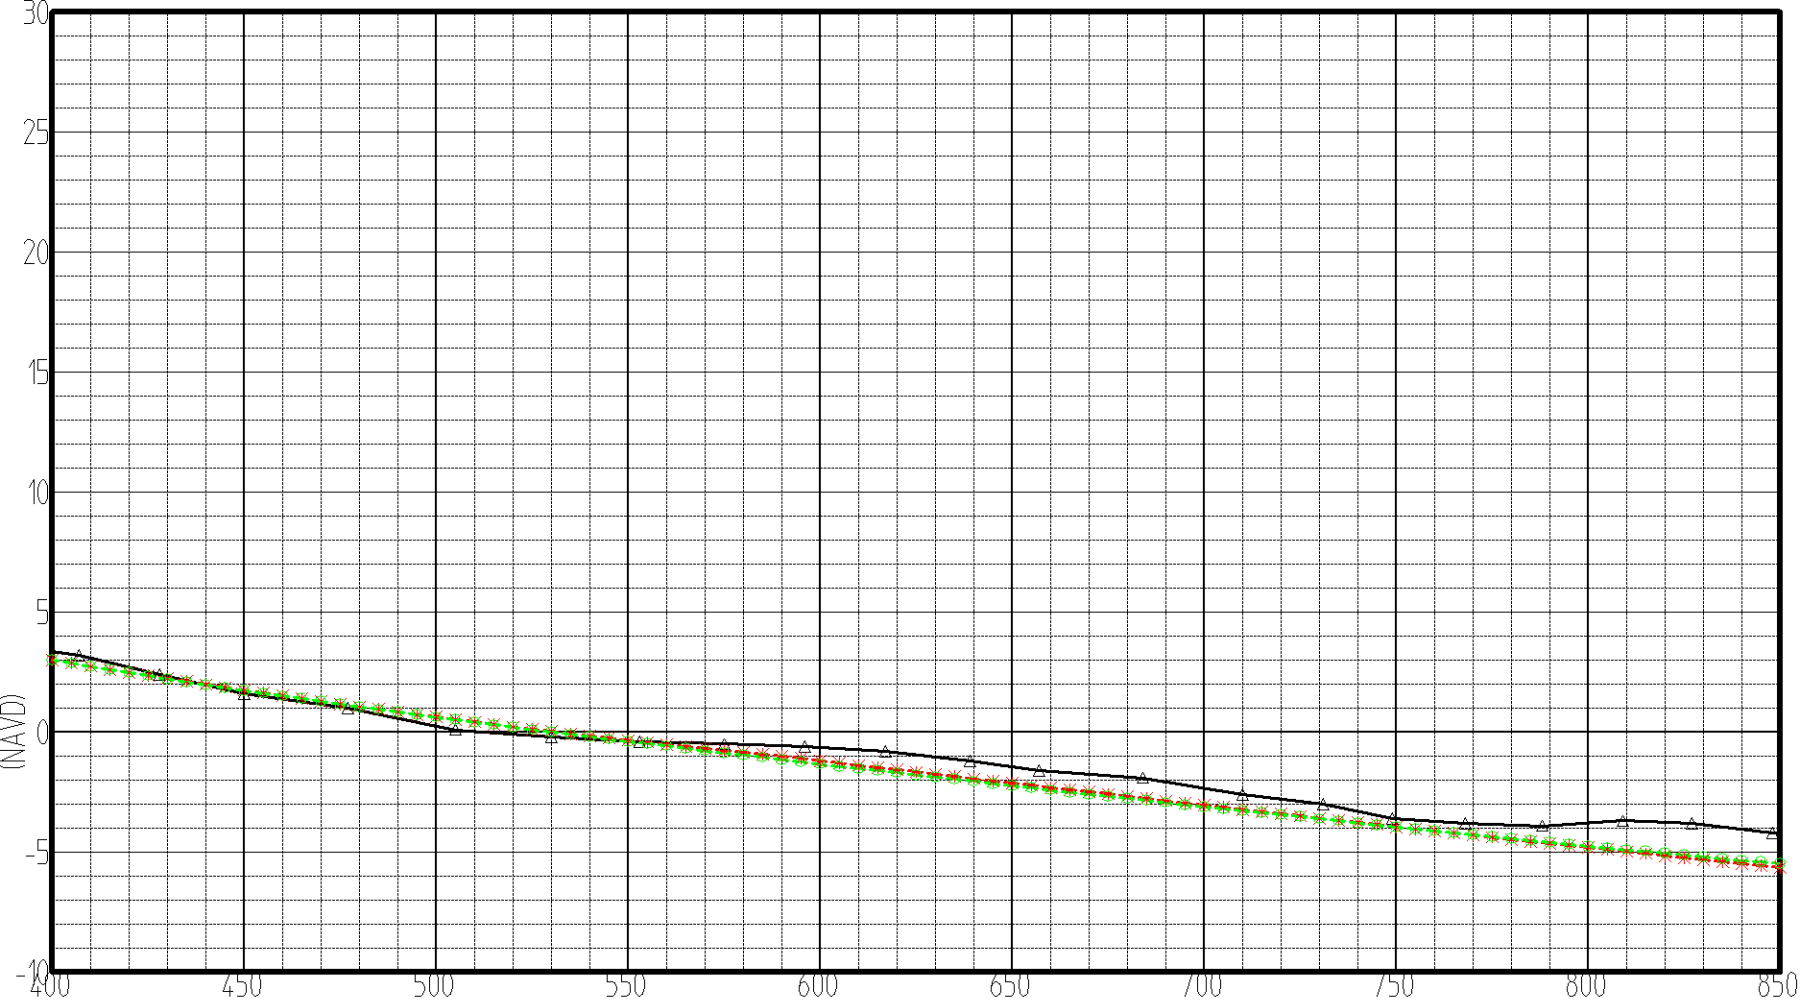
Range: R-148 2/3

BEACH PROFILE

—△—△— ST. JOHNS 2007-2008 COMBI

- - * - - 15YR SBEACH ERODED

- - ○ - - 25YR SBCH ERODED

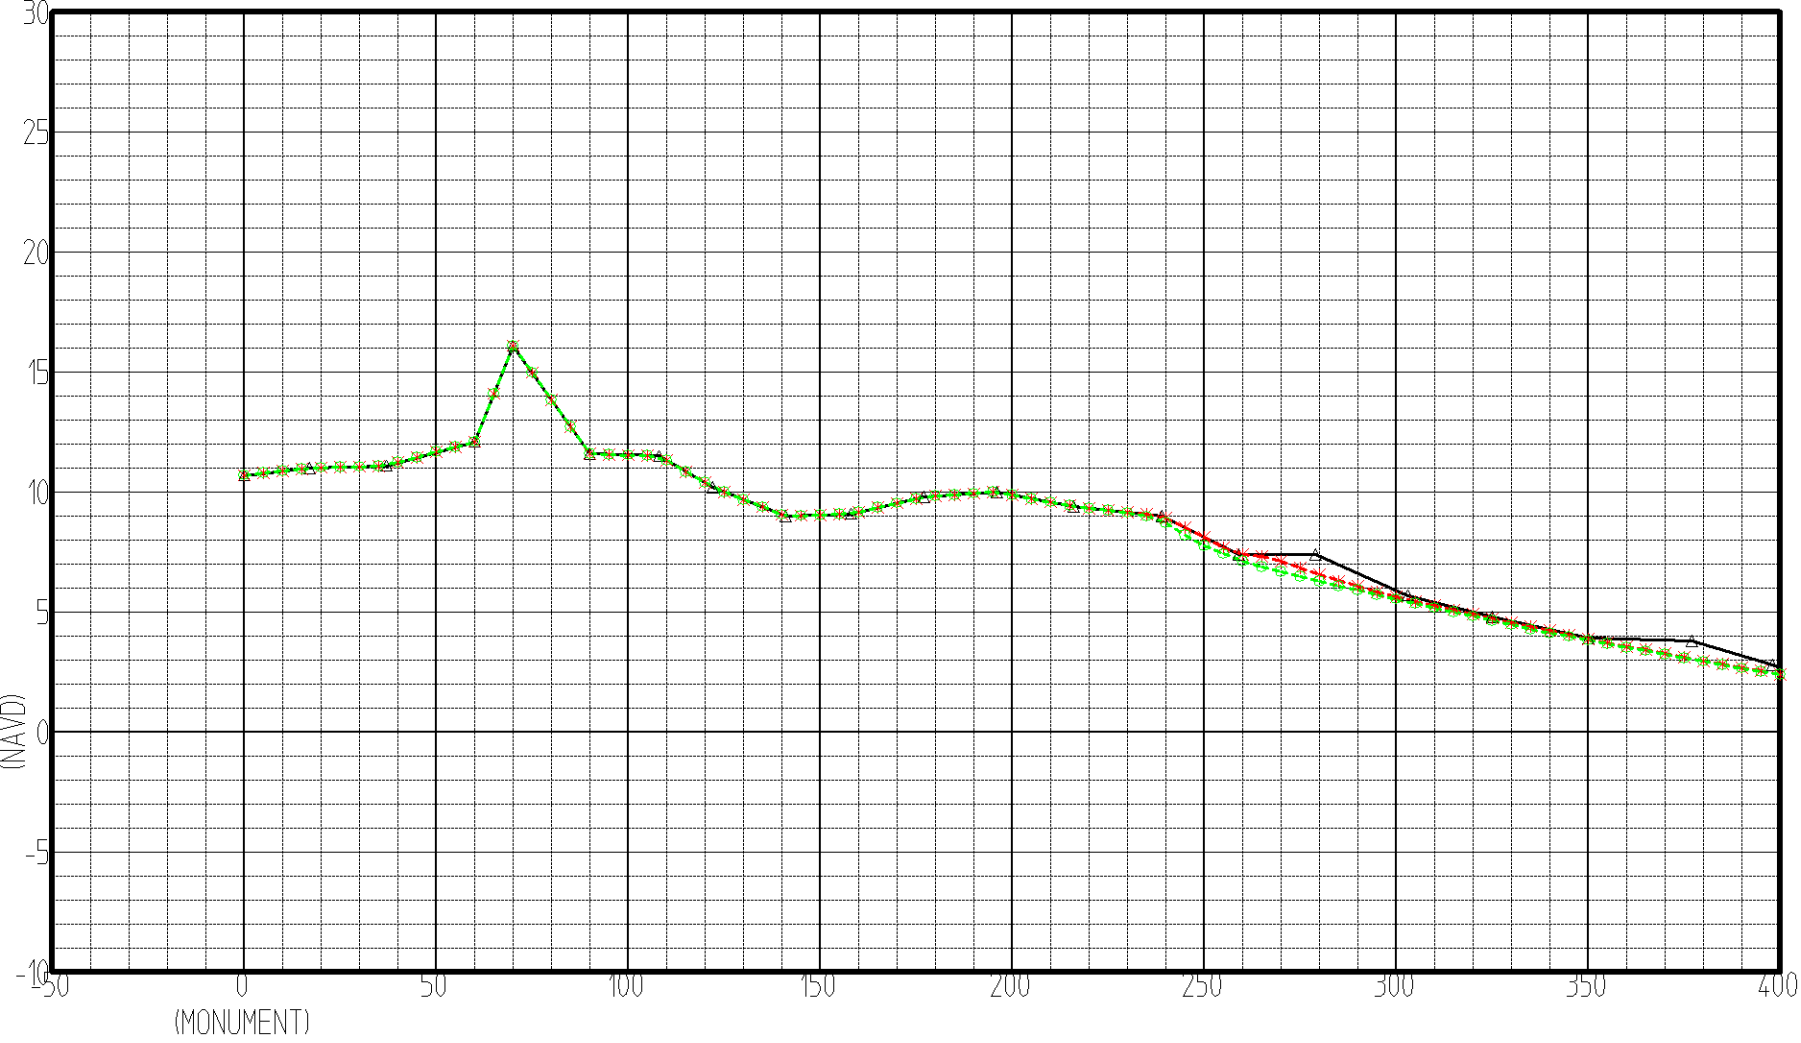
Range: R-149

BEACH PROFILE

—△—△— ST. JOHNS 2007-2008 COMBI

- - * - - * - - 15YR SBCH ERODED

- - o - - o - - 25YR SBCH ERODED

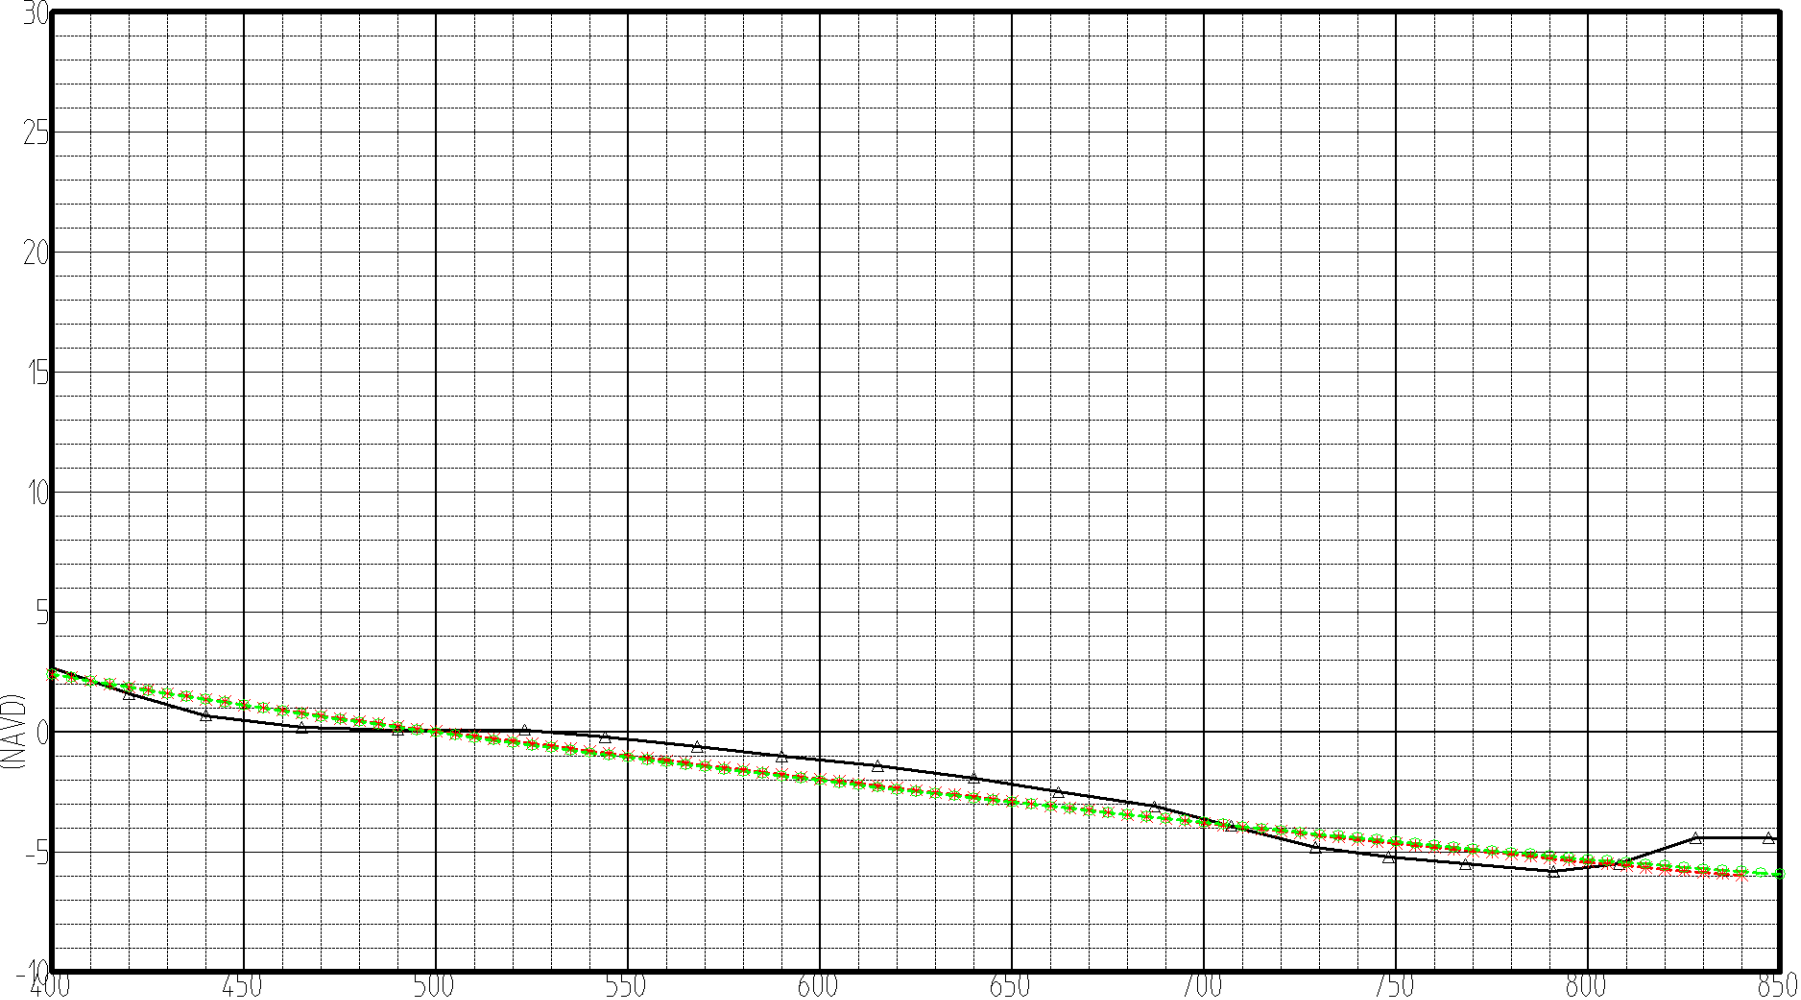
Range: R-149 2/3

BEACH PROFILE

—△—△— ST. JOHNS 2007-2008 COMBI

- - - * - - - 15YR SBEACH ERODED

- - - o - - - 25YR SBCH ERODED

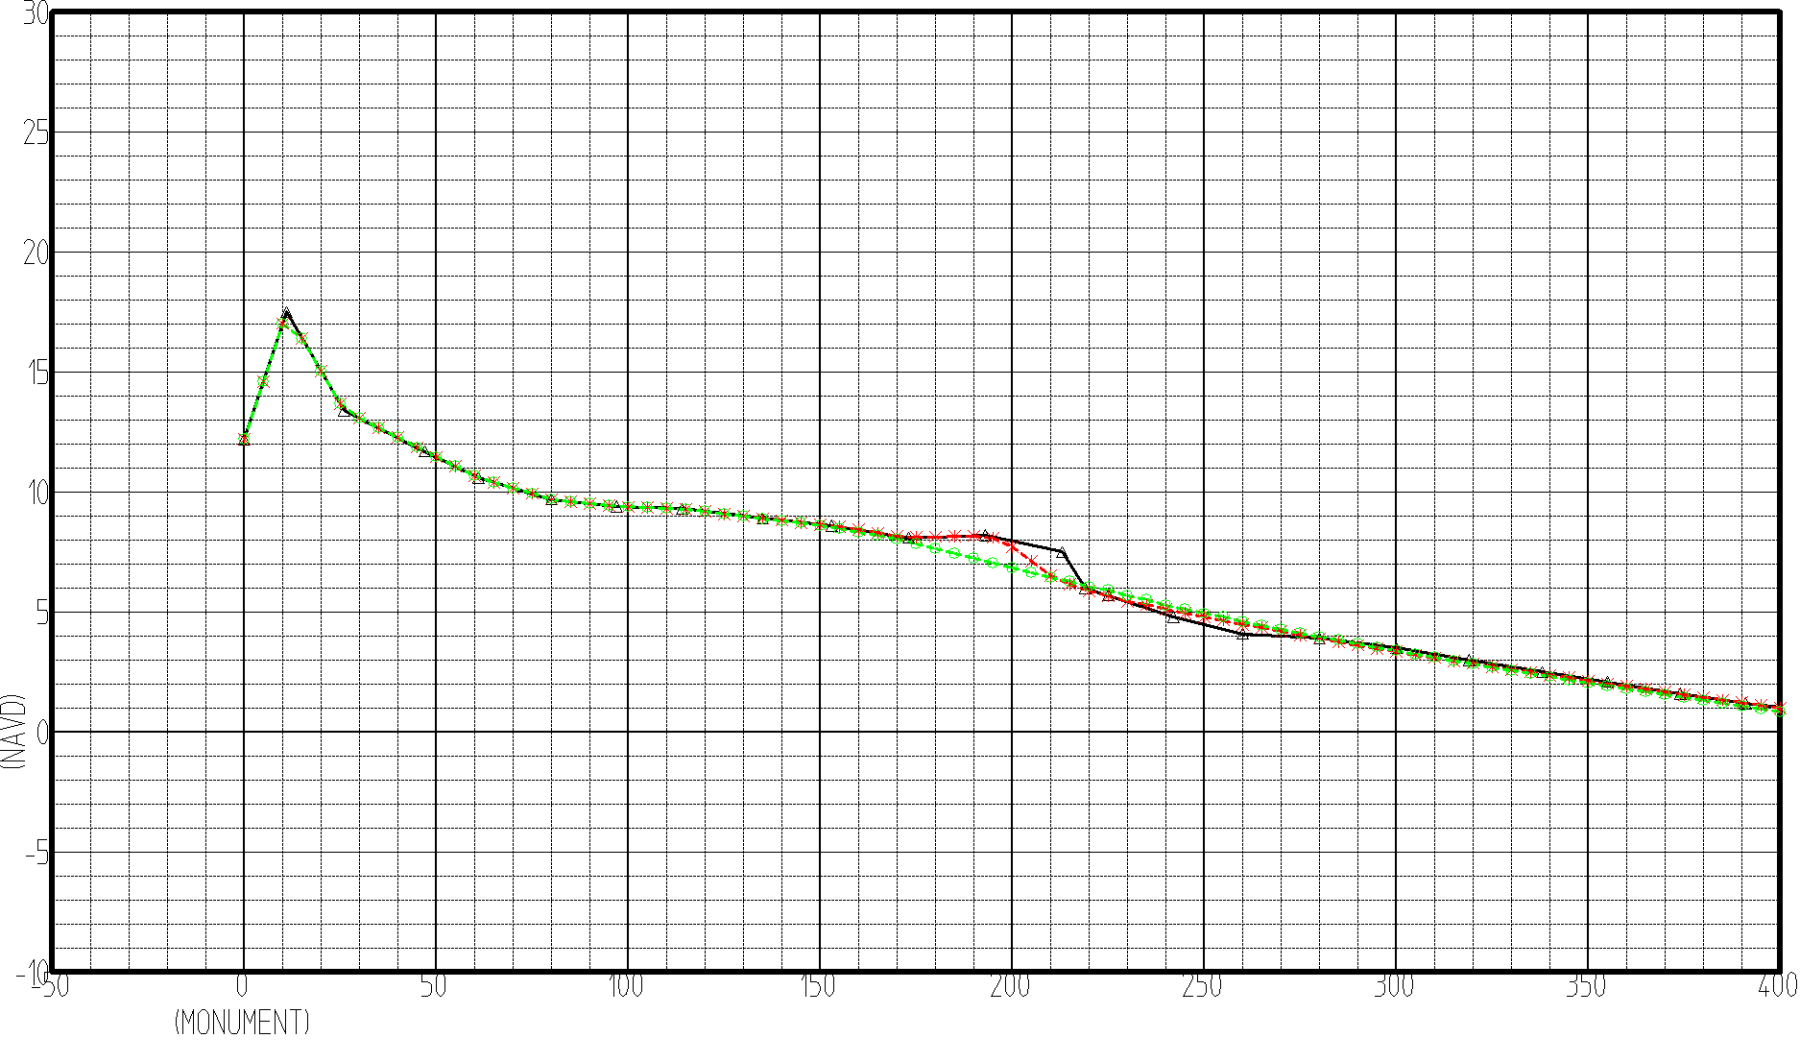
Range: R-150

BEACH PROFILE

—△—△— ST. JOHNS 2007-2008 COMBI

- - * - - 15YR SBCH ERODED

- - o - - 25YR SBCH ERODED
