Appendix VIII

SBEACH 15 and 25 yr. Storm Erosion Profiles

St. Johns County

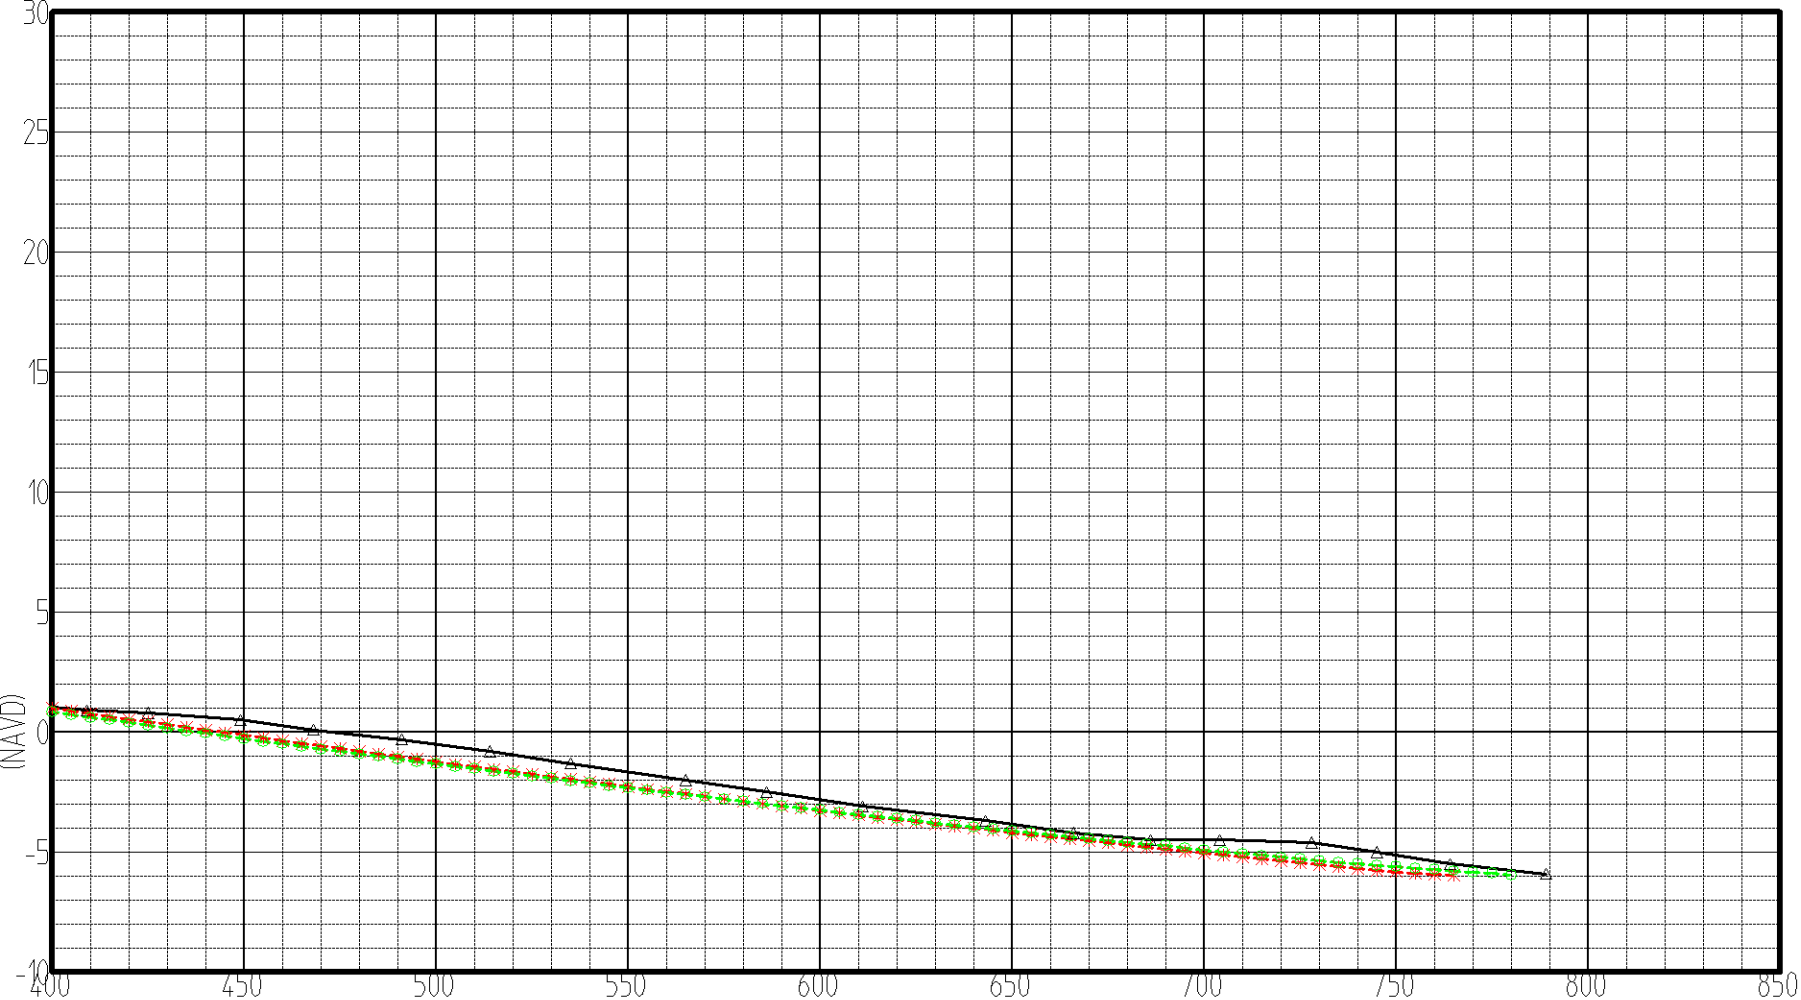
Range: R-150
 BEARING: 75.00
 2/2

BEACH PROFILE
 —△—△— ST. JOHNS 2007-2008 COMBI
 - - * - - * - - 15YR SBEACH ERODED
 - - o - - o - - 25YR SBCH ERODED

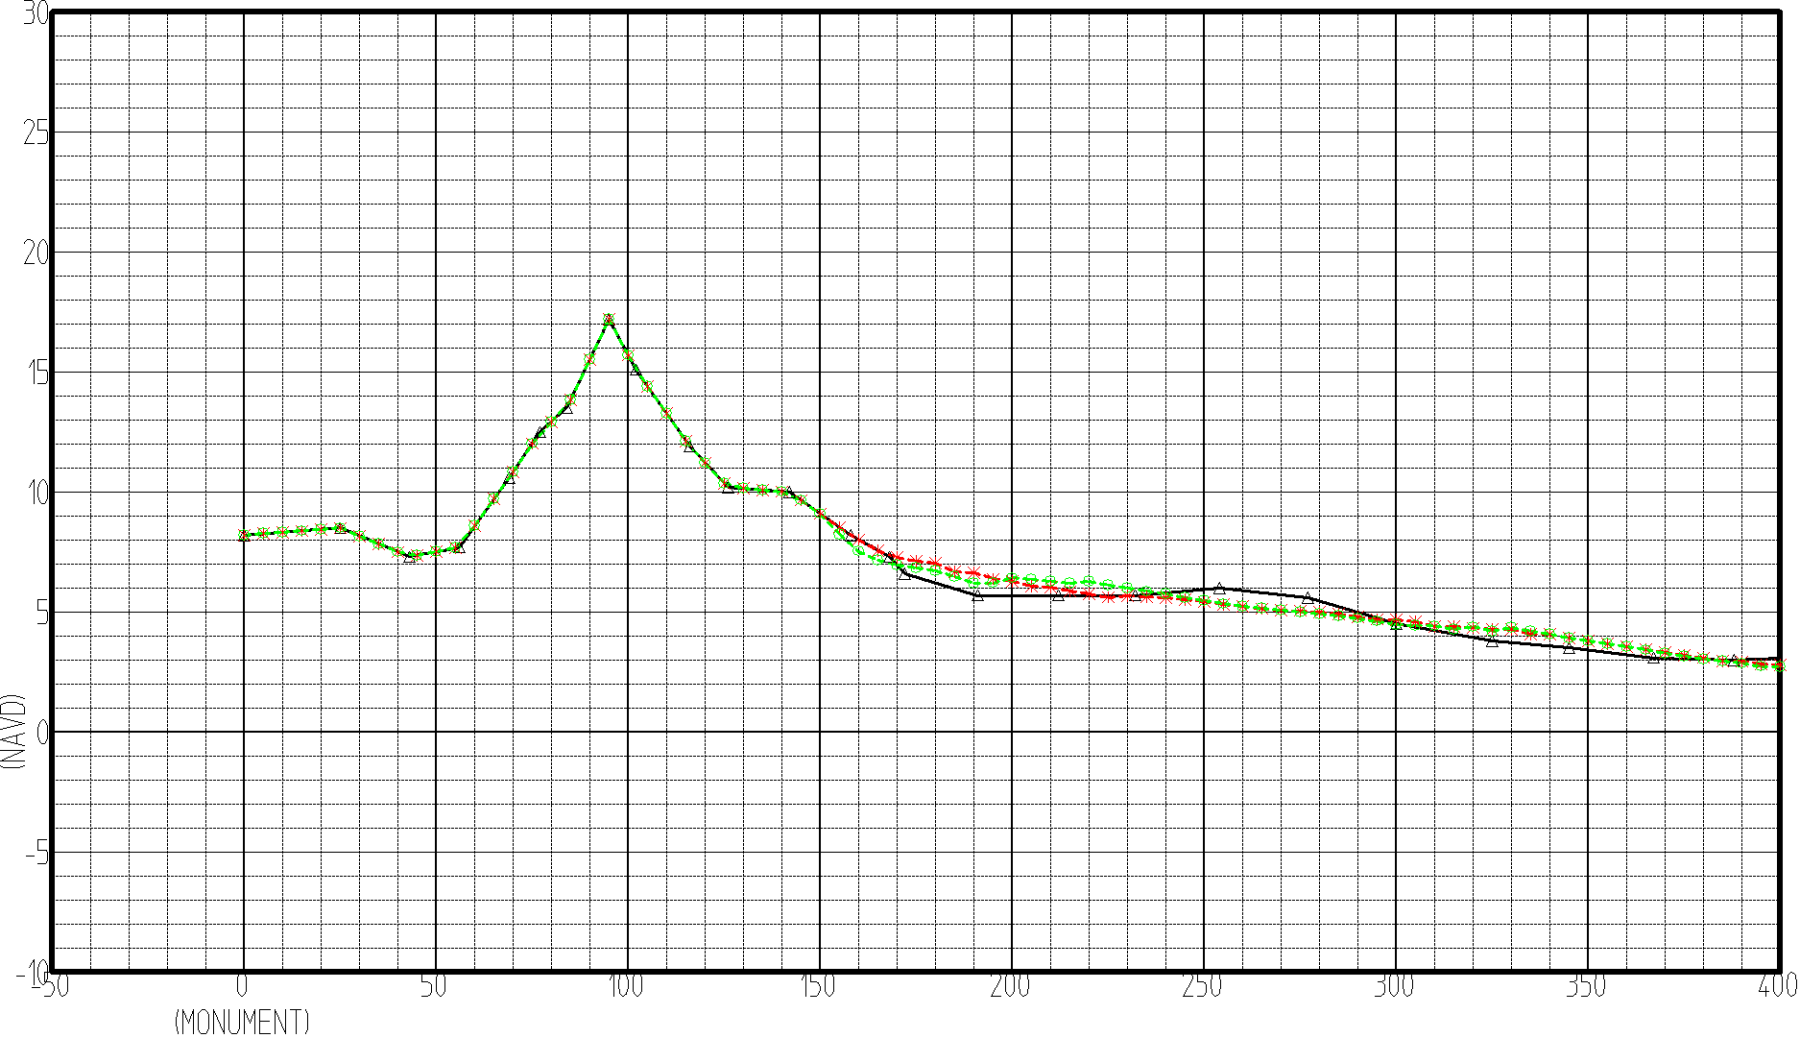
Range: R-151
 BEARING: 75.00
 1/3

BEACH PROFILE
 —△—△— ST. JOHNS 2007-2008 COMBI
 - - * - - 15YR SBEACH ERODED
 - - o - - 25YR SBCH ERODED

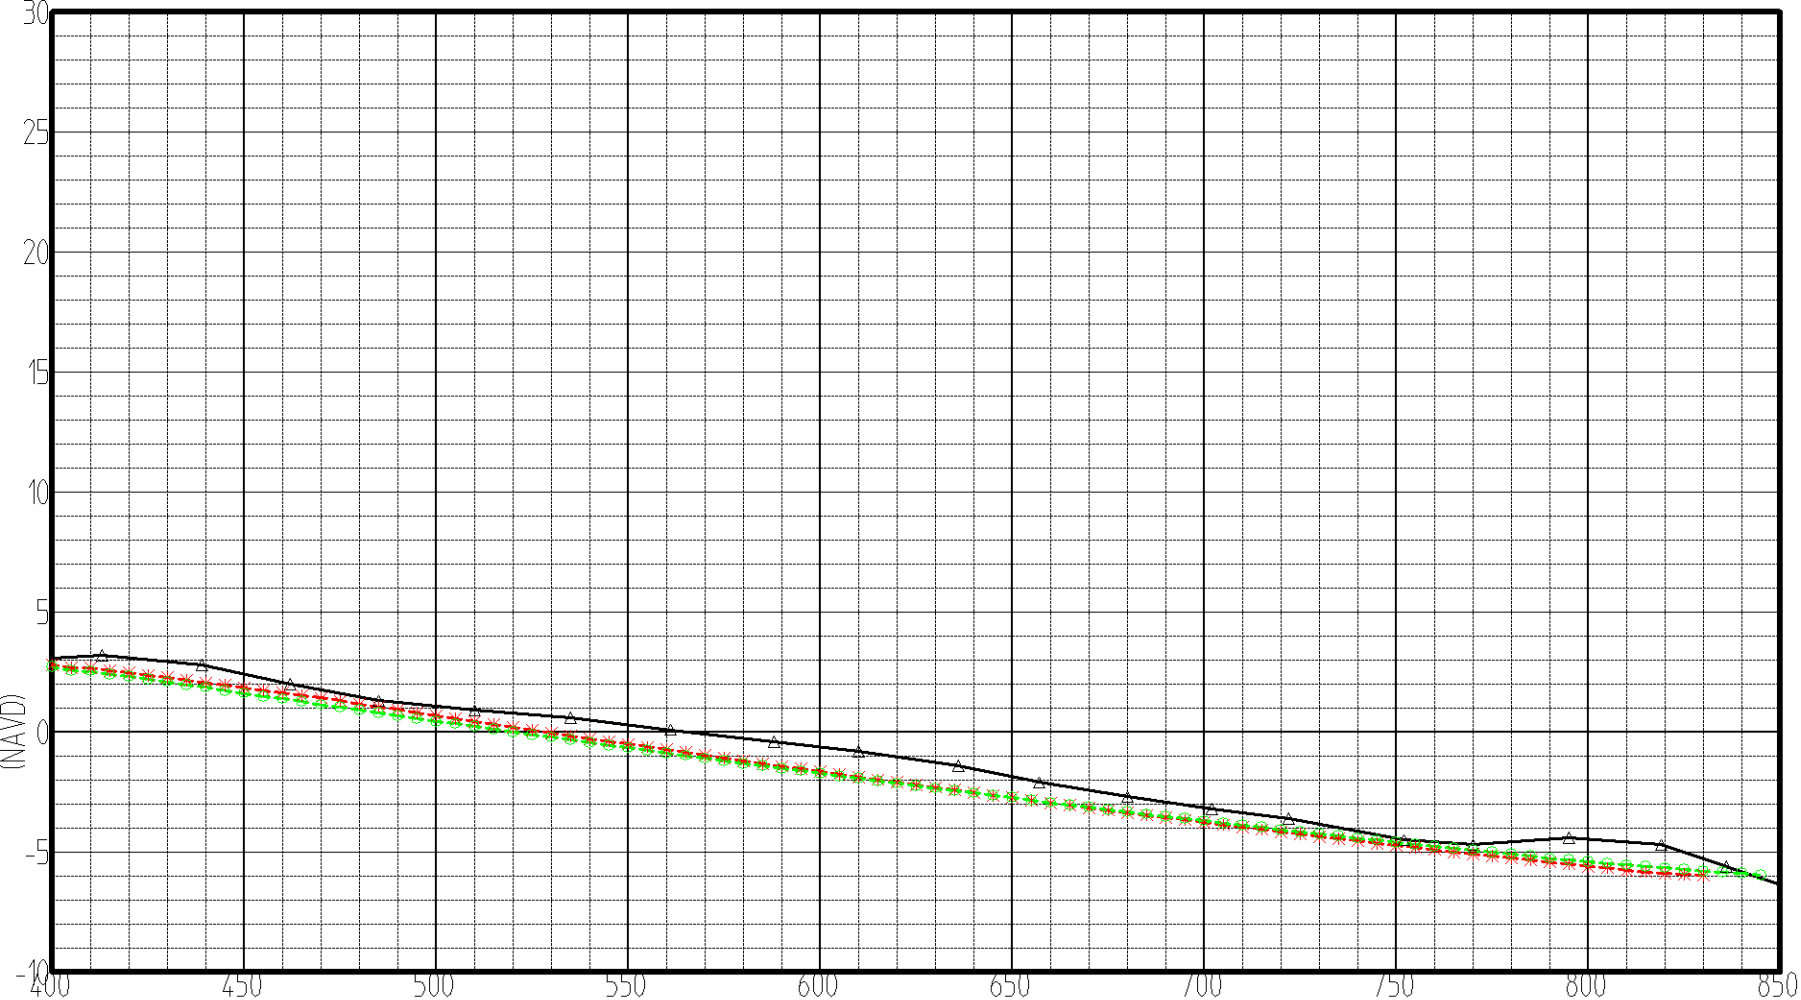
Range: R-151 2/3
 BEARING: 75.00

BEACH PROFILE
 —△— ST. JOHNS 2007-2008 COMBI
 - - * - - 15YR SBEACH ERODED
 - - o - - 25YR SBCH ERODED

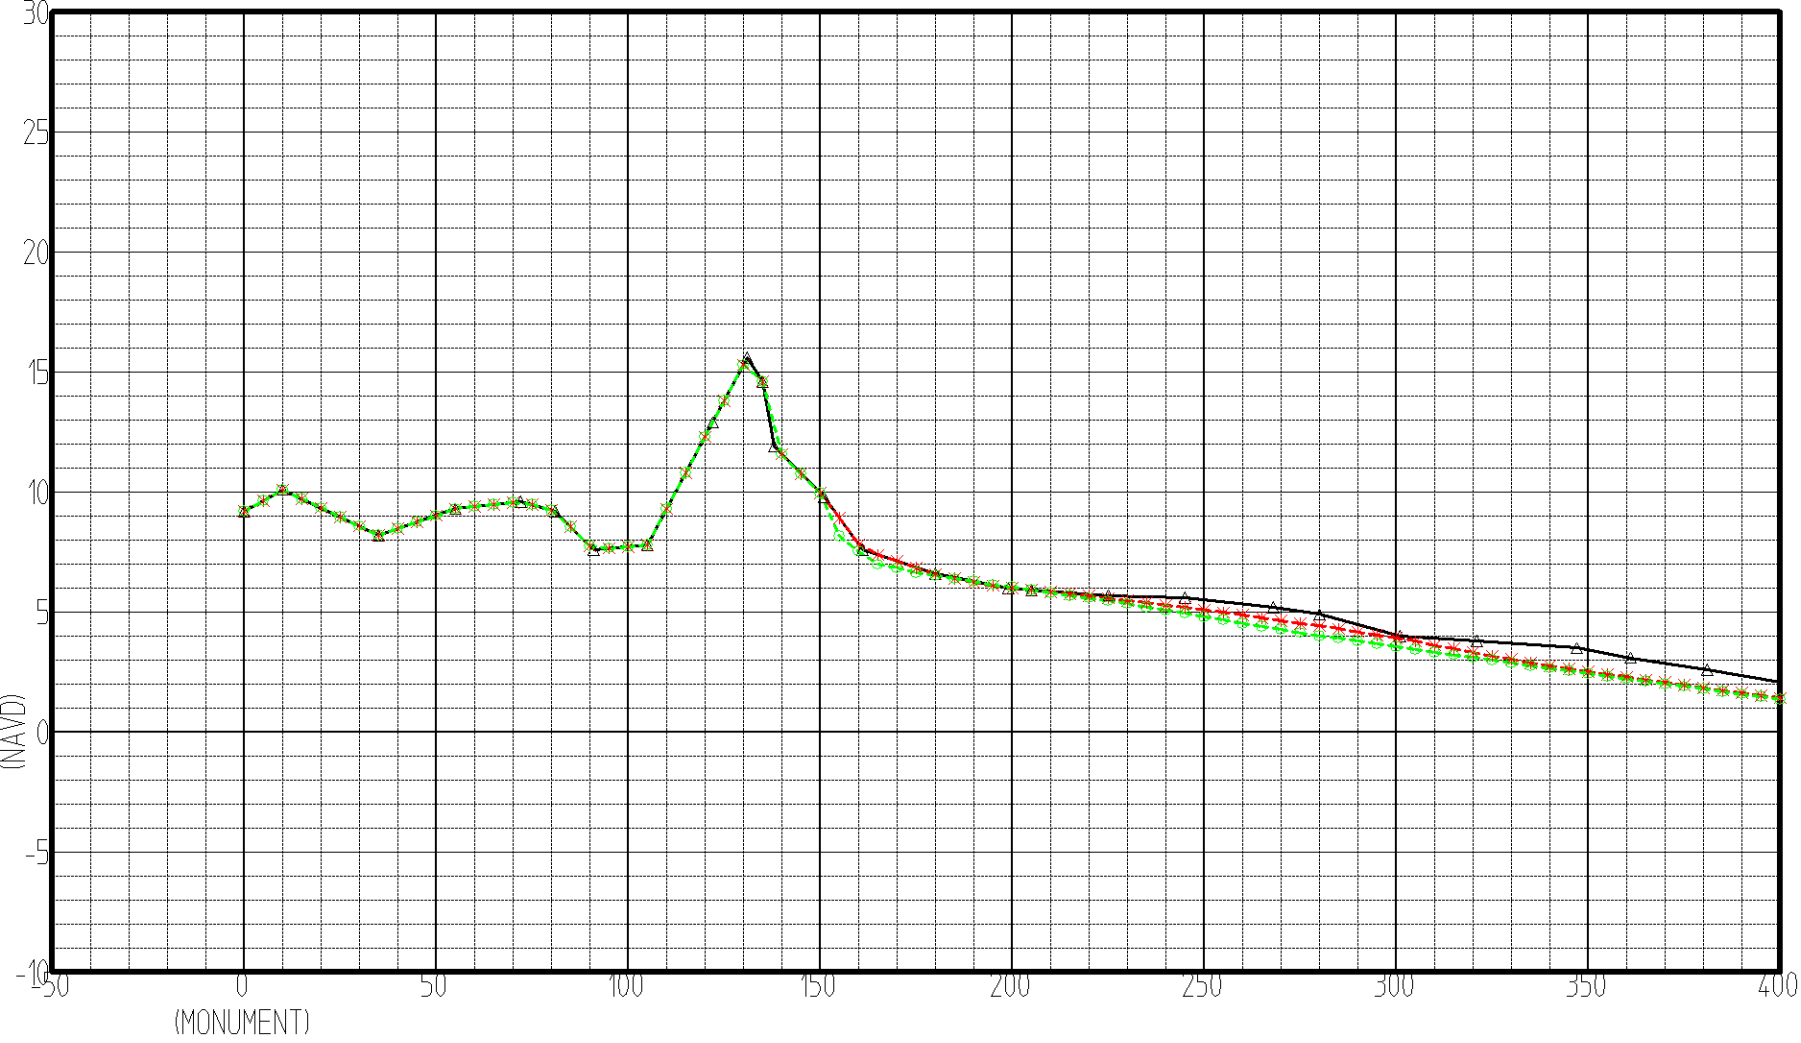
Range: R-152

BEACH PROFILE

—△—△— ST. JOHNS 2007-2008 COMBI

- - - * - - - 15YR SBCH ERODED

- - - o - - - 25YR SBCH ERODED

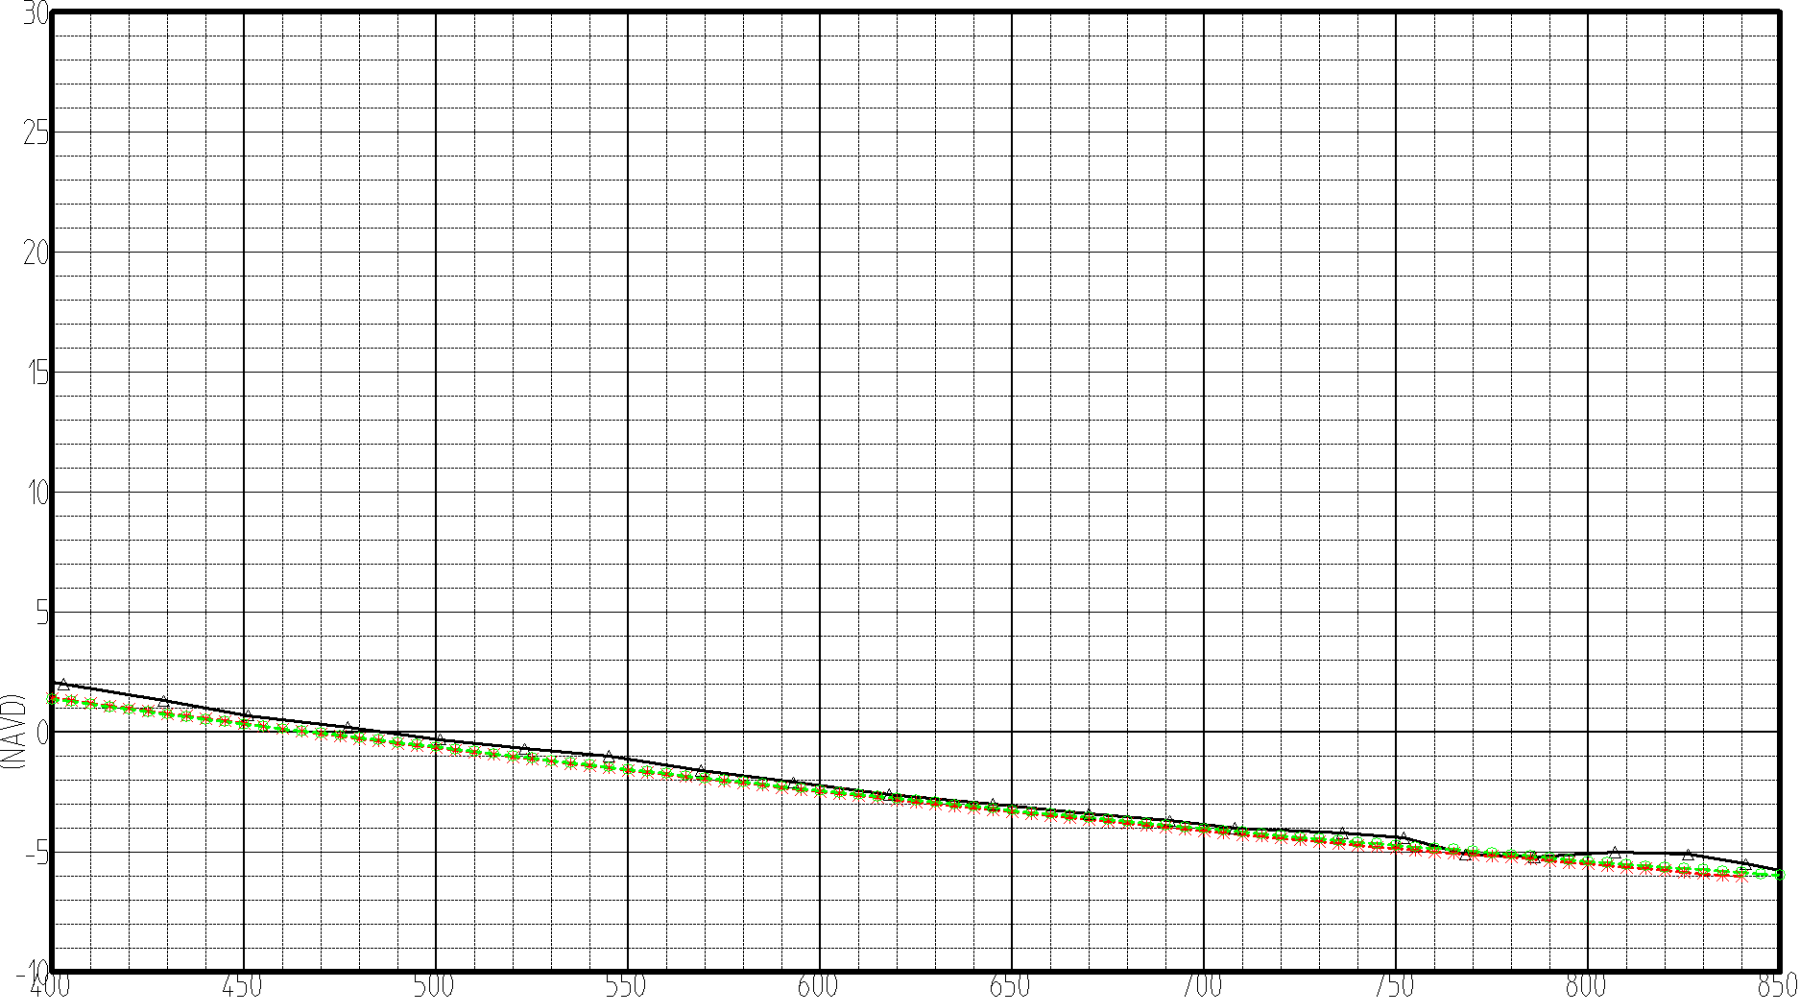
Range: R-152 2/3
 BEARING: 75.00

BEACH PROFILE
 —△—△— ST. JOHNS 2007-2008 COMBI
 - - * - - 15YR SBEACH ERODED
 - - o - - 25YR SBCH ERODED

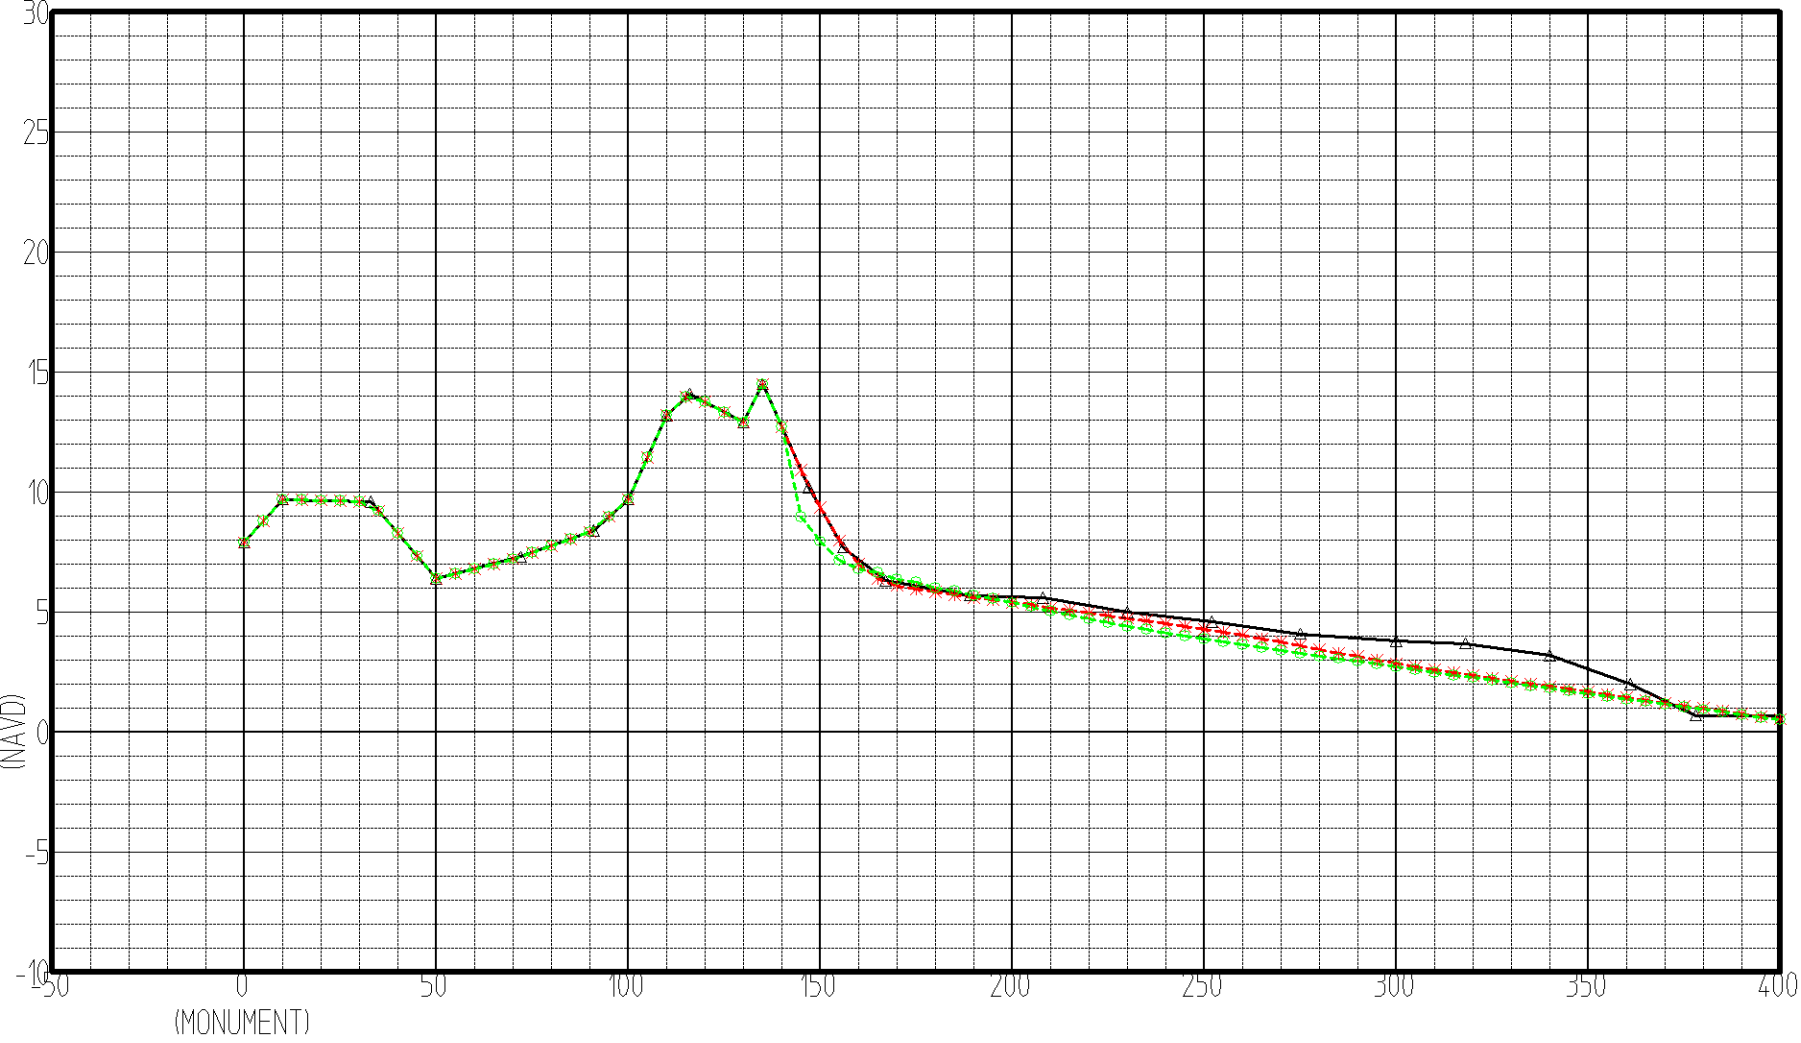
BEACH PROFILE
 —△—△— ST. JOHNS 2007-2008 COMBI
 - - * - - 15YR SBCH ERODED
 - - o - - 25YR SBCH ERODED

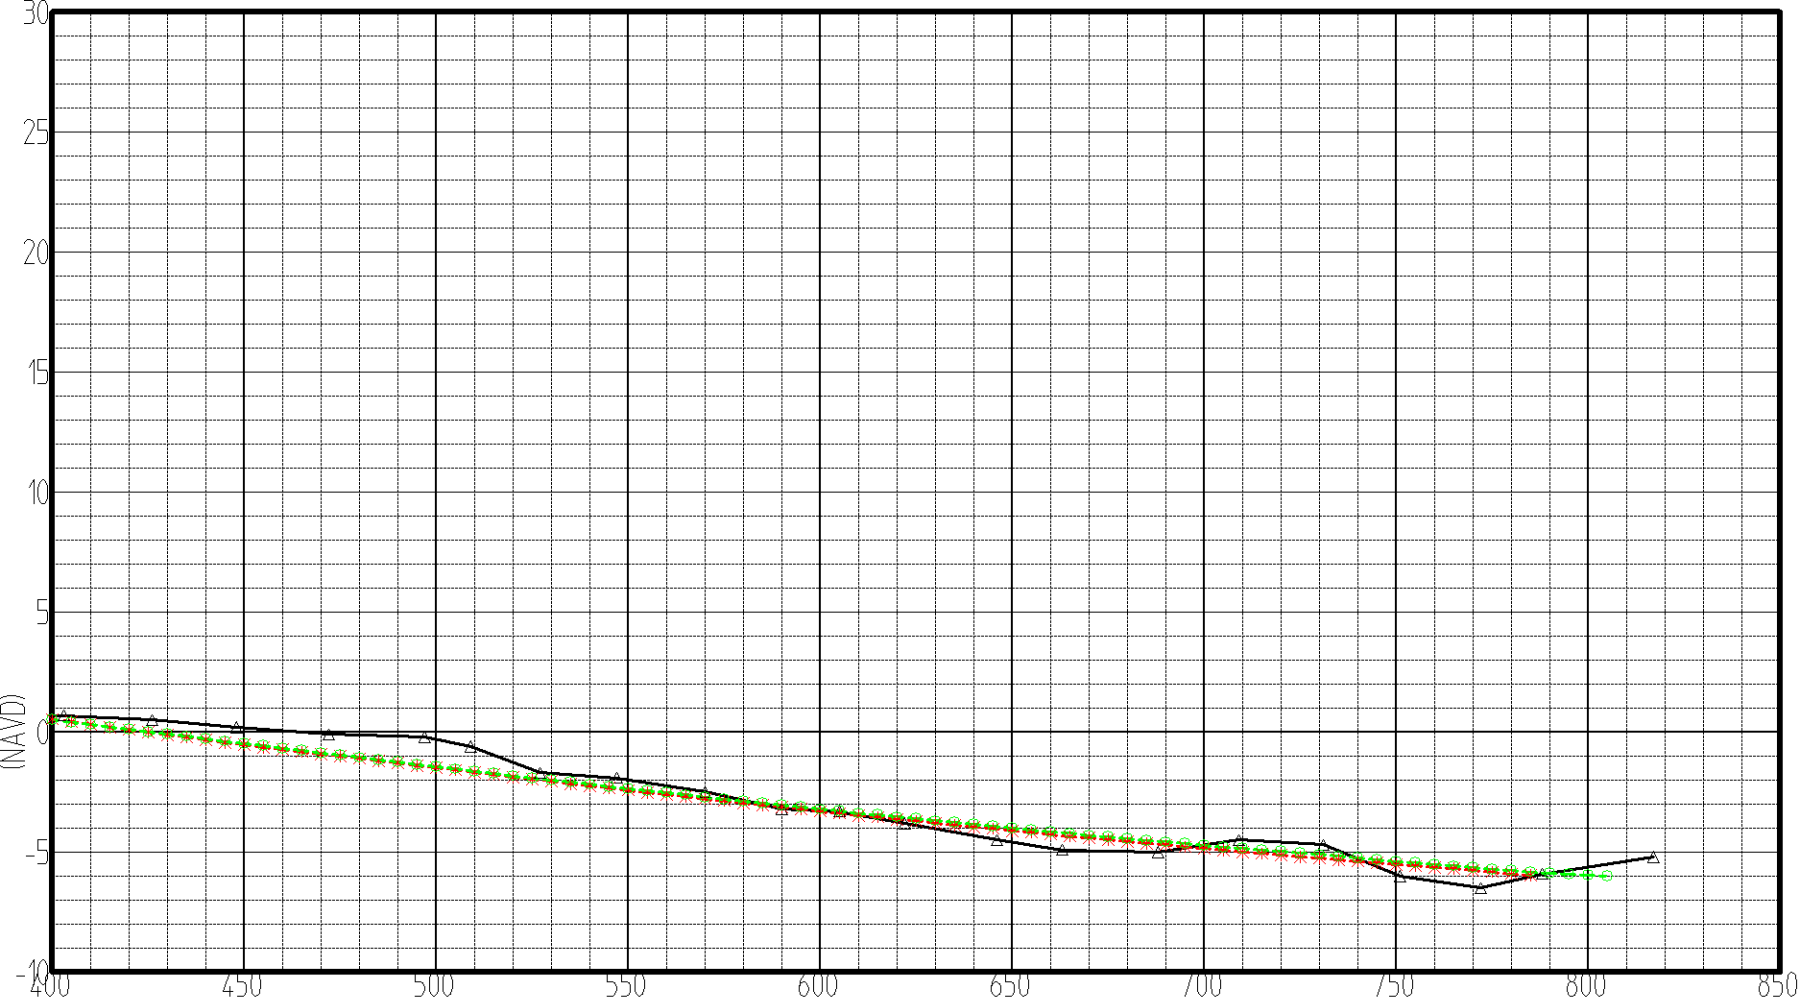
Range: R-153
 BEARING: 75.00
 2/2

BEACH PROFILE
 —△— ST. JOHNS 2007-2008 COMBI
 - - * - - 15YR SBEACH ERODED
 - - o - - 25YR SBCH ERODED

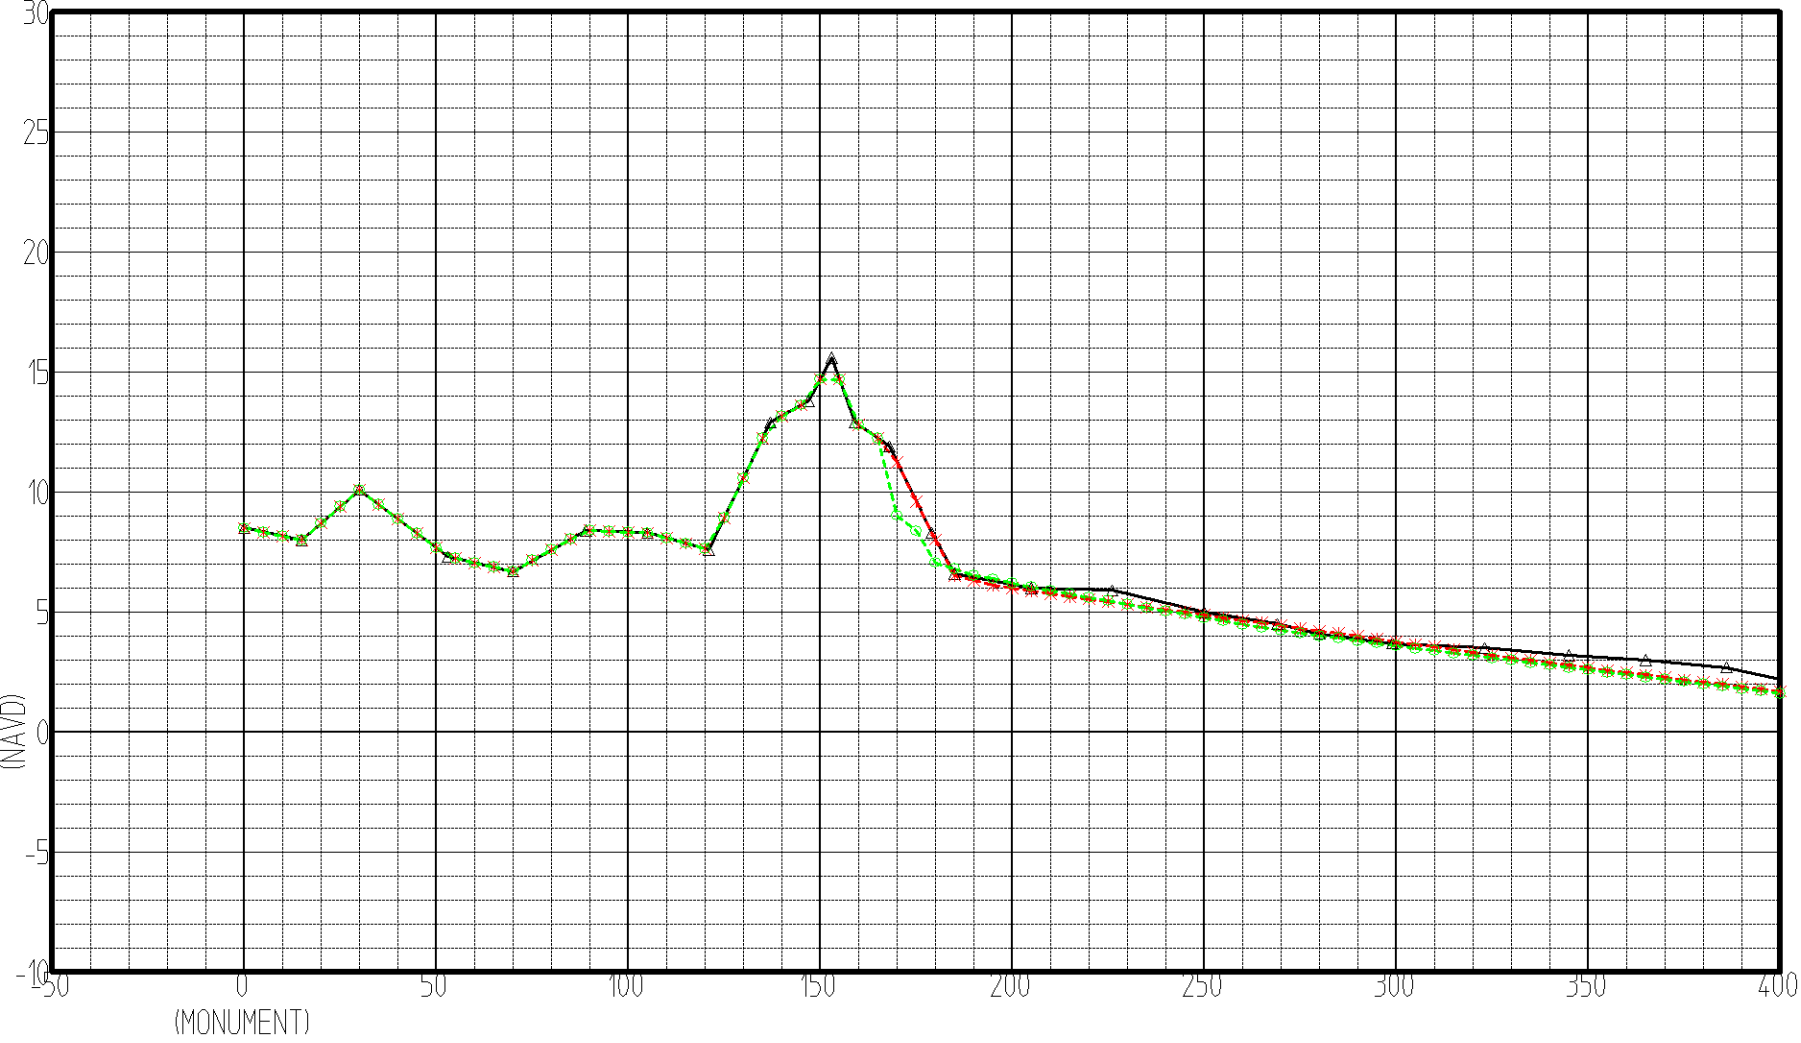
Range: R-154
 BEARING: 75.00
 1/3

BEACH PROFILE
 —△—△— ST. JOHNS 2007-2008 COMBI
 - - * - - 15YR SBCH ERODED
 - - o - - 25YR SBCH ERODED

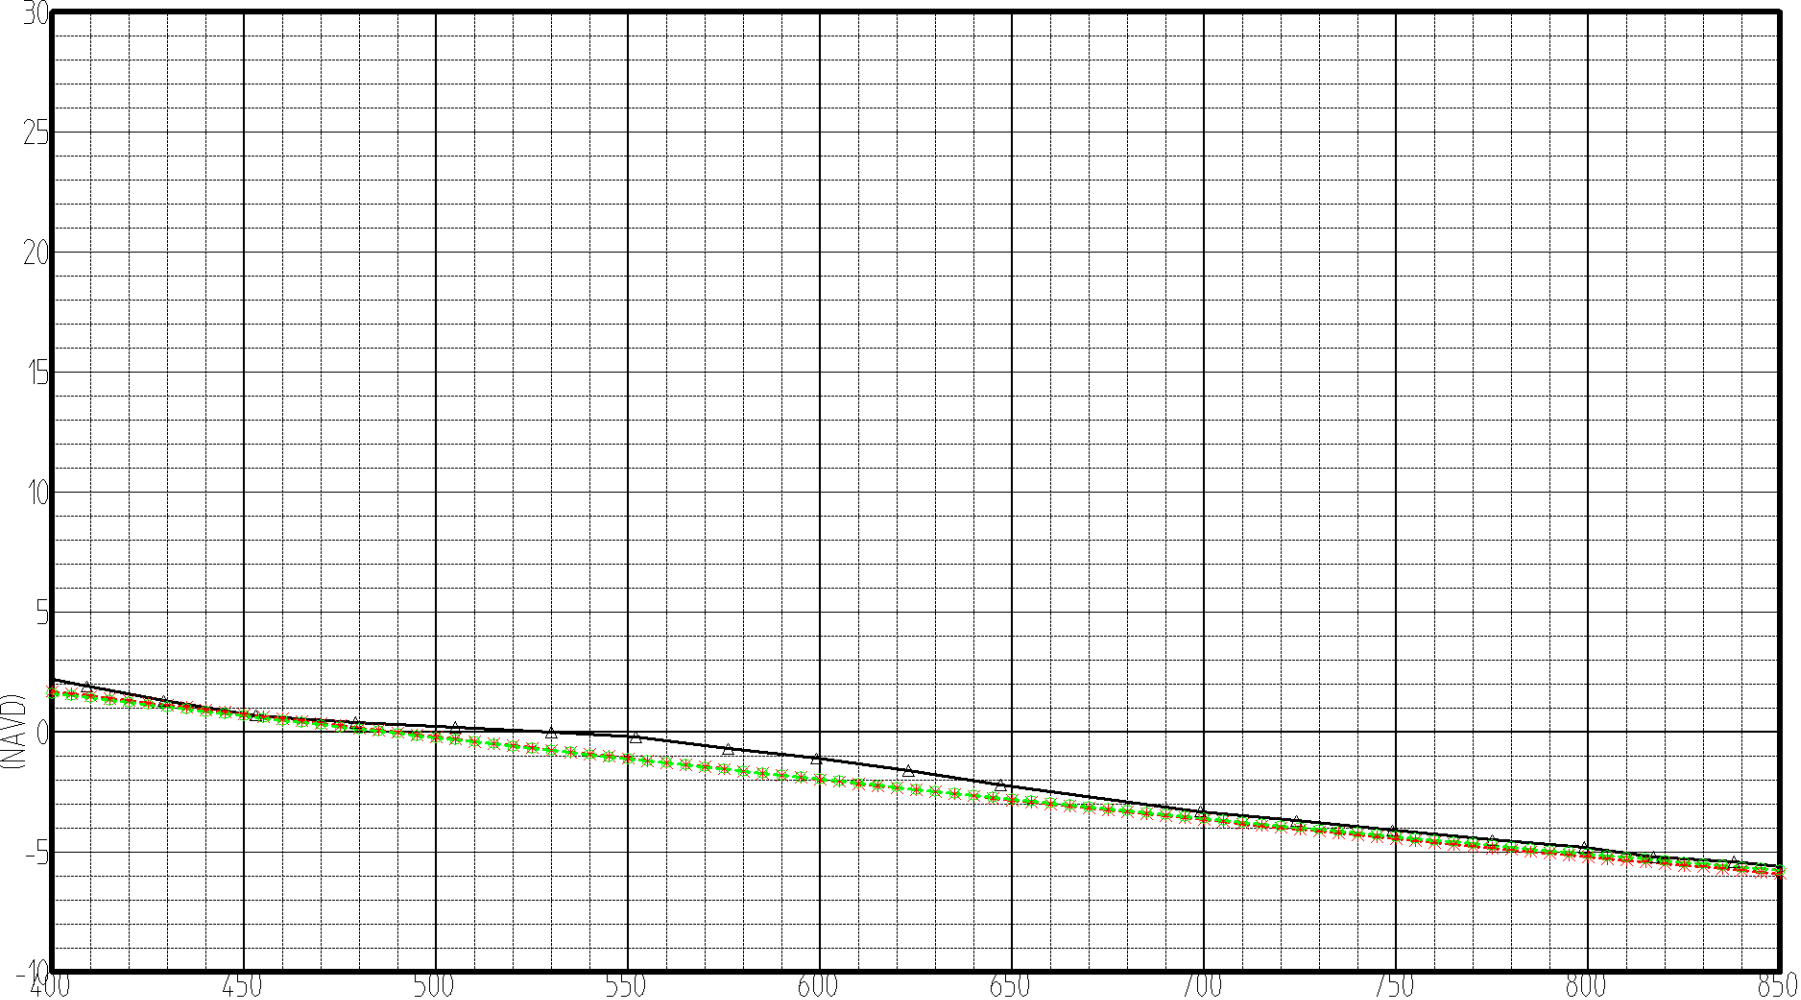
Range: R-154 2/3
 BEARING: 75.00

BEACH PROFILE
 —△—△— ST. JOHNS 2007-2008 COMBI
 - - * - - 15YR SBEACH ERODED
 - - o - - 25YR SBCH ERODED

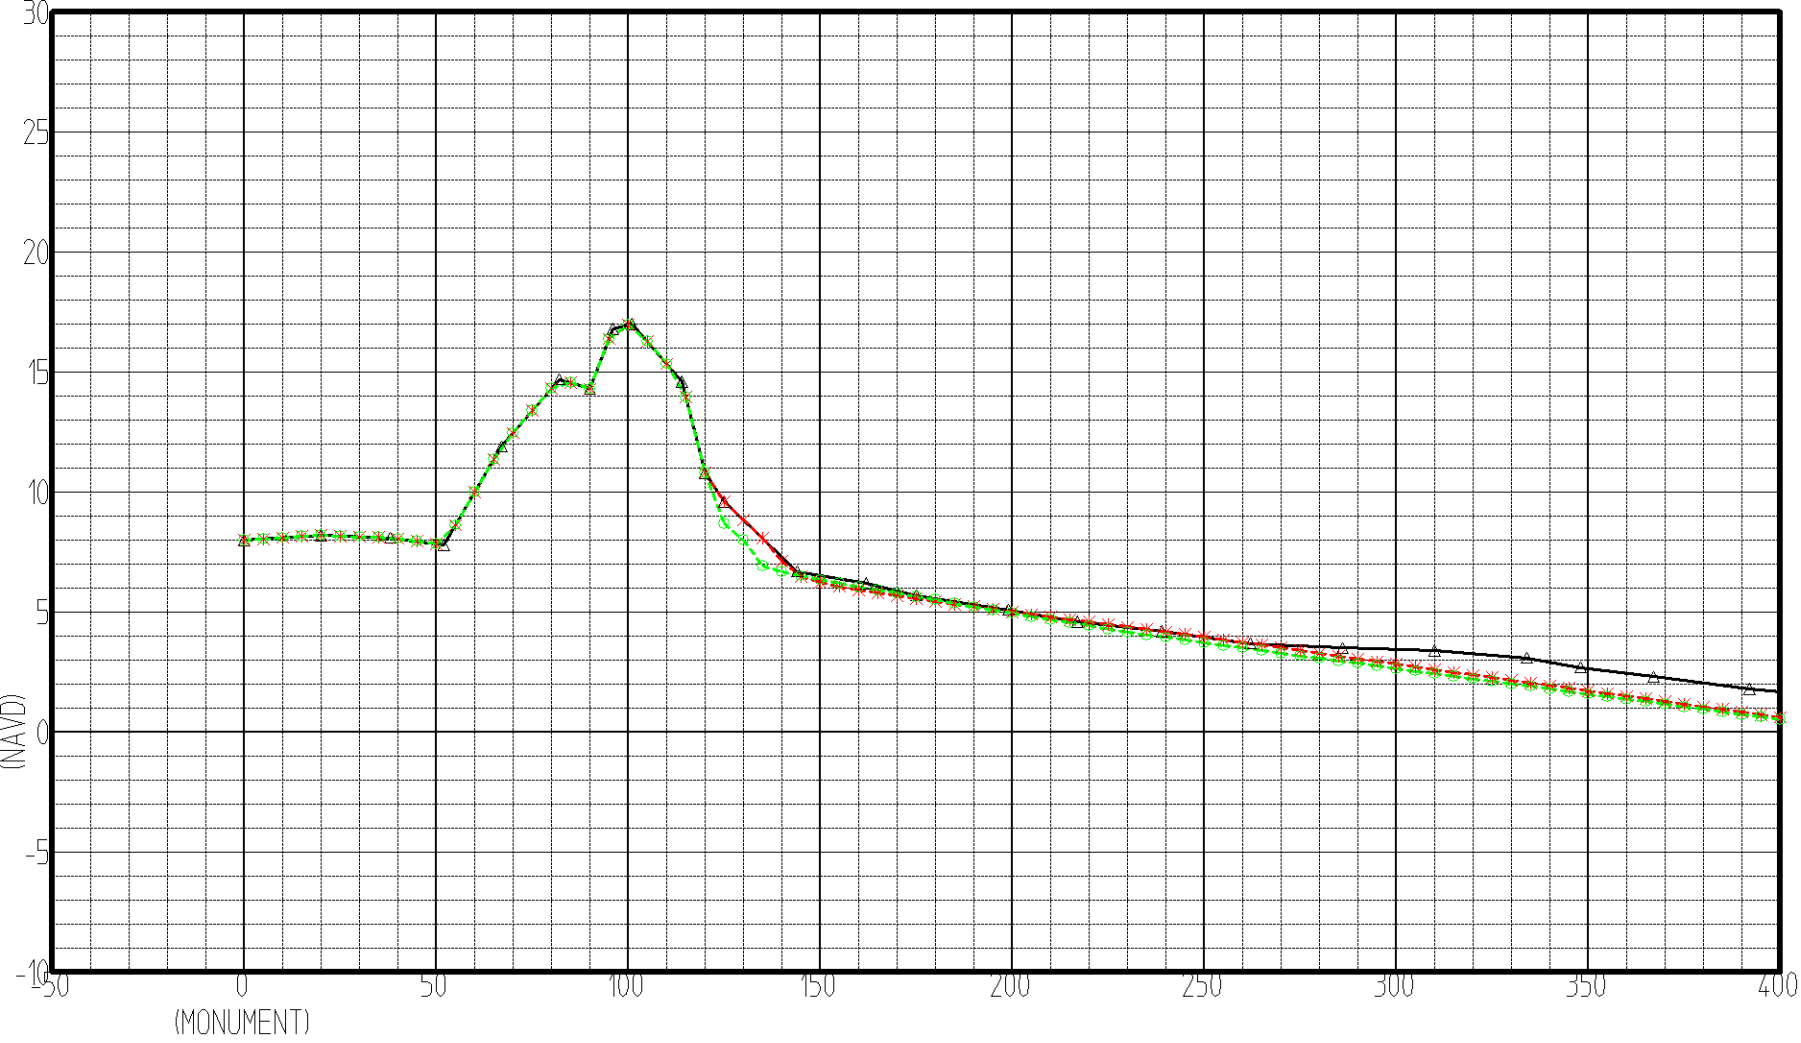
Range: R-155

BEACH PROFILE

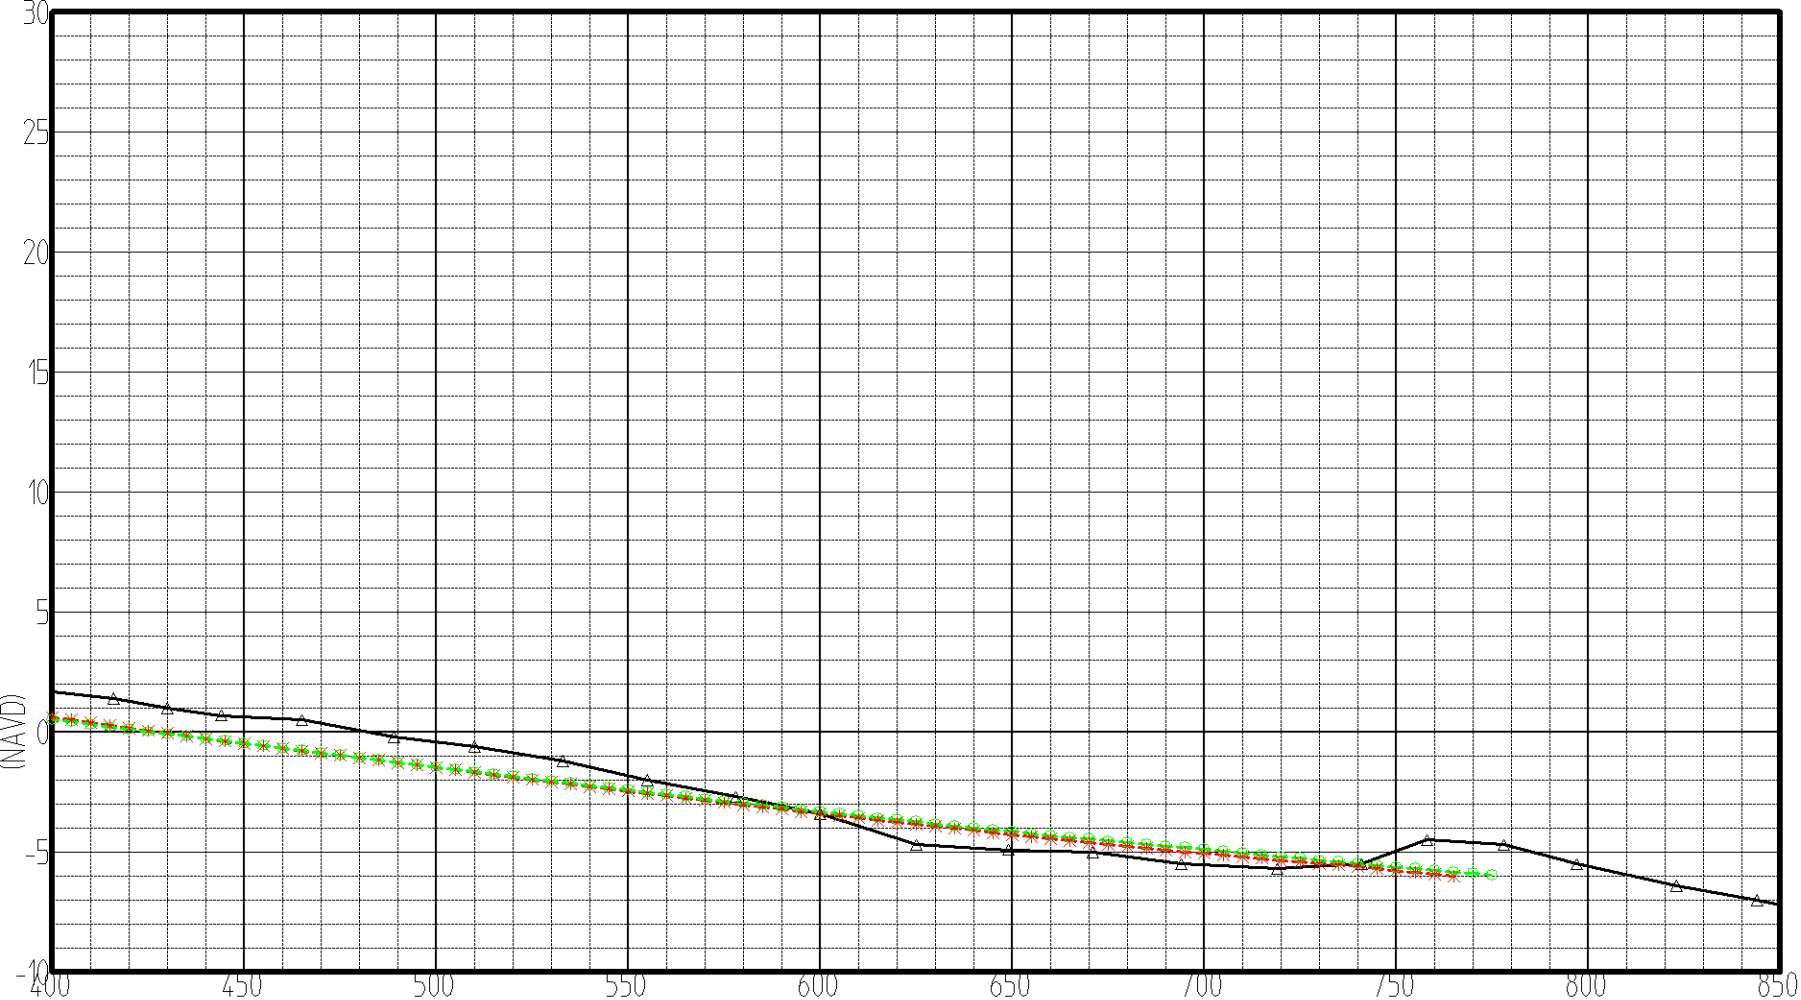
Range: R-155
 BEARING: 75.00
 2/3

BEACH PROFILE
 —△—△— ST. JOHNS 2007-2008 COMBI
 - - * - - - 15YR SBCH ERODED
 - - o - - - 25YR SBCH ERODED

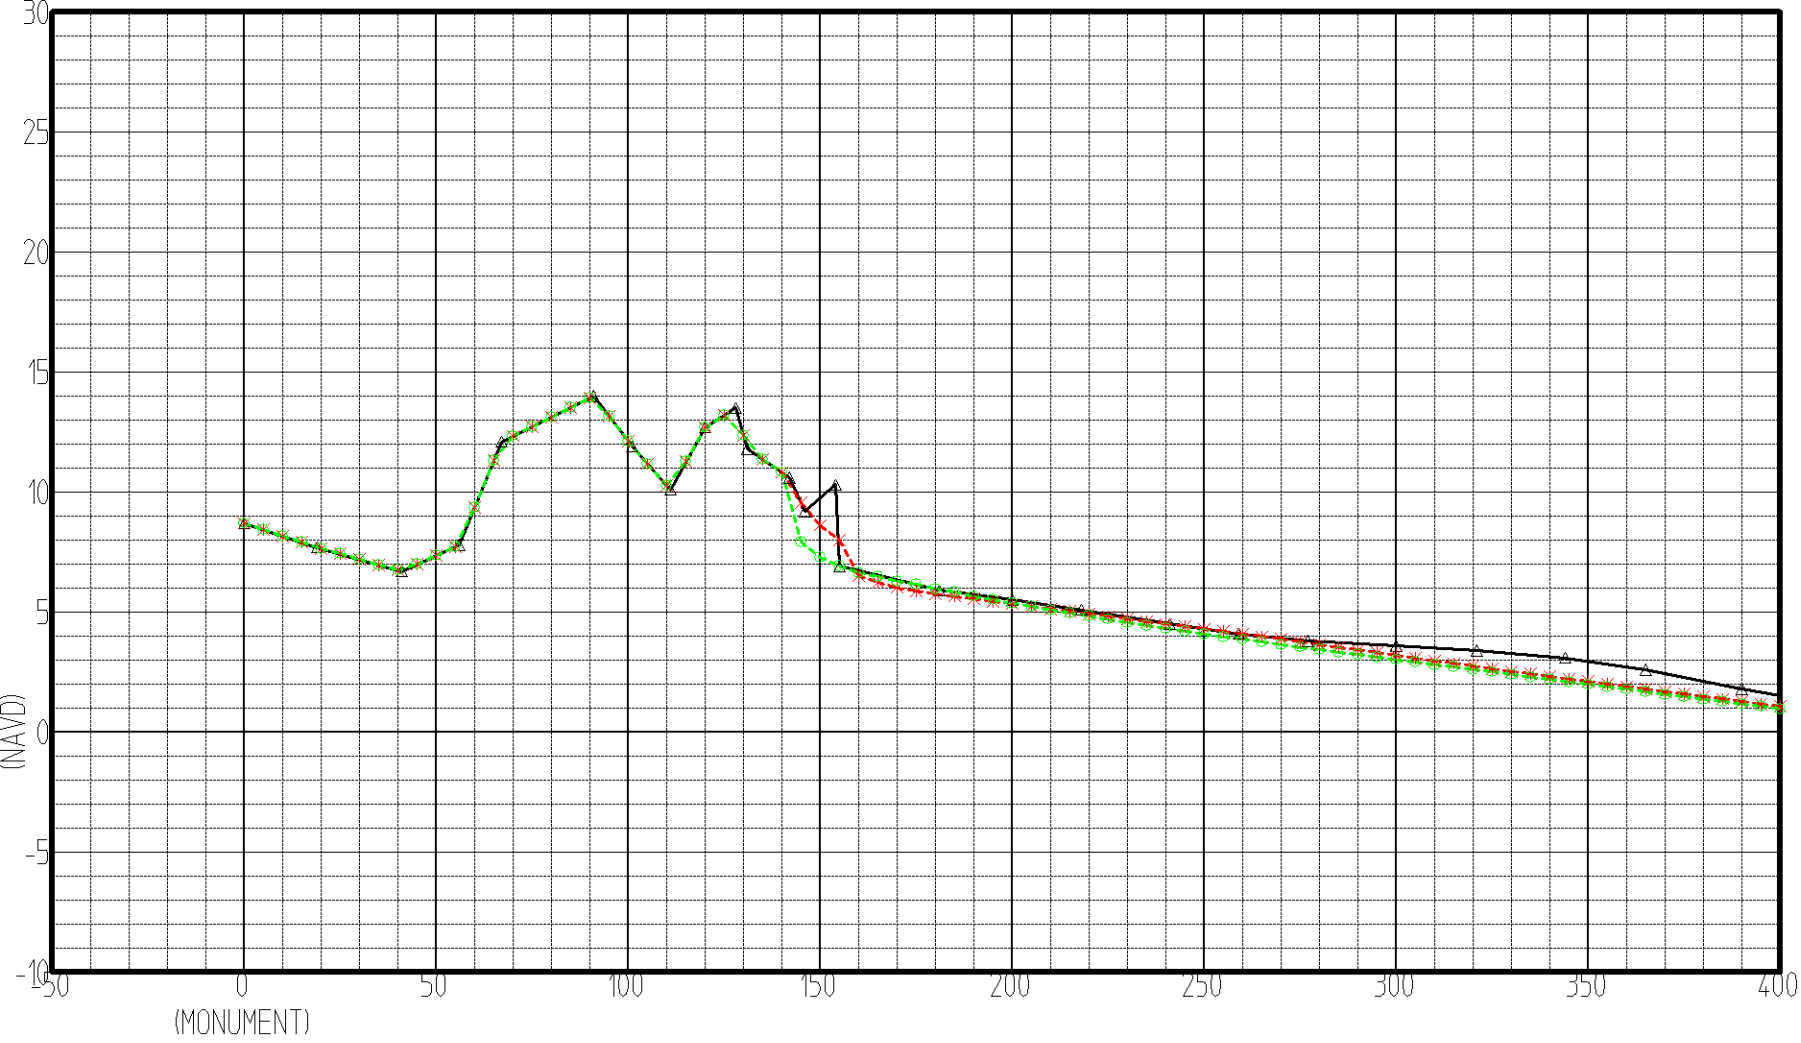
Range: T-156 1/3

BEACH PROFILE
