Appendix VIII

SBEACH 15 and 25 yr. Storm Erosion Profiles

St. Johns County

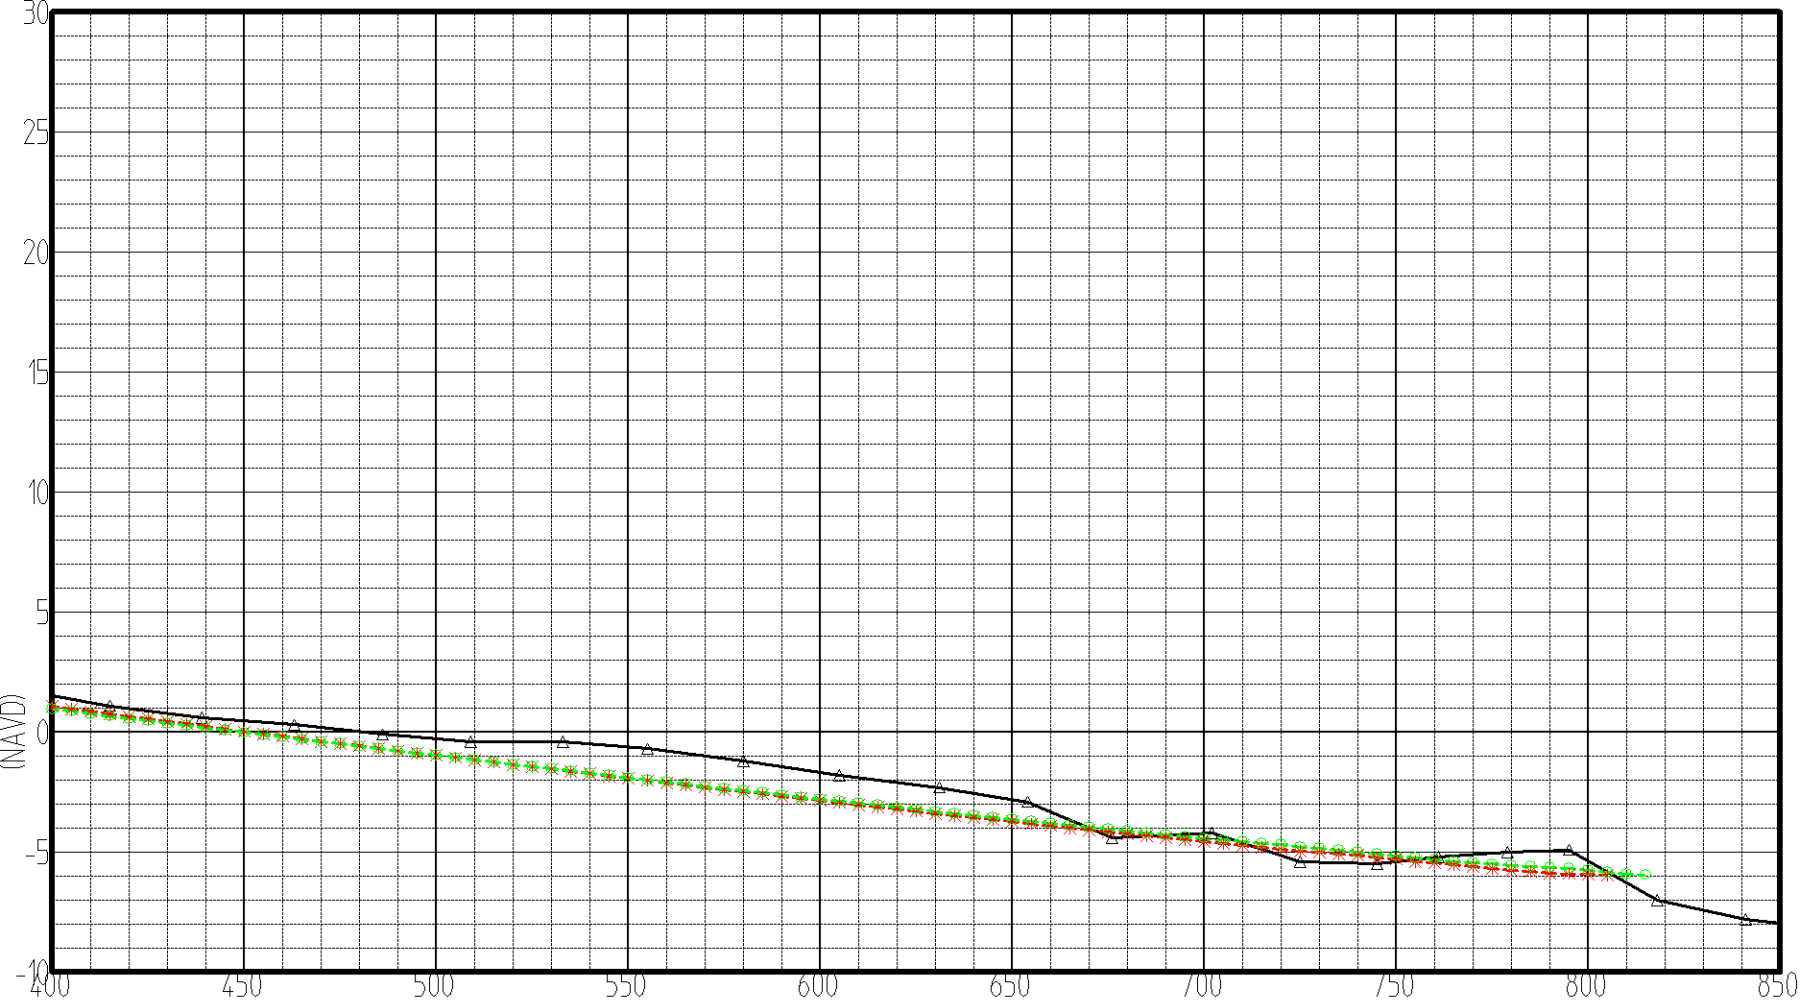
Range: T-156 2/3
 BEARING: 75.00

BEACH PROFILE
 —△—△— ST. JOHNS 2007-2008 COMBI
 - - * - - 15YR SBCH ERODED
 - - o - - 25YR SBCH ERODED

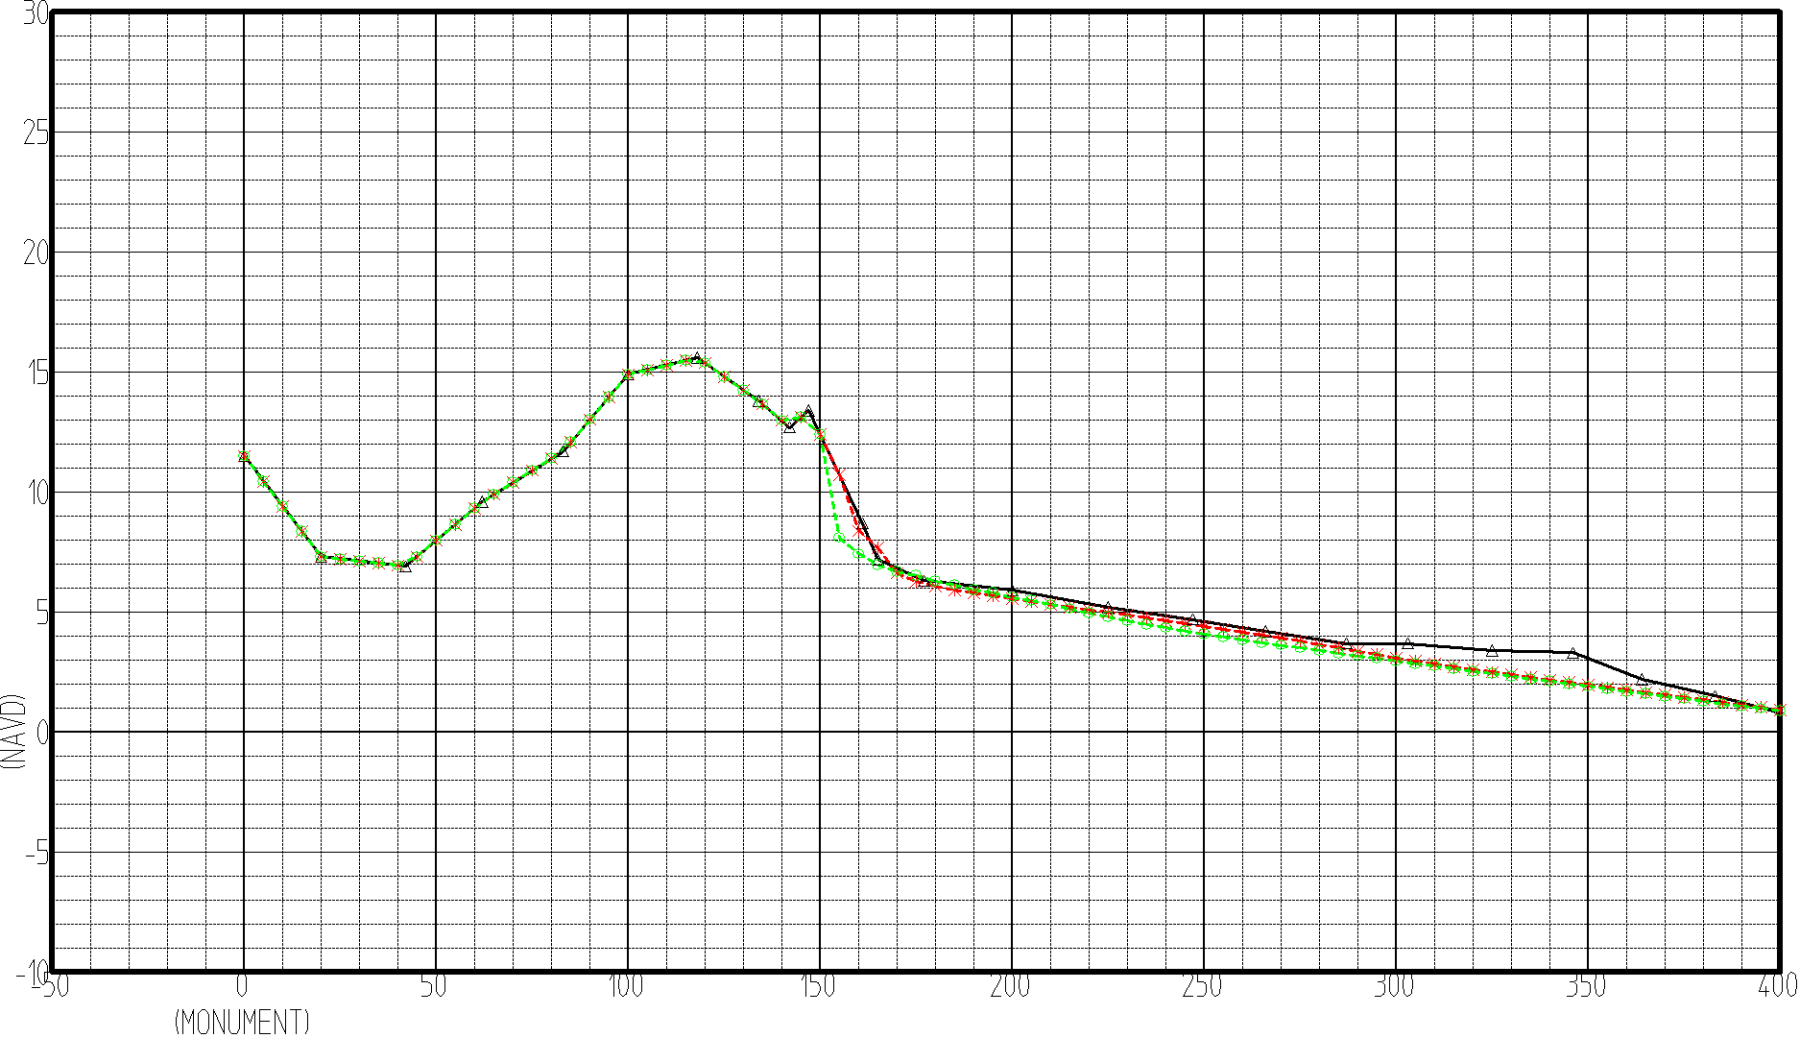
Range: T-157

BEACH PROFILE

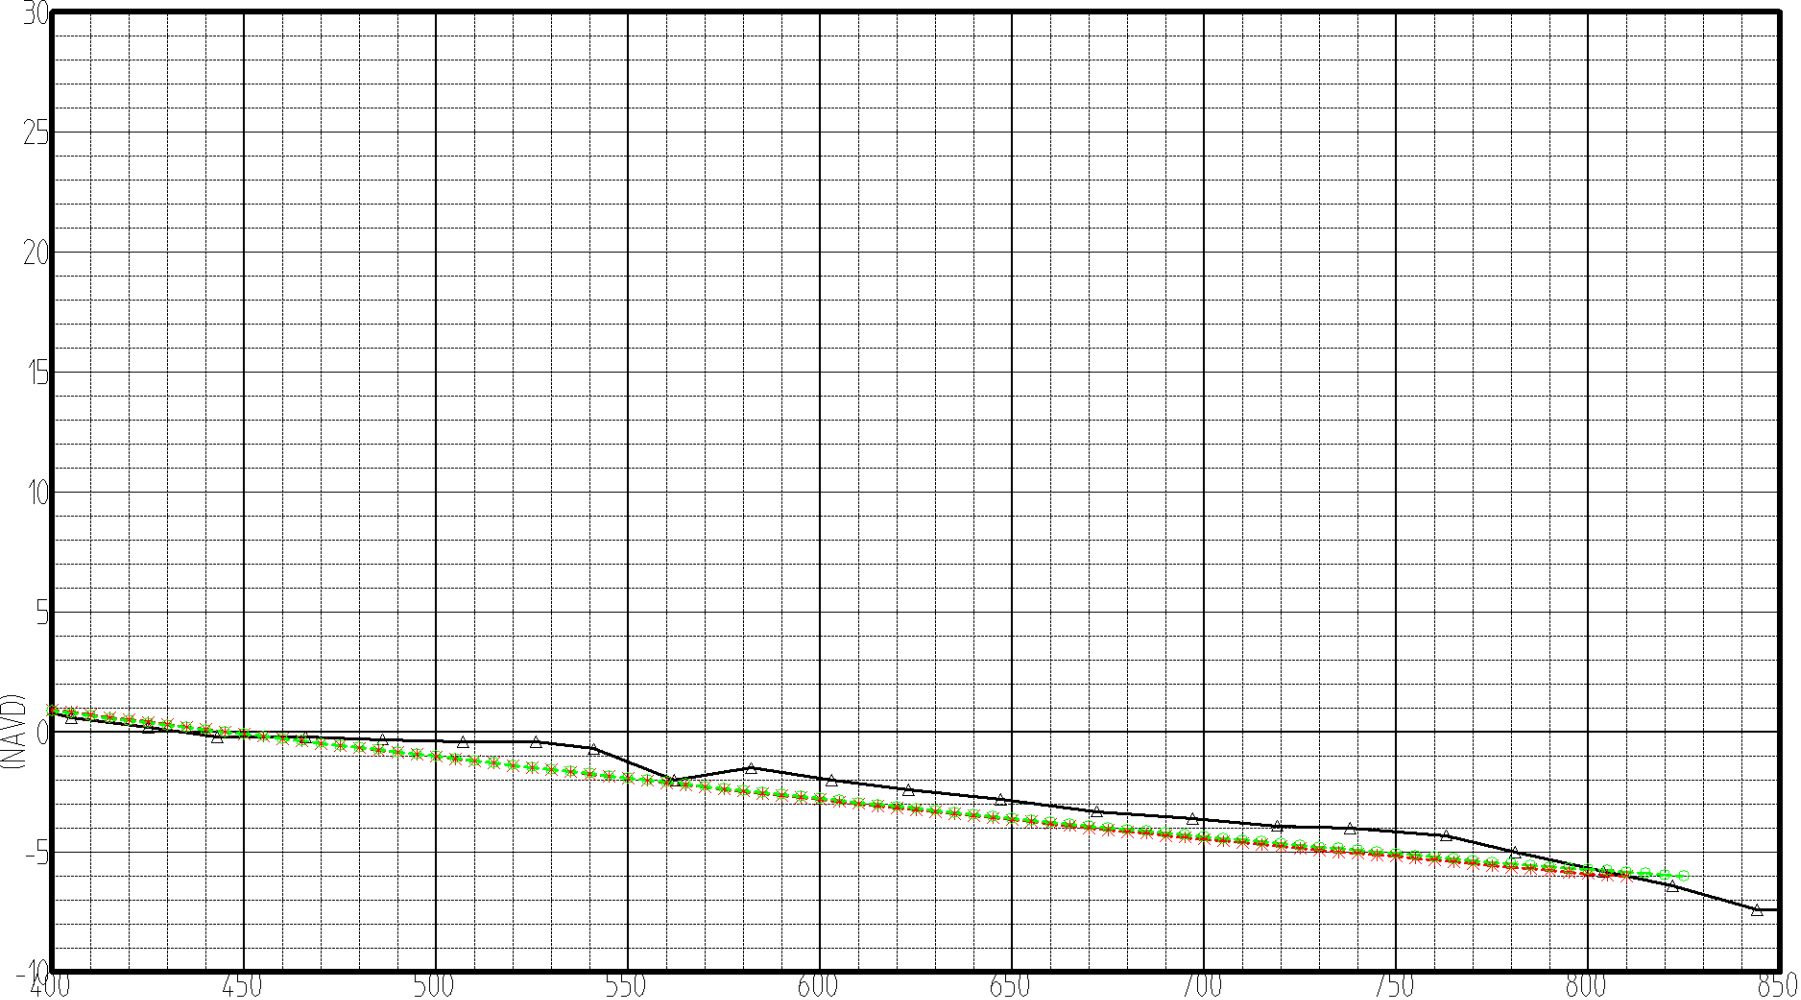
Range: T-157 2/3
 BEARING: 75.00

BEACH PROFILE
 —△—△— ST. JOHNS 2007-2008 COMBI
 - - * - - 15YR SBCH ERODED
 - - o - - 25YR SBCH ERODED

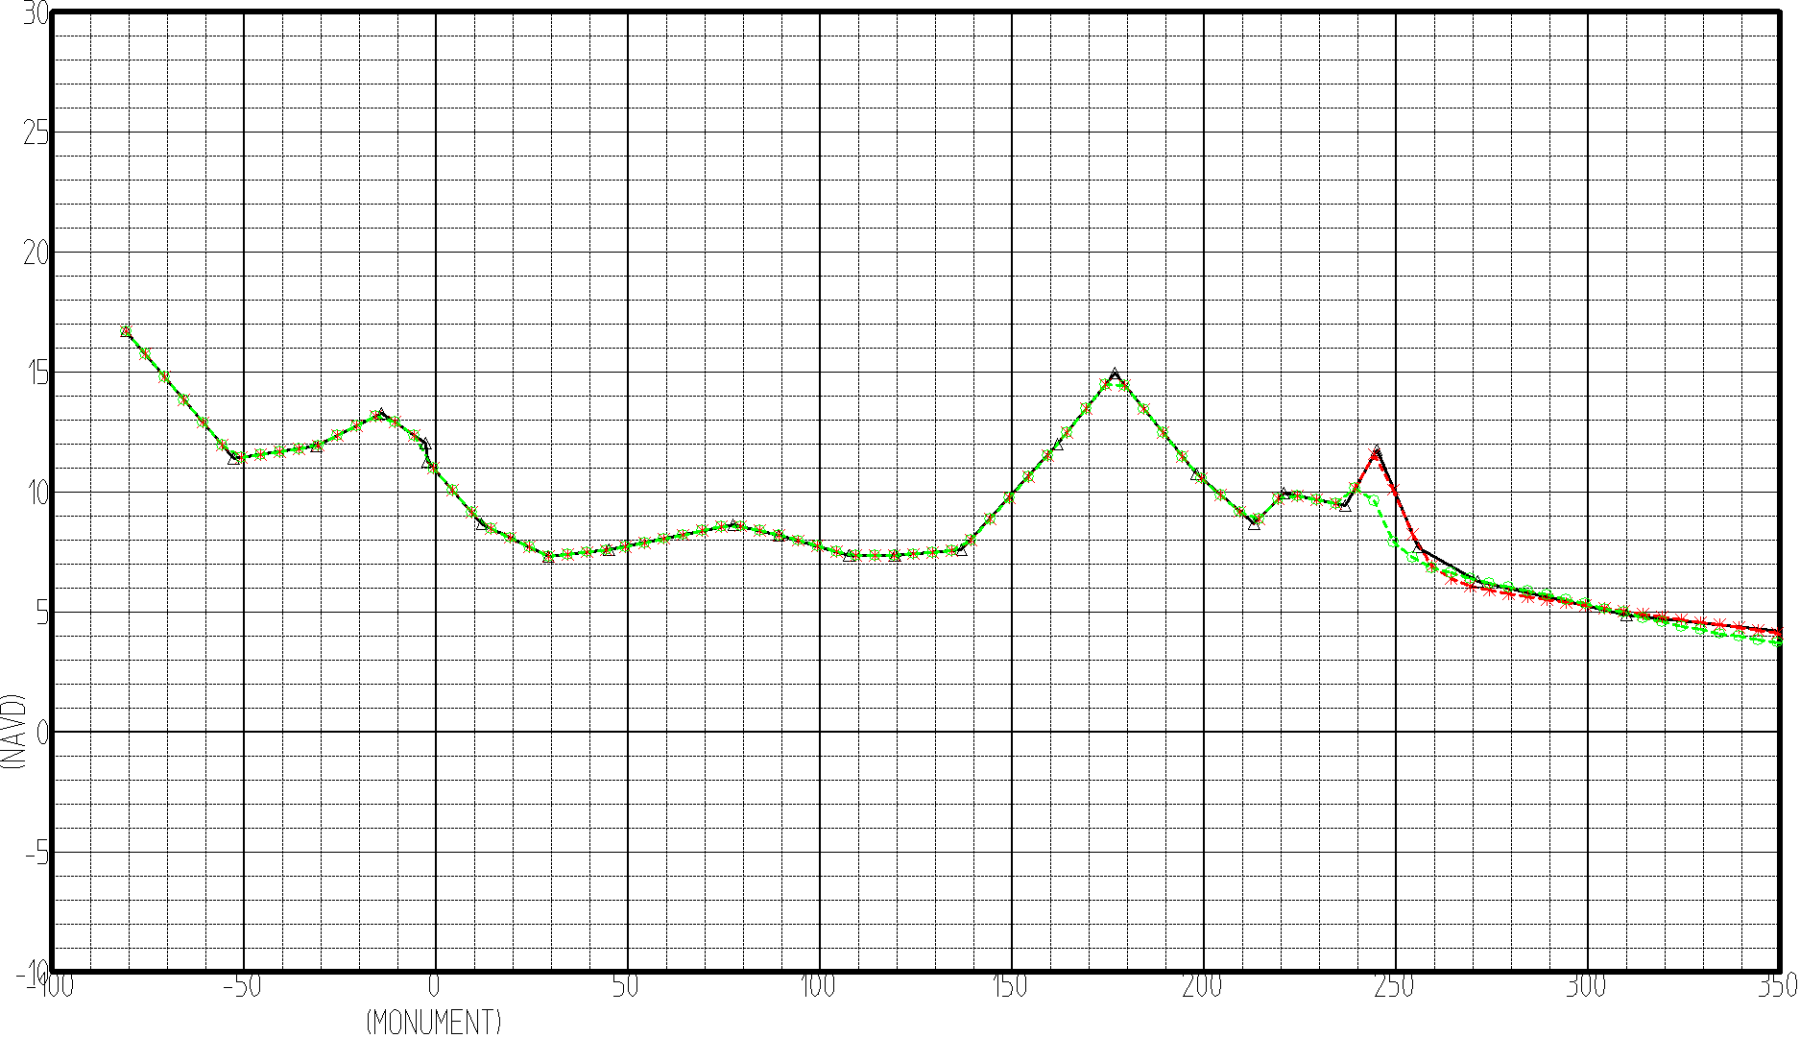
Range: R-158

BEACH PROFILE

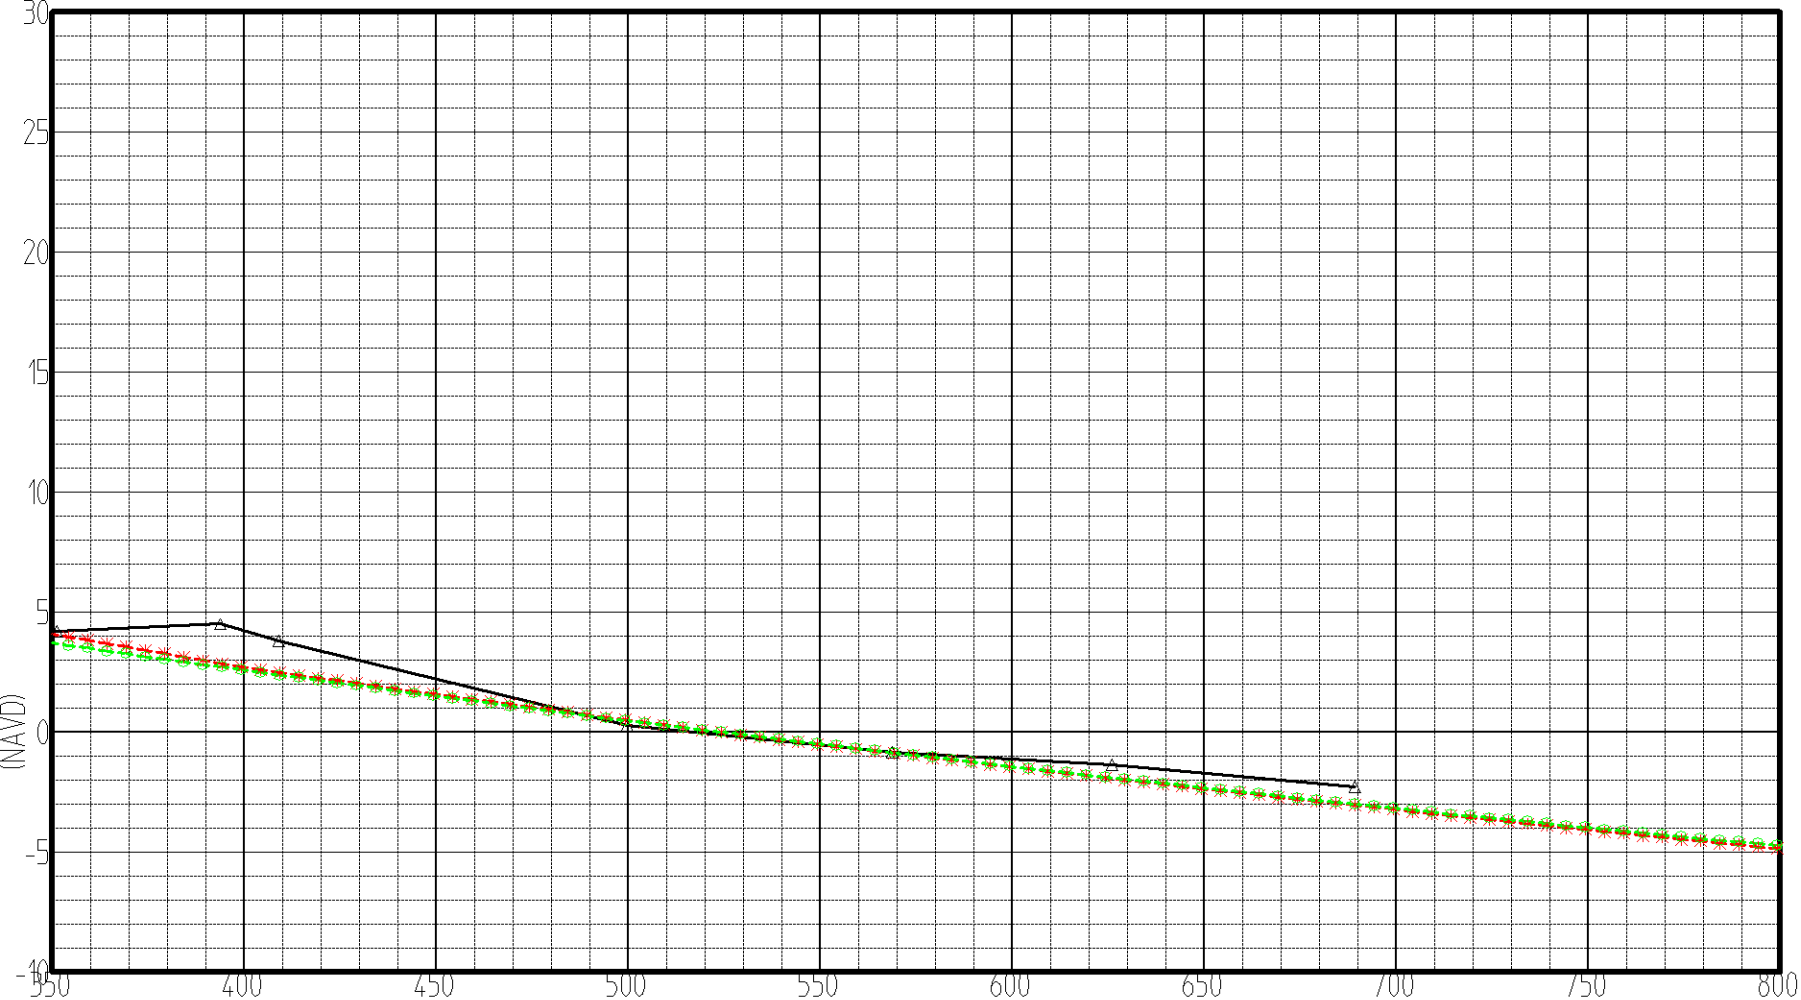
Range: R-158 2/3

—△—△— ST. JOHNS 2007-2008 COMBI
- - * - - * 15YR SBEACH ERODED
- - o - - o 25YR SBCH ERODED

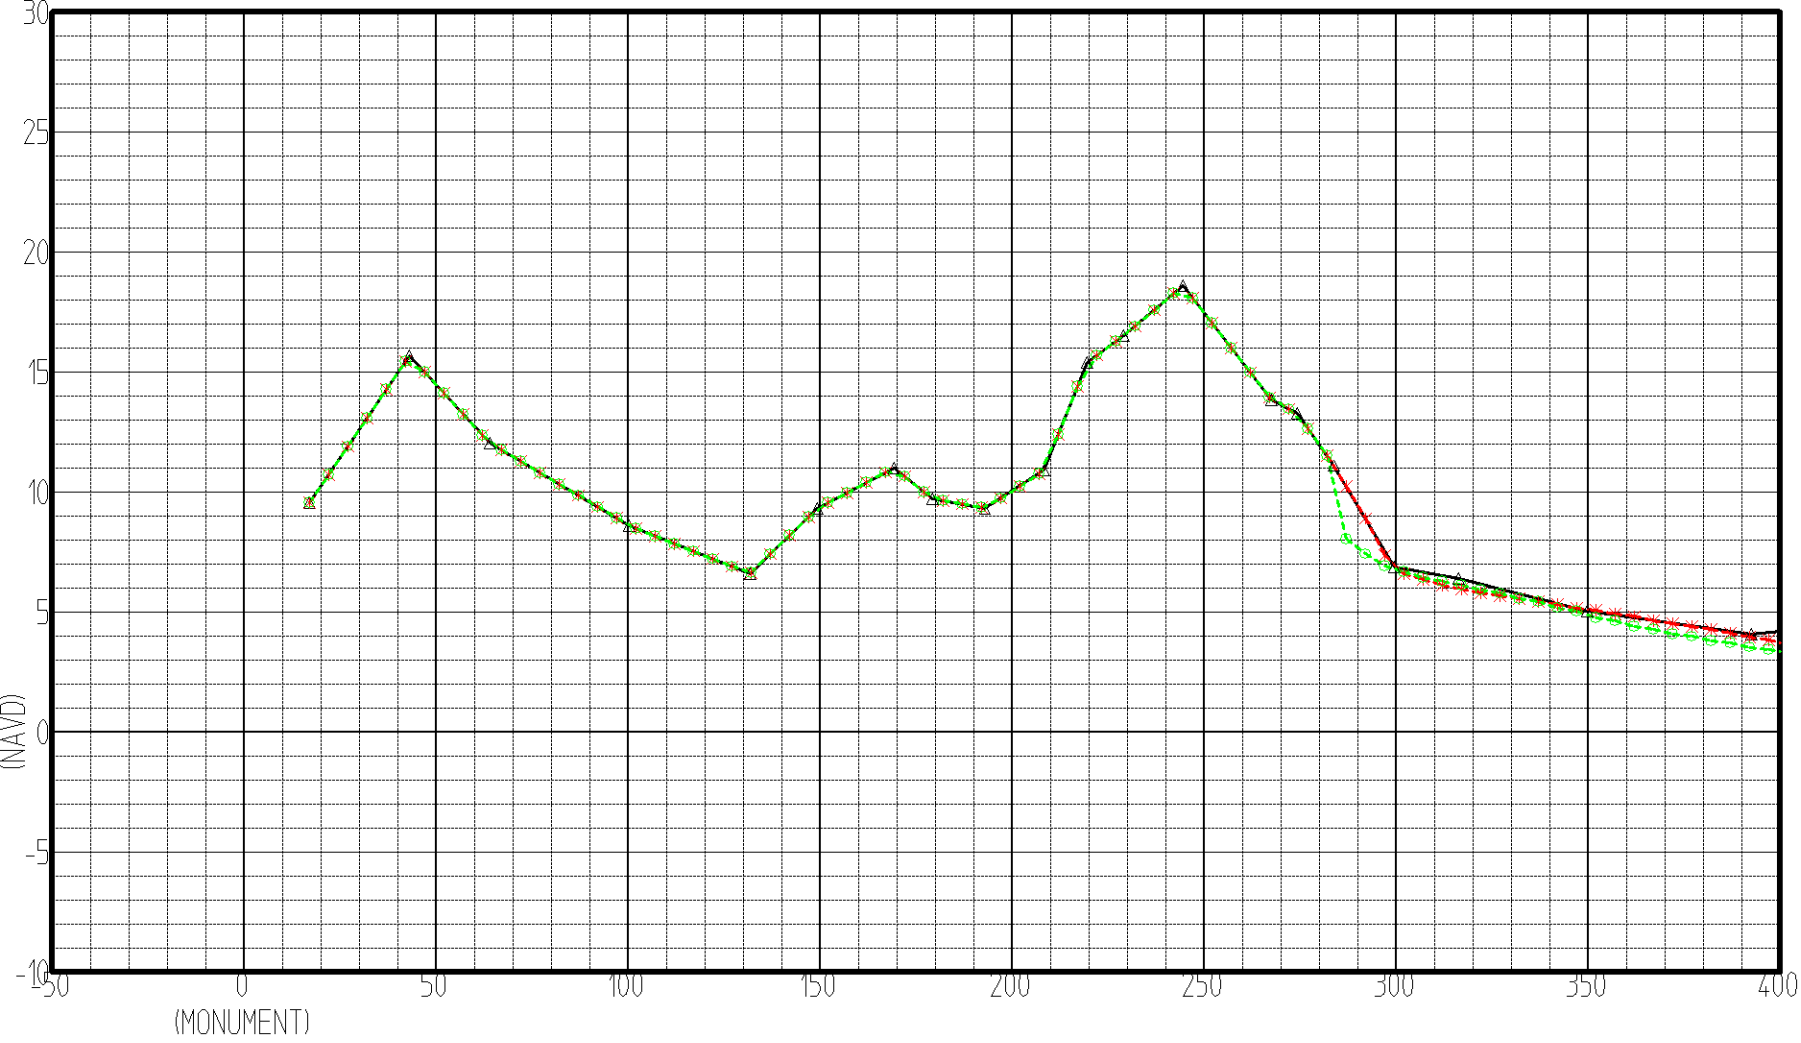
Range: T-159 1/3
 BEARING: 75.00

BEACH PROFILE
 —△—△— ST. JOHNS 2007-2008 COMBI
 - - * - - * - - 15YR SBEACH ERODED
 - - o - - o - - 25YR SBCH ERODED

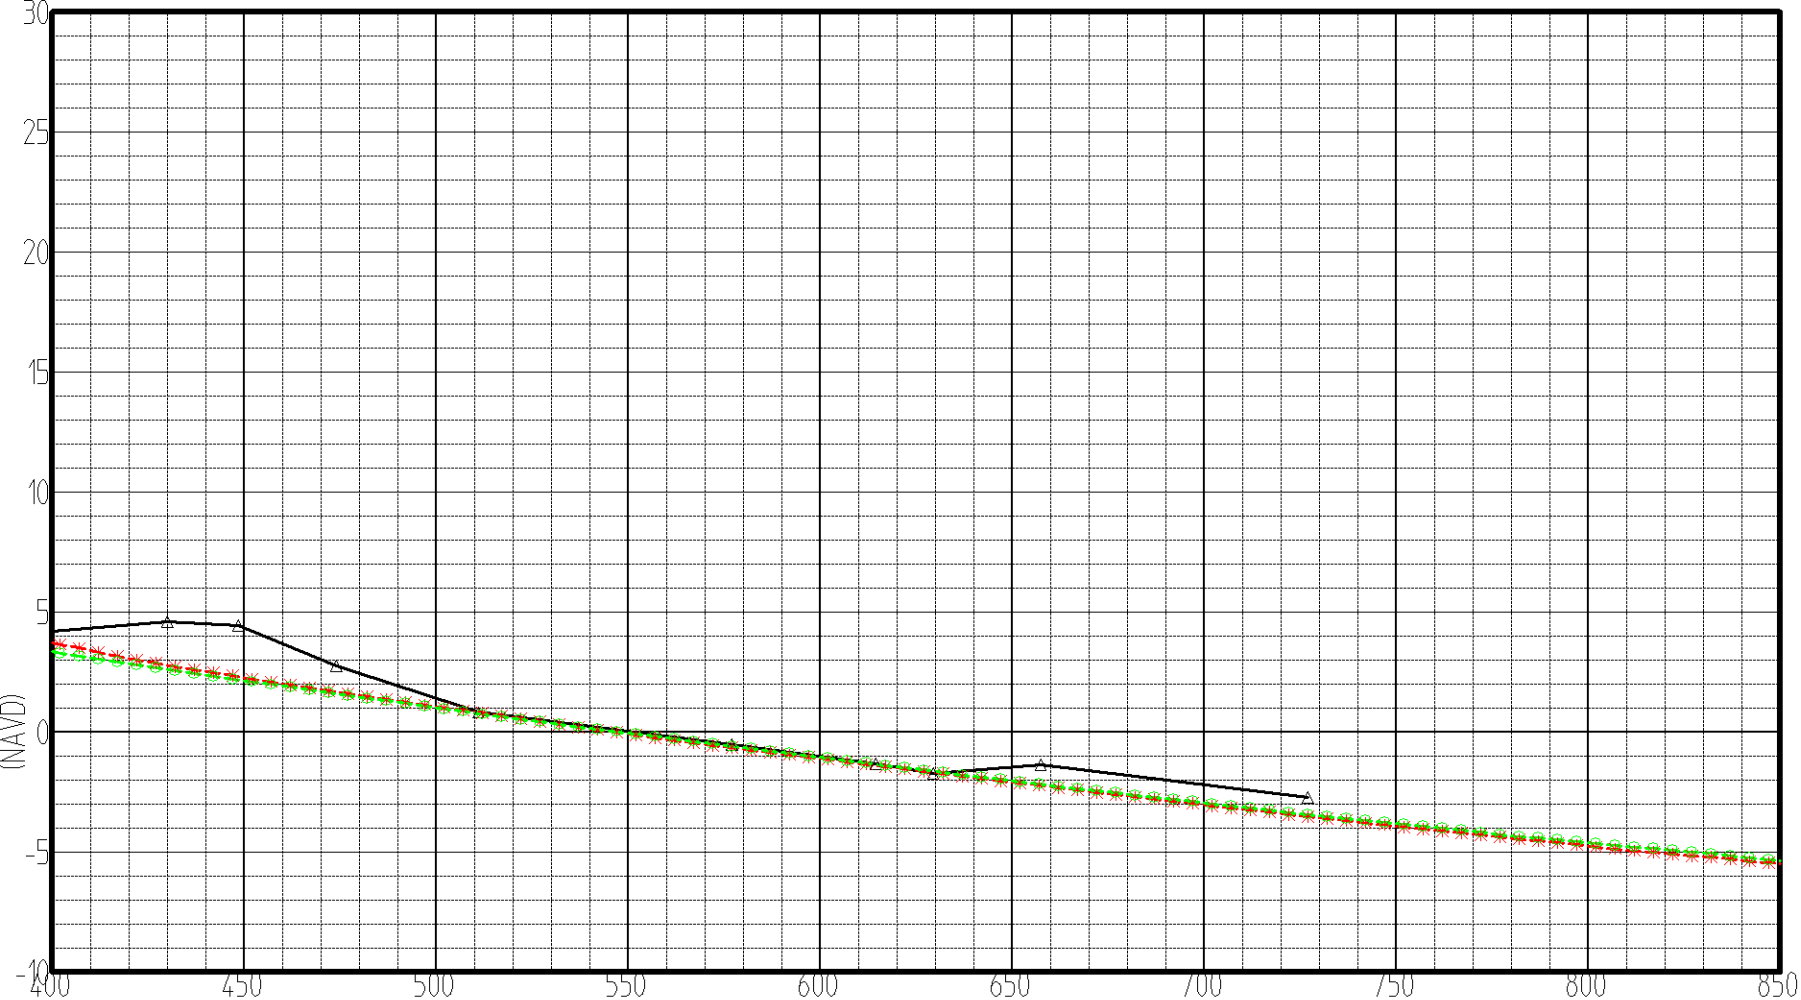
Range: T-159 2/3
 BEARING: 75.00

BEACH PROFILE
 —△—△— ST. JOHNS 2007-2008 COMBI
 - - * - - 15YR SBEACH ERODED
 - - o - - 25YR SBCH ERODED

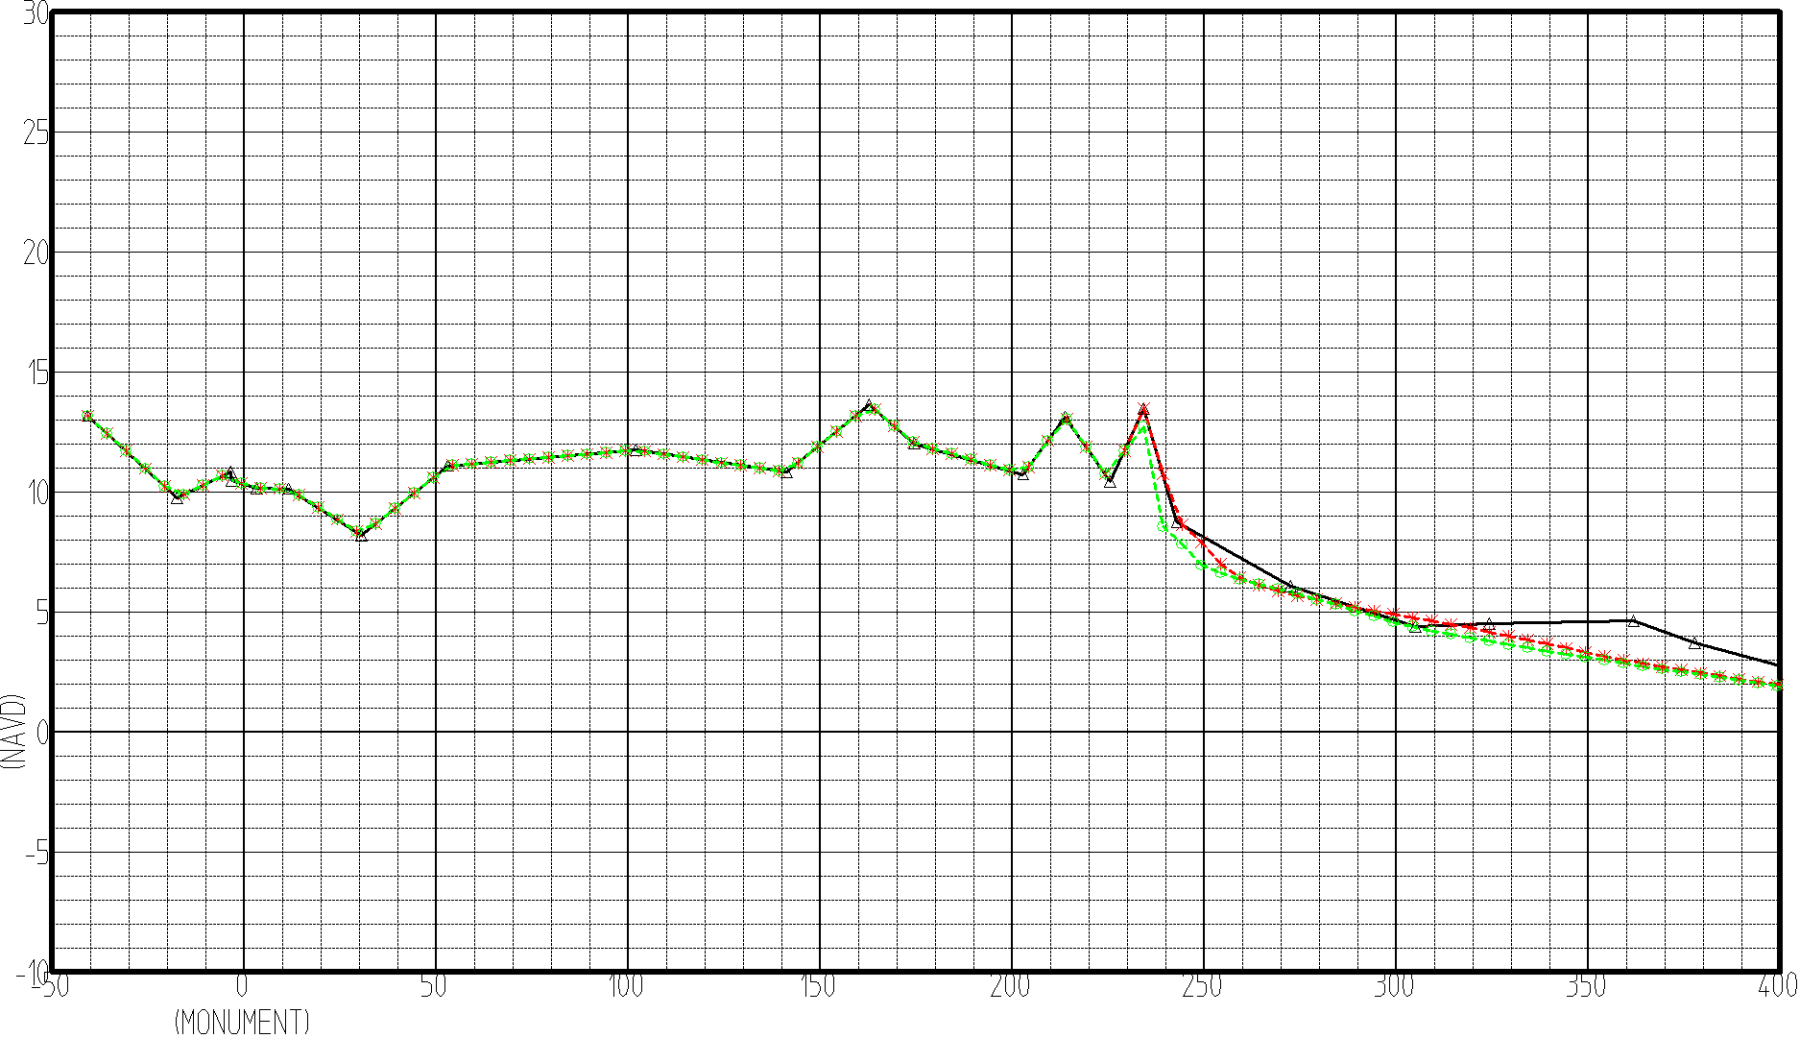
Range: R-160
 BEARING: 75.00
 1/2

BEACH PROFILE
 —△—△— ST. JOHNS 2007-2008 COMBI
 - - * - - 15YR SBCH ERODED
 - - o - - 25YR SBCH ERODED

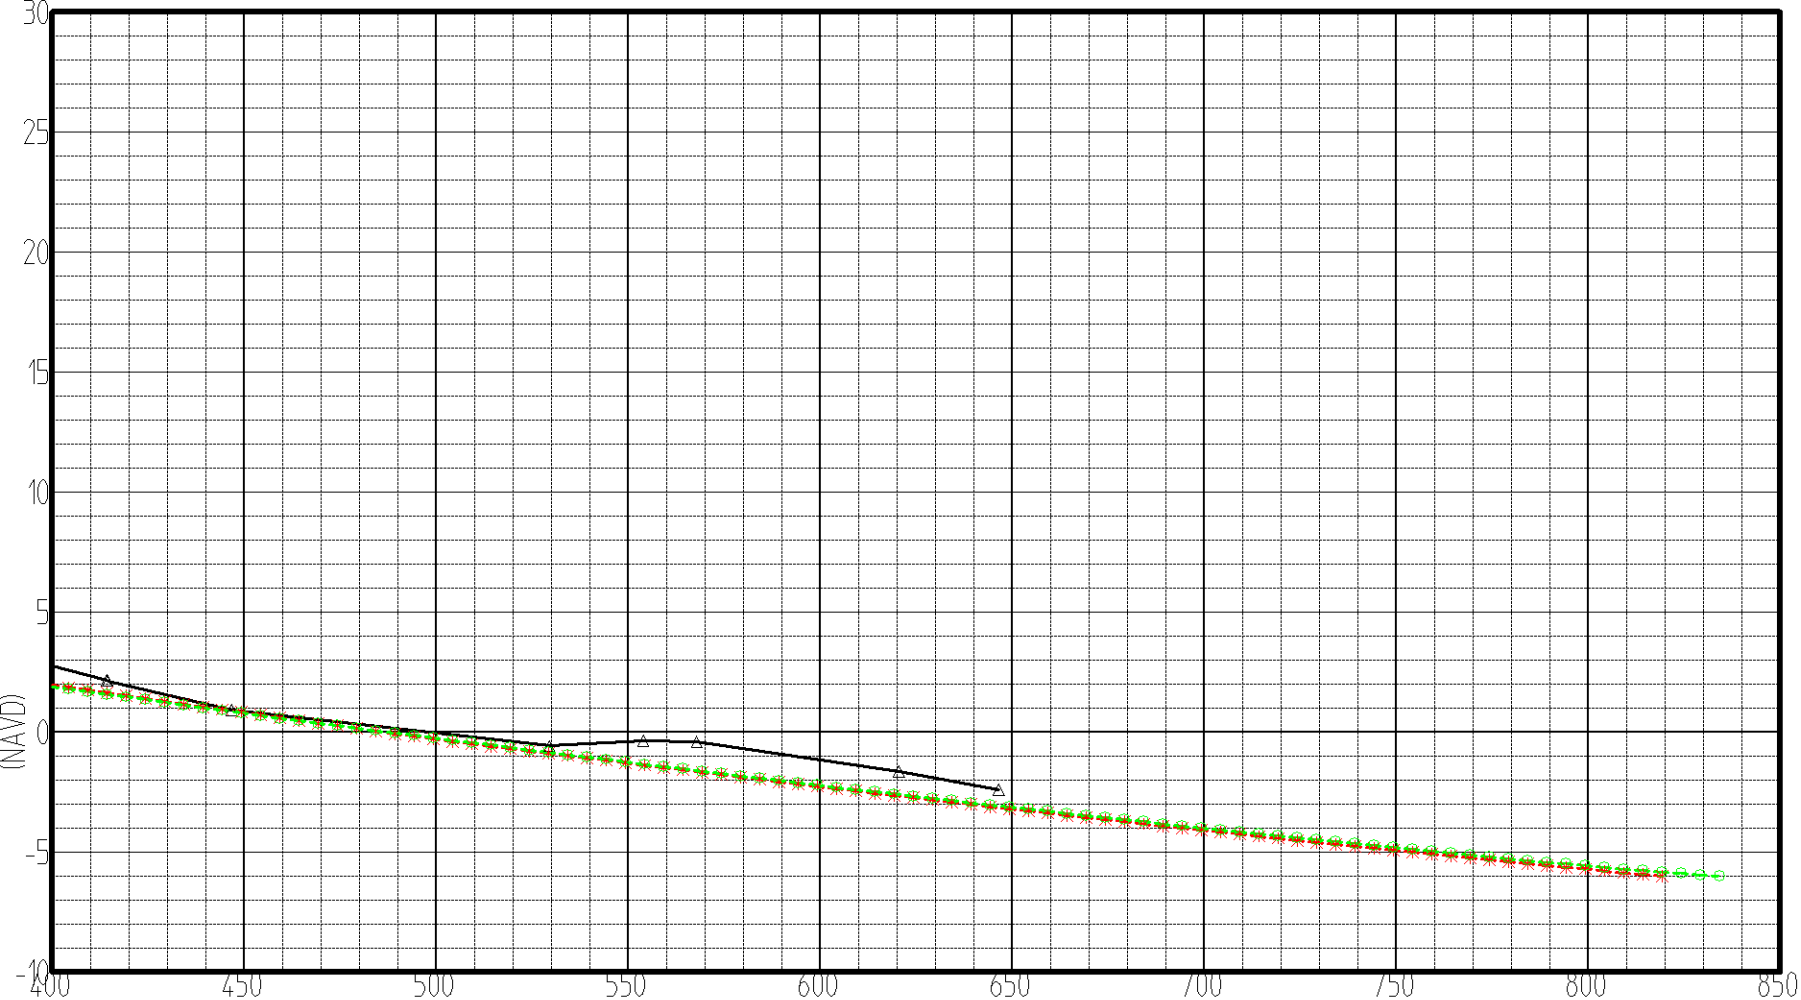
Range: R-160

BEACH PROFILE

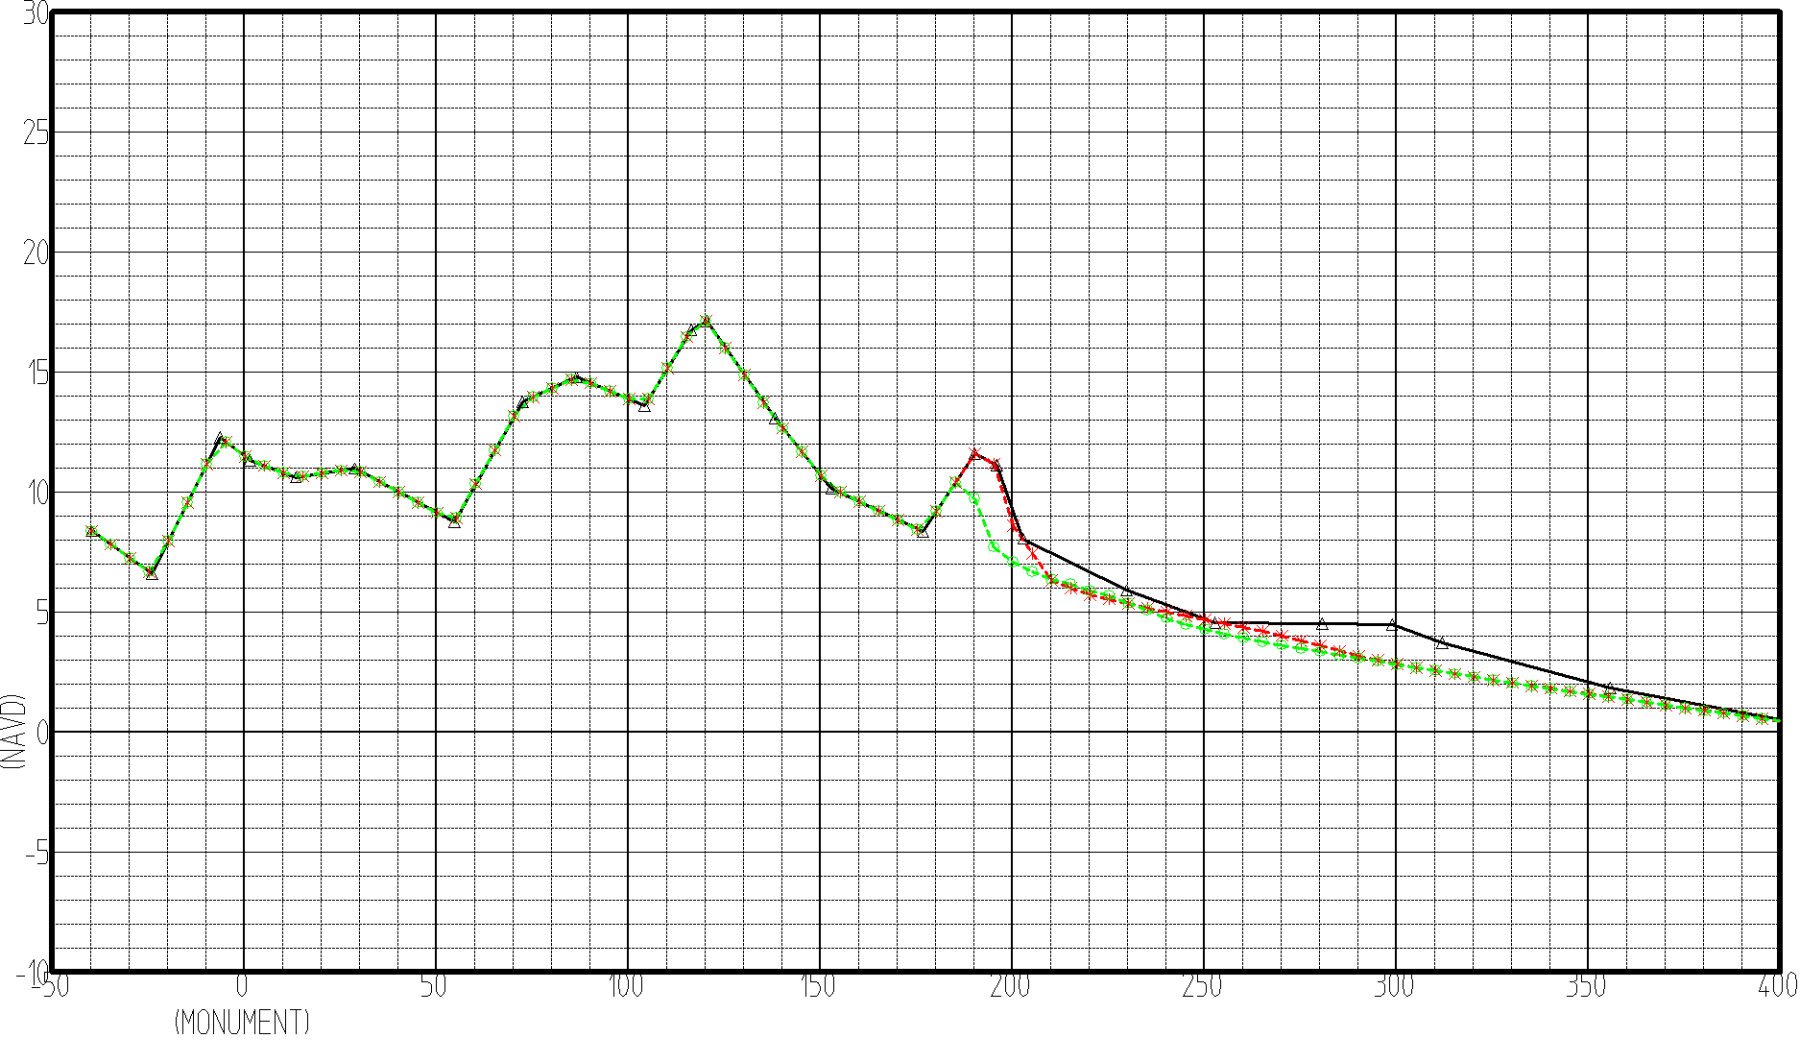
Range: T-161 1/2
 BEARING: 75.00

BEACH PROFILE
 —△—△— ST. JOHNS 2007-2008 COMBI
 - - * - - * - - 15YR SBEACH ERODED
 - - o - - o - - 25YR SBCH ERODED

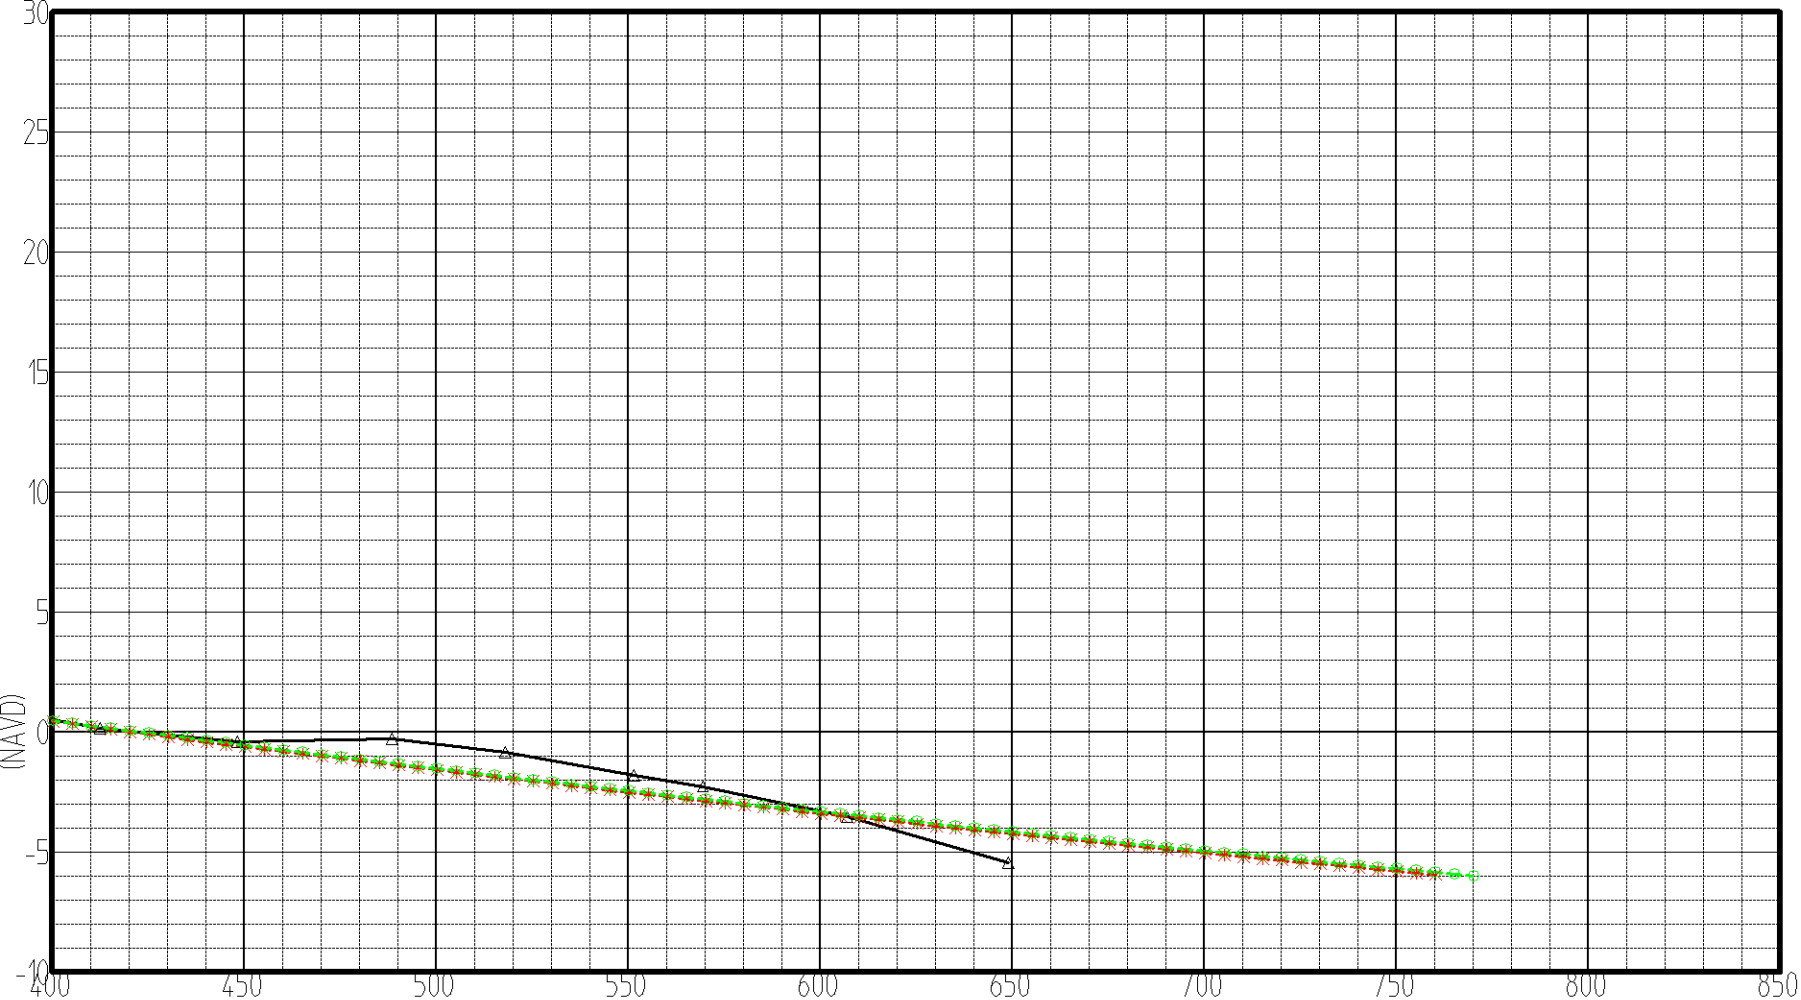
Range: T-161 2/2
 BEARING: 75.00

BEACH PROFILE
 —△—△— ST. JOHNS 2007-2008 COMBI
 - - * - - 15YR SBEACH ERODED
 - - o - - 25YR SBCH ERODED

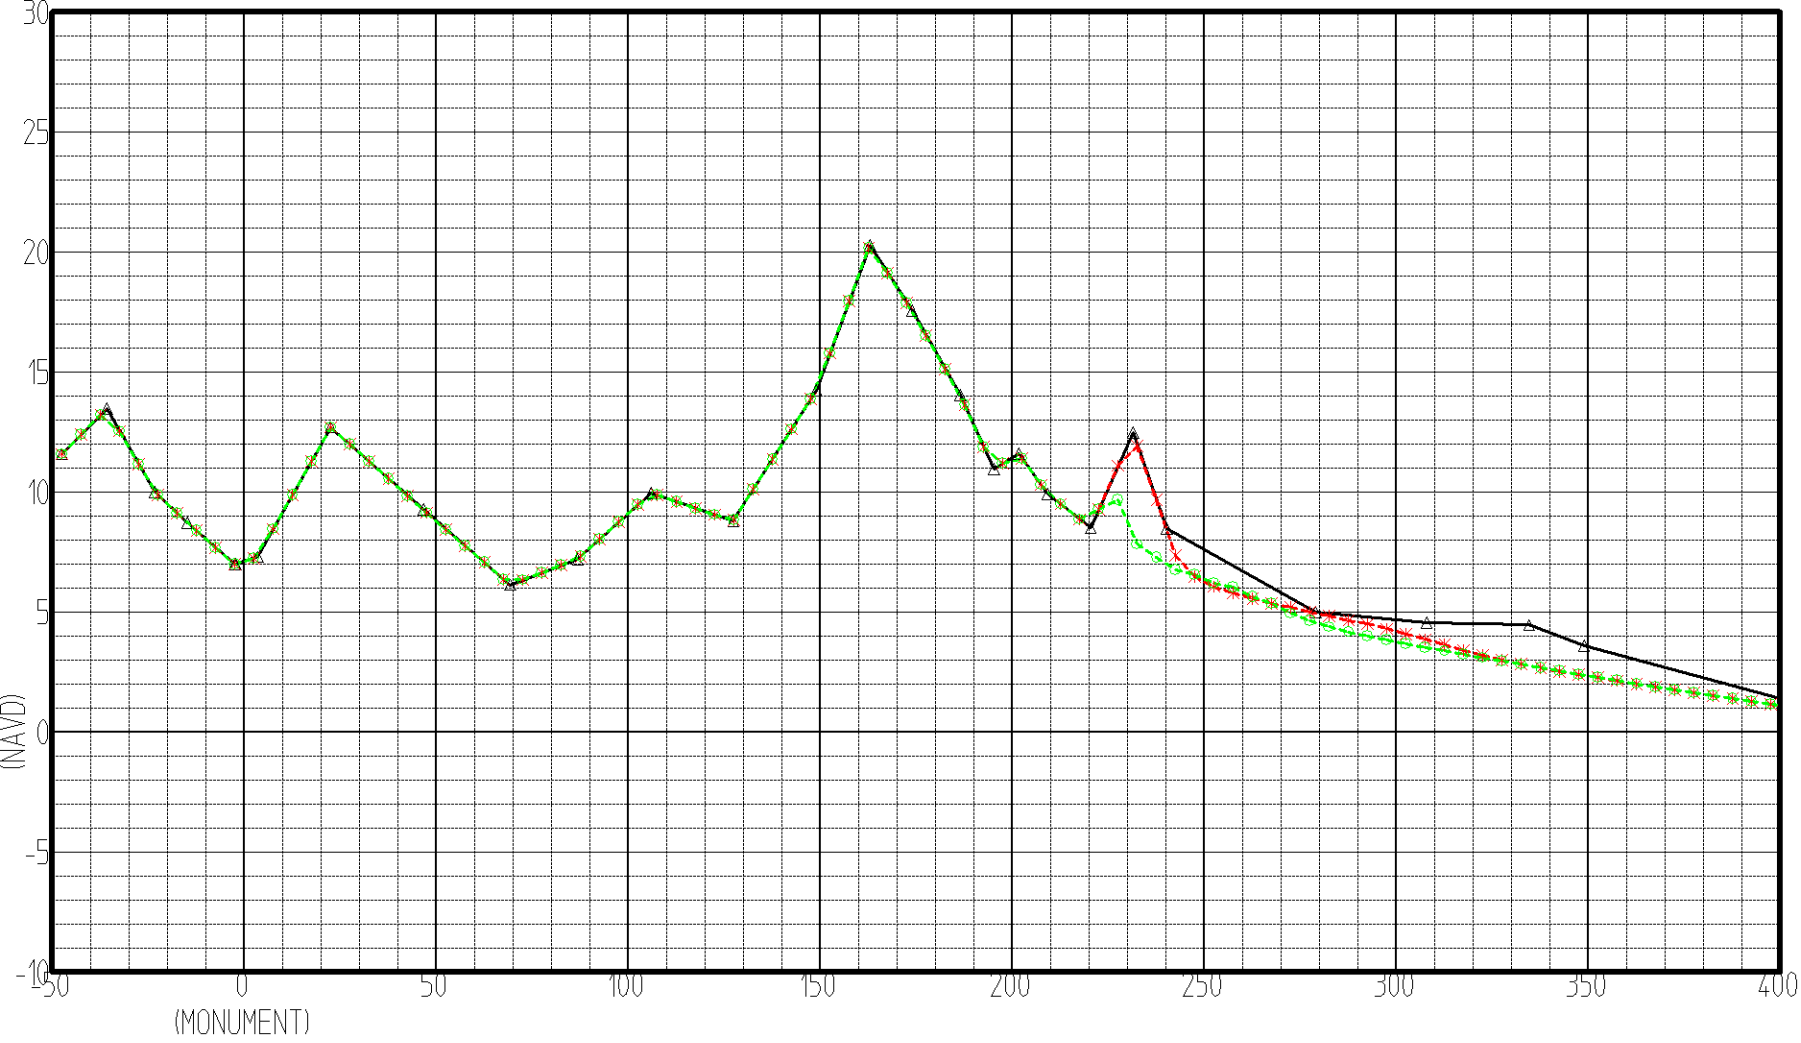
Range: R-162
 BEARING: 75.00
 1/2

BEACH PROFILE
 —△—△— ST. JOHNS 2007-2008 COMBI
 - - * - - * - - 15YR SBEACH ERODED
 - - o - - o - - 25YR SBCH ERODED
