Appendix VIII

SBEACH 15 and 25 yr. Storm Erosion Profiles

St. Johns County

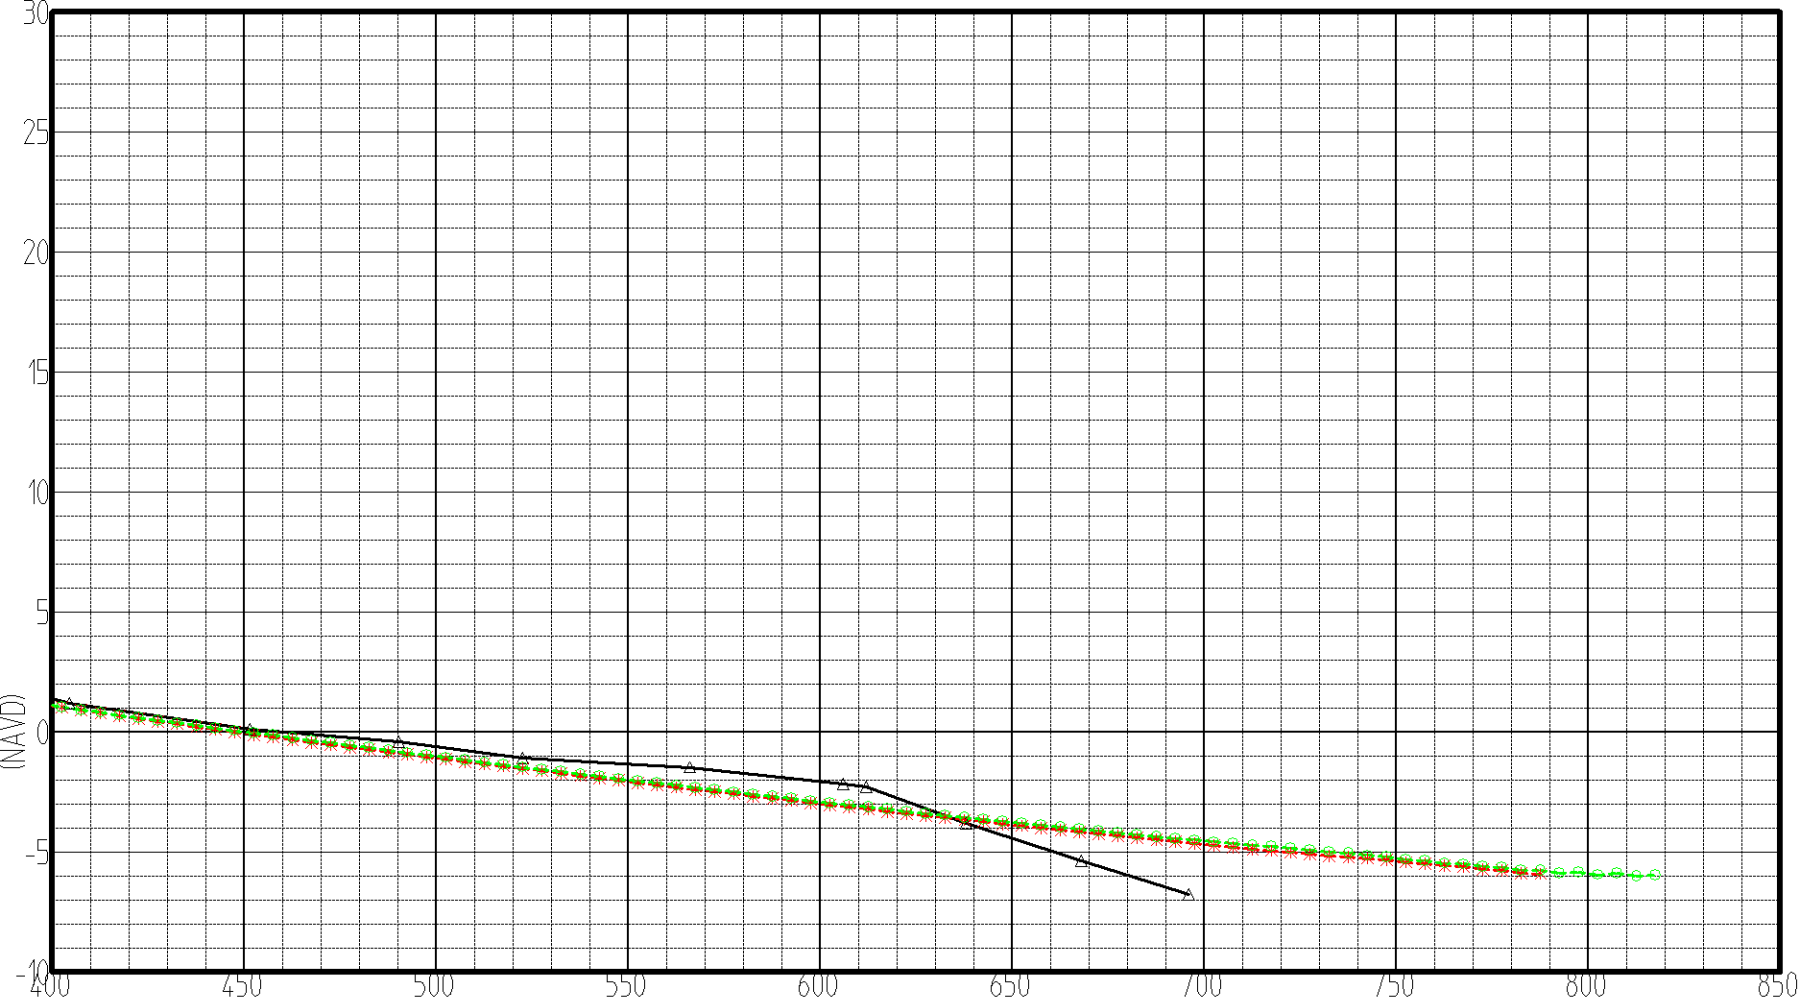
Range: R-162
 BEARING: 75.00
 2/2

BEACH PROFILE
 —△—△— ST. JOHNS 2007-2018 COMBI
 - - * - - 15YR SBEACH ERODED
 - - o - - 25YR SBCH ERODED

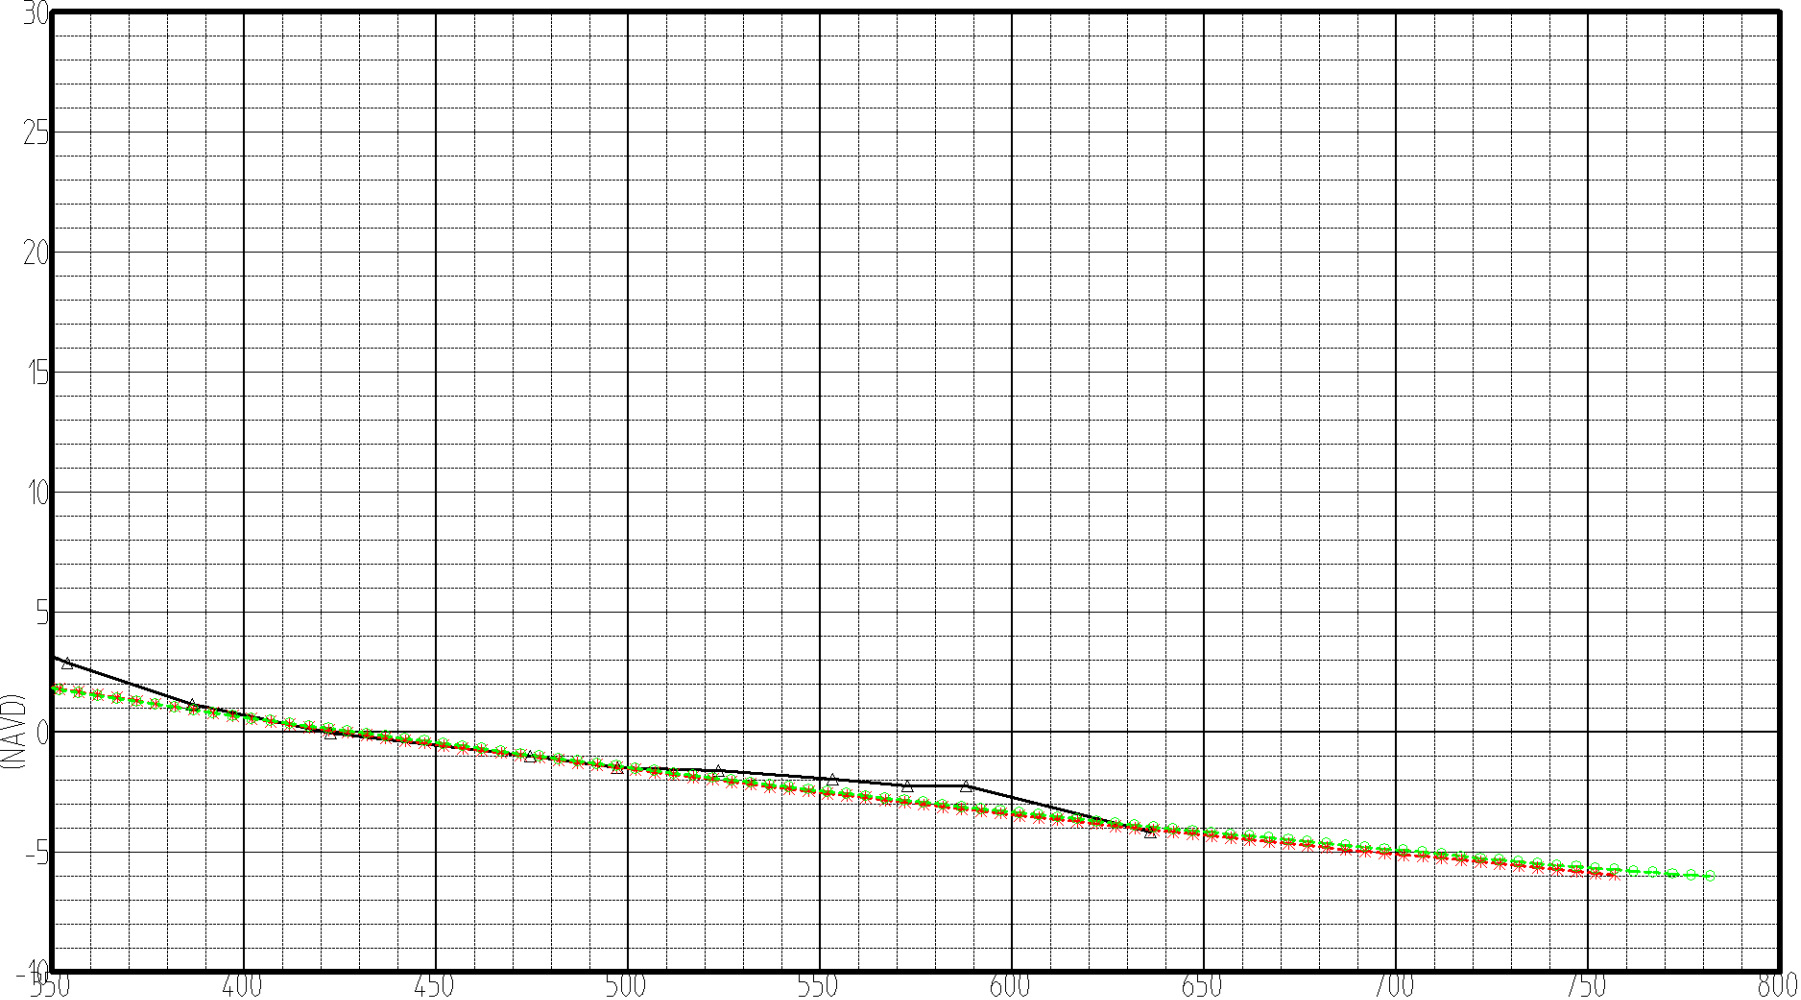
Range: R-163
 BEARING: 75.00
 2/2

BEACH PROFILE
 —△—△— ST. JOHNS 2007-2008 COMBI
 - - * - - 15YR SBEACH ERODED
 - - o - - 25YR SBCH ERODED

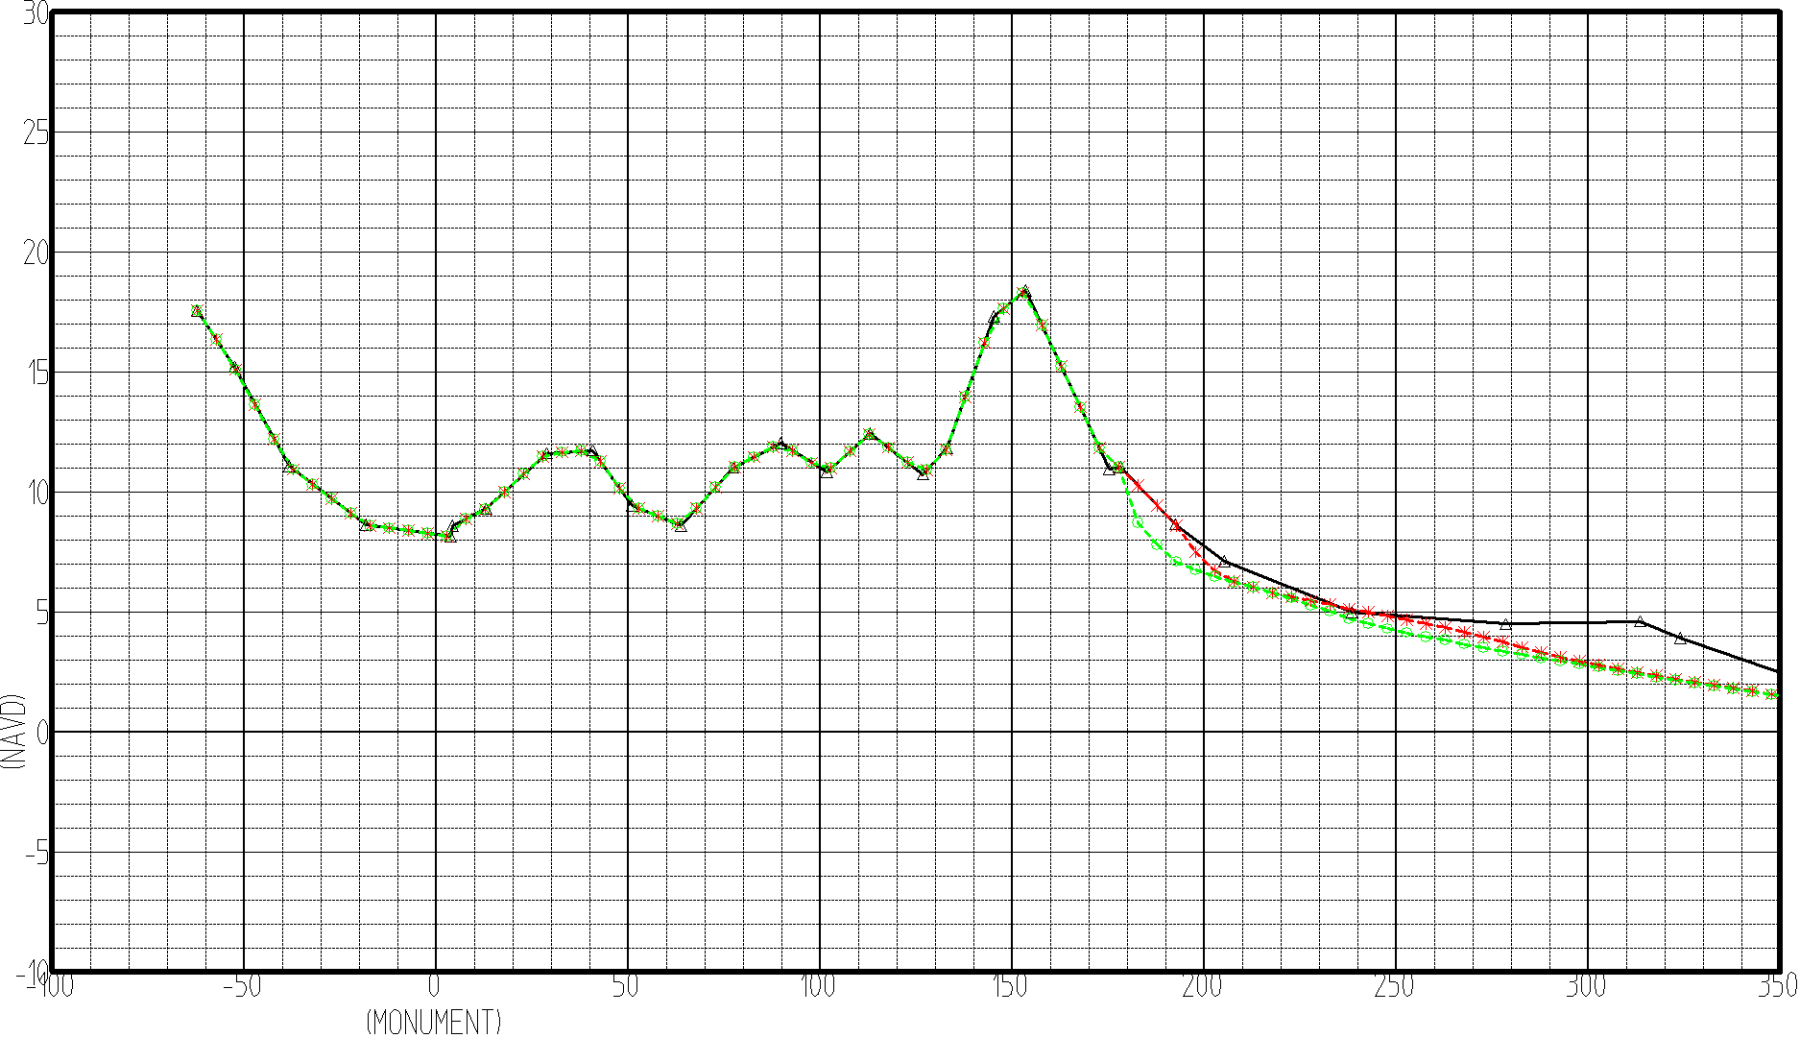
Range: R-164

BEACH PROFILE

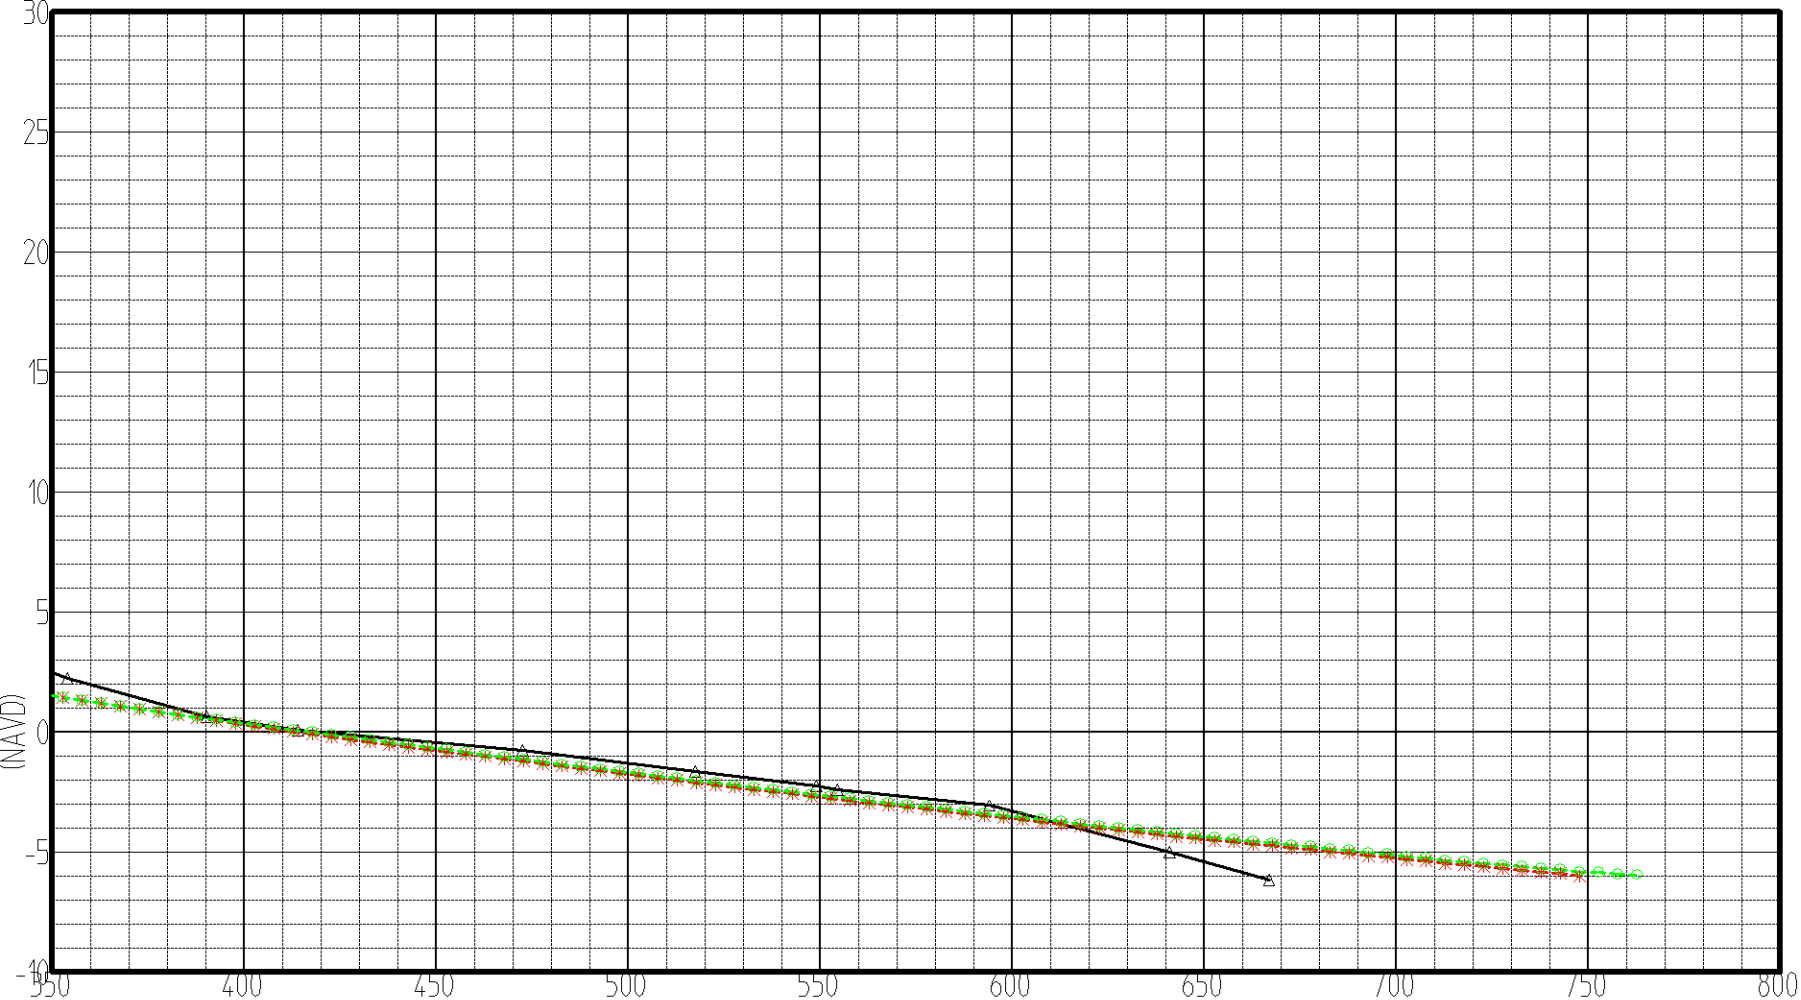
Range: R-164
 BEARING: 75.00
 2/2

BEACH PROFILE
 —△—△— ST. JOHNS 2007-2008 COMBI
 - - * - - - 15YR SBEACH ERODED
 - - o - - - 25YR SBCH ERODED

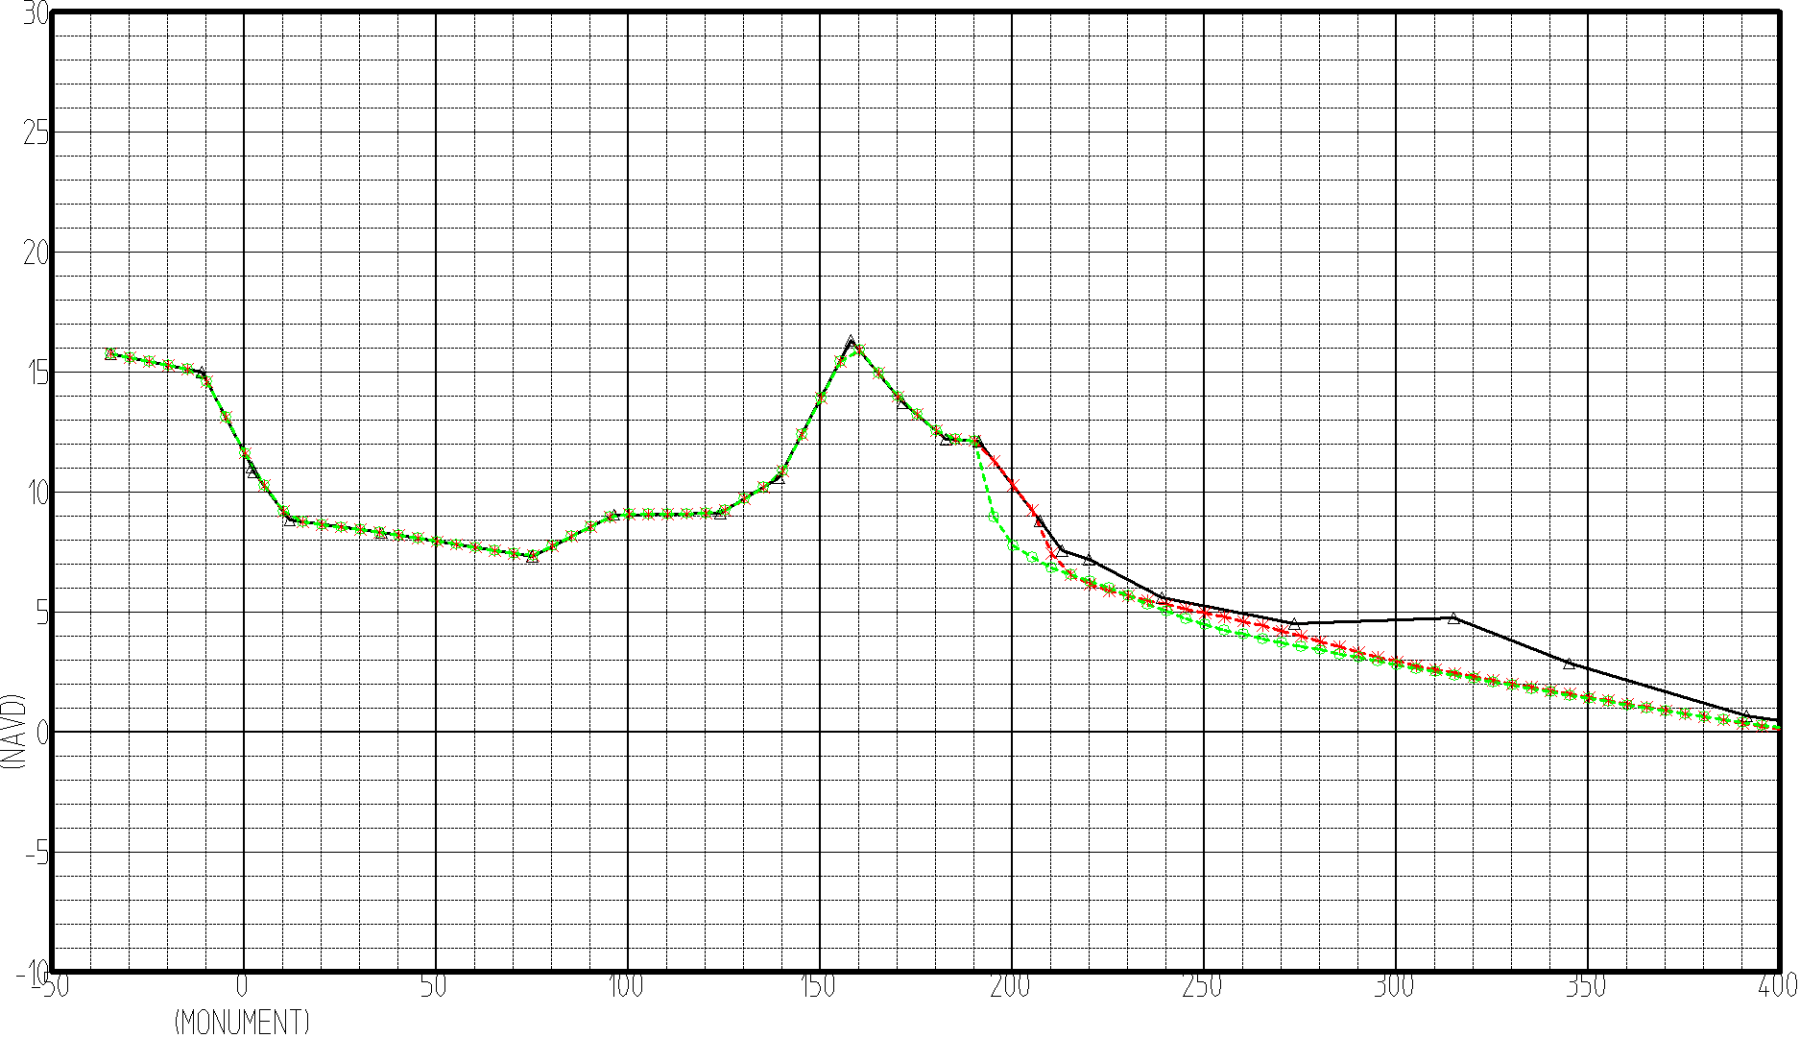
Range: R-165

BEACH PROFILE

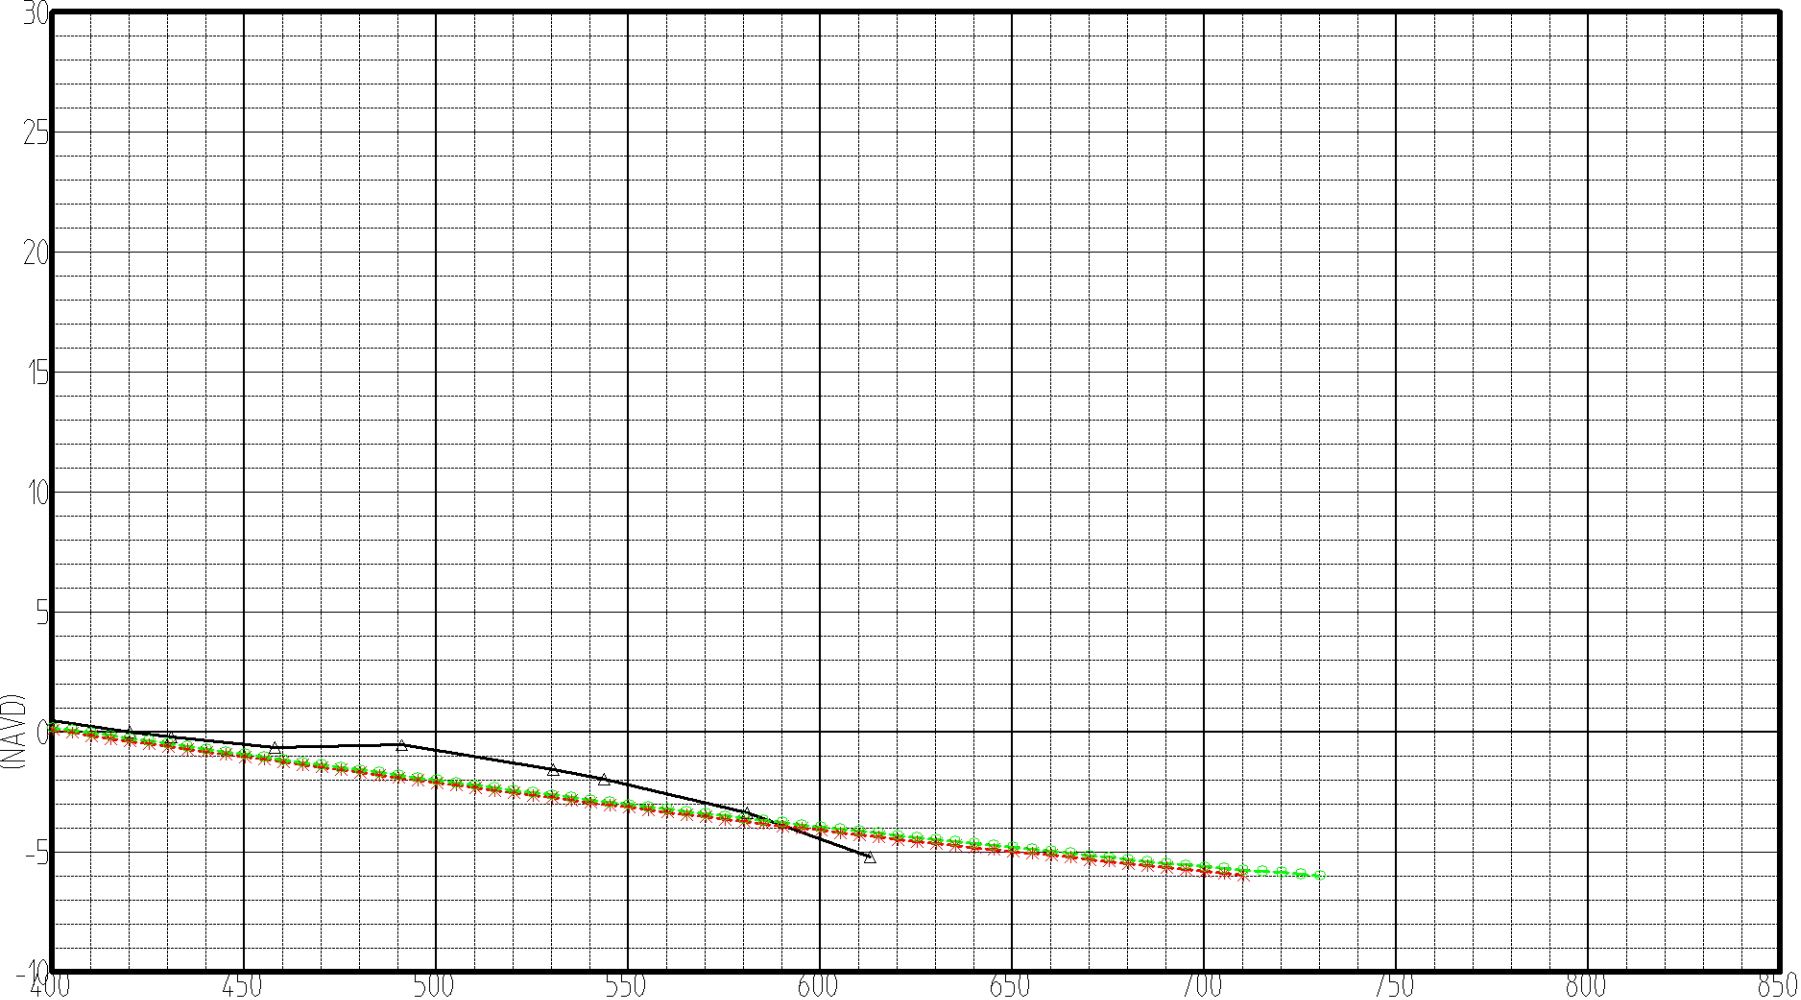
Range: R-165
 BEARING: 75.00
 2/2

BEACH PROFILE
 —△—△— ST. JOHNS 2007-2008 COMBI
 - - * - - 15YR SBEACH ERODED
 - - o - - 25YR SBCH ERODED

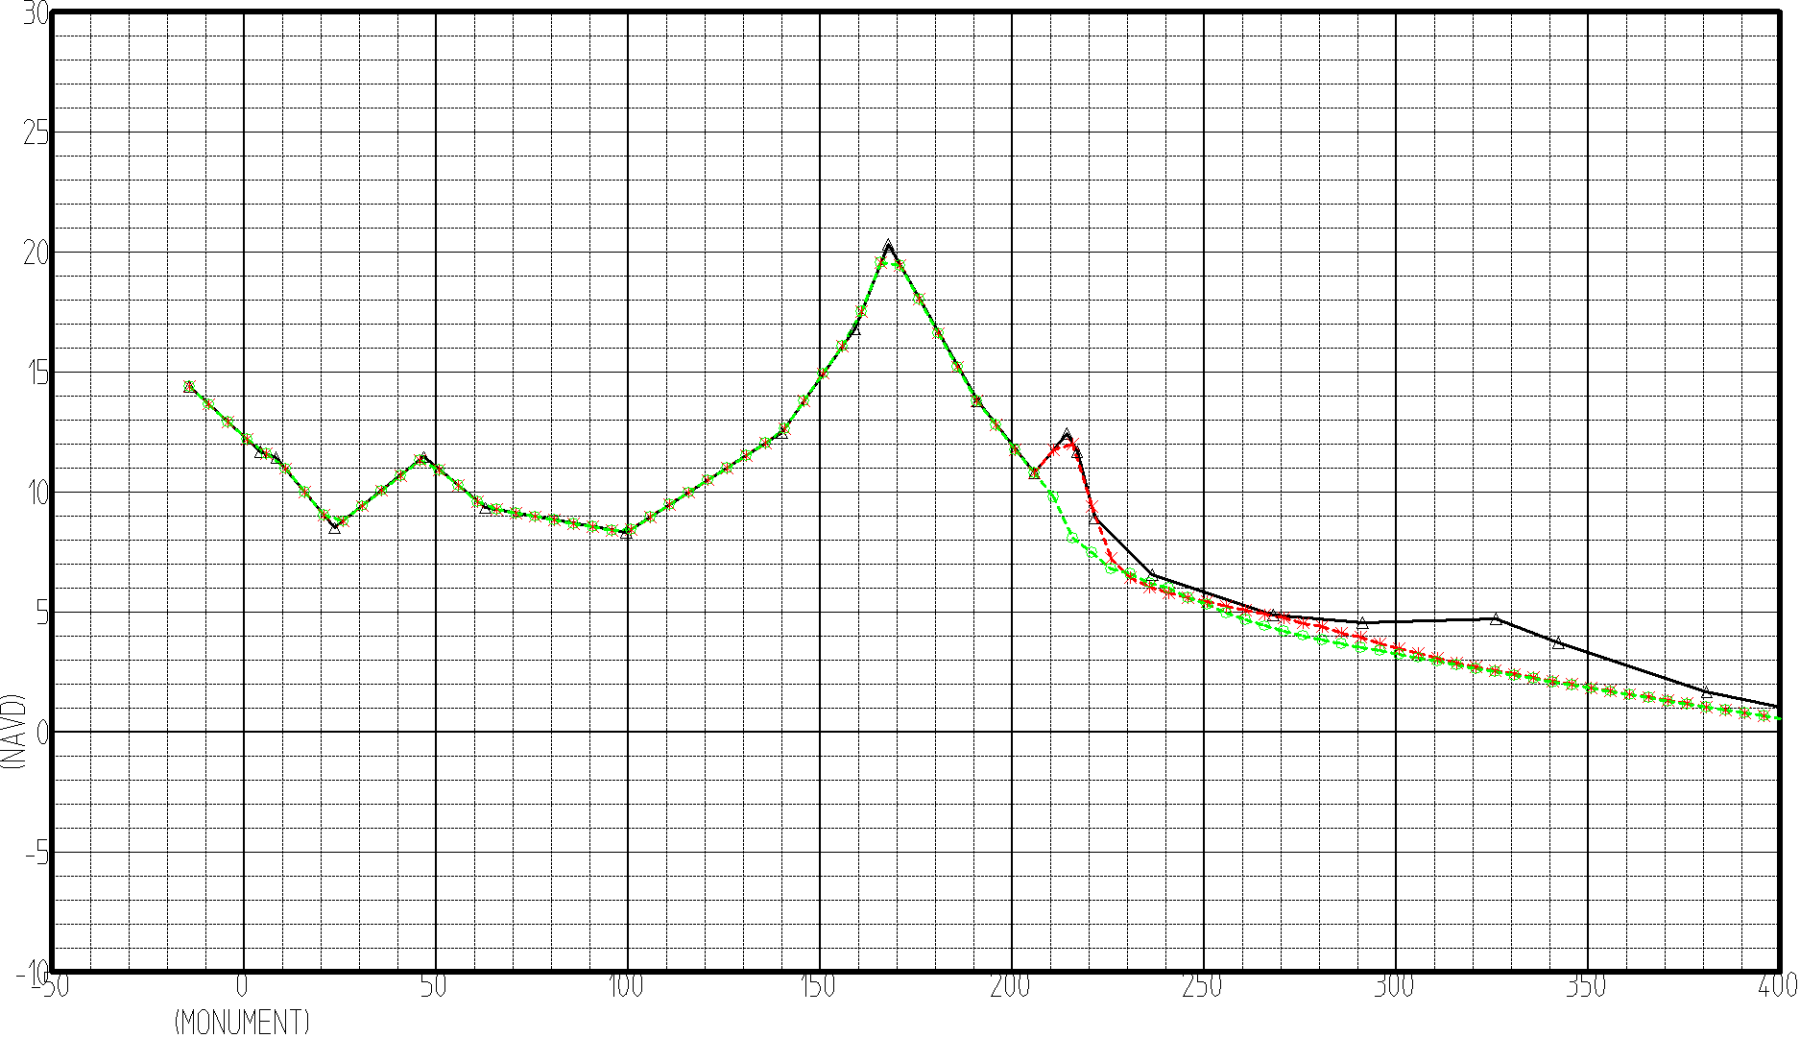
Range: R-166
 BEARING: 75.00
 1/2

BEACH PROFILE
 —△—△— ST. JOHNS 2007-2008 COMBI
 - - * - - 15YR SBEACH ERODED
 - - o - - 25YR SBCH ERODED

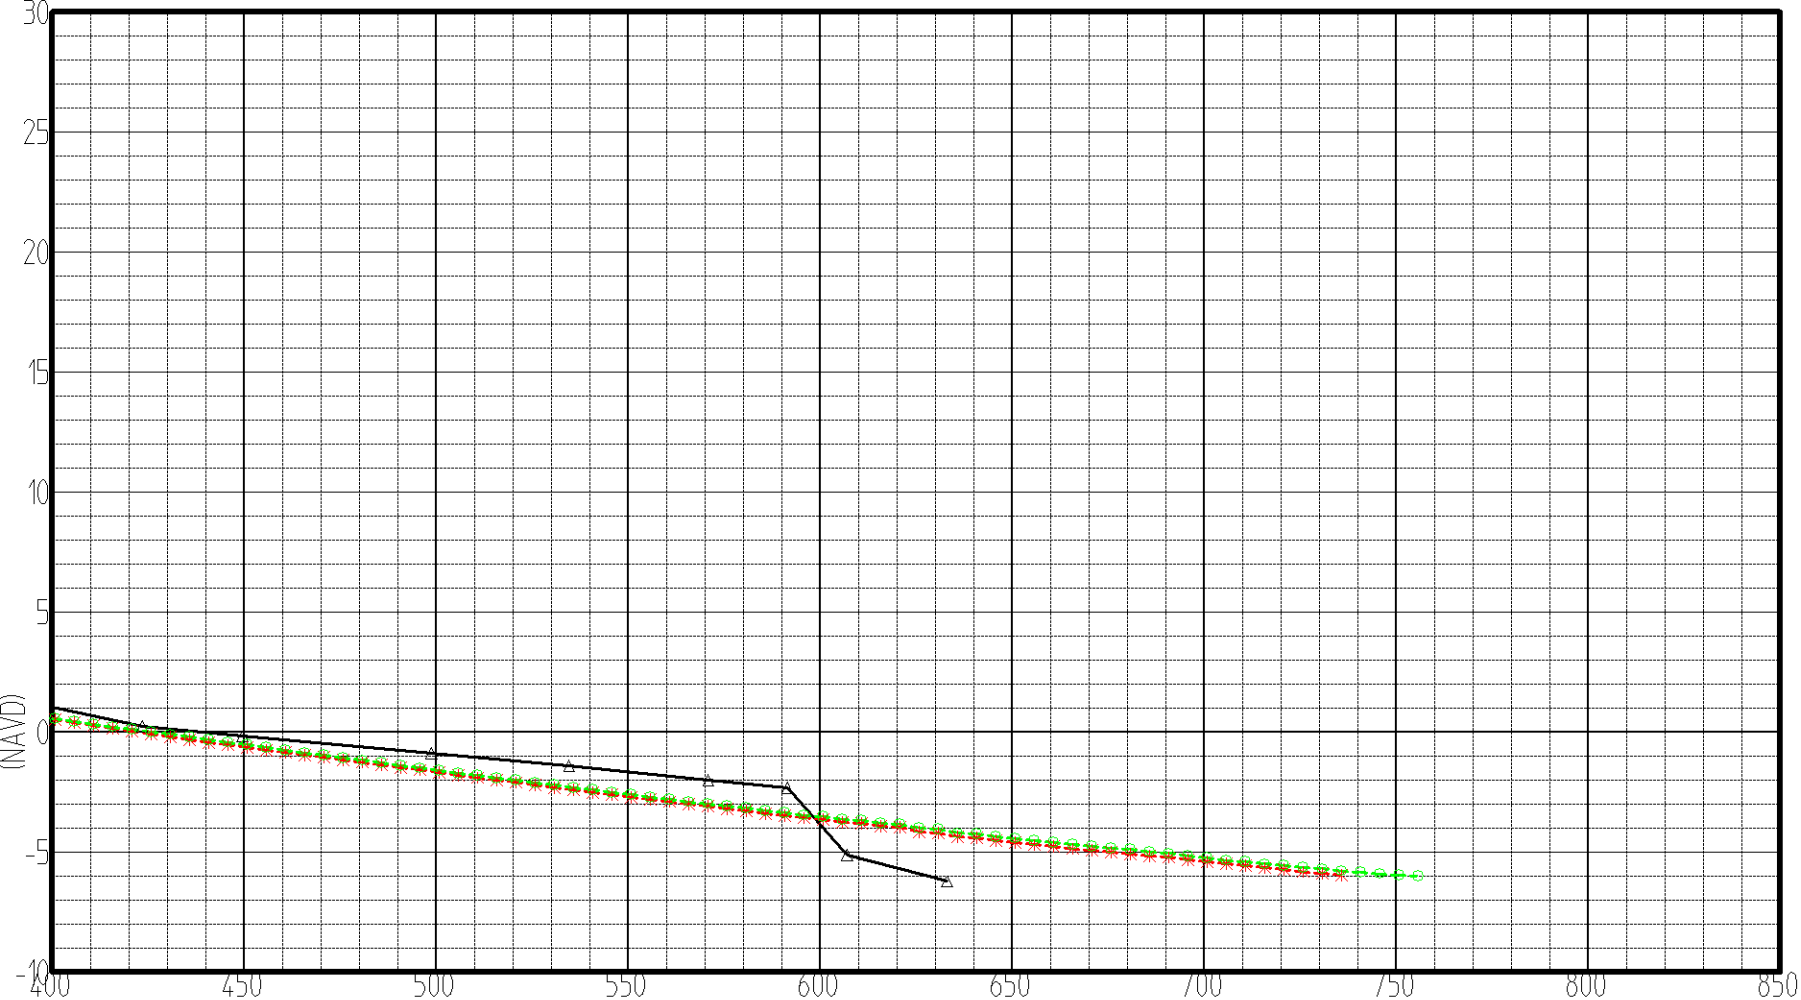
Range: R-166
 BEARING: 75.00
 2/2

BEACH PROFILE
 —△—△— ST. JOHNS 2007-2008 COMBI
 - - * - - - 15YR SBEACH ERODED
 - - o - - - 25YR SBCH ERODED

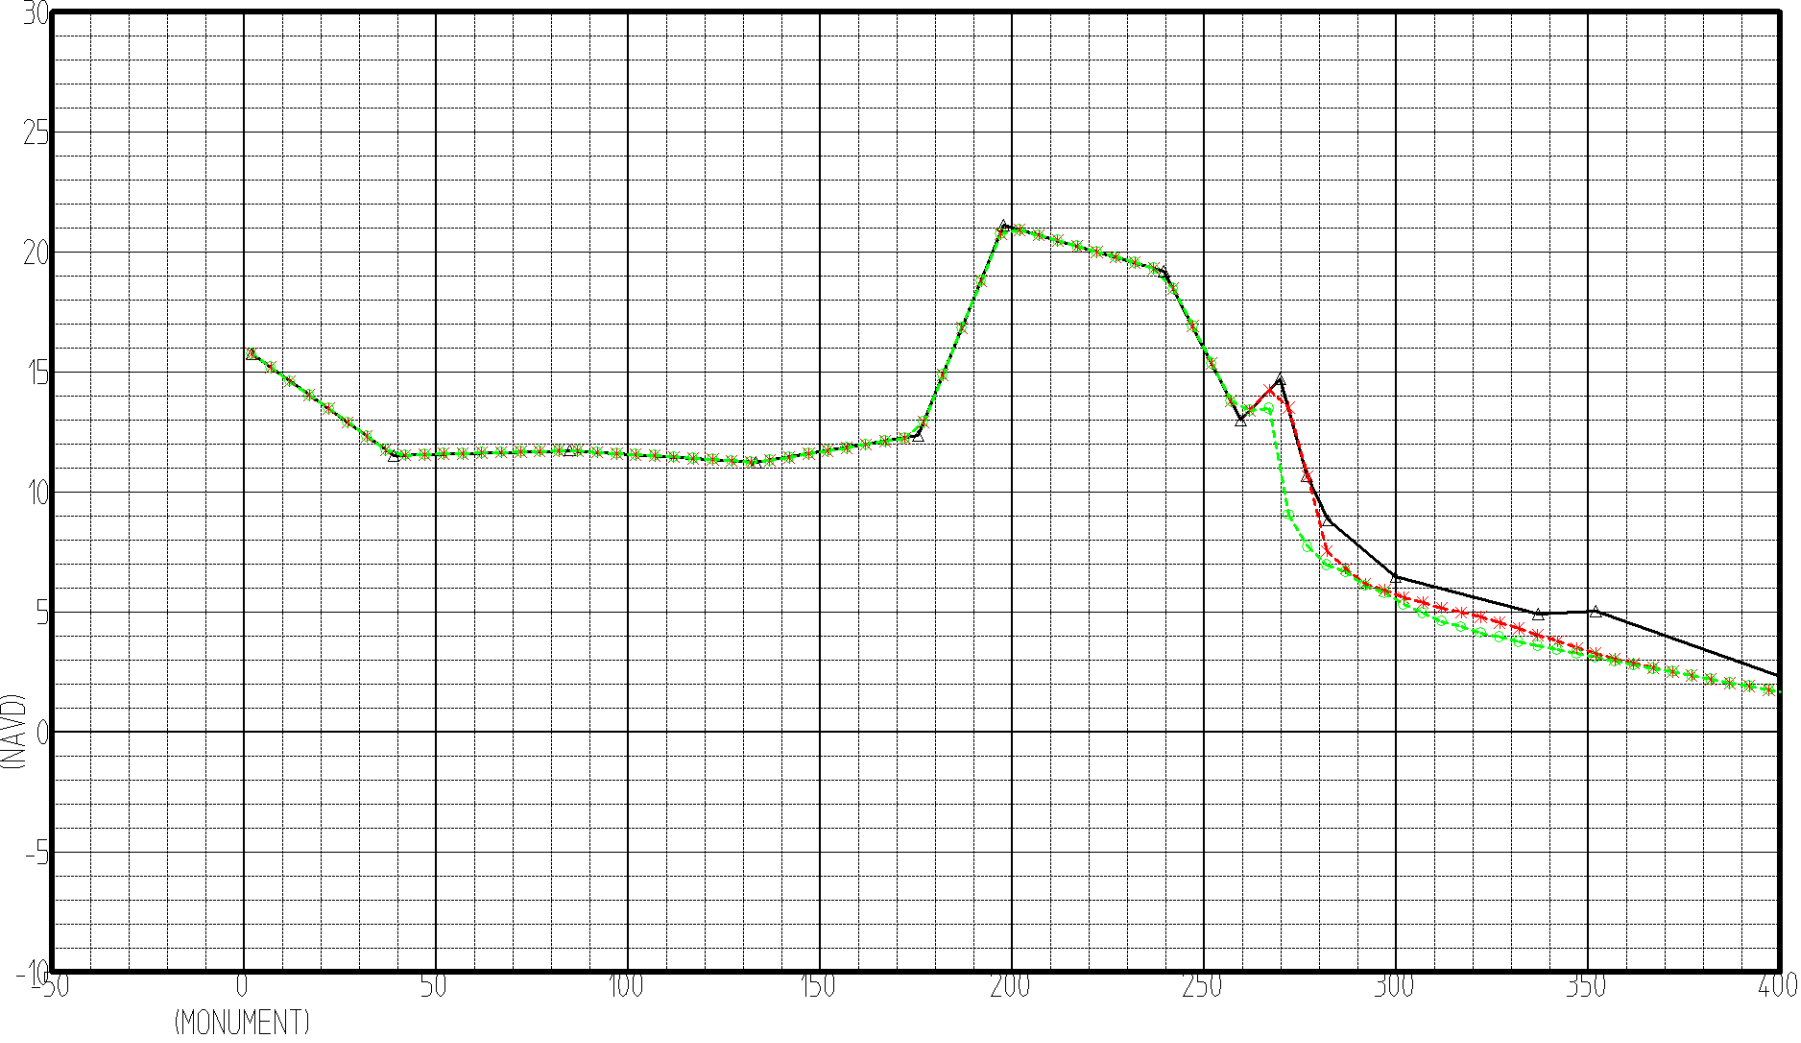
Range: R-167
 BEARING: 75.00
 1/2

BEACH PROFILE
 —△—△— ST. JOHNS 2007-2008 COMBI
 - - * - - 15YR SBEACH ERODED
 - - o - - 25YR SBCH ERODED

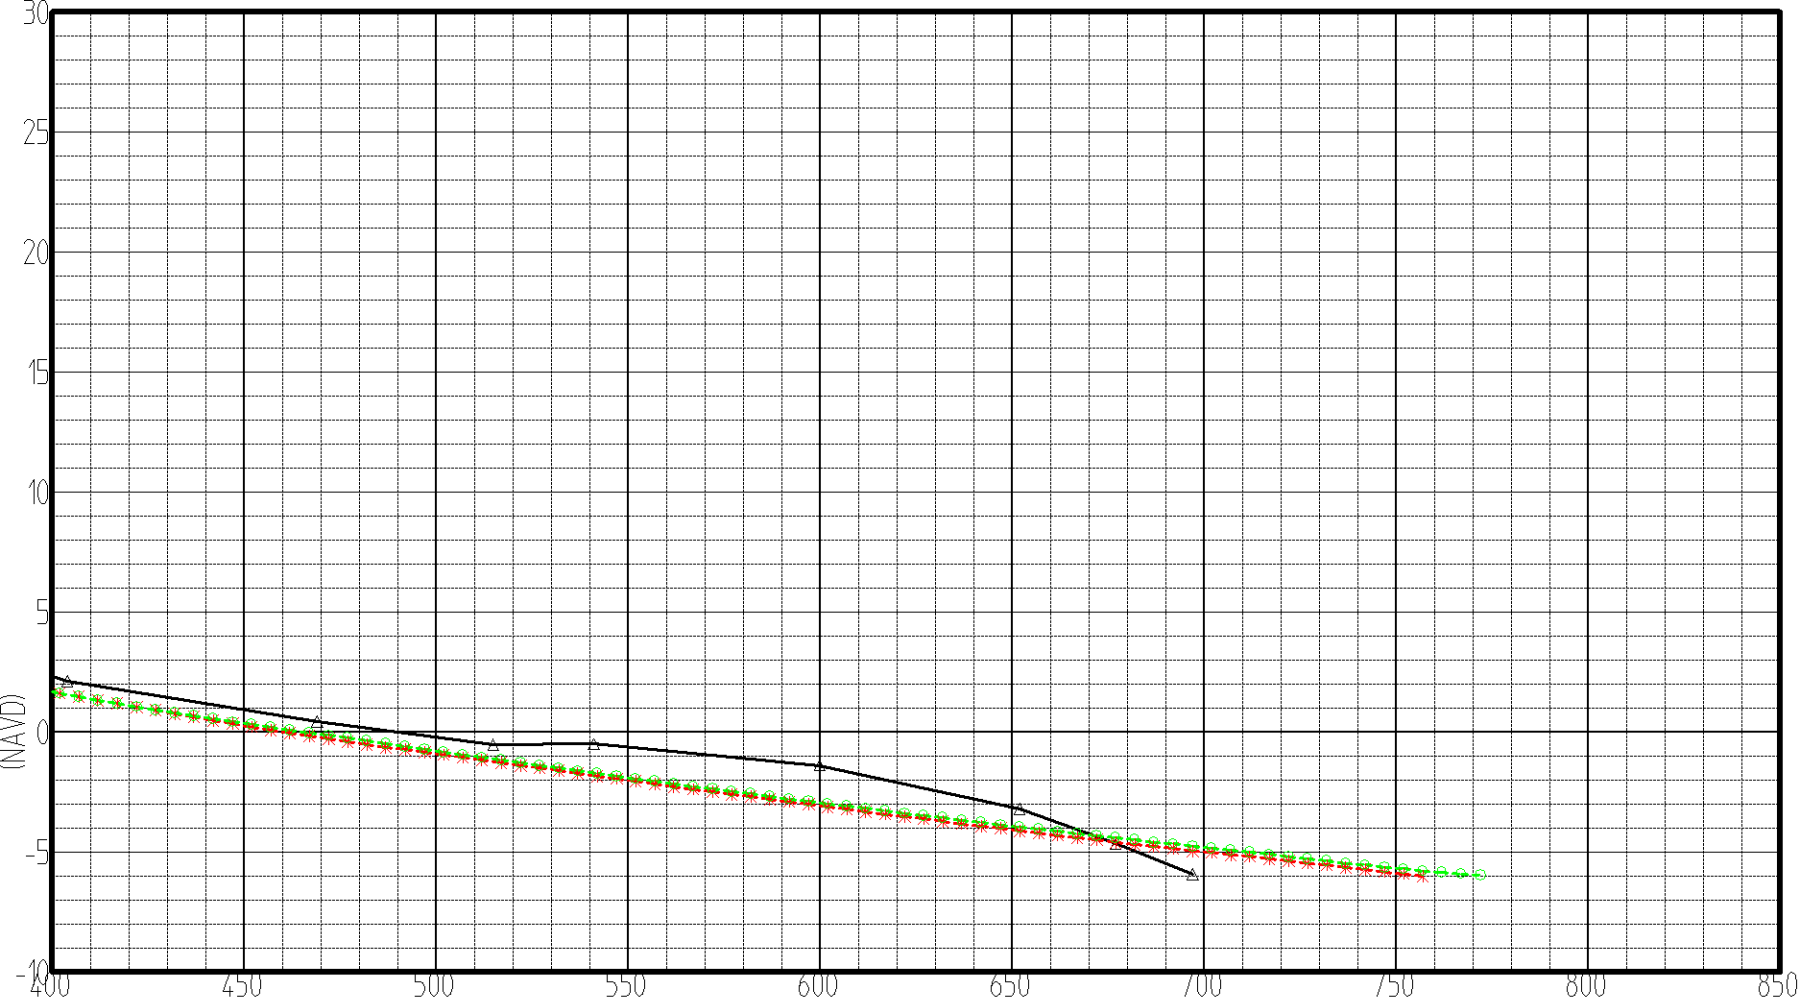
Range: R-167 2/2

BEACH PROFILE

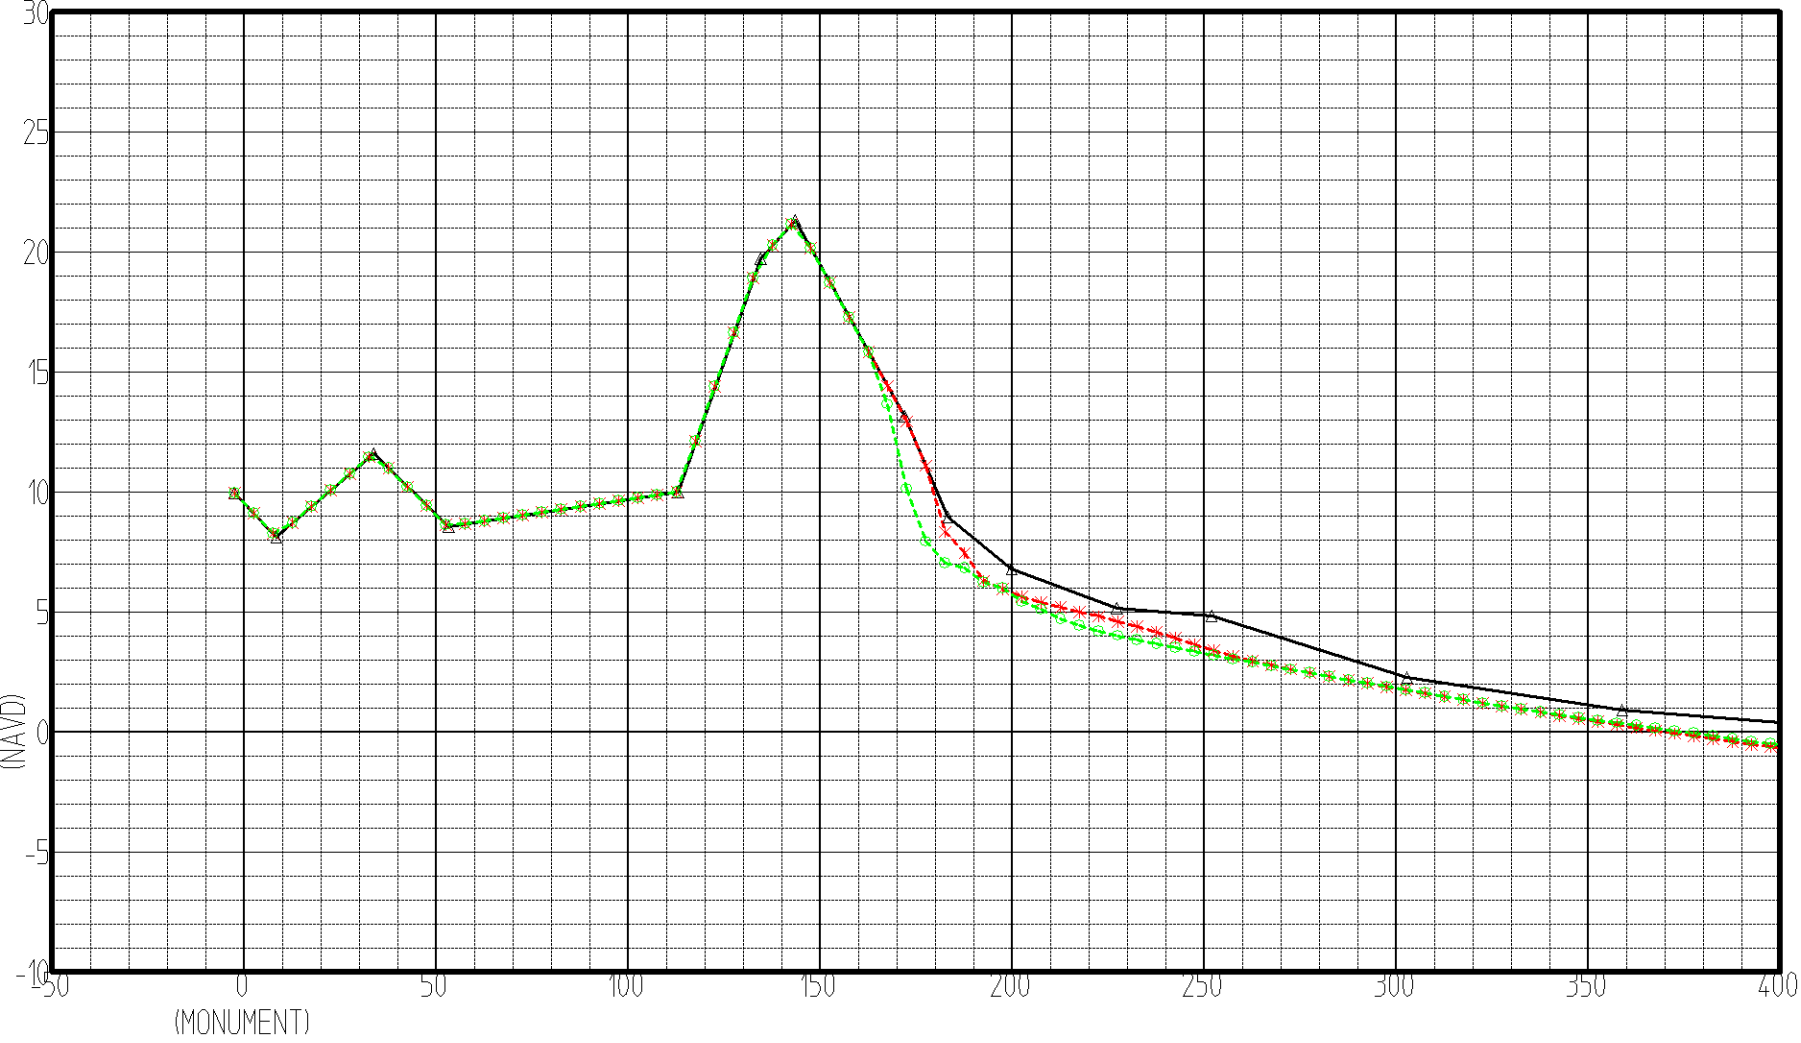
Range: R-168
 BEARING: 75.00
 1/2

BEACH PROFILE
 —△—△— ST. JOHNS 2007-2008 COMBI
 - - * - - 15YR SBCH ERODED
 - - o - - 25YR SBCH ERODED

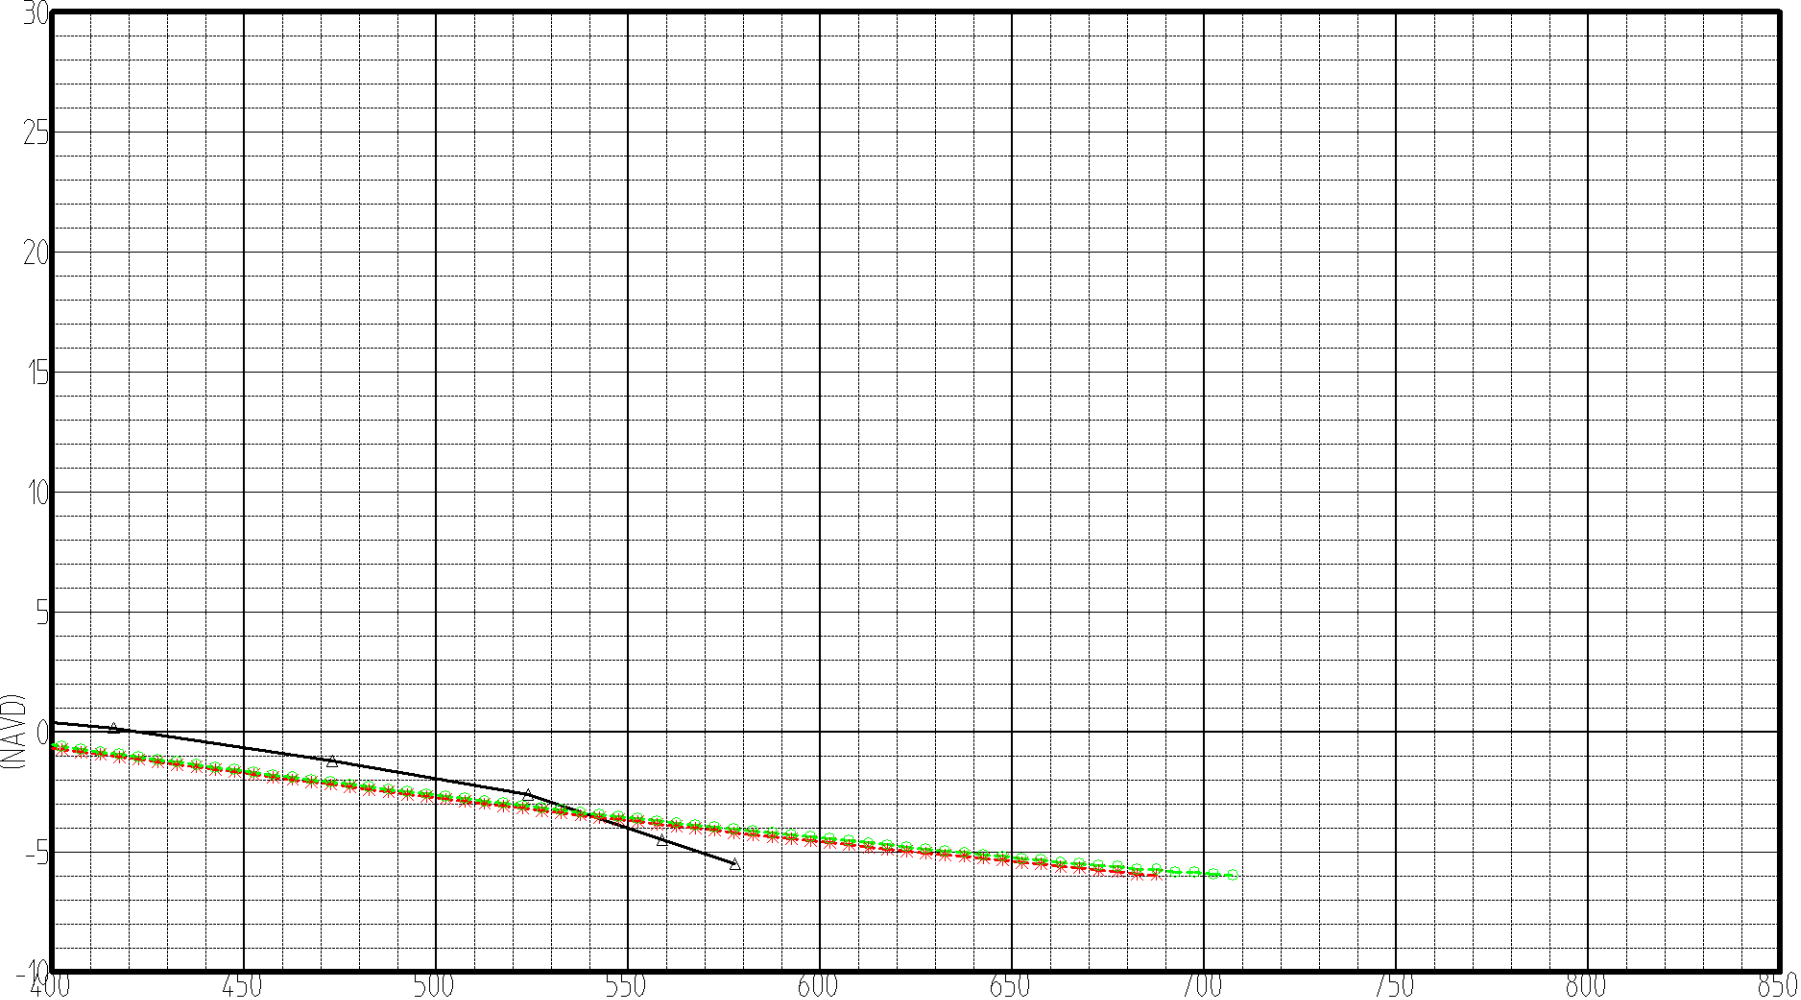
Range: R-168

BEACH PROFILE
