Appendix VIII

SBEACH 15 and 25 yr. Storm Erosion Profiles

St. Johns County

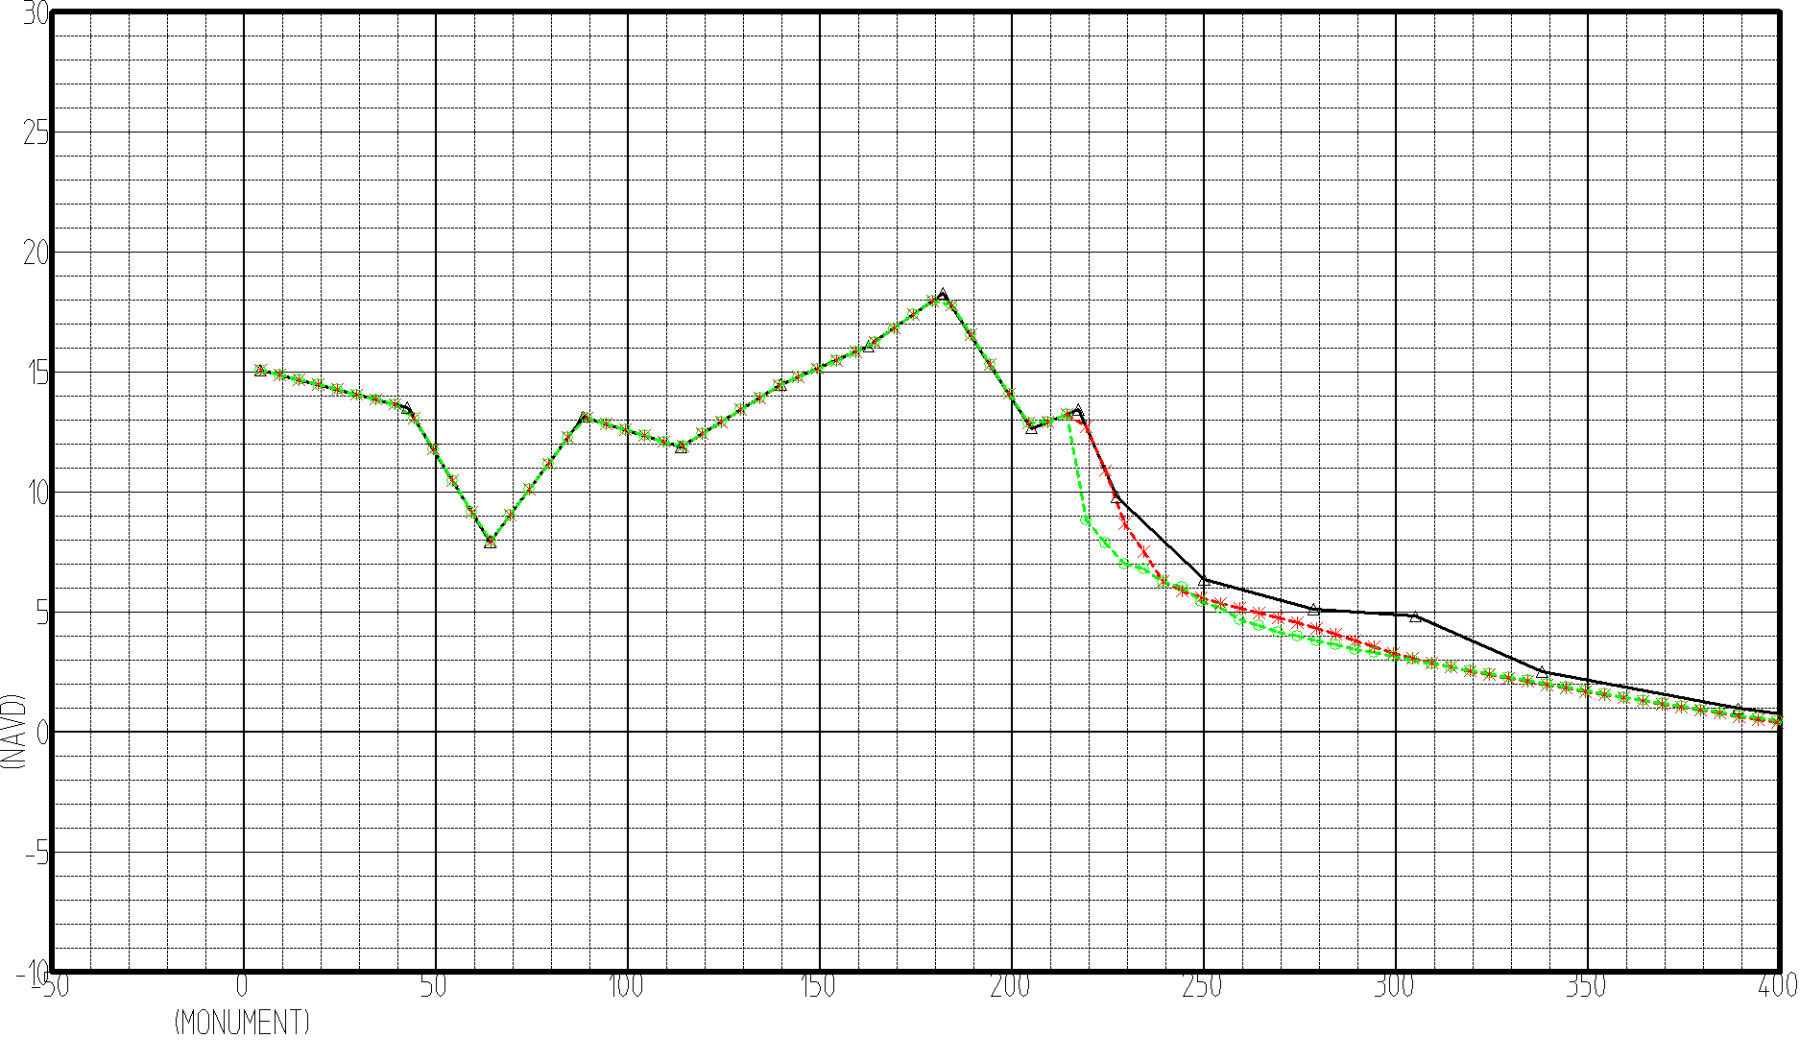
Range: R-169
 BEARING: 75.00
 1/2

BEACH PROFILE
 —△—△— ST. JOHNS 2007-2008 COMBI
 - - * - - - 15YR SBEACH ERODED
 - - o - - - 25YR SBCH ERODED

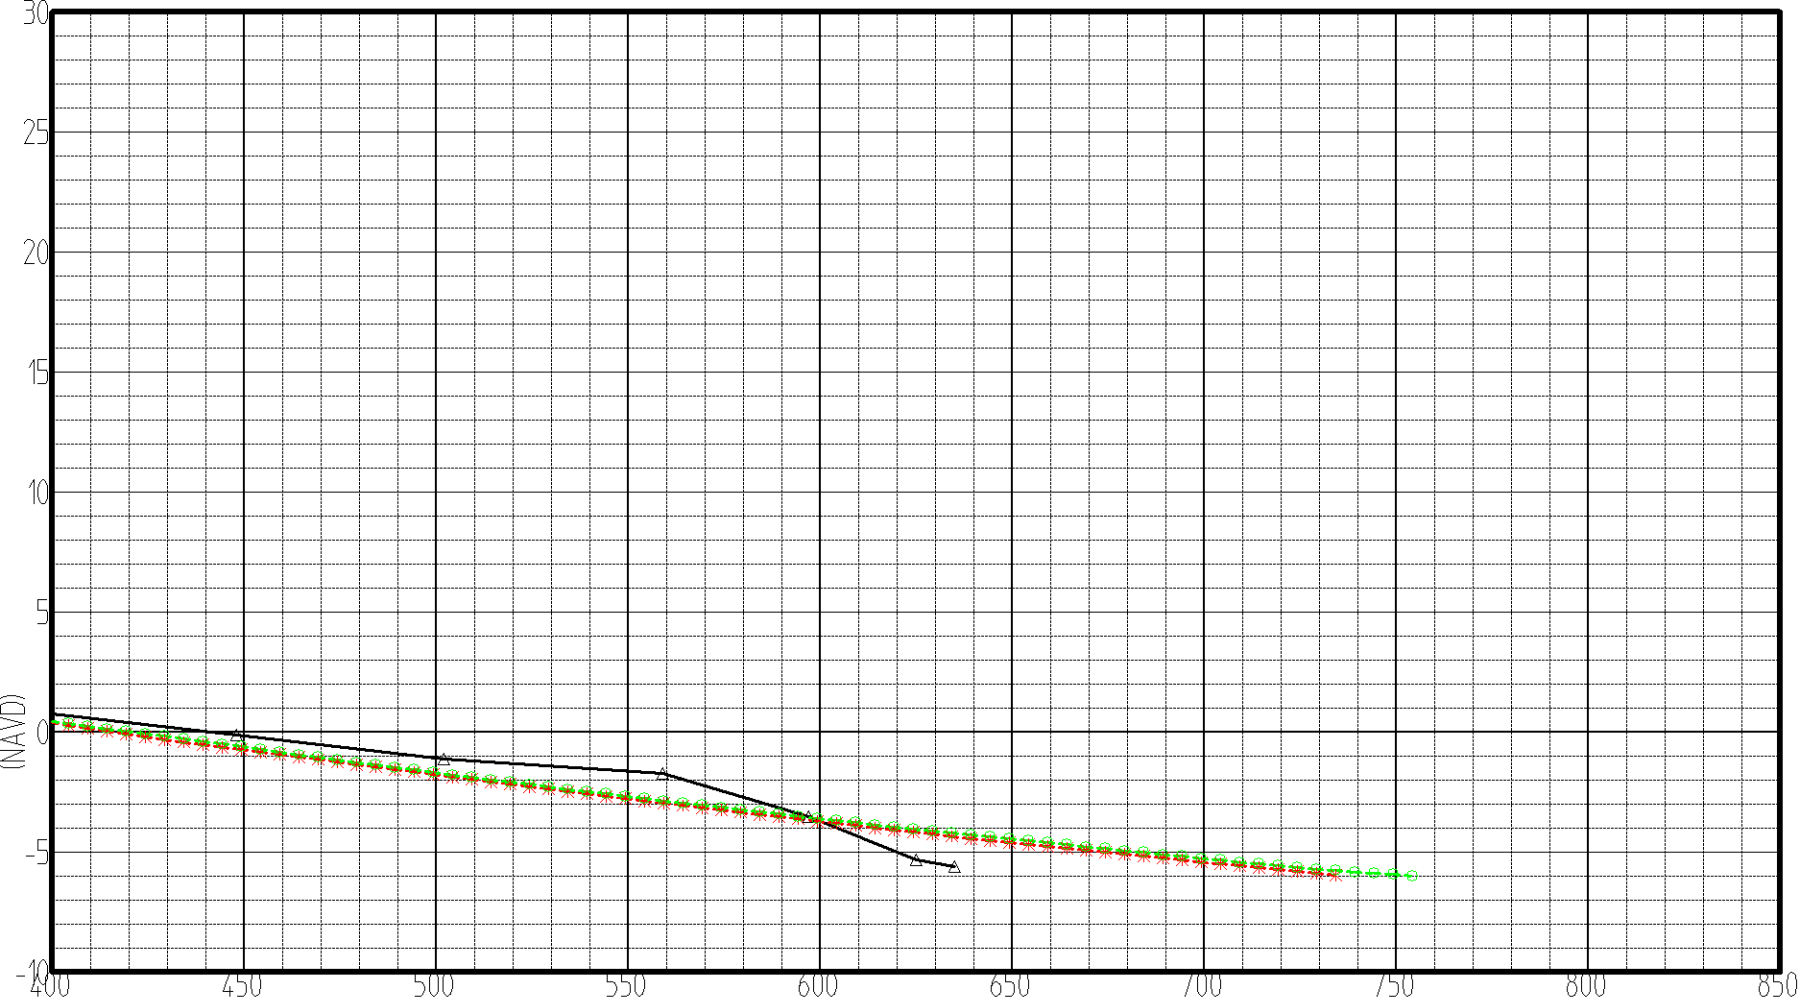
Range: R-169 2/2

BEACH PROFILE

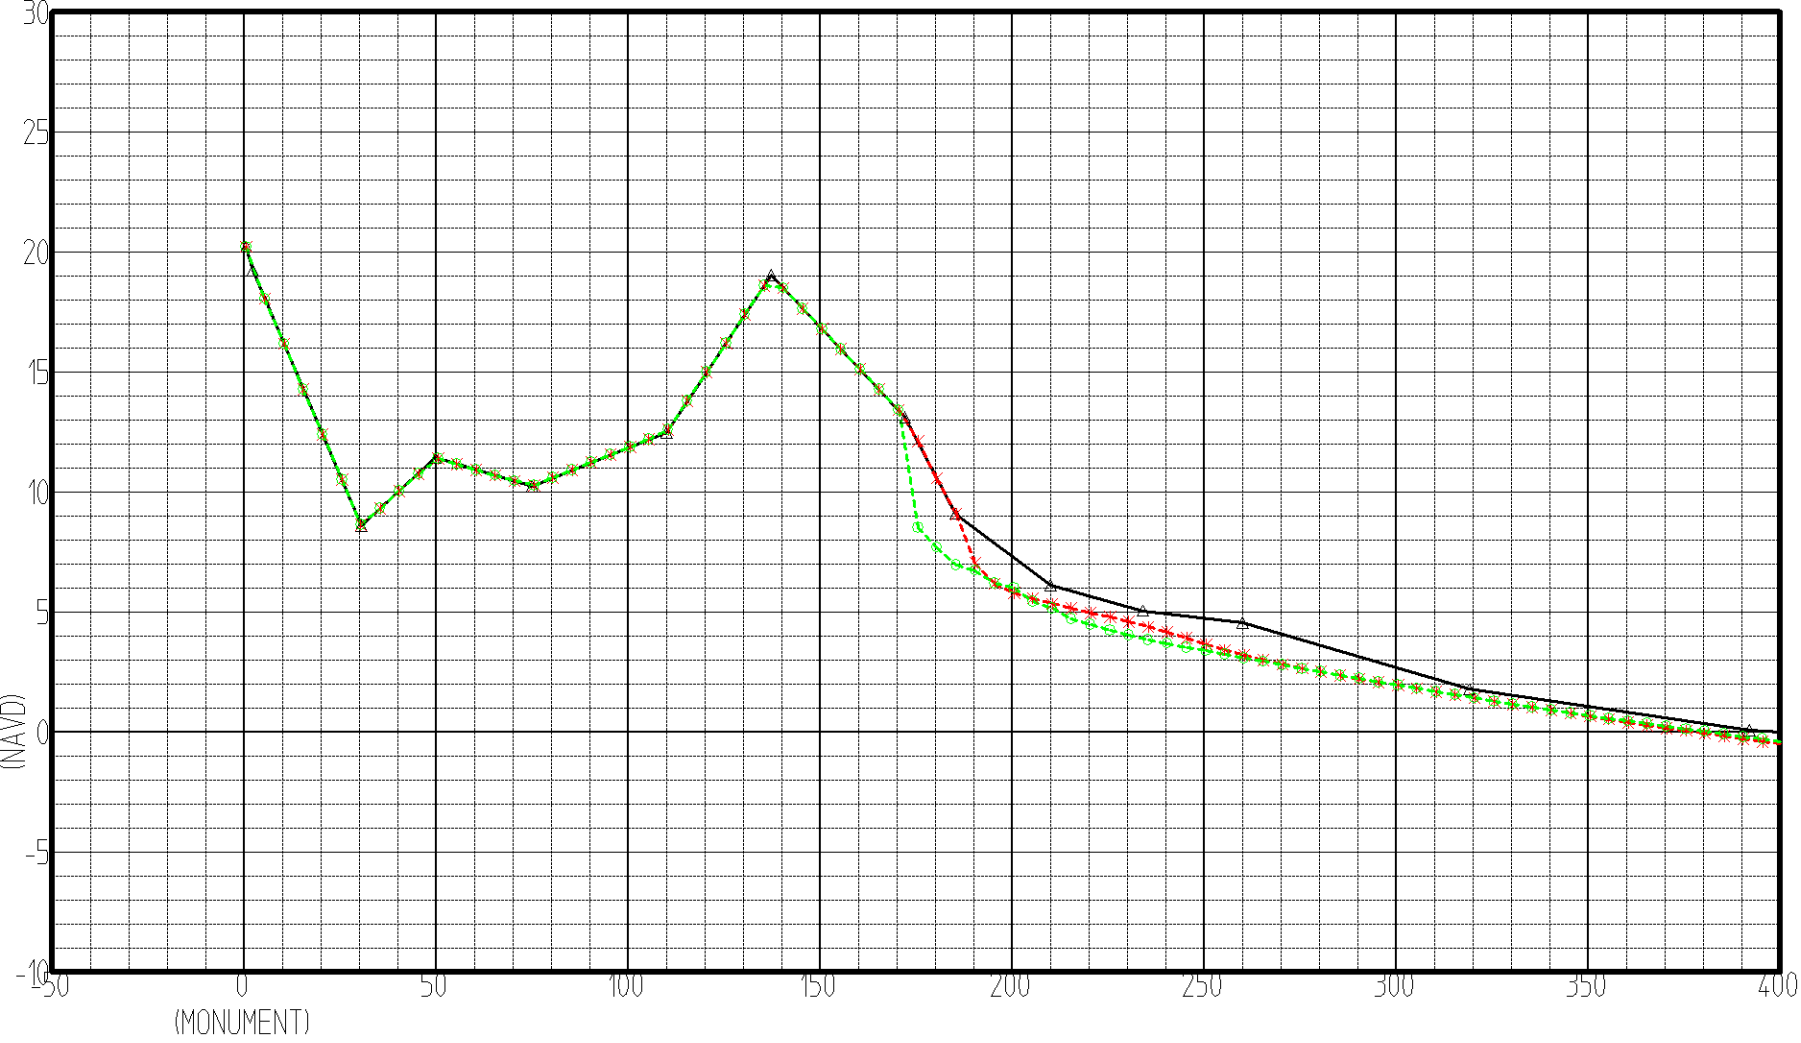
Range: R-170
 BEARING: 75.00
 1/2

BEACH PROFILE
 —△—△— ST. JOHNS 2007-2008 COMBI
 - - * - - 15YR SBEACH ERODED
 - - o - - 25YR SBCH ERODED

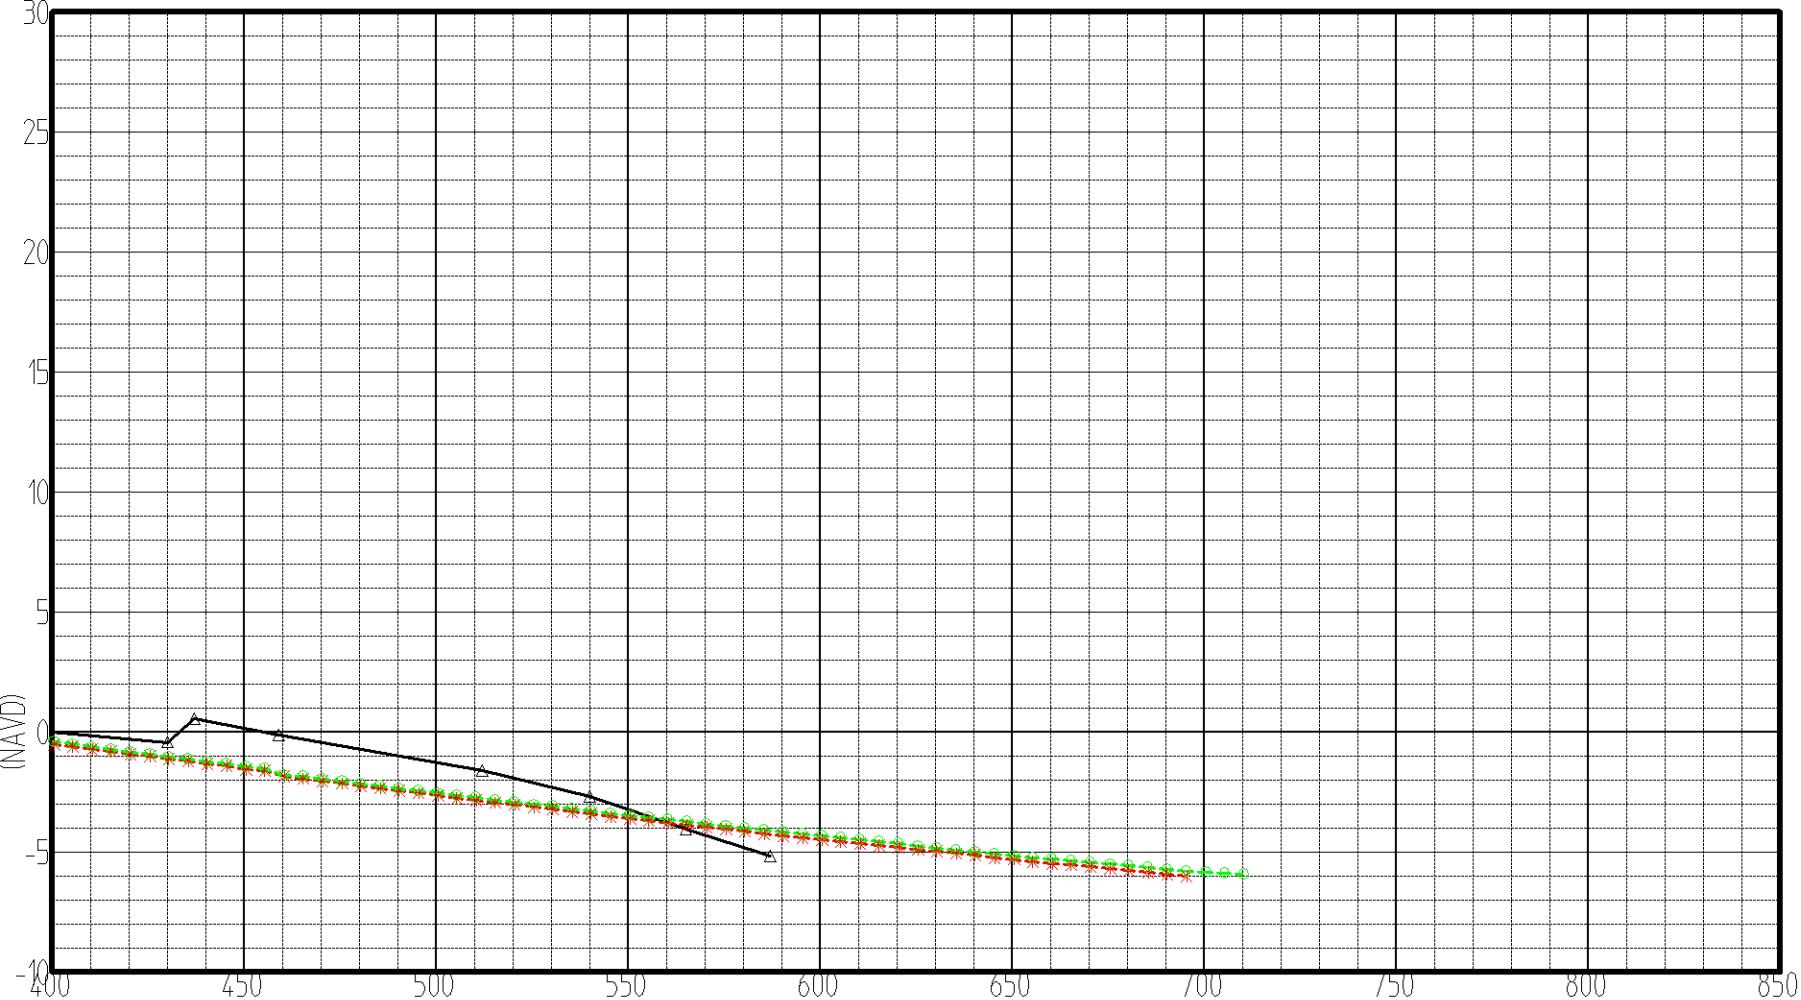
Range: R-170 2/2

BEACH PROFILE

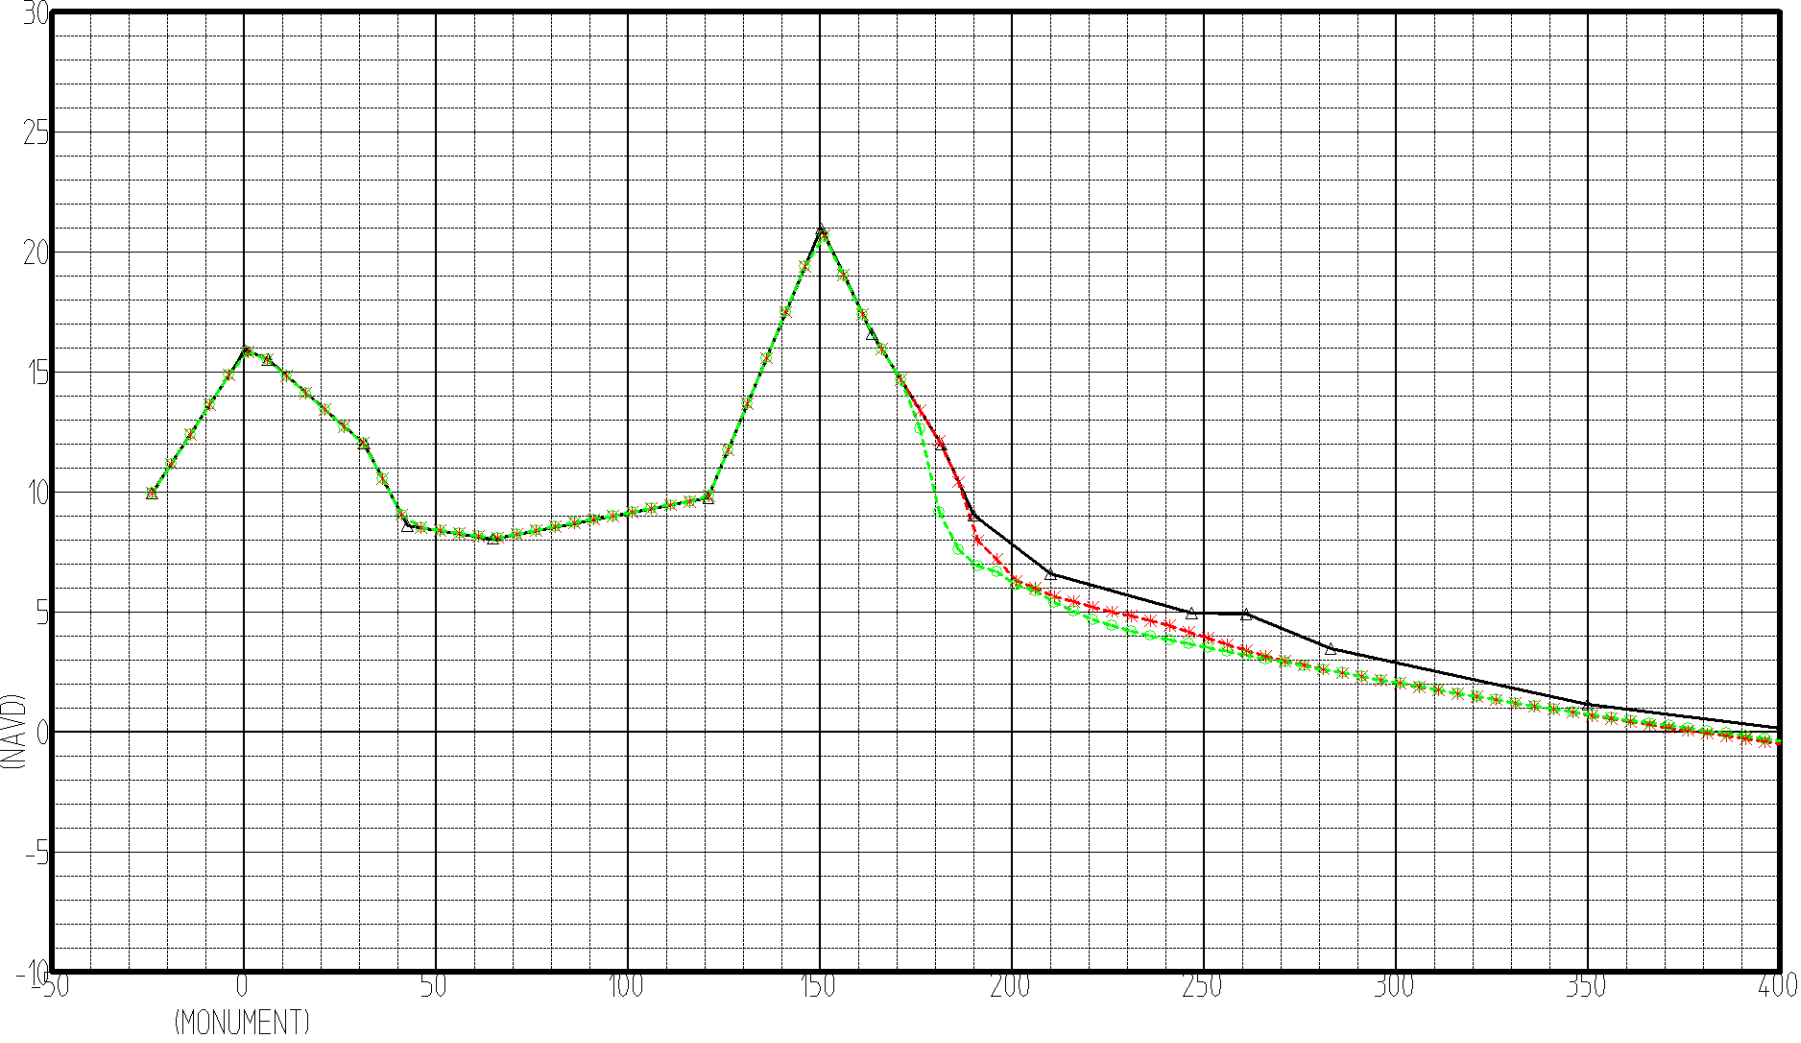
Range: T-171 1/2
 BEARING: 75.00

BEACH PROFILE
 —△—△— ST. JOHNS 2007-2008 COMBI
 - - * - - 15YR SBCH ERODED
 - - o - - 25YR SBCH ERODED

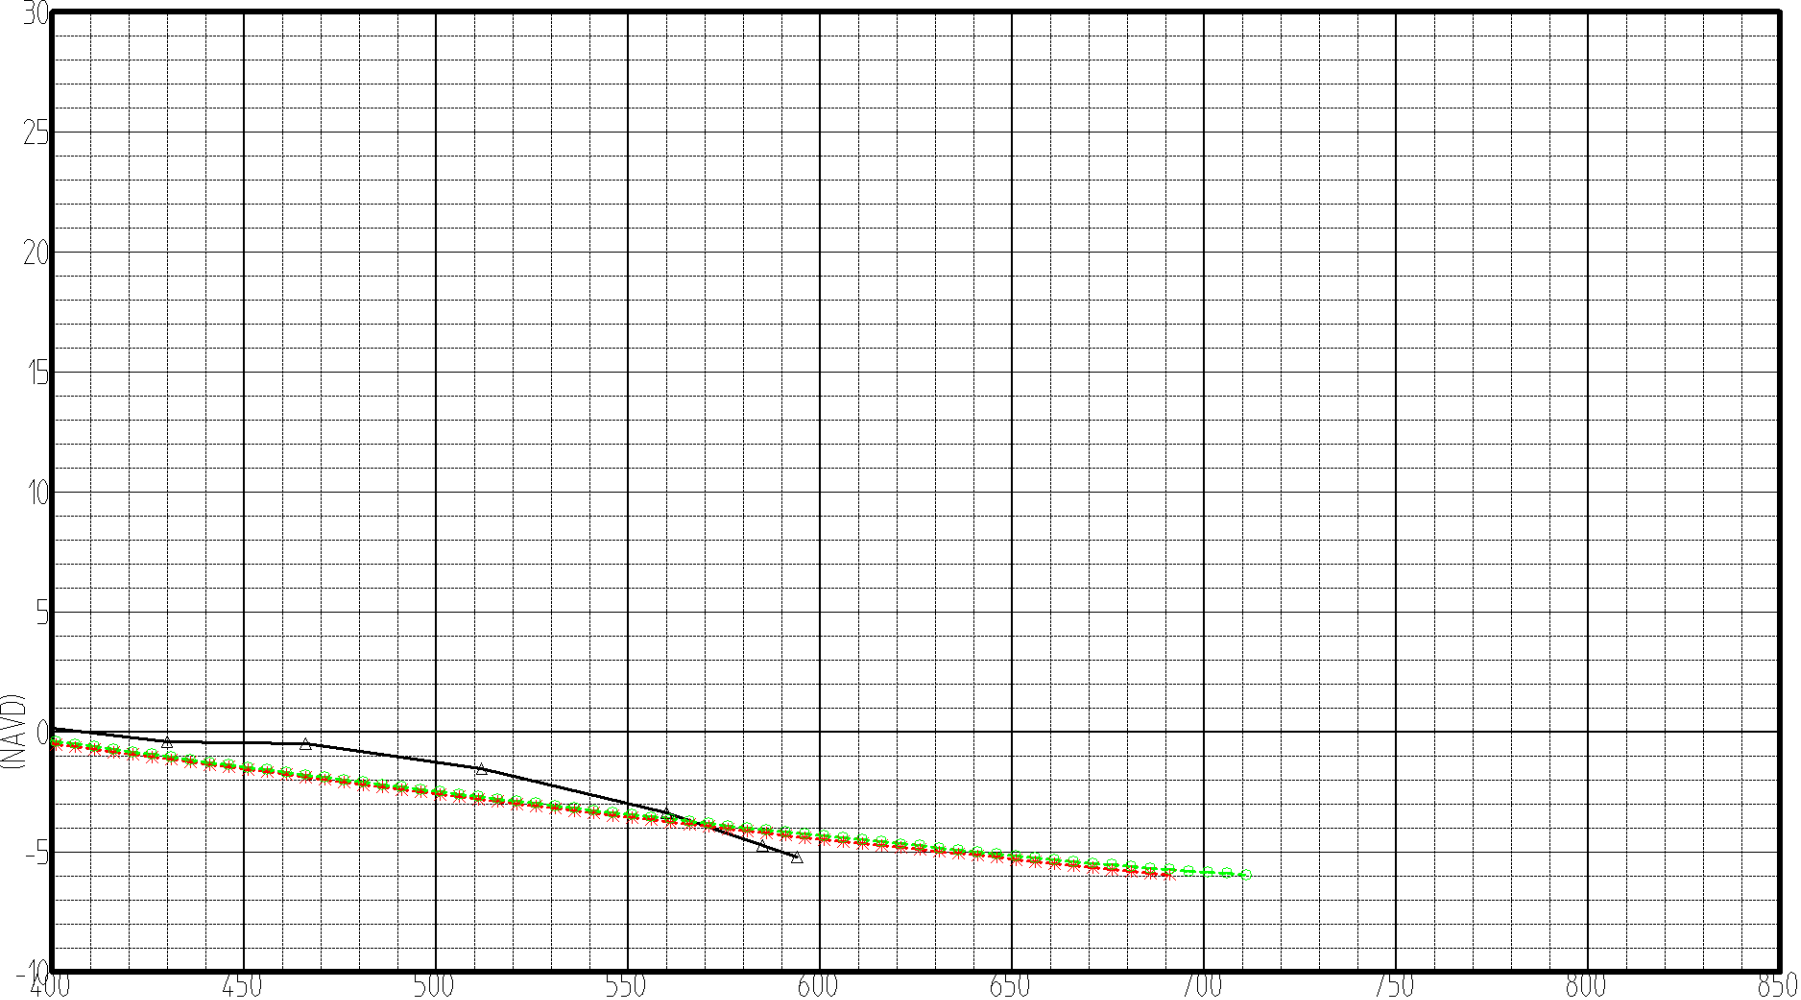
Range: T-171 2/2
 BEARING: 75.00

BEACH PROFILE
 —△—△— ST. JOHNS 2007-2008 COMBI
 - - * - - 15YR SBEACH ERODED
 - - o - - 25YR SBCH ERODED

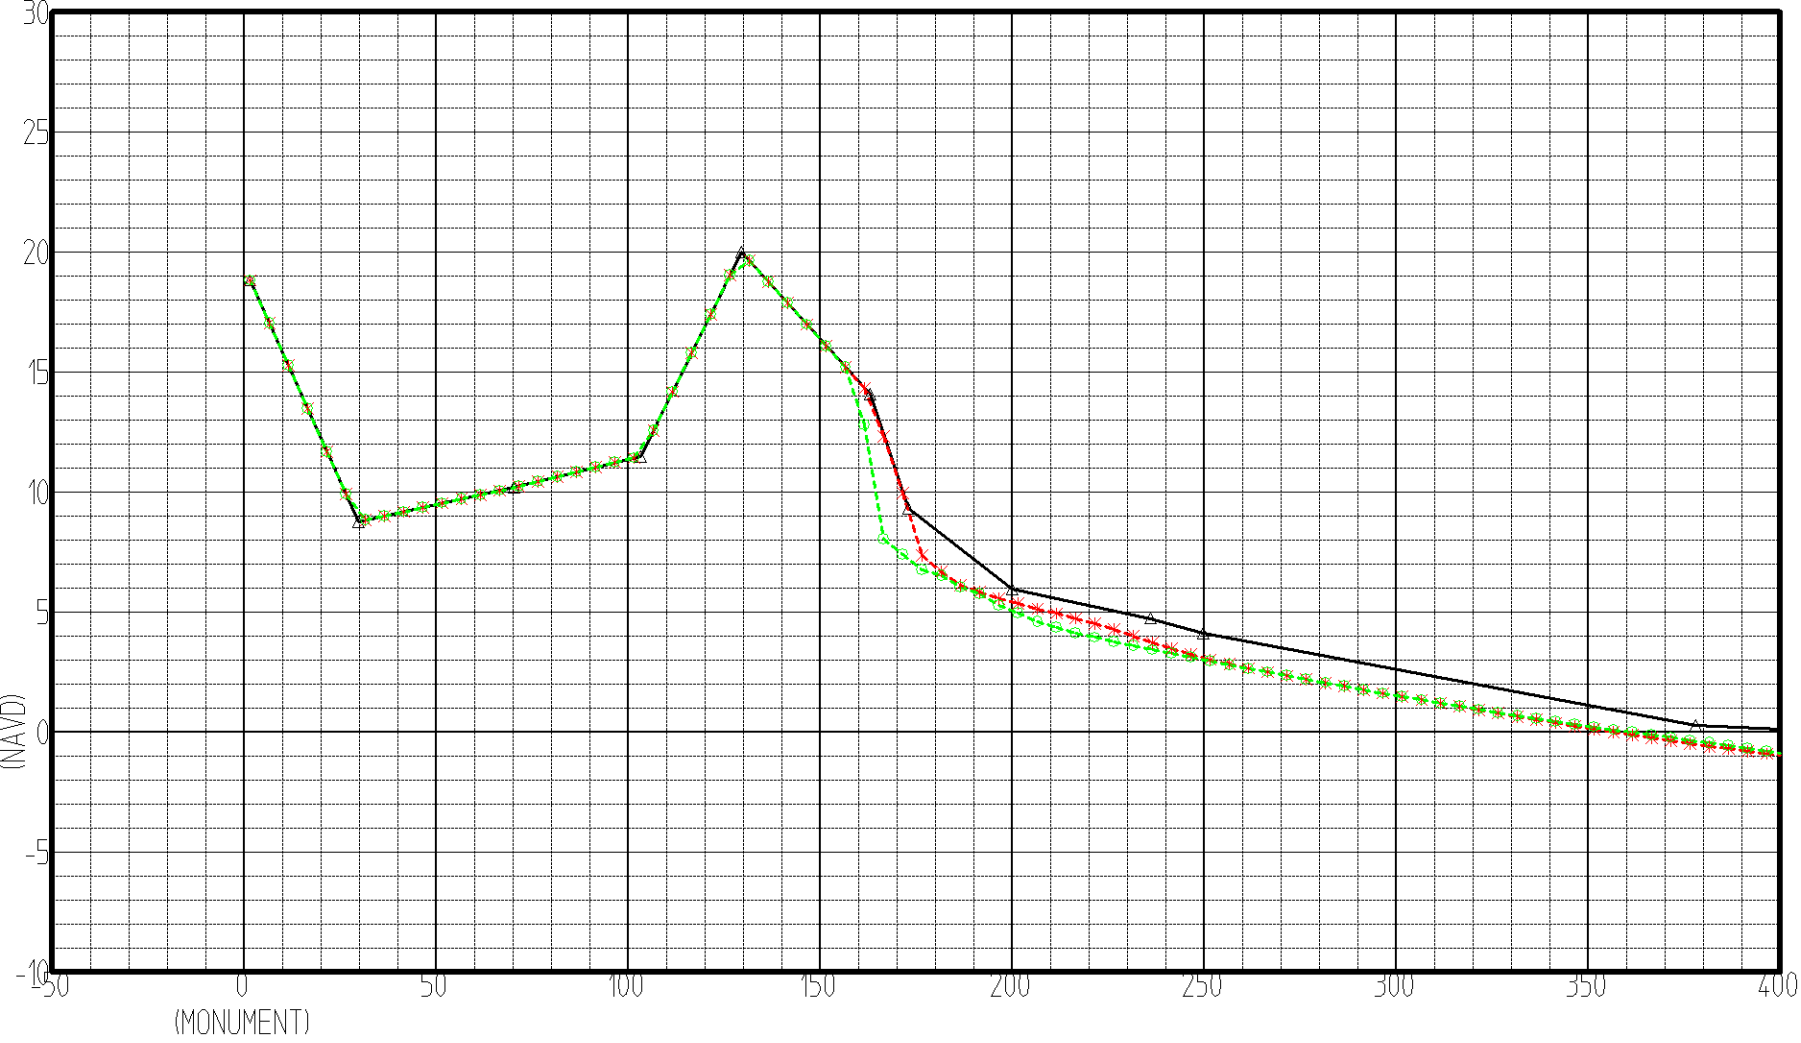
Range: T-172 1/2
 BEARING: 75.00

BEACH PROFILE
 —△—△— ST. JOHNS 2007-2008 COMBI
 - - * - - * - - 15YR SBCH ERODED
 - - o - - o - - 25YR SBCH ERODED

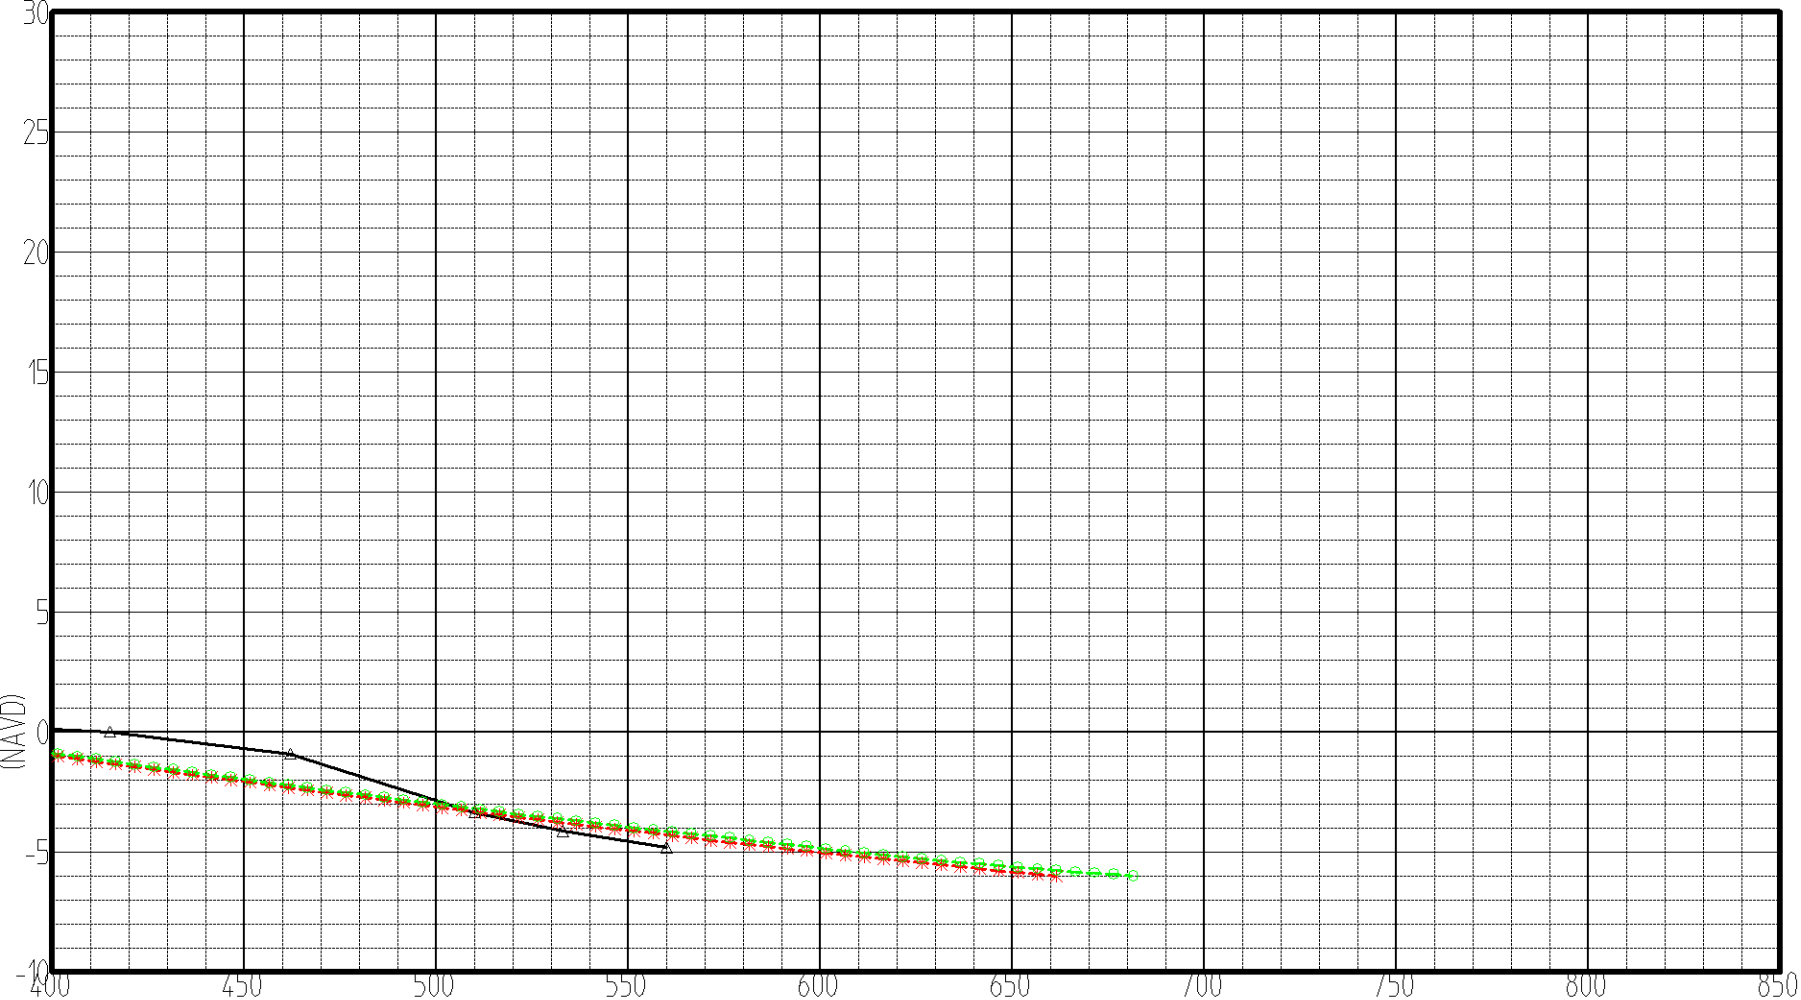
Range: T-172 2/2
 BEARING: 75.00

BEACH PROFILE
 —△—△— ST. JOHNS 2007-2008 COMBI
 - - * - - * - - 15YR SBEACH ERODED
 - - o - - o - - 25YR SBCH ERODED

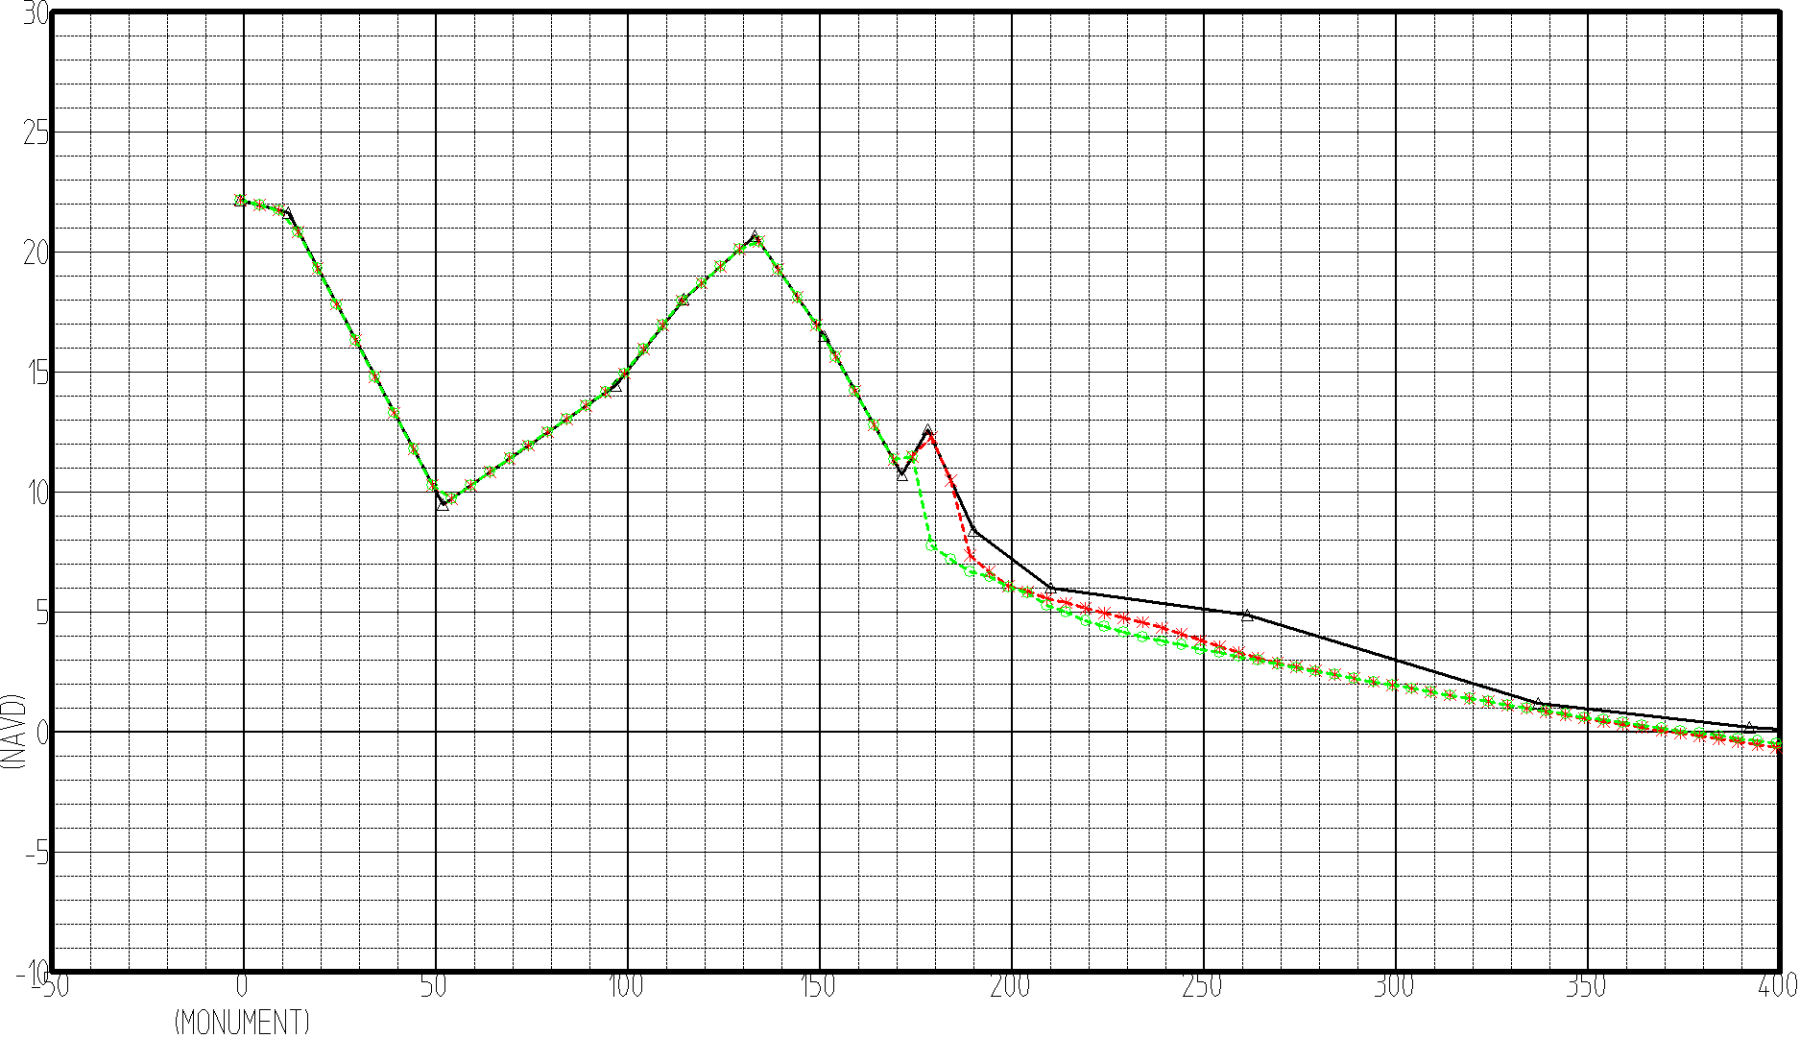
BEACH PROFILE
 —△—△— ST. JOHNS 2007-2008 COMBI
 - - * - - 15YR SBEACH ERODED
 - - o - - 25YR SBCH ERODED

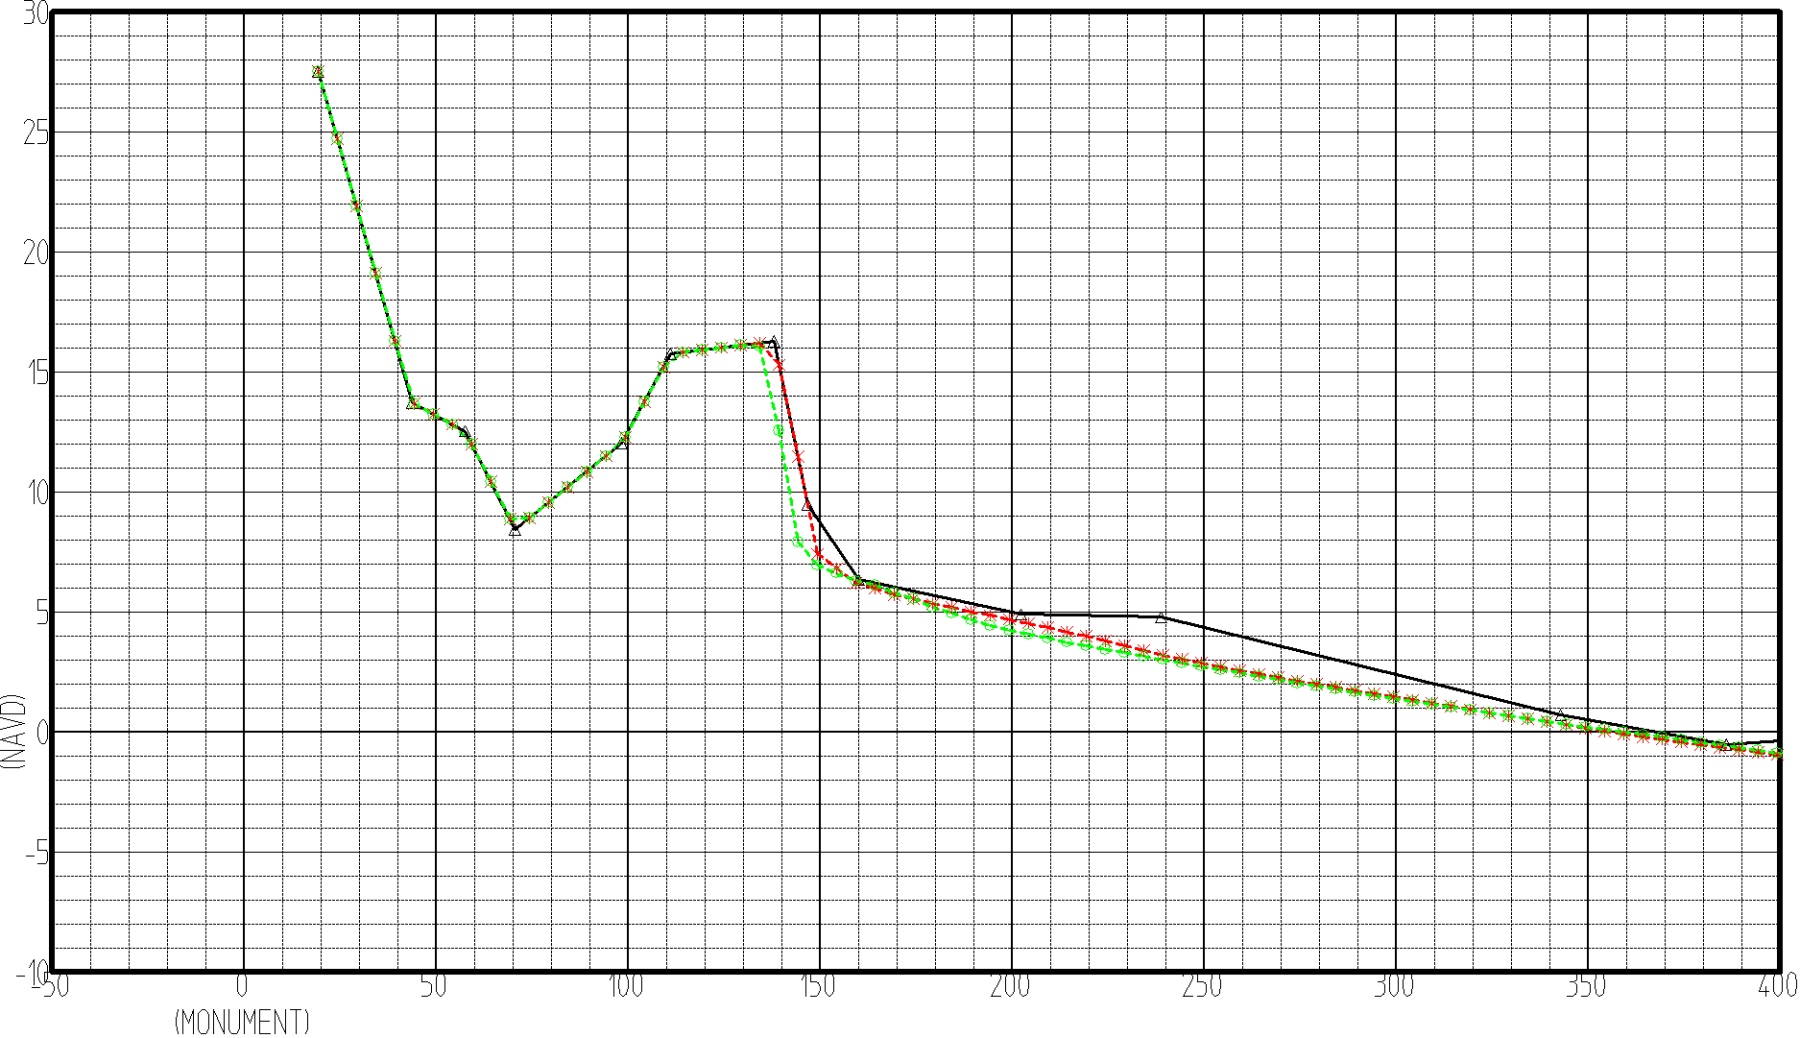
Range: R-173 2/2

BEACH PROFILE
 —△—△— ST. JOHNS 2007-2008 COMBI
 - - * - - 15YR SBEACH ERODED
 - - o - - 25YR SBCH ERODED

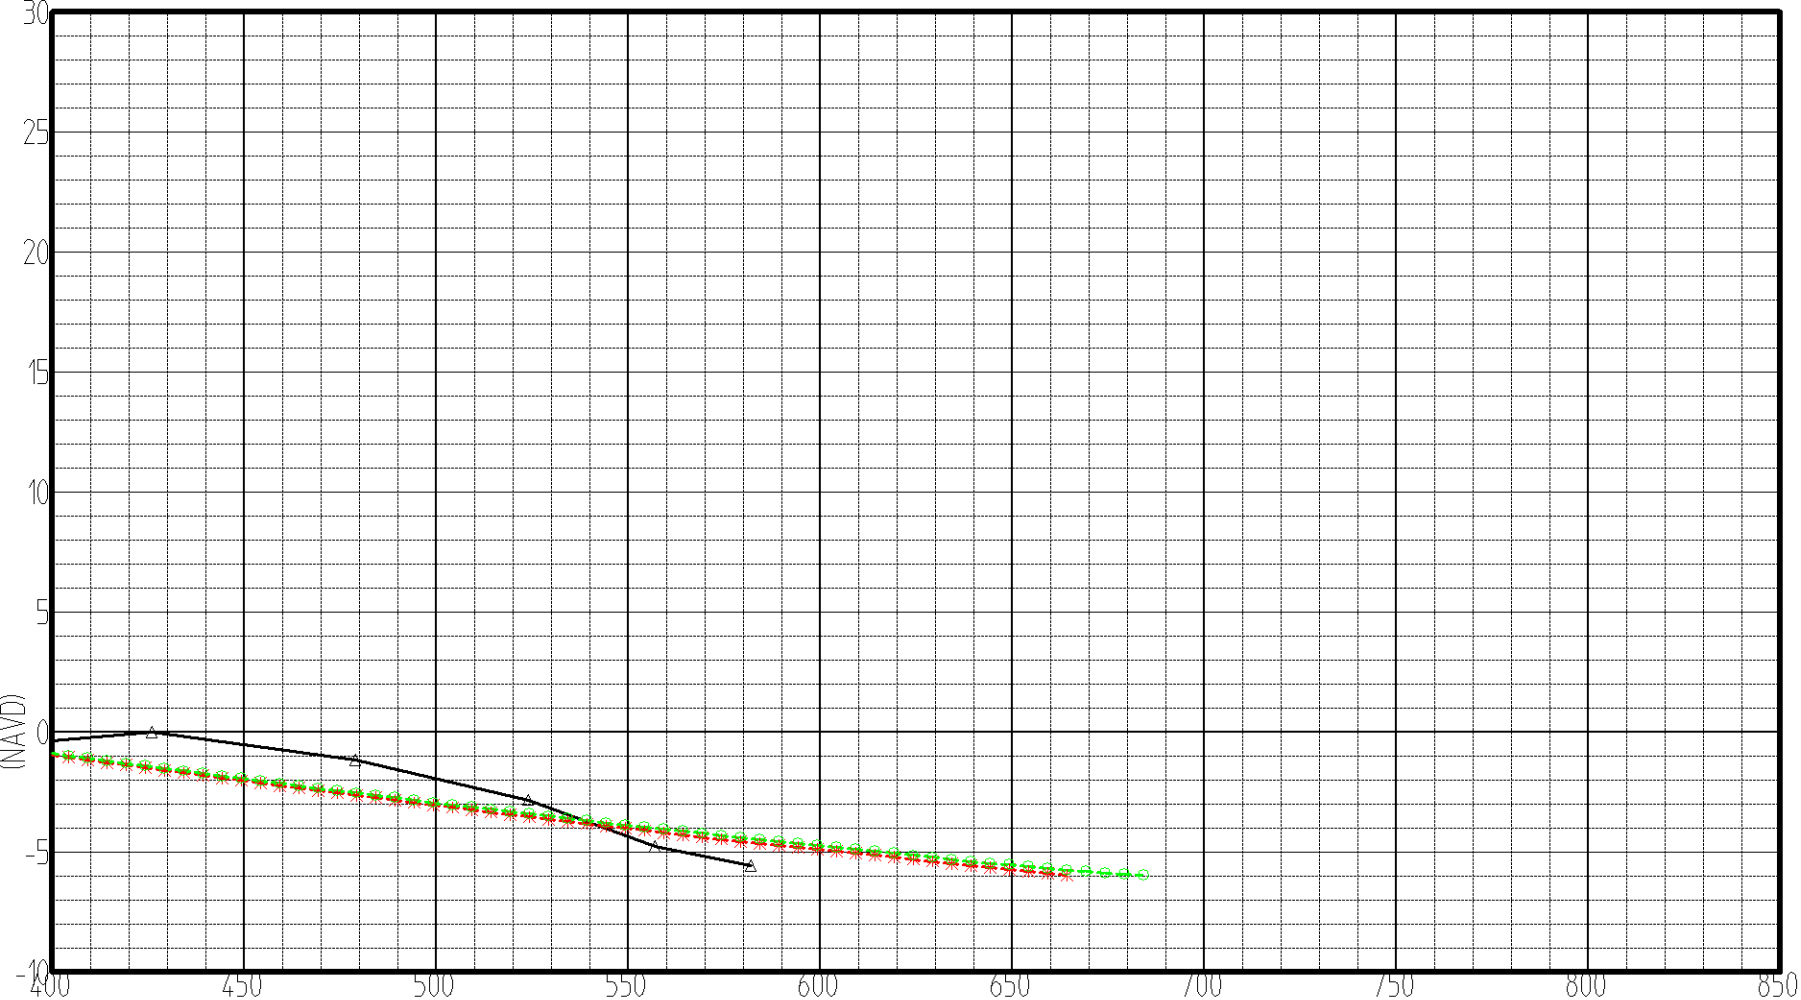
Range: R-174
 BEARING: 75.00
 1/2

BEACH PROFILE
 —△—△— ST. JOHNS 2007-2008 COMBI
 - - * - - 15YR SBEACH ERODED
 - - o - - 25YR SBCH ERODED

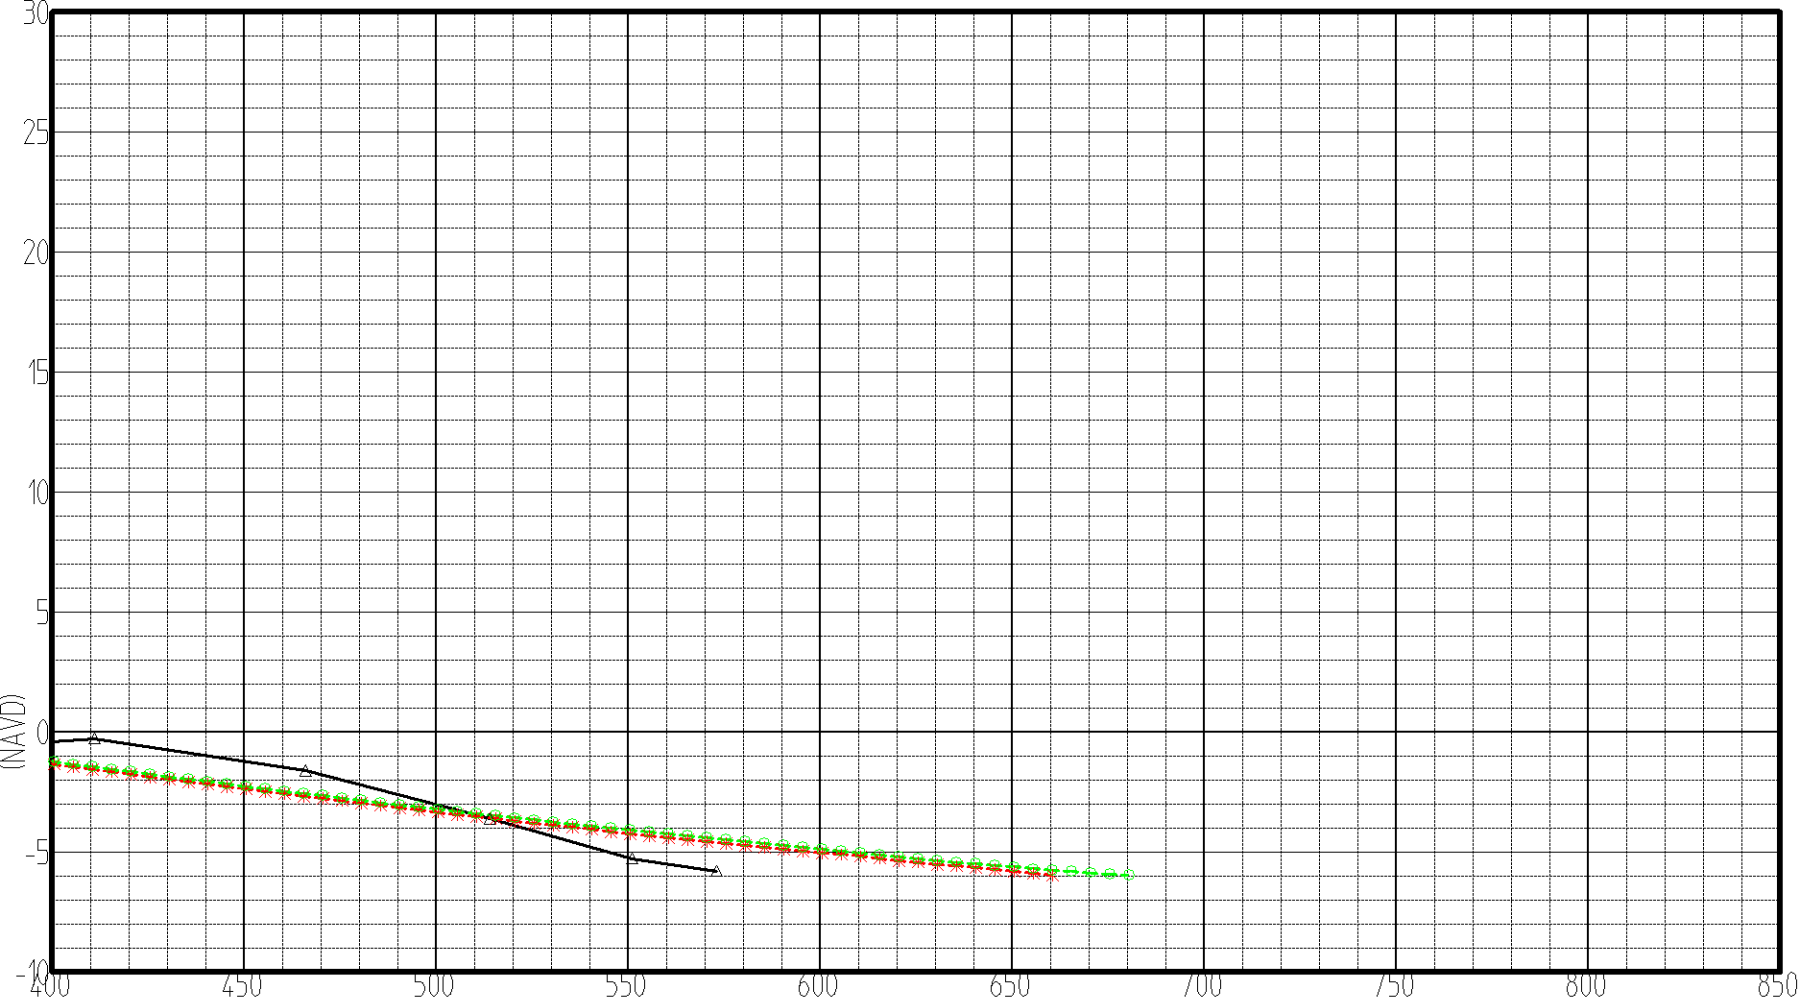
Range: R-175 1/2

BEACH PROFILE
 —△—△— ST. JOHNS 2007-2008 COMBI
 - - * - - * - - 15YR SBCH ERODED
 - - o - - o - - 25YR SBCH ERODED
