Appendix VIII

SBEACH 15 and 25 yr. Storm Erosion Profiles

St. Johns County

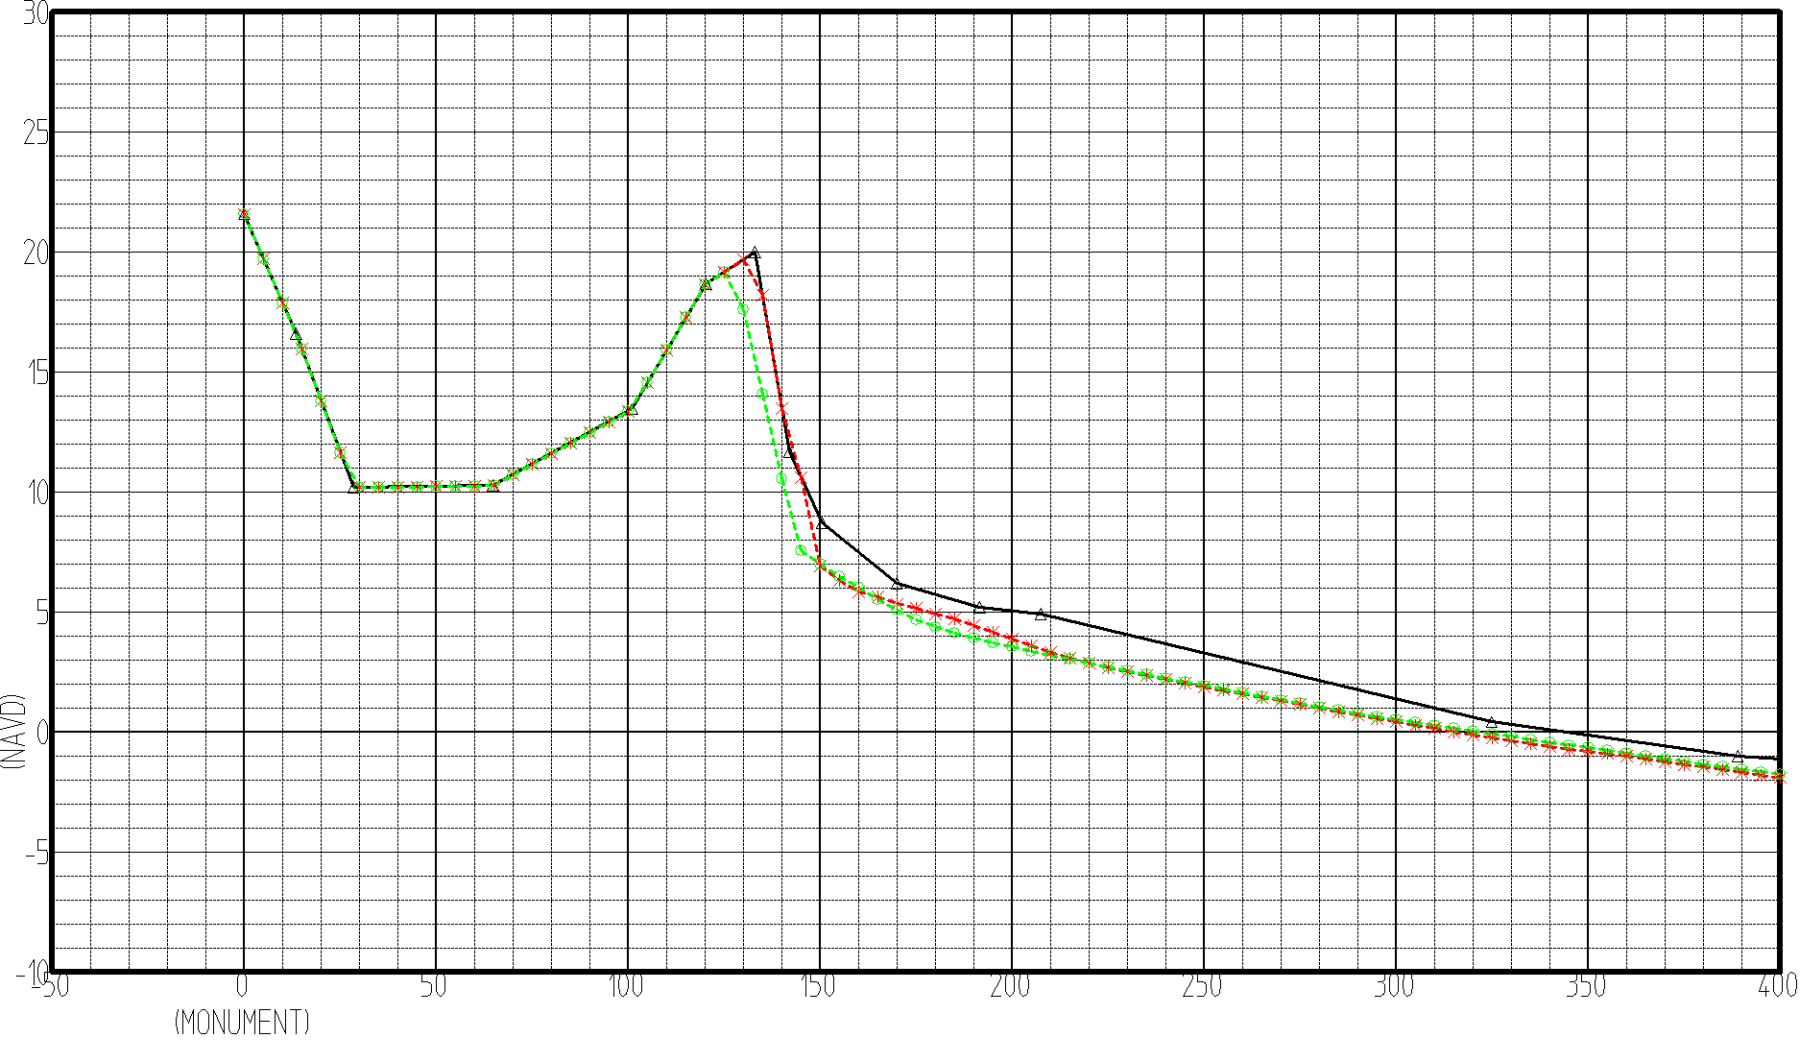
Range: R-175
 BEARING: 75.00
 2/2

BEACH PROFILE
 —△—△— ST. JOHNS 2007-2008 COMBI
 - - * - - 15YR SBEACH ERODED
 - - o - - 25YR SBCH ERODED

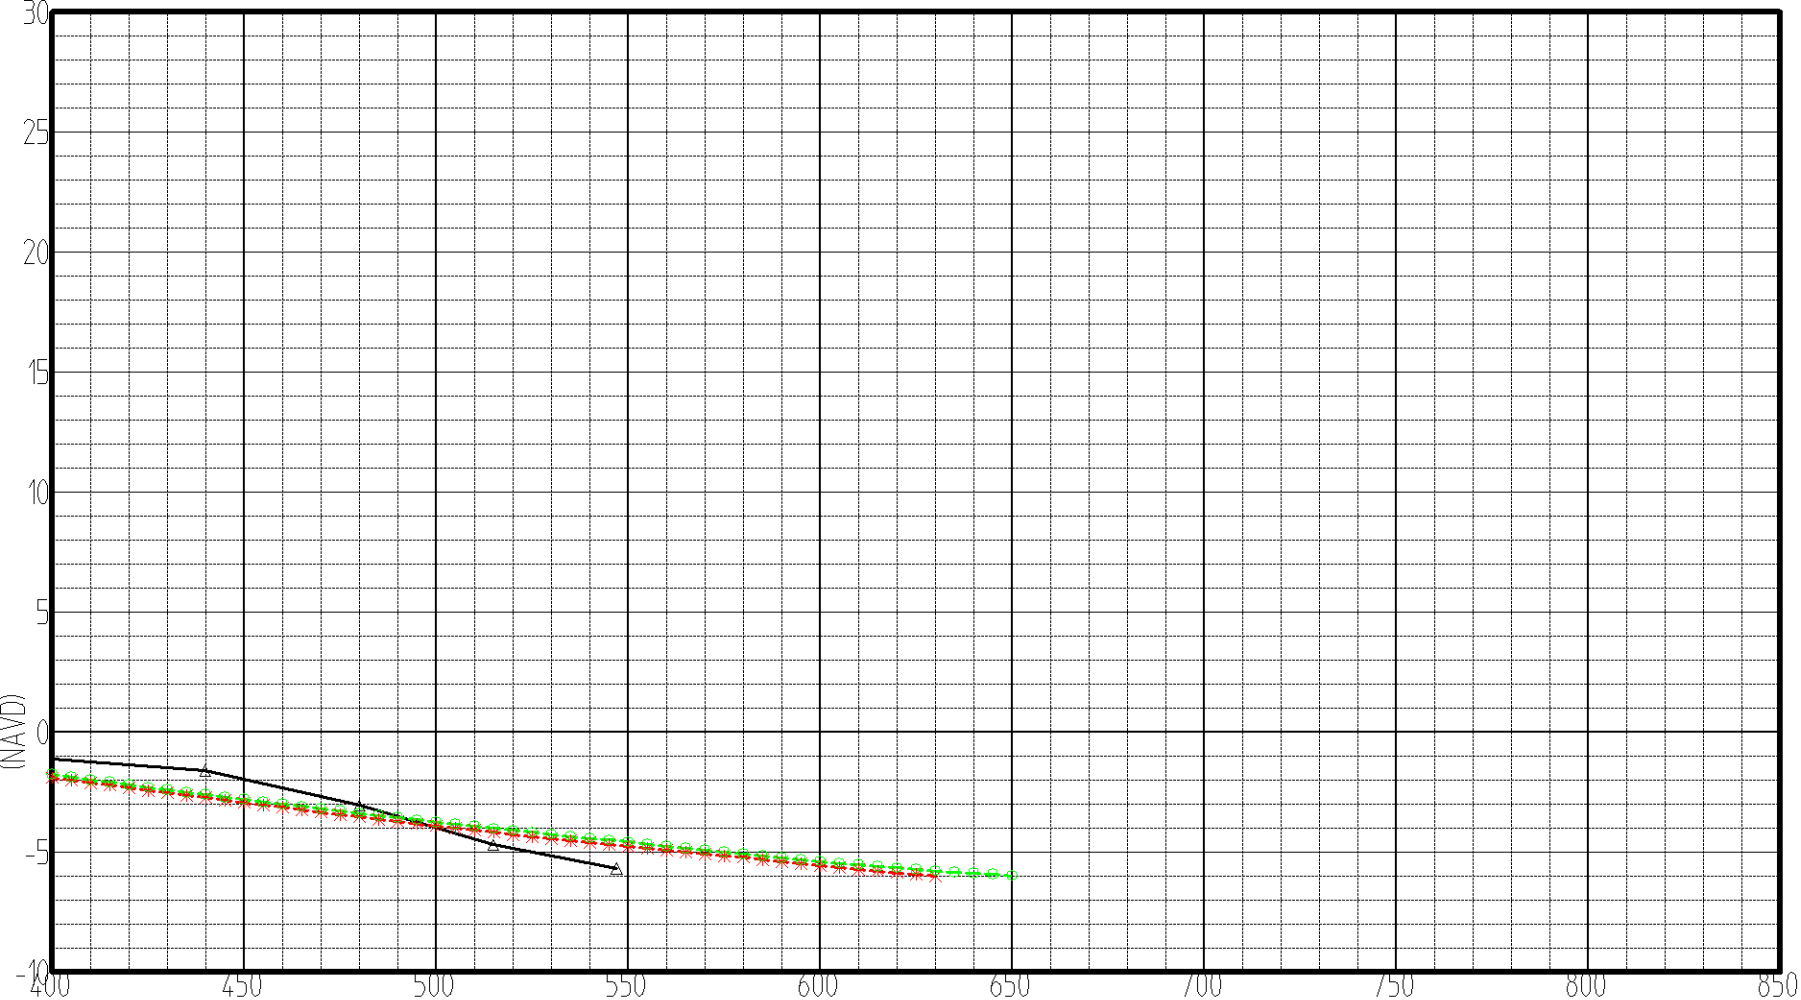
Range: R-176
 BEARING: 75.00
 1/2

BEACH PROFILE

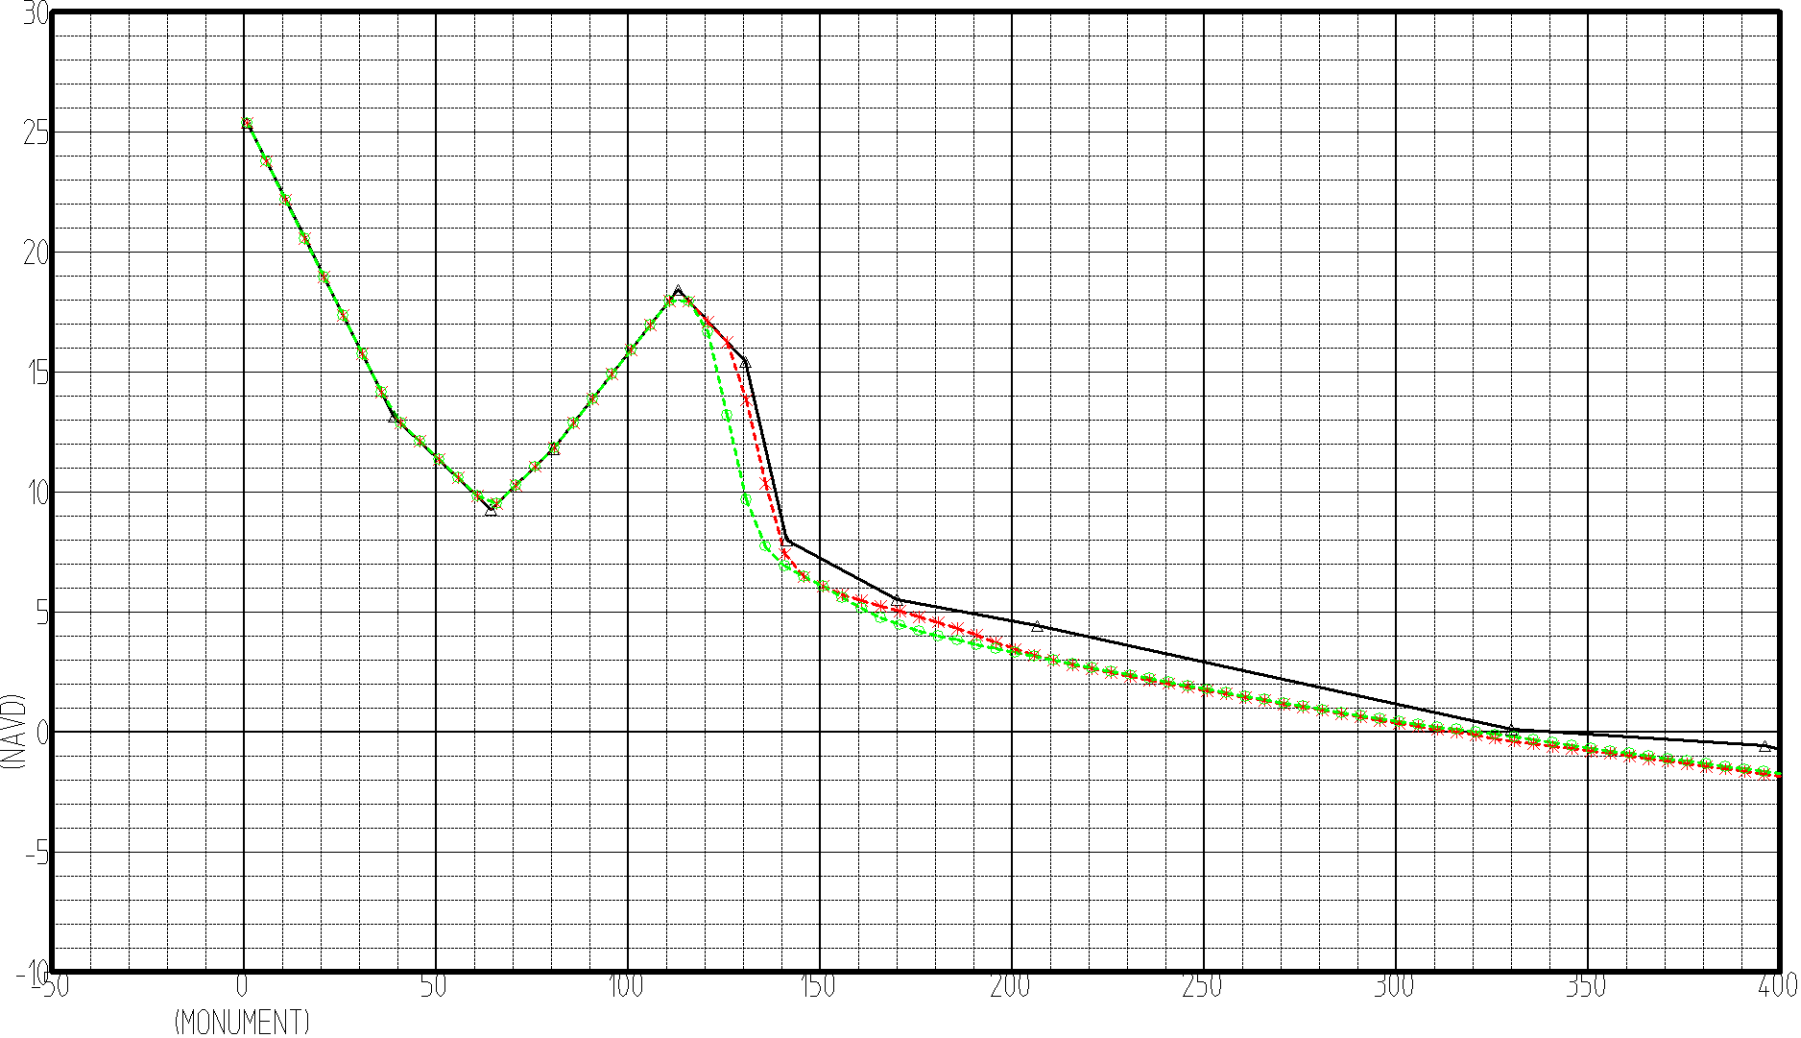
Range: R-176

BEACH PROFILE
 —△—△— ST. JOHNS 2007-2008 COMBI
 - - * - - 15YR SBEACH ERODED
 - - o - - 25YR SBCH ERODED

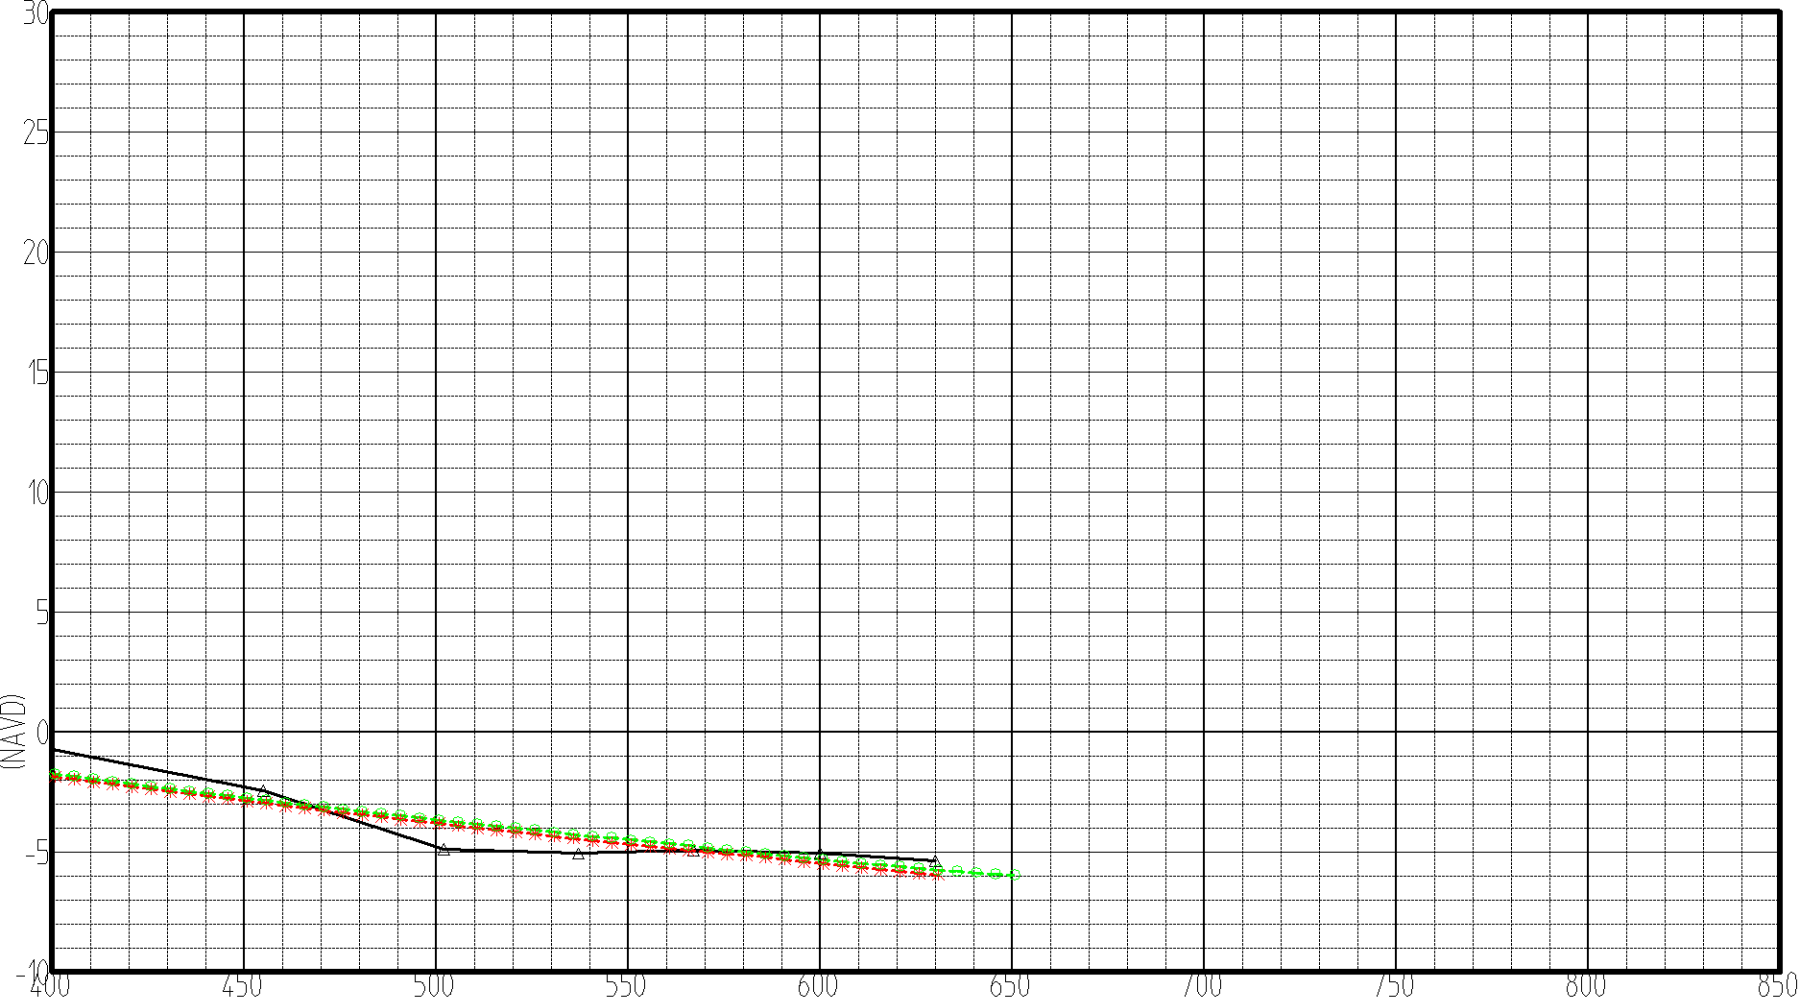
Range: R-177
 BEARING: 75.00
 1/2

BEACH PROFILE
 —△—△— ST. JOHNS 2007-2008 COMBI
 - - * - - 15YR SBACH ERODED
 - - o - - 25YR SBCH ERODED

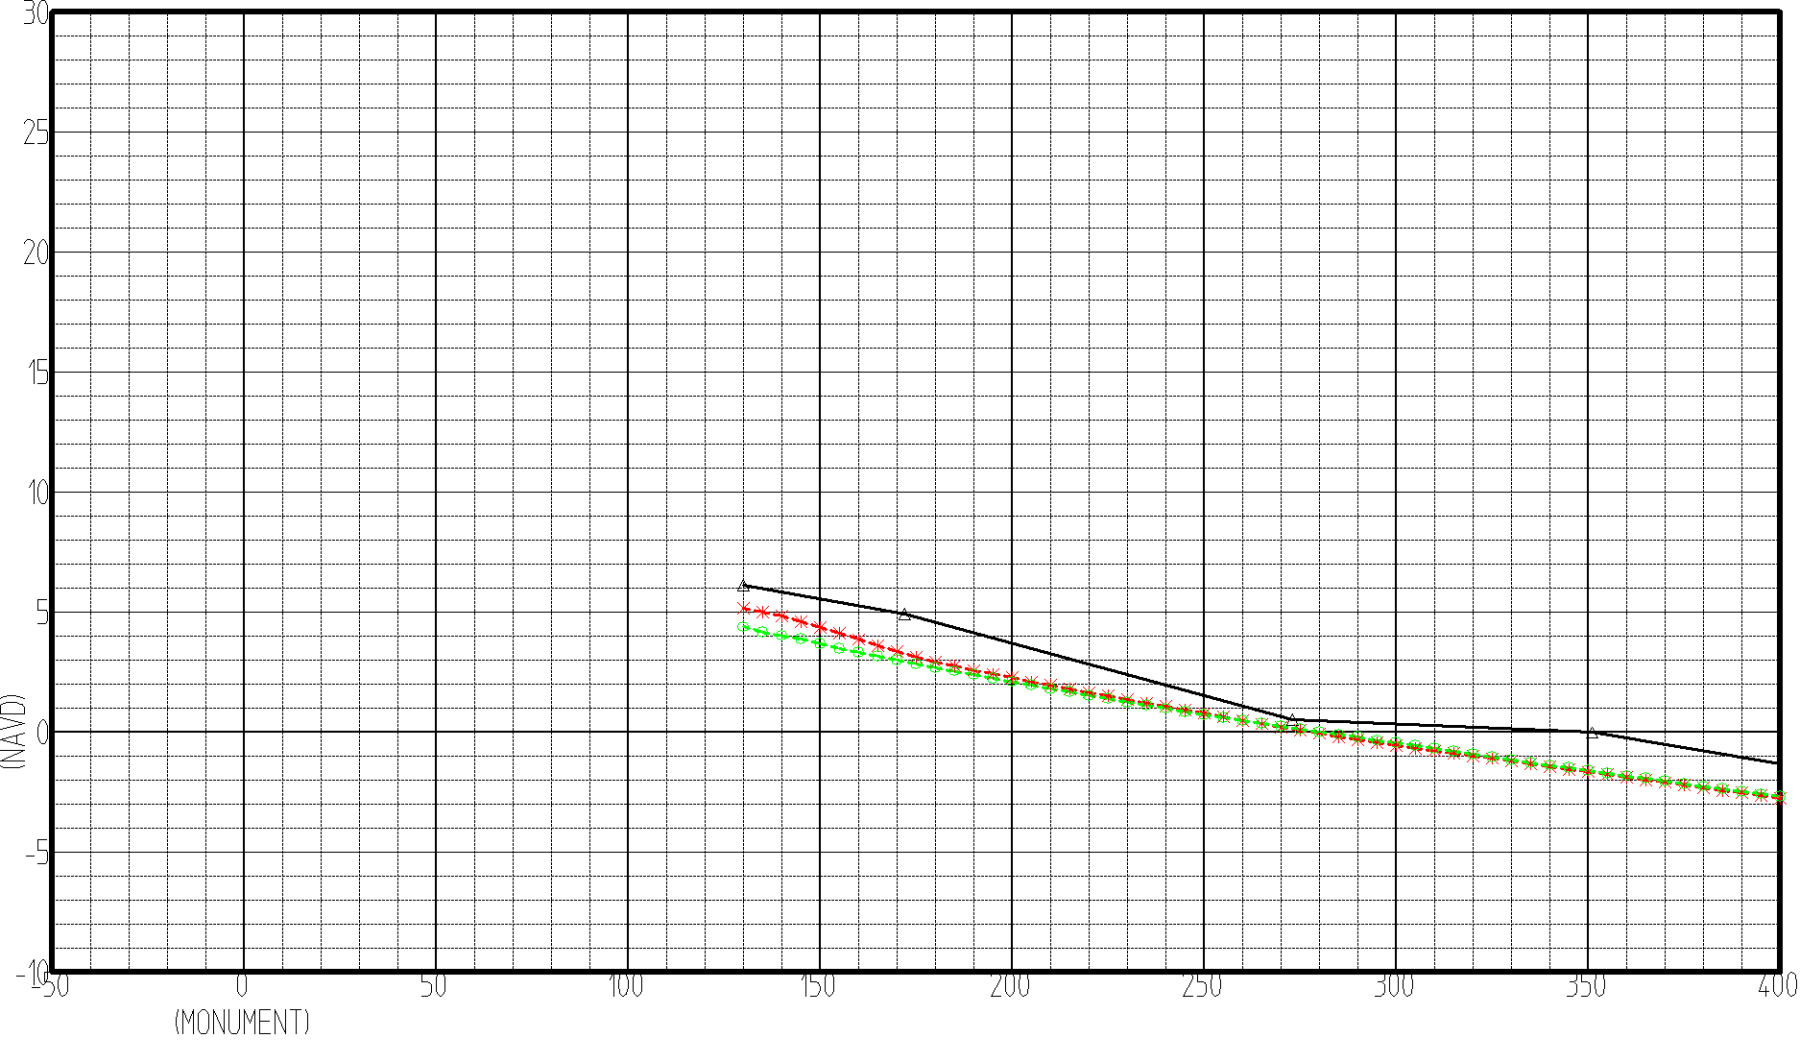
Range: R-177
 BEARING: 75.00
 2/2

BEACH PROFILE
 —△— ST. JOHNS 2007-2008 COMBI
 - - * - - 15YR SBEACH ERODED
 - - ○ - - 25YR SBCH ERODED

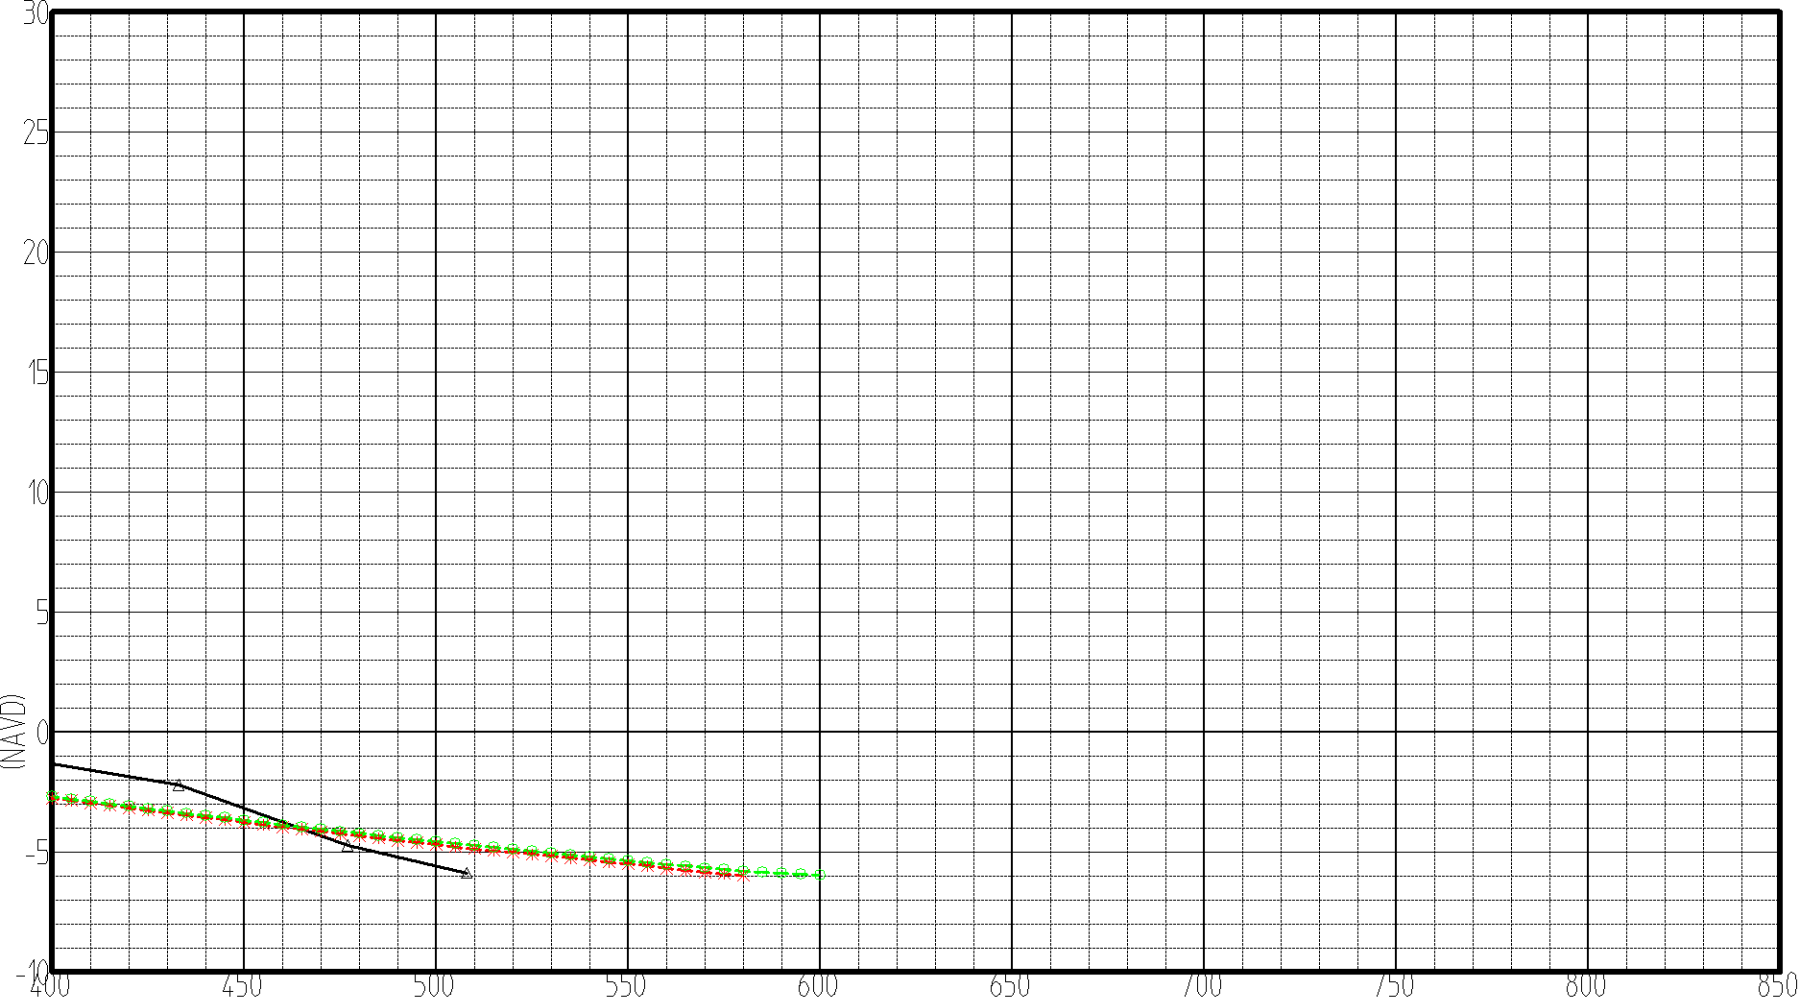
Range: R-178
 BEARING: 75.00
 1/2

BEACH PROFILE

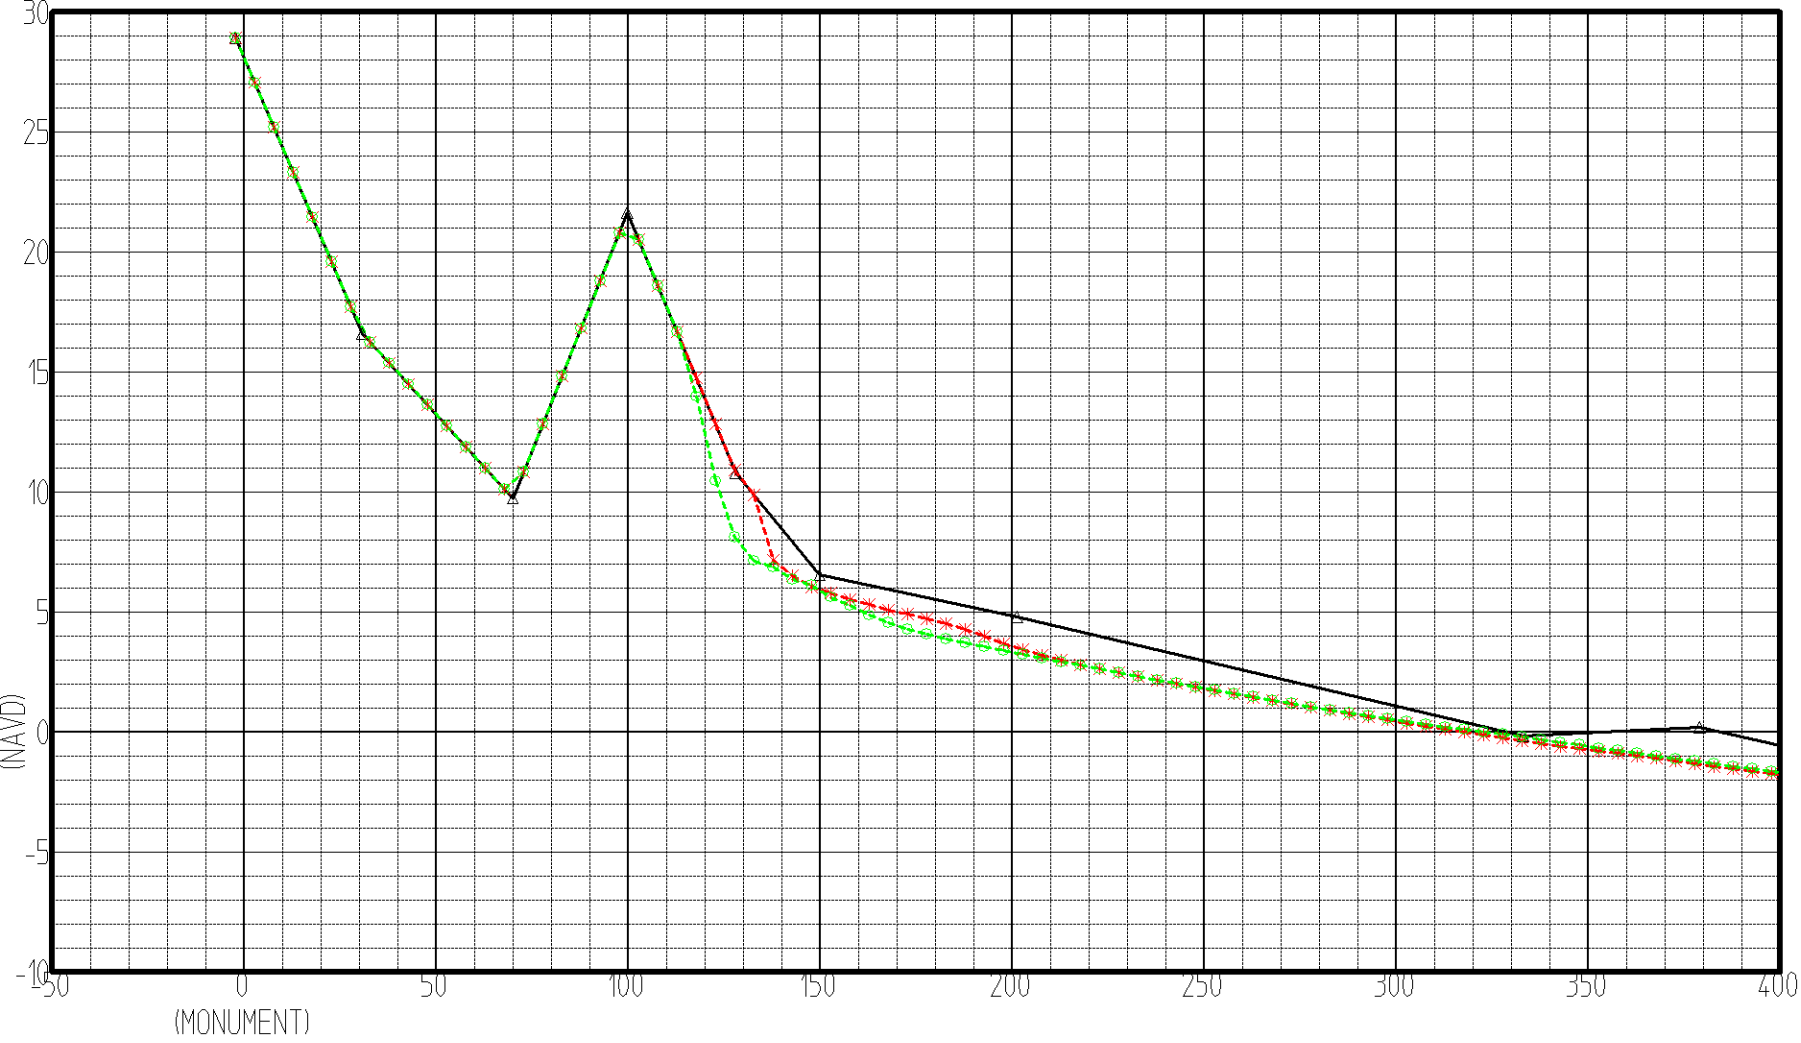
Range: R-178

BEACH PROFILE
 —△—△— ST. JOHNS 2007-2008 COMBI
 - - * - - - 15YR SBEACH ERODED
 - - o - - - 25YR SBCH ERODED

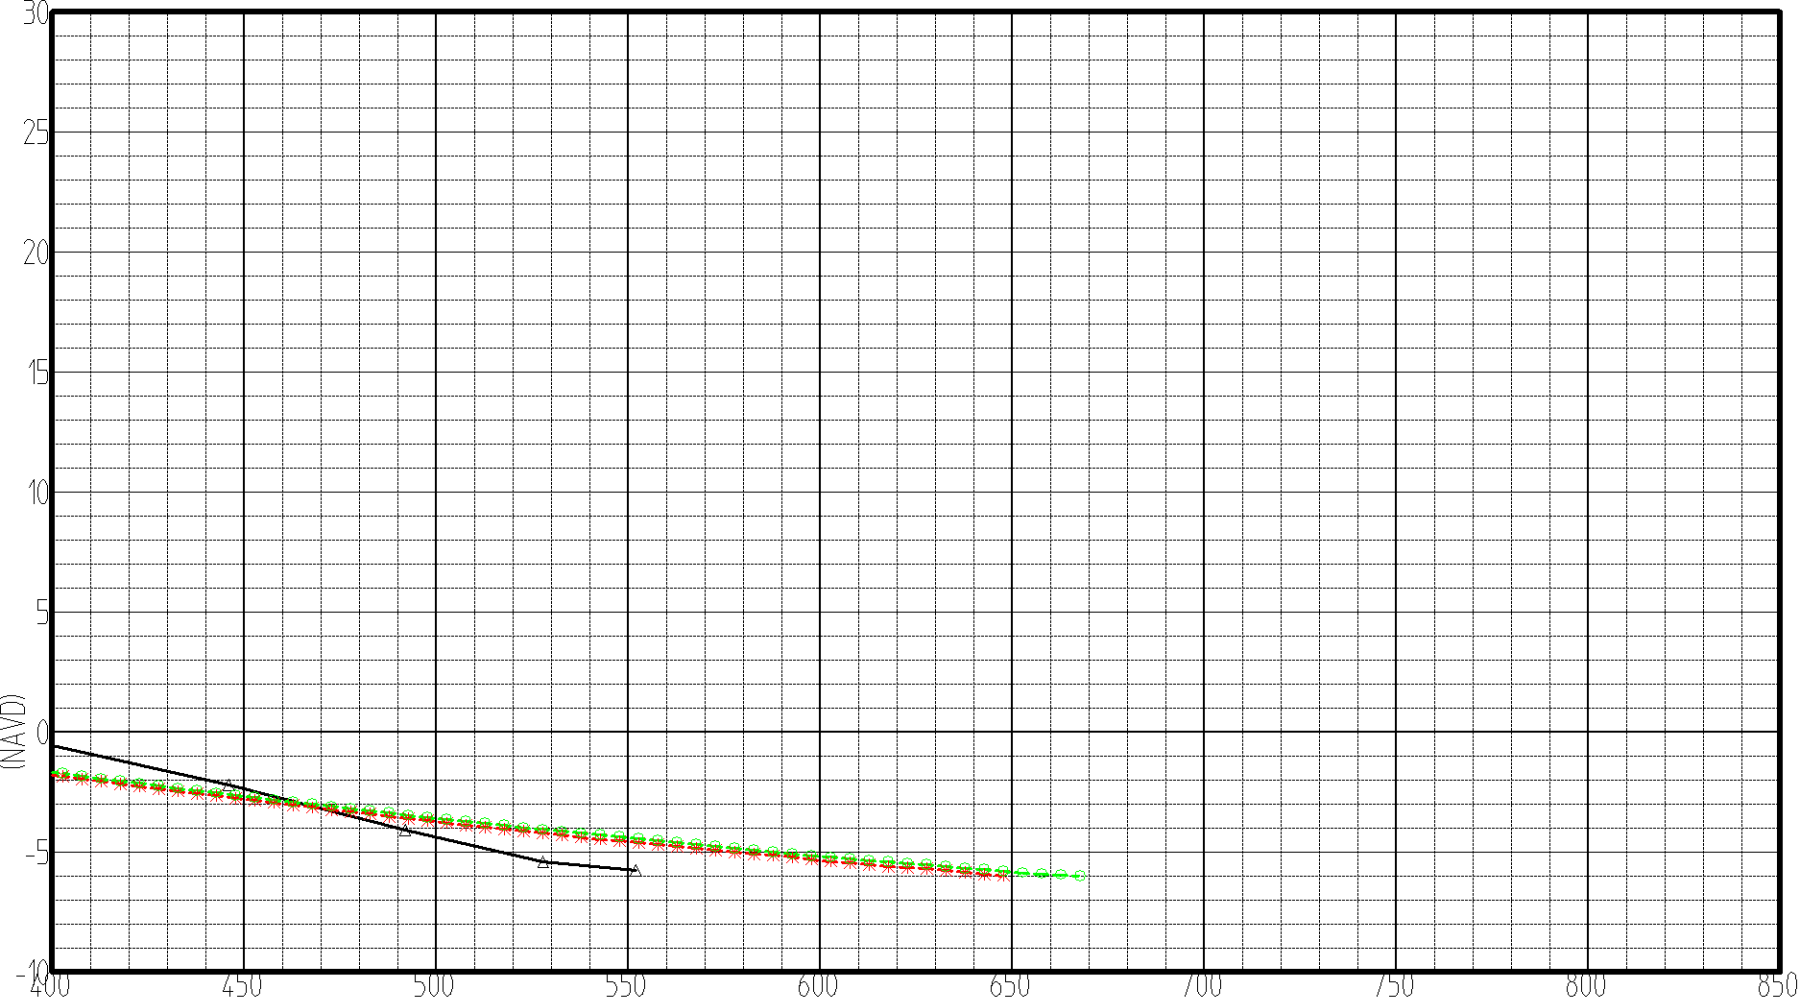
Range: R-179
 BEARING: 75.00
 1/2

BEACH PROFILE
 —△—△— ST. JOHNS 2007-2008 COMBI
 - - * - - 15YR SBACH ERODED
 - - o - - 25YR SBCH ERODED

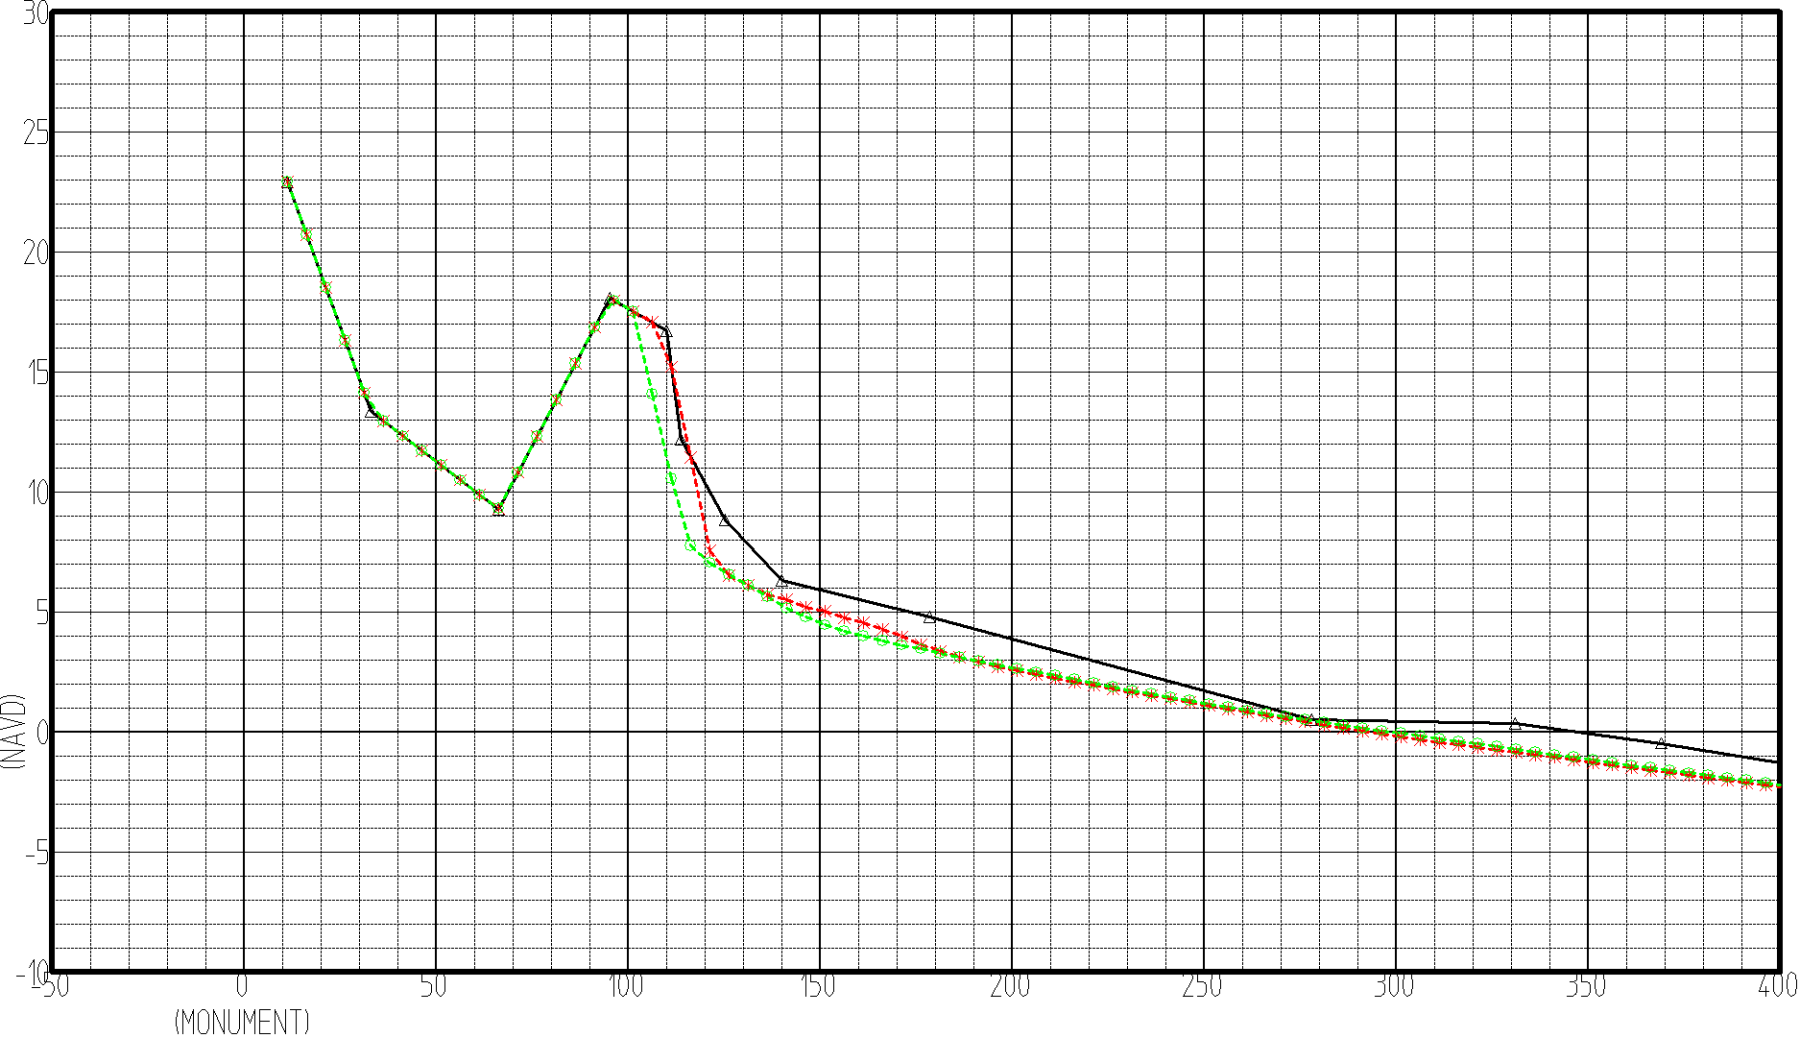
Range: R-179
 BEARING: 75.00
 2/2

BEACH PROFILE
 —△—△— ST. JOHNS 2007-2008 COMBI
 - - * - - 15YR SBEACH ERODED
 - - o - - 25YR SBCH ERODED

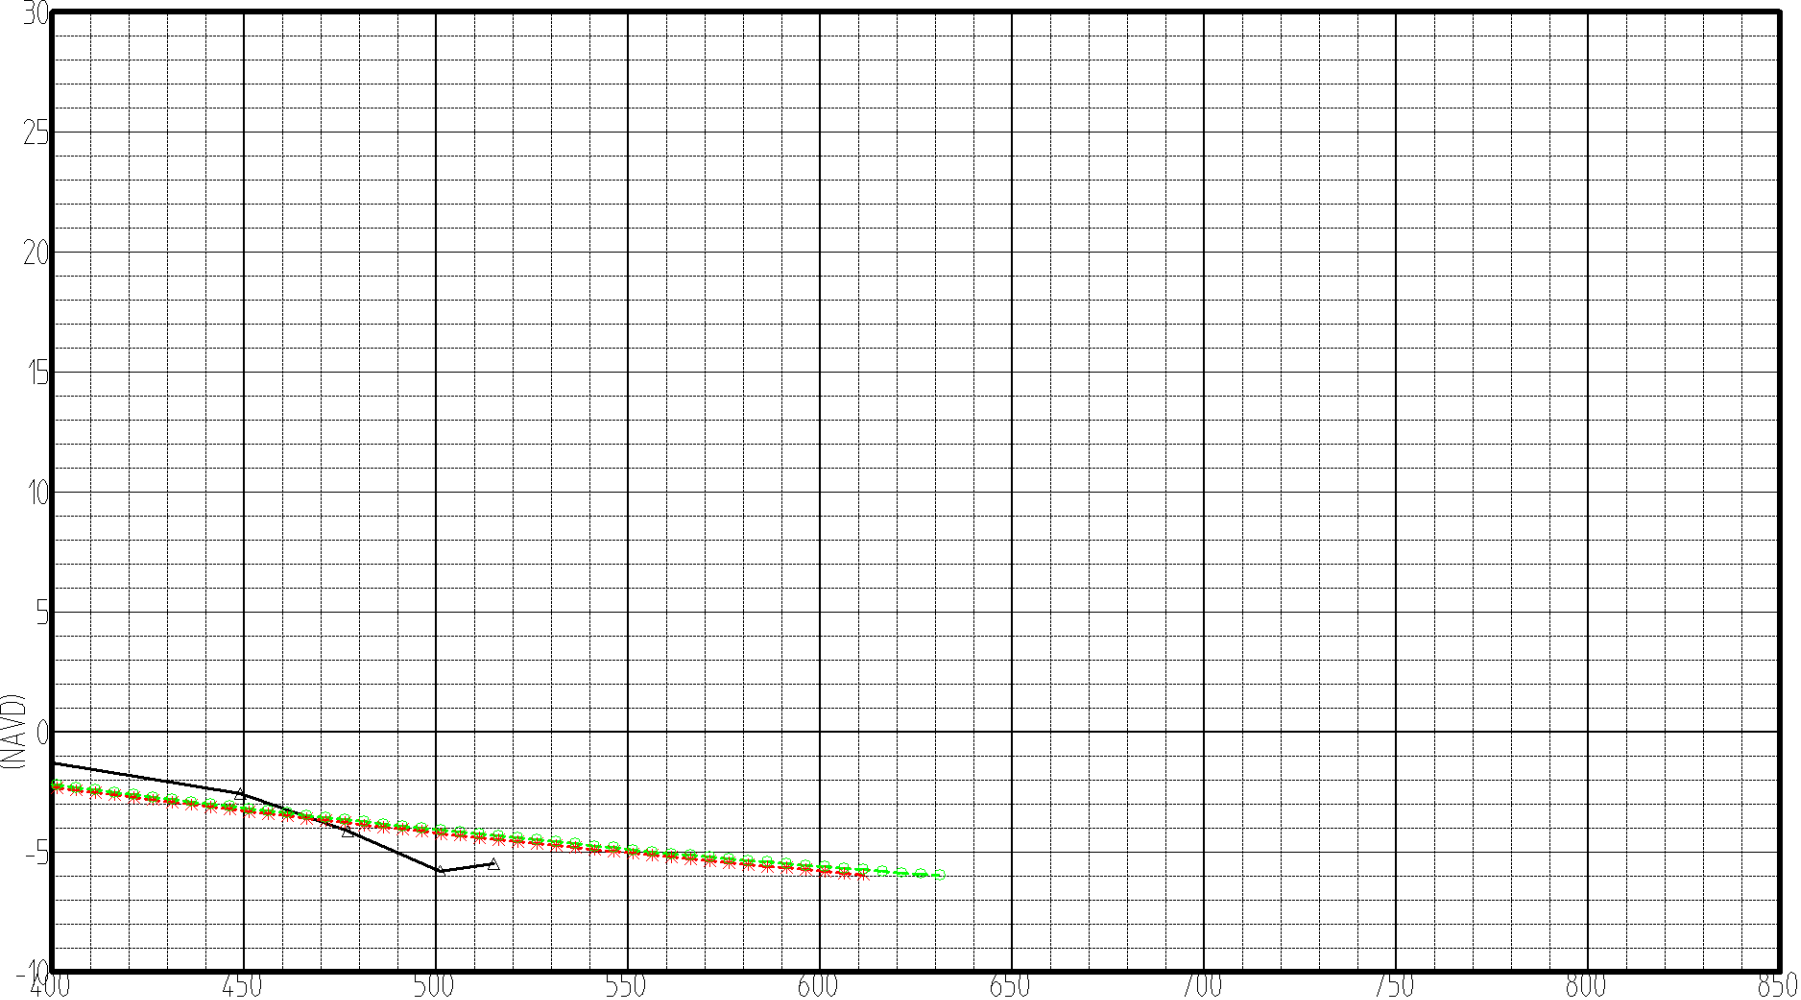
Range: R-180
 BEARING: 75.00
 1/2

BEACH PROFILE

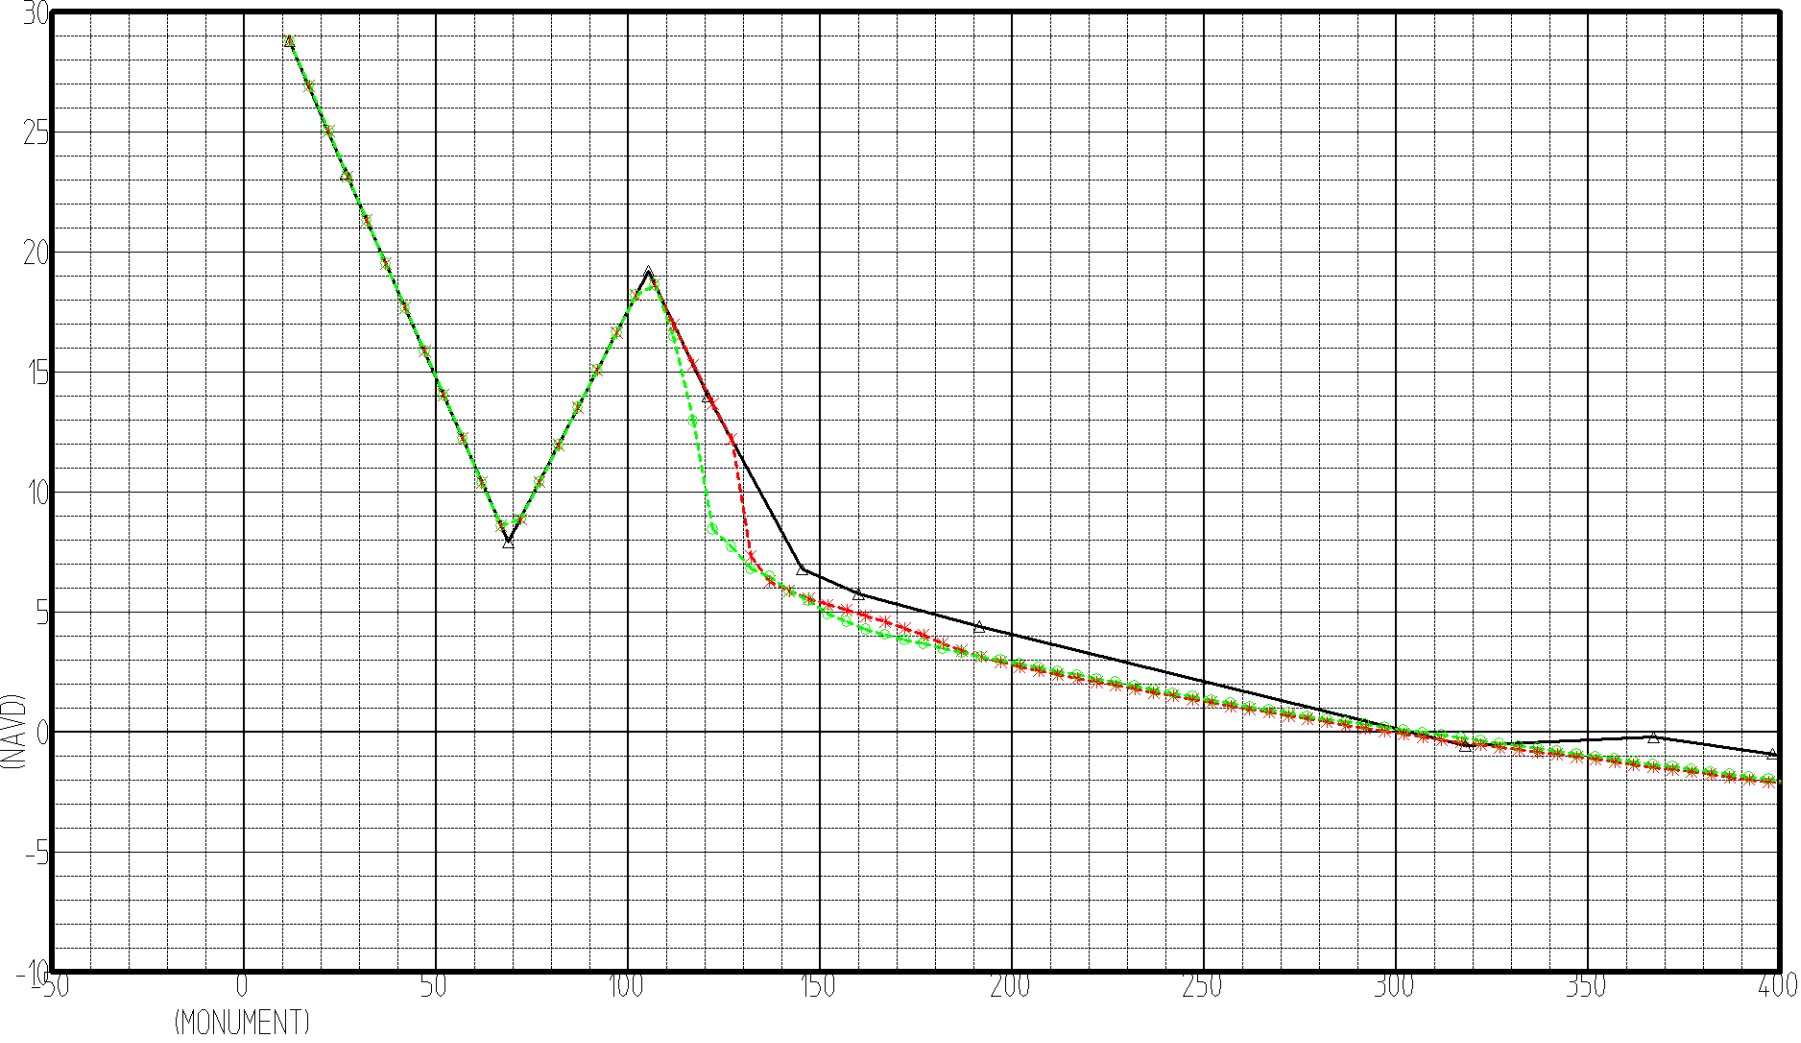
Range: R-180

BEACH PROFILE
 —△—△— ST. JOHNS 2007-2008 COMBI
 - - * - - 15YR SBCH ERODED
 - - o - - 25YR SBCH ERODED

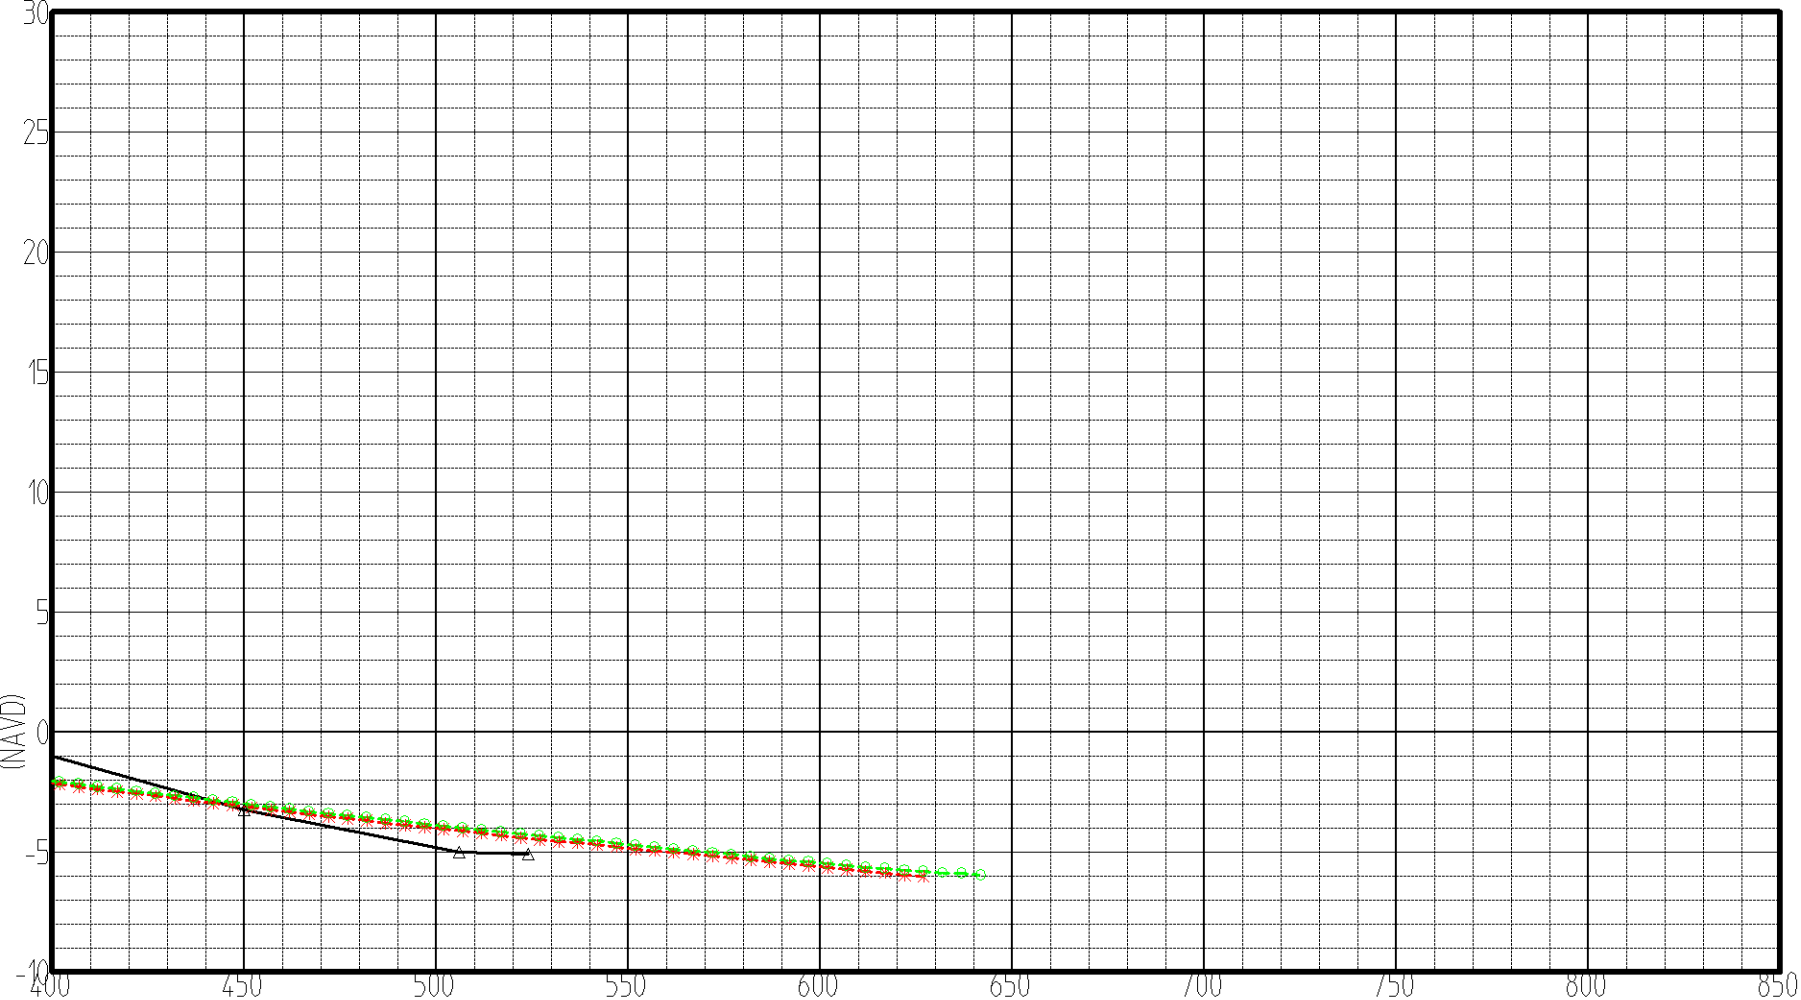
Range: T-181
 BEARING: 75.00
 1/2

BEACH PROFILE
 —△—△— ST. JOHNS 2007-2008 COMBI
 - - * - - 15YR SBCH ERODED
 - - o - - 25YR SBCH ERODED
