Appendix VIII

SBEACH 15 and 25 yr. Storm Erosion Profiles

St. Johns County

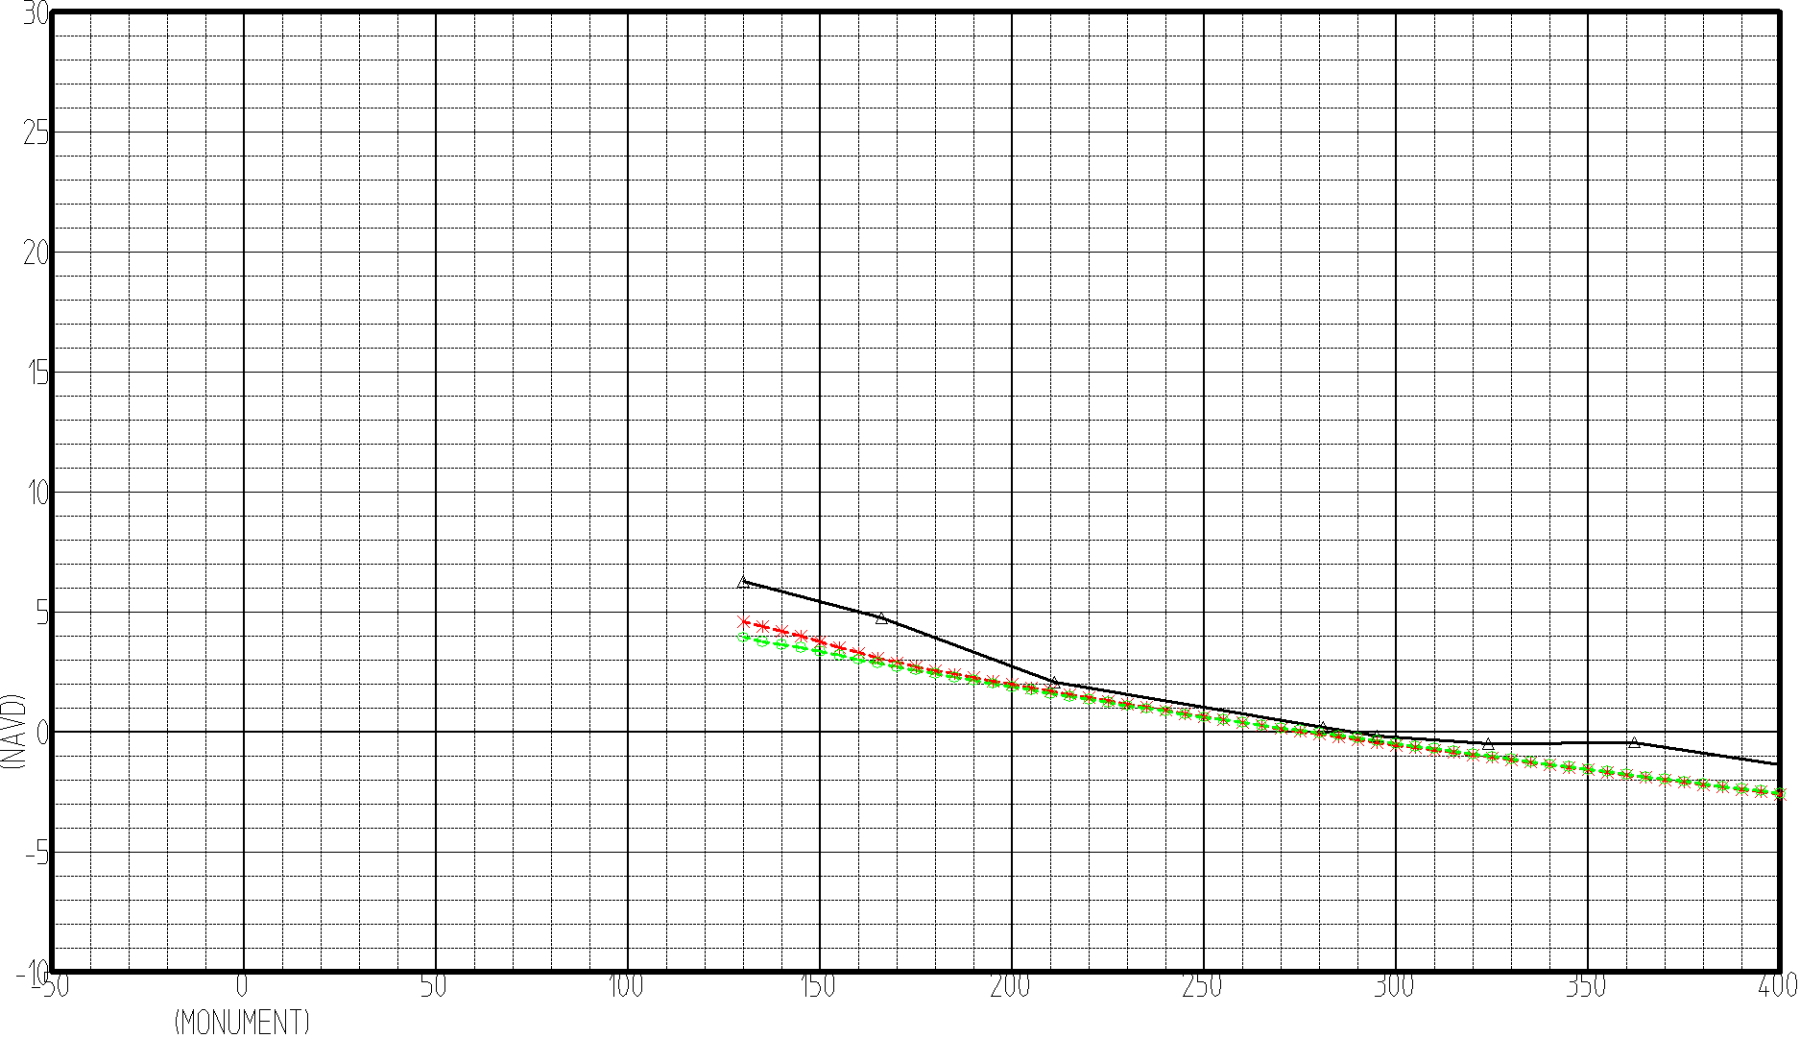
Range: T-181
 BEARING: 75.00
 2/2

BEACH PROFILE
 —△—△— ST. JOHNS 2007-2008 COMBI
 - - * - - - 15YR SBEACH ERODED
 - - o - - - 25YR SBCH ERODED

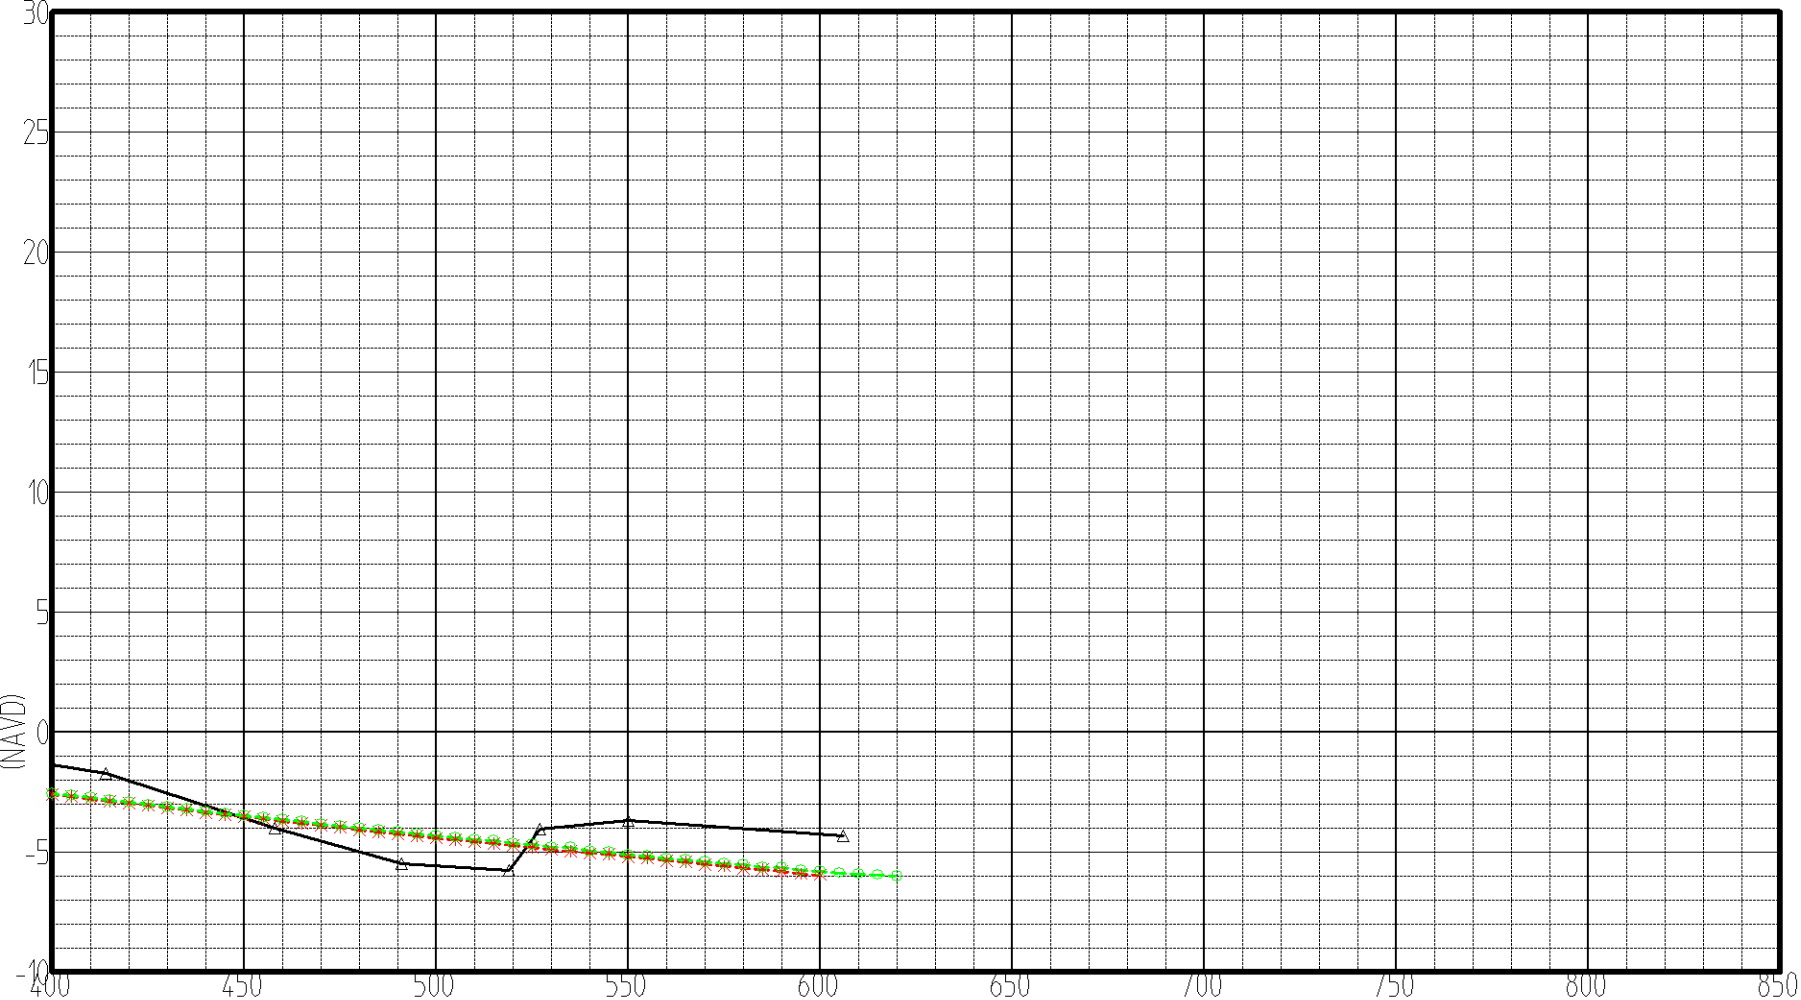
Range: R-182
 BEARING: 75.00
 1/2

BEACH PROFILE
 —△—△— ST. JOHNS 2007-2008 COMBI
 - - * - - 15YR SBACH ERODED
 - - o - - 25YR SBCH ERODED

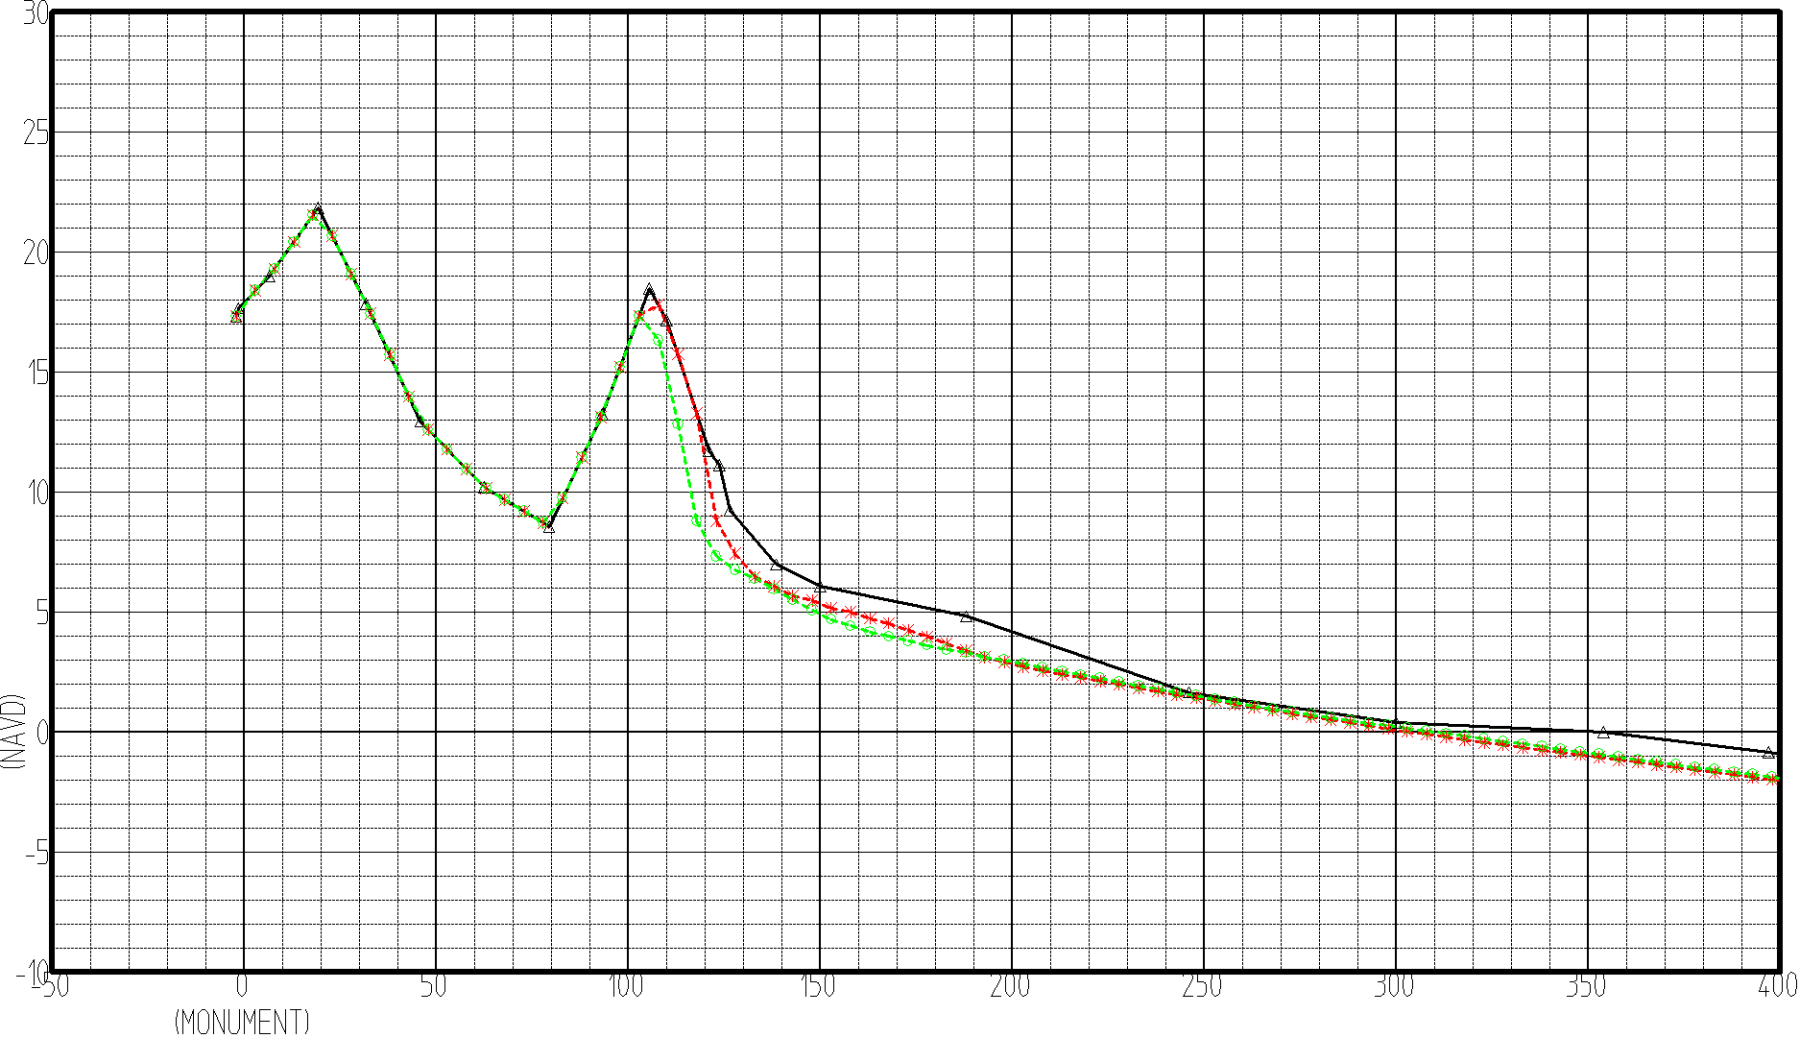
Range: R-182
 BEARING: 75.00
 2/2

BEACH PROFILE
 —△—△— ST. JOHNS 2007-2008 COMBI
 - - * - - 15YR SBACH ERODED
 - - o - - 25YR SBCH ERODED

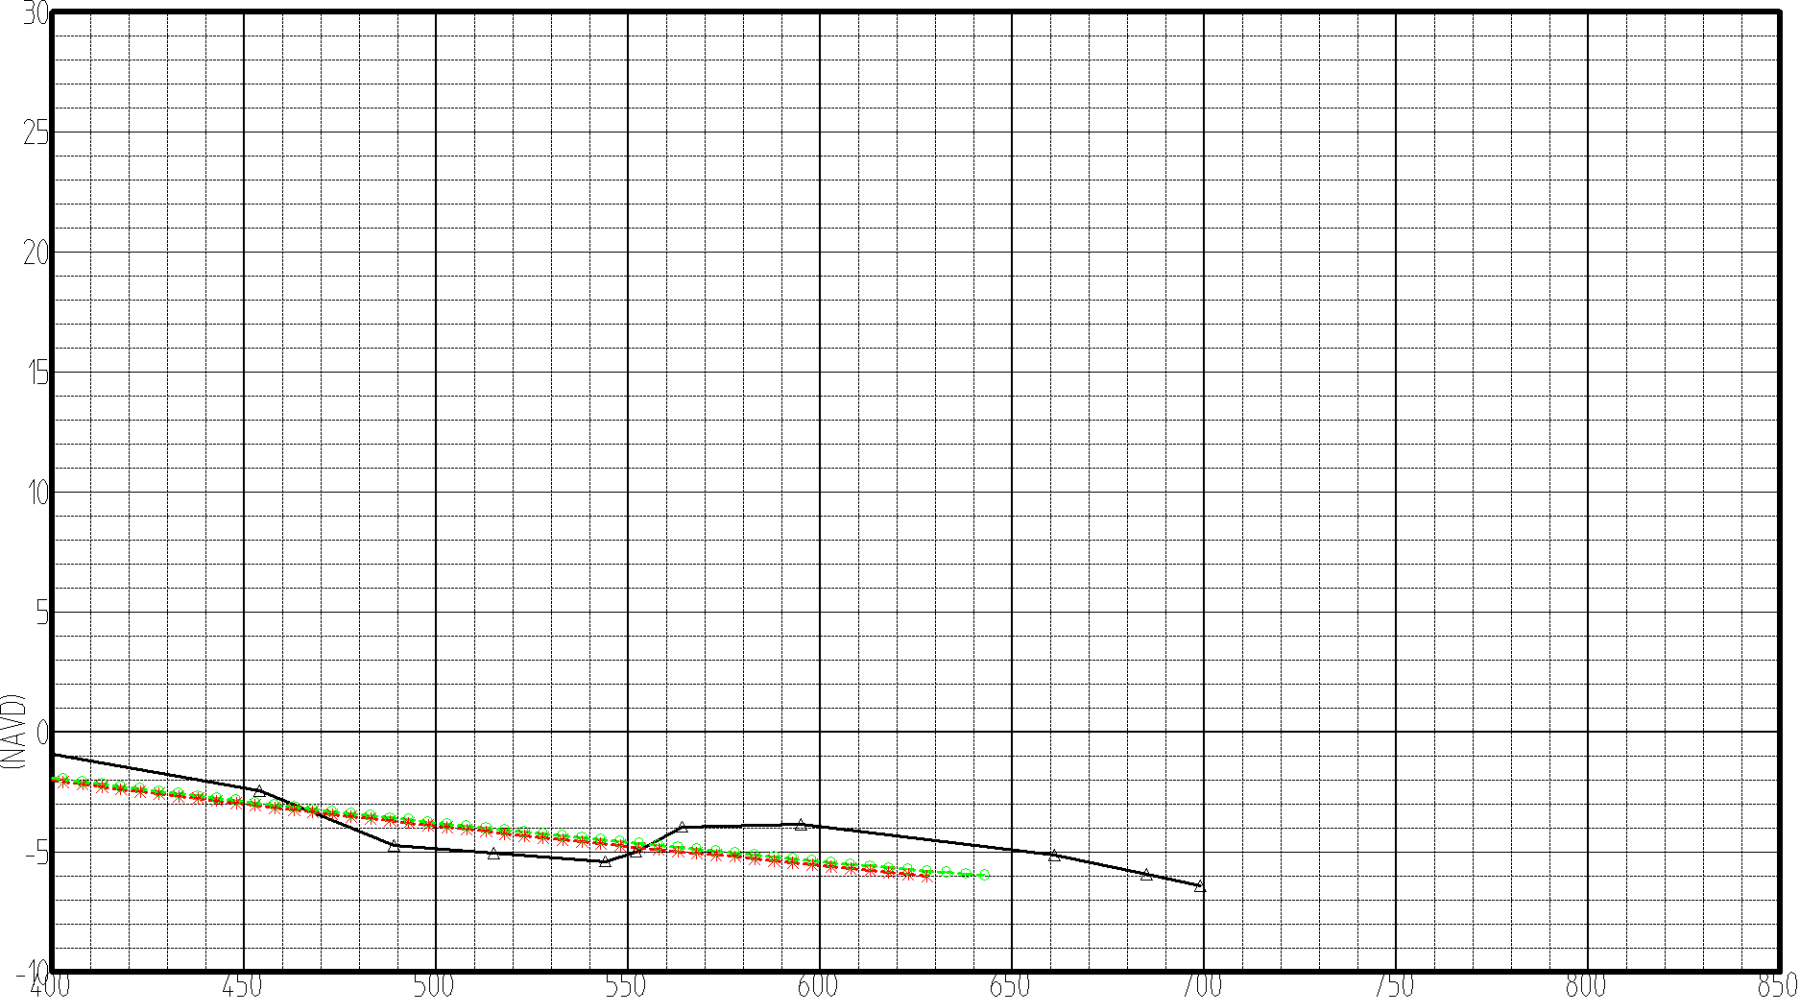
Range: T-183
 BEARING: 75.00
 1/2

BEACH PROFILE

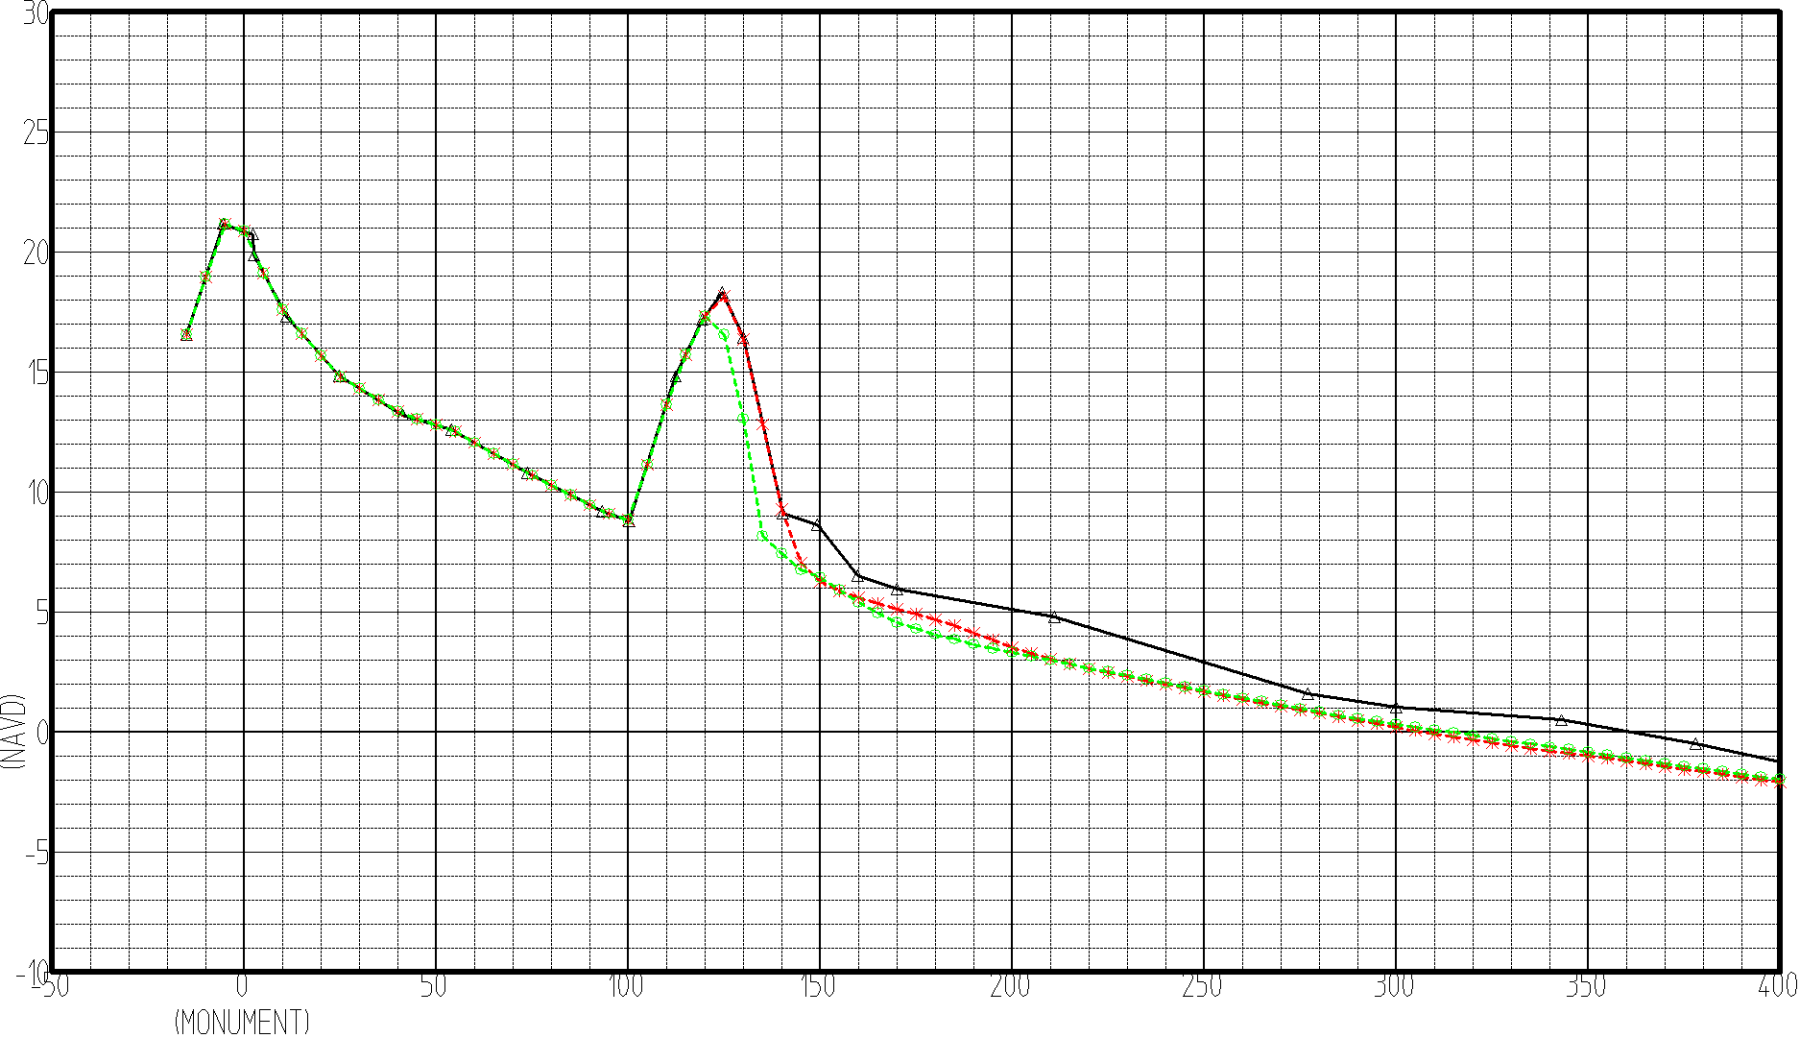
Range: T-183

BEACH PROFILE
 —△—△— ST. JOHNS 2007-2008 COMBI
 - - * - - 15YR SBEACH ERODED
 - - o - - 25YR SBCH ERODED

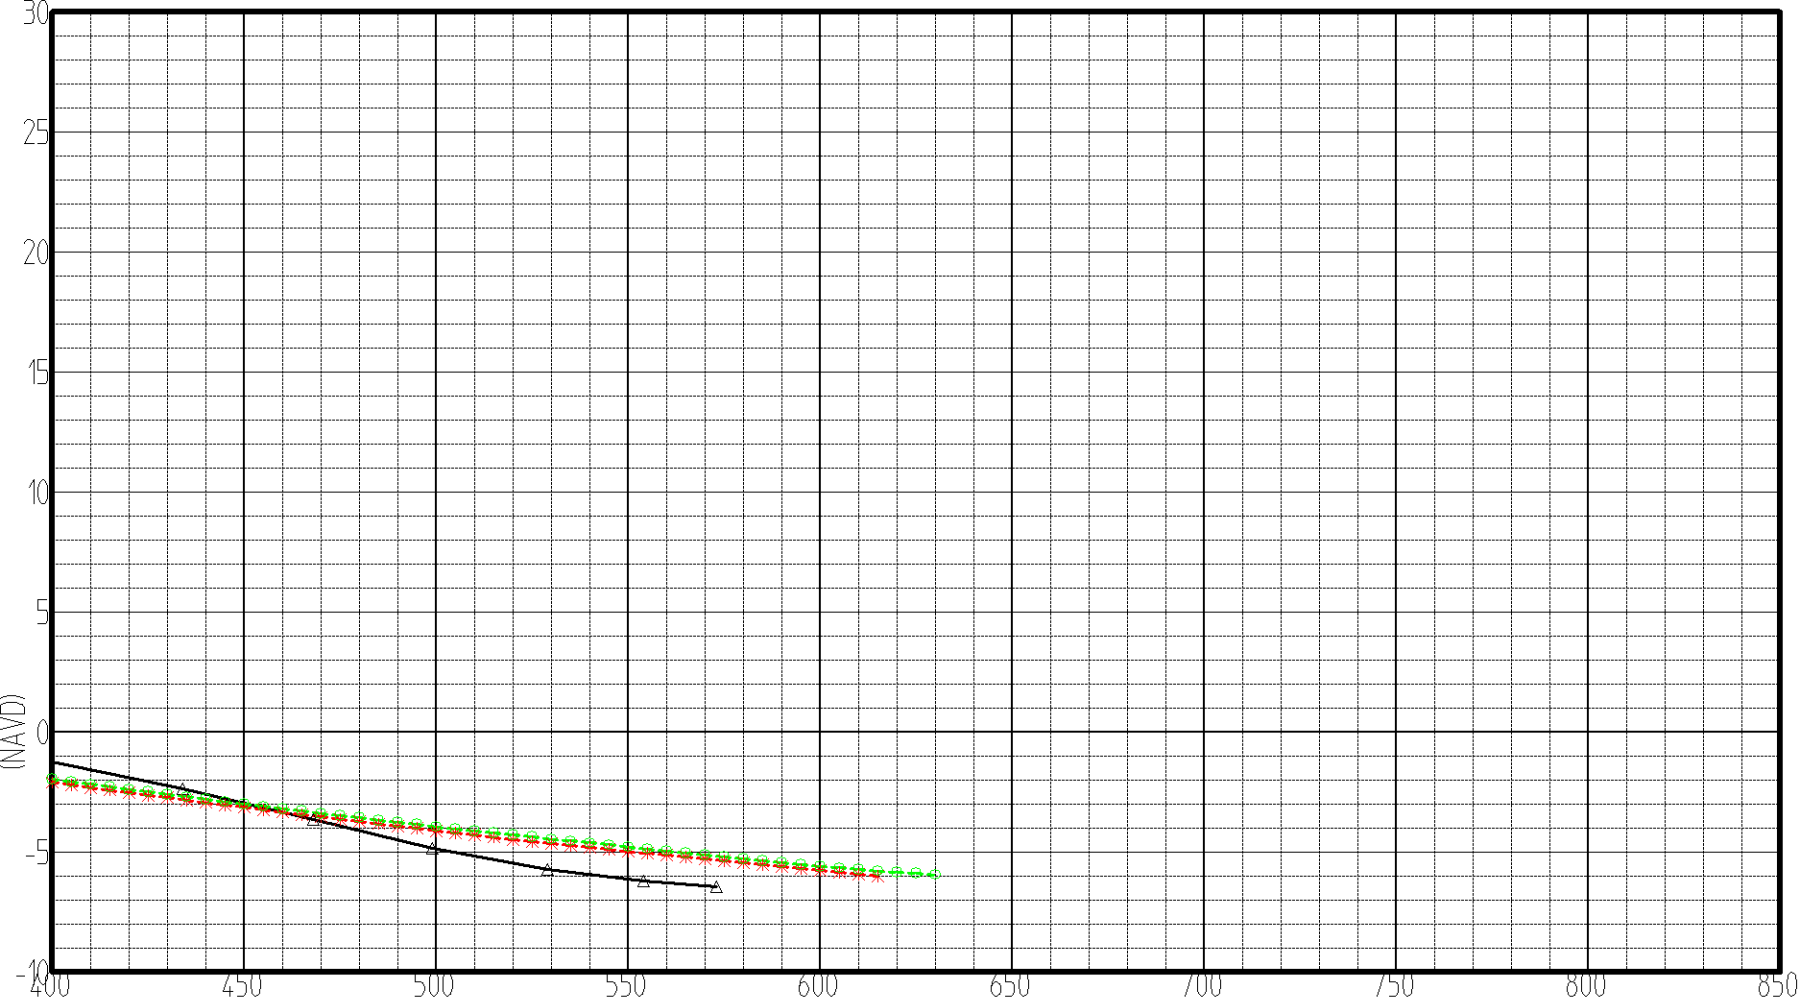
Range: T-184
 BEARING: 75.00
 1/2

BEACH PROFILE
 —△—△— ST. JOHNS 2007-2008 COMBI
 - - * - - 15YR SBEACH ERODED
 - - o - - 25YR SBCH ERODED

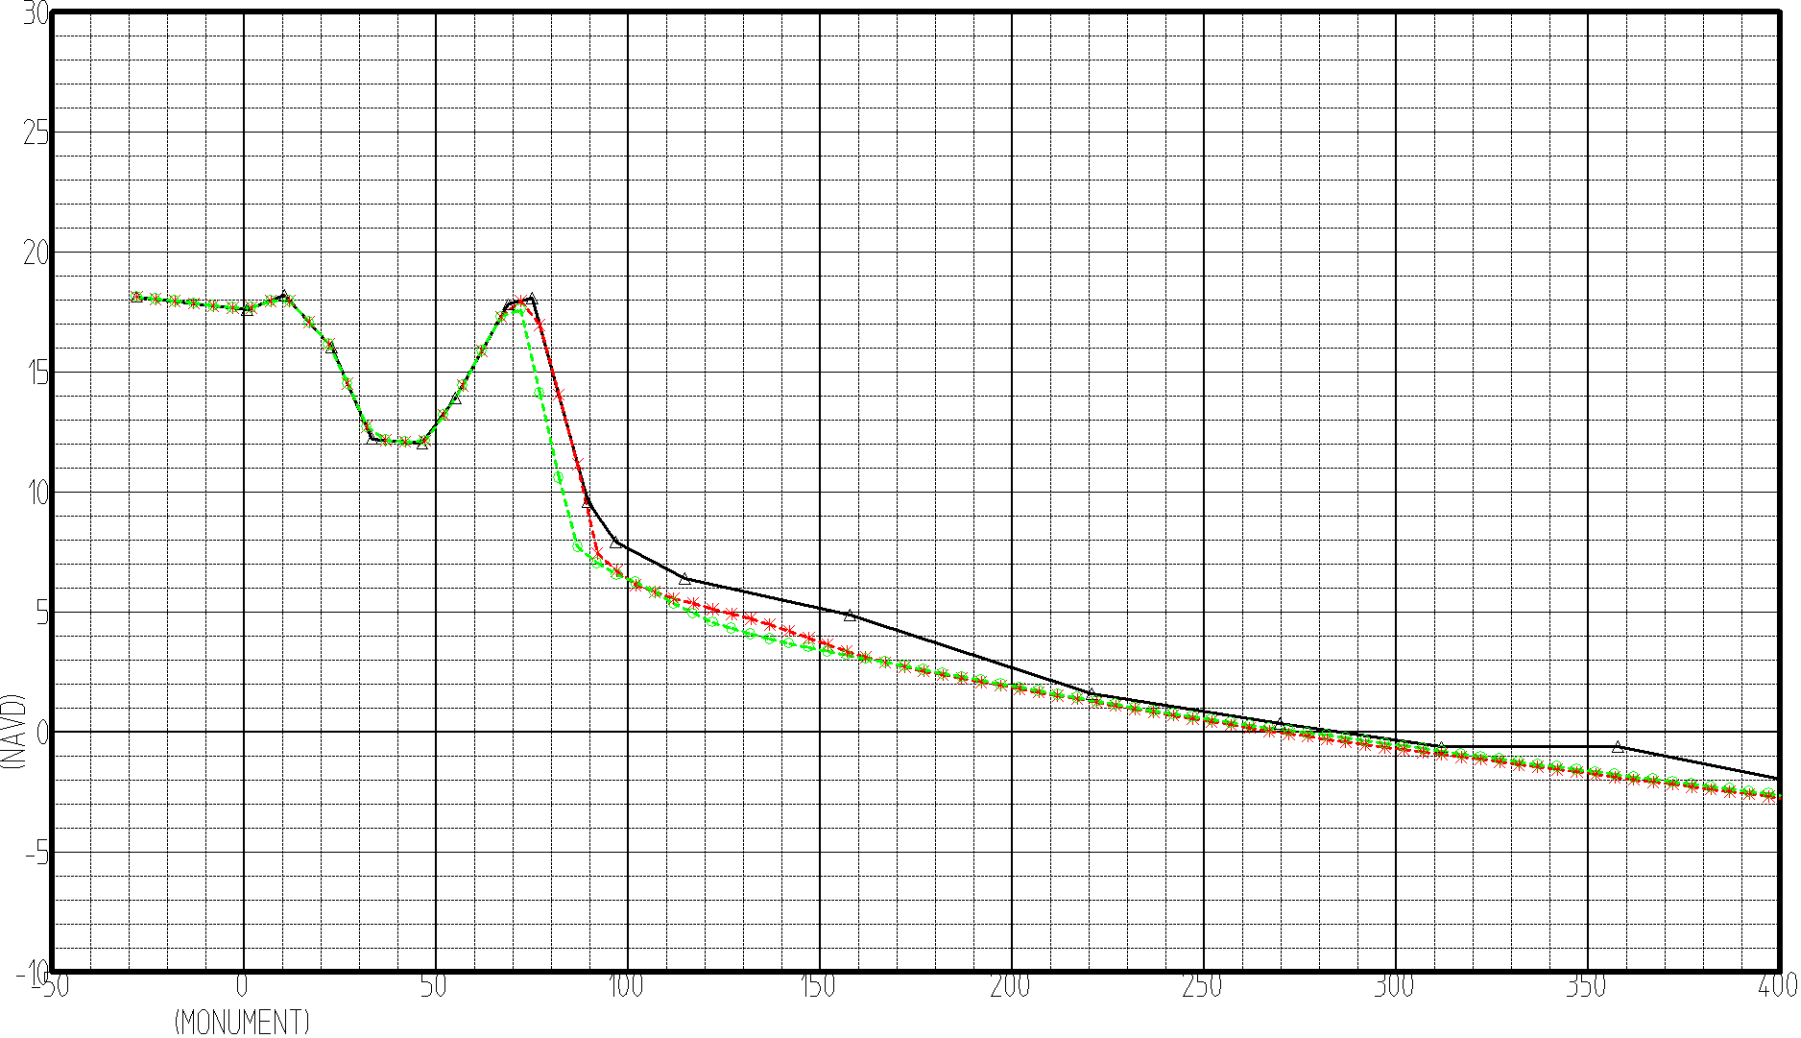
Range: T-184
 BEARING: 75.00
 2/2

BEACH PROFILE
 —△—△— ST. JOHNS 2007-2008 COMBI
 - - * - - 15YR SBCH ERODED
 - - o - - 25YR SBCH ERODED

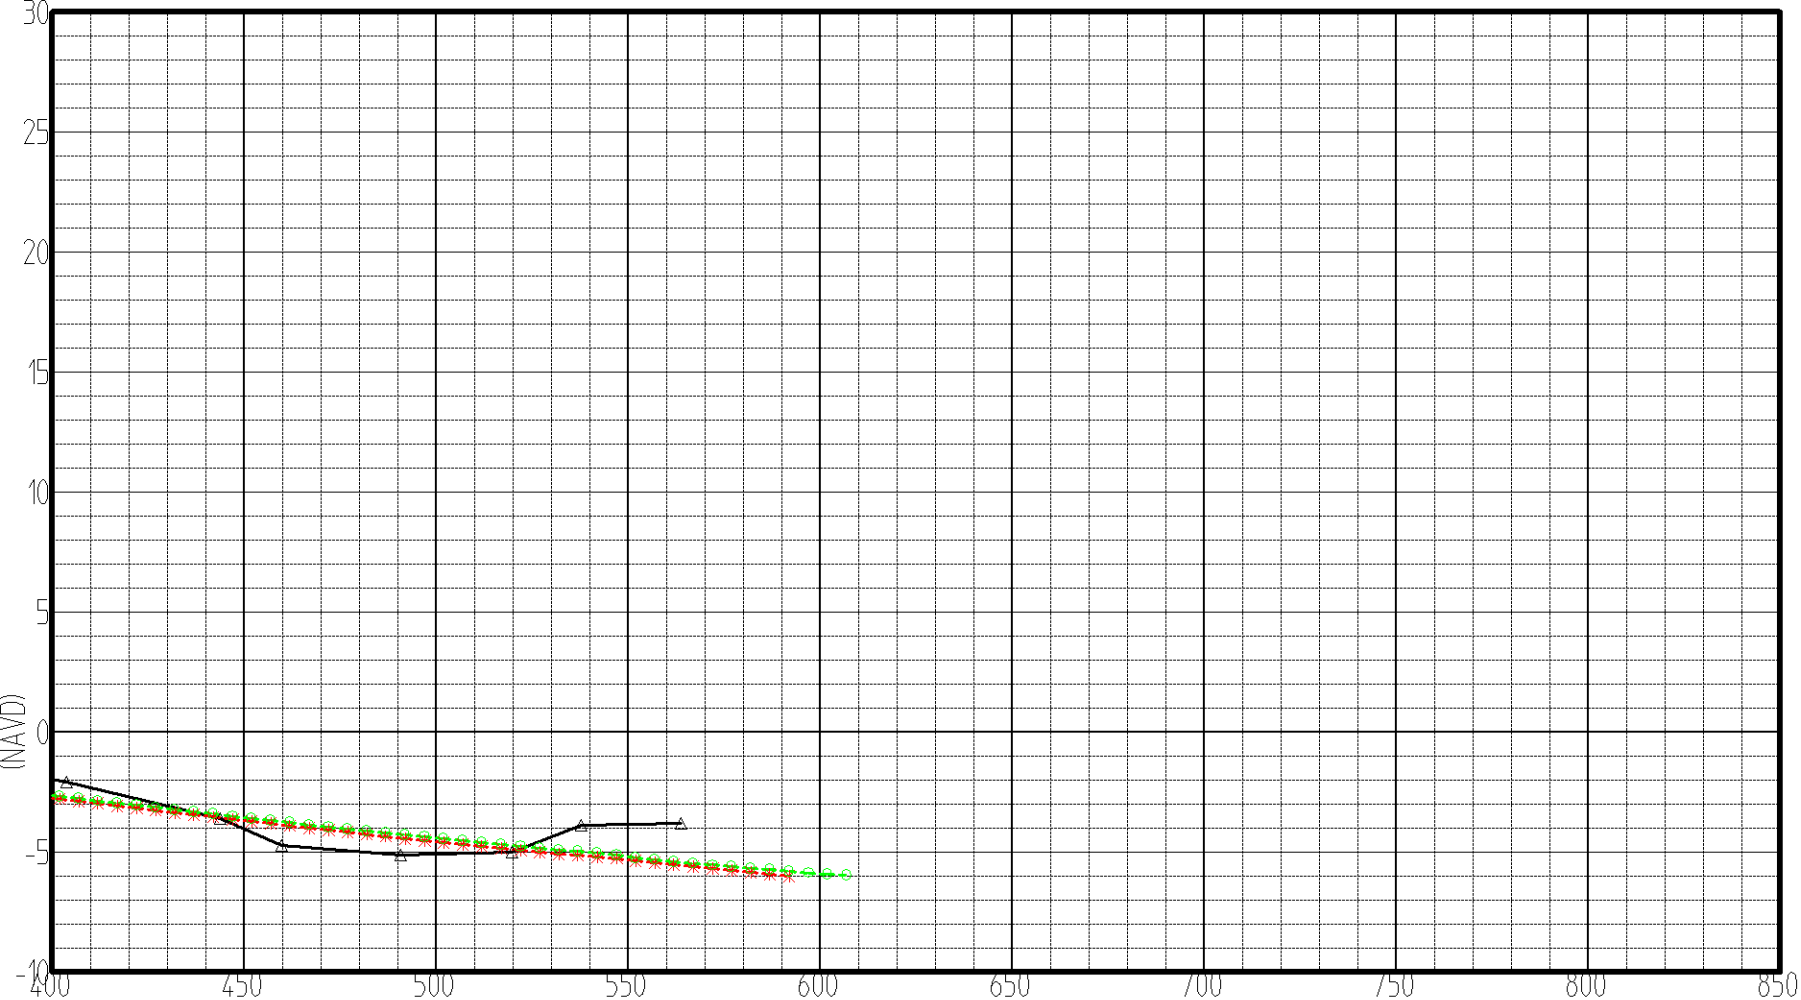
Range: T-185
 BEARING: 75.00
 1/2

BEACH PROFILE

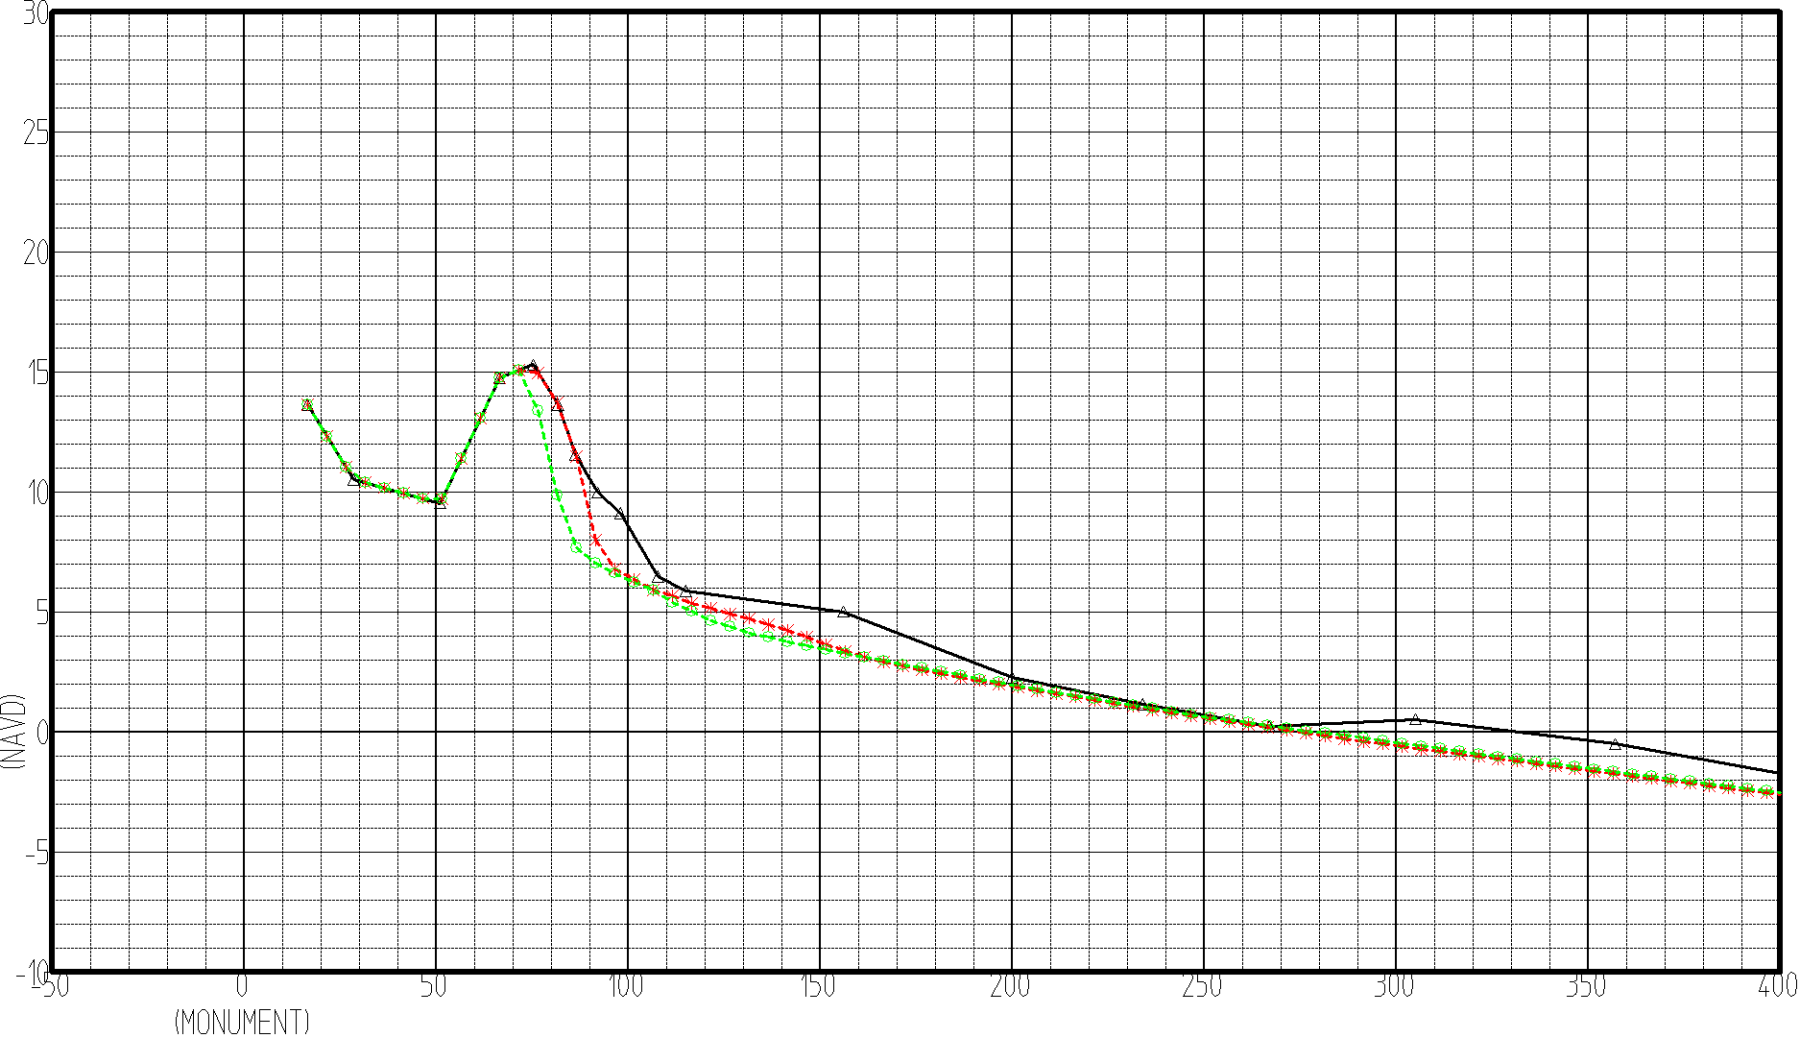
Range: T-185

BEACH PROFILE
 —△—△— ST. JOHNS 2007-2008 COMBI
 - - * - - 15YR SBCH ERODED
 - - o - - 25YR SBCH ERODED

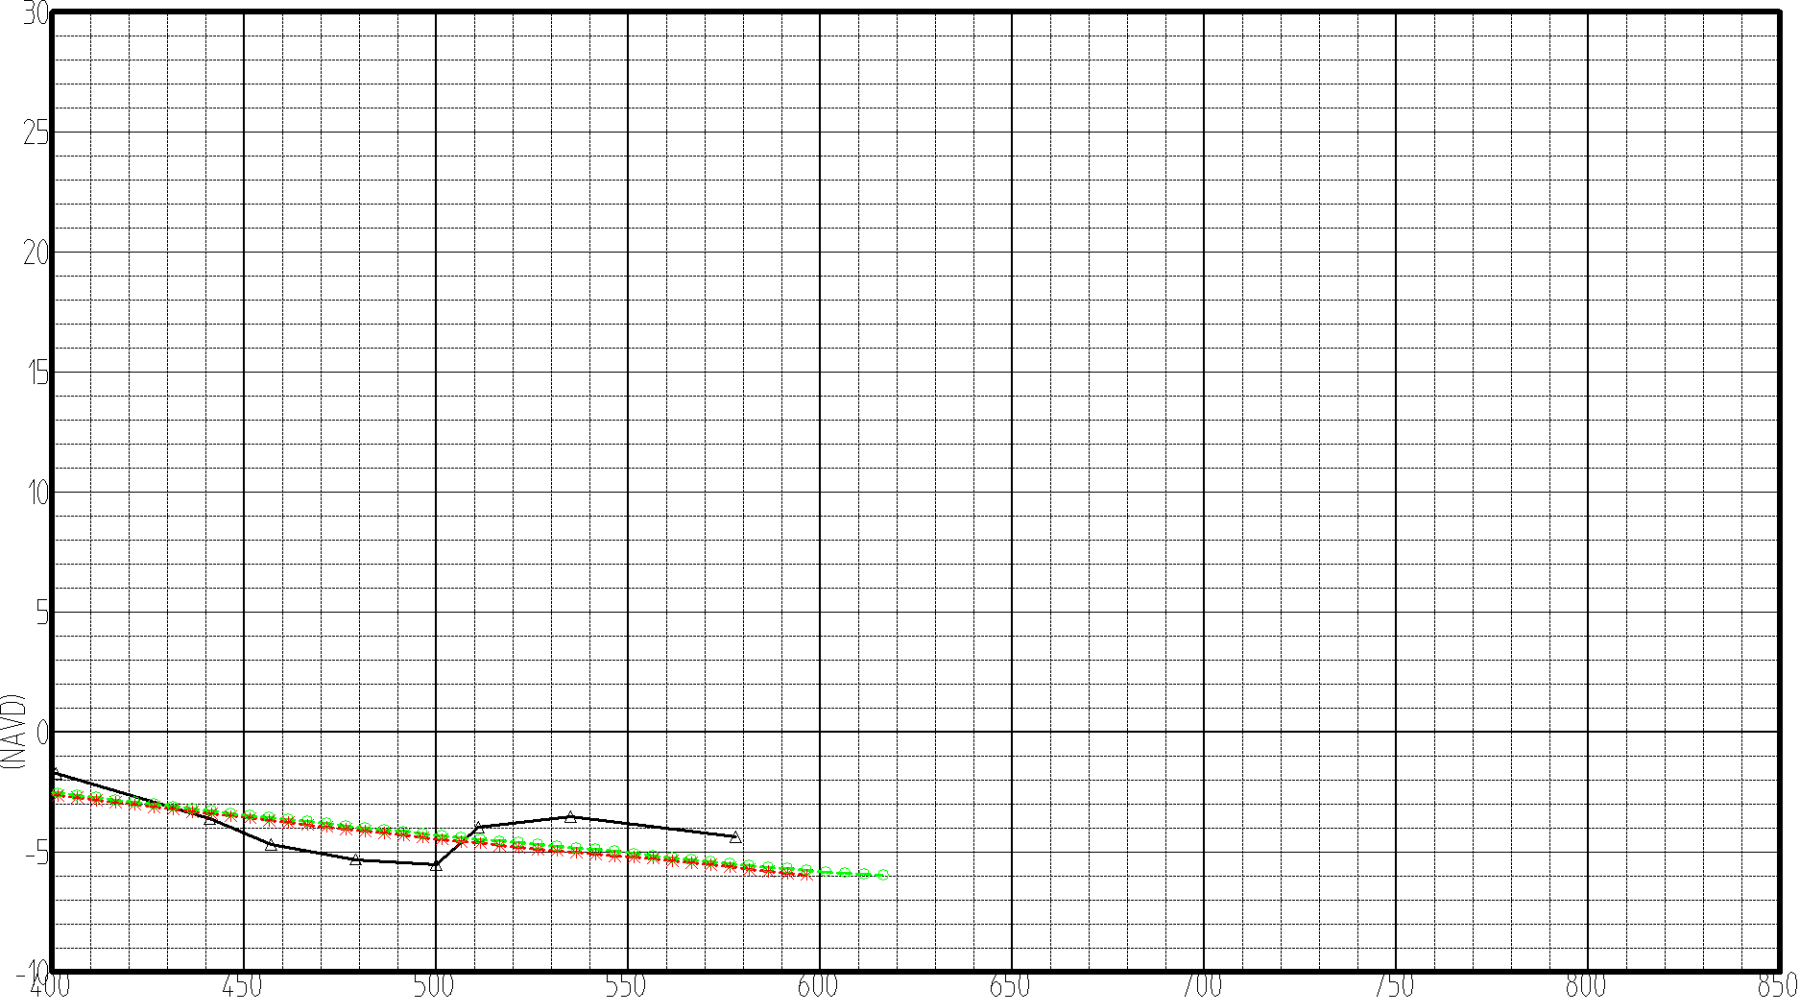
Range: R-186
 BEARING: 75.00
 1/2

BEACH PROFILE

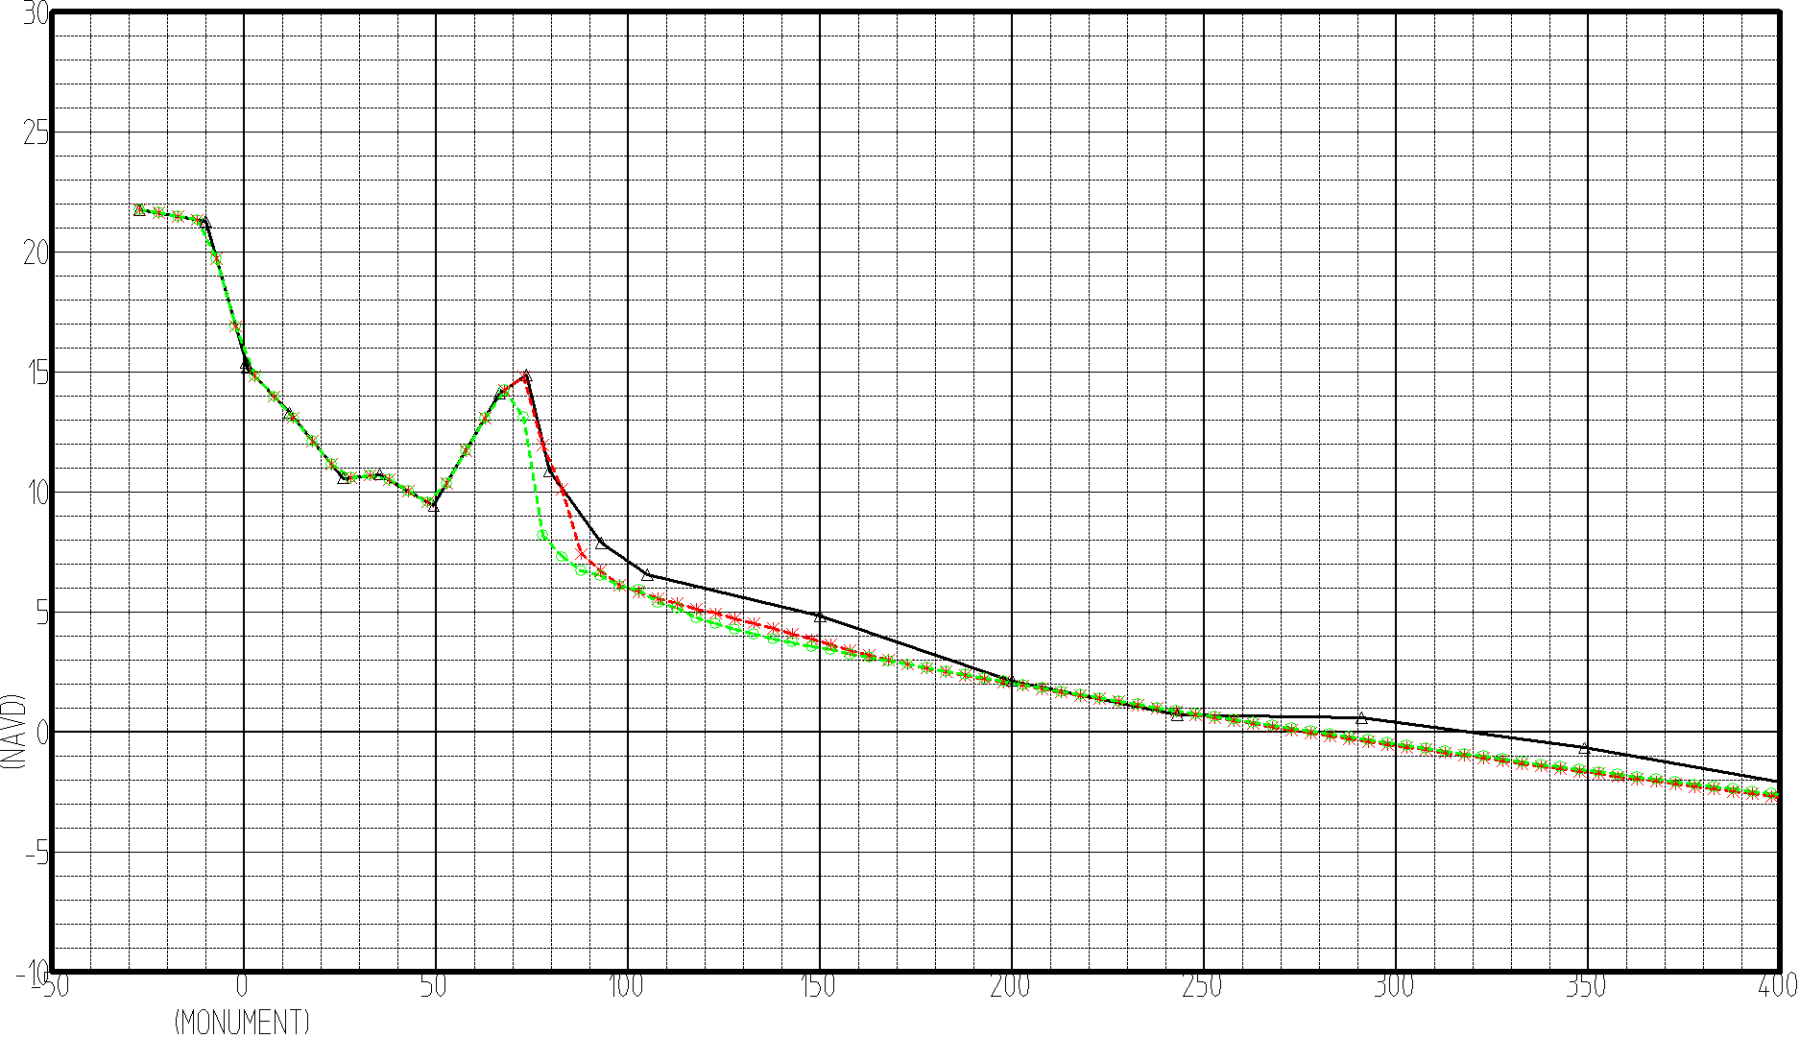
Range: R-186

BEACH PROFILE
 —△—△— ST. JOHNS 2007-2008 COMBI
 - - * - - 15YR SBCH ERODED
 - - o - - 25YR SBCH ERODED

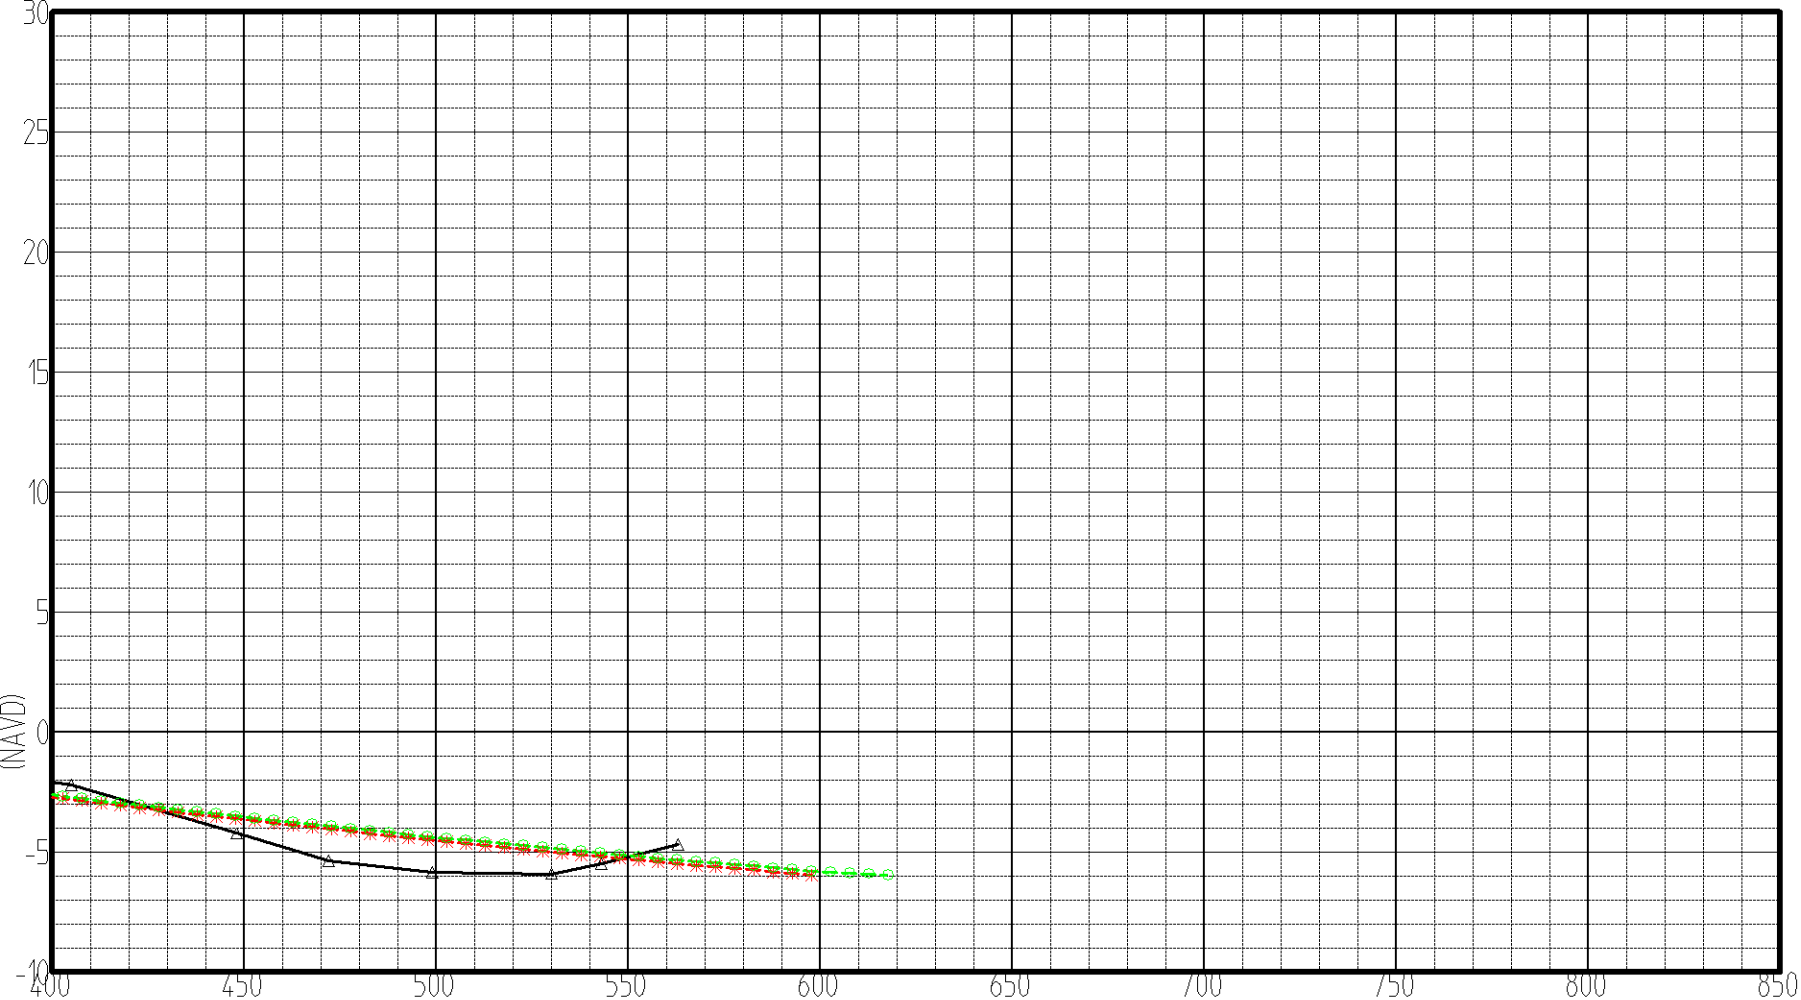
Range: R-187
 BEARING: 75.00
 1/2

BEACH PROFILE
