Appendix VIII

SBEACH 15 and 25 yr. Storm Erosion Profiles

St. Johns County

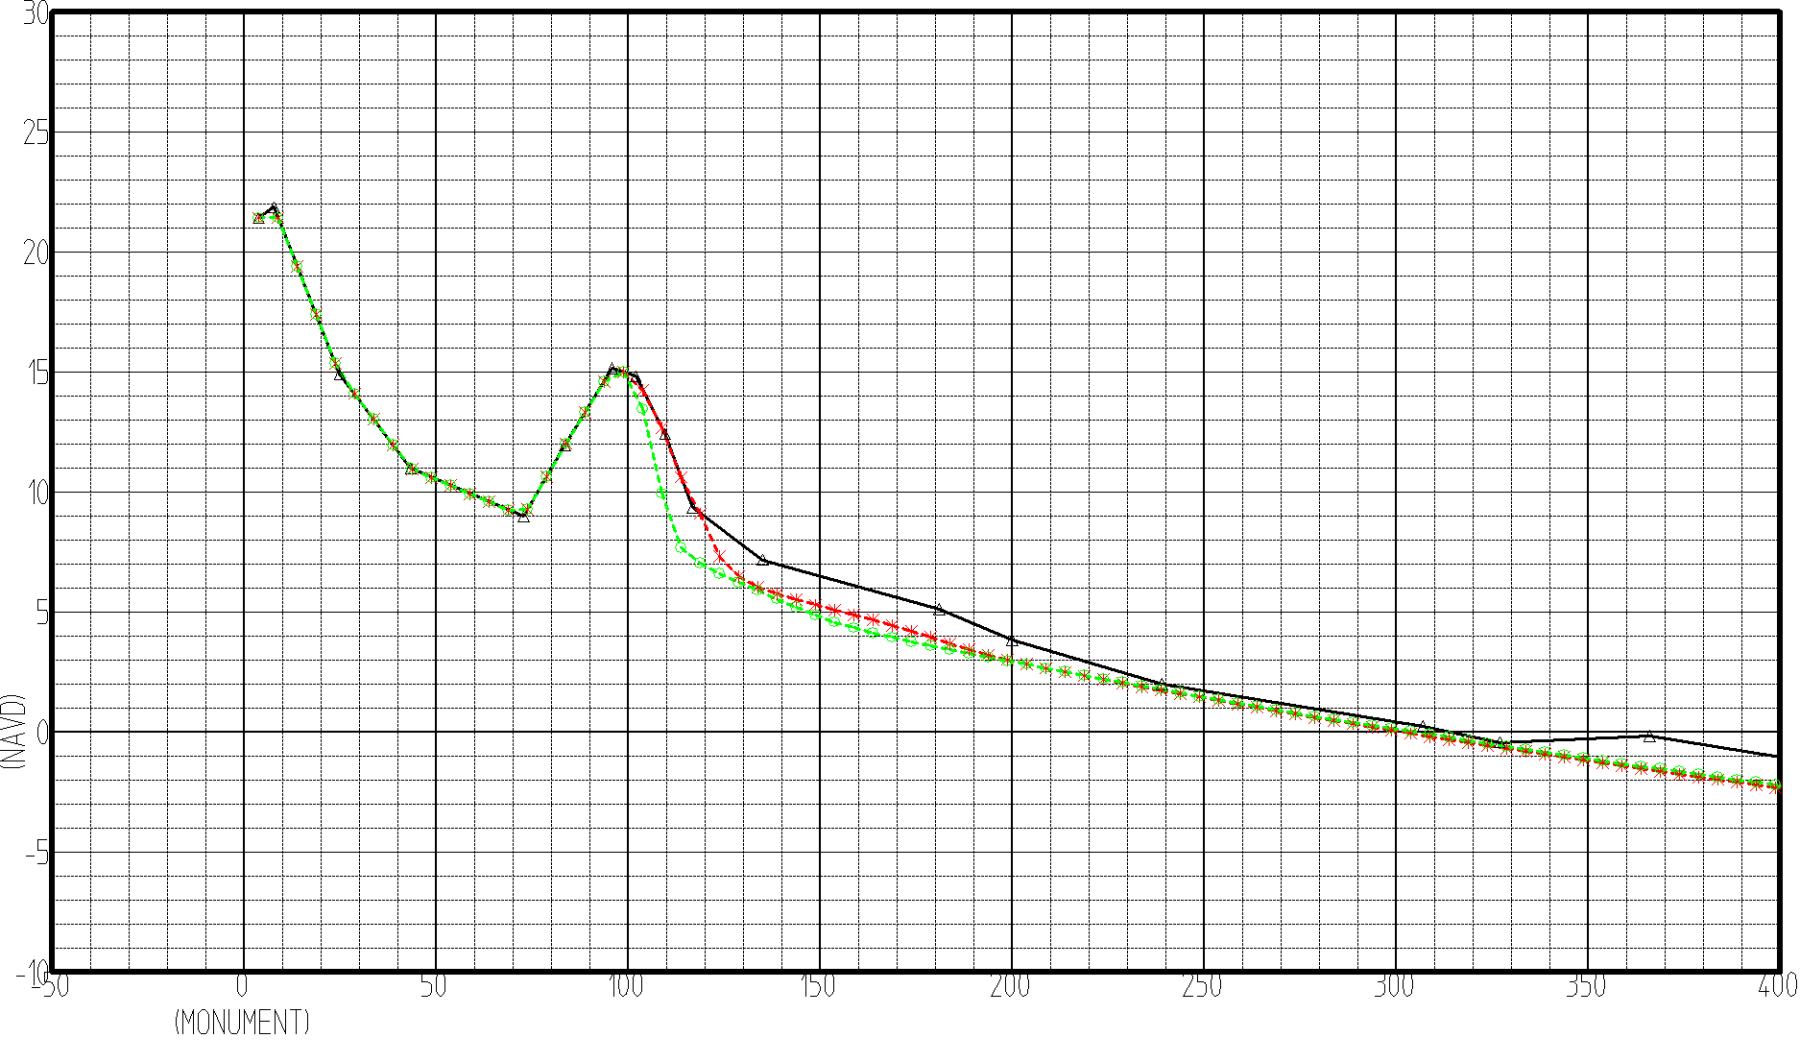
Range: R-187

BEACH PROFILE
 —△—△— ST. JOHNS 2007-2008 COMBI
 - - * - - 15YR SBCH ERODED
 - - o - - 25YR SBCH ERODED

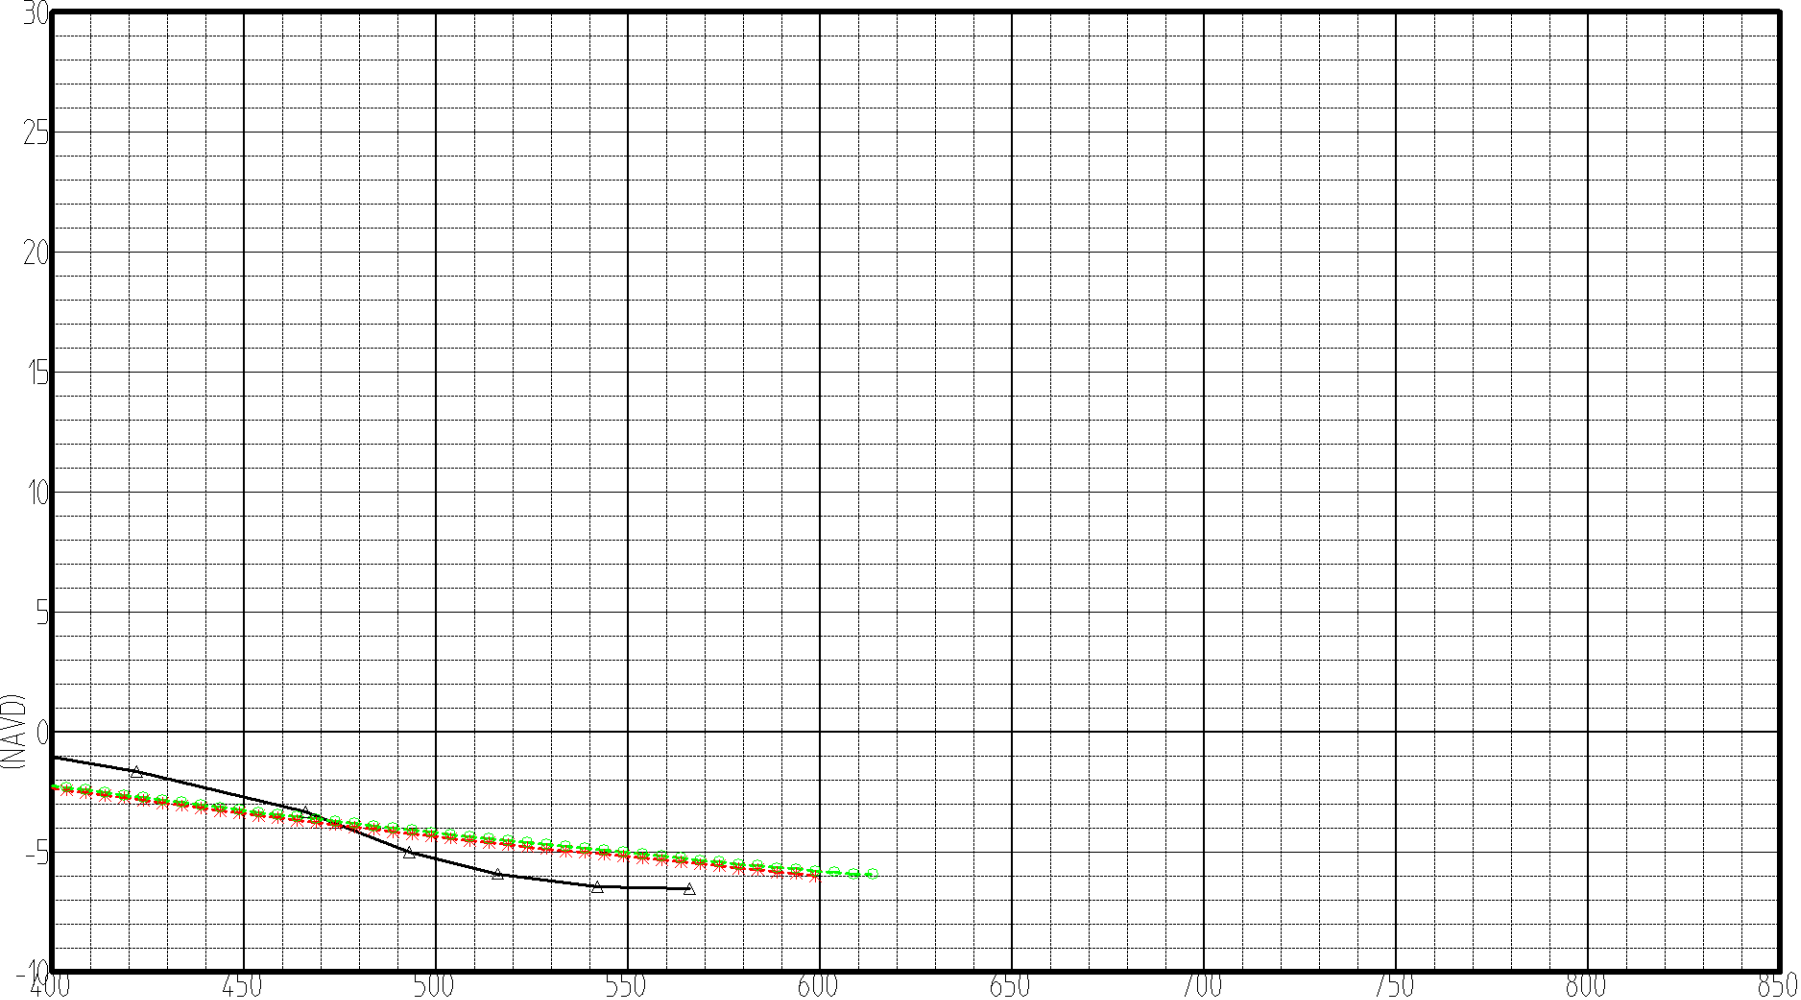
Range: R-188
 BEARING: 75.00
 1/2

BEACH PROFILE
 —△—△— ST. JOHNS 2007-2008 COMBI
 - - * - - 15YR SBEACH ERODED
 - - o - - 25YR SBCH ERODED

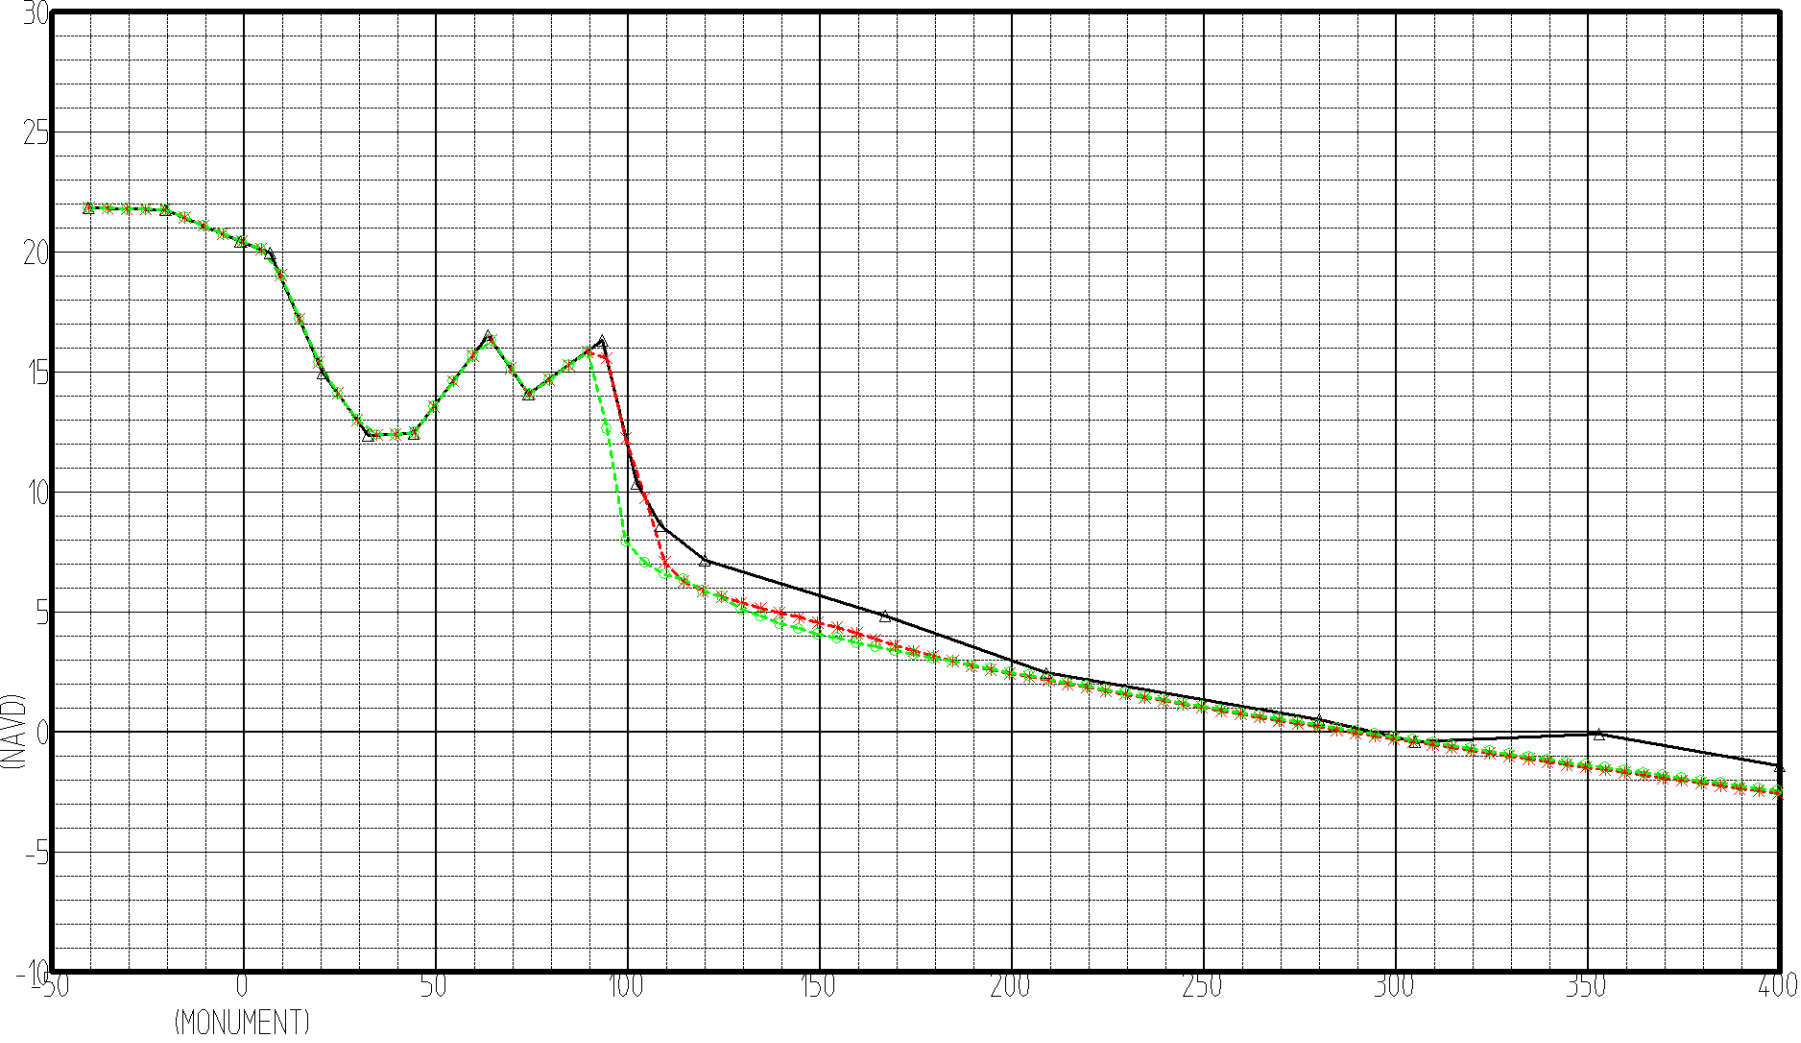
Range: R-188
 BEARING: 75.00
 2/2

BEACH PROFILE
 —△—△— ST. JOHNS 2007-2008 COMBI
 - - * - - 15YR SBEACH ERODED
 - - o - - 25YR SBCH ERODED

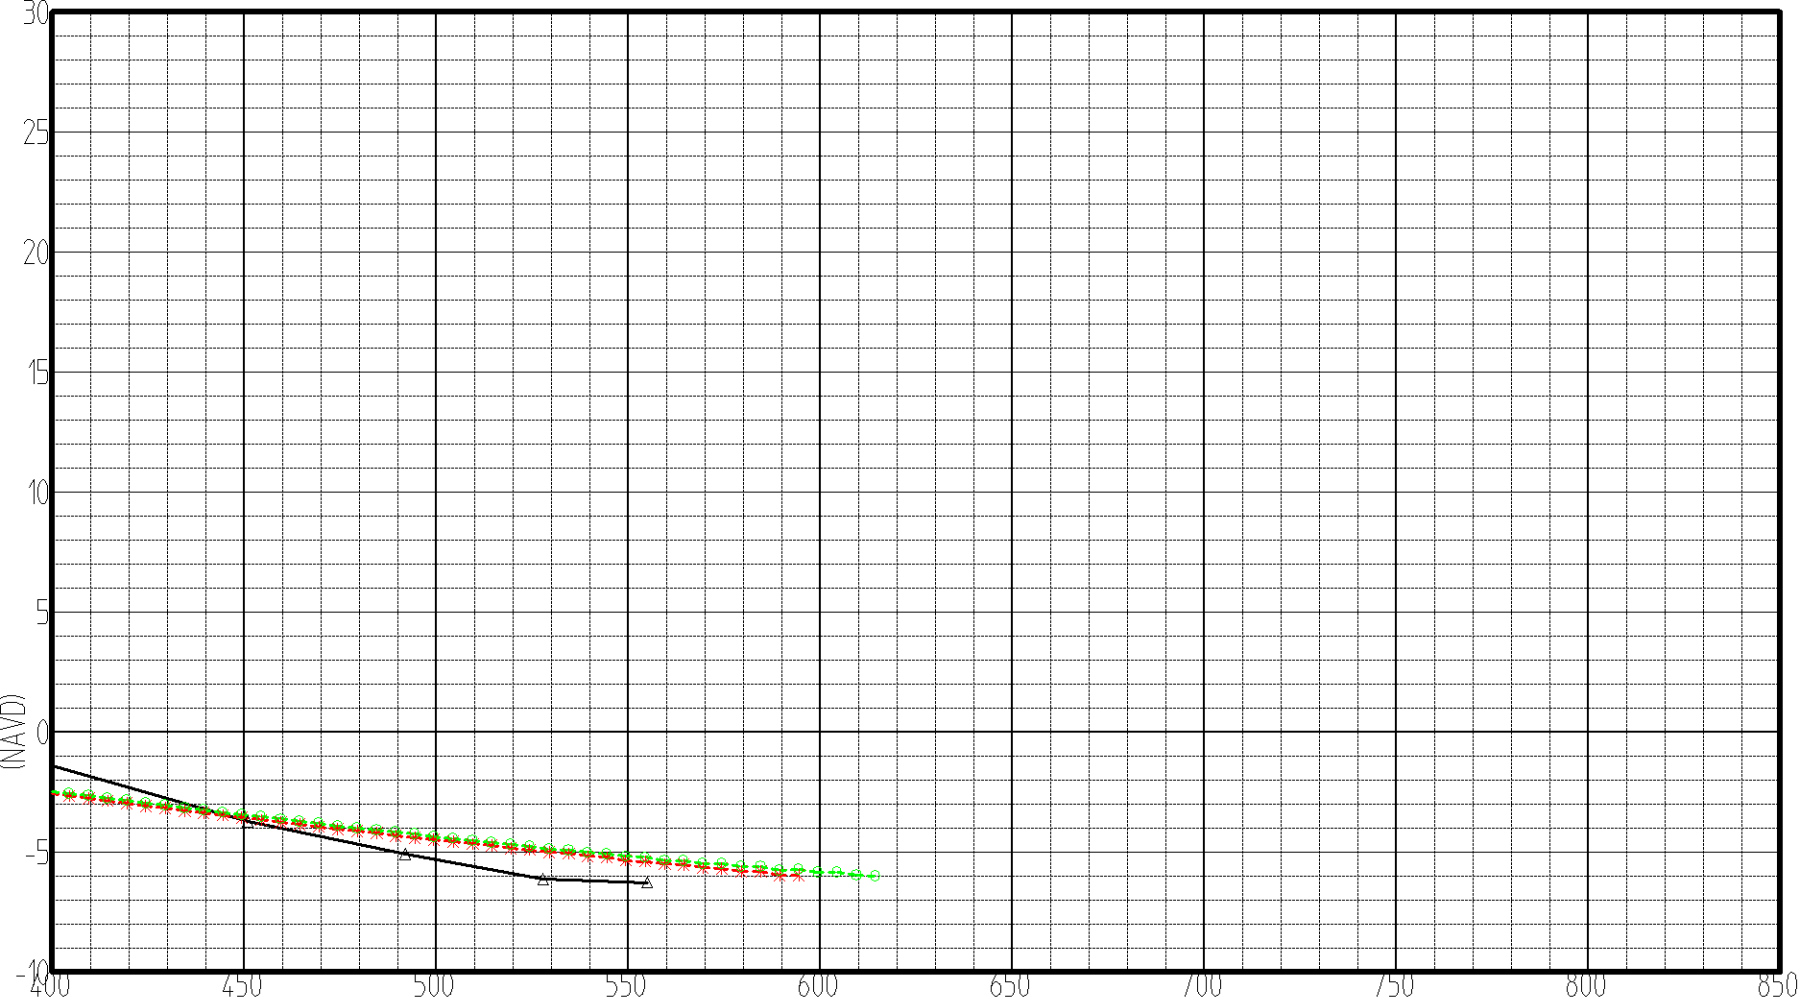
Range: R-189
 BEARING: 75.00
 1/2

BEACH PROFILE
 —△—△— ST. JOHNS 2007-2008 COMBI
 - - * - - 15YR SBEACH ERODED
 - - o - - 25YR SBCH ERODED

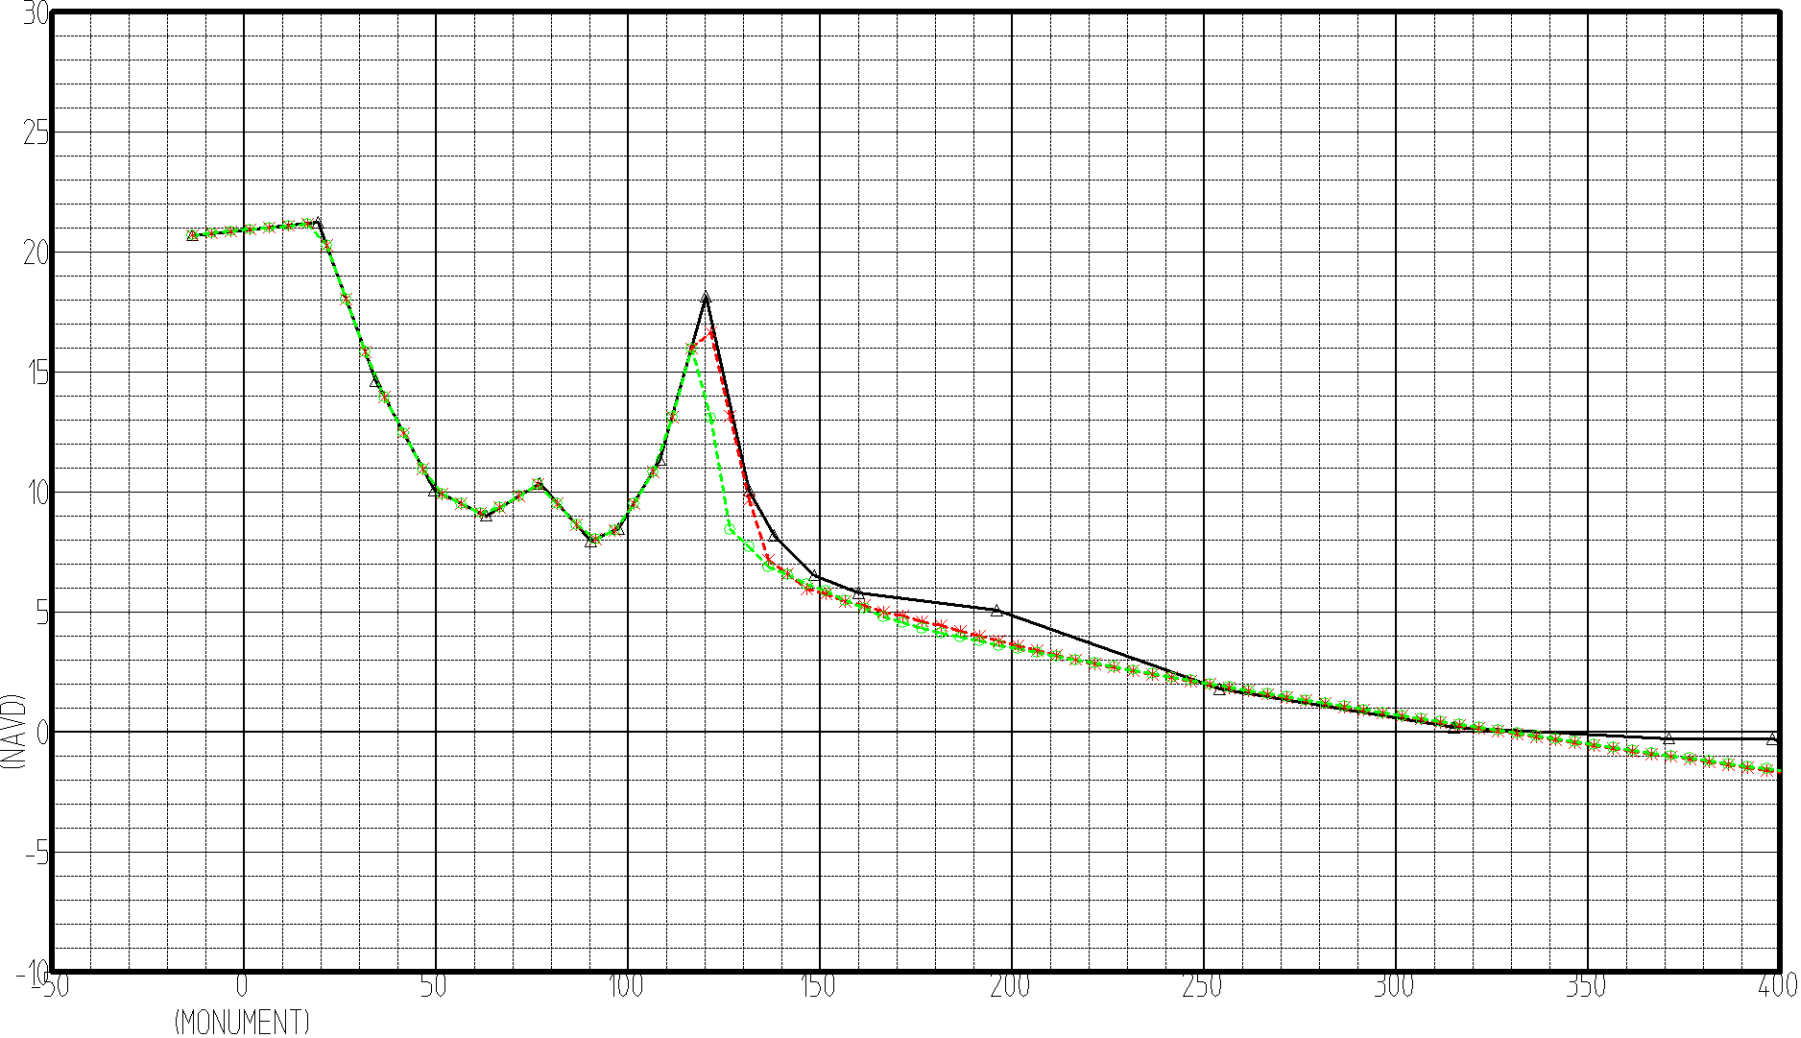
Range: R-189 2/2
 BEARING: 75.00

BEACH PROFILE
 —△—△— ST. JOHNS 2007-2008 COMBI
 - - * - - 15YR SBCH ERODED
 - - o - - 25YR SBCH ERODED

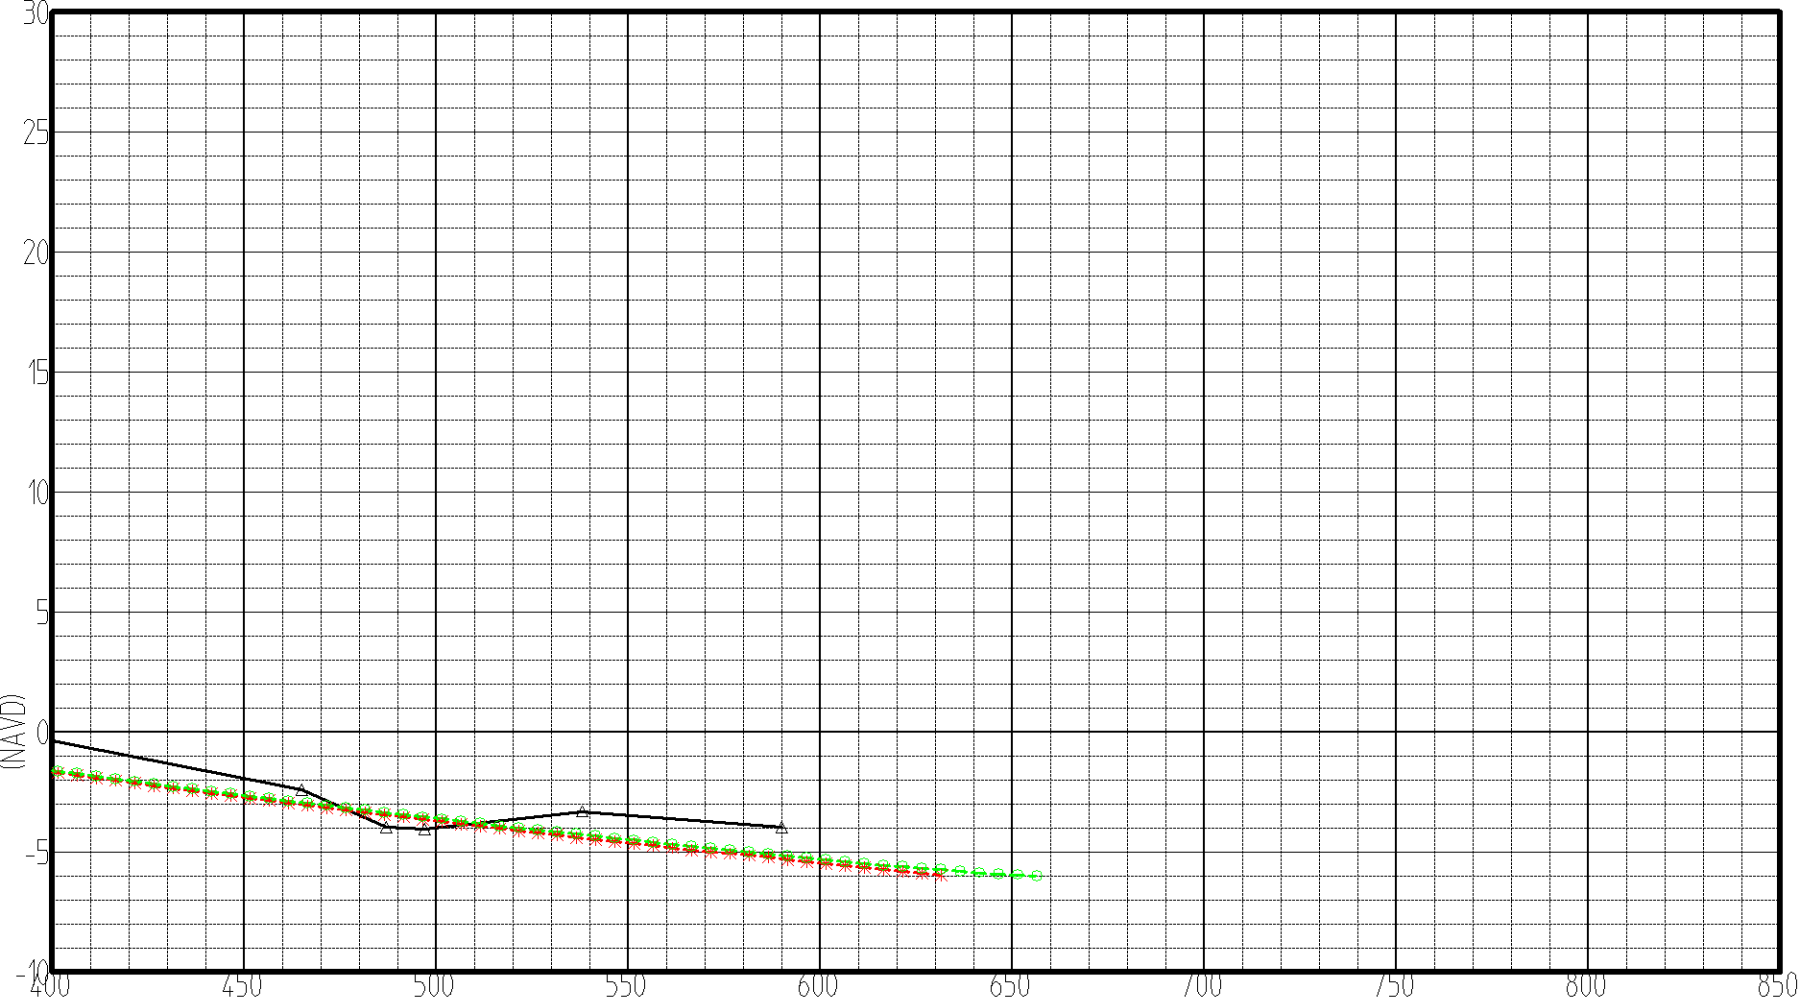
Range: R-190
 BEARING: 75.00
 1/2

BEACH PROFILE

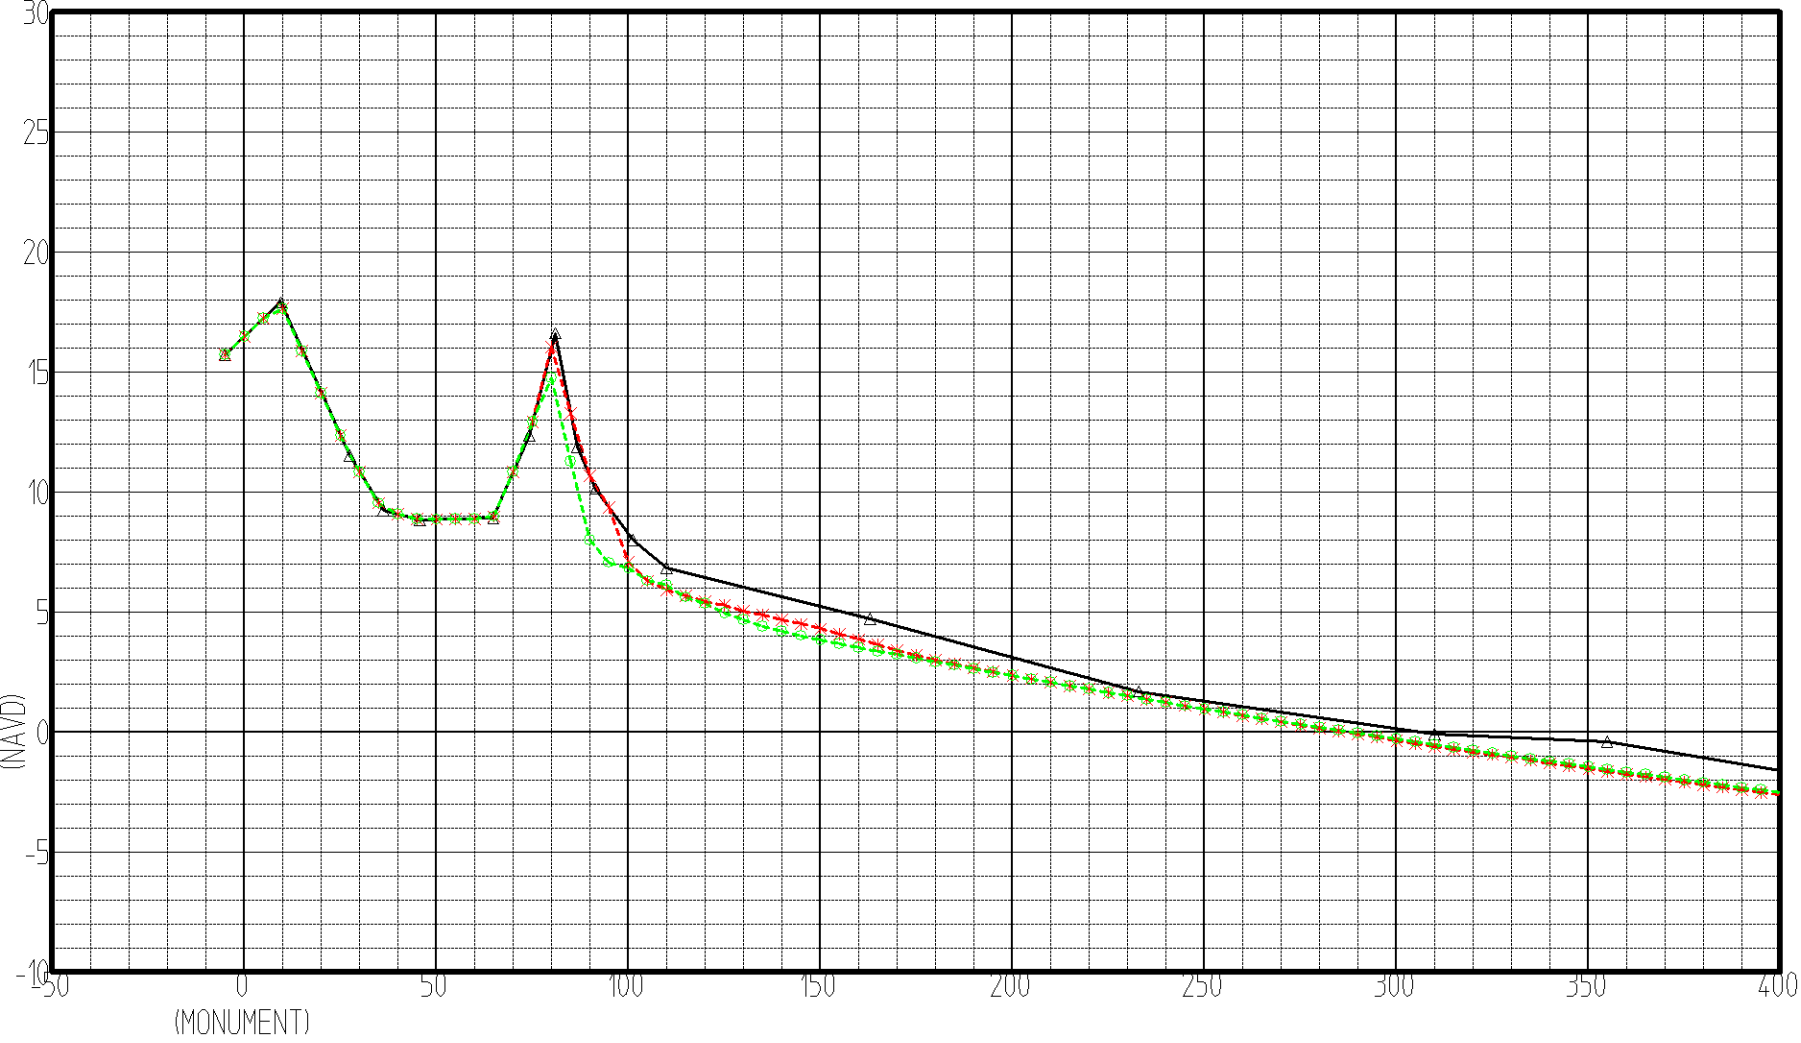
Range: R-190

BEACH PROFILE

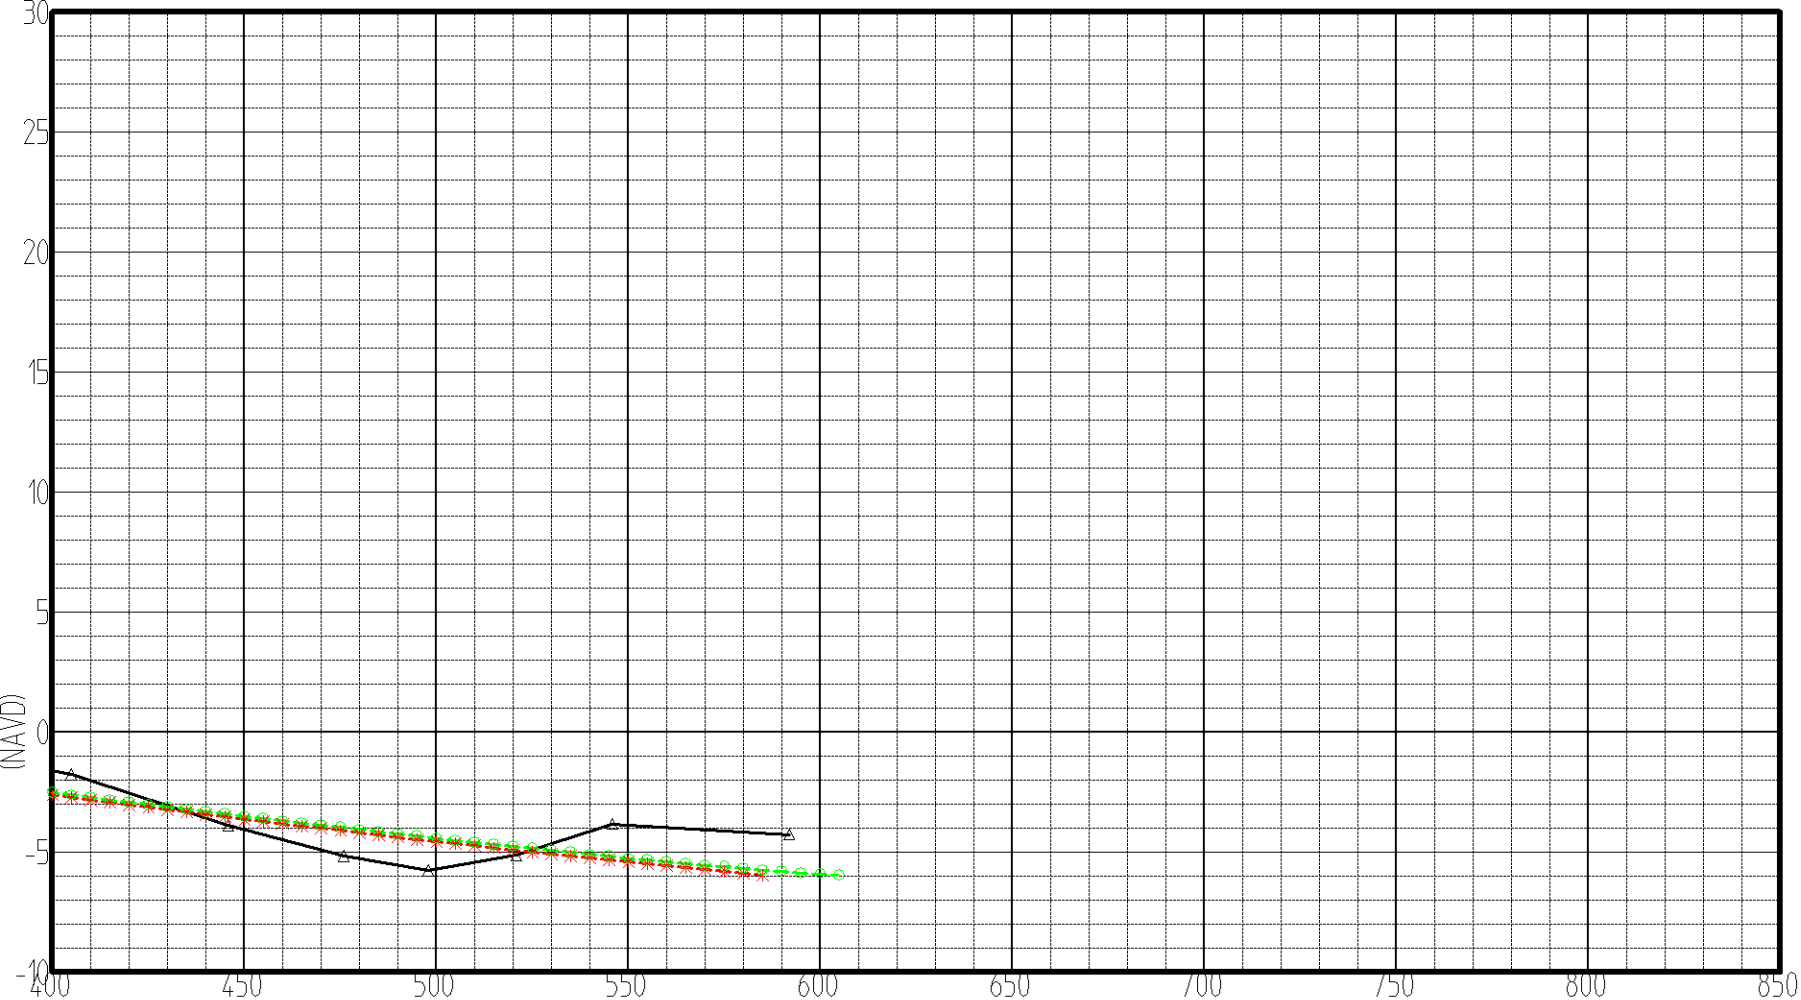
Range: R-191

BEACH PROFILE
 —△— ST. JOHNS 2007-2008 COMBI
 - - * - - 15YR SBEACH ERODED
 - - o - - 25YR SBCH ERODED

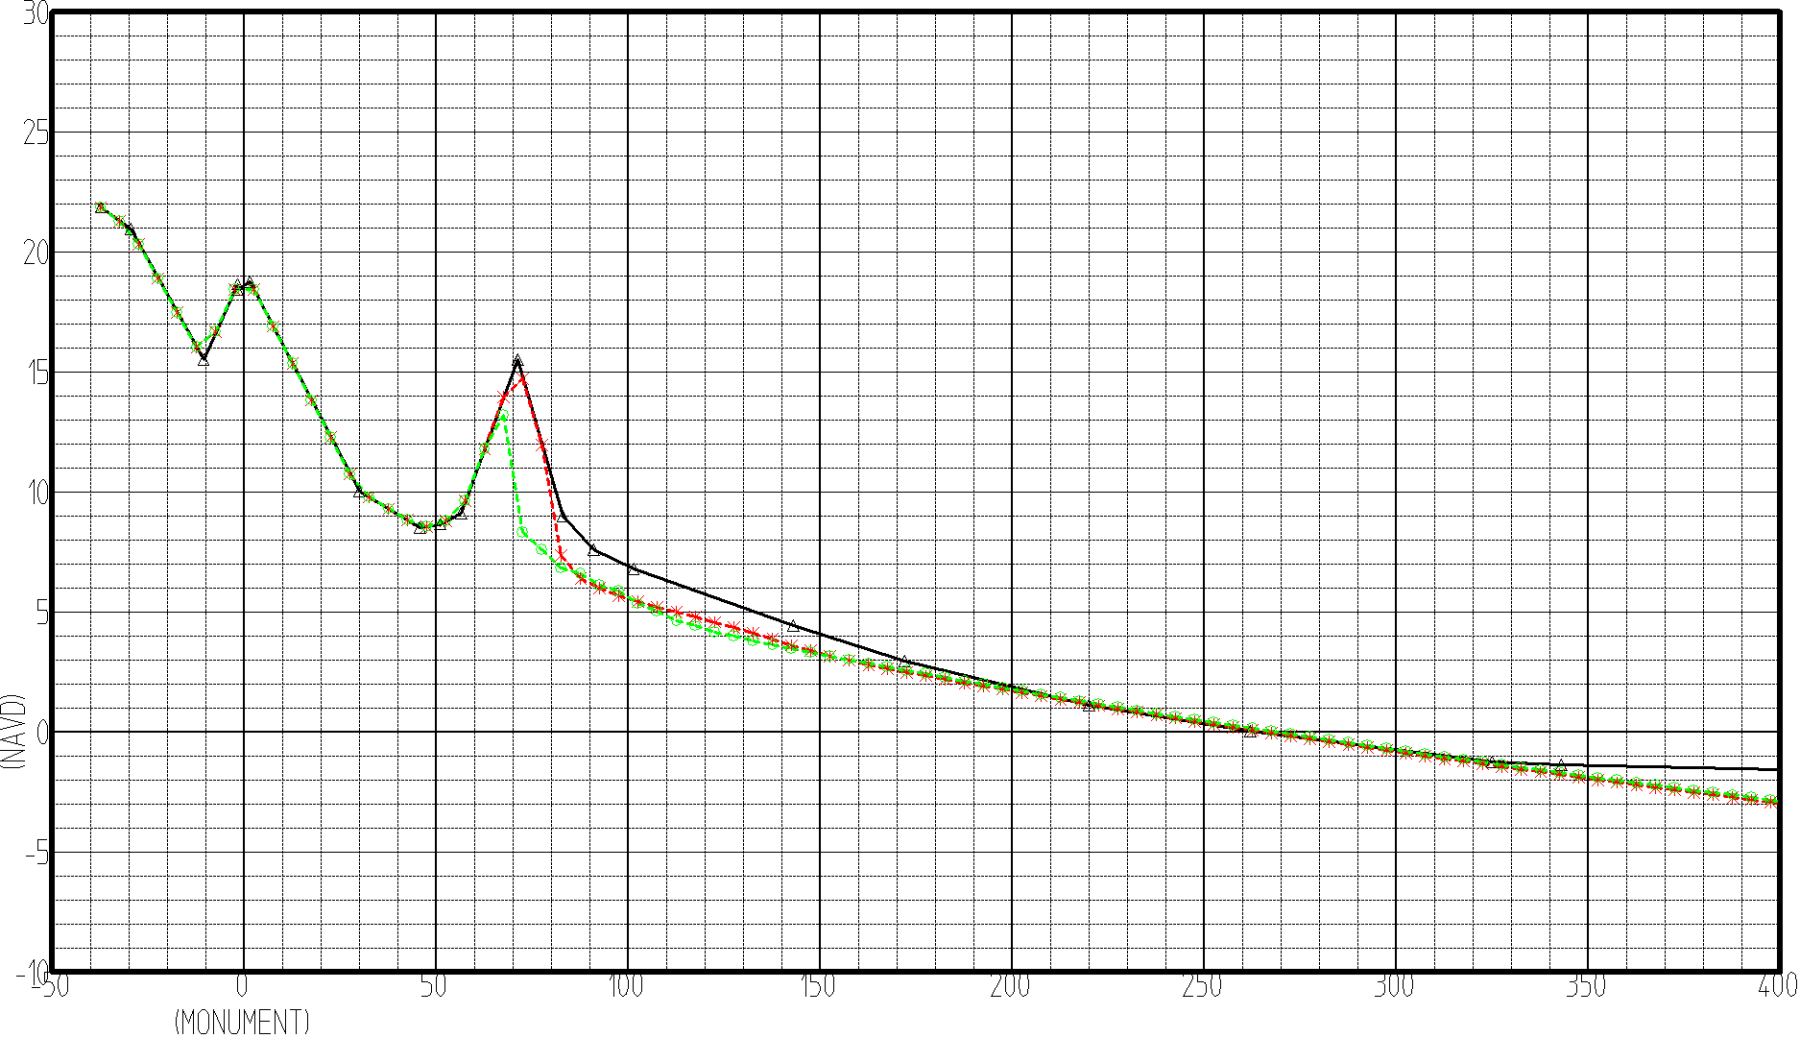
Range: R-191
 BEARING: 75.00
 2/2

BEACH PROFILE

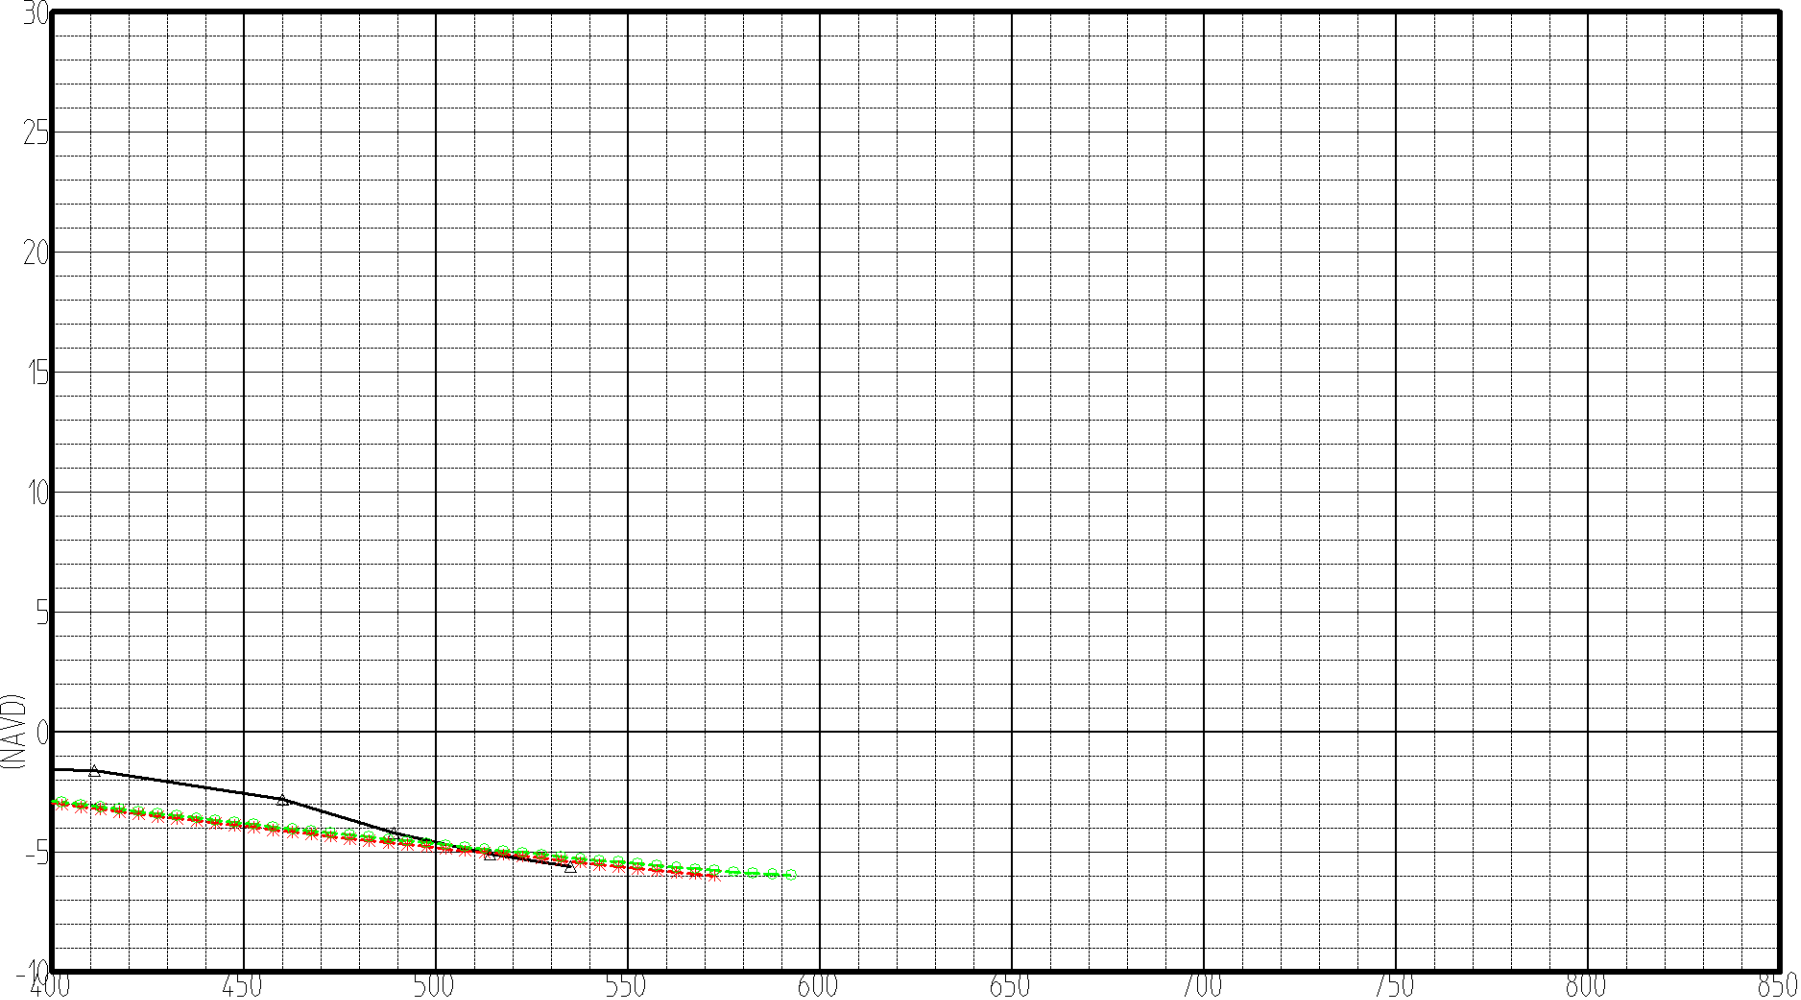
Range: R-192

BEACH PROFILE
 —△—△— ST. JOHNS 2007-2008 COMBI
 - - * - - 15YR SBCH ERODED
 - - o - - 25YR SBCH ERODED

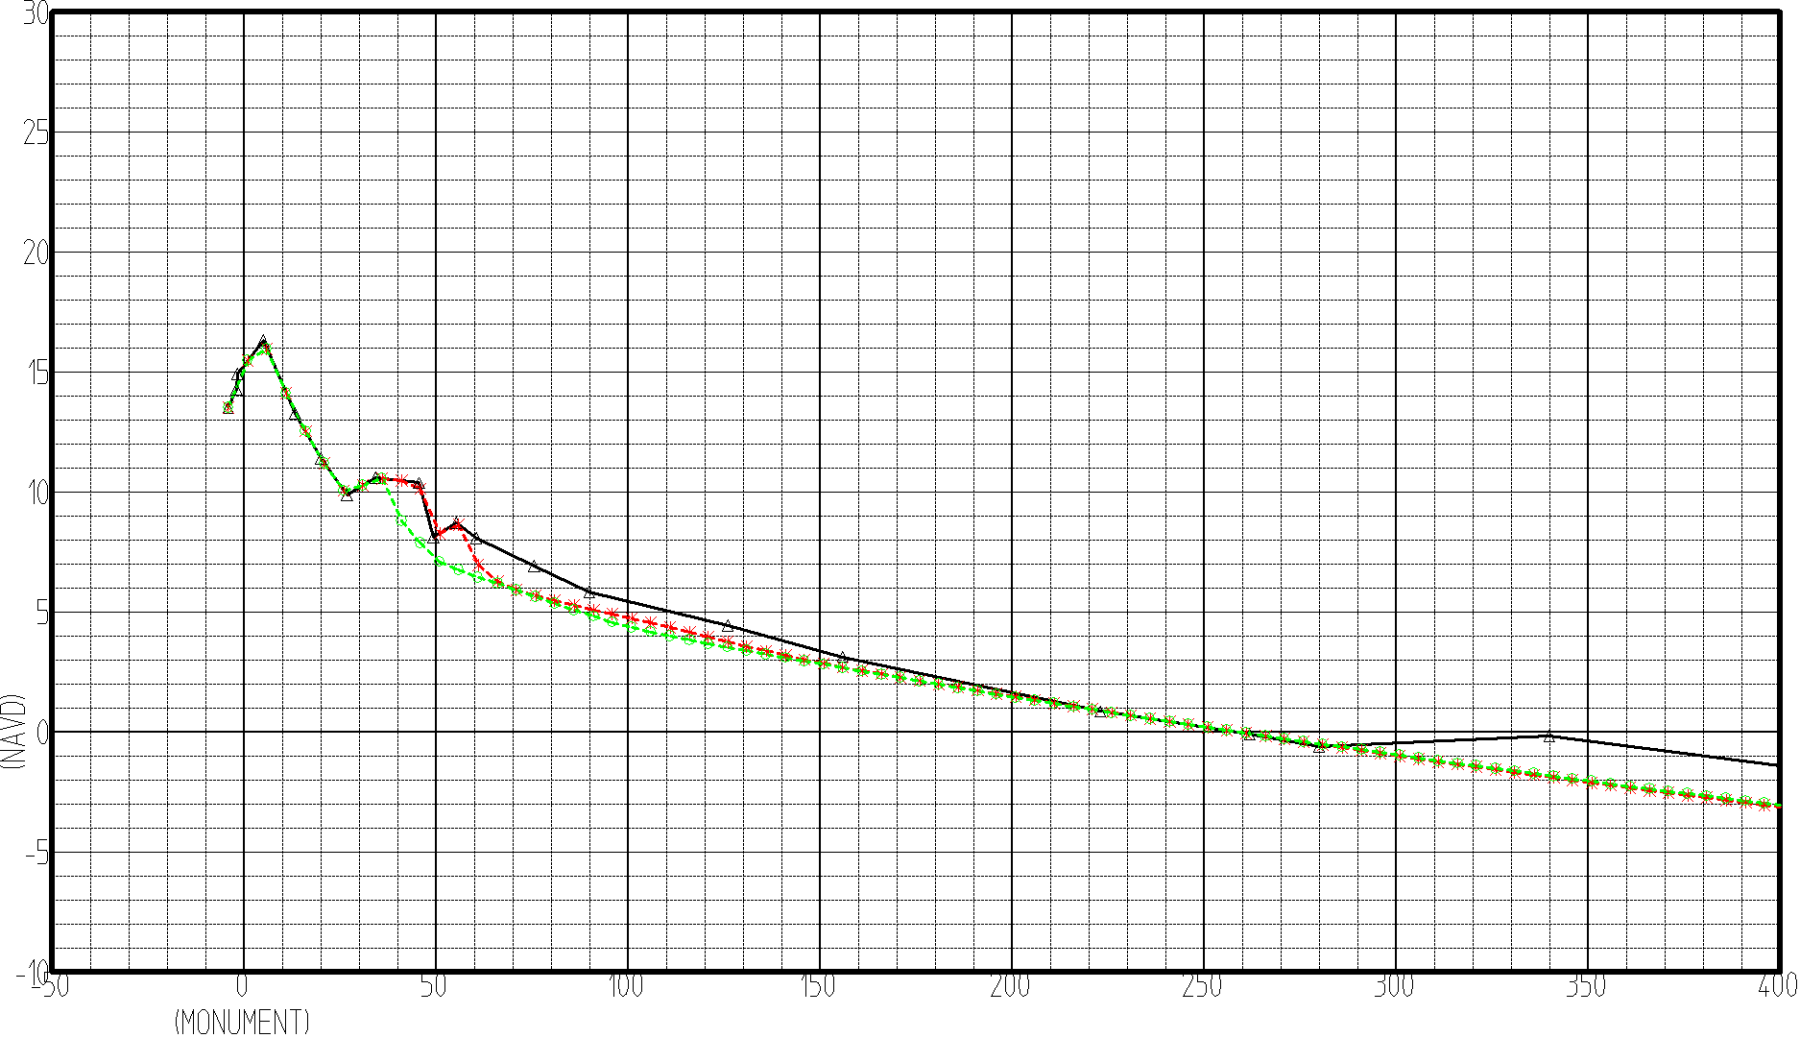
Range: R-192
 BEARING: 75.00
 2/2

BEACH PROFILE

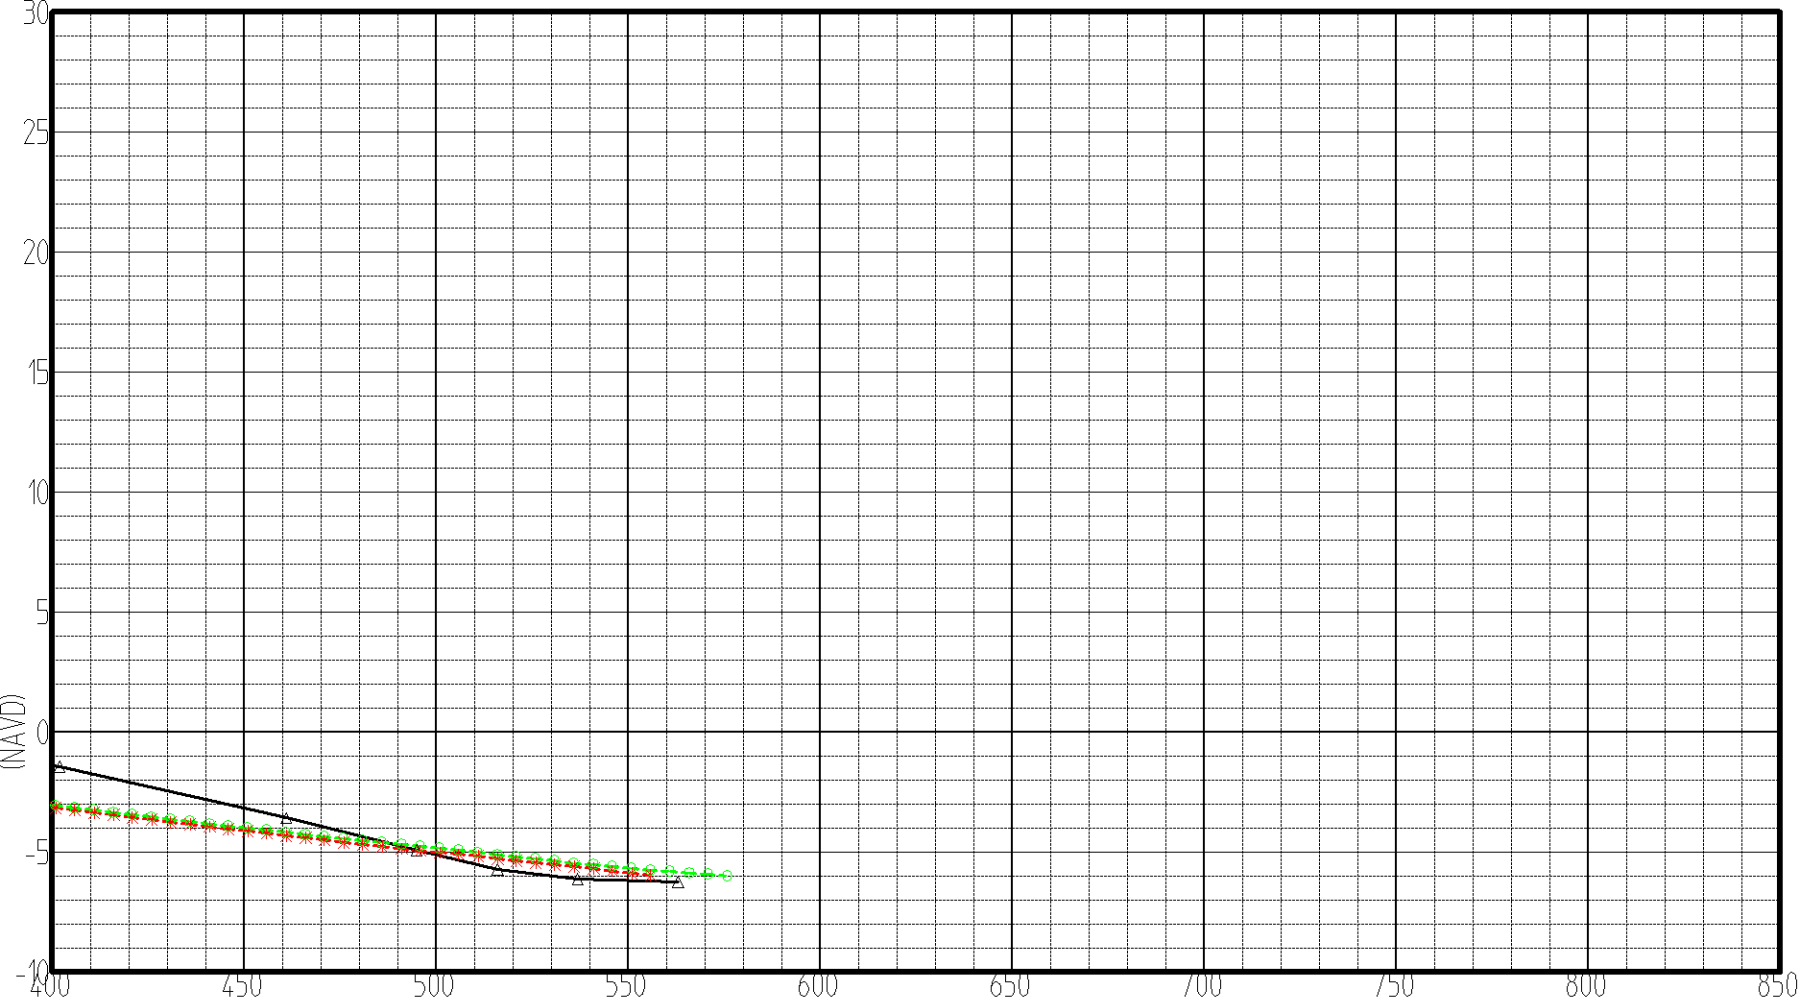
Range: R-193
 BEARING: 75.00
 2/2

BEACH PROFILE
 —△—△— ST. JOHNS 2007-2008 COMBI
 - - * - - 15YR SBEACH ERODED
 - - o - - 25YR SBCH ERODED
