Appendix VIII

SBEACH 15 and 25 yr. Storm Erosion Profiles

St. Johns County

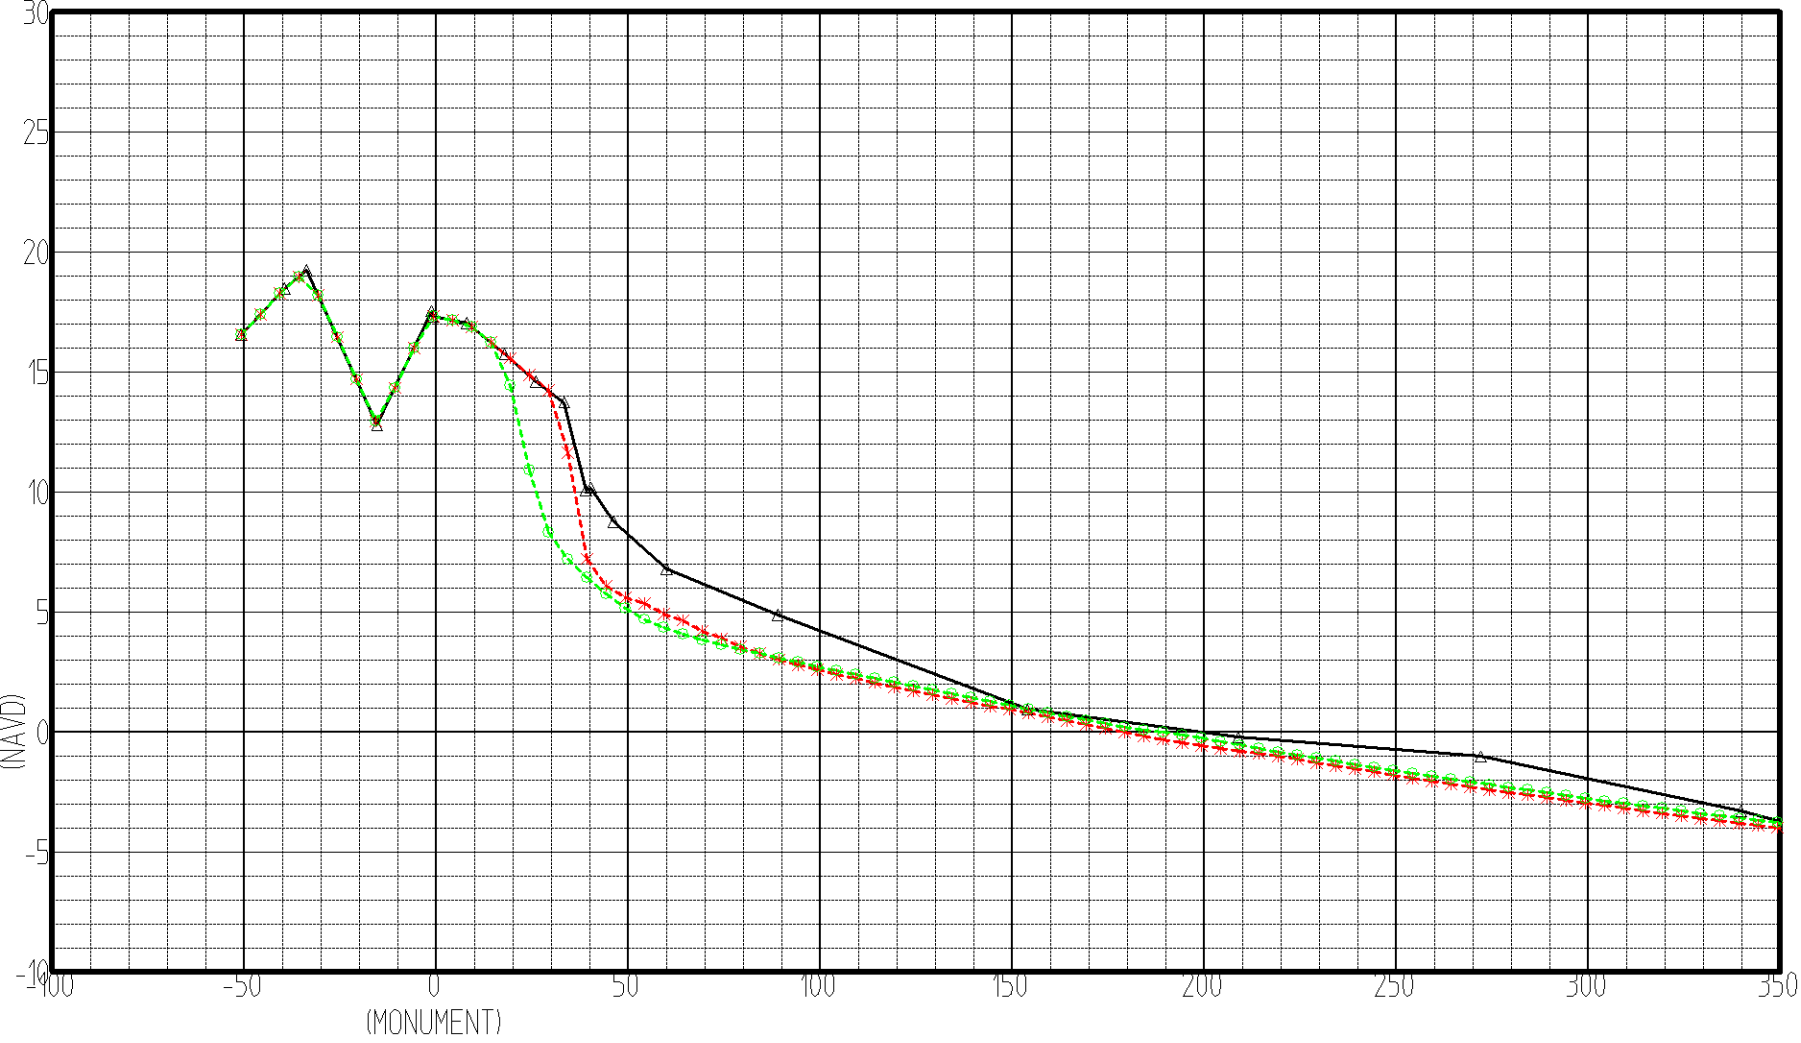
Range: T-194 1/2

BEACH PROFILE

—△—△— ST. JOHNS 2007-2008 COMBI

- - * - - 15YR SBEACH ERODED

- - o - - 25YR SBCH ERODED

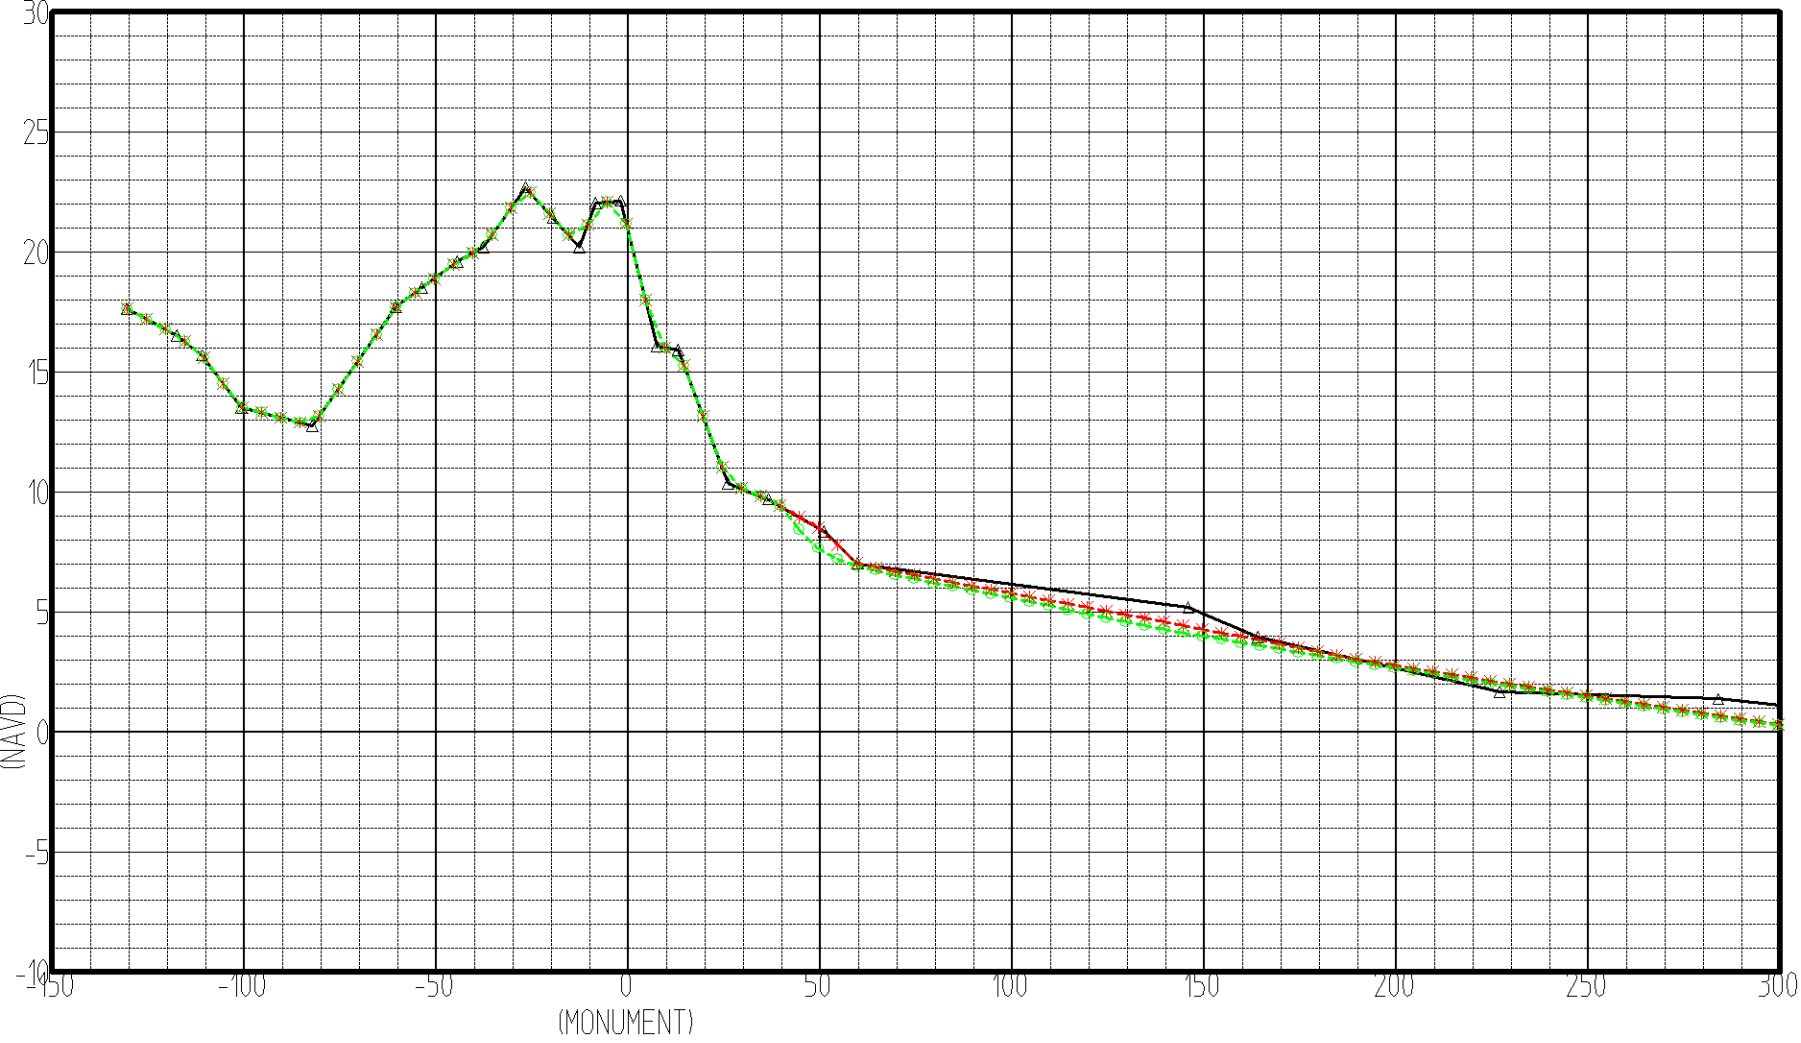
Range: R-195
 BEARING: 75.00
 1/2

BEACH PROFILE
 —△—△— ST. JOHNS 2007-2018 COMBI
 - - * - - * - - 15YR SBEACH ERODED
 - - o - - o - - 25YR SBCH ERODED

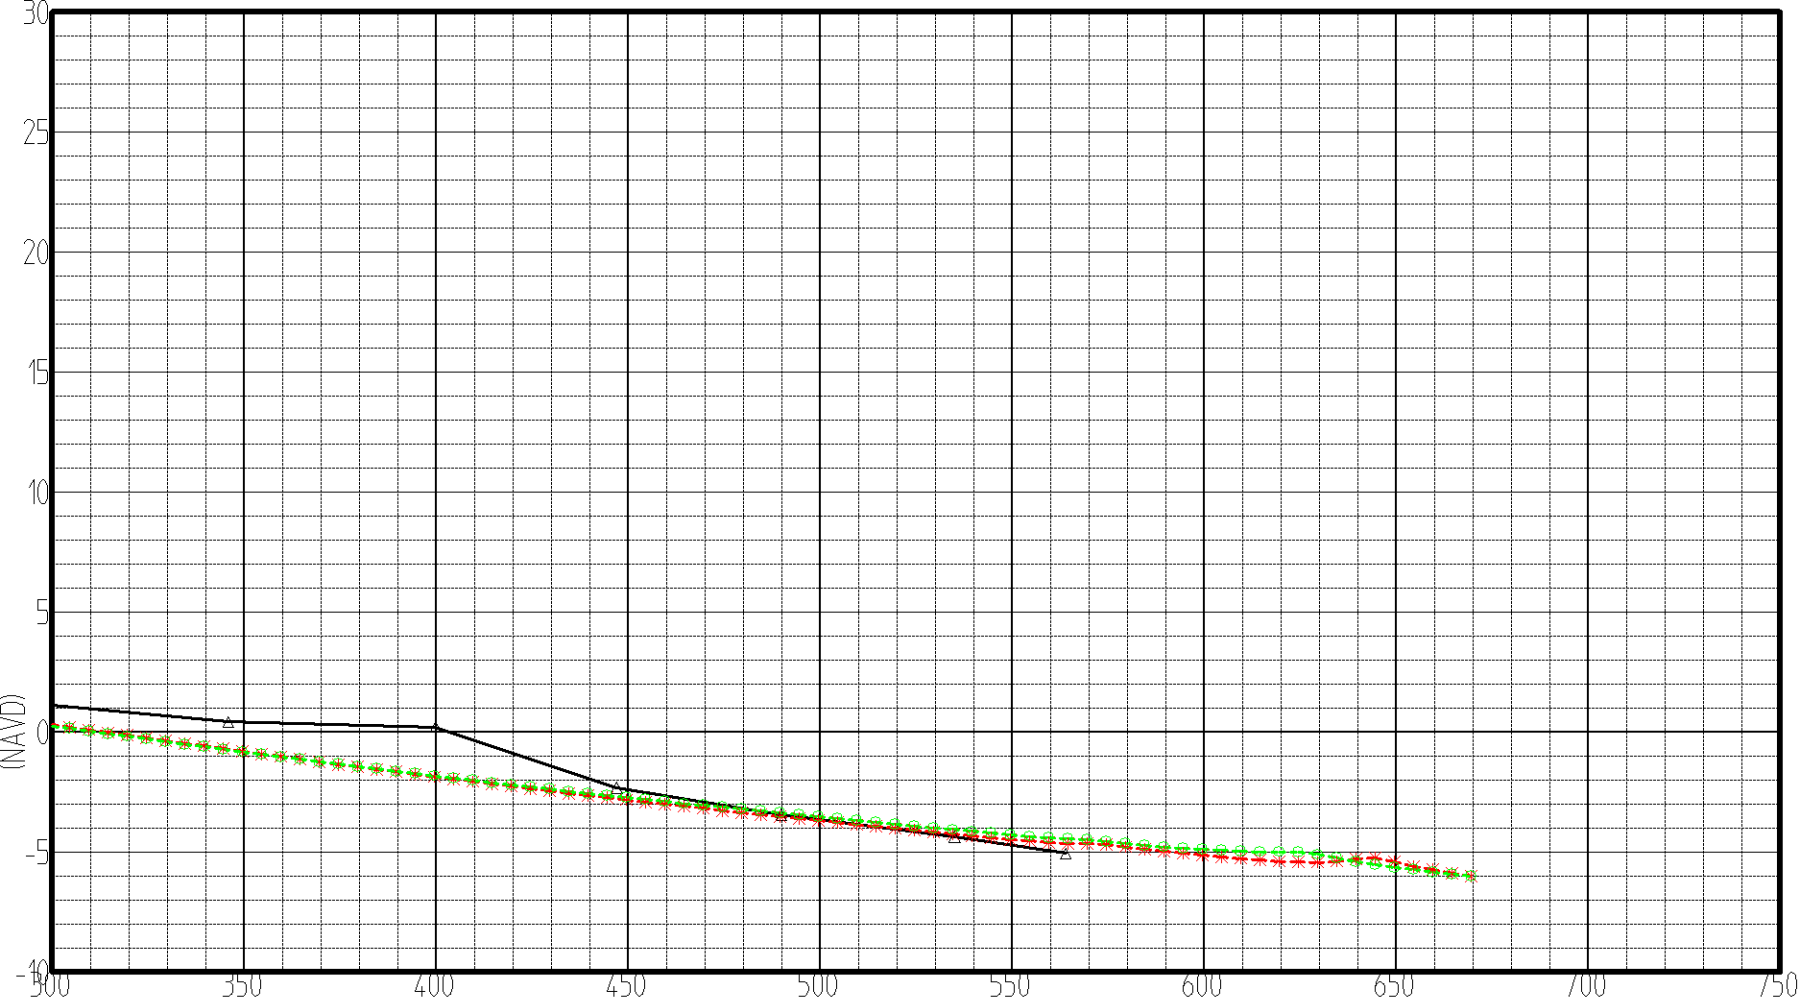
Range: R-195
 BEARING: 75.00
 2/2

BEACH PROFILE
 —△—△— ST. JOHNS 2007-2008 COMBI
 - - * - - - 15YR SBEACH ERODED
 - - o - - - 25YR SBCH ERODED

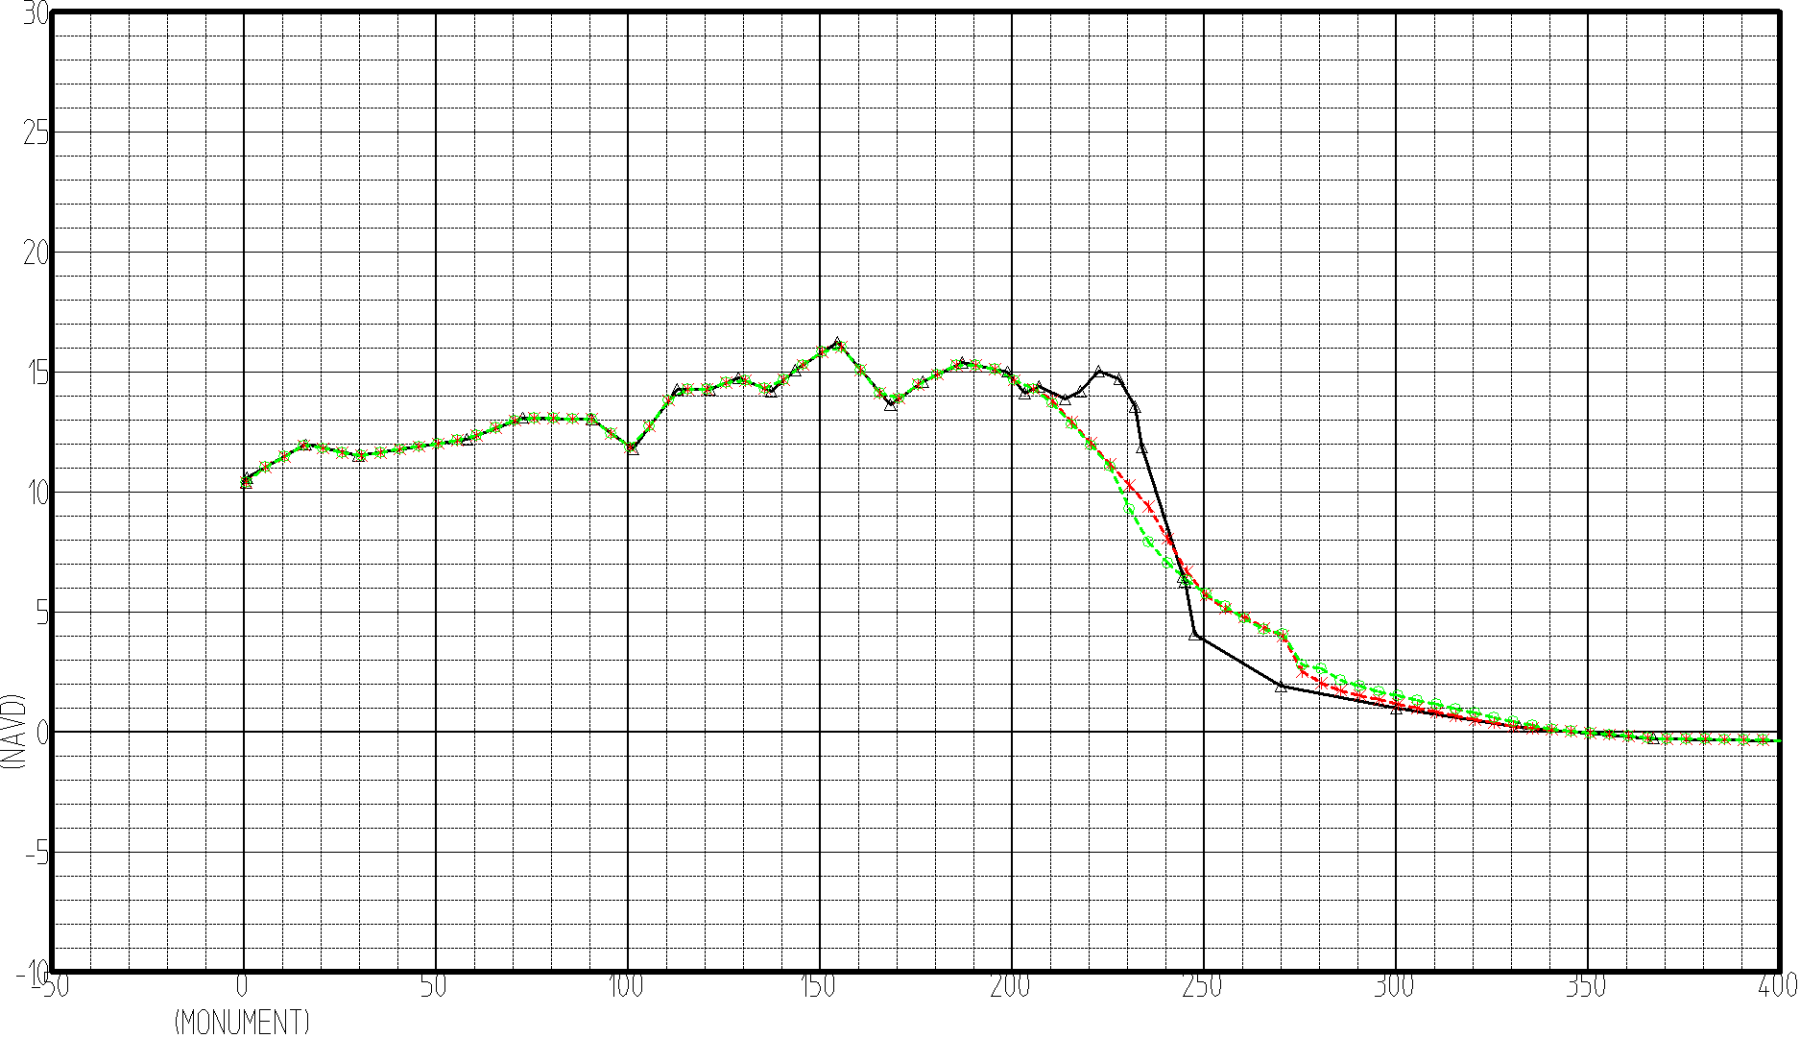
Range: R-198
 BEARING: 75.00
 1/3

BEACH PROFILE
 —△—△— ST. JOHNS 2007-2008 COMBI
 - - * - - 15YR SBCH ERODED
 - - o - - 25YR SBCH ERODED

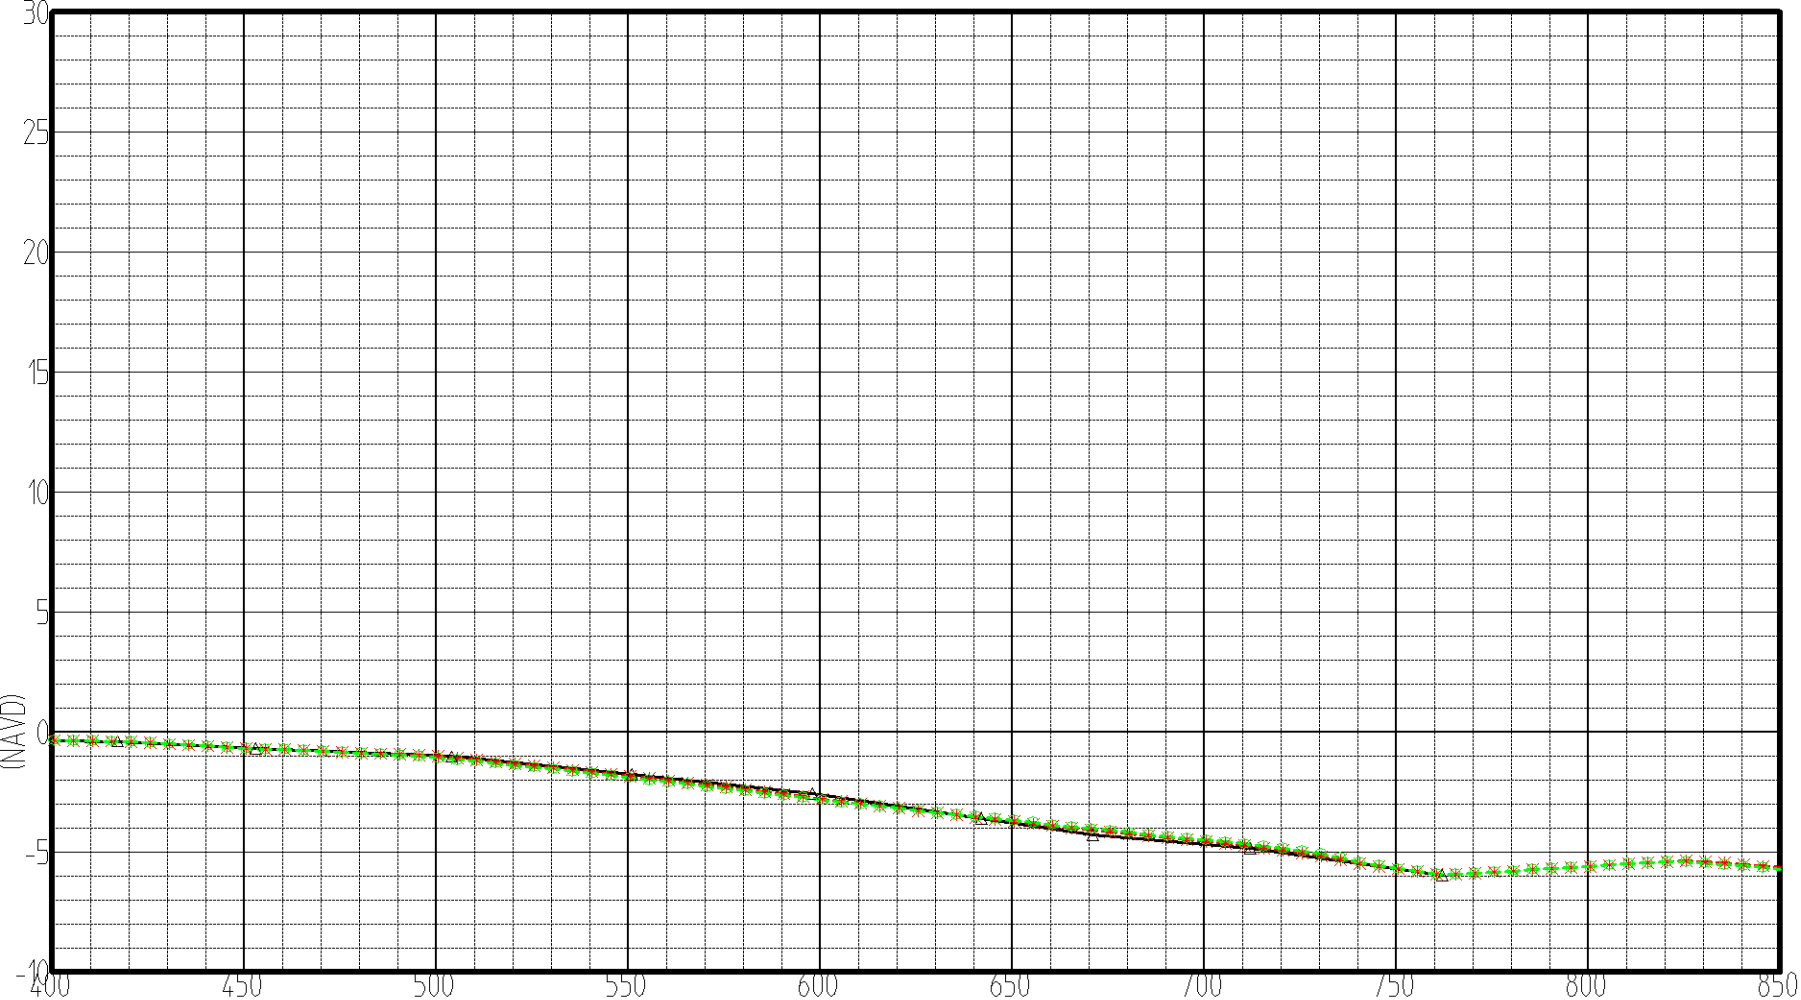
Range: R-198

BEACH PROFILE

—△—△— ST. JOHNS 2007-2008 COMBI

- - * - - * - - 15YR SBEACH ERODED

- - o - - o - - 25YR SBCH ERODED

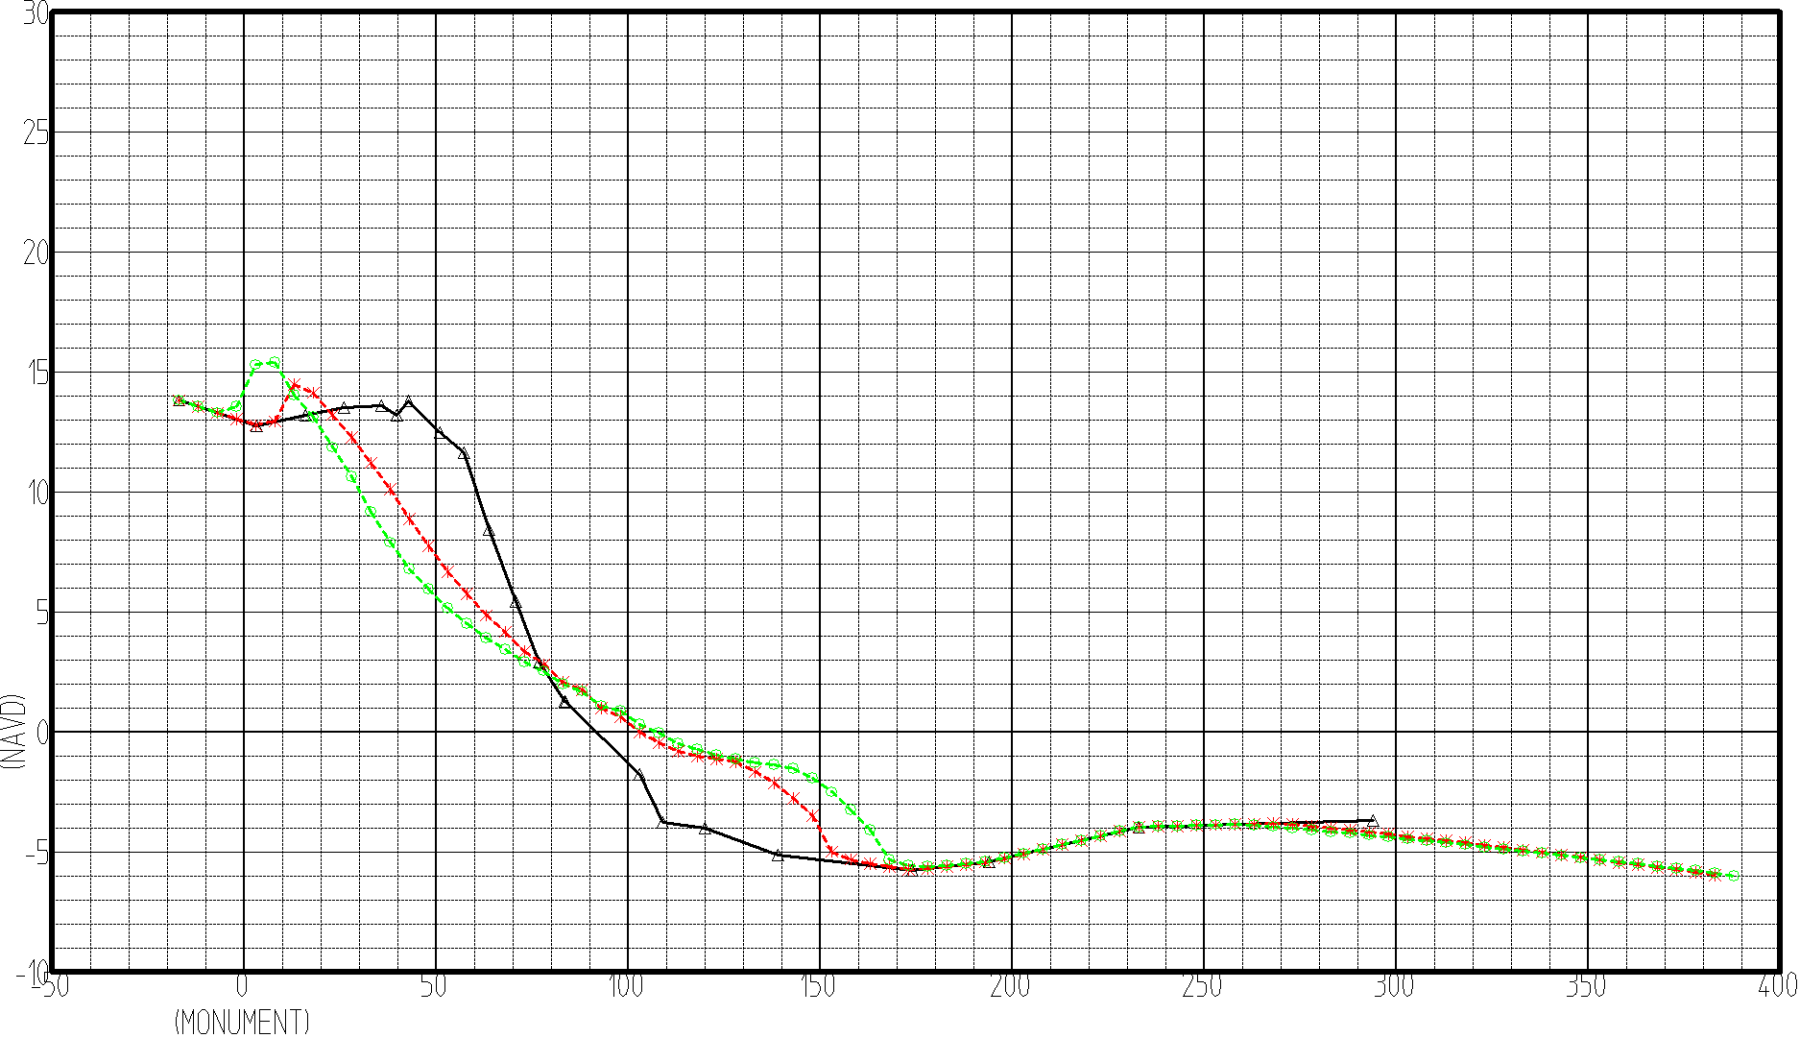
Range: R-199
 BEARING: 75.00
 1/1

BEACH PROFILE
 —△—△— ST. JOHNS 2007-2008 COMBI
 - - * - - 15YR SBEACH ERODED
 - - o - - 25YR SBCH ERODED

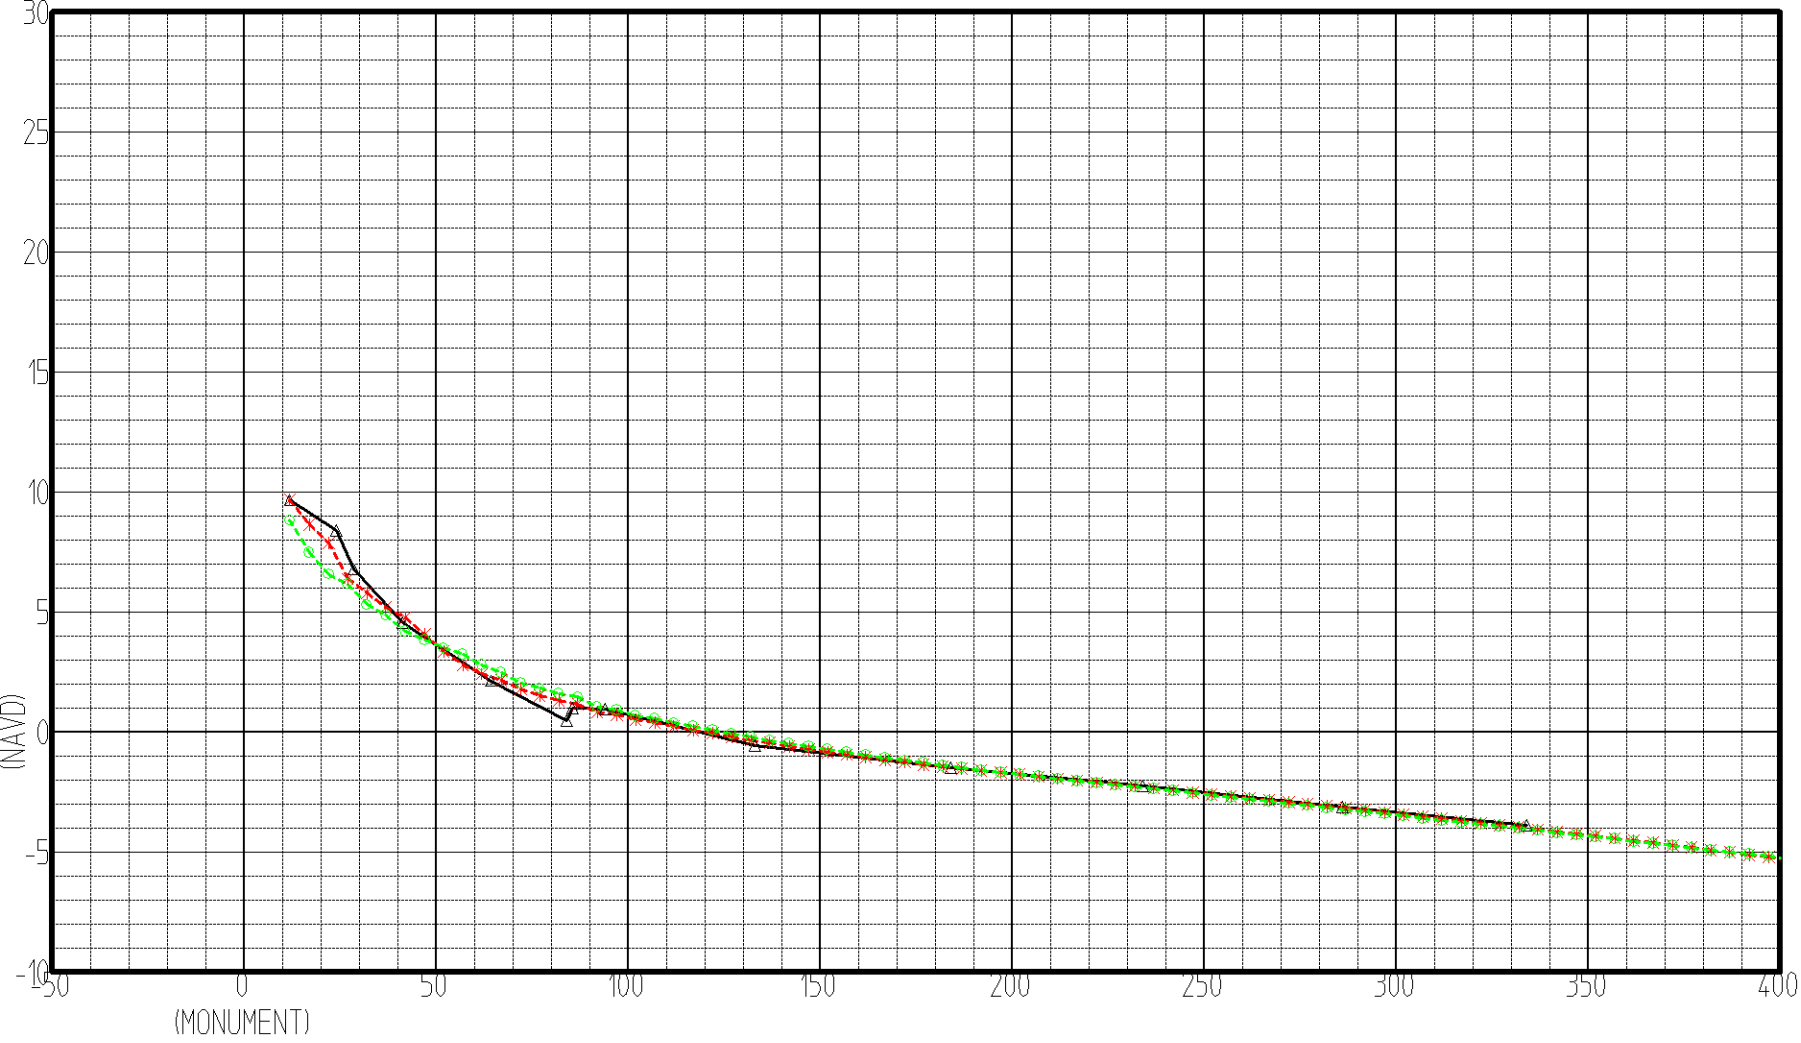
Range: R-200

BEACH PROFILE

—△—△— ST. JOHNS 2007-2008 COMBI

- - * - - * - - 15YR SBEACH ERODED

- - ○ - - ○ - - 25YR SBCH ERODED

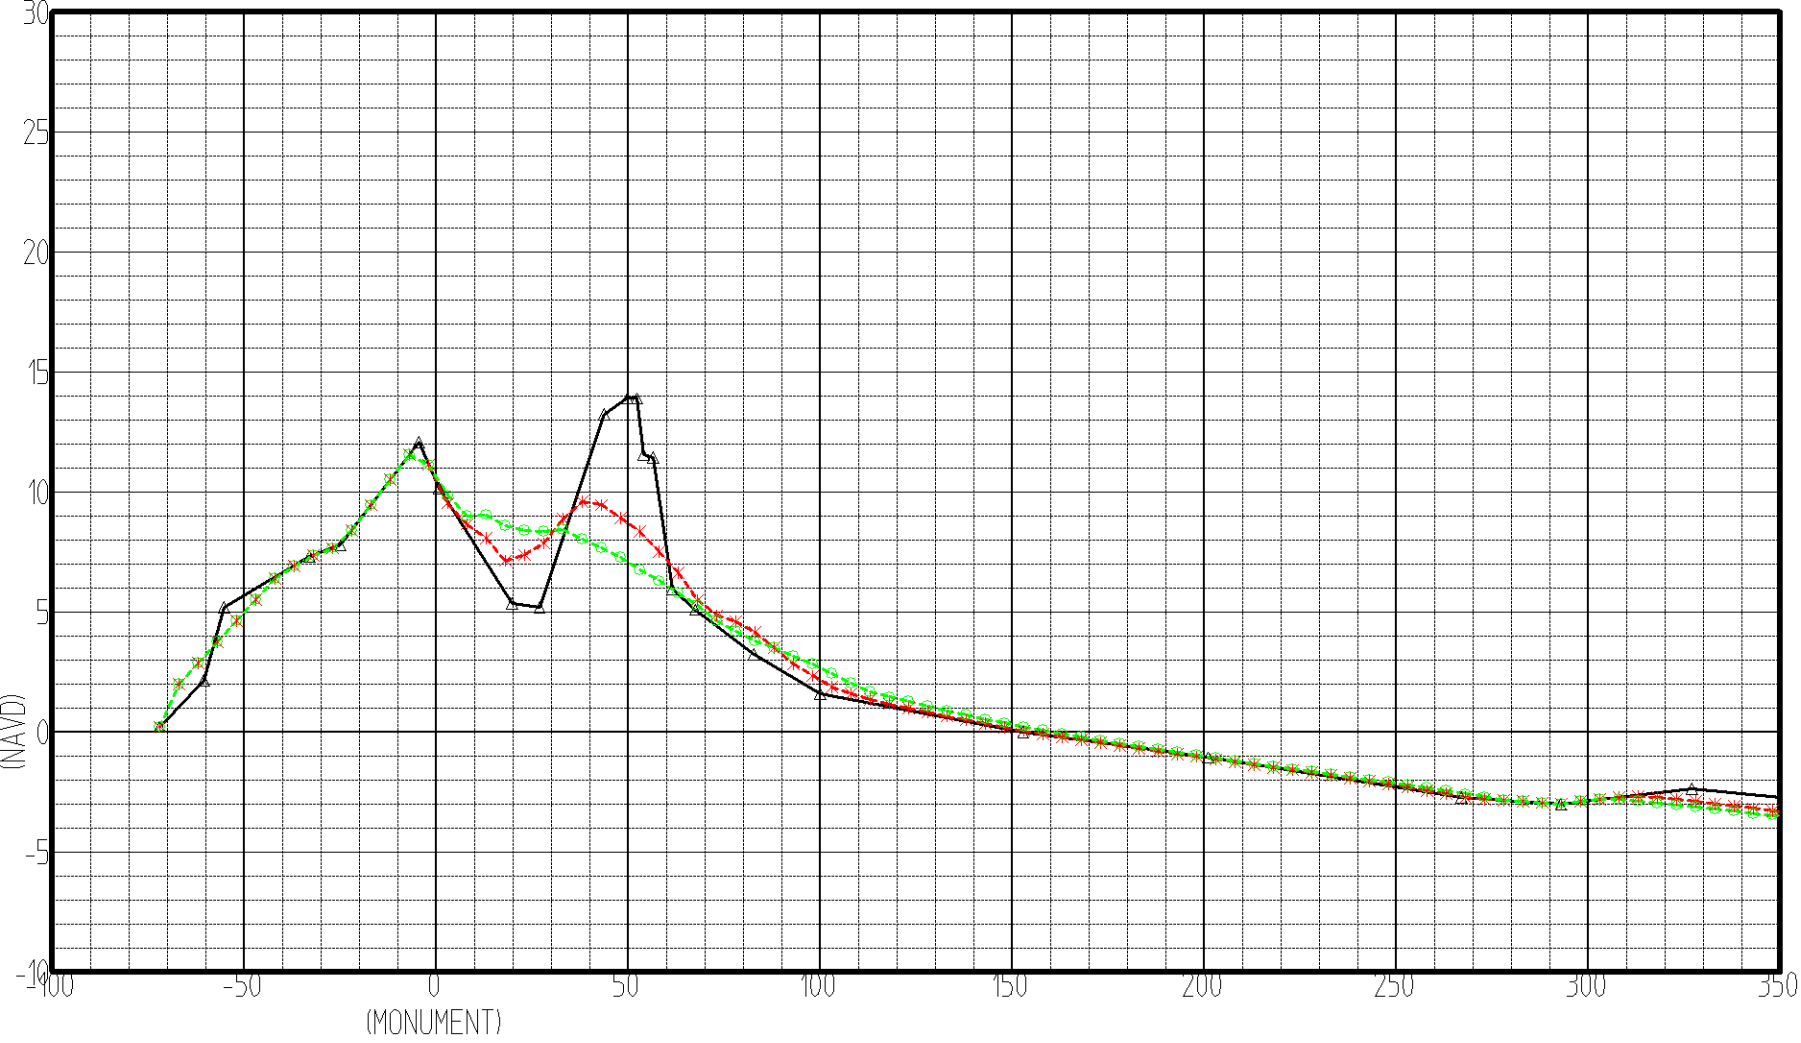
Range: R-201

BEACH PROFILE

—△—△— ST. JOHNS 2007-2008 COMBI

- - * - - * - - 15YR SBACH ERODED

- - o - - o - - 25YR SBCH ERODED

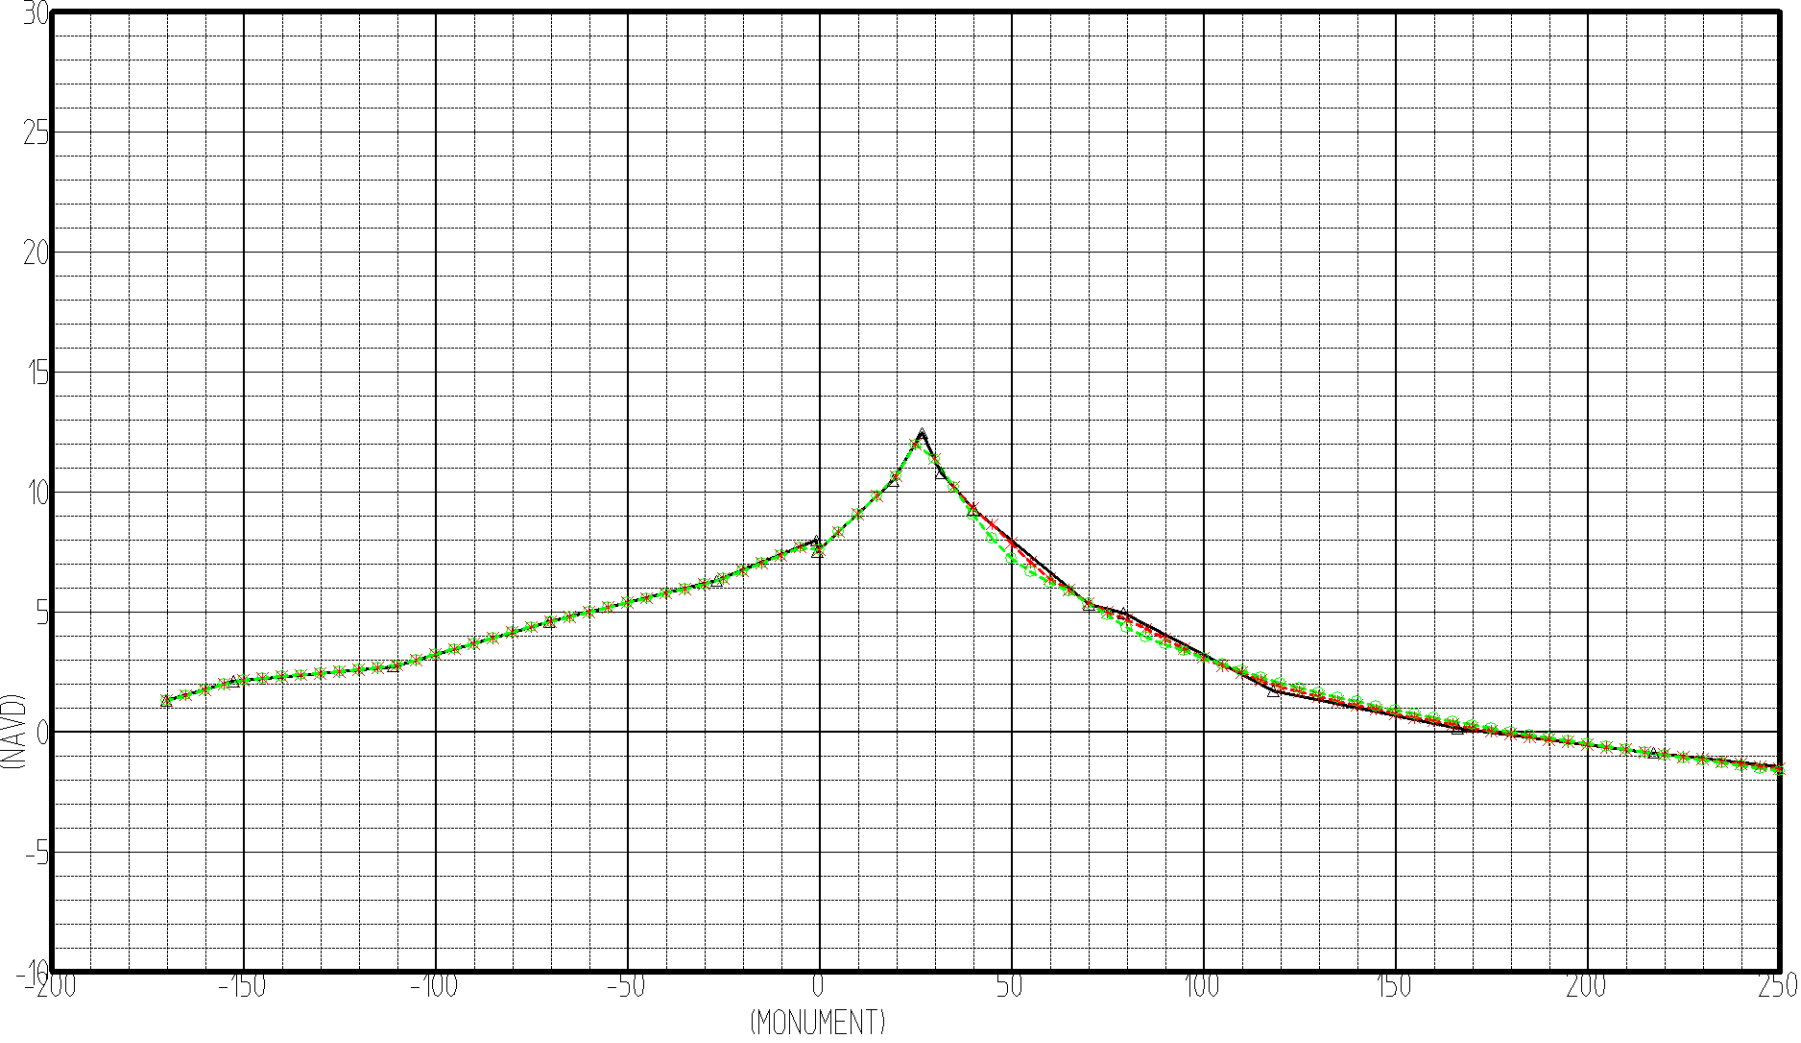
Range: R-202 1/2

BEACH PROFILE

—△—△— ST. JOHNS 2007-2008 COMBI
 - - * - - * - - 15YR SBEACH ERODED
 - - o - - o - - 25YR SBCH ERODED

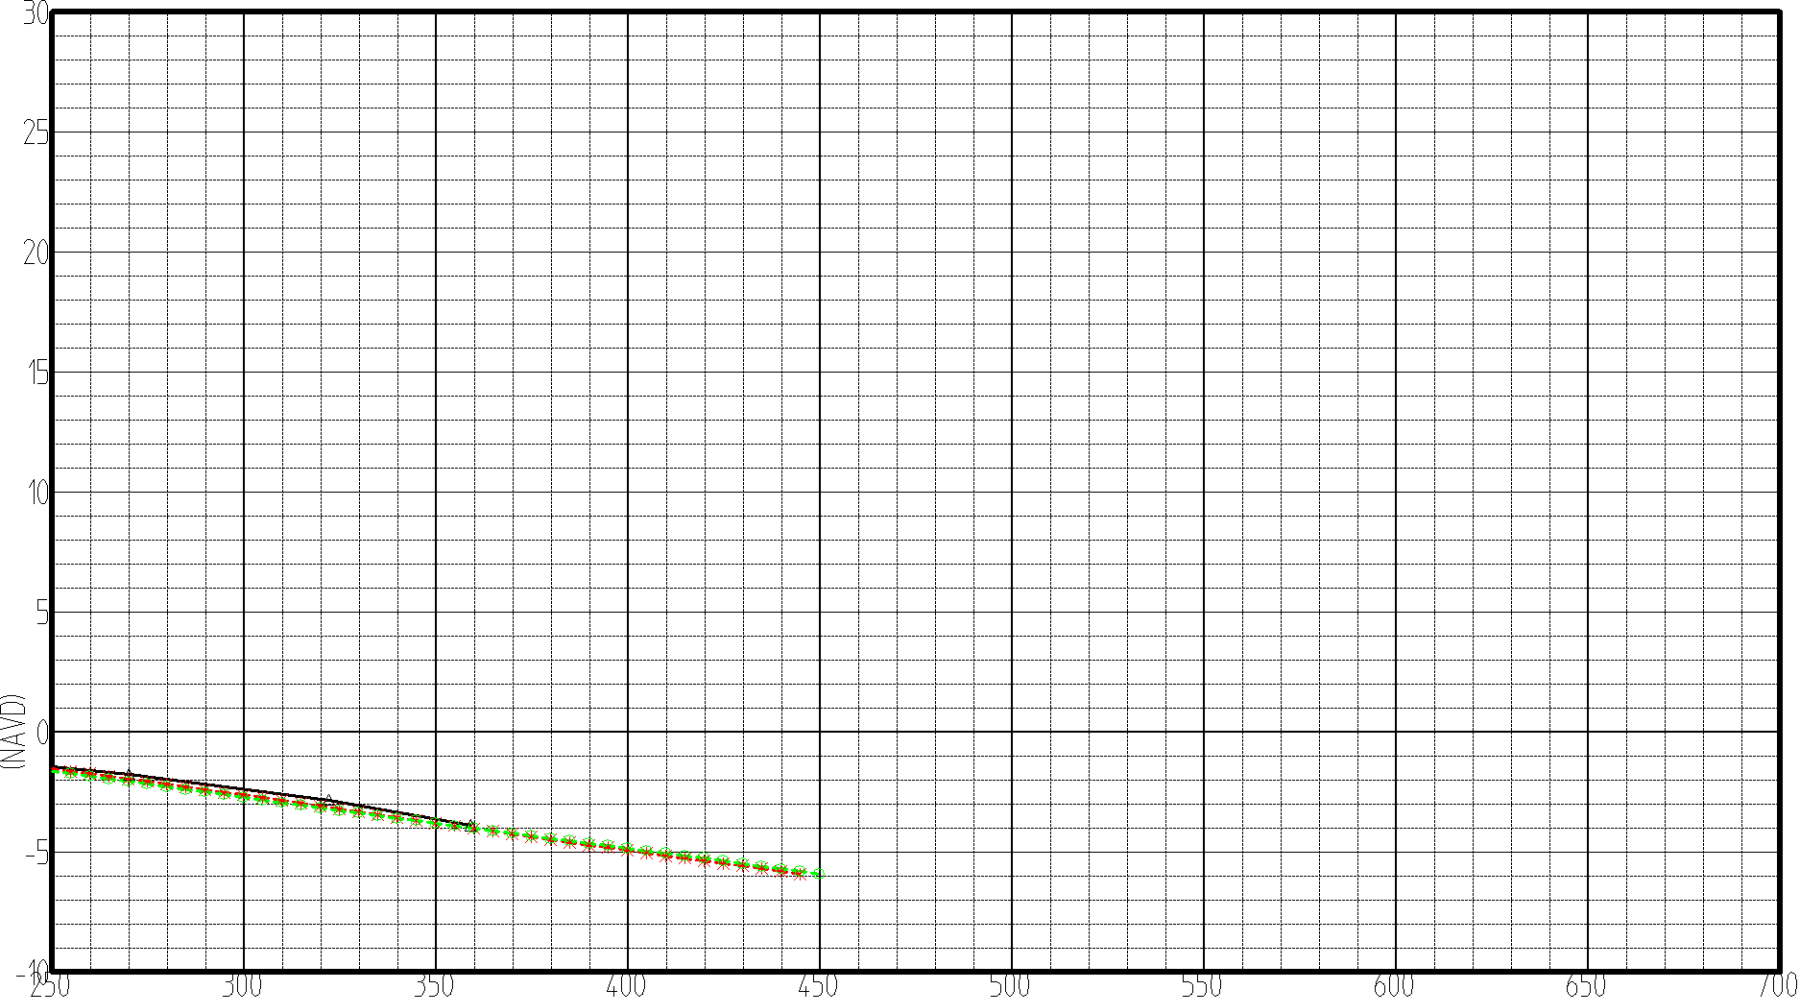
Range: R-202 2/2

BEACH PROFILE

—△—△— ST. JOHNS 2007-2008 COMBI

- - - * - - - 15YR SBEACH ERODED

- - - o - - - 25YR SBCH ERODED

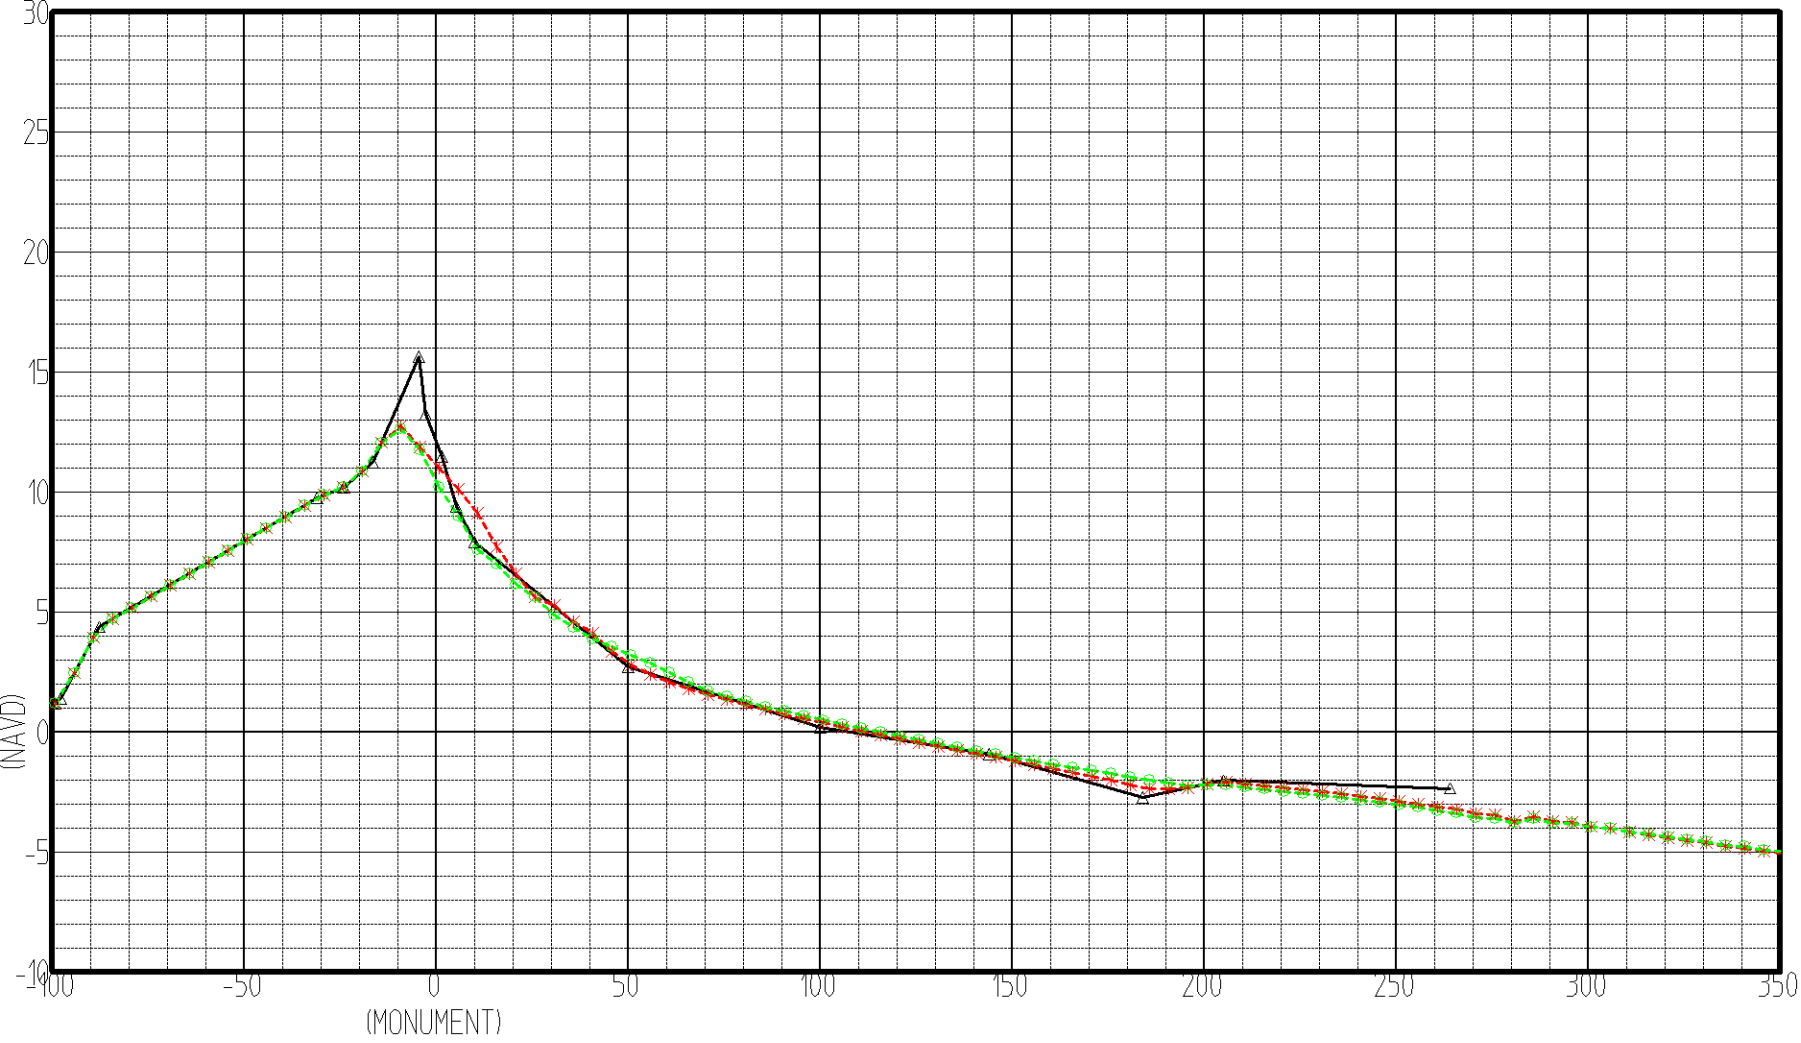
Range: R-203
 BEARING: 75.00
 1/2

BEACH PROFILE
 —△—△— ST. JOHNS 2007-2008 COMBI
 - - * - - * - - 15YR SBEACH ERODED
 - - o - - o - - 25YR SBCH ERODED

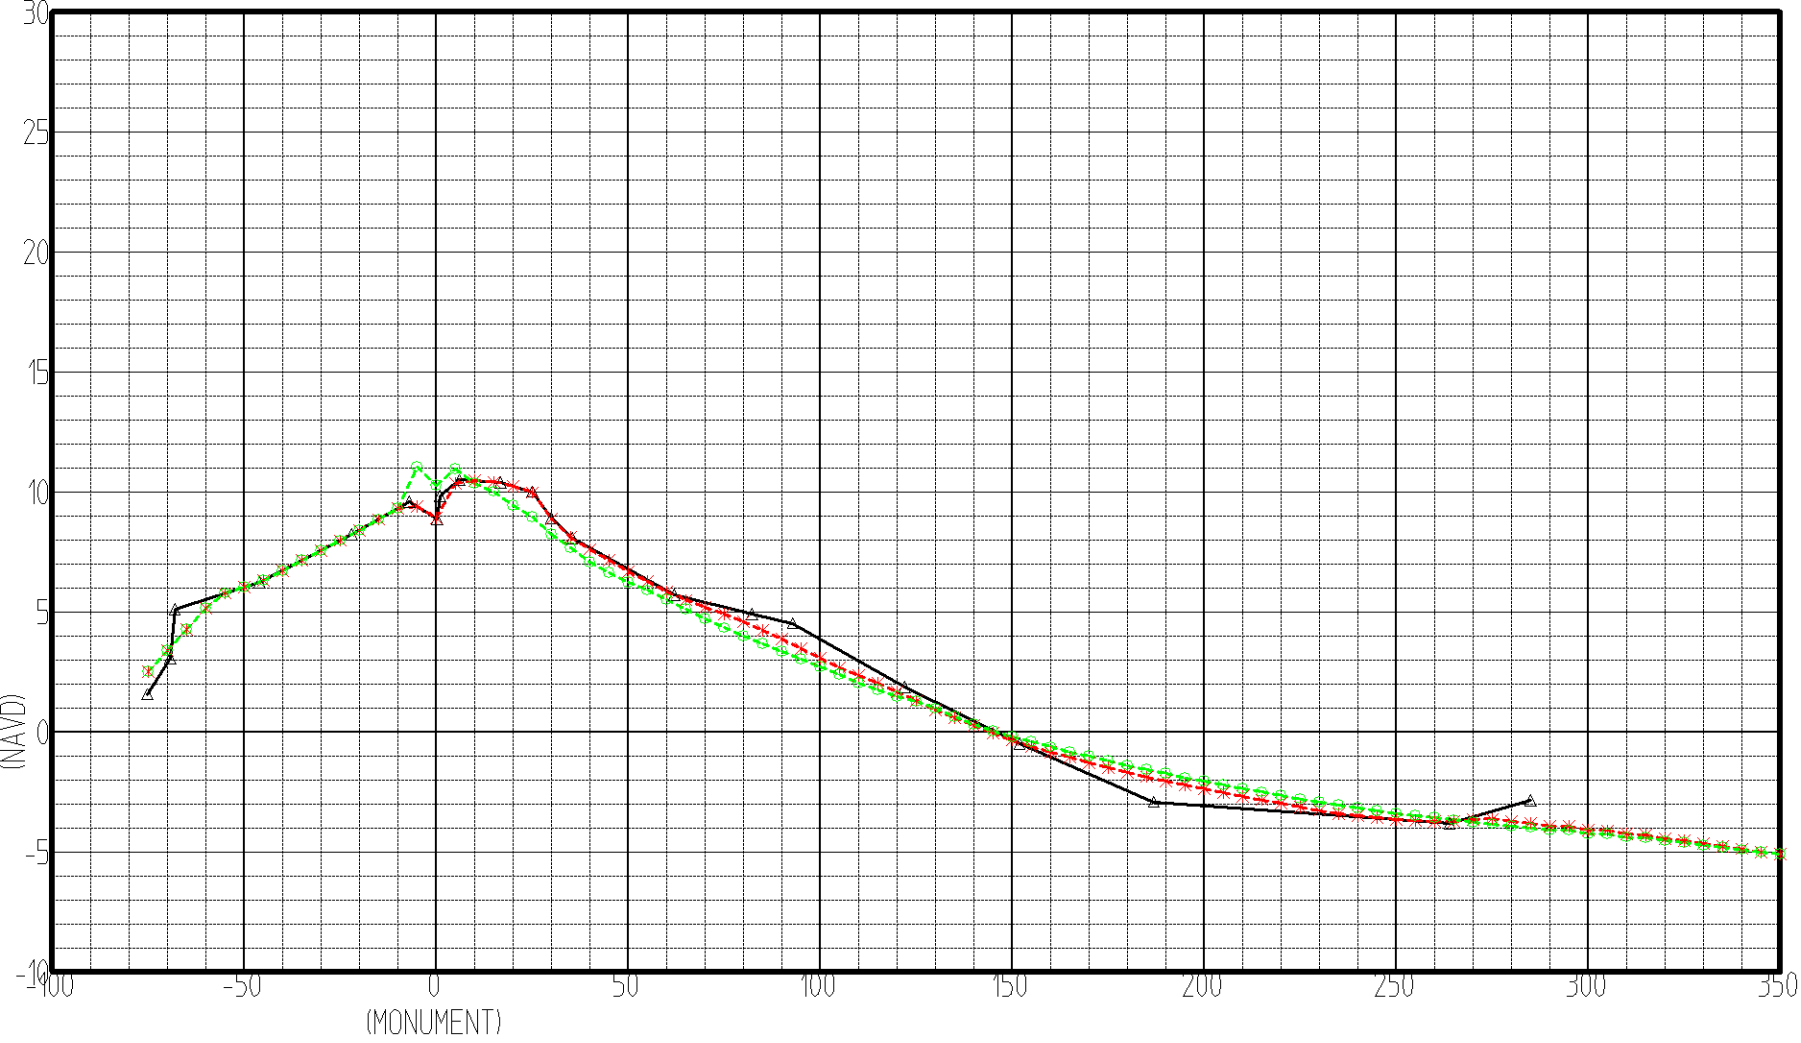
Range: R-204
 BEARING: 75.00
 1/2

BEACH PROFILE
 —△—△— ST. JOHNS 2007-2008 COMBI
 - - * - - 15YR SBEACH ERODED
 - - o - - 25YR SBCH ERODED
