Appendix VIII

SBEACH 15 and 25 yr. Storm Erosion Profiles

St. Johns County

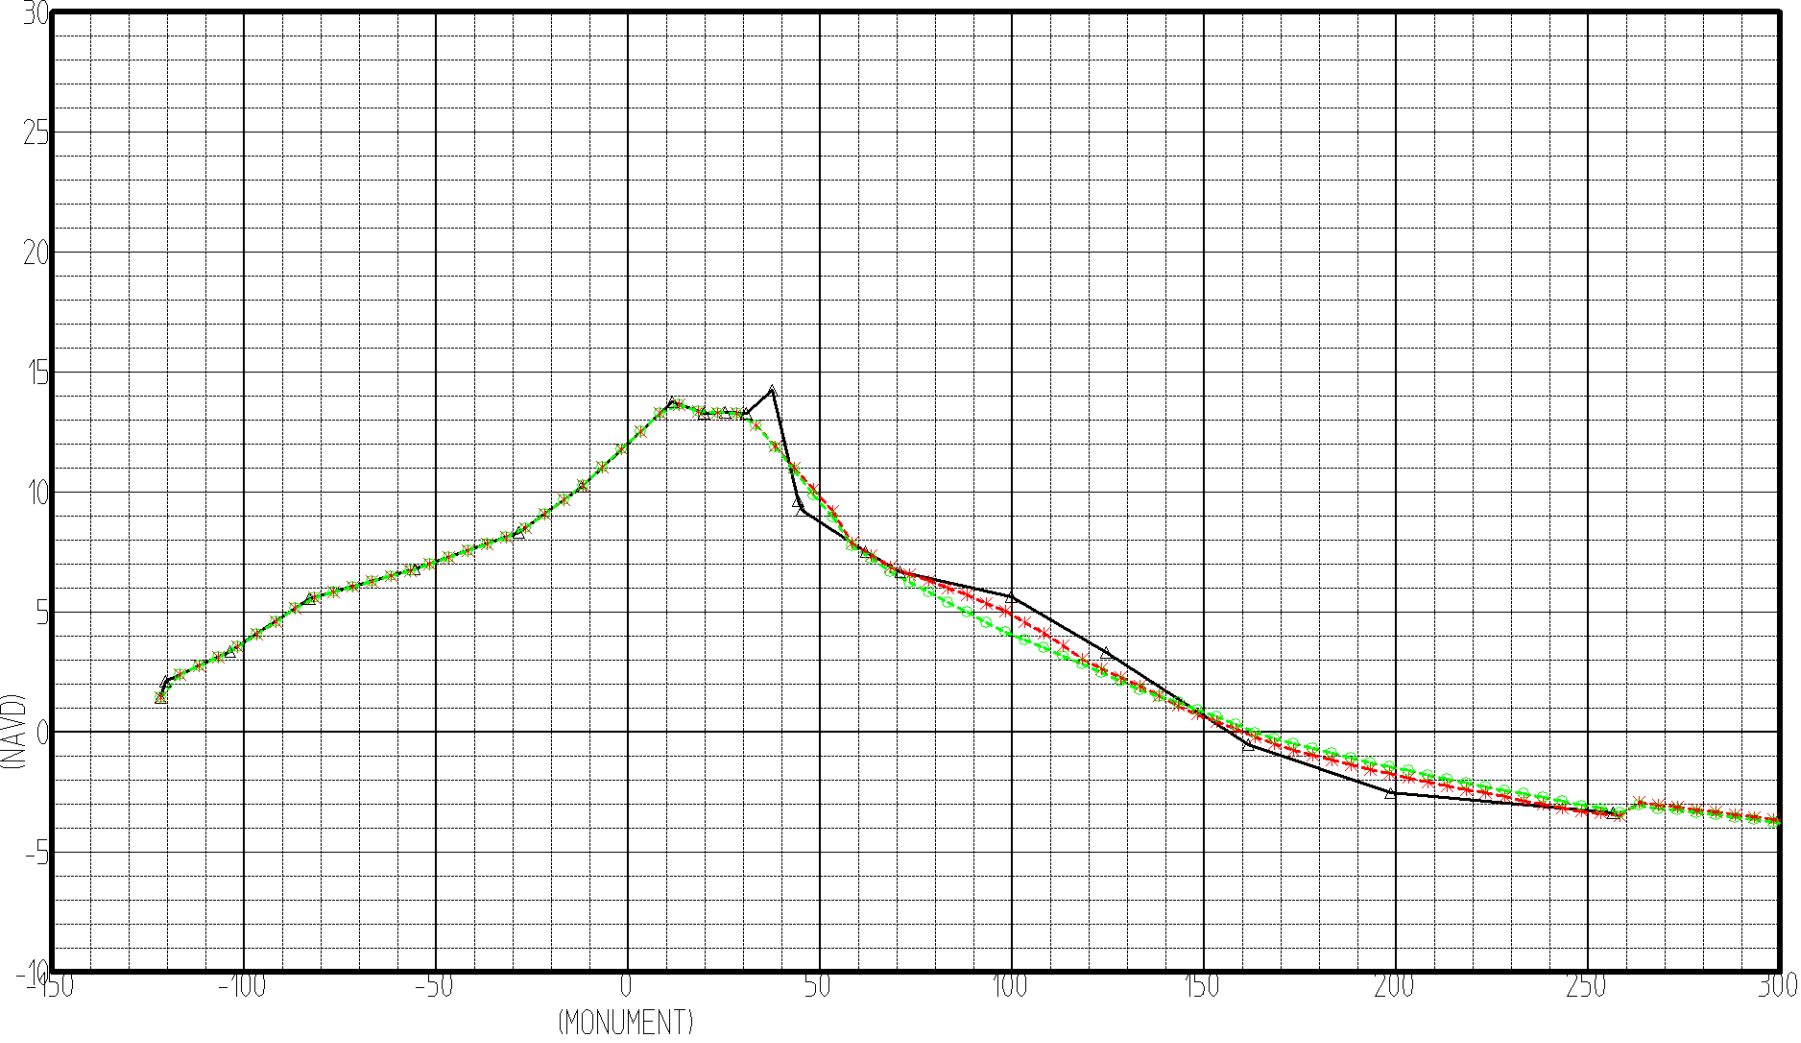
Range: R-205

BEACH PROFILE

—△—△— ST. JOHNS 2007-2008 COMBI

- - * - - * - - 15YR SBEACH ERODED

- - o - - o - - 25YR SBCH ERODED

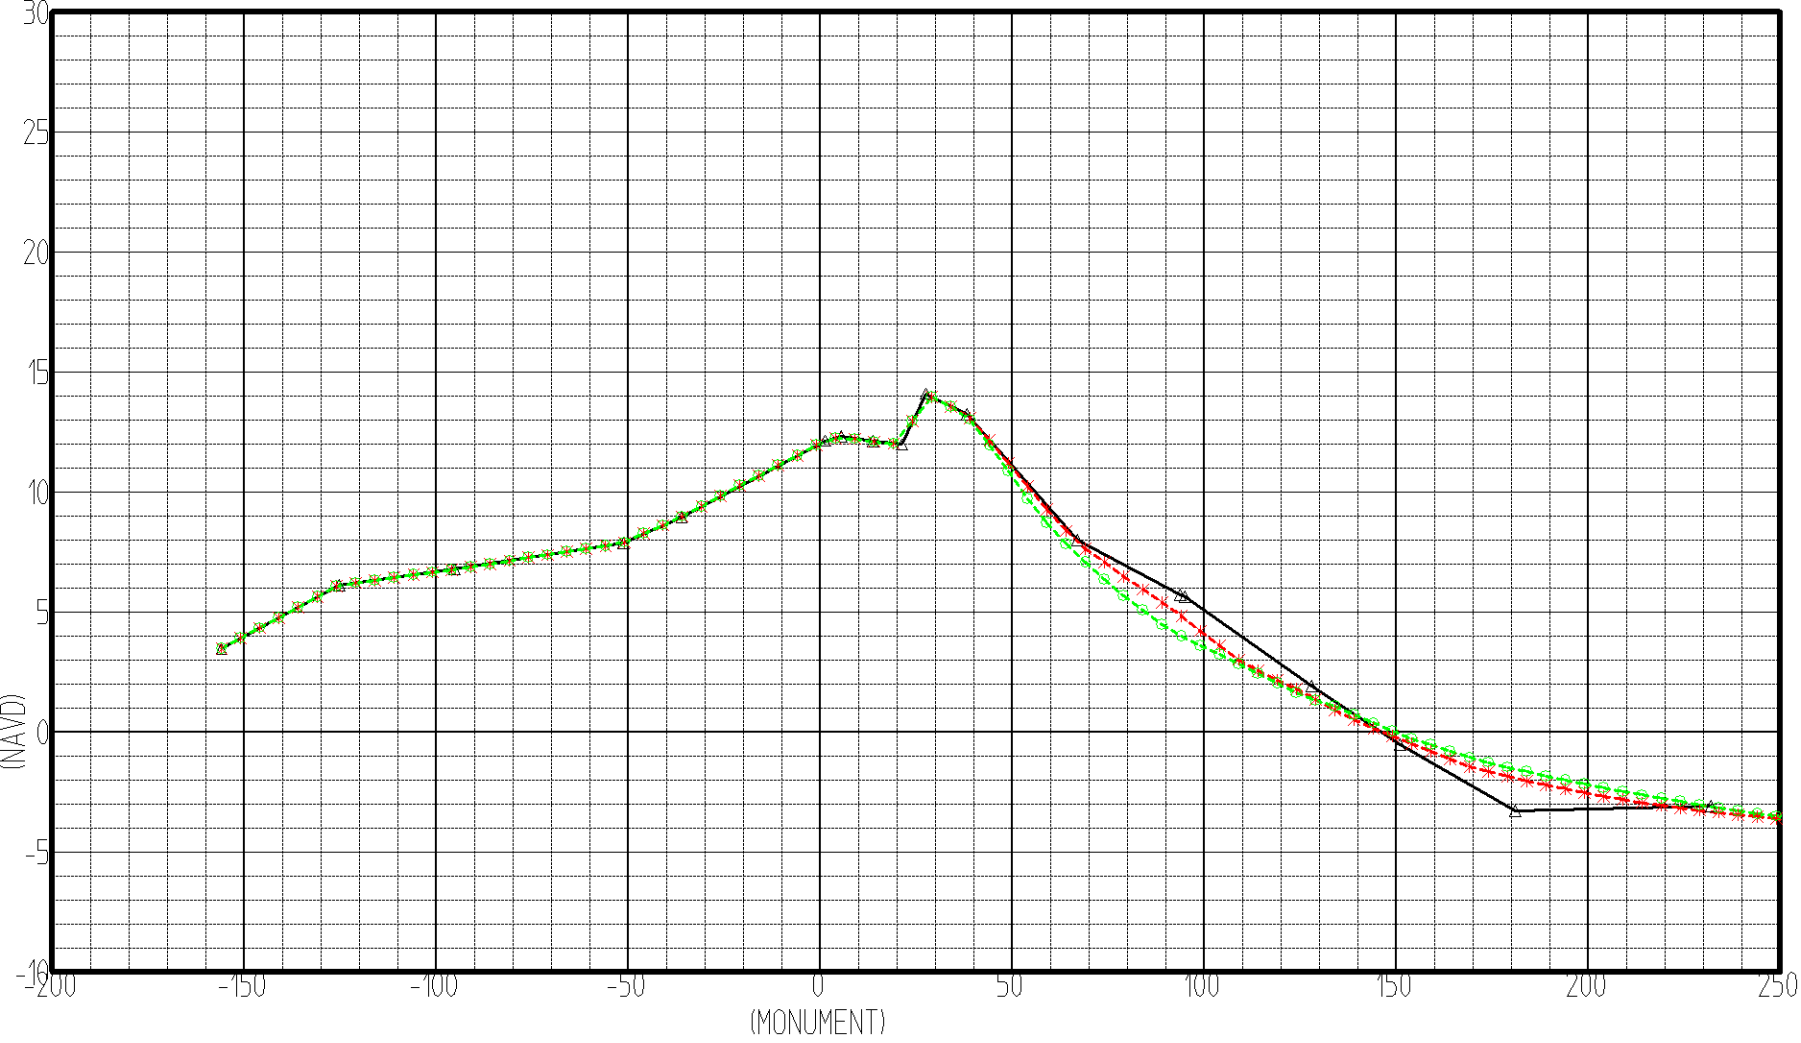
Range: R-206
 BEARING: 75.00
 1/2

BEACH PROFILE
 —△—△— ST. JOHNS 2007-2008 COMBI
 - - * - - 15YR SBEACH ERODED
 - - o - - 25YR SBCH ERODED

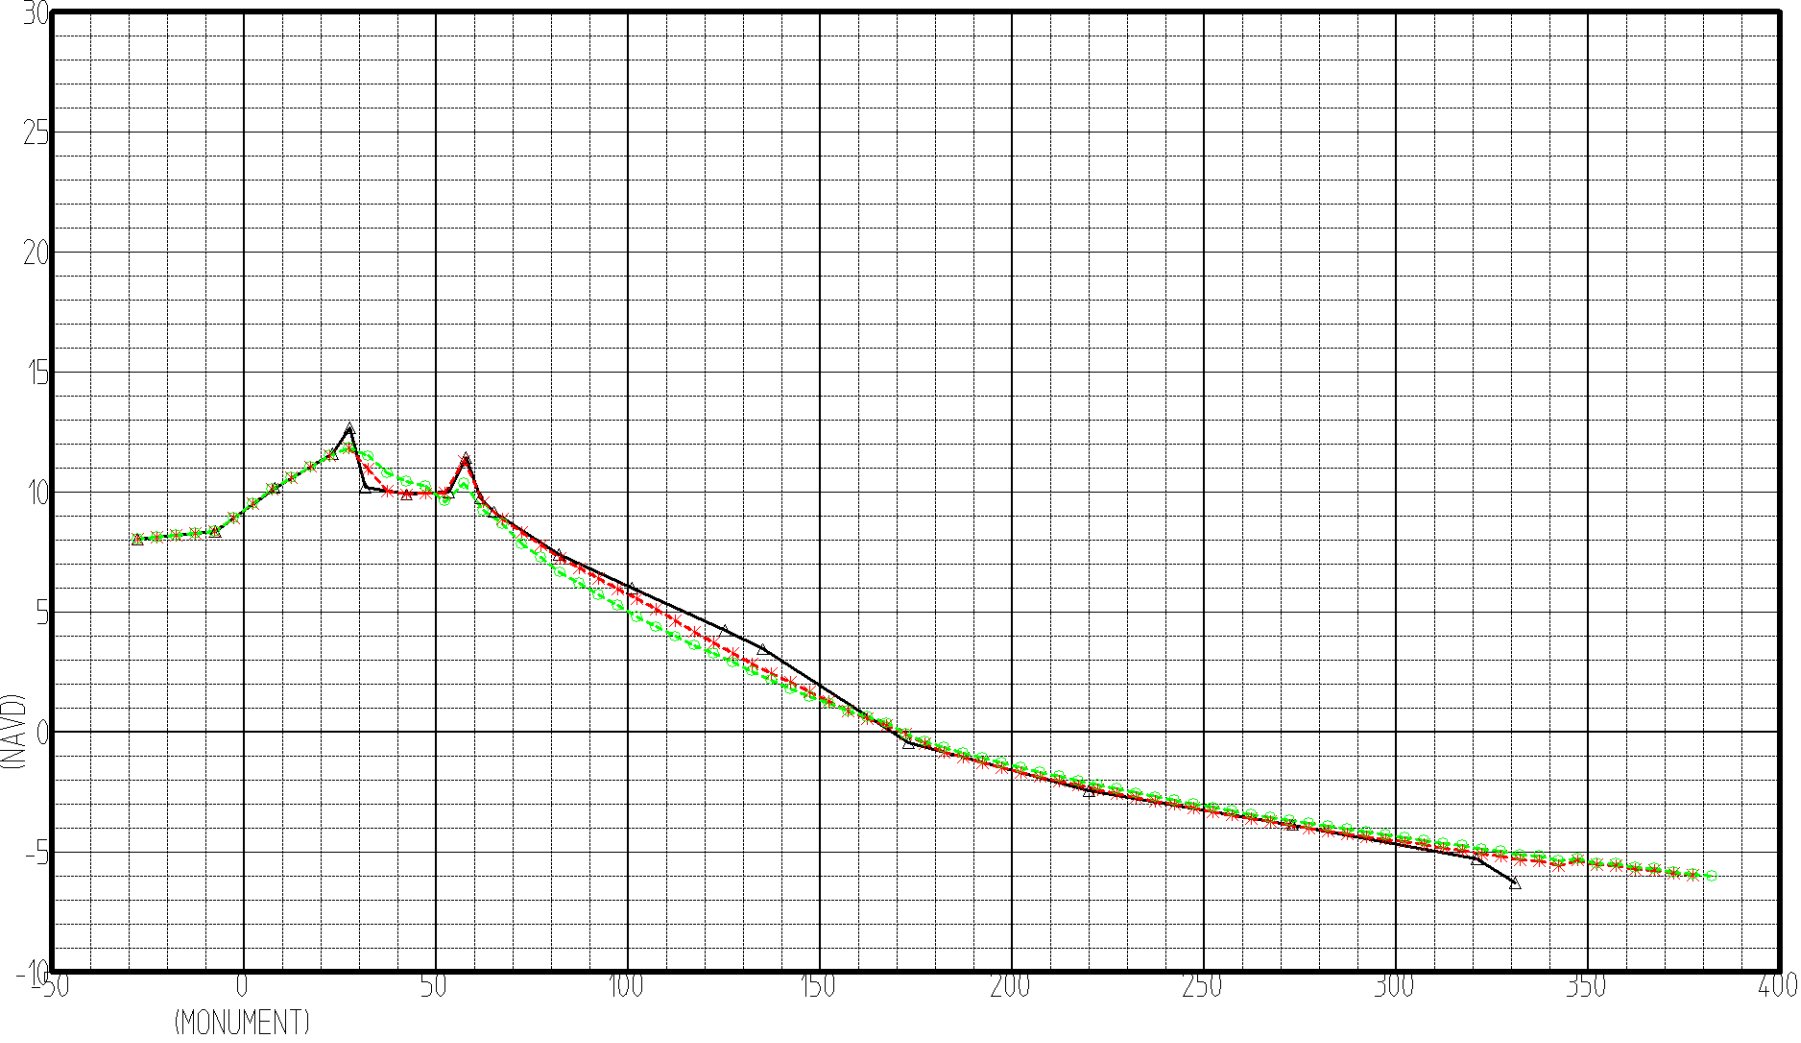
Range: R-207

BEACH PROFILE

—△—△— ST. JOHNS 2007-2008 COMBI

- - - * - - - 15YR SBCH ERODED

- - - o - - - 25YR SBCH ERODED

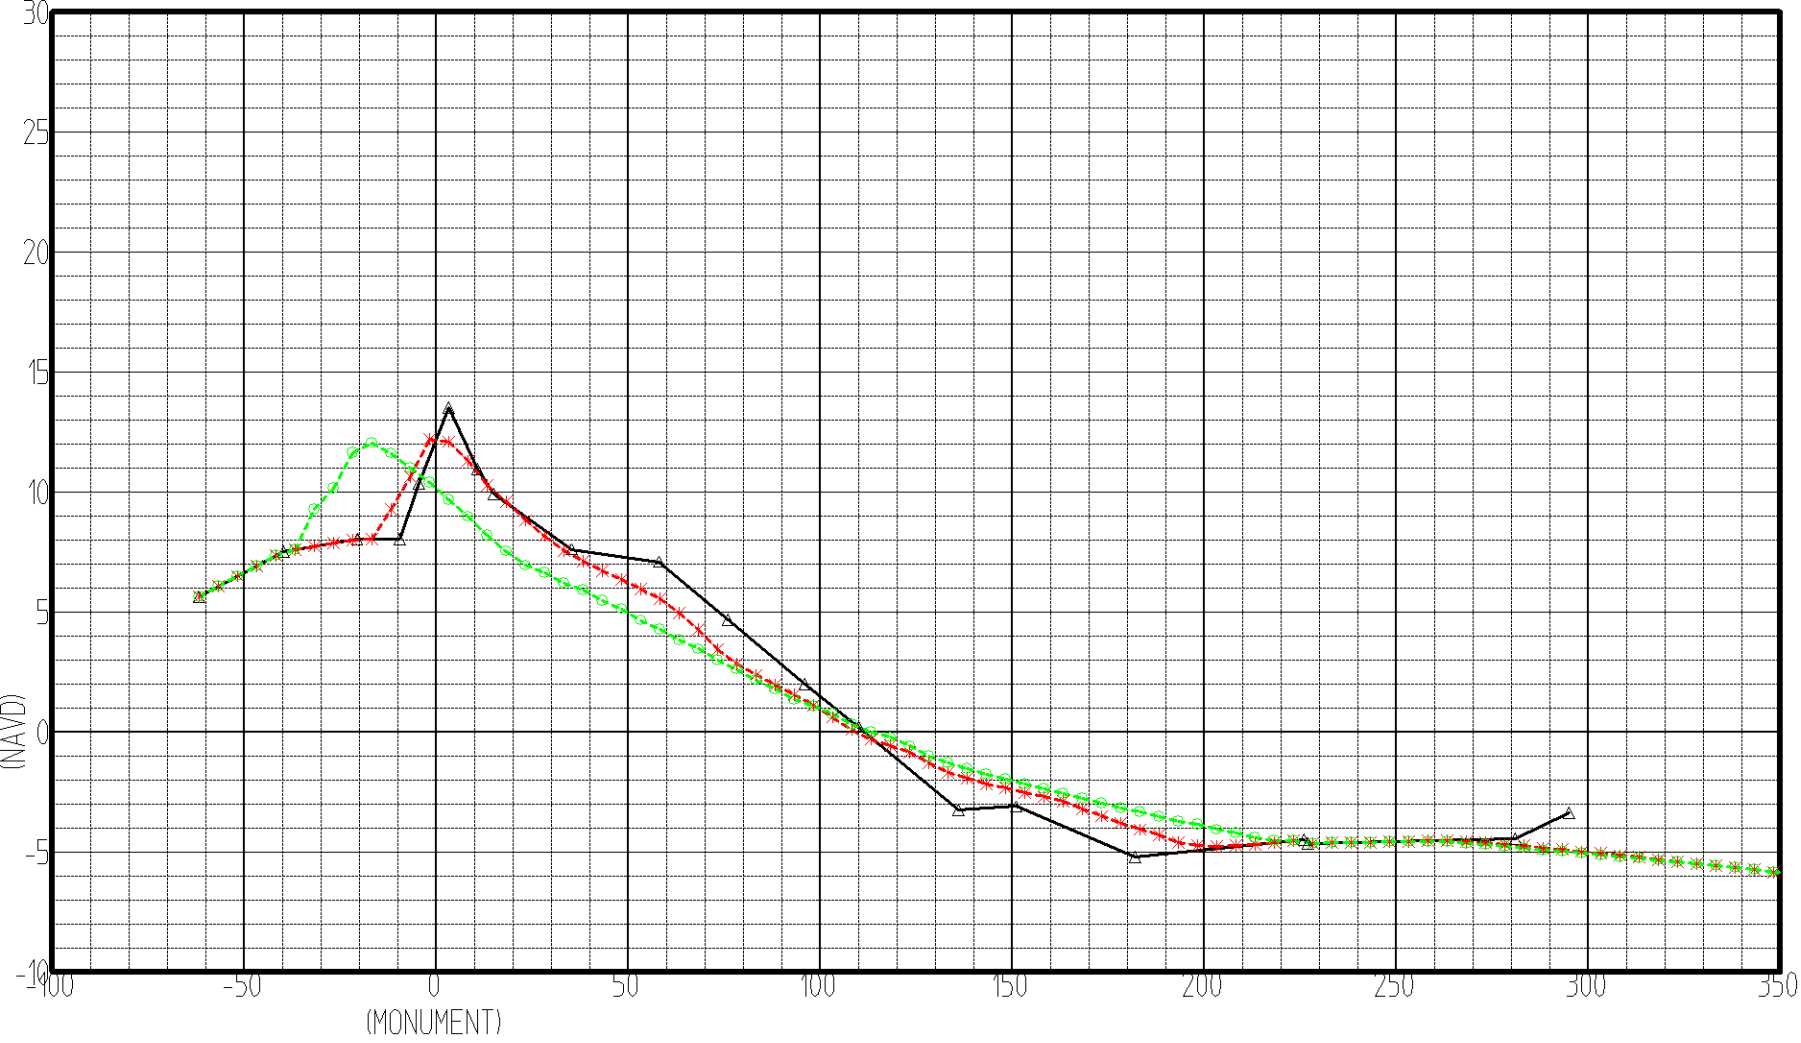
Range: R-208
 BEARING: 75.00
 1/2

BEACH PROFILE
 —△—△— ST. JOHNS 2007-2008 COMBI
 - - * - - 15YR SBCH ERODED
 - - o - - 25YR SBCH ERODED

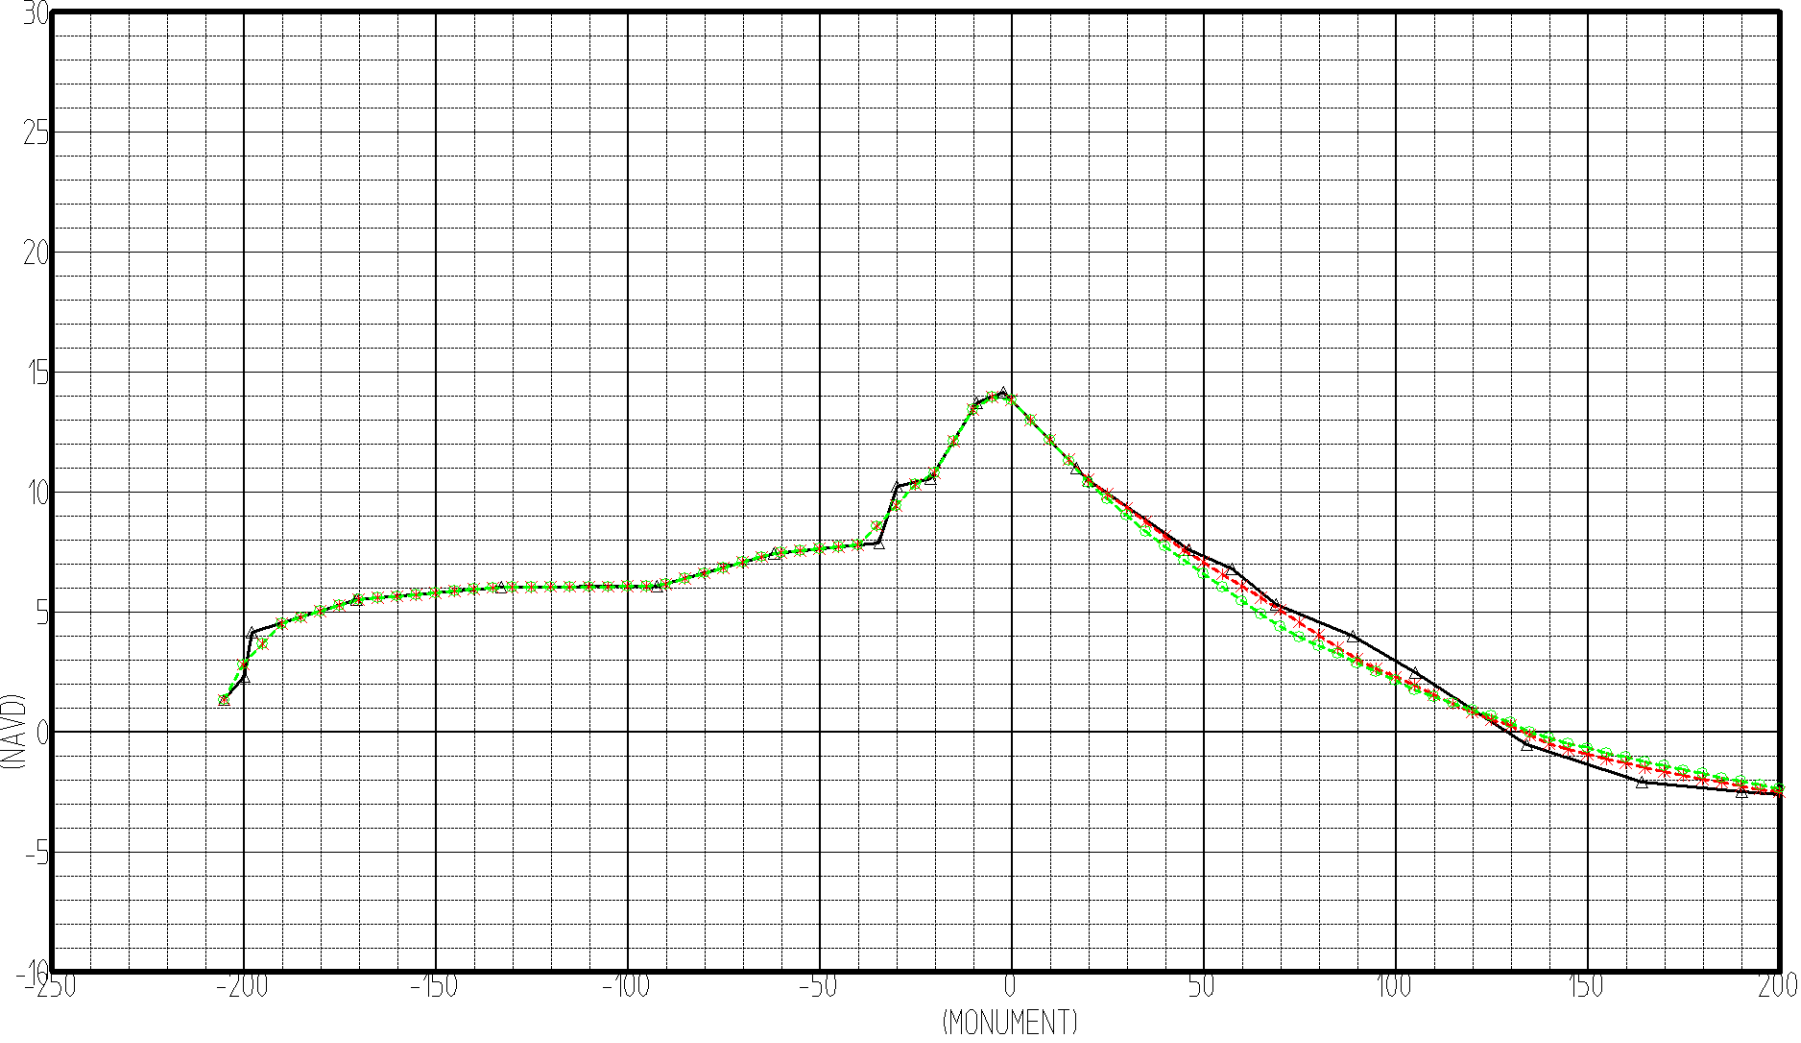
Range: R-209
 BEARING: 75.00
 1/2

BEACH PROFILE
 —△—△— ST. JOHNS 2007-2018 COMBI
 - - * - - * - - 15YR SBEACH ERODED
 - - o - - o - - 25YR SBCH ERODED

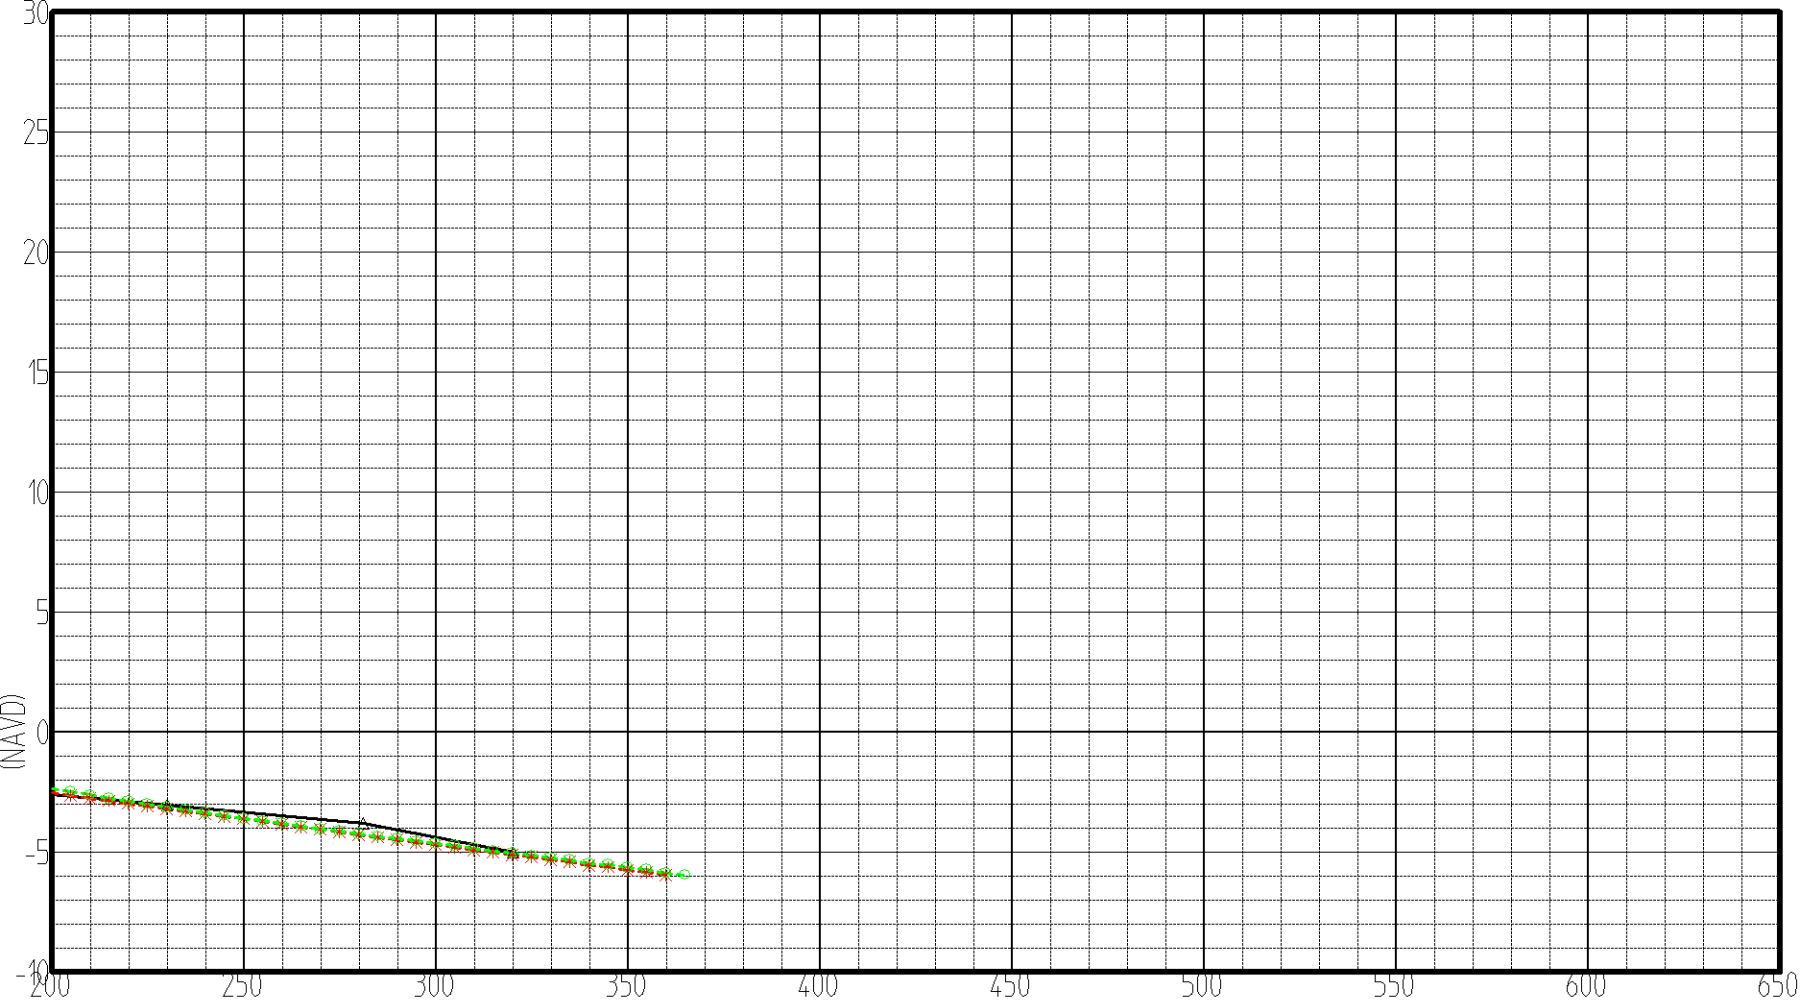
BEACH PROFILE

—△—△— ST. JOHNS 2007-2008 COMBI
