Appendix XI

SBEACH 15 and 25 yr. Storm Erosion Profiles

Brevard County

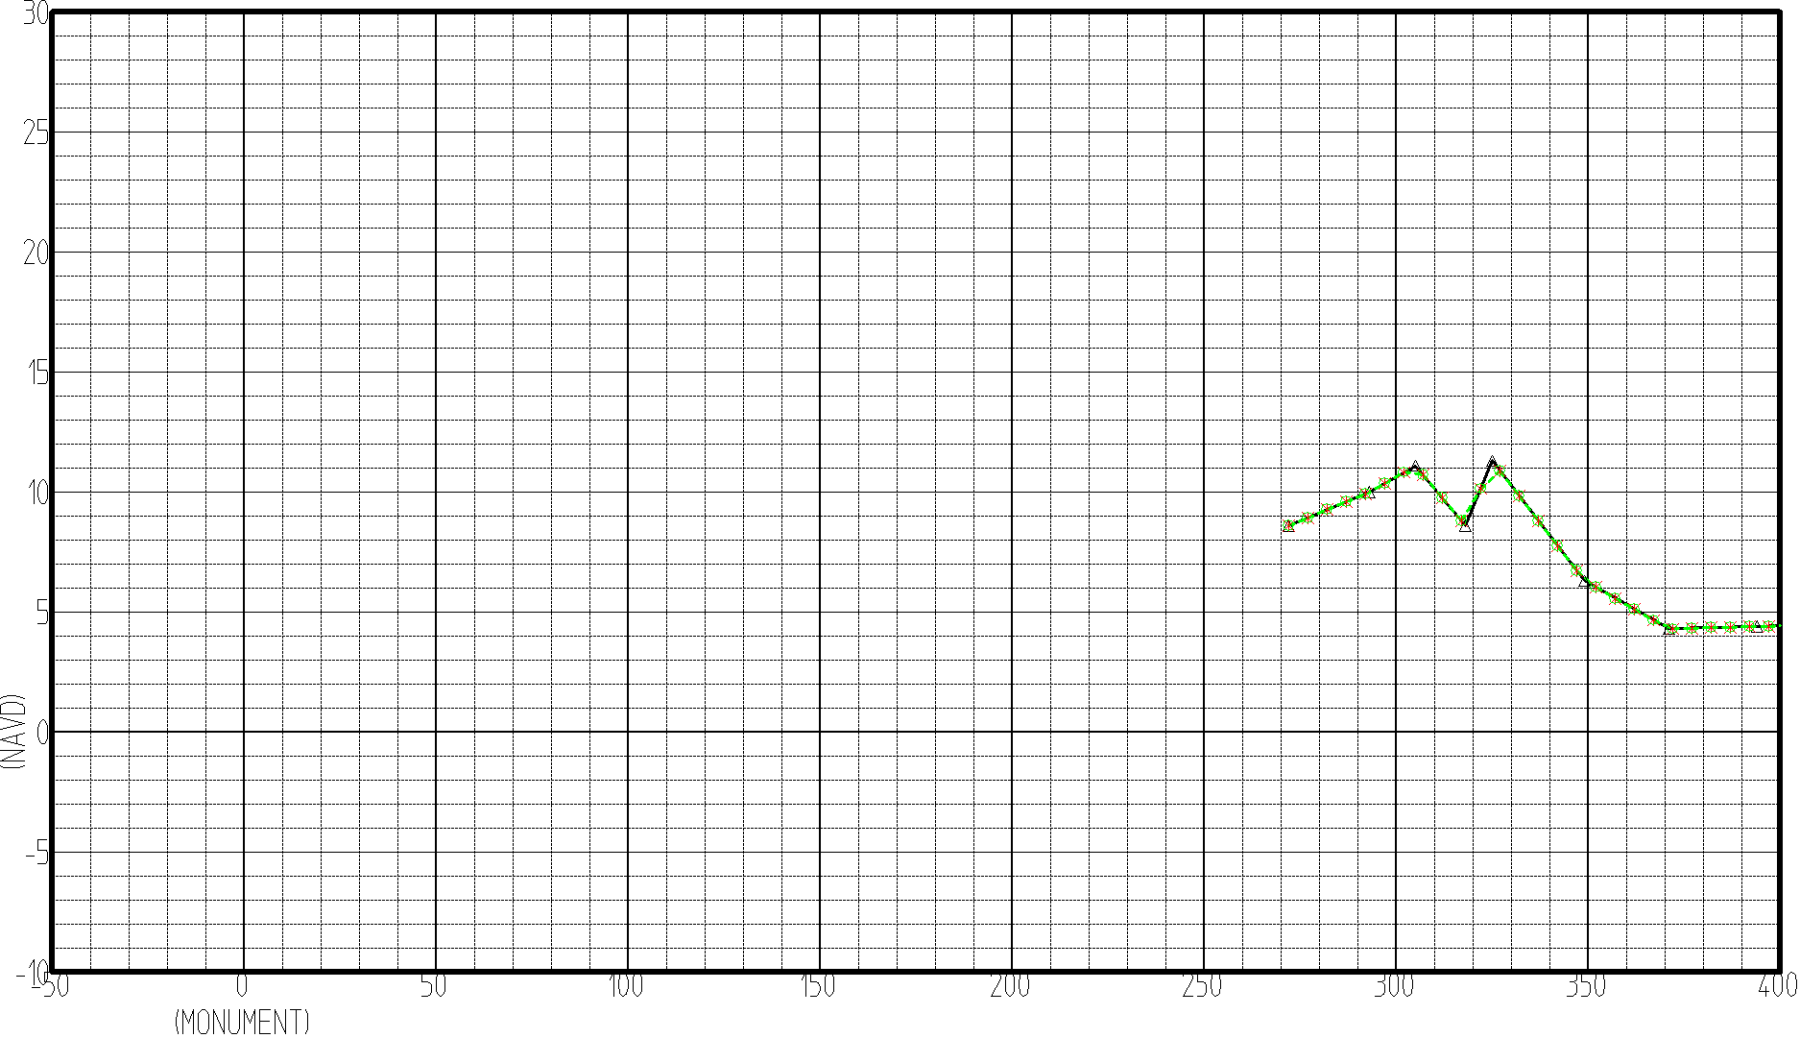
Range: R-1-T 1/4
 BEARING: 90.00

BEACH PROFILE
 —△—△— 2005-2008 INPUT PRF
 - - * - - * - - 15-YR SBEACH ERODED PRF
 - - o - - o - - 25-YR SBEACH ERODED PRF

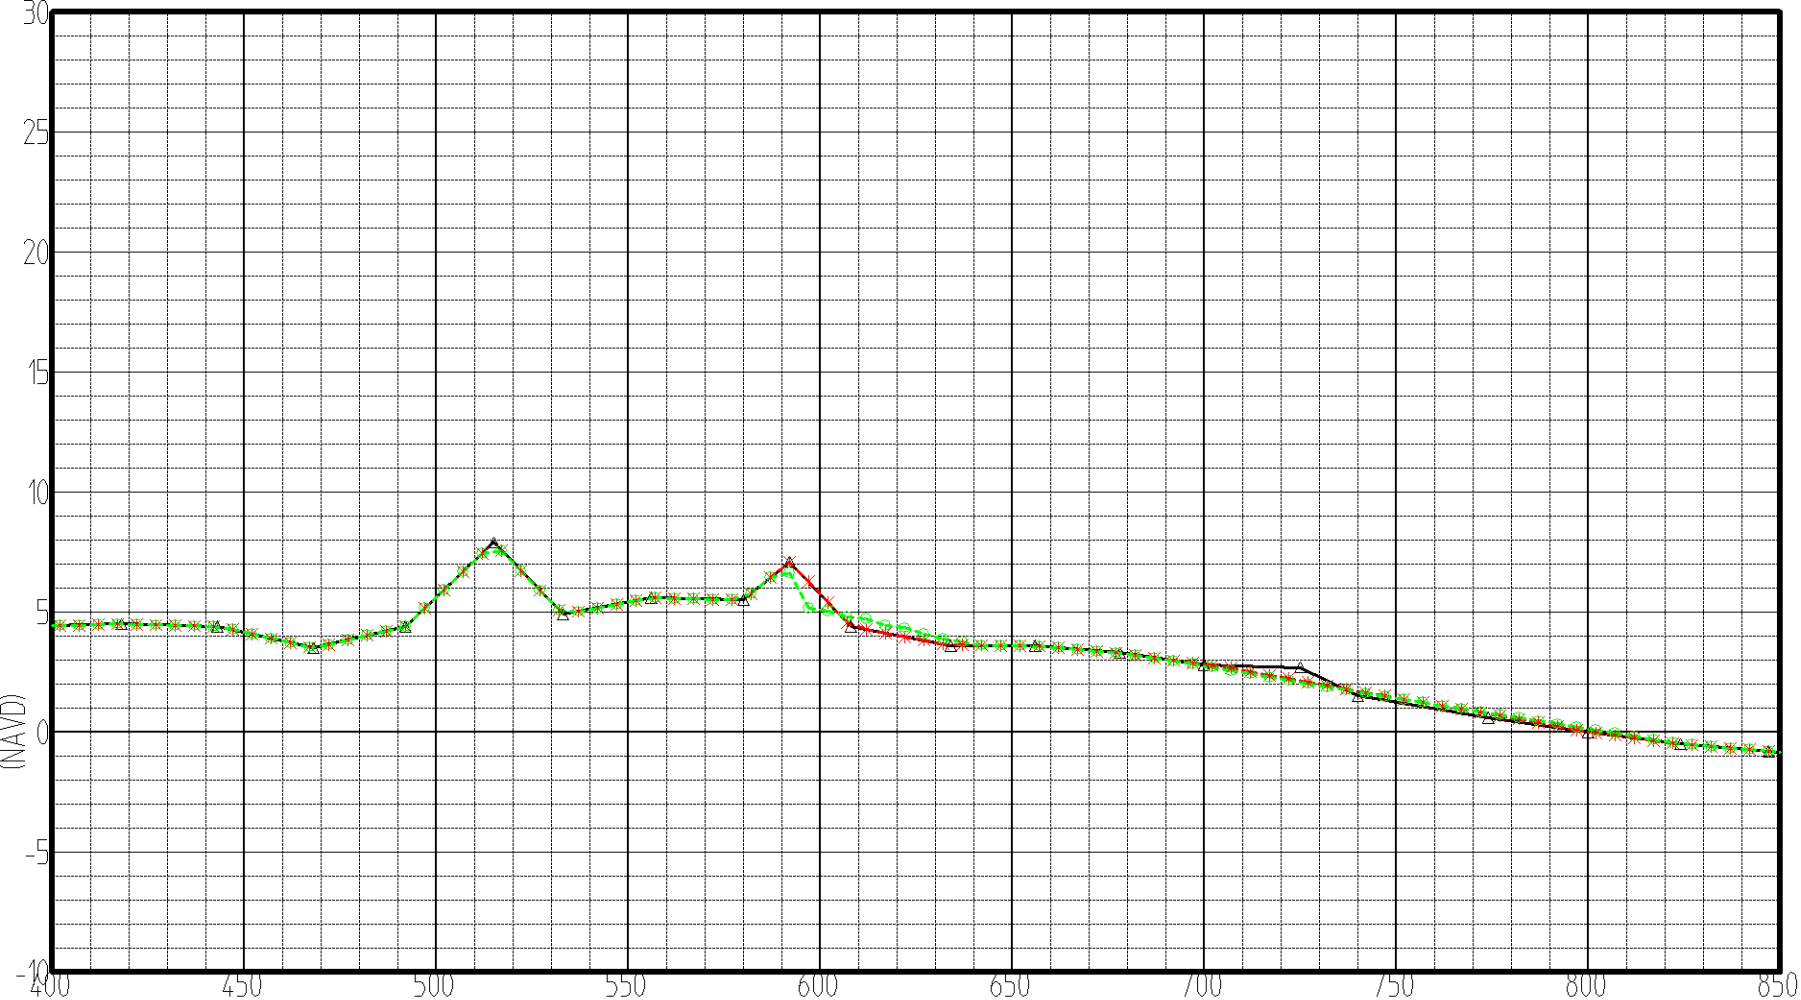
Range: R-1-T
 BEARING: 90.00
 2/4

BEACH PROFILE
 —△—△— 2005-2008 INPUT PRF
 - - * - - * - - 15-YR SBEACH ERODED PRF
 - - o - - o - - 25-YR SBEACH ERODED PRF

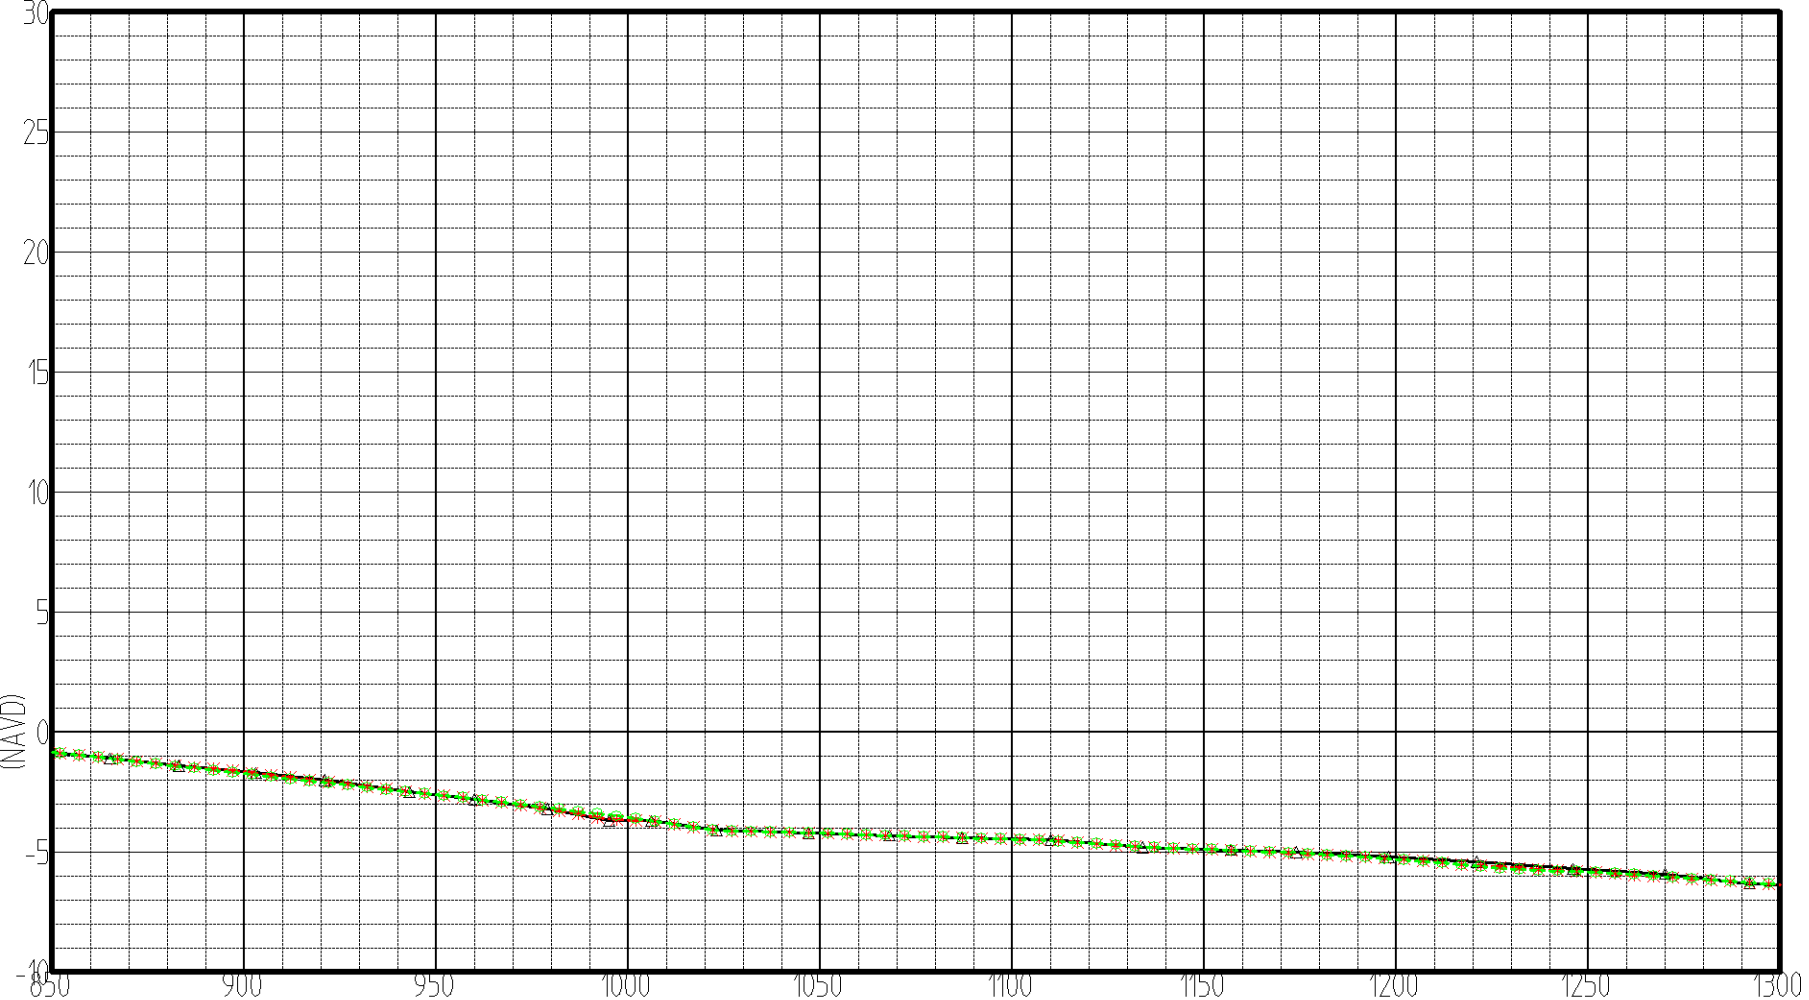
Range: R-1-T 3/4
 BEARING: 90.00

BEACH PROFILE
 —△—△— 2005-2008 INPUT PRF
 - - * - - * - - 15-YR SBEACH ERODED PRF
 - - o - - o - - 25-YR SBEACH ERODED PRF

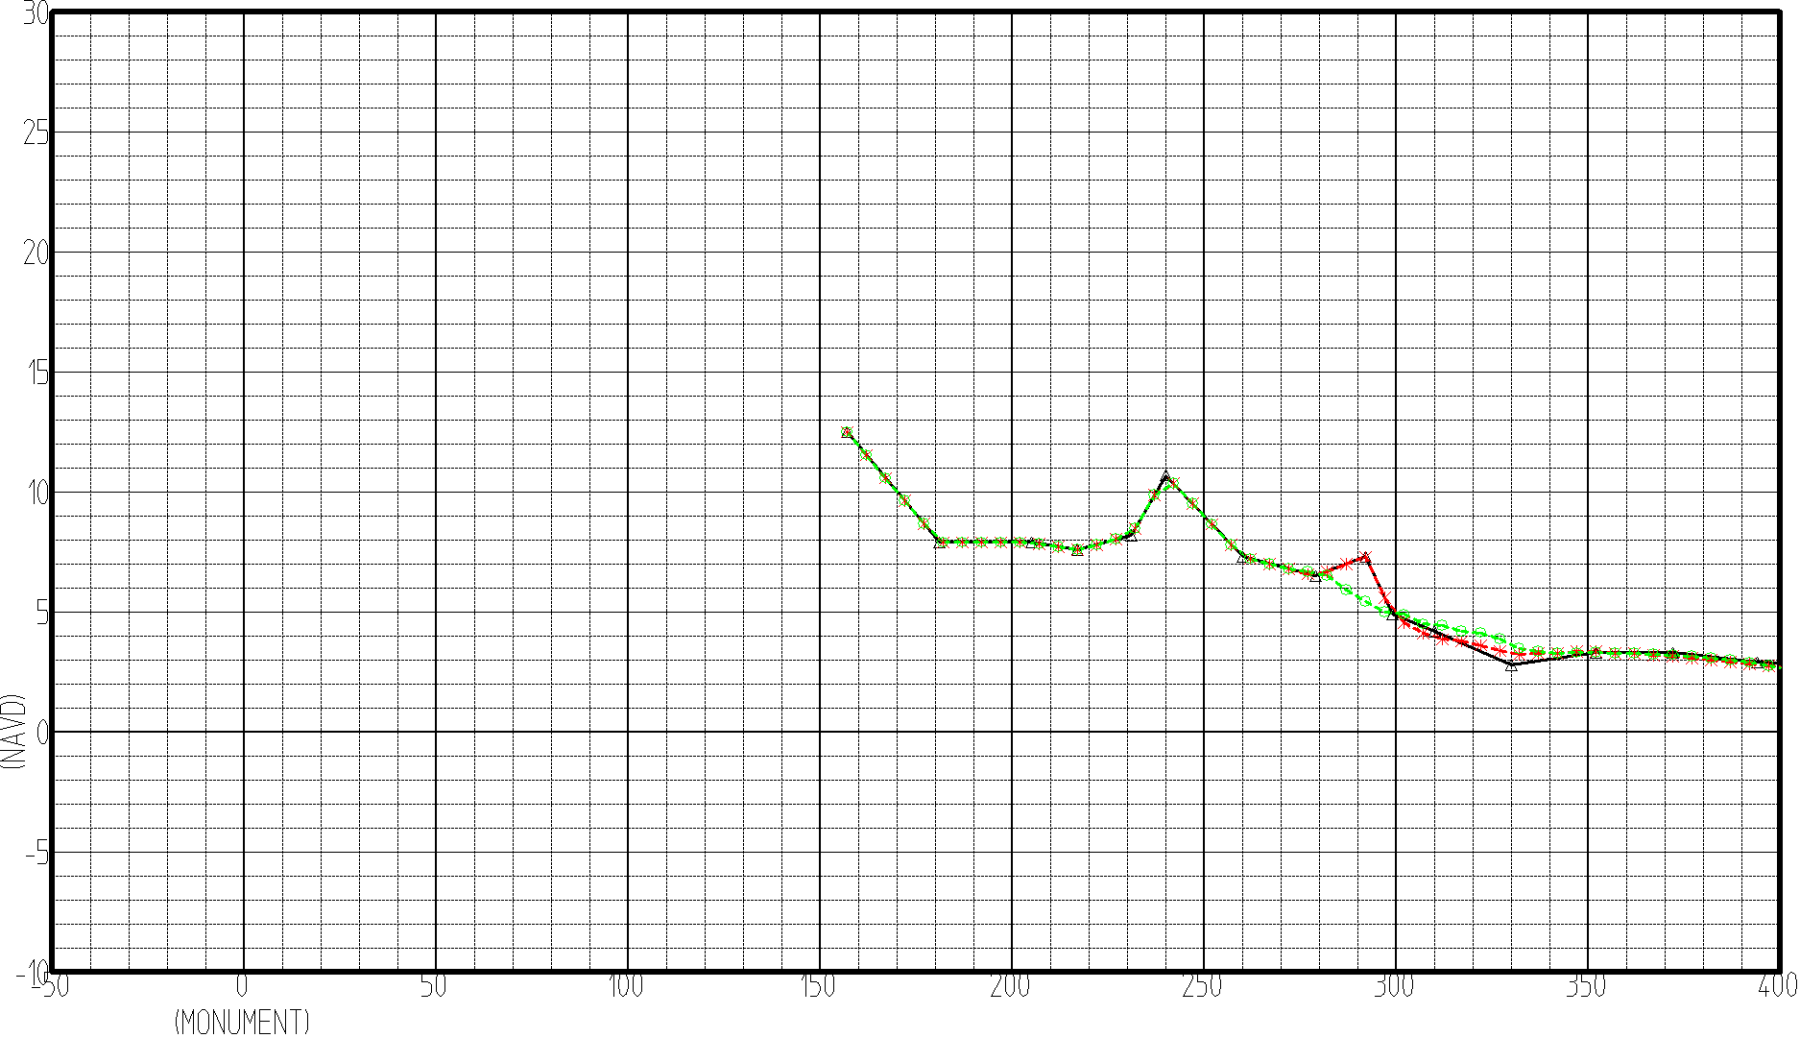
Range: R-2

BEACH PROFILE

—△—△— 2005-2008 INPUT PRF

- - - * - - - 15-YR SBEACH ERODED PRF

- - - o - - - 25-YR SBEACH ERODED PRF

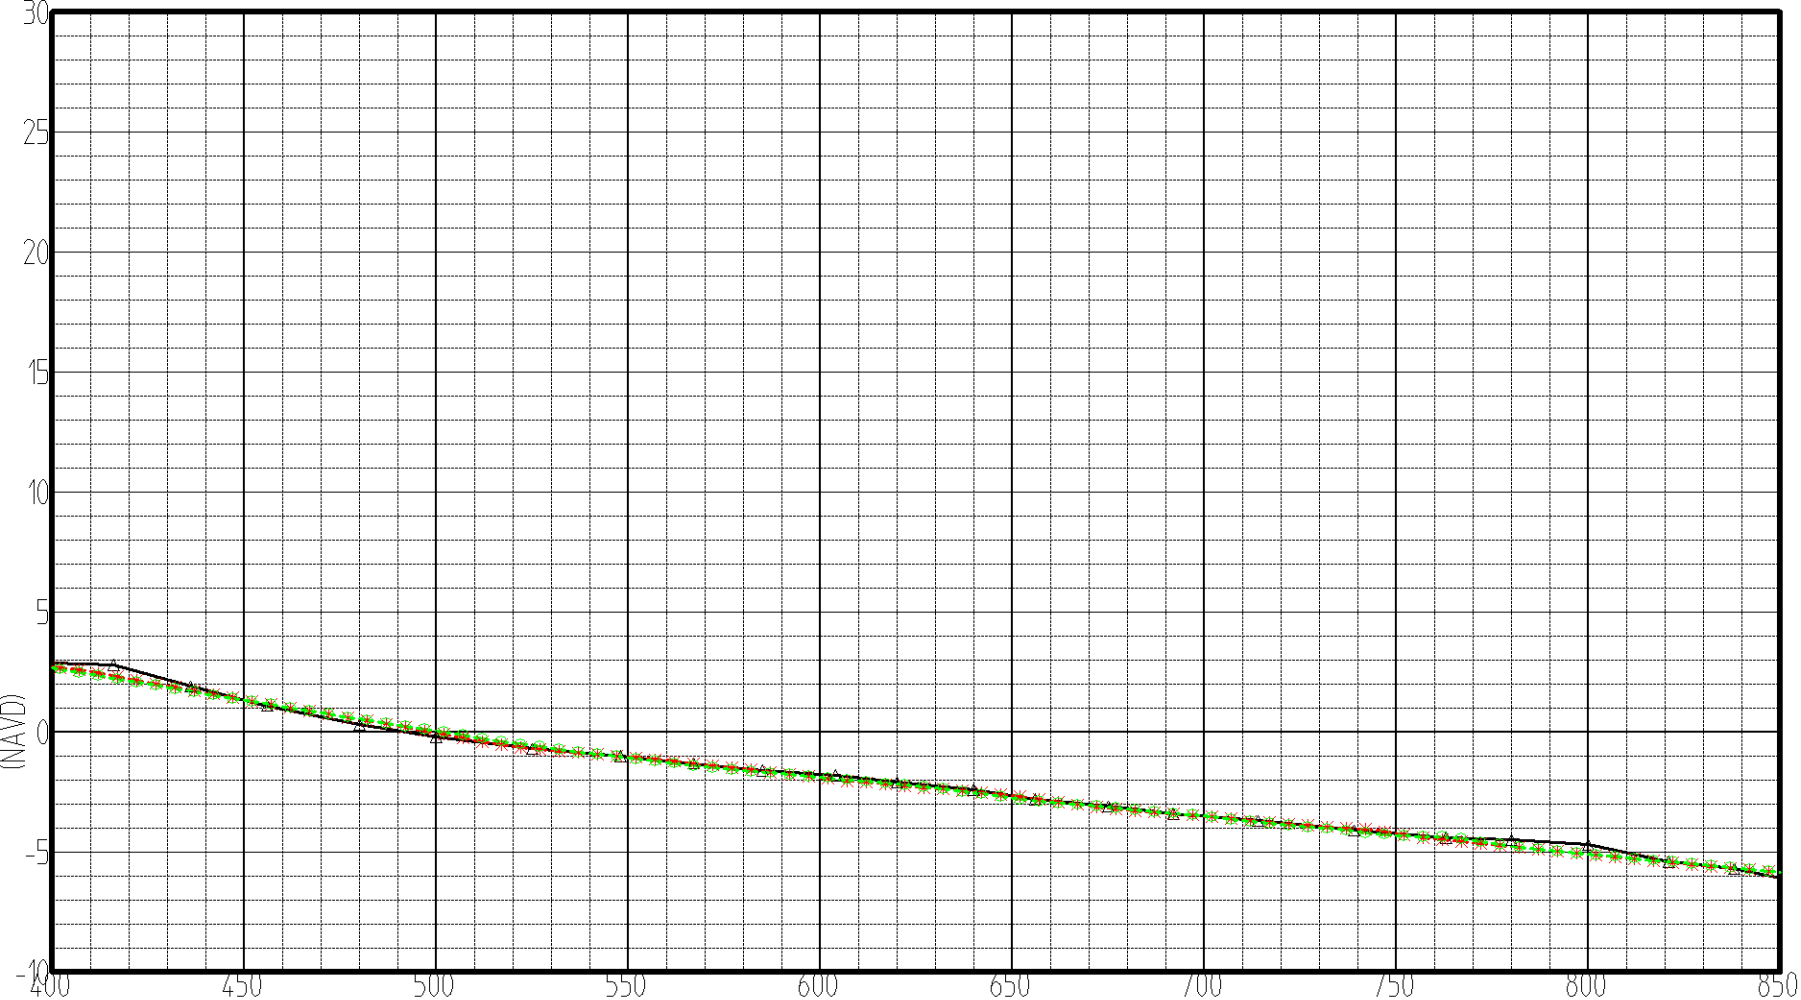
Range: R-2 2/4

BEACH PROFILE

—△—△— 2005-2008 INPUT PRF

- - - * - - - 15-YR SBEACH ERODED PRF

- - - o - - - 25-YR SBEACH ERODED PRF

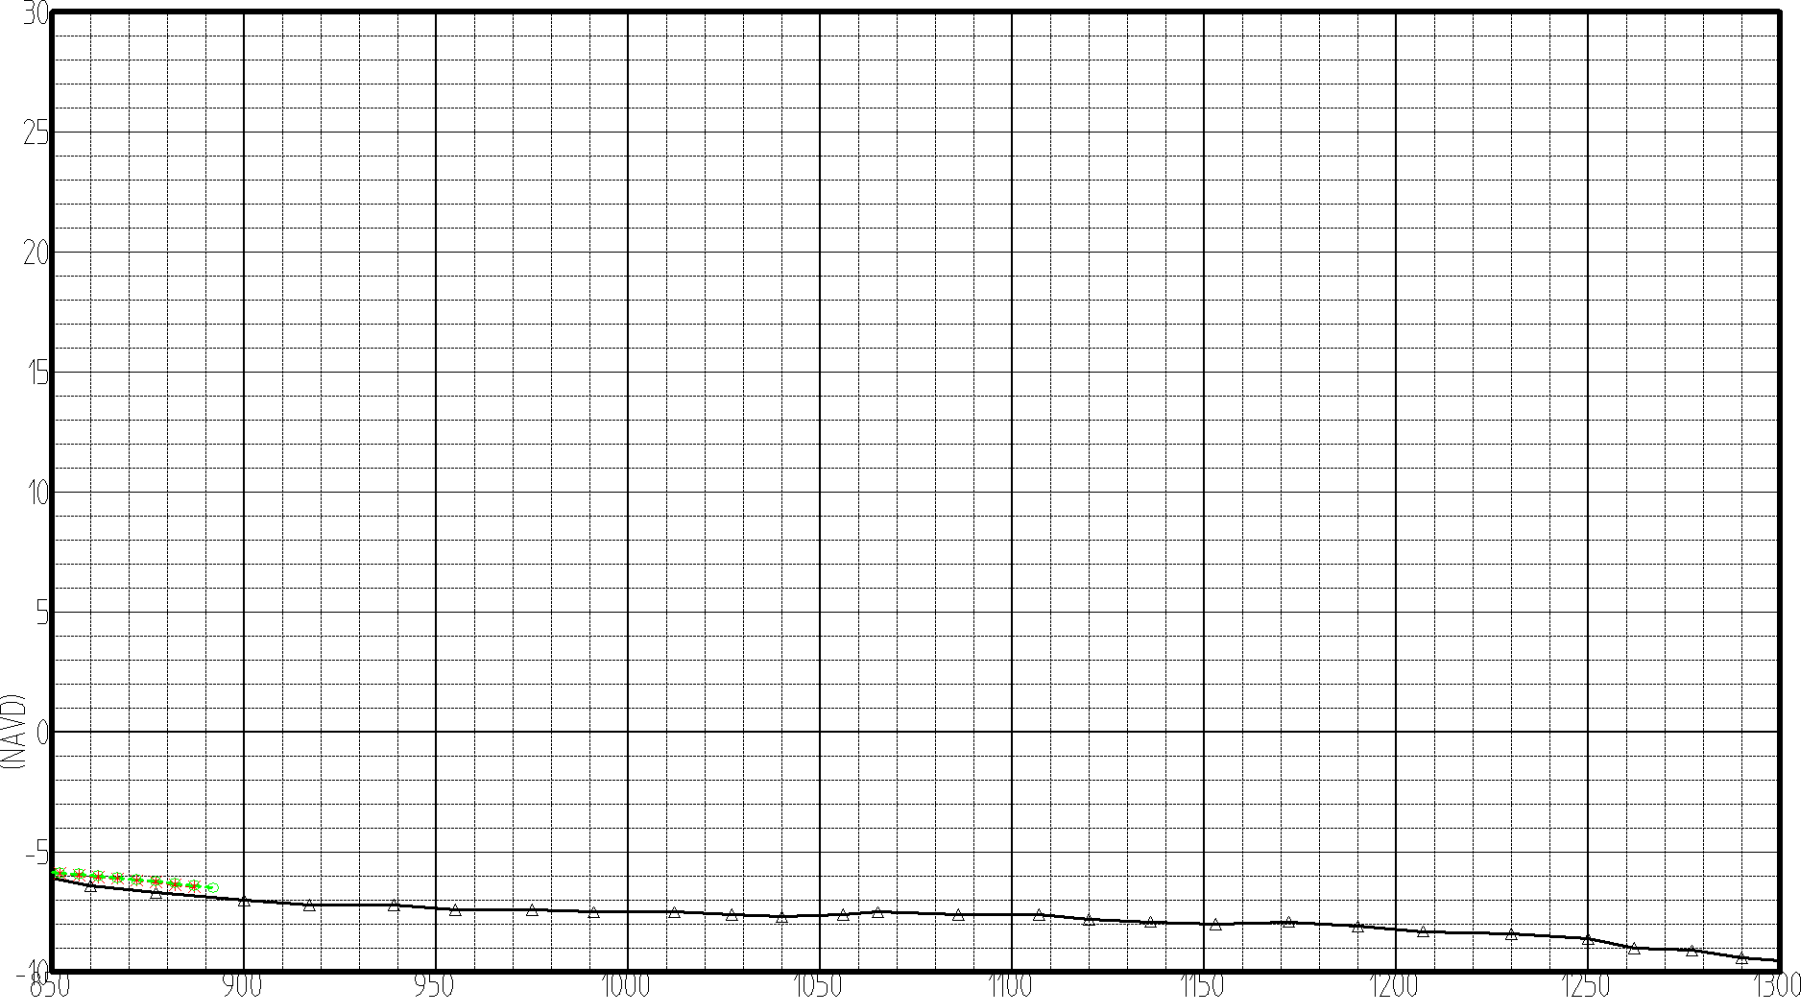
Range: R-2
 BEARING: 90.00
 3/4

BEACH PROFILE
 —△—△— 2005-2008 INPUT PRF
 - - * - - * - - 15-YR SBEACH ERODED PRF
 - - o - - o - - 25-YR SBEACH ERODED PRF

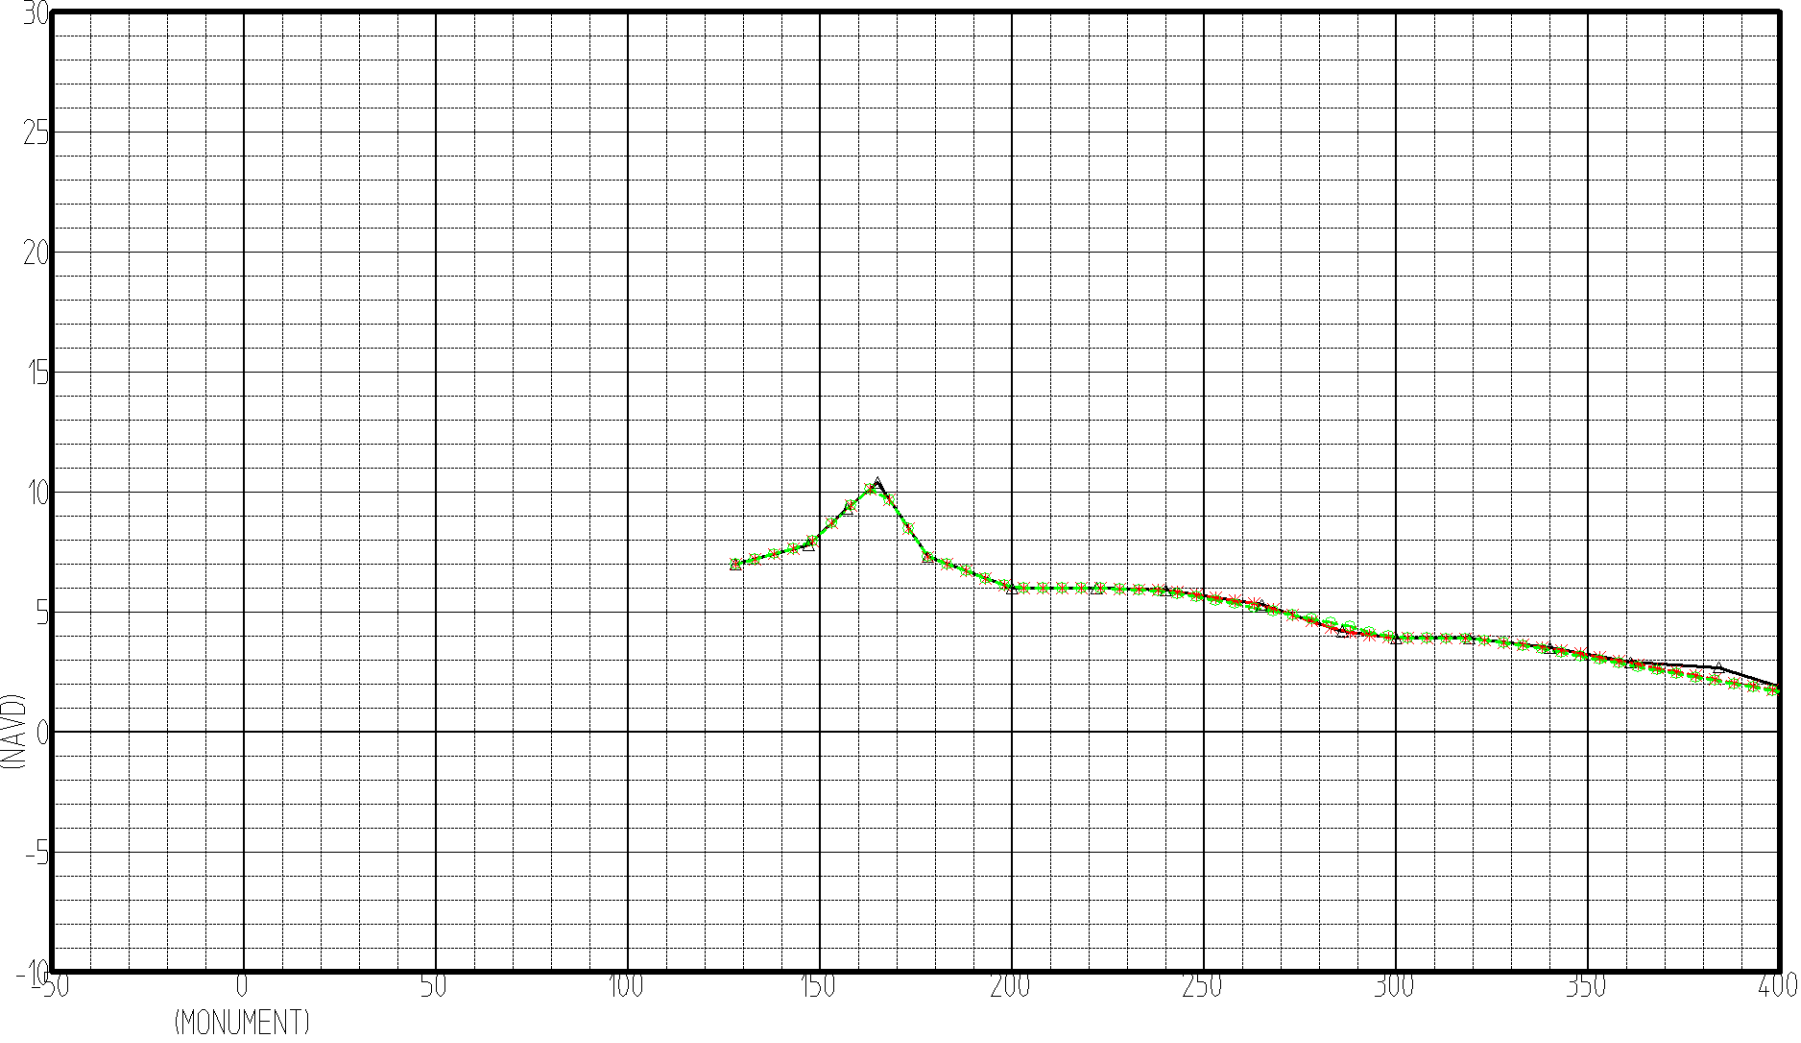
Range: R-3 1/3

- △—△— 2005-2008 INPUT PRF
- - - * - - - 15-YR SBEACH ERODED PRF
- - - o - - - 25-YR SBEACH ERODED PRF

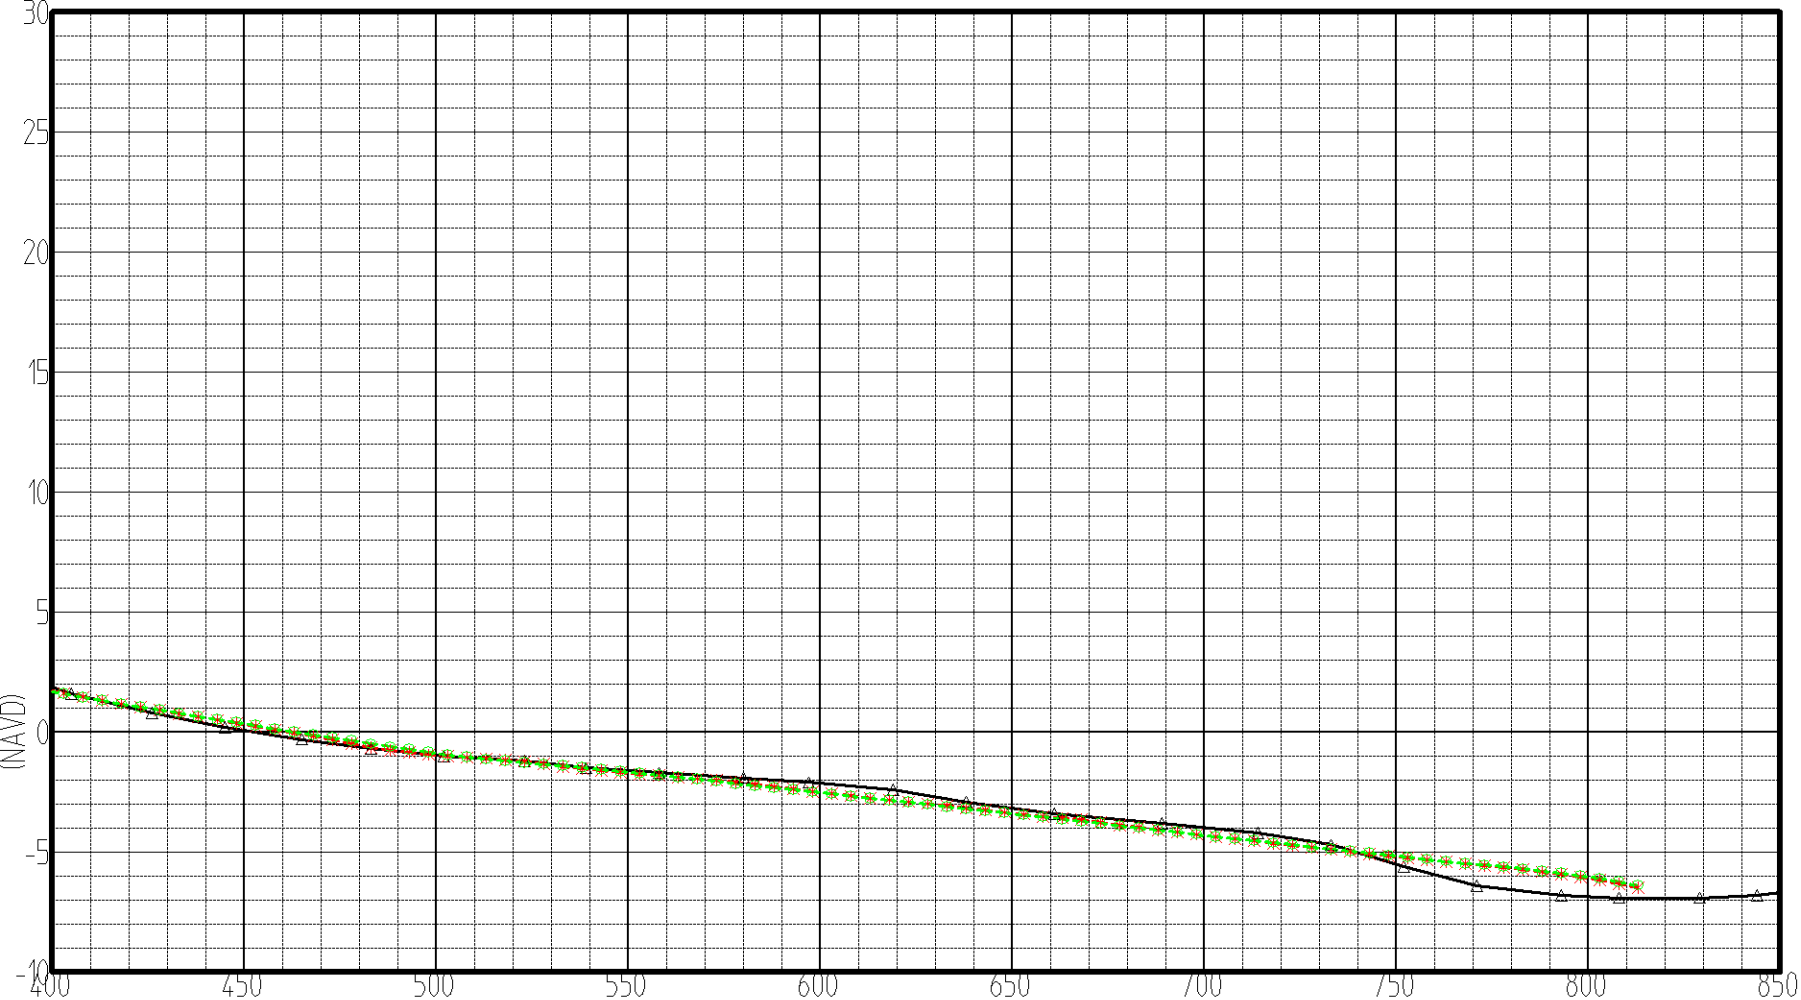
Range: R-3 2/3

BEACH PROFILE

- △—△— 2005-2008 INPUT PRF
- - - * - - - 15-YR SBEACH ERODED PRF
- - - o - - - 25-YR SBEACH ERODED PRF

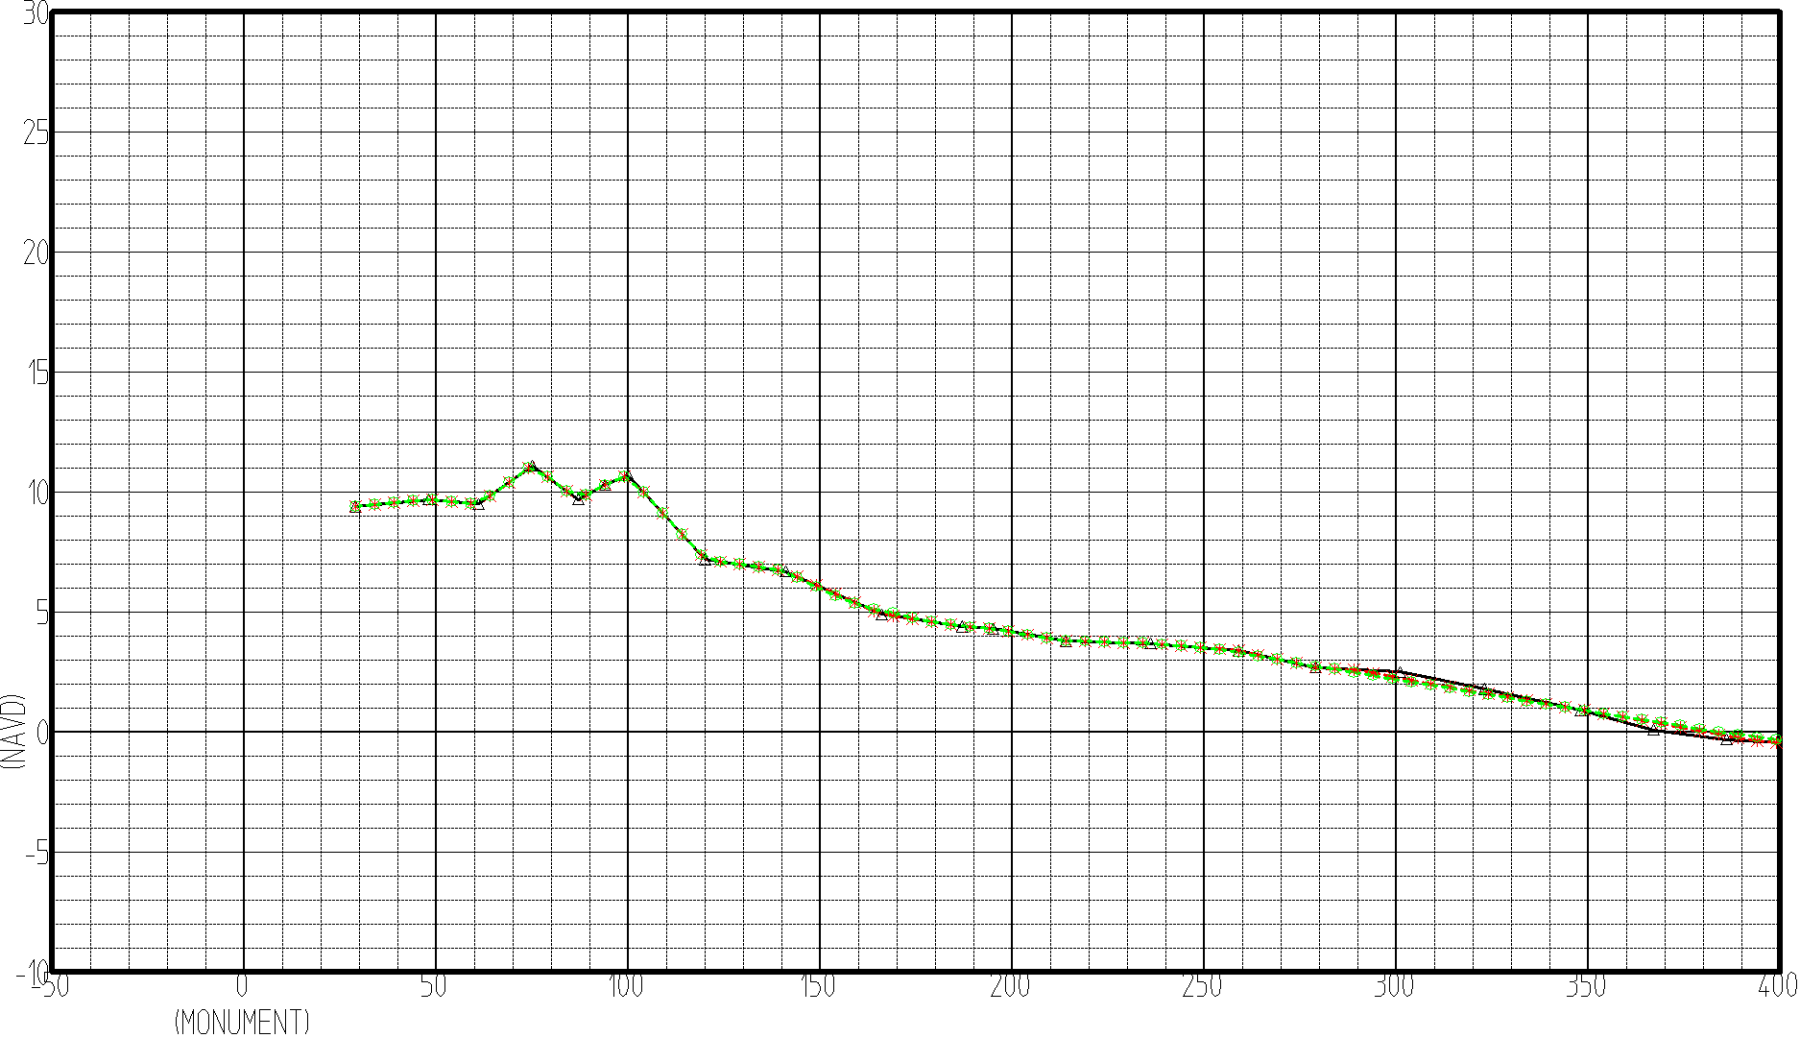
Range: T-4
 BEARING: 90.00
 1/3

BEACH PROFILE
 —△—△— 2005-2008 INPUT PRF
 - - - * - - - 15-YR SBEACH ERODED PRF
 - - - o - - - 25-YR SBEACH ERODED PRF

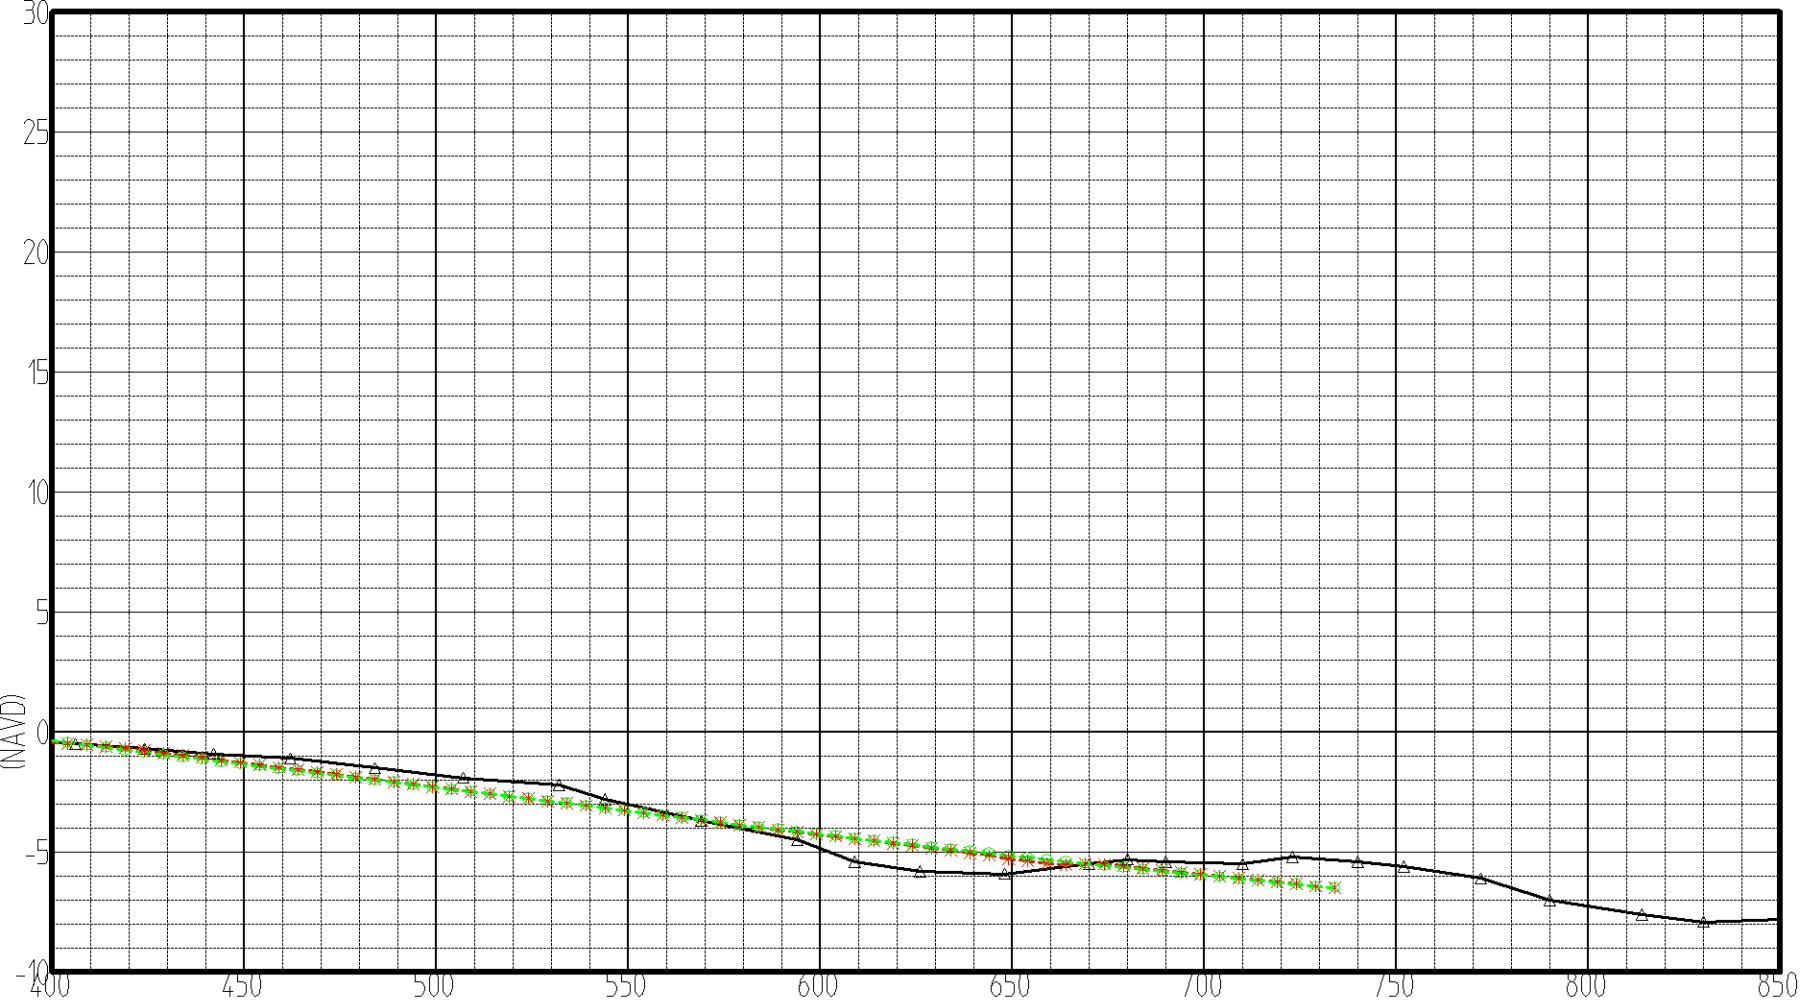
Range: T-4

BEACH PROFILE

—△—△— 2005-2008 INPUT PRF

- - - * - - - 15-YR SBEACH ERODED PRF

- - - o - - - 25-YR SBEACH ERODED PRF

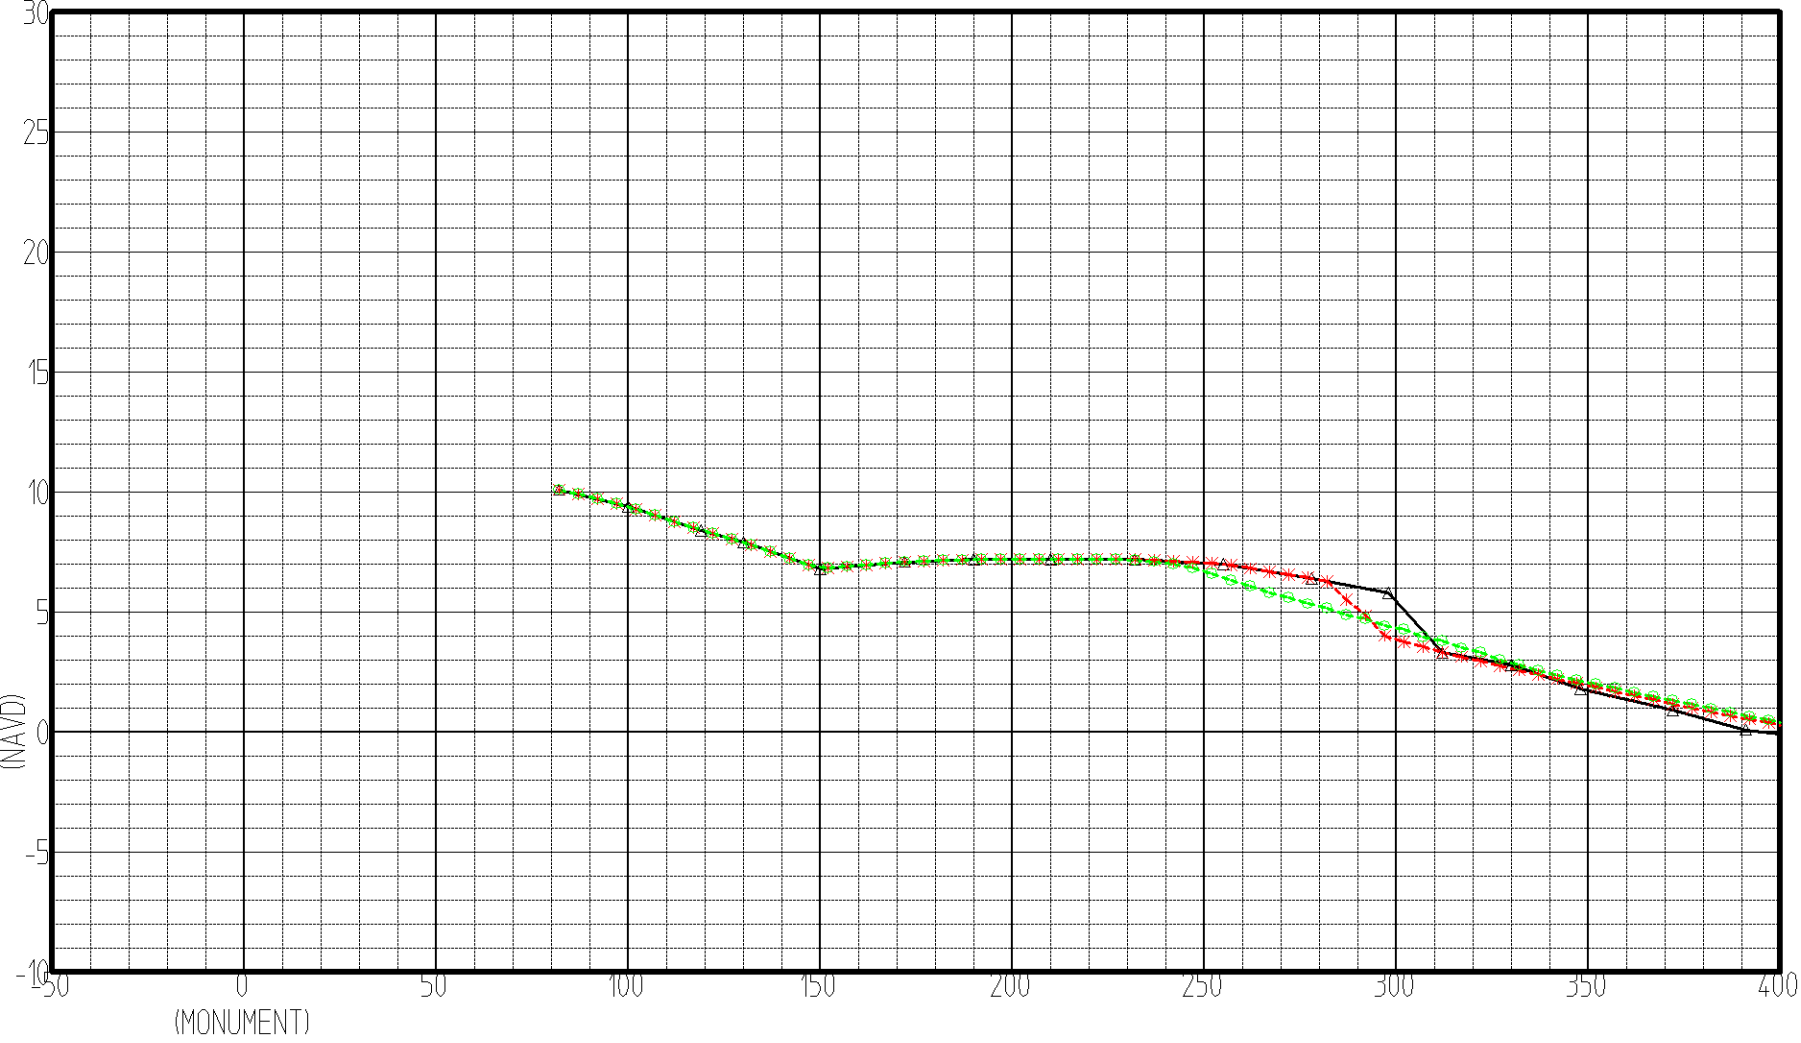
Range: R-5

BEACH PROFILE

—△—△— 2005-2008 INPUT PRF

- - - * - - - 15-YR SBEACH ERODED PRF

- - - o - - - 25-YR SBEACH ERODED PRF

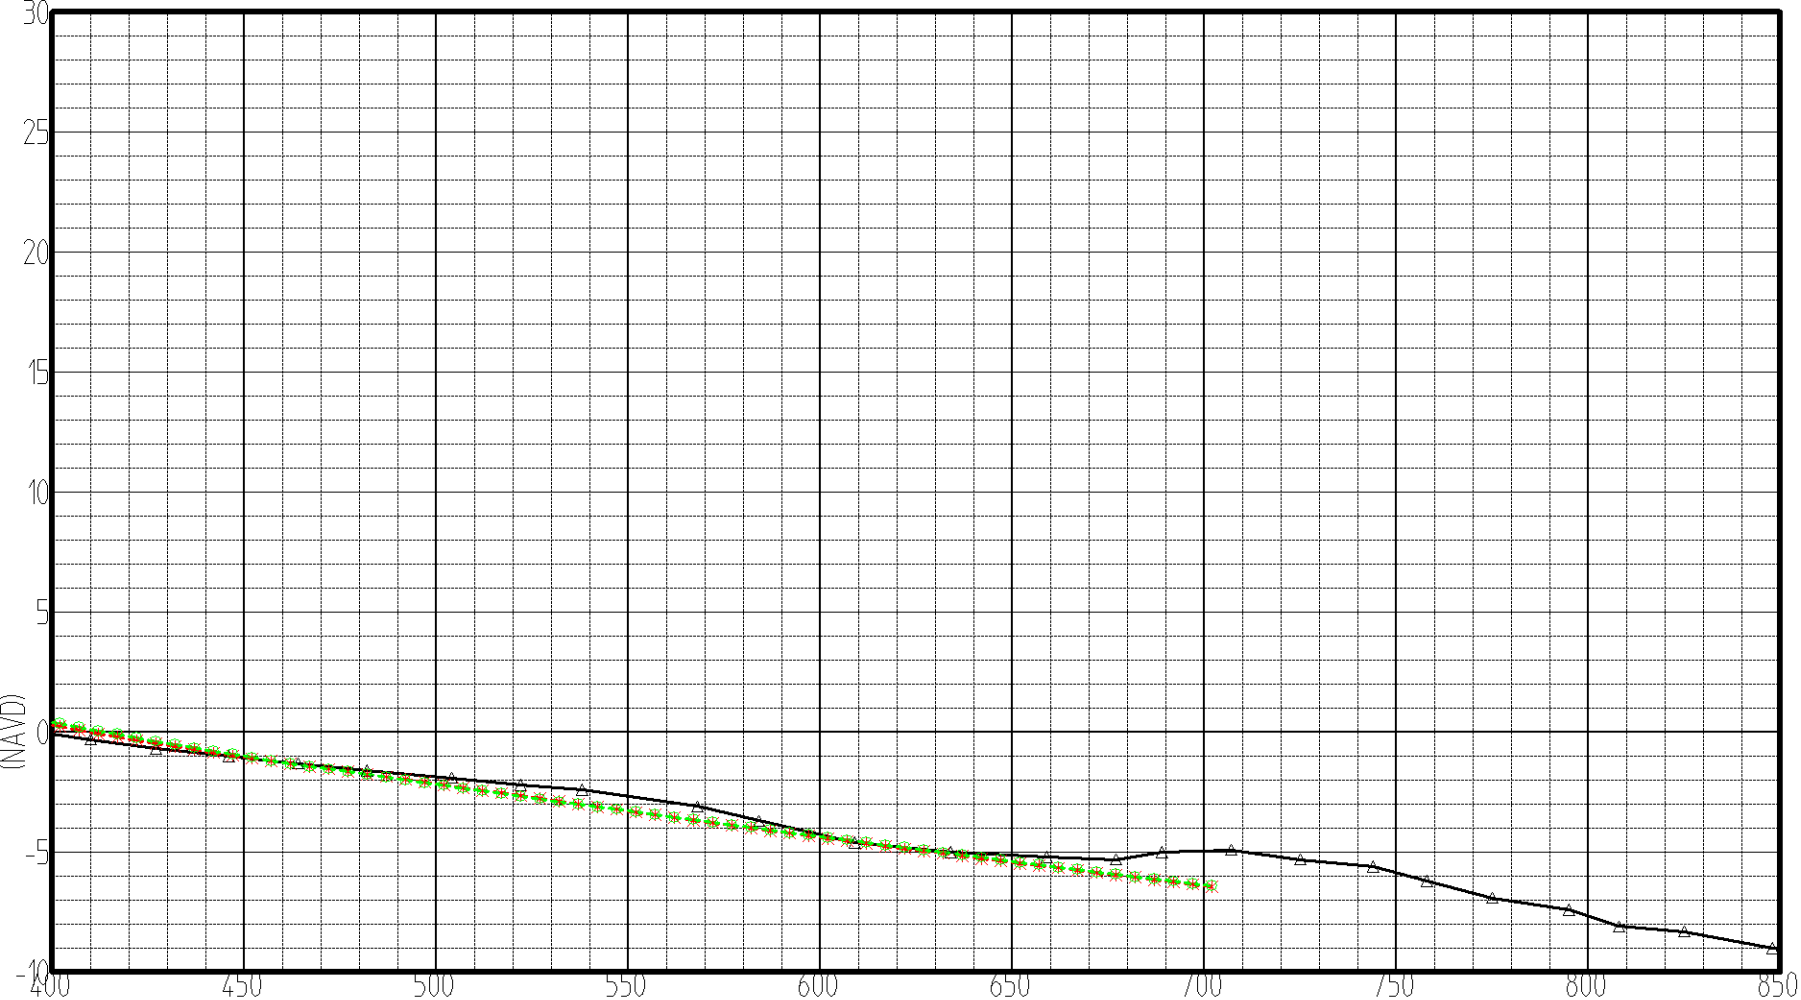
Range: R-5

BEACH PROFILE

—△—△— 2005-2008 INPUT PRF

- - - * - - - 15-YR SBEACH ERODED PRF

- - - o - - - 25-YR SBEACH ERODED PRF
