Appendix XI

SBEACH 15 and 25 yr. Storm Erosion Profiles

Brevard County

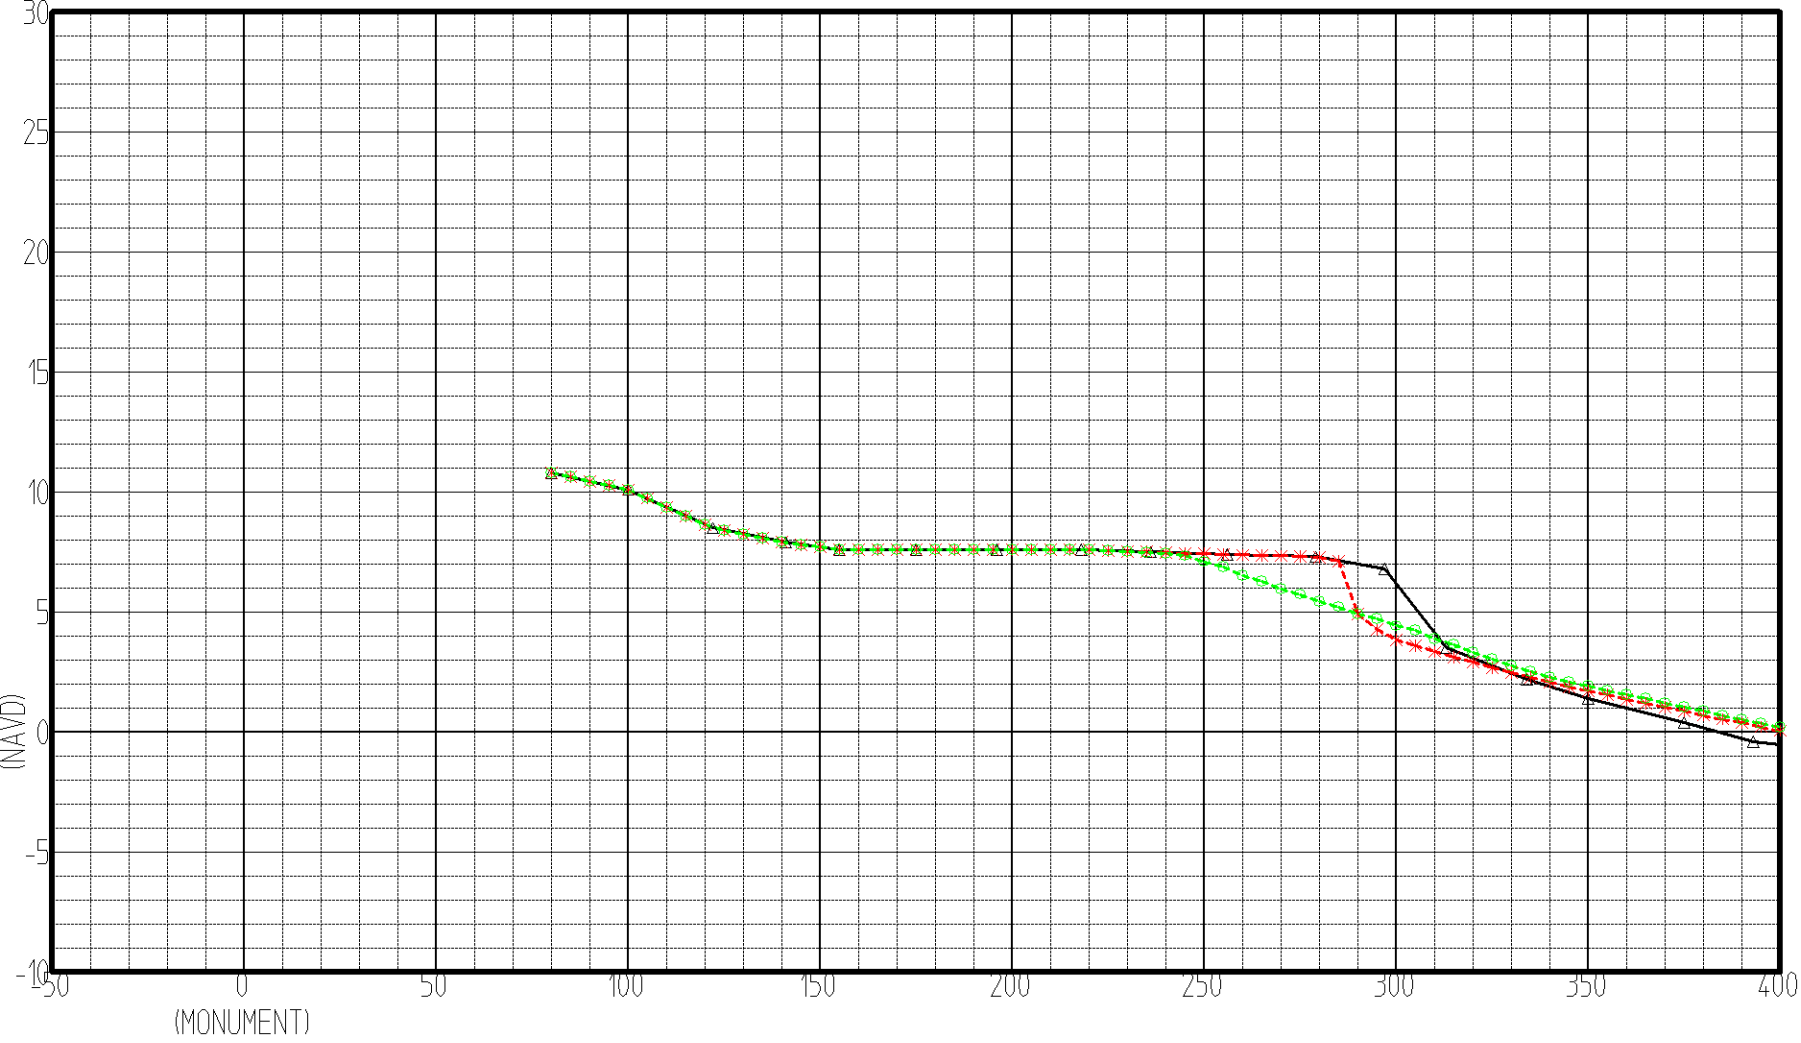
Range: R-6-T

BEACH PROFILE

—△—△— 2005-2008 INPUT PRF

- - - * - - - 15-YR SBEACH ERODED PRF

- - - o - - - 25-YR SBEACH ERODED PRF

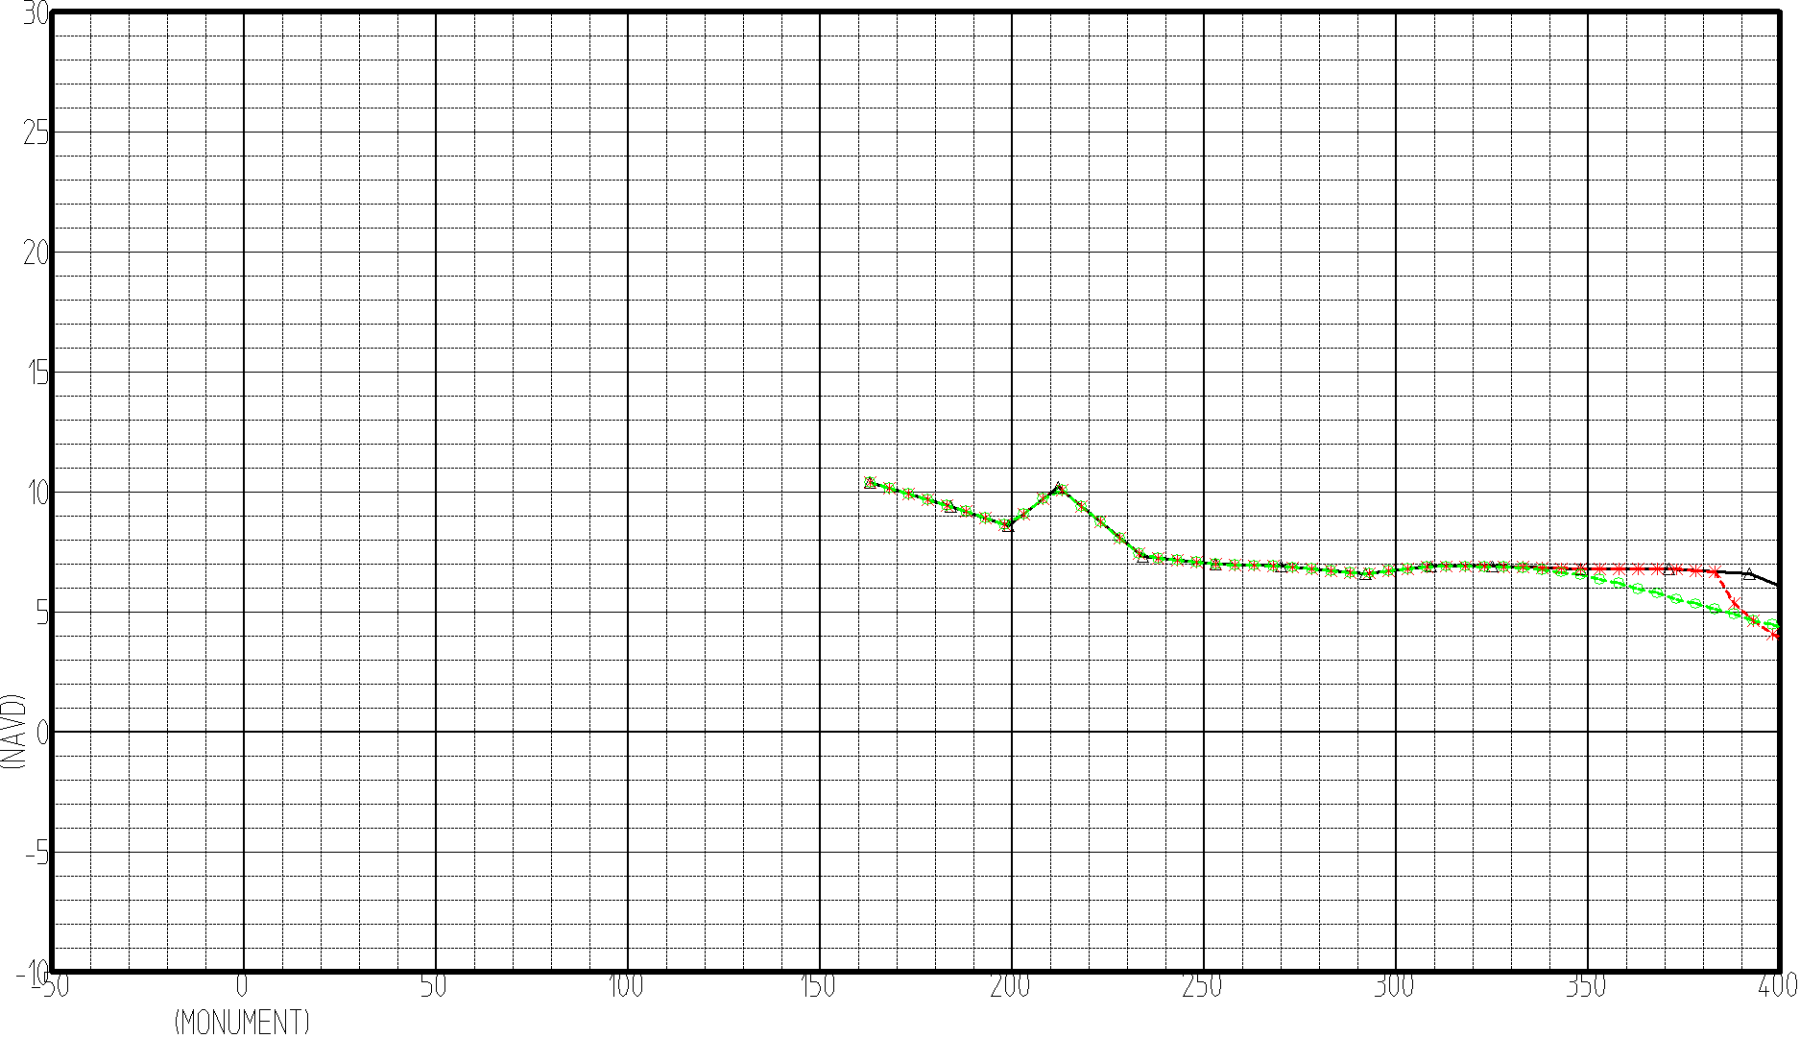
Range: R-7-T
 BEARING: 90.00
 1/3

BEACH PROFILE
 —△—△— 2005-2008 INPUT PRF
 - - * - - * - - 15-YR SBEACH ERODED PRF
 - - o - - o - - 25-YR SBEACH ERODED PRF

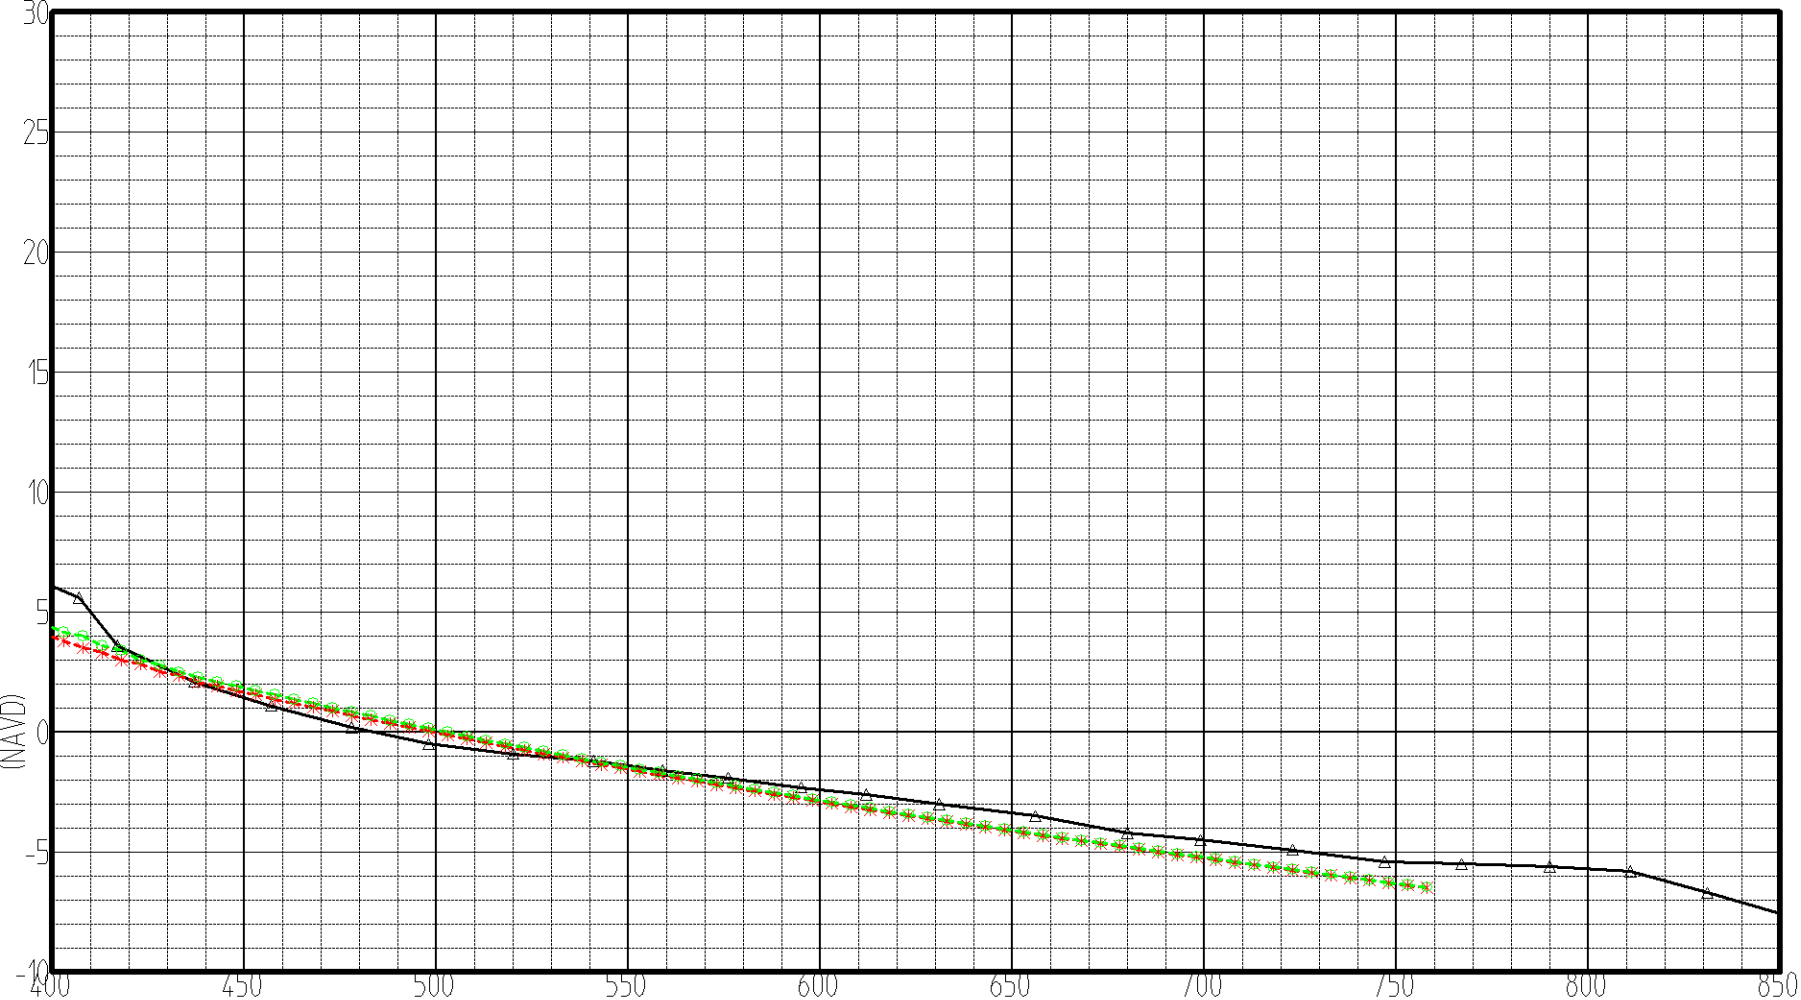
Range: R-7-T 2/3

BEACH PROFILE

—△—△— 2005-2008 INPUT PRF

- - * - - * - - 15-YR SBEACH ERODED PRF

- - ○ - - ○ - - 25-YR SBEACH ERODED PRF

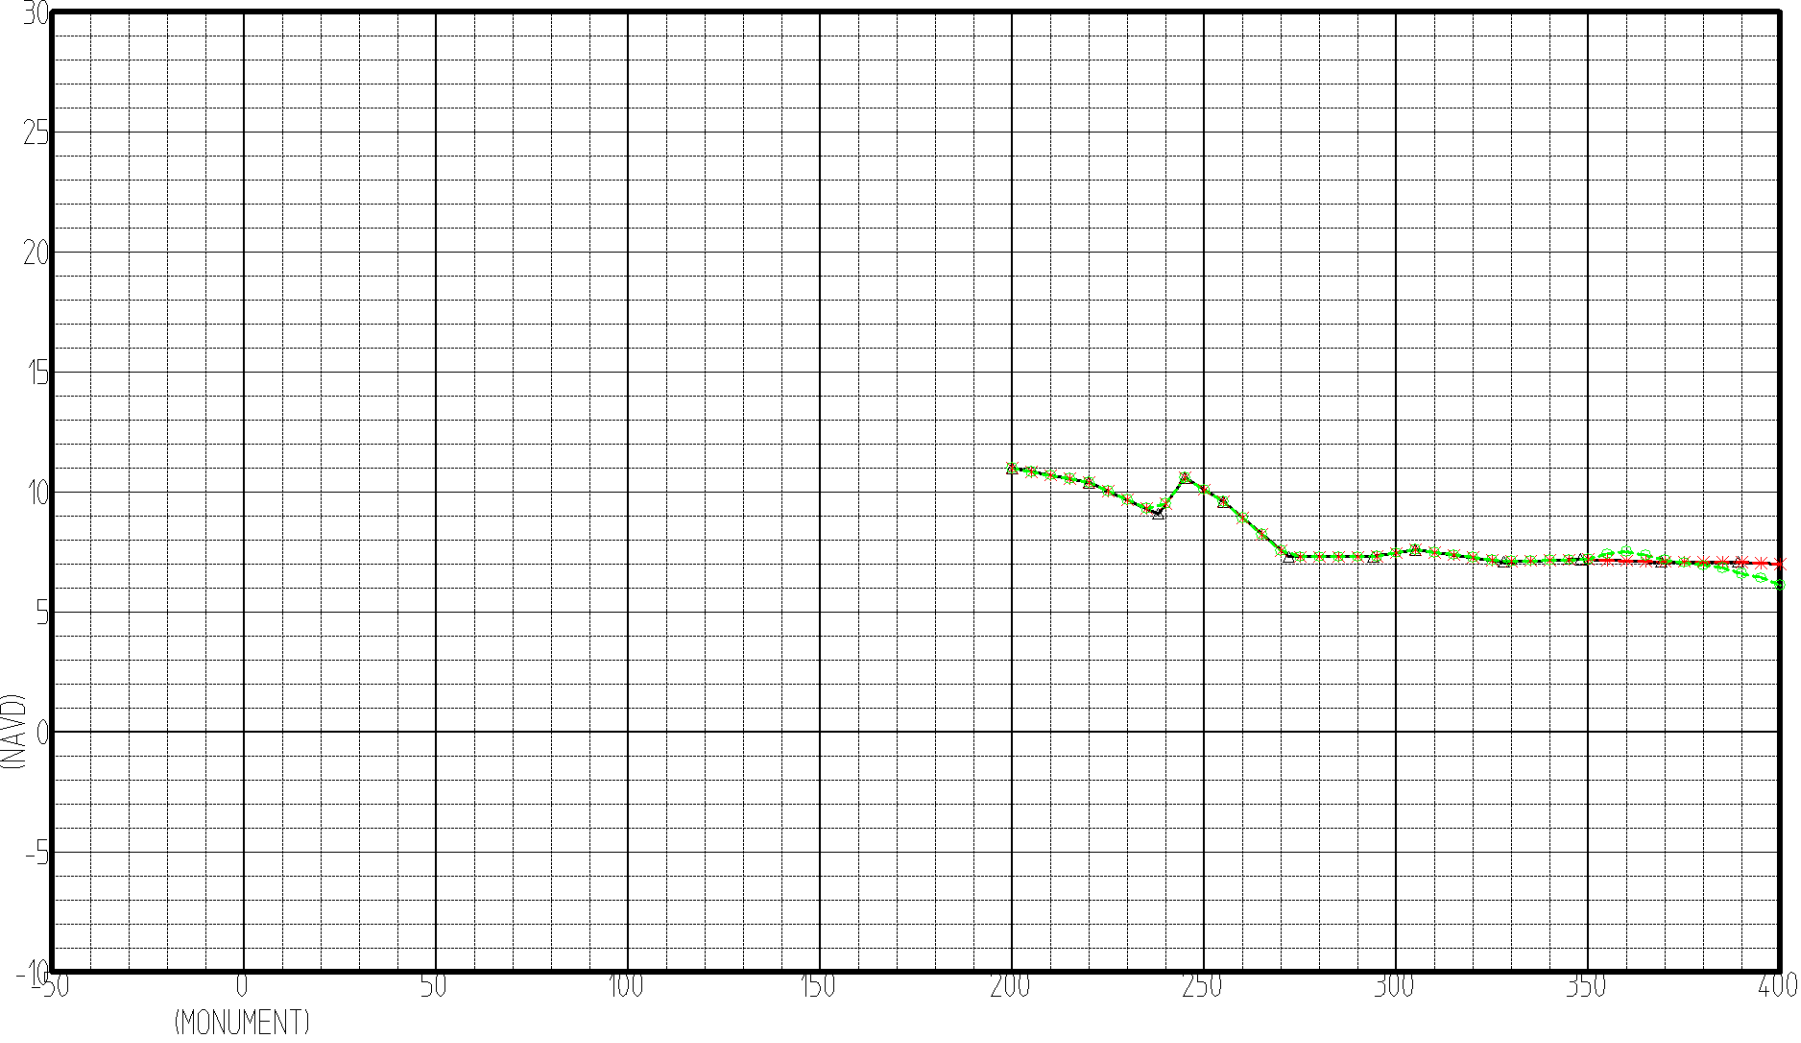
Range: R-8

BEACH PROFILE

—△—△— 2005-2008 INPUT PRF

- - - * - - - 15-YR SBEACH ERODED PRF

- - - o - - - 25-YR SBEACH ERODED PRF

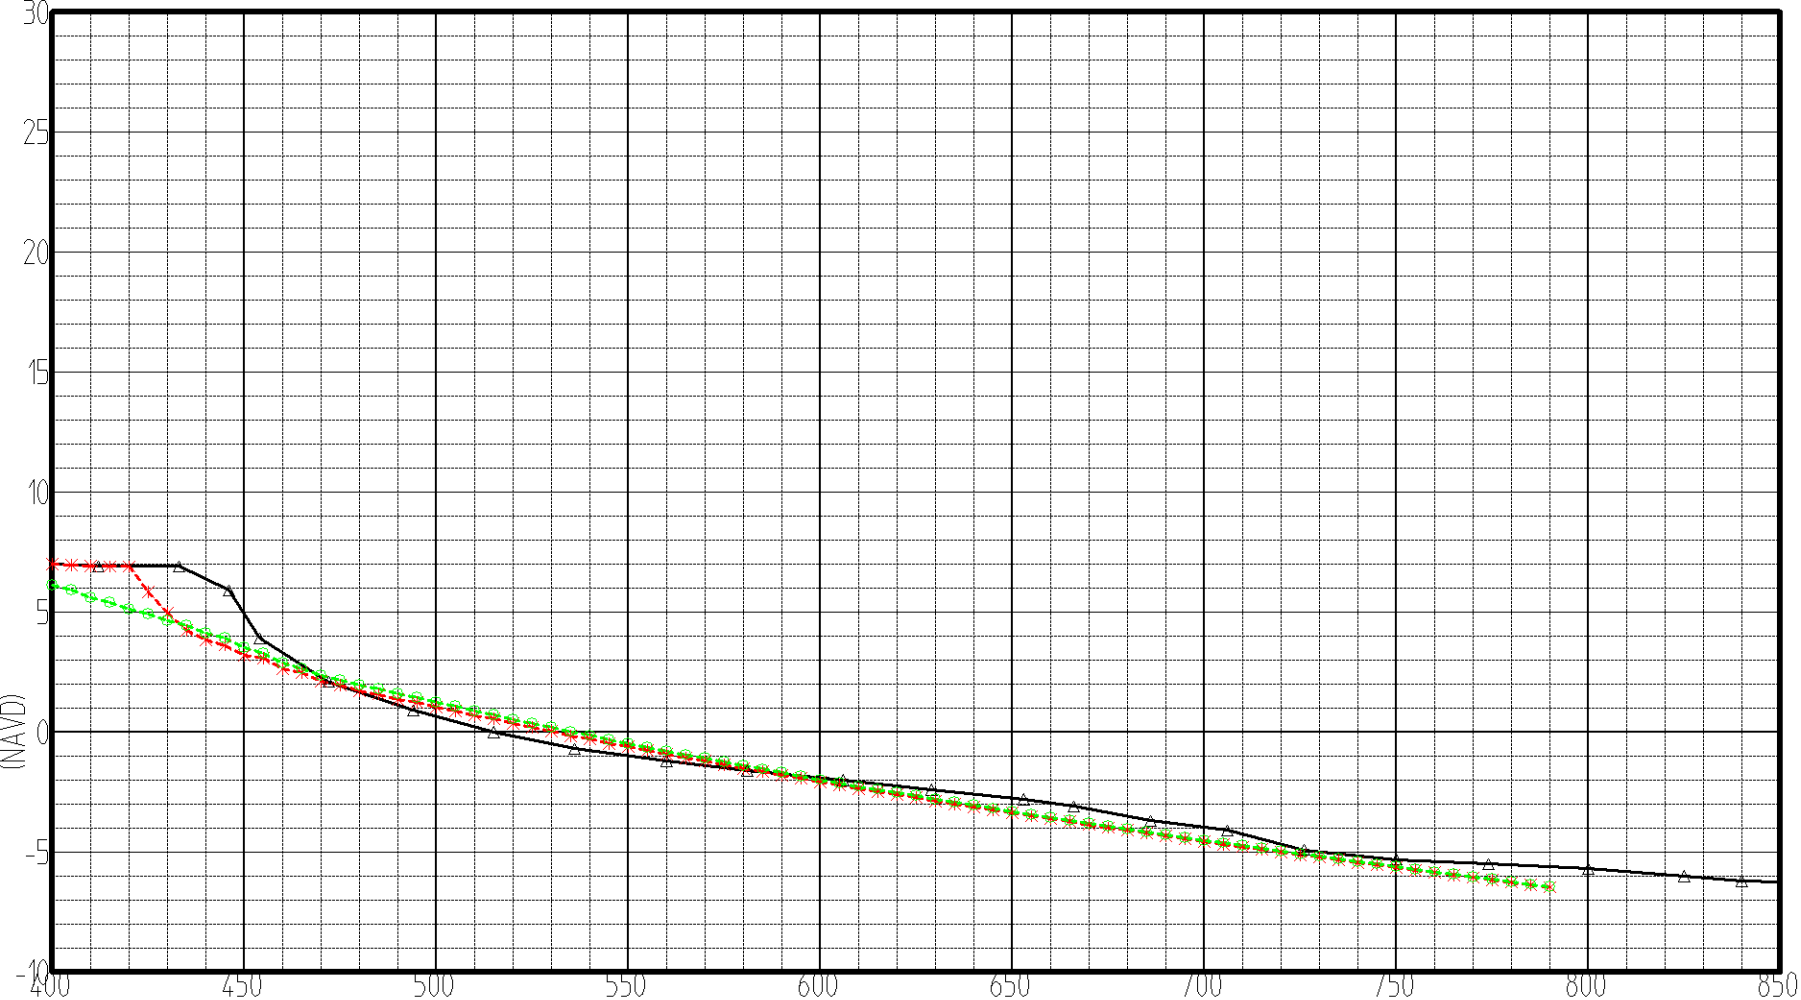
Range: R-8
 BEARING: 90.00
 2/3

BEACH PROFILE
 —△—△— 2005-2008 INPUT PRF
 - - * - - * - - 15-YR SBEACH ERODED PRF
 - - o - - o - - 25-YR SBEACH ERODED PRF

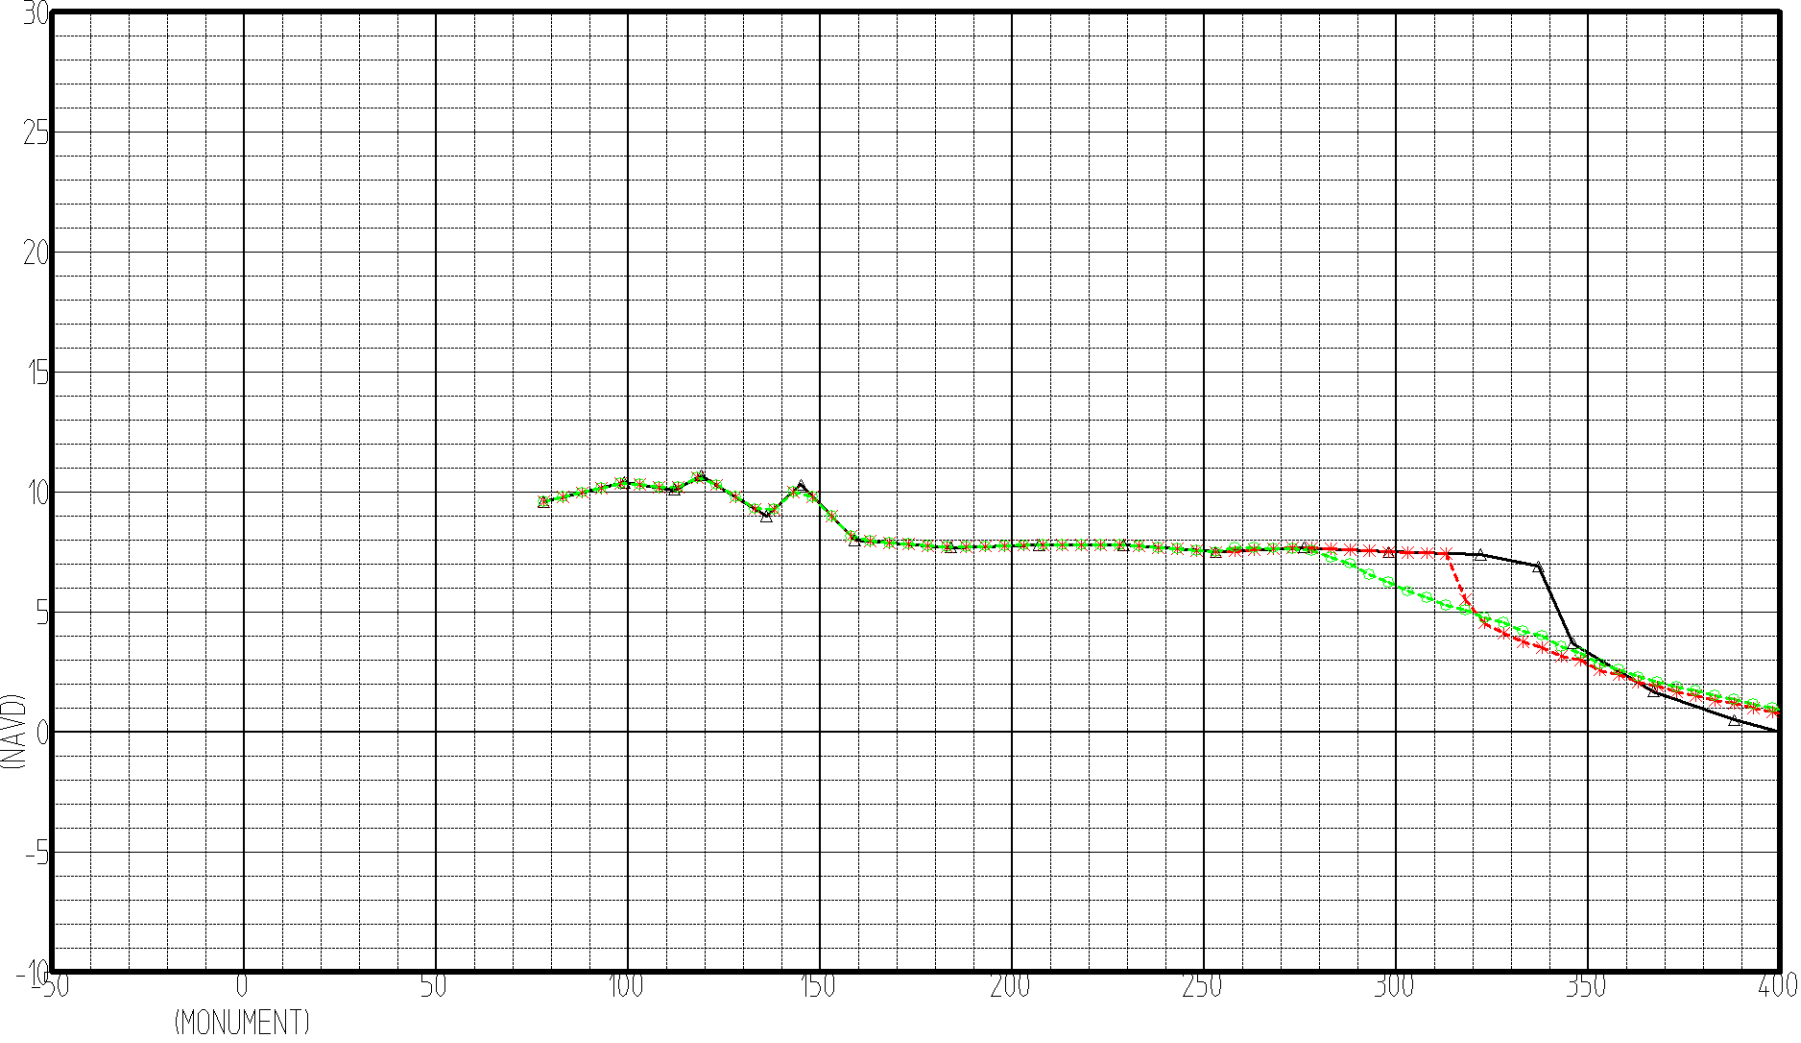
Range: R-9

BEACH PROFILE

—△—△— 2005-2008 INPUT PRF

- - * - - * - - 15-YR SBEACH ERODED PRF

- - o - - o - - 25-YR SBEACH ERODED PRF

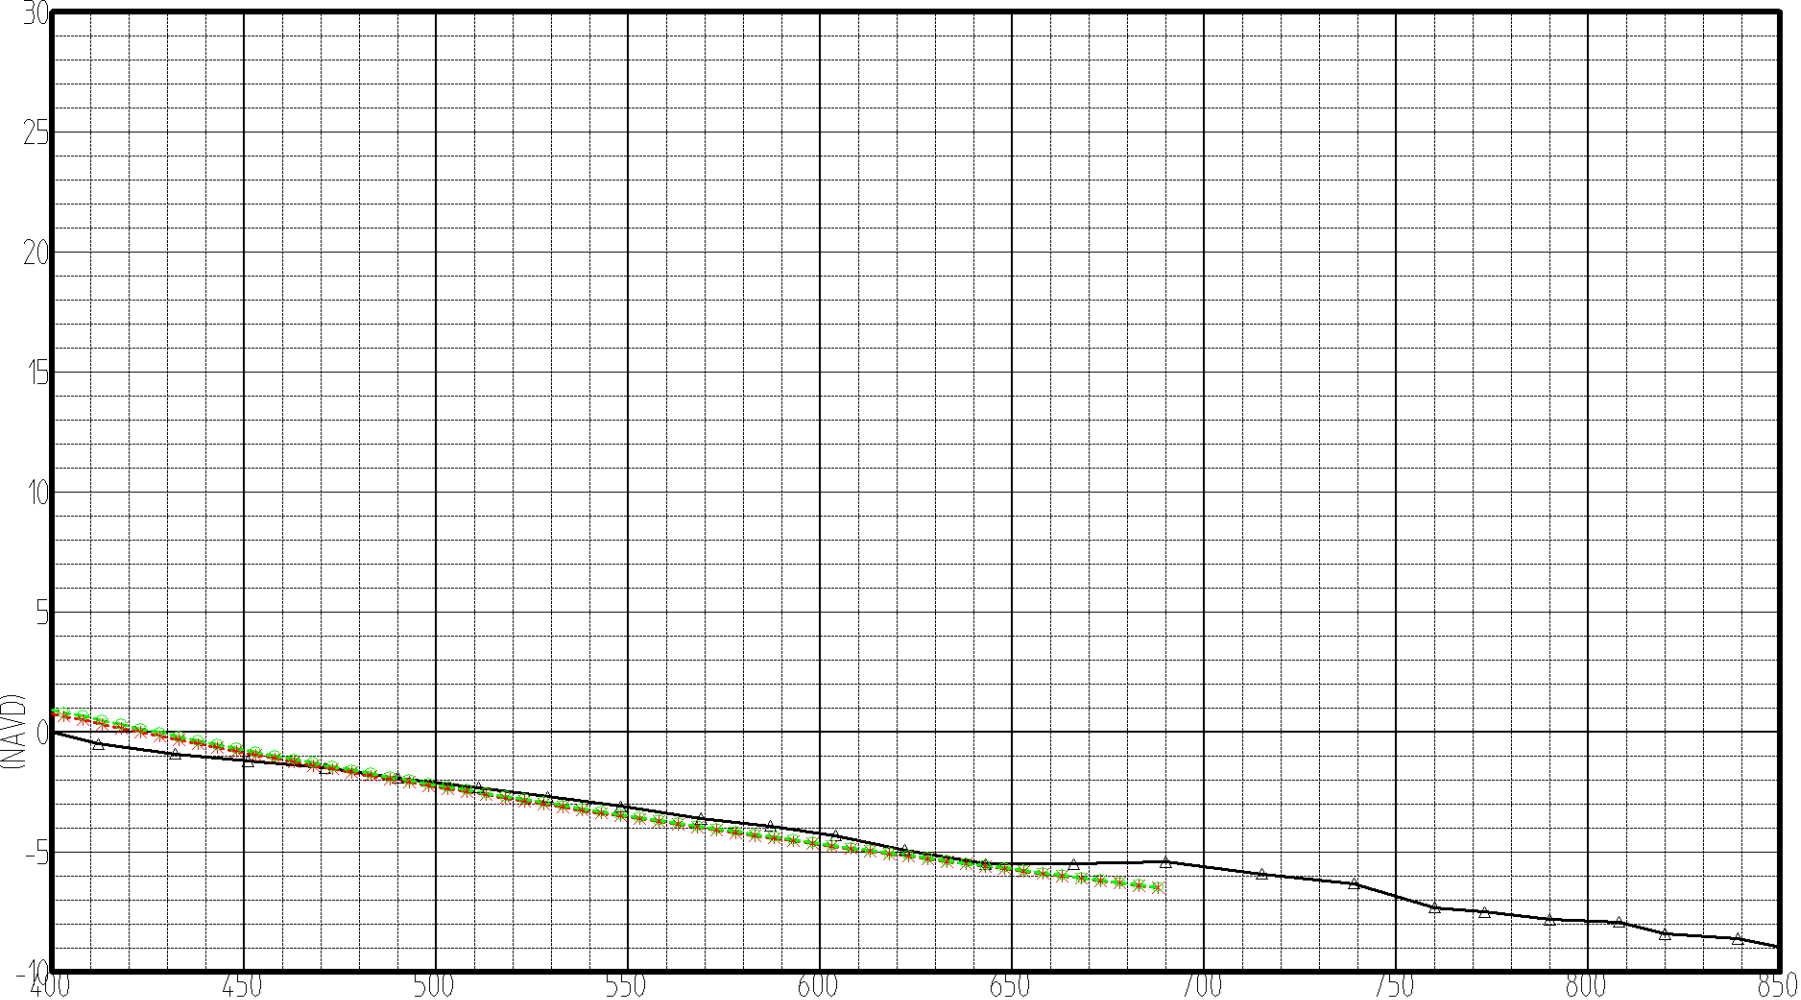
Range: R-9 2/3

BEACH PROFILE

- △—△— 2005-2008 INPUT PRF
- - - * - - - 15-YR SBEACH ERODED PRF
- - - o - - - 25-YR SBEACH ERODED PRF

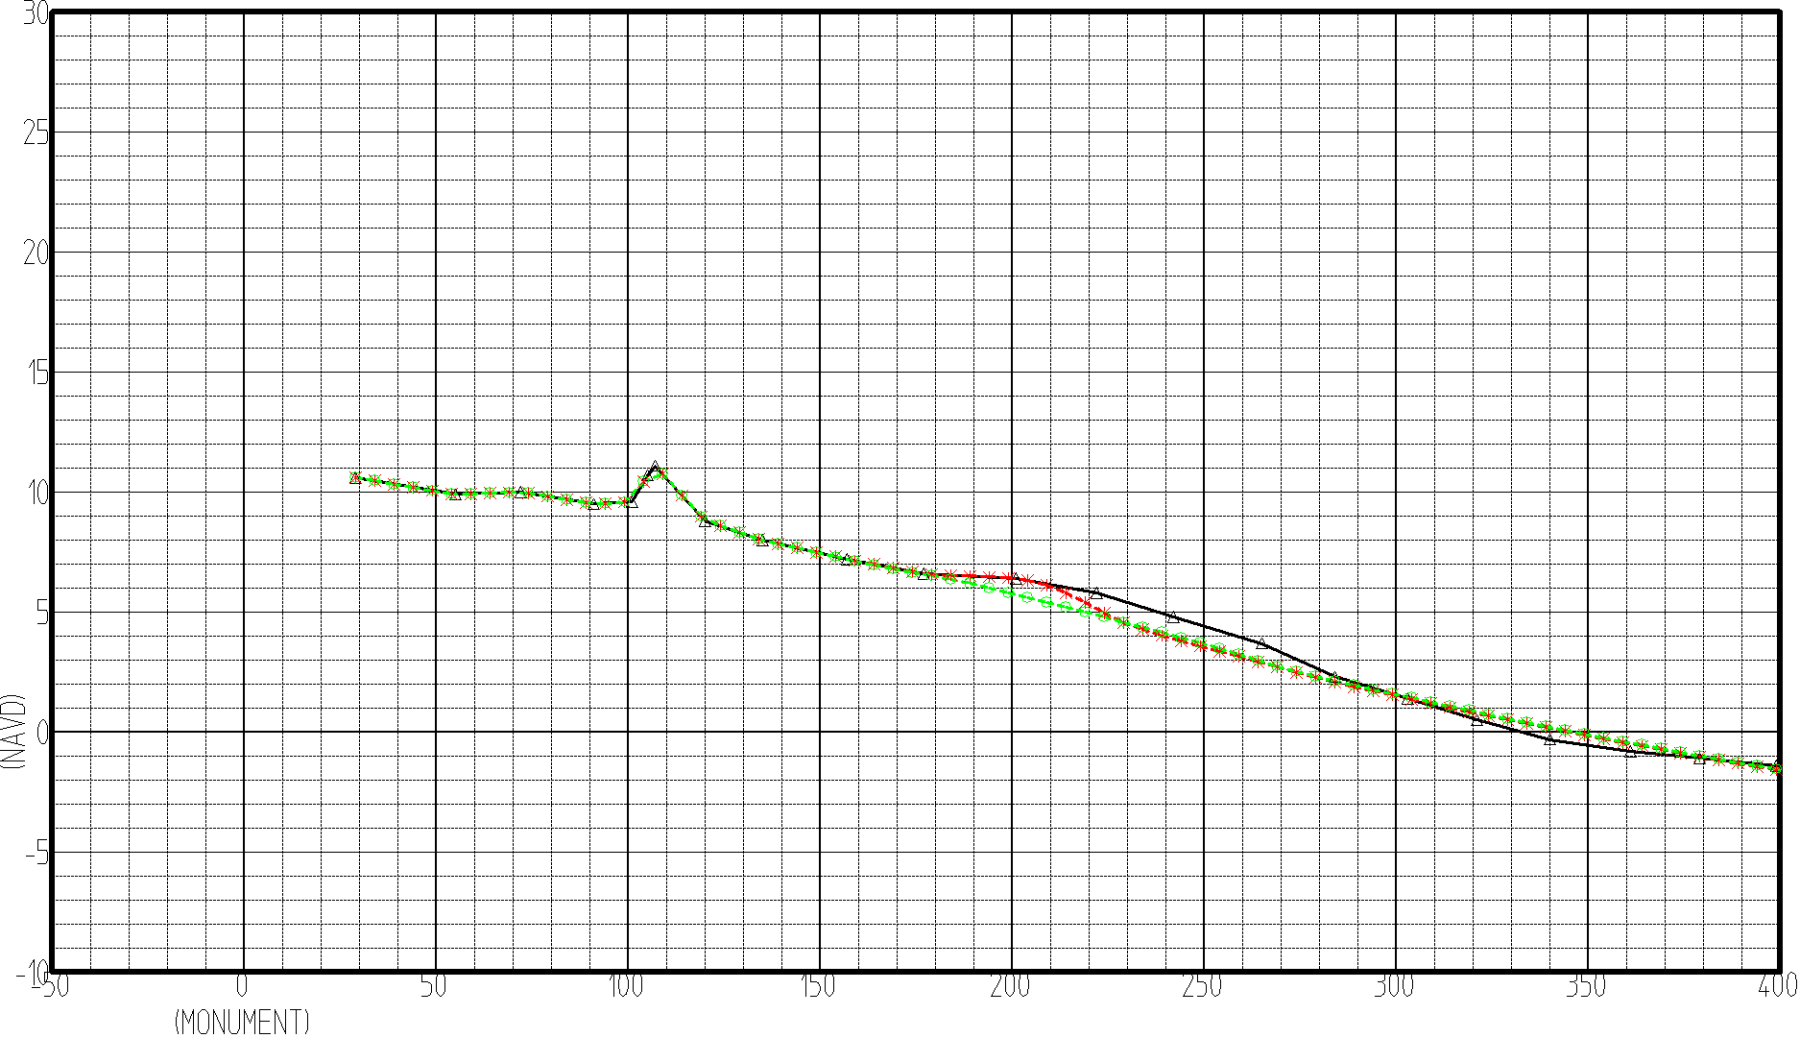
Range: T-10 1/3

- △—△— 2005-2008 INPUT PRF
- - - * - - - 15-YR SBEACH ERODED PRF
- - - o - - - 25-YR SBEACH ERODED PRF

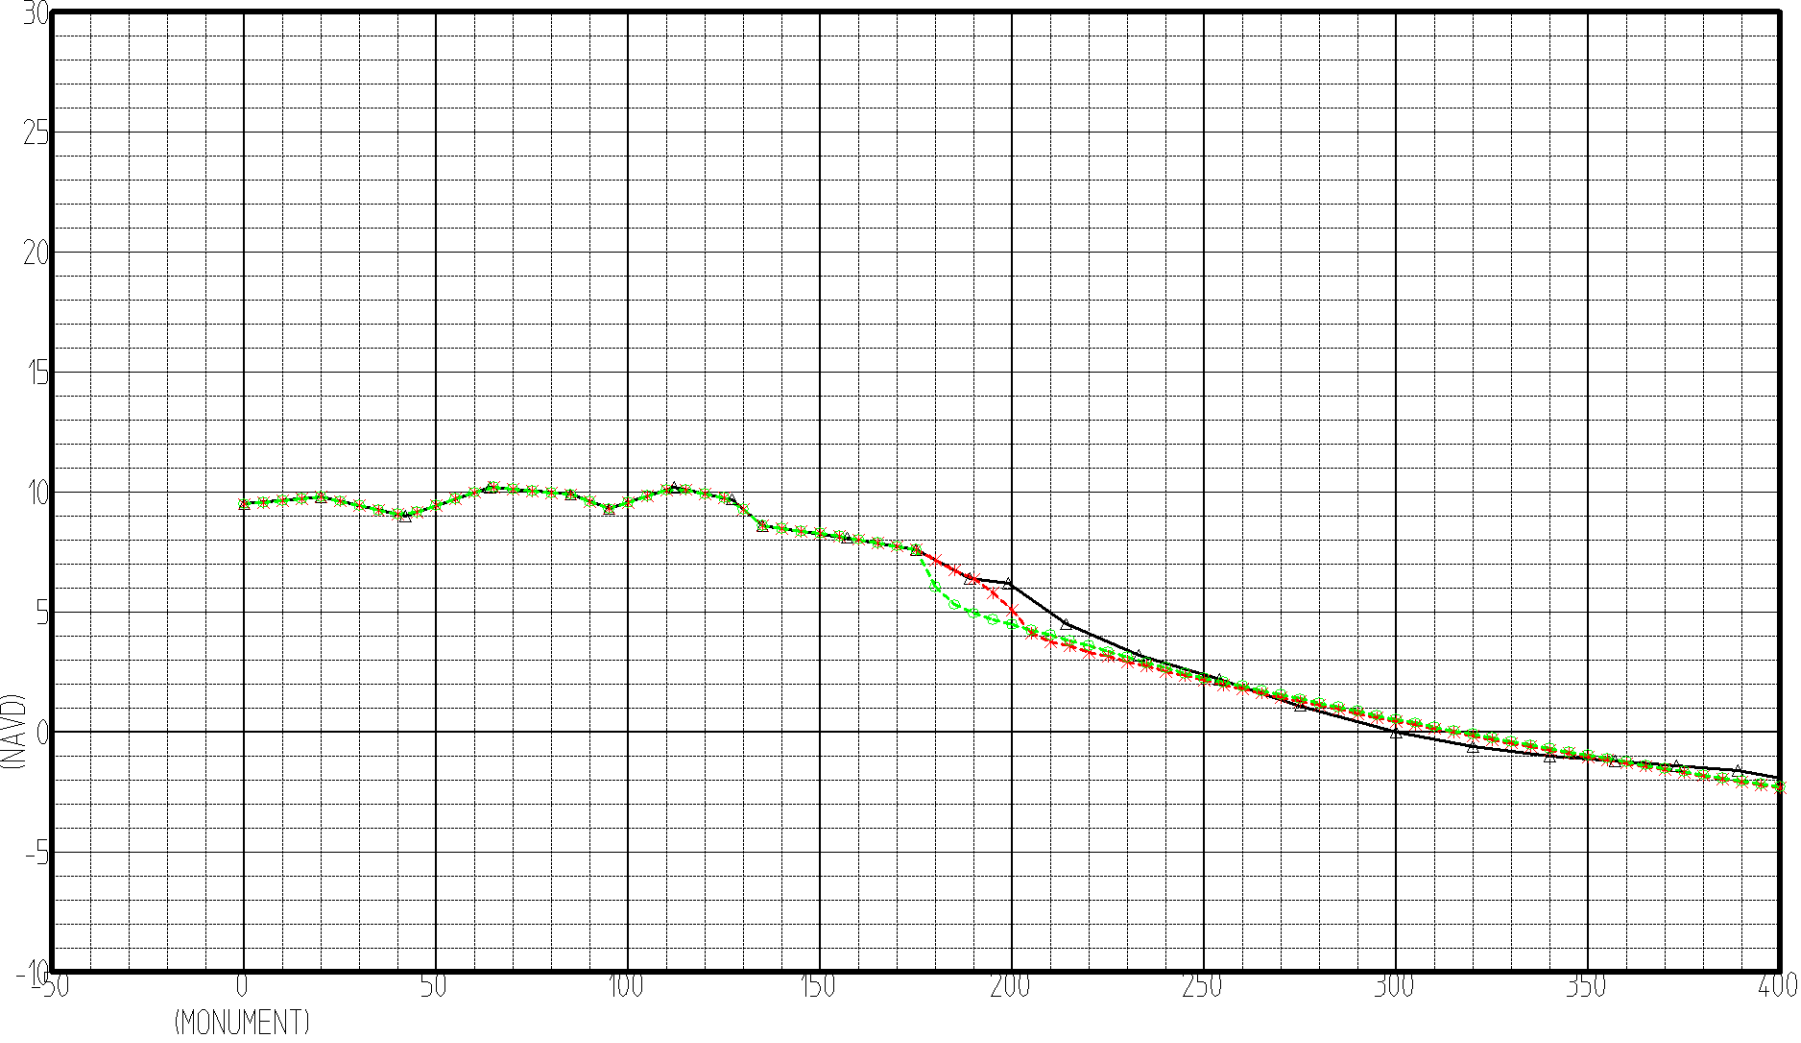
Range: R-11

BEACH PROFILE

—△—△— 2005-2008 INPUT PRF

- - - * - - - 15-YR SBEACH ERODED PRF

- - - o - - - 25-YR SBEACH ERODED PRF

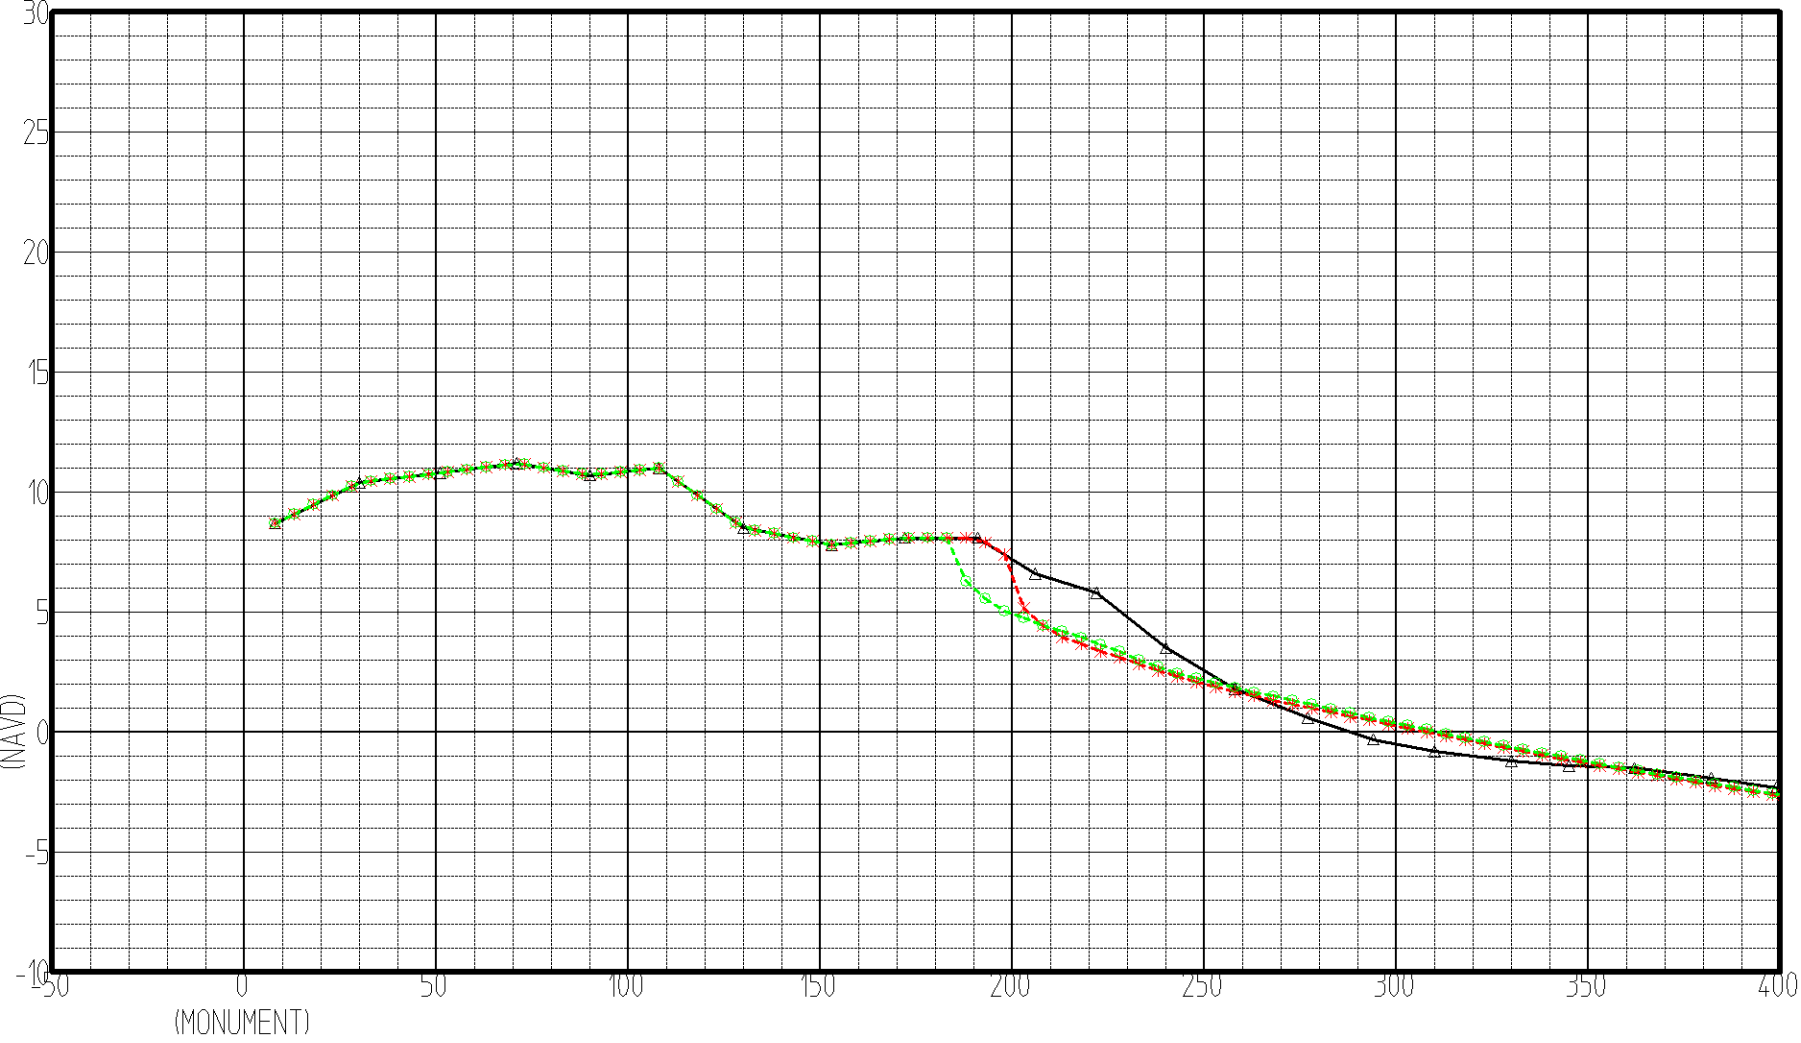
Range: R-12

BEACH PROFILE

—△—△— 2005-2008 INPUT PRF

- - - * - - - 15-YR SBEACH ERODED PRF

- - - o - - - 25-YR SBEACH ERODED PRF

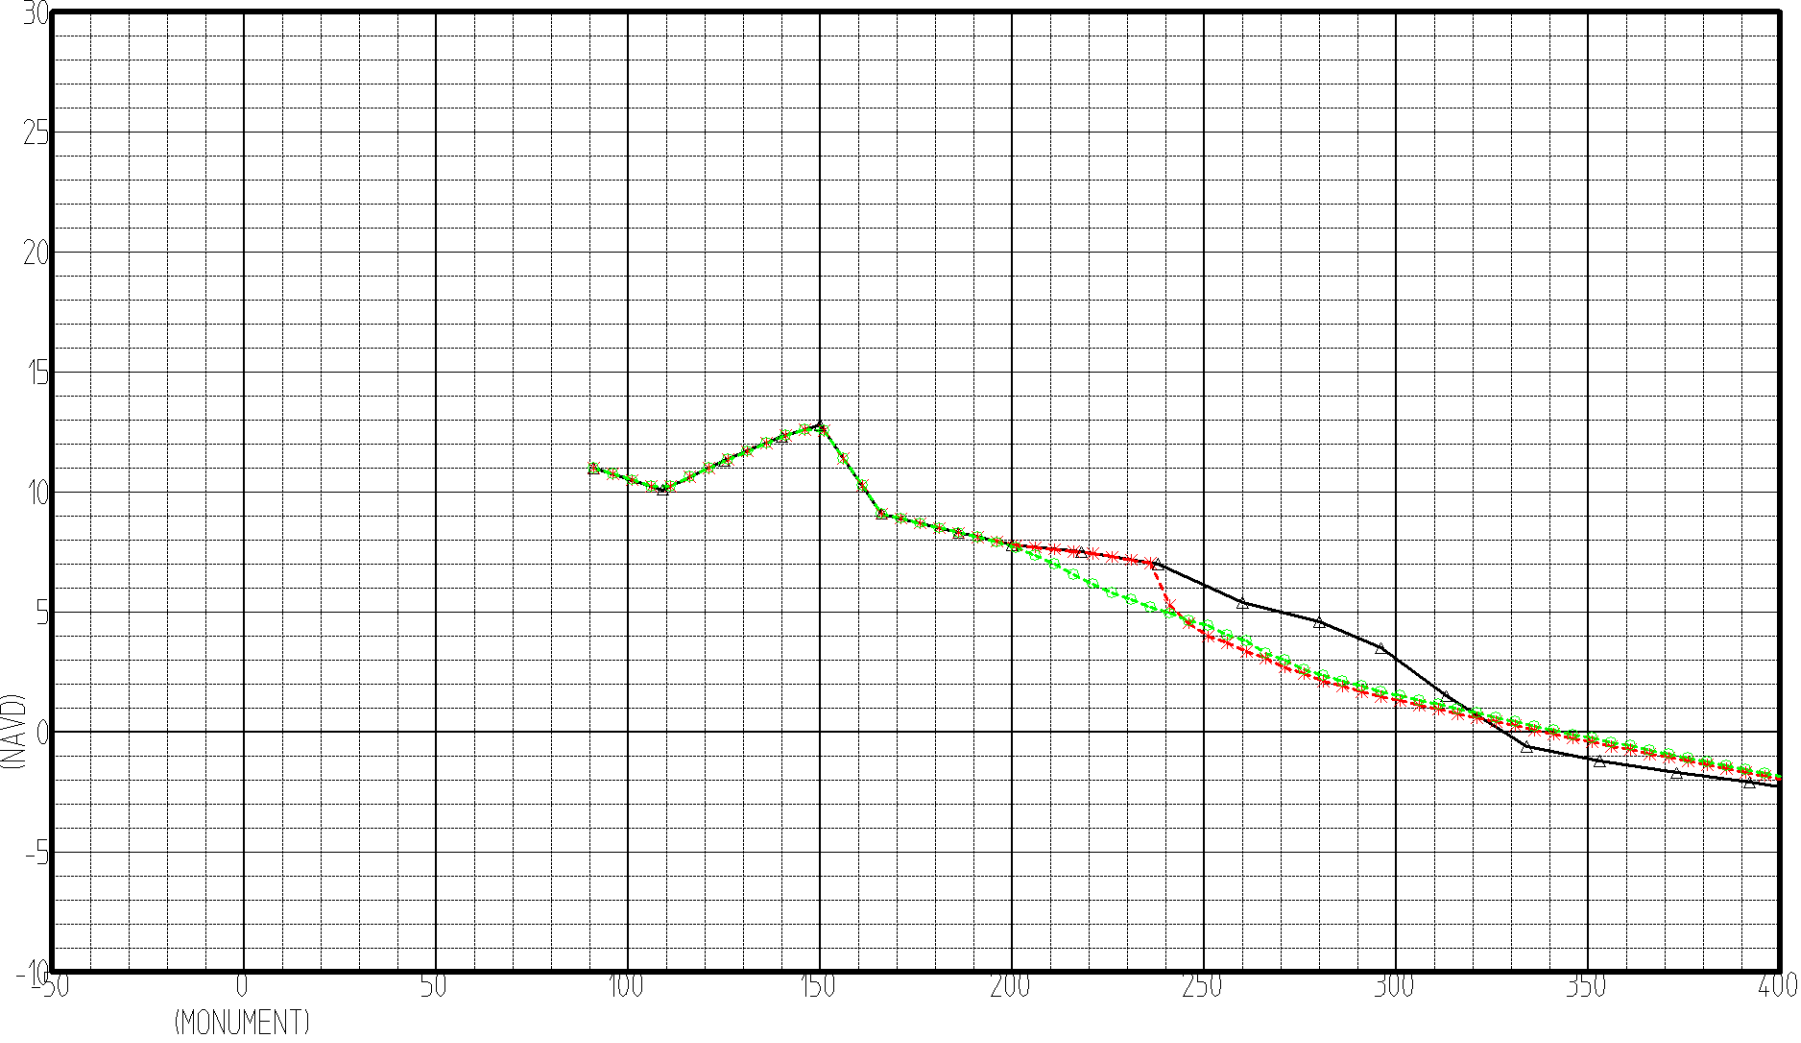
Range: R-14

BEACH PROFILE

—△—△— 2005-2008 INPUT PRF

- - - * - - - 15-YR SBEACH ERODED PRF

- - - o - - - 25-YR SBEACH ERODED PRF

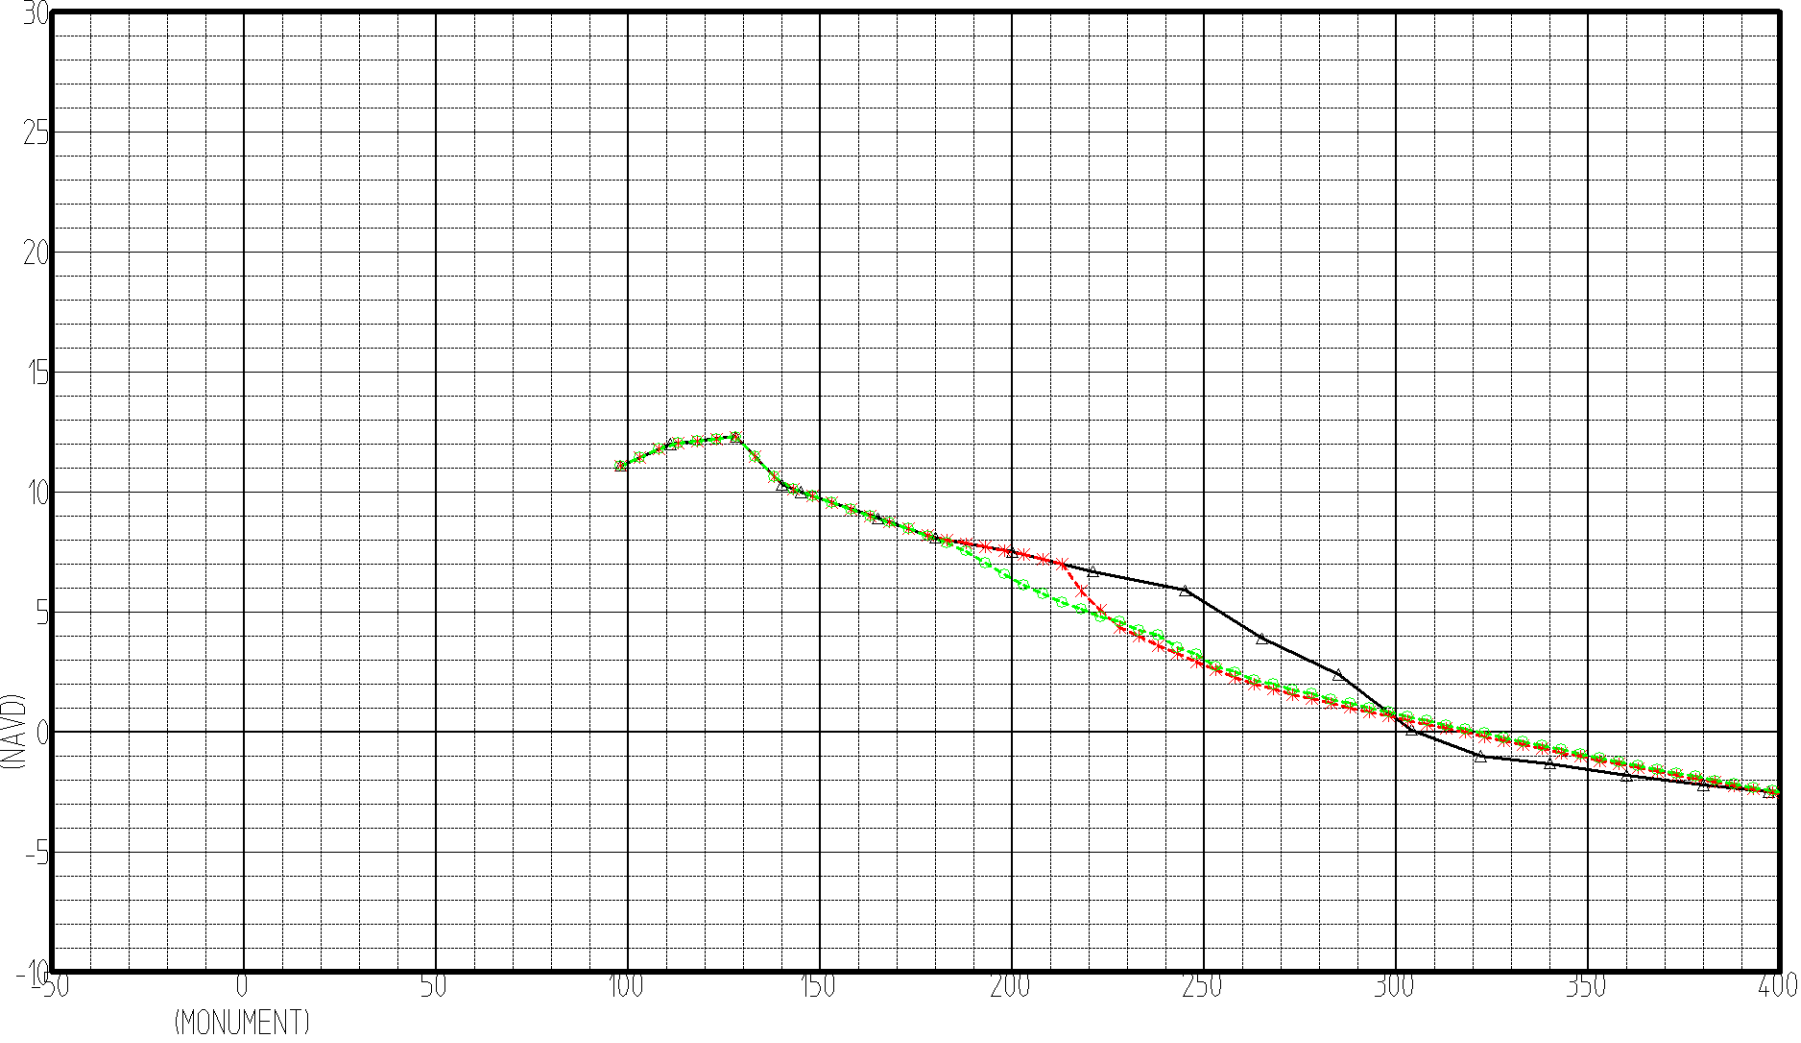
Range: R-15-T

BEACH PROFILE

—△—△— 2005-2008 INPUT PRF

- - - * - - - 15-YR SBEACH ERODED PRF

- - - o - - - 25-YR SBEACH ERODED PRF
