Appendix XI

SBEACH 15 and 25 yr. Storm Erosion Profiles

Brevard County

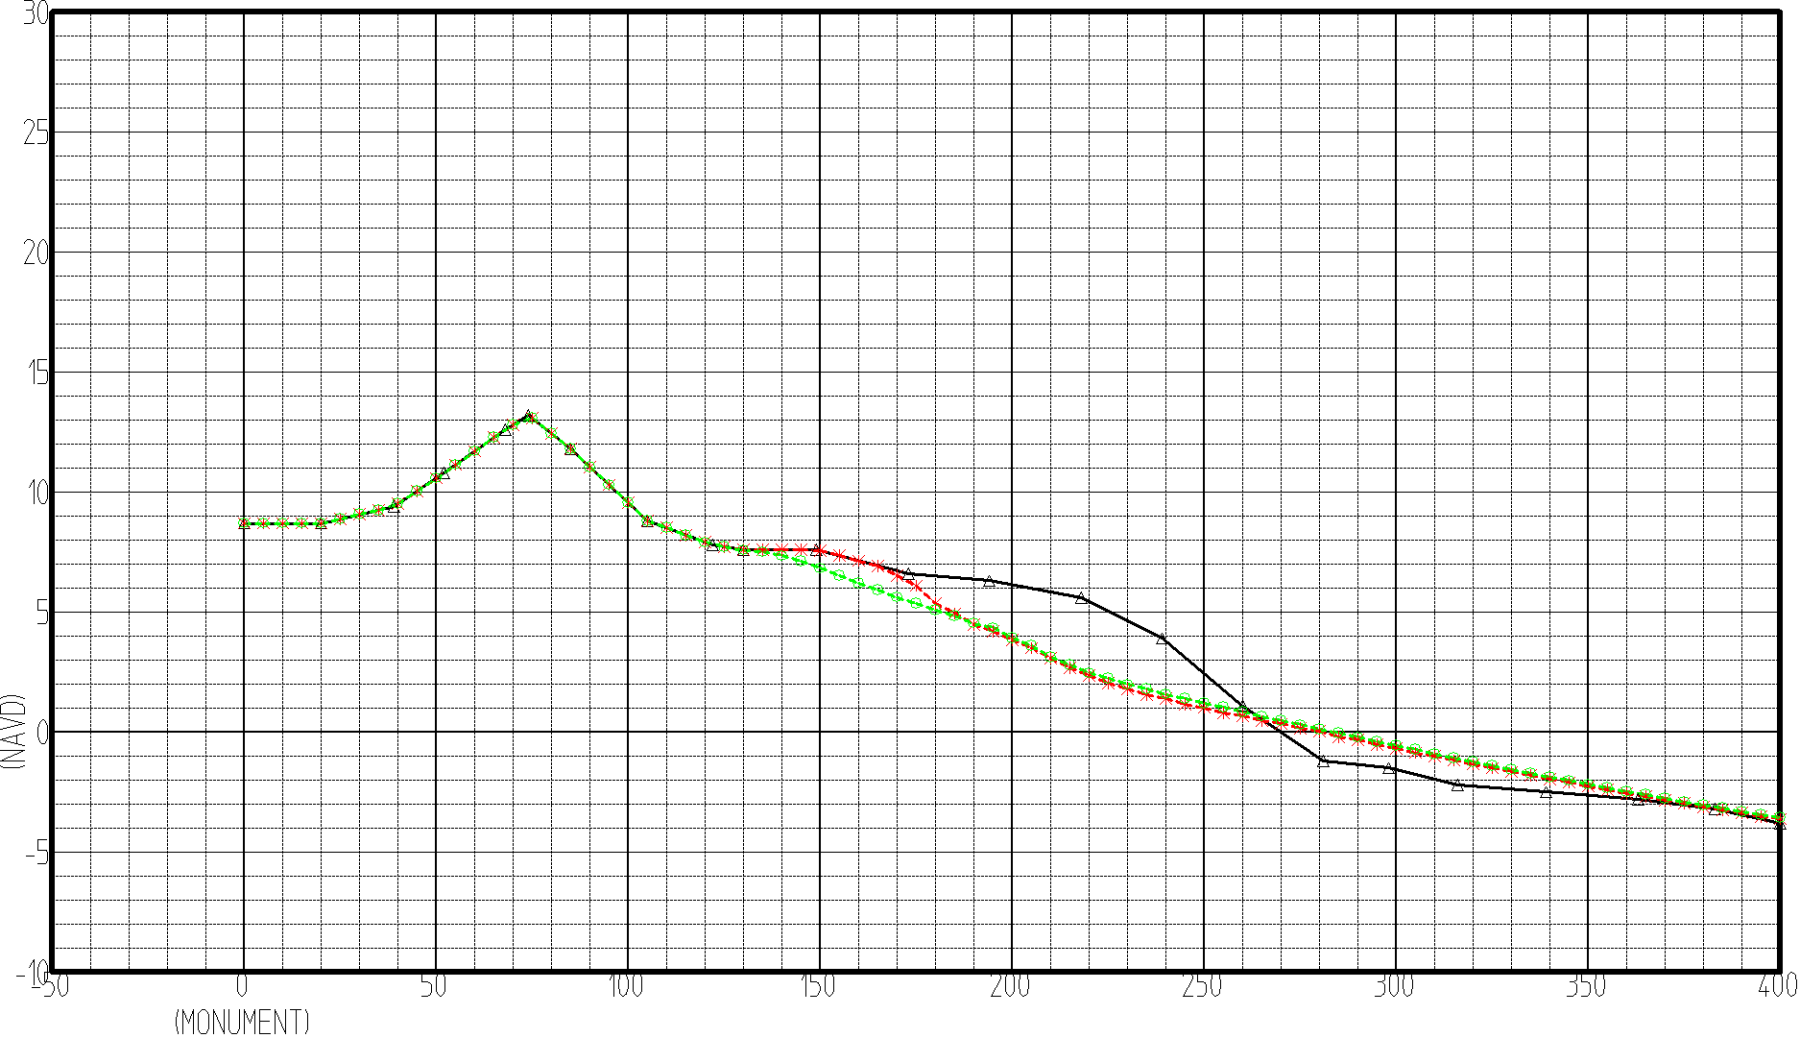
Range: R-16

BEACH PROFILE

—△—△— 2005-2008 INPUT PRF

- - - * - - - 15-YR SBEACH ERODED PRF

- - - o - - - 25-YR SBEACH ERODED PRF

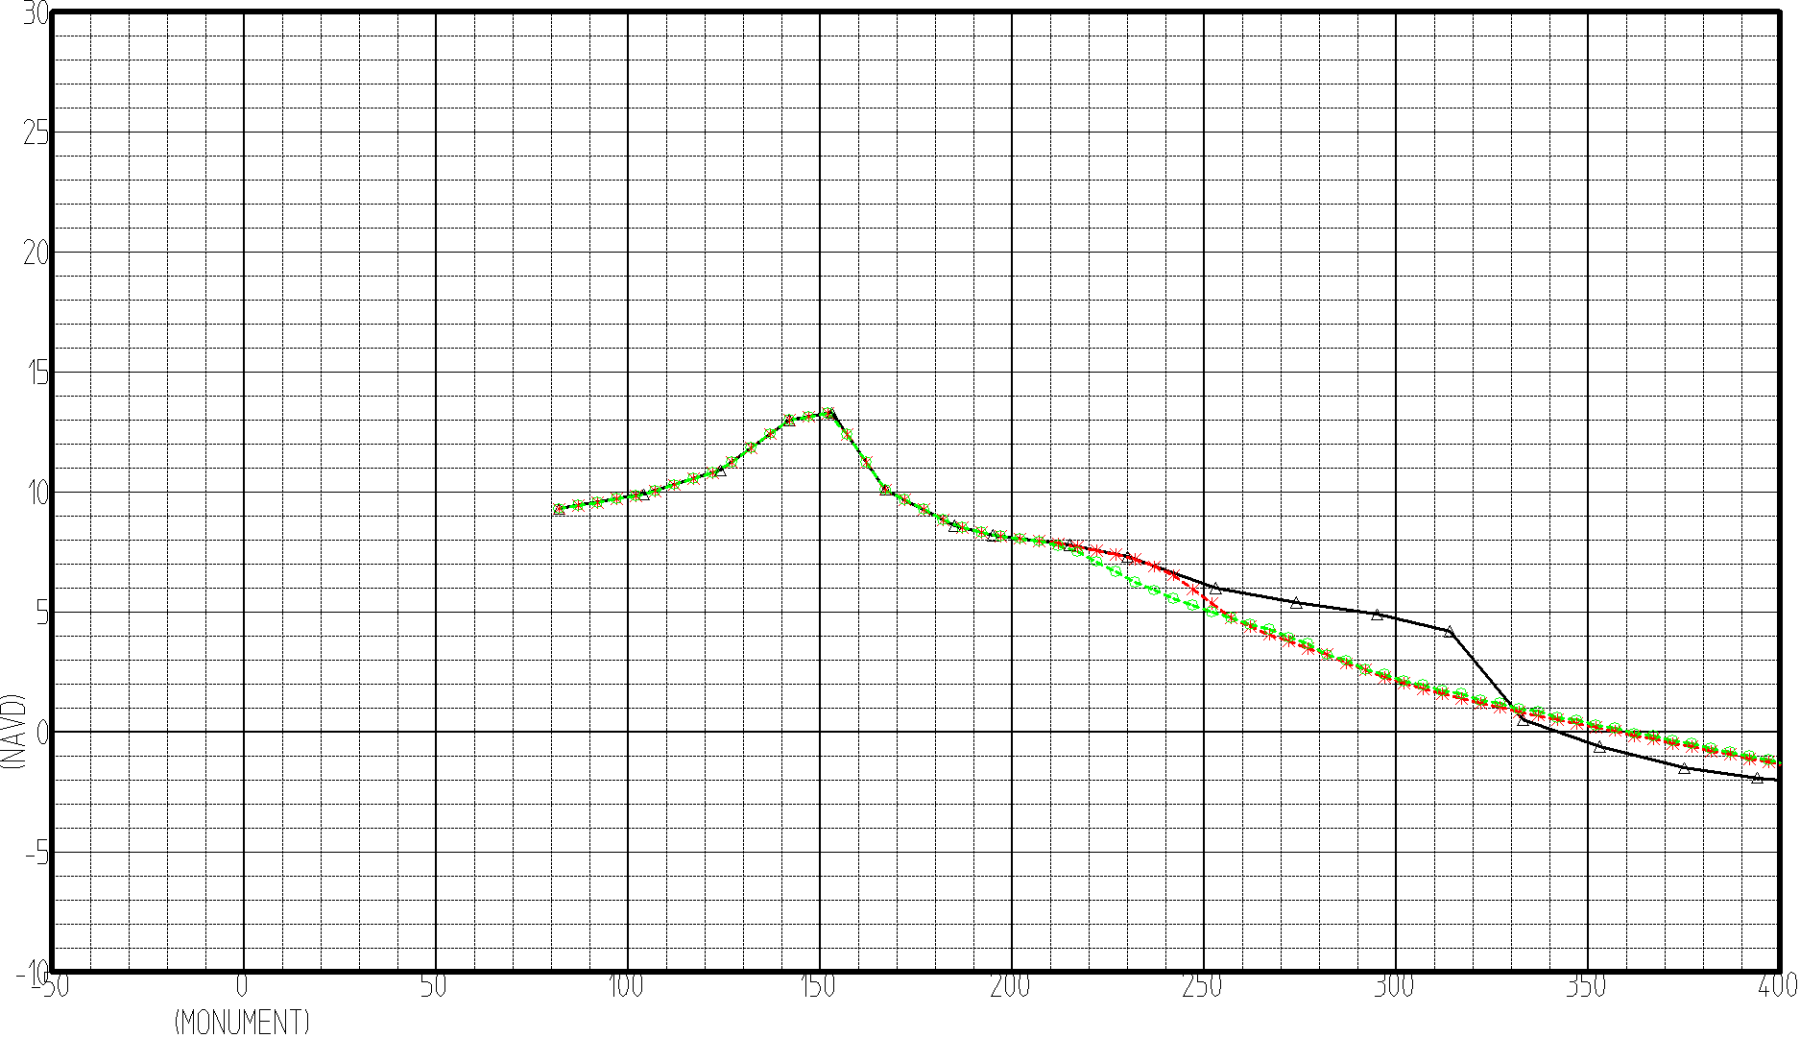
Range: R-17

BEACH PROFILE

—△—△— 2005-2008 INPUT PRF

- - - * - - - 15-YR SBEACH ERODED PRF

- - - o - - - 25-YR SBEACH ERODED PRF

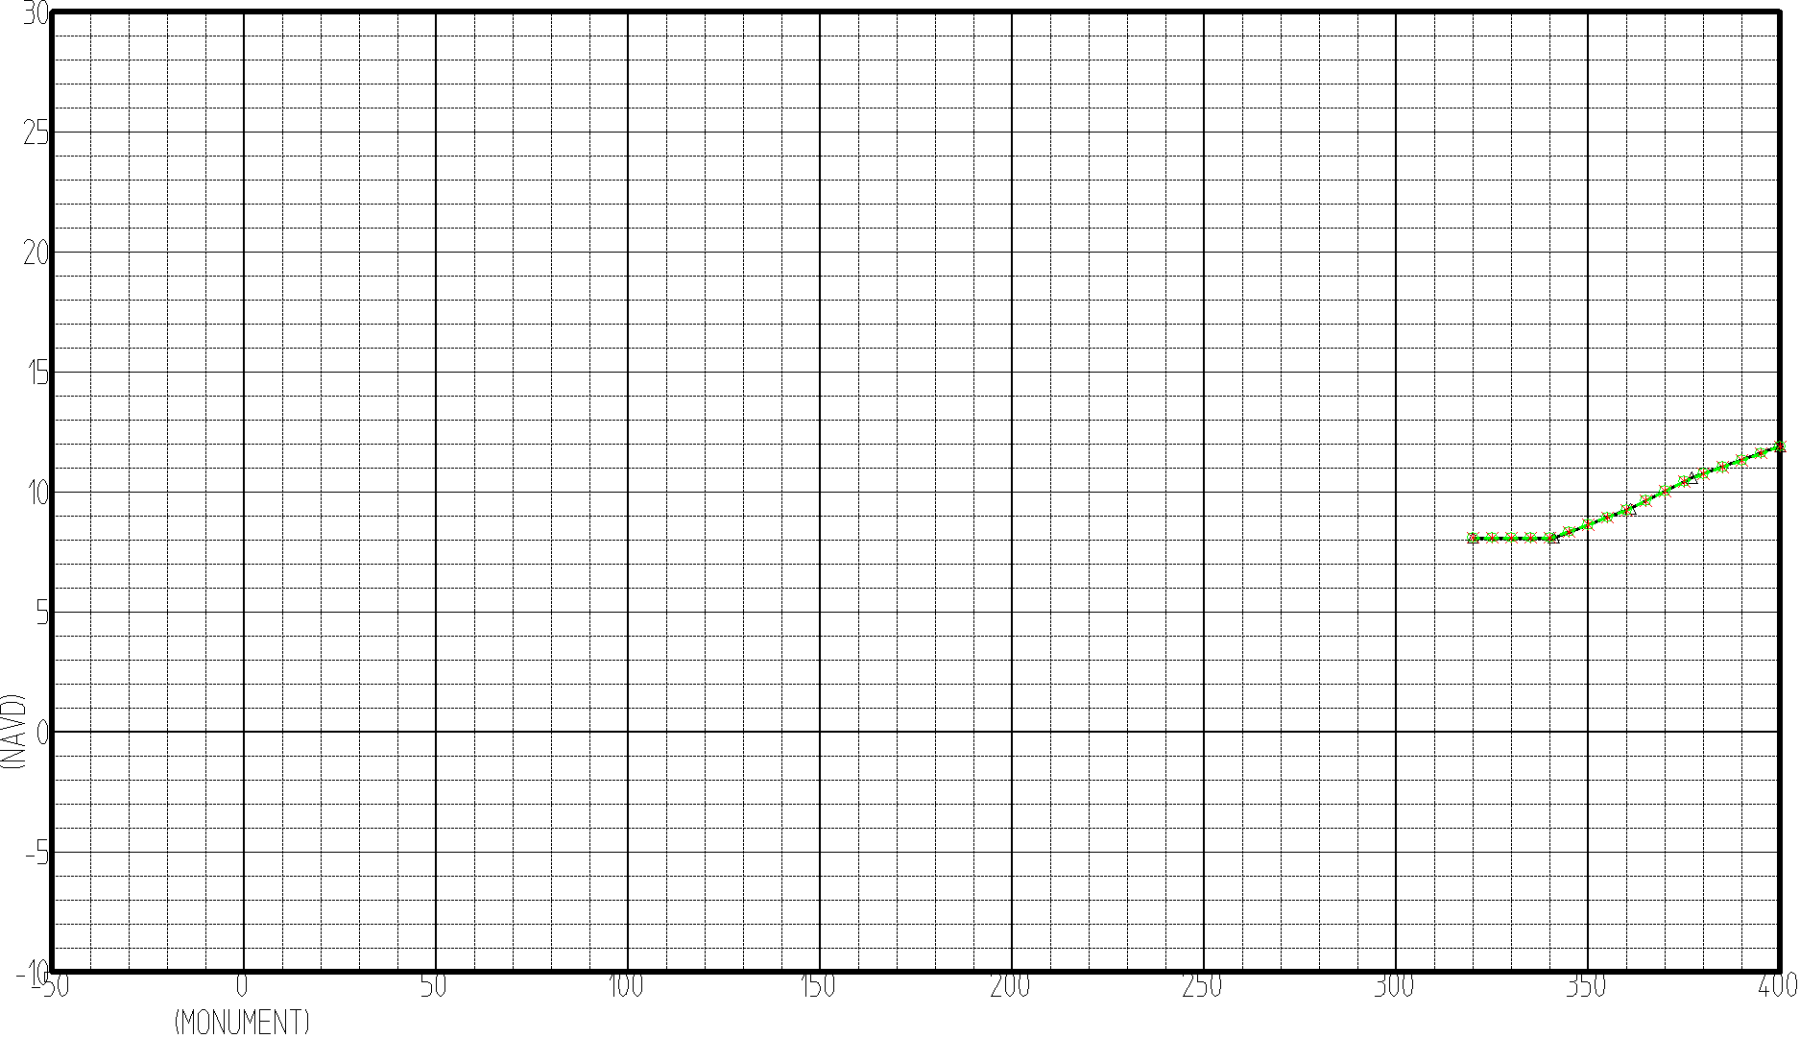
Range: R-18 1/3

- △—△— 2005-2008 INPUT PRF
- - - * - - - 15-YR SBEACH ERODED PRF
- - - o - - - 25-YR SBEACH ERODED PRF

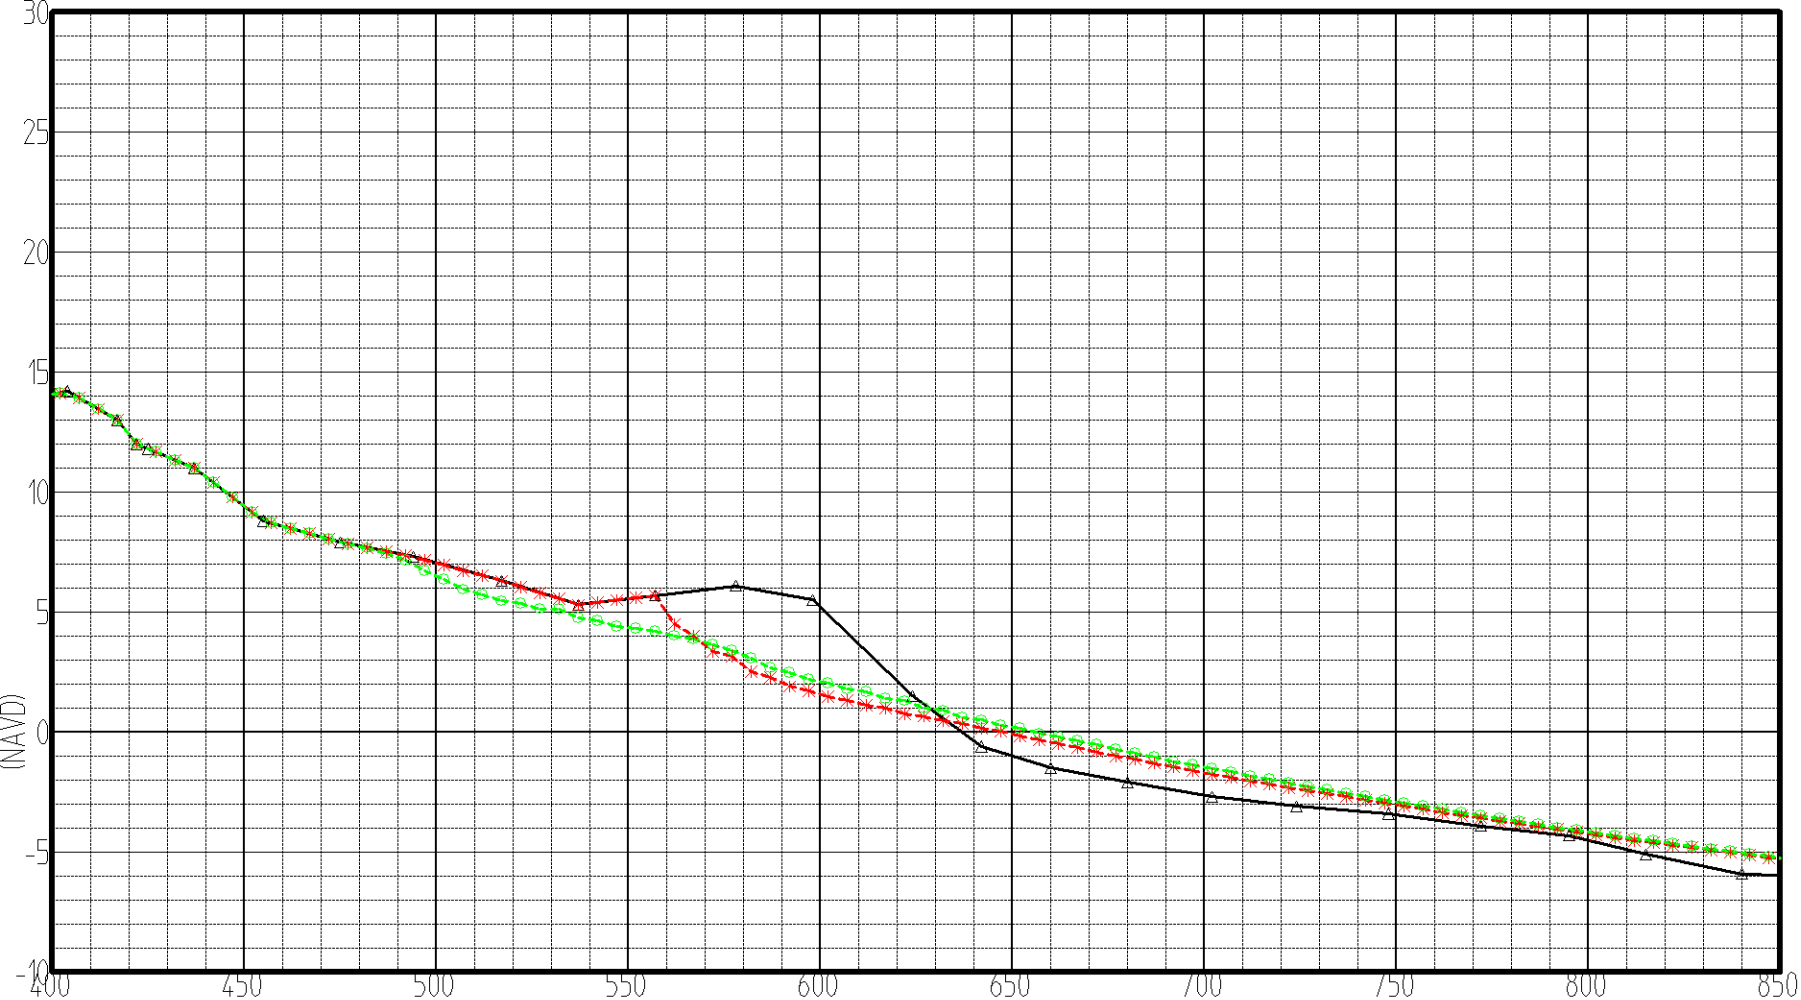
Range: R-22
 BEARING: 90.00
 2/4

BEACH PROFILE
 —△—△— 2005-2008 INPUT PRF
 - - * - - * - - 15-YR SBEACH ERODED PRF
 - - o - - o - - 25-YR SBEACH ERODED PRF

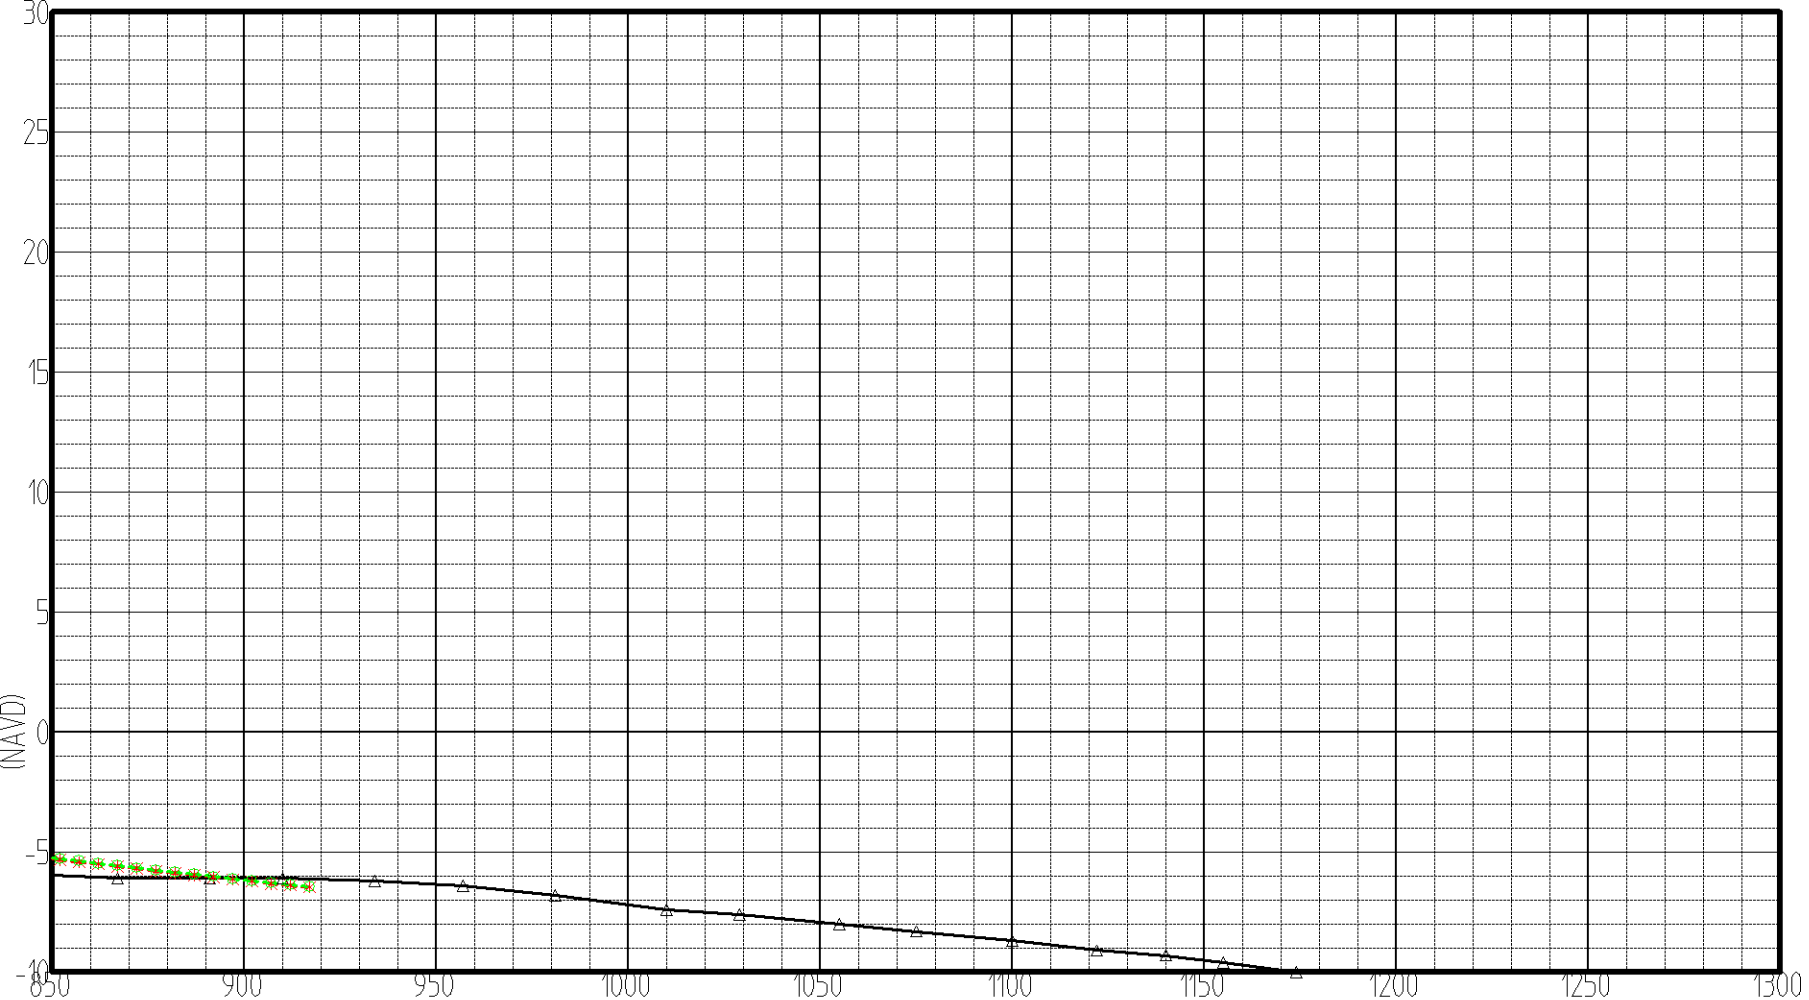
Range: R-22

BEACH PROFILE

—△—△— 2005-2008 INPUT PRF

- - - * - - - 15-YR SBEACH ERODED PRF

- - - o - - - 25-YR SBEACH ERODED PRF

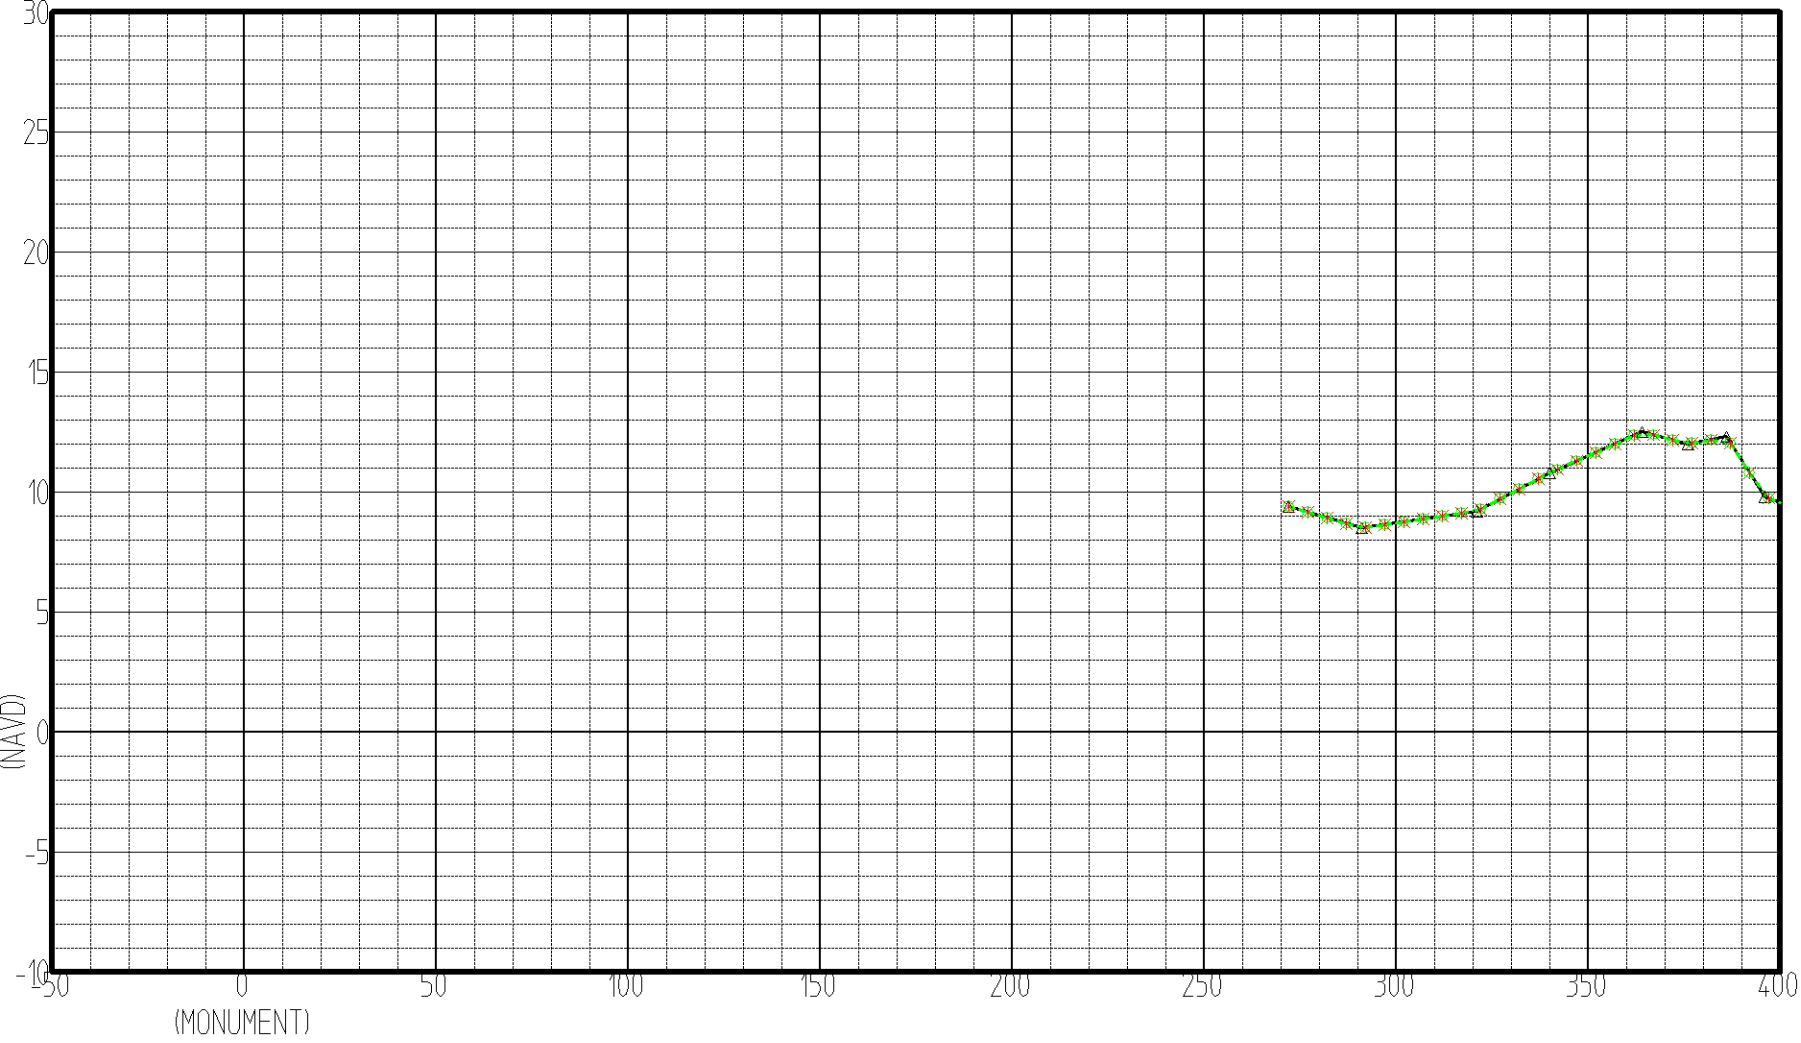
Range: R-23 1/3

BEACH PROFILE

- △—△— 2005-2008 INPUT PRF
- - - * - - - 15-YR SBEACH ERODED PRF
- - - o - - - 25-YR SBEACH ERODED PRF

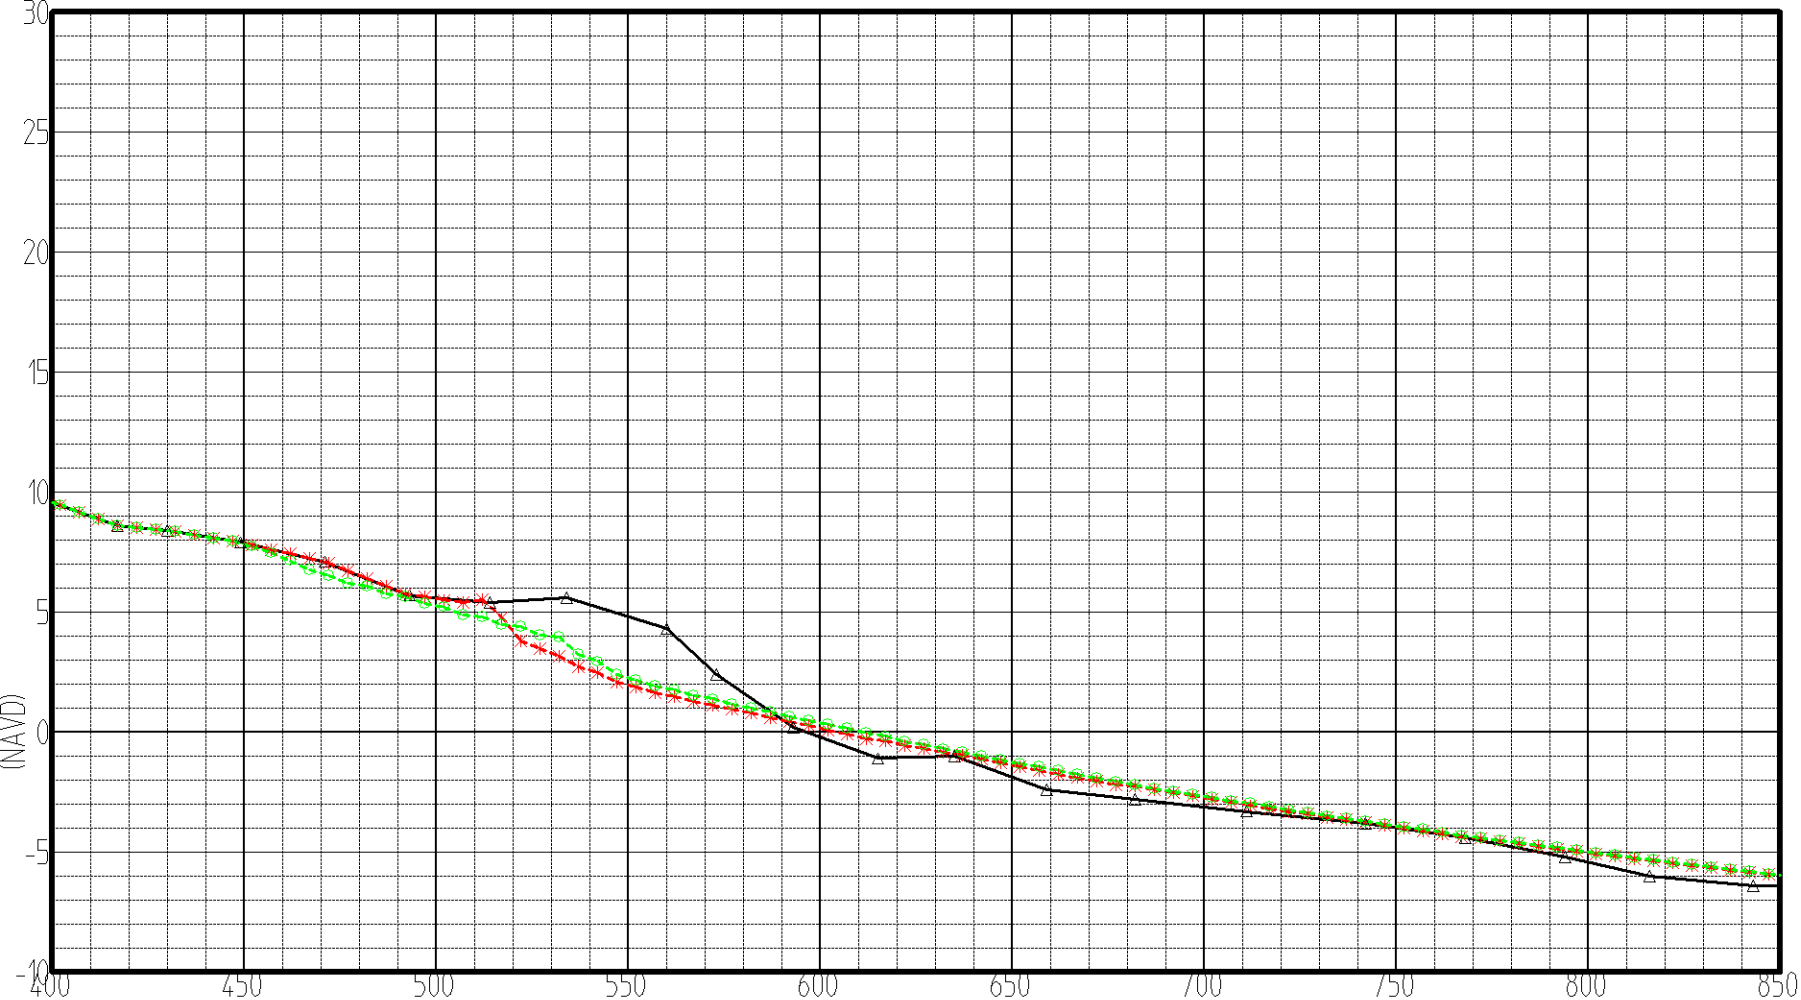
Range: R-23 2/3

BEACH PROFILE

—△—△— 2005-2008 INPUT PRF

- - - * - - - 15-YR SBEACH ERODED PRF

- - - o - - - 25-YR SBEACH ERODED PRF

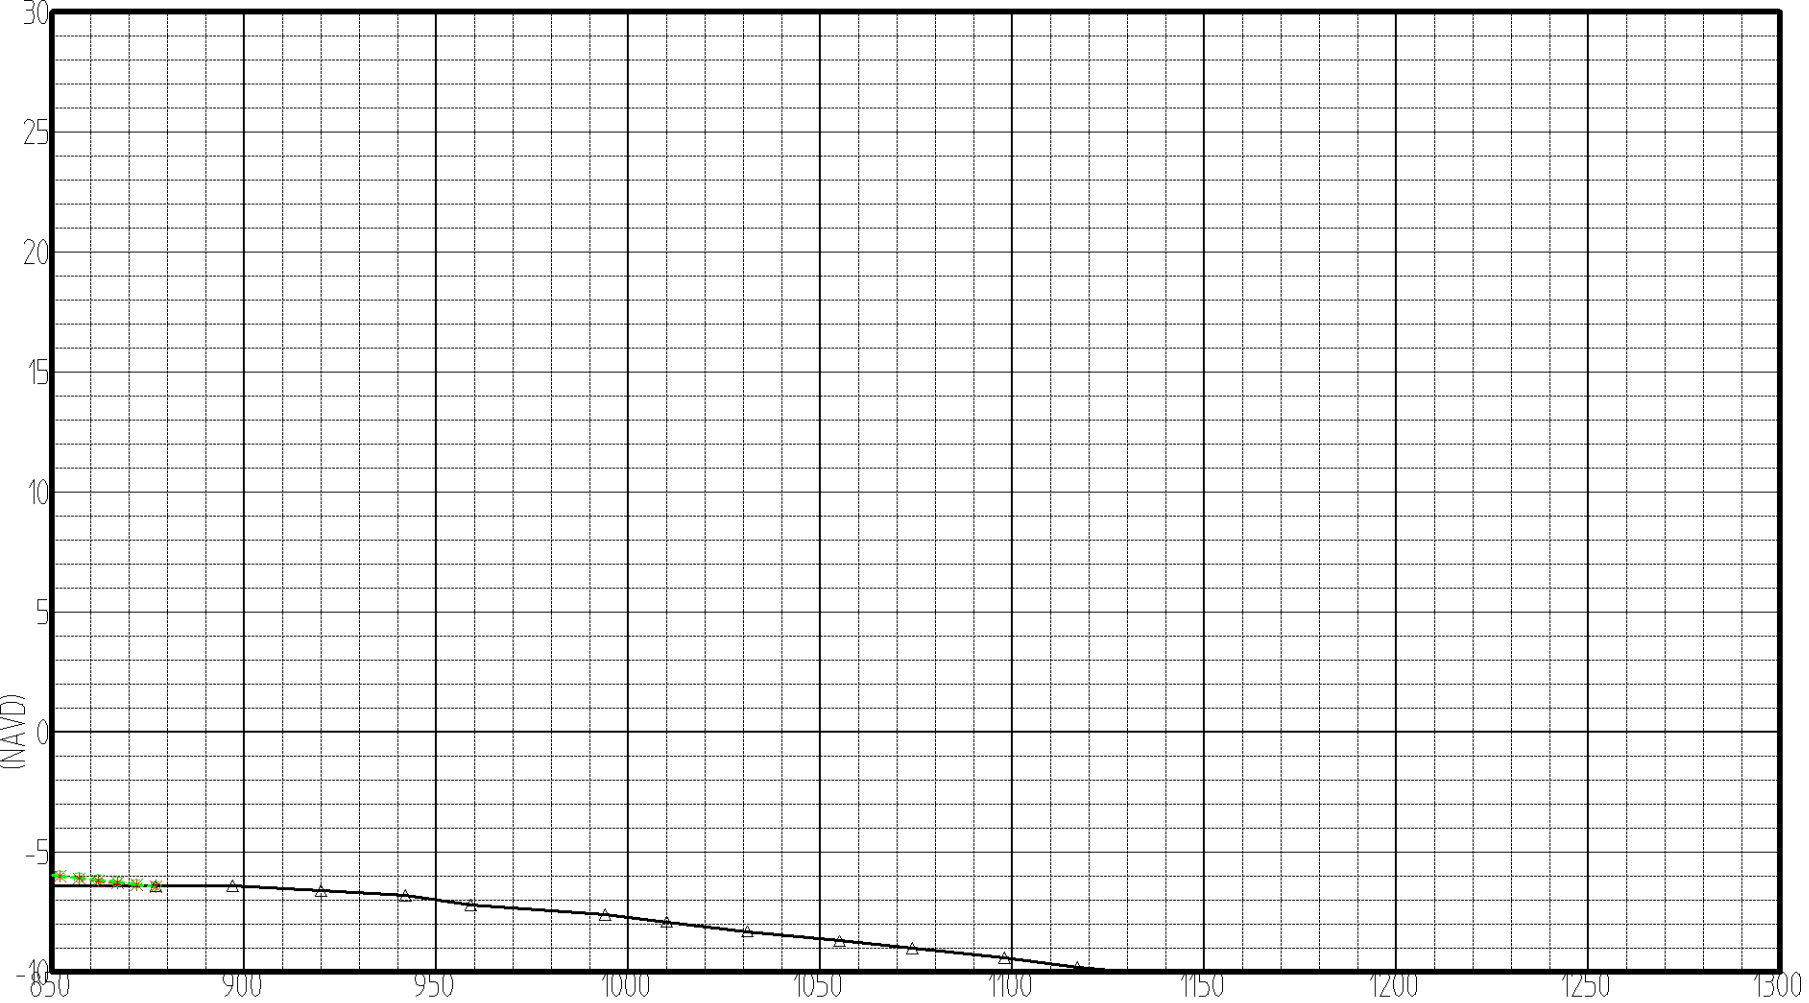
Range: R-23
 BEARING: 90.00
 3/3

BEACH PROFILE
 —△—△— 2005-2008 INPUT PRF
 - - * - - * - - 15-YR SBEACH ERODED PRF
 - - o - - o - - 25-YR SBEACH ERODED PRF

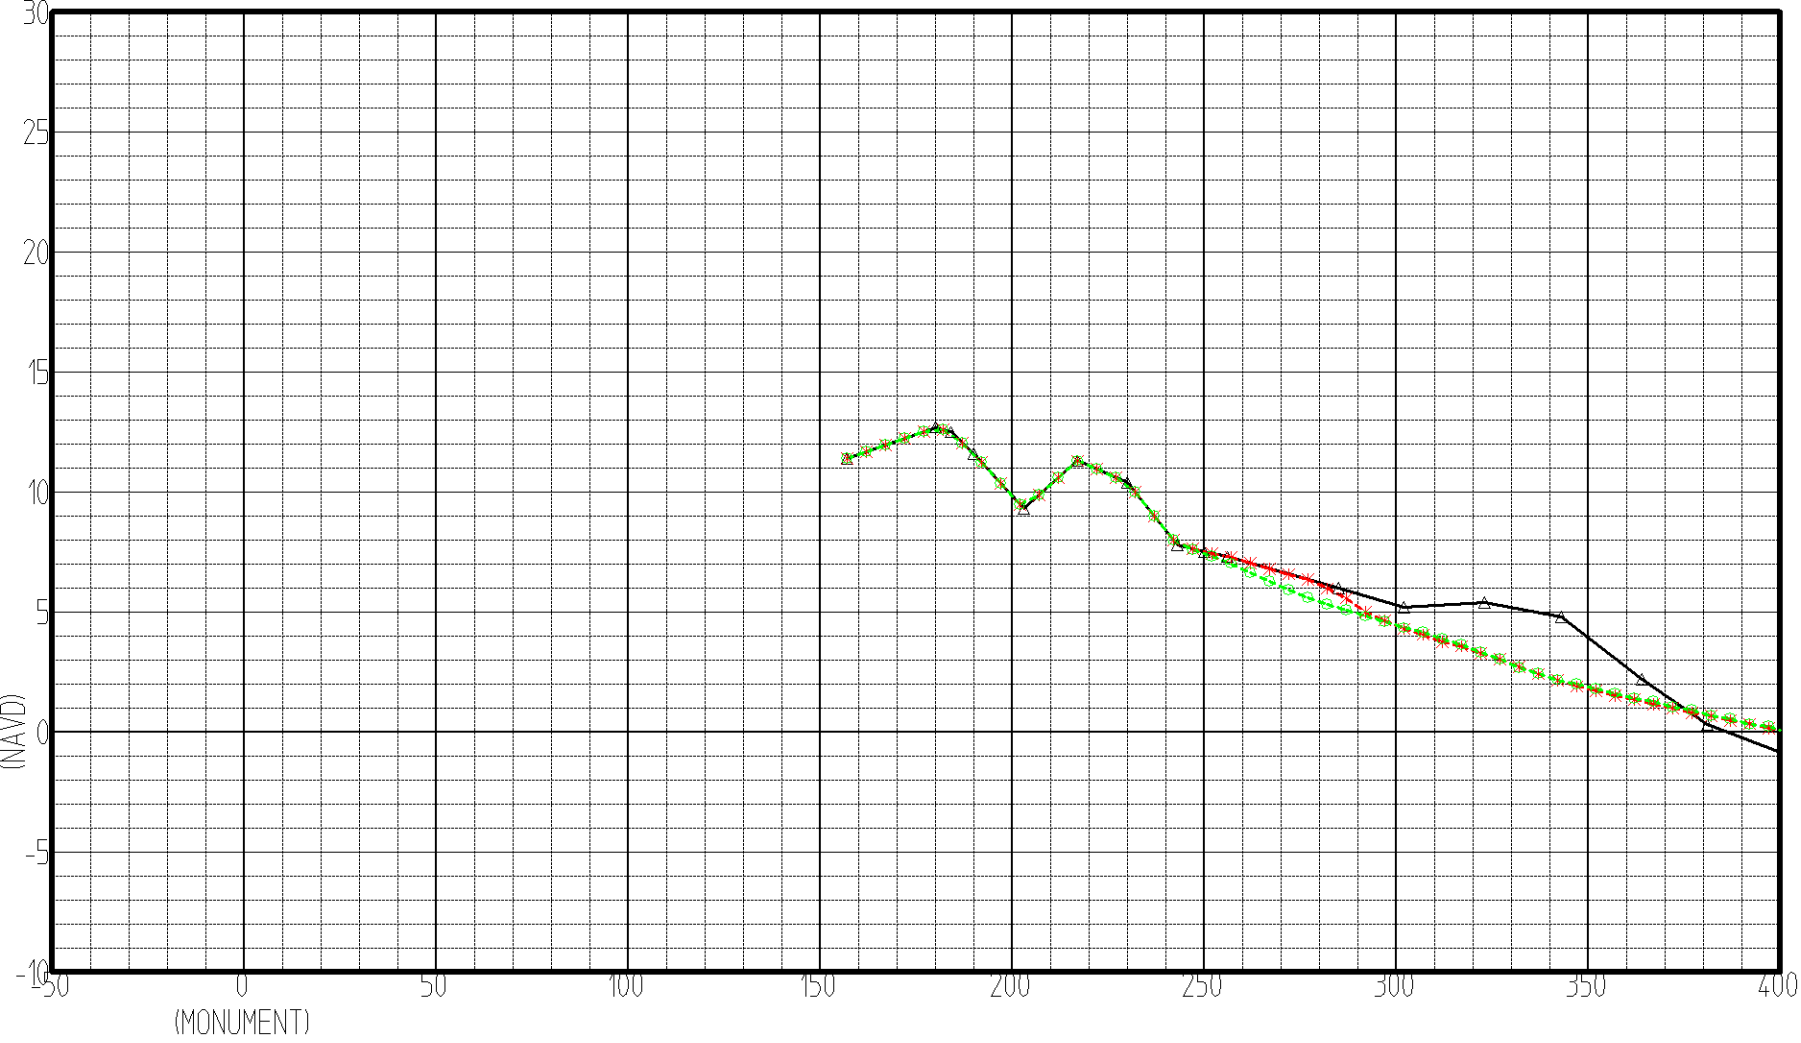
Range: R-24
 BEARING: 90.00
 1/3

BEACH PROFILE
 —△—△— 2005-2008 INPUT PRF
 - - - * - - - 15-YR SBEACH ERODED PRF
 - - - o - - - 25-YR SBEACH ERODED PRF

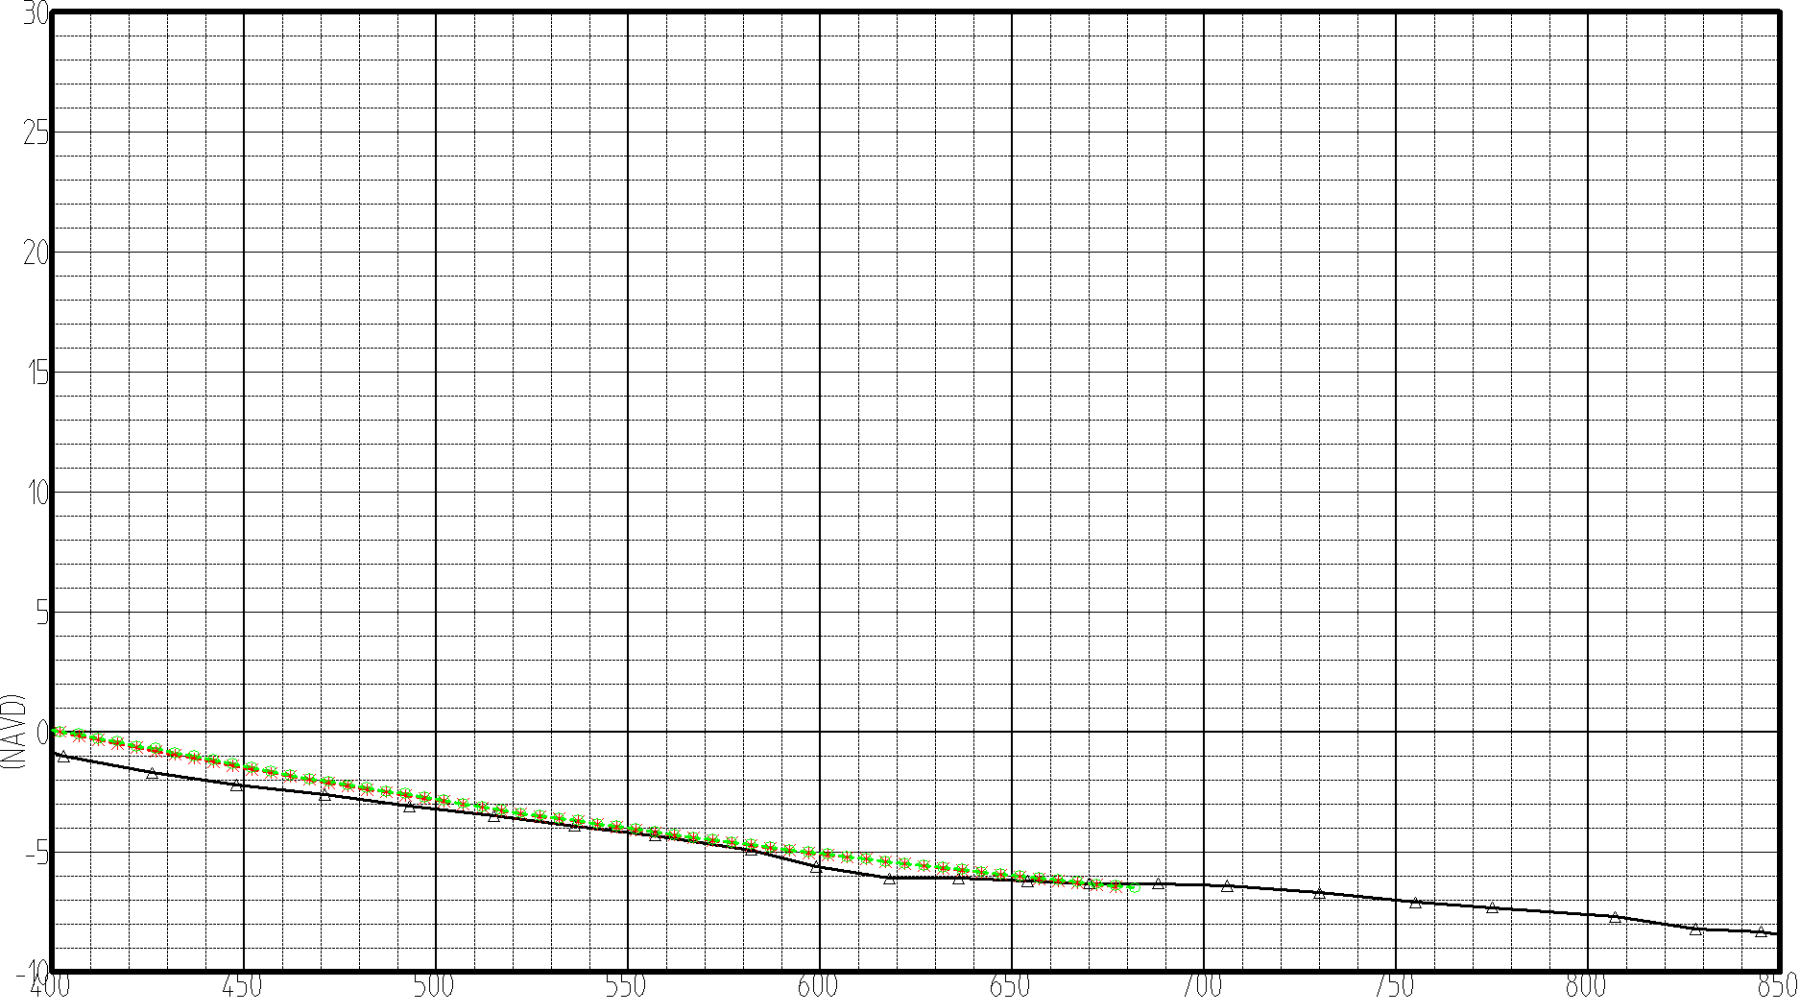
Range: R-24 2/3

BEACH PROFILE

—△—△— 2005-2008 INPUT PRF

- - - * - - - 15-YR SBEACH ERODED PRF

- - - o - - - 25-YR SBEACH ERODED PRF

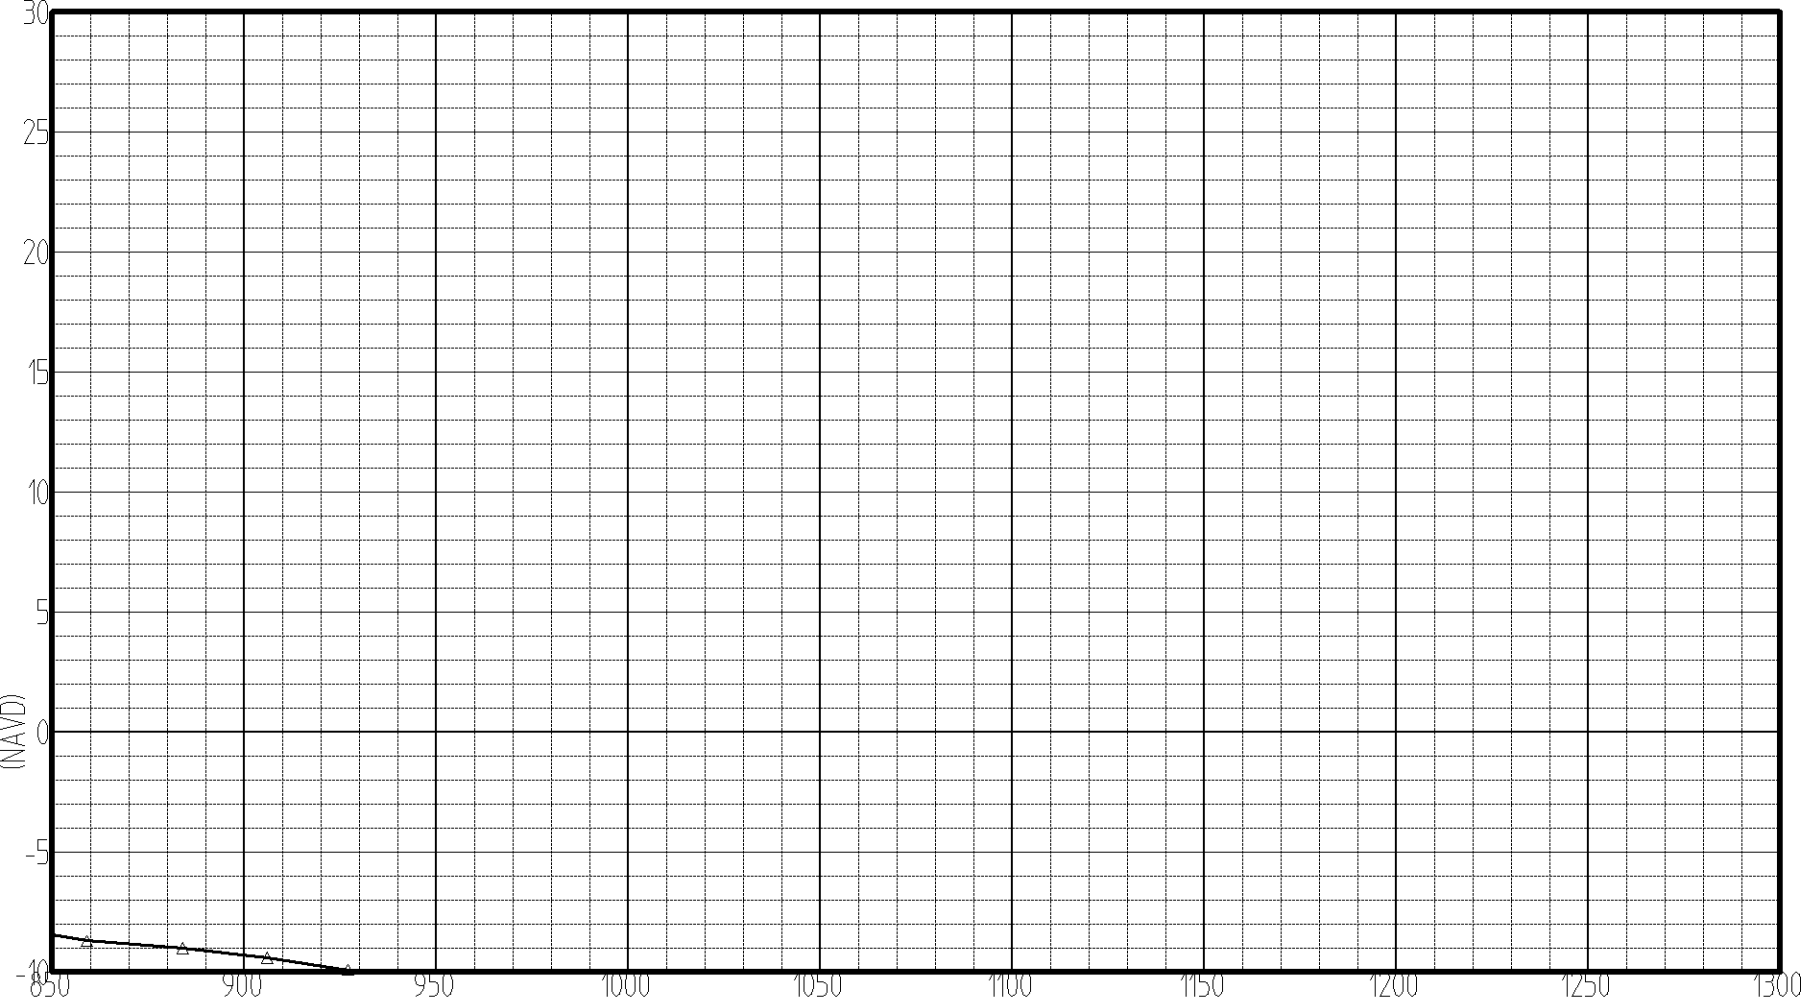
Range: R-24 3/3

BEACH PROFILE

- △—△— 2005-2008 INPUT PRF
- - - * - - - 15-YR SBEACH ERODED PRF
- - - ○ - - - 25-YR SBEACH ERODED PRF

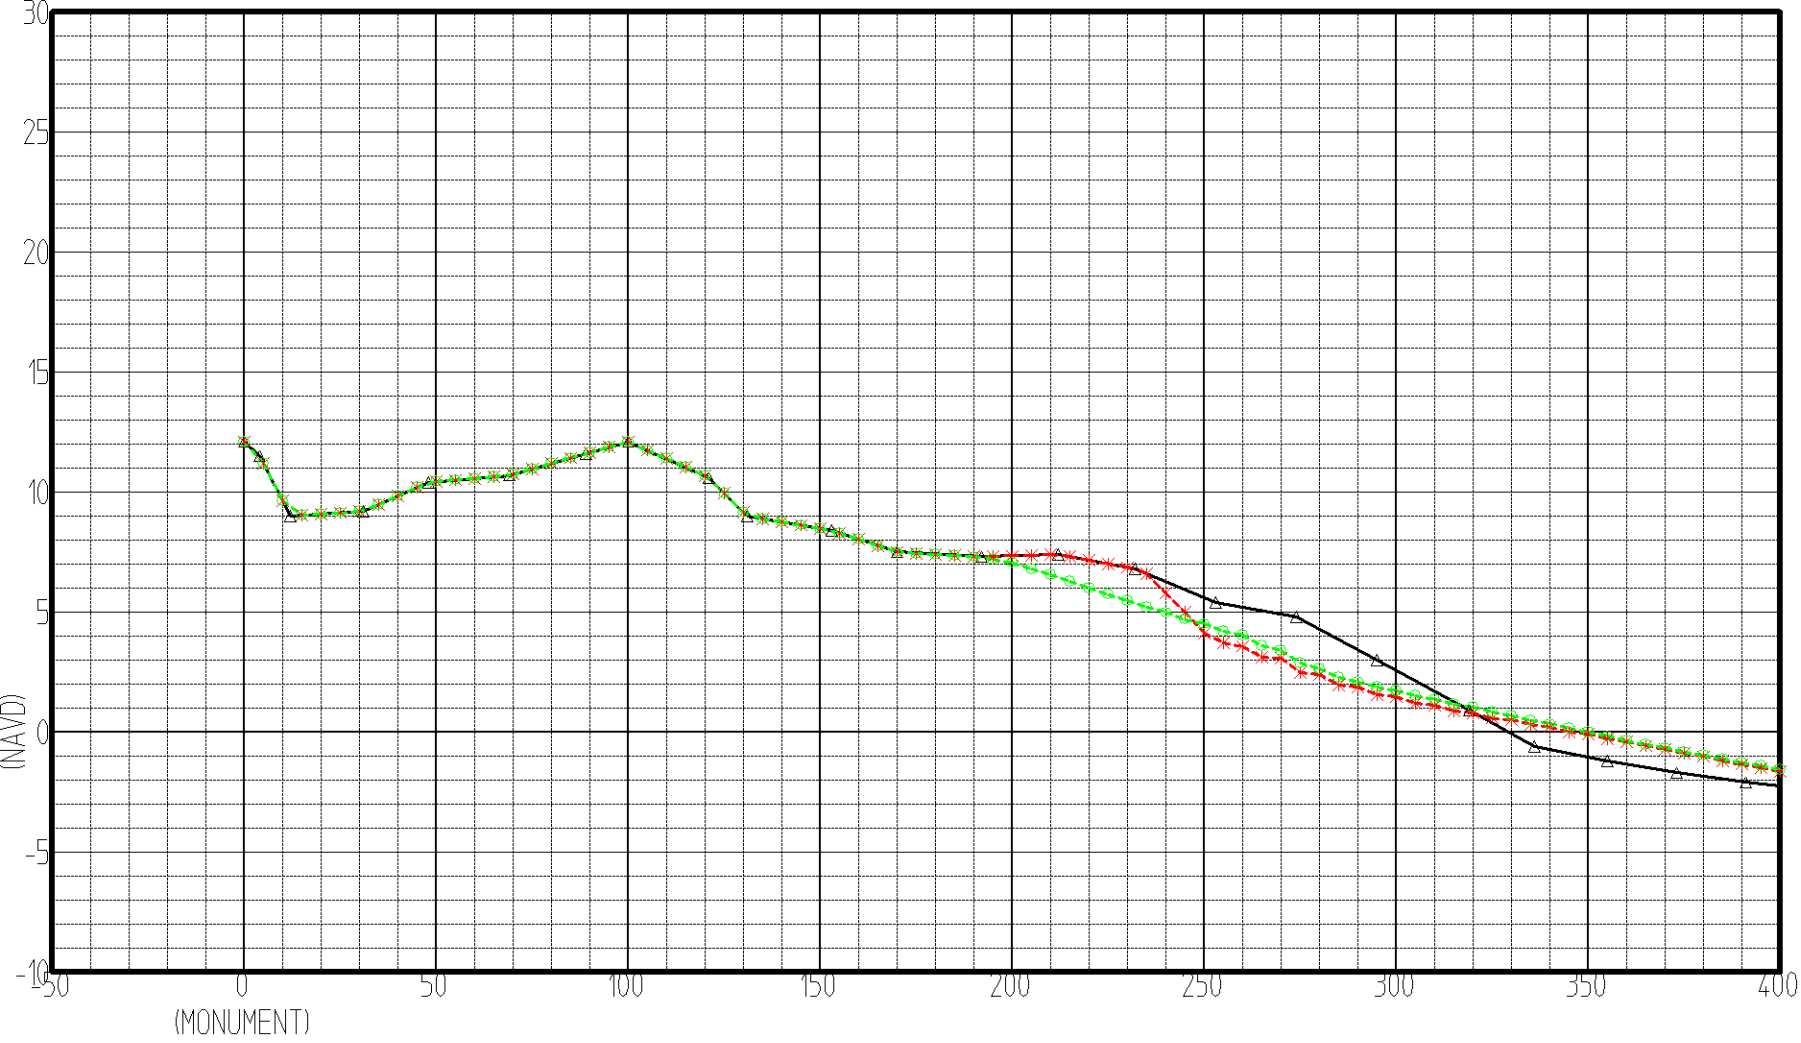
Range: R-25

BEACH PROFILE

- △—△— 2005-2008 INPUT PRF
- - * - - * - - 15-YR SBEACH ERODED PRF
- - o - - o - - 25-YR SBEACH ERODED PRF
