Appendix XI

SBEACH 15 and 25 yr. Storm Erosion Profiles

Brevard County

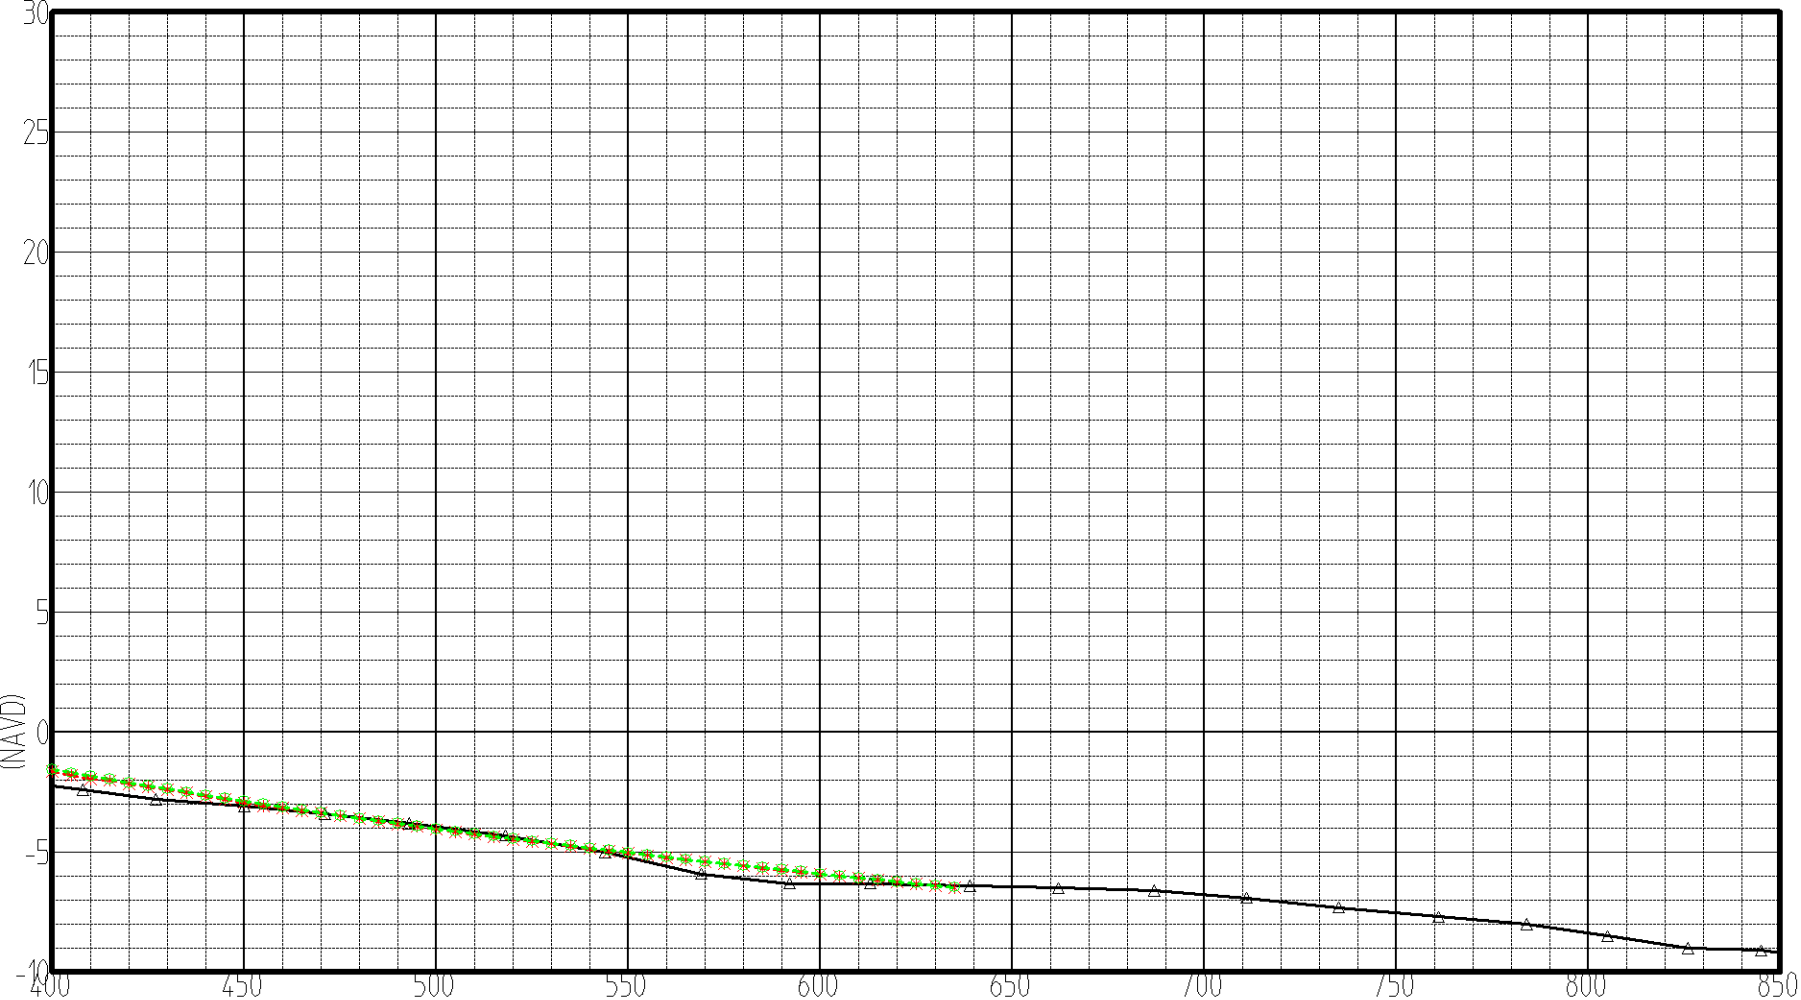
Range: R-25 2/3

BEACH PROFILE

—△—△— 2005-2008 INPUT PRF
 - - * - - * - - 15-YR SBEACH ERODED PRF
 - - o - - o - - 25-YR SBEACH ERODED PRF

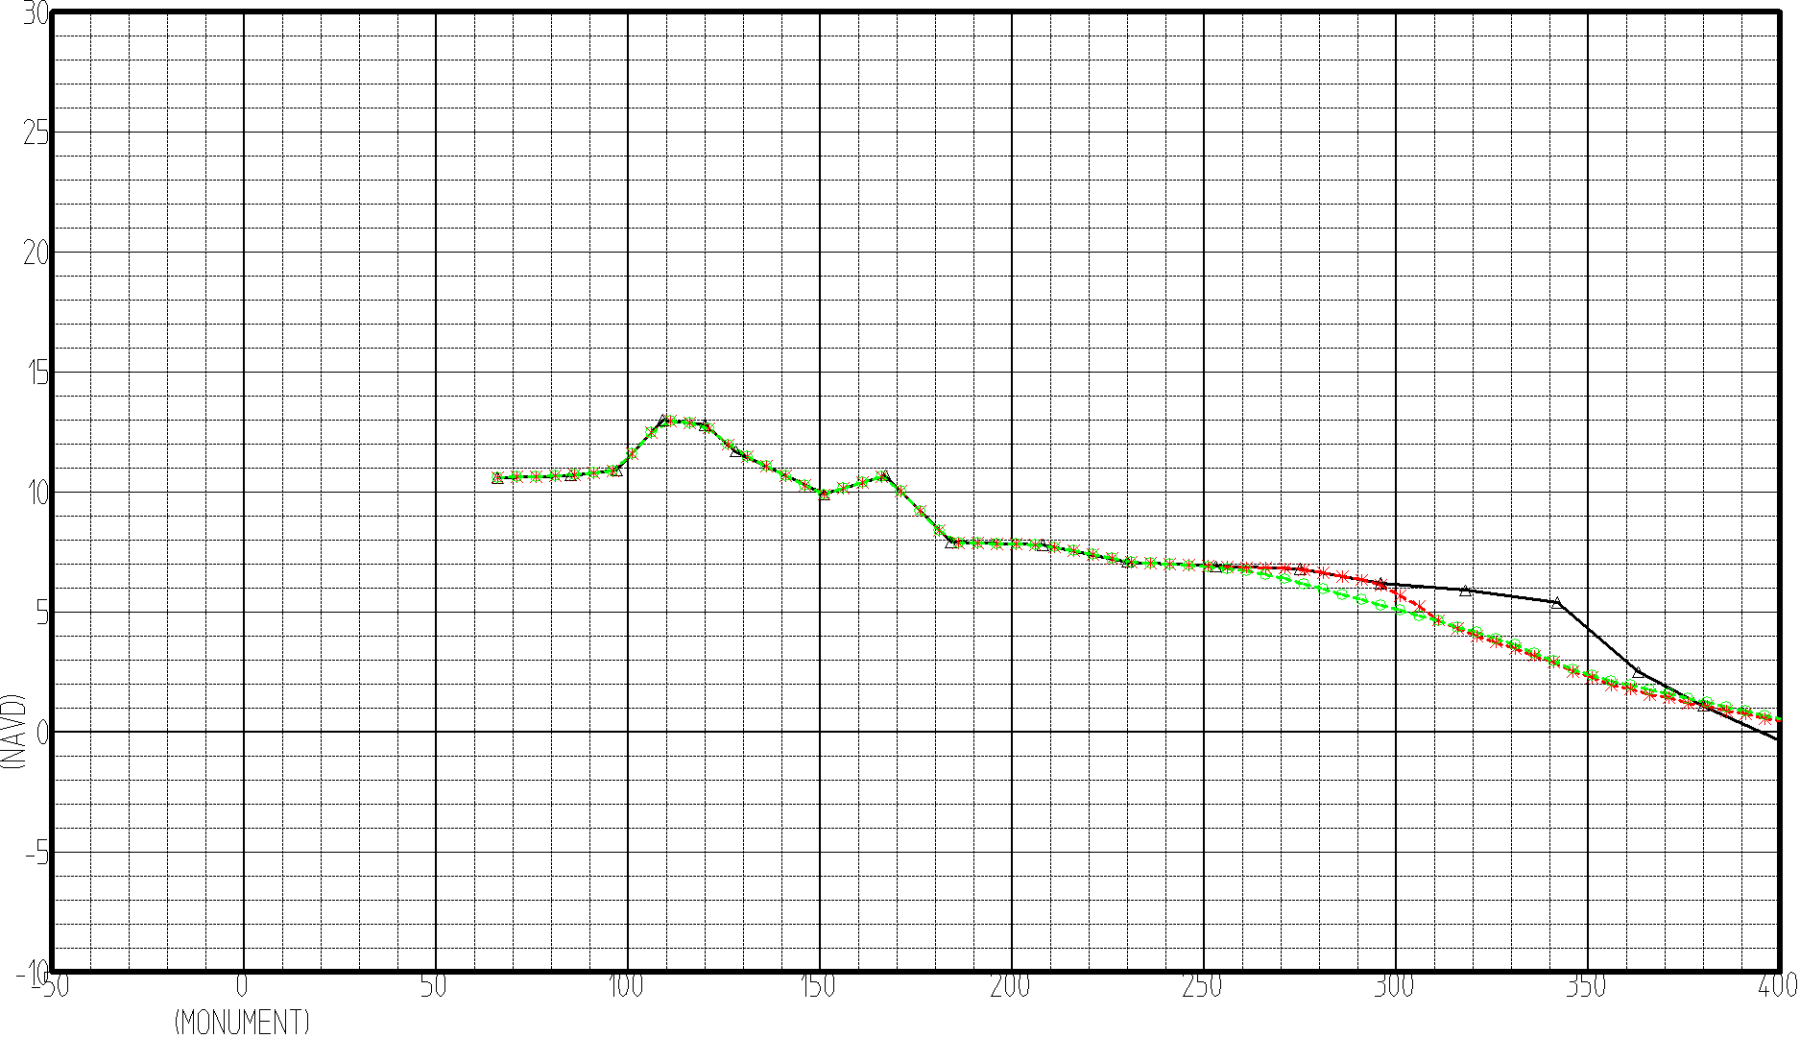
Range: R-26
 BEARING: 90.00
 1/3

BEACH PROFILE
 —△—△— 2005-2008 INPUT PRF
 - - * - - * - - 15-YR SBEACH ERODED PRF
 - - o - - o - - 25-YR SBEACH ERODED PRF

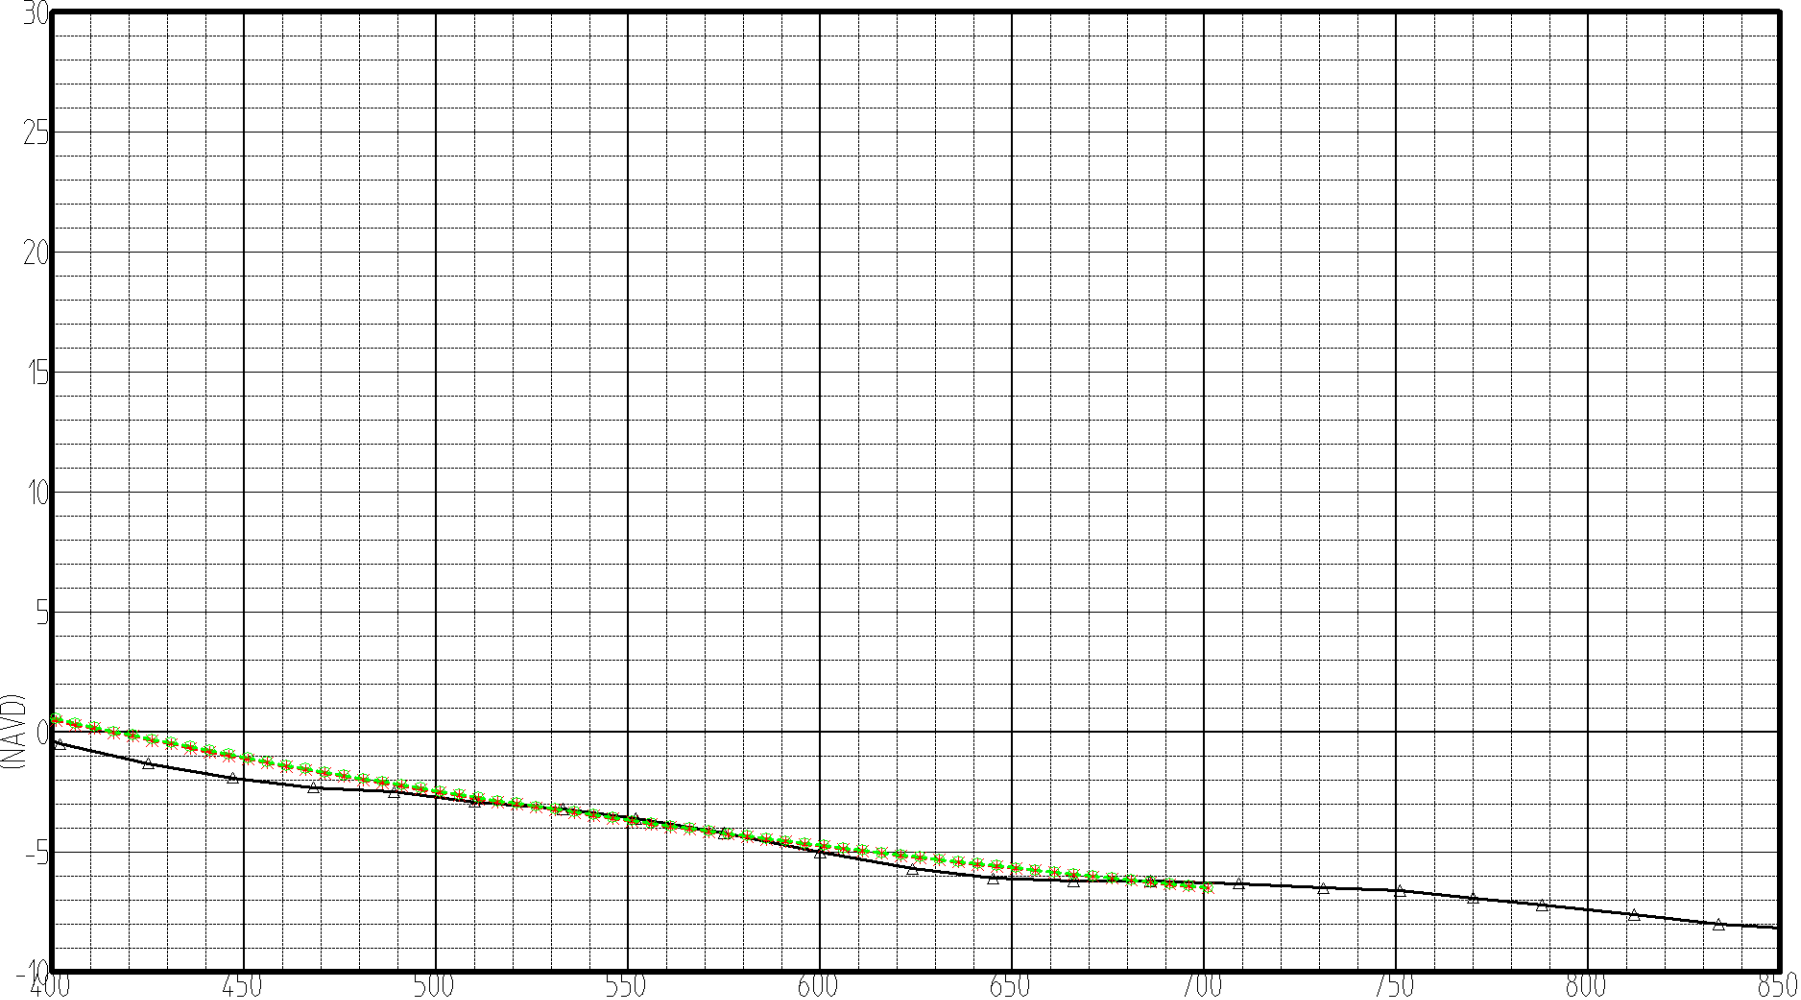
Range: R-26

BEACH PROFILE

—△—△— 2005-2008 INPUT PRF

- - - * - - - 15-YR SBEACH ERODED PRF

- - - o - - - 25-YR SBEACH ERODED PRF

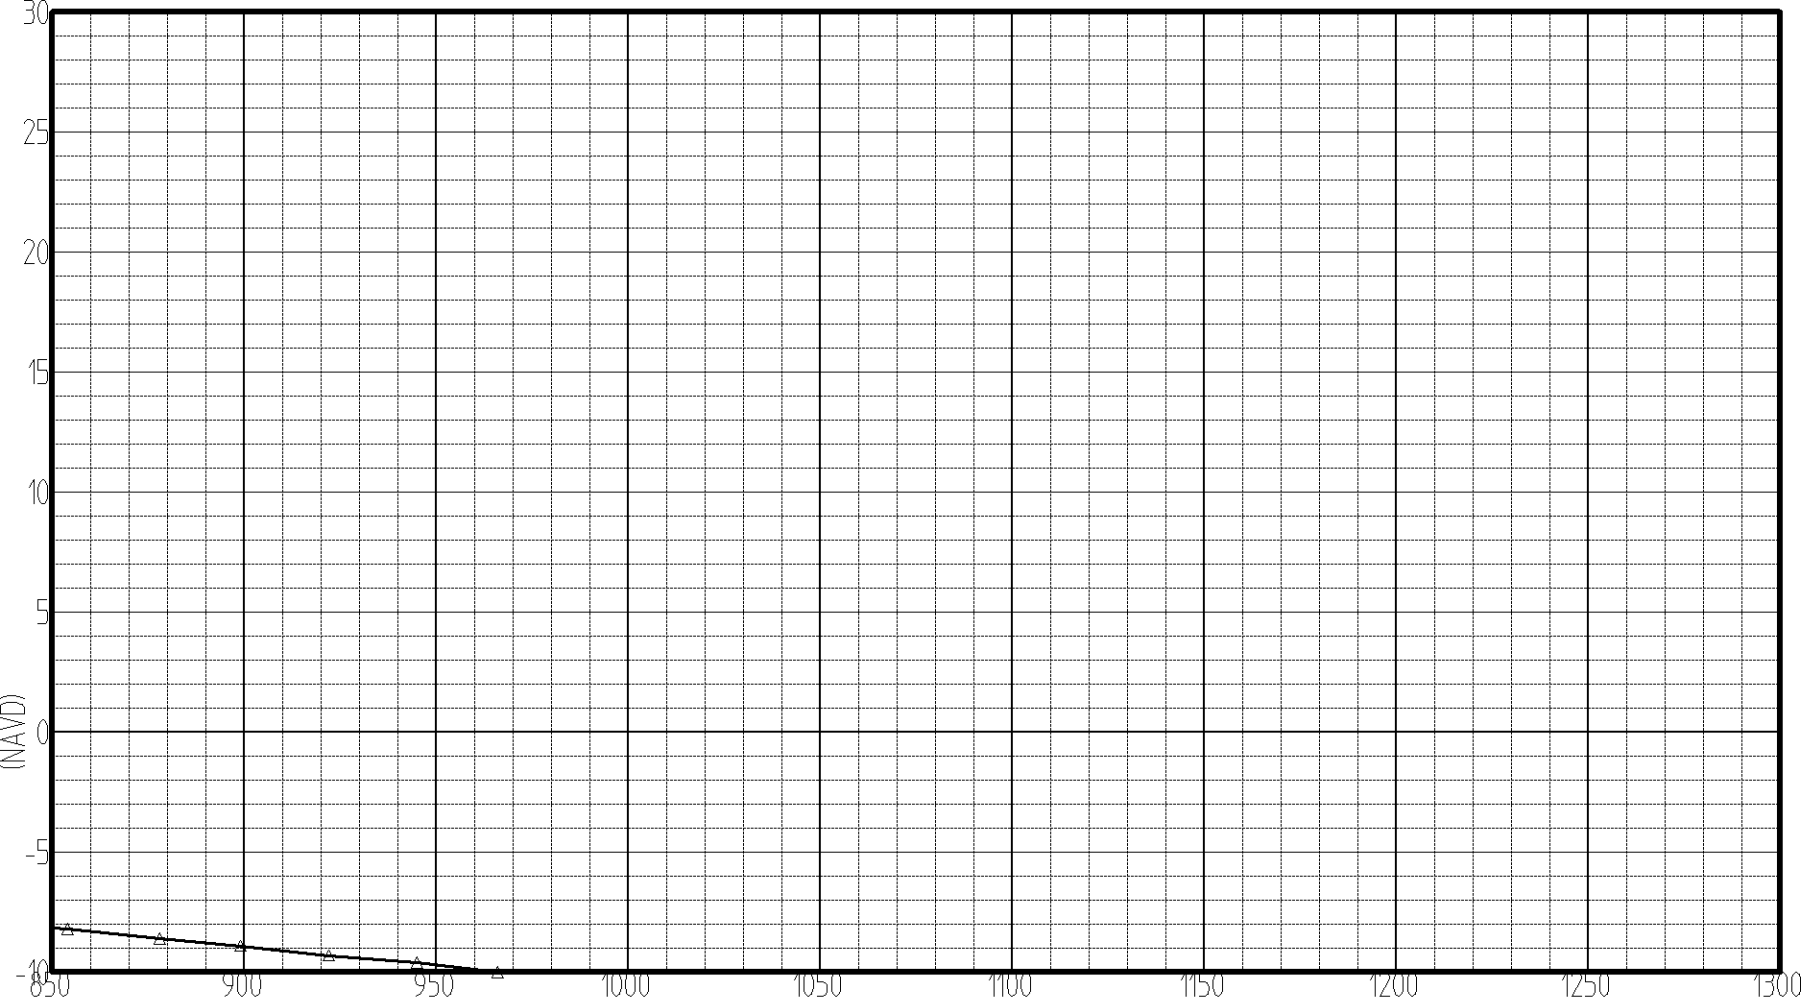
Range: R-26
 BEARING: 90.00
 3/3

BEACH PROFILE
 —△—△— 2005-2008 INPUT PRF
 - - - * - - - 15-YR SBEACH ERODED PRF
 - - - o - - - 25-YR SBEACH ERODED PRF

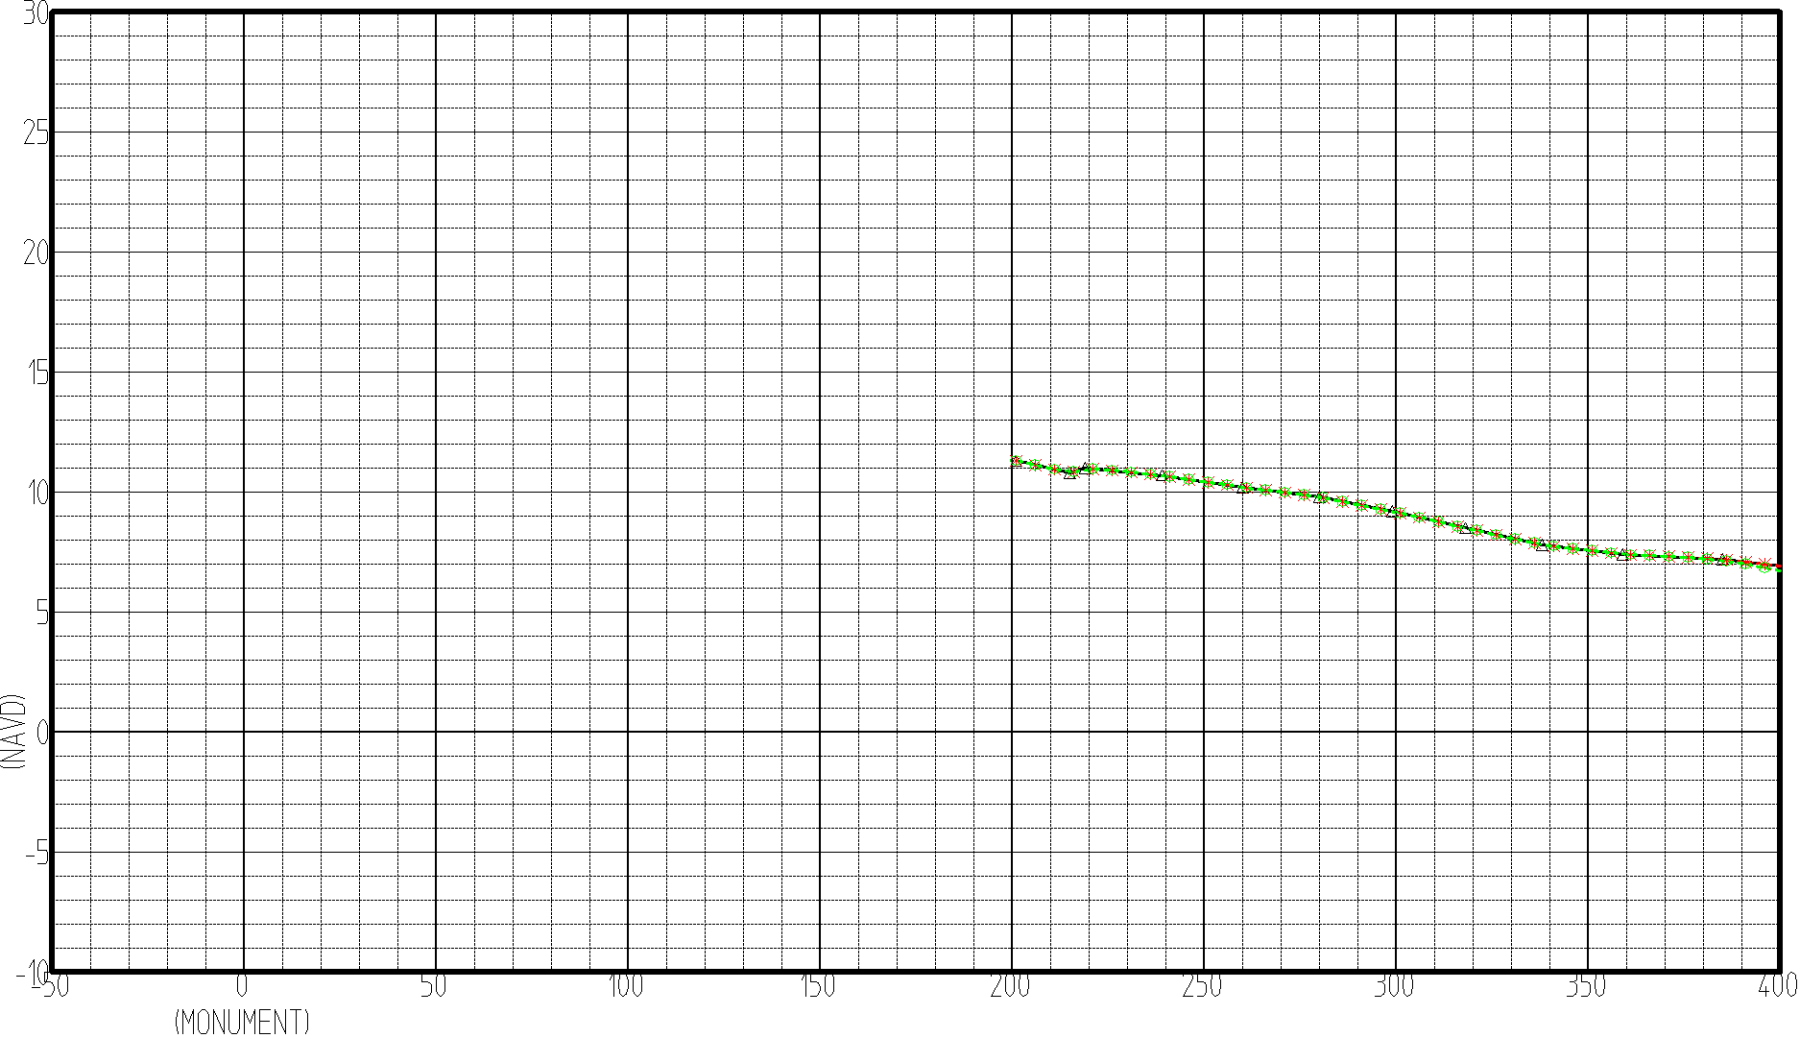
Range: R-28-T
 BEARING: 90.00
 1/3

BEACH PROFILE
 —△—△— 2005-2008 INPUT PRF
 - - * - - * - - 15-YR SBEACH ERODED PRF
 - - o - - o - - 25-YR SBEACH ERODED PRF

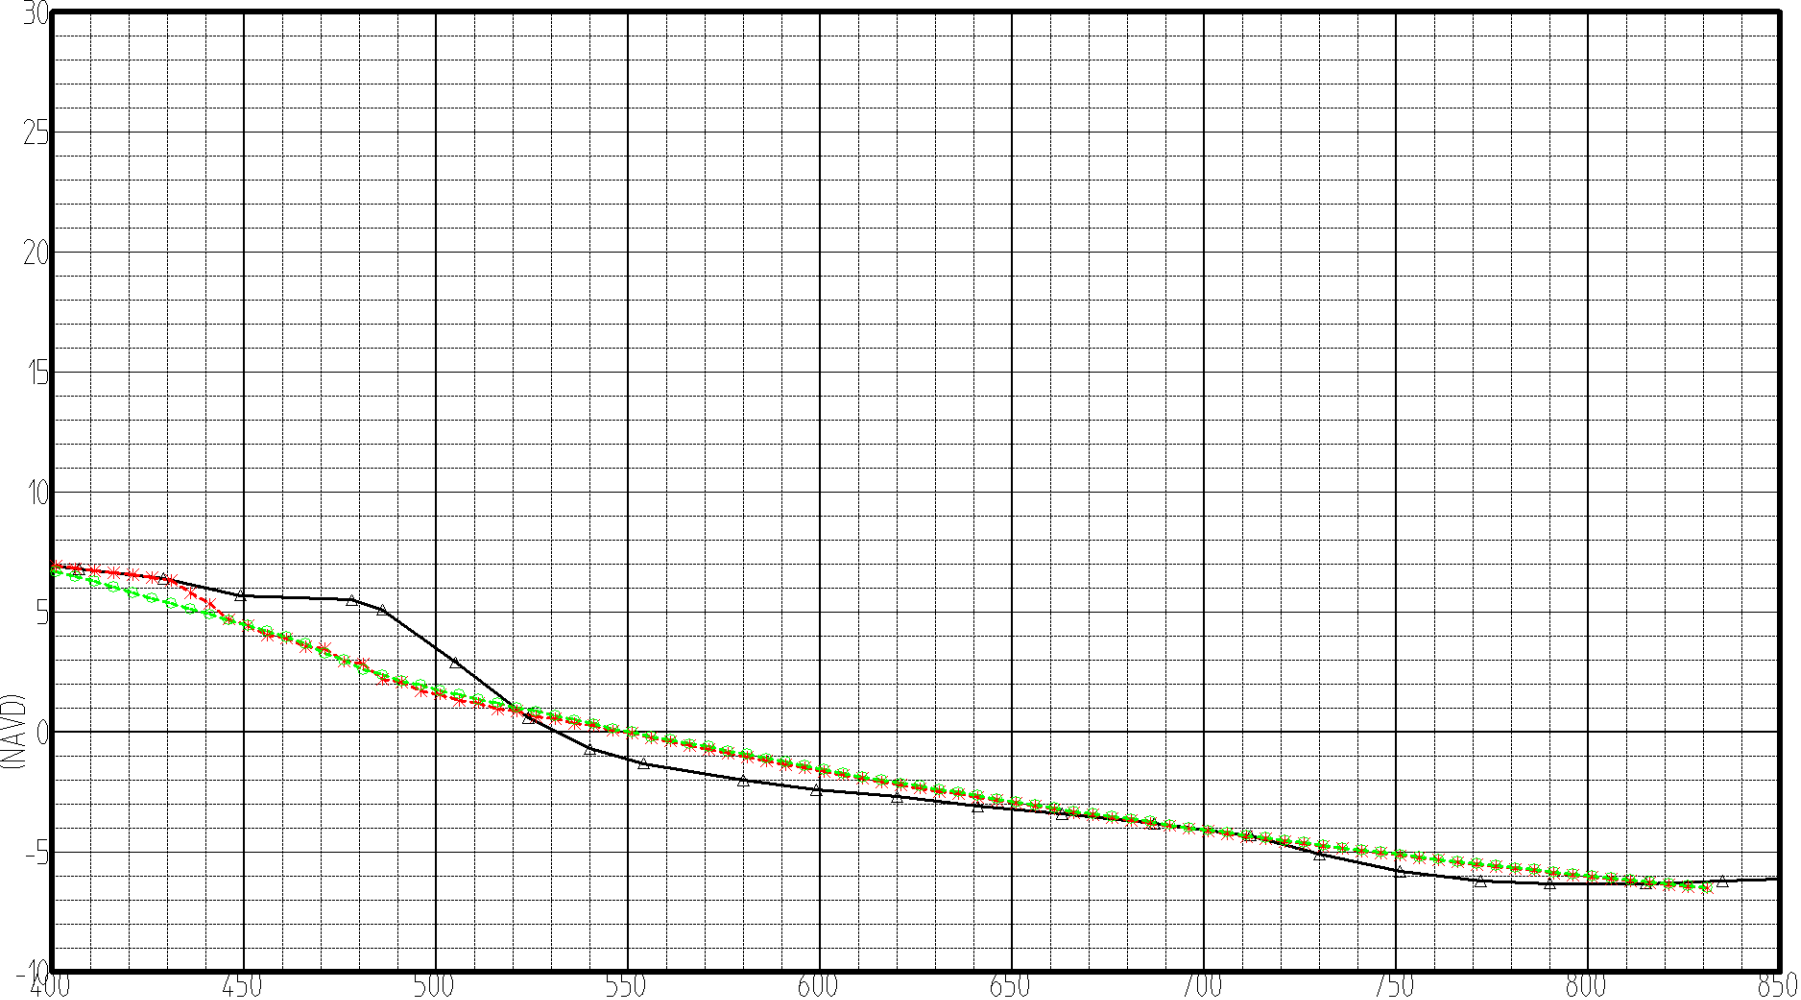
Range: R-28-T 2/3
 BEARING: 90.00

BEACH PROFILE
 —△—△— 2005-2008 INPUT PRF
 - - * - - * - - 15-YR SBEACH ERODED PRF
 - - o - - o - - 25-YR SBEACH ERODED PRF

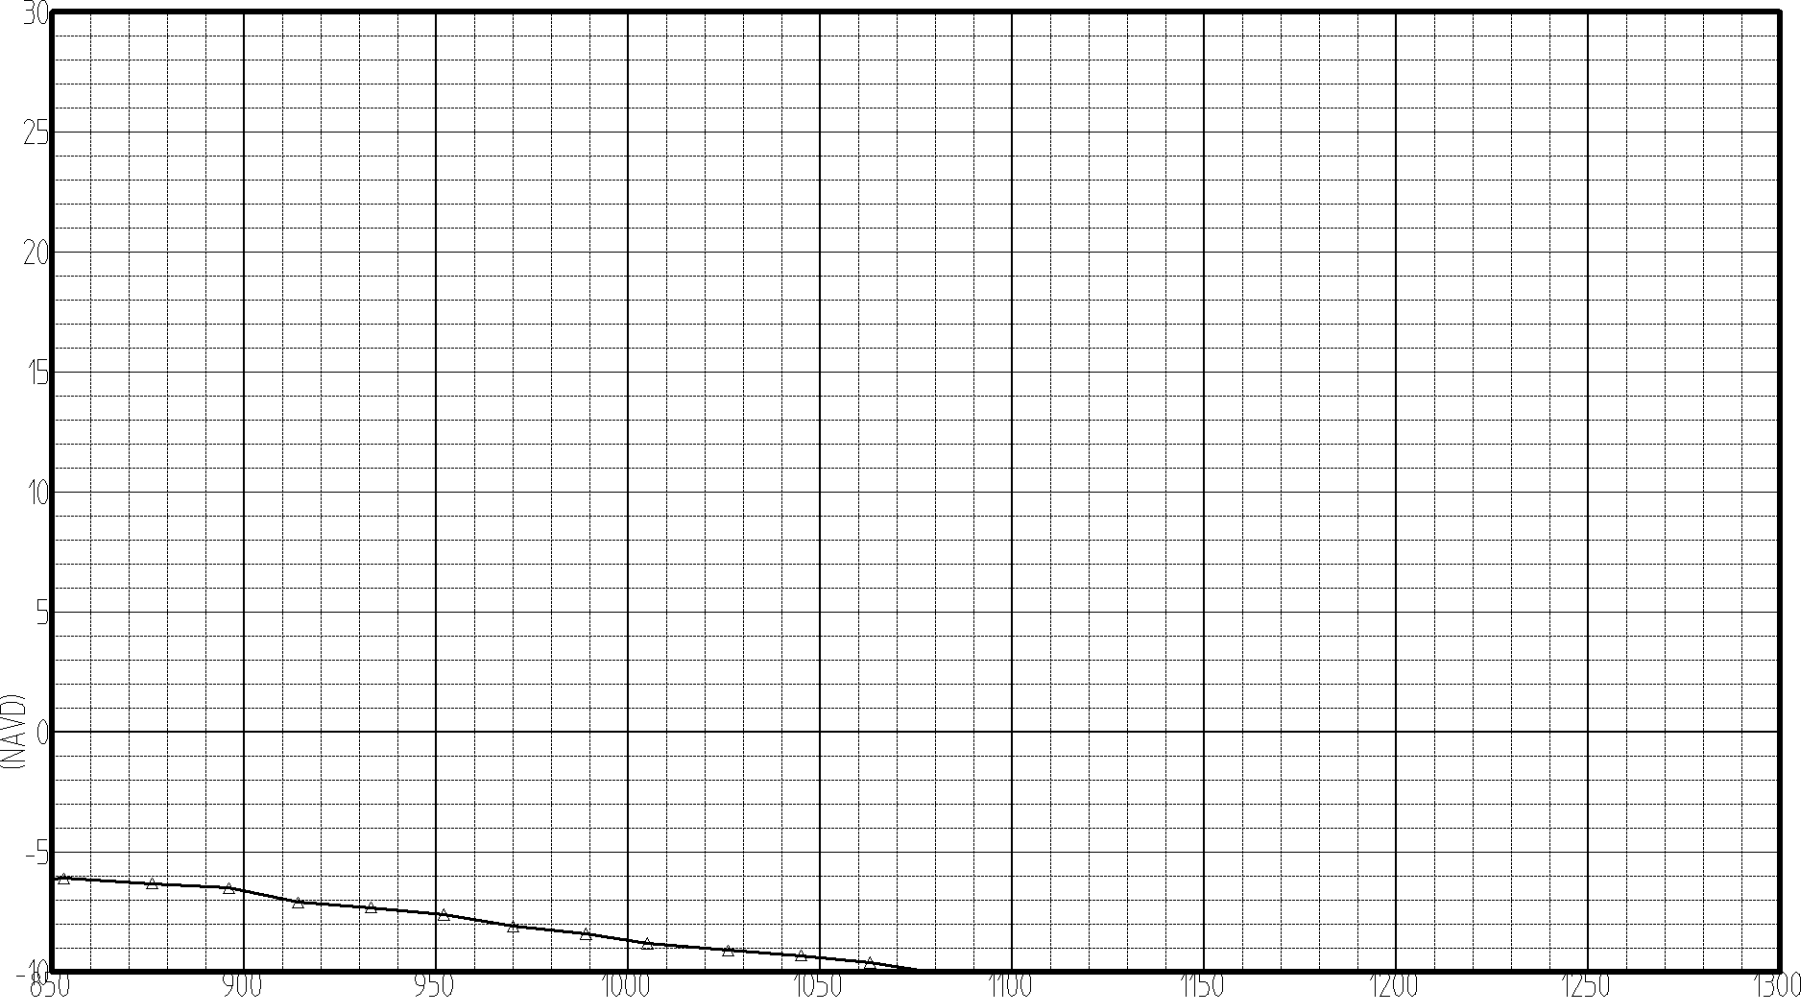
Range: R-28-T

BEACH PROFILE

—△—△— 2005-2008 INPUT PRF

- - - * - - - 15-YR SBEACH ERODED PRF

- - - o - - - 25-YR SBEACH ERODED PRF

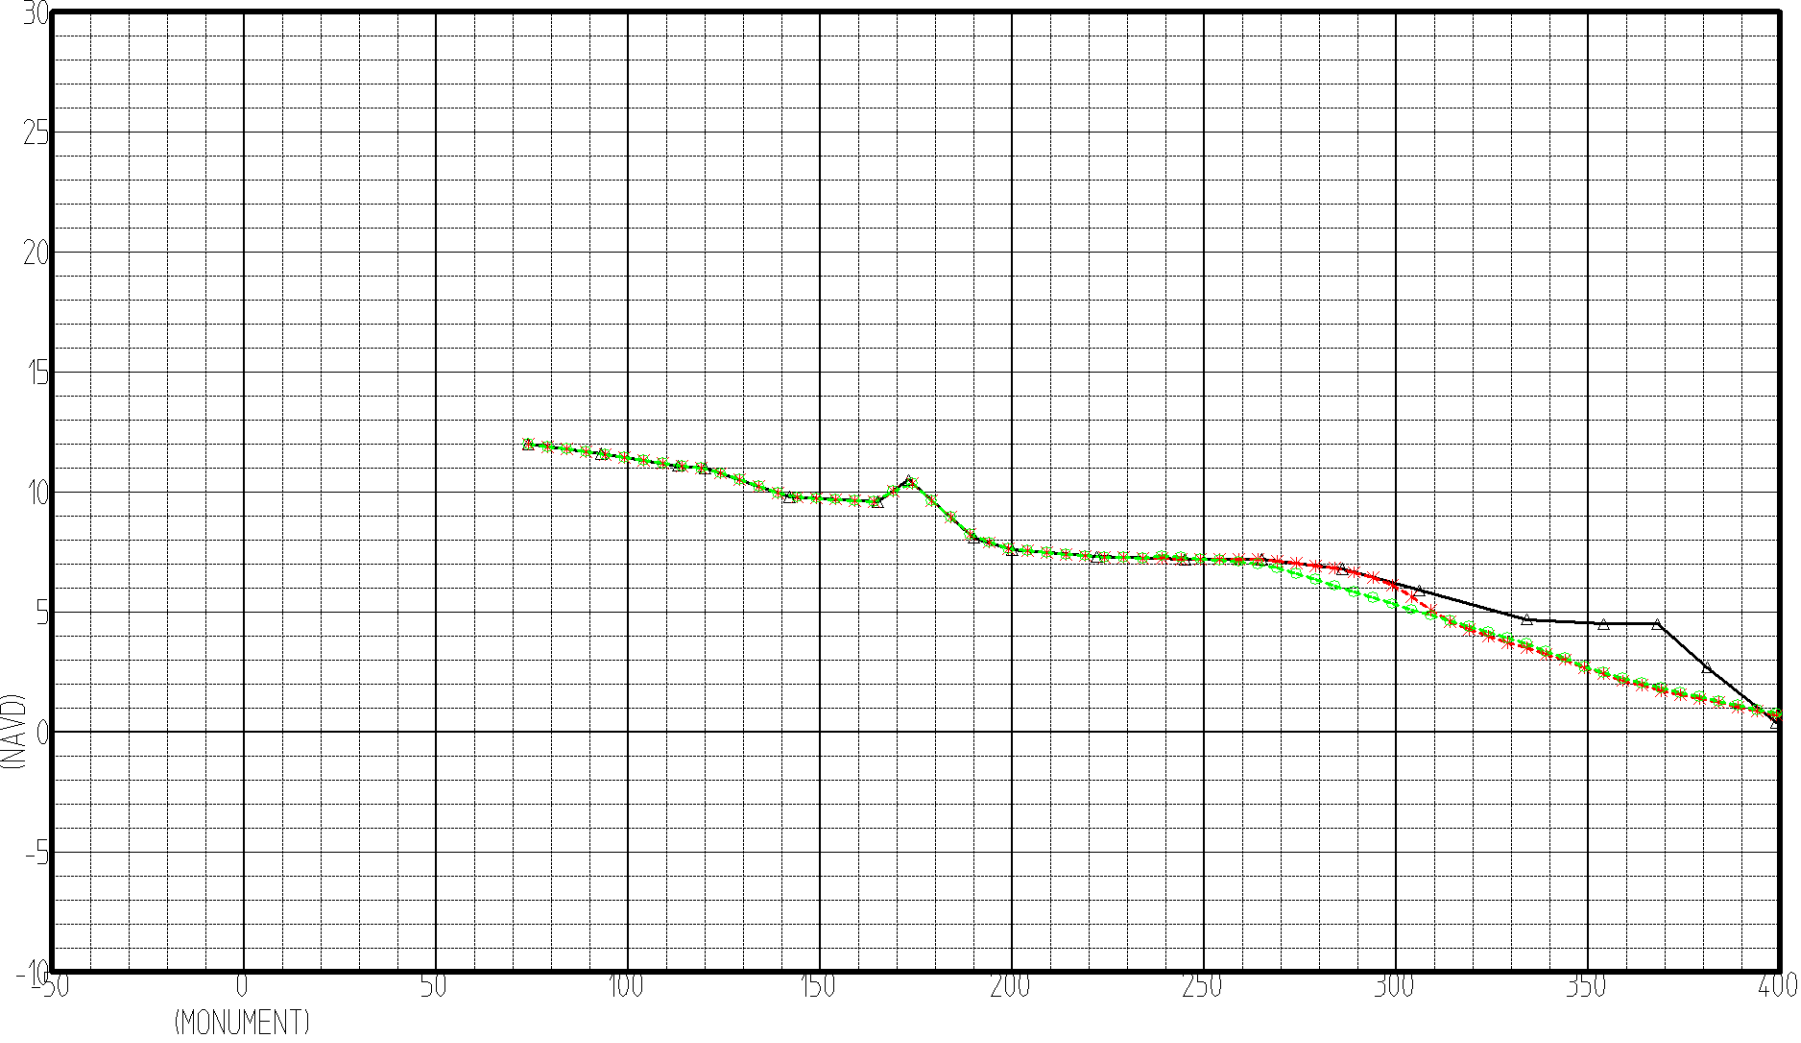
Range: R-29-T 1/3

BEACH PROFILE

—△—△— 2005-2008 INPUT PRF

- - - * - - - 15-YR SBEACH ERODED PRF

- - - o - - - 25-YR SBEACH ERODED PRF

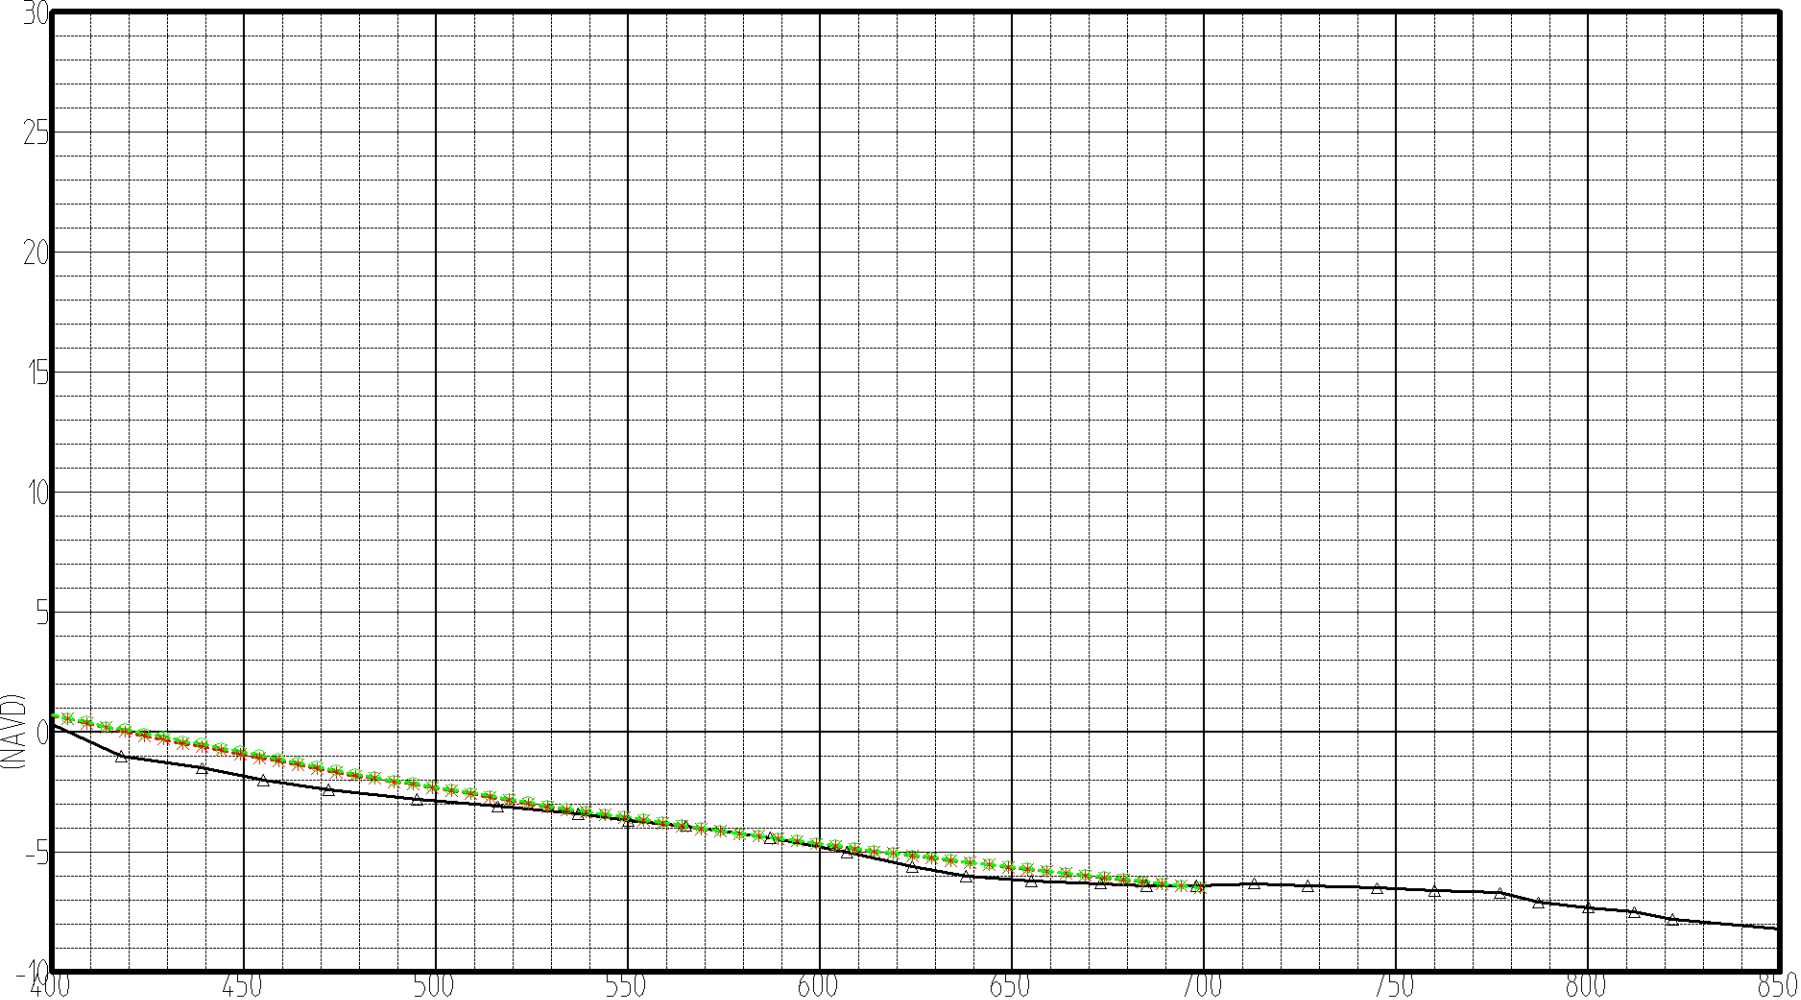
Range: R-29-T

BEACH PROFILE

—△—△— 2005-2008 INPUT PRF

- - - * - - - 15-YR SBEACH ERODED PRF

- - - o - - - 25-YR SBEACH ERODED PRF

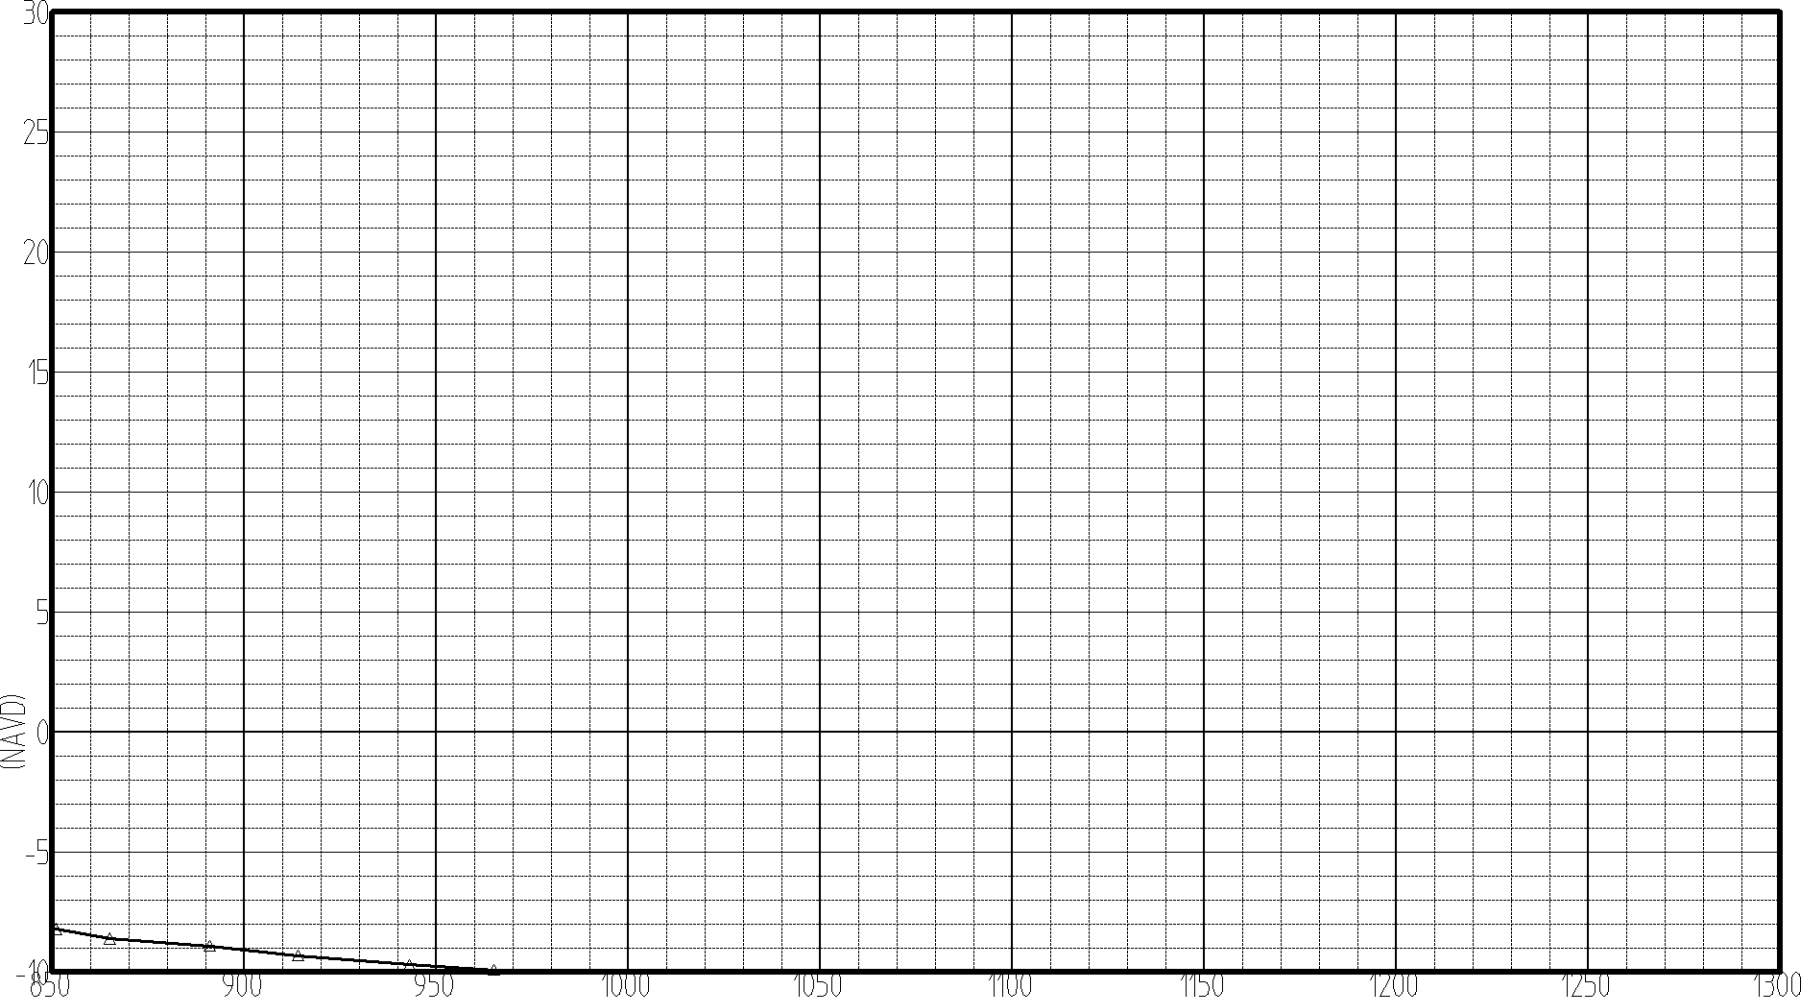
Range: R-29-T 3/3
 BEARING: 90.00

BEACH PROFILE
 —△—△— 2005-2008 INPUT PRF
 - - * - - * - - 15-YR SBEACH ERODED PRF
 - - o - - o - - 25-YR SBEACH ERODED PRF

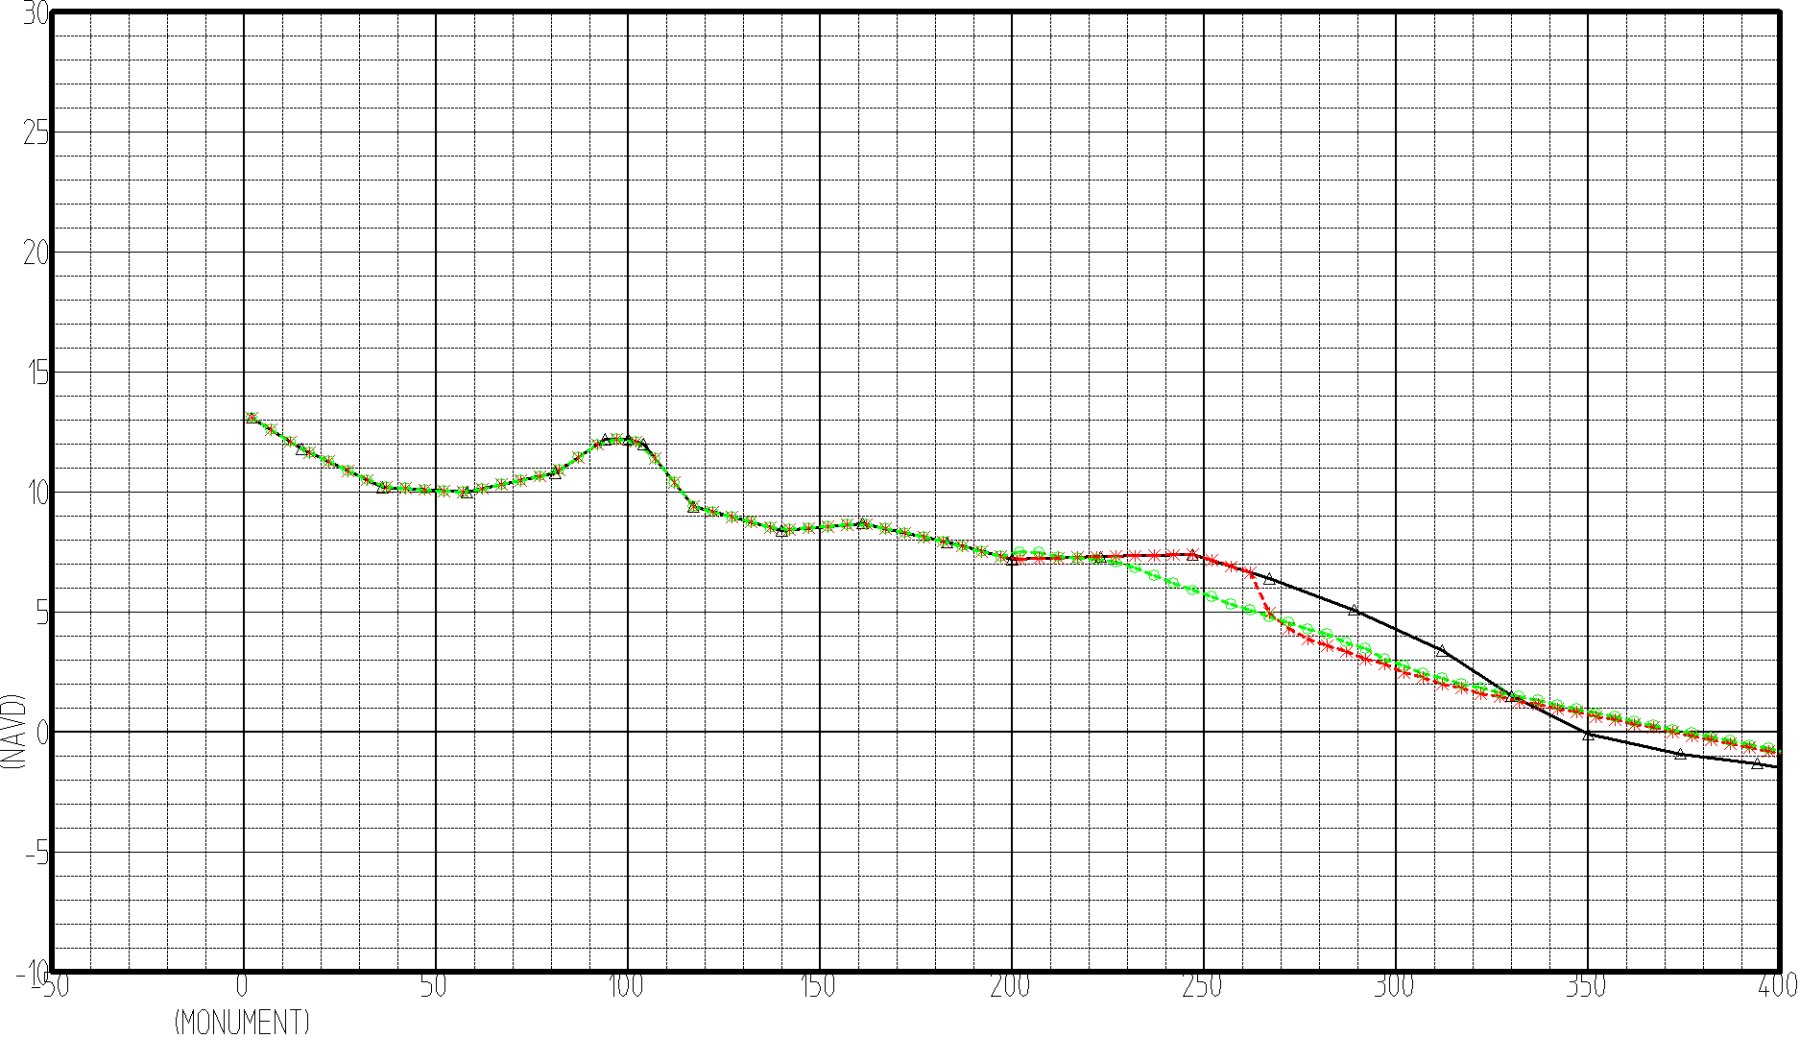
Range: R-30
 BEARING: 90.00
 1/3

BEACH PROFILE
 —△—△— 2005-2008 INPUT PRF
 - - * - - * - - 15-YR SBEACH ERODED PRF
 - - o - - o - - 25-YR SBEACH ERODED PRF

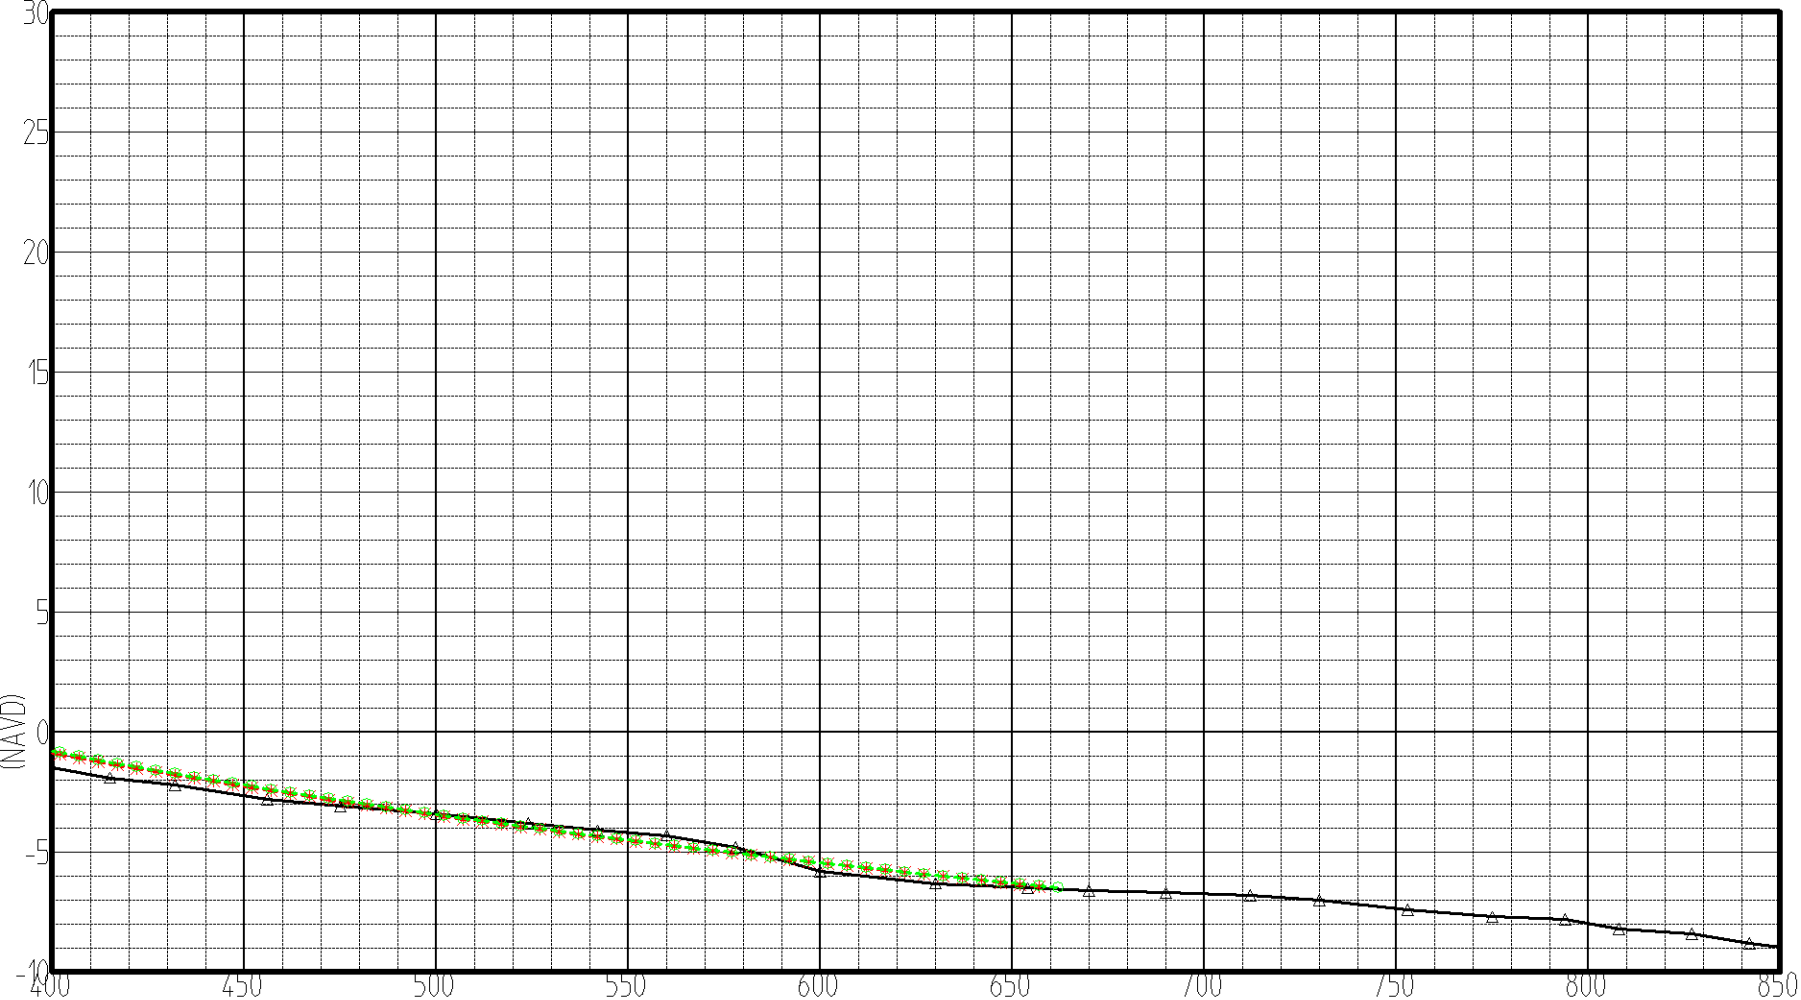
Range: R-30

BEACH PROFILE

—△—△— 2005-2008 INPUT PRF

- - - * - - - 15-YR SBEACH ERODED PRF

- - - o - - - 25-YR SBEACH ERODED PRF
