Appendix XI

SBEACH 15 and 25 yr. Storm Erosion Profiles

Brevard County

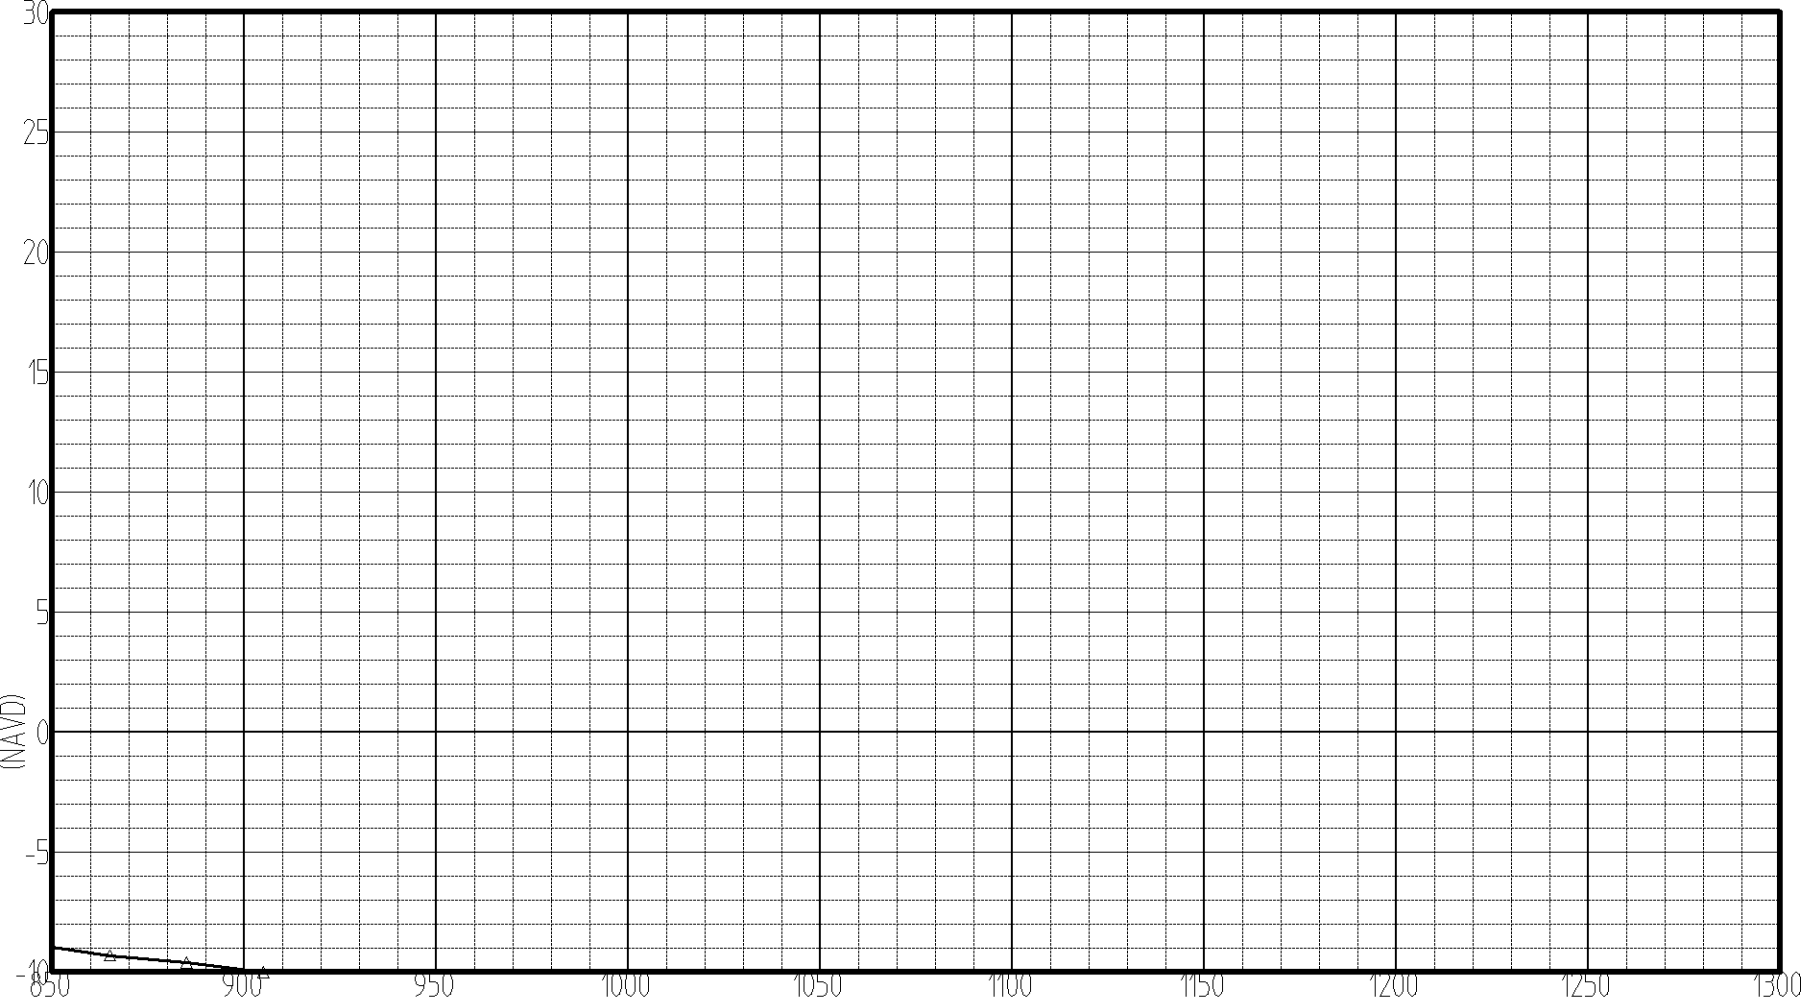
Range: R-30

BEACH PROFILE

—△—△— 2005-2008 INPUT PRF

- - - * - - - 15-YR SBEACH ERODED PRF

- - - o - - - 25-YR SBEACH ERODED PRF

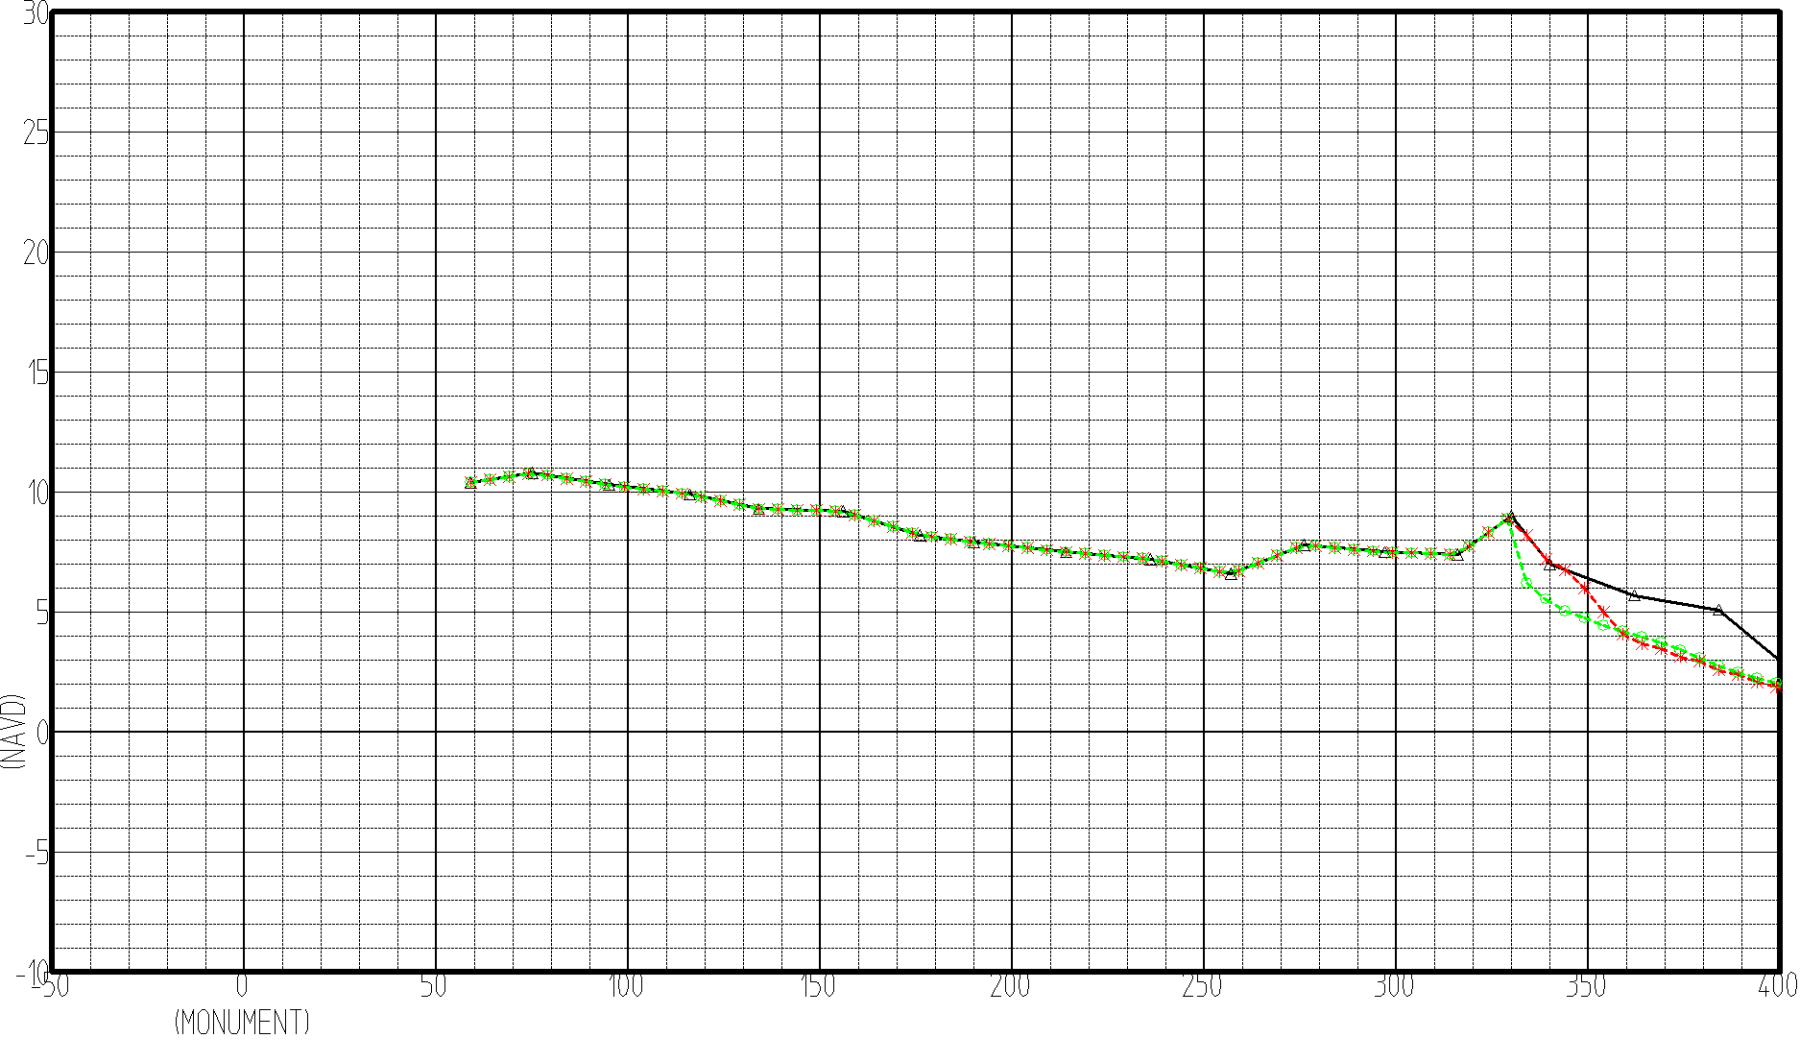
Range: R-31

BEACH PROFILE

—△—△— 2005-2008 INPUT PRF

- - * - - * - - 15-YR SBEACH ERODED PRF

- - ○ - - ○ - - 25-YR SBEACH ERODED PRF

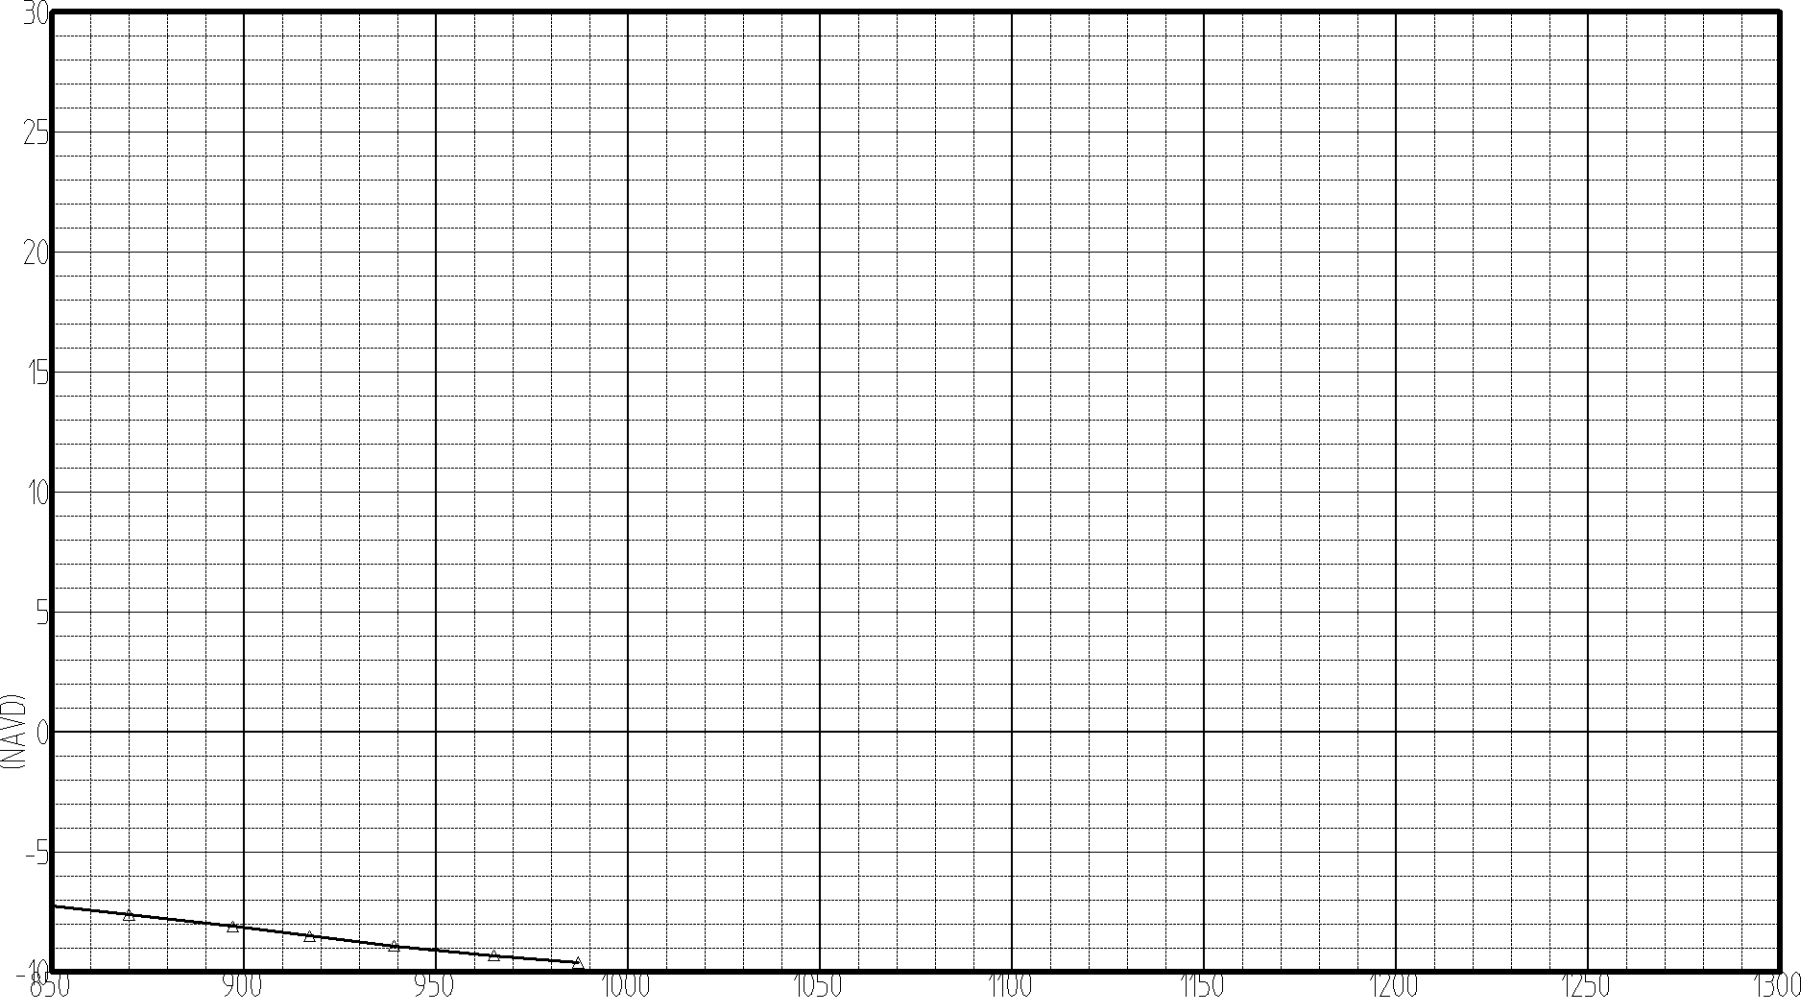
Range: R-31

BEACH PROFILE

—△—△— 2005-2008 INPUT PRF

- - - * - - - 15-YR SBEACH ERODED PRF

- - - o - - - 25-YR SBEACH ERODED PRF

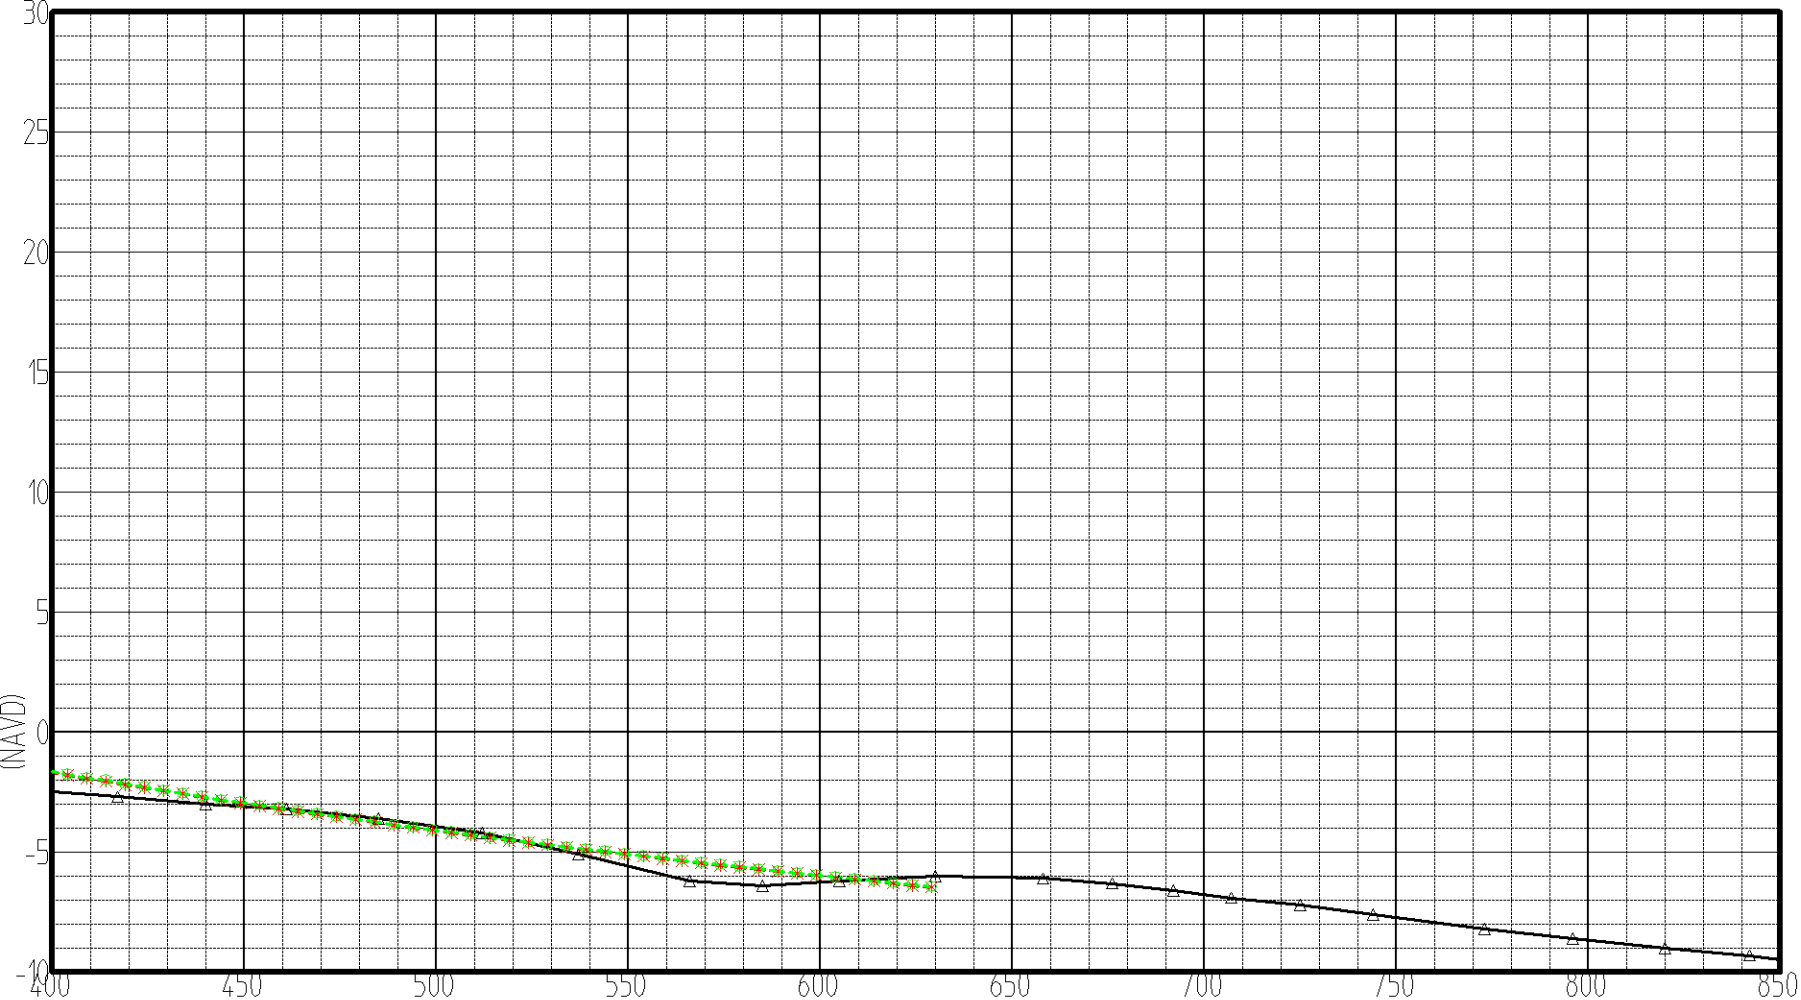
Range: R-32

BEACH PROFILE

—△—△— 2005-2008 INPUT PRF

- - - * - - - 15-YR SBEACH ERODED PRF

- - - o - - - 25-YR SBEACH ERODED PRF

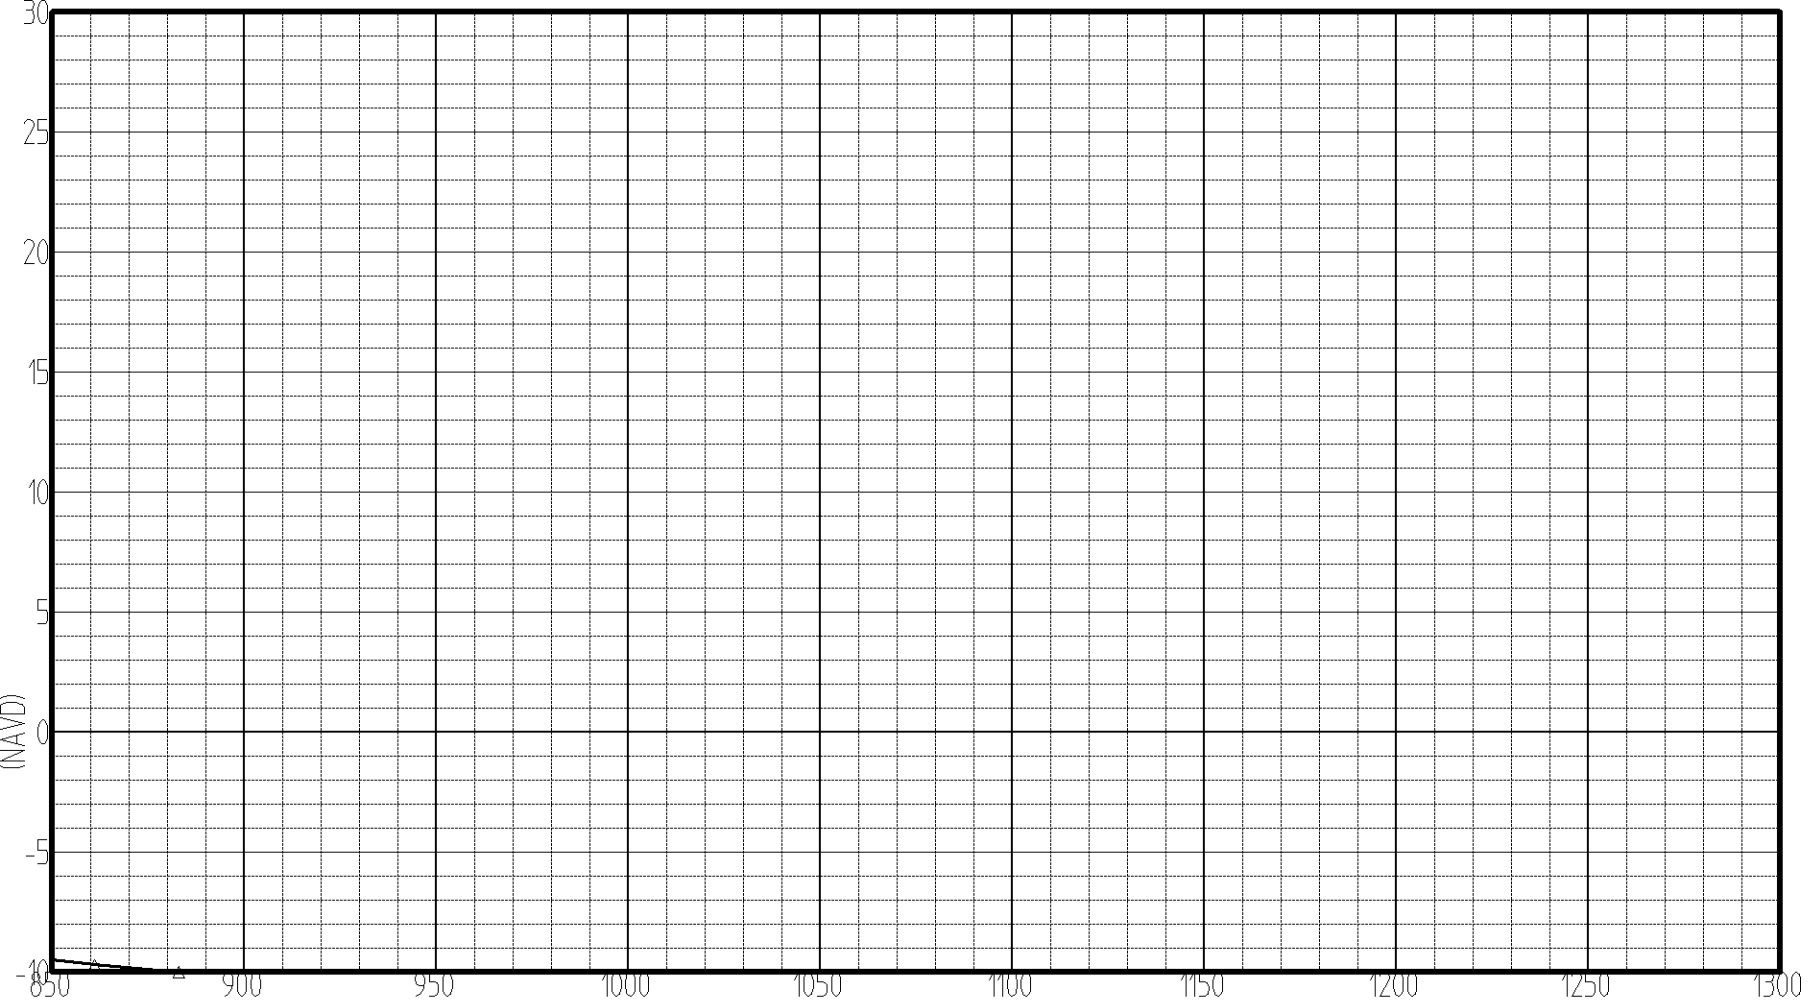
Range: R-32 3/3

BEACH PROFILE

- △—△— 2005-2008 INPUT PRF
- - - * - - - 15-YR SBEACH ERODED PRF
- - - o - - - 25-YR SBEACH ERODED PRF

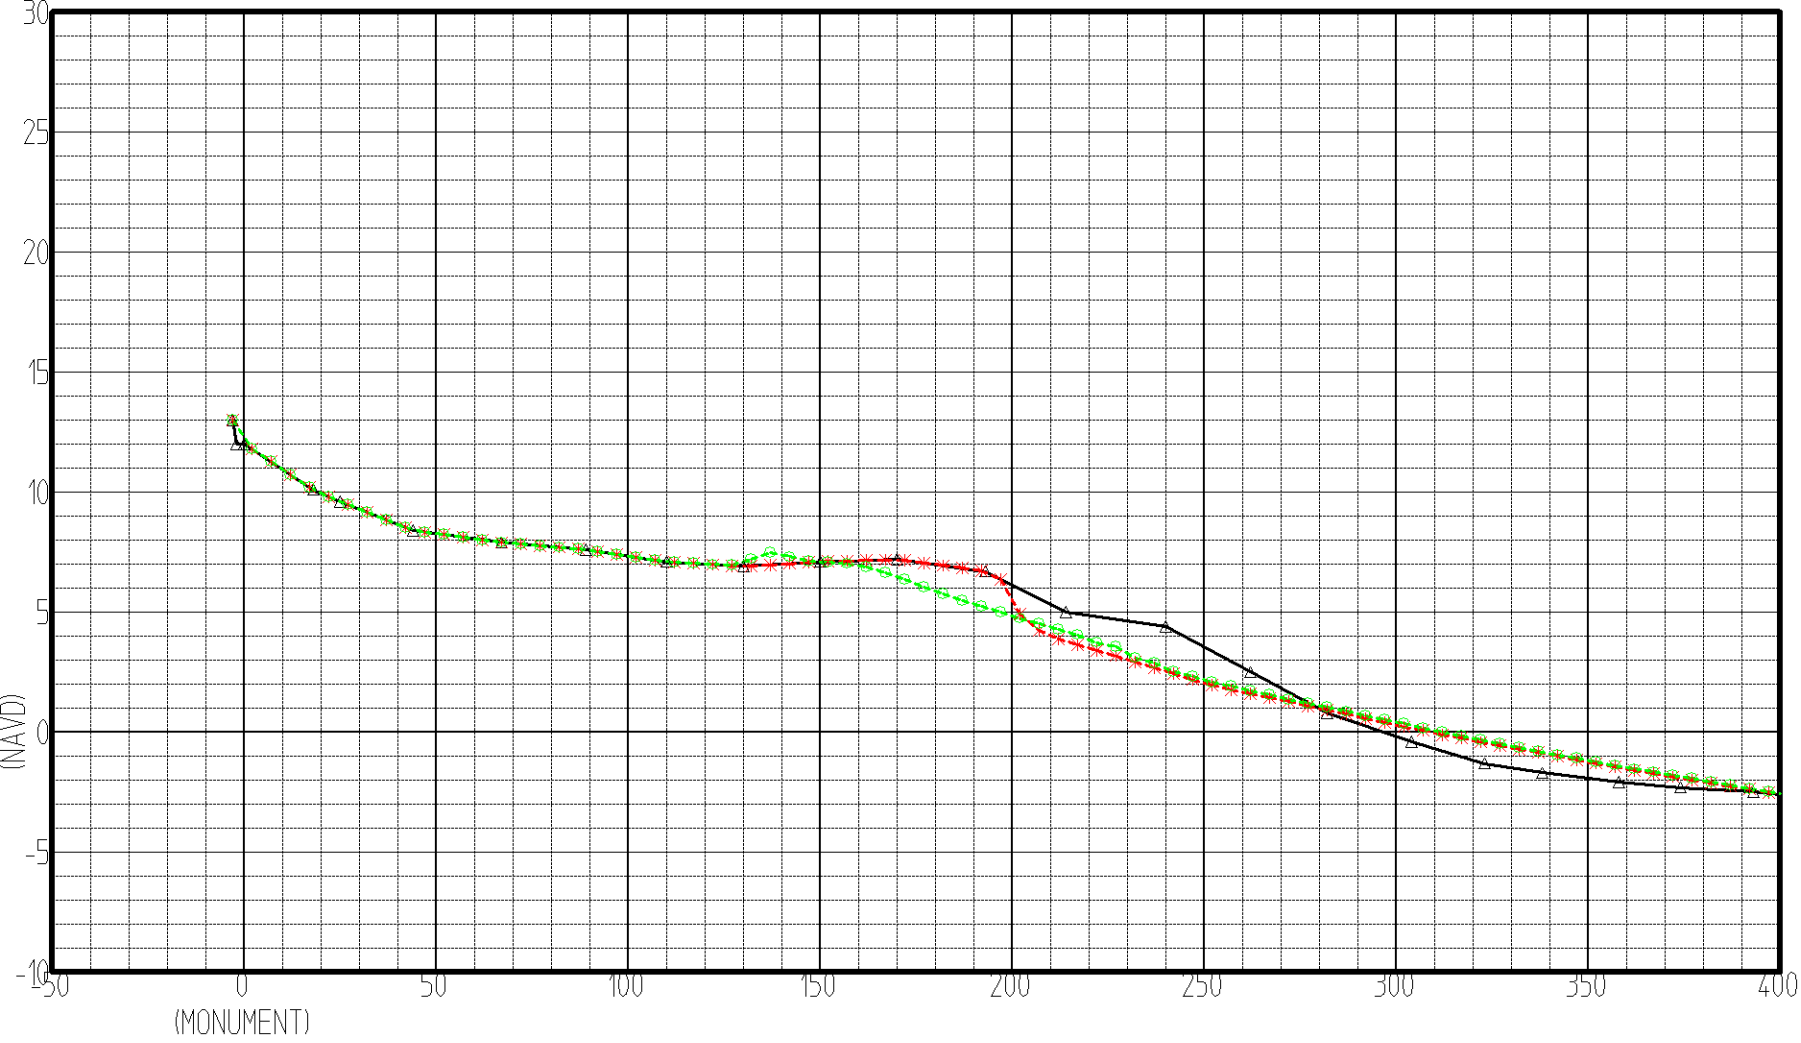
Range: R-33

BEACH PROFILE

—△—△— 2005-2008 INPUT PRF

- - * - - * - - 15-YR SBEACH ERODED PRF

- - o - - o - - 25-YR SBEACH ERODED PRF

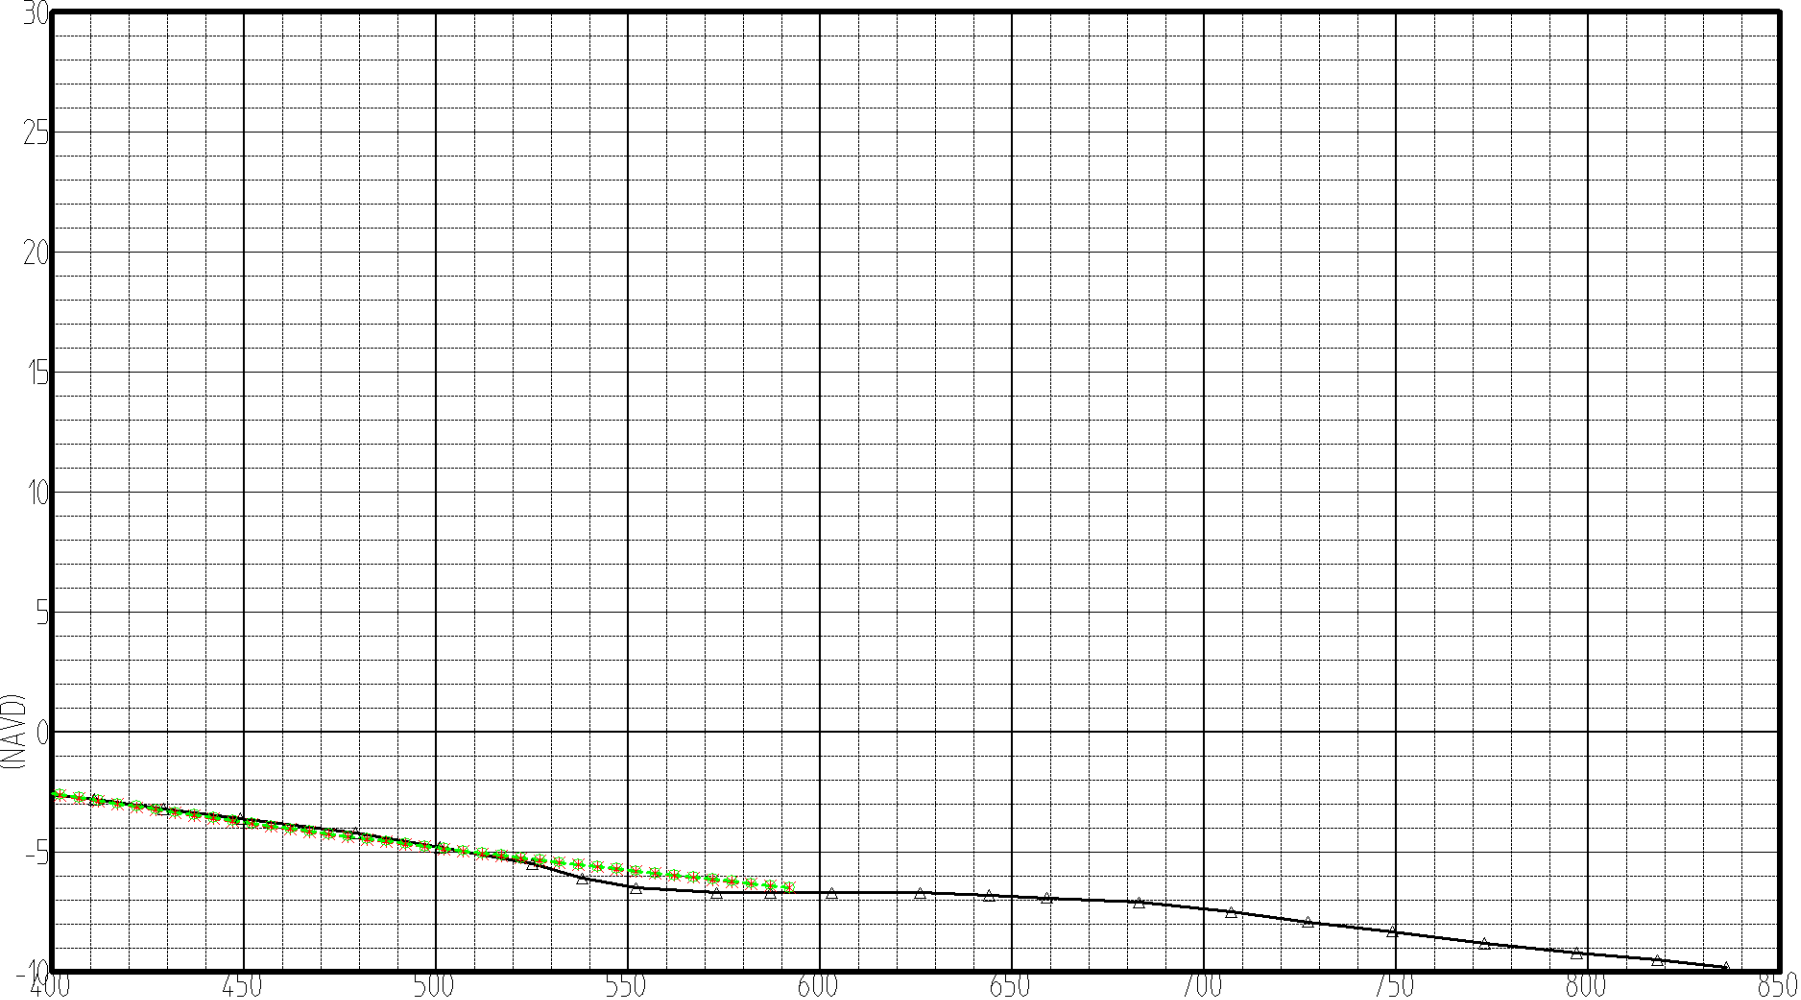
Range: R-33

BEACH PROFILE

—△—△— 2005-2008 INPUT PRF

- - - * - - - 15-YR SBEACH ERODED PRF

- - - o - - - 25-YR SBEACH ERODED PRF

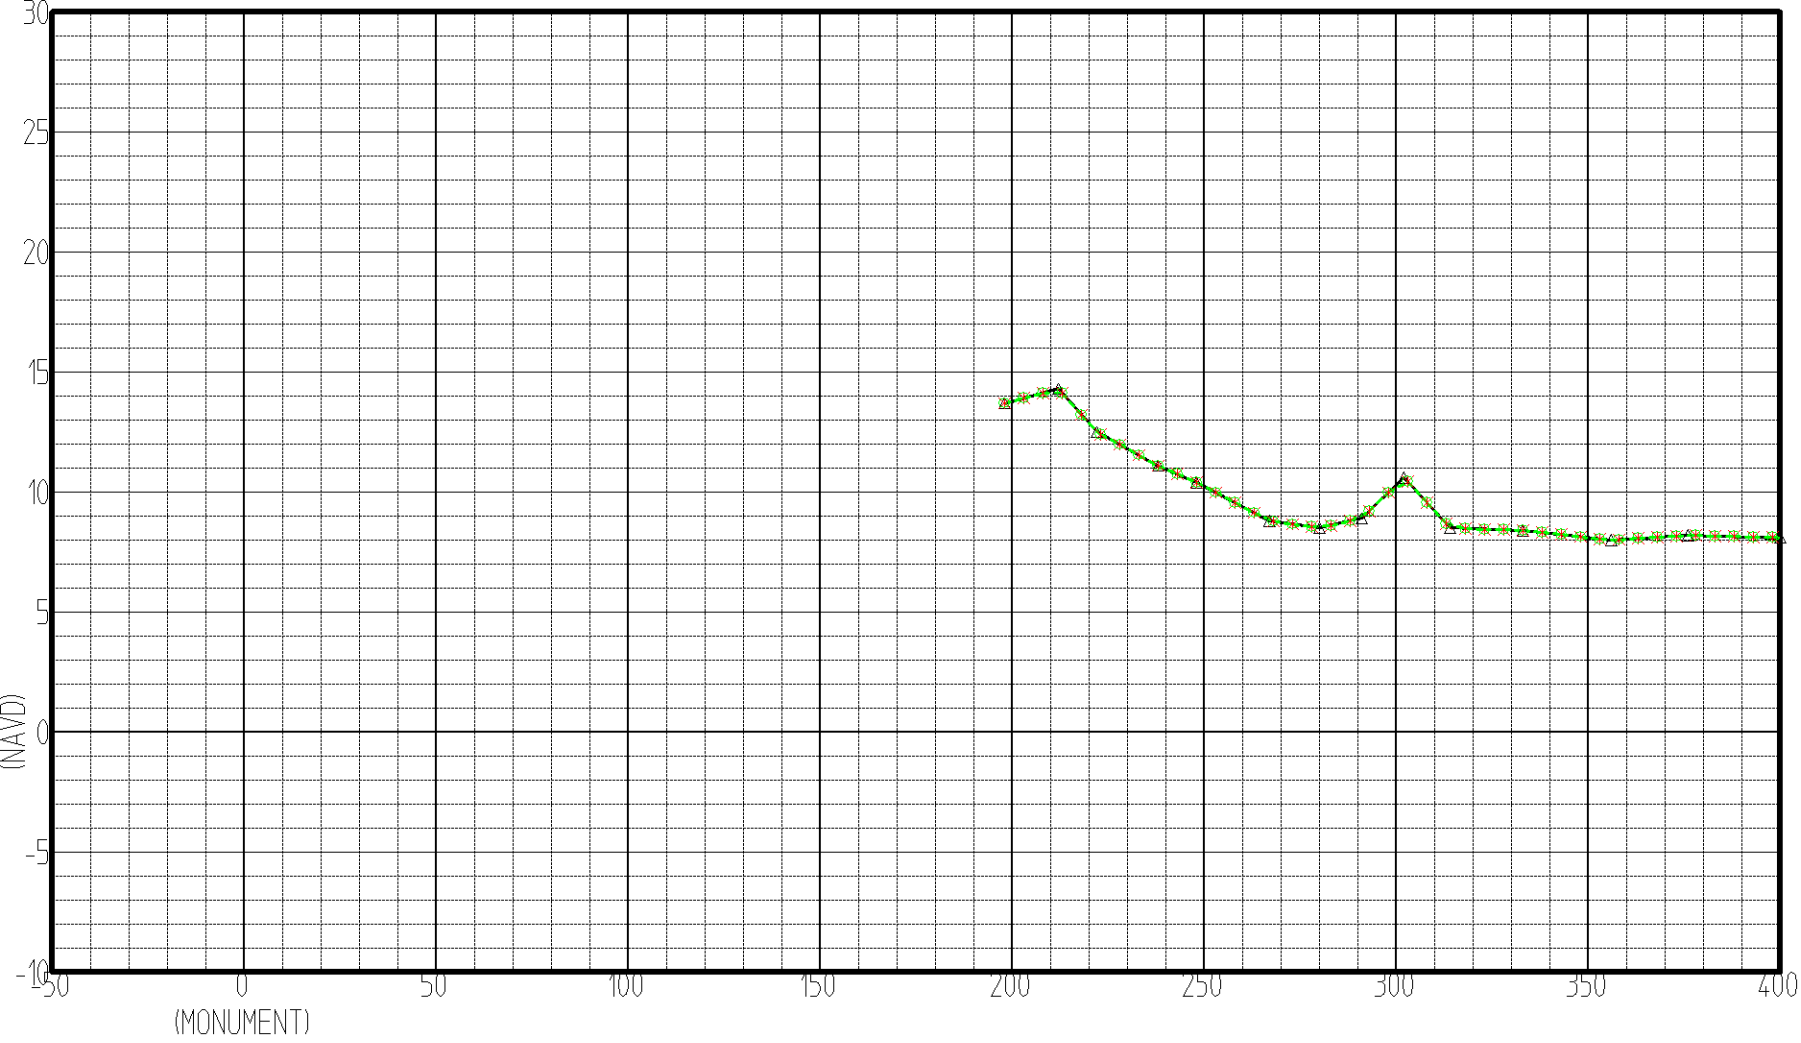
Range: R-34

BEACH PROFILE

—△—△— 2005-2008 INPUT PRF

- - - * - - - 15-YR SBEACH ERODED PRF

- - - o - - - 25-YR SBEACH ERODED PRF

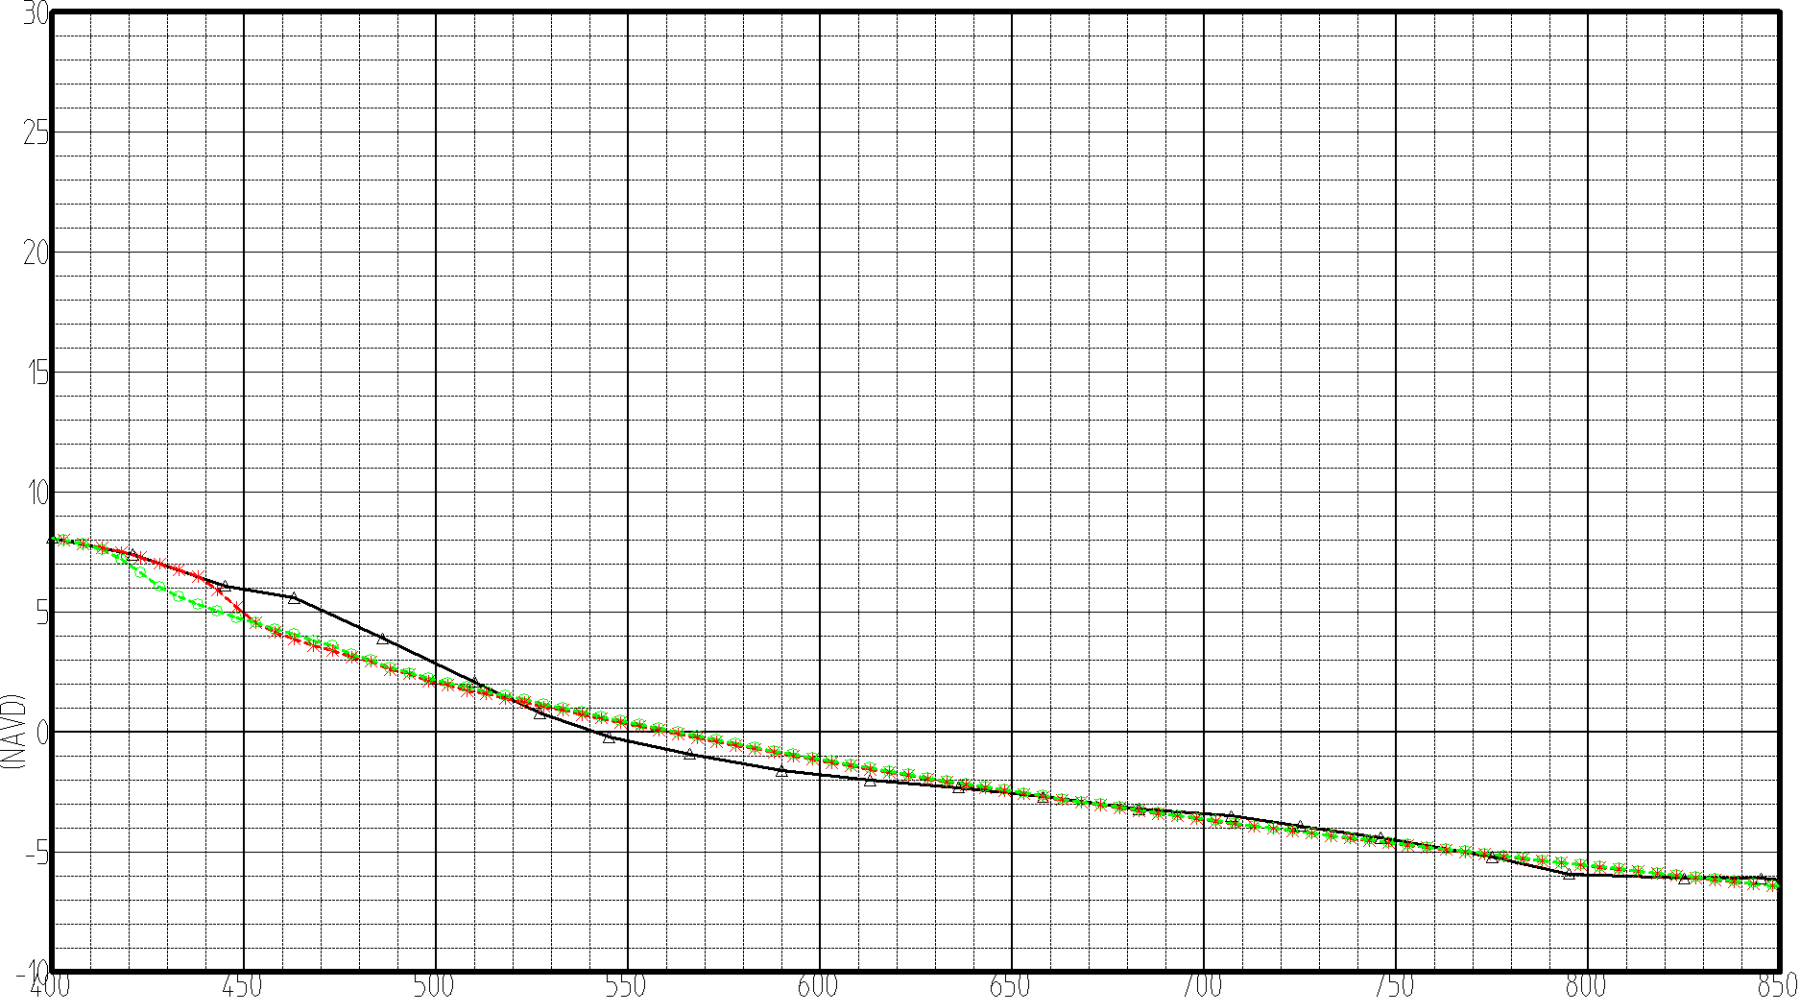
Range: R-34 2/3

BEACH PROFILE

—△—△— 2005-2008 INPUT PRF

- - - * - - - 15-YR SBEACH ERODED PRF

- - - o - - - 25-YR SBEACH ERODED PRF

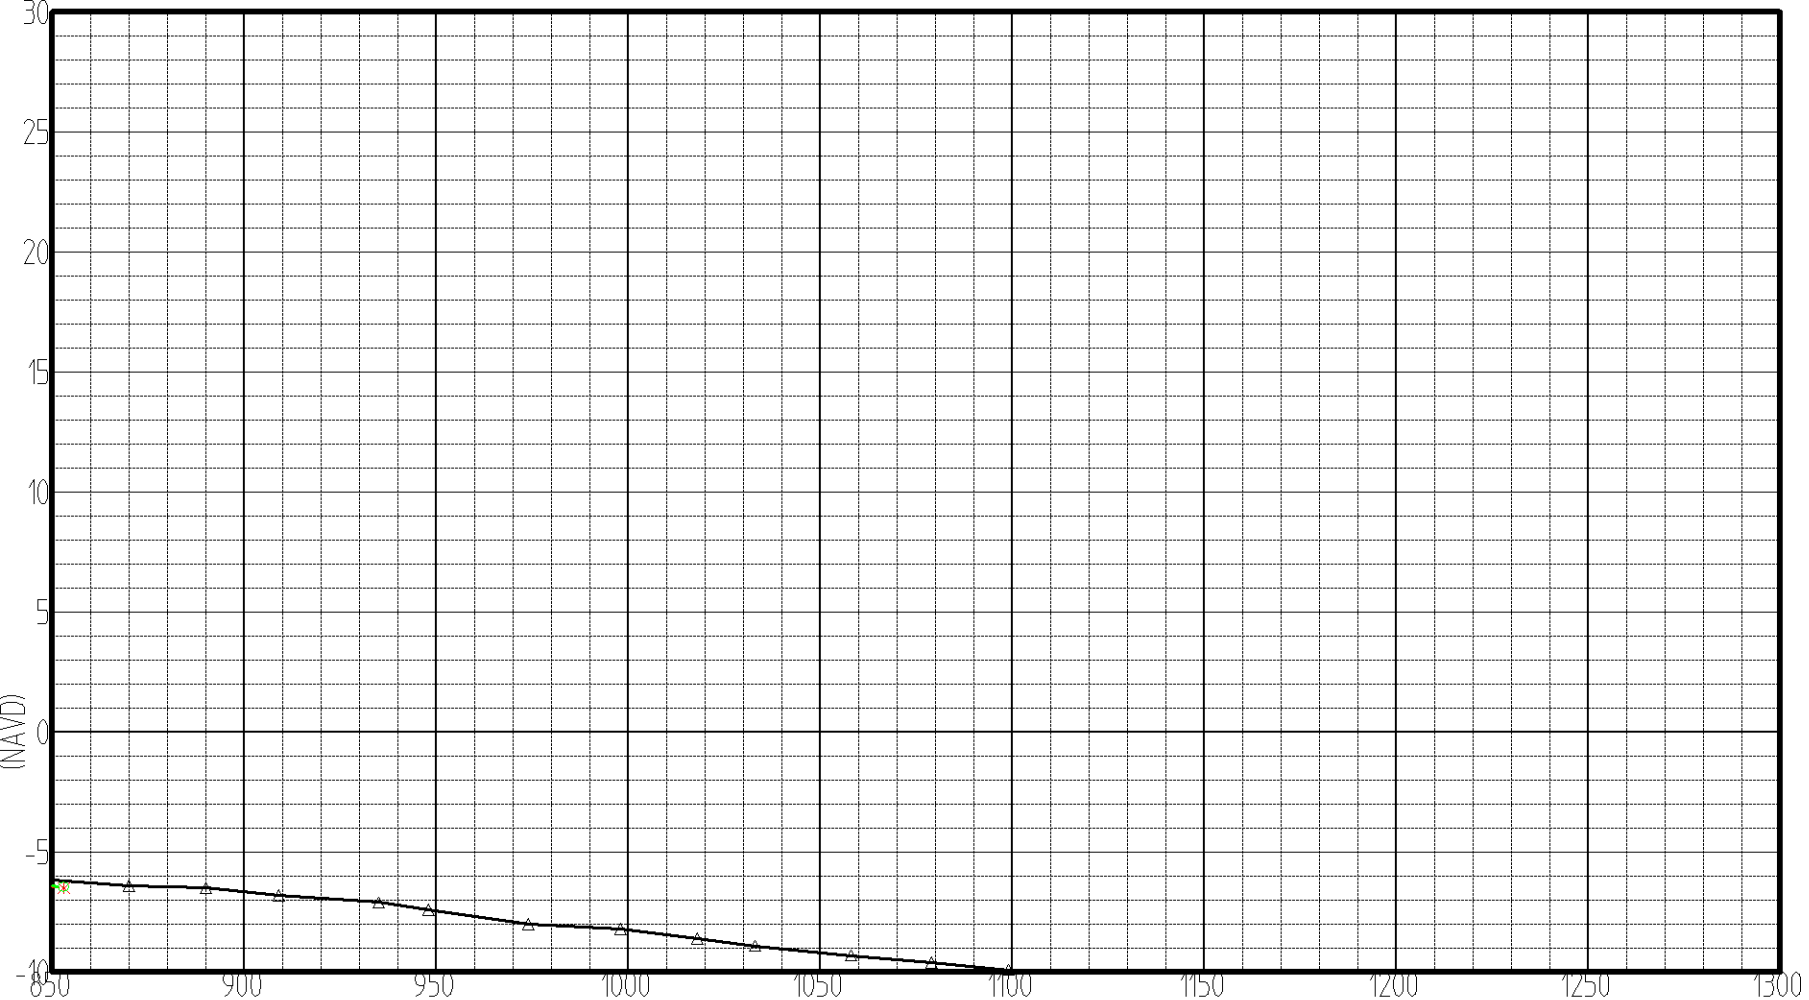
Range: R-34
 BEARING: 90.00
 3/3

BEACH PROFILE
 —△—△— 2005-2008 INPUT PRF
 - - * - - * - - 15-YR SBEACH ERODED PRF
 - - o - - o - - 25-YR SBEACH ERODED PRF

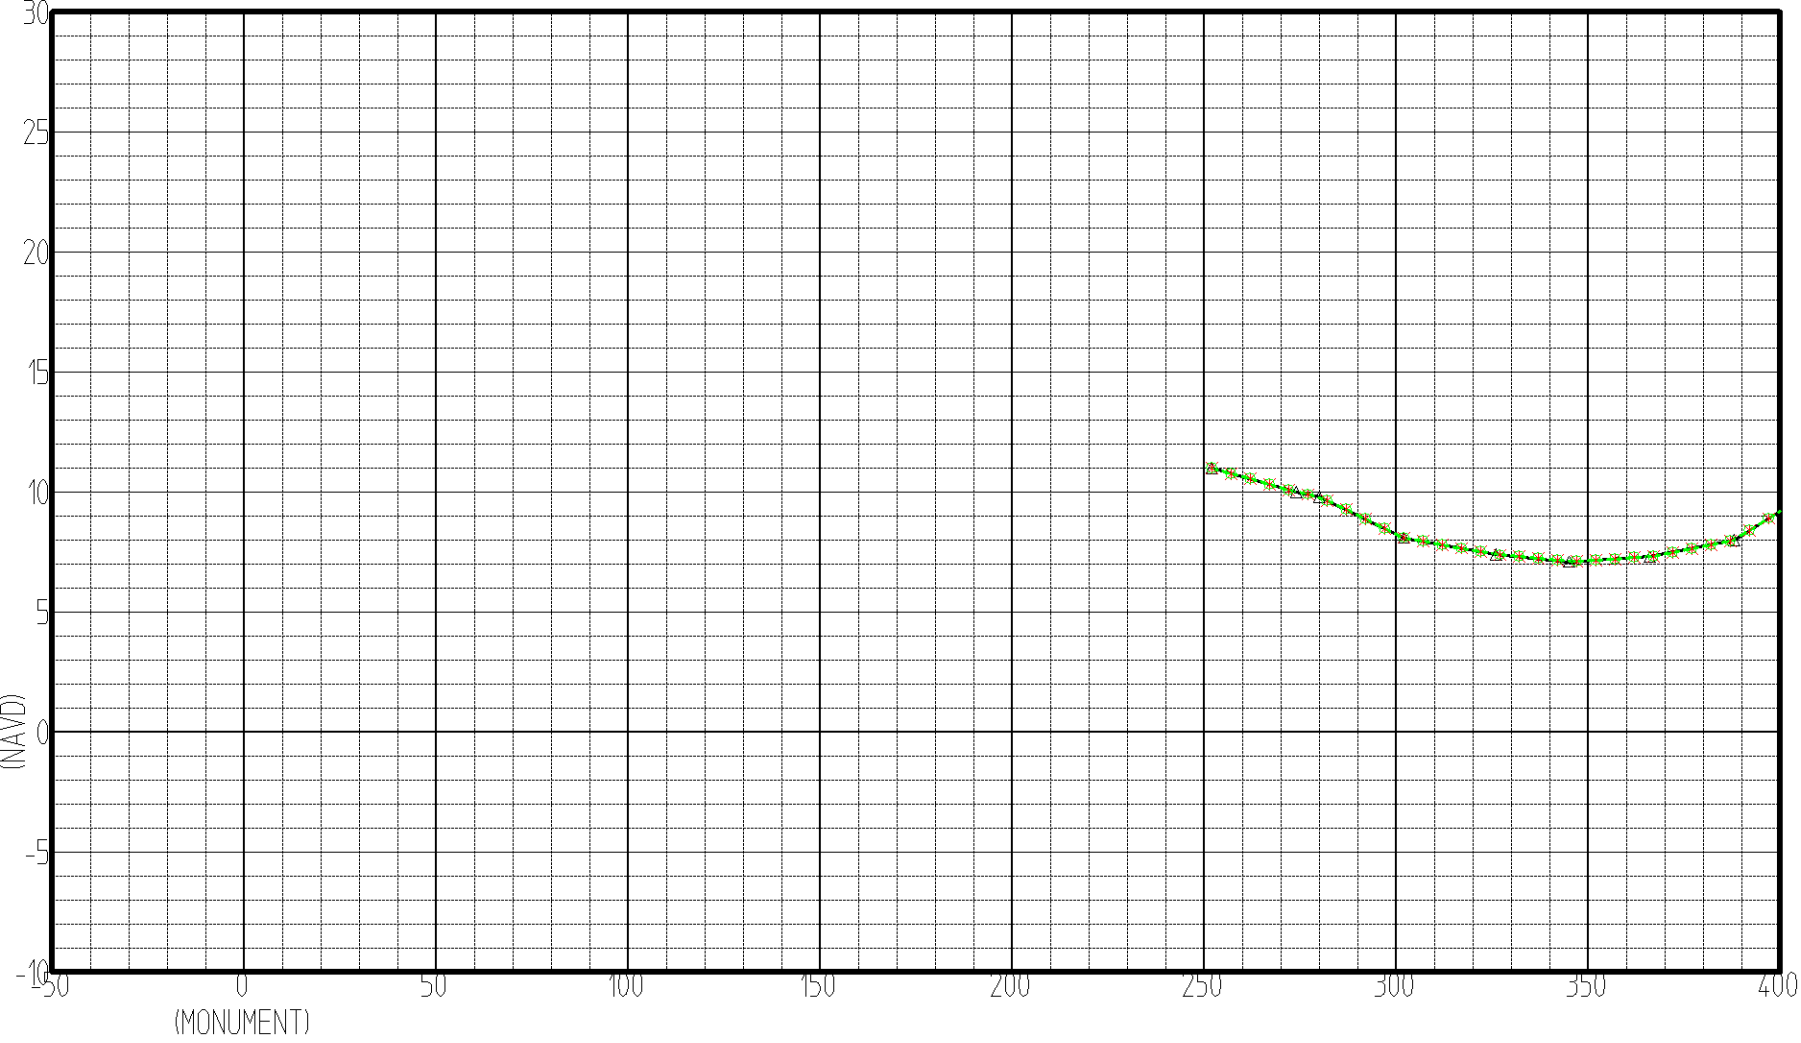
Range: R-35-T 1/3

BEACH PROFILE

- △—△— 2005-2008 INPUT PRF
- - - * - - - 15-YR SBEACH ERODED PRF
- - - o - - - 25-YR SBEACH ERODED PRF

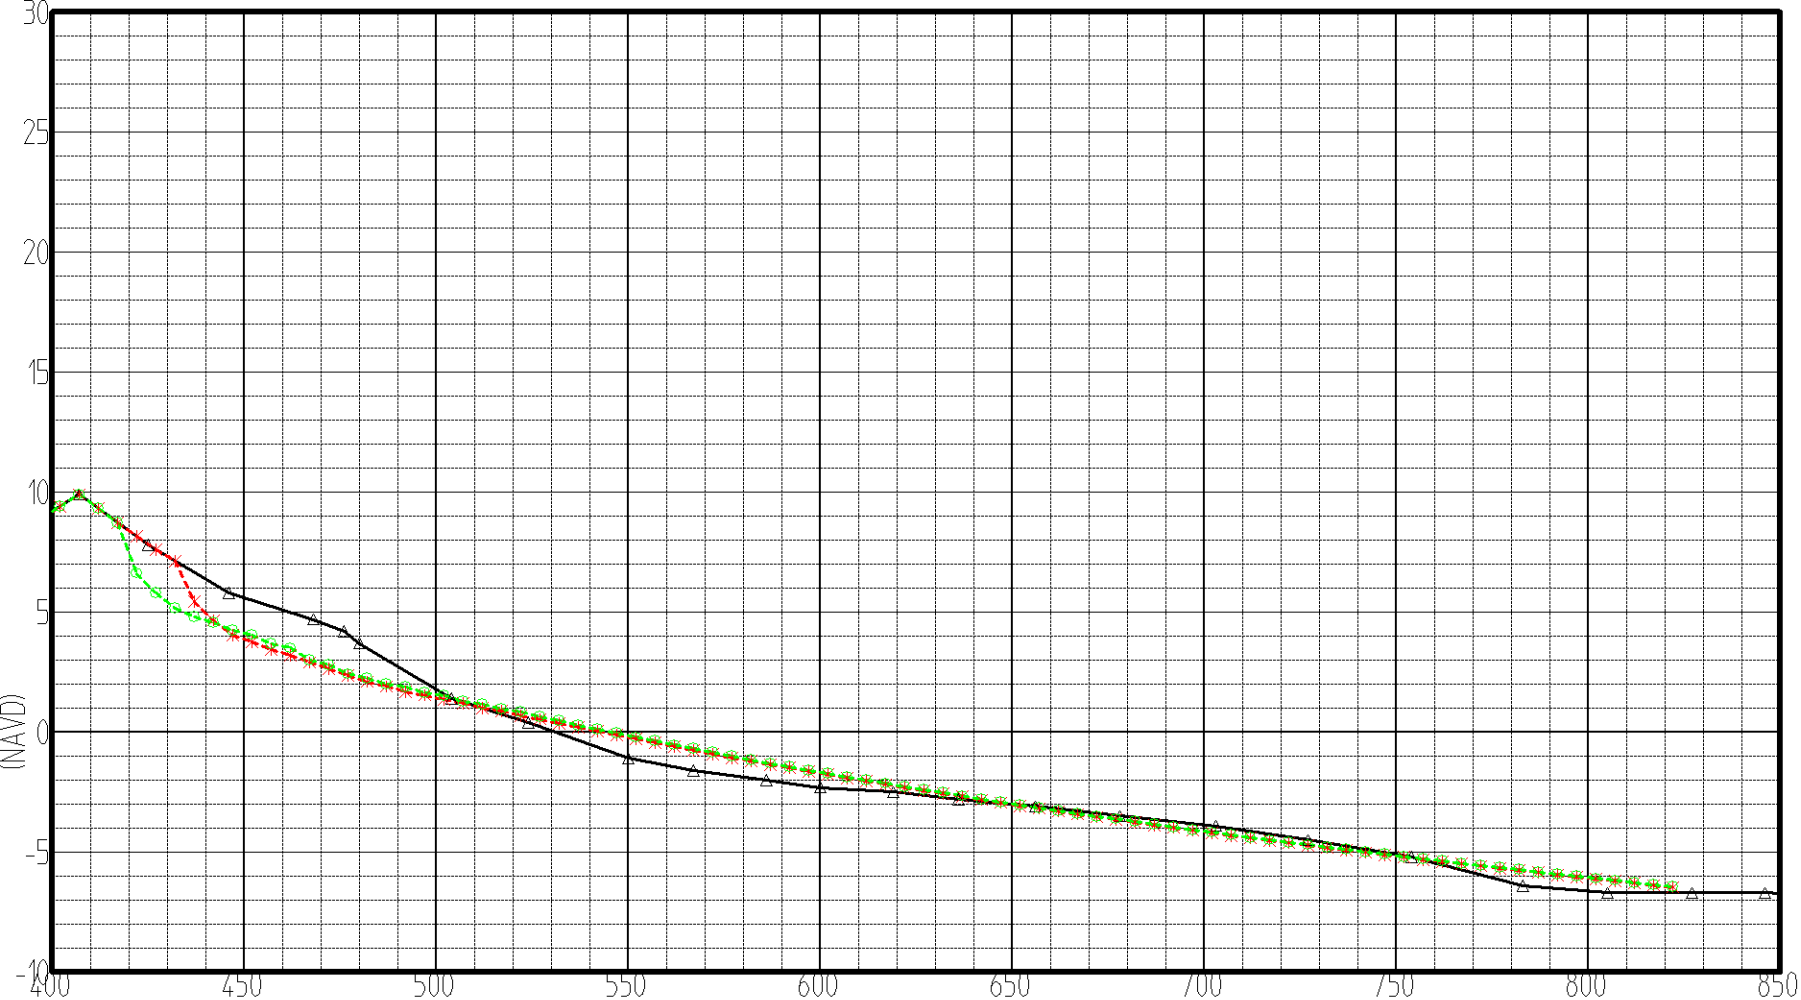
Range: R-35-T 2/3
 BEARING: 90.00

BEACH PROFILE
 —△—△— 2005-2008 INPUT PRF
 - - * - - * - - 15-YR SBEACH ERODED PRF
 - - o - - o - - 25-YR SBEACH ERODED PRF
