Appendix XI

SBEACH 15 and 25 yr. Storm Erosion Profiles

Brevard County

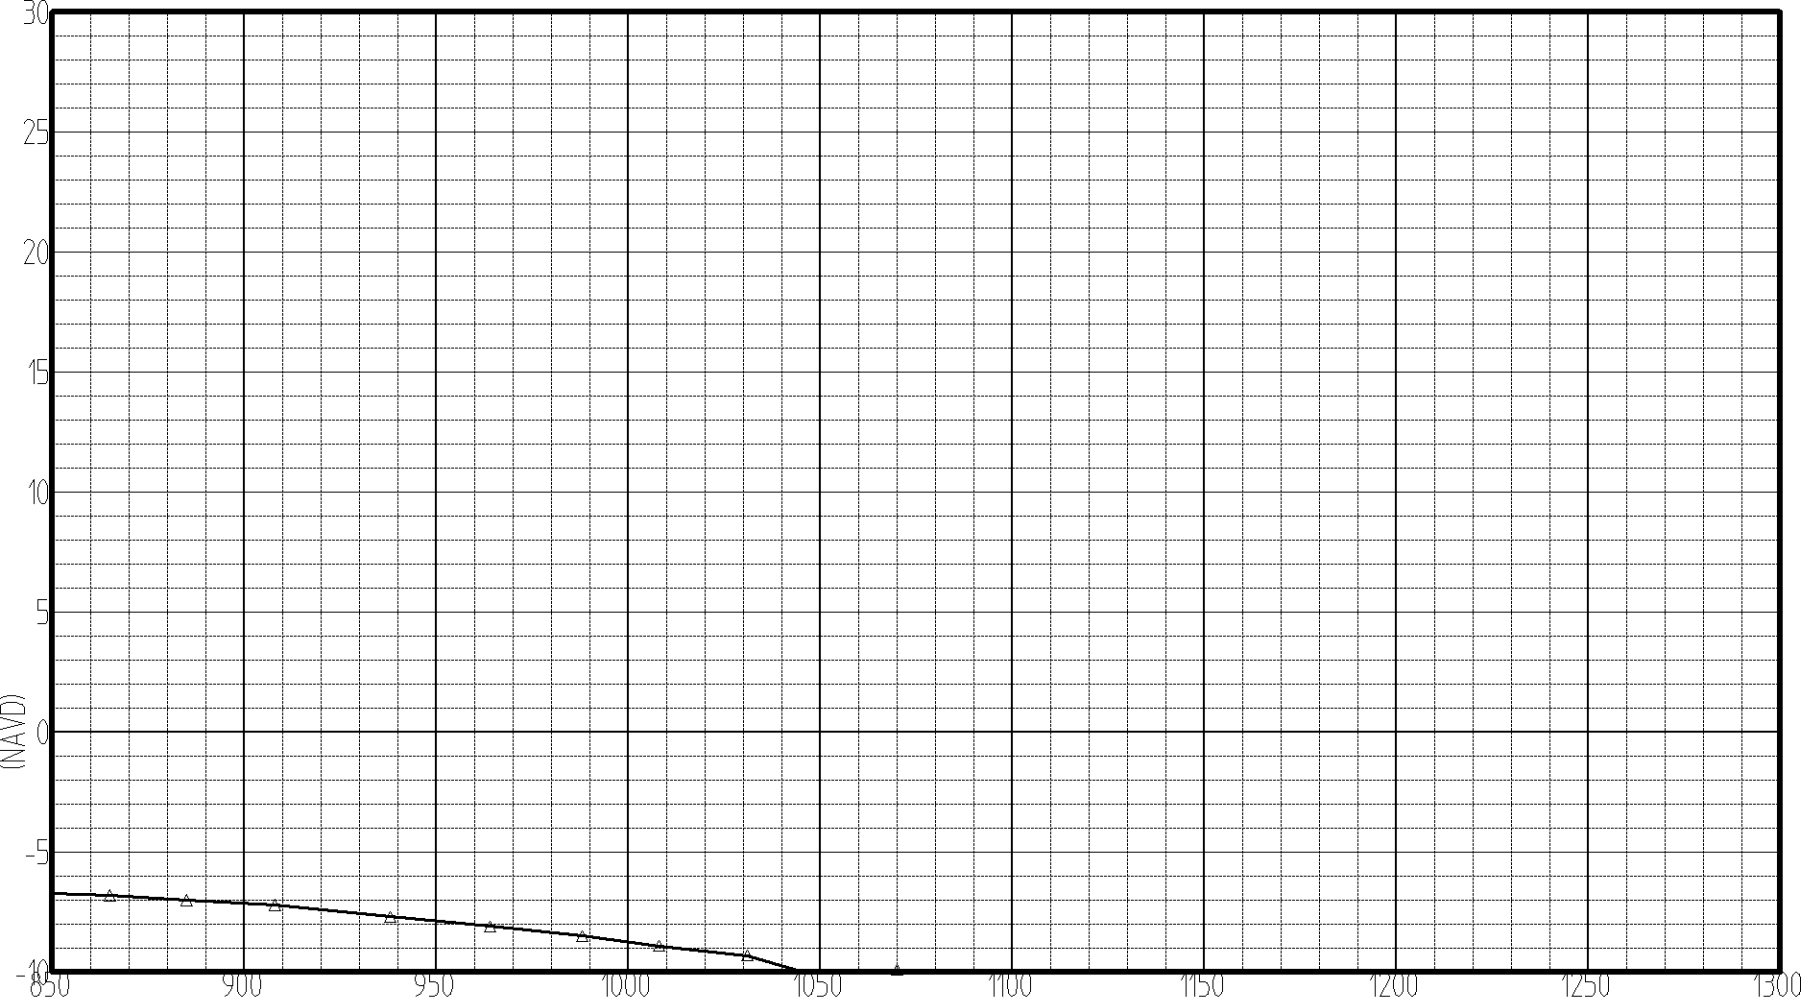
Range: R-35-T
 BEARING: 90.00
 3/3

BEACH PROFILE
 —△—△— 2005-2008 INPUT PRF
 - - - * - - - 15-YR SBEACH ERODED PRF
 - - - o - - - 25-YR SBEACH ERODED PRF

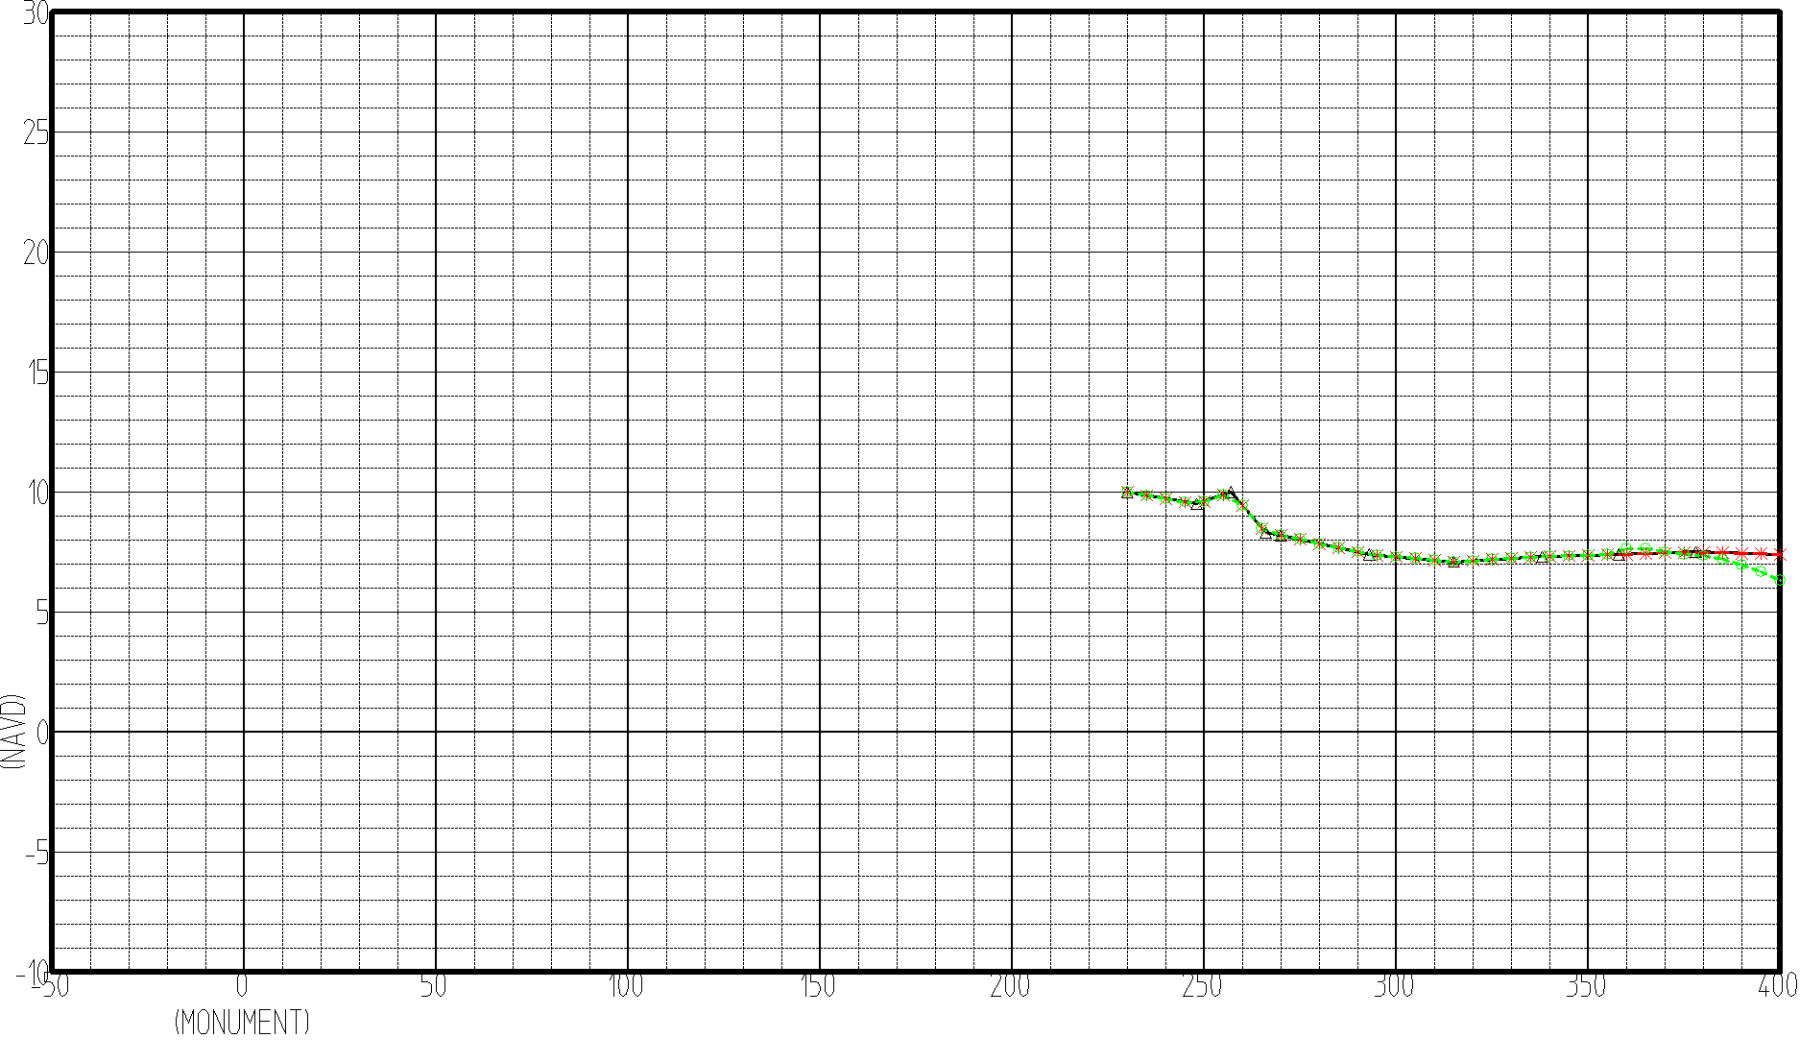
Range: R-36
 BEARING: 90.00
 1/3

BEACH PROFILE
 —△—△— 2005-2008 INPUT PRF
 - - * - - * - - 15-YR SBEACH ERODED PRF
 - - o - - o - - 25-YR SBEACH ERODED PRF

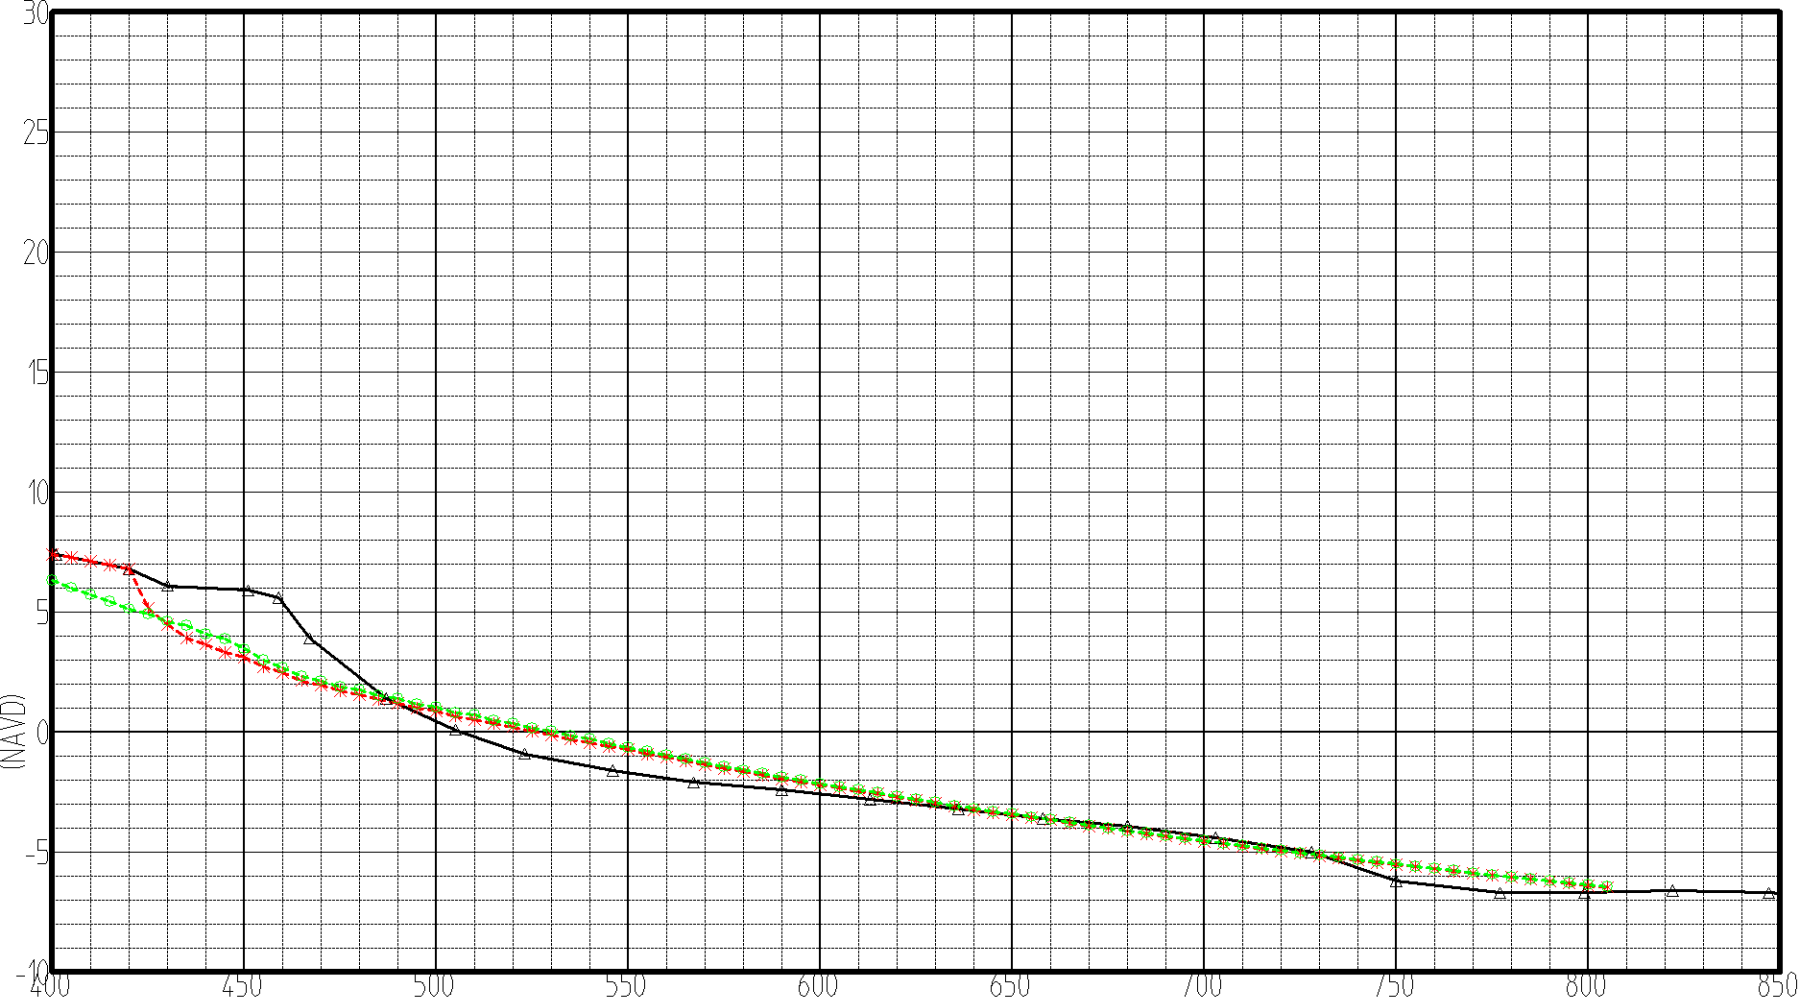
Range: R-36
 BEARING: 90.00
 2/3

BEACH PROFILE
 —△—△— 2005-2008 INPUT PRF
 - - * - - * - - 15-YR SBEACH ERODED PRF
 - - o - - o - - 25-YR SBEACH ERODED PRF

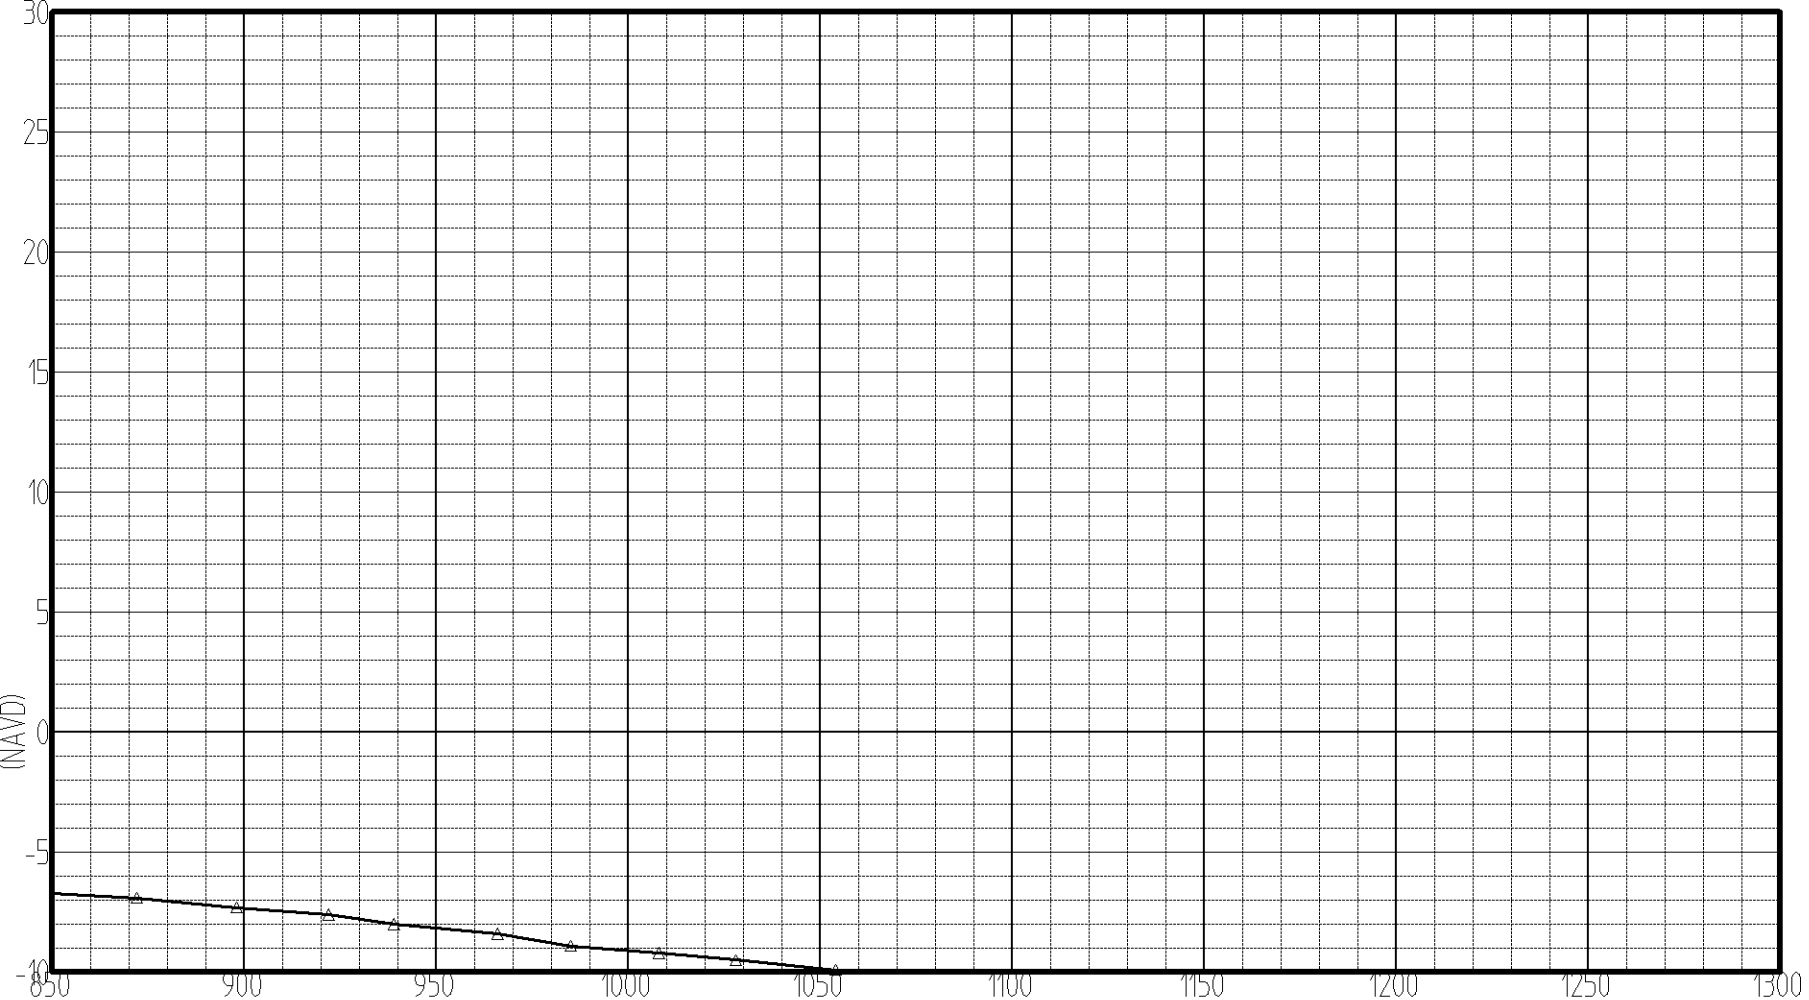
BEACH PROFILE
 —△—△— 2005-2008 INPUT PRF
 - - * - - * - - 15-YR SBEACH ERODED PRF
 - - ○ - - ○ - - 25-YR SBEACH ERODED PRF

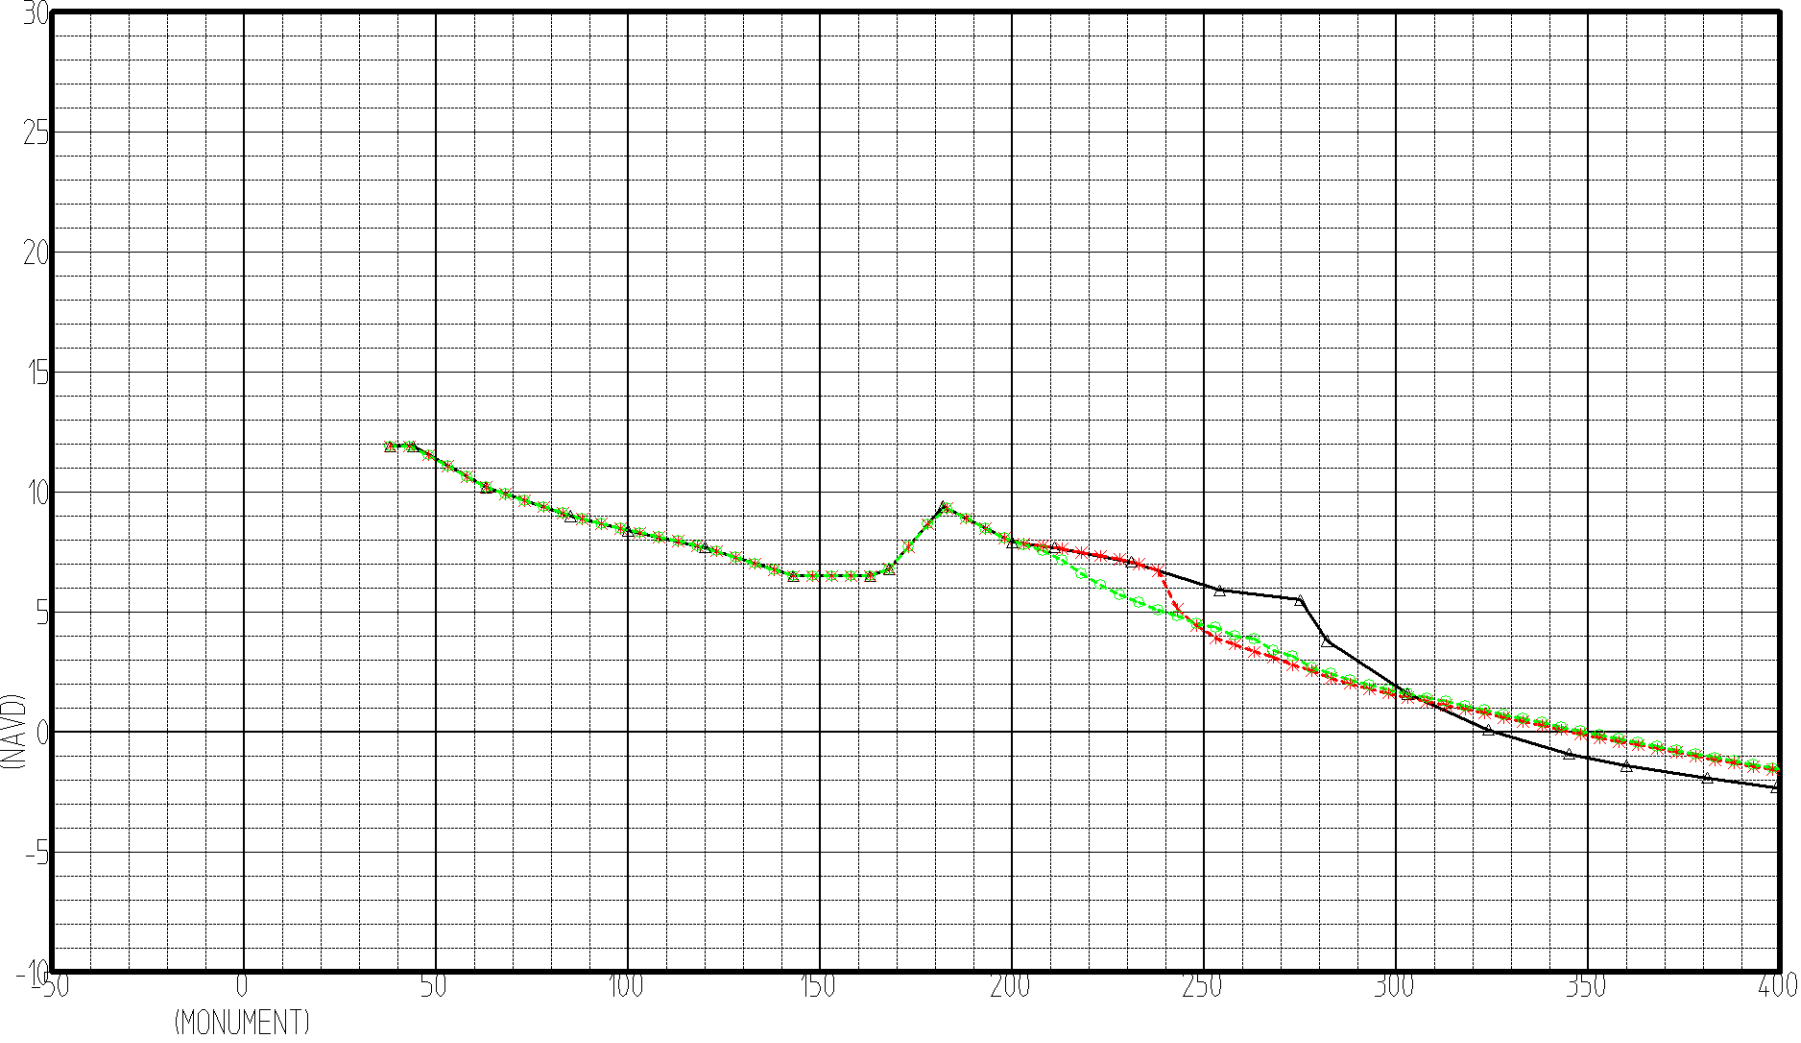
Range: R-37

BEACH PROFILE

—△—△— 2005-2008 INPUT PRF

- - - * - - - 15-YR SBEACH ERODED PRF

- - - o - - - 25-YR SBEACH ERODED PRF

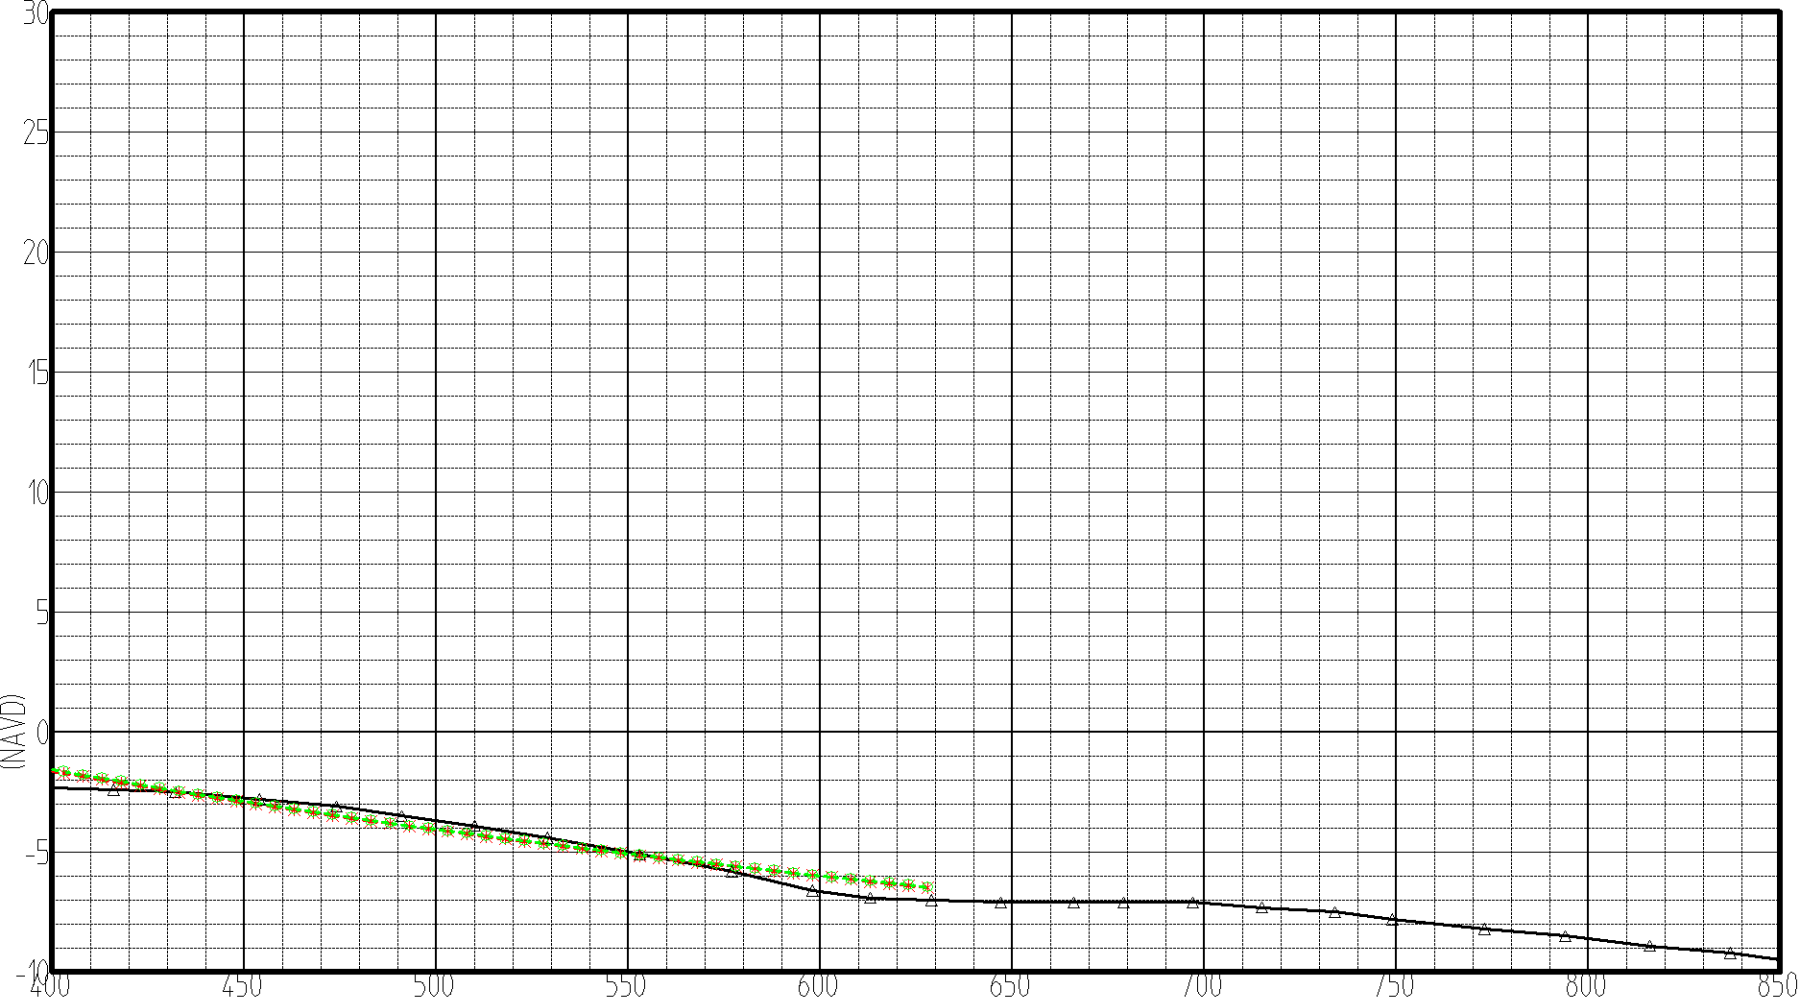
Range: R-37 2/3

BEACH PROFILE

—△—△— 2005-2008 INPUT PRF

- - - * - - - 15-YR SBEACH ERODED PRF

- - - o - - - 25-YR SBEACH ERODED PRF

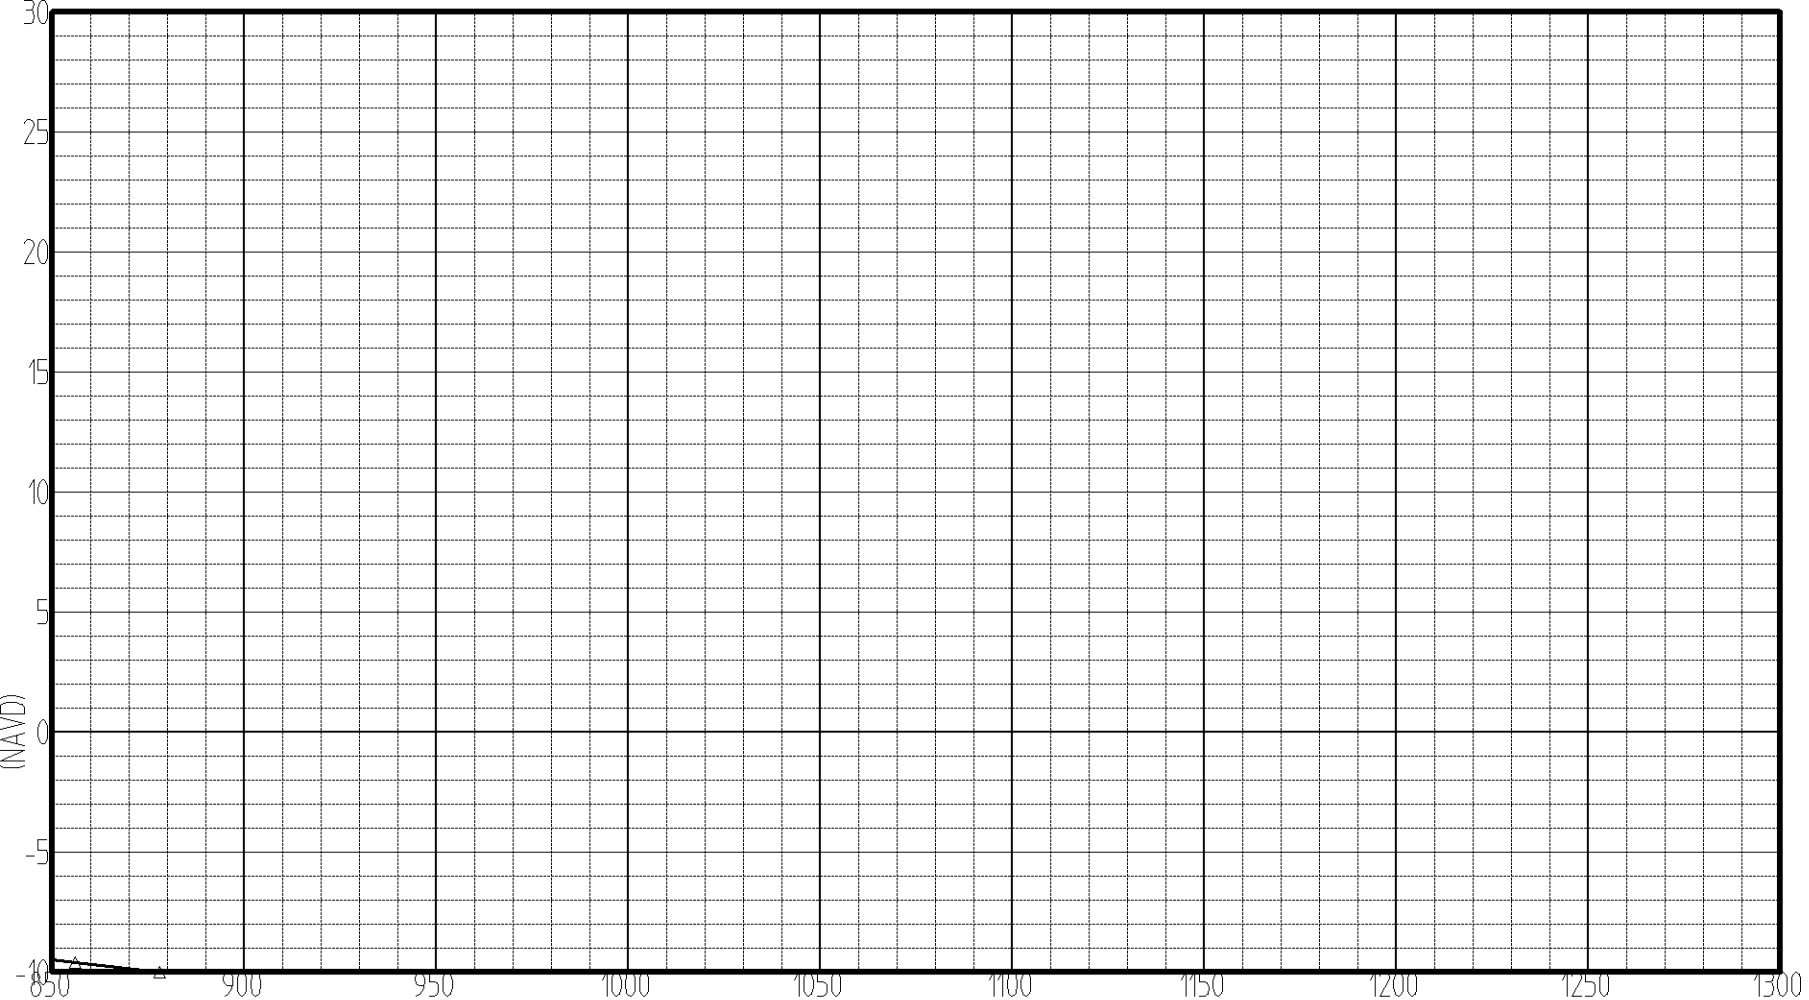
Range: R-37 3/3

BEACH PROFILE

- △—△— 2005-2008 INPUT PRF
- - - * - - - 15-YR SBEACH ERODED PRF
- - - o - - - 25-YR SBEACH ERODED PRF

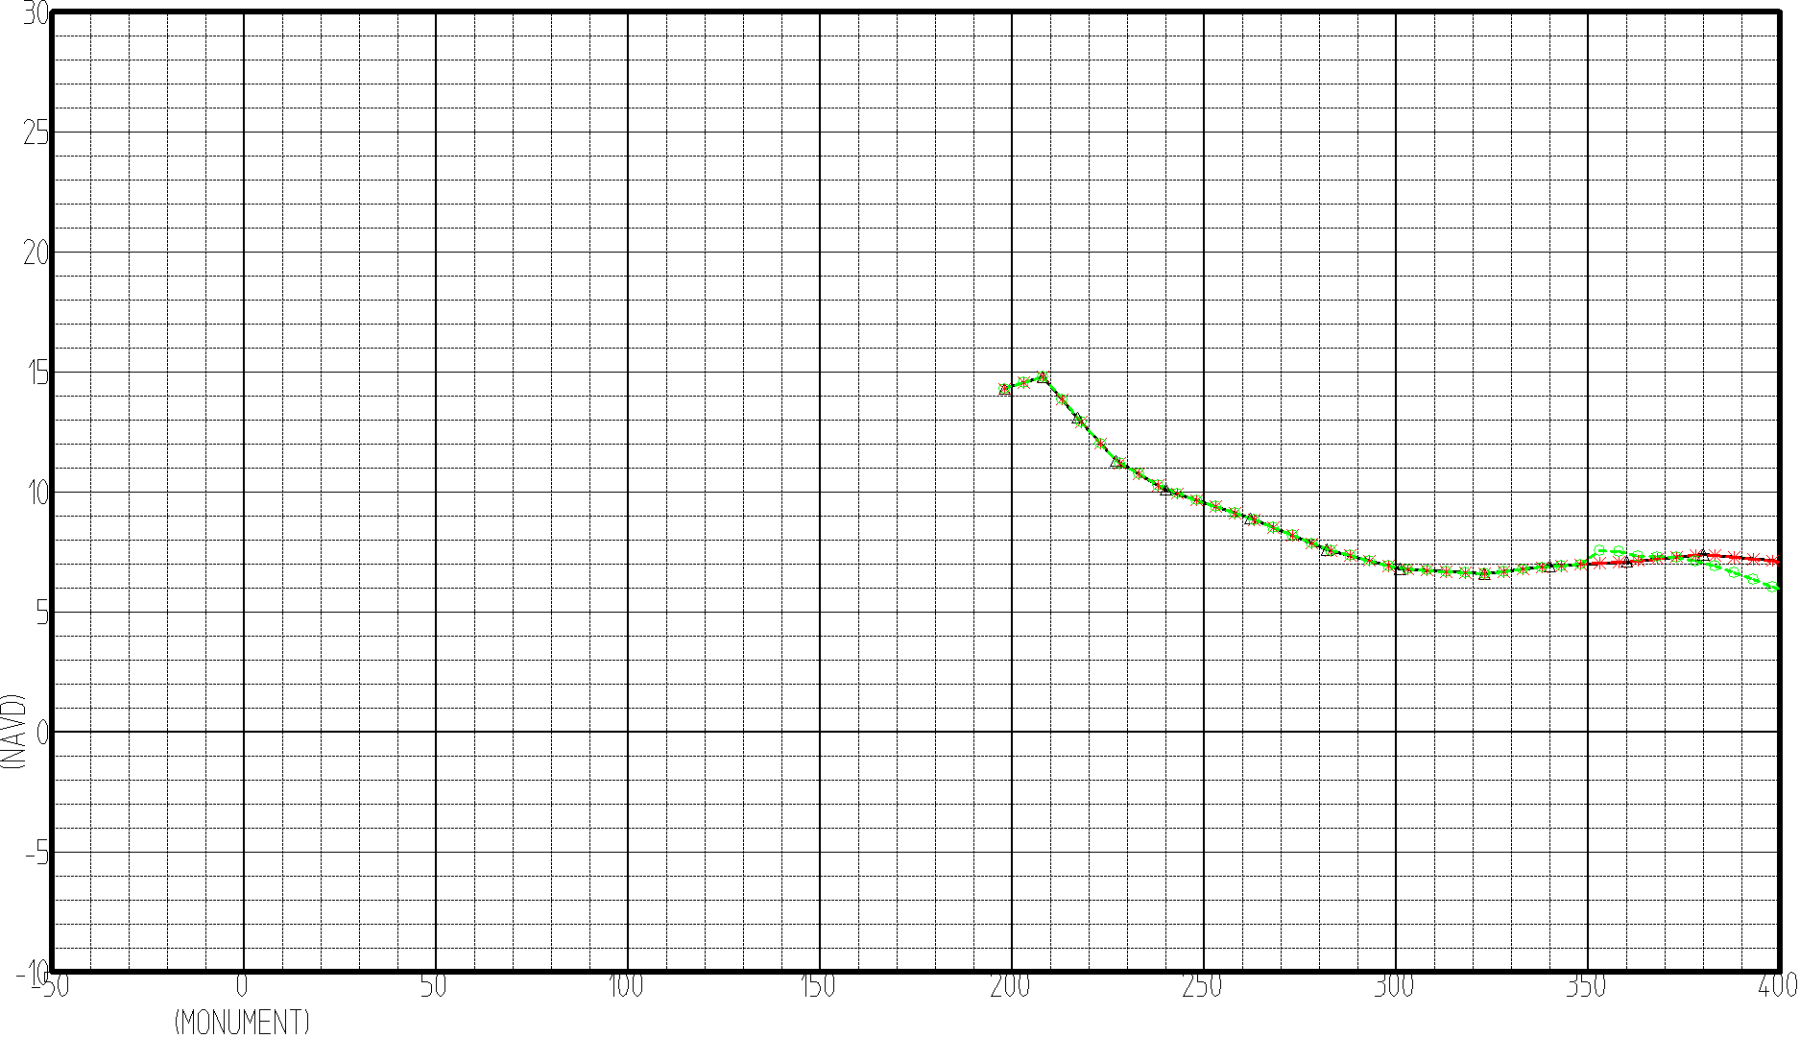
Range: R-38
 BEARING: 90.00
 1/3

BEACH PROFILE
 —△—△— 2005-2008 INPUT PRF
 - - * - - * - - 15-YR SBEACH ERODED PRF
 - - ○ - - ○ - - 25-YR SBEACH ERODED PRF

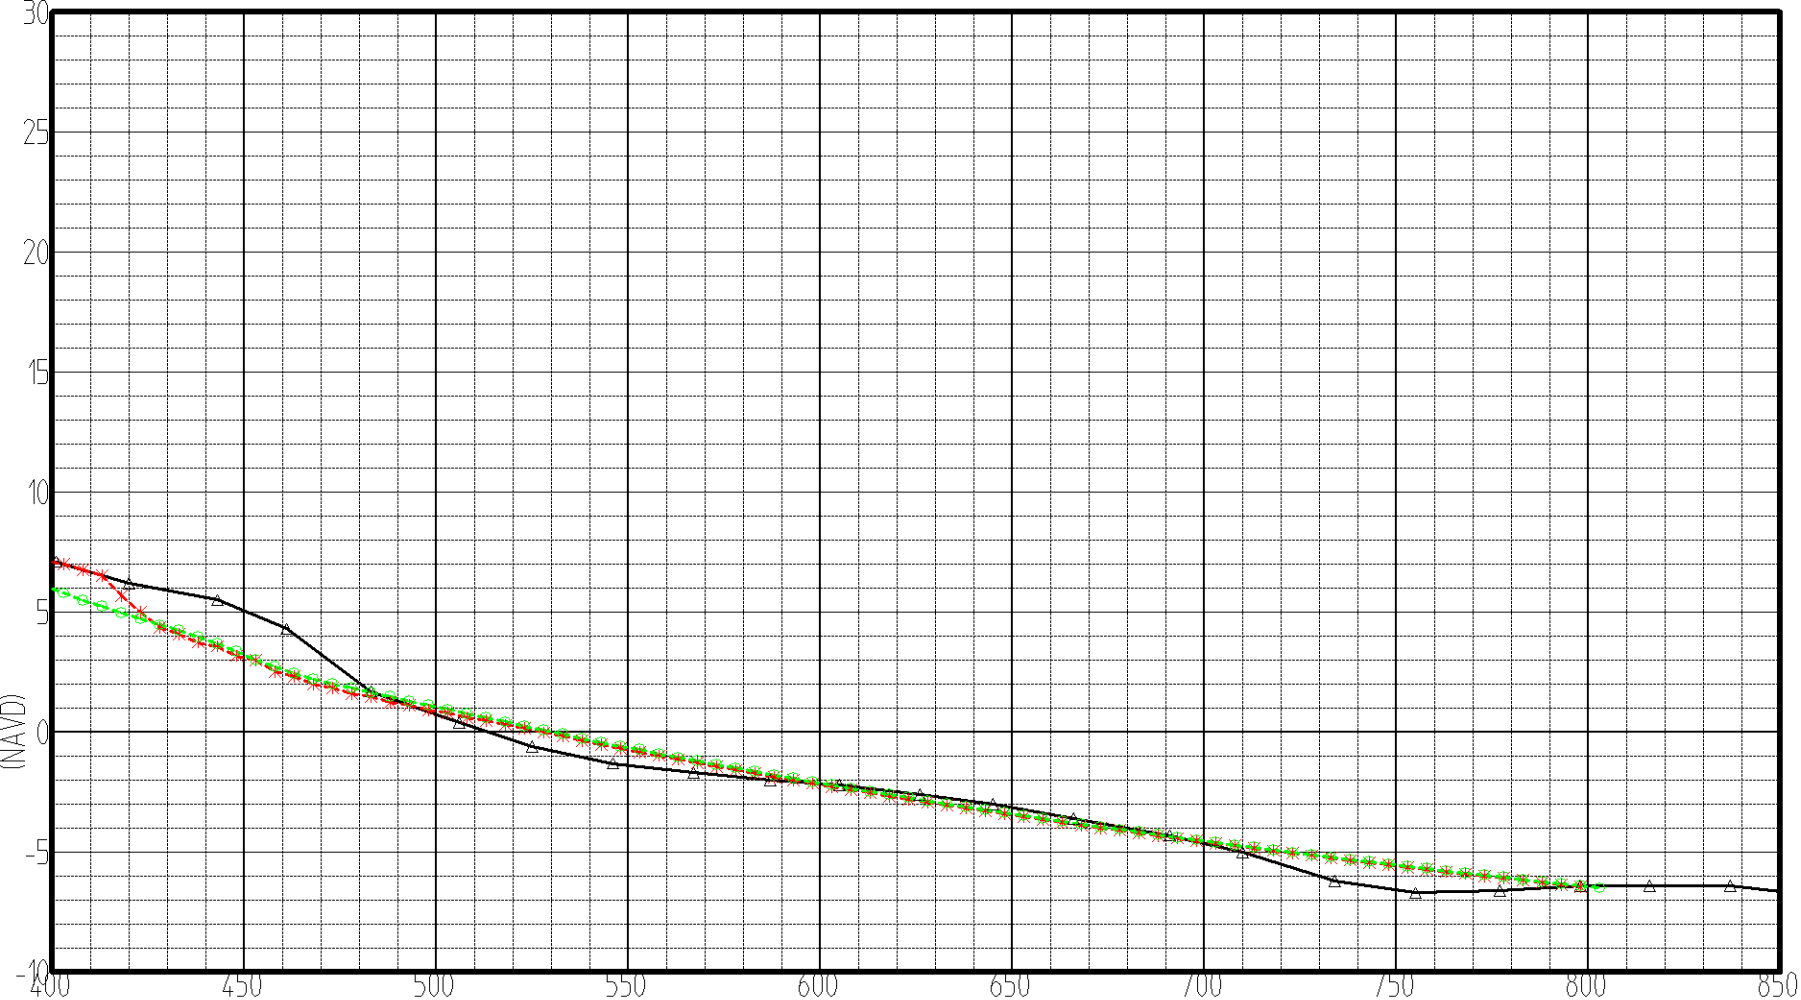
Range: R-38

BEACH PROFILE

—△—△— 2005-2008 INPUT PRF

- - * - - * - - 15-YR SBEACH ERODED PRF

- - ○ - - ○ - - 25-YR SBEACH ERODED PRF

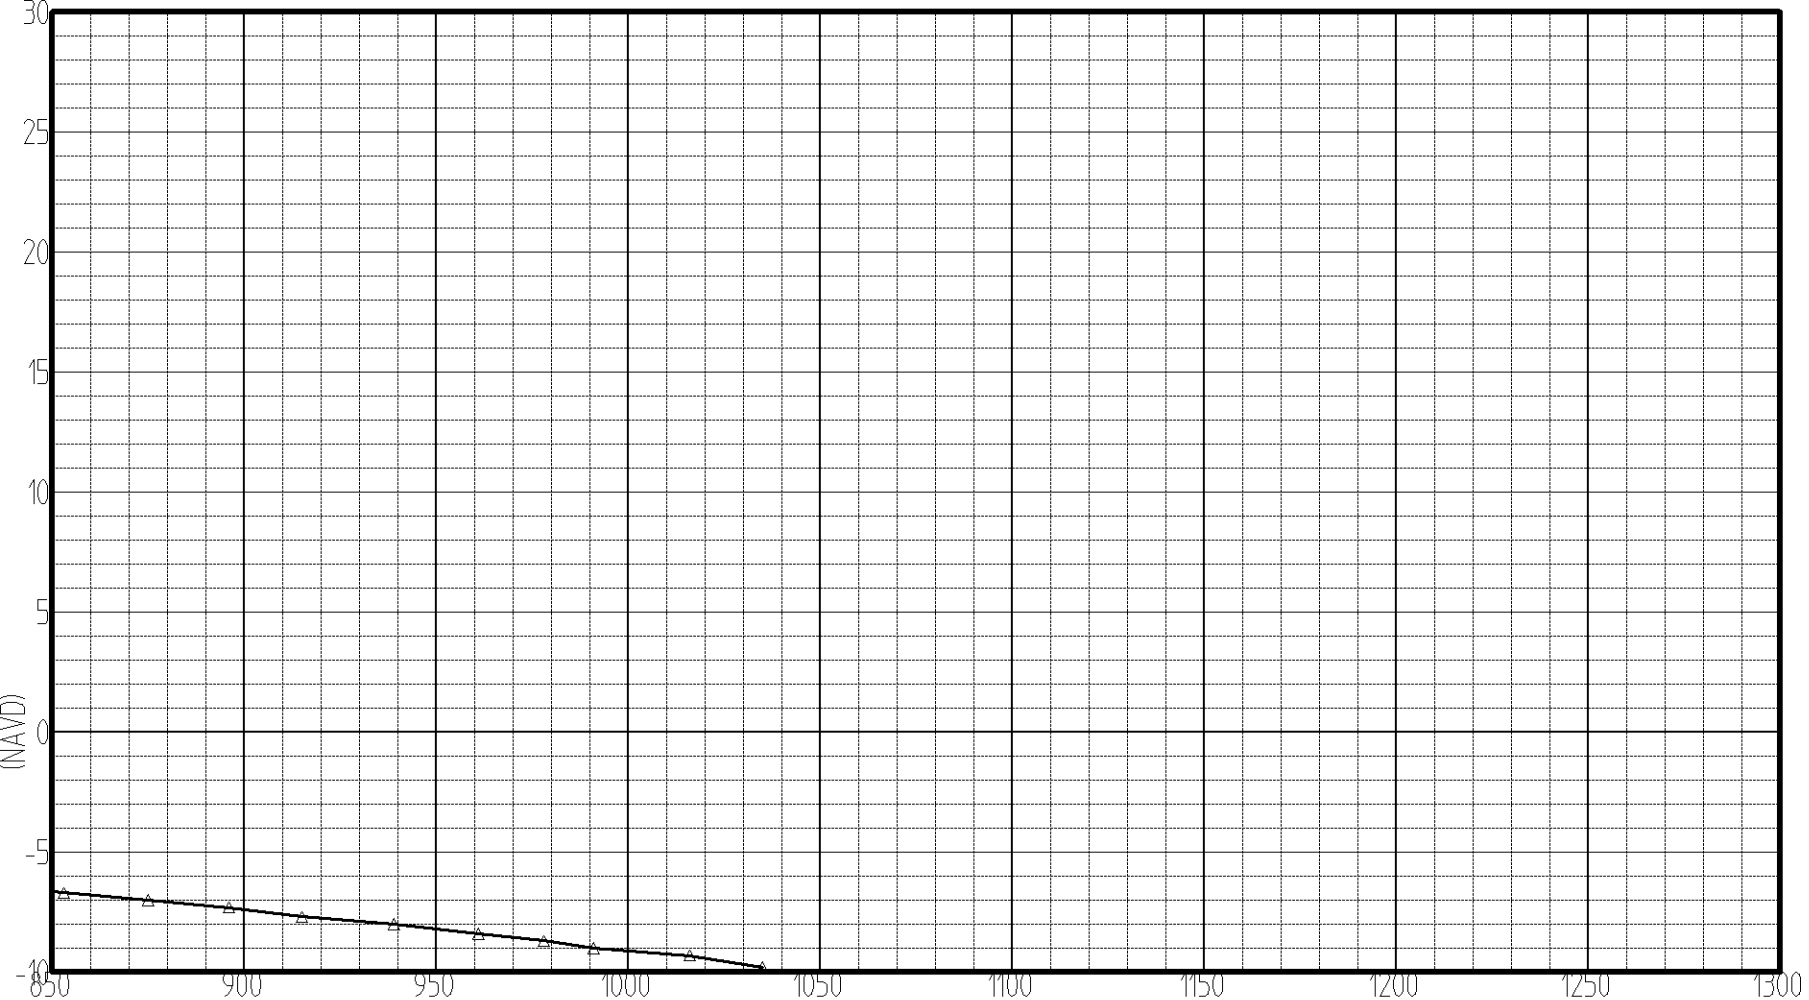
Range: R-38

BEACH PROFILE

—△—△— 2005-2008 INPUT PRF

- - - * - - - 15-YR SBEACH ERODED PRF

- - - o - - - 25-YR SBEACH ERODED PRF

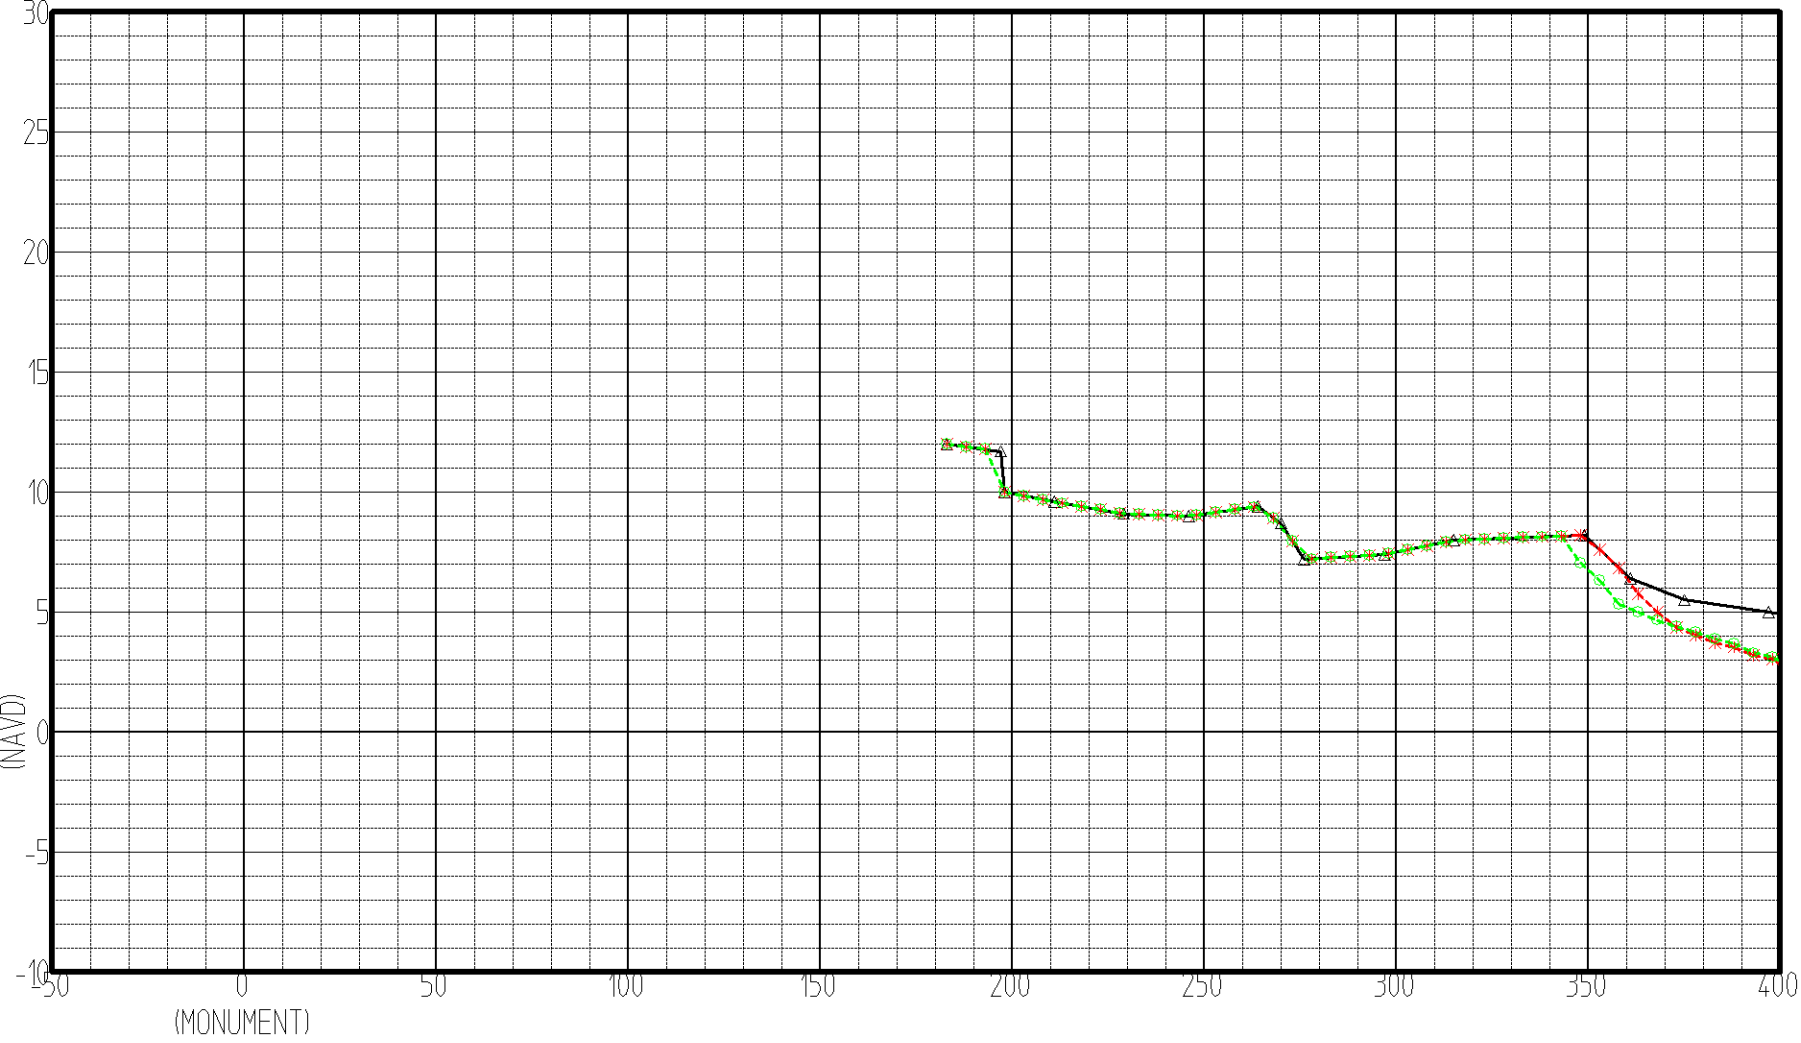
Range: R-39

BEACH PROFILE

—△—△— 2005-2008 INPUT PRF

- - - * - - - 15-YR SBEACH ERODED PRF

- - - o - - - 25-YR SBEACH ERODED PRF

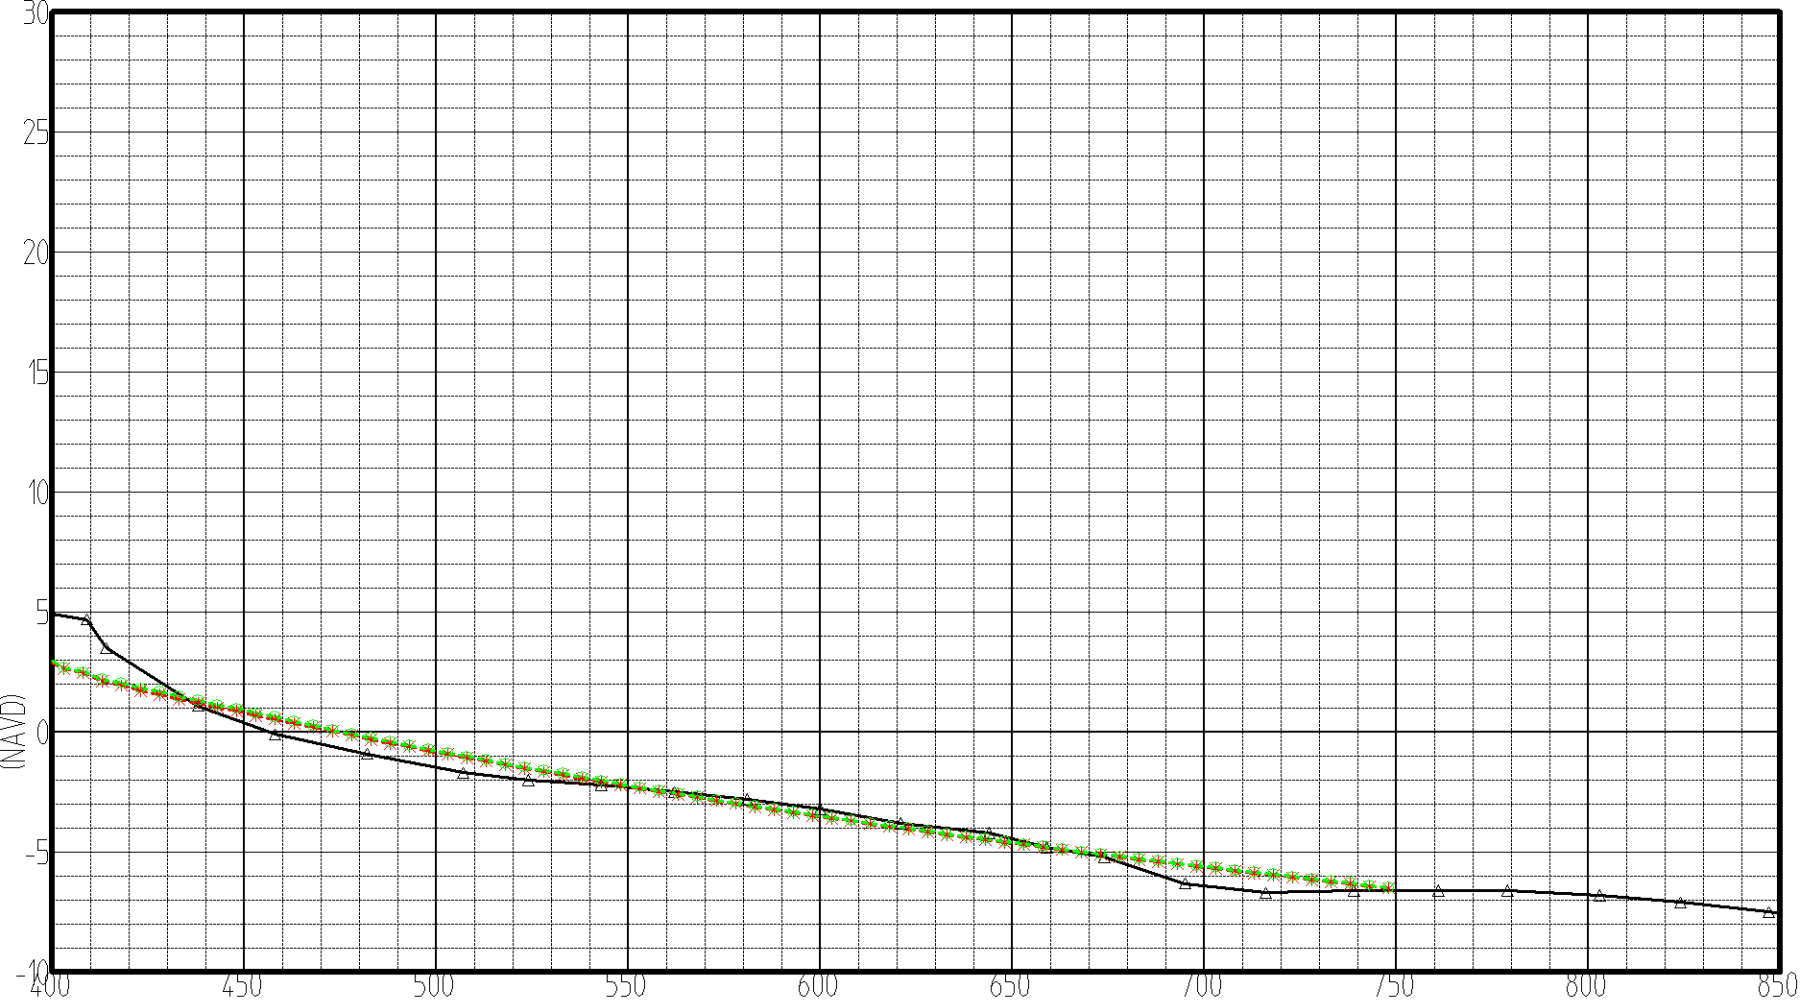
Range: R-39 2/3
 BEARING: 90.00

BEACH PROFILE
 —△—△— 2005-2008 INPUT PRF
 - - * - - * - - 15-YR SBEACH ERODED PRF
 - - o - - o - - 25-YR SBEACH ERODED PRF
