Appendix XI

SBEACH 15 and 25 yr. Storm Erosion Profiles

Brevard County

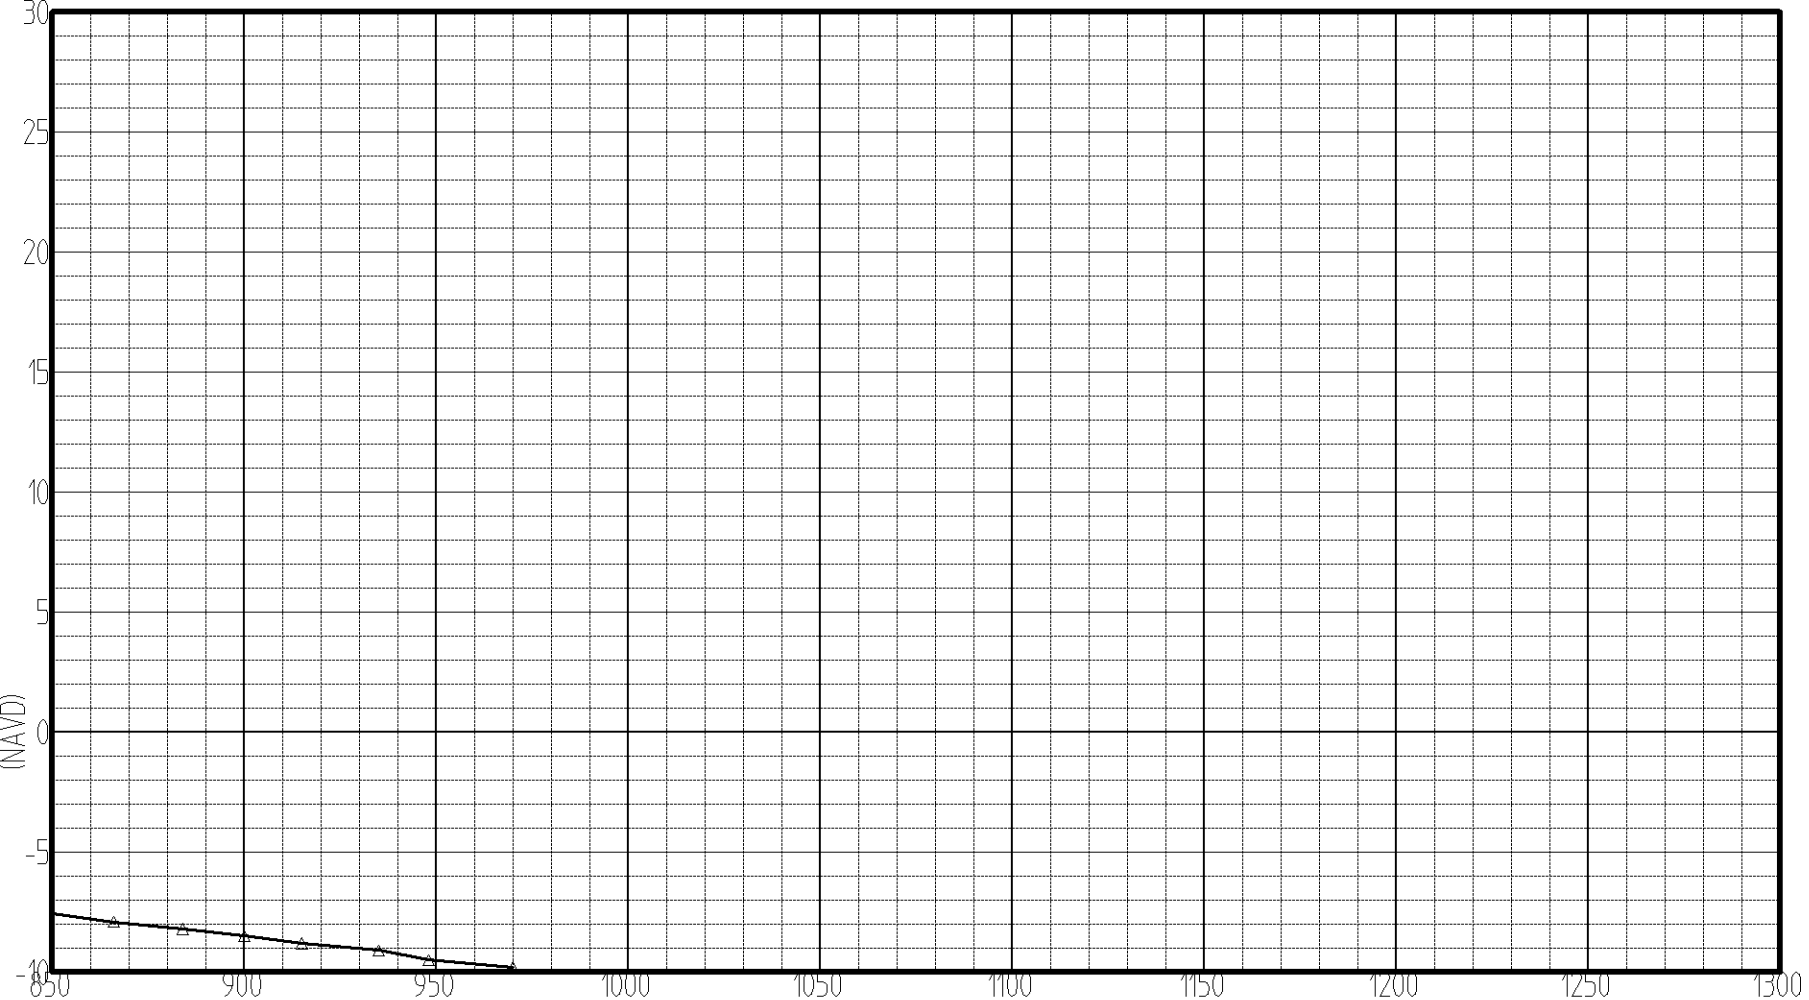
Range: R-39
 BEARING: 90.00
 3/3

BEACH PROFILE
 —△—△— 2005-2008 INPUT PRF
 - - * - - * - - 15-YR SBEACH ERODED PRF
 - - ○ - - ○ - - 25-YR SBEACH ERODED PRF

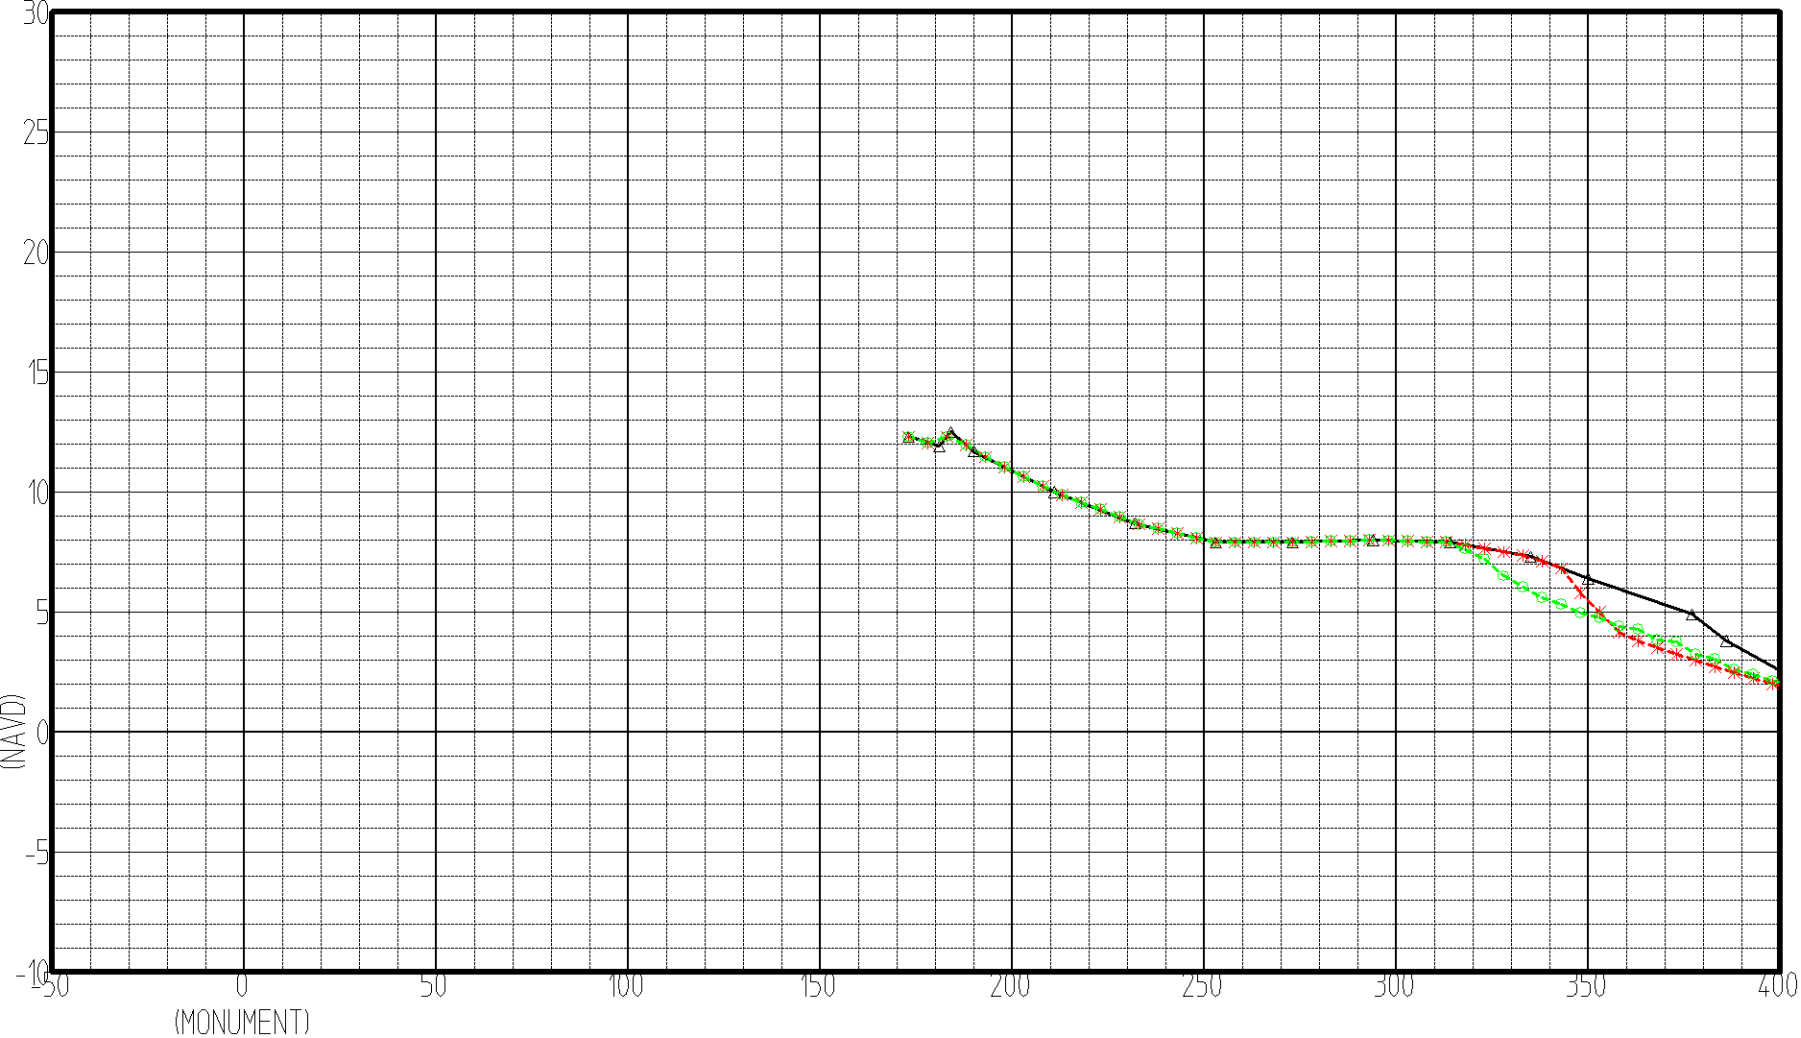
Range: R-40

BEACH PROFILE

—△—△— 2005-2008 INPUT PRF

- - * - - * - - 15-YR SBEACH ERODED PRF

- - o - - o - - 25-YR SBEACH ERODED PRF

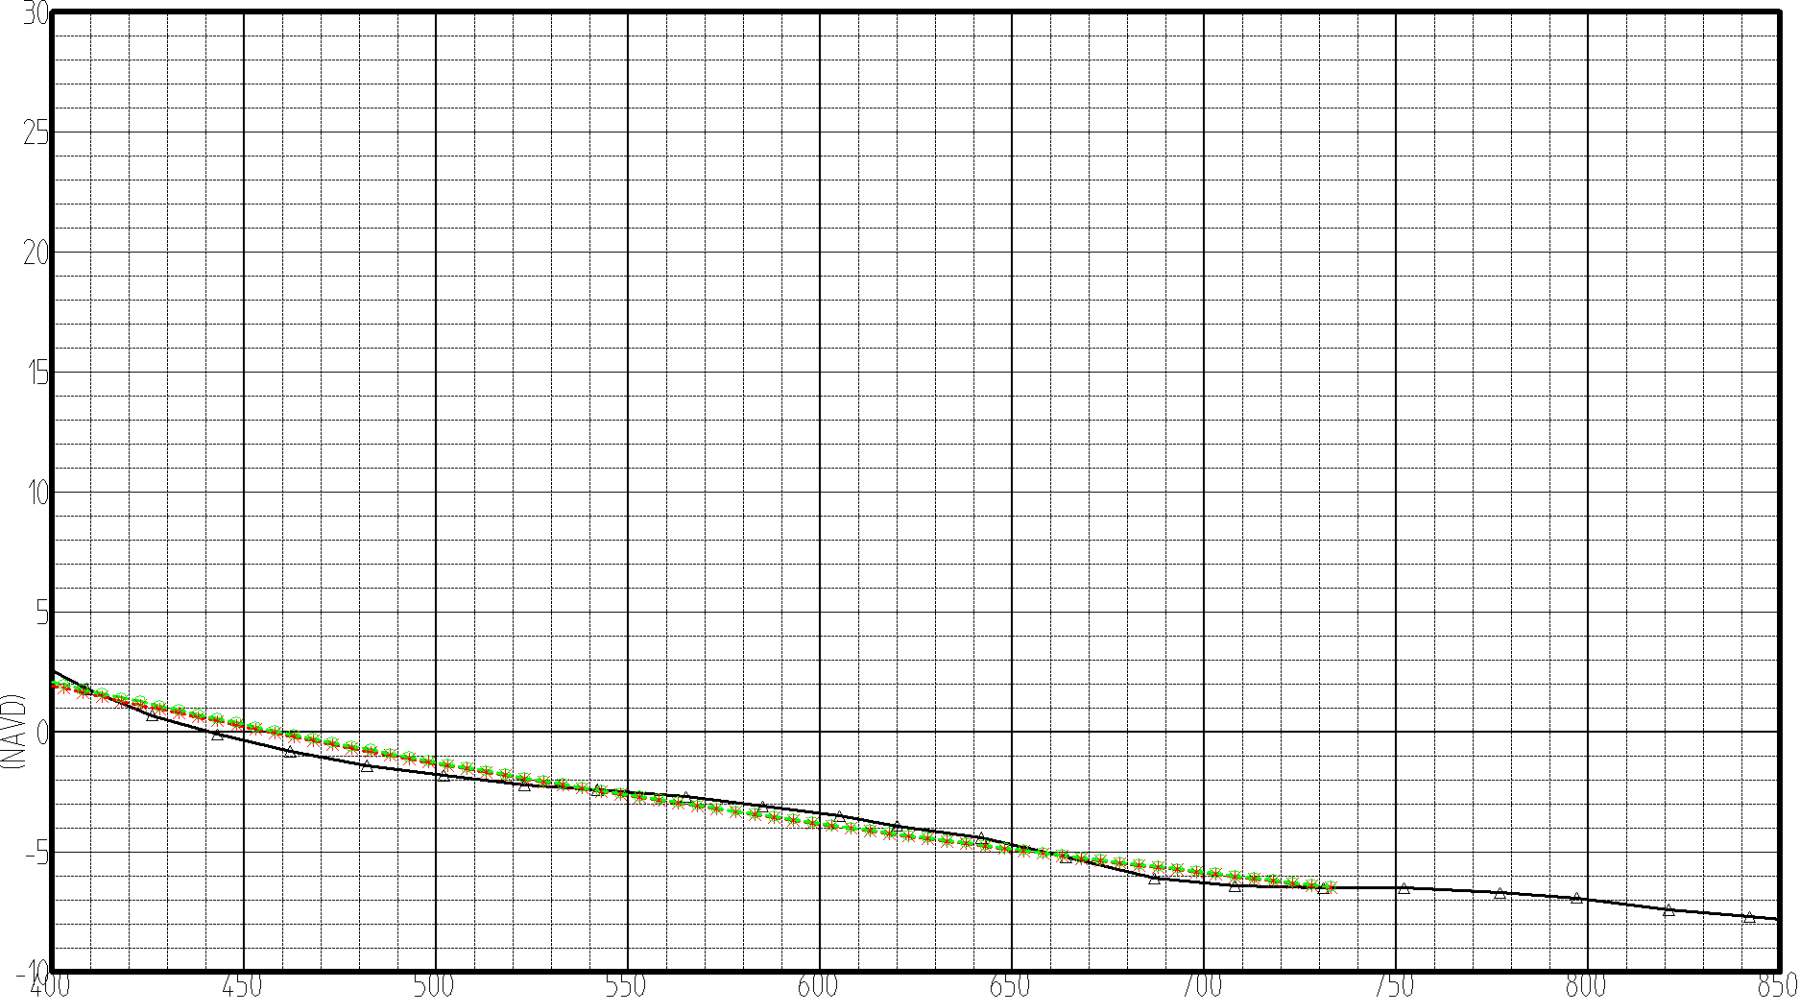
Range: R-40

BEACH PROFILE

—△—△— 2005-2008 INPUT PRF

- - * - - * - - 15-YR SBEACH ERODED PRF

- - ○ - - ○ - - 25-YR SBEACH ERODED PRF

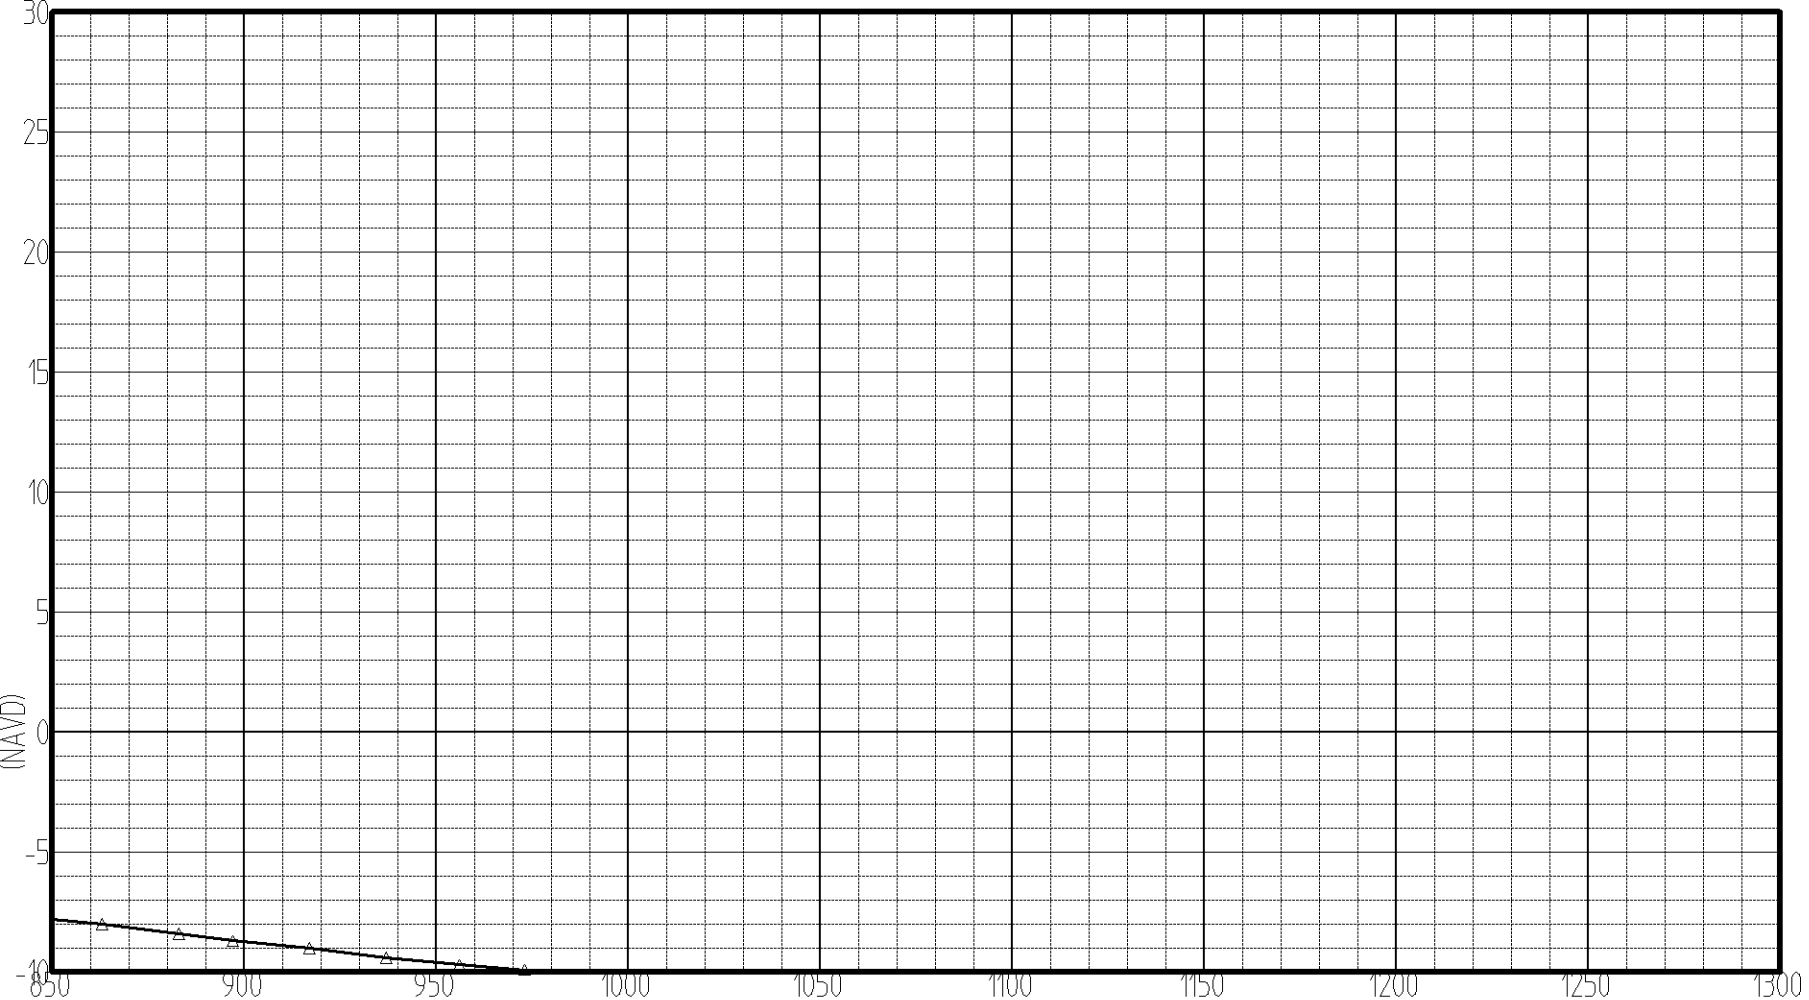
Range: R-40
 BEARING: 90.00
 3/3

BEACH PROFILE
 —△—△— 2005-2008 INPUT PRF
 - - * - - * - - 15-YR SBEACH ERODED PRF
 - - o - - o - - 25-YR SBEACH ERODED PRF

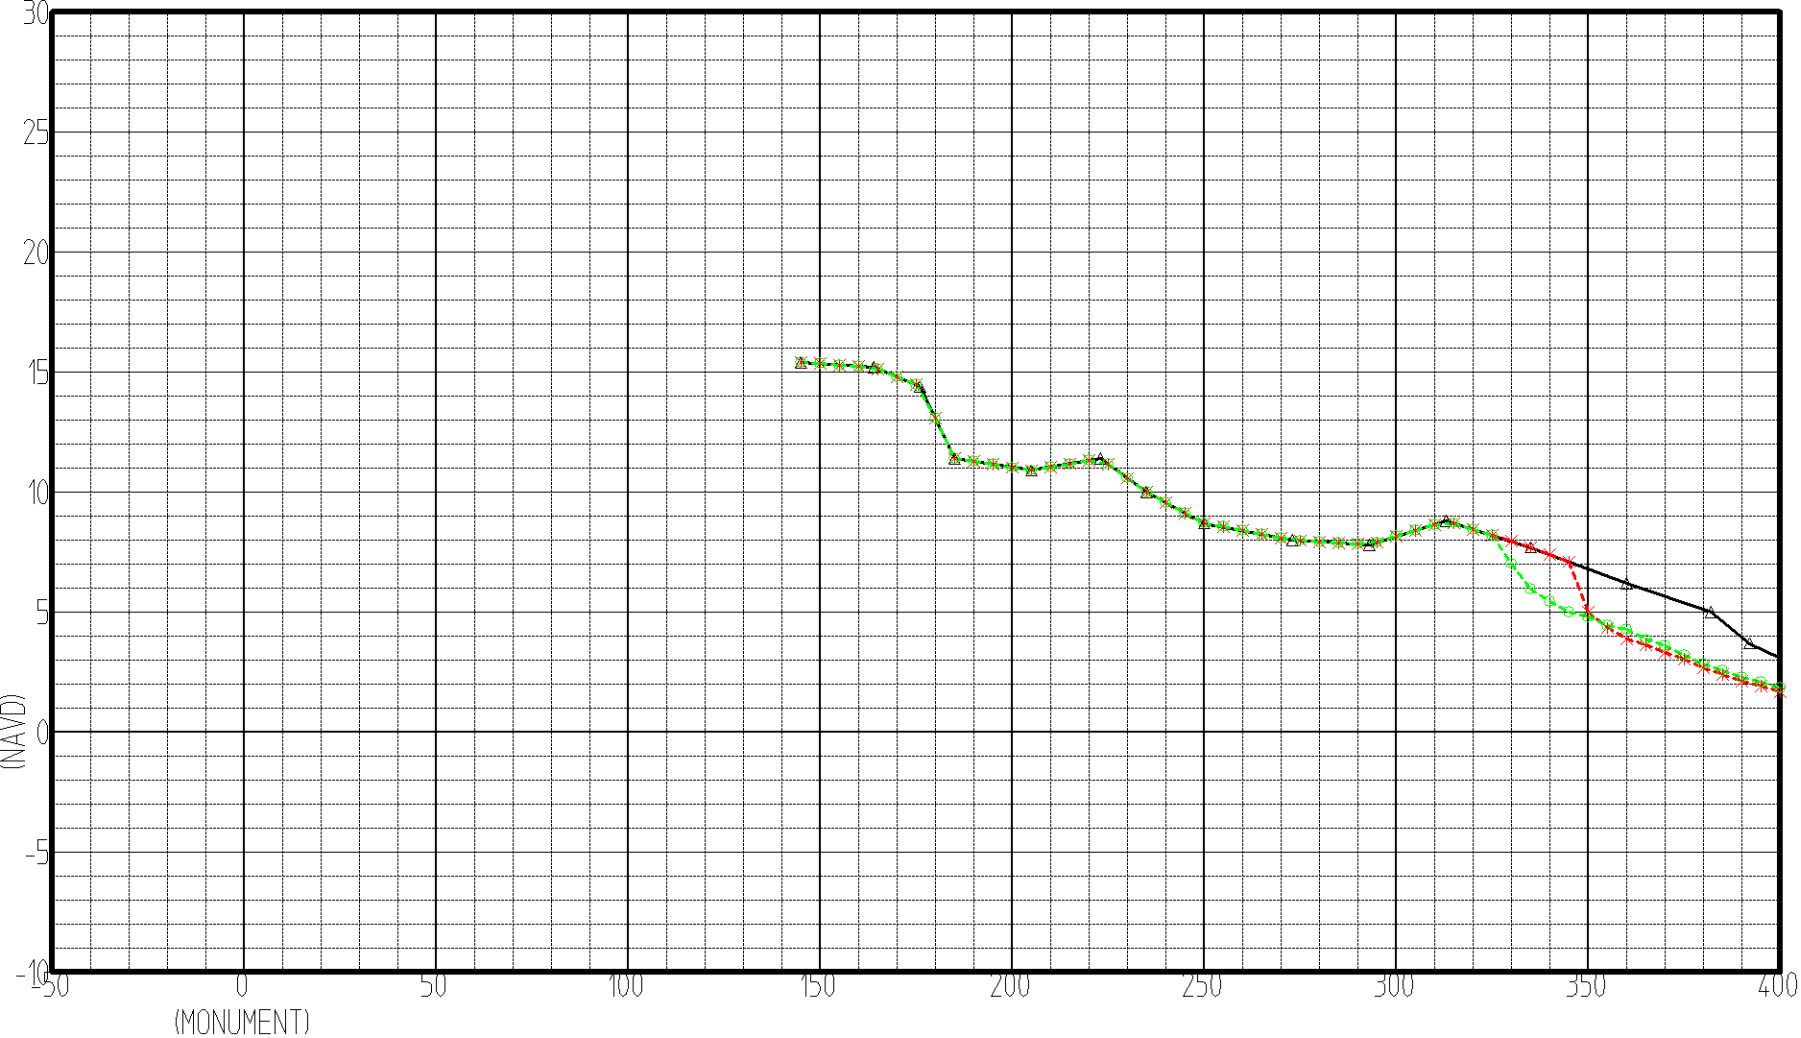
Range: R-41-T 1/3

BEACH PROFILE

—△—△— 2005-2008 INPUT PRF

- - - * - - - 15-YR SBEACH ERODED PRF

- - - o - - - 25-YR SBEACH ERODED PRF

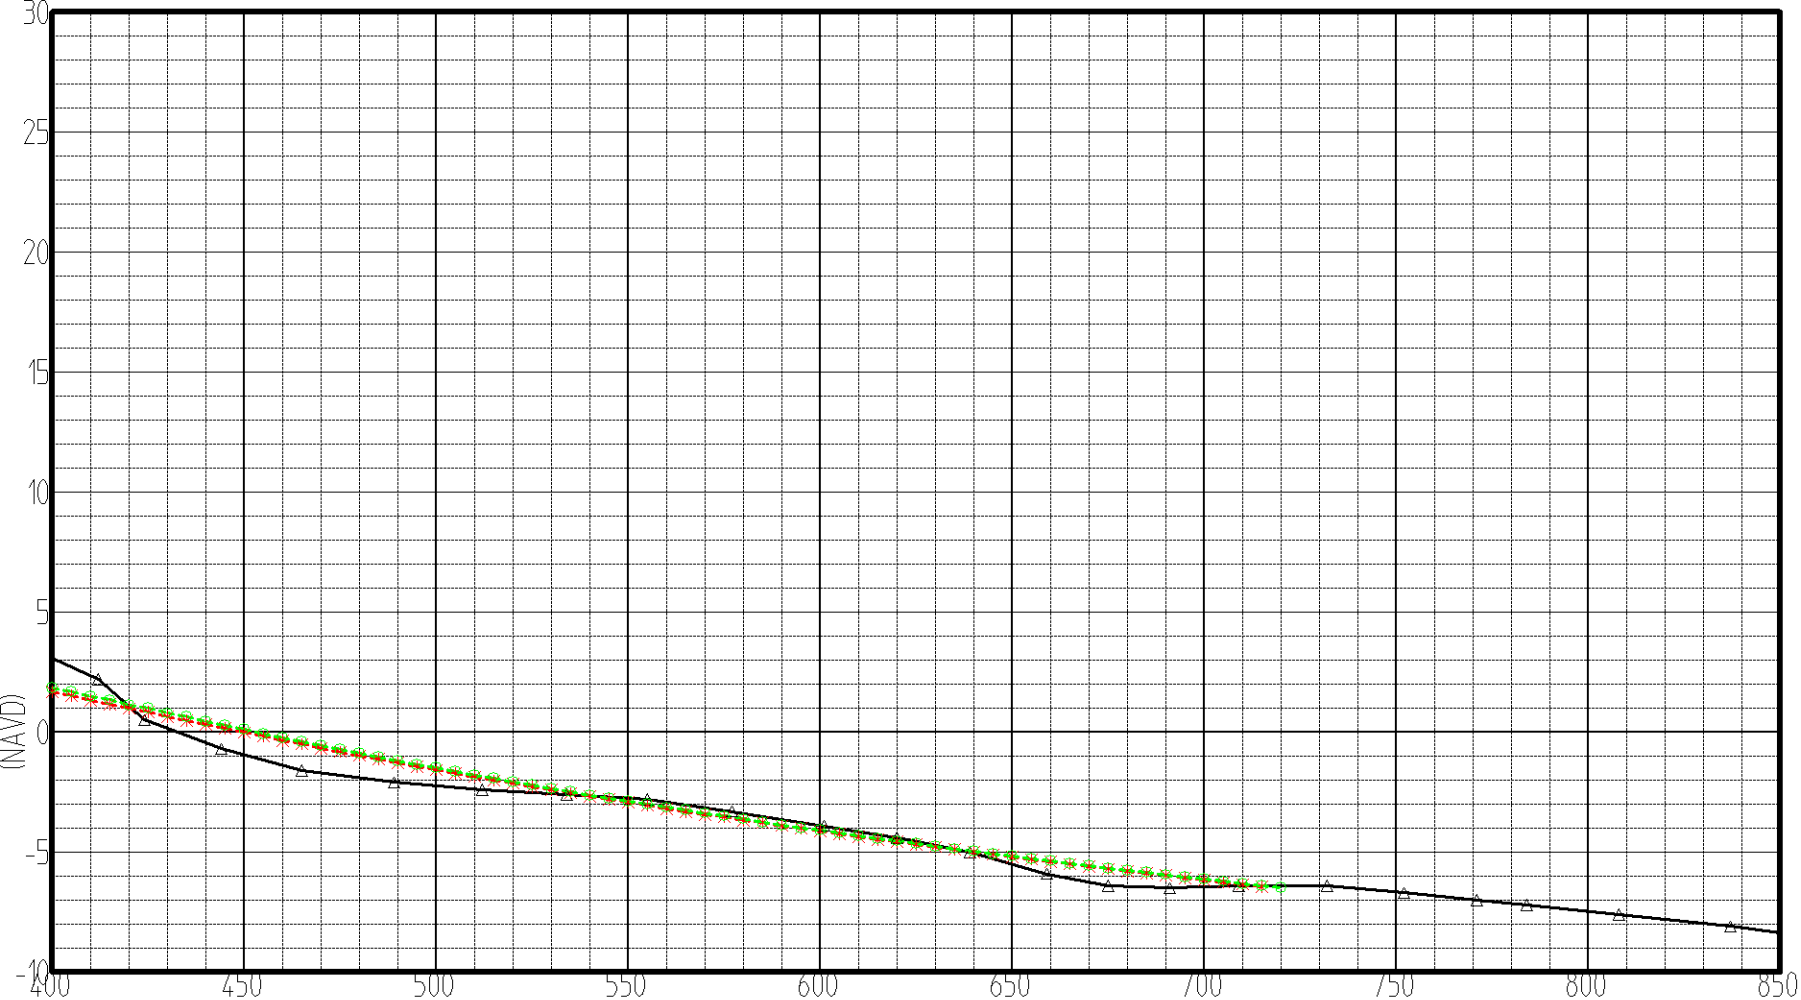
Range: R-41-T 2/3

BEACH PROFILE

—△—△— 2005-2008 INPUT PRF

- - - * - - - 15-YR SBEACH ERODED PRF

- - - o - - - 25-YR SBEACH ERODED PRF

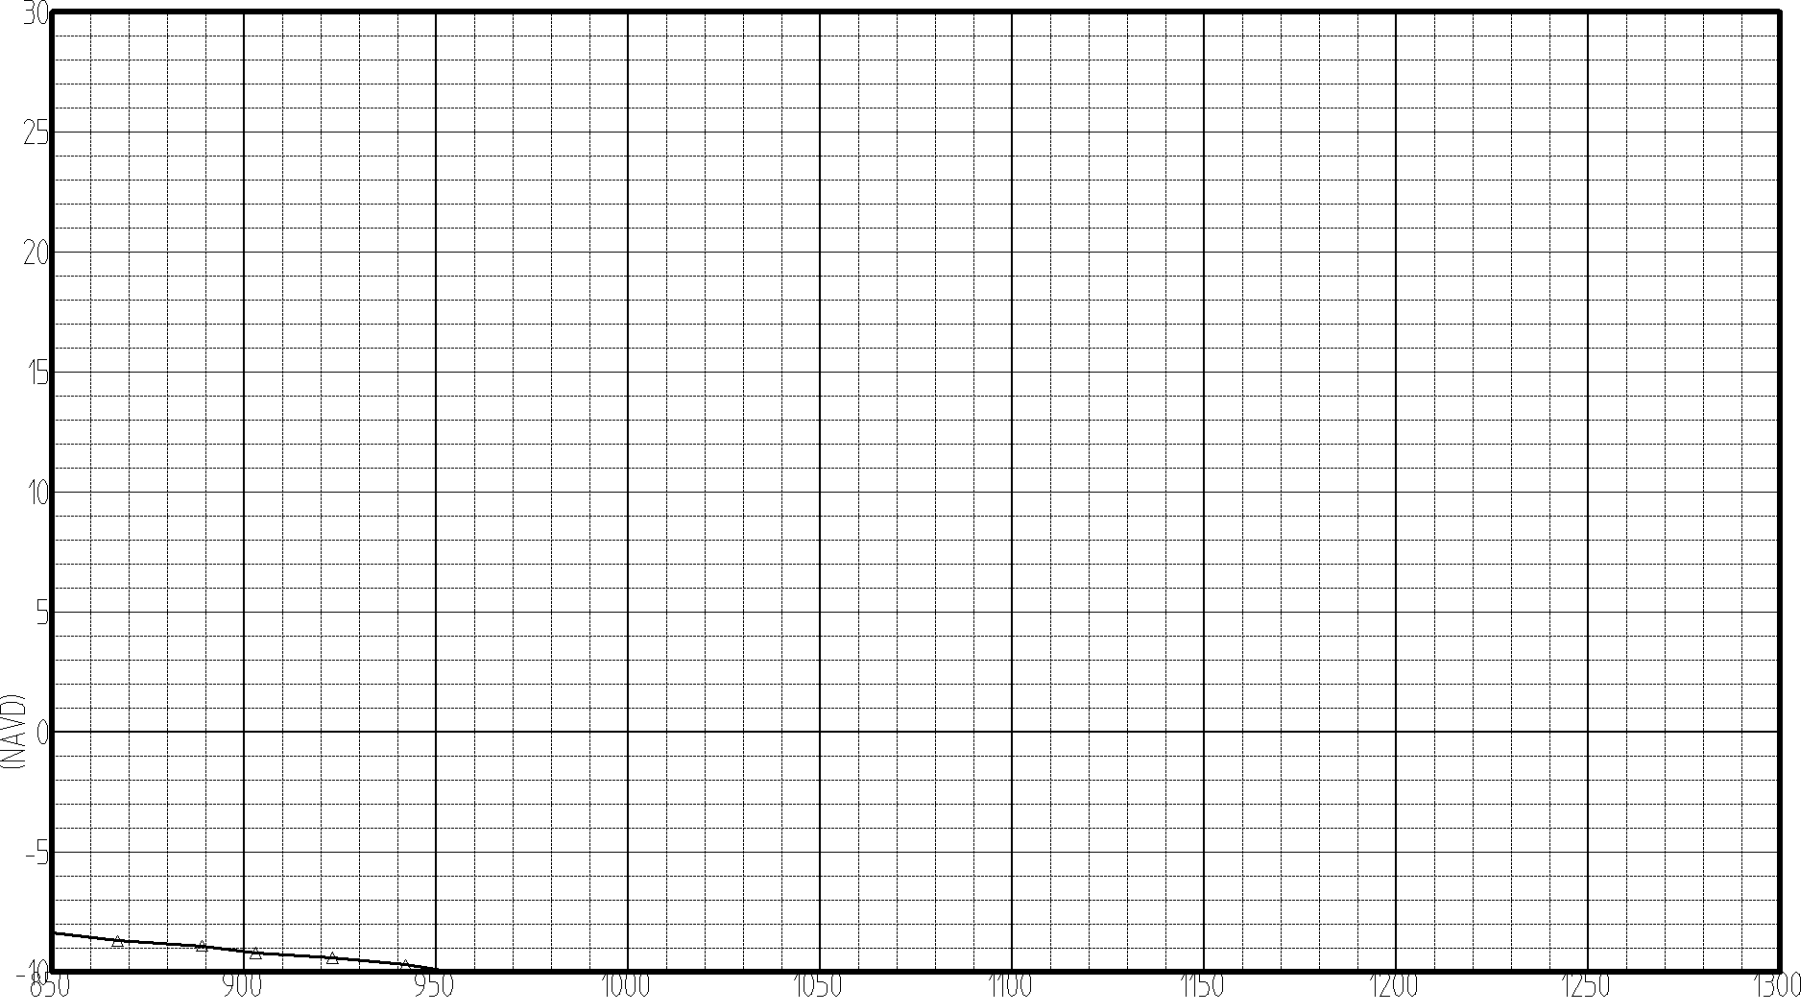
Range: R-41-T

BEACH PROFILE

—△—△— 2005-2008 INPUT PRF

- - - * - - - * - - - 15-YR SBEACH ERODED PRF

- - - o - - - o - - - 25-YR SBEACH ERODED PRF

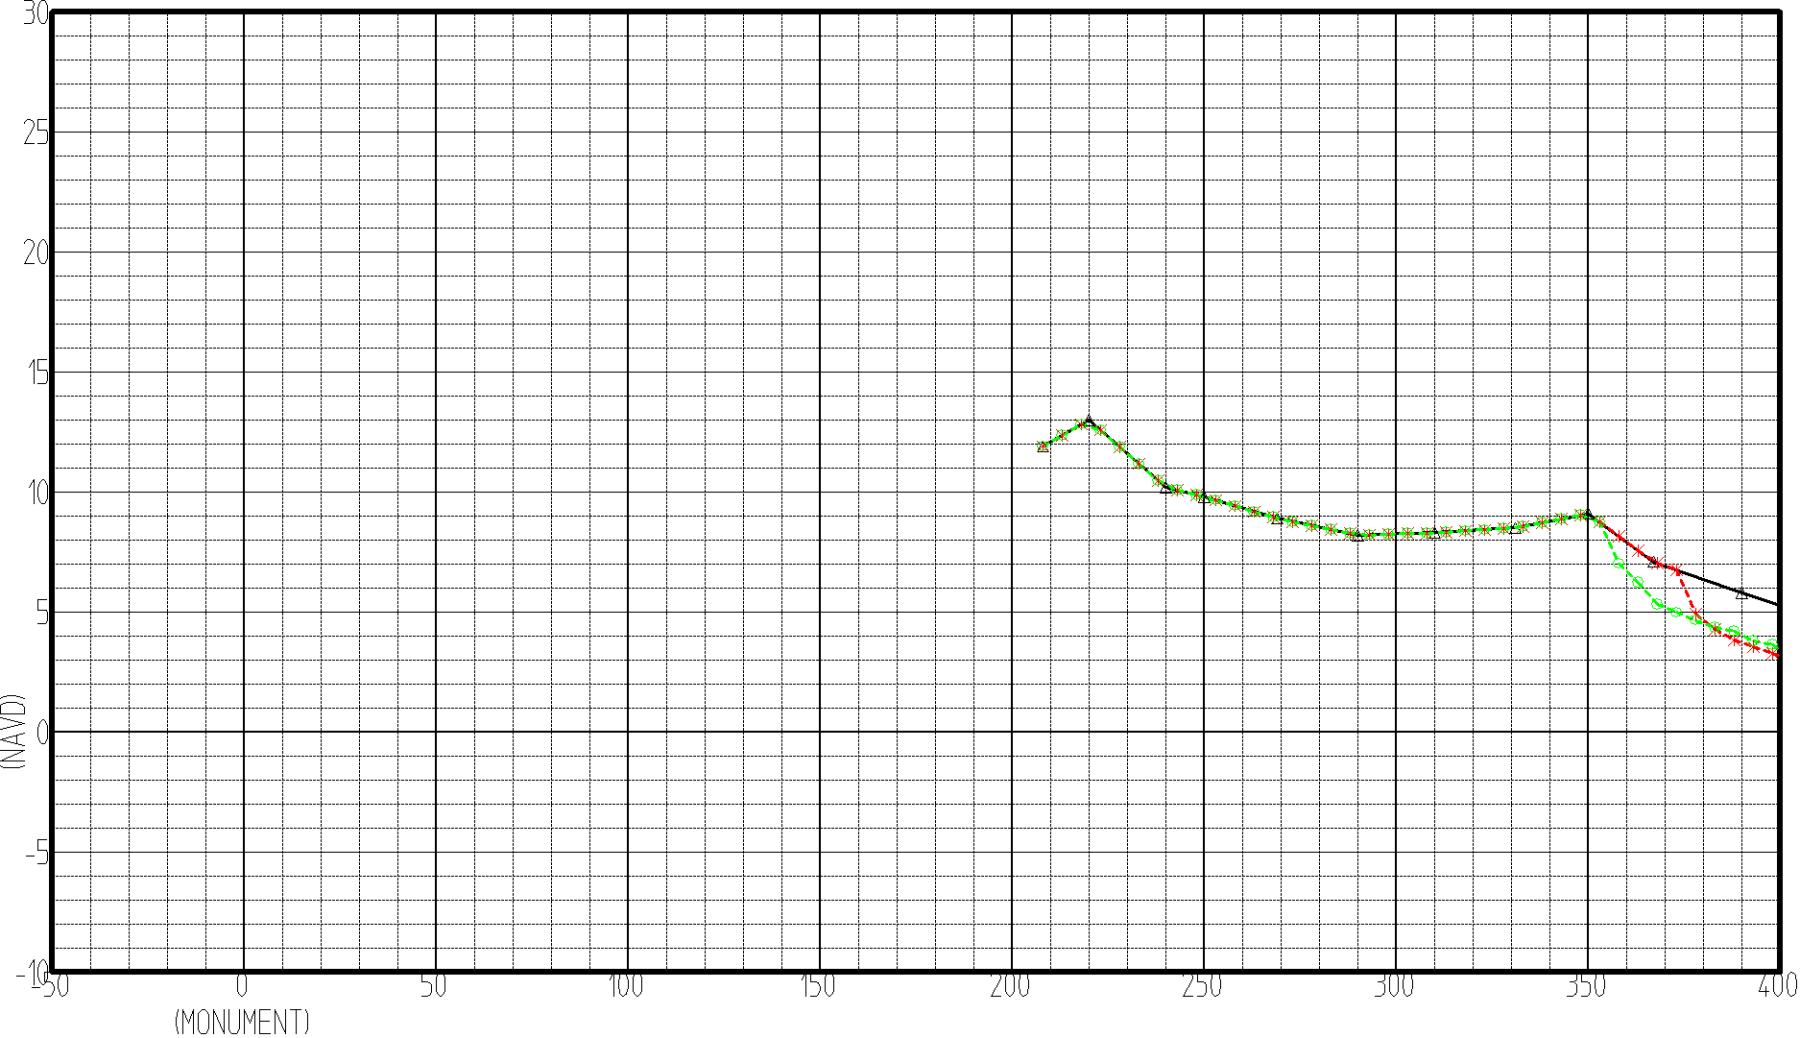
Range: R-42 1/3

BEACH PROFILE

- △—△— 2005-2008 INPUT PRF
- - - * - - - 15-YR SBEACH ERODED PRF
- - - o - - - 25-YR SBEACH ERODED PRF

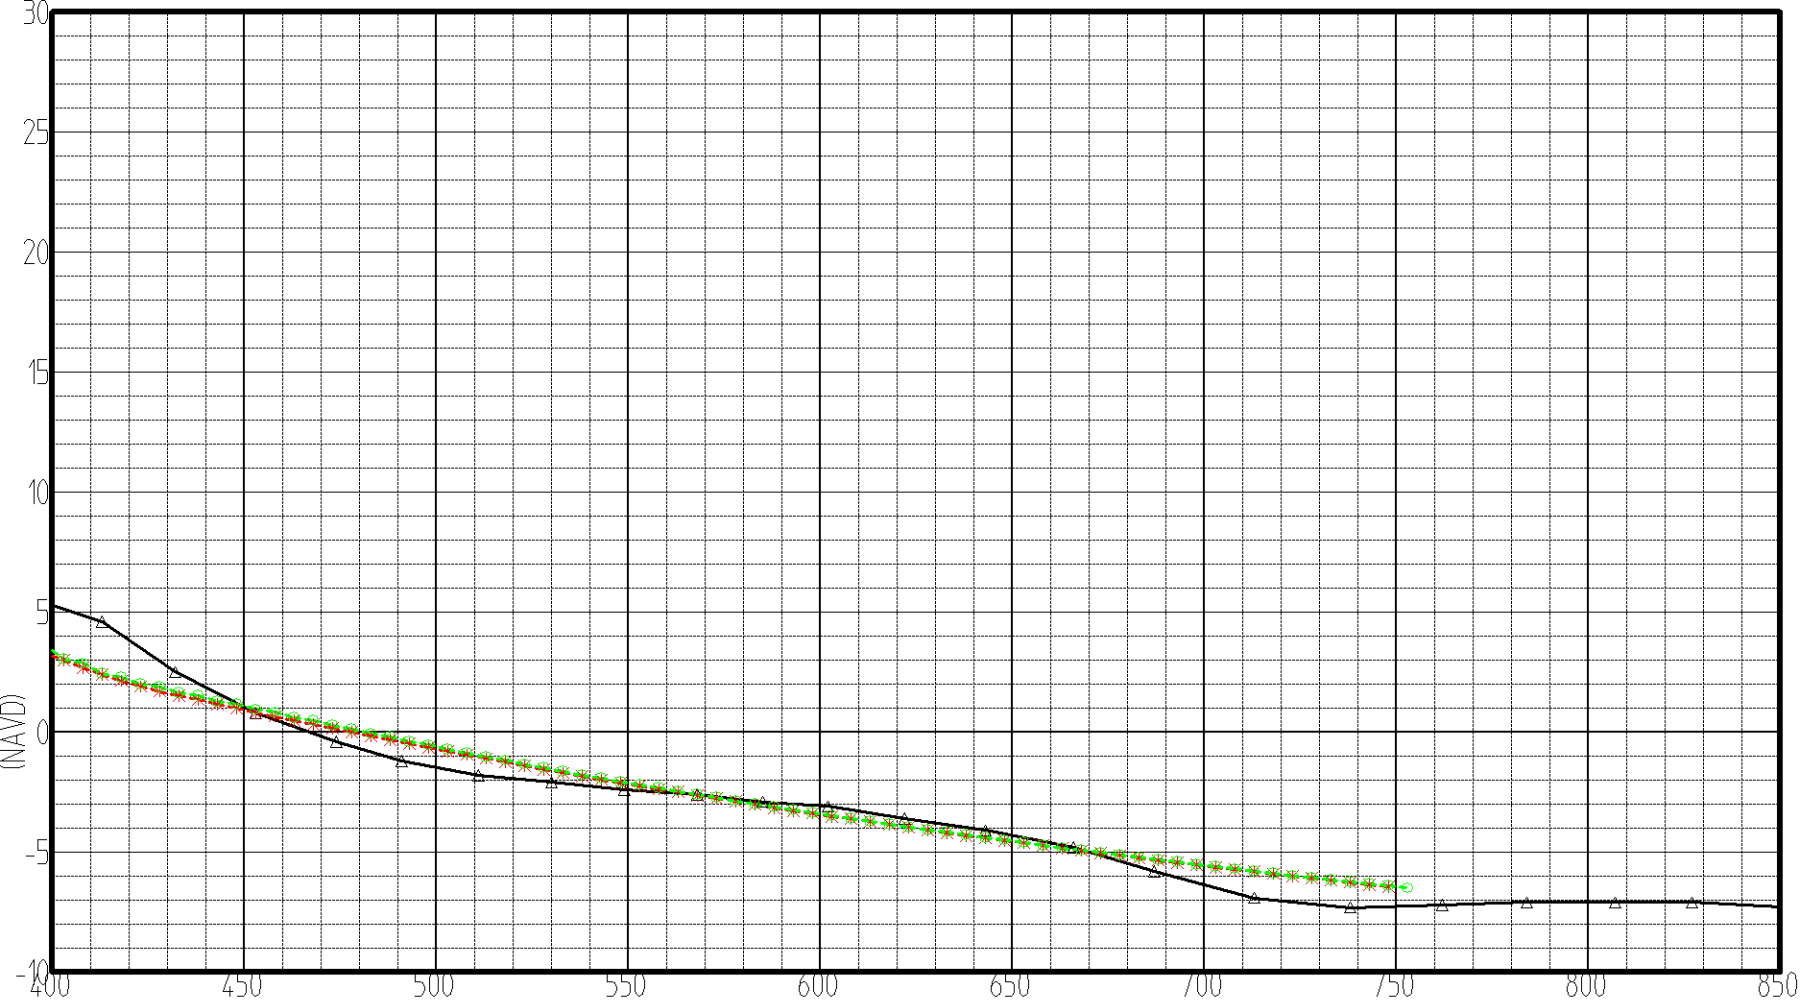
Range: R-42 2/3

BEACH PROFILE

—△—△— 2005-2008 INPUT PRF

- - * - - * - - 15-YR SBEACH ERODED PRF

- - o - - o - - 25-YR SBEACH ERODED PRF

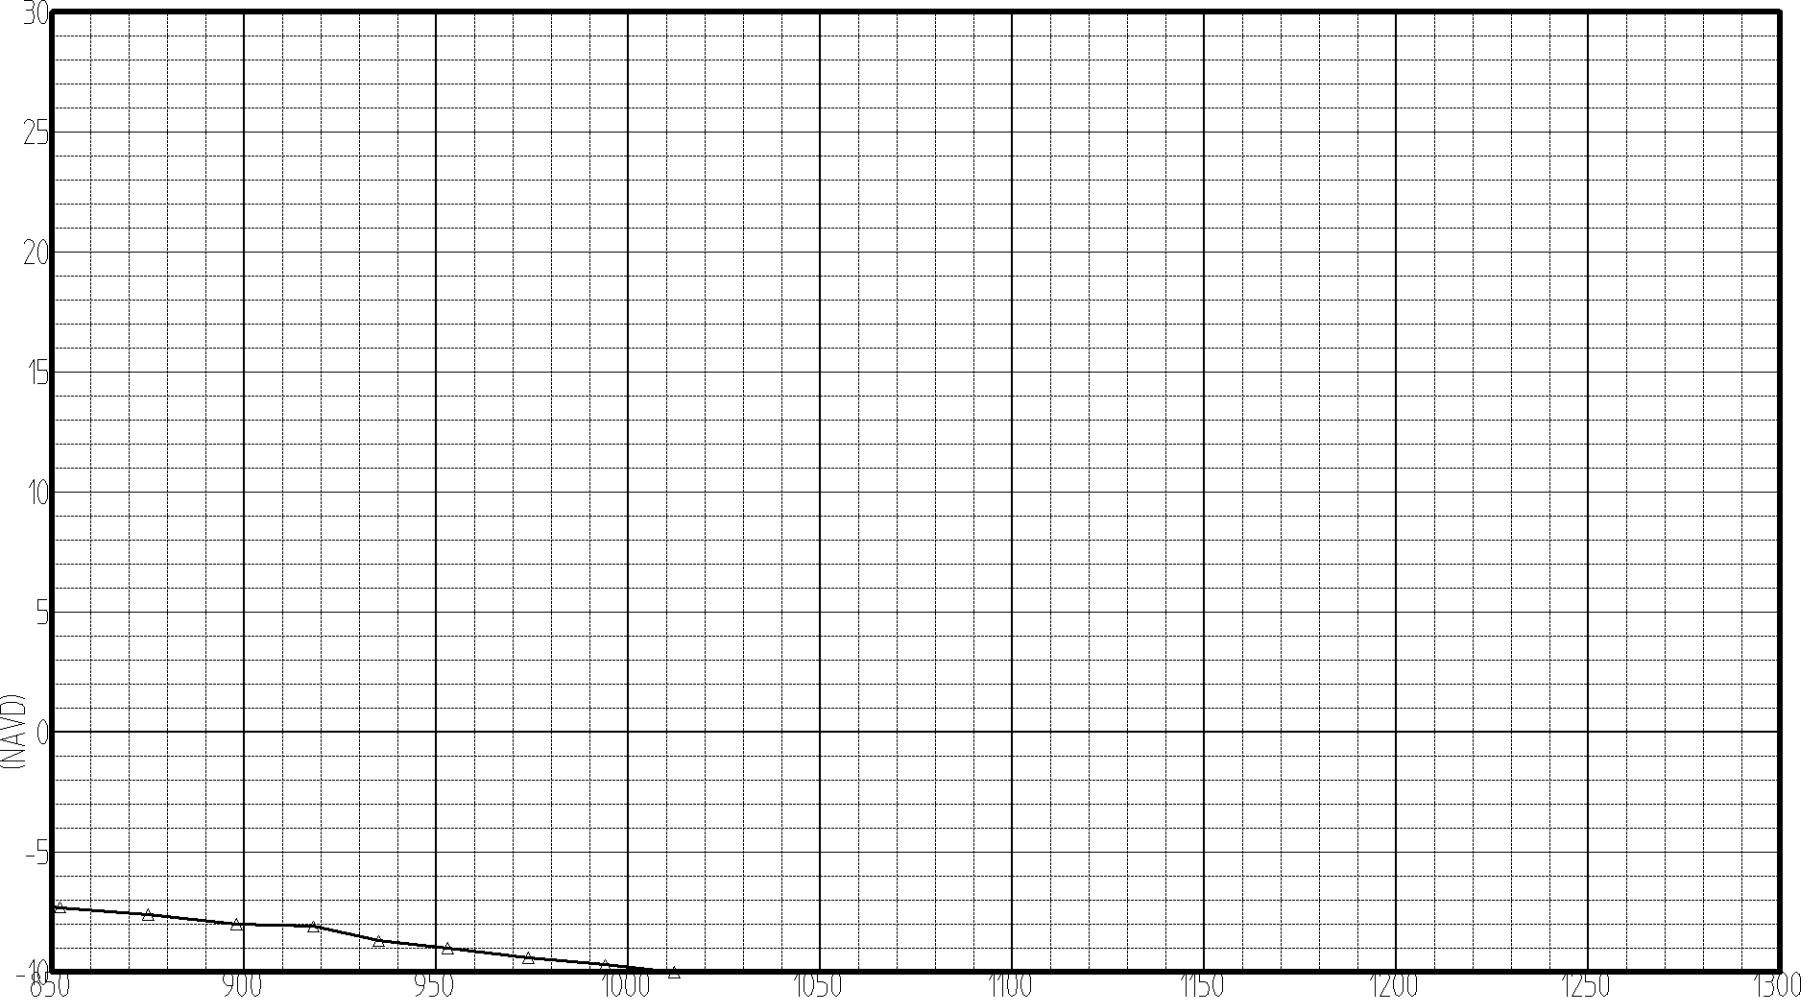
Range: R-42
 BEARING: 90.00
 3/3

BEACH PROFILE
 —△—△— 2005-2008 INPUT PRF
 - - * - - * - - 15-YR SBEACH ERODED PRF
 - - ○ - - ○ - - 25-YR SBEACH ERODED PRF

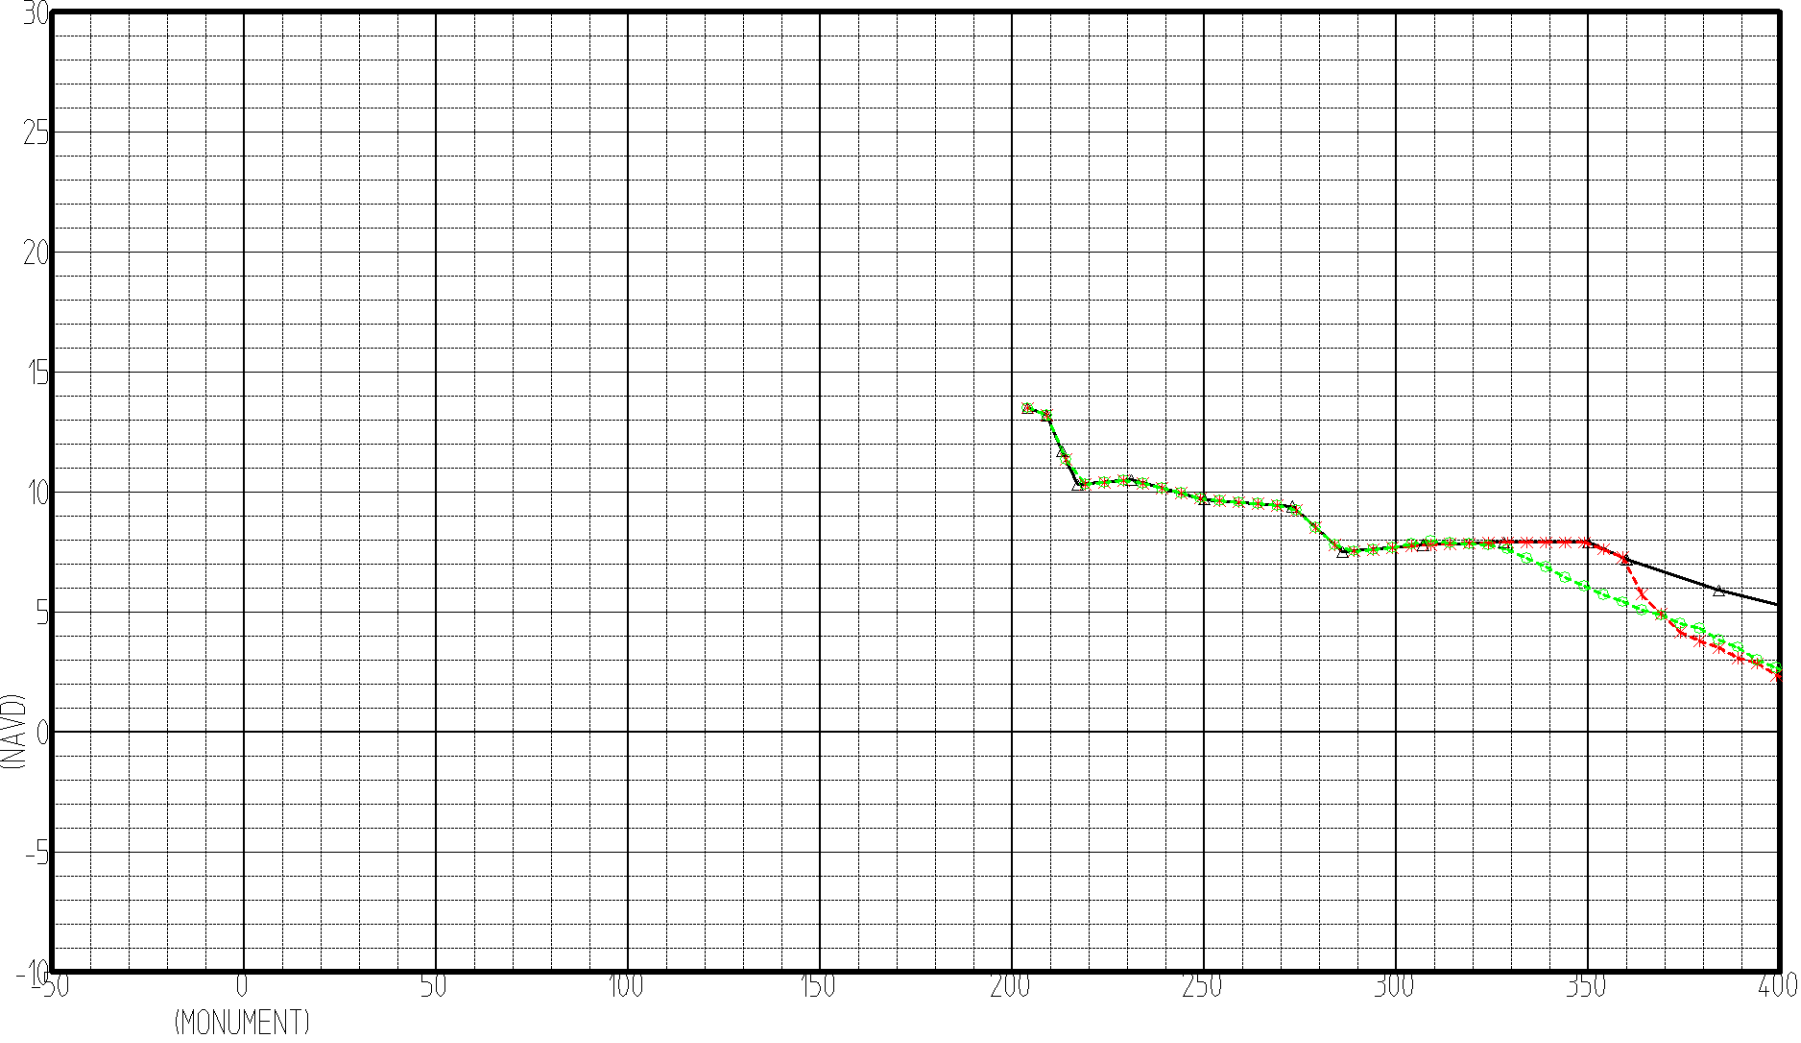
Range: R-43-T 1/3
 BEARING: 90.00

BEACH PROFILE
 —△—△— 2005-2008 INPUT PRF
 - - * - - * - - 15-YR SBEACH ERODED PRF
 - - o - - o - - 25-YR SBEACH ERODED PRF

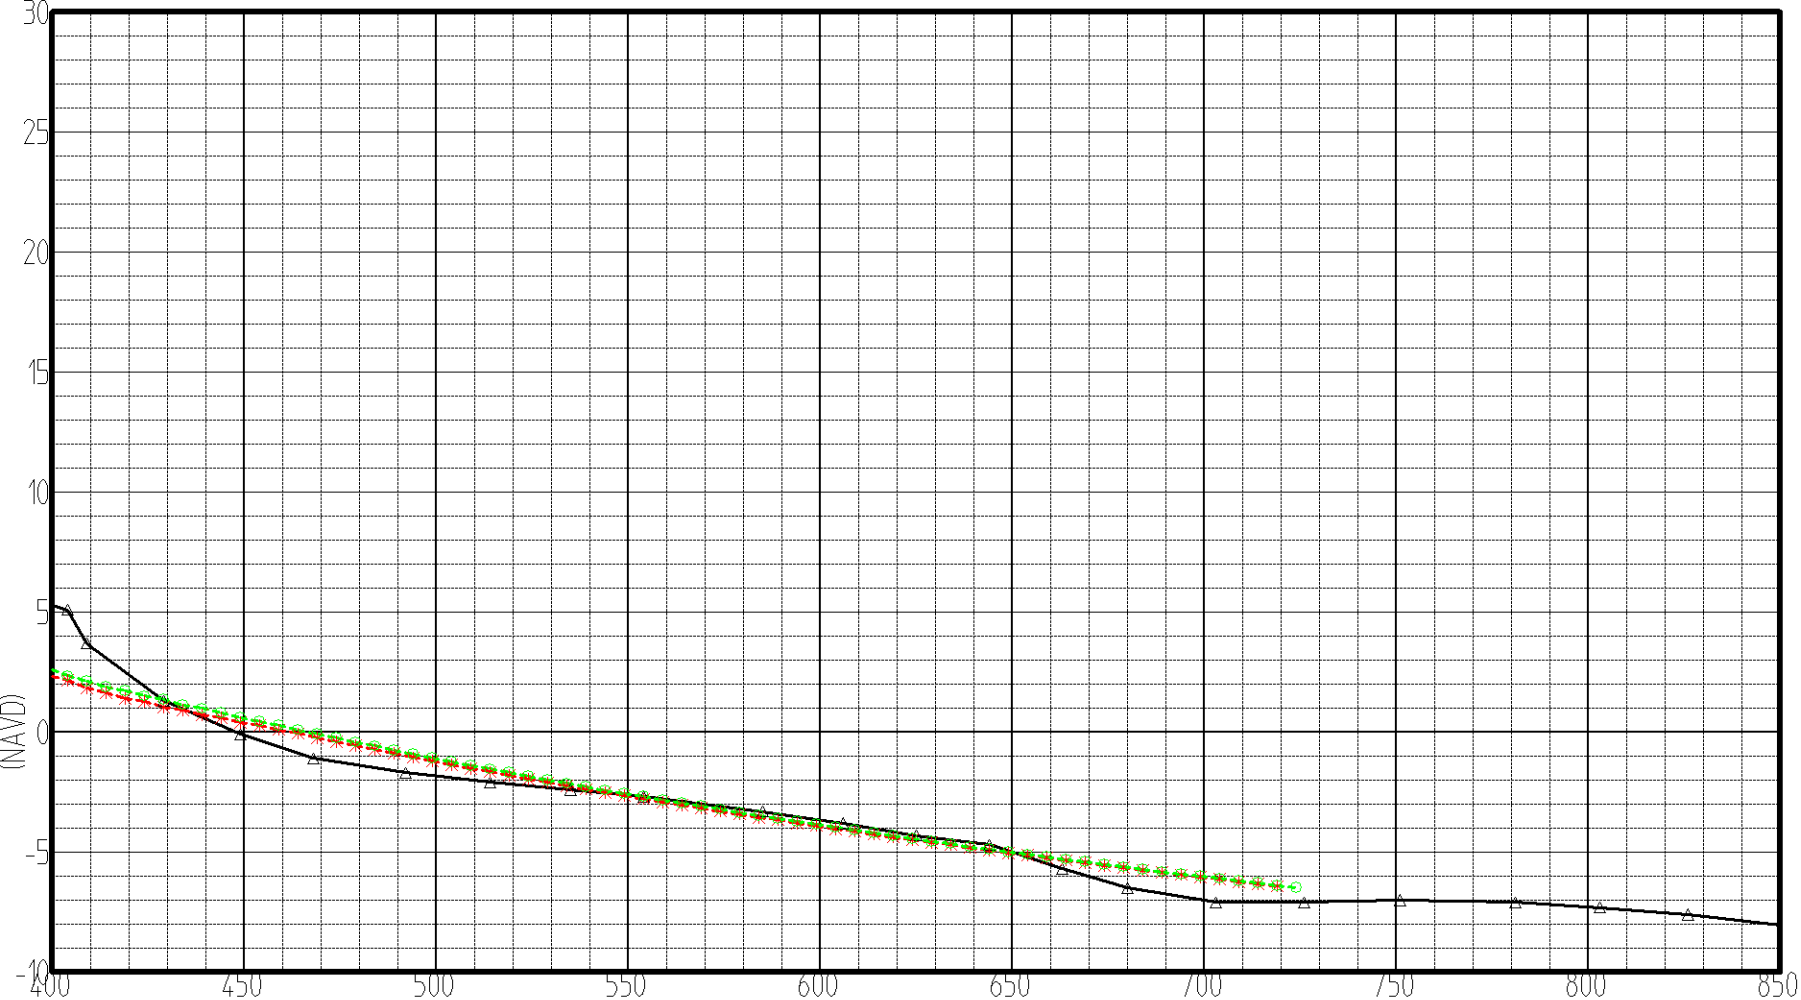
Range: R-43-T 2/3

BEACH PROFILE

—△—△— 2005-2008 INPUT PRF

- - - * - - - 15-YR SBEACH ERODED PRF

- - - o - - - 25-YR SBEACH ERODED PRF
