Appendix XI

SBEACH 15 and 25 yr. Storm Erosion Profiles

Brevard County

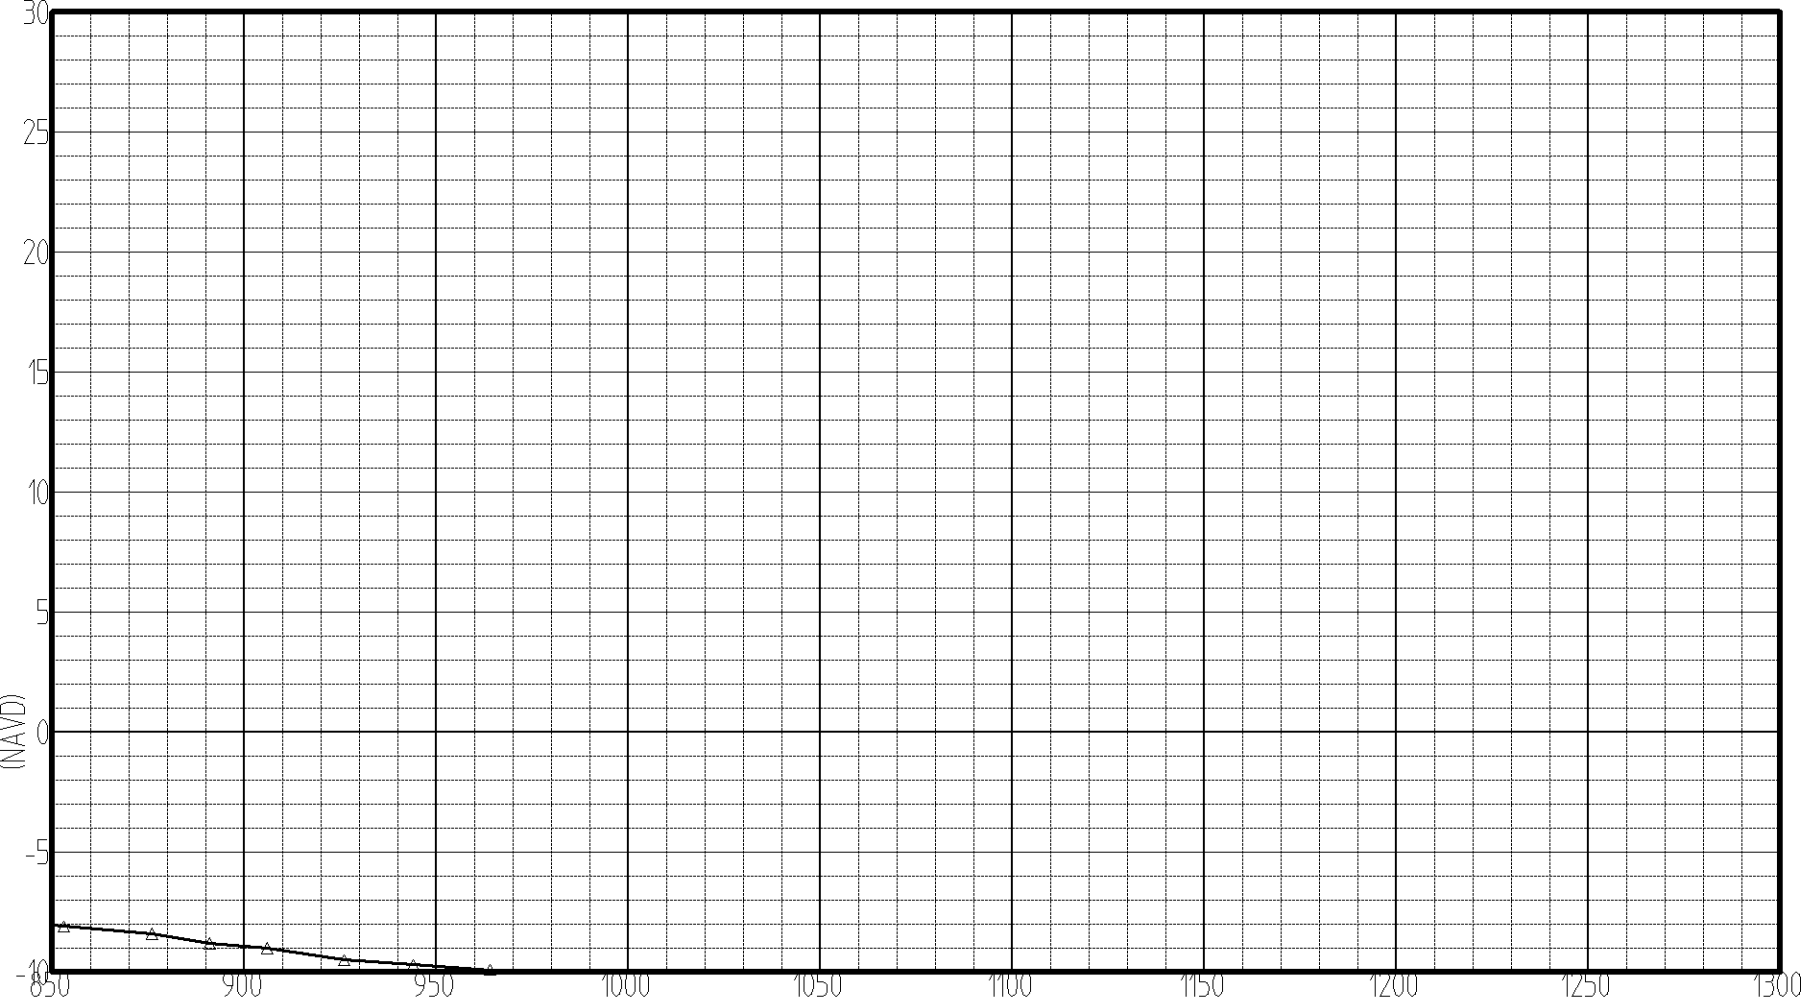
Range: R-43-T

BEACH PROFILE

—△—△— 2005-2008 INPUT PRF

- - - * - - - 15-YR SBEACH ERODED PRF

- - - o - - - 25-YR SBEACH ERODED PRF

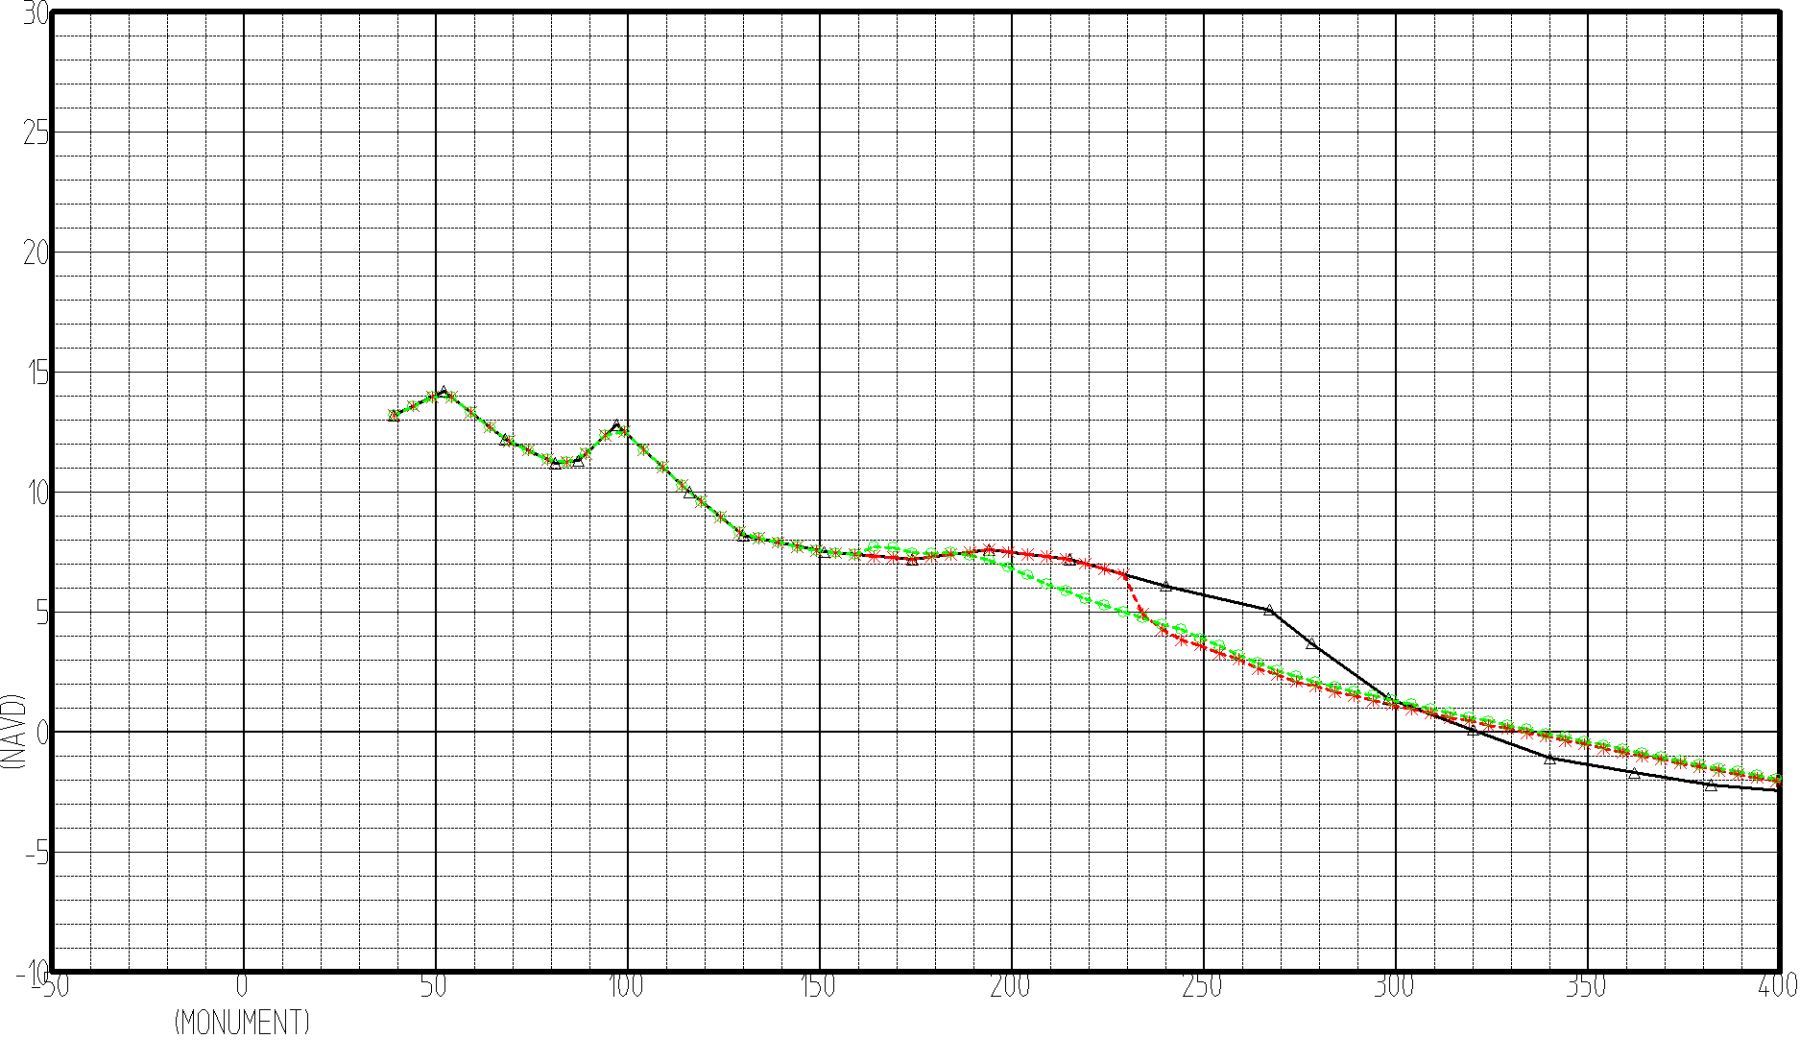
Range: R-44

BEACH PROFILE

- △—△— 2005-2008 INPUT PRF
- - * - - * - - 15-YR SBEACH ERODED PRF
- - o - - o - - 25-YR SBEACH ERODED PRF

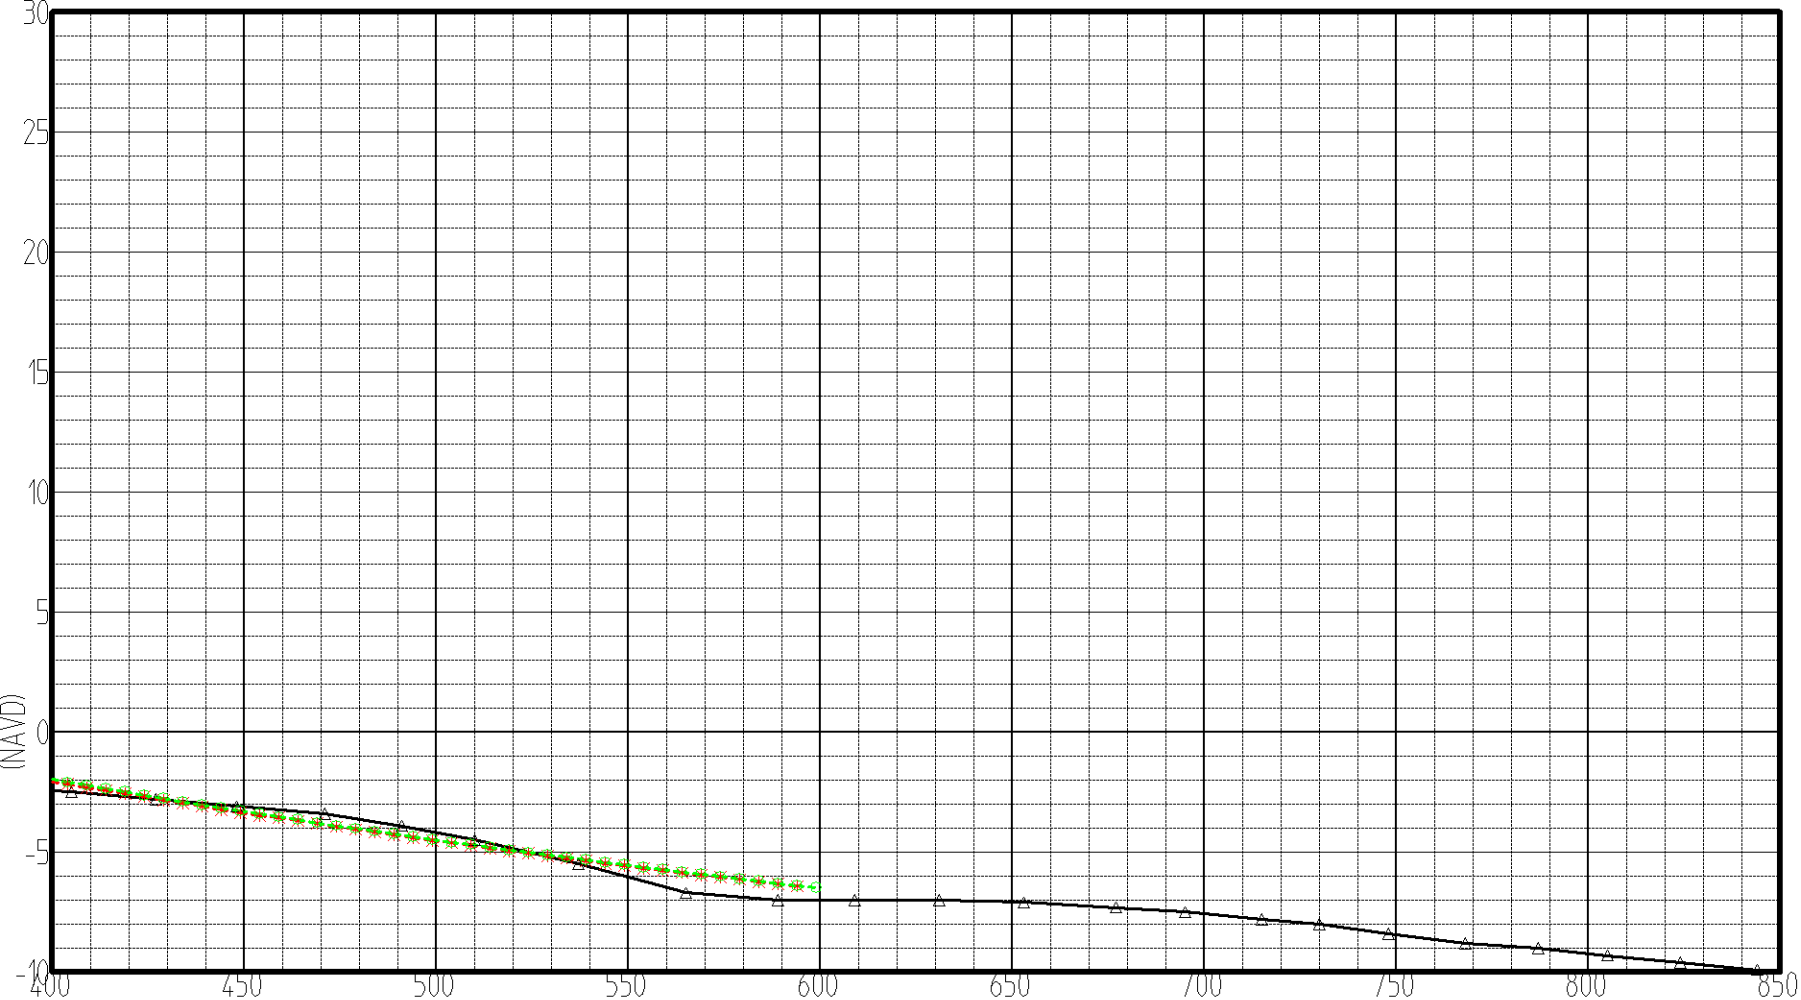
Range: R-44 2/3
 BEARING: 90.00

BEACH PROFILE
 —△—△— 2005-2008 INPUT PRF
 - - * - - * - - 15-YR SBEACH ERODED PRF
 - - o - - o - - 25-YR SBEACH ERODED PRF

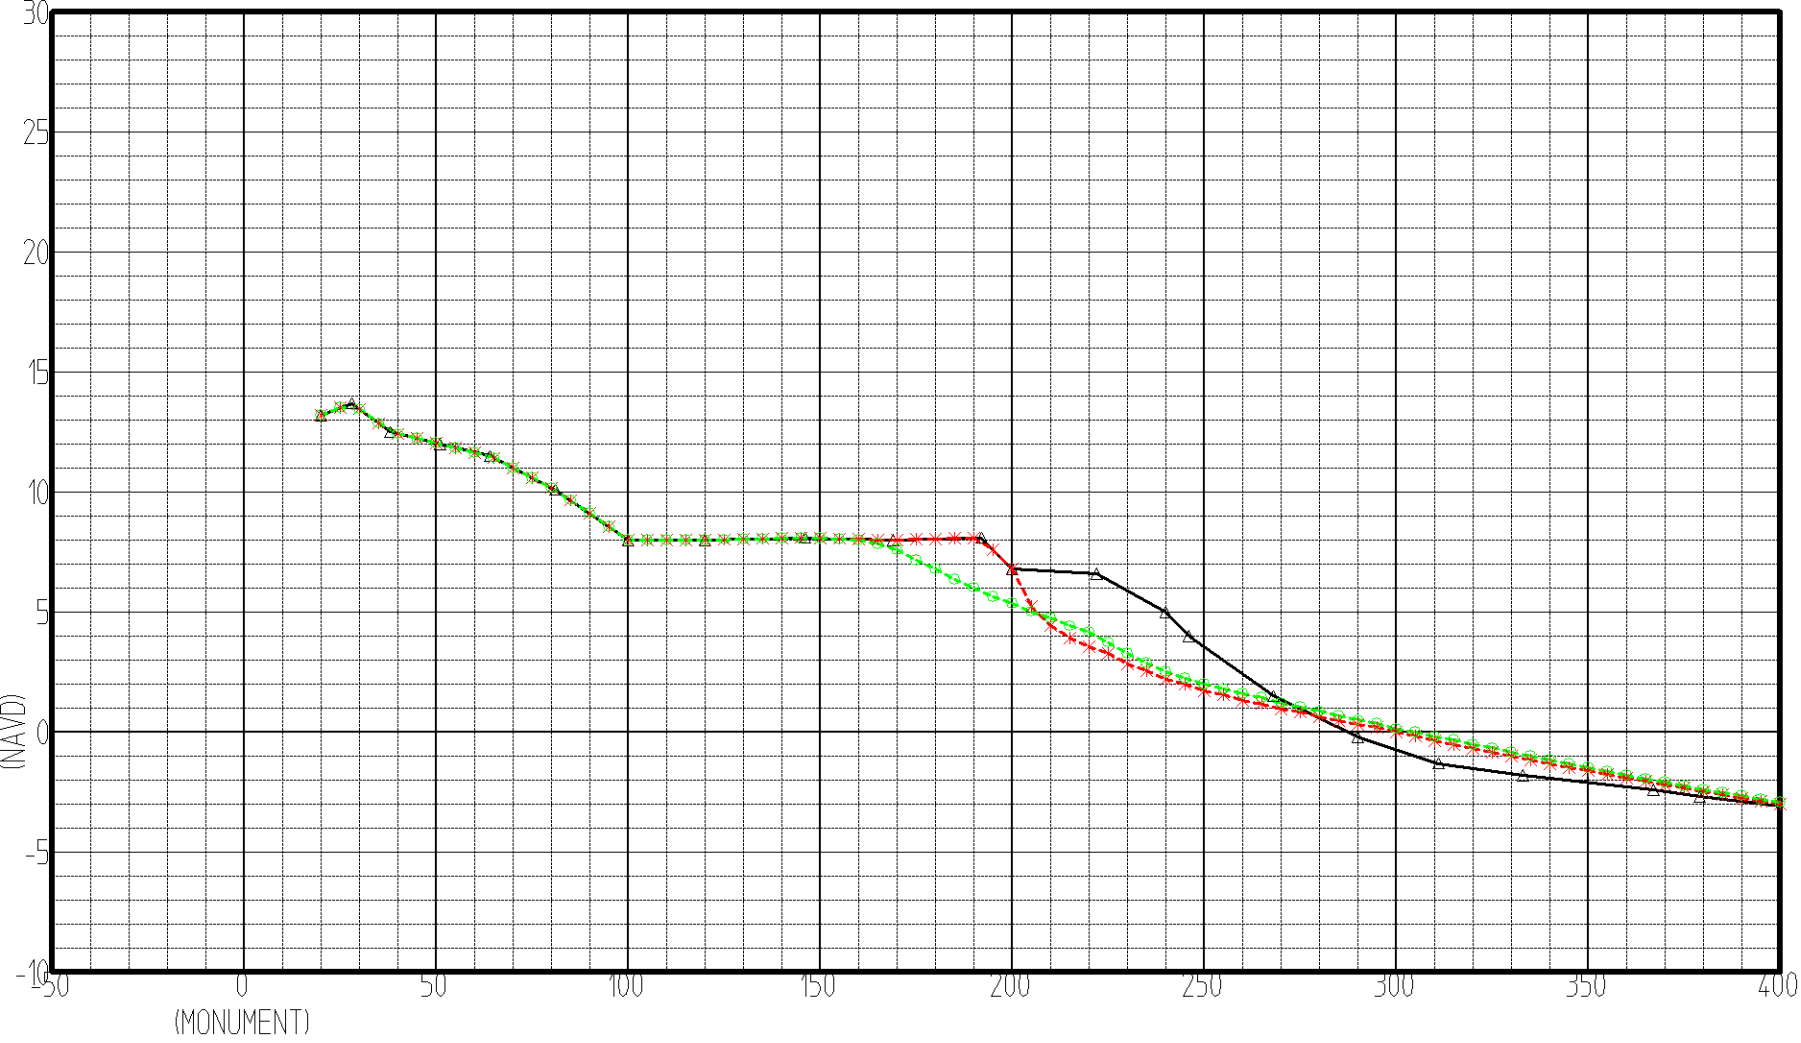
Range: R-45

BEACH PROFILE

—△—△— 2005-2008 INPUT PRF

- - - * - - - 15-YR SBEACH ERODED PRF

- - - o - - - 25-YR SBEACH ERODED PRF

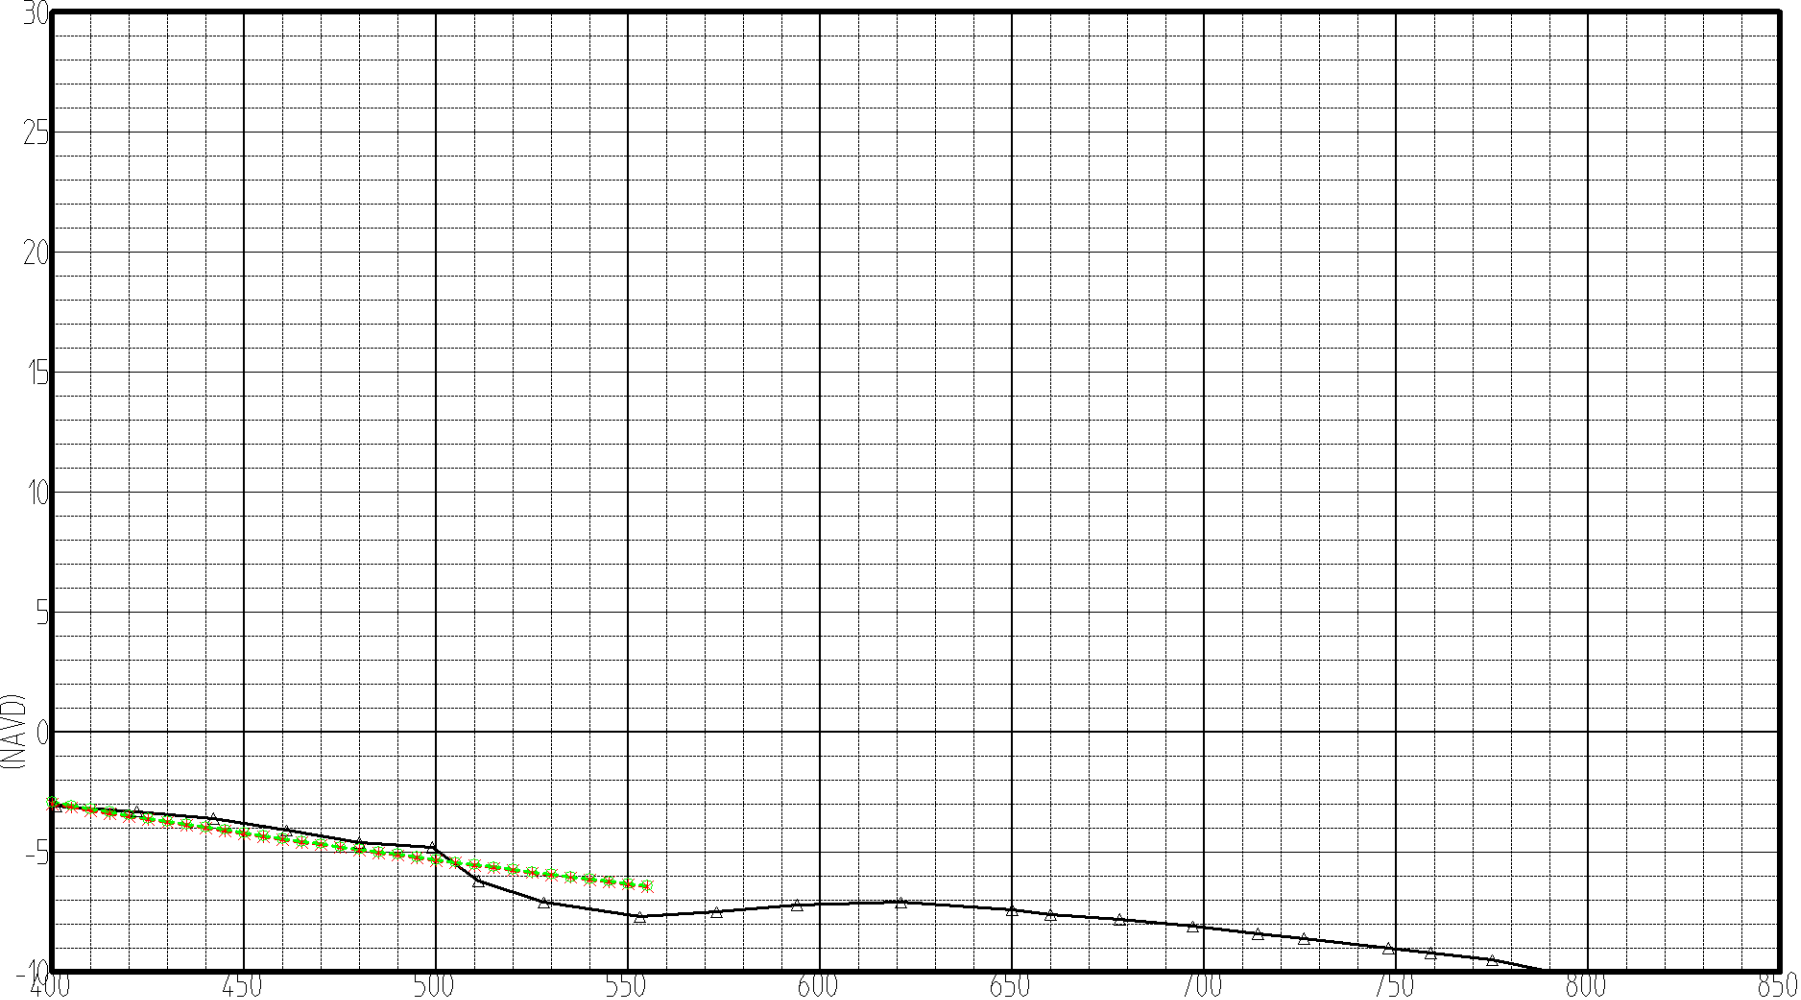
Range: R-45

BEACH PROFILE

—△—△— 2005-2008 INPUT PRF

- - - * - - - 15-YR SBEACH ERODED PRF

- - - o - - - 25-YR SBEACH ERODED PRF

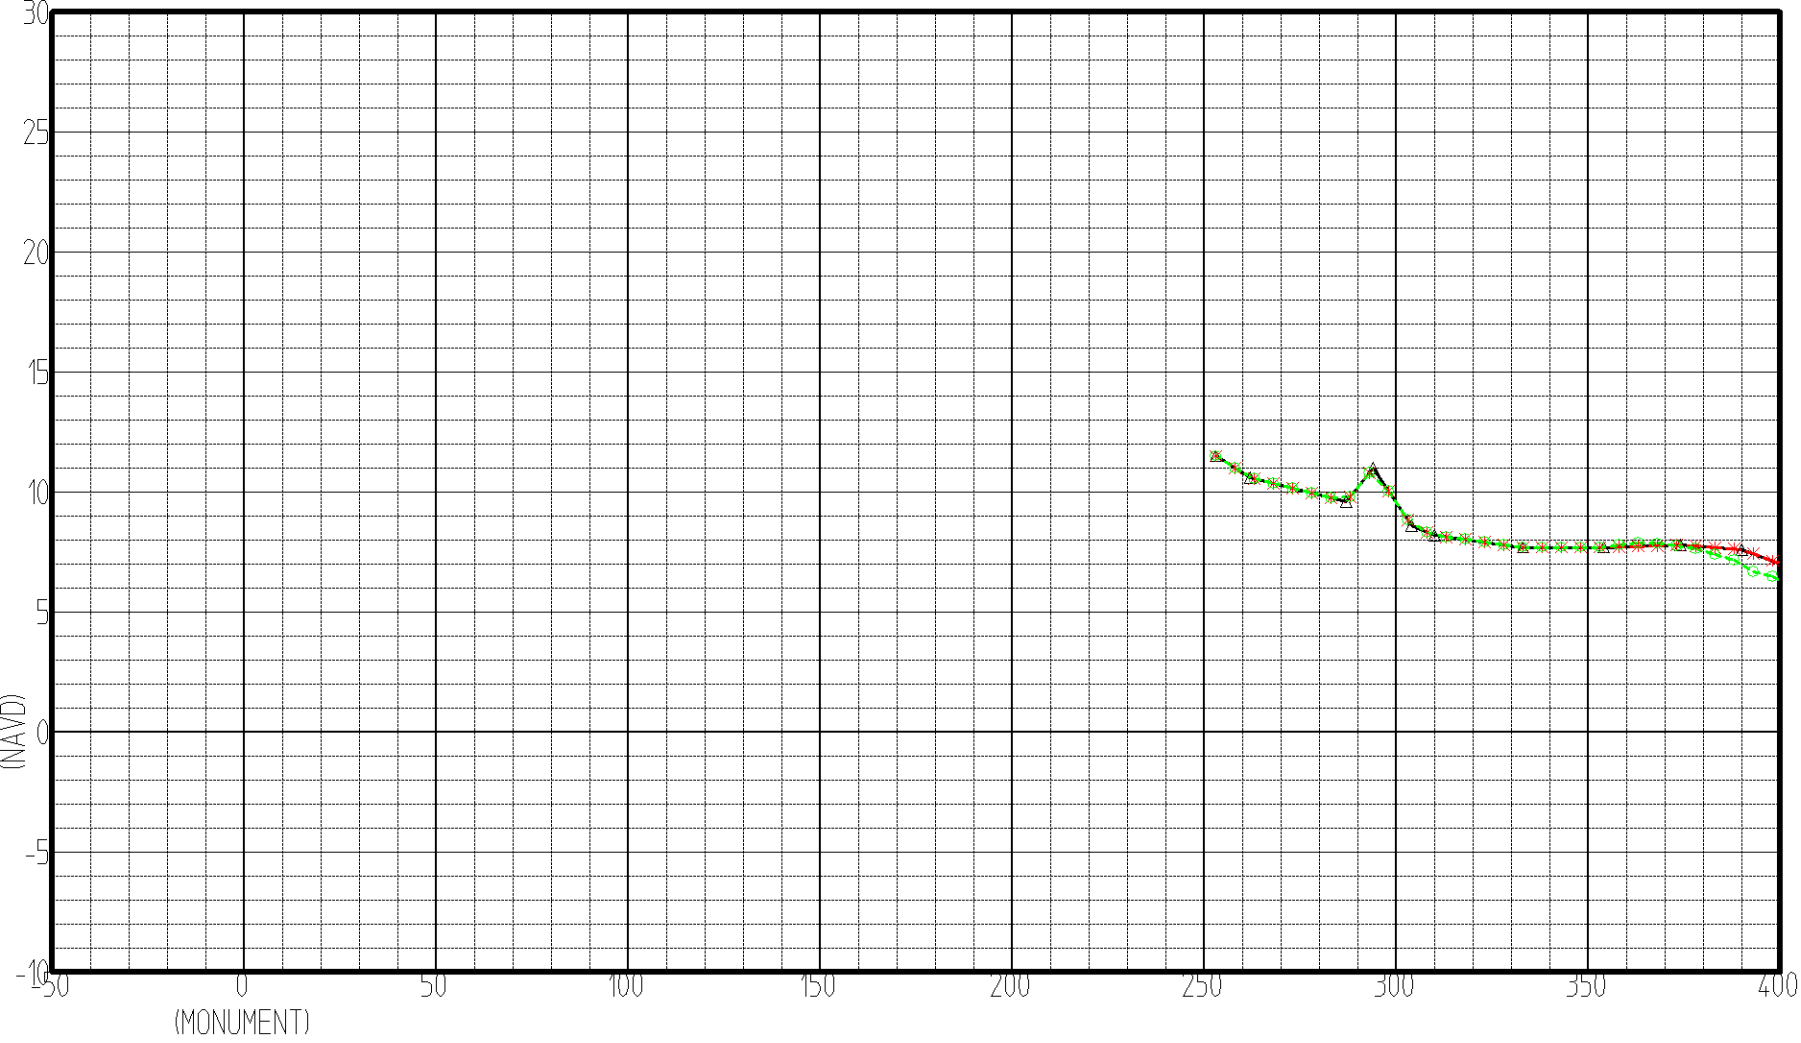
Range: R-46
 BEARING: 90.00
 1/3

BEACH PROFILE
 —△—△— 2005-2008 INPUT PRF
 - - * - - * - - 15-YR SBEACH ERODED PRF
 - - o - - o - - 25-YR SBEACH ERODED PRF

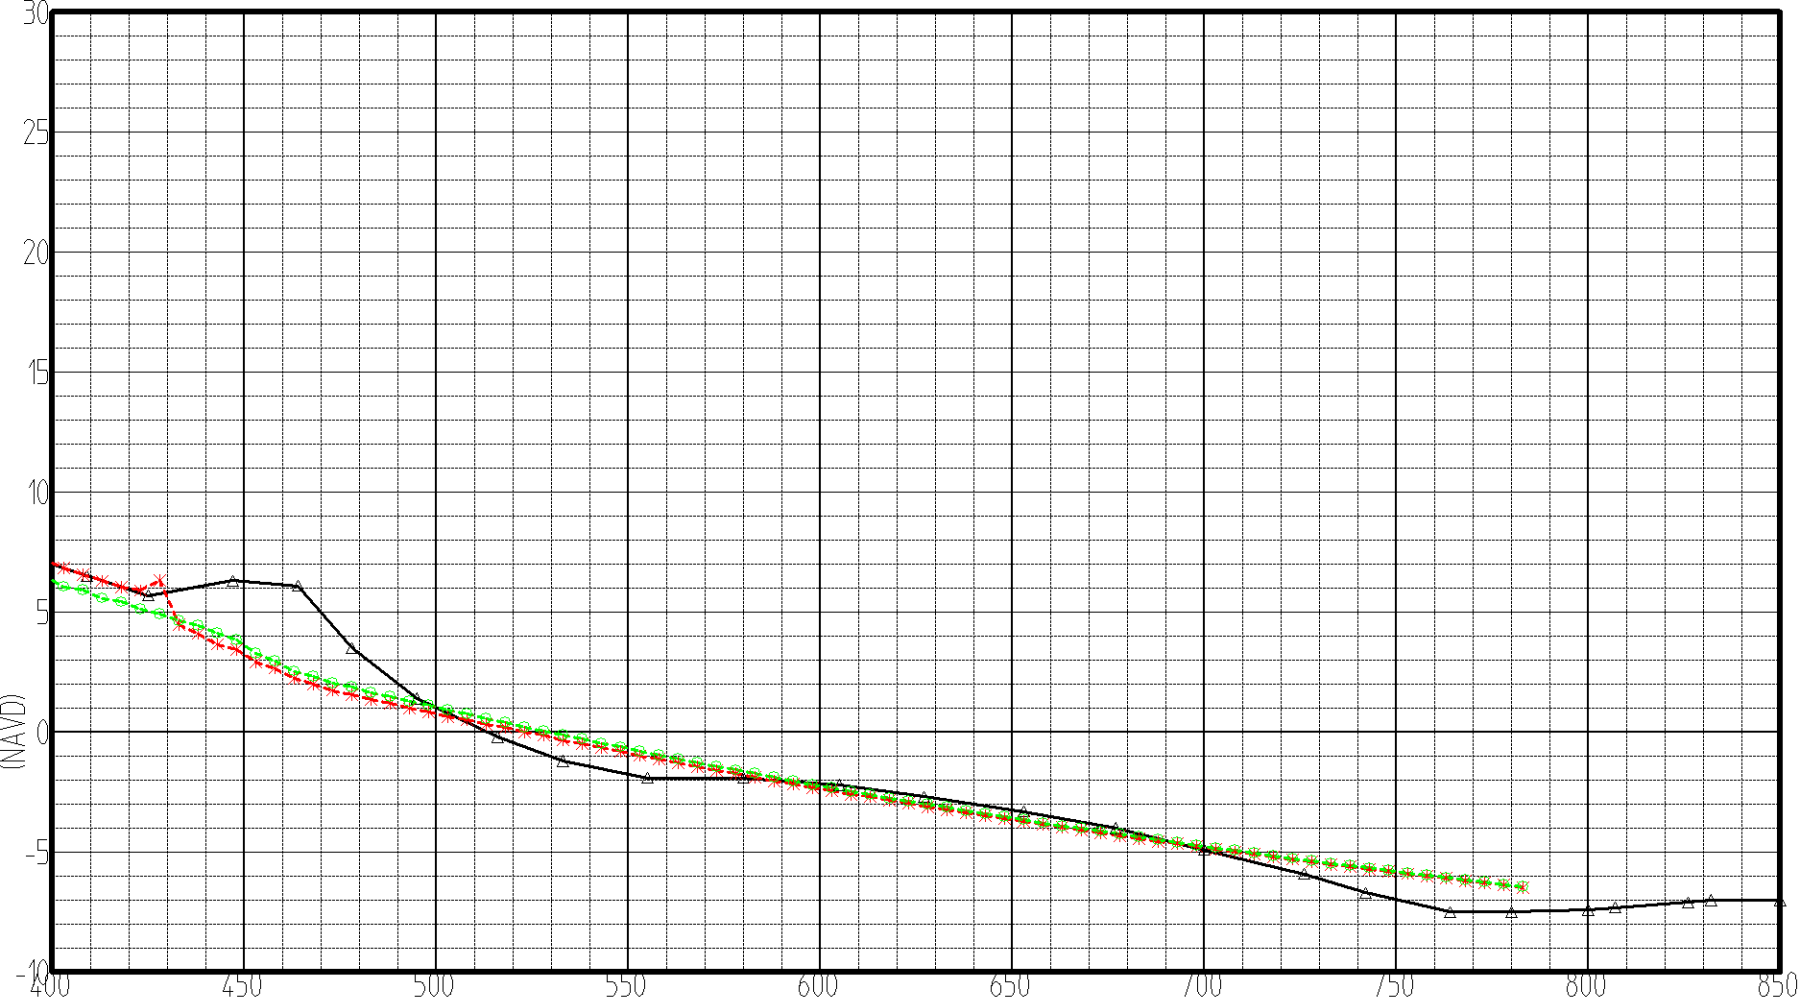
Range: R-46
 BEARING: 90.00
 2/3

BEACH PROFILE
 —△—△— 2005-2008 INPUT PRF
 - - * - - * - - 15-YR SBEACH ERODED PRF
 - - o - - o - - 25-YR SBEACH ERODED PRF

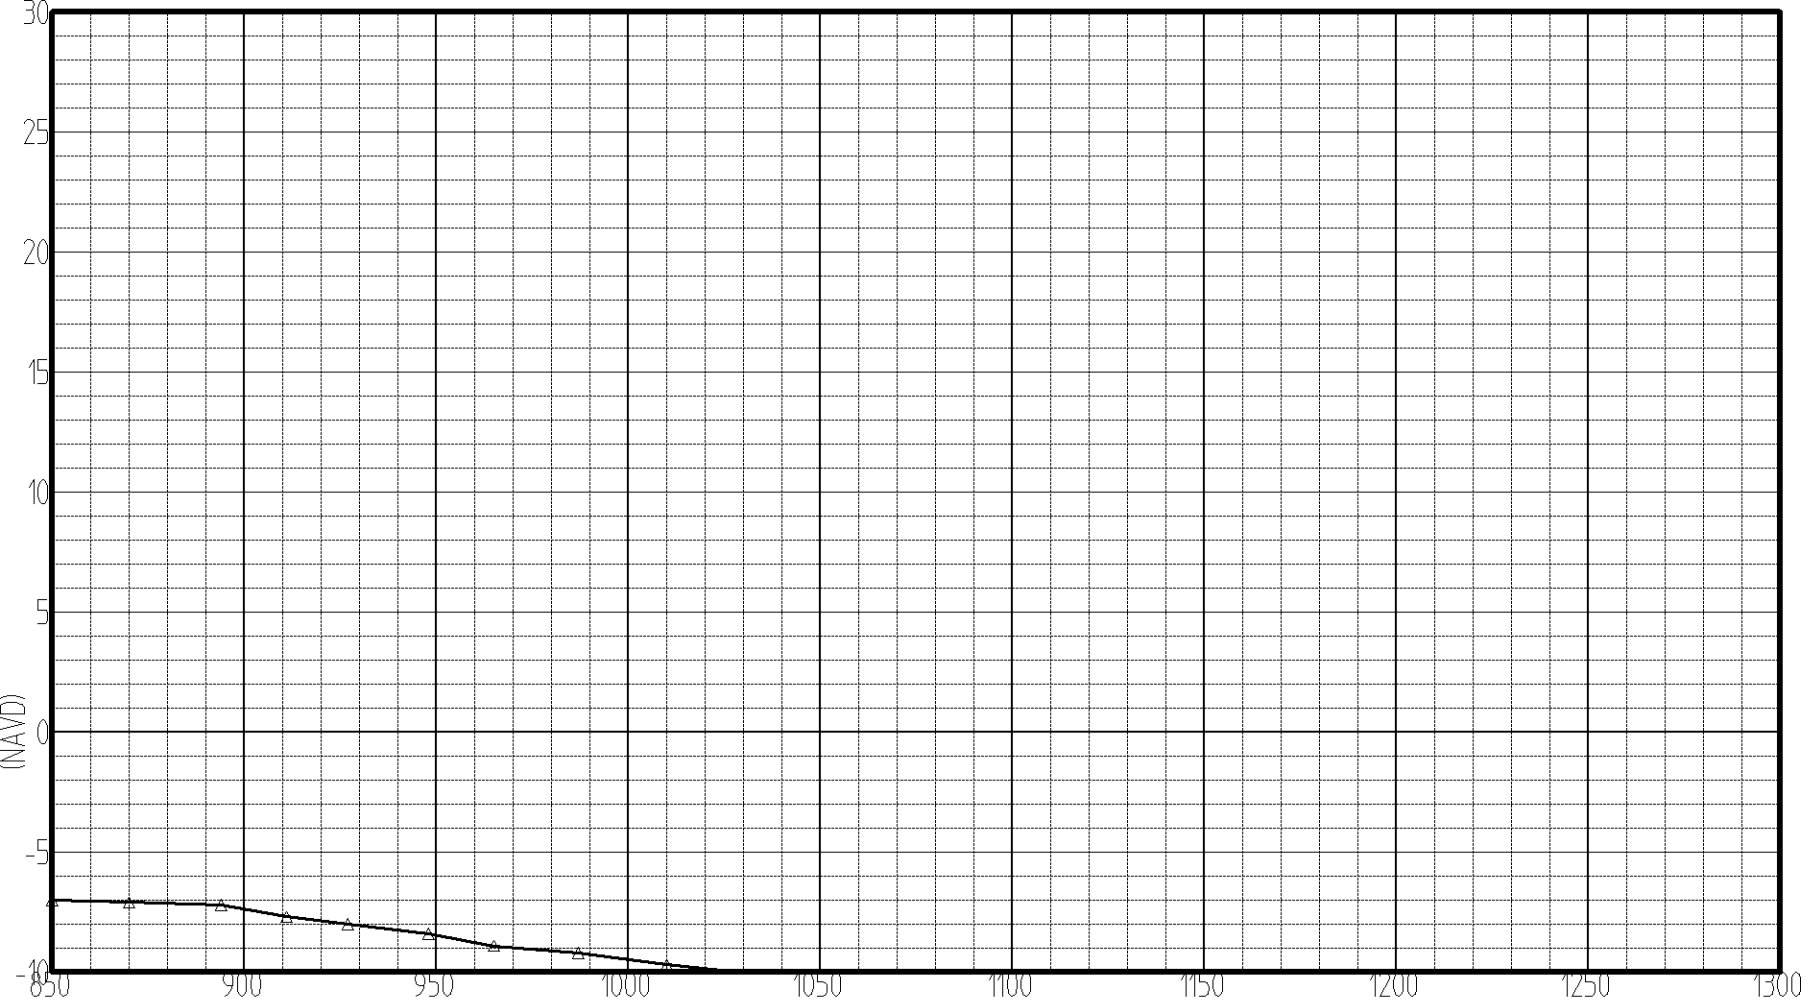
Range: R-46
 BEARING: 90.00
 3/3

BEACH PROFILE
 —△—△— 2005-2008 INPUT PRF
 - - * - - * - - 15-YR SBEACH ERODED PRF
 - - o - - o - - 25-YR SBEACH ERODED PRF

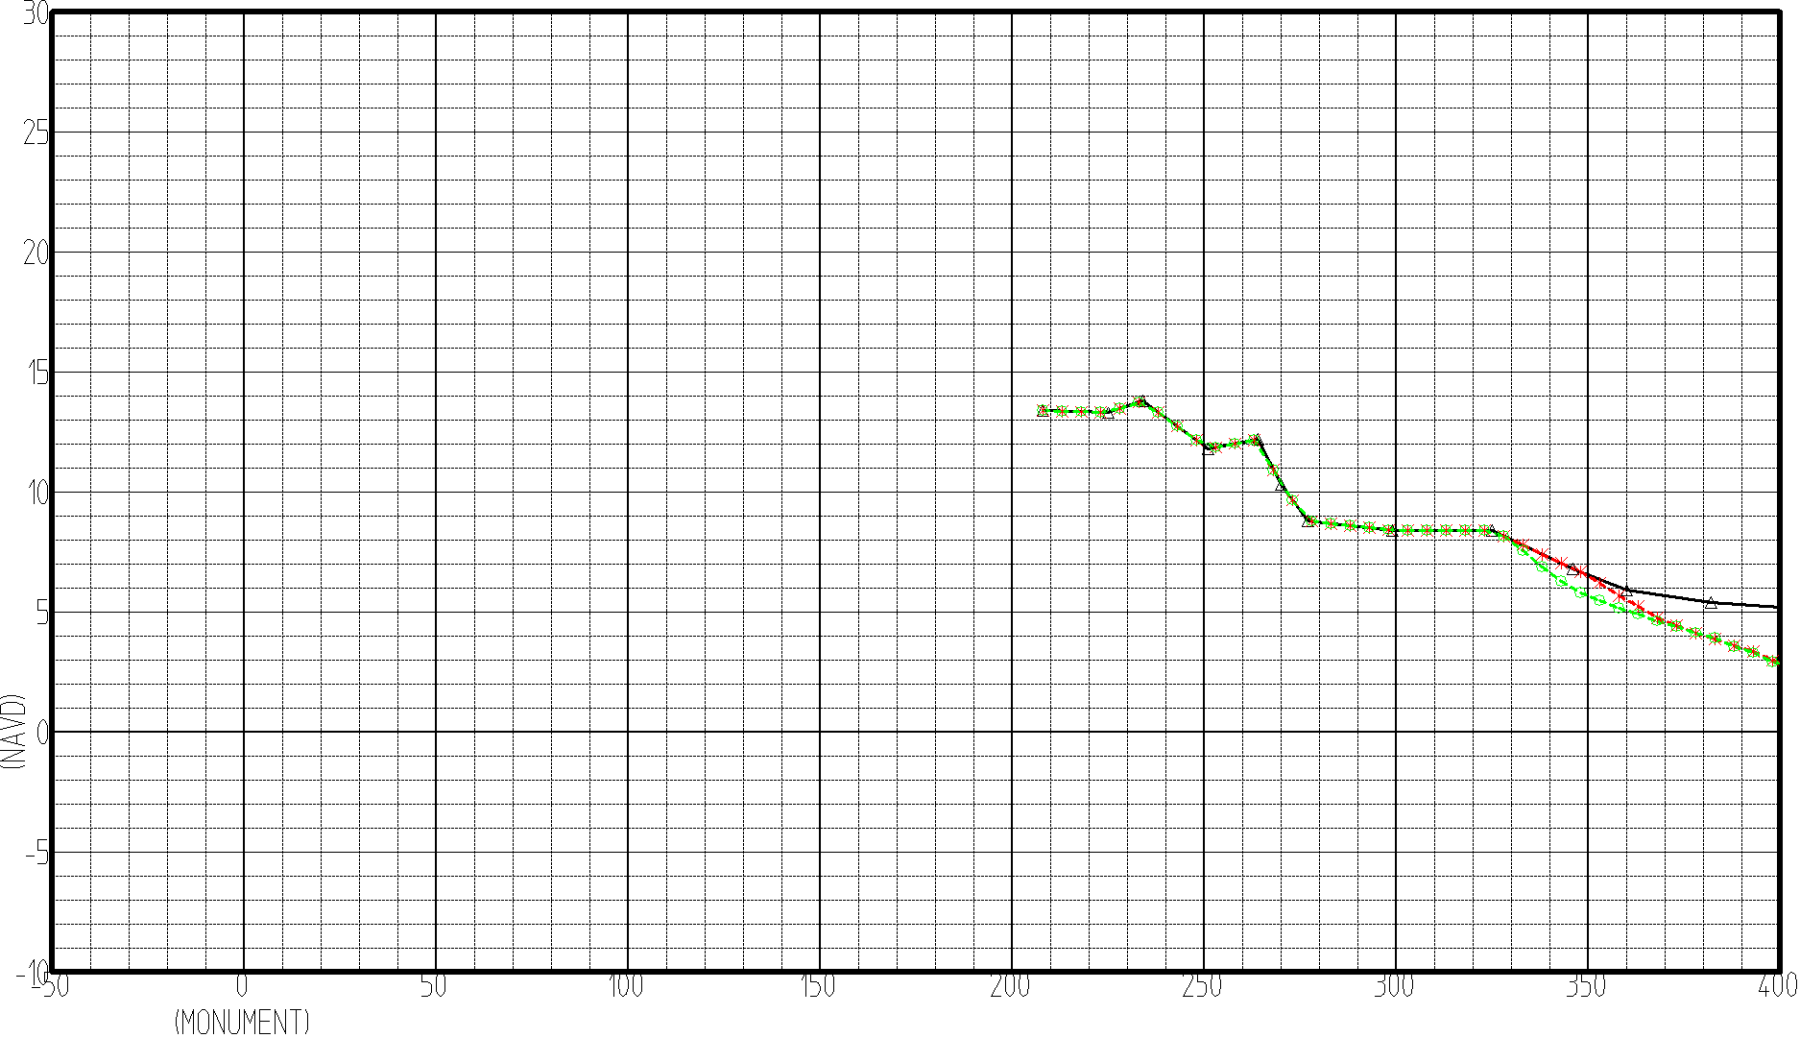
Range: R-47

BEACH PROFILE

- △—△— 2005-2008 INPUT PRF
- - - * - - - 15-YR SBEACH ERODED PRF
- - - o - - - 25-YR SBEACH ERODED PRF

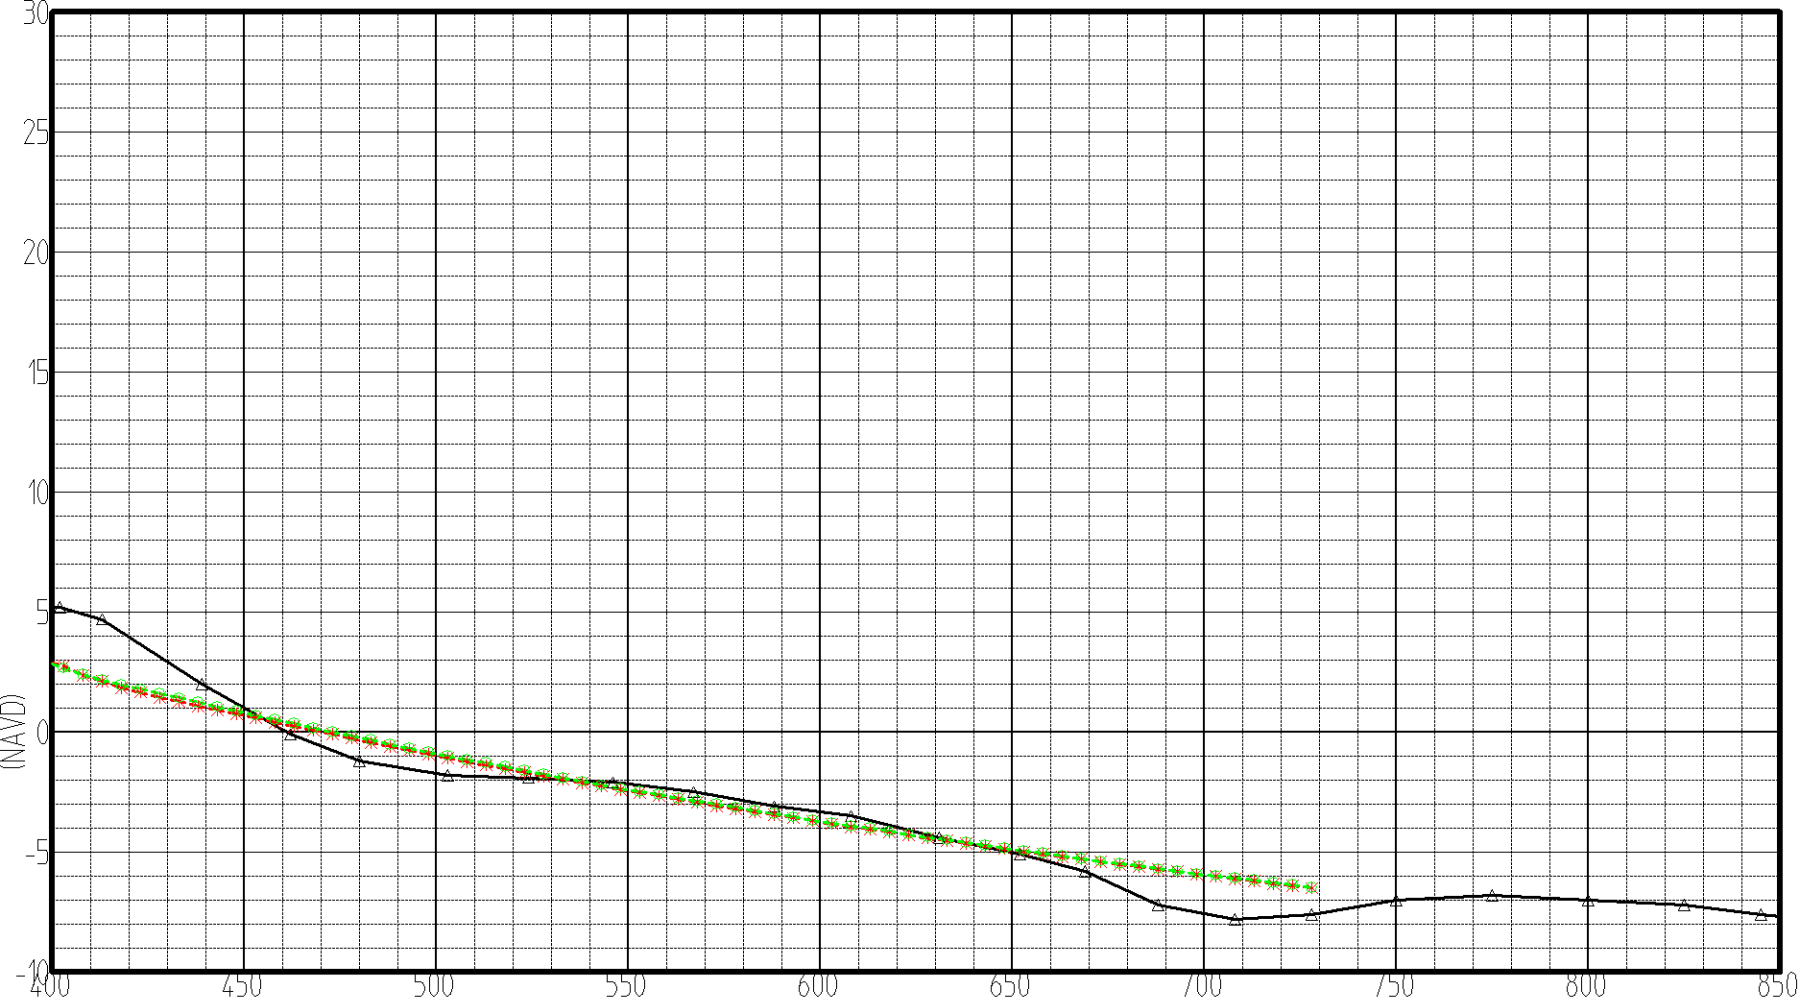
Range: R-47
 BEARING: 90.00
 2/3

BEACH PROFILE
 —△—△— 2005-2008 INPUT PRF
 - - * - - * - - 15-YR SBEACH ERODED PRF
 - - o - - o - - 25-YR SBEACH ERODED PRF

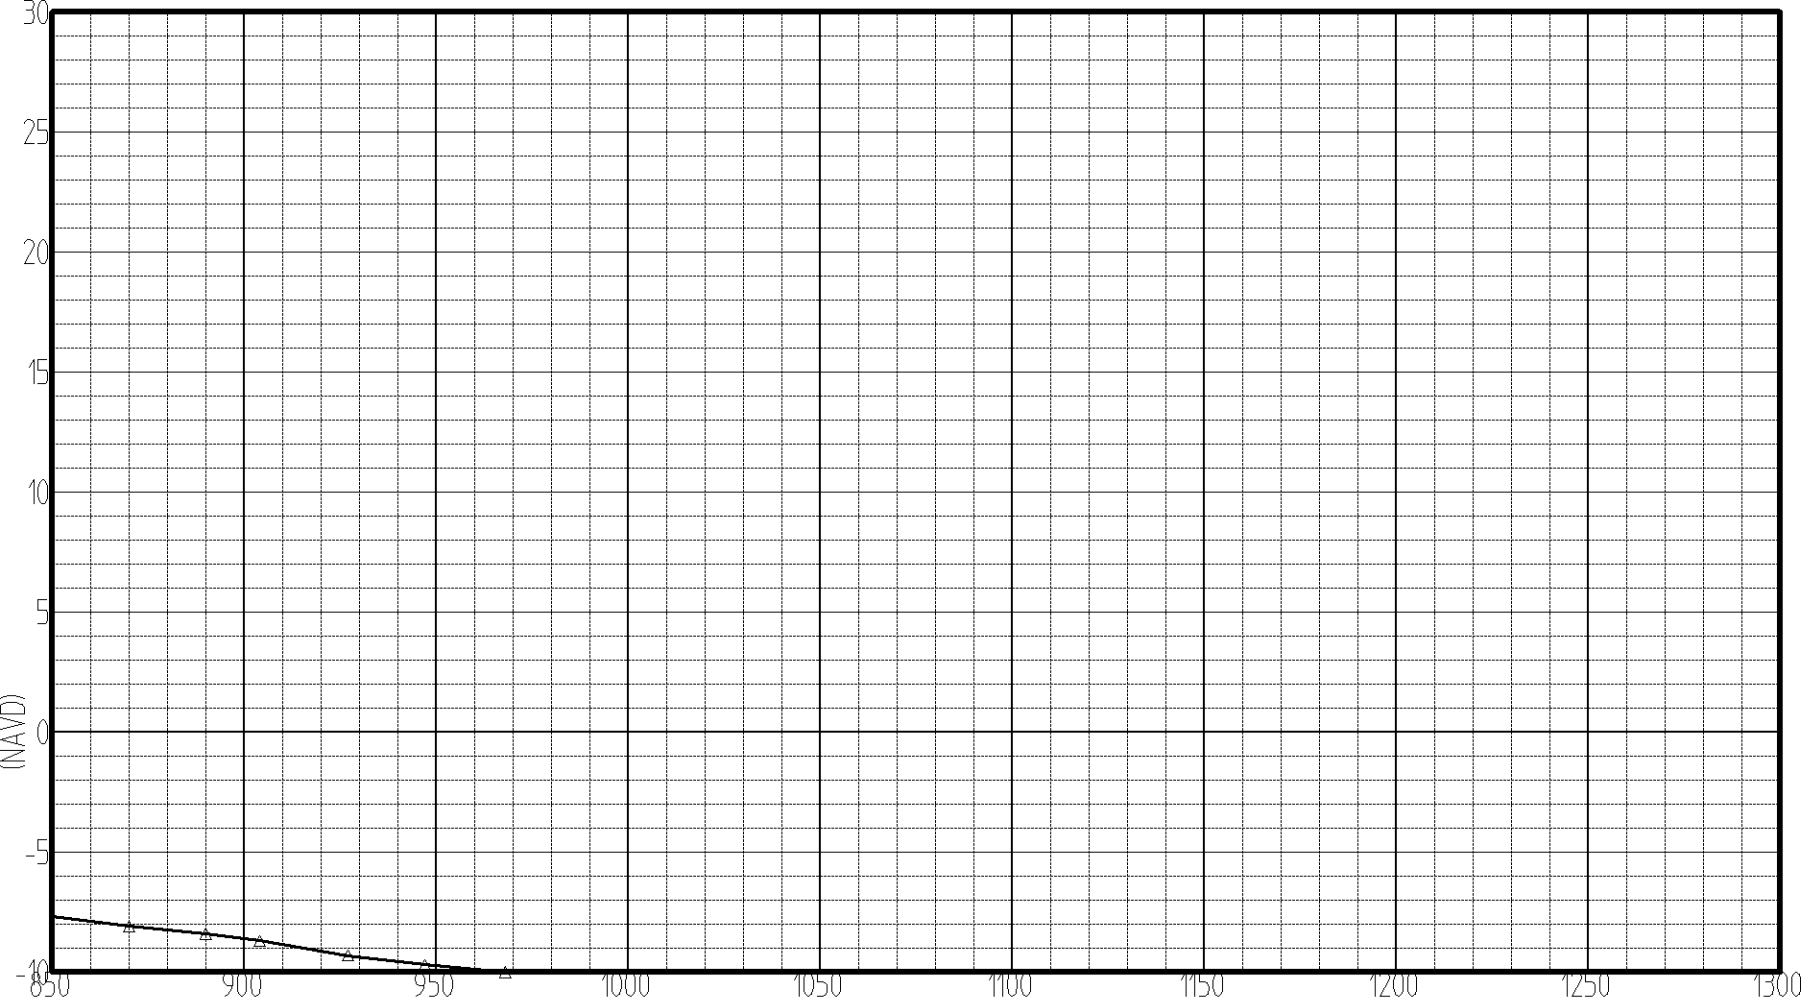
Range: R-47
 BEARING: 90.00
 3/3

BEACH PROFILE
 —△—△— 2005-2008 INPUT PRF
 - - - * - - - 15-YR SBEACH ERODED PRF
 - - - o - - - 25-YR SBEACH ERODED PRF

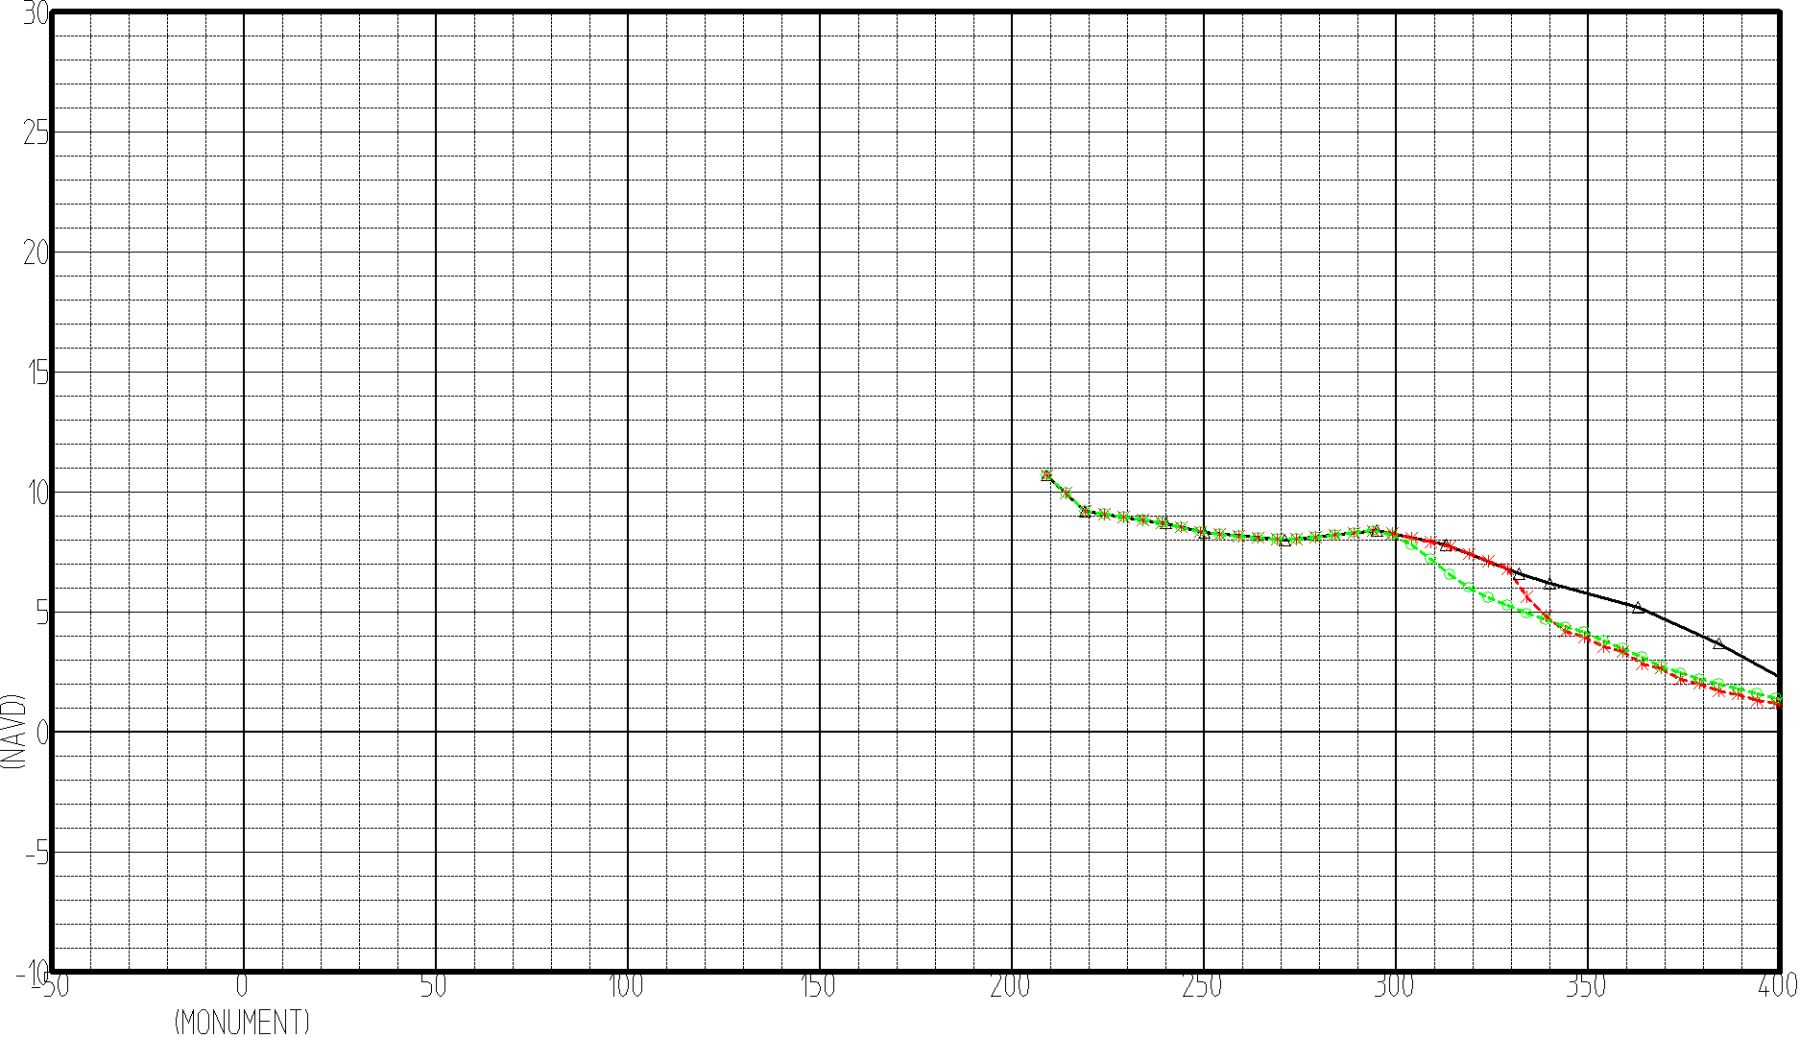
Range: R-48

BEACH PROFILE

—△—△— 2005-2008 INPUT PRF

- - - * - - - 15-YR SBEACH ERODED PRF

- - - o - - - 25-YR SBEACH ERODED PRF
