Appendix XI

SBEACH 15 and 25 yr. Storm Erosion Profiles

Brevard County

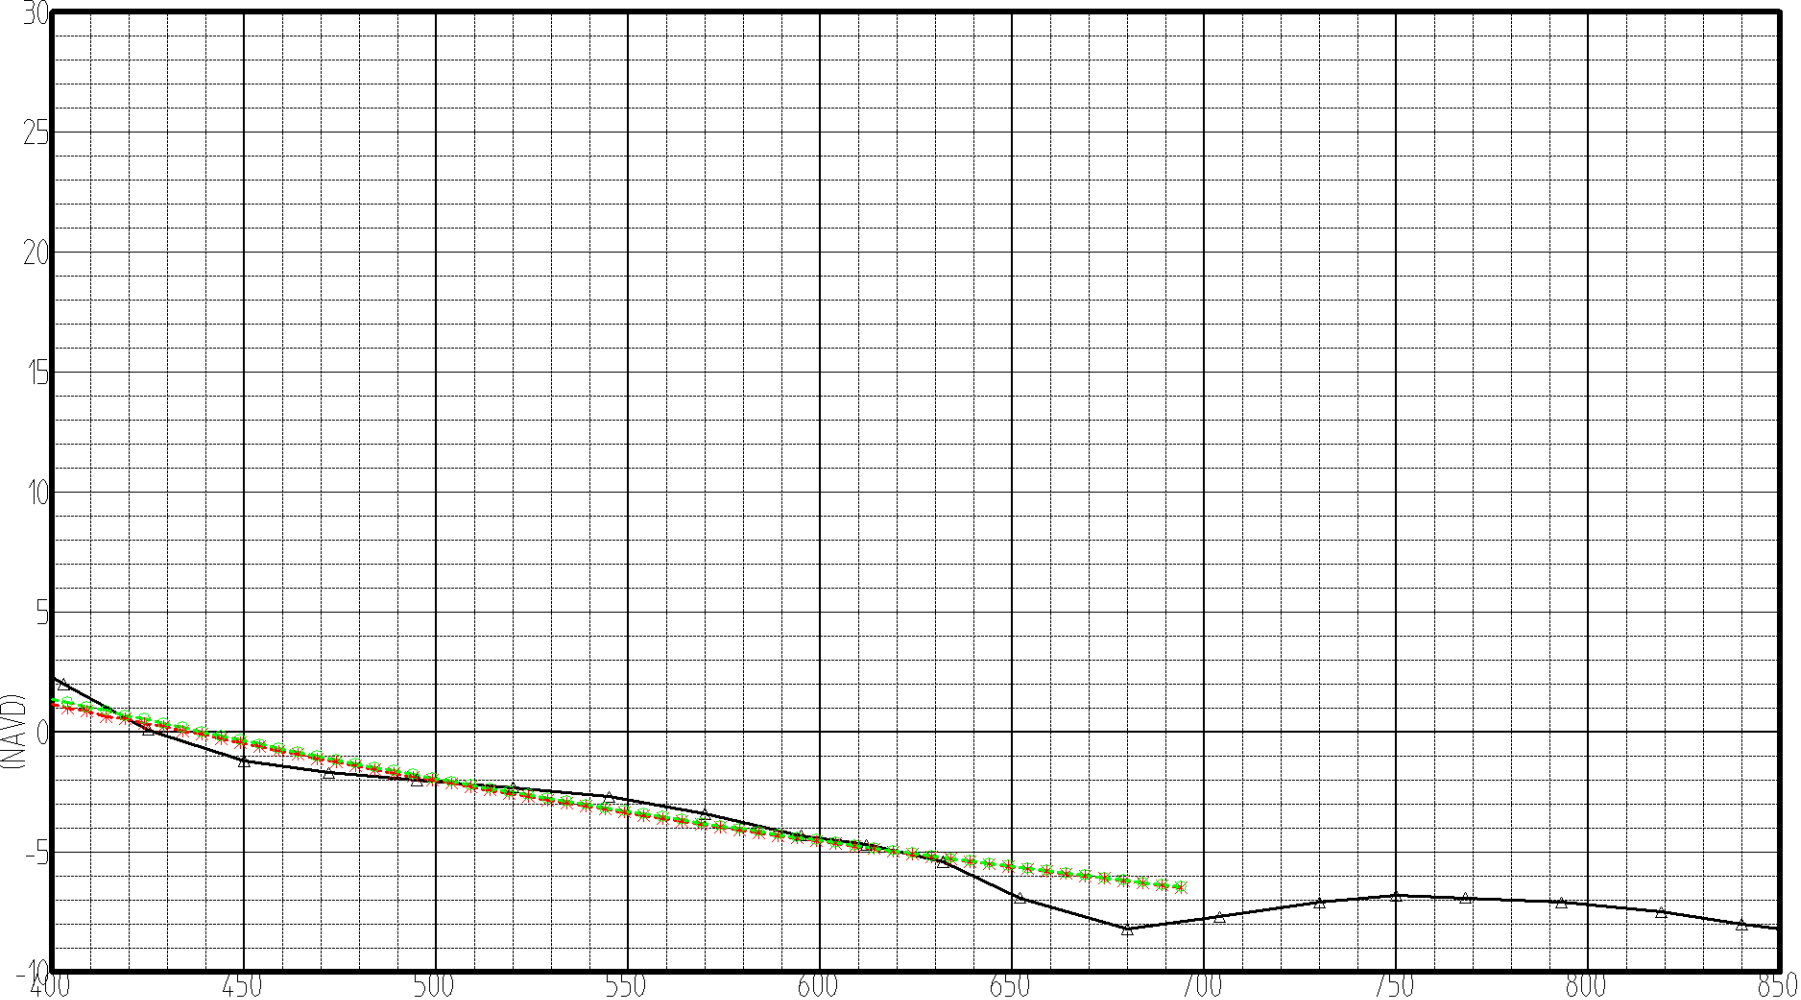
Range: R-48
 BEARING: 90.00
 2/3

BEACH PROFILE
 —△—△— 2005-2008 INPUT PRF
 - - - * - - - 15-YR SBEACH ERODED PRF
 - - - o - - - 25-YR SBEACH ERODED PRF

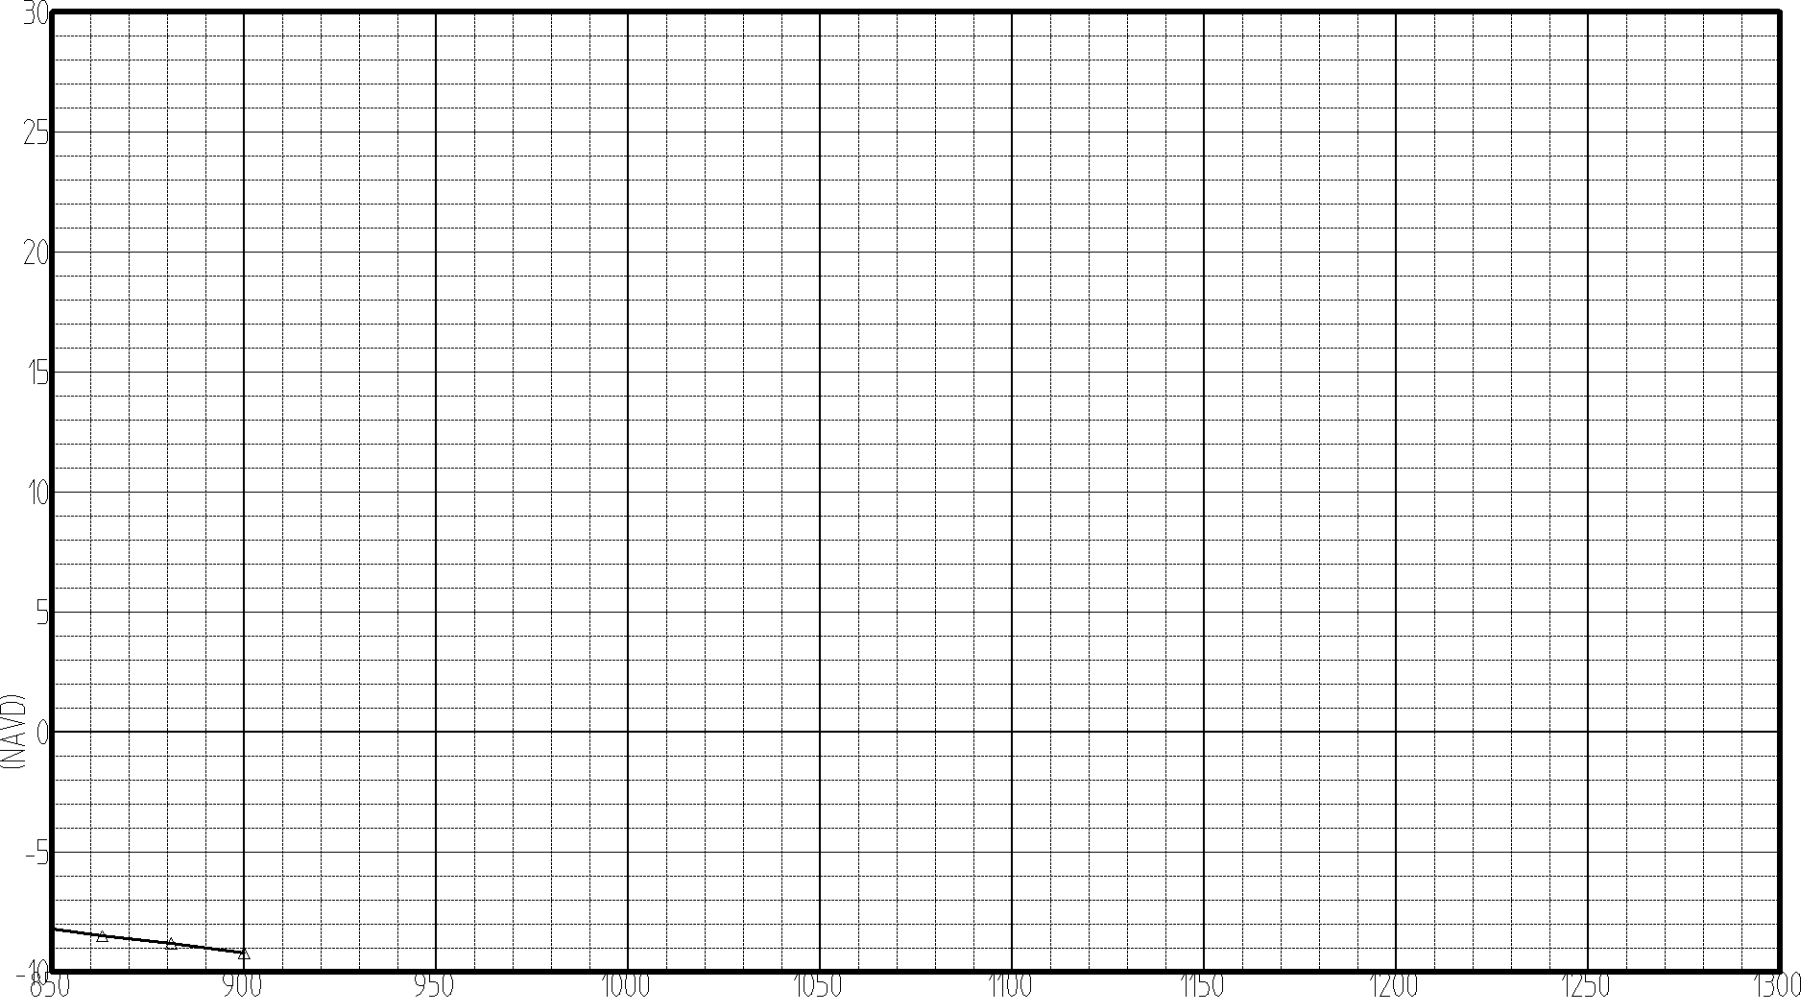
Range: R-48
 BEARING: 90.00
 3/3

BEACH PROFILE
 —△—△— 2005-2008 INPUT PRF
 - - - * - - - 15-YR SBEACH ERODED PRF
 - - - o - - - 25-YR SBEACH ERODED PRF

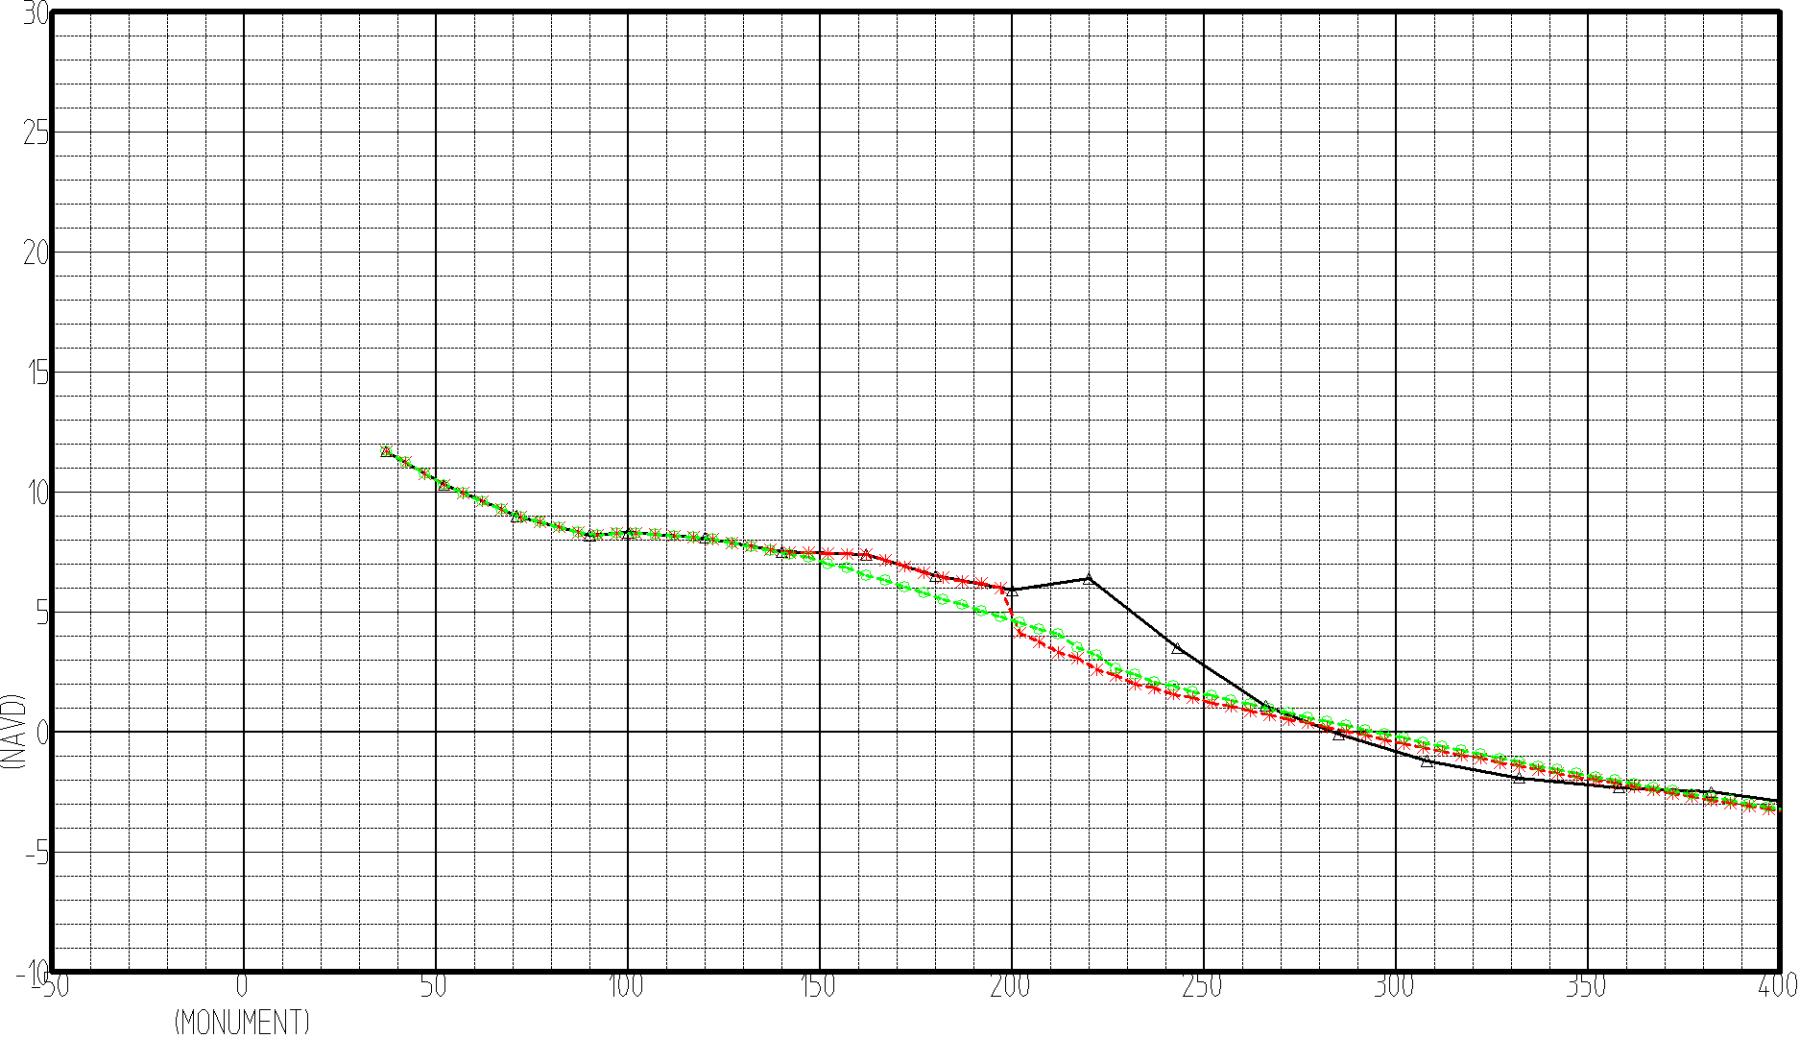
Range: R-49

BEACH PROFILE

—△—△— 2005-2008 INPUT PRF

- - - * - - - 15-YR SBEACH ERODED PRF

- - - o - - - 25-YR SBEACH ERODED PRF

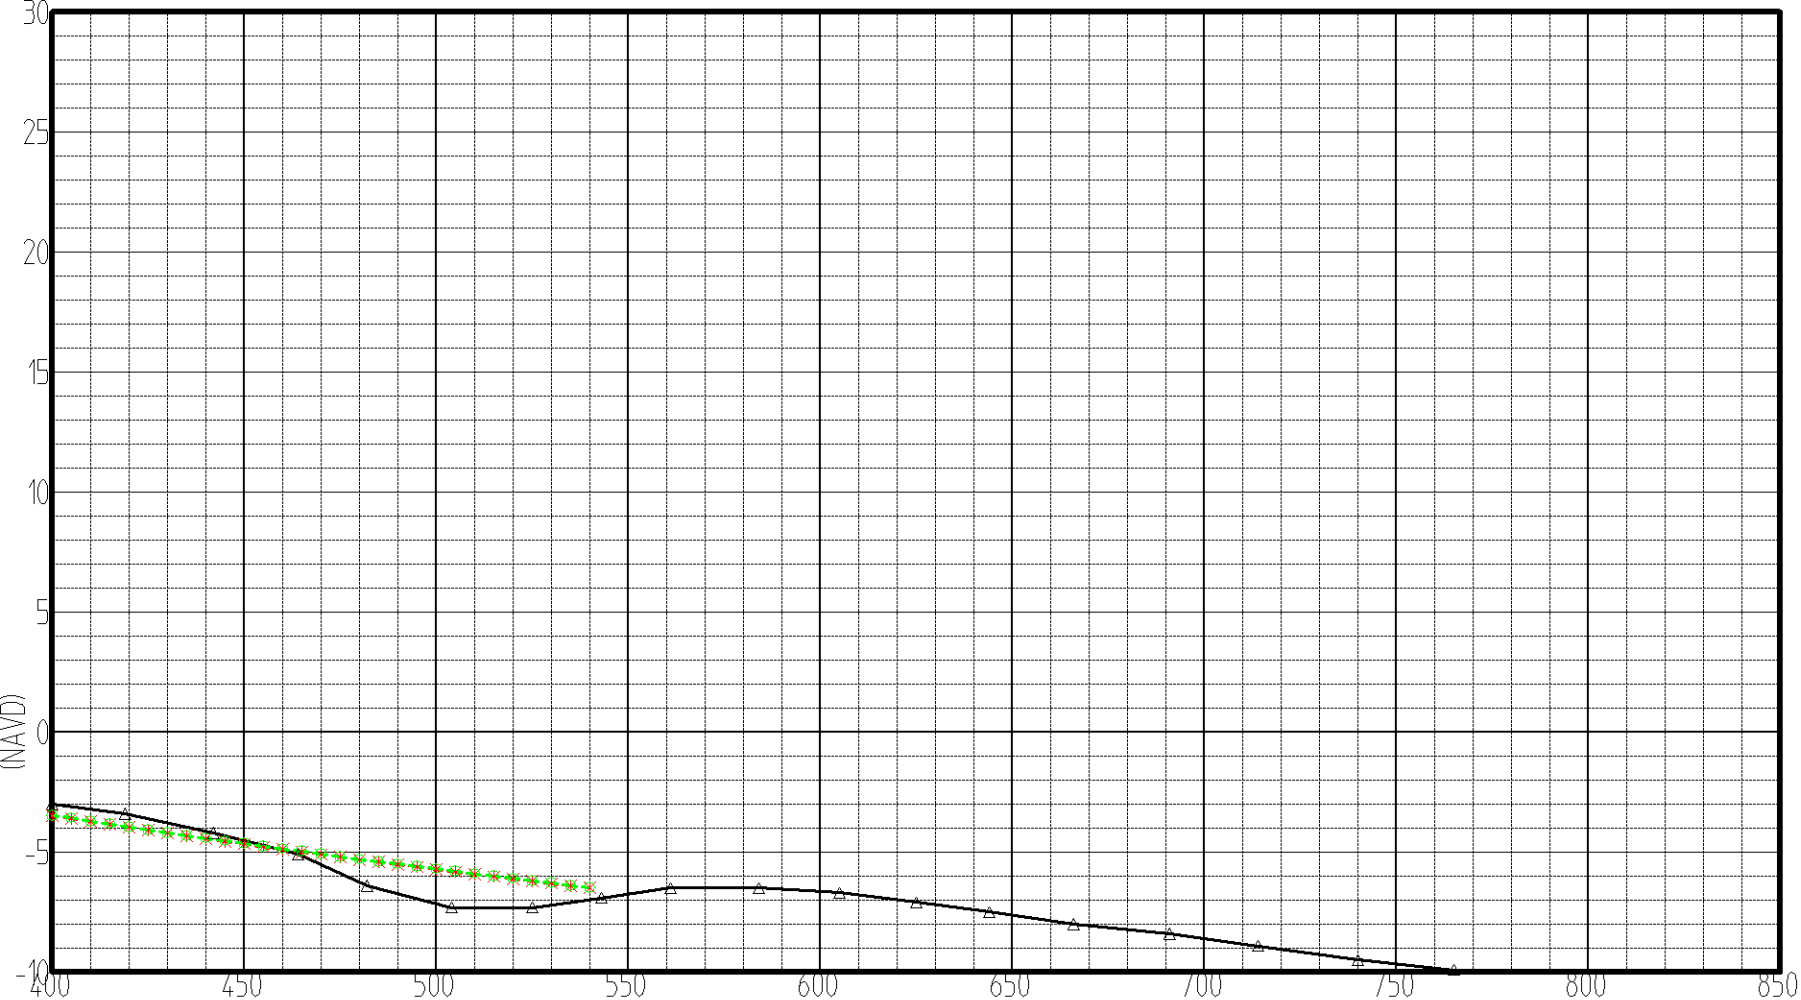
Range: R-50-T

BEACH PROFILE

—△—△— 2005-2008 INPUT PRF

- - - * - - - 15-YR SBEACH ERODED PRF

- - - o - - - 25-YR SBEACH ERODED PRF

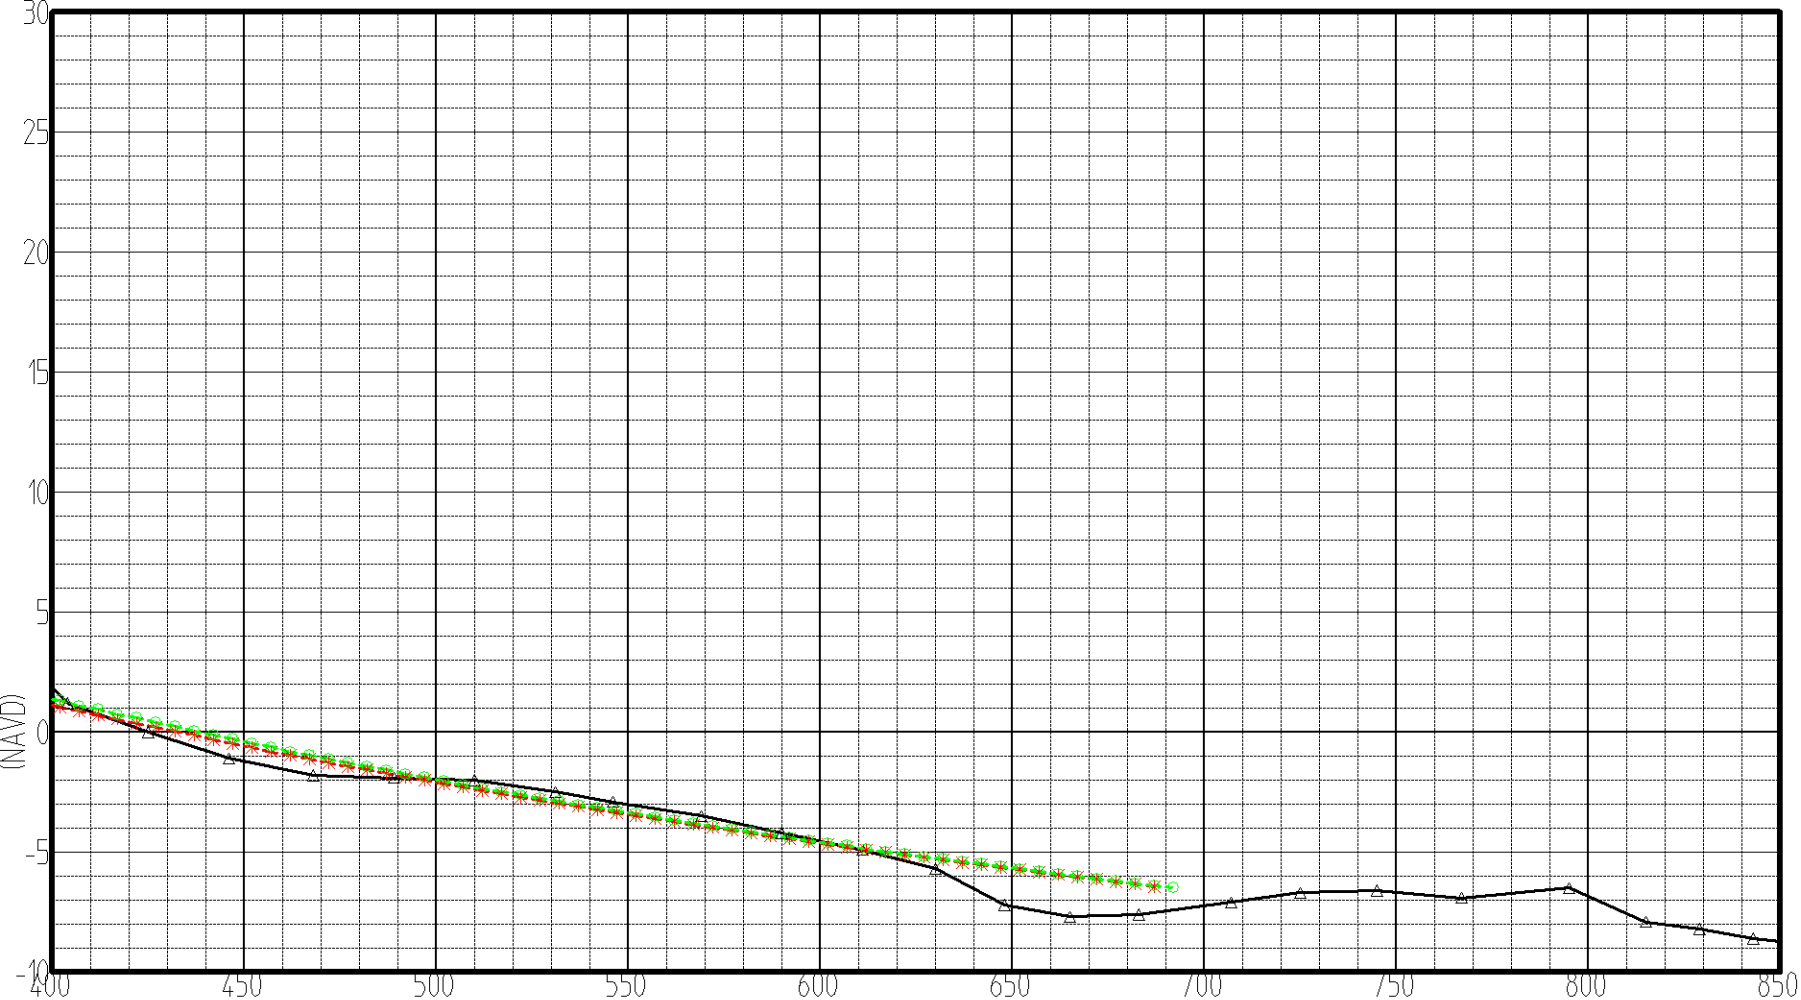
Range: R-51-T 2/3

BEACH PROFILE

—△—△— 2005-2008 INPUT PRF

- - - * - - - 15-YR SBEACH ERODED PRF

- - - o - - - 25-YR SBEACH ERODED PRF

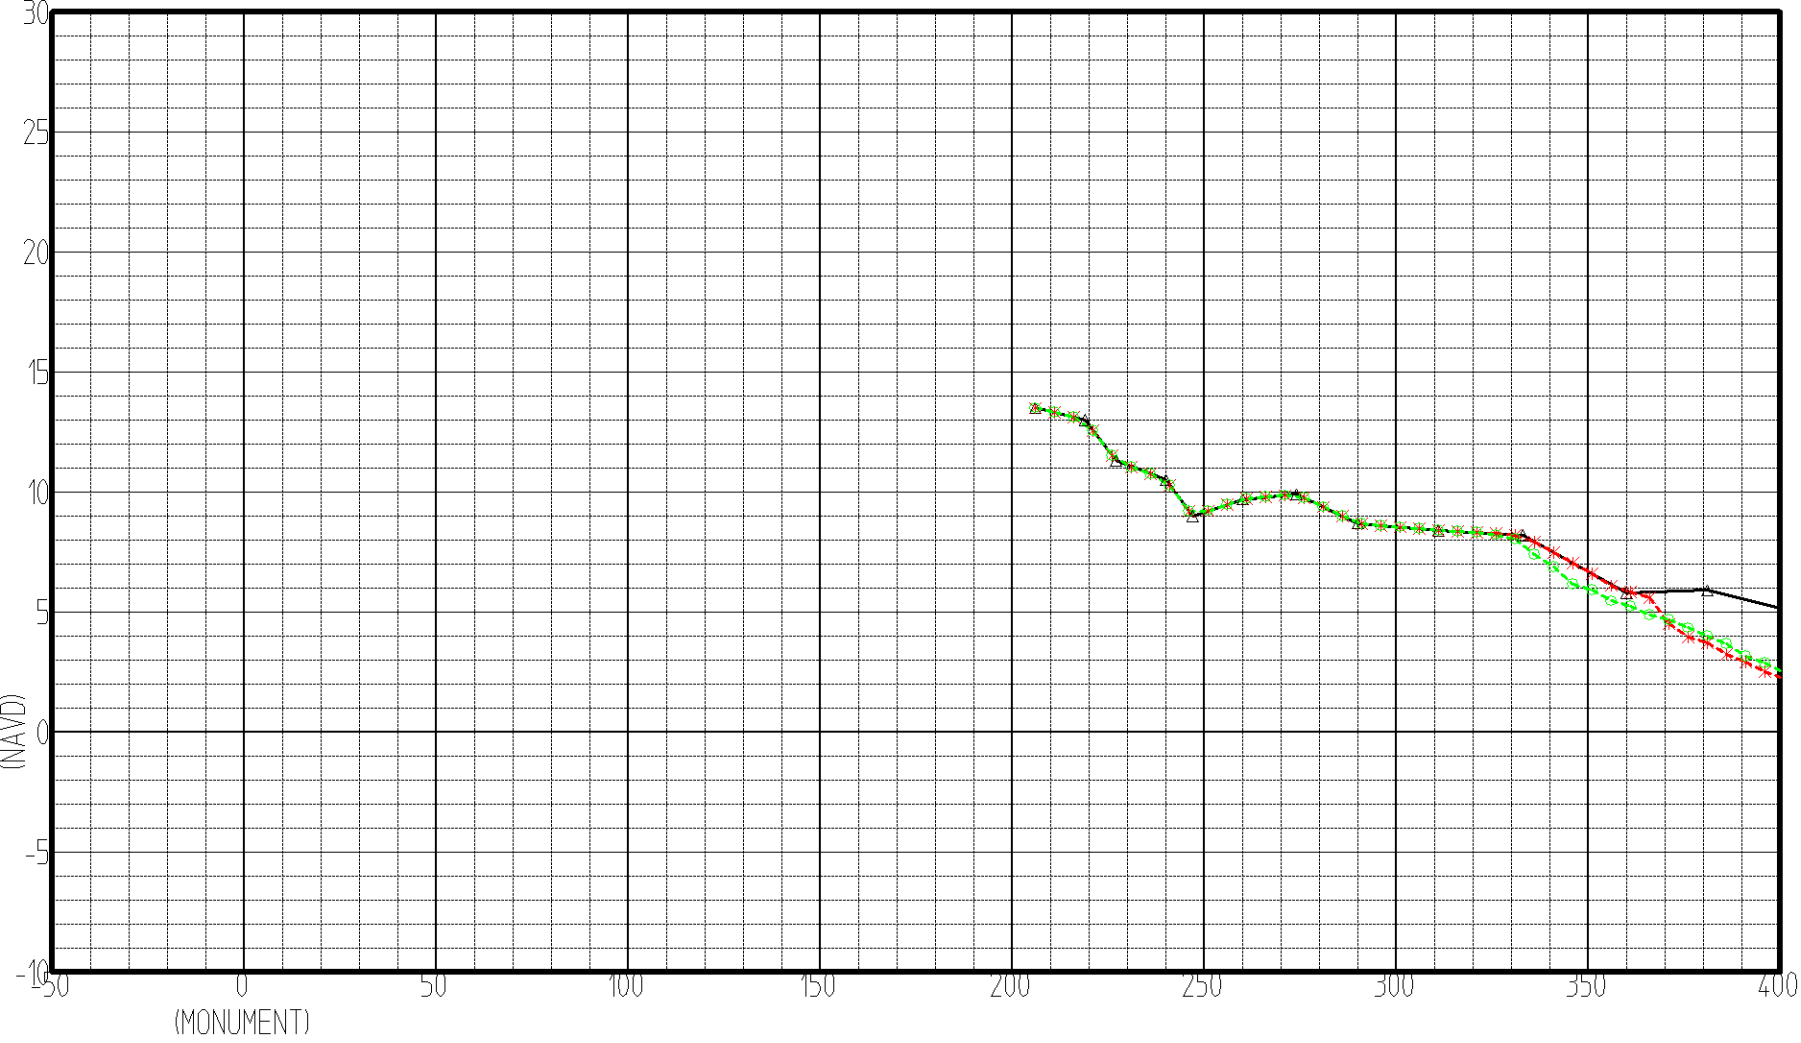
Range: R-52-T 1/3
 BEARING: 90.00

BEACH PROFILE
 —△—△— 2005-2008 INPUT PRF
 - - * - - * - - 15-YR SBEACH ERODED PRF
 - - o - - o - - 25-YR SBEACH ERODED PRF

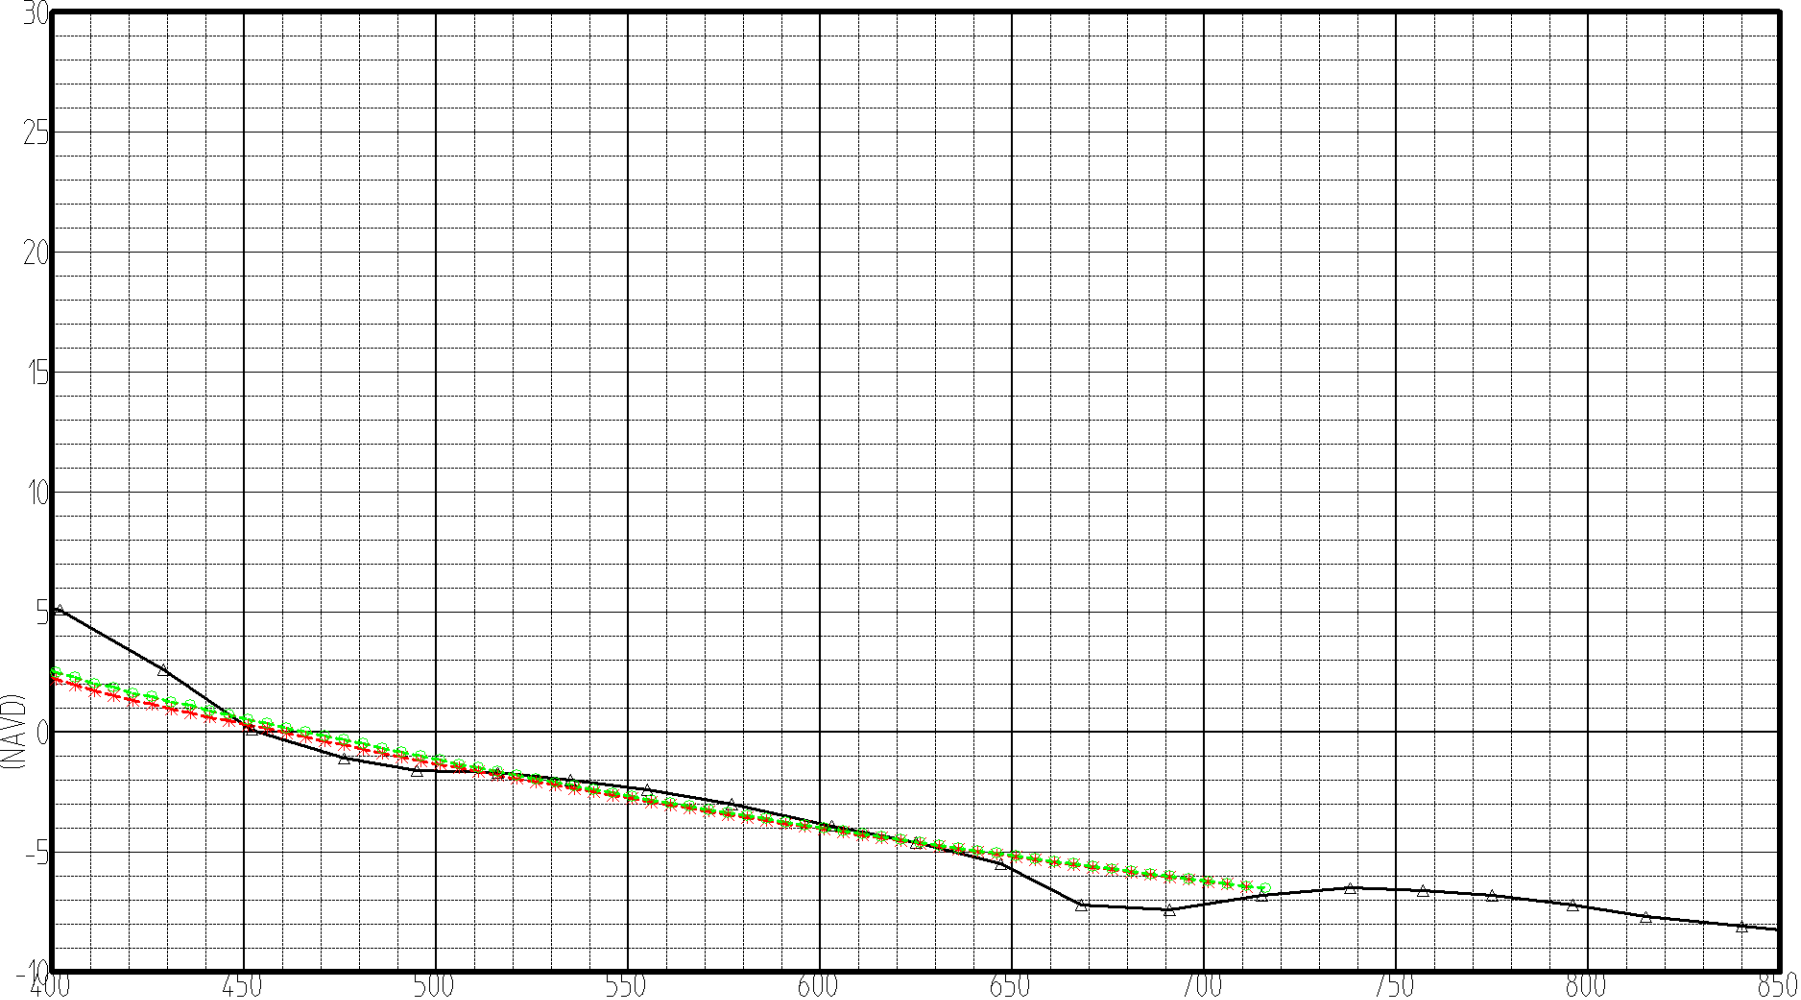
Range: R-52-T 2/3

BEACH PROFILE

—△—△— 2005-2008 INPUT PRF

- - - * - - - 15-YR SBEACH ERODED PRF

- - - o - - - 25-YR SBEACH ERODED PRF

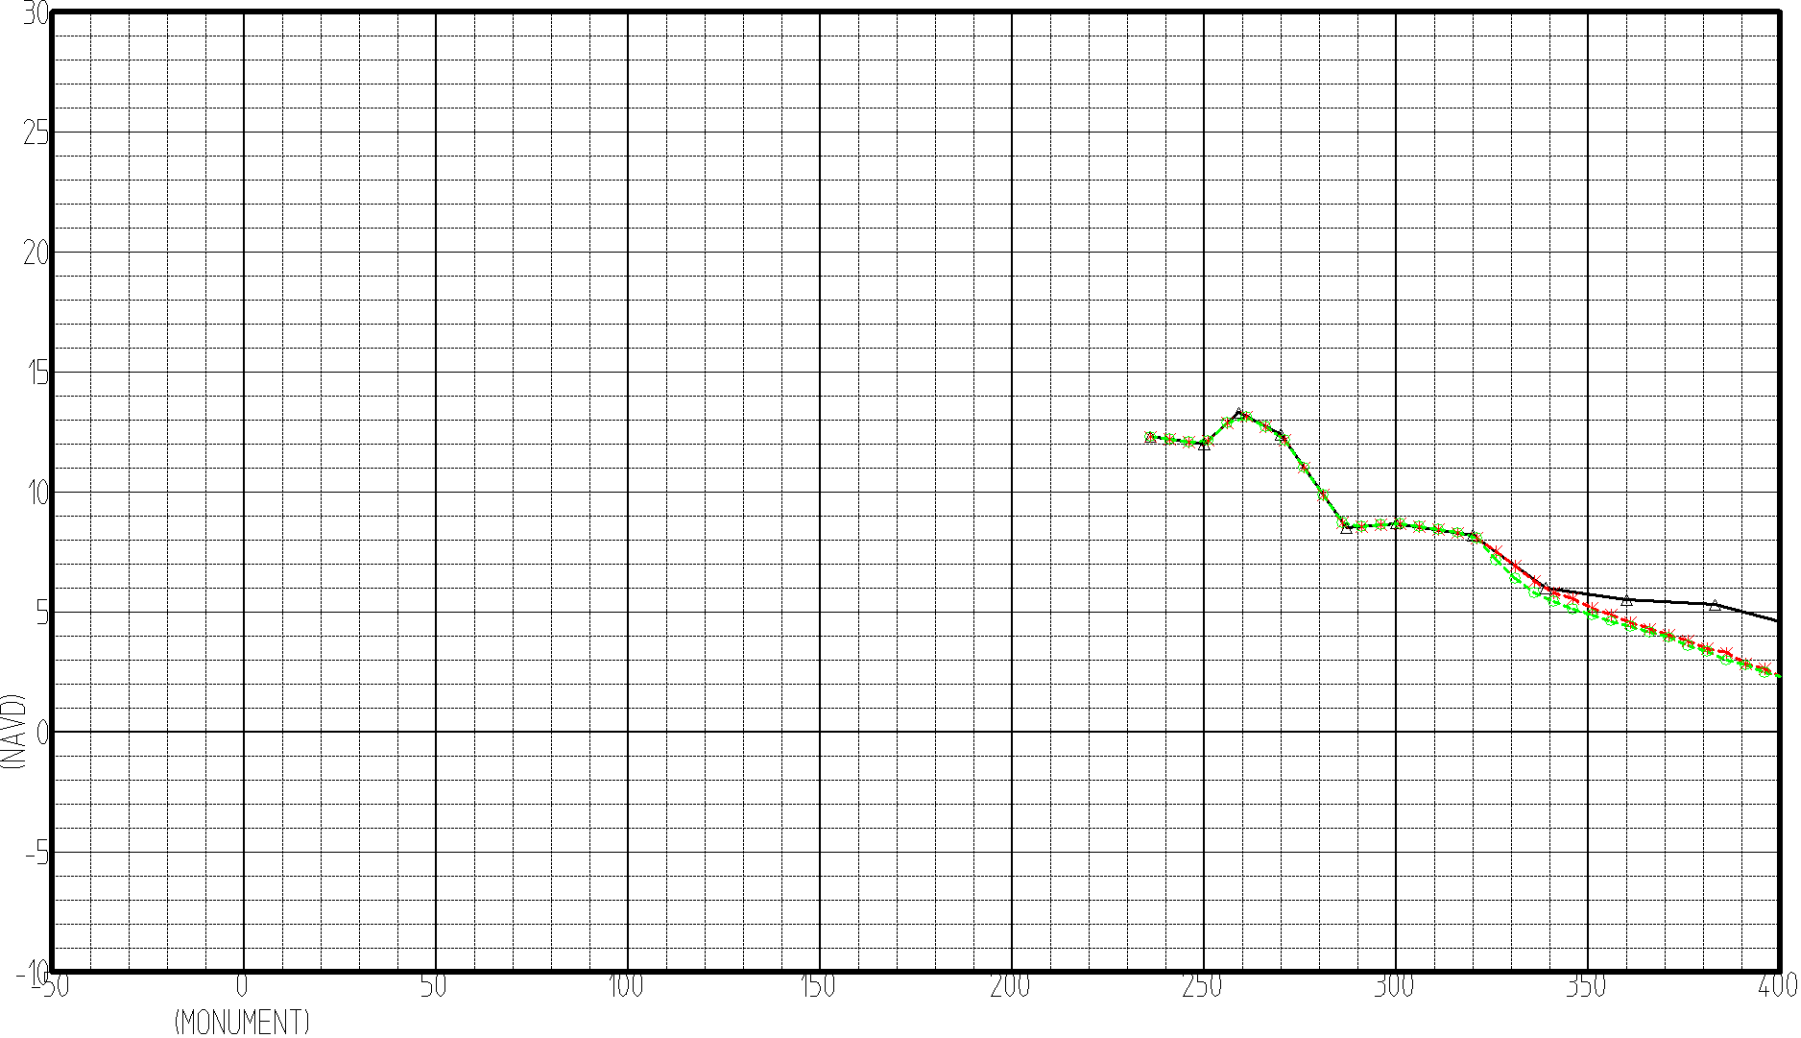
Range: R-53-T 1/3

BEACH PROFILE

- △—△— 2005-2008 INPUT PRF
- - - * - - - 15-YR SBEACH ERODED PRF
- - - o - - - 25-YR SBEACH ERODED PRF

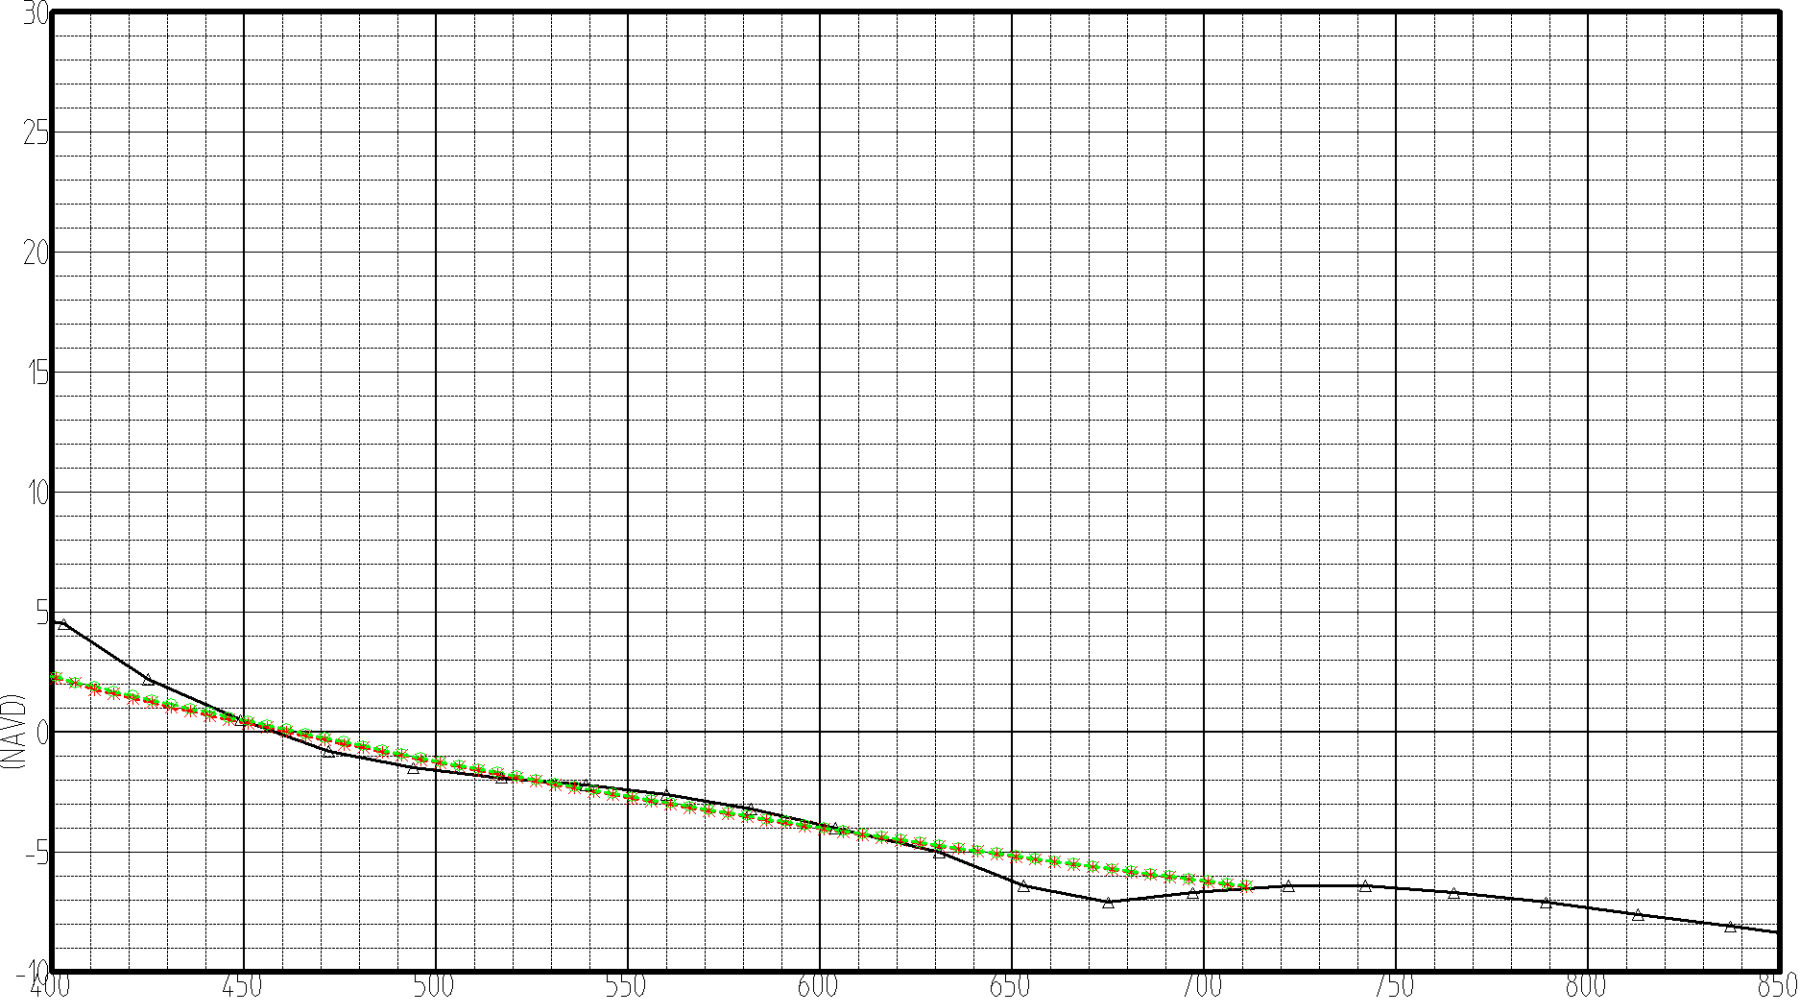
Range: R-53-T

BEACH PROFILE

—△—△— 2005-2008 INPUT PRF

- - - * - - - 15-YR SBEACH ERODED PRF

- - - o - - - 25-YR SBEACH ERODED PRF

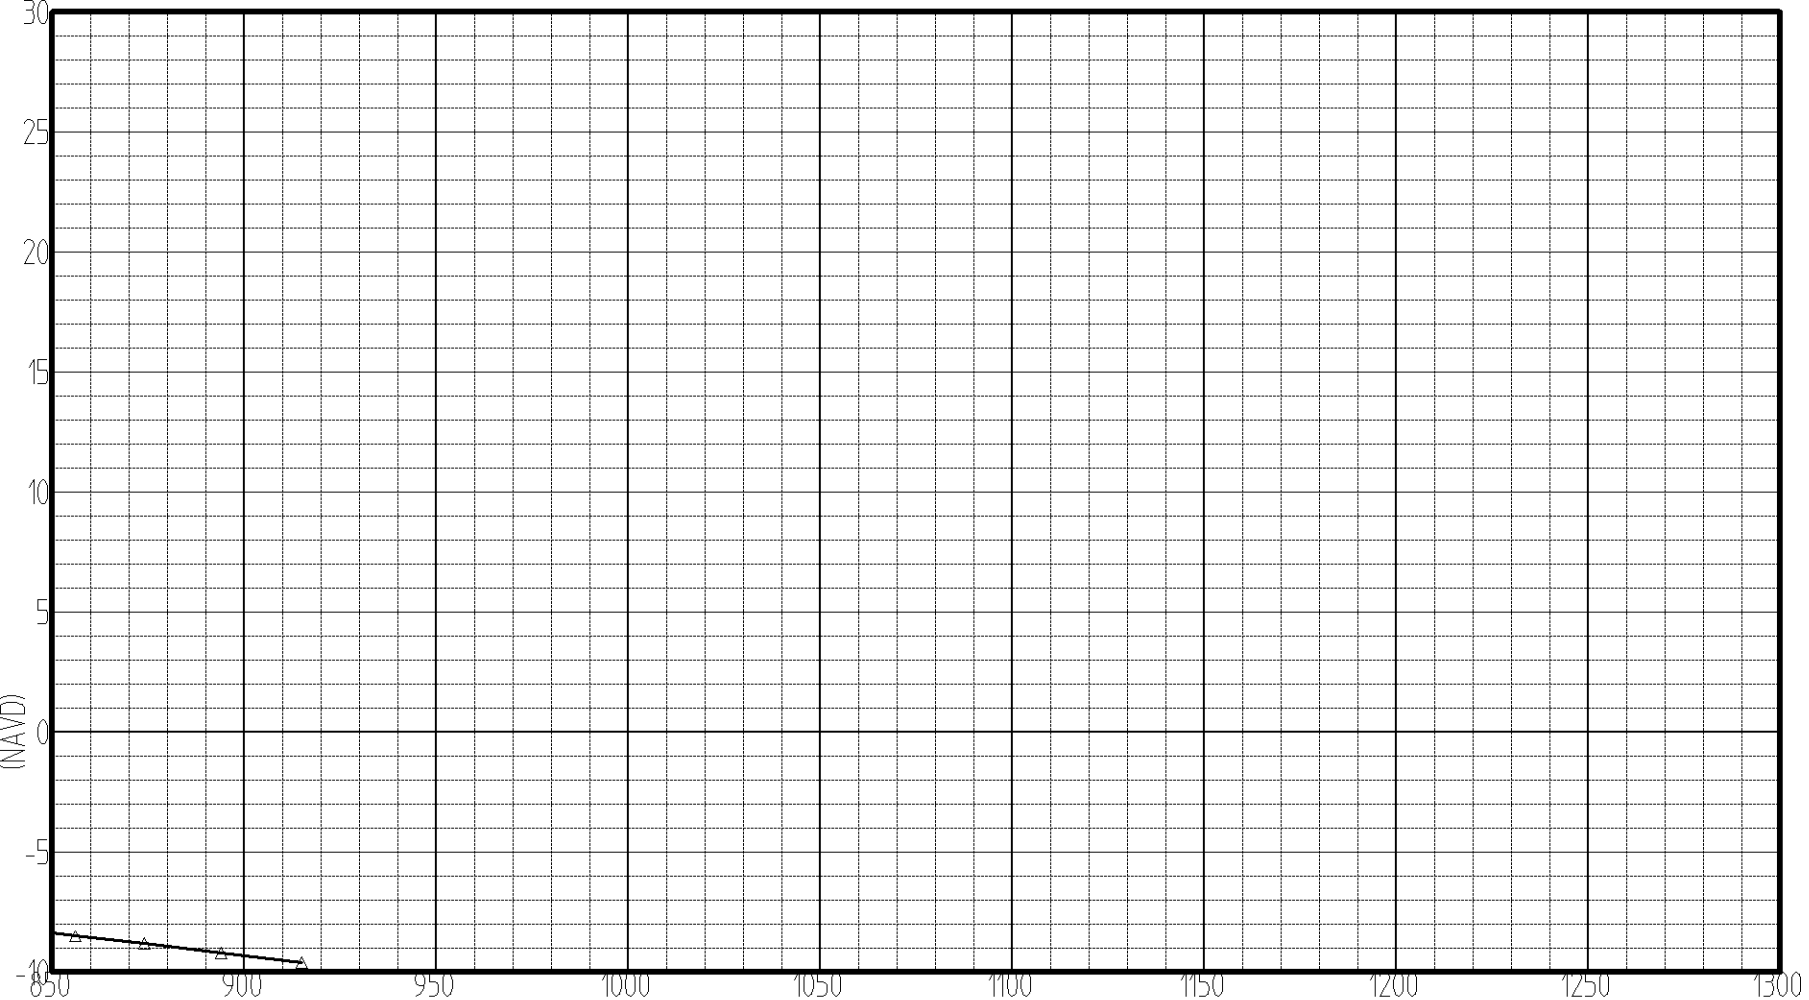
Range: R-53-T 3/3
 BEARING: 90.00

BEACH PROFILE
 —△—△— 2005-2008 INPUT PRF
 - - * - - * - - 15-YR SBEACH ERODED PRF
 - - ○ - - ○ - - 25-YR SBEACH ERODED PRF

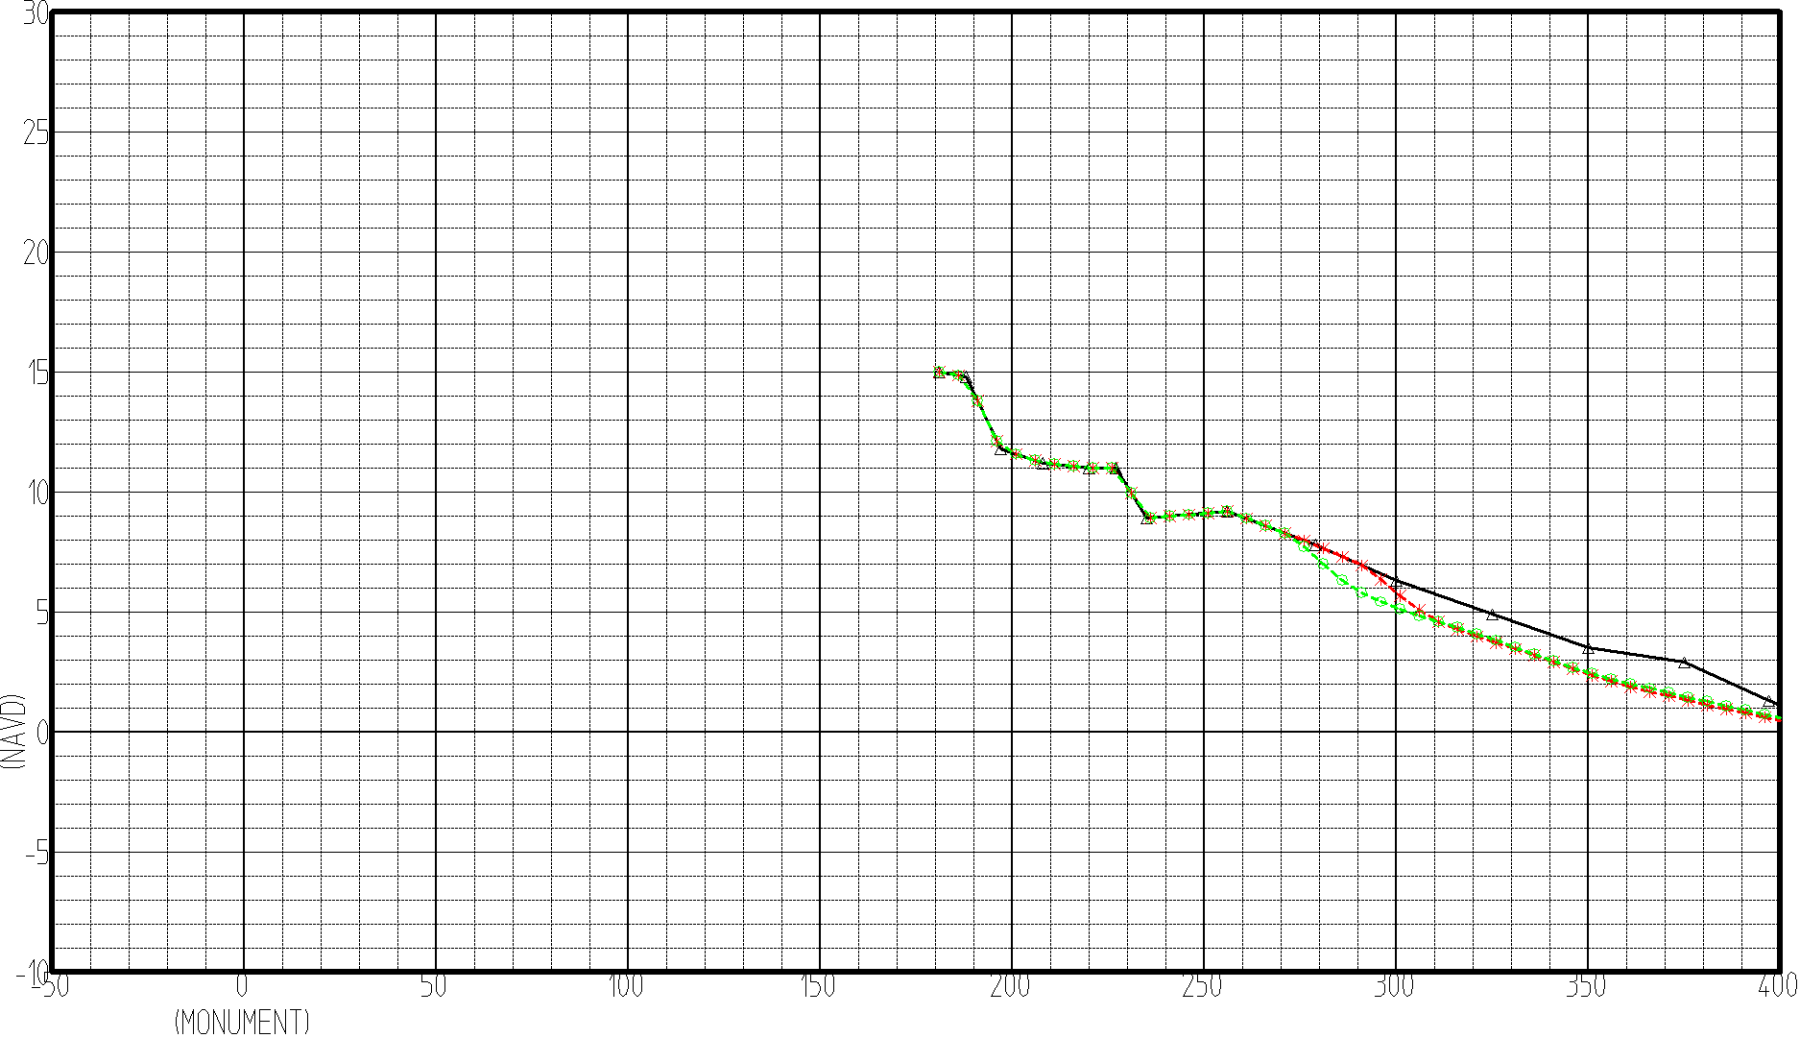
Range: R-54
 BEARING: 90.00
 1/3

BEACH PROFILE
 —△—△— 2005-2008 INPUT PRF
 - - * - - * - - 15-YR SBEACH ERODED PRF
 - - o - - o - - 25-YR SBEACH ERODED PRF

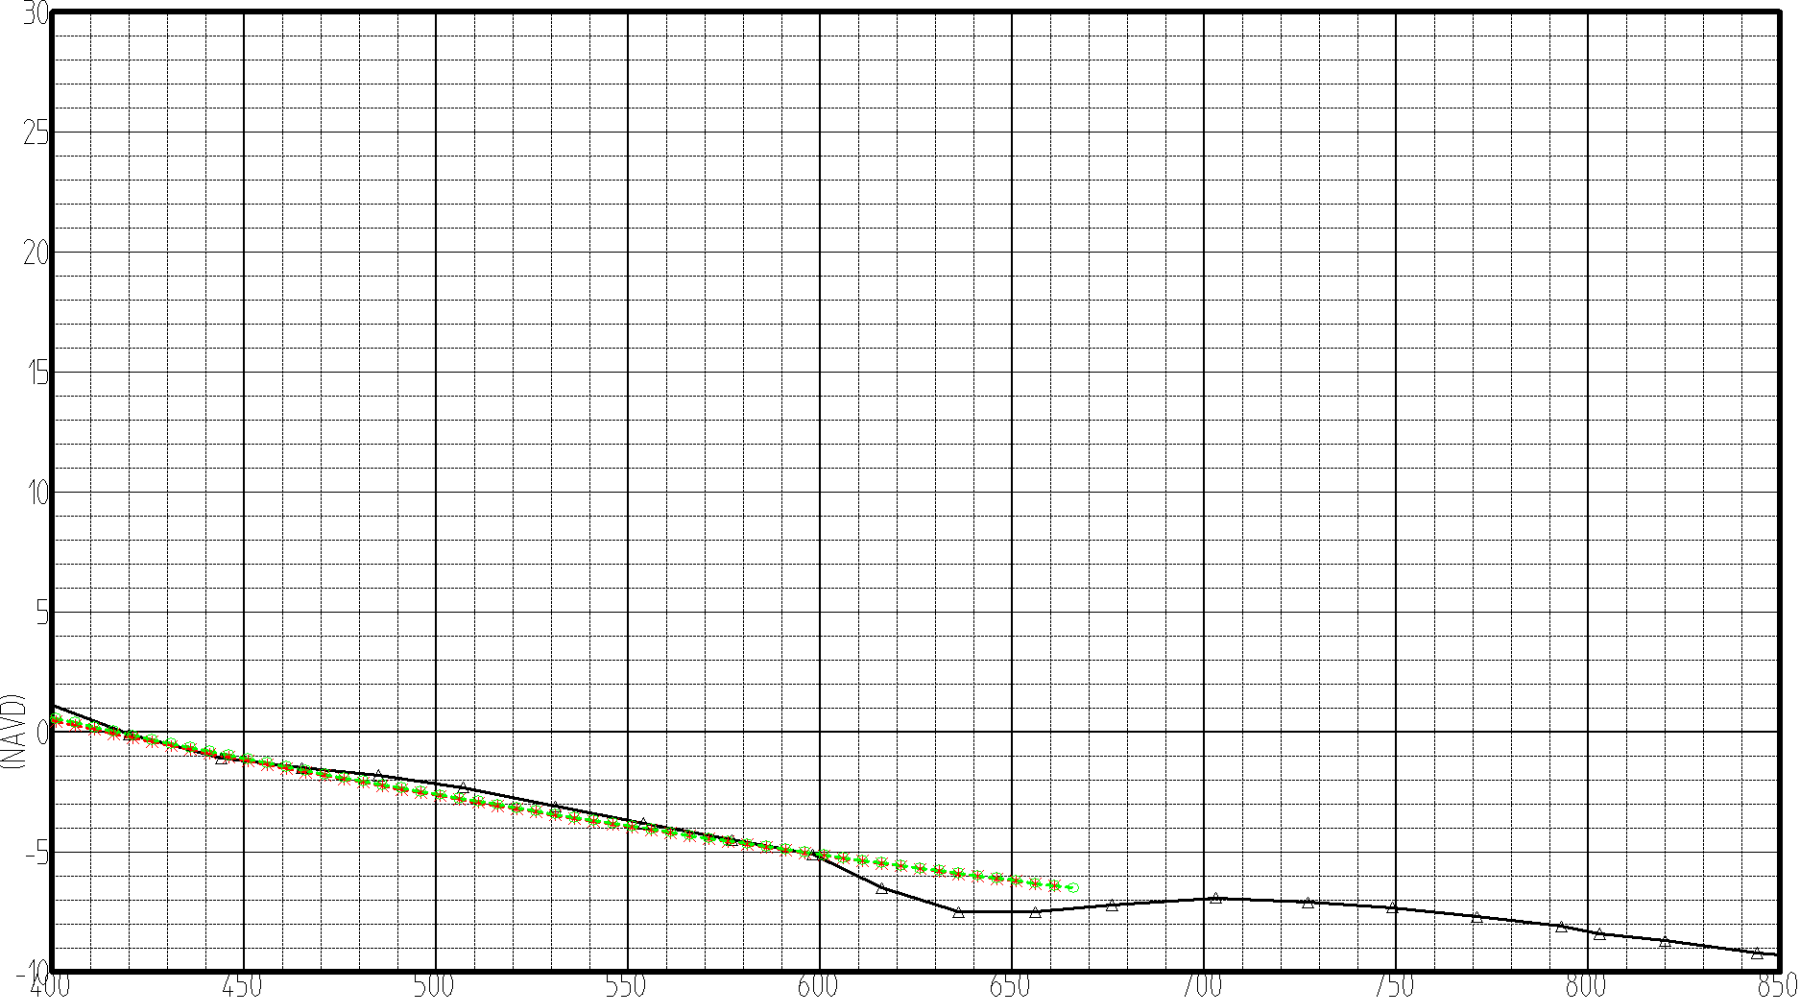
Range: R-54
 BEARING: 90.00
 2/3

BEACH PROFILE
 —△—△— 2005-2008 INPUT PRF
 - - * - - * - - 15-YR SBEACH ERODED PRF
 - - o - - o - - 25-YR SBEACH ERODED PRF
