Appendix XI

SBEACH 15 and 25 yr. Storm Erosion Profiles

Brevard County

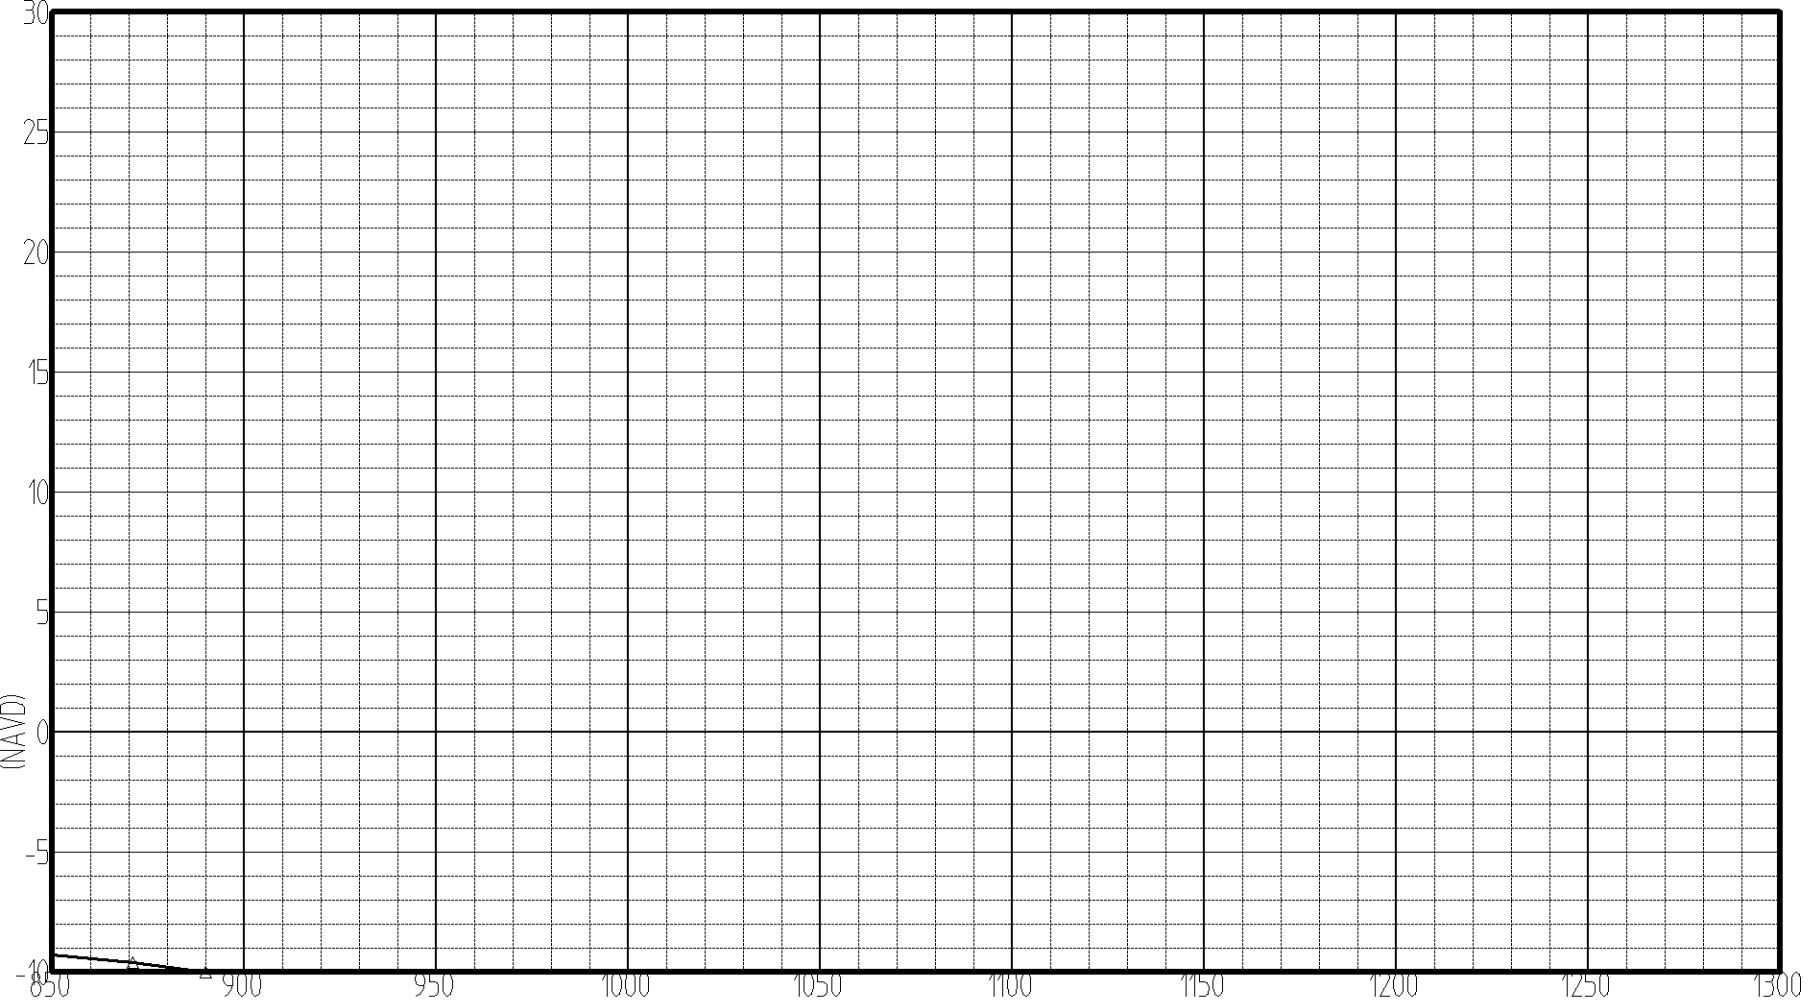
Range: R-54 3/3

BEACH PROFILE

—△—△— 2005-2008 INPUT PRF

- - - * - - - 15-YR SBEACH ERODED PRF

- - - o - - - 25-YR SBEACH ERODED PRF

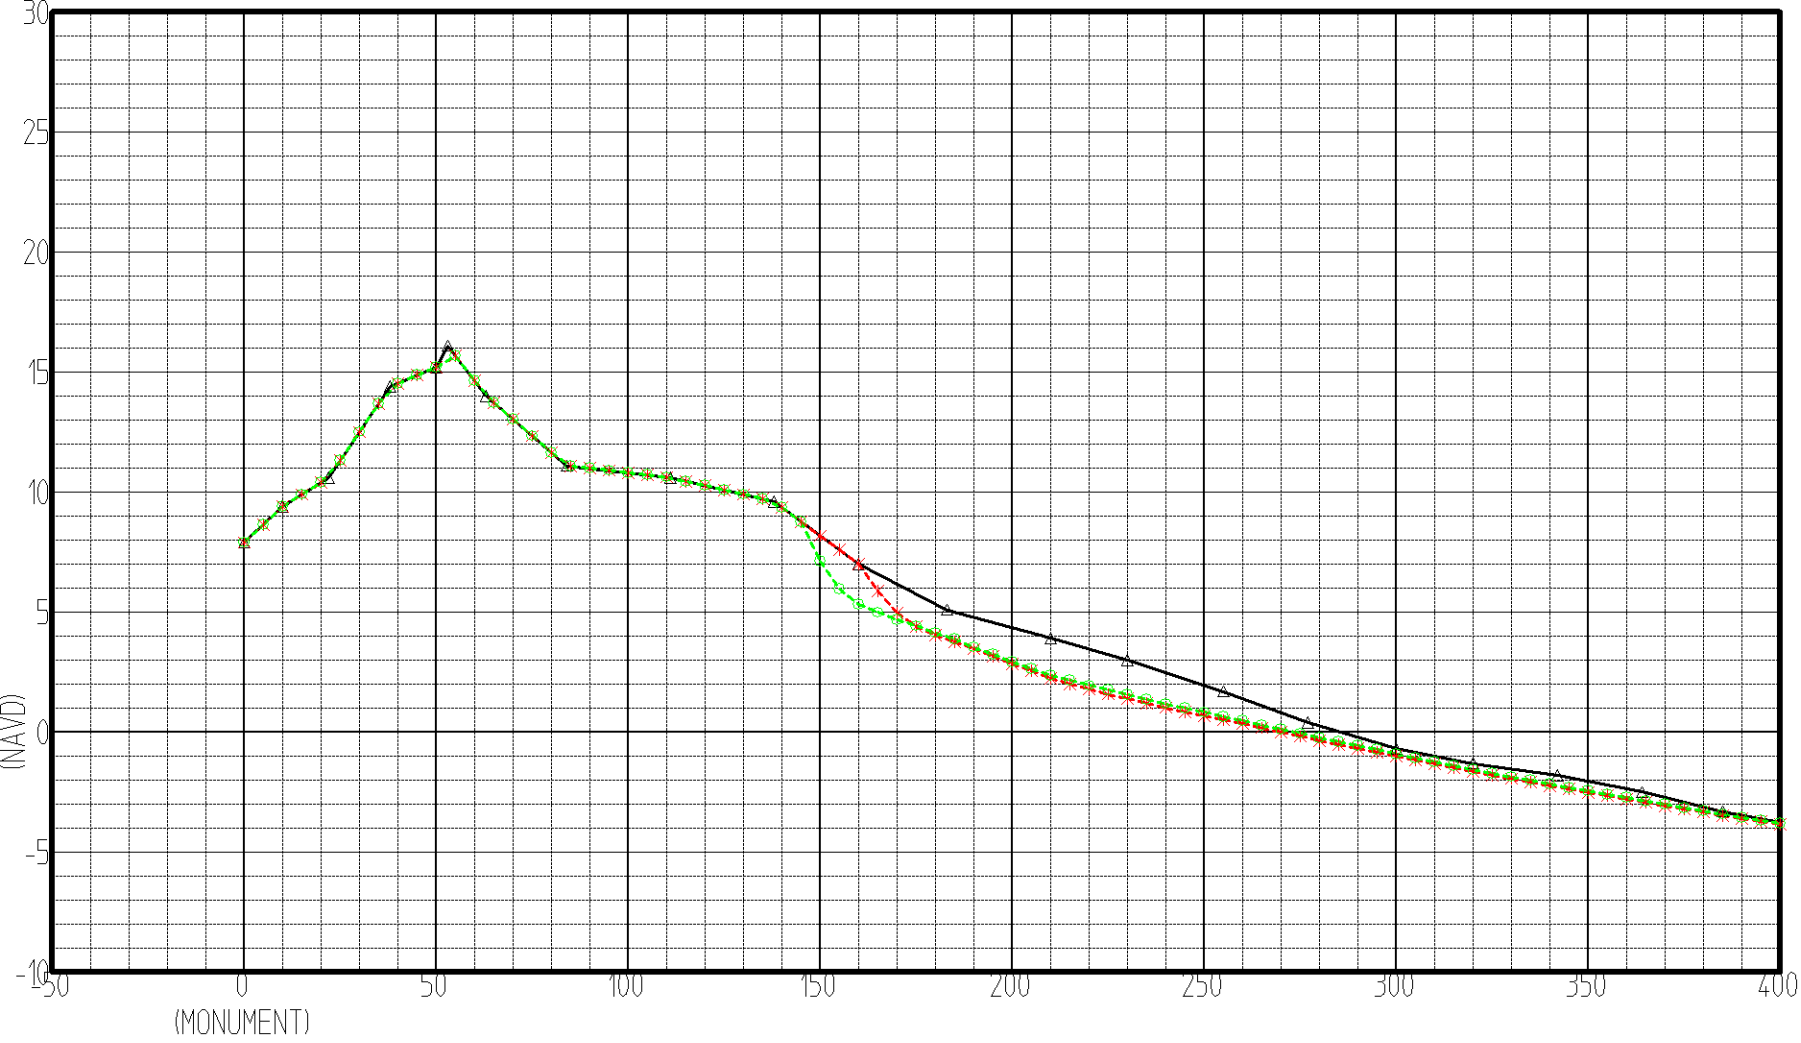
Range: R-55-T 1/3
 BEARING: 90.00

BEACH PROFILE
 —△—△— 2005-2008 INPUT PRF
 - - * - - * - - 15-YR SBEACH ERODED PRF
 - - o - - o - - 25-YR SBEACH ERODED PRF

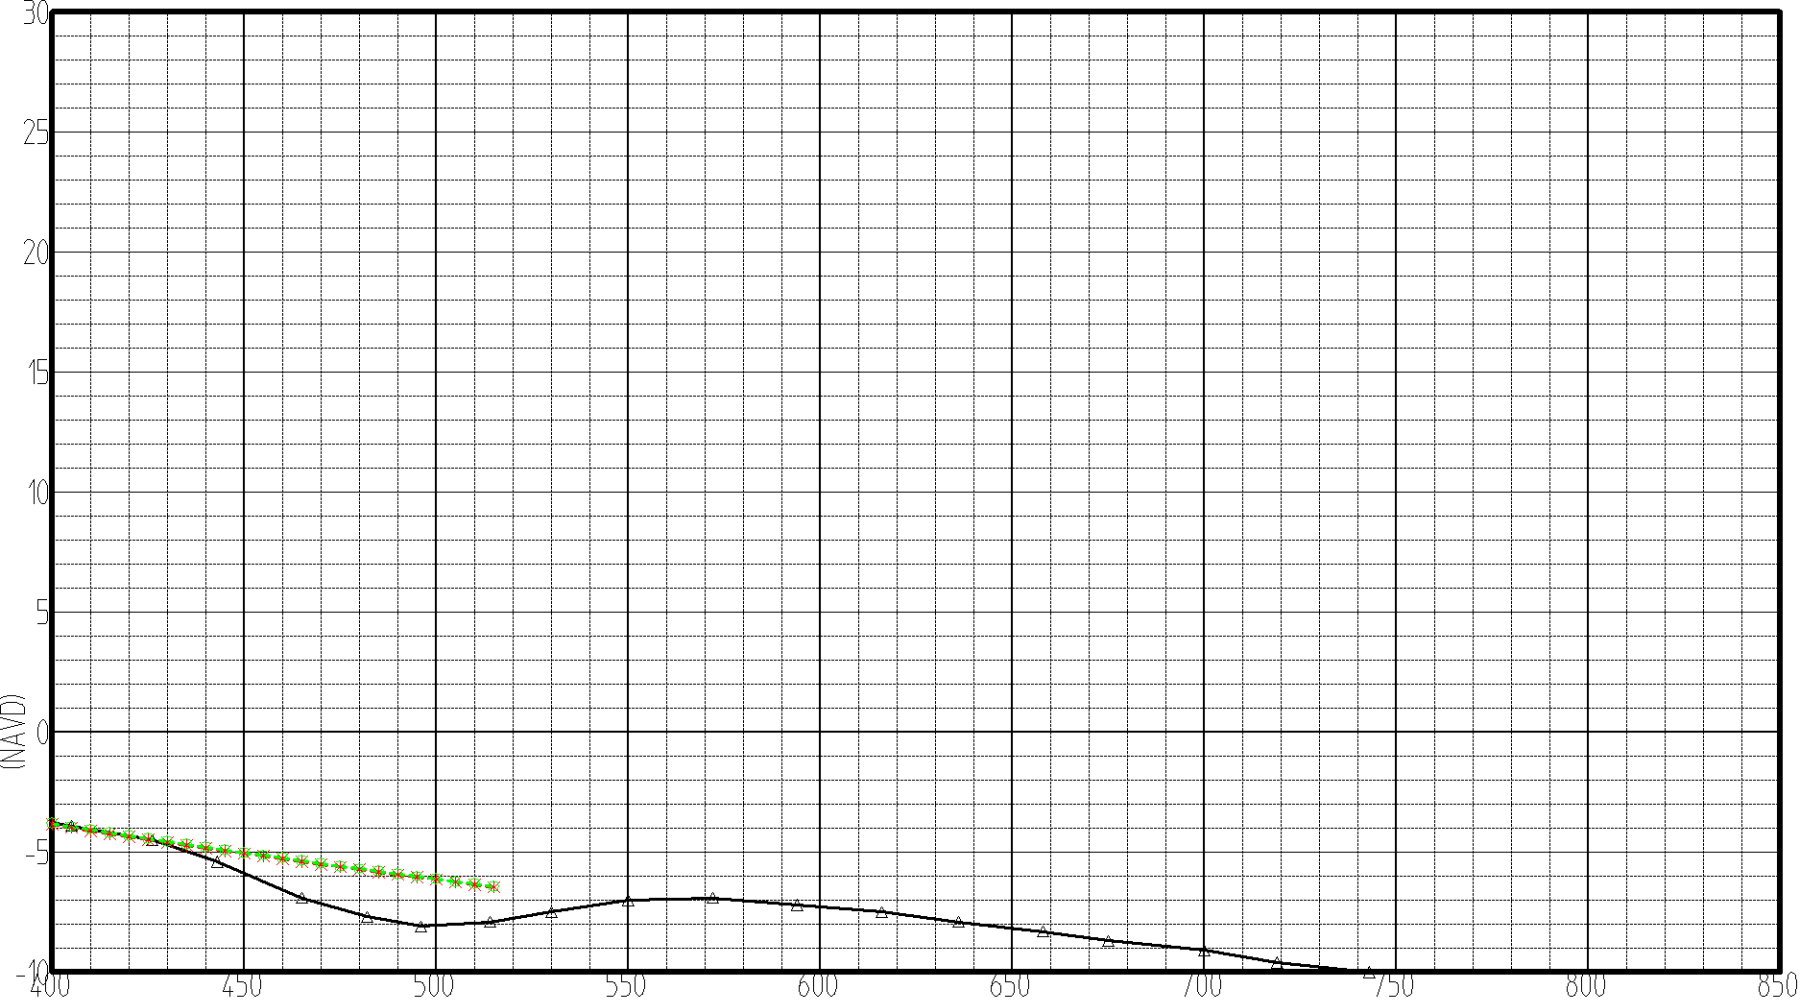
Range: R-55-T 2/3
 BEARING: 90.00

BEACH PROFILE
 —△—△— 2005-2008 INPUT PRF
 - - * - - * - - 15-YR SBEACH ERODED PRF
 - - o - - o - - 25-YR SBEACH ERODED PRF

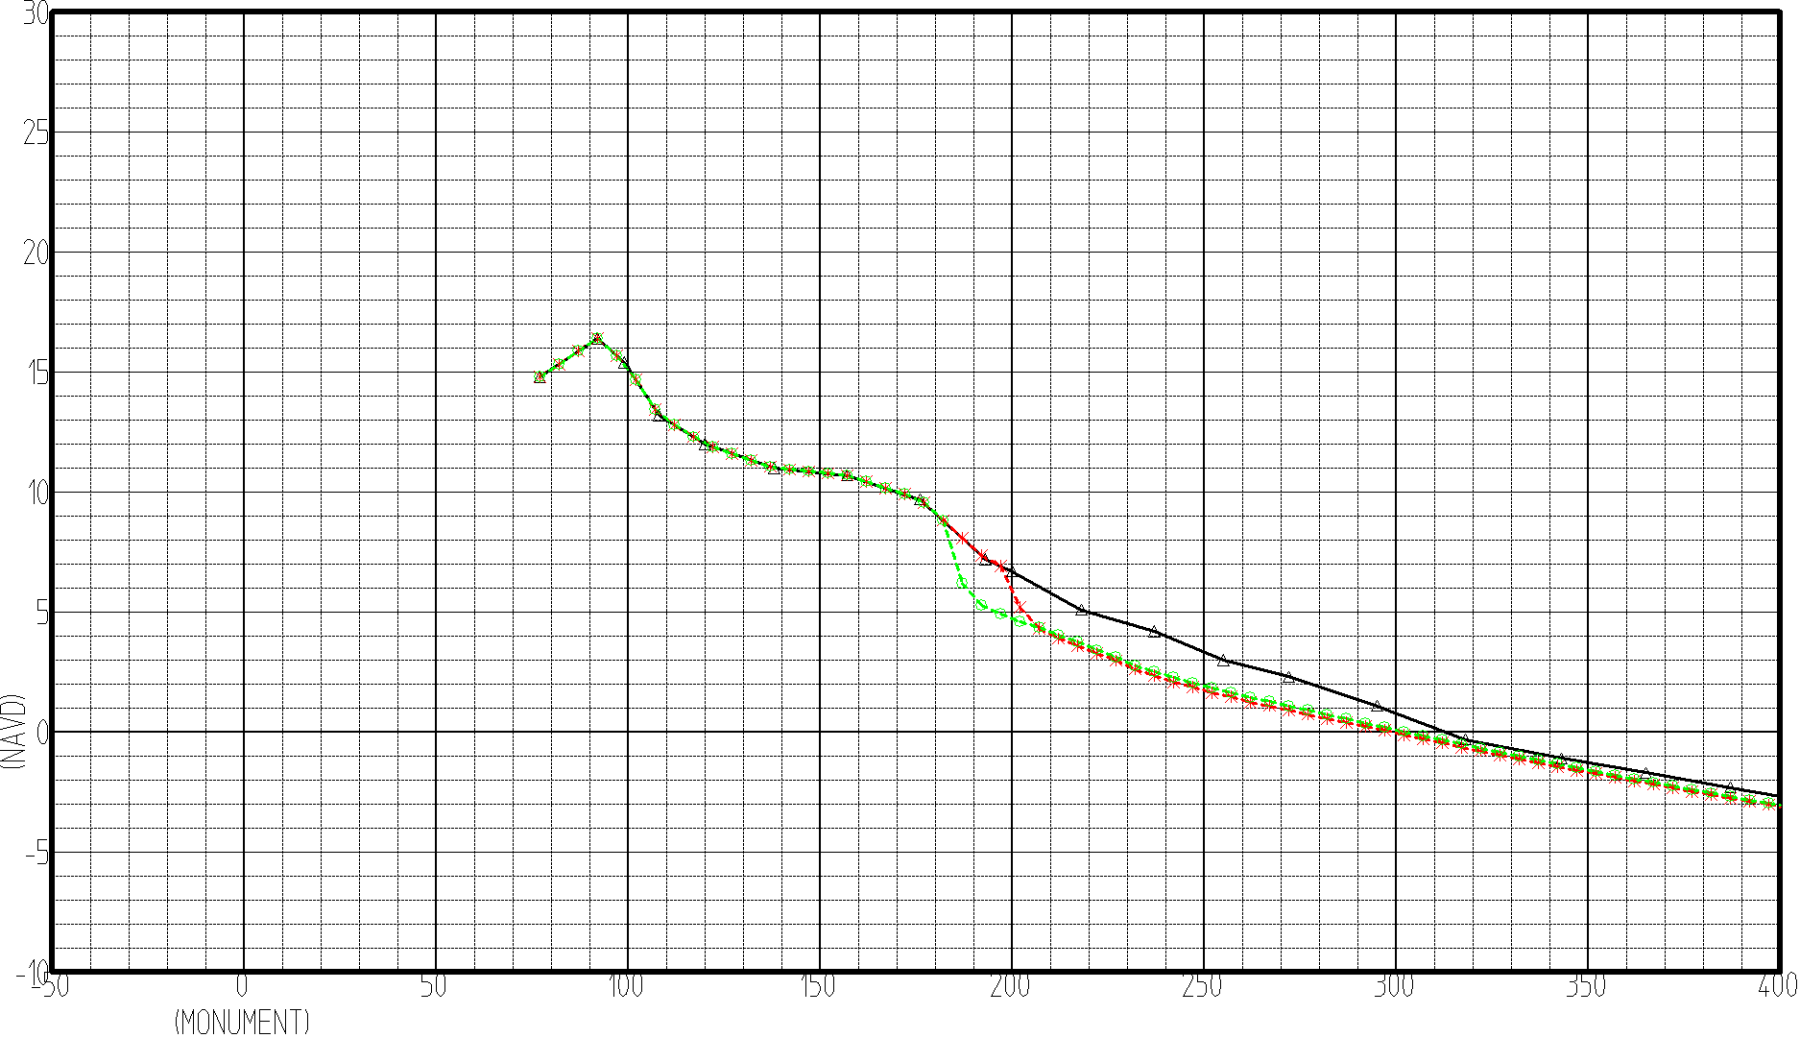
Range: R-56-T
 BEARING: 90.00
 1/2

BEACH PROFILE
 —△—△— 2005-2008 INPUT PRF
 - - * - - * - - 15-YR SBEACH ERODED PRF
 - - o - - o - - 25-YR SBEACH ERODED PRF

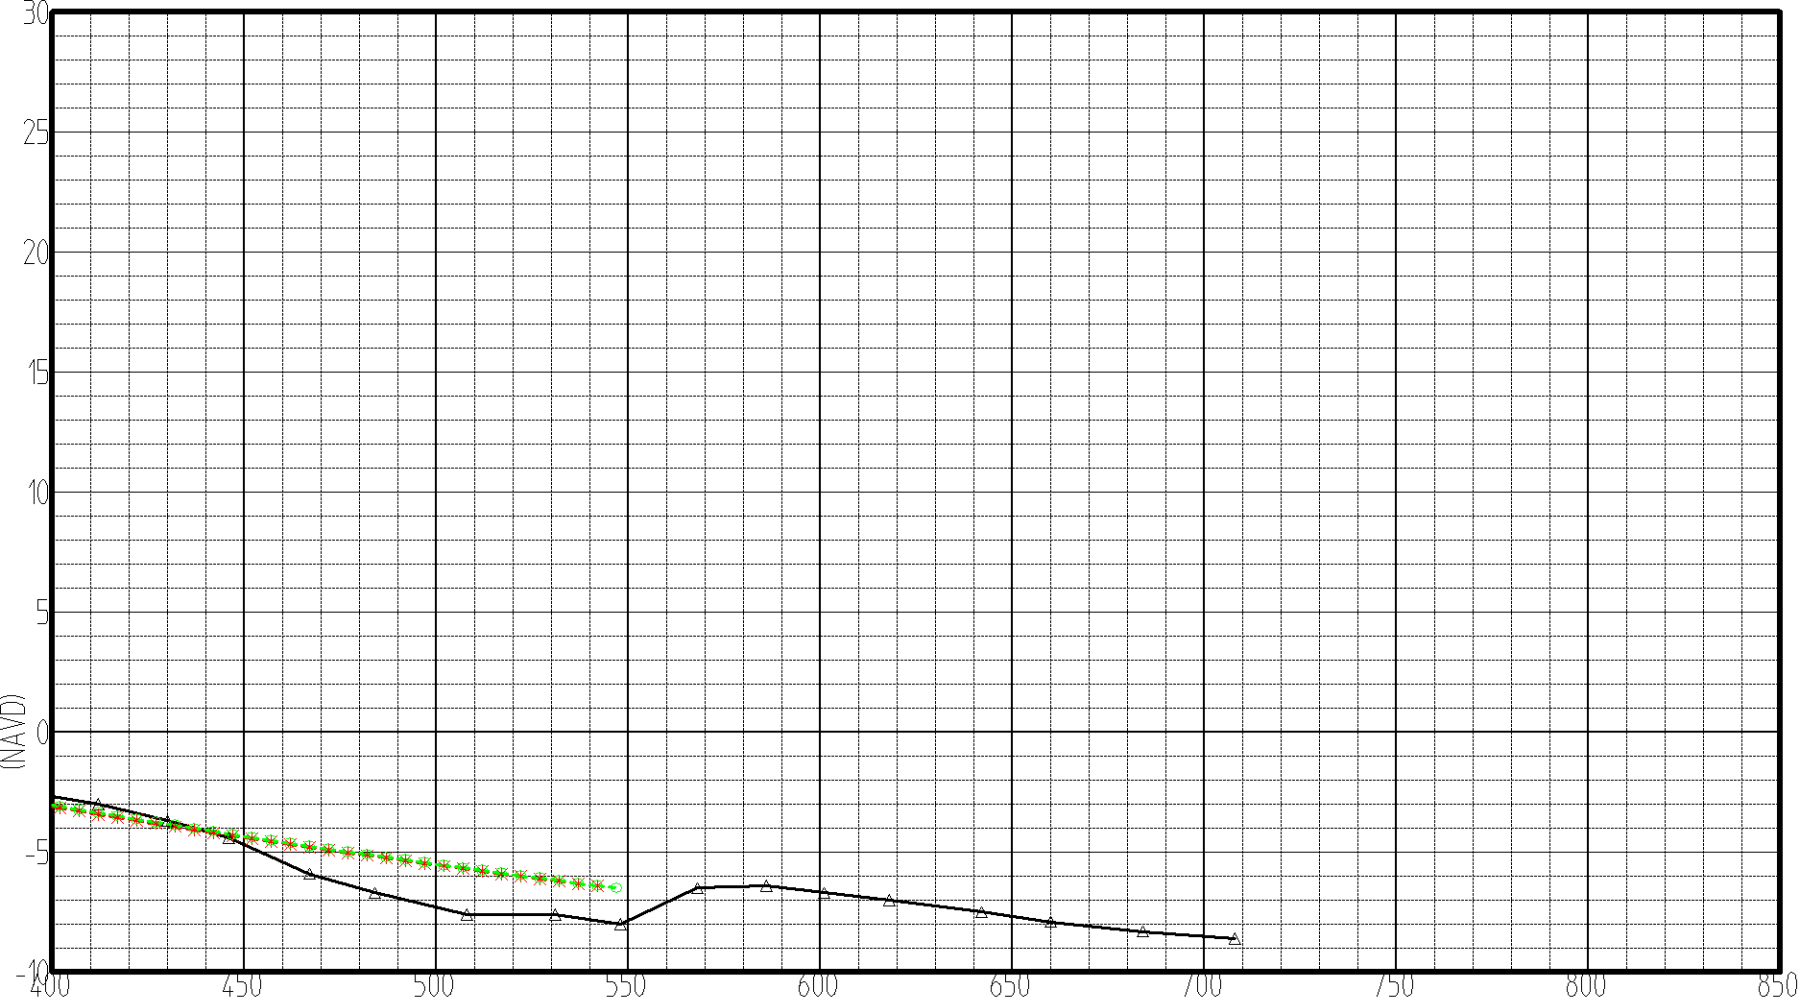
Range: R-56-T 2/2

BEACH PROFILE

—△—△— 2005-2008 INPUT PRF
 - - * - - * - - 15-YR SBEACH ERODED PRF
 - - o - - o - - 25-YR SBEACH ERODED PRF

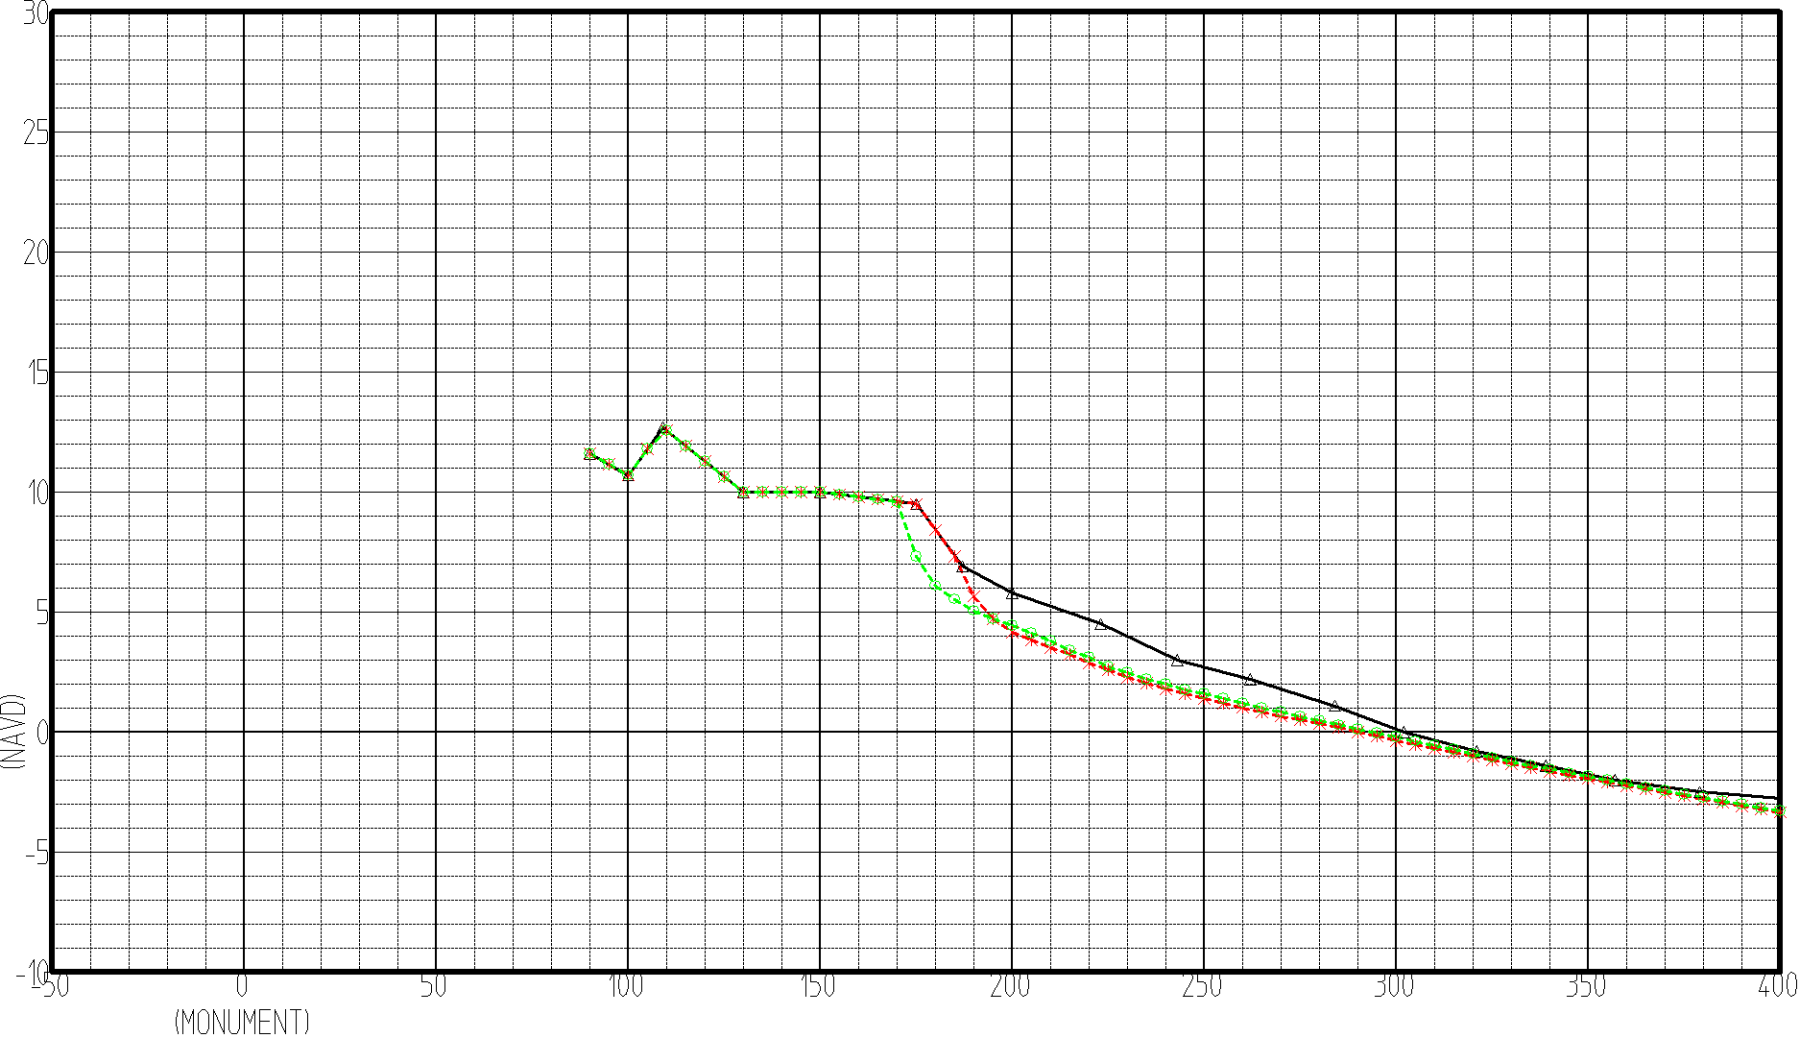
Range: R-57-T
 BEARING: 90.00
 1/2

BEACH PROFILE
 —△—△— 2005-2008 INPUT PRF
 - - * - - * - - 15-YR SBEACH ERODED PRF
 - - o - - o - - 25-YR SBEACH ERODED PRF

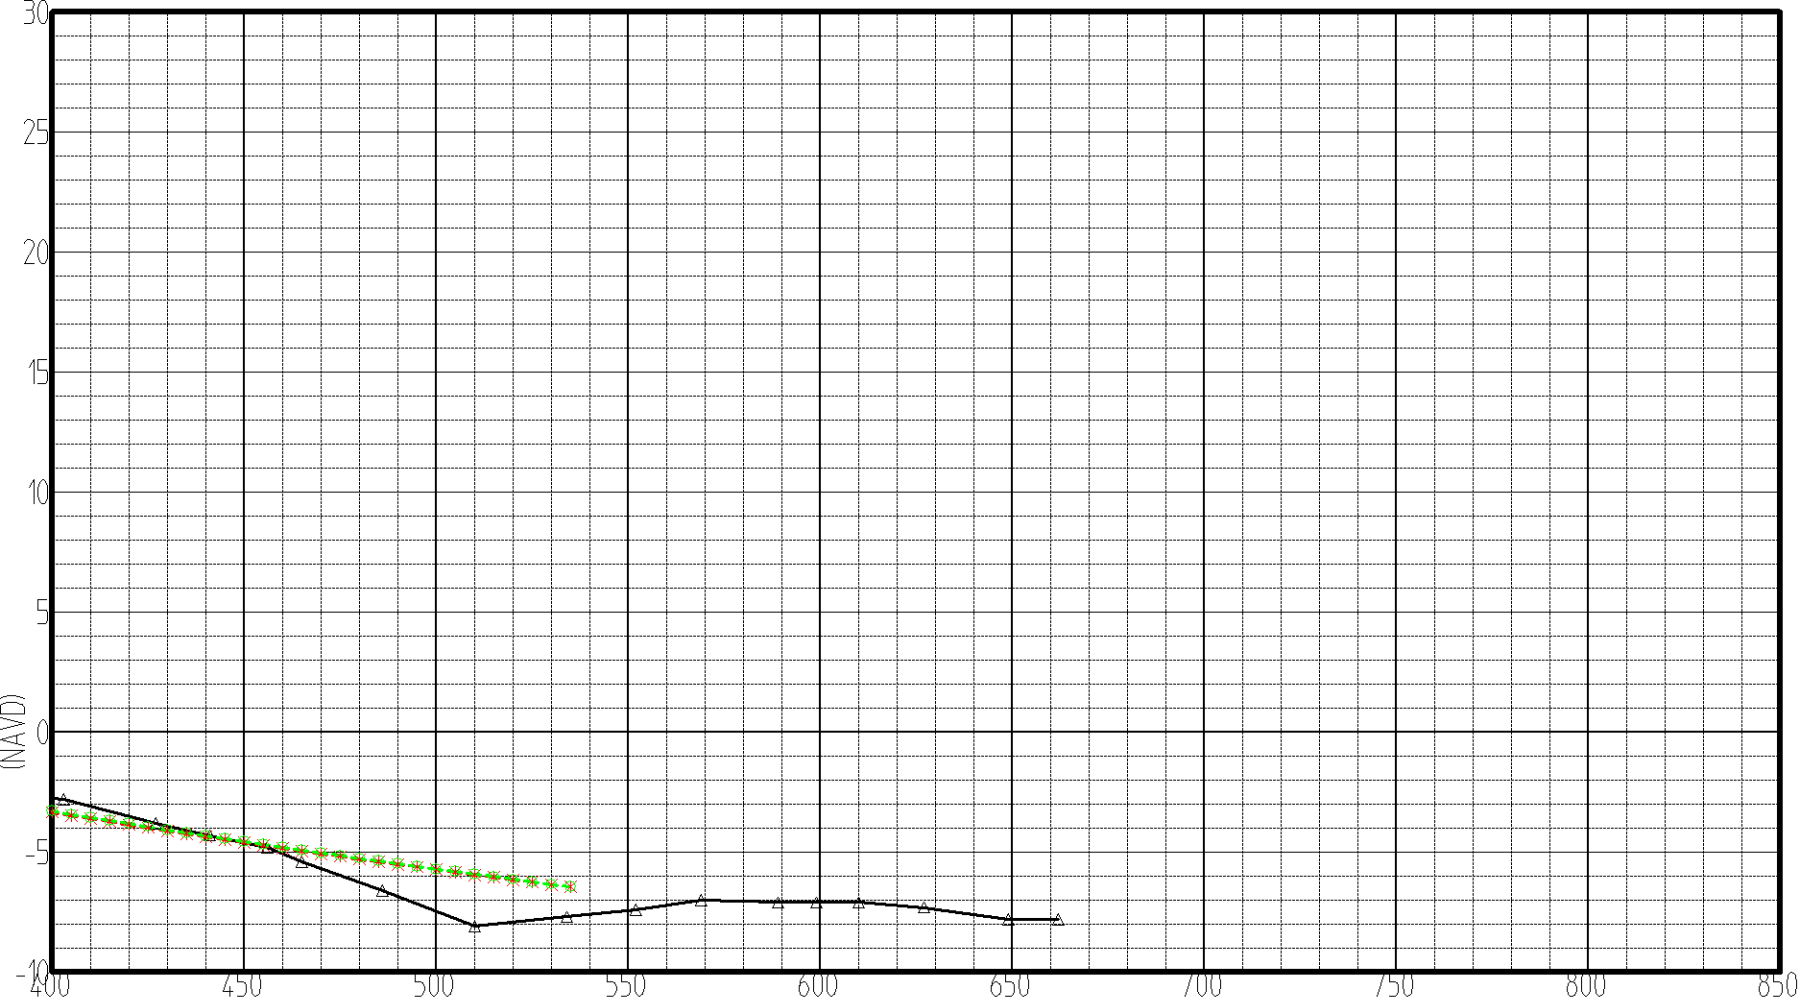
Range: R-57-T

BEACH PROFILE

—△—△— 2005-2008 INPUT PRF

- - - * - - - 15-YR SBEACH ERODED PRF

- - - o - - - 25-YR SBEACH ERODED PRF

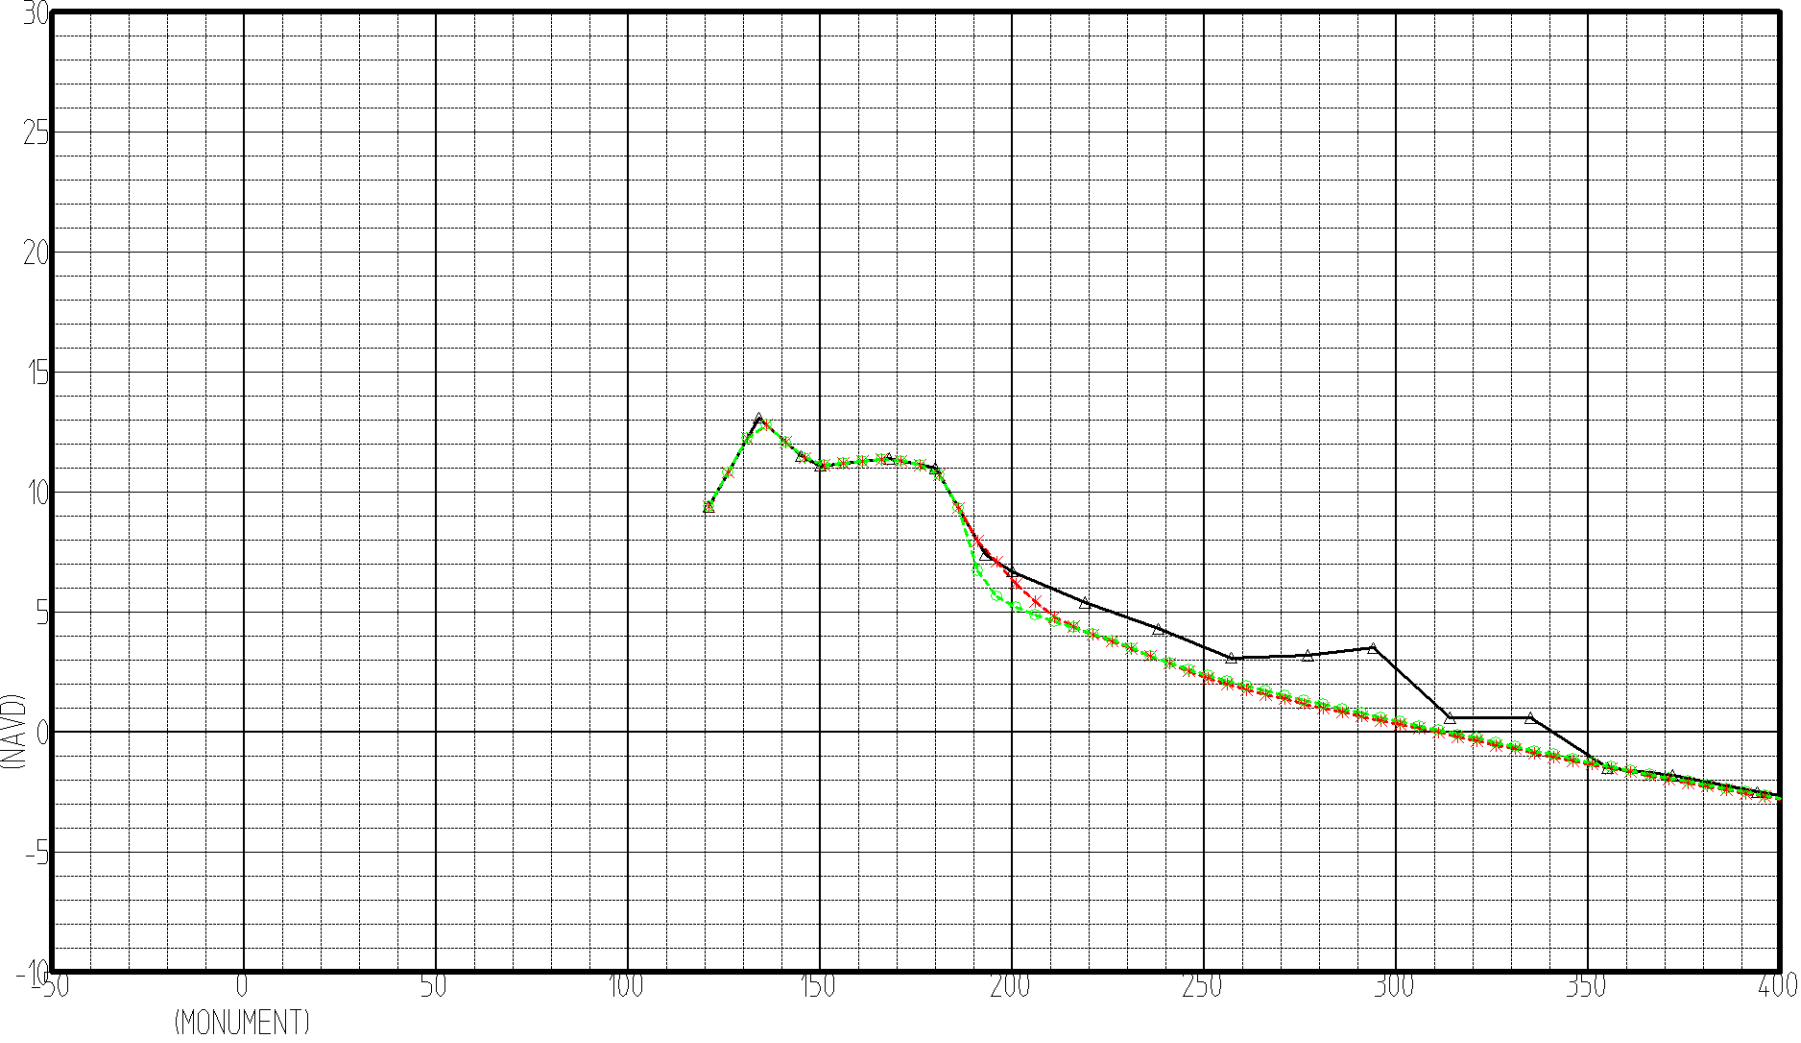
Range: R-58-T

BEACH PROFILE

—△—△— 2005-2008 INPUT PRF

- - - * - - - 15-YR SBEACH ERODED PRF

- - - o - - - 25-YR SBEACH ERODED PRF

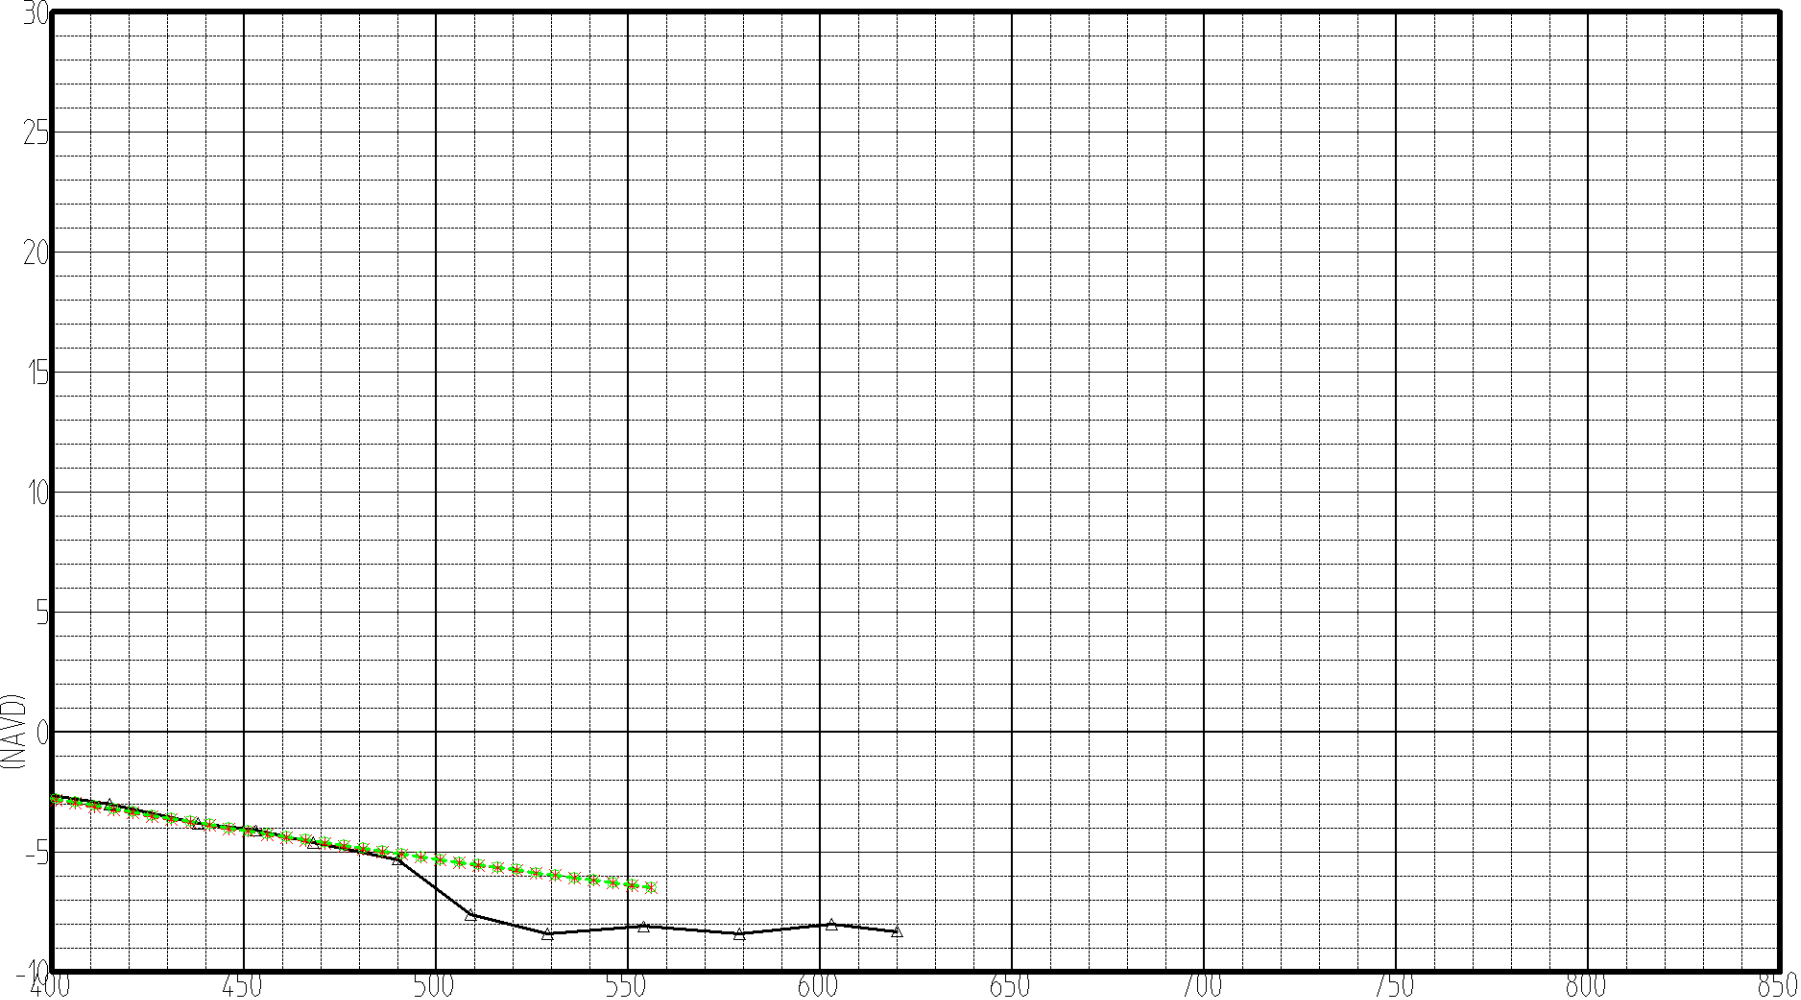
Range: R-58-T

BEACH PROFILE

—△—△— 2005-2008 INPUT PRF

- - - * - - - 15-YR SBEACH ERODED PRF

- - - o - - - 25-YR SBEACH ERODED PRF

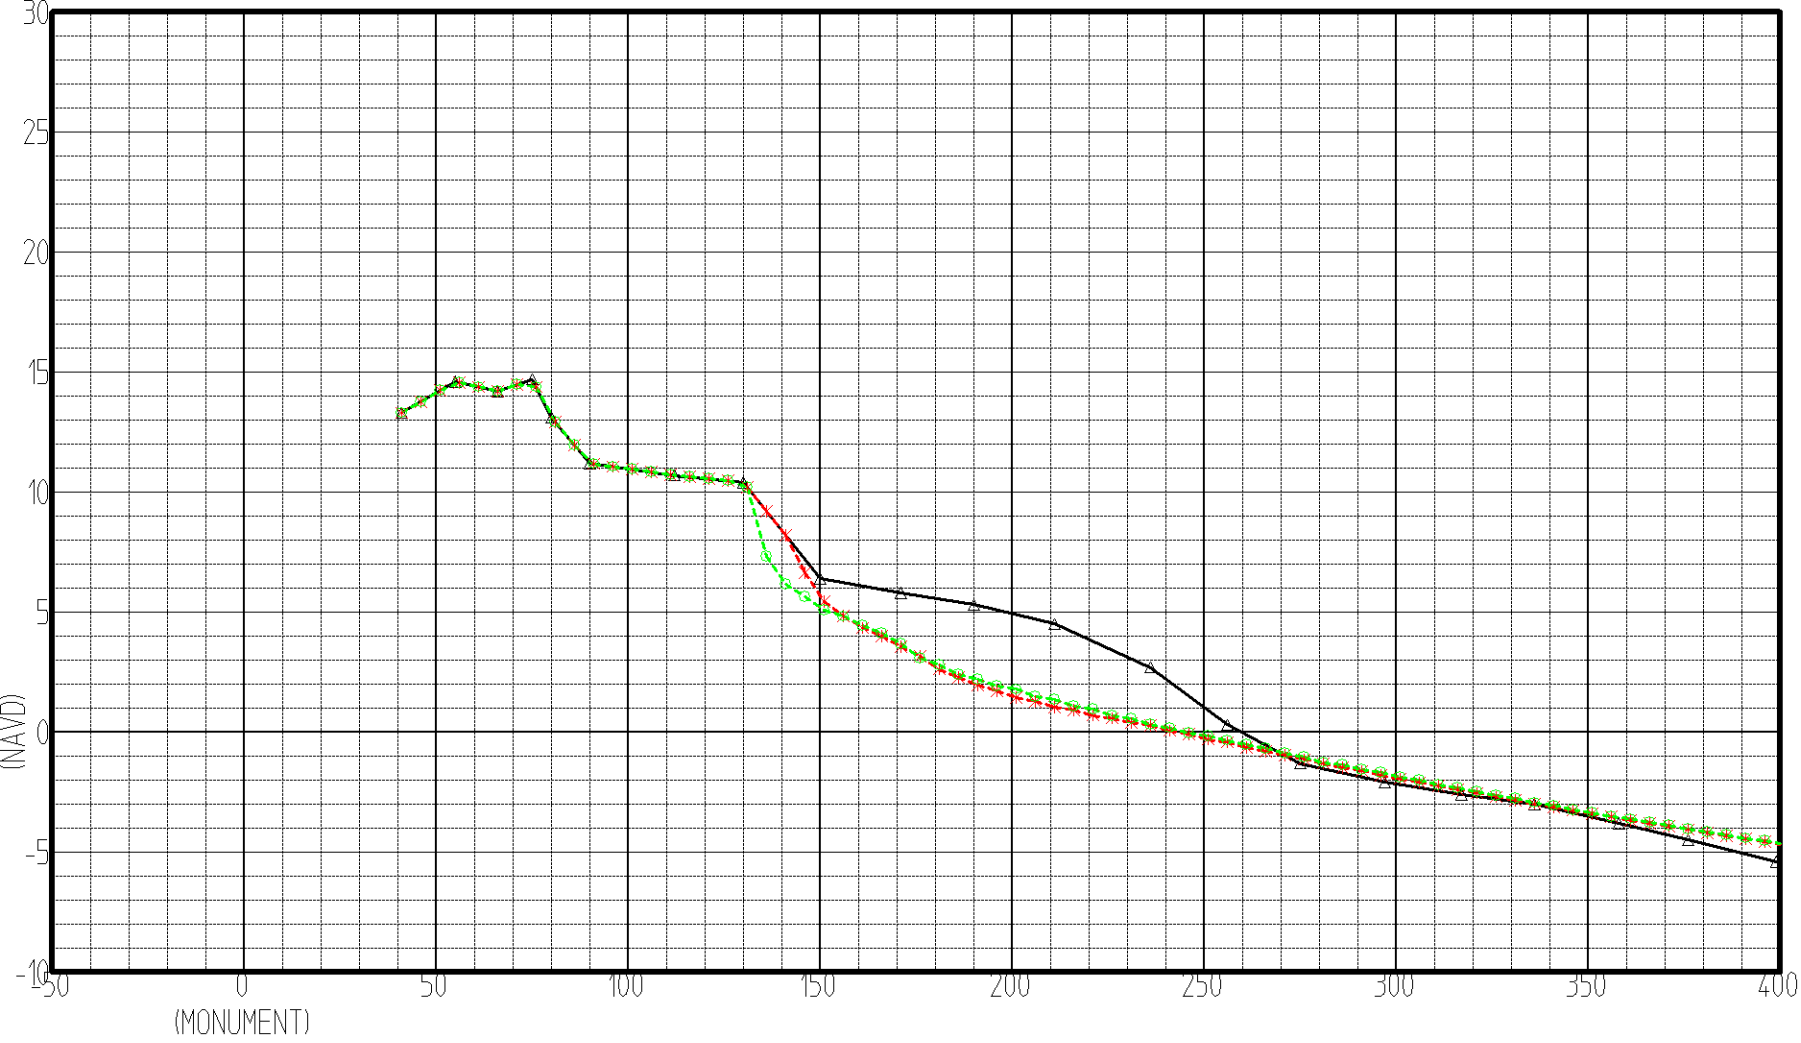
Range: R-59-T

BEACH PROFILE

—△—△— 2005-2008 INPUT PRF

- - - * - - - 15-YR SBEACH ERODED PRF

- - - o - - - 25-YR SBEACH ERODED PRF

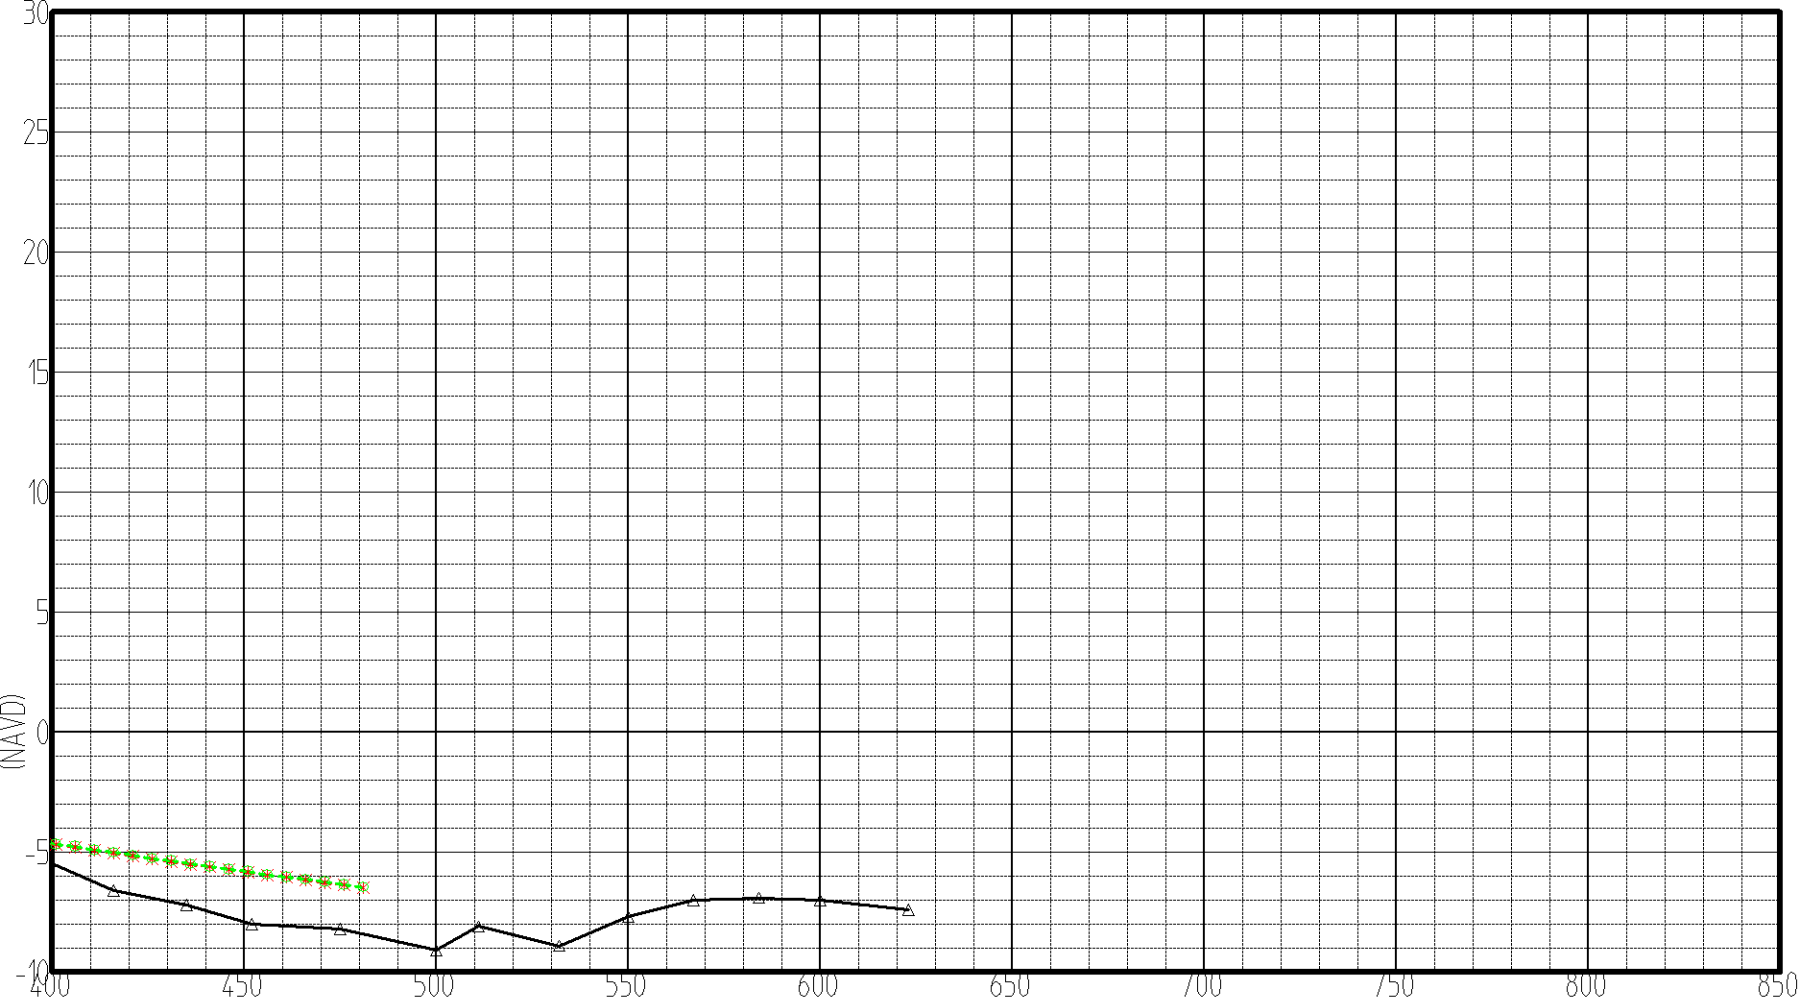
Range: R-59-T
 BEARING: 90.00
 2/2

BEACH PROFILE
 —△—△— 2005-2008 INPUT PRF
 - - * - - * - - 15-YR SBEACH ERODED PRF
 - - o - - o - - 25-YR SBEACH ERODED PRF

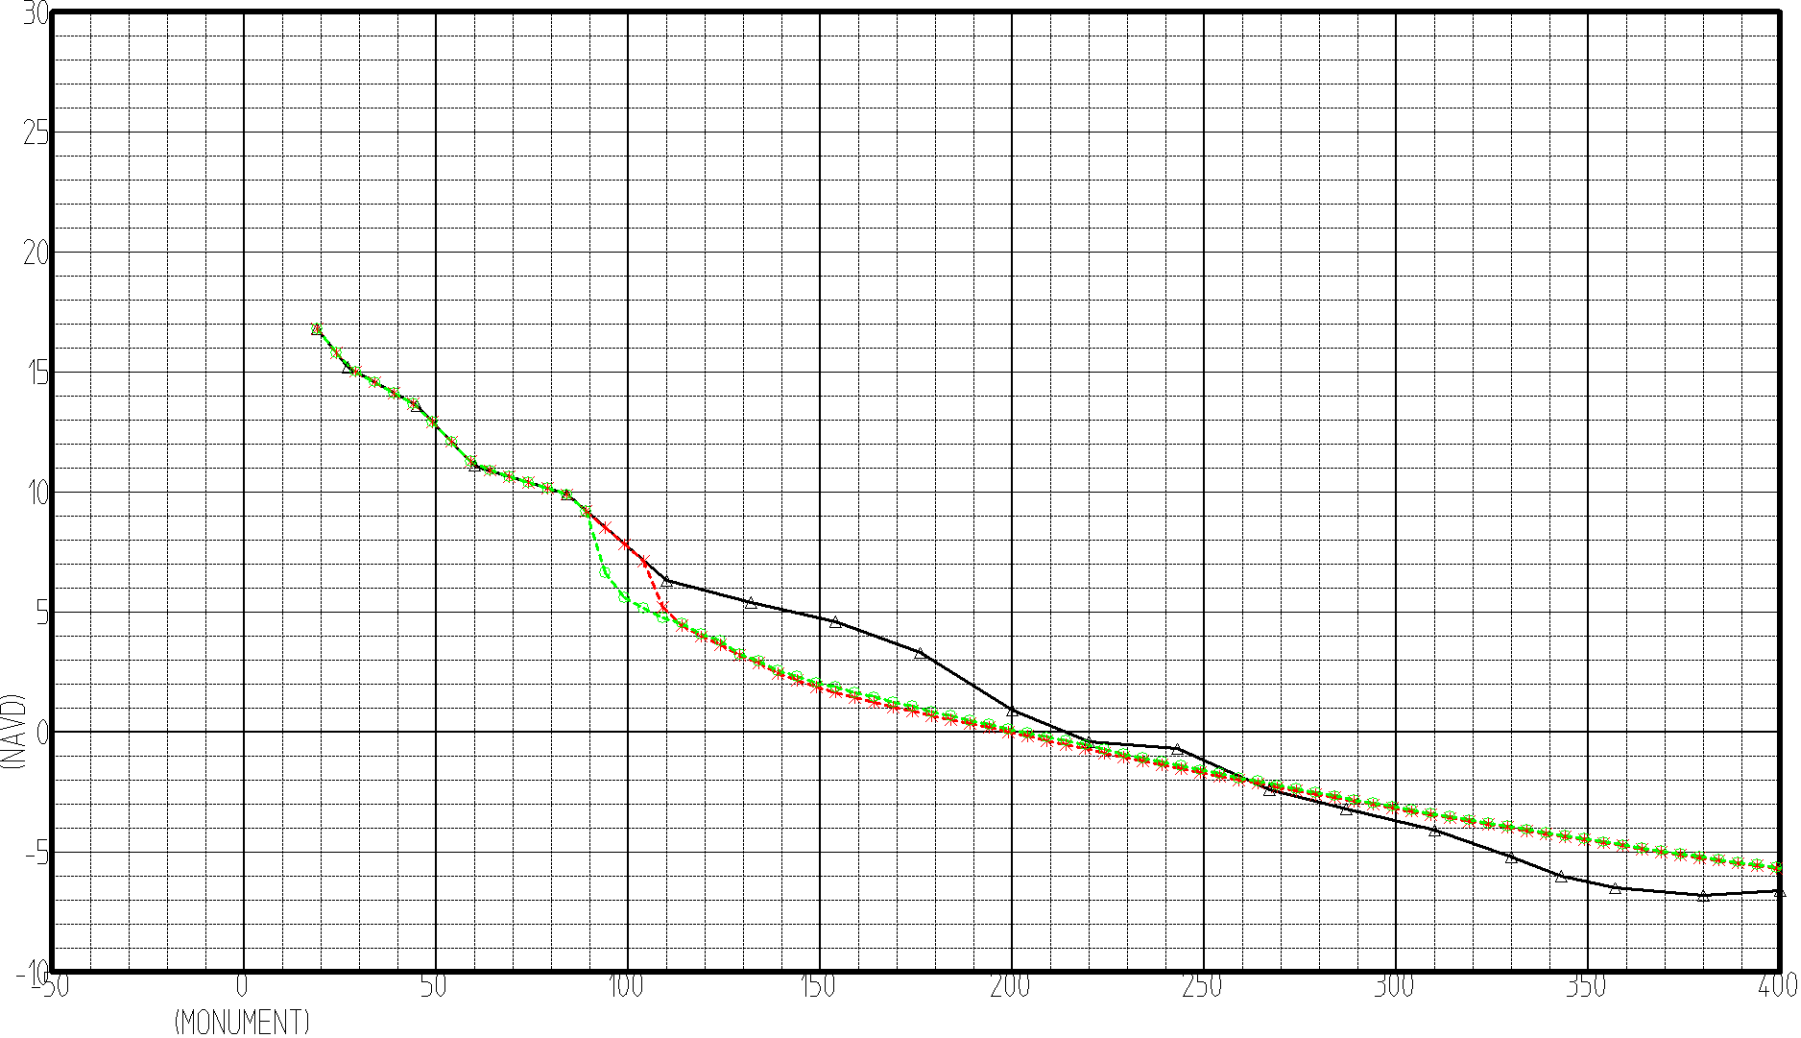
Range: R-60-T

BEACH PROFILE

—△—△— 2005-2008 INPUT PRF

- - - * - - - 15-YR SBEACH ERODED PRF

- - - o - - - 25-YR SBEACH ERODED PRF
