Appendix XI

SBEACH 15 and 25 yr. Storm Erosion Profiles

Brevard County

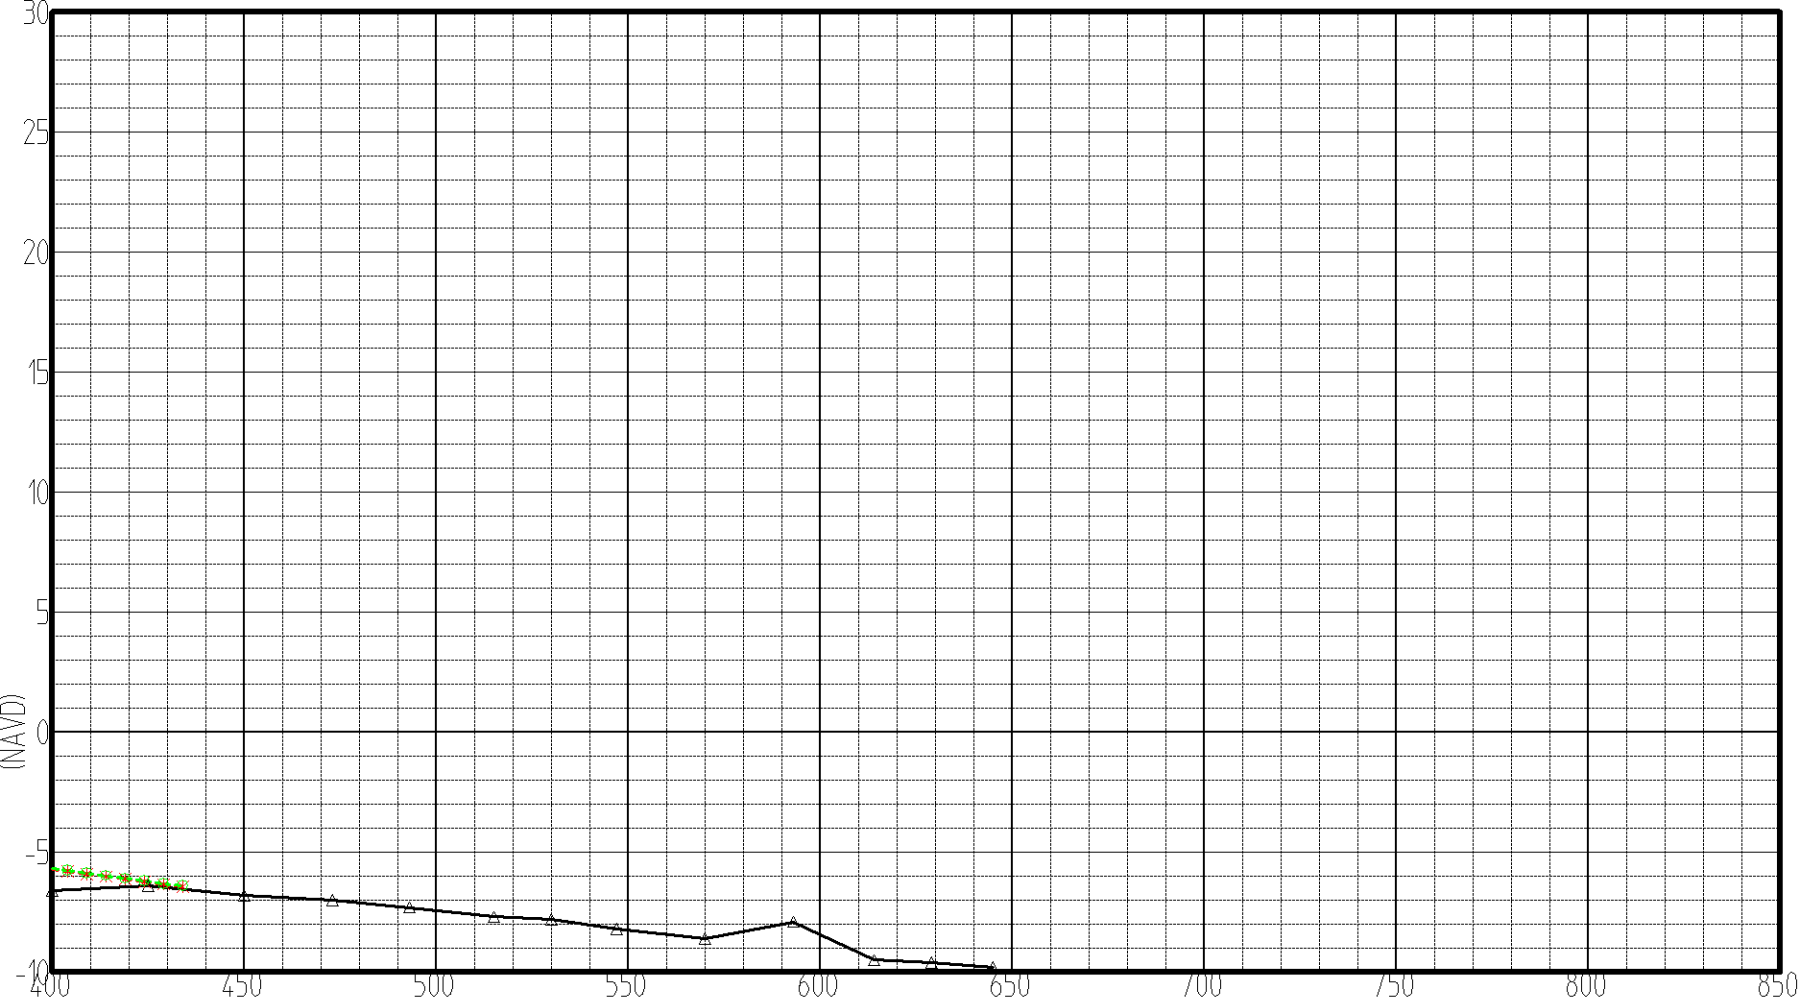
Range: R-60-T

BEACH PROFILE

—△—△— 2005-2008 INPUT PRF

- - - * - - - * - - - 15-YR SBEACH ERODED PRF

- - - o - - - o - - - 25-YR SBEACH ERODED PRF

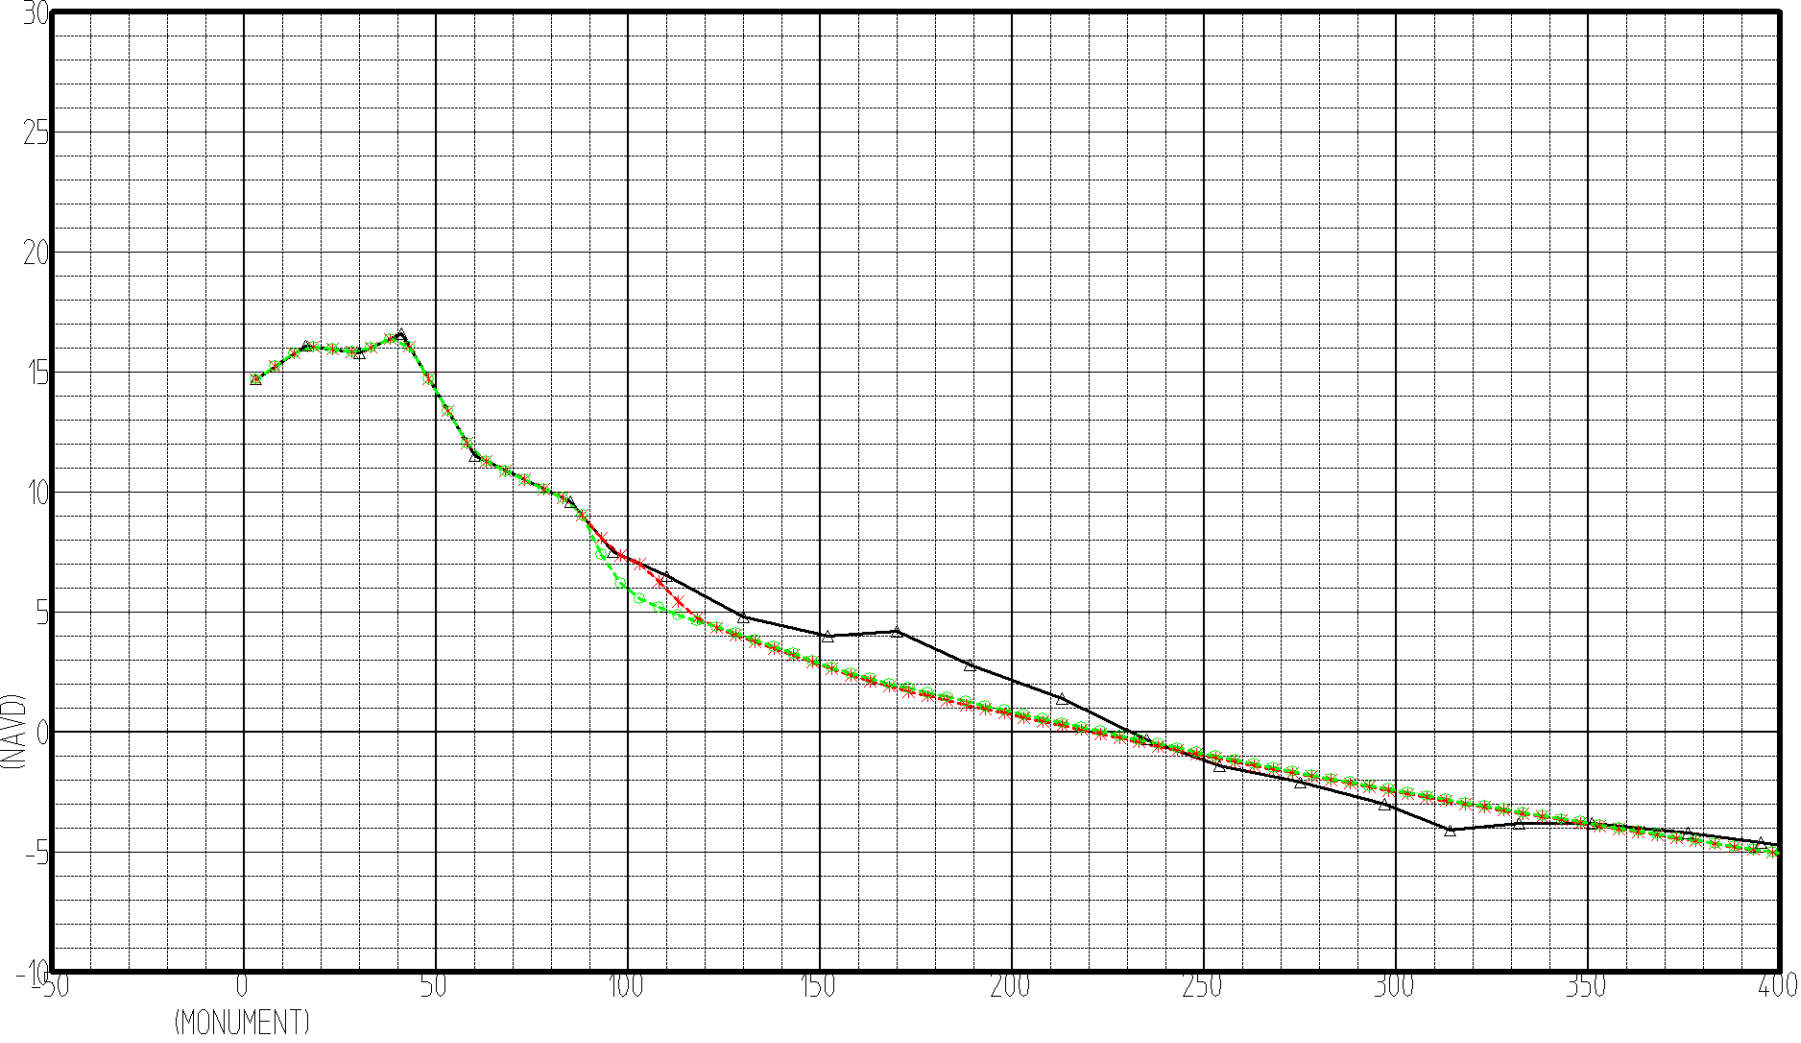
Range: R-61-T

BEACH PROFILE

—△—△— 2005-2008 INPUT PRF

- - - * - - - 15-YR SBEACH ERODED PRF

- - - o - - - 25-YR SBEACH ERODED PRF

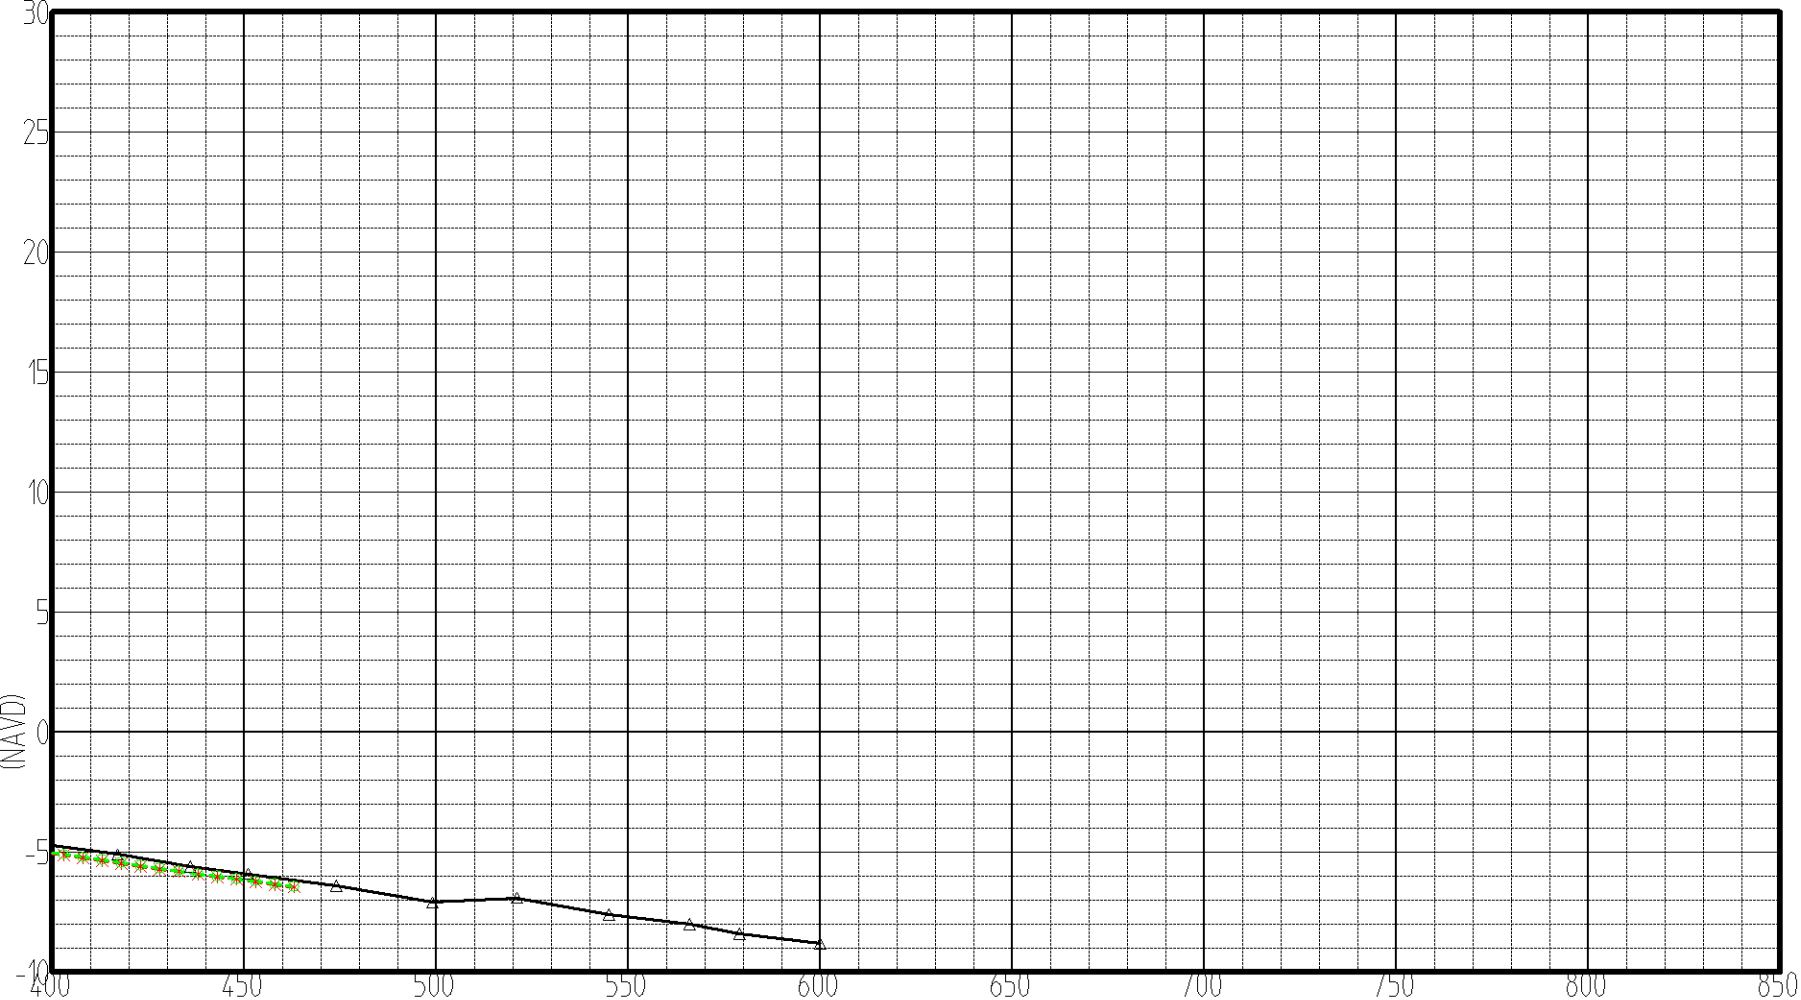
Range: R-61-T 2/2
 BEARING: 90.00

BEACH PROFILE
 —△—△— 2005-2008 INPUT PRF
 - - * - - * - - 15-YR SBEACH ERODED PRF
 - - o - - o - - 25-YR SBEACH ERODED PRF

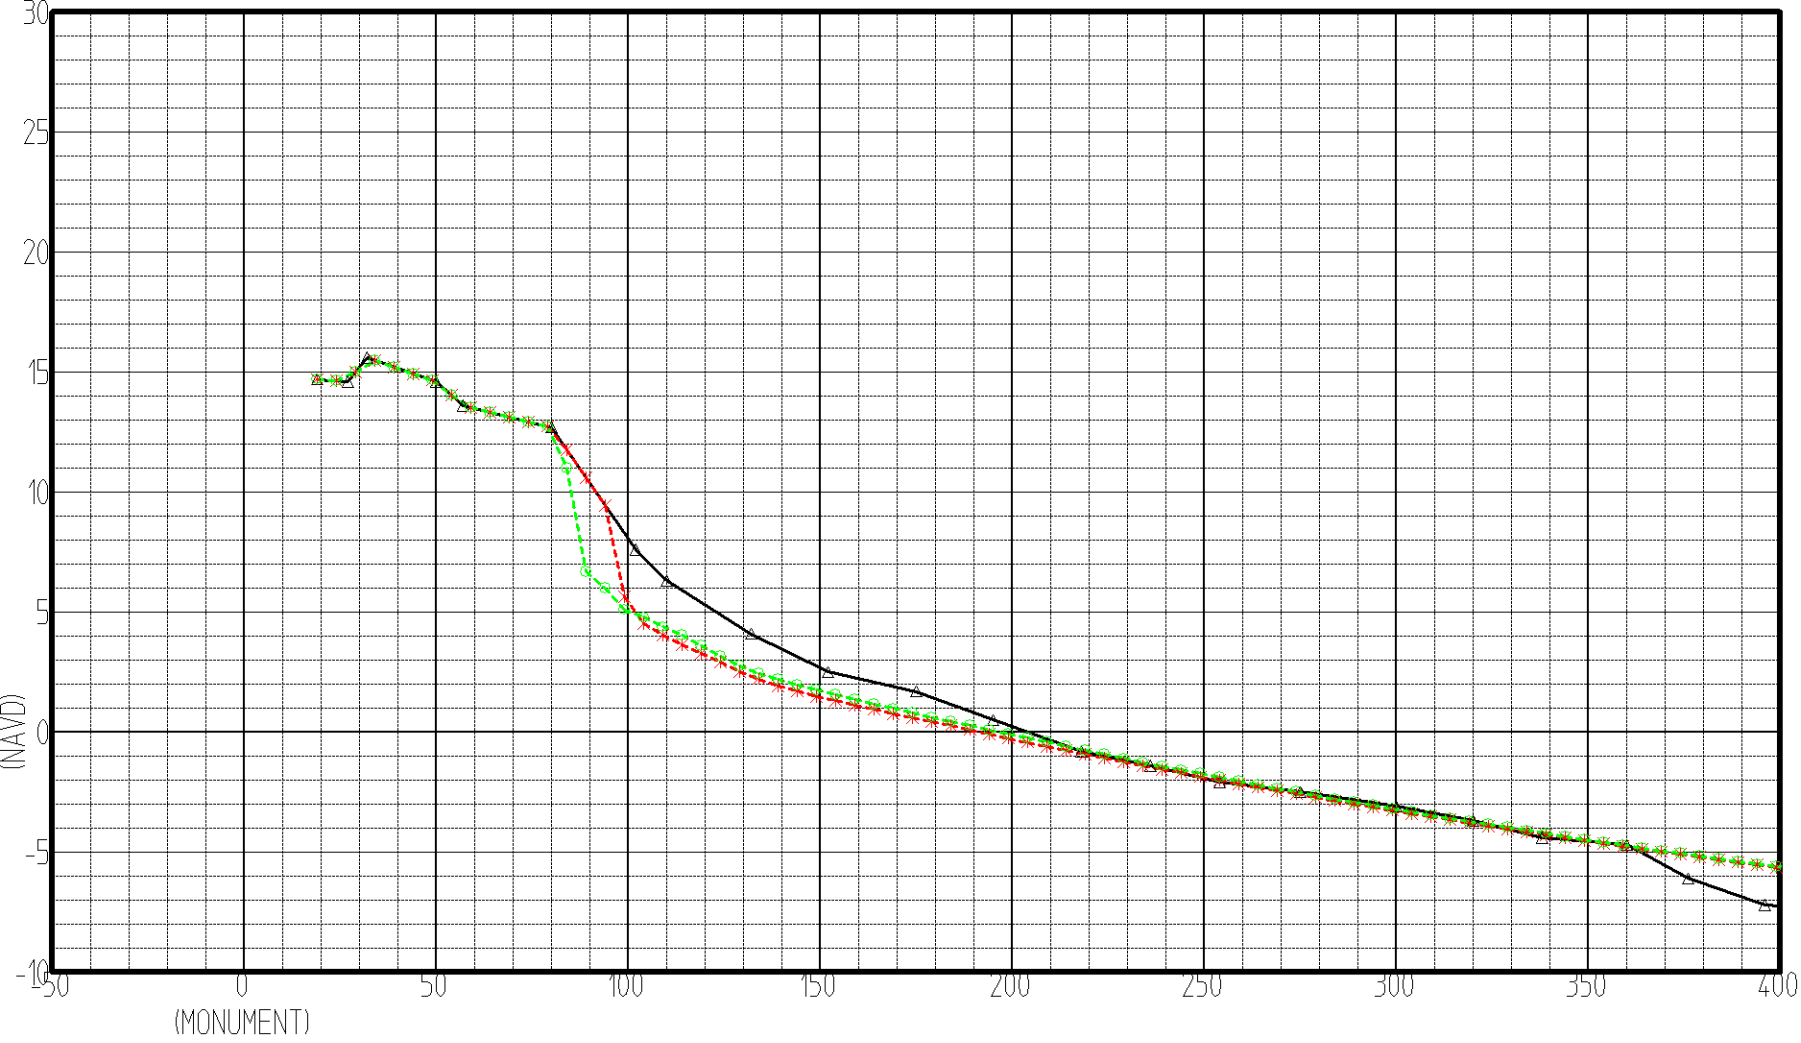
Range: R-62-T

BEACH PROFILE

—△—△— 2005-2008 INPUT PRF

- - - * - - - 15-YR SBEACH ERODED PRF

- - - o - - - 25-YR SBEACH ERODED PRF

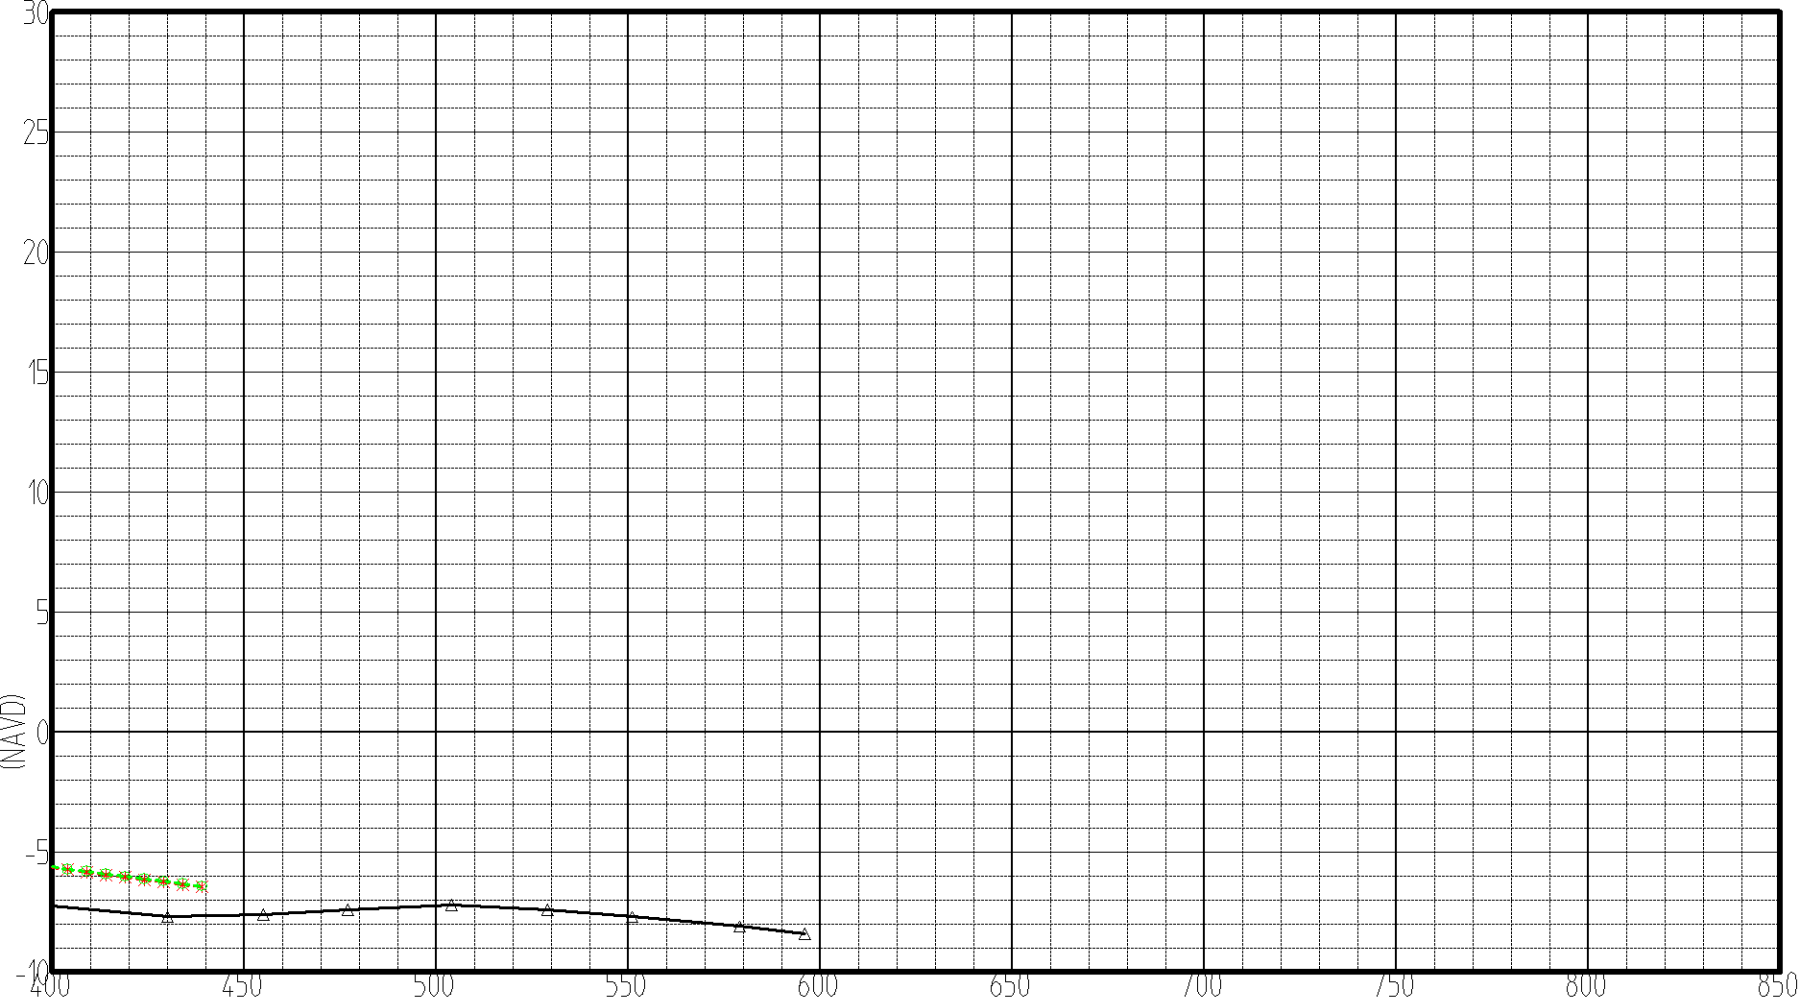
Range: R-62-T 2/2

BEACH PROFILE

—△—△— 2005-2008 INPUT PRF

- - - * - - - 15-YR SBEACH ERODED PRF

- - - o - - - 25-YR SBEACH ERODED PRF

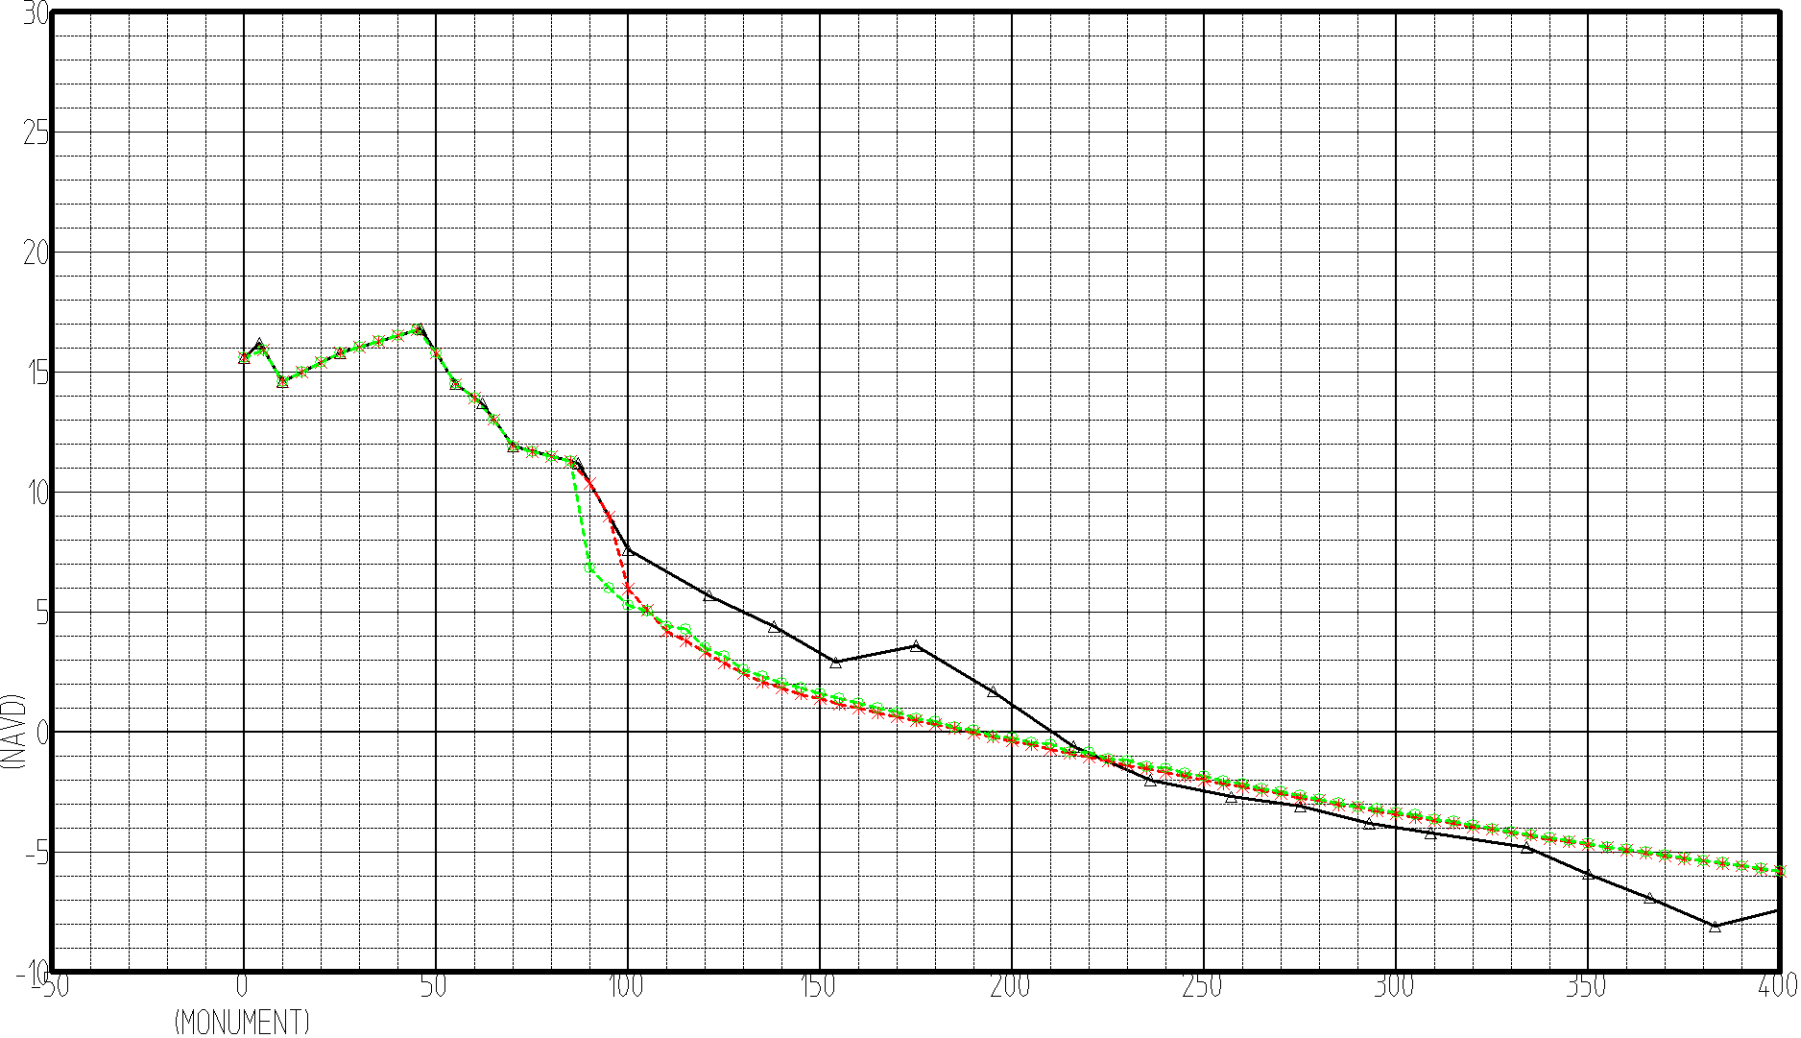
Range: R-63-T 1/2
 BEARING: 90.00

BEACH PROFILE
 —△—△— 2005-2008 INPUT PRF
 - - * - - * - - 15-YR SBEACH ERODED PRF
 - - o - - o - - 25-YR SBEACH ERODED PRF

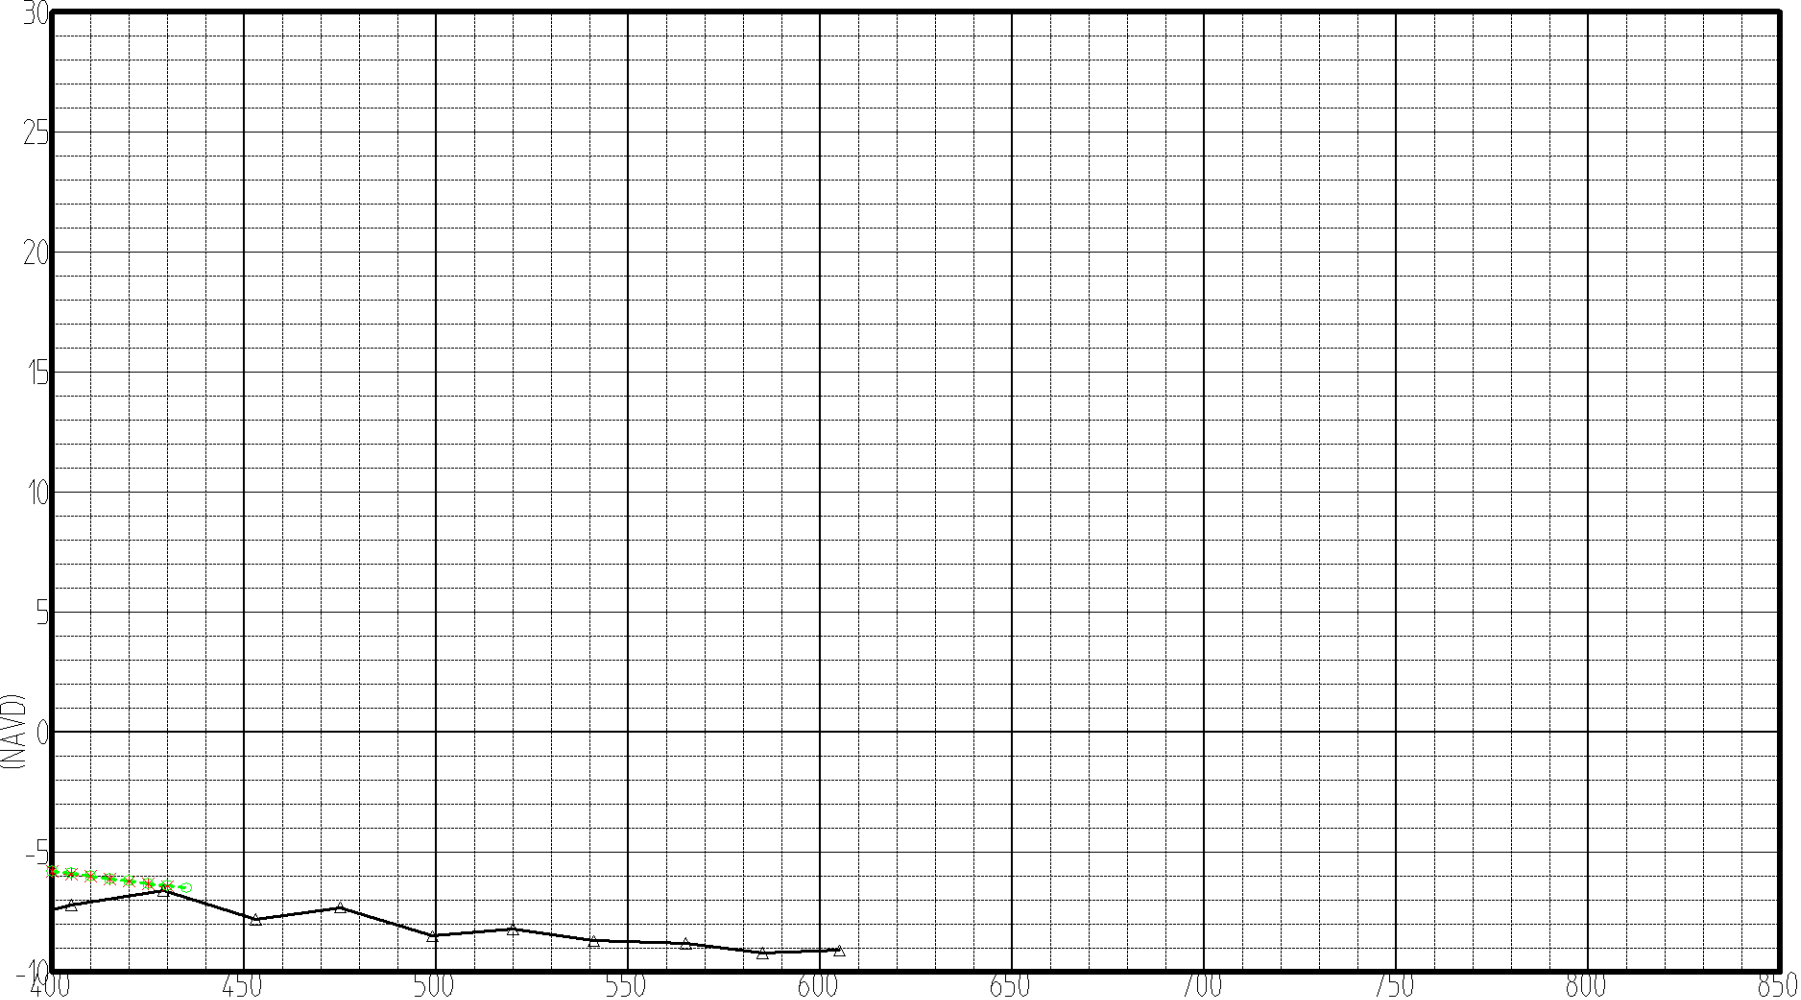
Range: R-63-T 2/2

BEACH PROFILE

—△—△— 2005-2008 INPUT PRF

- - - * - - - 15-YR SBEACH ERODED PRF

- - - o - - - 25-YR SBEACH ERODED PRF

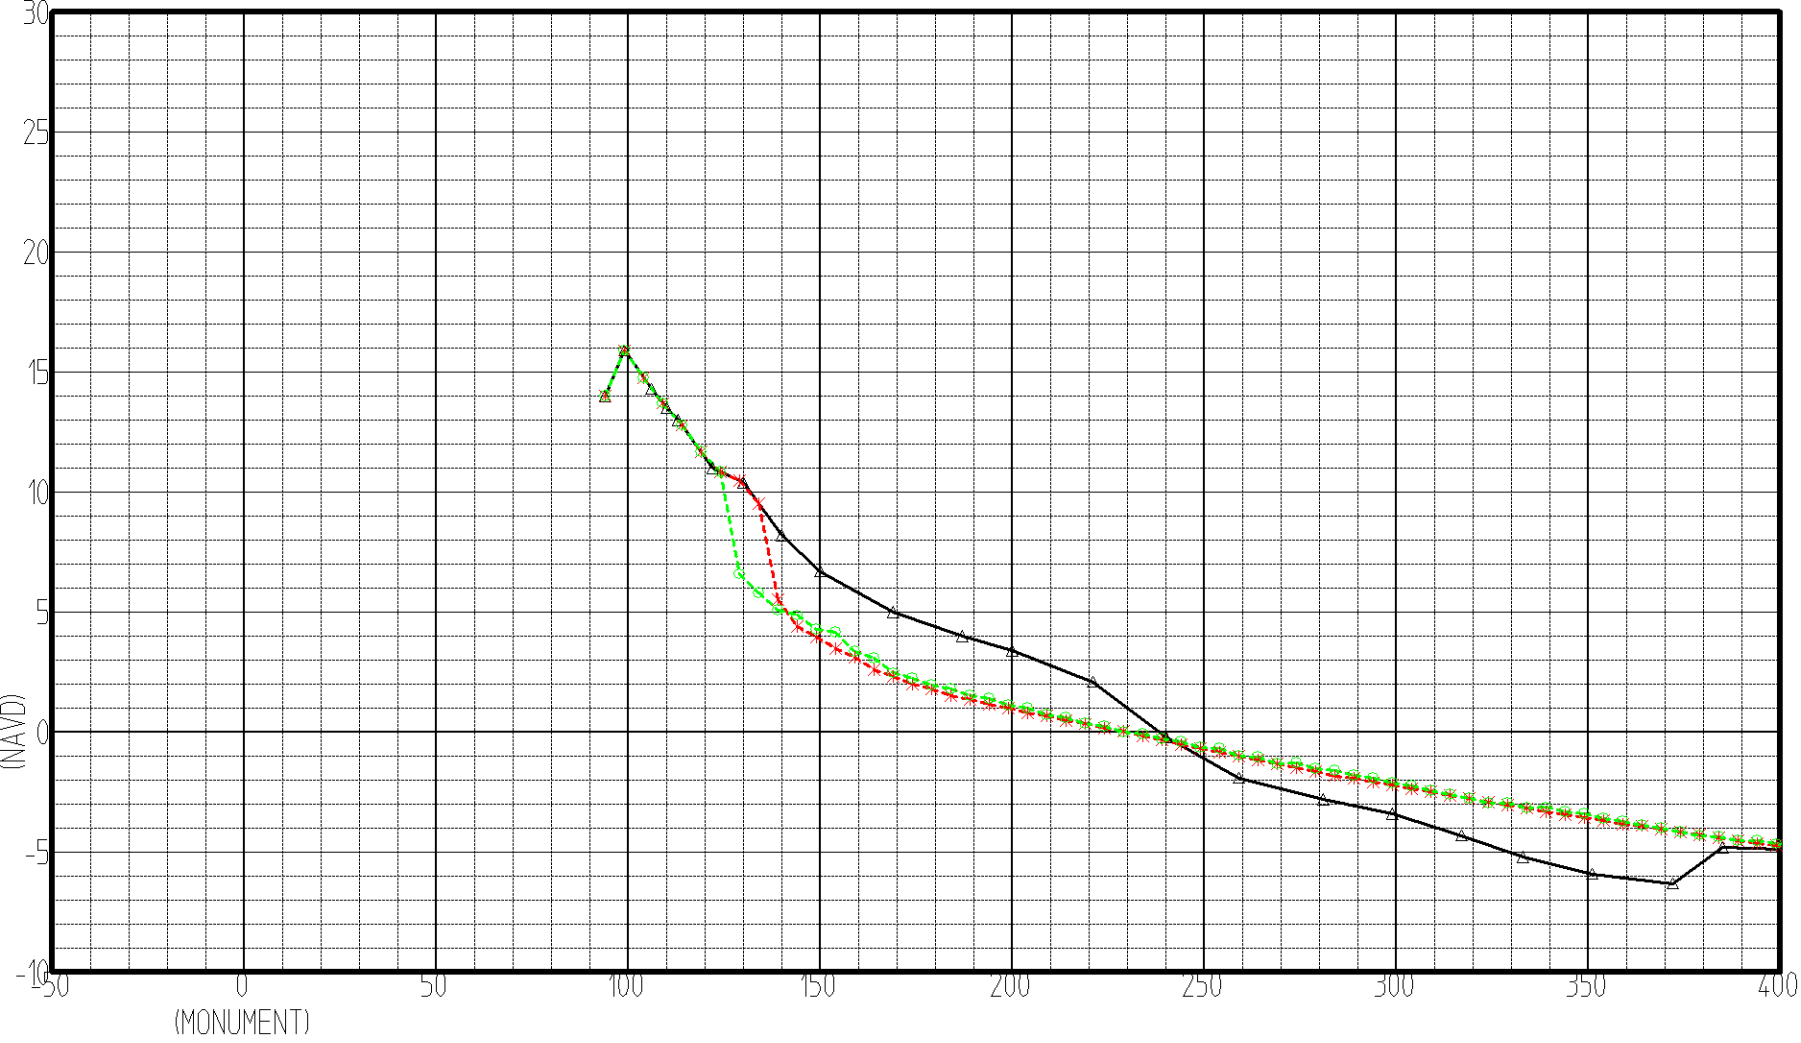
Range: R-64-T
 BEARING: 90.00
 1/2

BEACH PROFILE
 —△—△— 2005-2008 INPUT PRF
 - - * - - * - - 15-YR SBEACH ERODED PRF
 - - o - - o - - 25-YR SBEACH ERODED PRF

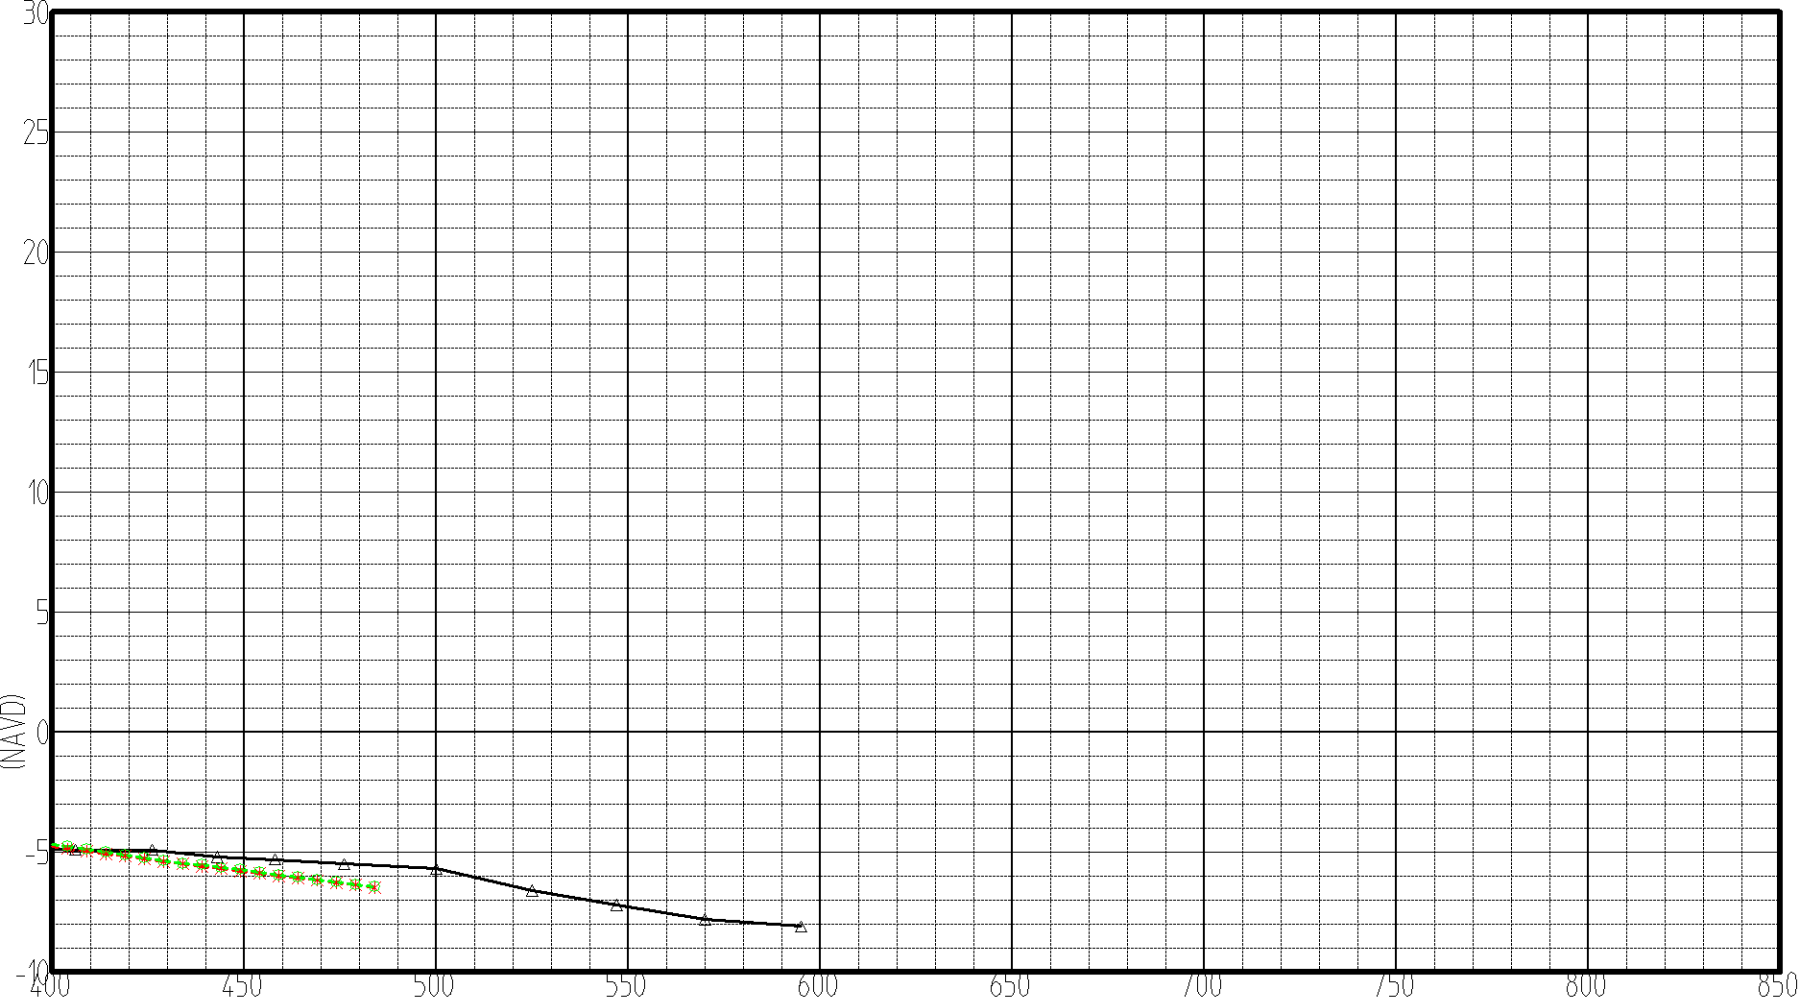
Range: R-64-T

BEACH PROFILE

—△—△— 2005-2008 INPUT PRF

- - - * - - - 15-YR SBEACH ERODED PRF

- - - o - - - 25-YR SBEACH ERODED PRF

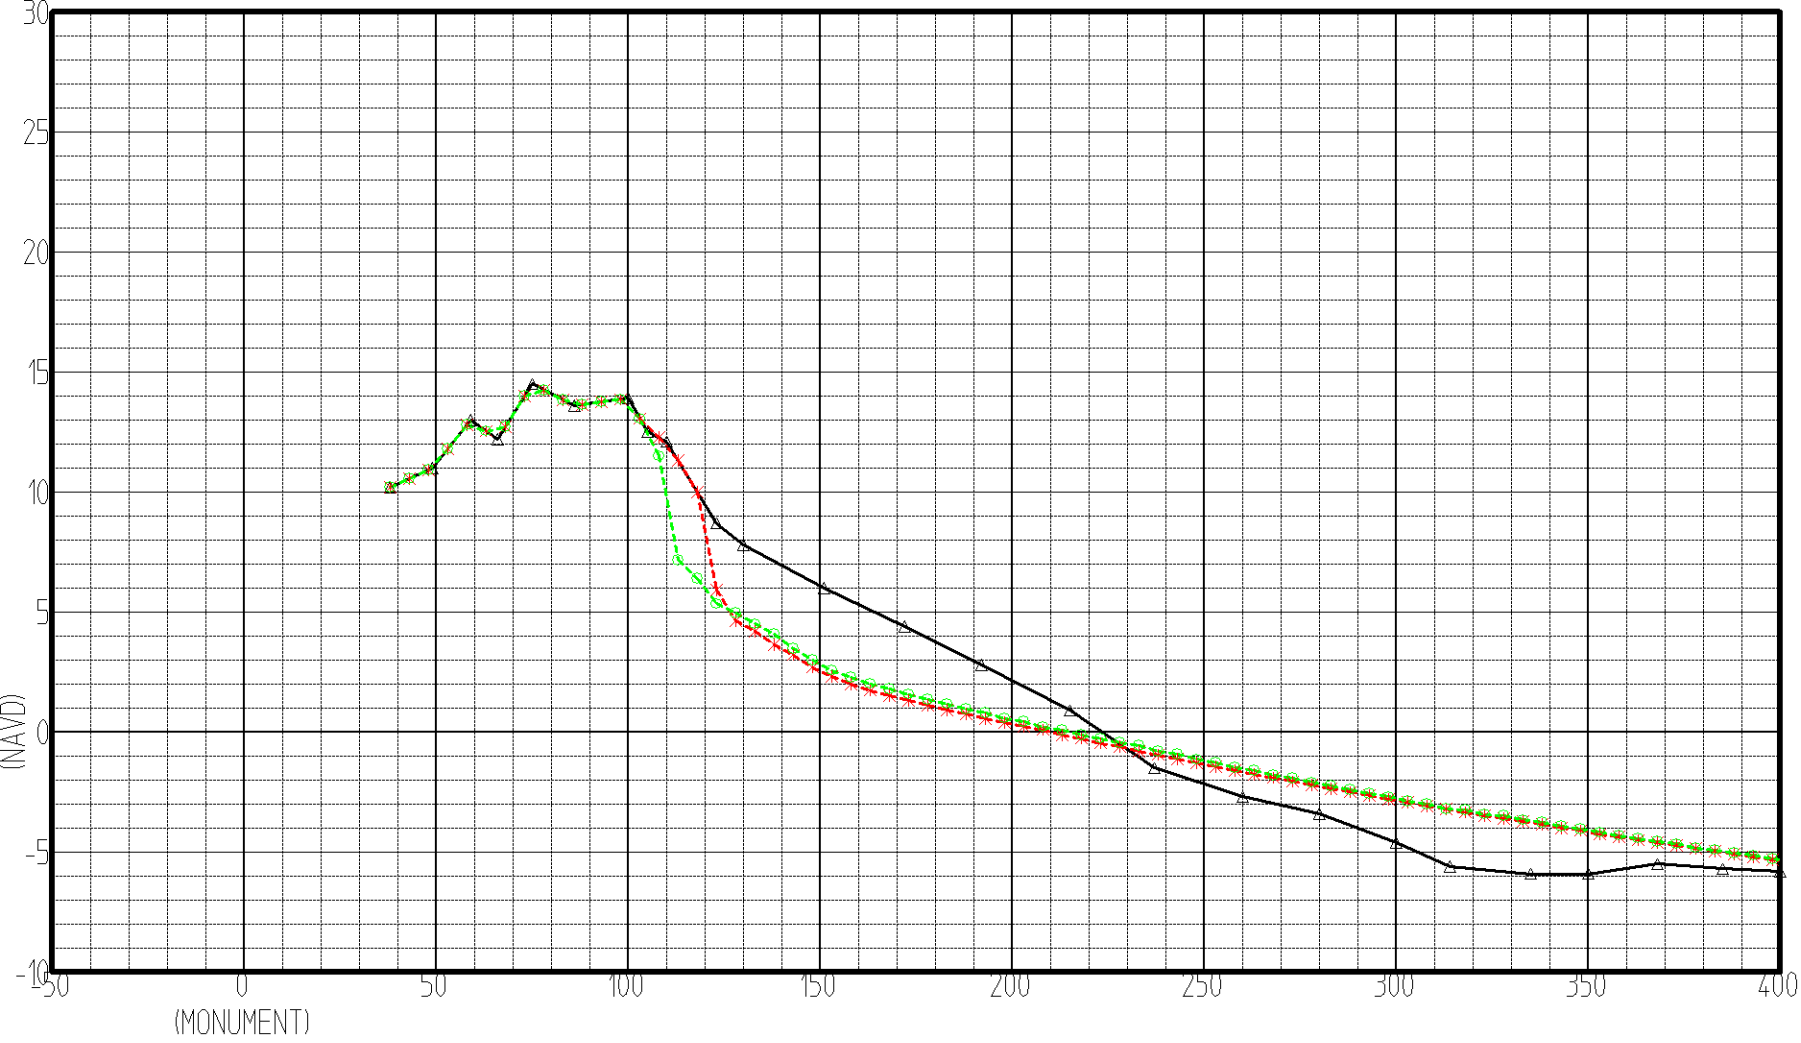
Range: R-65-T
 BEARING: 90.00
 1/2

BEACH PROFILE
 —△—△— 2005-2008 INPUT PRF
 - - * - - * - - 15-YR SBEACH ERODED PRF
 - - o - - o - - 25-YR SBEACH ERODED PRF

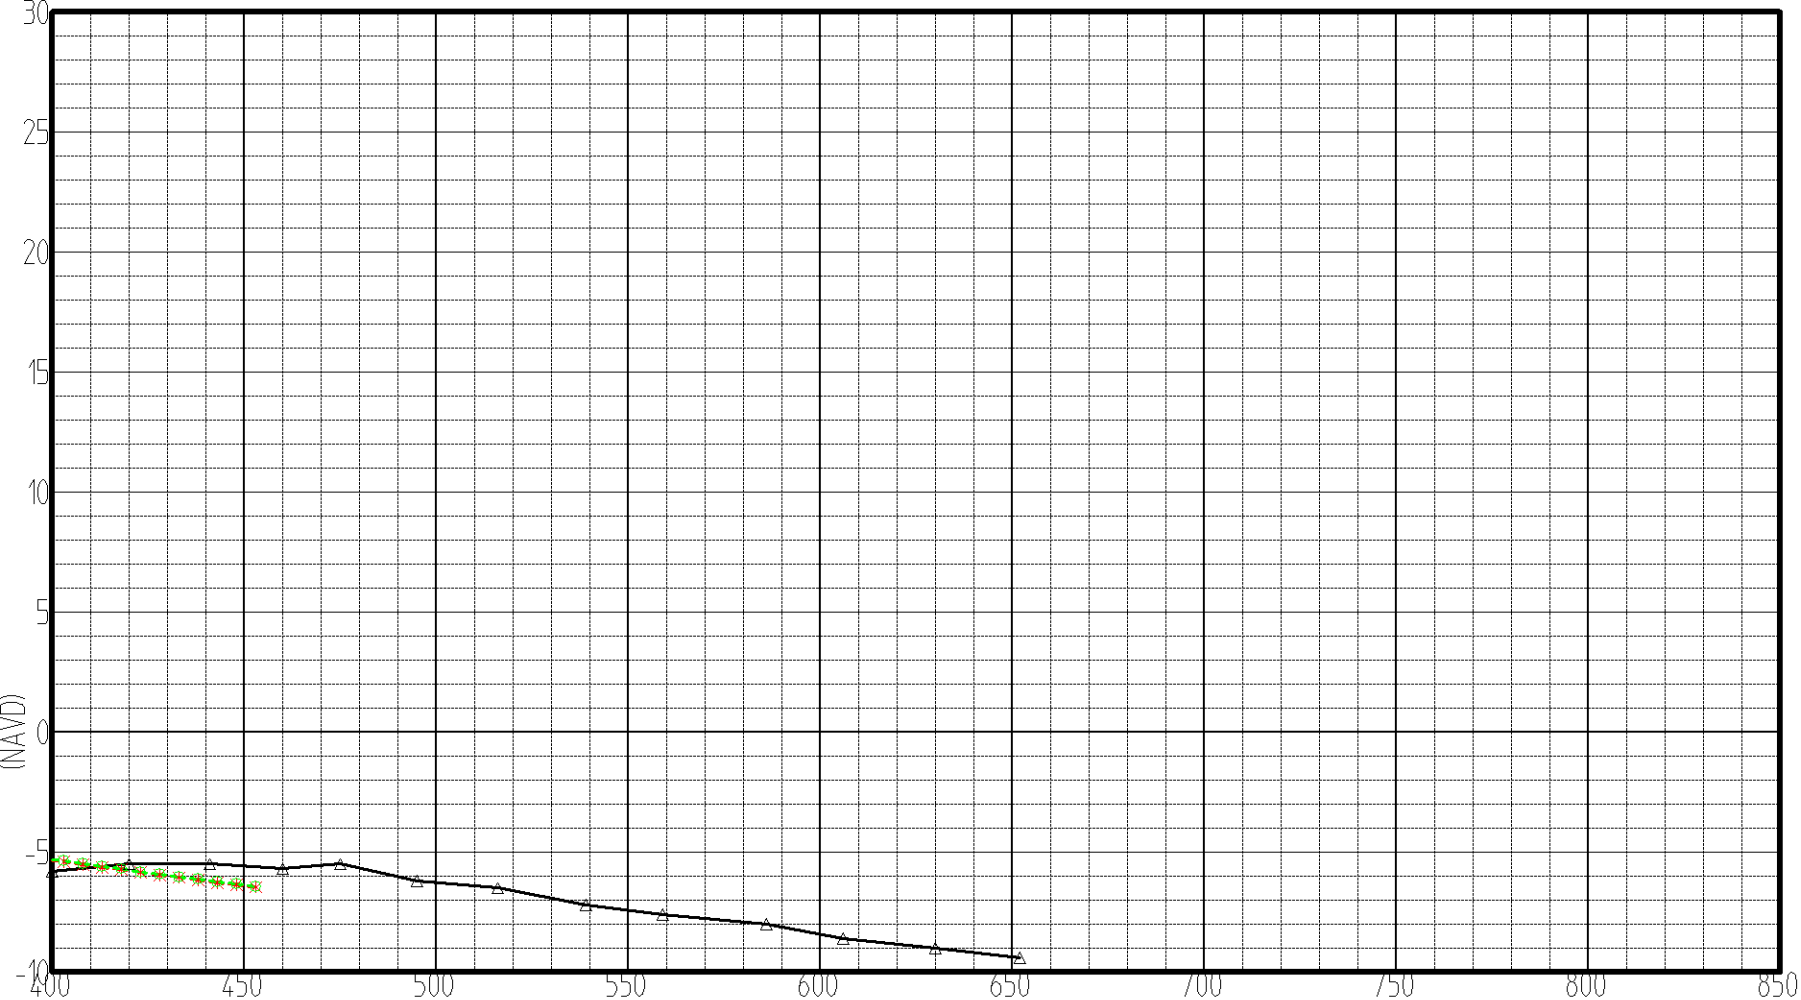
Range: R-65-T

BEACH PROFILE

—△—△— 2005-2008 INPUT PRF

- - - * - - - 15-YR SBEACH ERODED PRF

- - - o - - - 25-YR SBEACH ERODED PRF

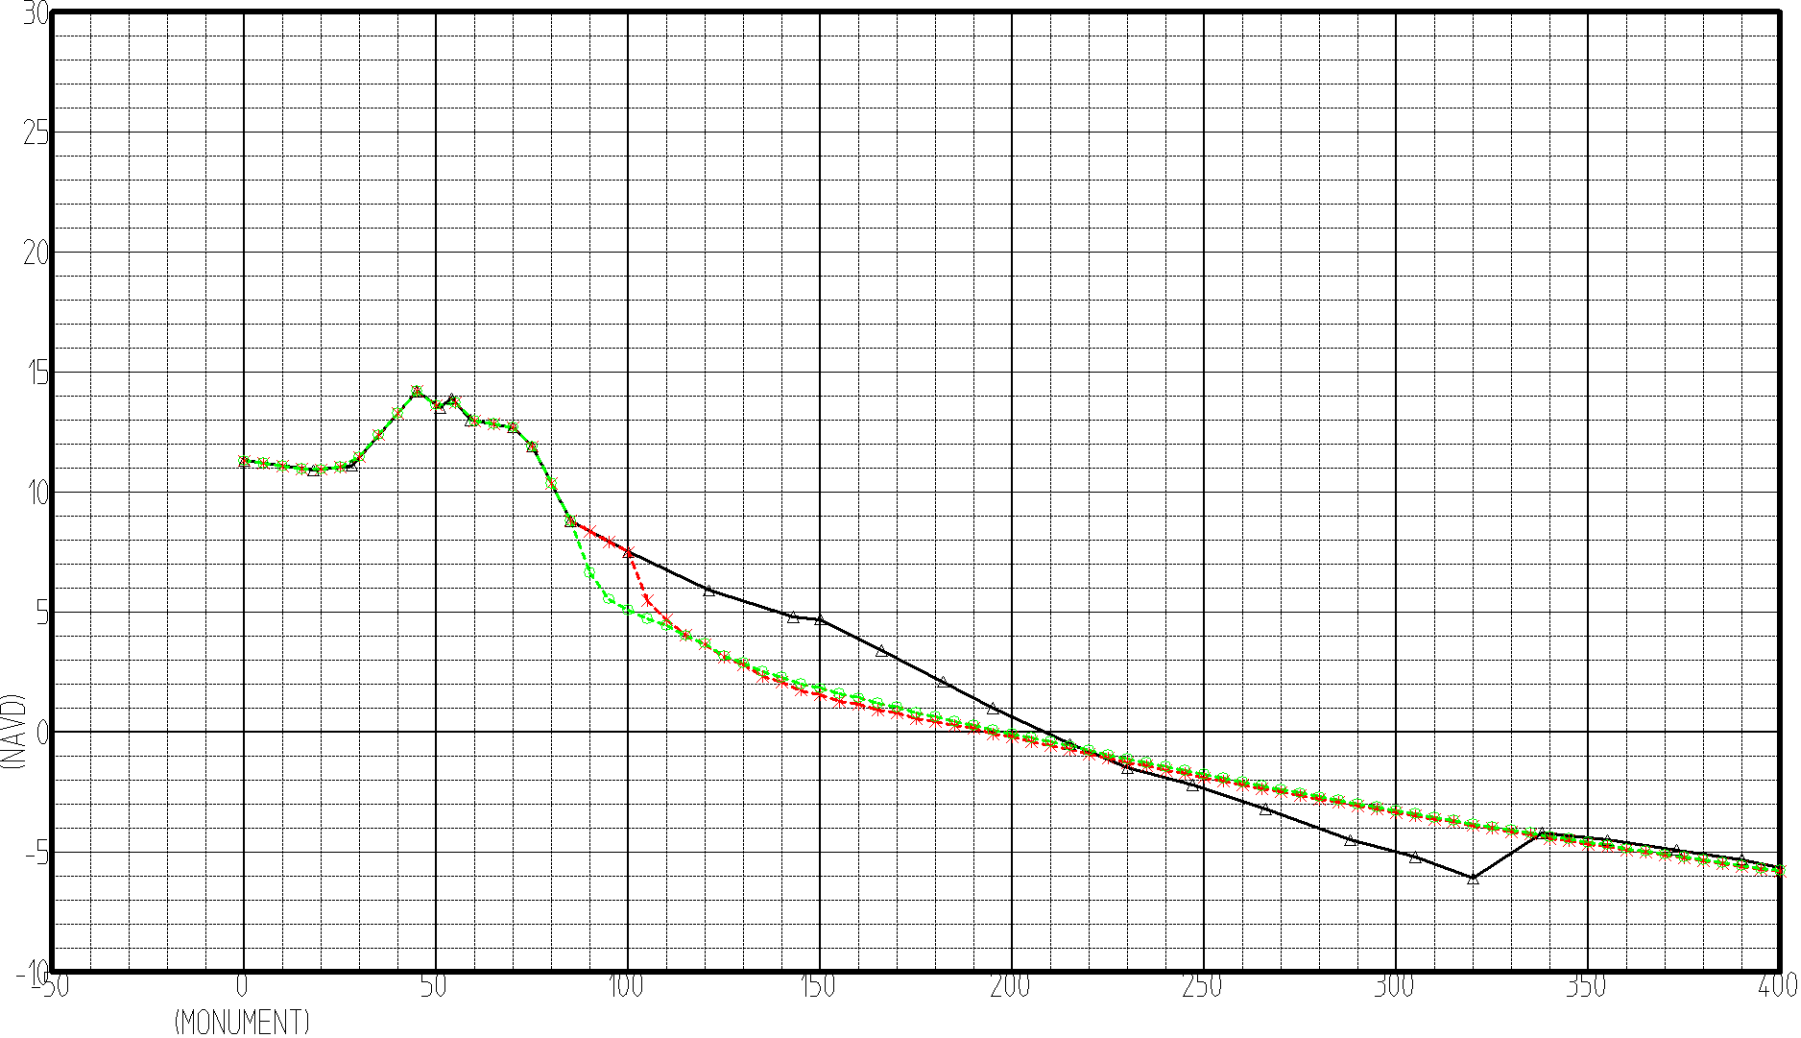
Range: R-66
 BEARING: 90.00
 1/2

BEACH PROFILE
 —△—△— 2005-2008 INPUT PRF
 - - * - - * - - 15-YR SBEACH ERODED PRF
 - - o - - o - - 25-YR SBEACH ERODED PRF
