Appendix XI

SBEACH 15 and 25 yr. Storm Erosion Profiles

Brevard County

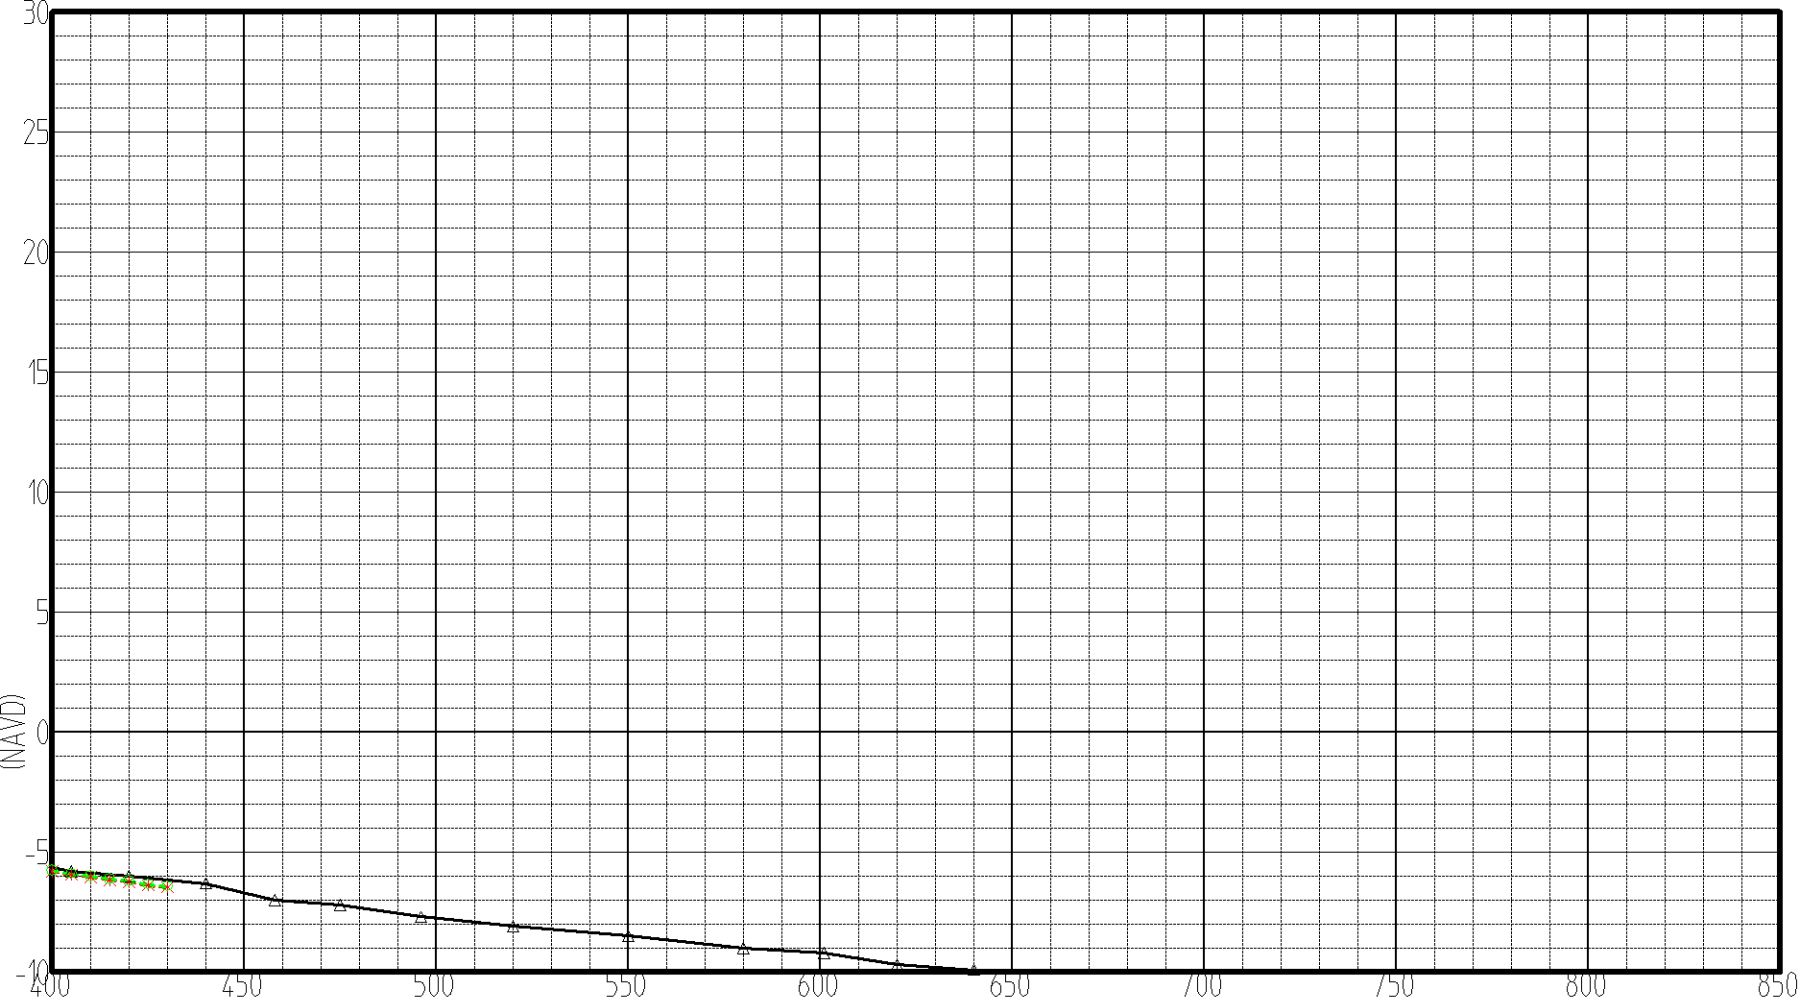
Range: R-66

BEACH PROFILE

—△—△— 2005-2008 INPUT PRF

- - - * - - - 15-YR SBEACH ERODED PRF

- - - o - - - 25-YR SBEACH ERODED PRF

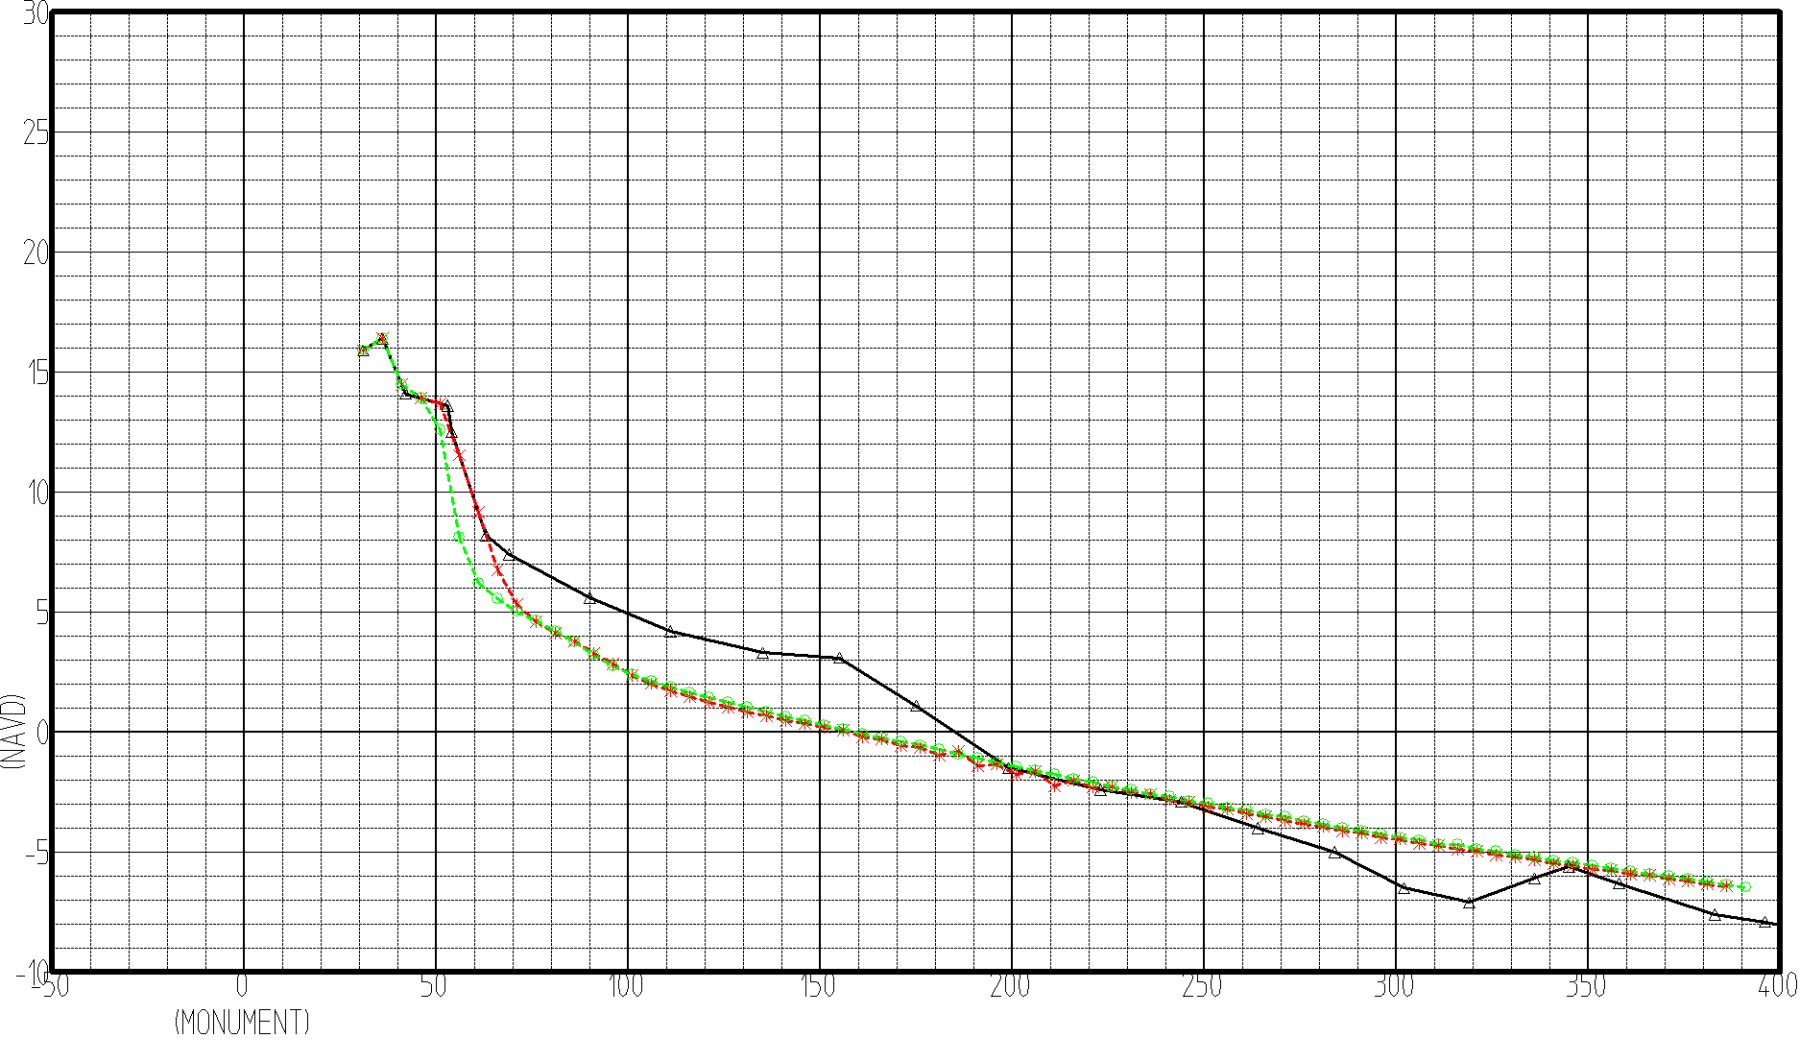
Range: R-67-T

BEACH PROFILE

—△—△— 2005-2008 INPUT PRF

- - - * - - - 15-YR SBEACH ERODED PRF

- - - o - - - 25-YR SBEACH ERODED PRF

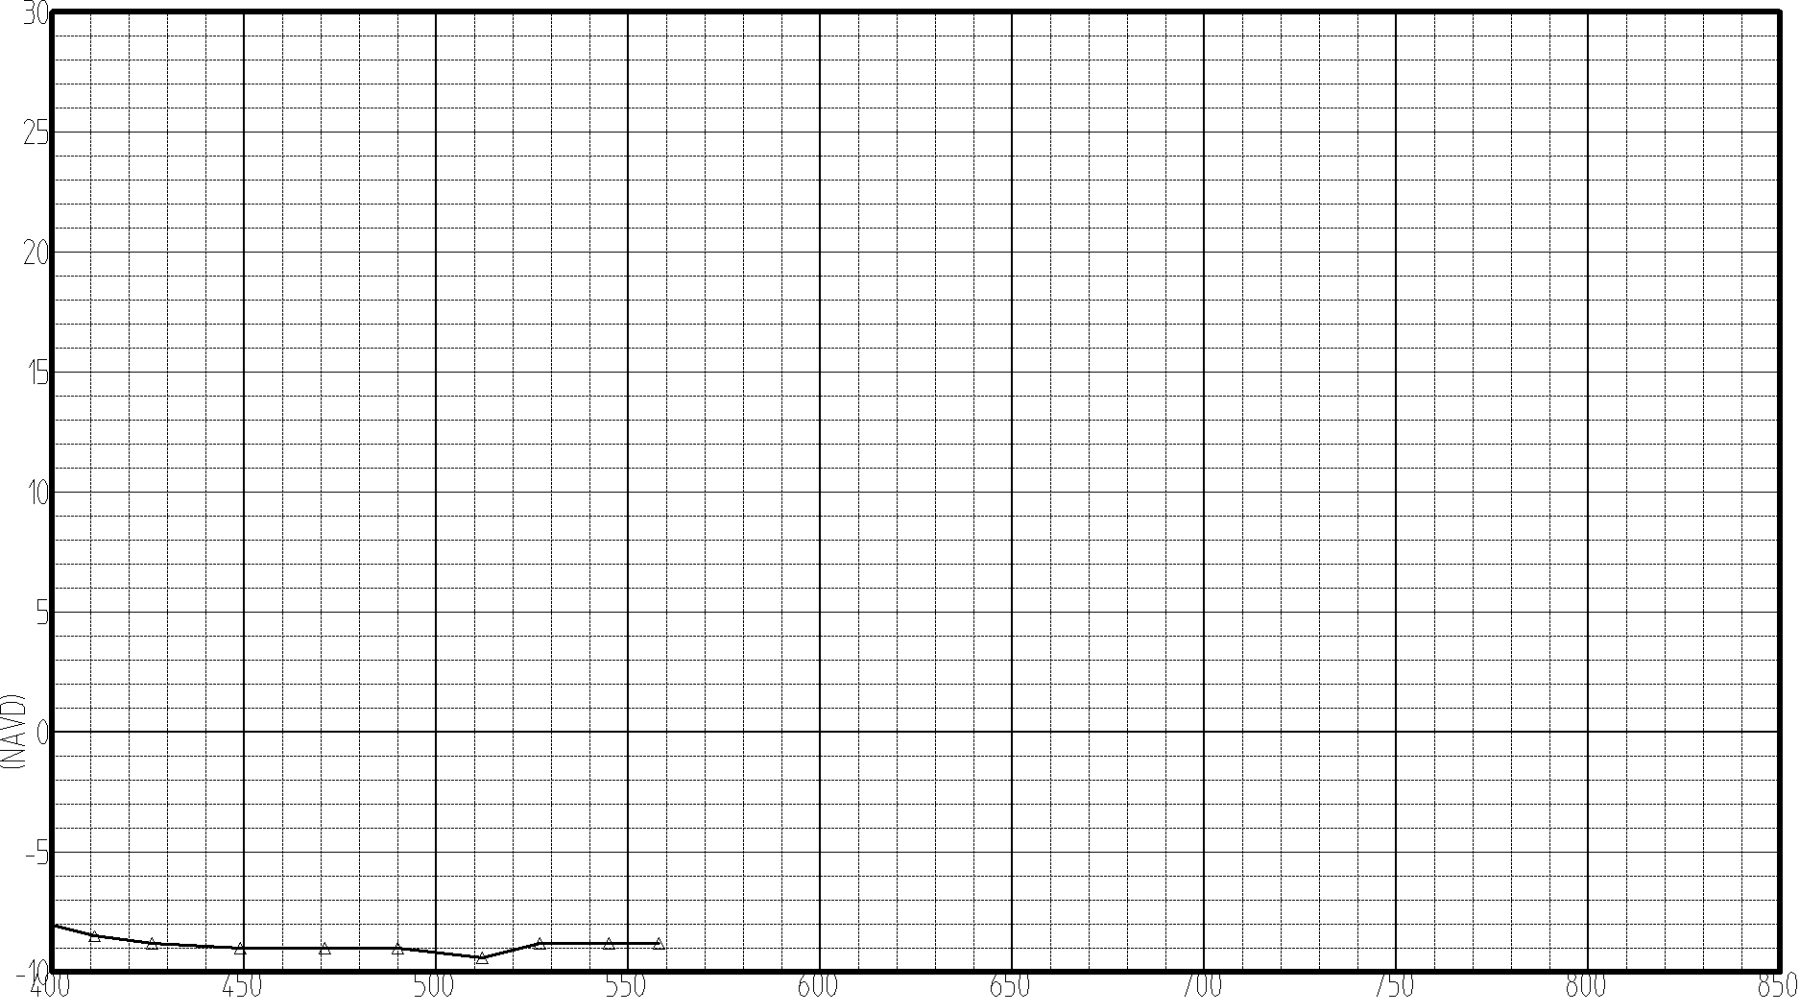
Range: R-67-T 2/2

BEACH PROFILE

—△—△— 2005-2008 INPUT PRF

- - - * - - - 15-YR SBEACH ERODED PRF

- - - o - - - 25-YR SBEACH ERODED PRF

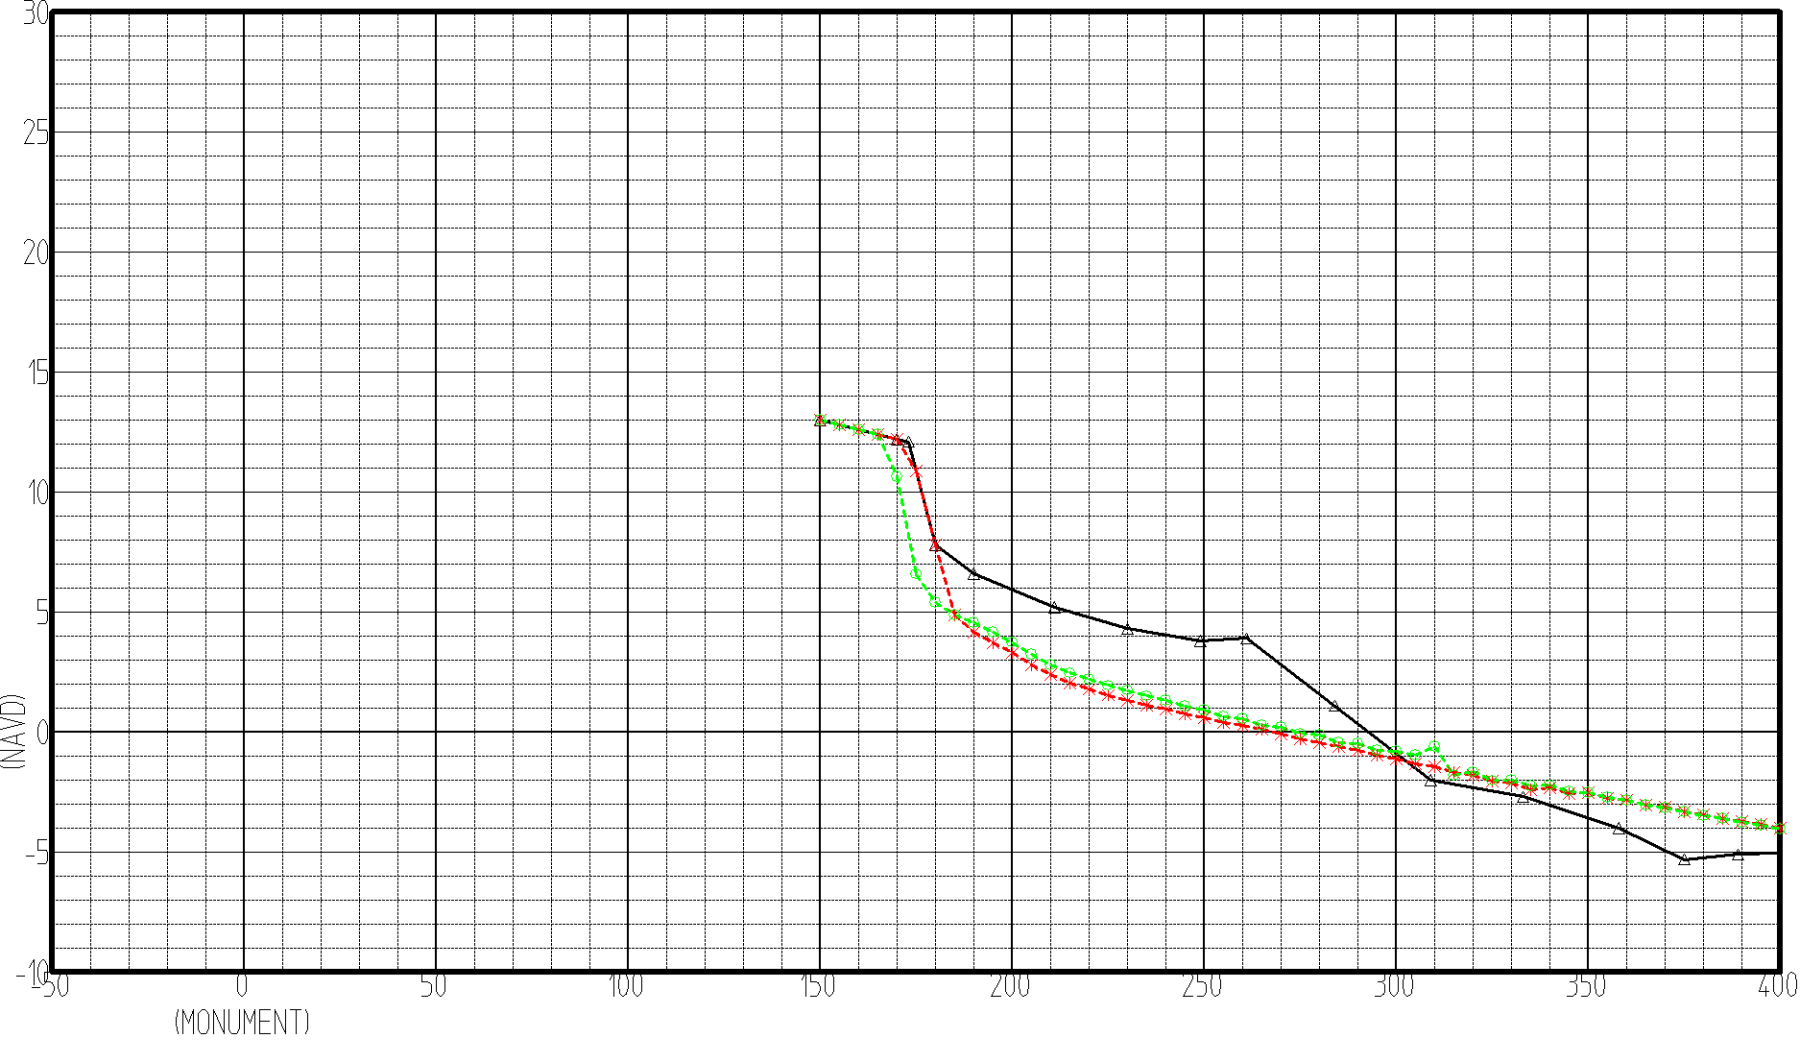
Range: R-68-T

BEACH PROFILE

—△—△— 2005-2008 INPUT PRF

- - - * - - - 15-YR SBEACH ERODED PRF

- - - o - - - 25-YR SBEACH ERODED PRF

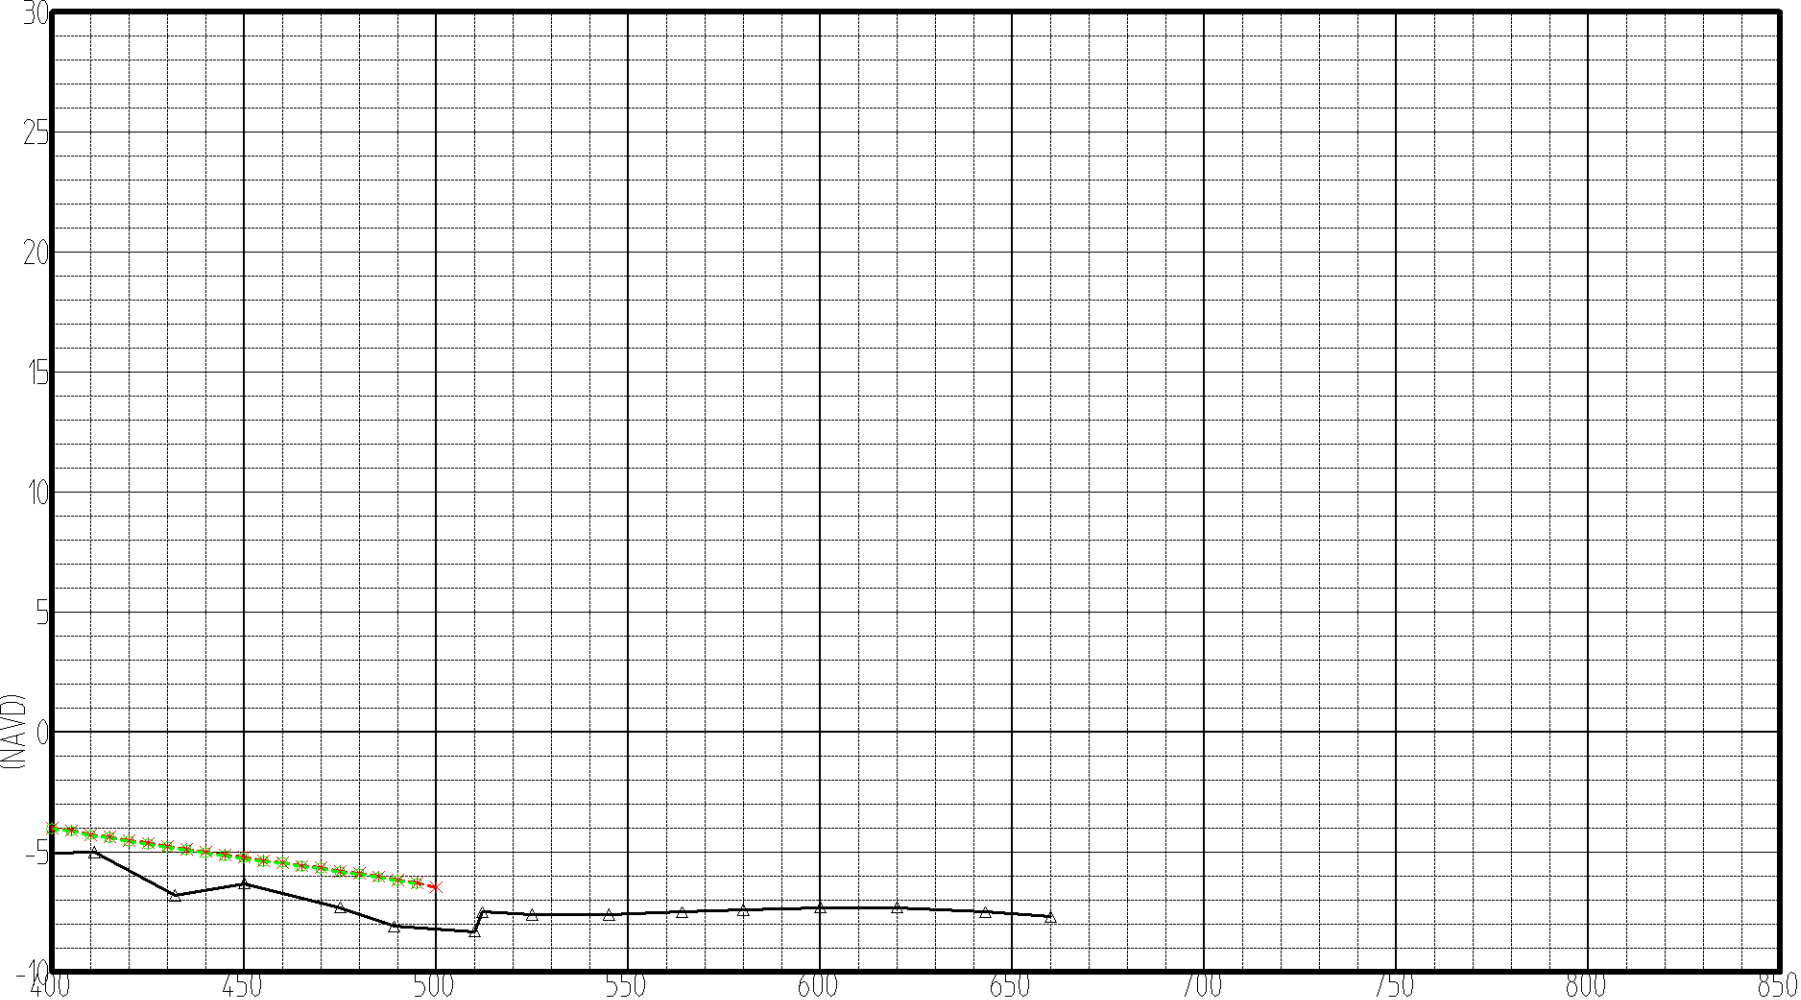
Range: R-68-T
 BEARING: 90.00
 2/2

BEACH PROFILE
 —△—△— 2005-2008 INPUT PRF
 - - * - - * - - 15-YR SBEACH ERODED PRF
 - - o - - o - - 25-YR SBEACH ERODED PRF

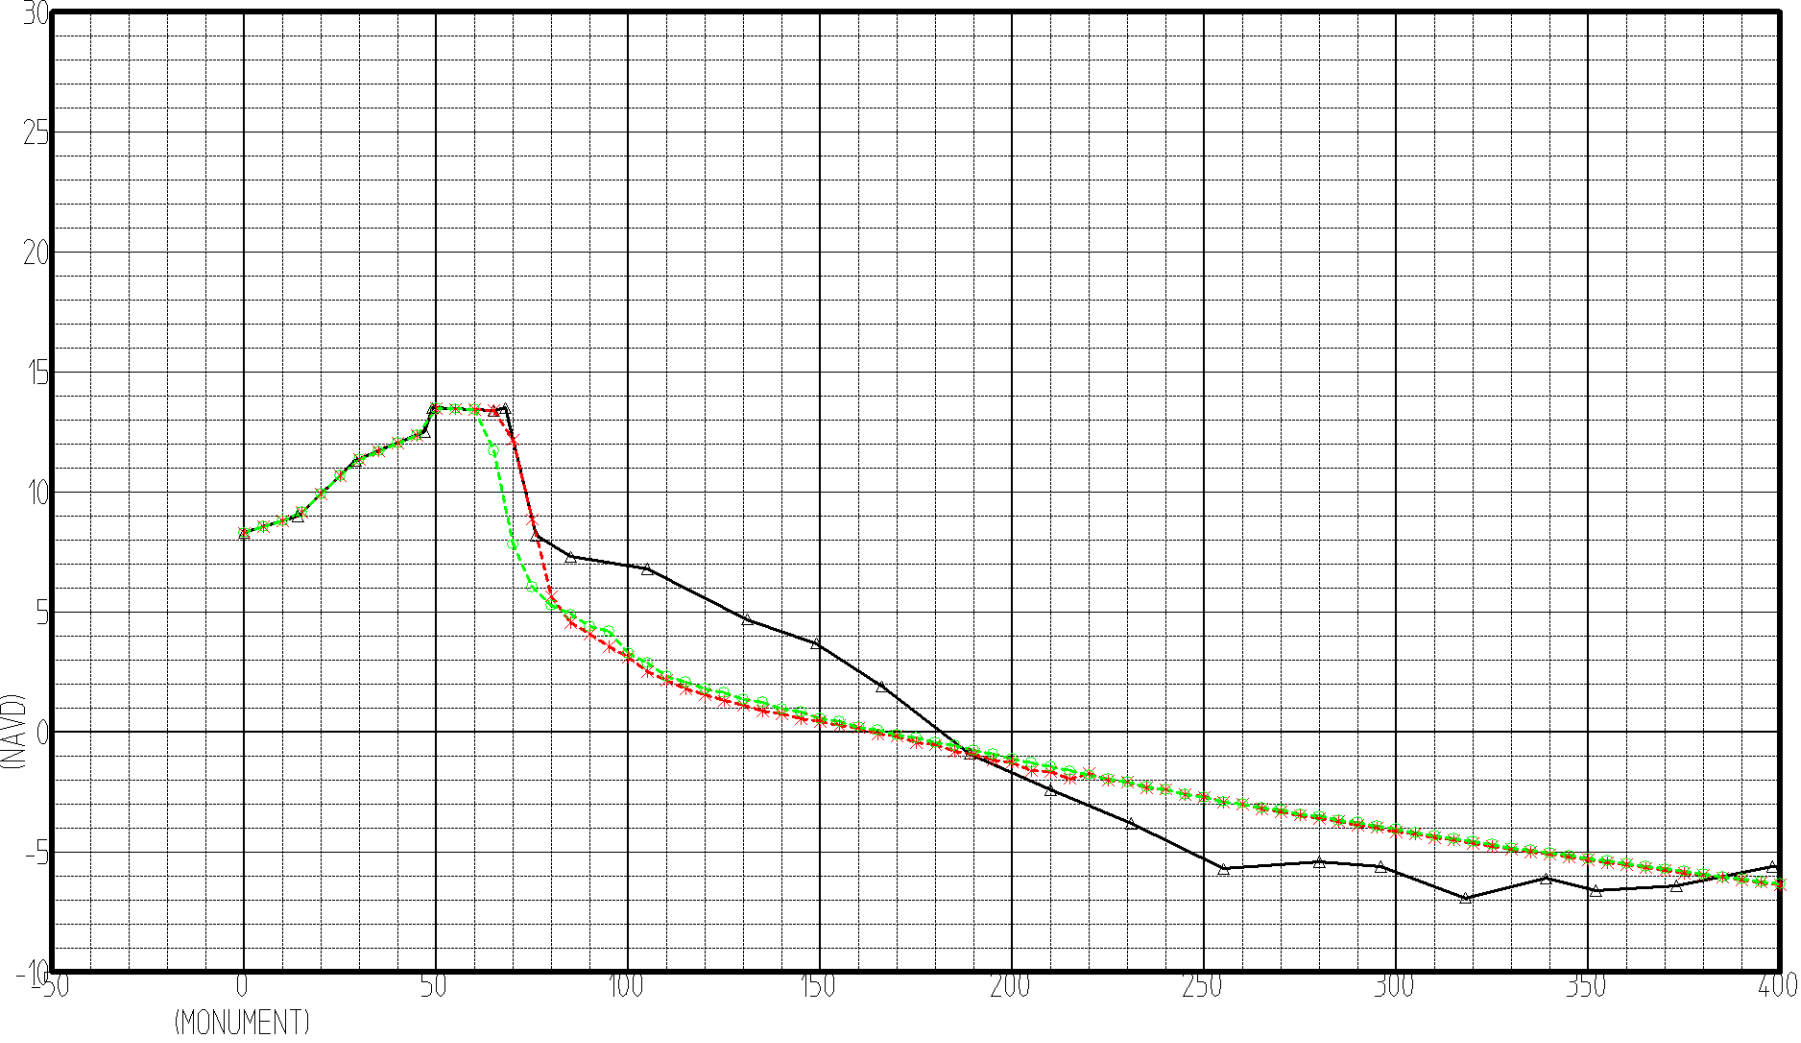
BEACH PROFILE
 —△—△— 2005-2008 INPUT PRF
 - - * - - * - - 15-YR SBEACH ERODED PRF
 - - o - - o - - 25-YR SBEACH ERODED PRF

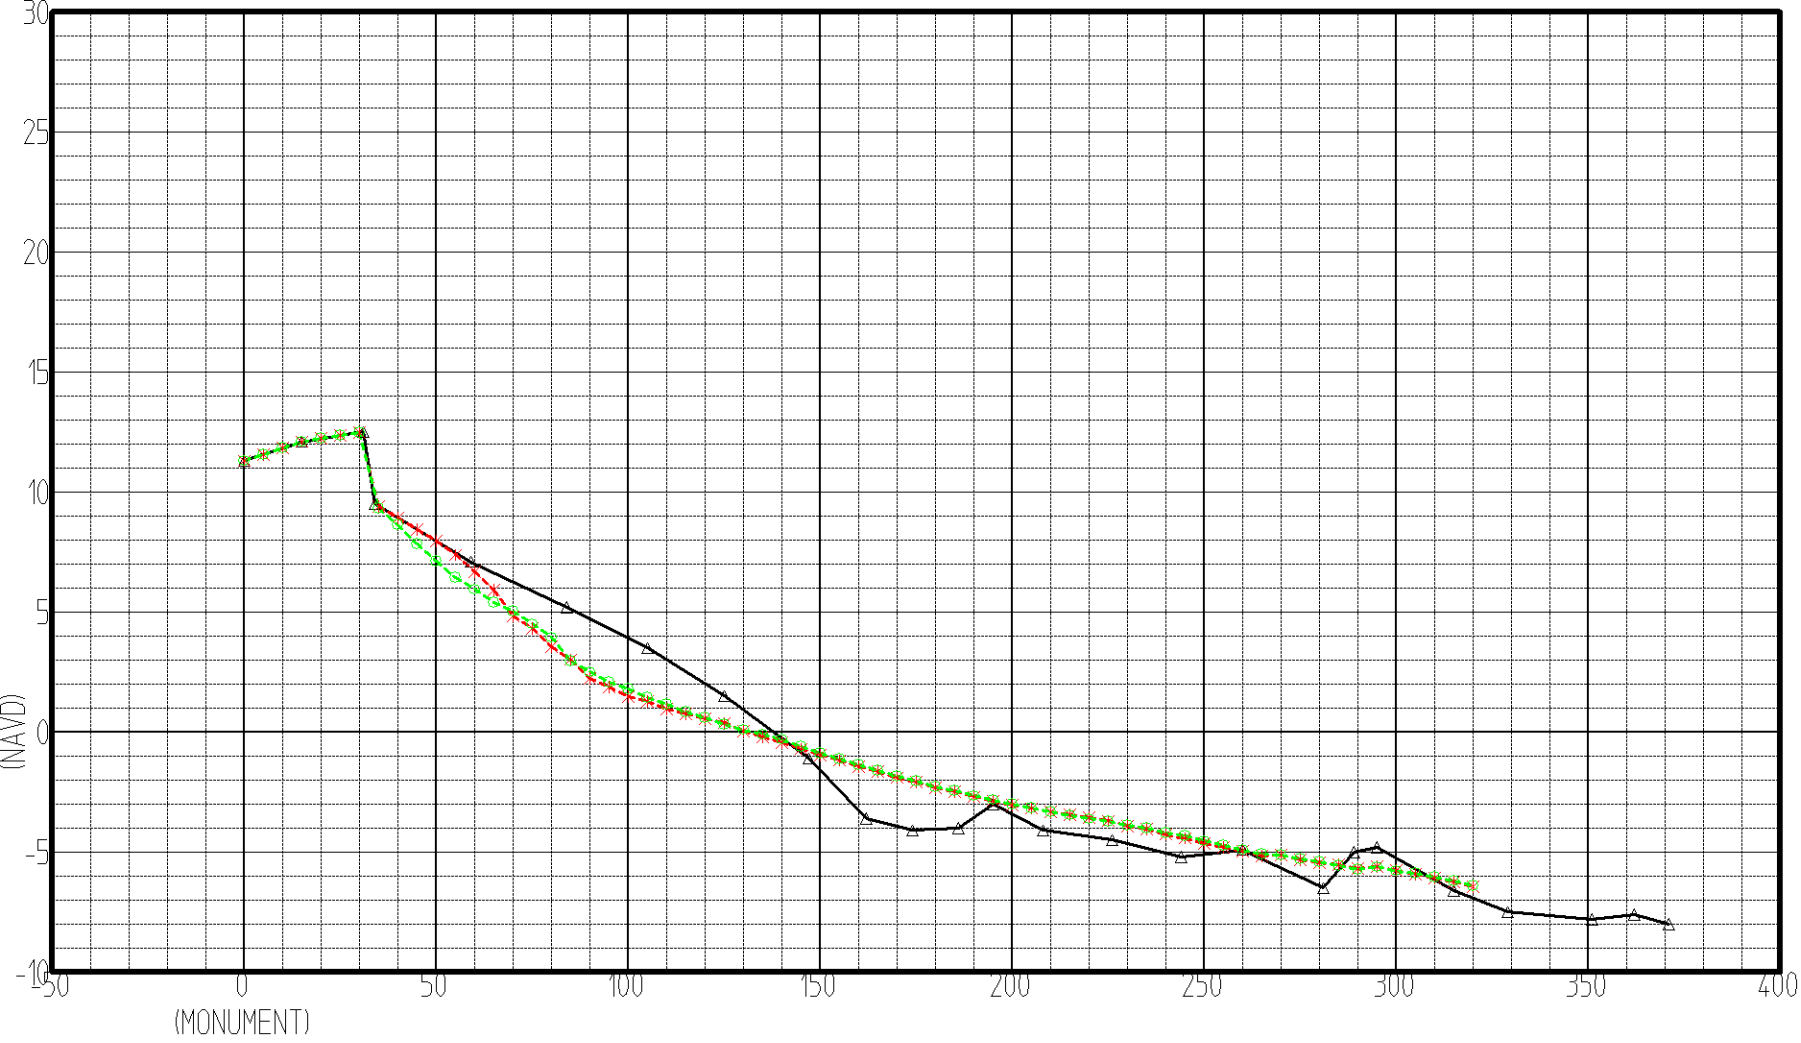
Range: R-84
 BEARING: 80.00
 1/1

BEACH PROFILE
 —△—△— 2005-2008 INPUT PRF
 - - * - - * - - 15-YR SBEACH ERODED PRF
 - - o - - o - - 25-YR SBEACH ERODED PRF

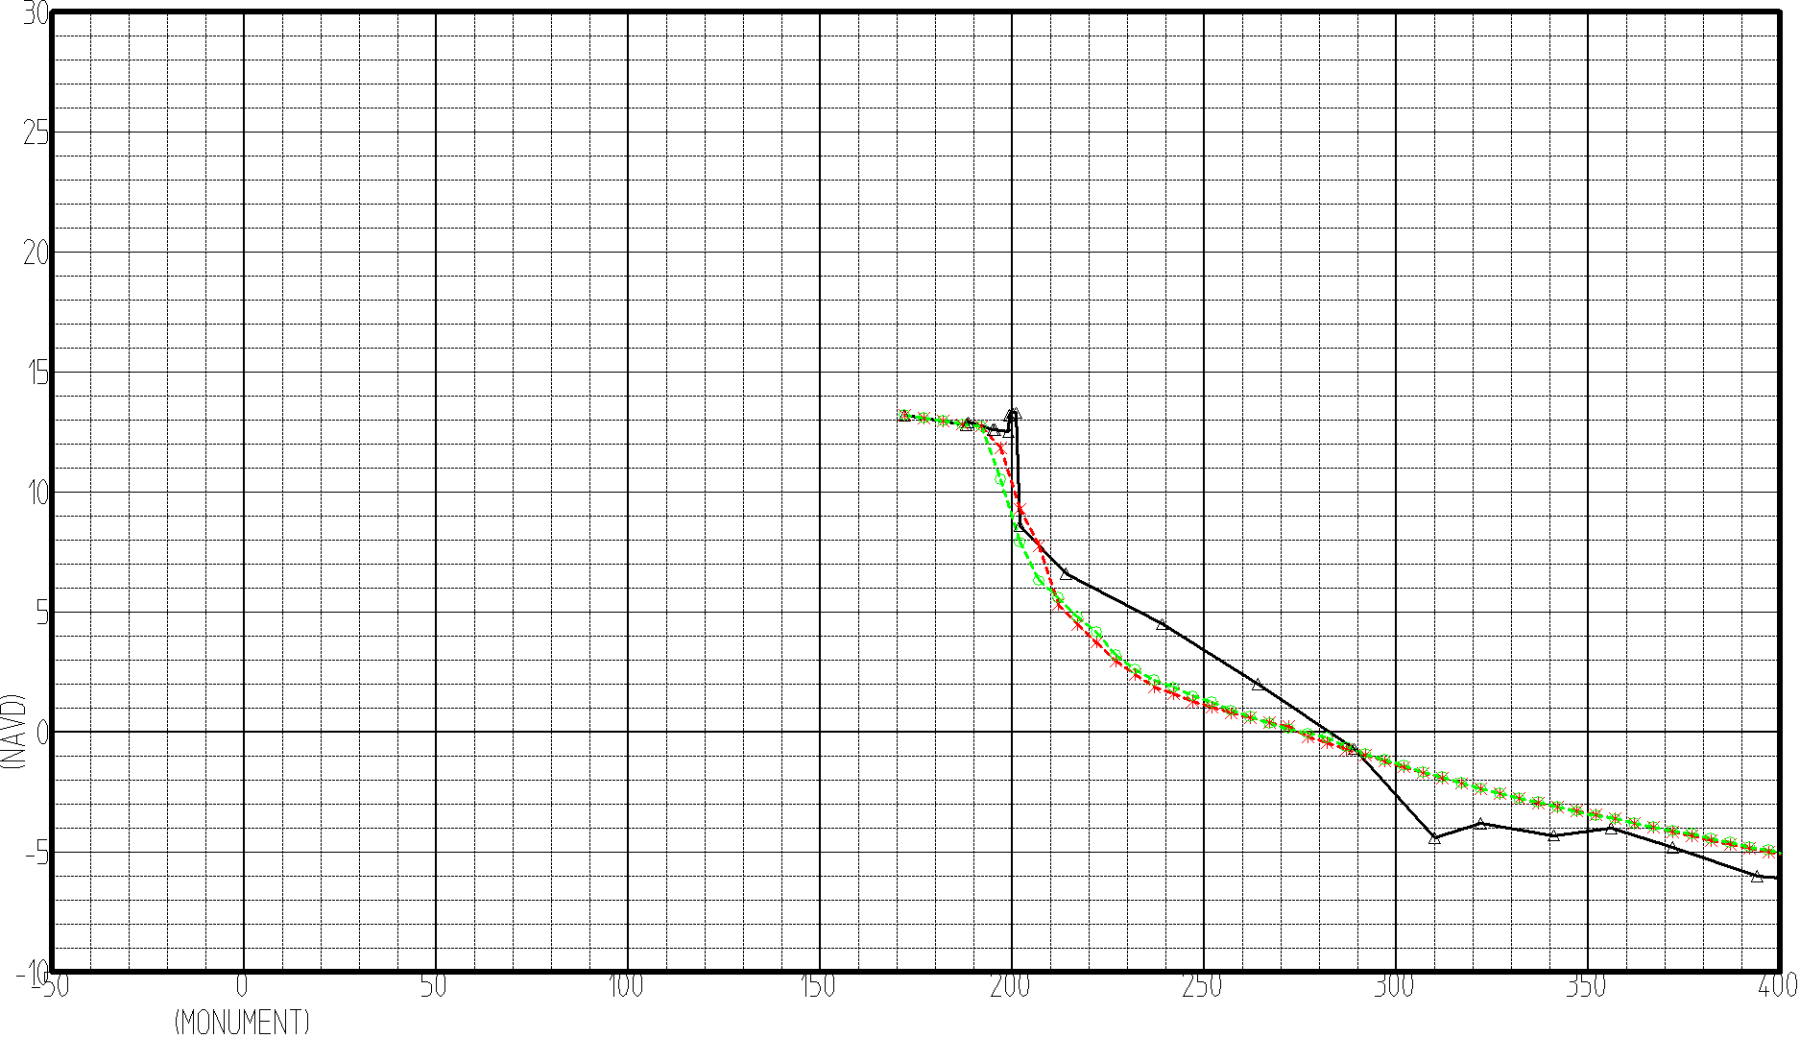
Range: R-91-T

BEACH PROFILE

—△—△— 2005-2008 INPUT PRF

- - - * - - - 15-YR SBEACH ERODED PRF

- - - o - - - 25-YR SBEACH ERODED PRF

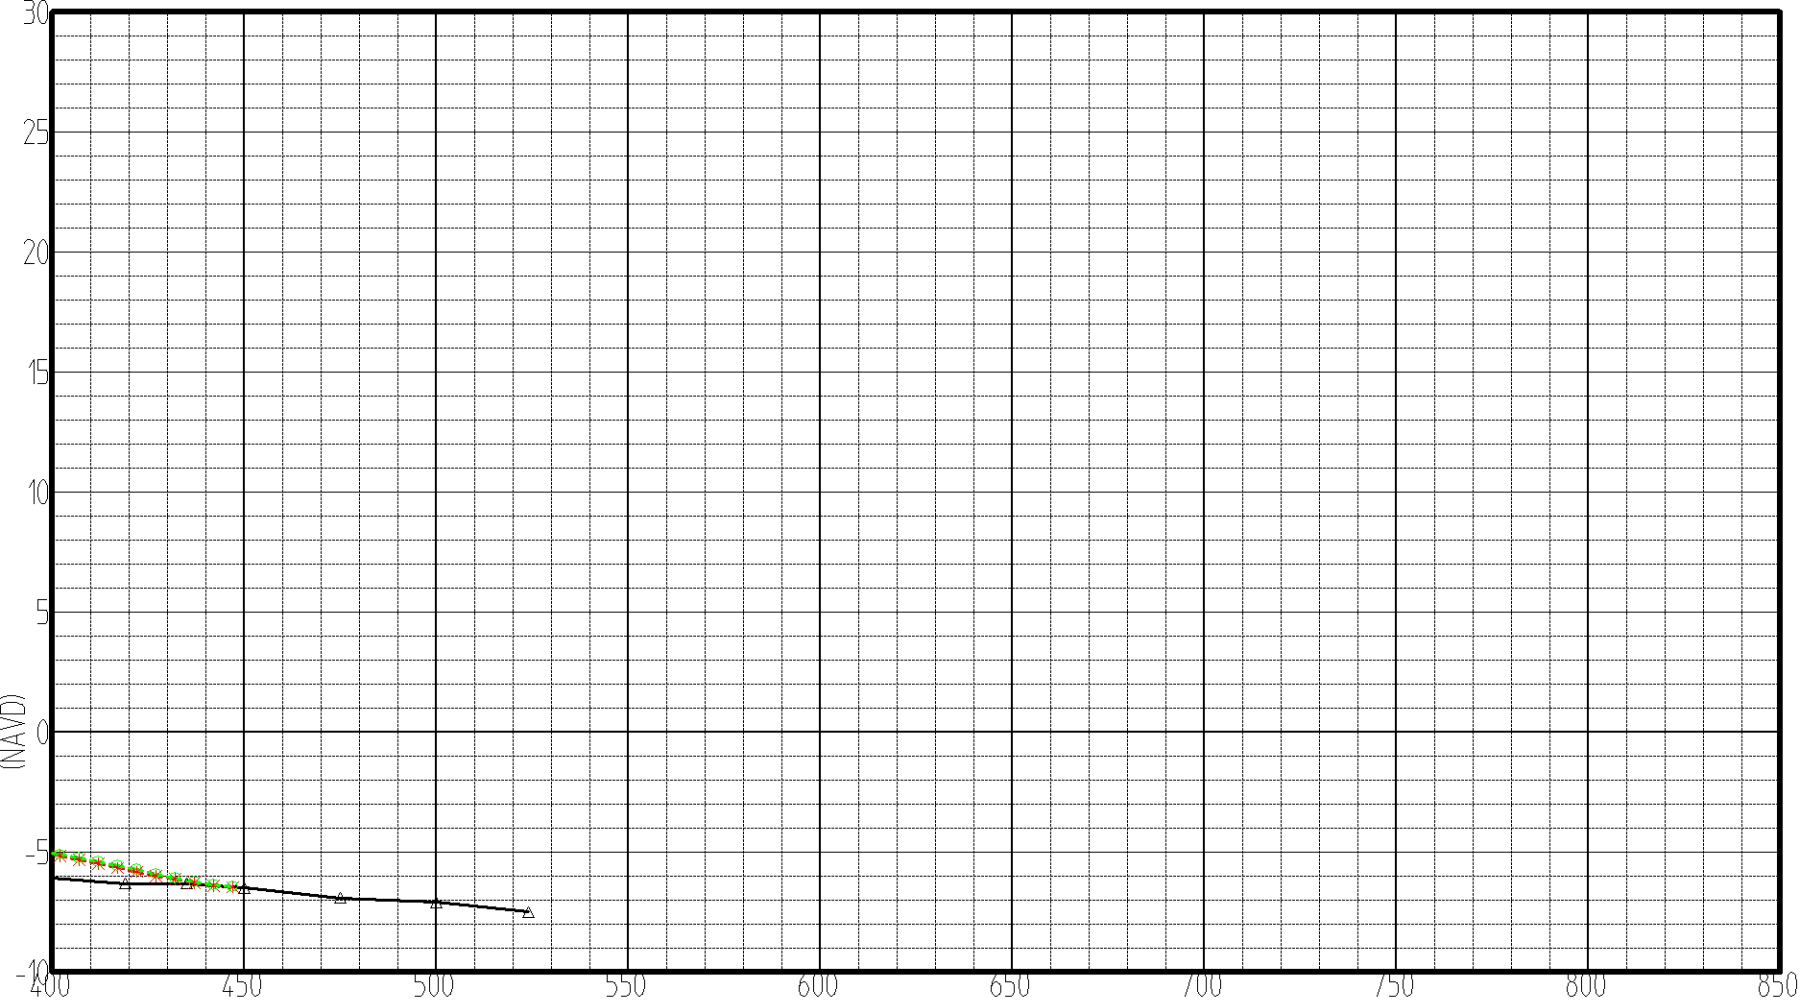
Range: R-91-T 2/2

BEACH PROFILE

- △—△— 2005-2008 INPUT PRF
- - - * - - - 15-YR SBEACH ERODED PRF
- - - o - - - 25-YR SBEACH ERODED PRF

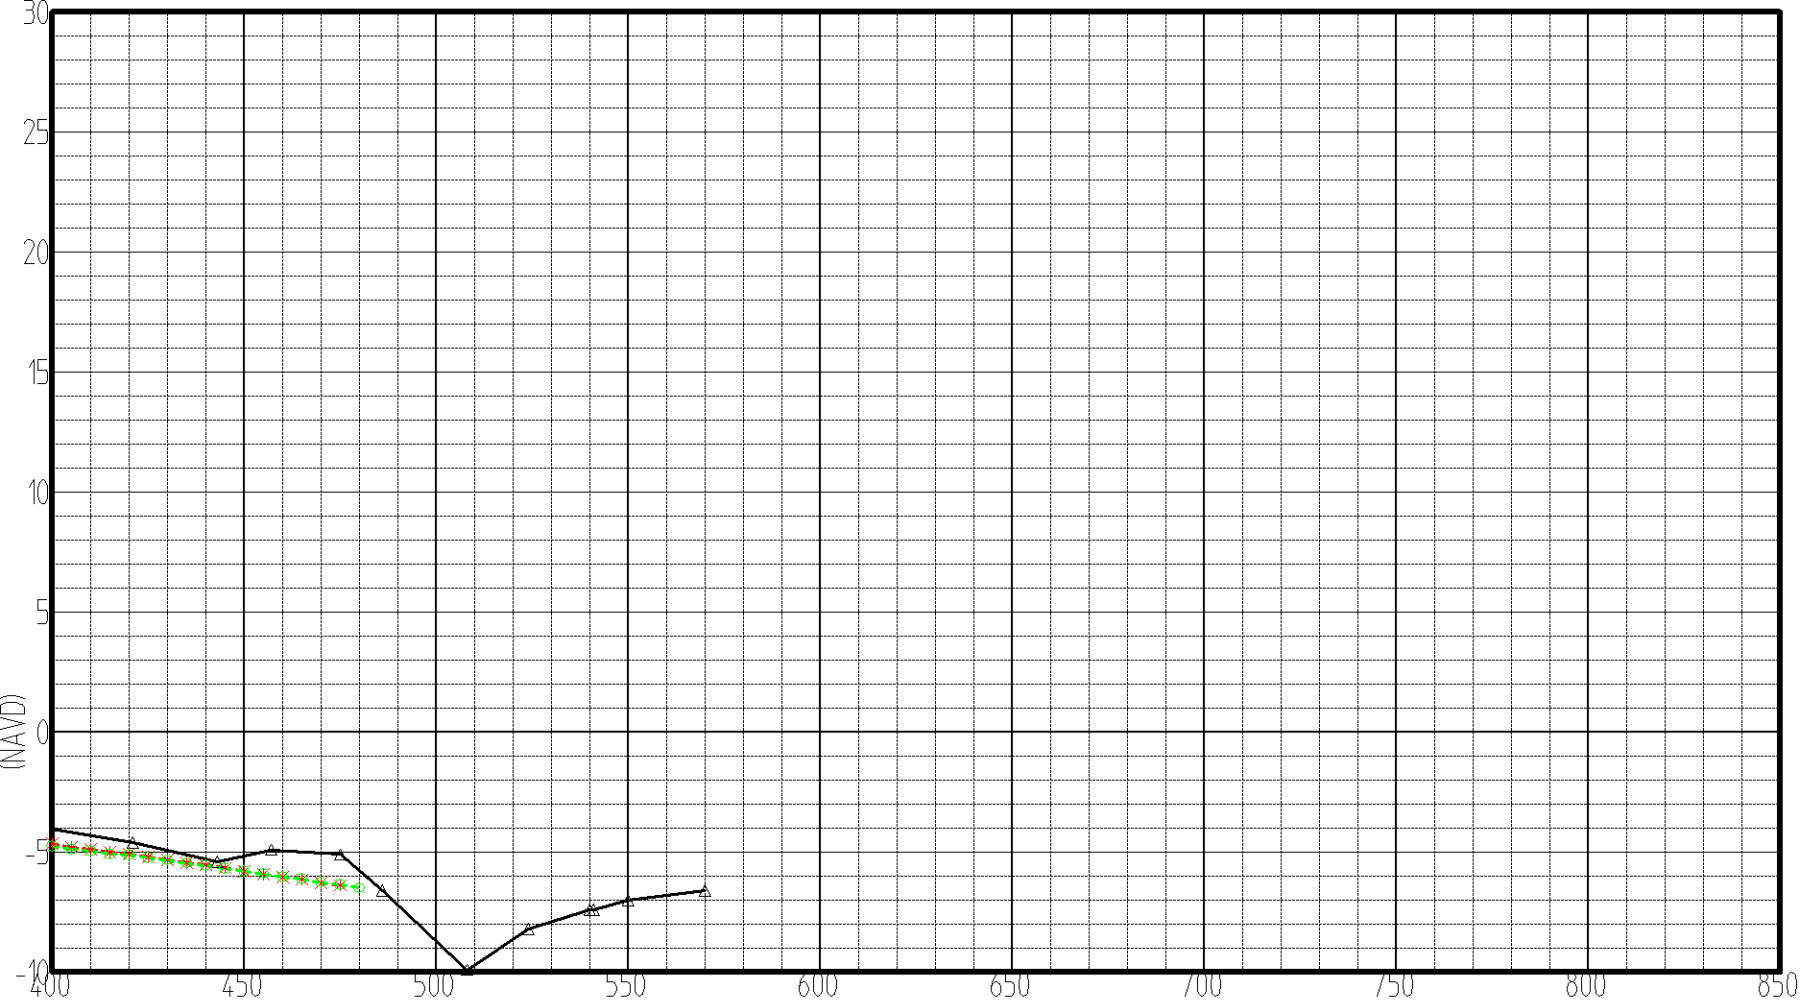
Range: R-92-T 2/2

BEACH PROFILE

—△—△— 2005-2008 INPUT PRF

- - - * - - - 15-YR SBEACH ERODED PRF

- - - o - - - 25-YR SBEACH ERODED PRF

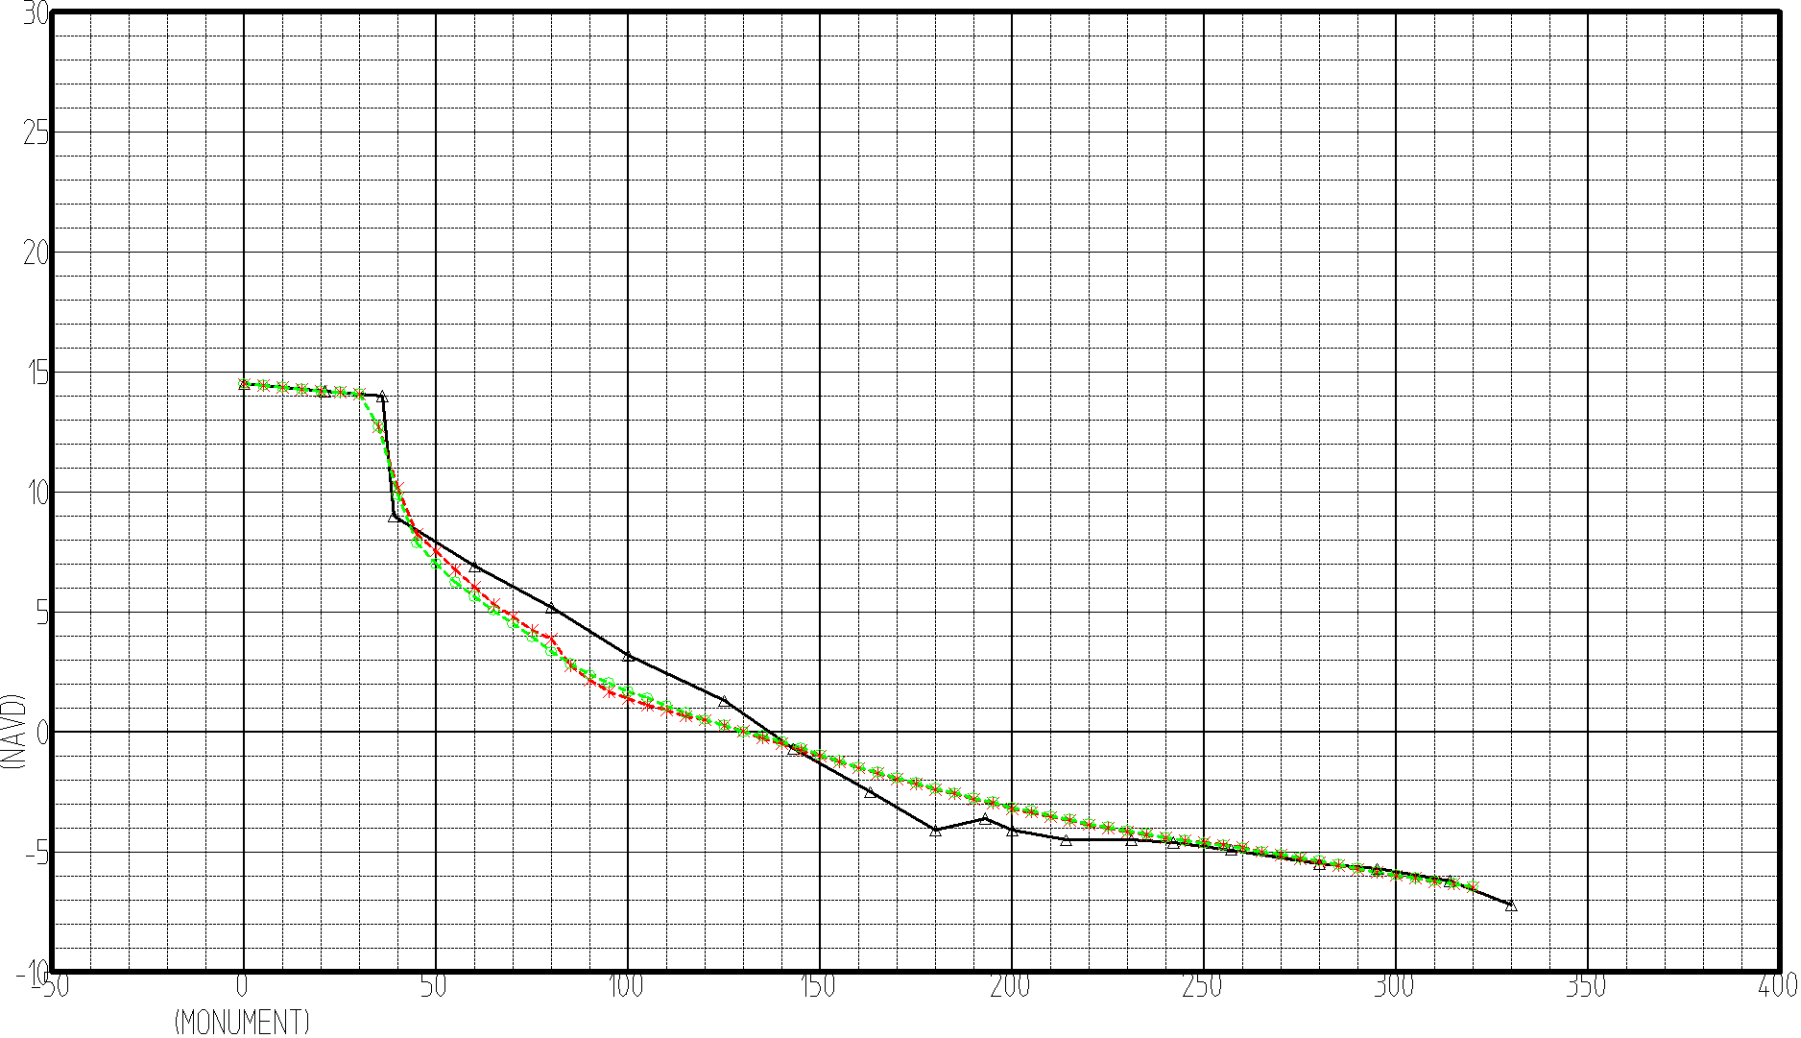
Range: R-93

BEACH PROFILE

—△—△— 2005-2008 INPUT PRF

- - - * - - - 15-YR SBEBACH ERODED PRF

- - - o - - - 25-YR SBEBACH ERODED PRF

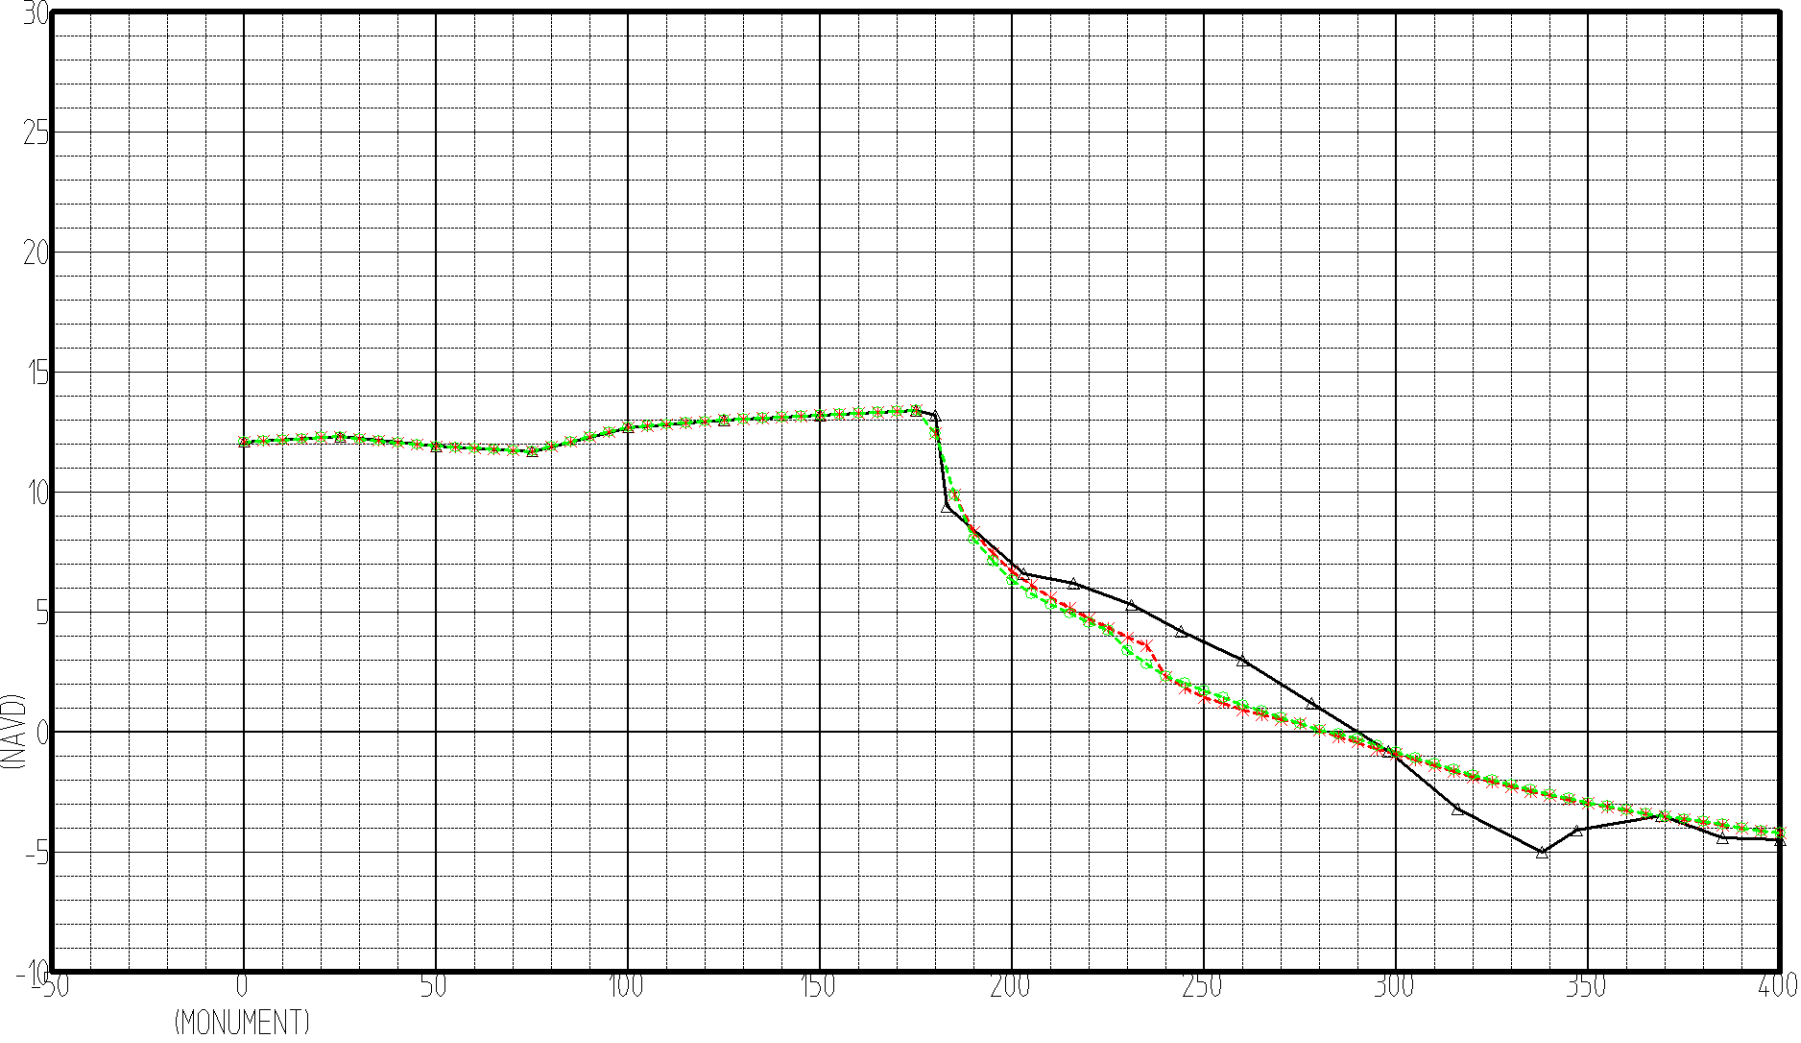
Range: R-94-T

BEACH PROFILE

—△—△— 2005-2008 INPUT PRF

- - - * - - - 15-YR SBEACH ERODED PRF

- - - o - - - 25-YR SBEACH ERODED PRF
