Appendix XI

SBEACH 15 and 25 yr. Storm Erosion Profiles

Brevard County

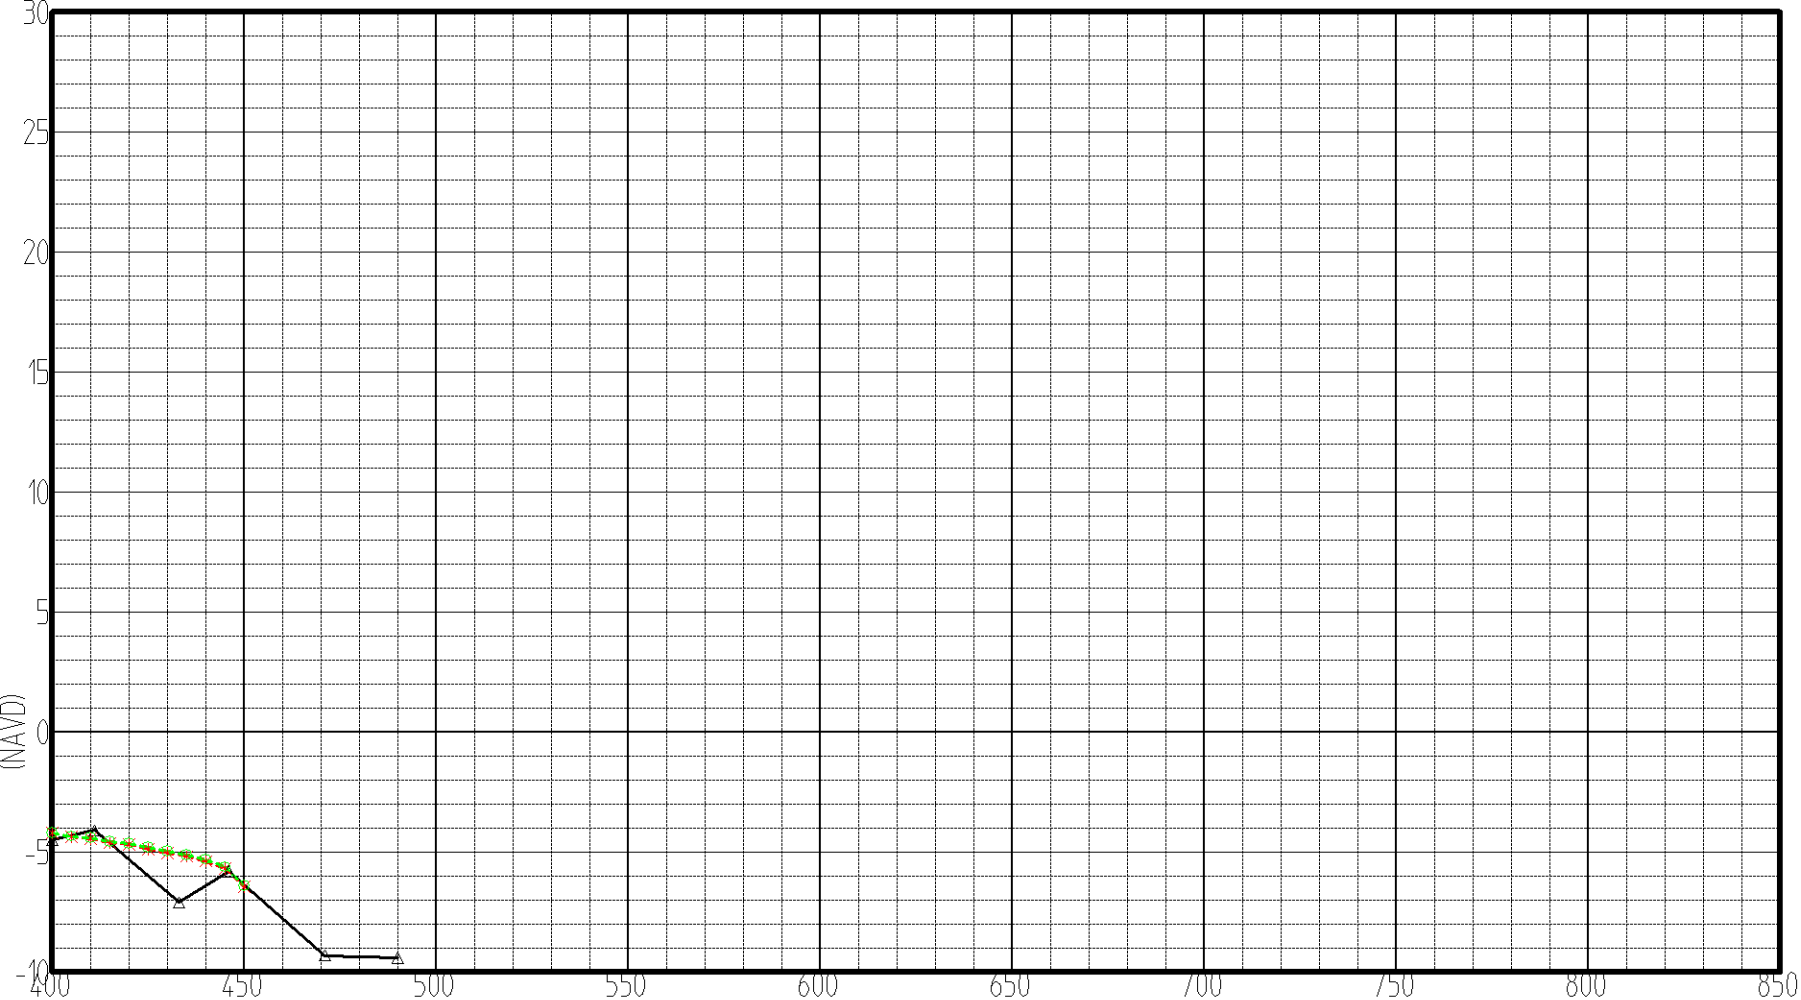
Range: R-94-T

BEACH PROFILE

—△—△— 2005-2008 INPUT PRF

- - - * - - - 15-YR SBEACH ERODED PRF

- - - o - - - 25-YR SBEACH ERODED PRF

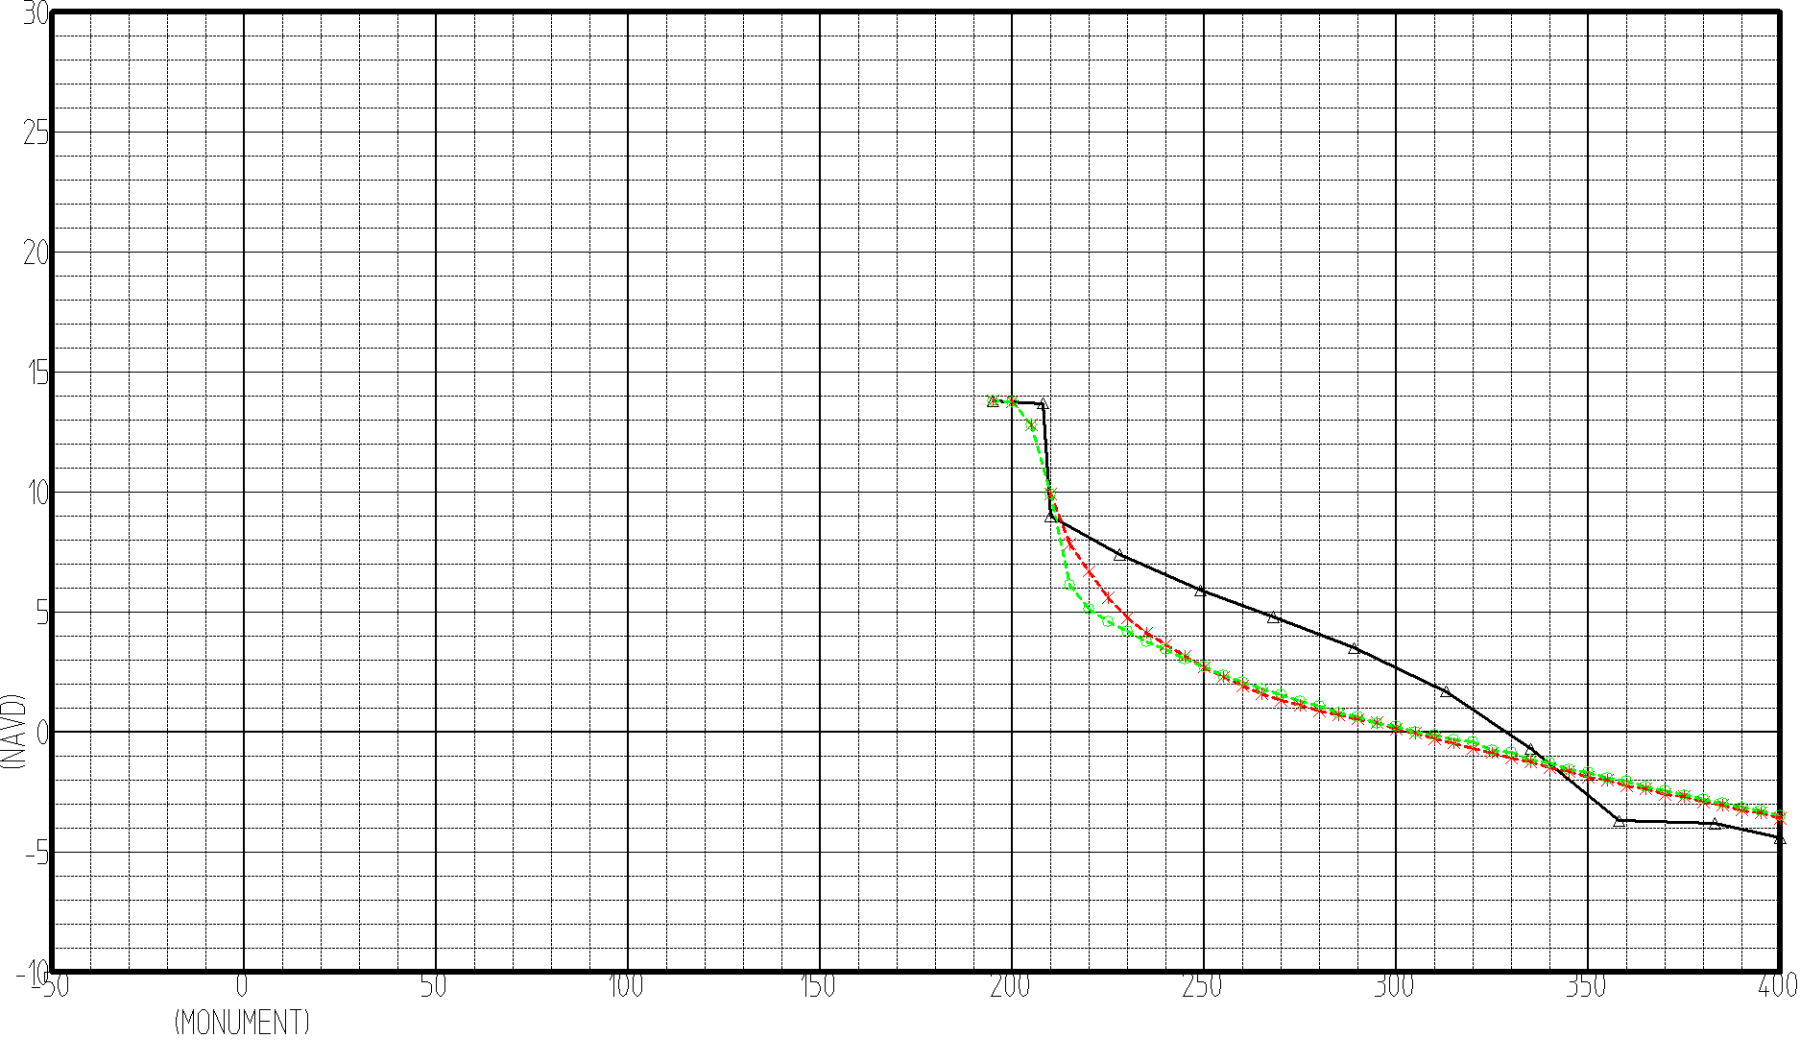
Range: R-95-T
 BEARING: 80.00
 1/2

BEACH PROFILE
 —△—△— 2005-2008 INPUT PRF
 - - * - - * - - 15-YR SBEACH ERODED PRF
 - - o - - o - - 25-YR SBEACH ERODED PRF

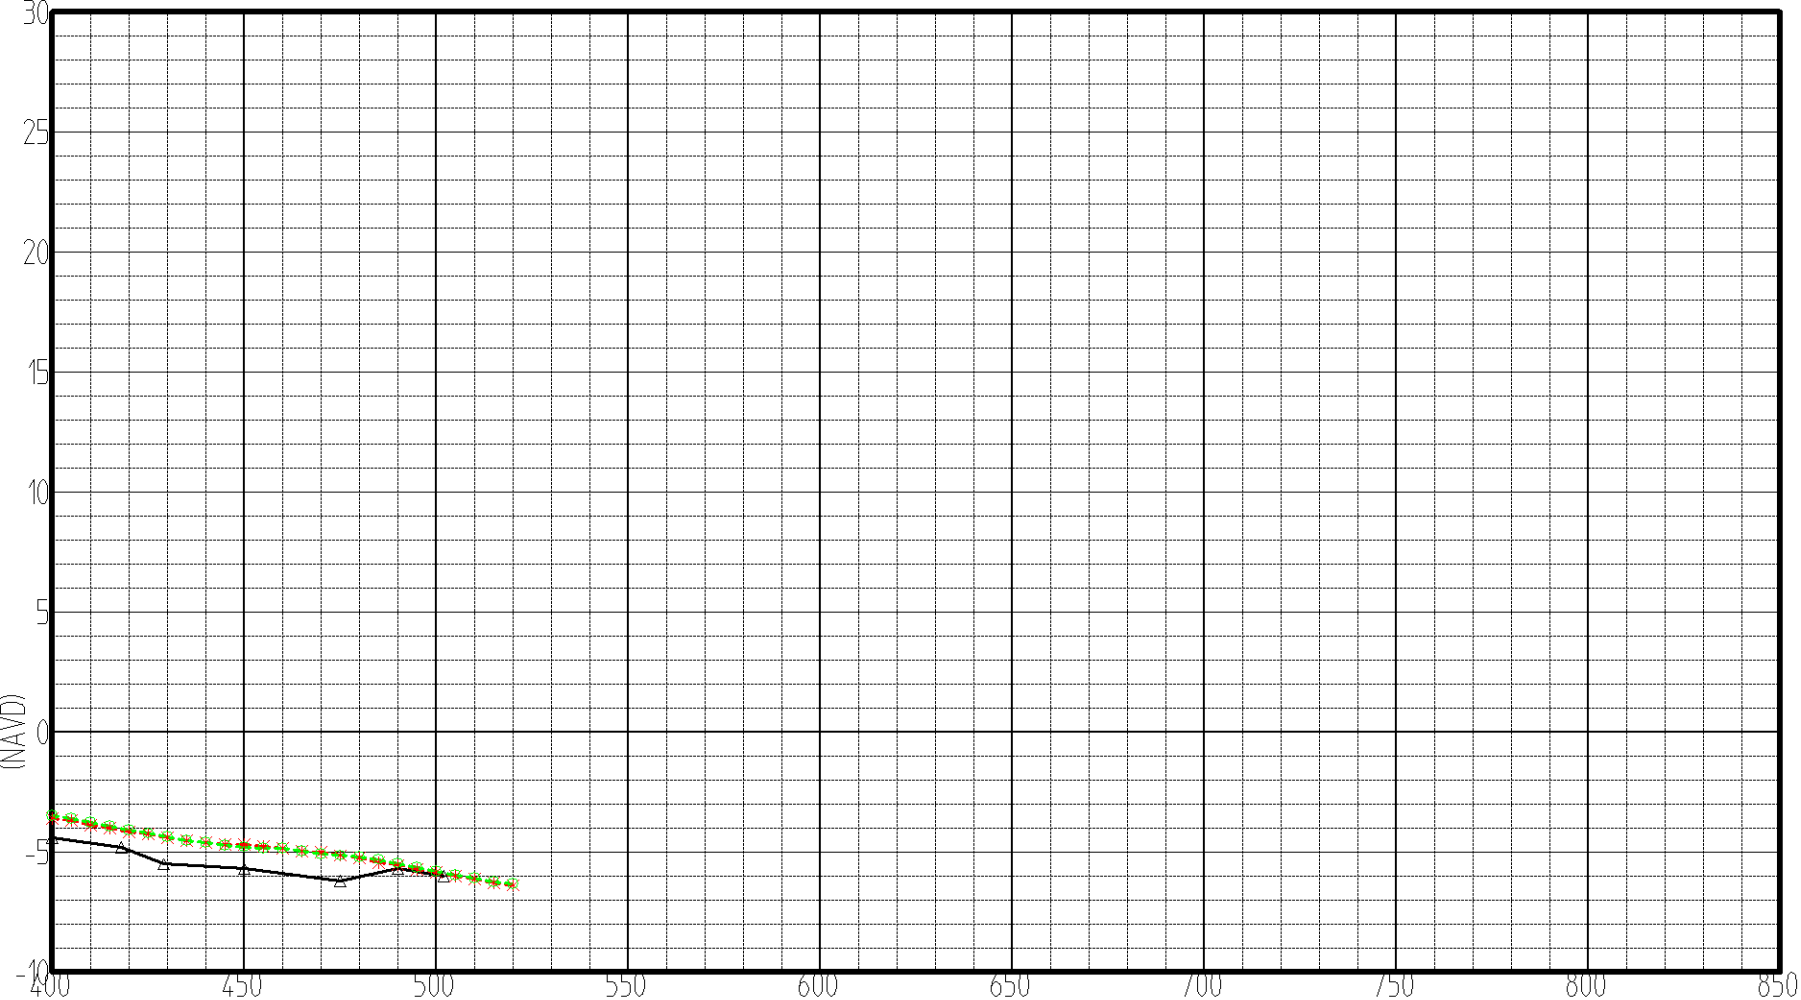
Range: R-95-T

BEACH PROFILE

—△—△— 2005-2008 INPUT PRF

- - - * - - - 15-YR SBEACH ERODED PRF

- - - o - - - 25-YR SBEACH ERODED PRF

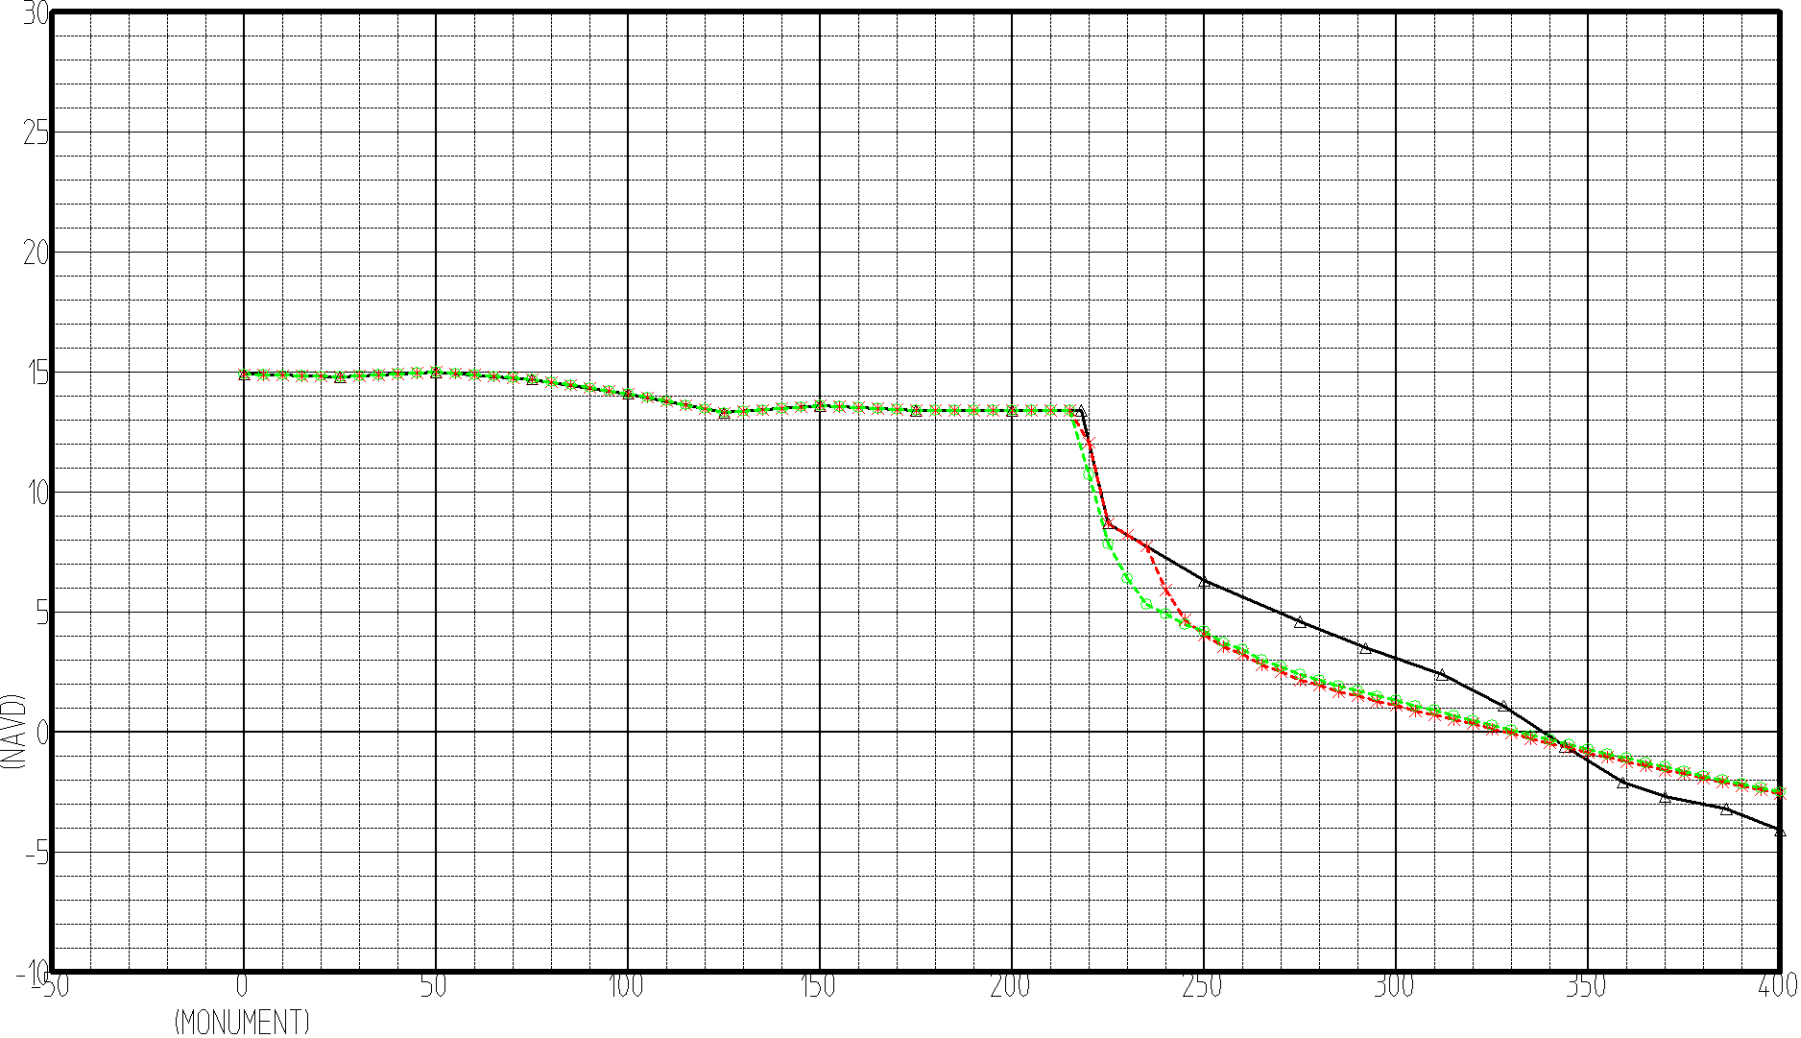
Range: R-96

BEACH PROFILE

—△—△— 2005-2008 INPUT PRF

- - - * - - - 15-YR SBEACH ERODED PRF

- - - o - - - 25-YR SBEACH ERODED PRF

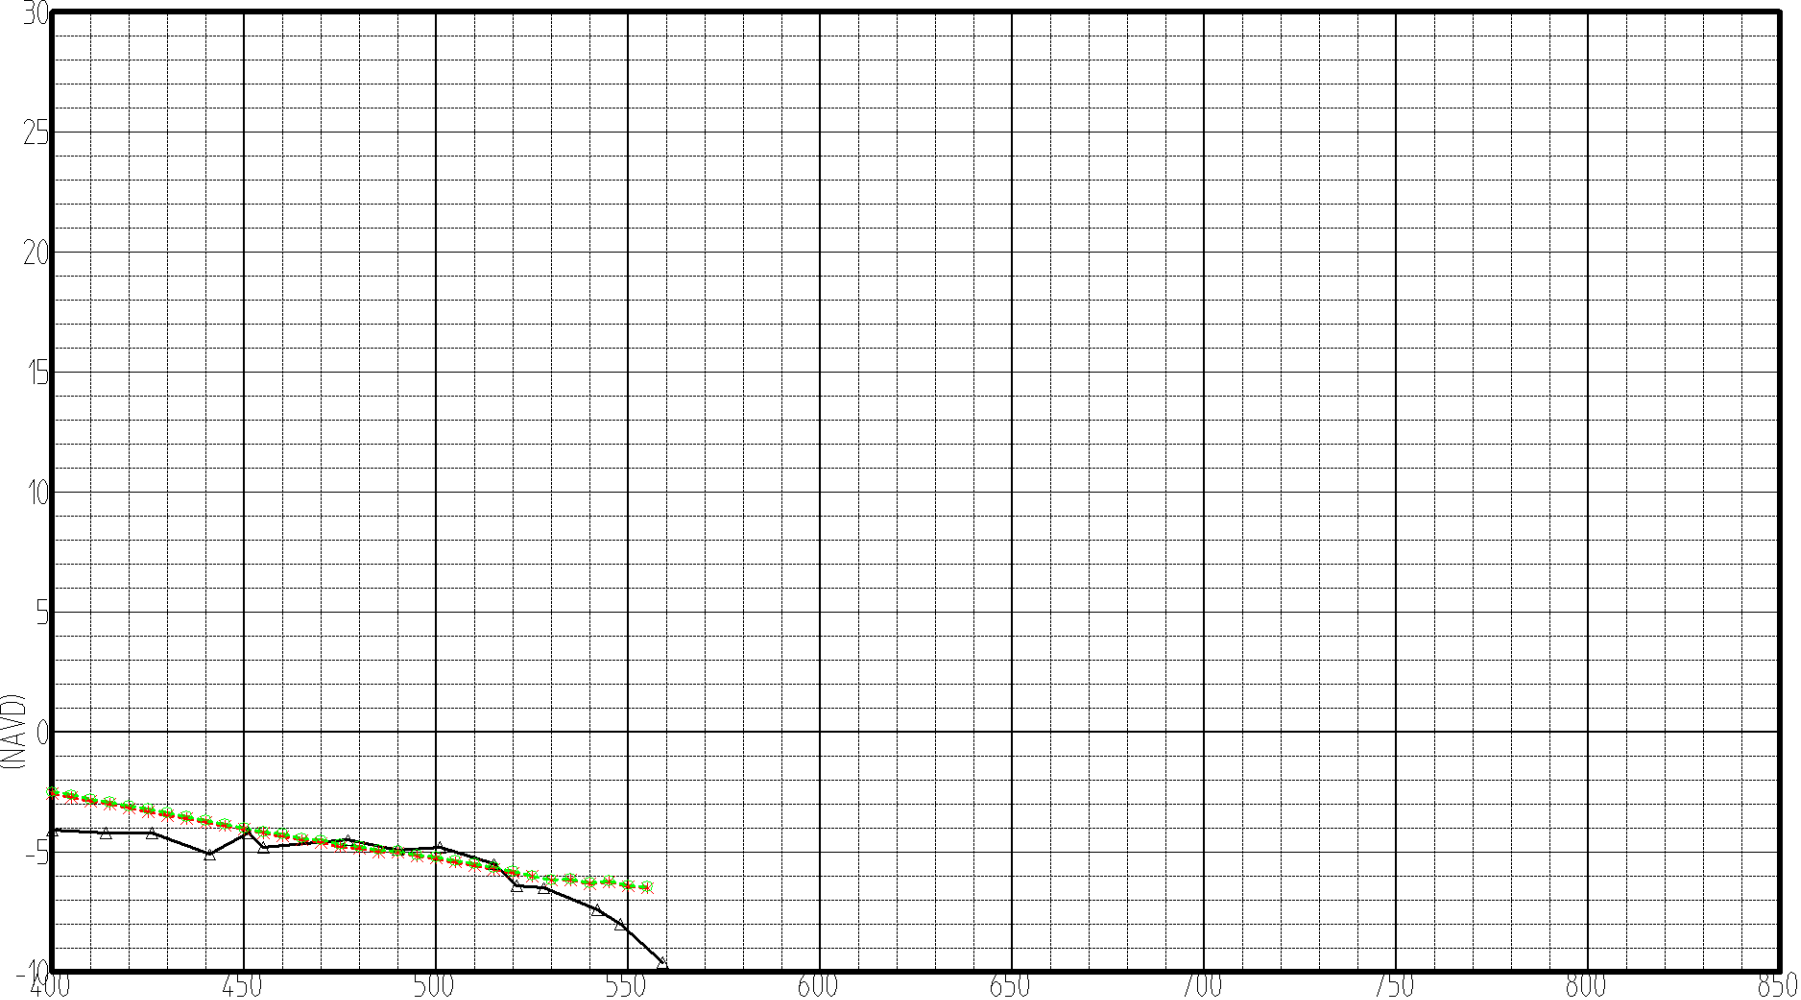
Range: R-96 2/2

BEACH PROFILE

—△—△— 2005-2008 INPUT PRF
 - - * - - * - - 15-YR SBEACH ERODED PRF
 - - o - - o - - 25-YR SBEACH ERODED PRF

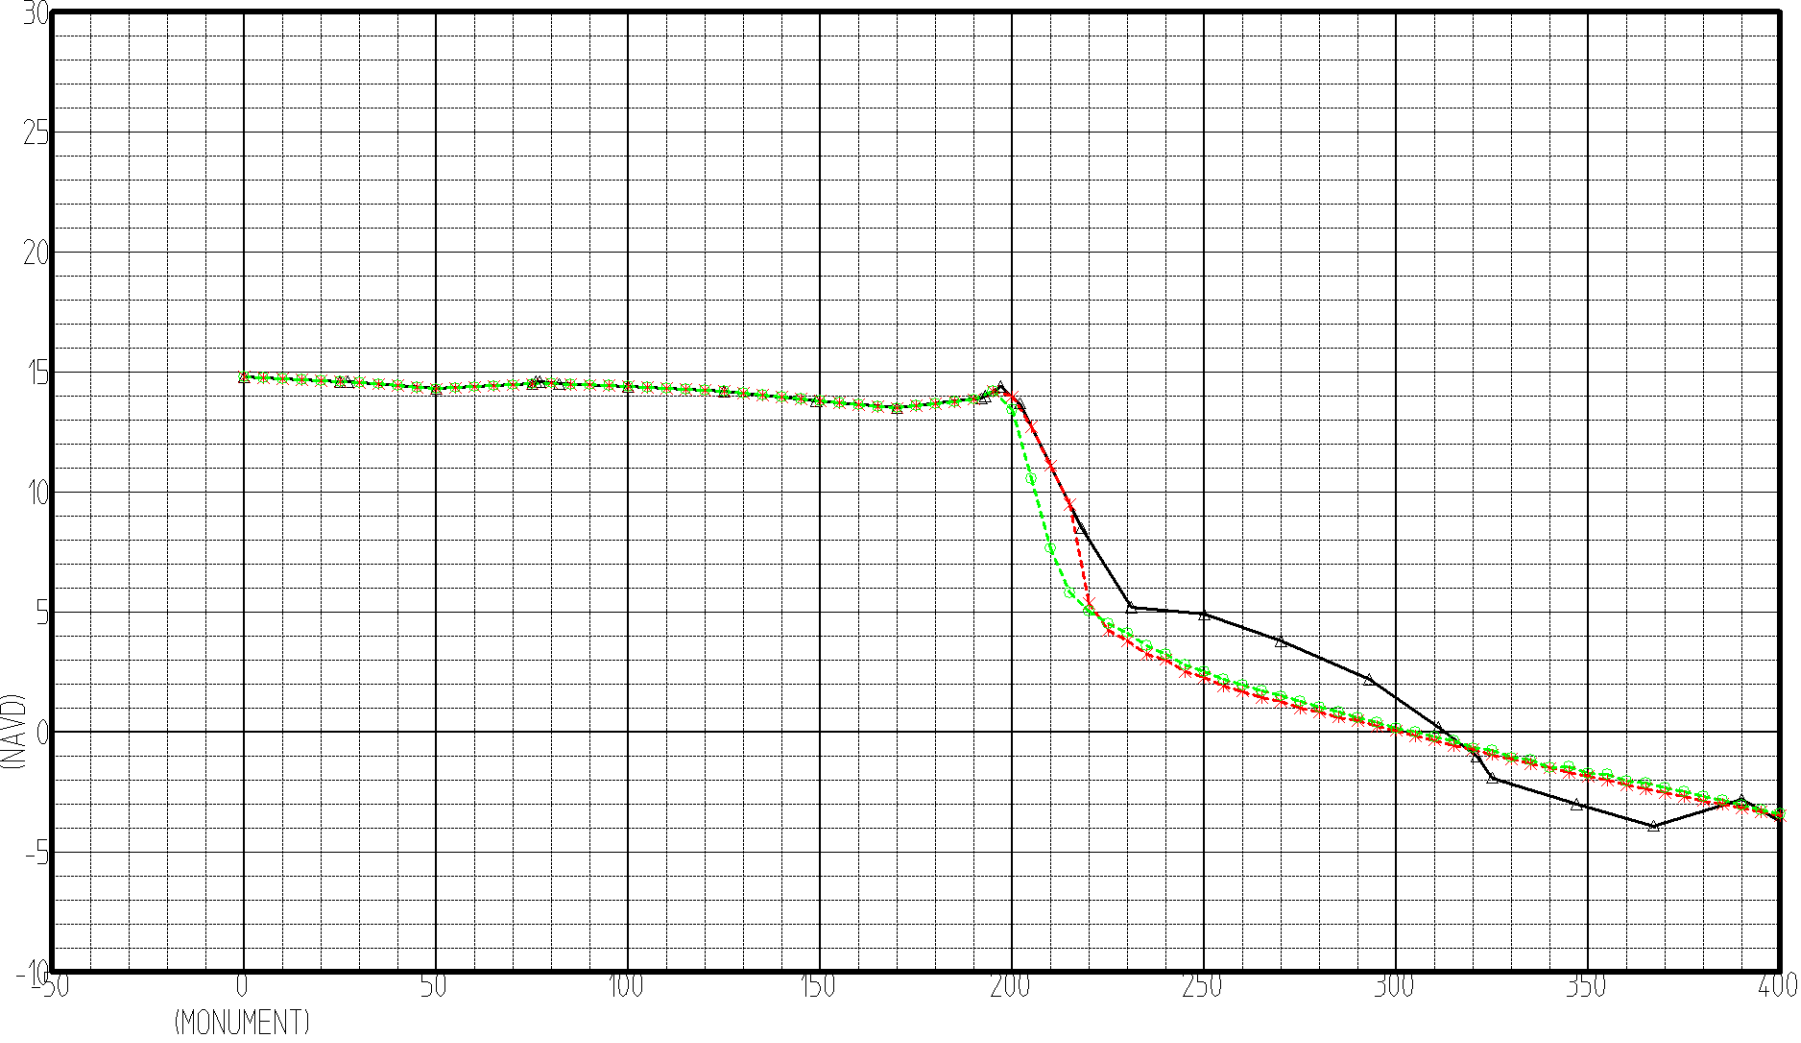
Range: R-97
 BEARING: 80.00
 1/2

BEACH PROFILE
 —△—△— 2005-2008 INPUT PRF
 - - * - - * - - 15-YR SBEACH ERODED PRF
 - - o - - o - - 25-YR SBEACH ERODED PRF

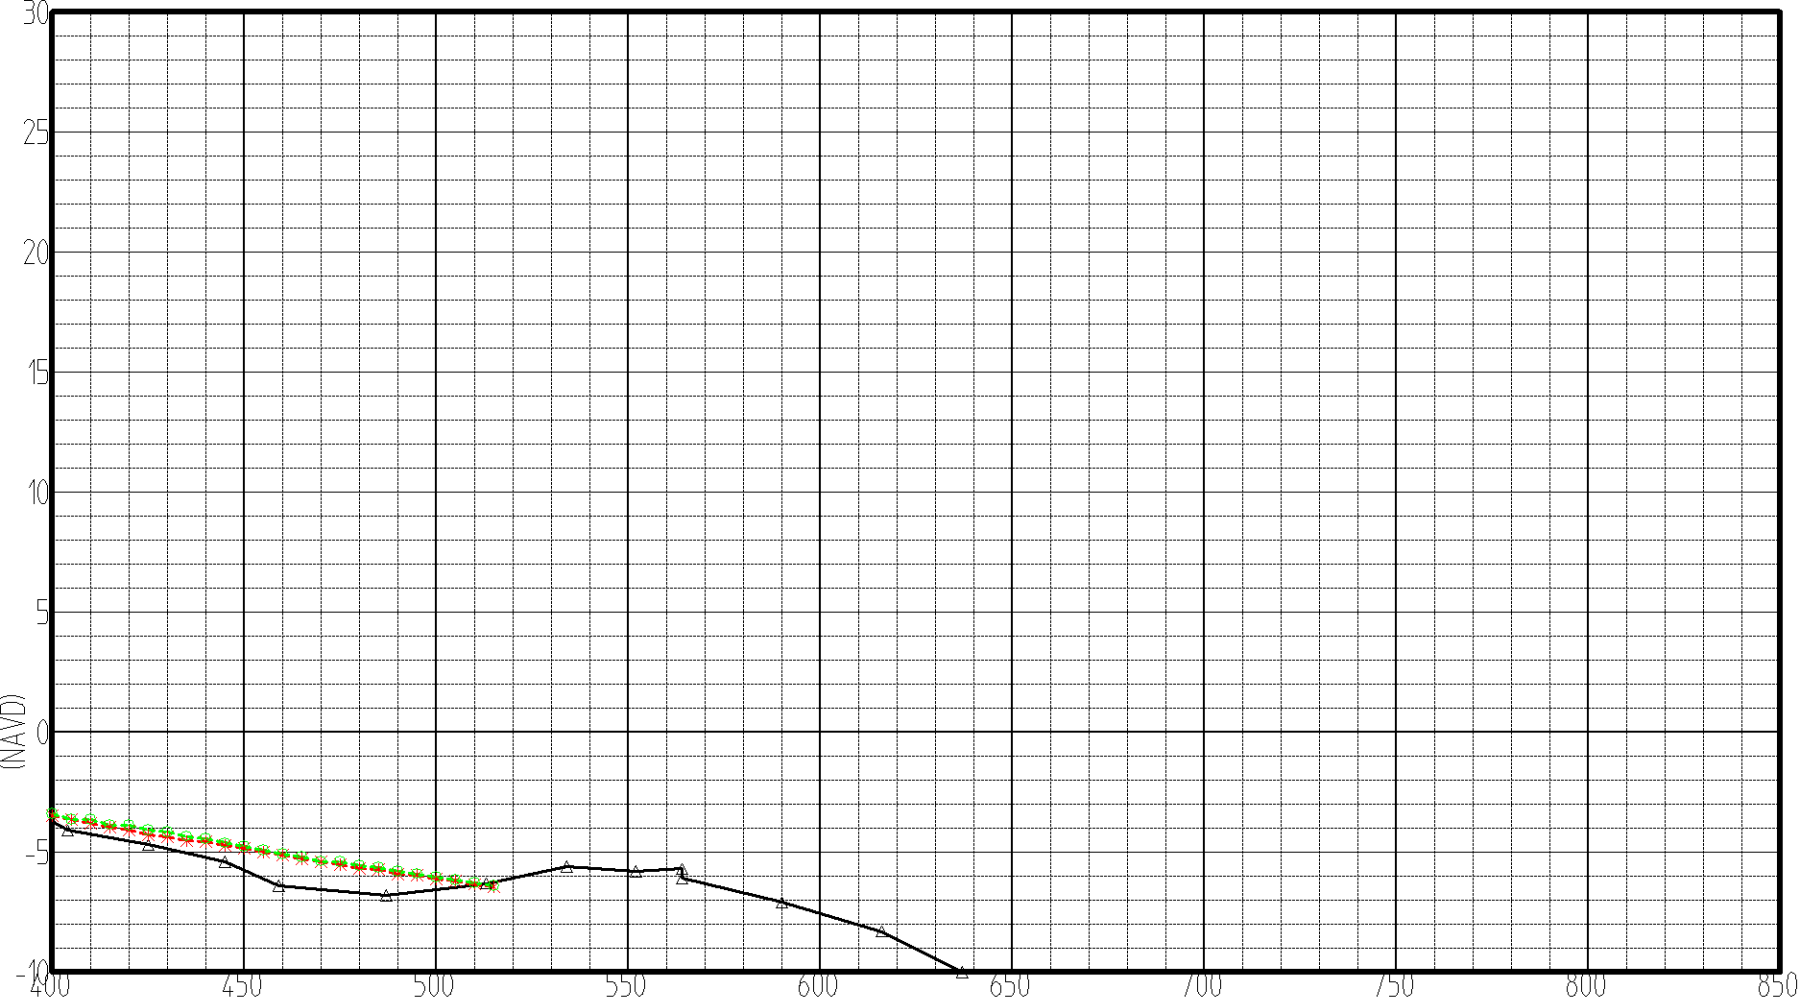
Range: R-97

BEACH PROFILE

—△—△— 2005-2008 INPUT PRF

- - - * - - - 15-YR SBEACH ERODED PRF

- - - o - - - 25-YR SBEACH ERODED PRF

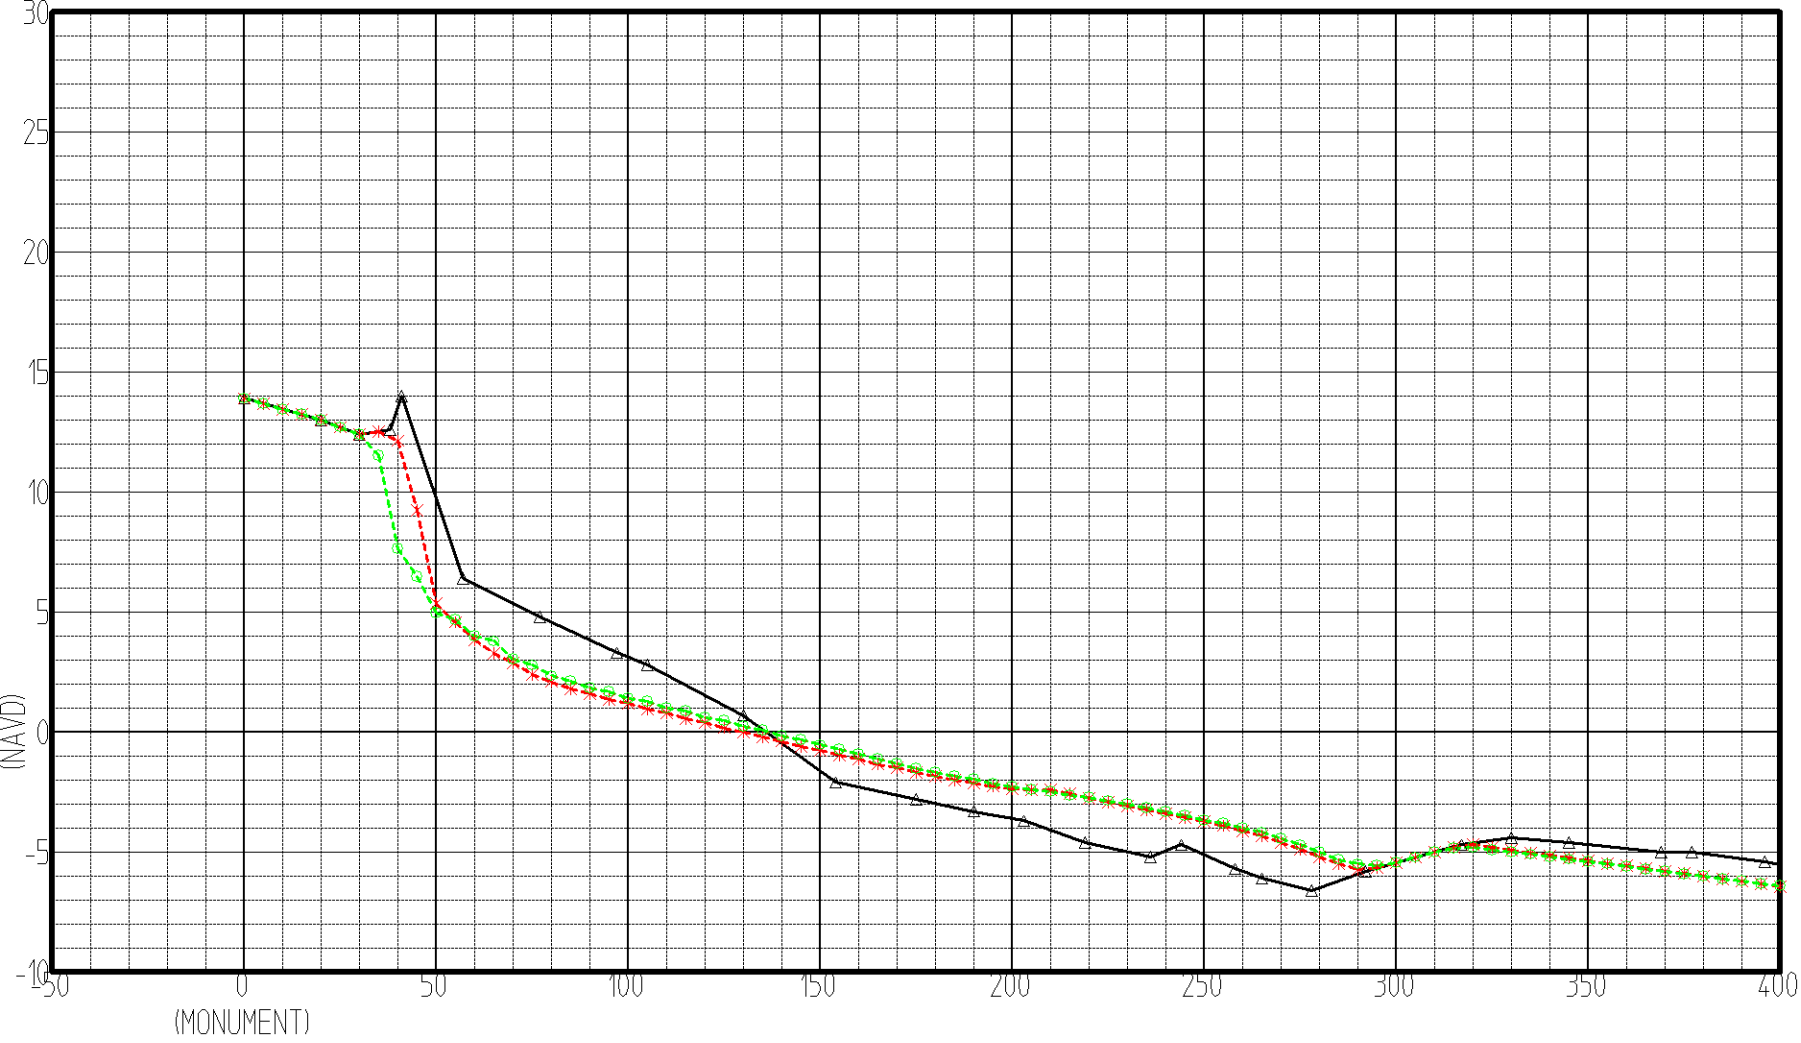
Range: R-98
 BEARING: 80.00
 1/2

BEACH PROFILE
 —△—△— 2005-2008 INPUT PRF
 - - * - - * - - 15-YR SBEACH ERODED PRF
 - - o - - o - - 25-YR SBEACH ERODED PRF

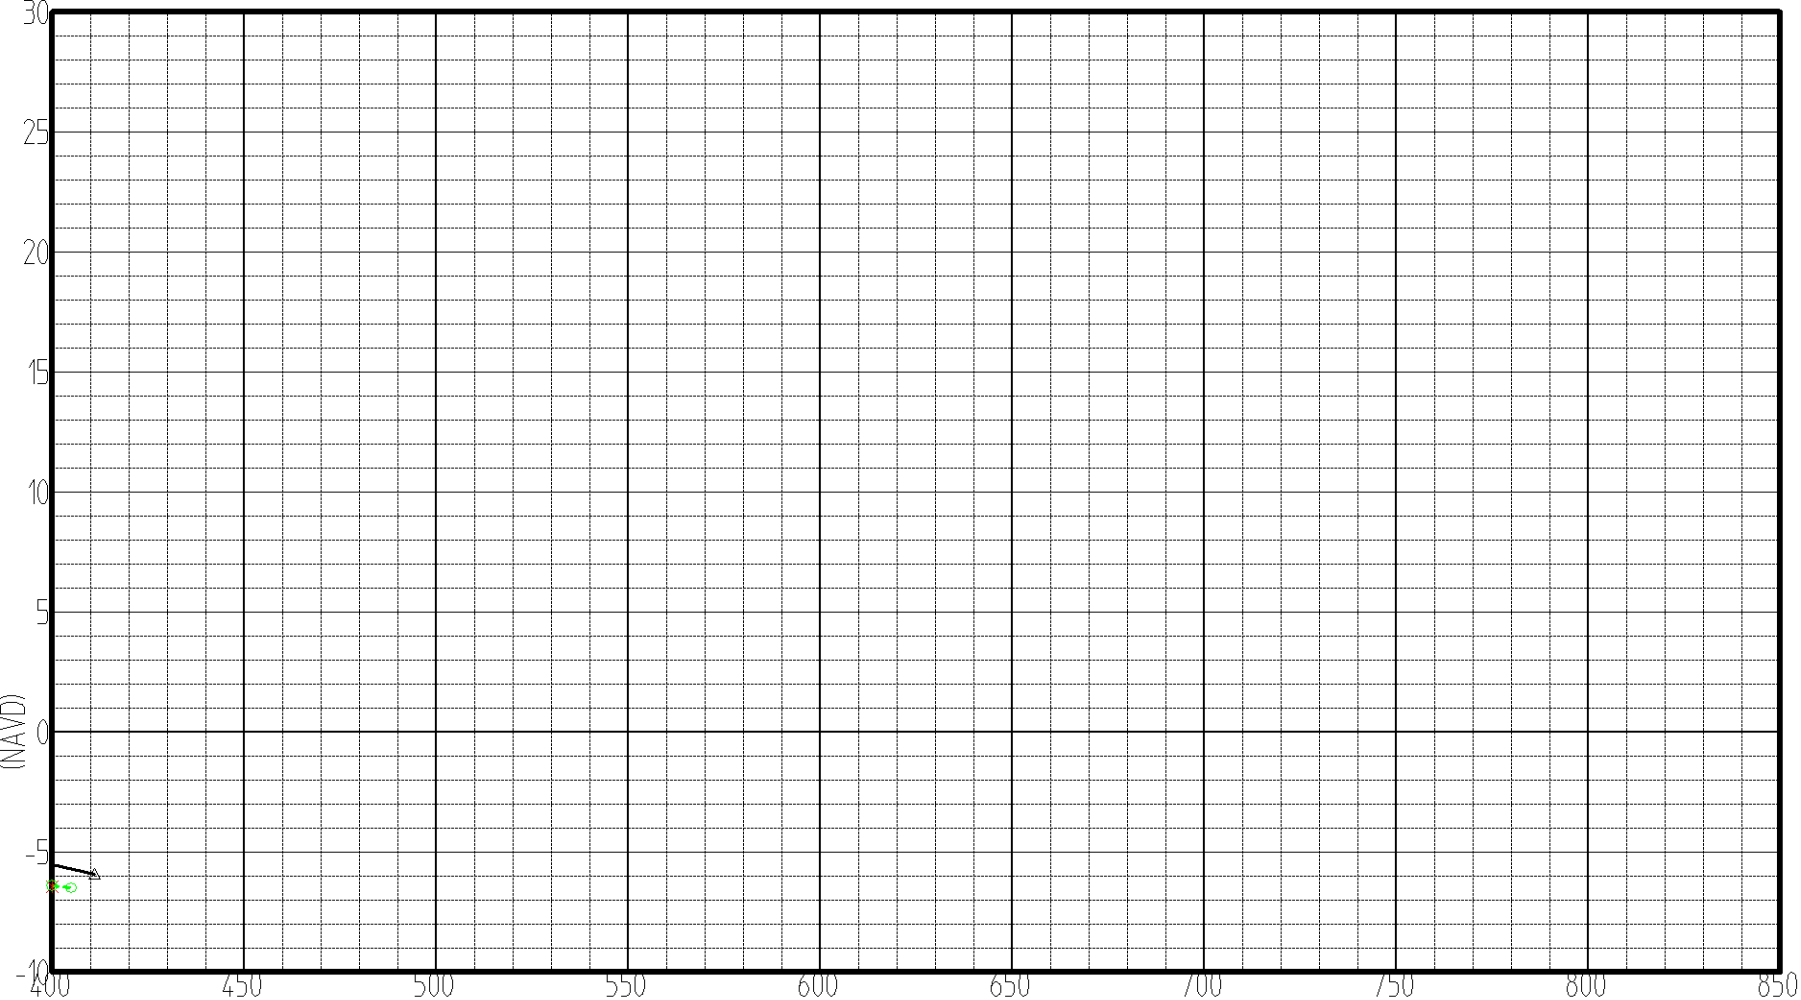
Range: R-98 2/2

BEACH PROFILE

- △—△— 2005-2008 INPUT PRF
- - - * - - - 15-YR SBEACH ERODED PRF
- - - o - - - 25-YR SBEACH ERODED PRF

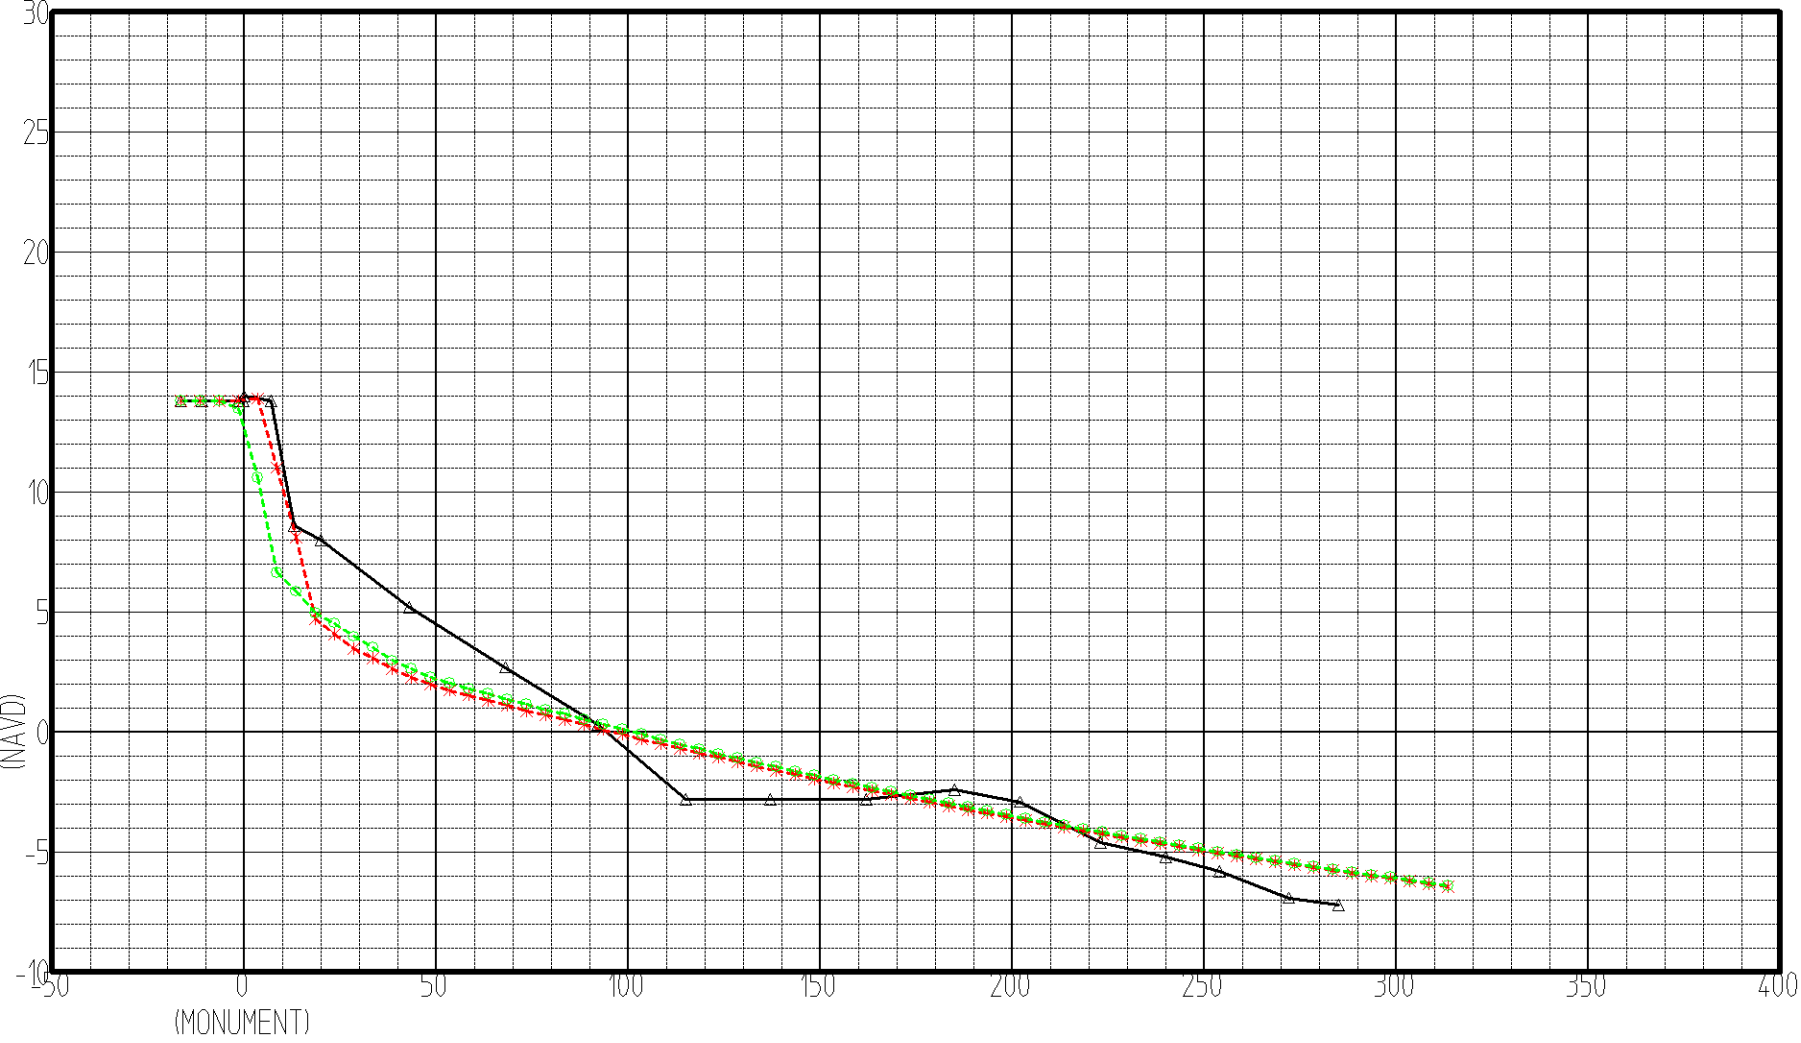
Range: R-100

BEACH PROFILE

—△—△— 2005-2008 INPUT PRF

- - - * - - - 15-YR SBEACH ERODED PRF

- - - o - - - 25-YR SBEACH ERODED PRF

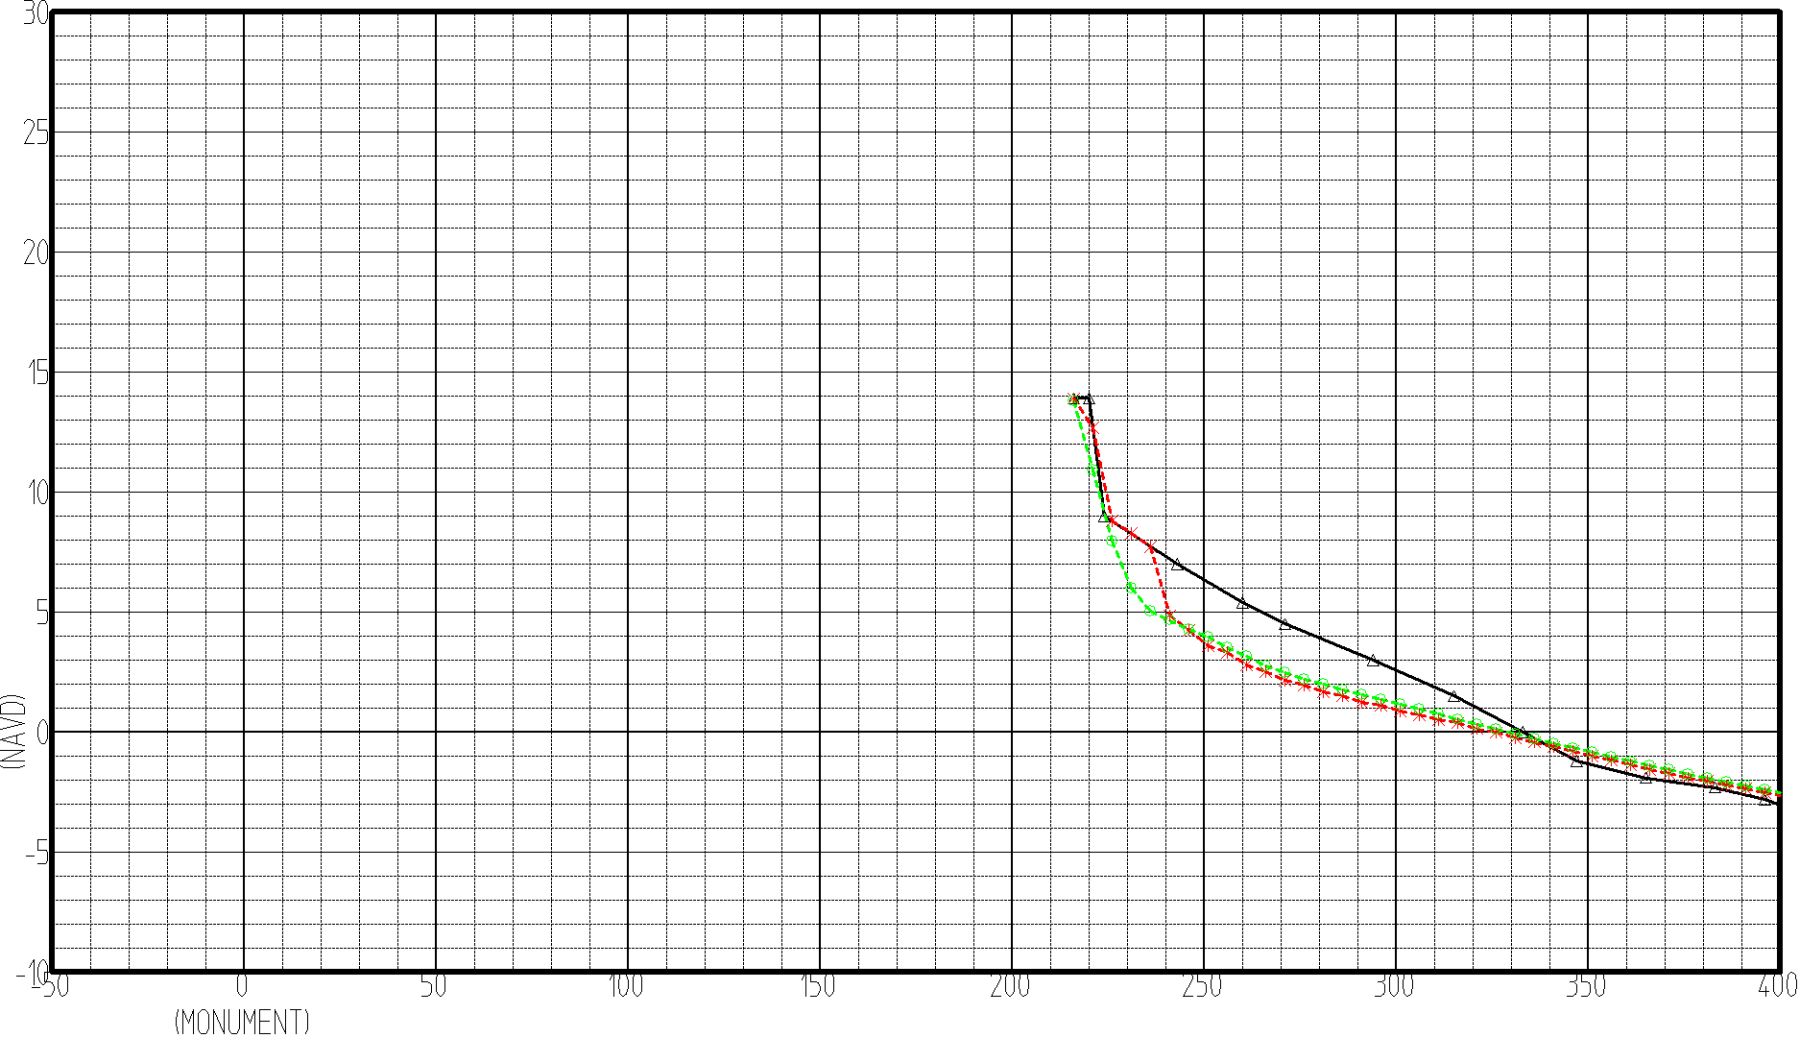
Range: R-101

BEACH PROFILE

—△—△— 2005-2008 INPUT PRF

- - * - - * - - 15-YR SBEACH ERODED PRF

- - o - - o - - 25-YR SBEACH ERODED PRF

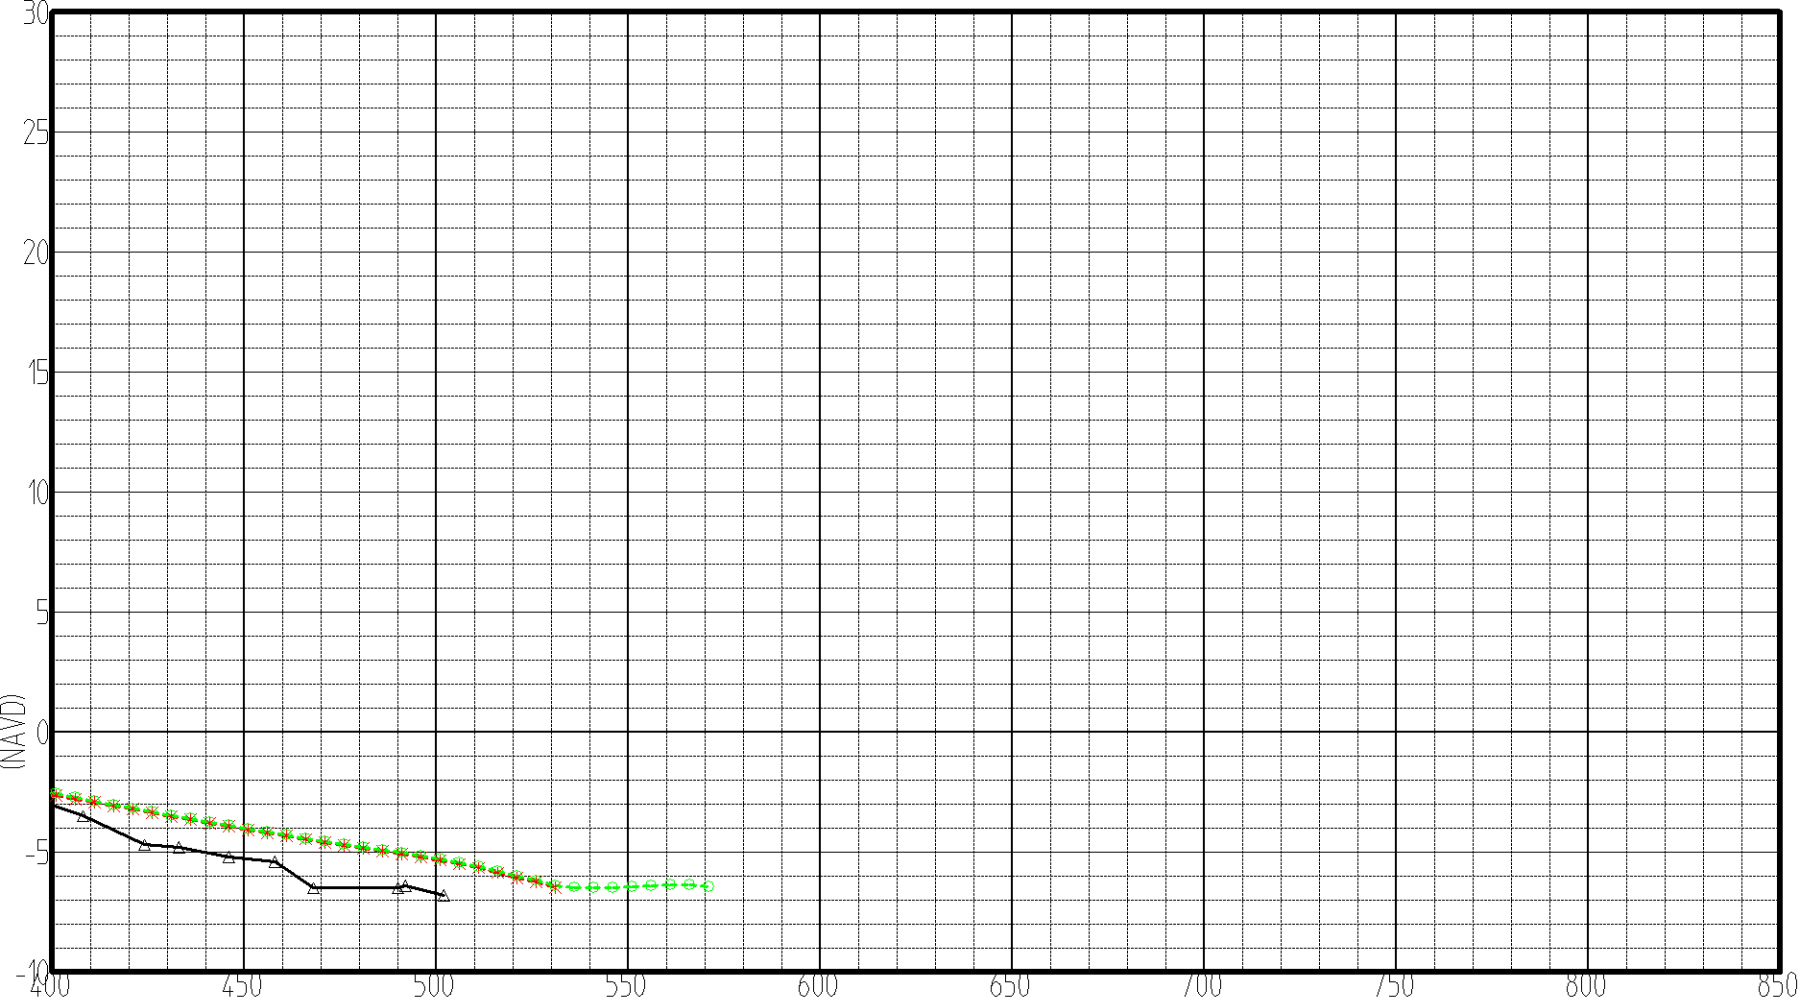
Range: R-101

BEACH PROFILE

—△—△— 2005-2008 INPUT PRF

- - - * - - - 15-YR SBEACH ERODED PRF

- - - o - - - 25-YR SBEACH ERODED PRF
