Appendix XI

SBEACH 15 and 25 yr. Storm Erosion Profiles

Brevard County

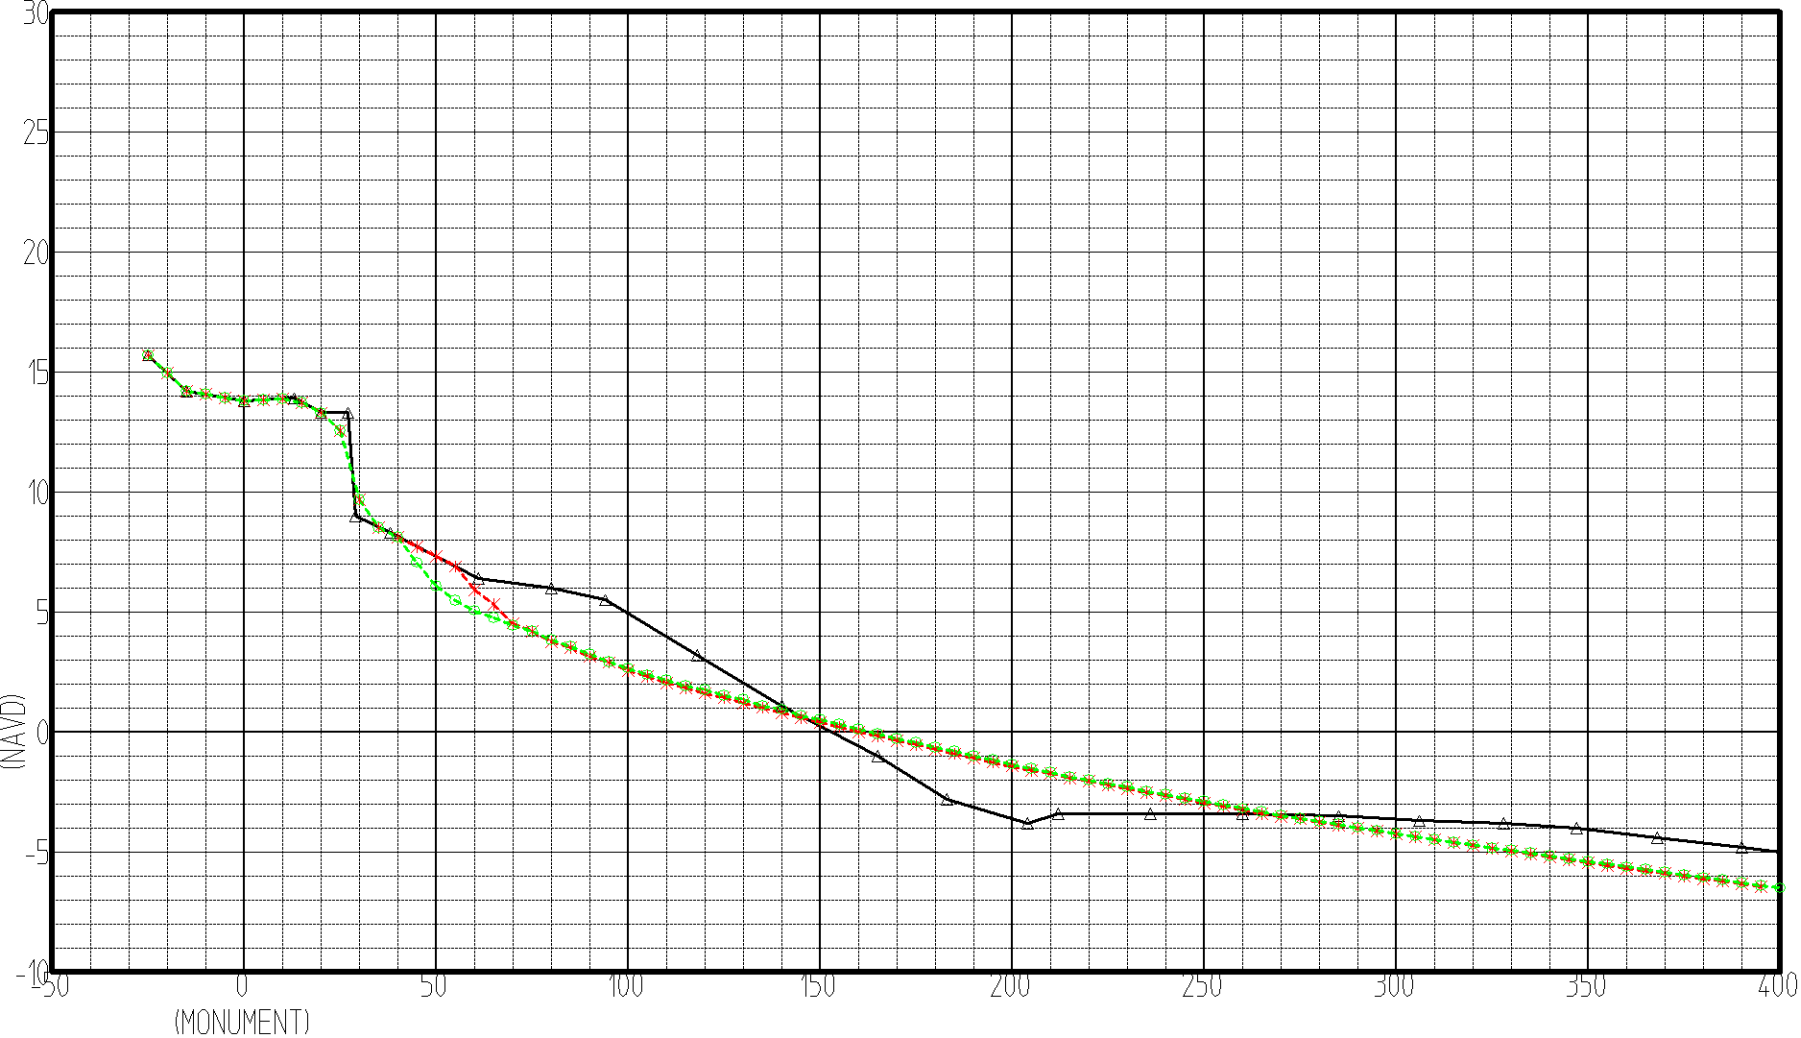
Range: R-102

BEACH PROFILE

—△—△— 2005-2008 INPUT PRF

- - - * - - - 15-YR SBEACH ERODED PRF

- - - o - - - 25-YR SBEACH ERODED PRF

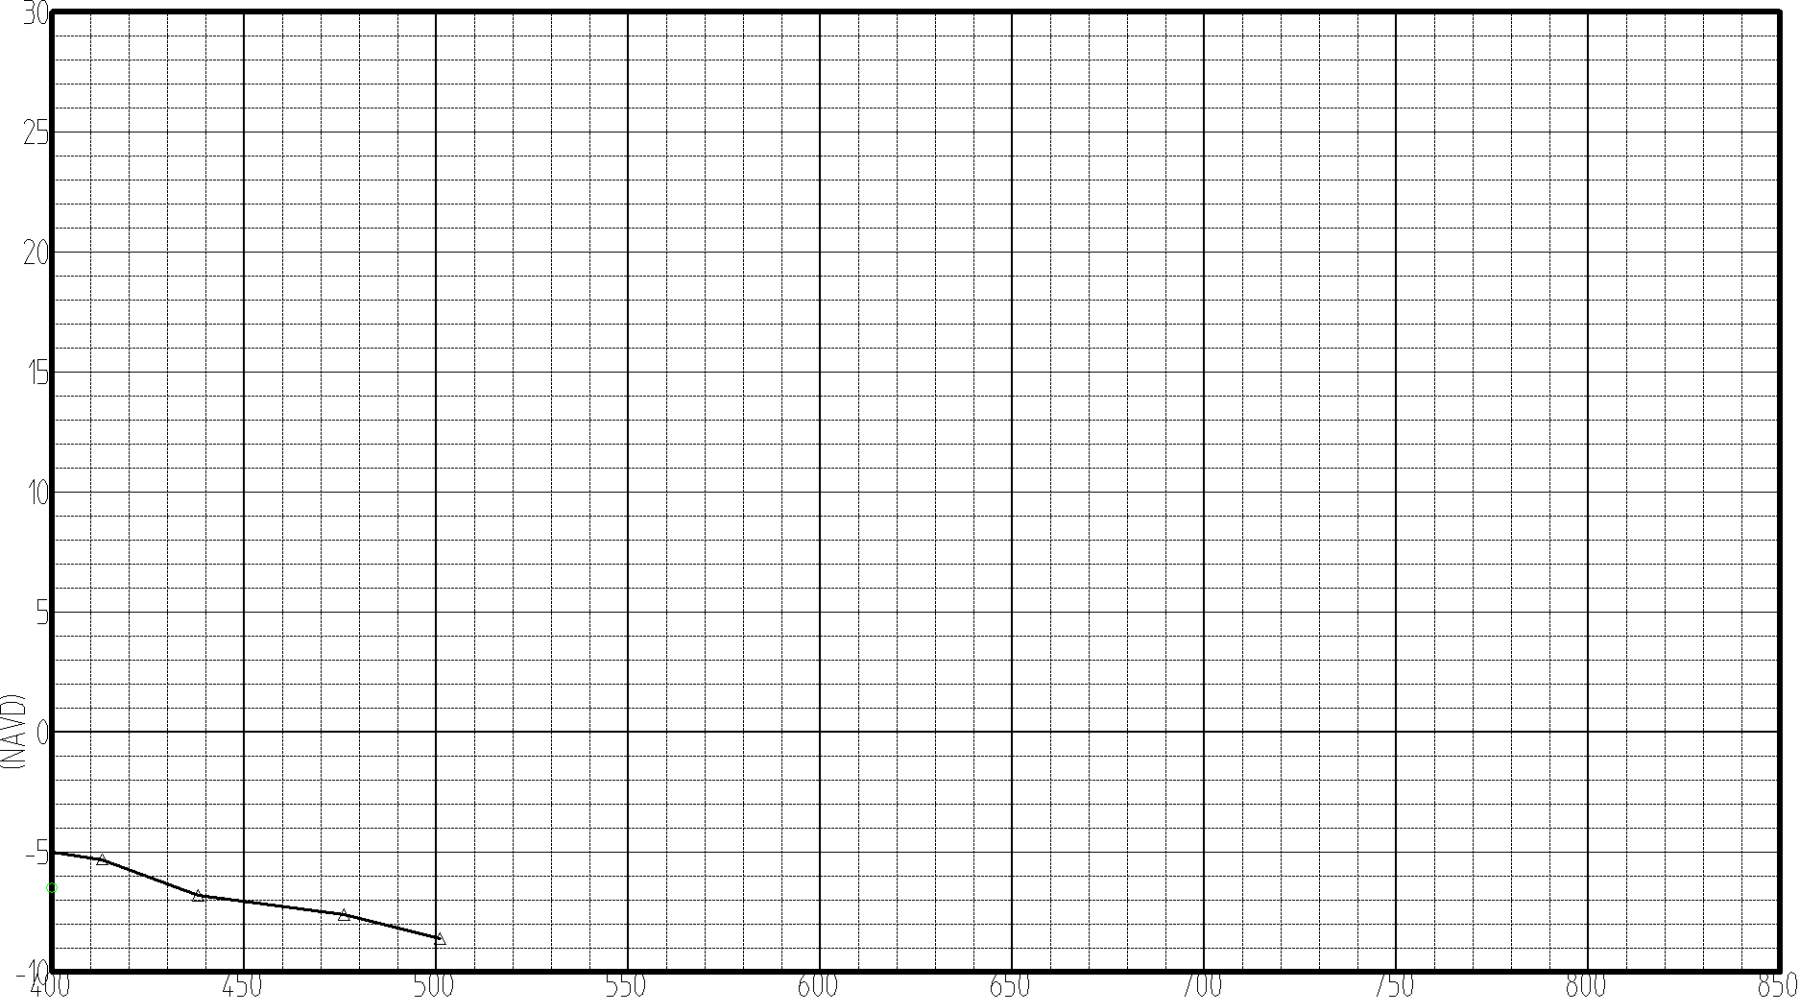
Range: R-102

BEACH PROFILE

—△—△— 2005-2008 INPUT PRF

- - - * - - - 15-YR SBEACH ERODED PRF

- - - o - - - 25-YR SBEACH ERODED PRF

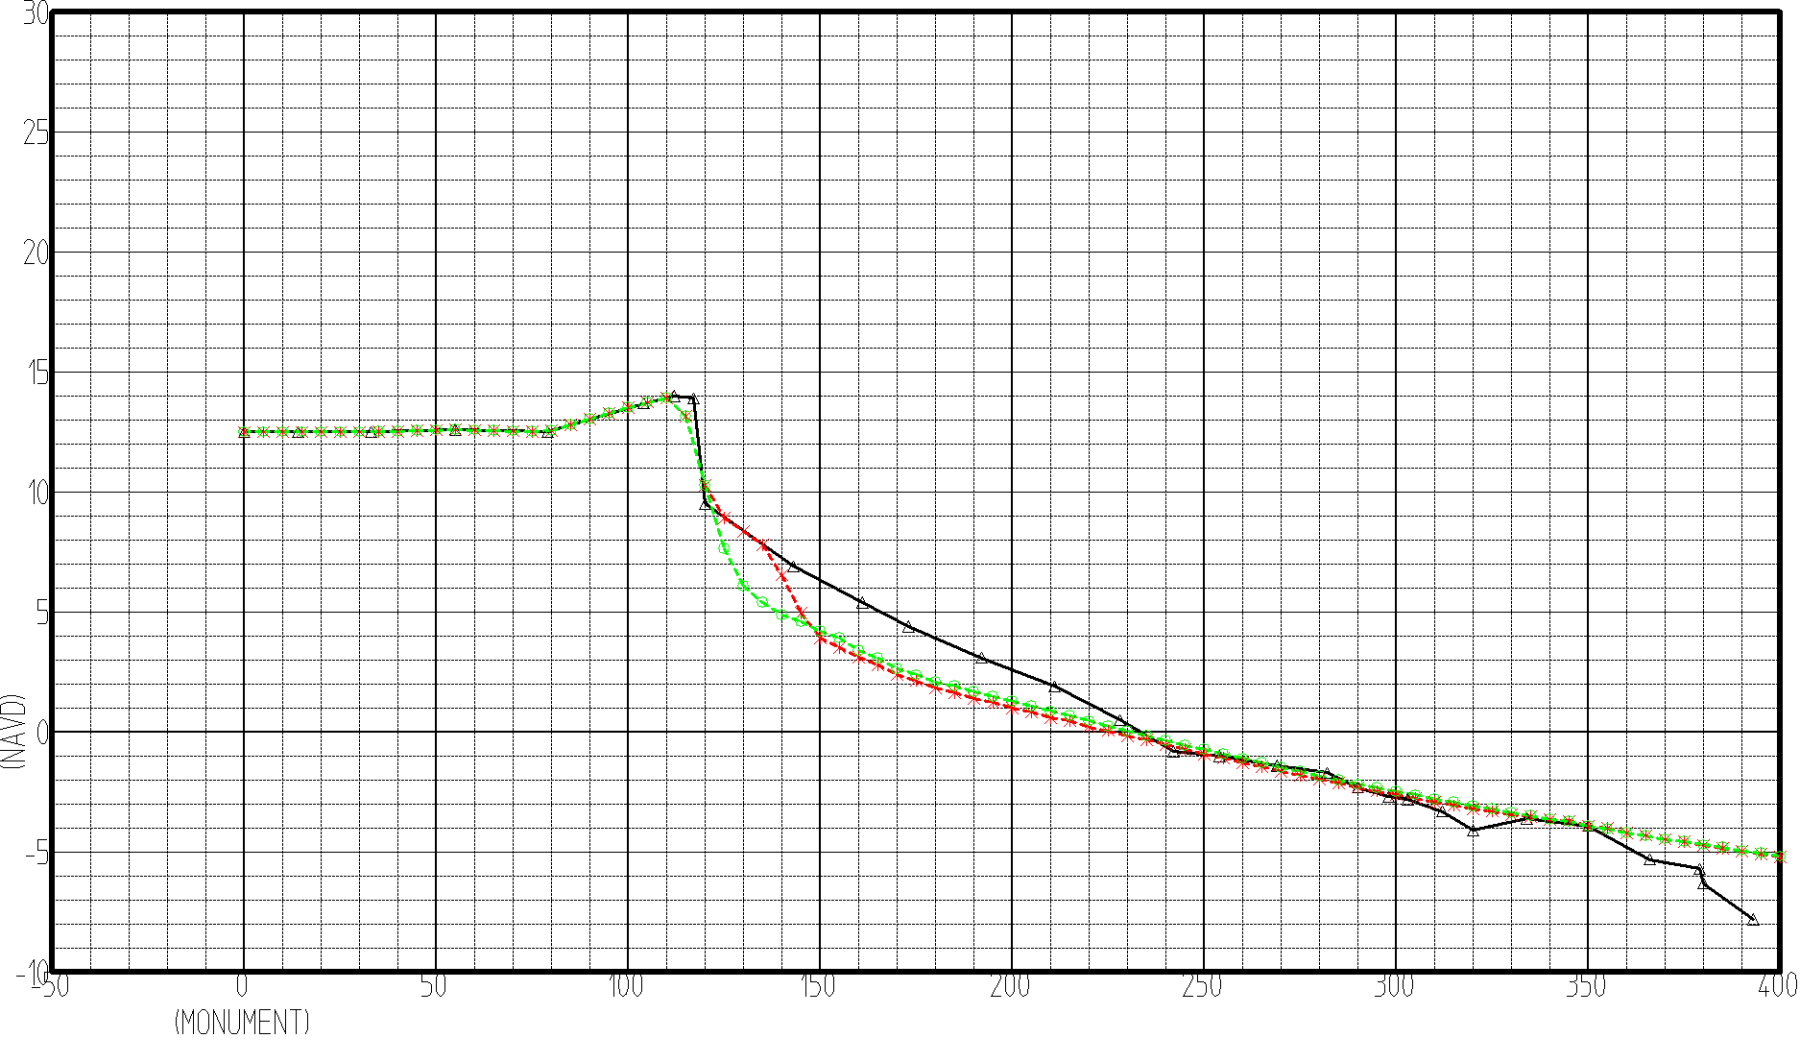
Range: R-104

BEACH PROFILE

—△—△— 2005-2008 INPUT PRF

- - * - - * - - 15-YR SBEACH ERODED PRF

- - o - - o - - 25-YR SBEACH ERODED PRF

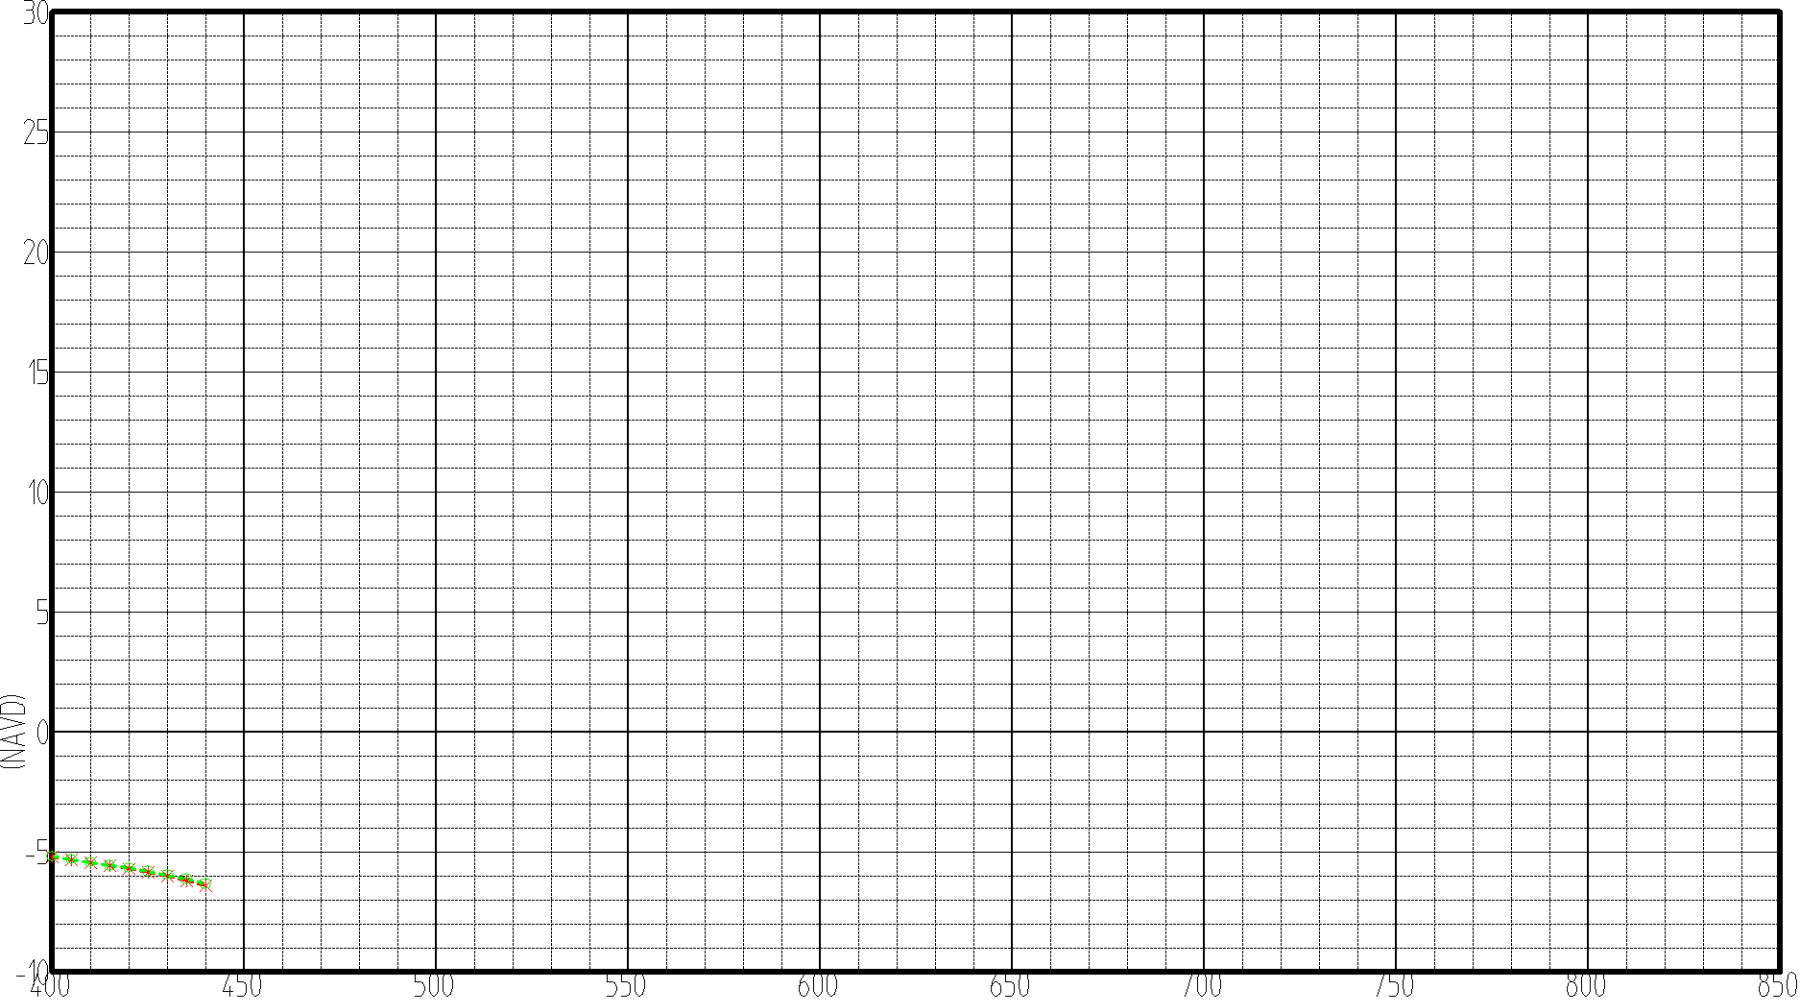
Range: R-104 2/2

BEACH PROFILE

- △—△— 2005-2008 INPUT PRF
- - * - - * - - 15-YR SBEACH ERODED PRF
- - ○ - - ○ - - 25-YR SBEACH ERODED PRF

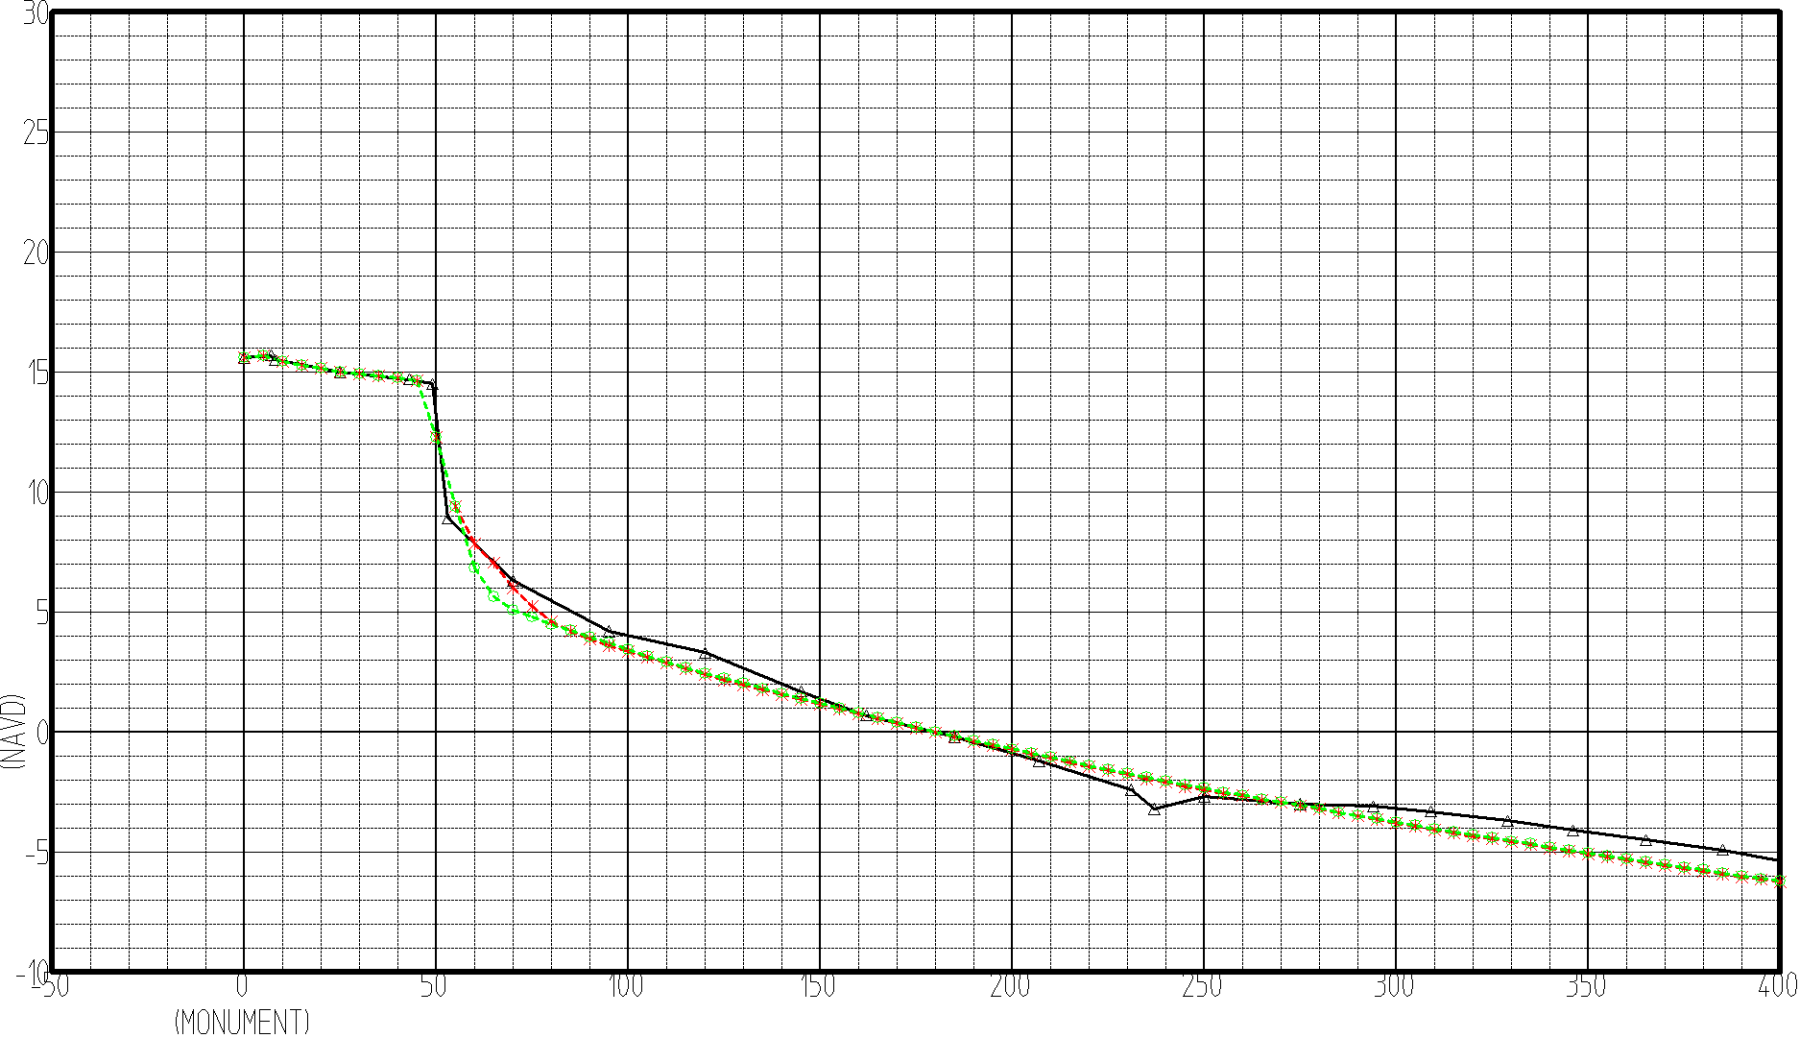
Range: R-105

BEACH PROFILE

—△—△— 2005-2008 INPUT PRF

- - * - - * - - 15-YR SBEACH ERODED PRF

- - o - - o - - 25-YR SBEACH ERODED PRF

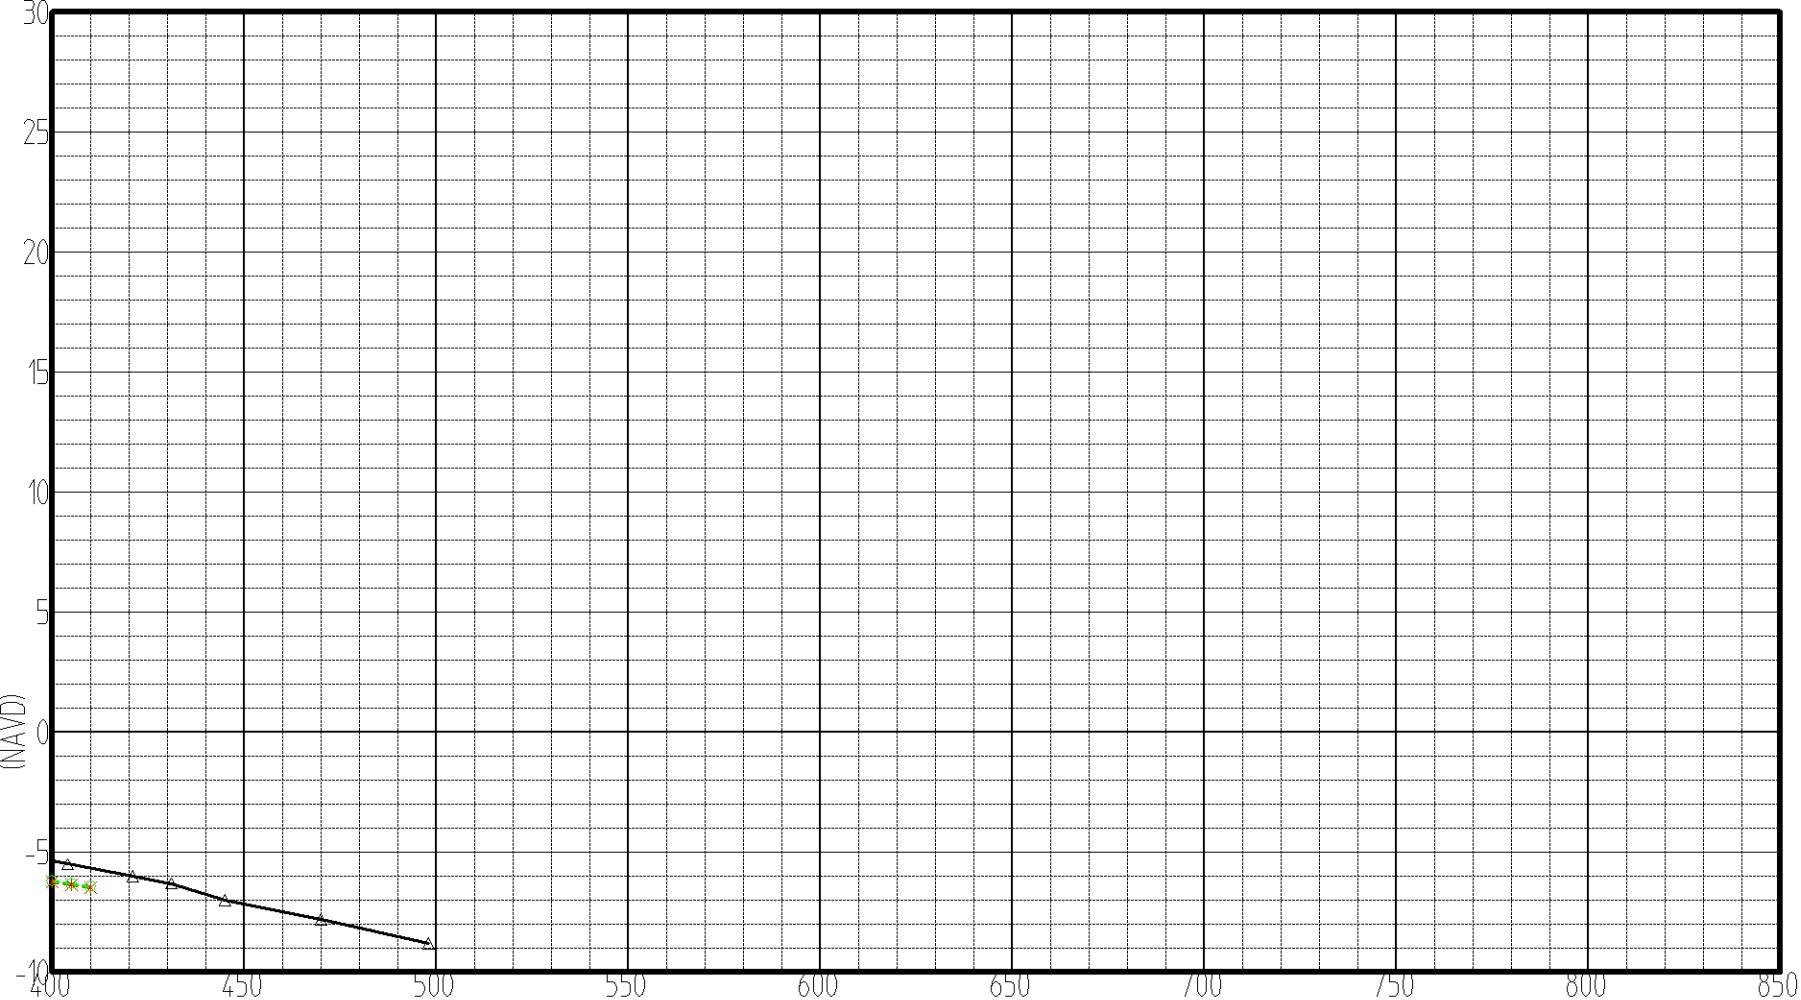
Range: R-105 2/2
 BEARING: 80.00

BEACH PROFILE
 —△—△— 2005-2008 INPUT PRF
 - - * - - * - - 15-YR SBEACH ERODED PRF
 - - o - - o - - 25-YR SBEACH ERODED PRF

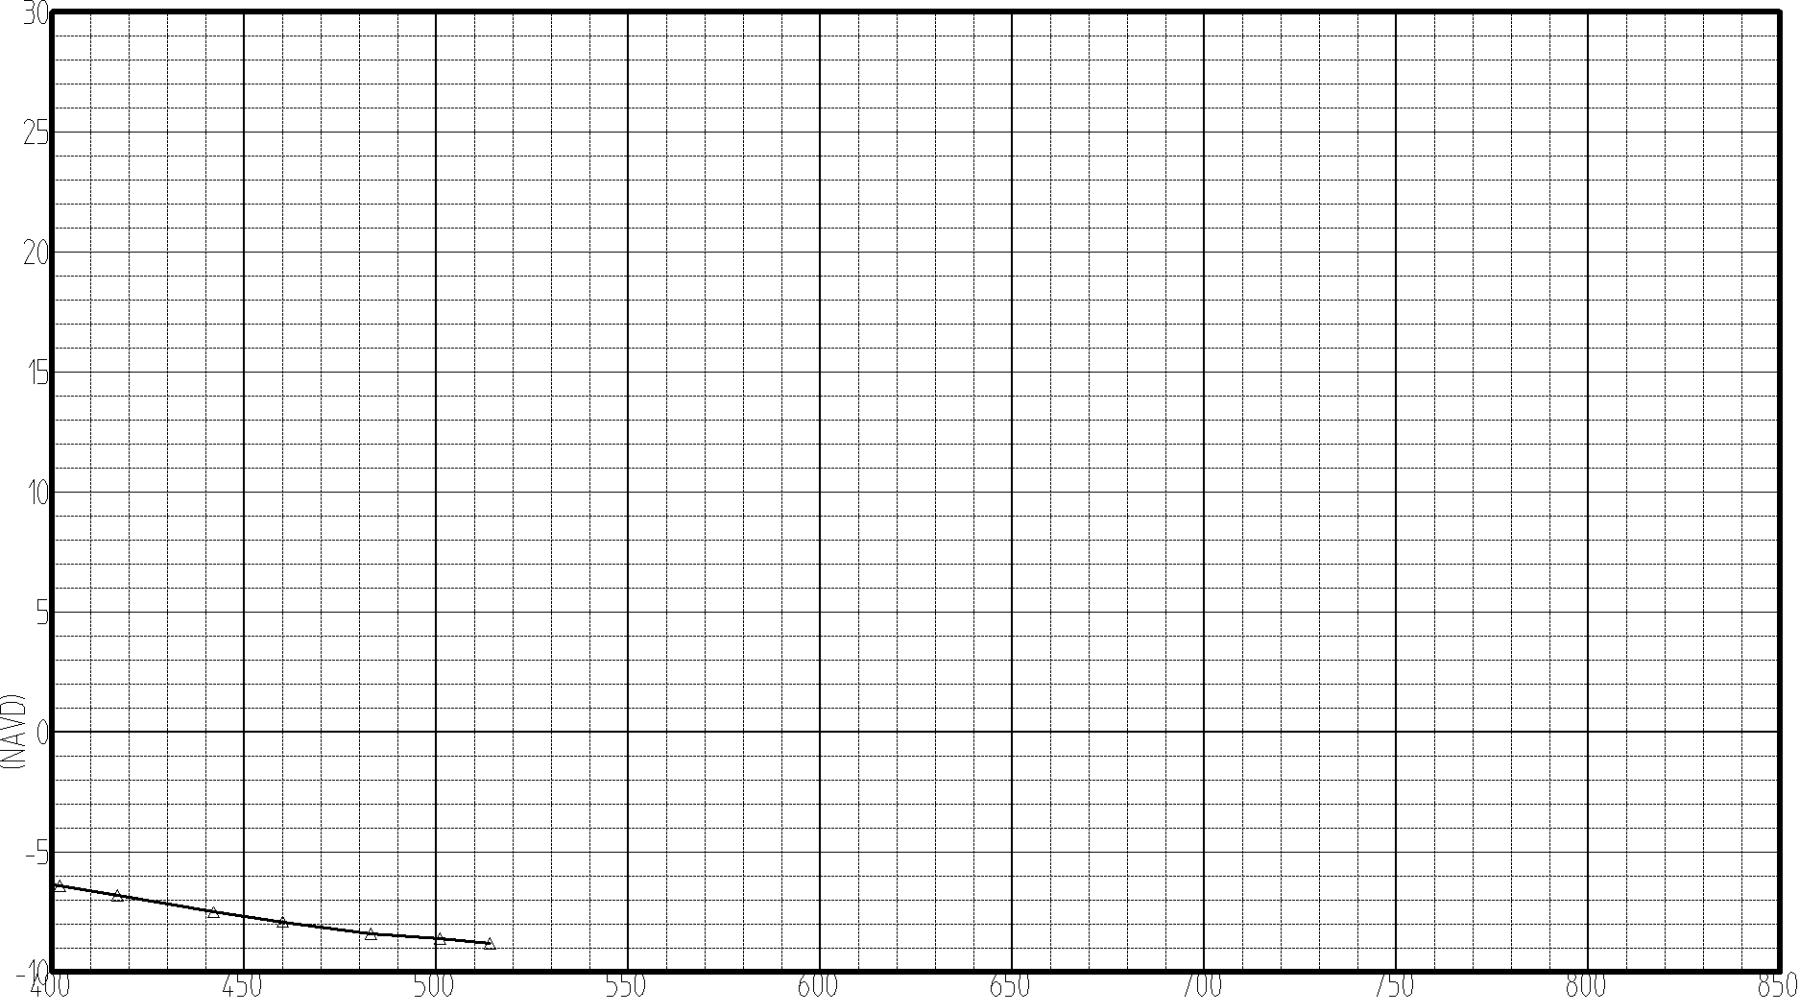
Range: R-106 2/2

BEACH PROFILE

- △—△— 2005-2008 INPUT PRF
- - - * - - - 15-YR SBEACH ERODED PRF
- - - o - - - 25-YR SBEACH ERODED PRF

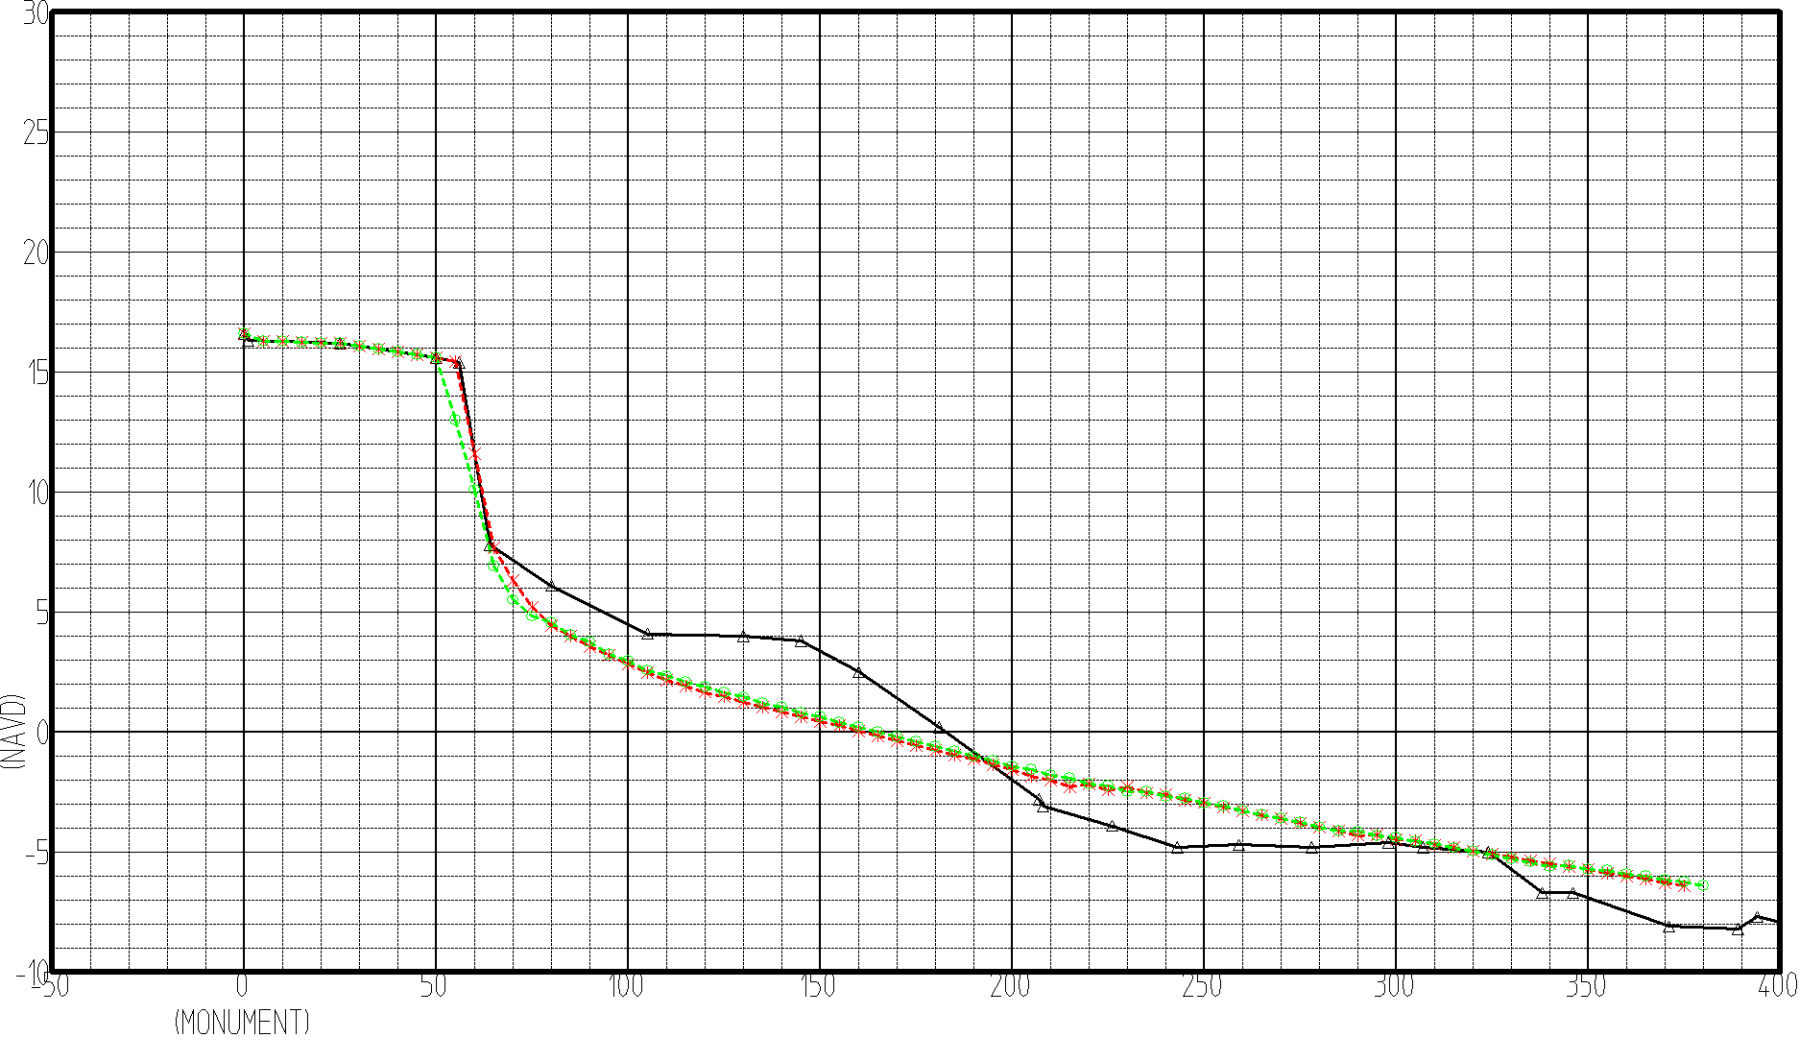
Range: R-107-T

BEACH PROFILE

—△—△— 2005-2008 INPUT PRF

- - - * - - - 15-YR SBEACH ERODED PRF

- - - o - - - 25-YR SBEACH ERODED PRF

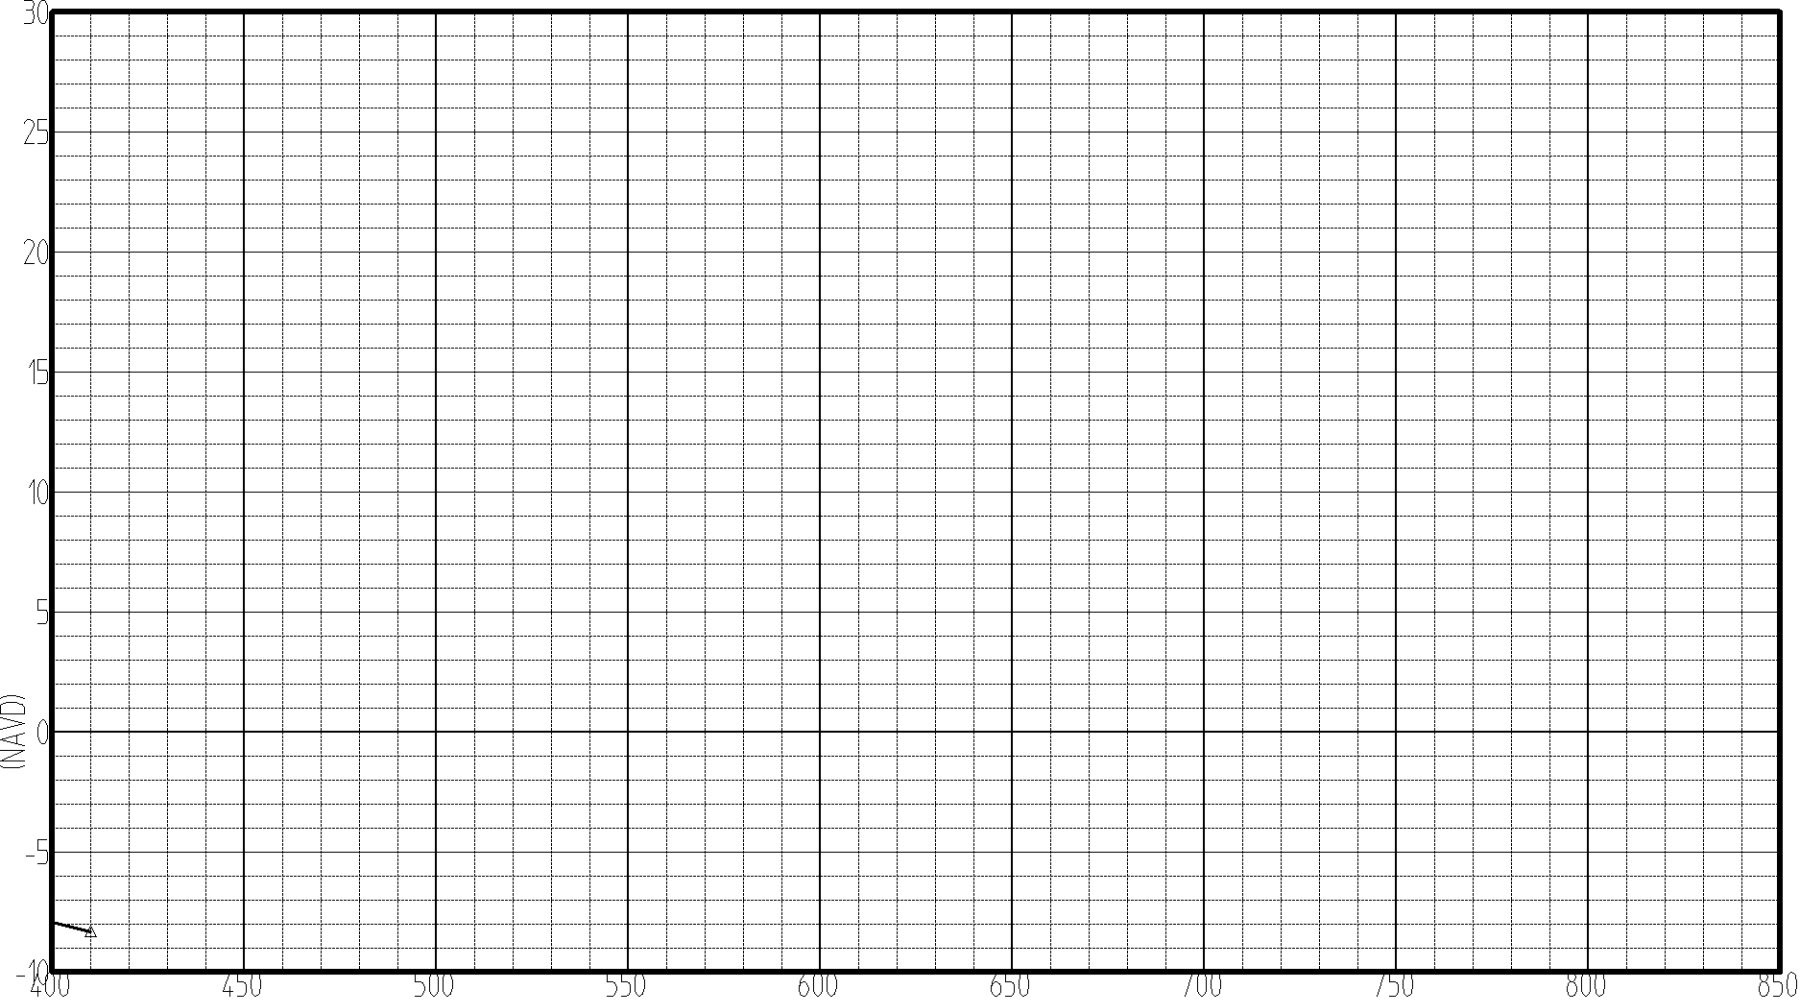
Range: R-107-T 2/2

BEACH PROFILE

- △—△— 2005-2008 INPUT PRF
- - - * - - - 15-YR SBEACH ERODED PRF
- - - o - - - 25-YR SBEACH ERODED PRF

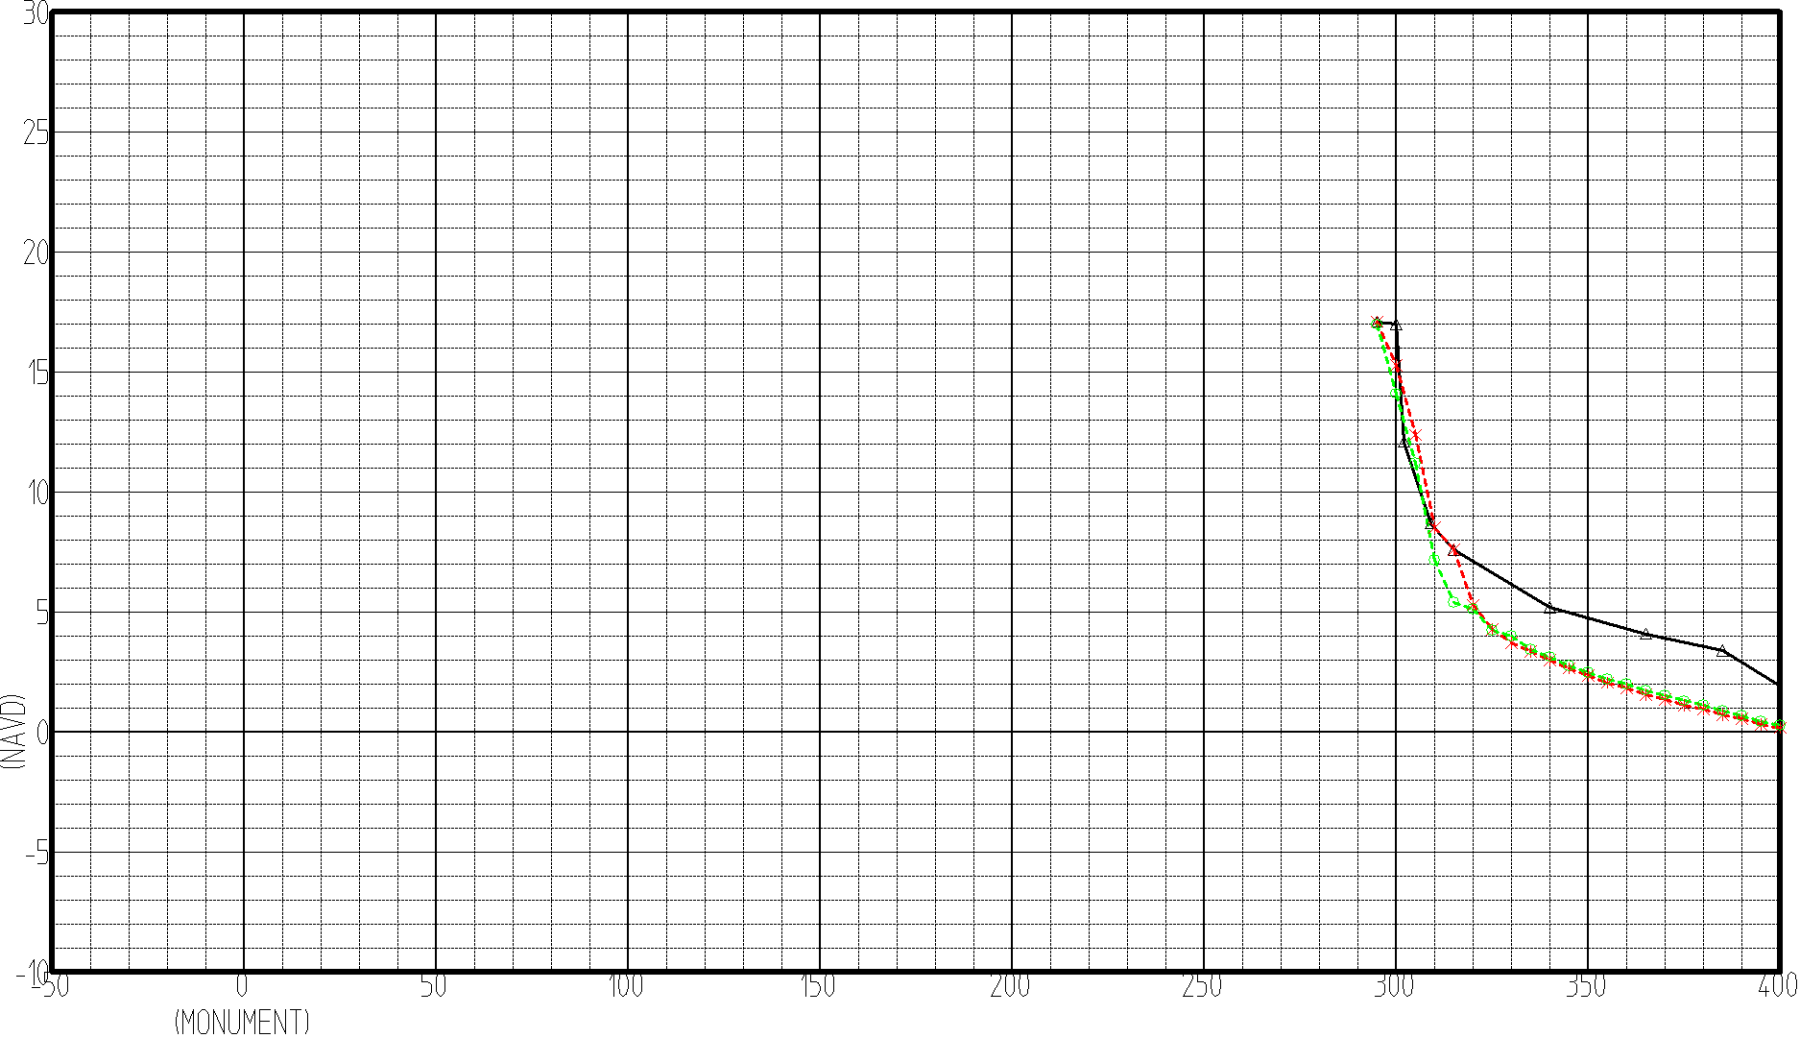
Range: R-108 1/2

BEACH PROFILE

- △—△— 2005-2008 INPUT PRF
- - - * - - - 15-YR SBEACH ERODED PRF
- - - o - - - 25-YR SBEACH ERODED PRF

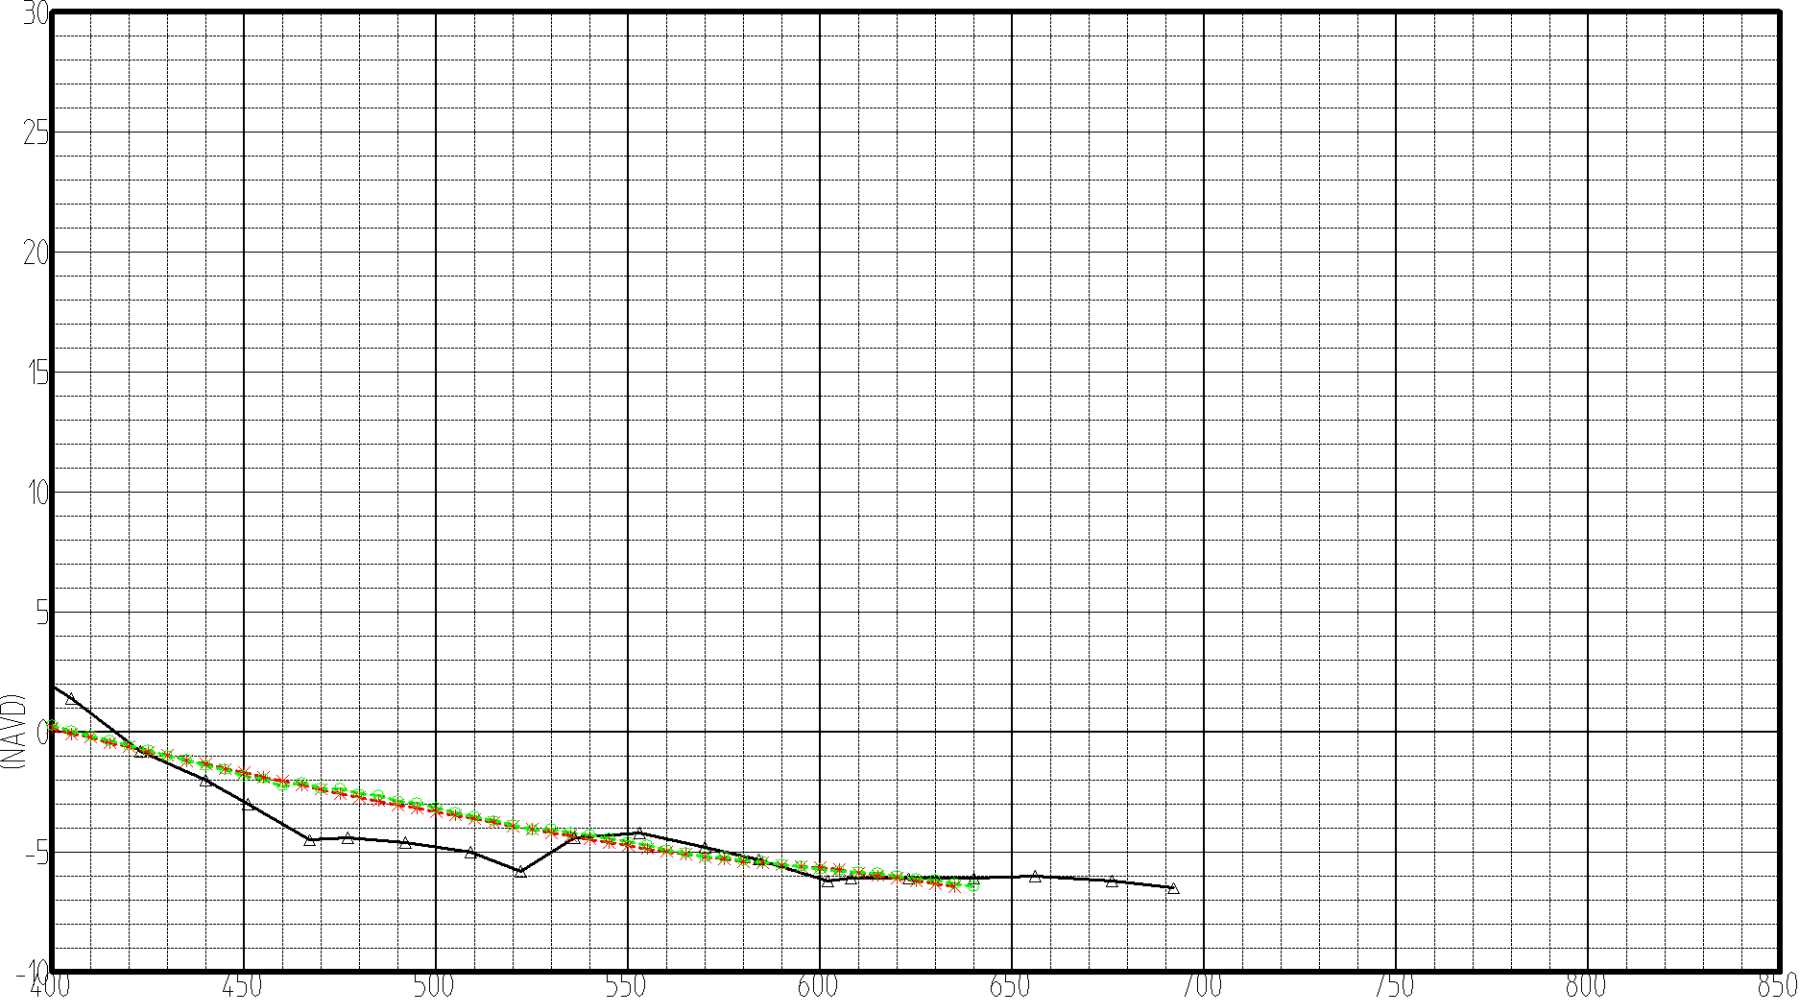
Range: R-108

BEACH PROFILE

—△—△— 2005-2008 INPUT PRF

- - - * - - - 15-YR SBEACH ERODED PRF

- - - o - - - 25-YR SBEACH ERODED PRF

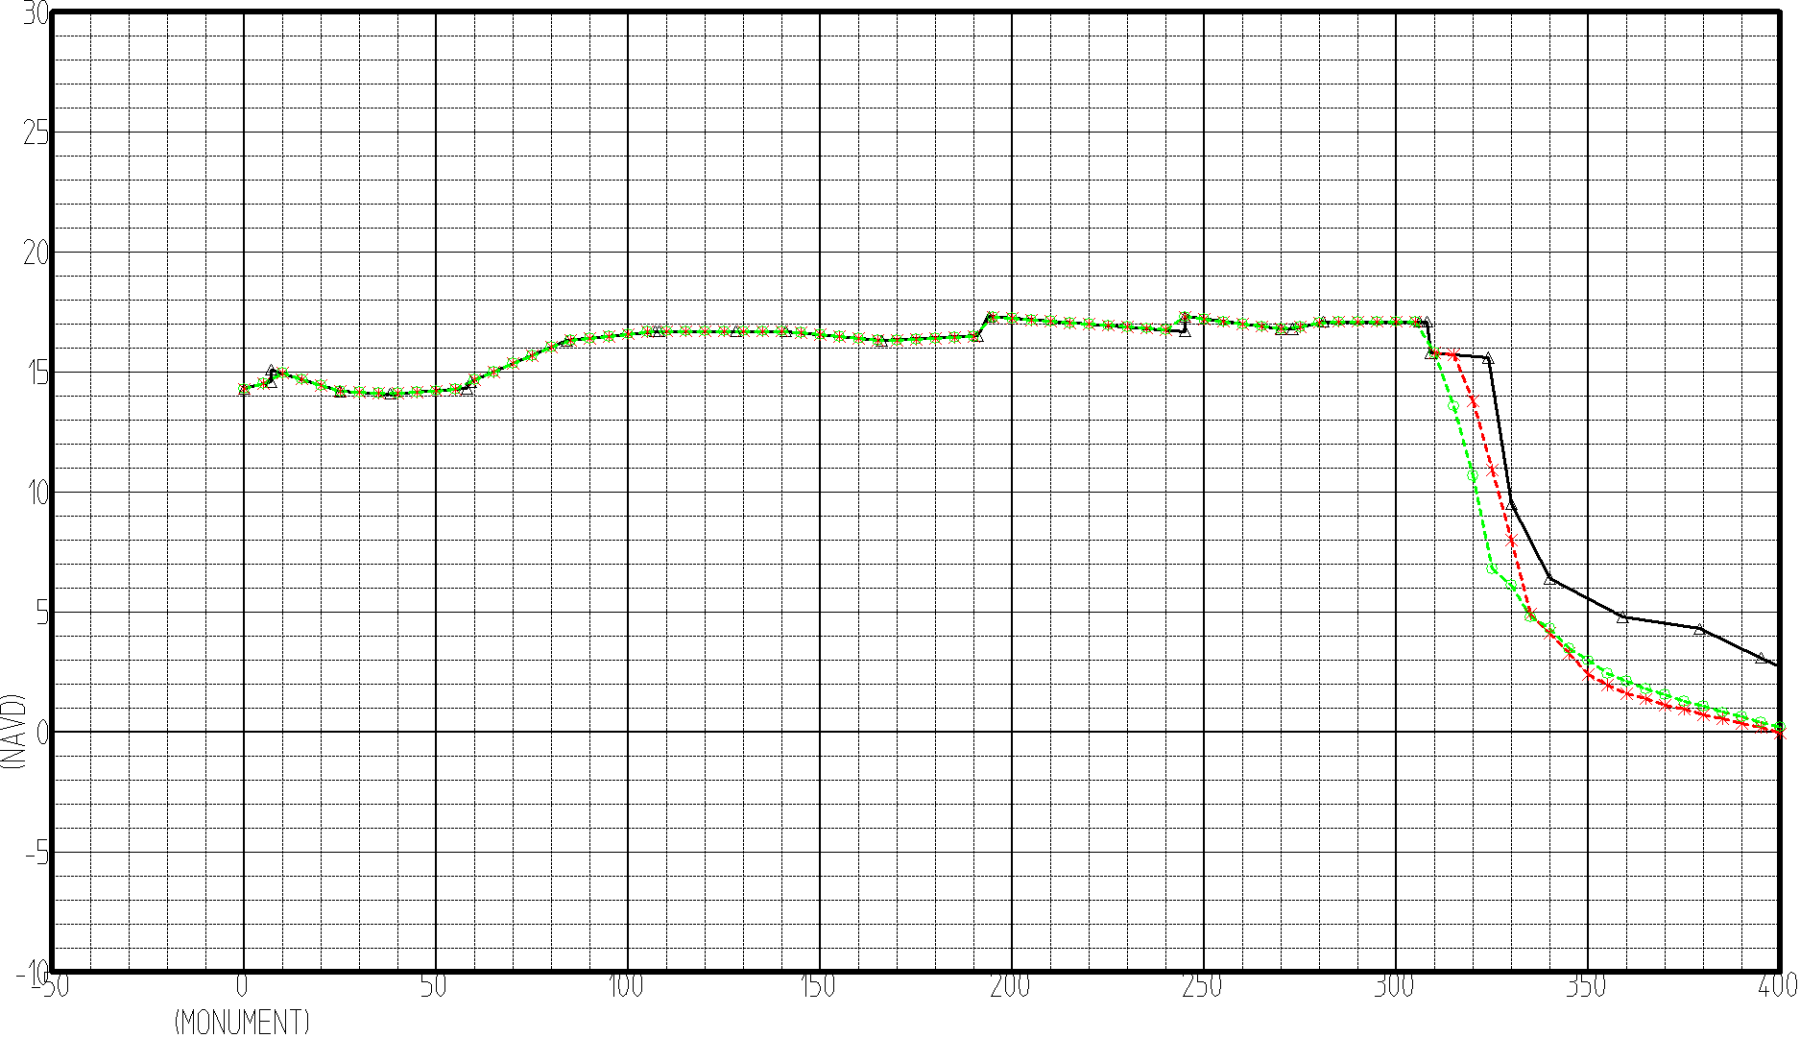
Range: R-109-T 1/2

BEACH PROFILE

- △—△— 2005-2008 INPUT PRF
- - * - - * - - 15-YR SBEACH ERODED PRF
- - o - - o - - 25-YR SBEACH ERODED PRF
