Appendix XI

SBEACH 15 and 25 yr. Storm Erosion Profiles

Brevard County

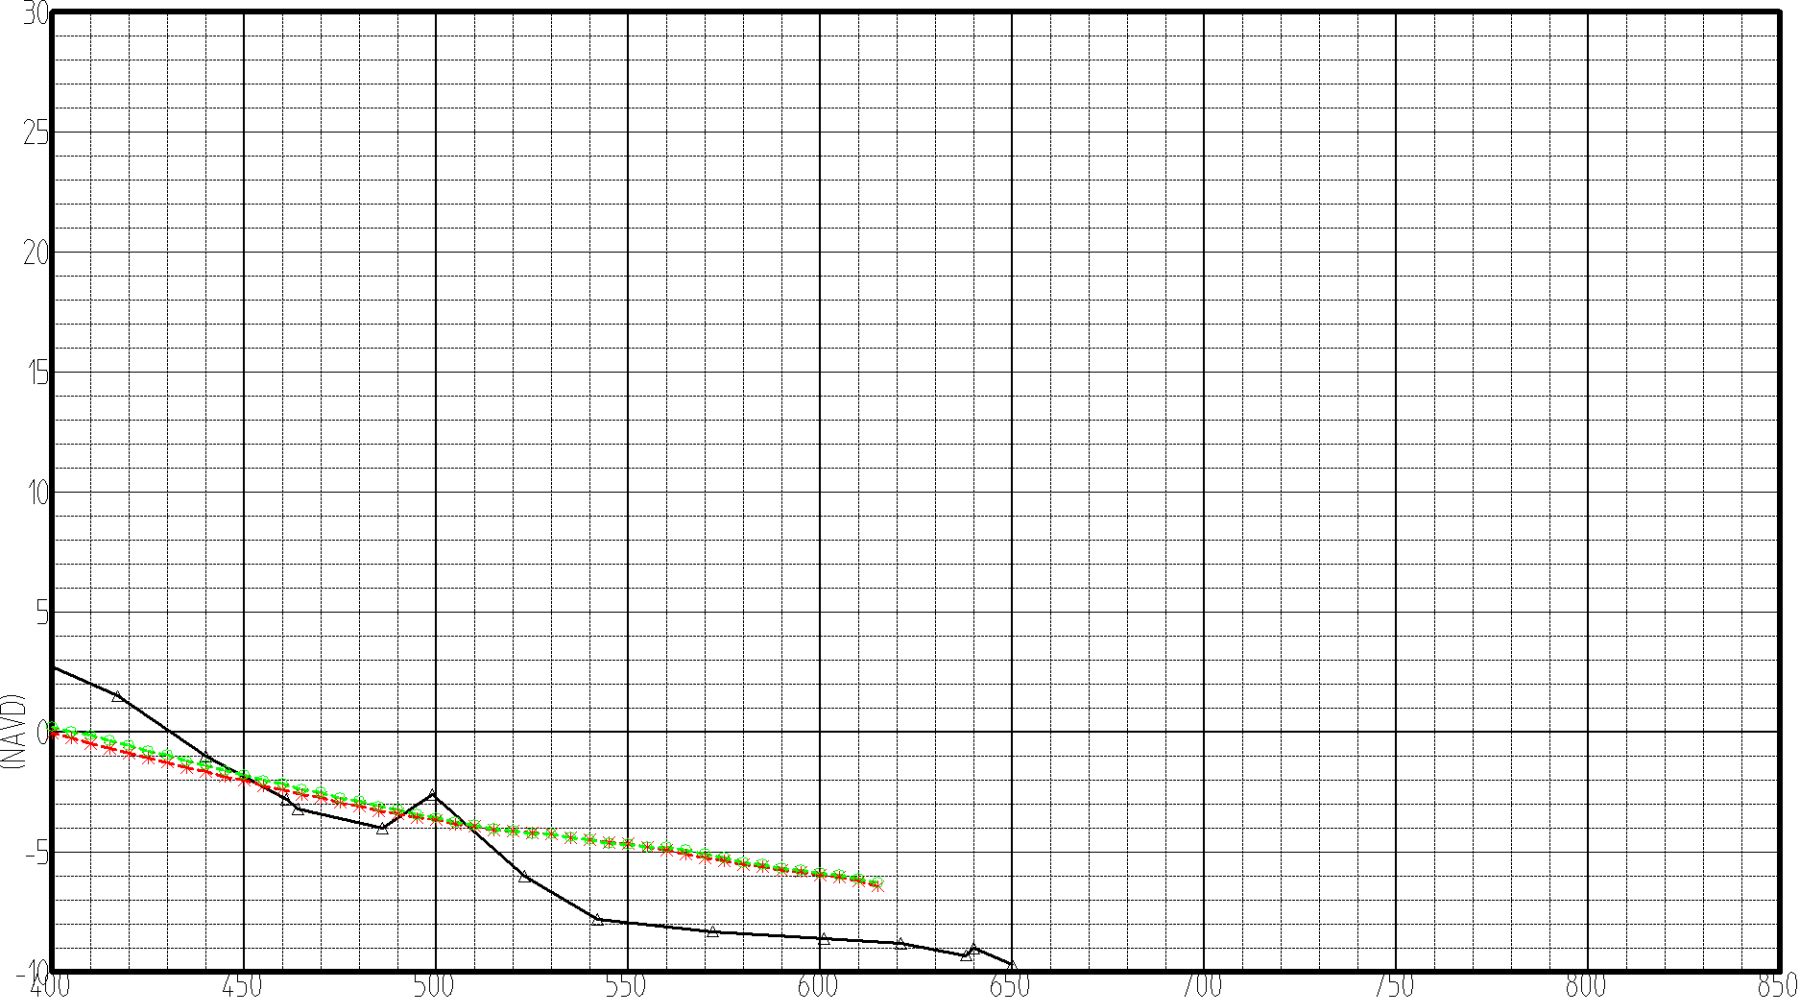
Range: R-109-T

BEACH PROFILE

—△—△— 2005-2008 INPUT PRF

- - - * - - - 15-YR SBEACH ERODED PRF

- - - o - - - 25-YR SBEACH ERODED PRF

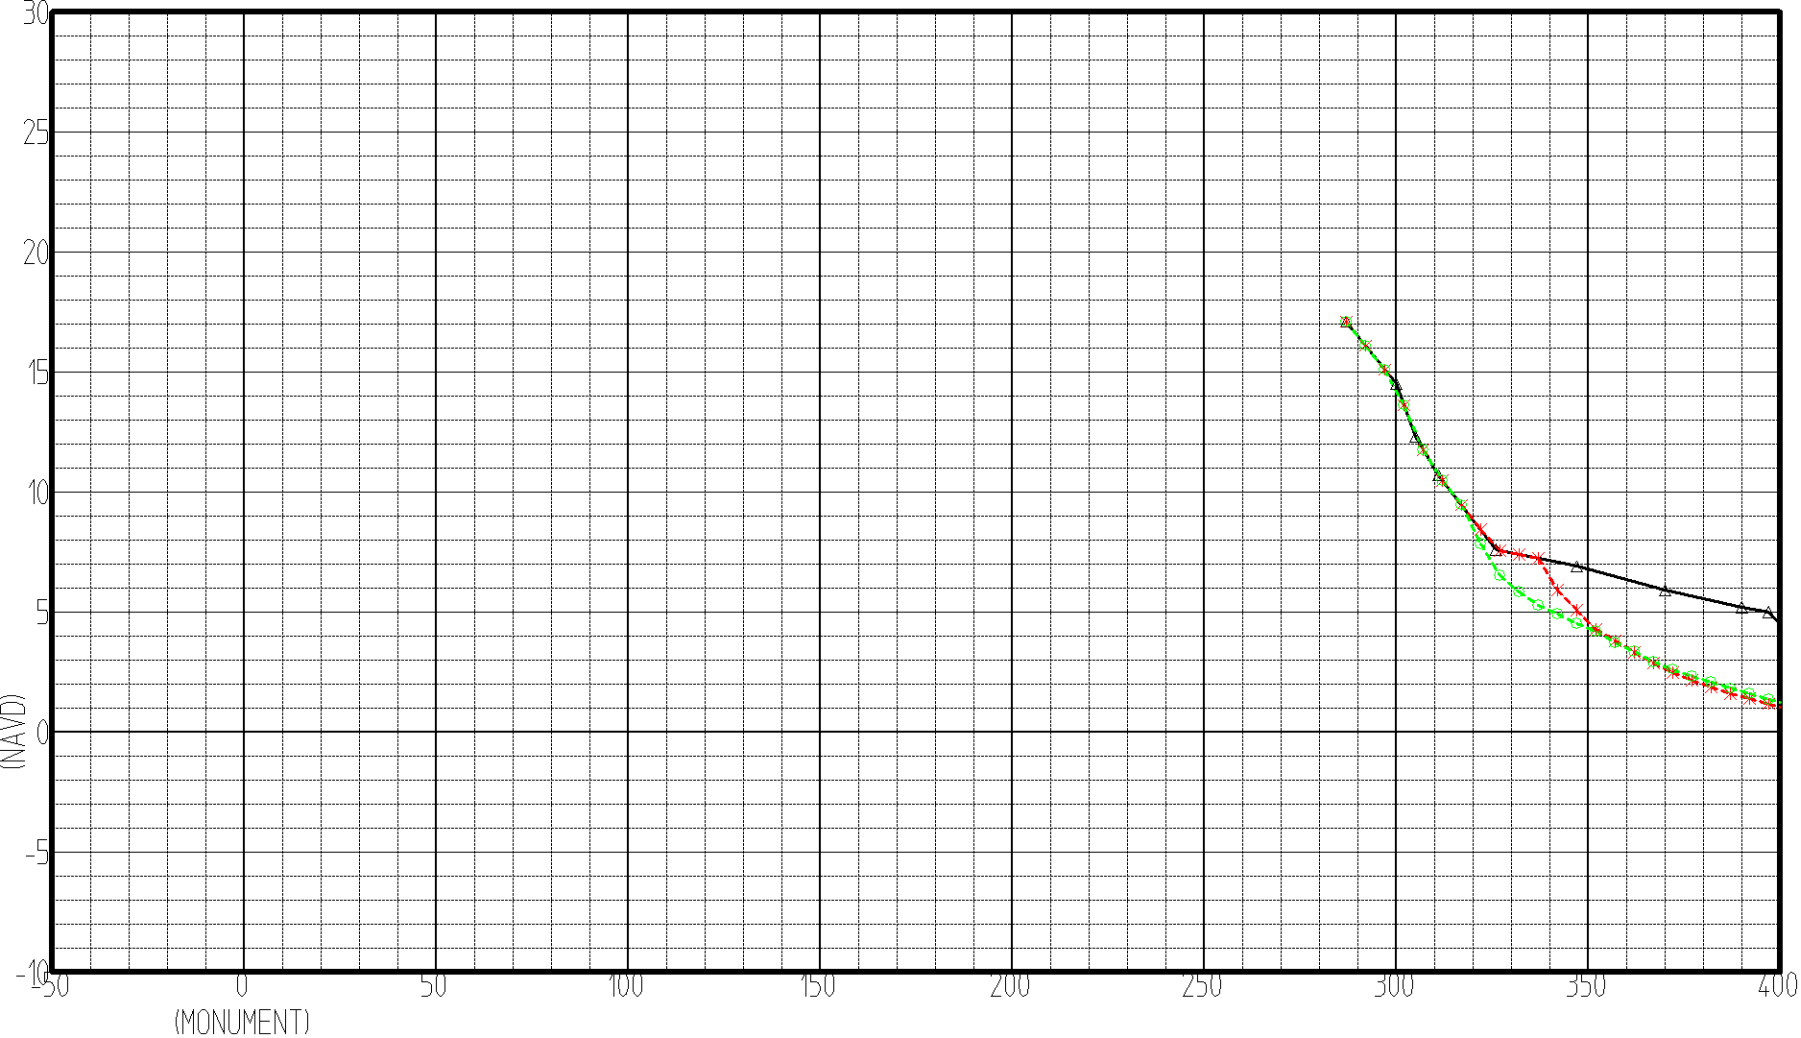
Range: R-110-T
 BEARING: 80.00
 1/2

BEACH PROFILE
 —△—△— 2005-2008 INPUT PRF
 - - * - - * - - 15-YR SBEACH ERODED PRF
 - - o - - o - - 25-YR SBEACH ERODED PRF

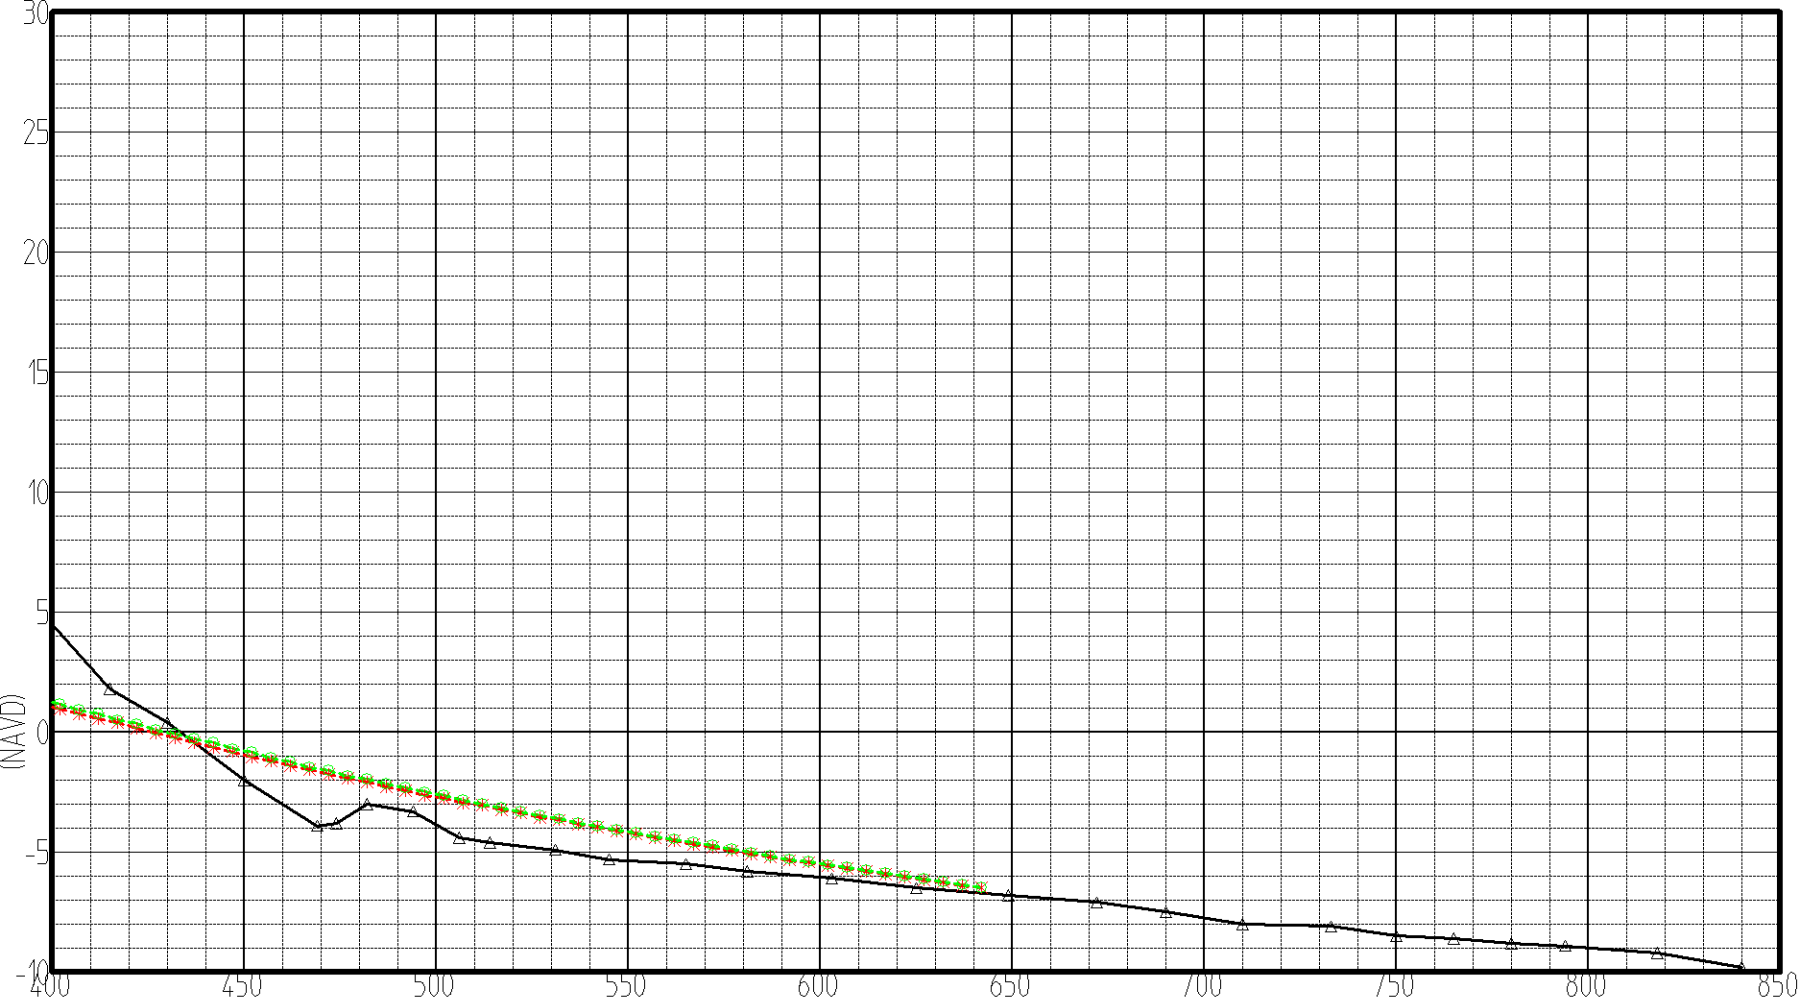
Range: R-110-T 2/2

BEACH PROFILE

—△—△— 2005-2008 INPUT PRF

- - - * - - - 15-YR SBEACH ERODED PRF

- - - o - - - 25-YR SBEACH ERODED PRF

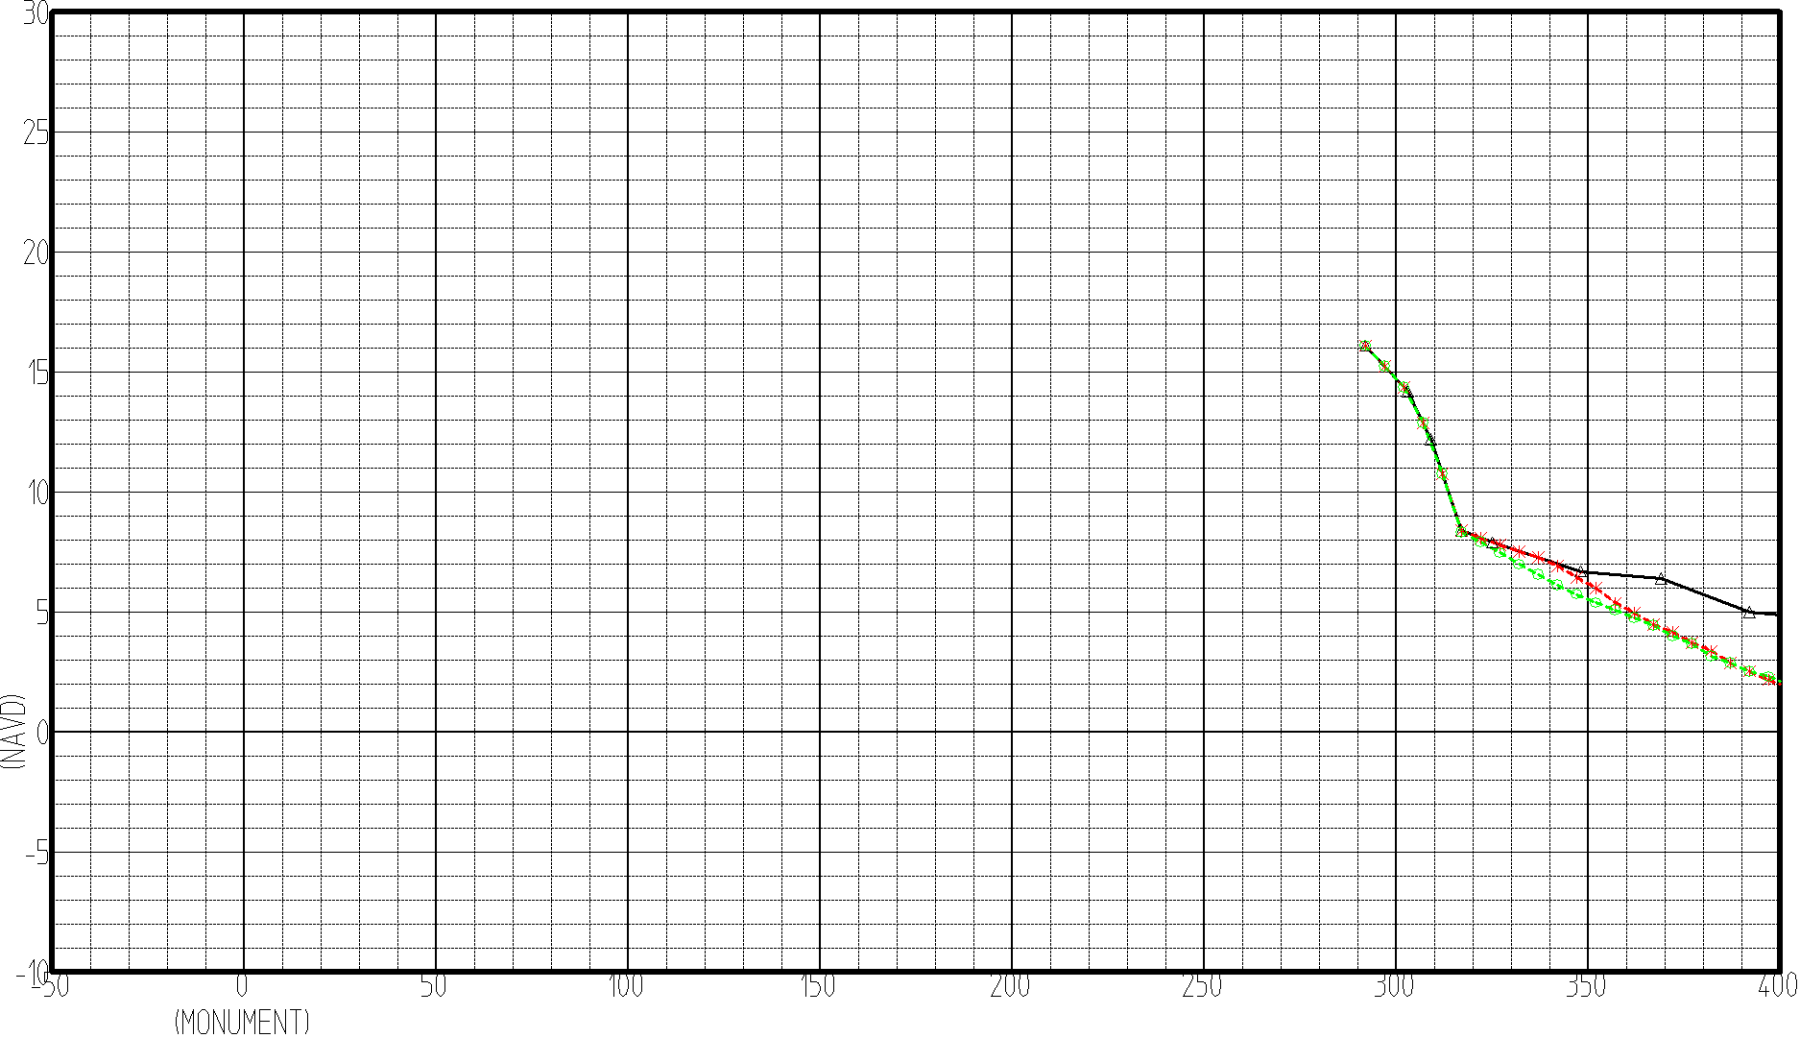
Range: R-111
 BEARING: 80.00
 1/2

BEACH PROFILE
 —△—△— 2005-2008 INPUT PRF
 - - * - - * - - 15-YR SBEACH ERODED PRF
 - - o - - o - - 25-YR SBEACH ERODED PRF

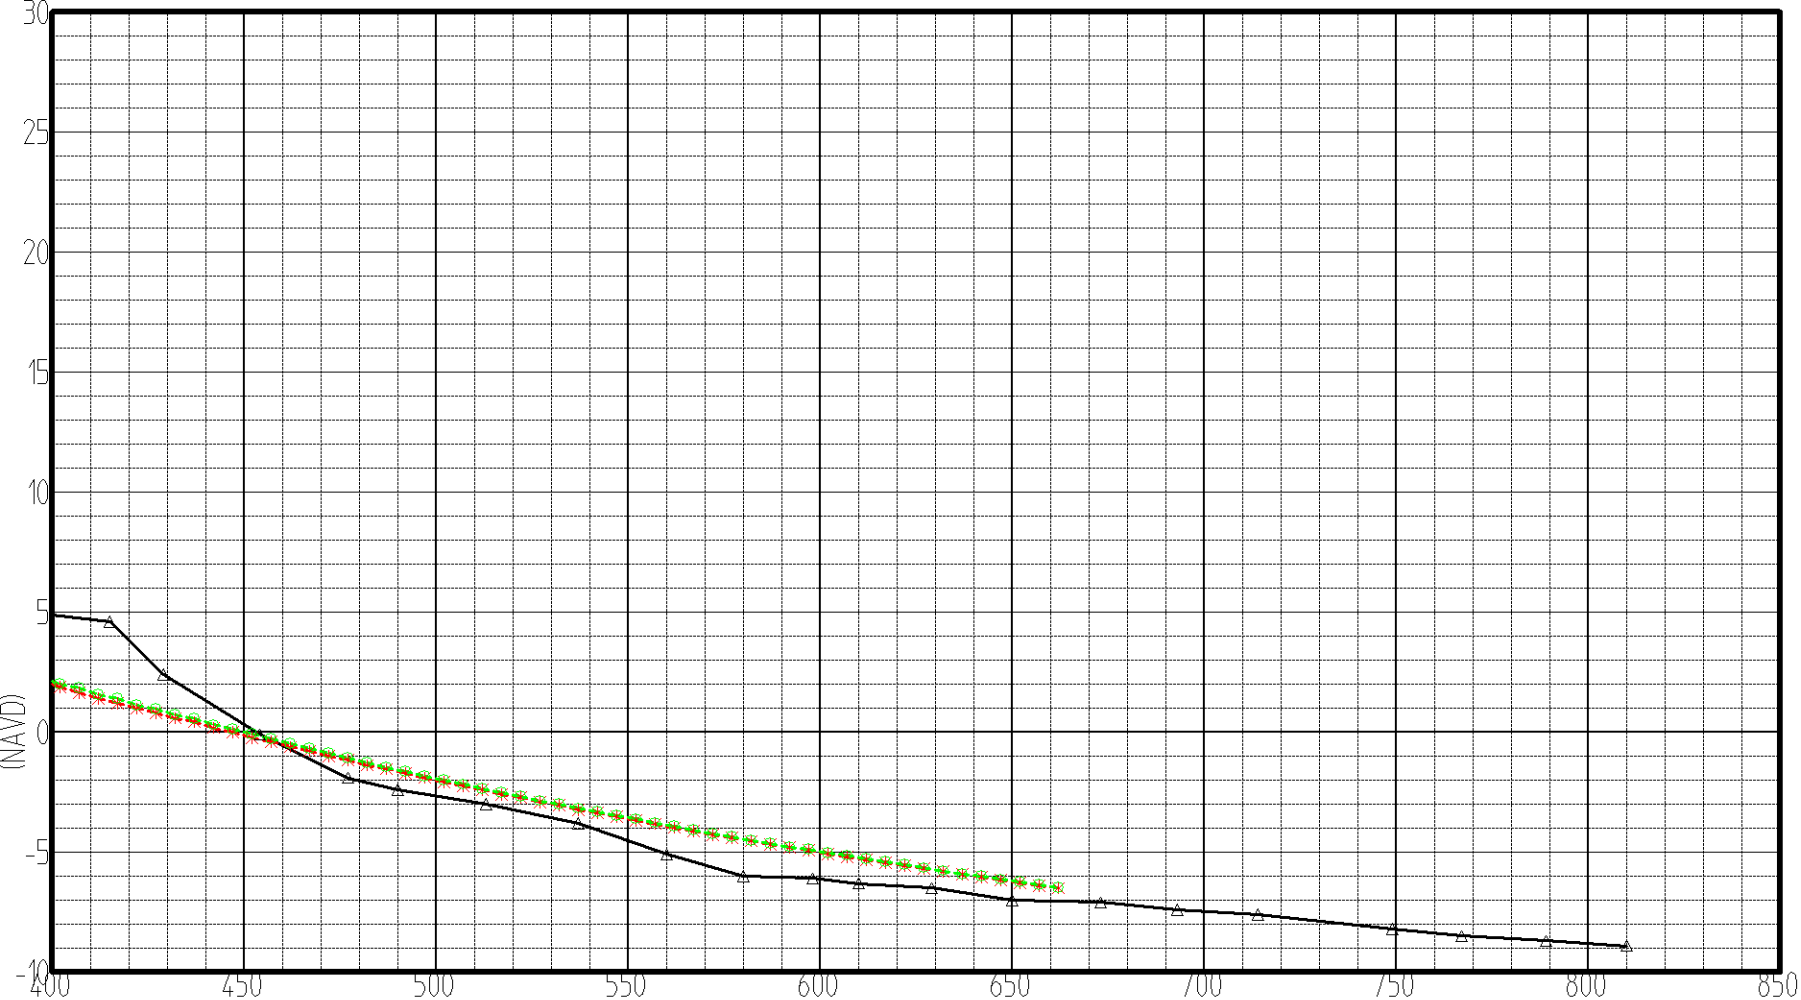
Range: R-111

BEACH PROFILE

—△—△— 2005-2008 INPUT PRF

- - - * - - - 15-YR SBEACH ERODED PRF

- - - o - - - 25-YR SBEACH ERODED PRF

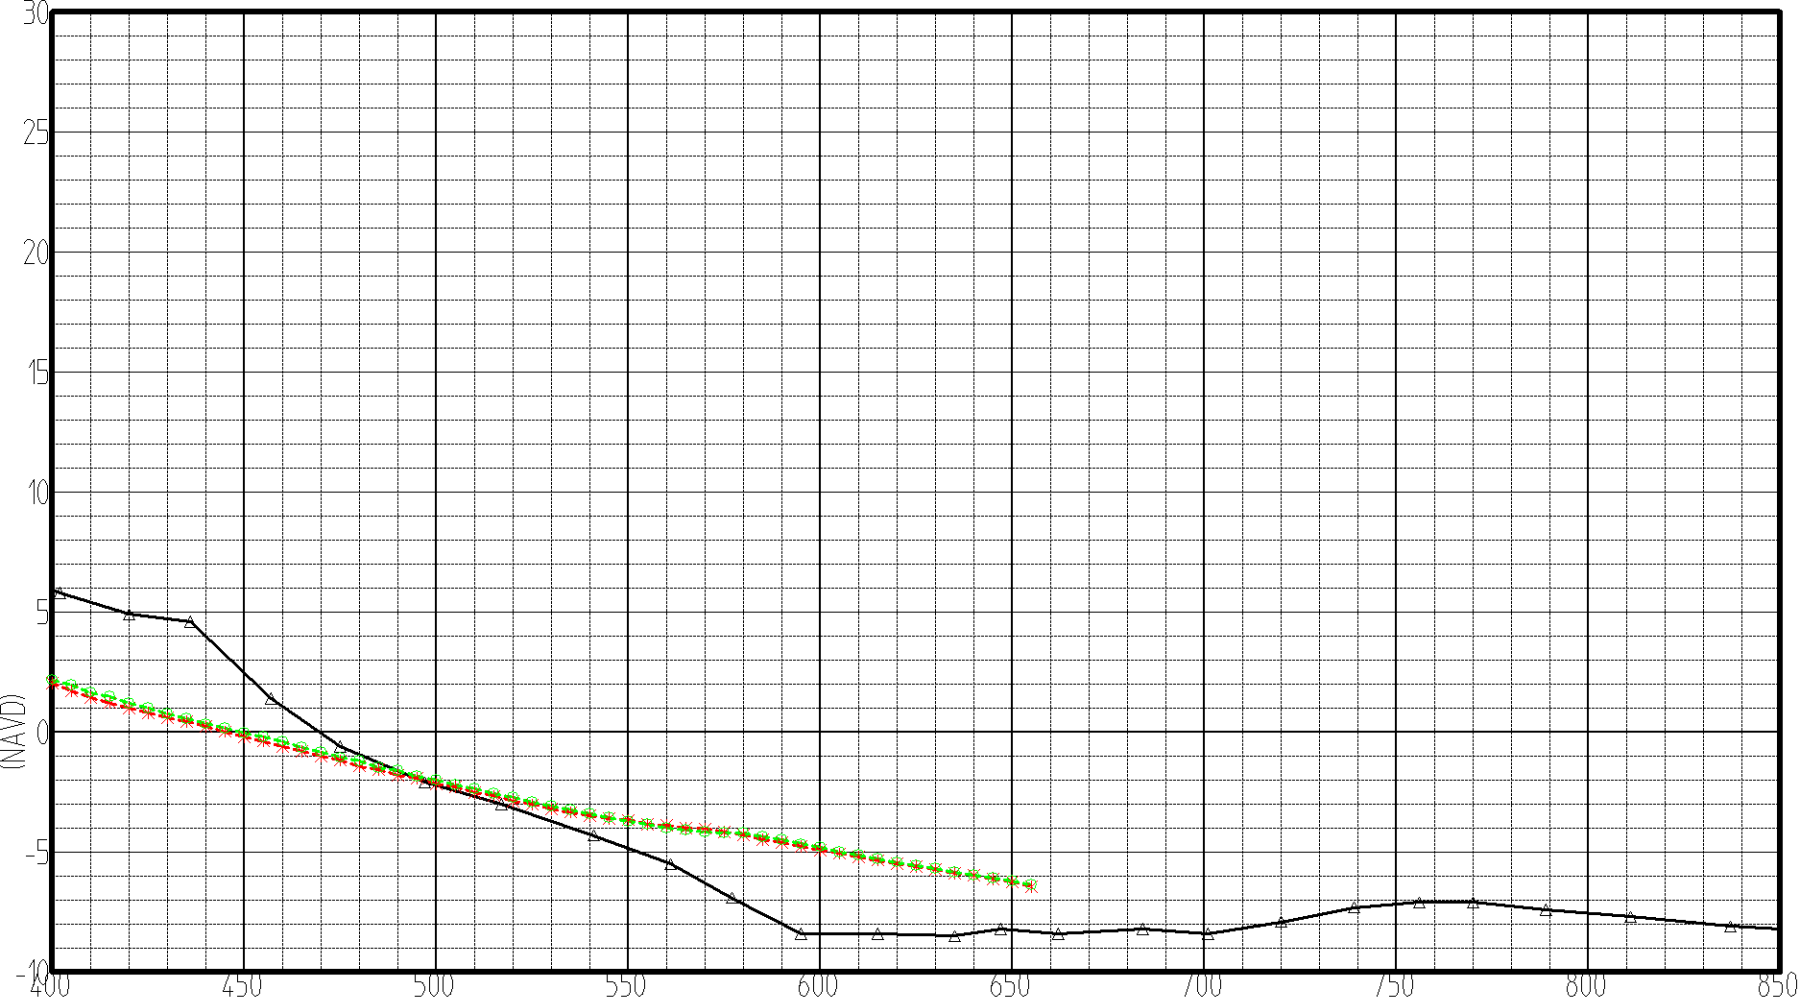
Range: R-112 2/3
 BEARING: 80.00

BEACH PROFILE
 —△—△— 2005-2008 INPUT PRF
 - - * - - * - - 15-YR SBEACH ERODED PRF
 - - o - - o - - 25-YR SBEACH ERODED PRF

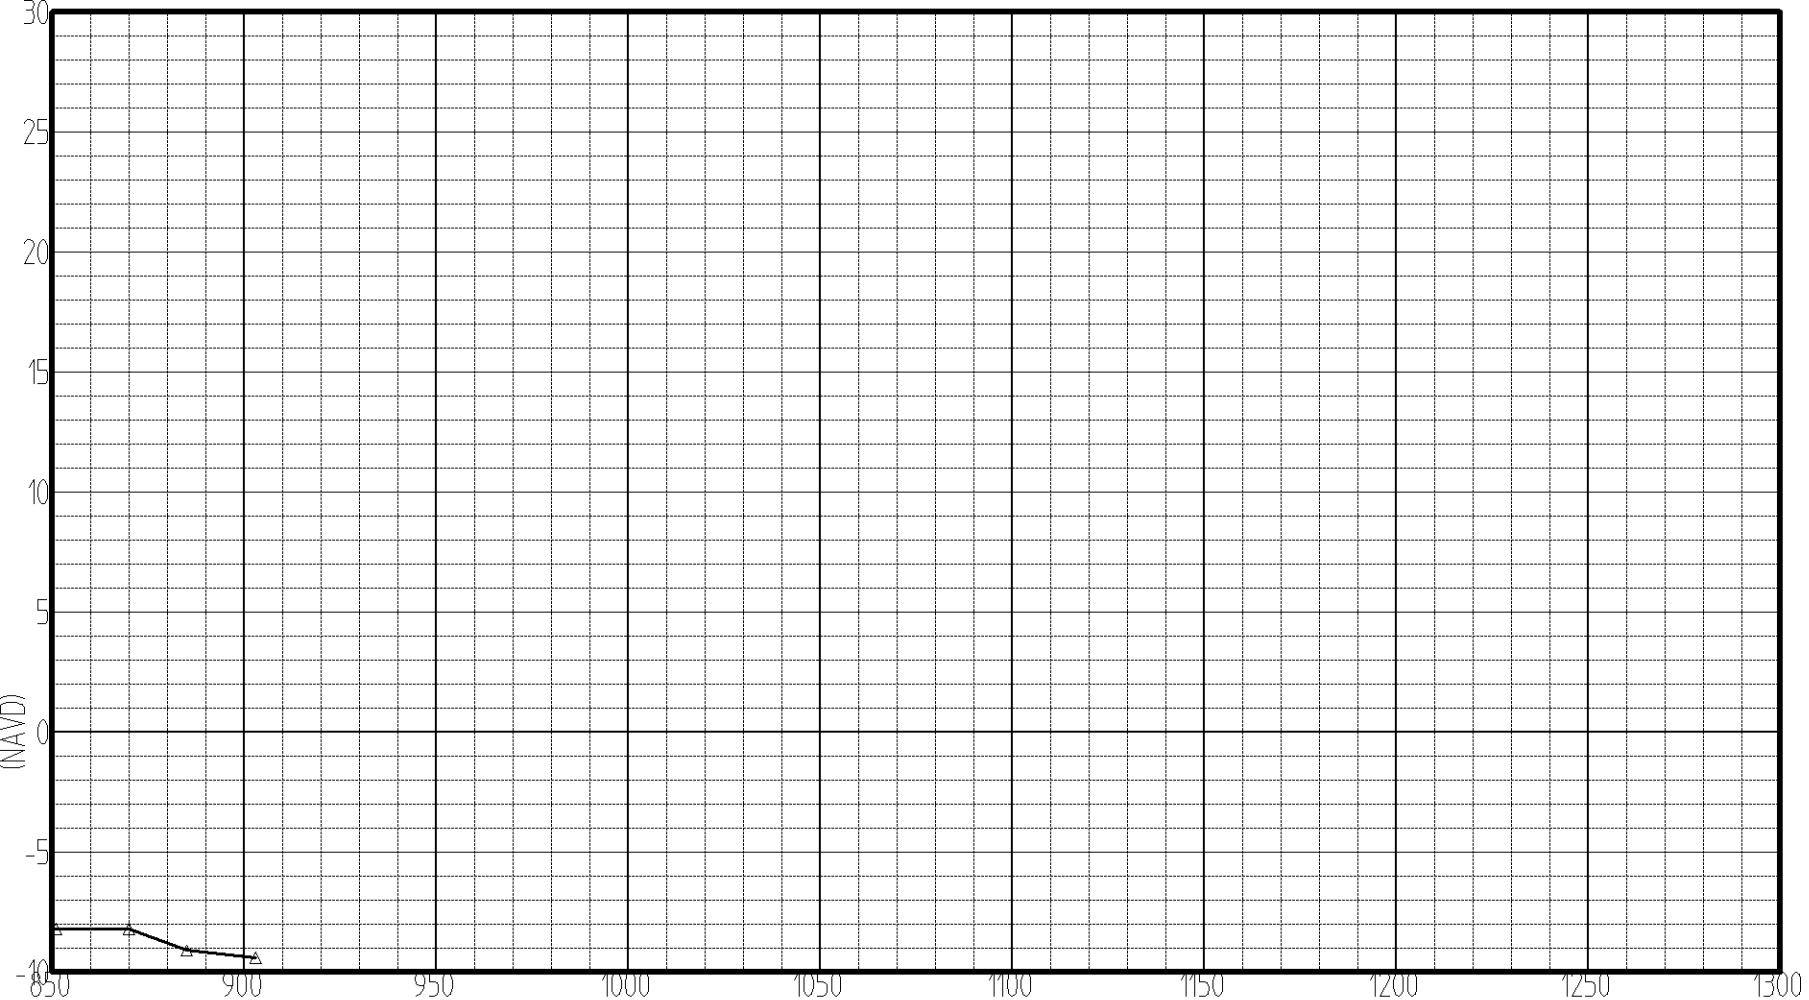
Range: R-112 3/3

- △—△— 2005-2008 INPUT PRF
- - - * - - - 15-YR SBEACH ERODED PRF
- - - o - - - 25-YR SBEACH ERODED PRF

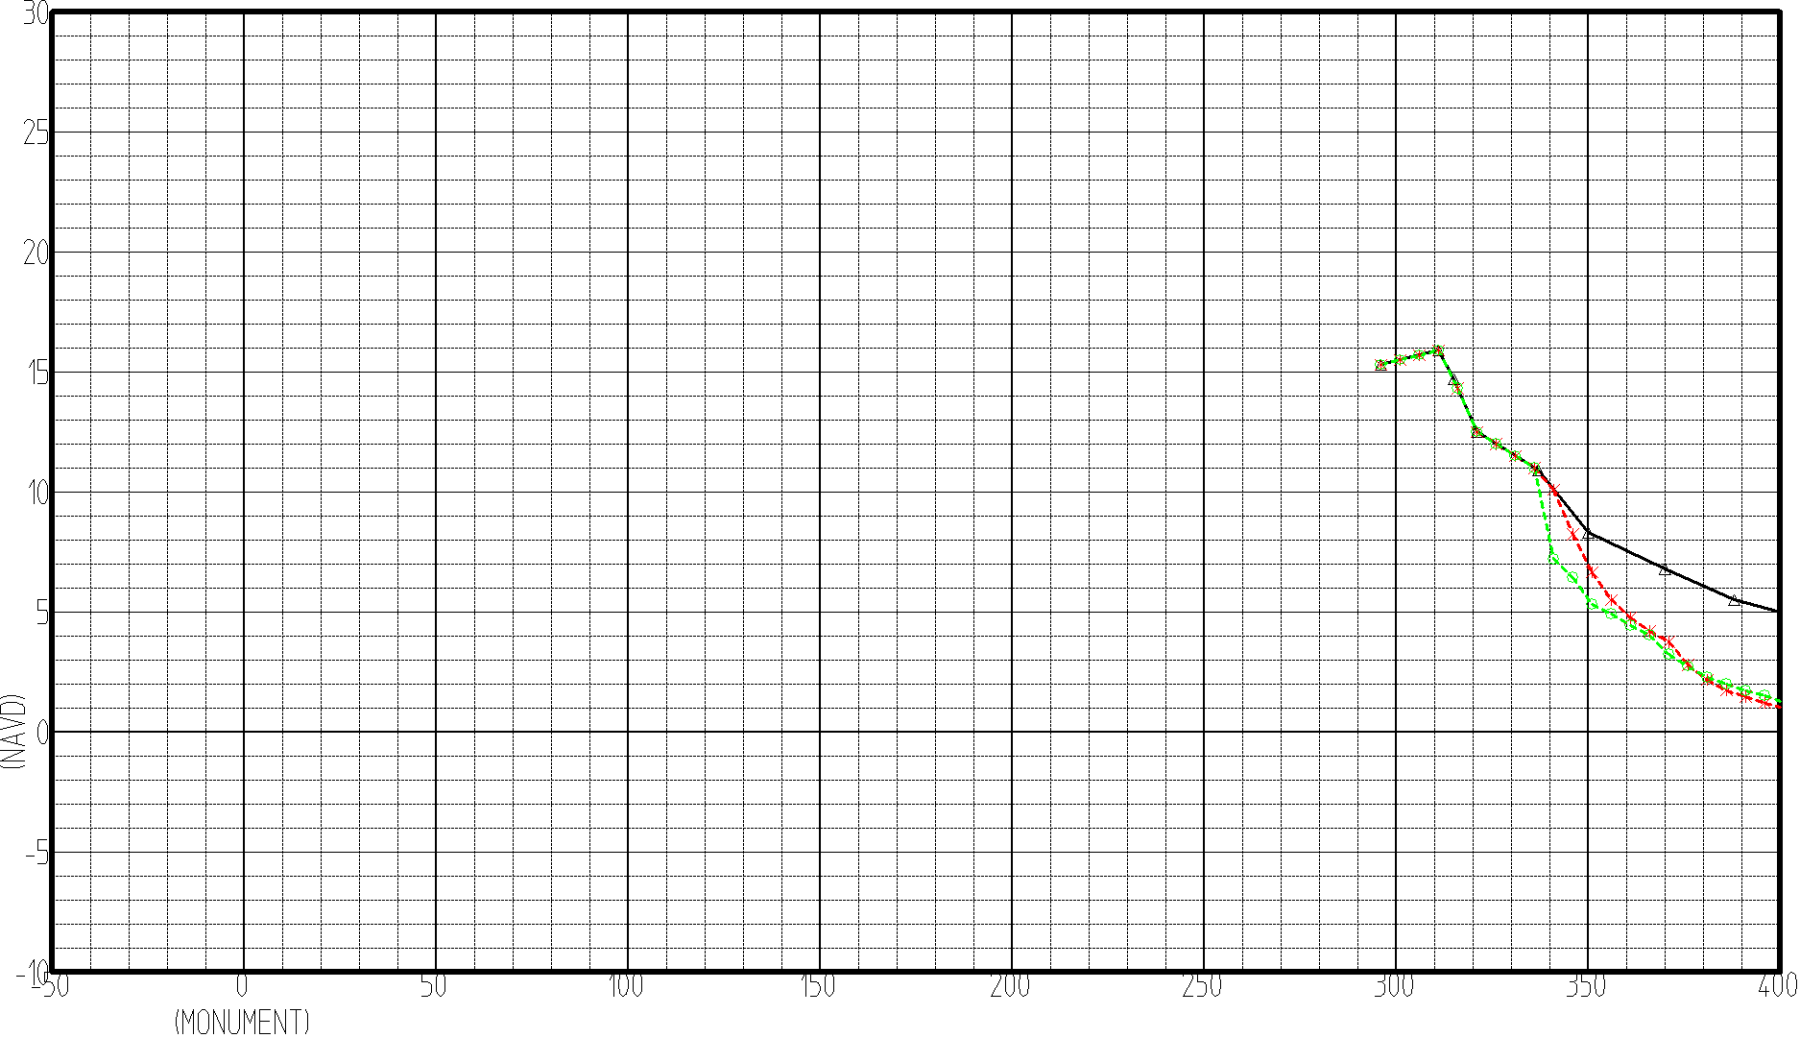
Range: R-113-T 1/2
 BEARING: 80.00

BEACH PROFILE
 —△—△— 2005-2008 INPUT PRF
 - - * - - * - - 15-YR SBEACH ERODED PRF
 - - o - - o - - 25-YR SBEACH ERODED PRF

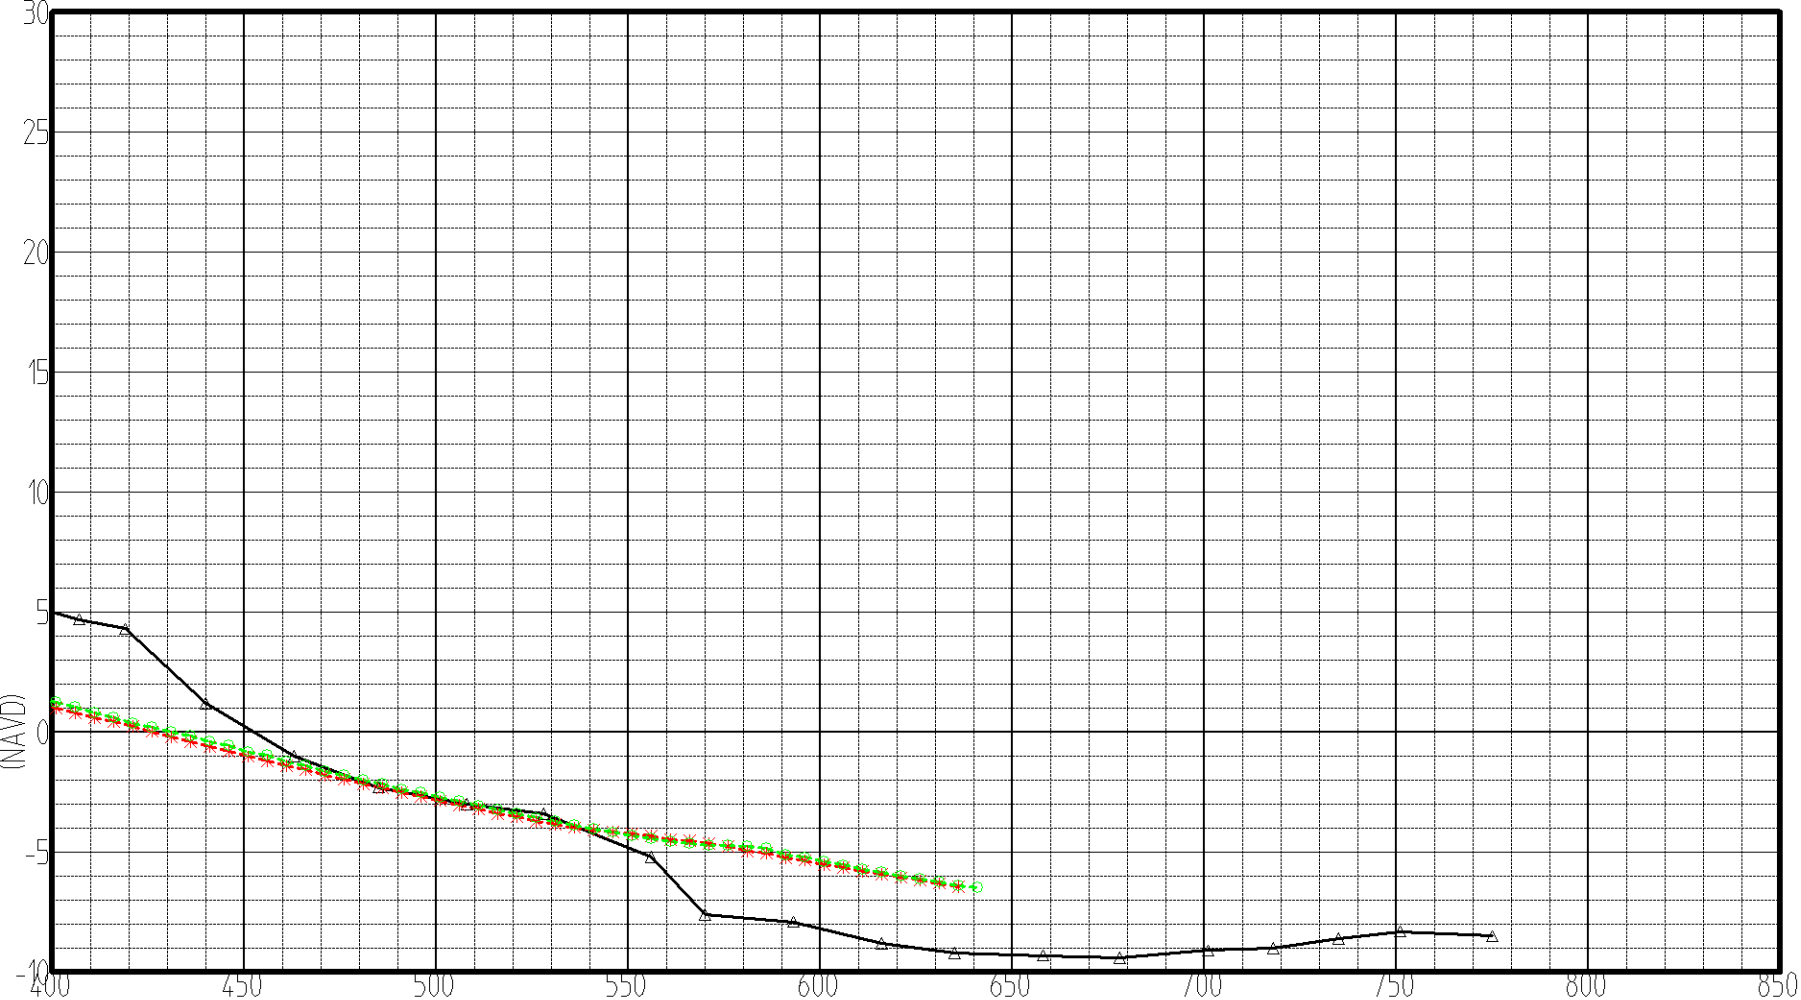
Range: R-113-T

—△—△— 2005-2008 INPUT PRF

- - - * - - - 15-YR SBEACH ERODED PRF

- - - o - - - 25-YR SBEACH ERODED PRF

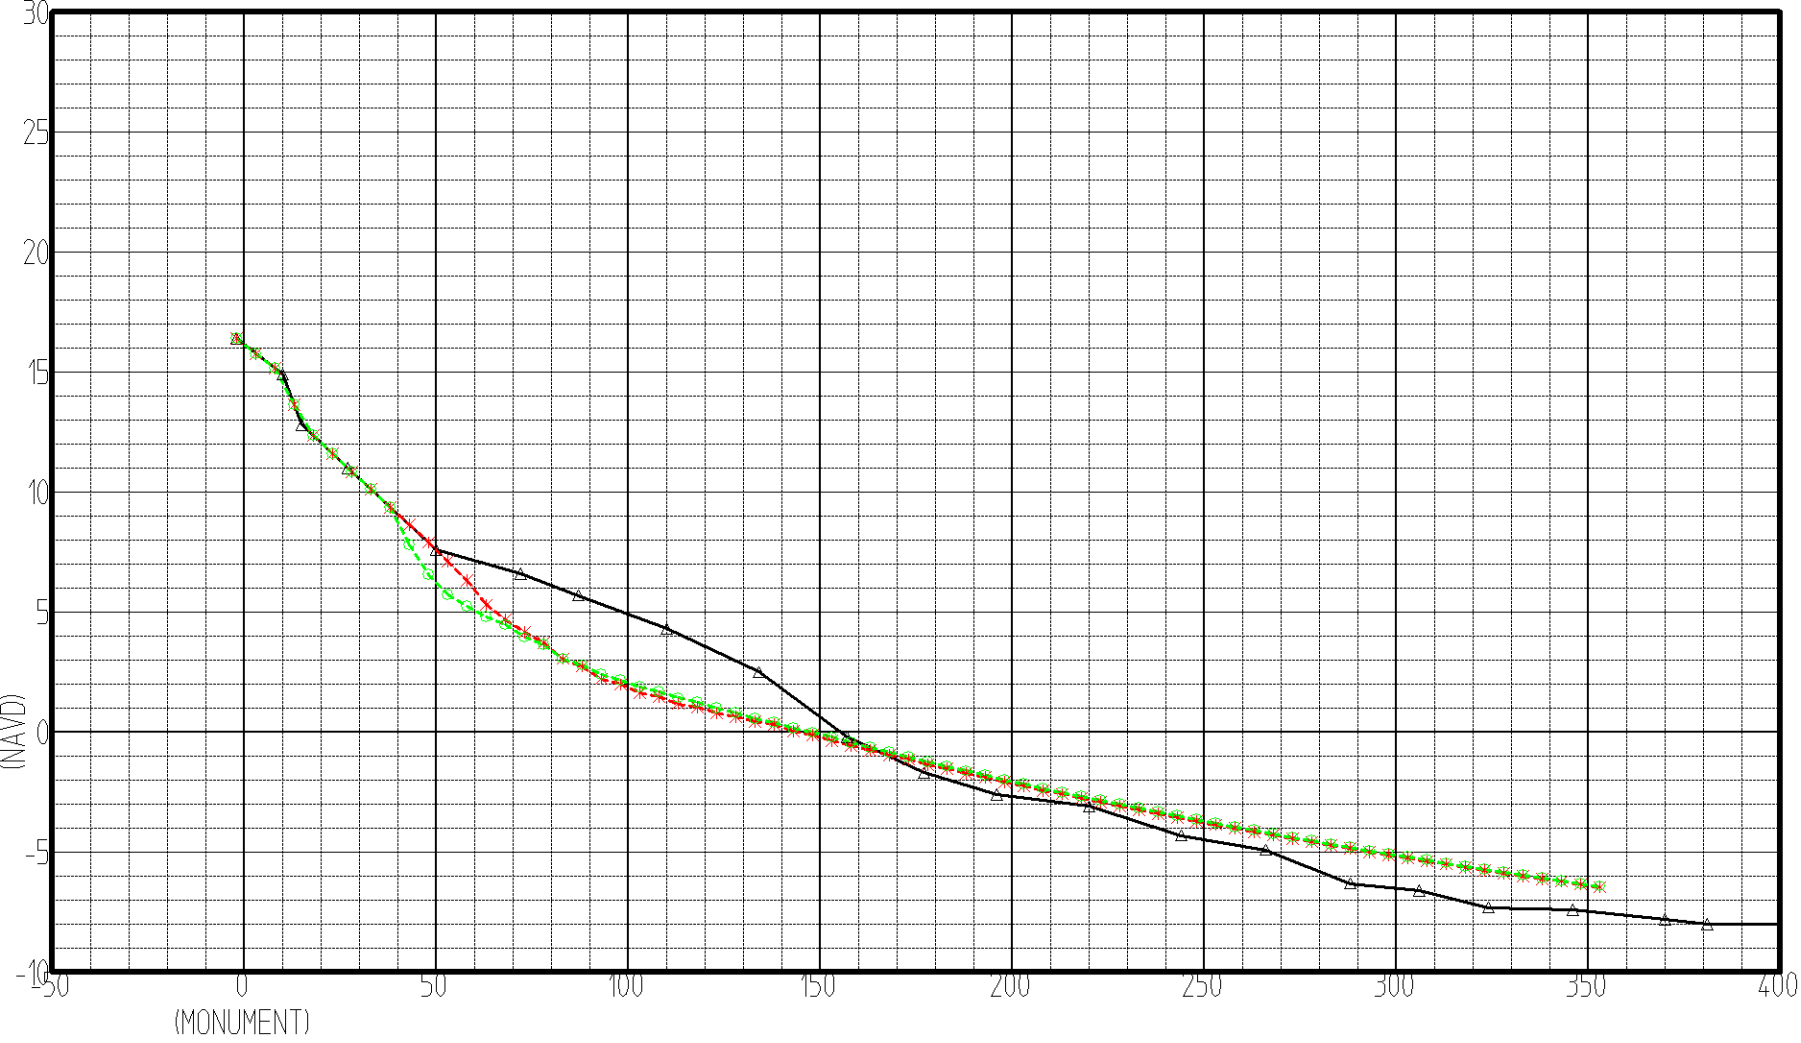
Range: R-114
 BEARING: 80.00
 1/2

BEACH PROFILE
 —△—△— 2005-2008 INPUT PRF
 - - * - - * - - 15-YR SBEACH ERODED PRF
 - - o - - o - - 25-YR SBEACH ERODED PRF

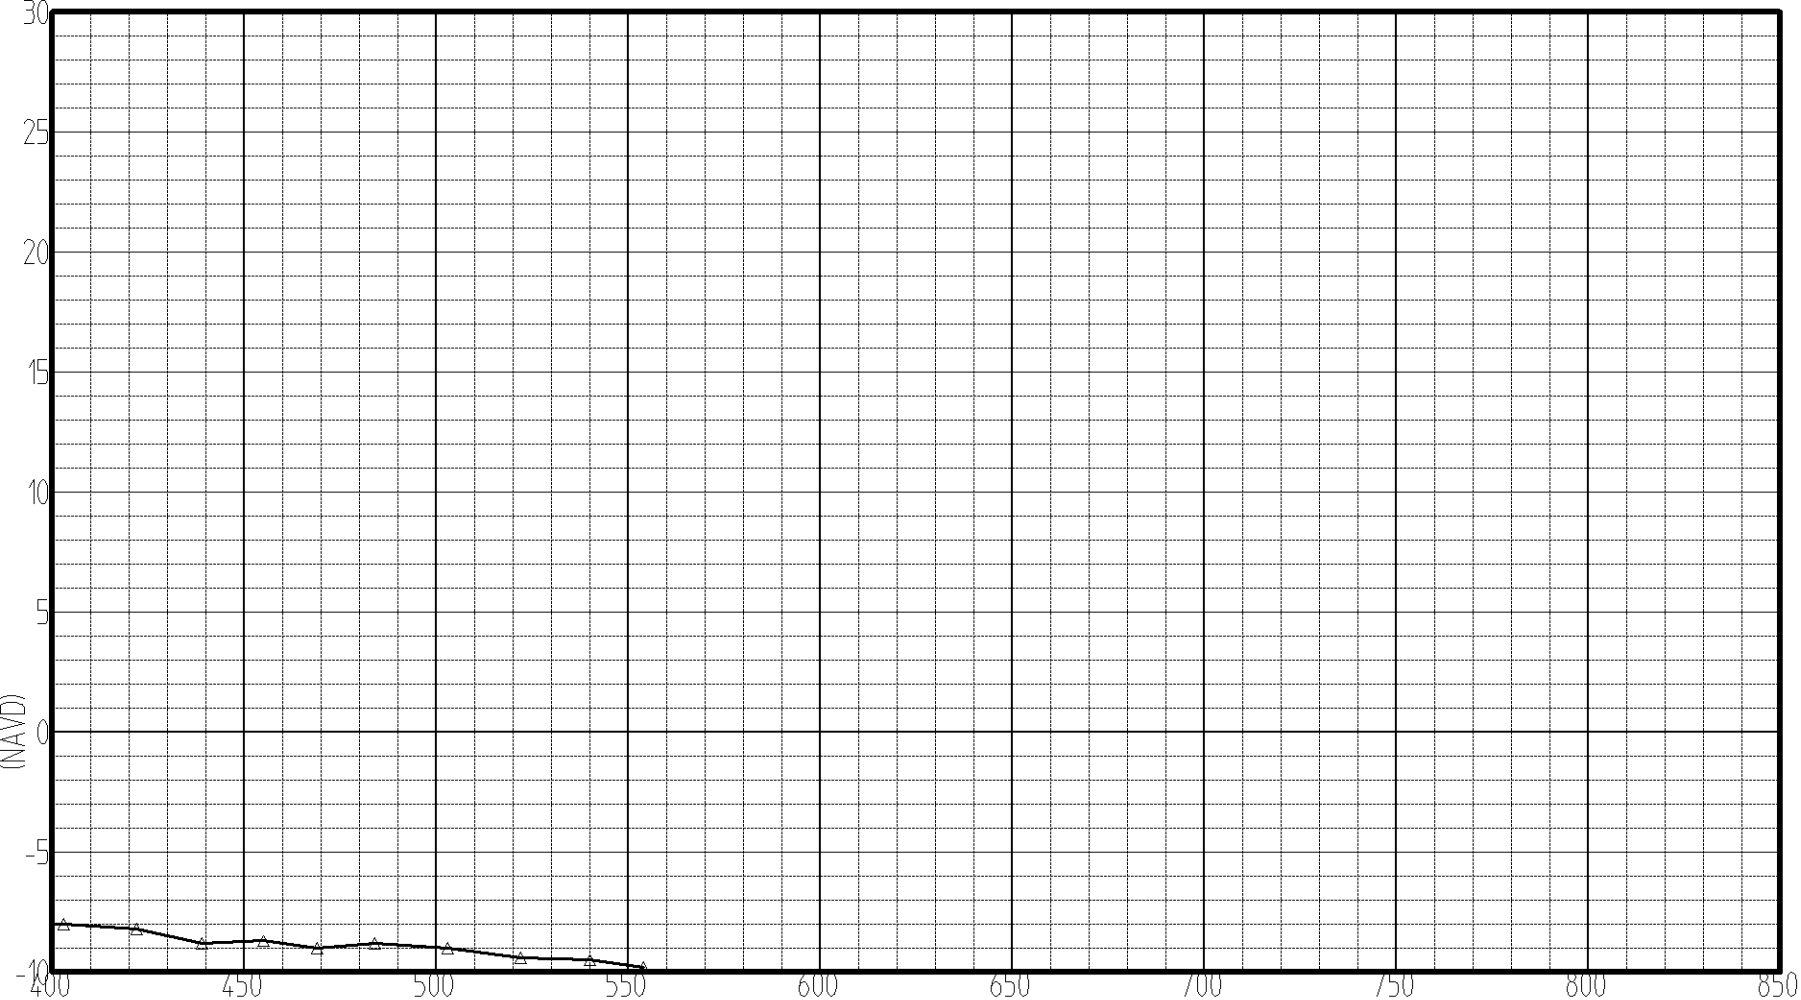
Range: R-114

—△—△— 2005-2008 INPUT PRF

- - - * - - - 15-YR SBEACH ERODED PRF

- - - o - - - 25-YR SBEACH ERODED PRF

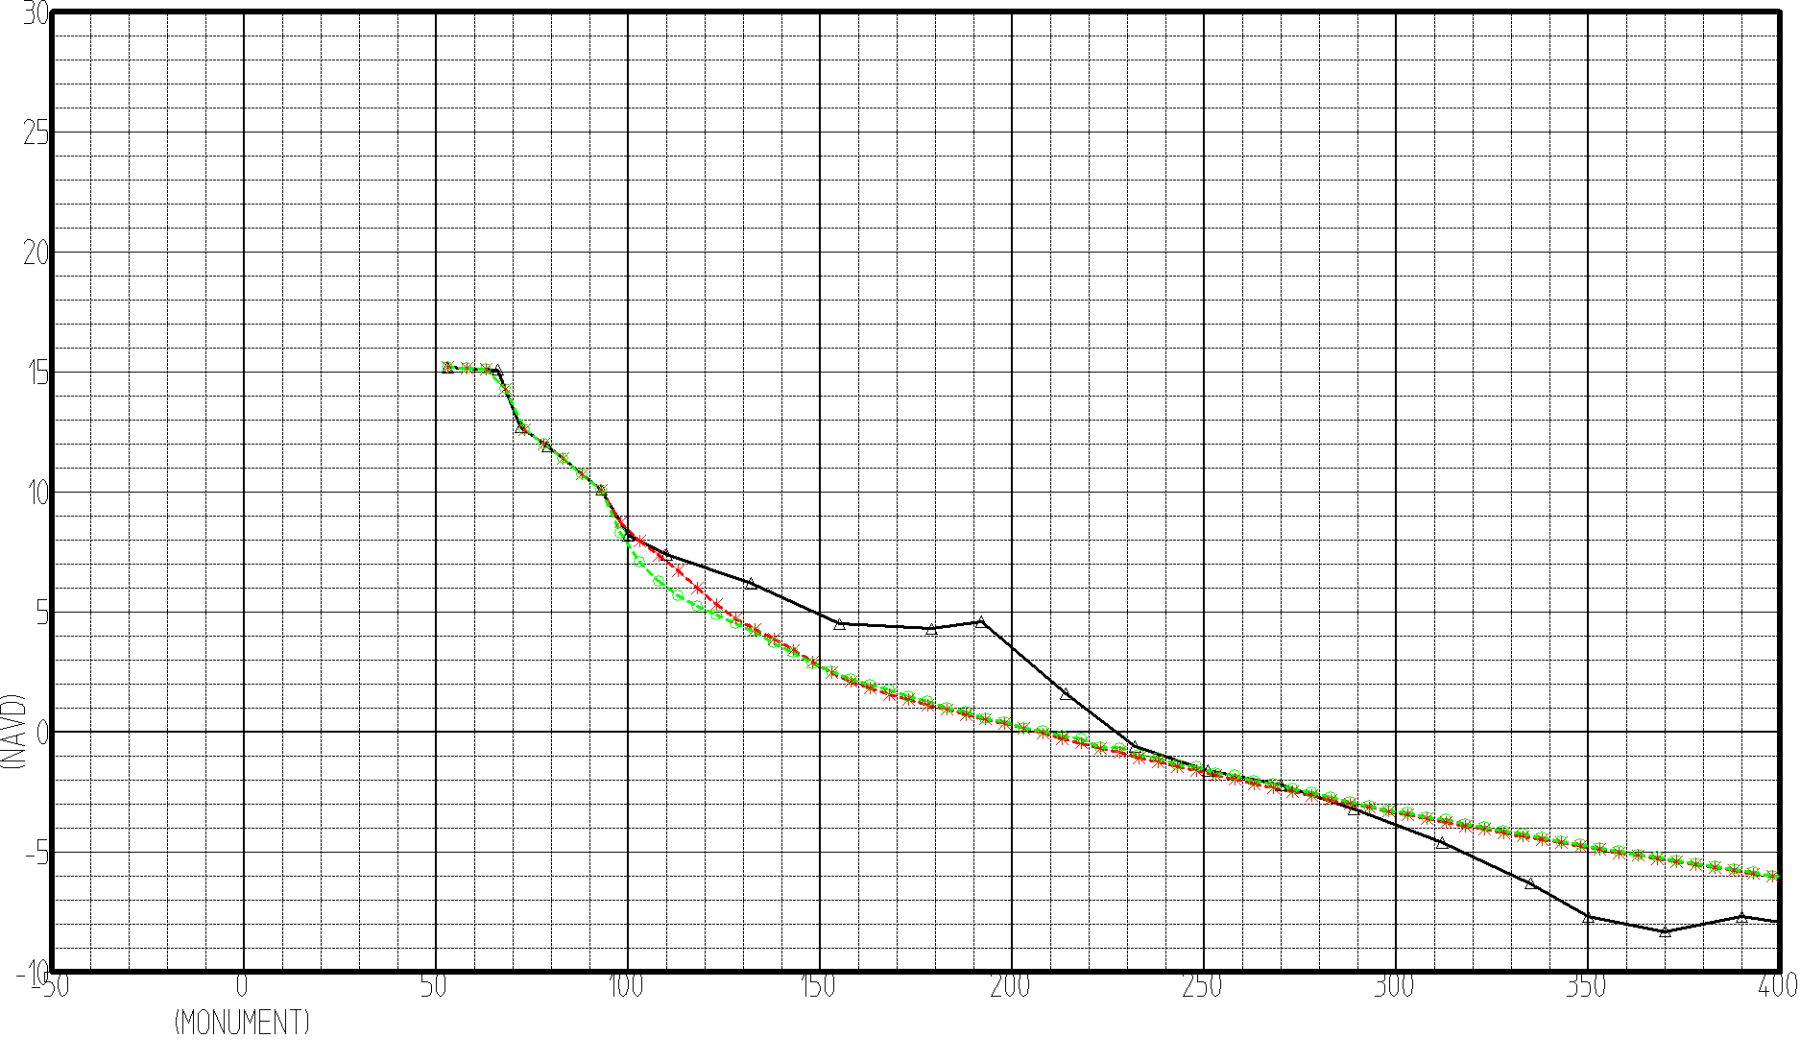
Range: R-115

—△—△— 2005-2008 INPUT PRF

- - - * - - - 15-YR SBEACH ERODED PRF

- - - o - - - 25-YR SBEACH ERODED PRF
