Appendix XI

SBEACH 15 and 25 yr. Storm Erosion Profiles

Brevard County

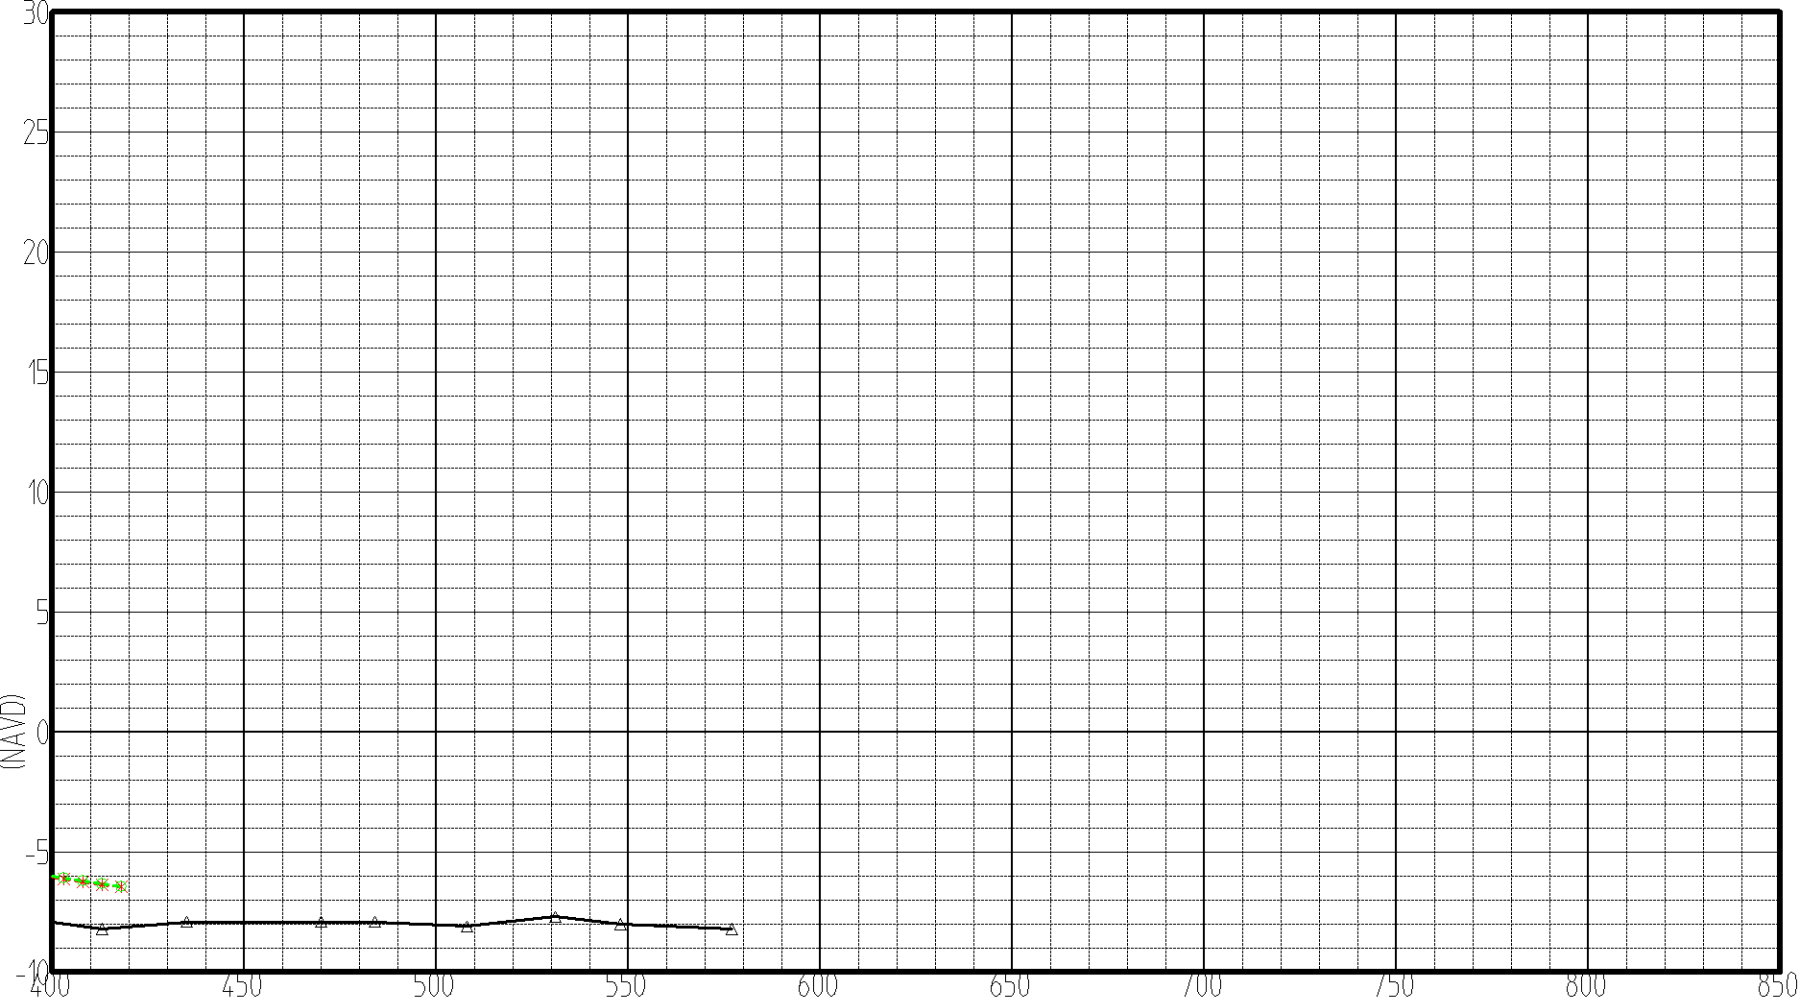
Range: R-115
 BEARING: 80.00
 2/2

BEACH PROFILE
 —△—△— 2005-2008 INPUT PRF
 - - * - - * - - 15-YR SBEACH ERODED PRF
 - - o - - o - - 25-YR SBEACH ERODED PRF

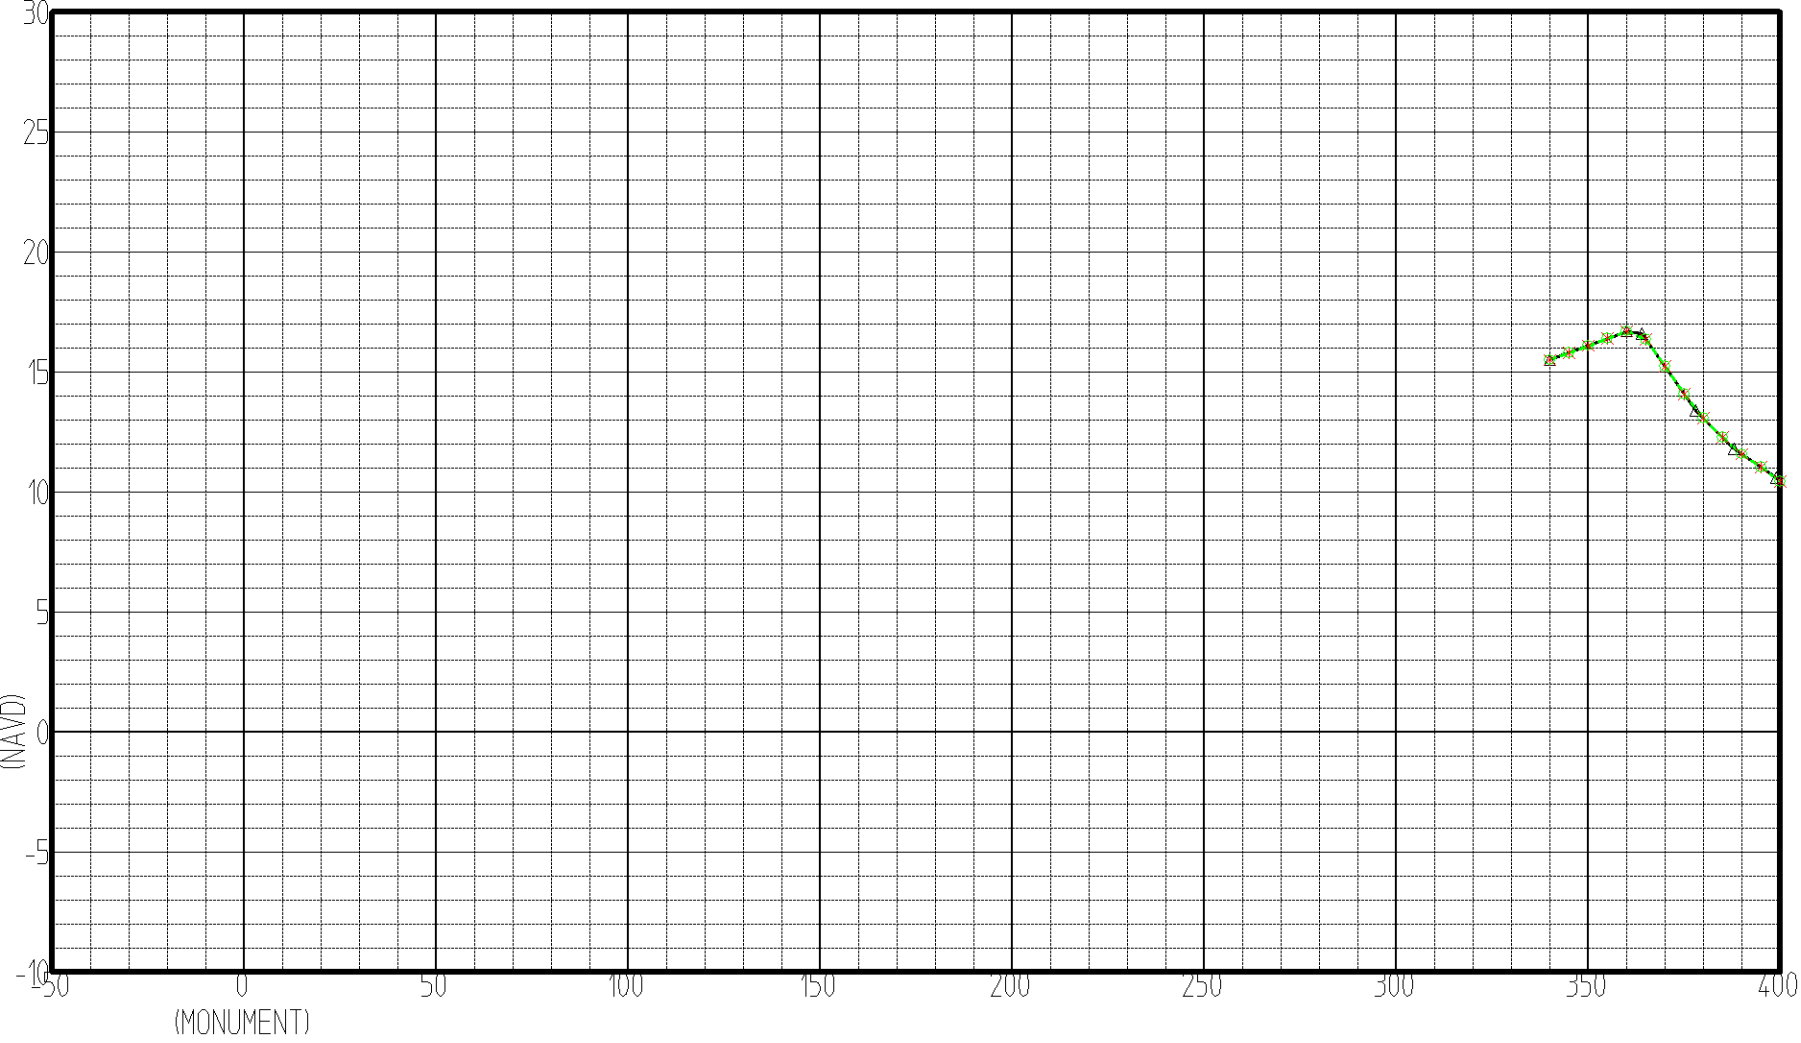
Range: R-116 1/3

- △—△— 2005-2008 INPUT PRF
- - - * - - - 15-YR SBEACH ERODED PRF
- - - o - - - 25-YR SBEACH ERODED PRF

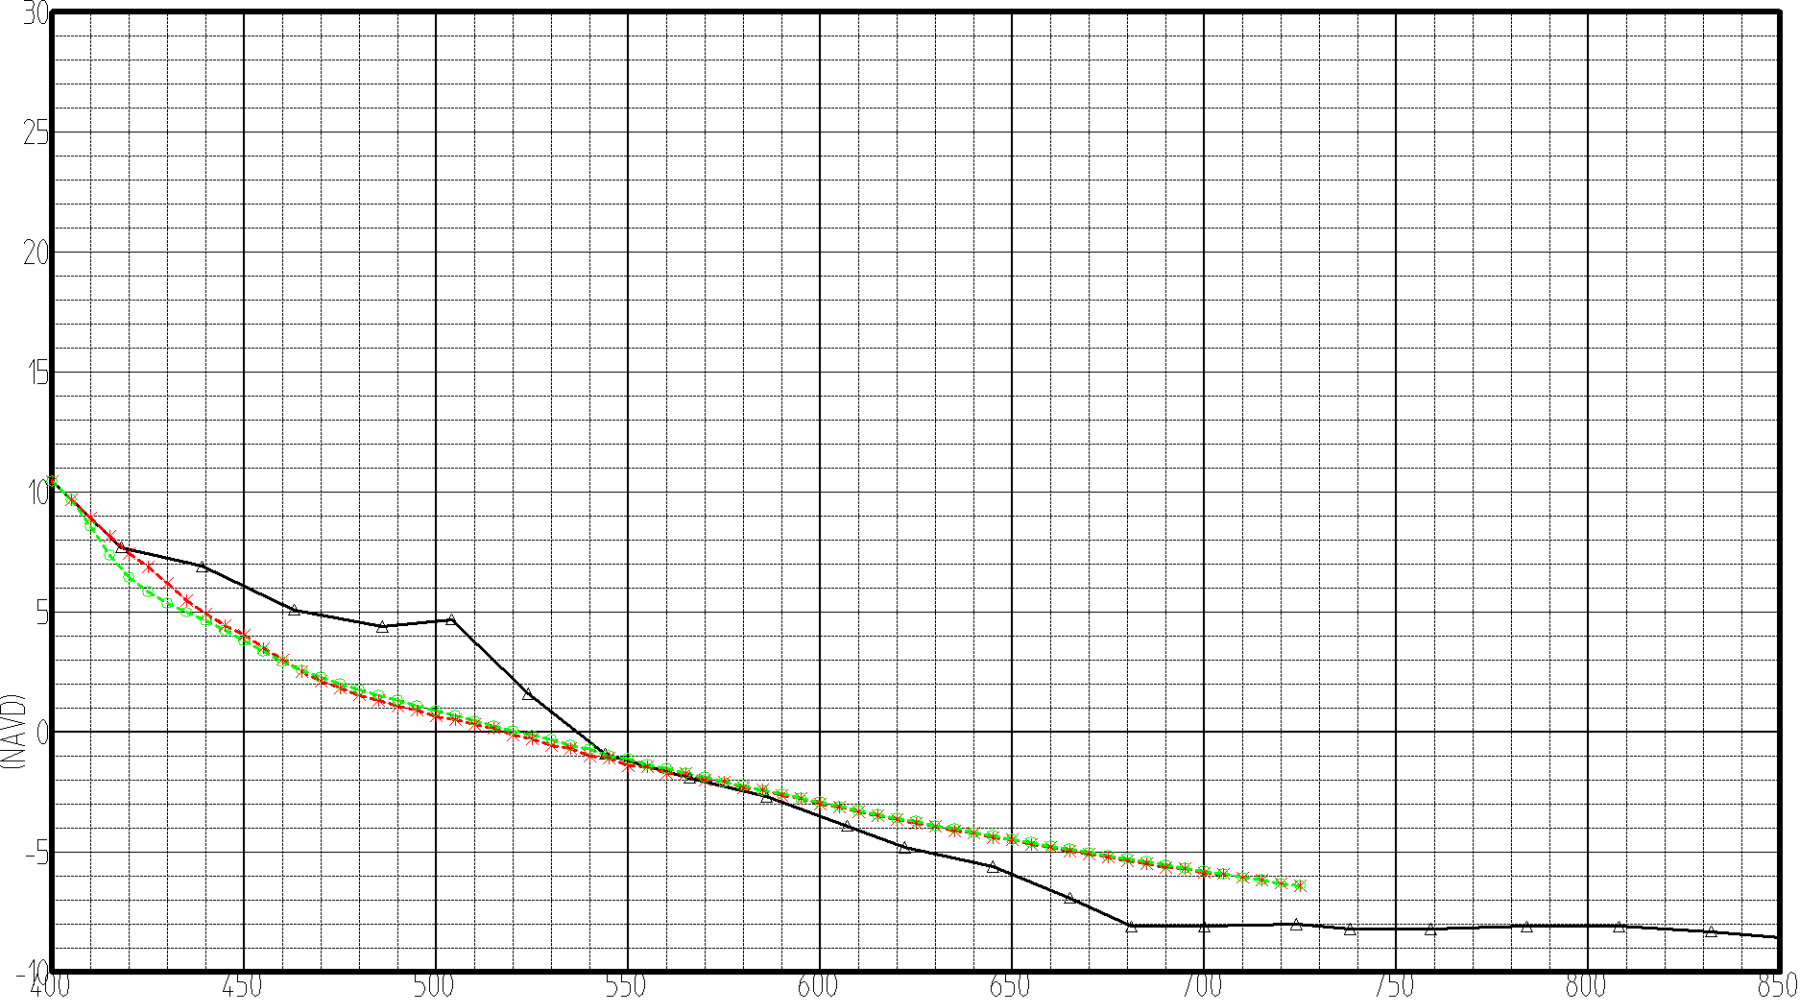
Range: R-116
 BEARING: 80.00
 2/3

BEACH PROFILE
 —△—△— 2005-2008 INPUT PRF
 - - * - - * - - 15-YR SBEACH ERODED PRF
 - - o - - o - - 25-YR SBEACH ERODED PRF

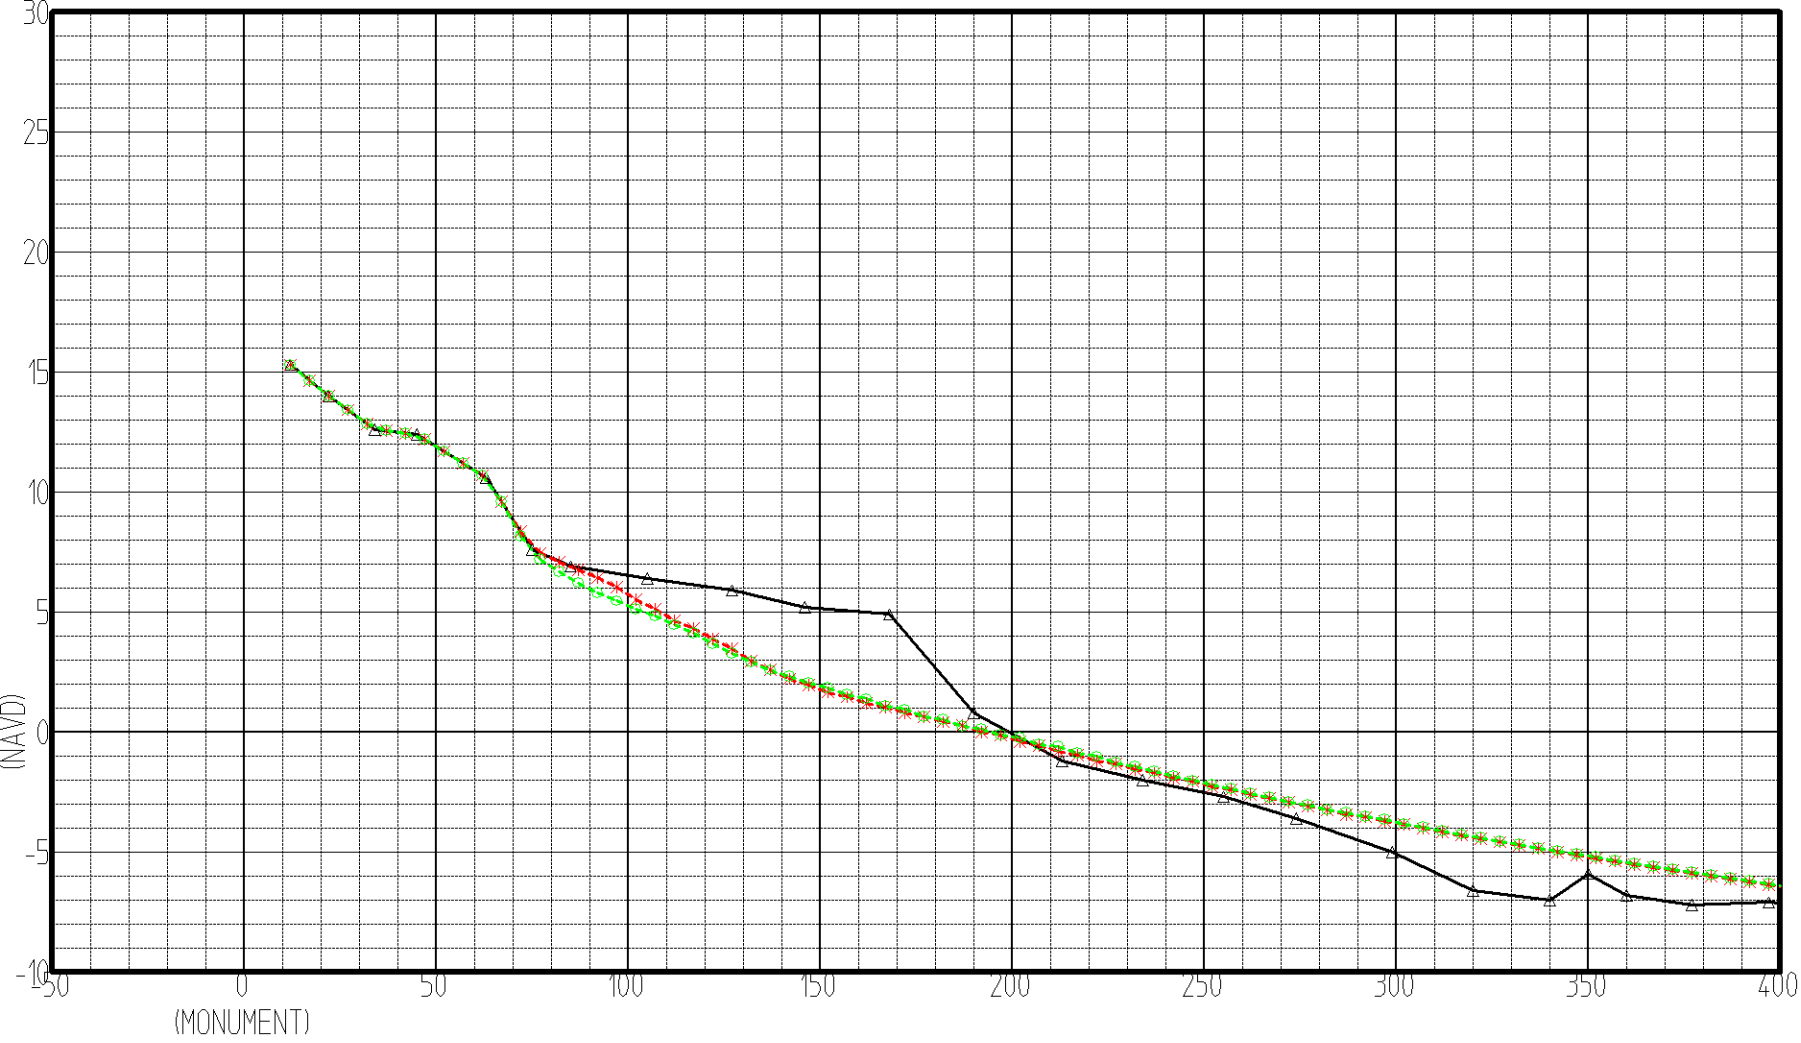
Range: R-117-T

—△—△— 2005-2008 INPUT PRF

- - * - - * - - 15-YR SBEACH ERODED PRF

- - o - - o - - 25-YR SBEACH ERODED PRF

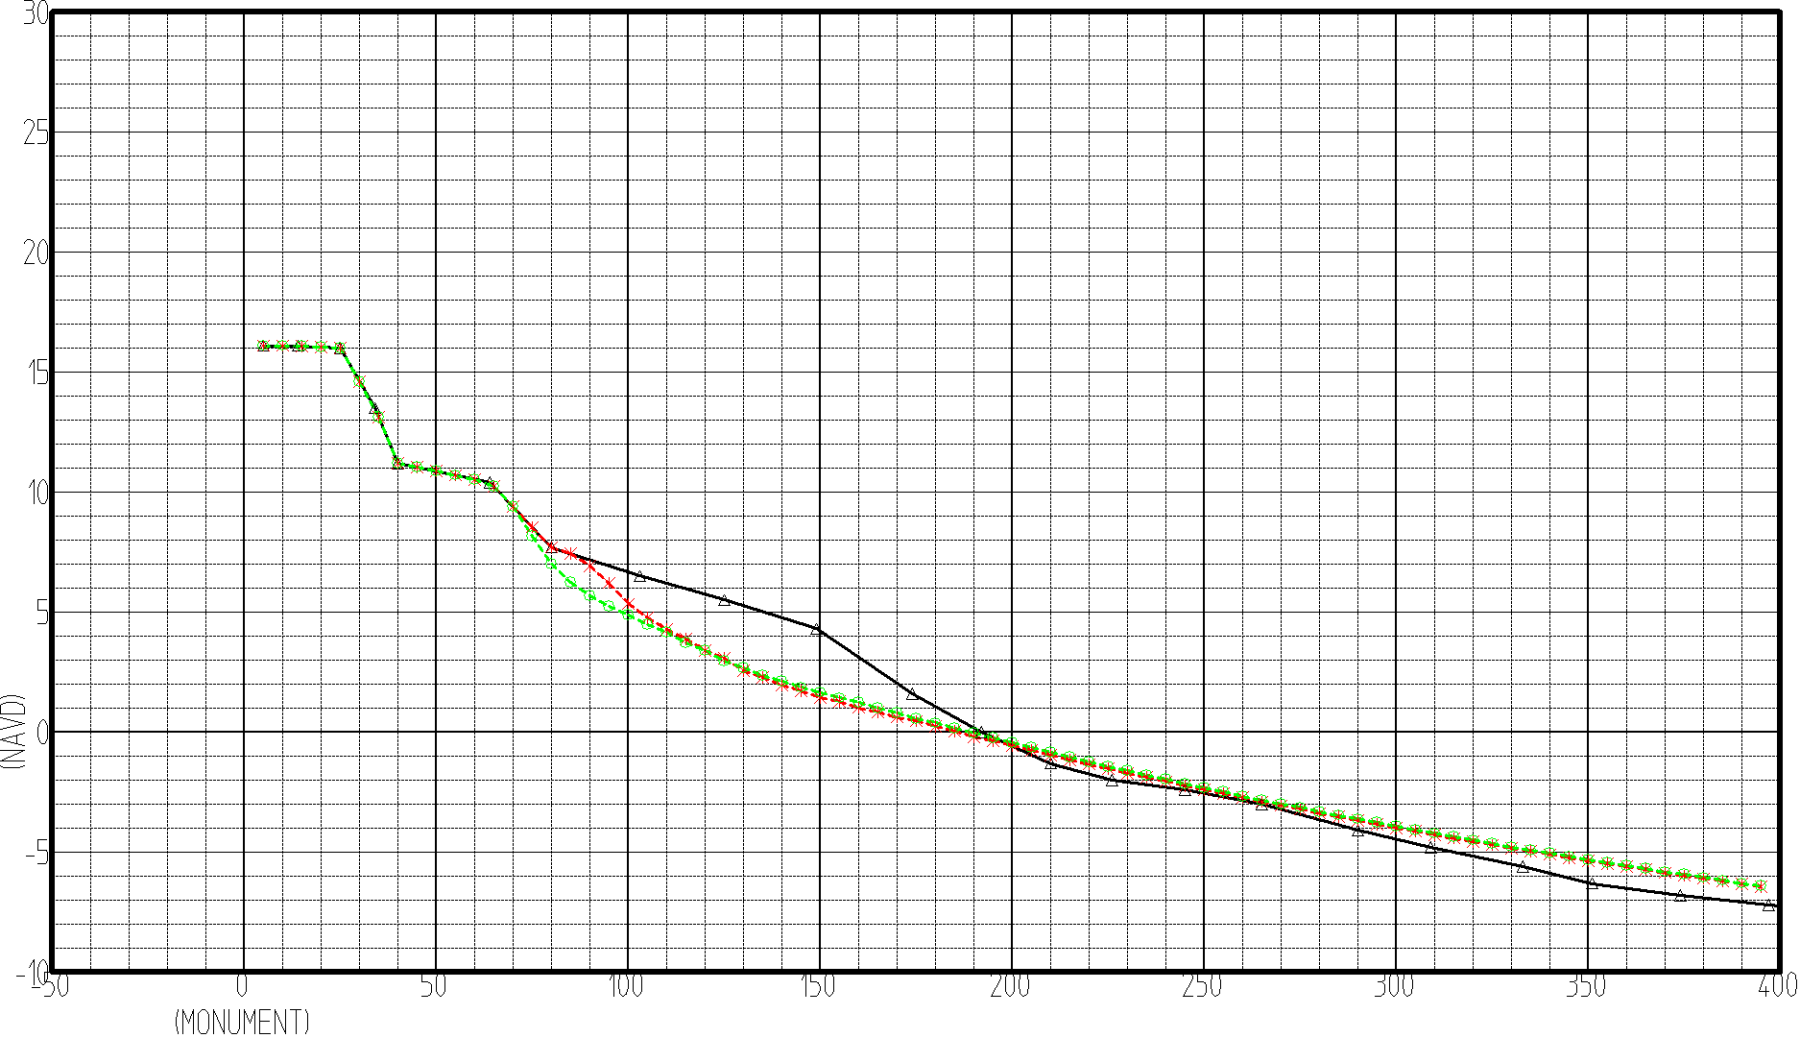
Range: R-118 1/2

- △—△— 2005-2008 INPUT PRF
- - - * - - - 15-YR SBEACH ERODED PRF
- - - o - - - 25-YR SBEACH ERODED PRF

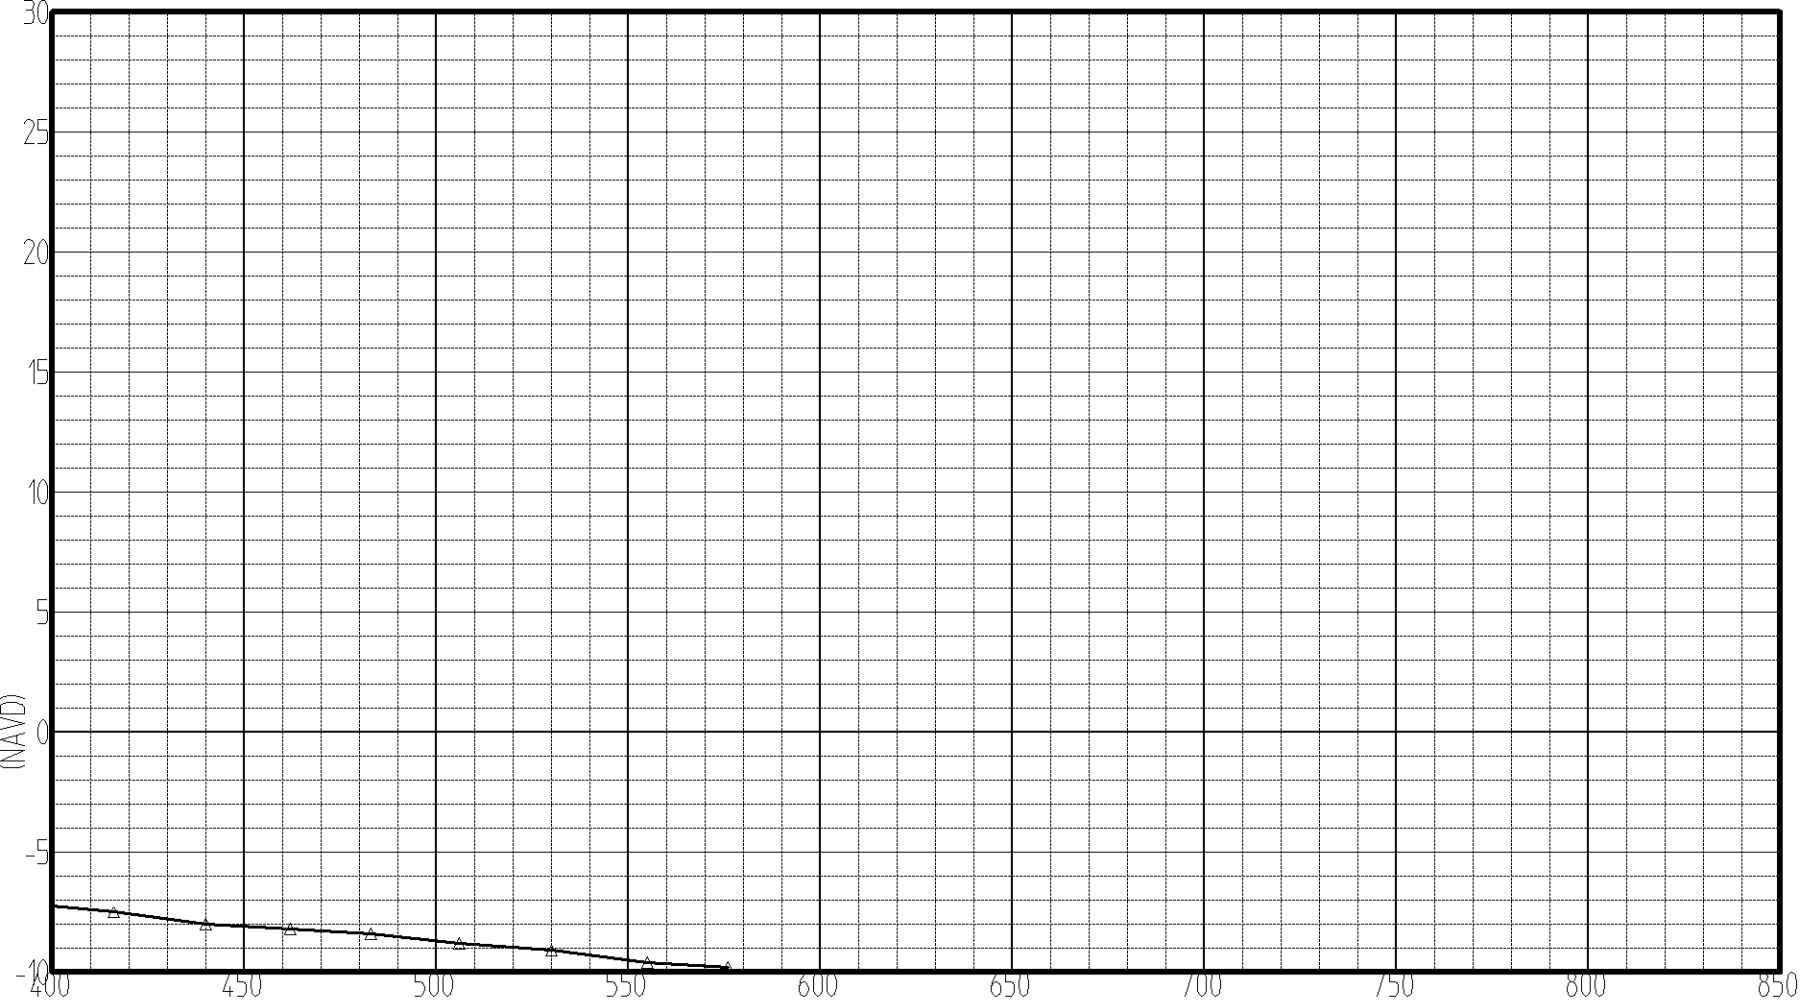
Range: R-118
 BEARING: 80.00
 2/2

BEACH PROFILE
 —△—△— 2005-2008 INPUT PRF
 - - * - - * - - 15-YR SBEACH ERODED PRF
 - - o - - o - - 25-YR SBEACH ERODED PRF

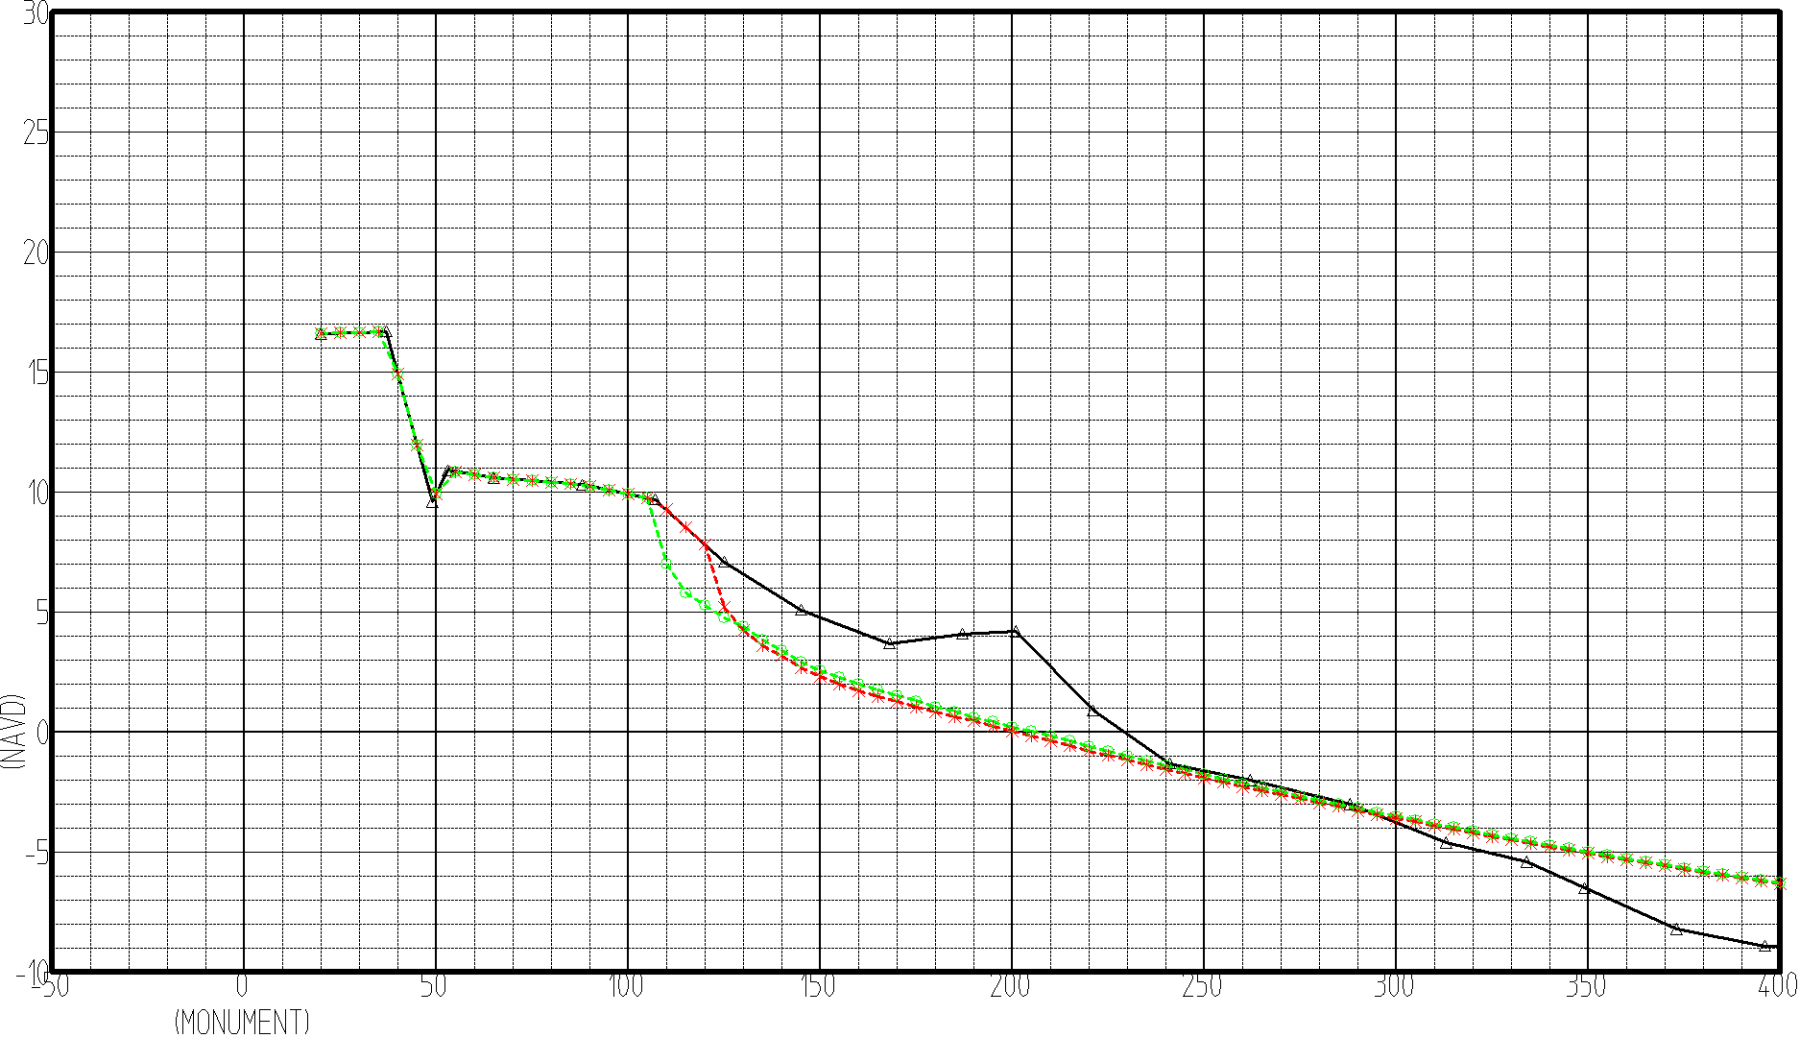
Range: R-119 1/2

- △—△— 2005-2008 INPUT PRF
- - * - - * - - 15-YR SBEACH ERODED PRF
- - o - - o - - 25-YR SBEACH ERODED PRF

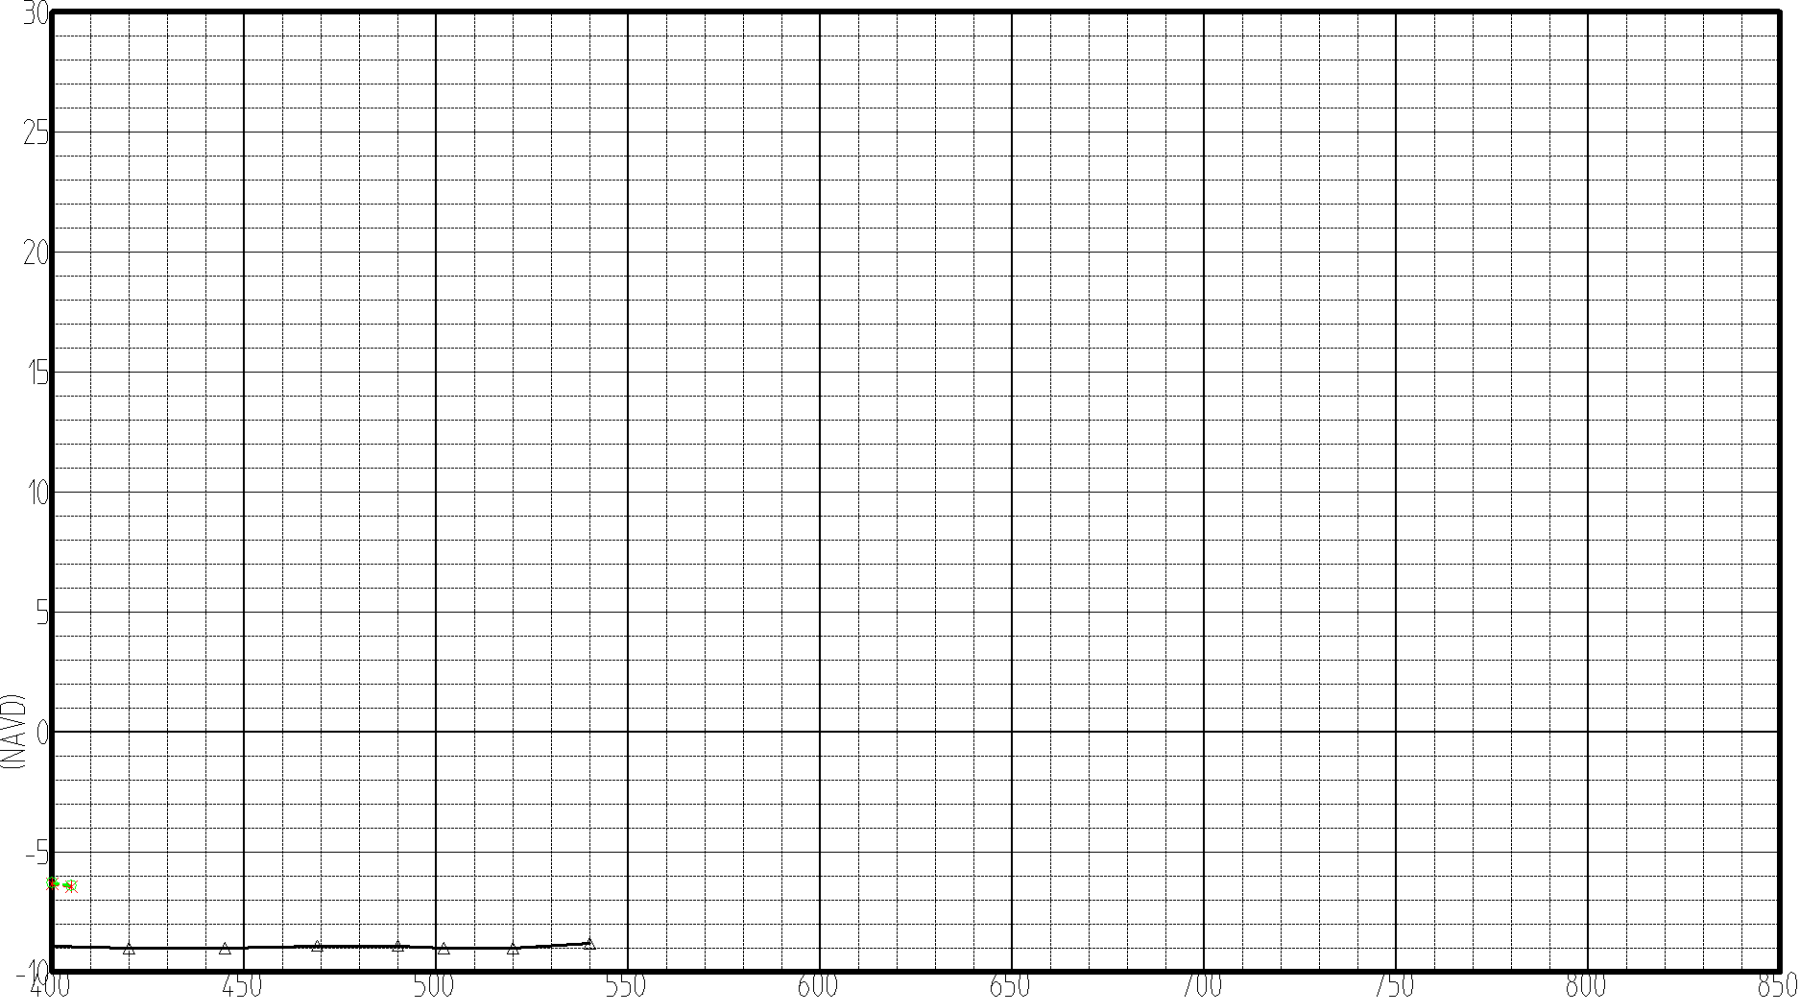
Range: R-119

—△—△— 2005-2008 INPUT PRF

- - - * - - - 15-YR SBEACH ERODED PRF

- - - o - - - 25-YR SBEACH ERODED PRF

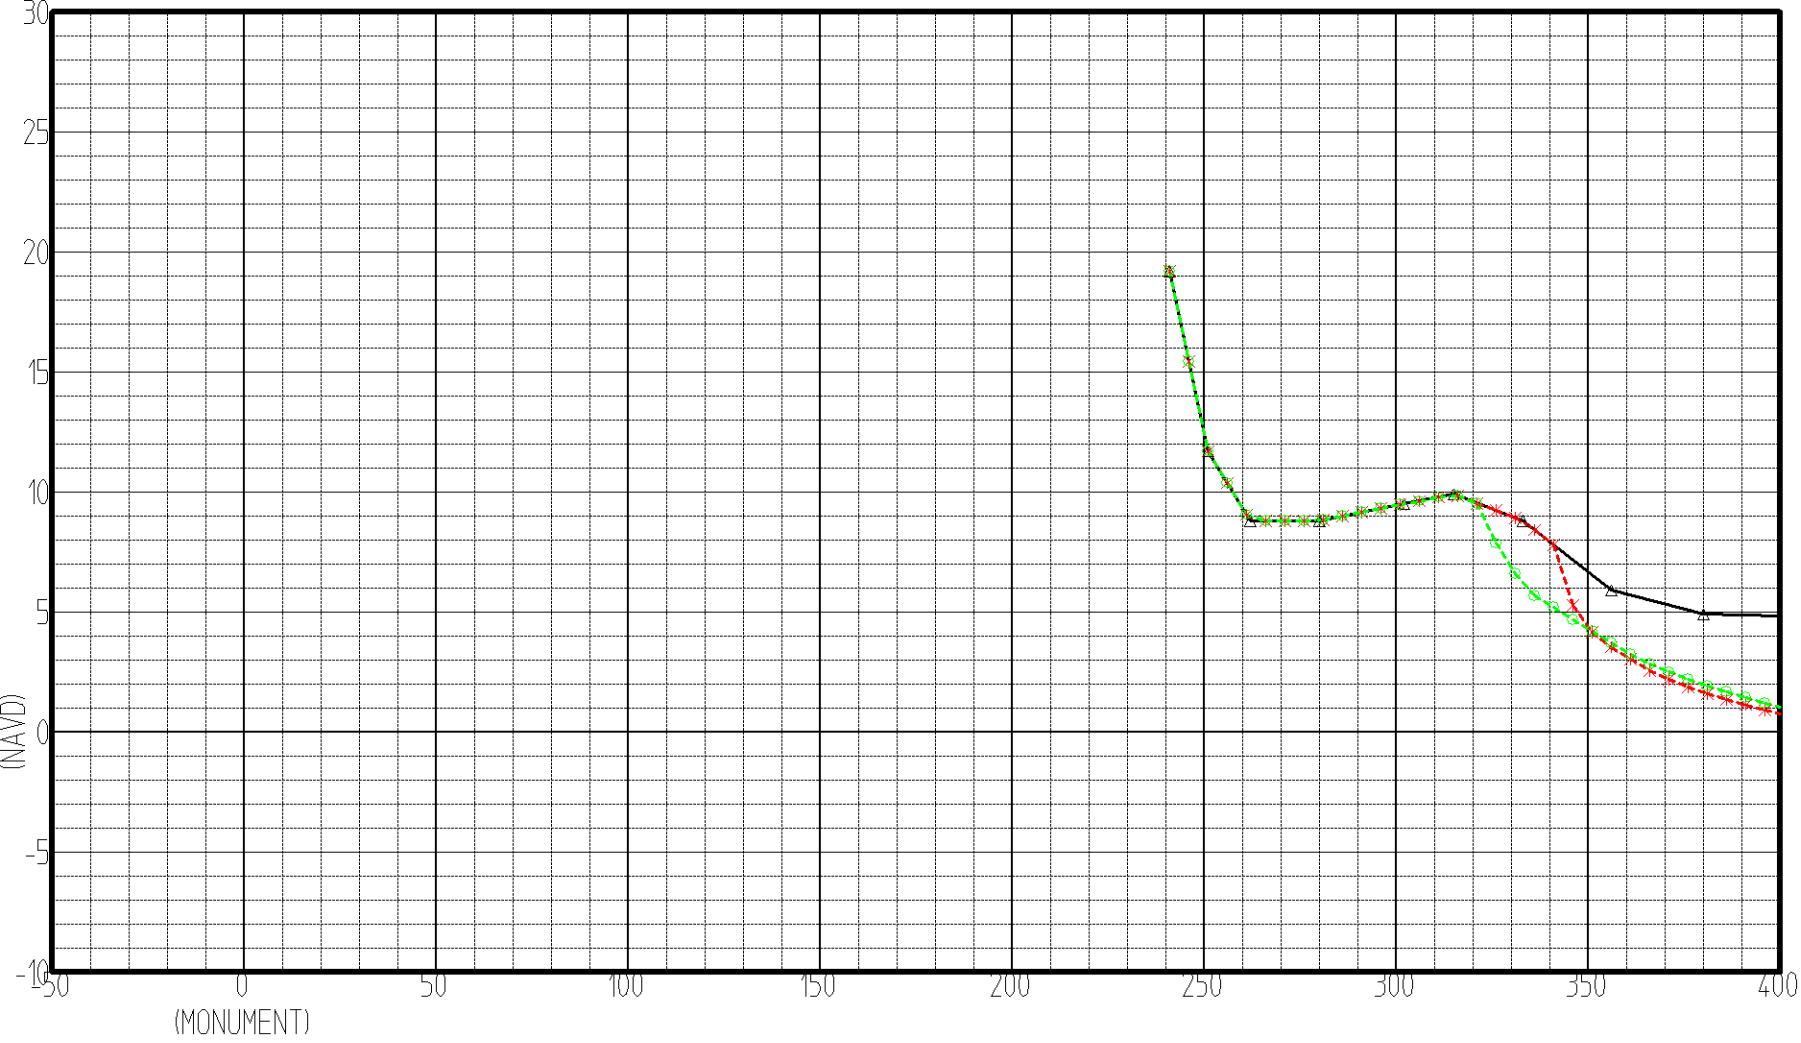
Range: R-120-T 1/2

- △—△— 2005-2008 INPUT PRF
- - * - - * - - 15-YR SBEACH ERODED PRF
- - o - - o - - 25-YR SBEACH ERODED PRF

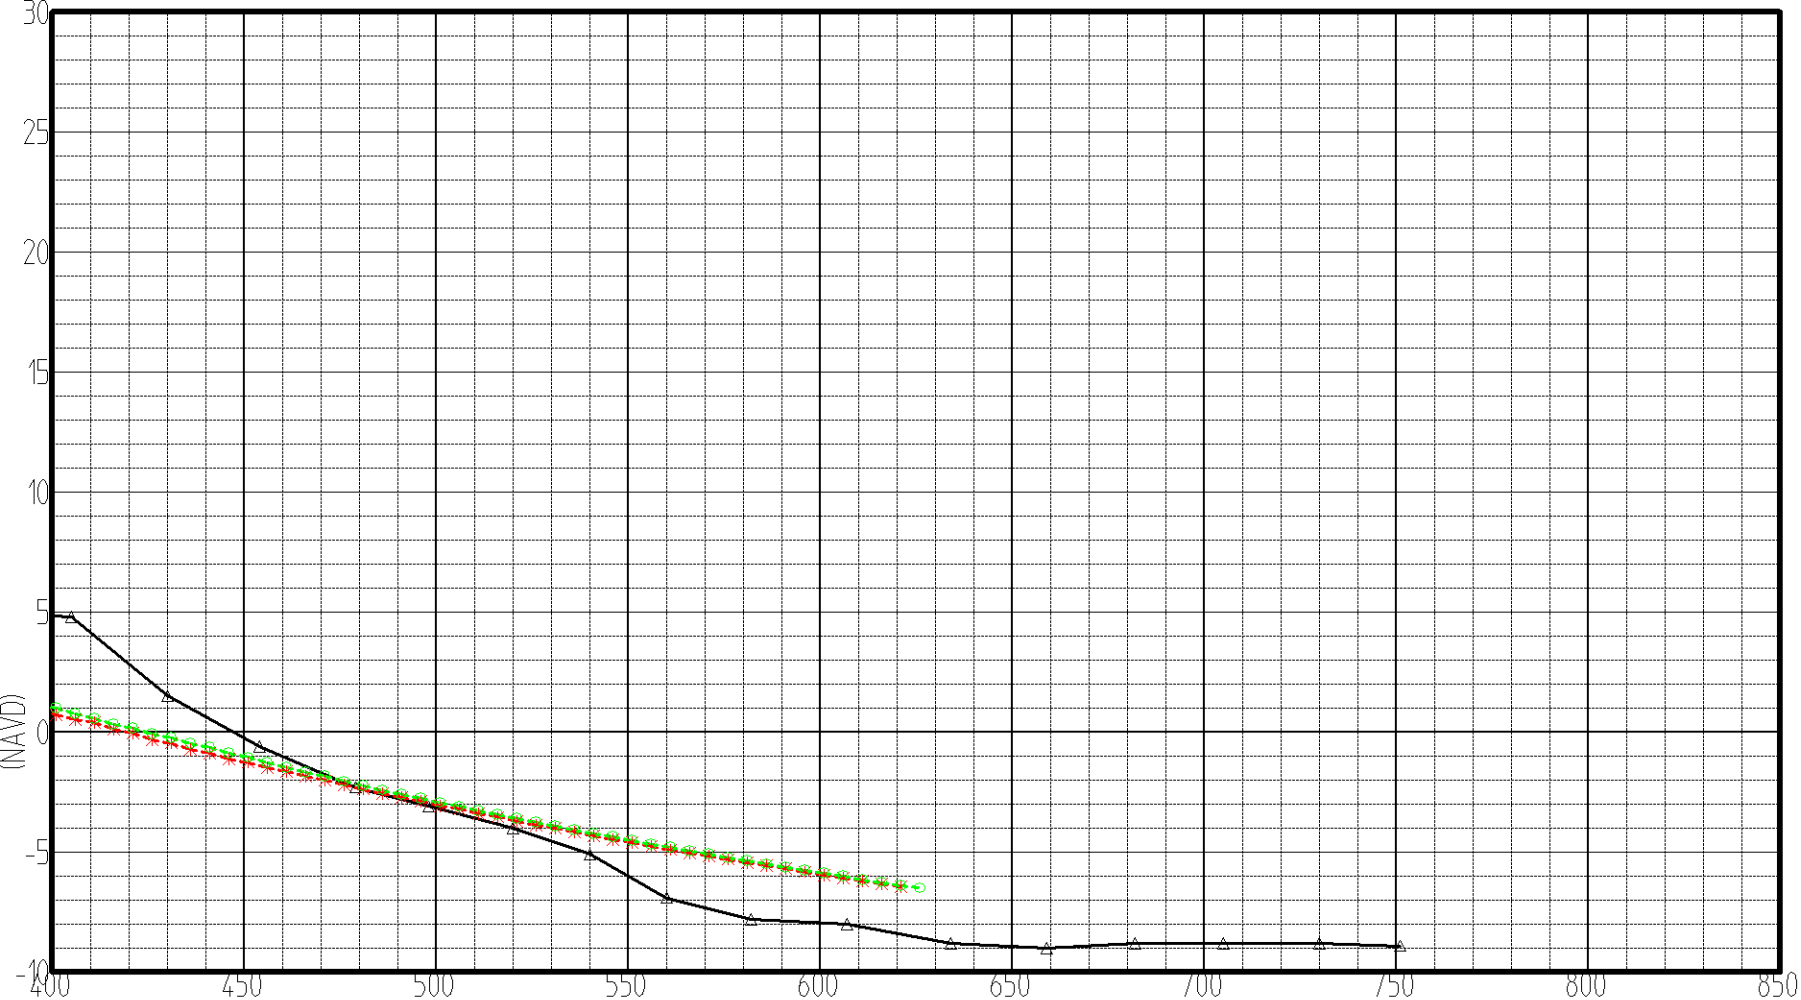
Range: R-120-T
 BEARING: 80.00
 2/2

BEACH PROFILE
 —△—△— 2005-2008 INPUT PRF
 - - * - - * - - 15-YR SBEACH ERODED PRF
 - - o - - o - - 25-YR SBEACH ERODED PRF

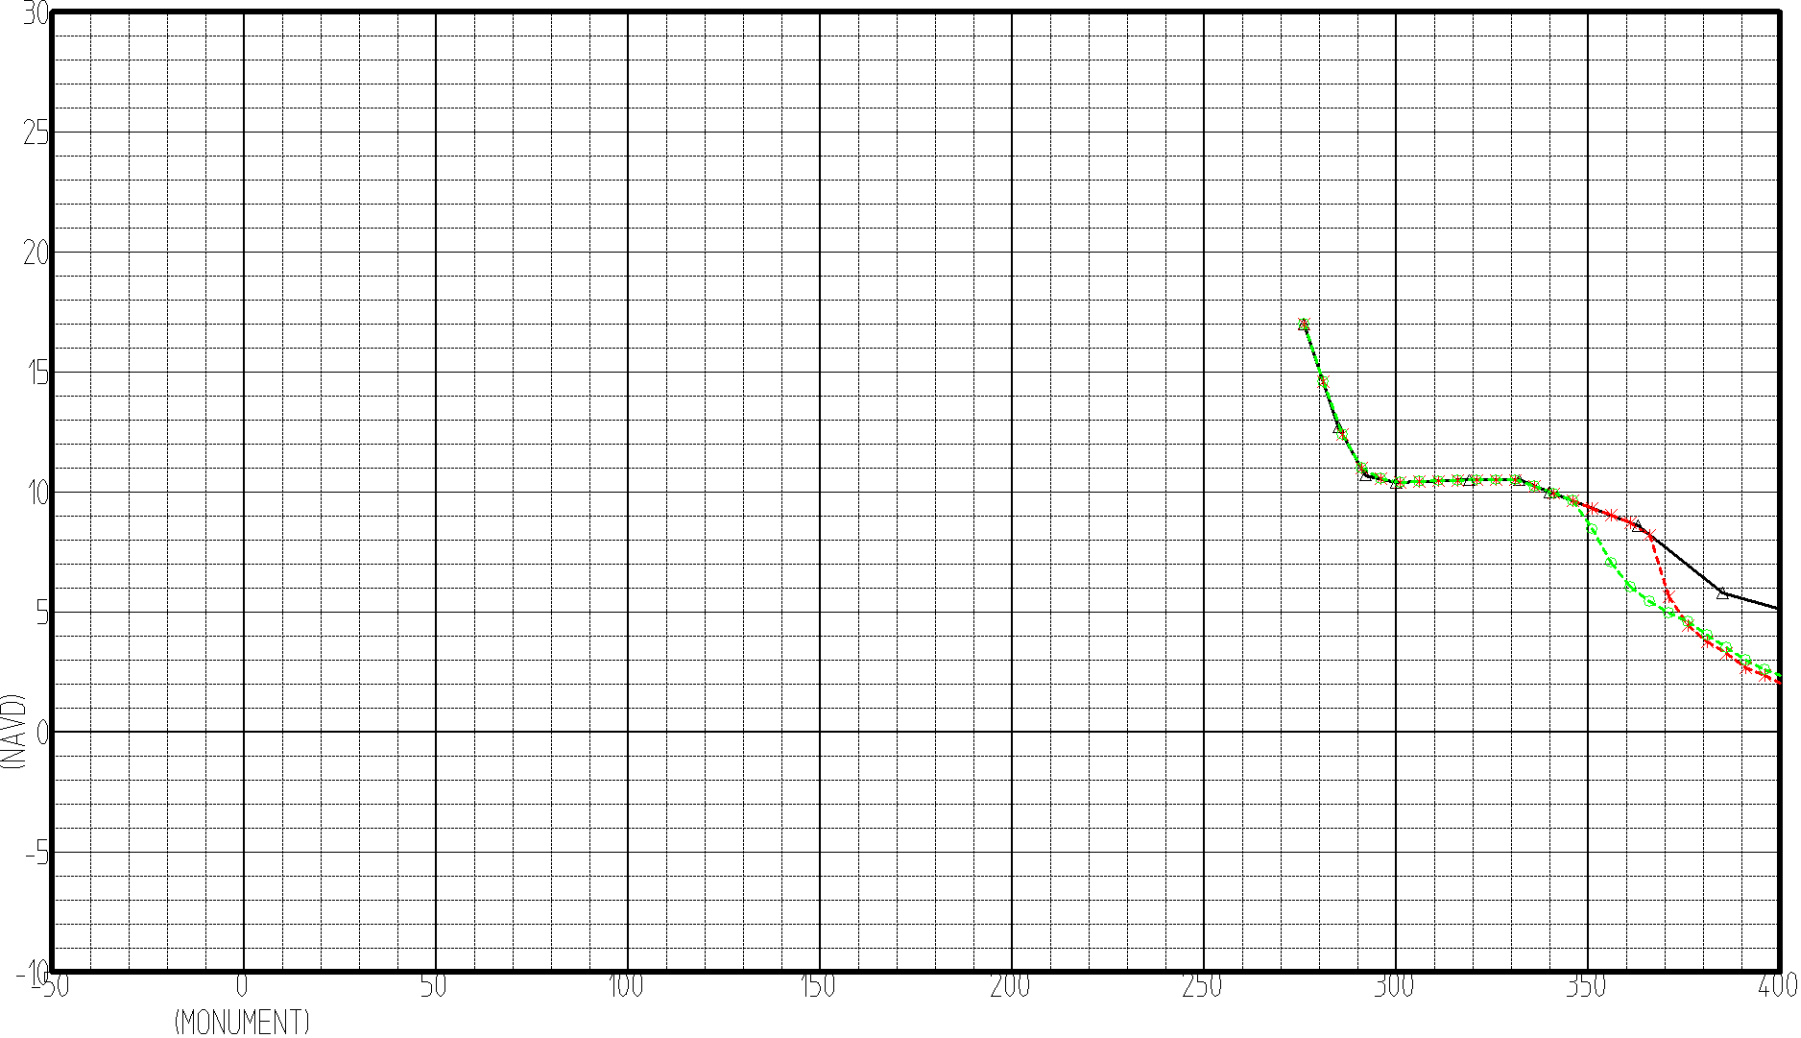
Range: R-121-T 1/2
 BEARING: 80.00

BEACH PROFILE
 —△—△— 2005-2008 INPUT PRF
 - - * - - * - - 15-YR SBEACH ERODED PRF
 - - o - - o - - 25-YR SBEACH ERODED PRF

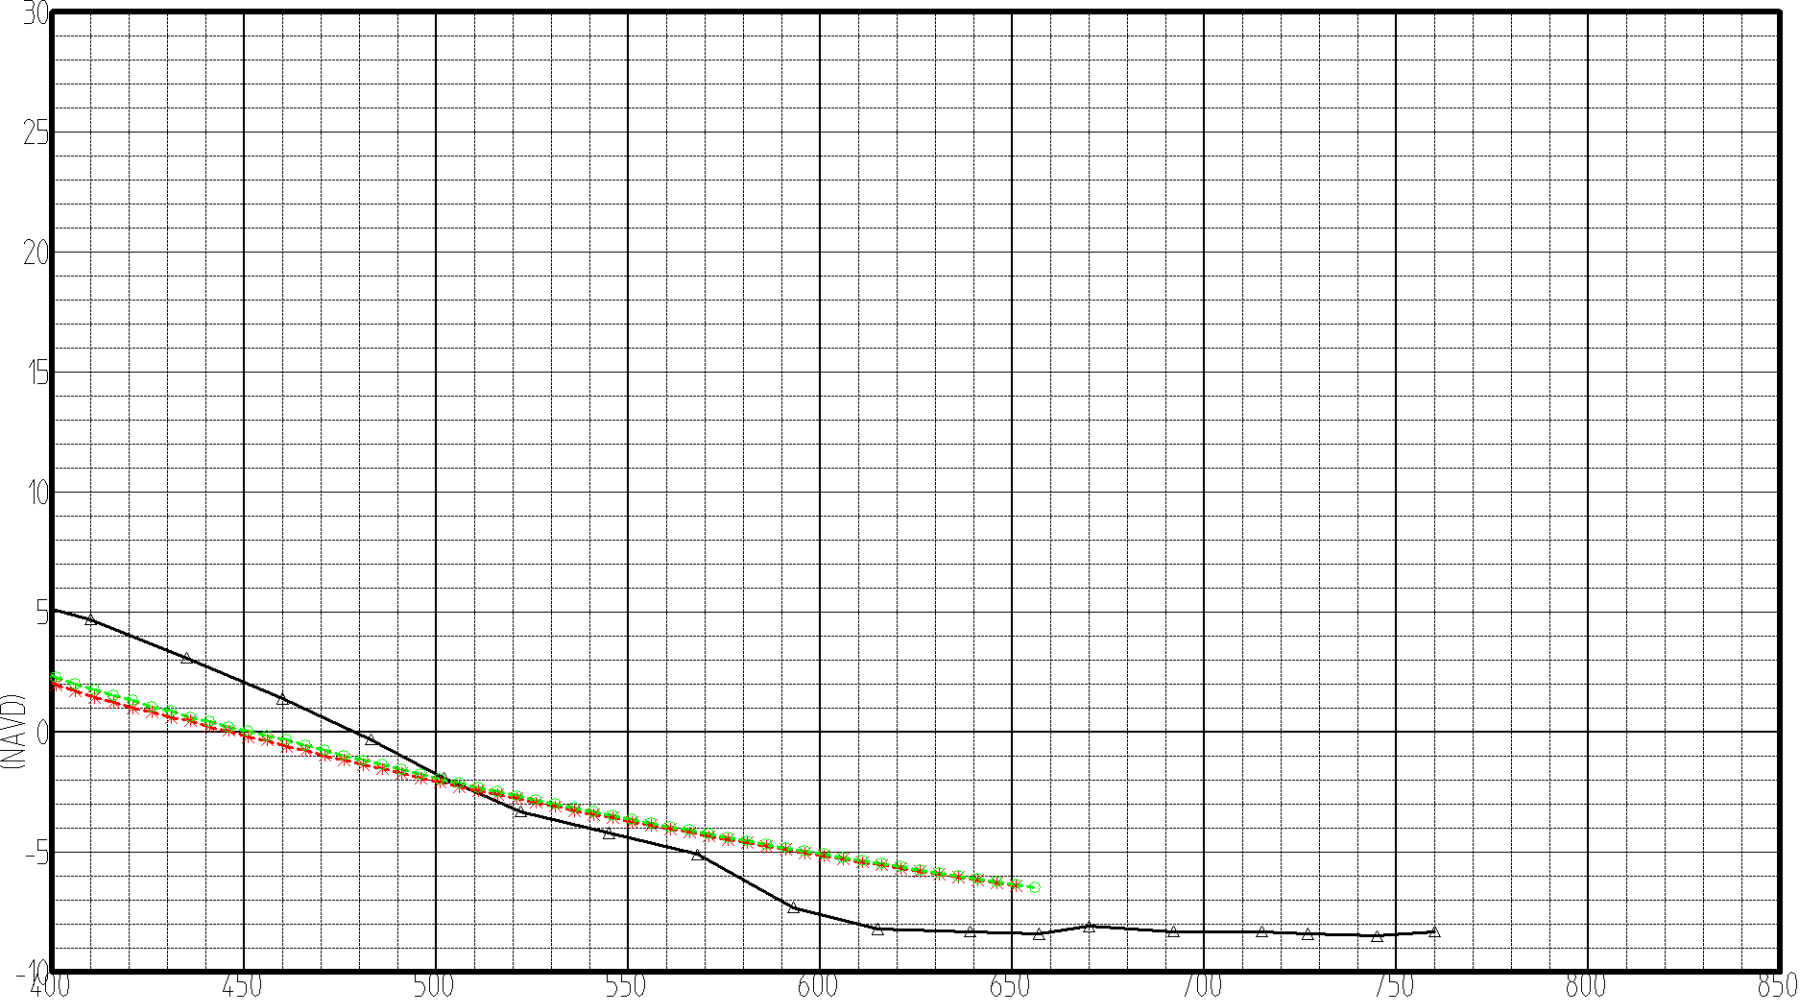
Range: R-121-T
 BEARING: 80.00
 2/2

BEACH PROFILE
 —△—△— 2005-2008 INPUT PRF
 - - * - - * - - 15-YR SBEACH ERODED PRF
 - - o - - o - - 25-YR SBEACH ERODED PRF
