Appendix XI

SBEACH 15 and 25 yr. Storm Erosion Profiles

Brevard County

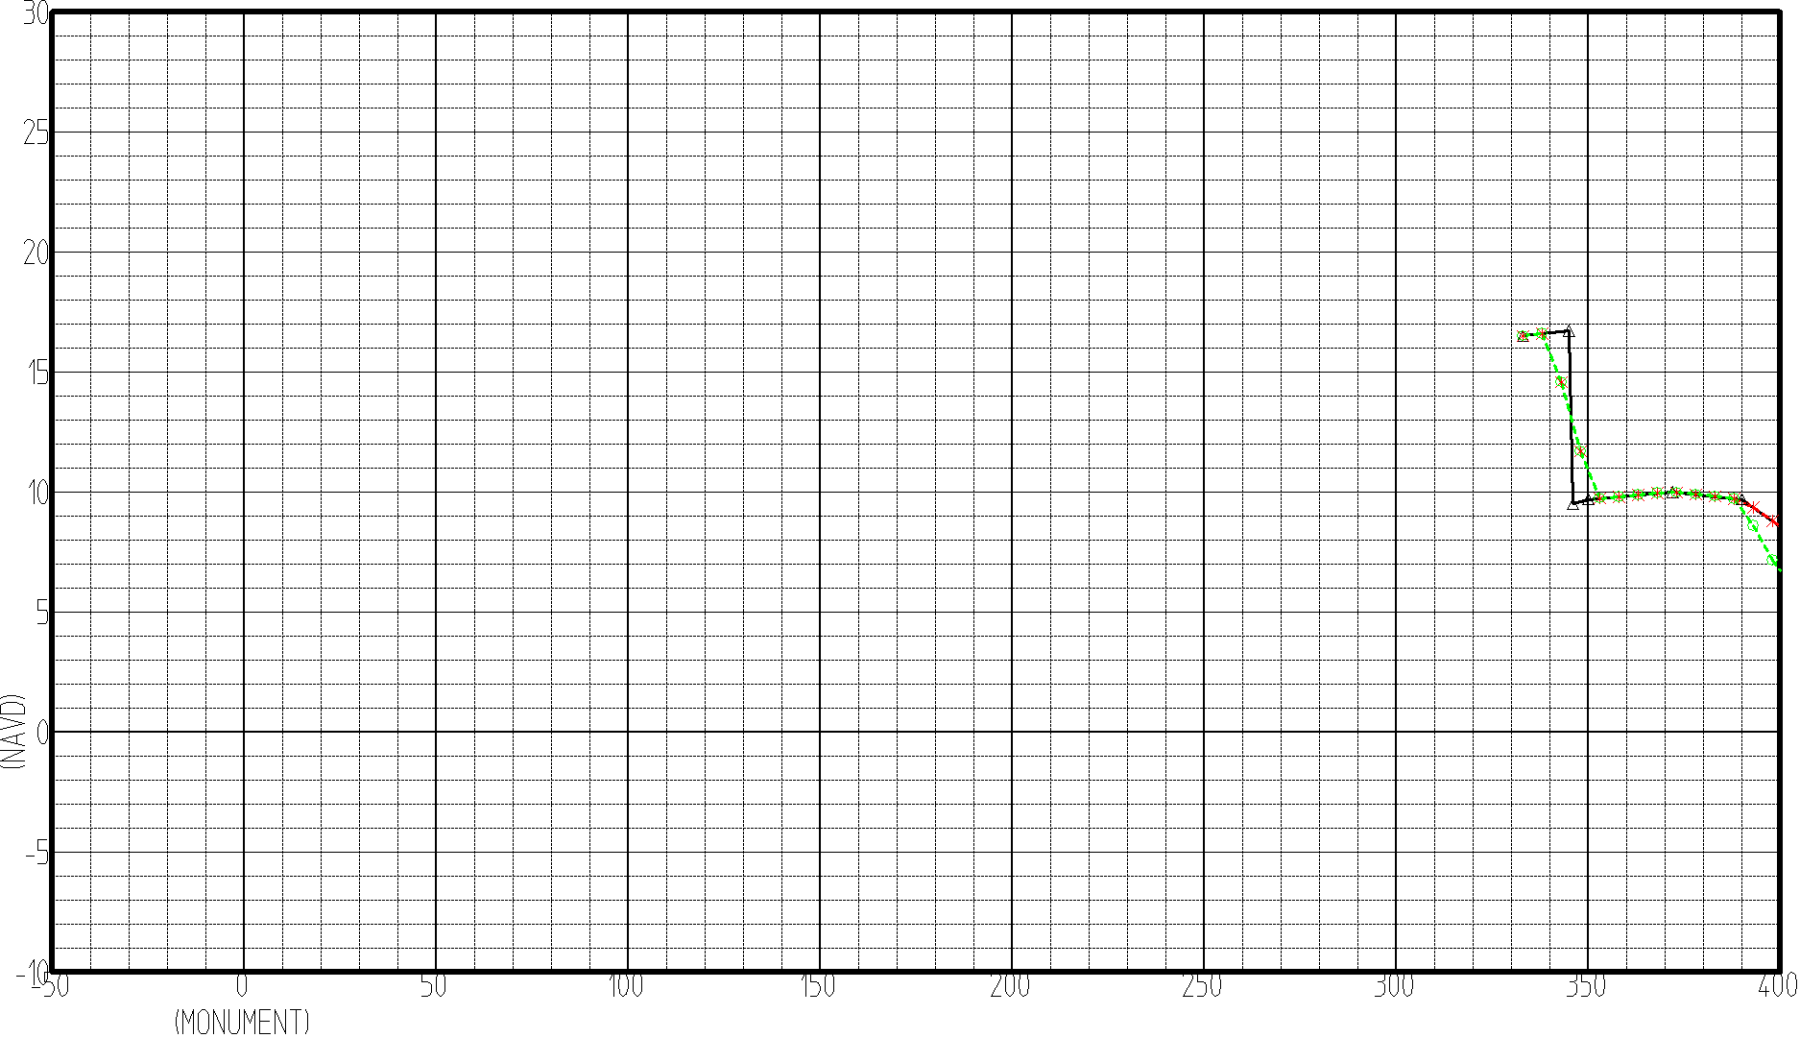
Range: R-122
 BEARING: 80.00
 1/3

BEACH PROFILE
 —△—△— 2005-2008 INPUT PRF
 - - * - - * - - 15-YR SBEACH ERODED PRF
 - - o - - o - - 25-YR SBEACH ERODED PRF

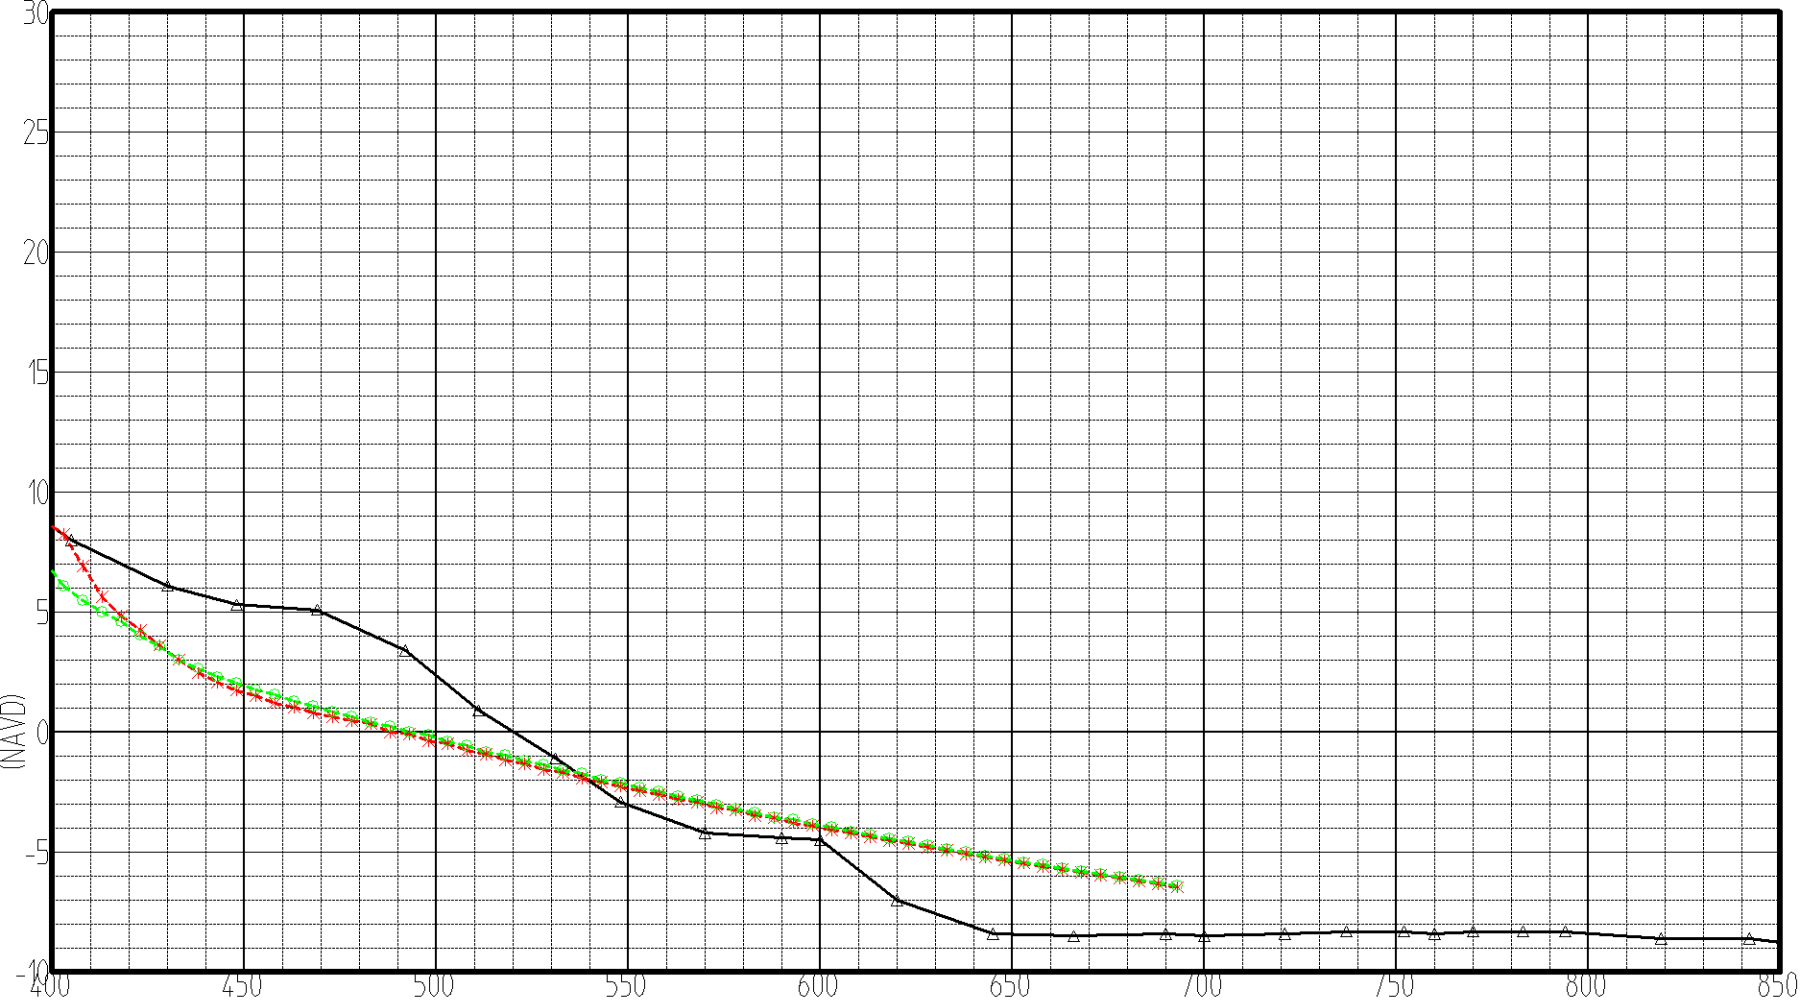
Range: R-122
 BEARING: 80.00
 2/3

BEACH PROFILE
 —△—△— 2005-2008 INPUT PRF
 - - * - - * - - 15-YR SBEACH ERODED PRF
 - - o - - o - - 25-YR SBEACH ERODED PRF

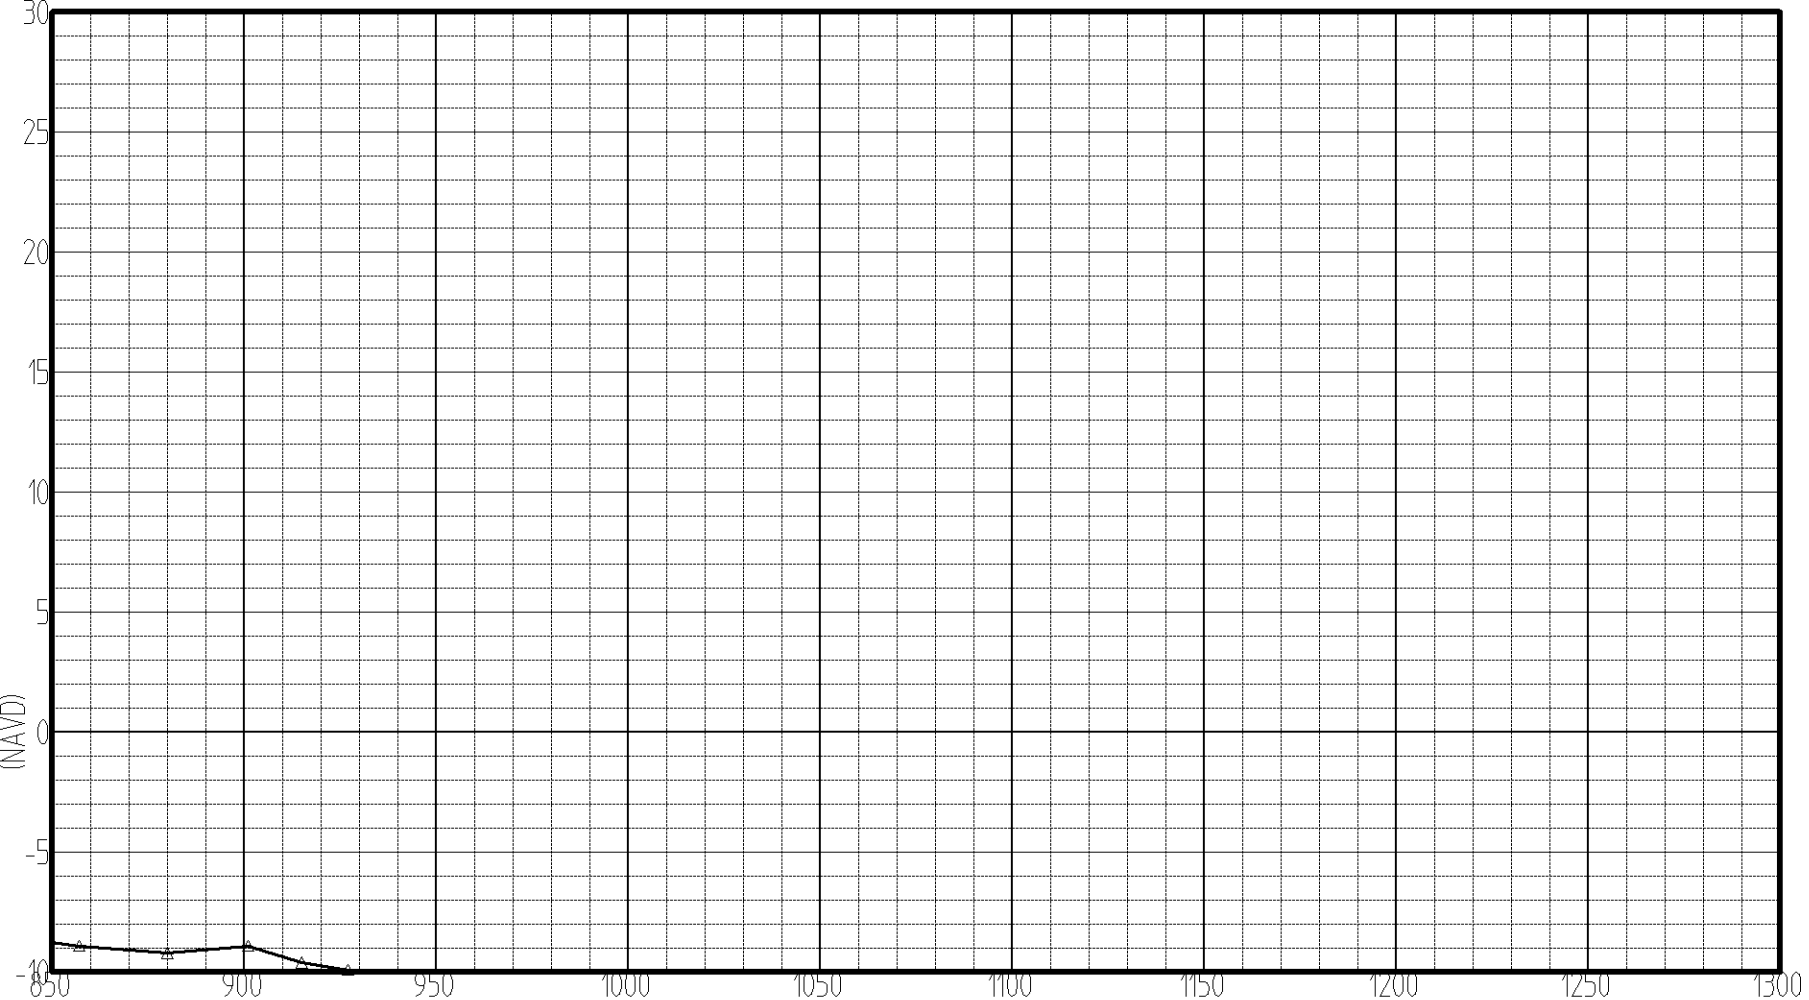
Range: R-122

—△—△— 2005-2008 INPUT PRF

- - - * - - - 15-YR SBEACH ERODED PRF

- - - o - - - 25-YR SBEACH ERODED PRF

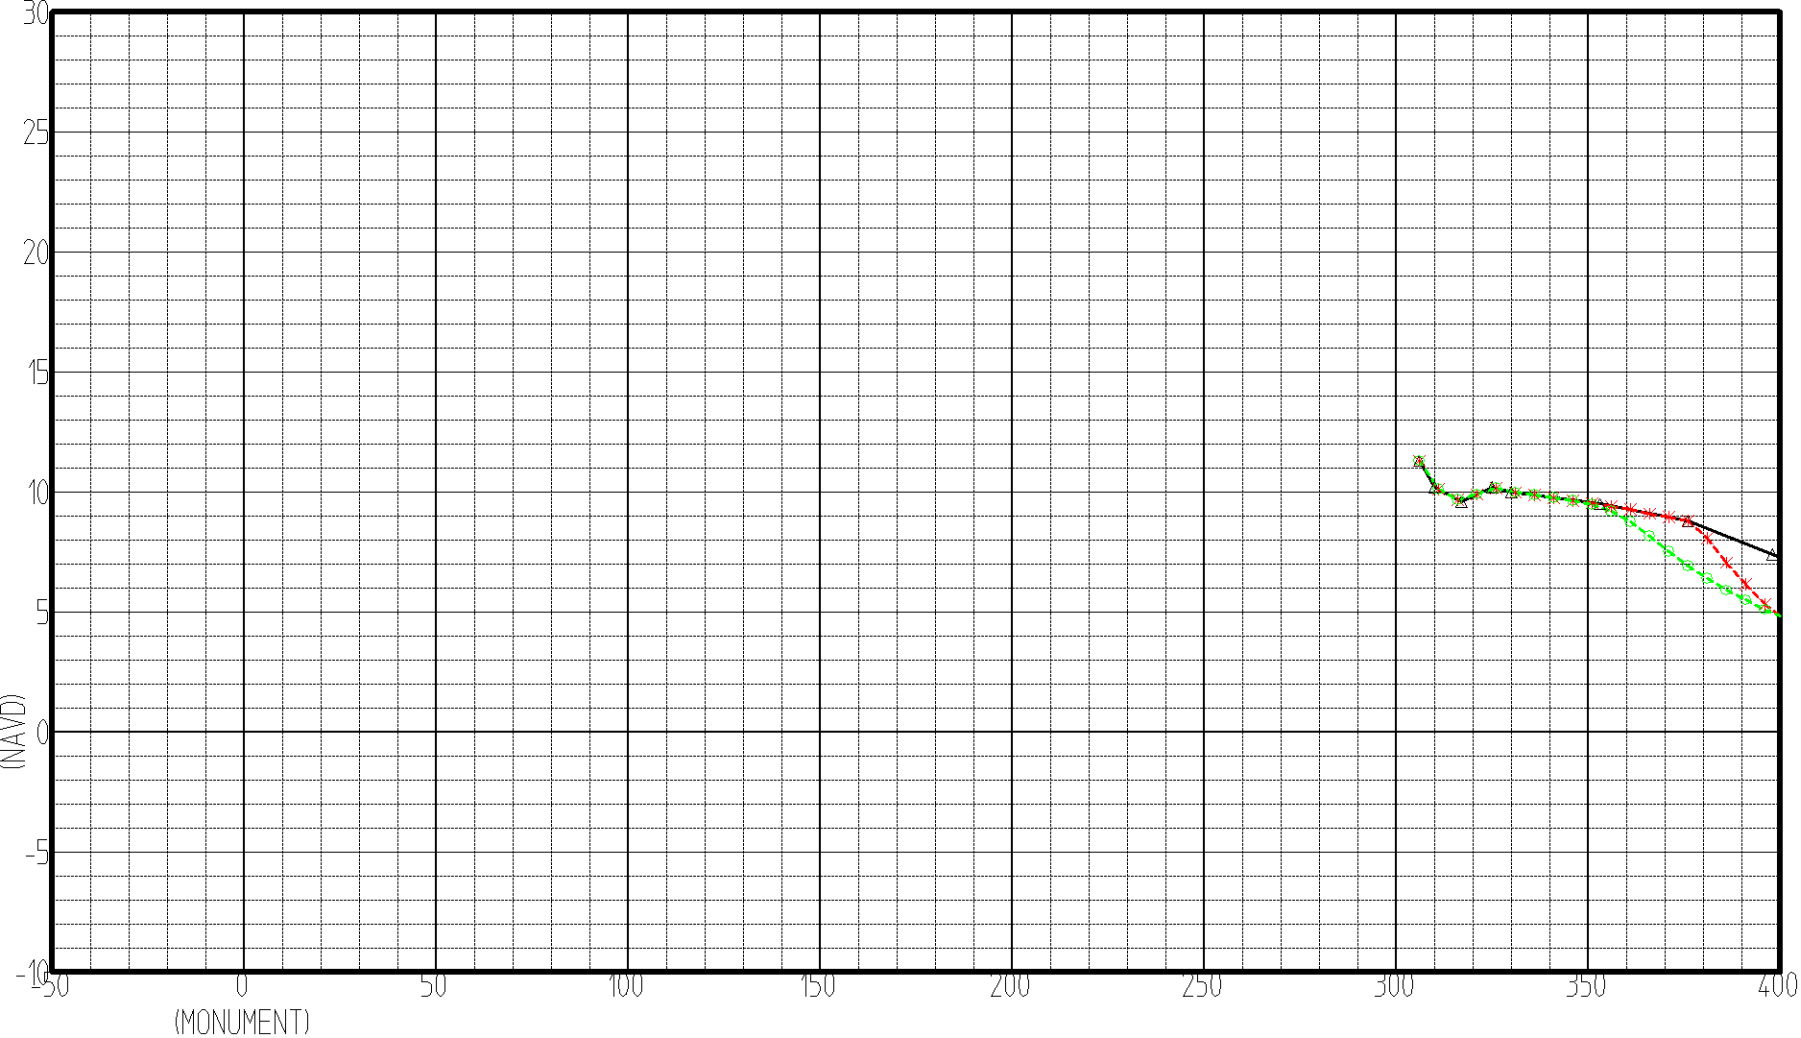
Range: R-123 1/2

—△—△— 2005-2008 INPUT PRF

- - - * - - - 15-YR SBEACH ERODED PRF

- - - o - - - 25-YR SBEACH ERODED PRF

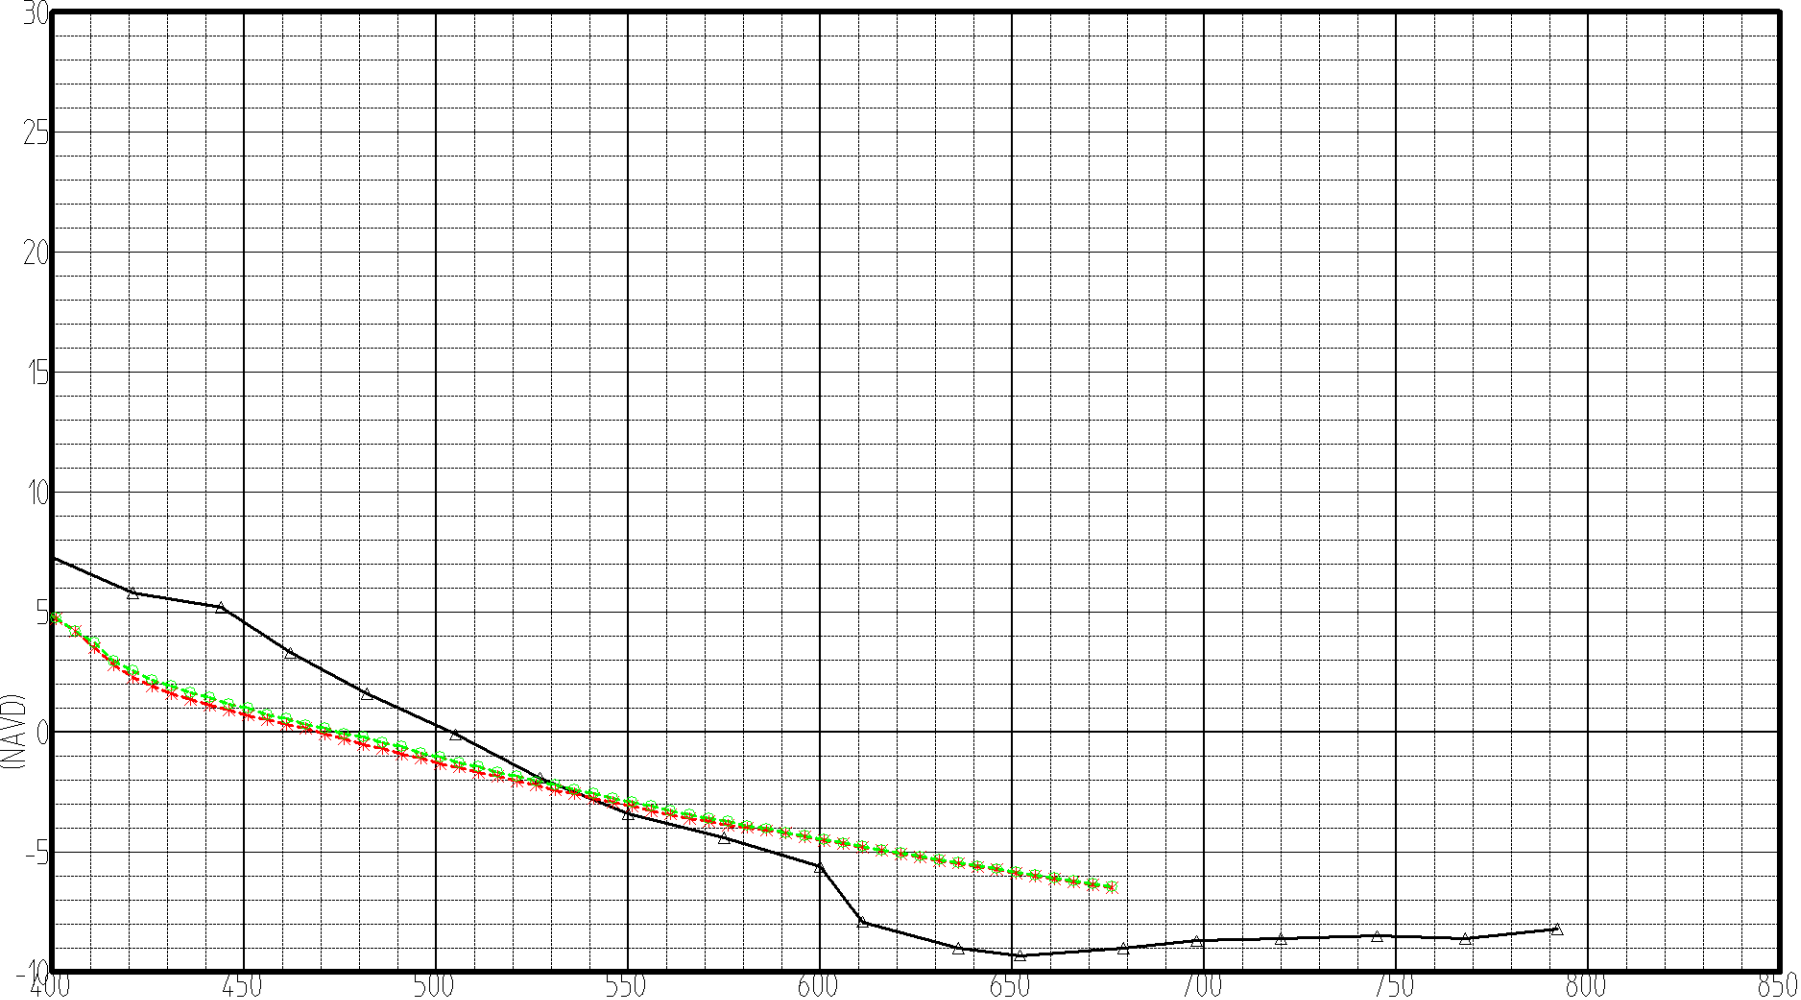
Range: R-123

—△—△— 2005-2008 INPUT PRF

- - - * - - - 15-YR SBEACH ERODED PRF

- - - o - - - 25-YR SBEACH ERODED PRF

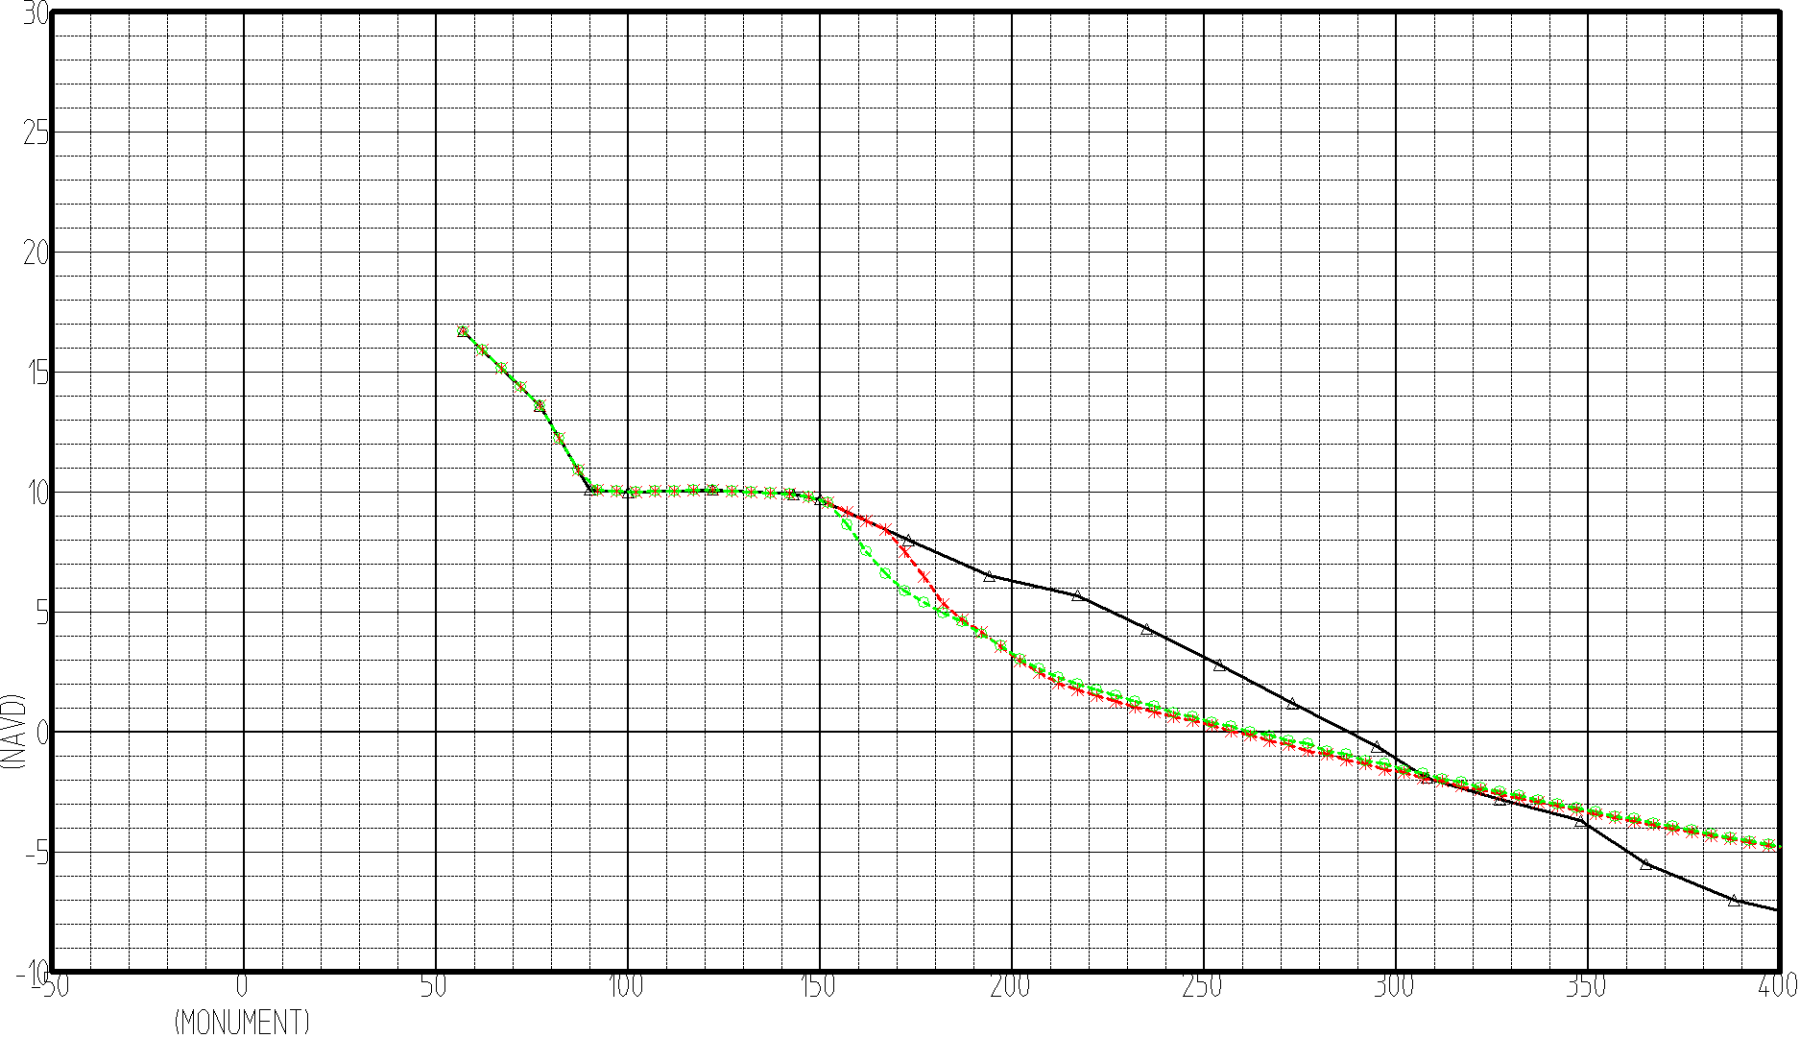
Range: R-124

—△—△— 2005-2008 INPUT PRF

- - * - - * - - 15-YR SBEACH ERODED PRF

- - ○ - - ○ - - 25-YR SBEACH ERODED PRF

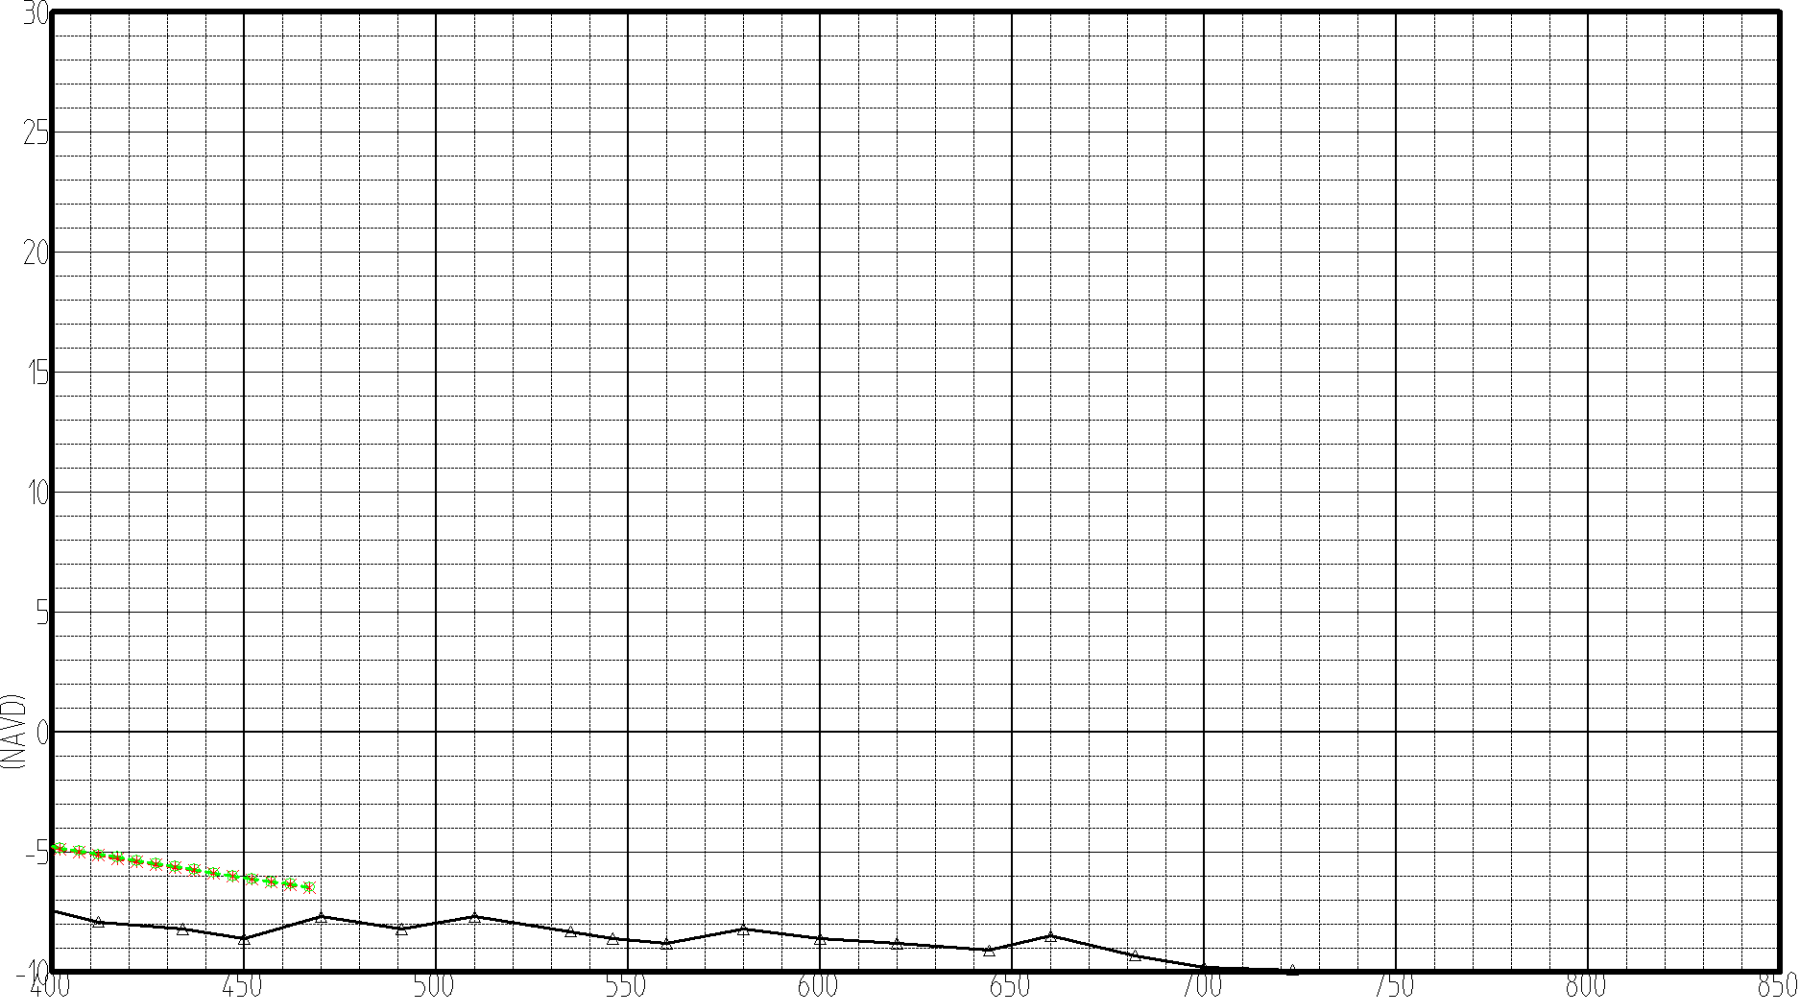
Range: R-124
 BEARING: 80.00
 2/2

BEACH PROFILE
 —△—△— 2005-2008 INPUT PRF
 - - * - - * - - 15-YR SBEACH ERODED PRF
 - - o - - o - - 25-YR SBEACH ERODED PRF

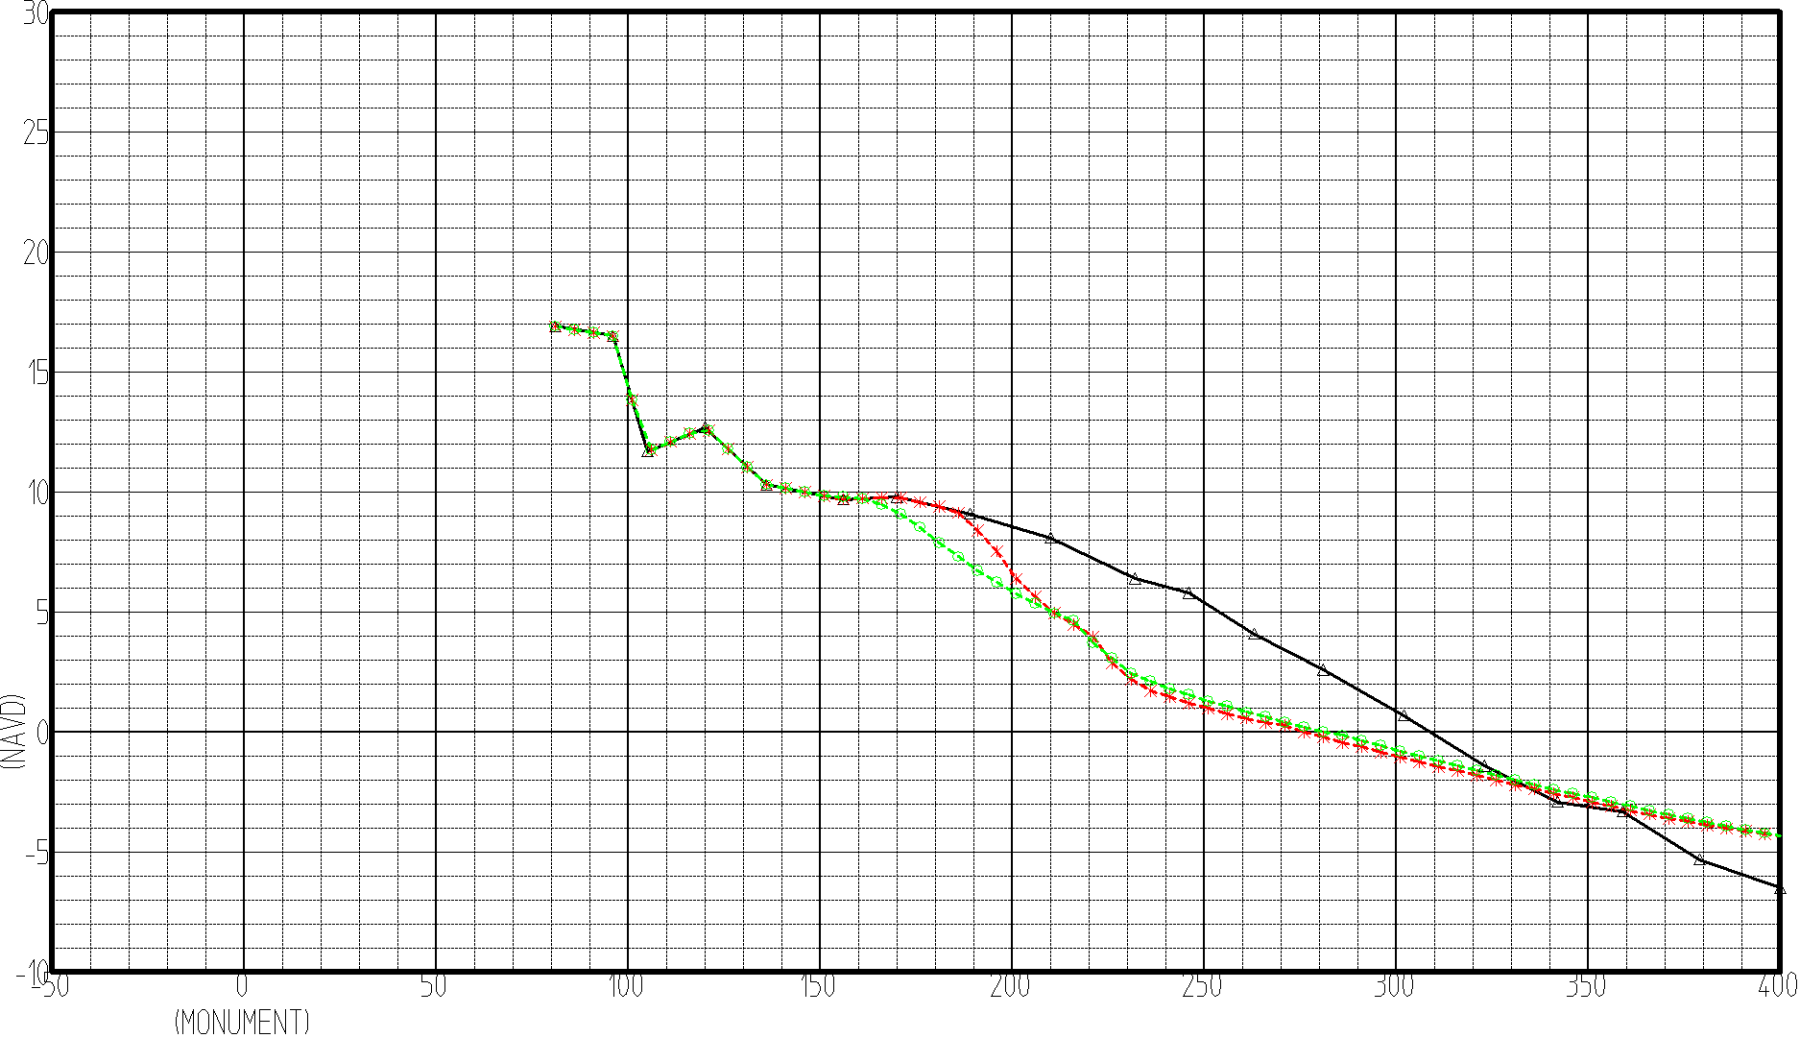
Range: R-125-T

—△—△— 2005-2008 INPUT PRF

- - - * - - - 15-YR SBEACH ERODED PRF

- - - o - - - 25-YR SBEACH ERODED PRF

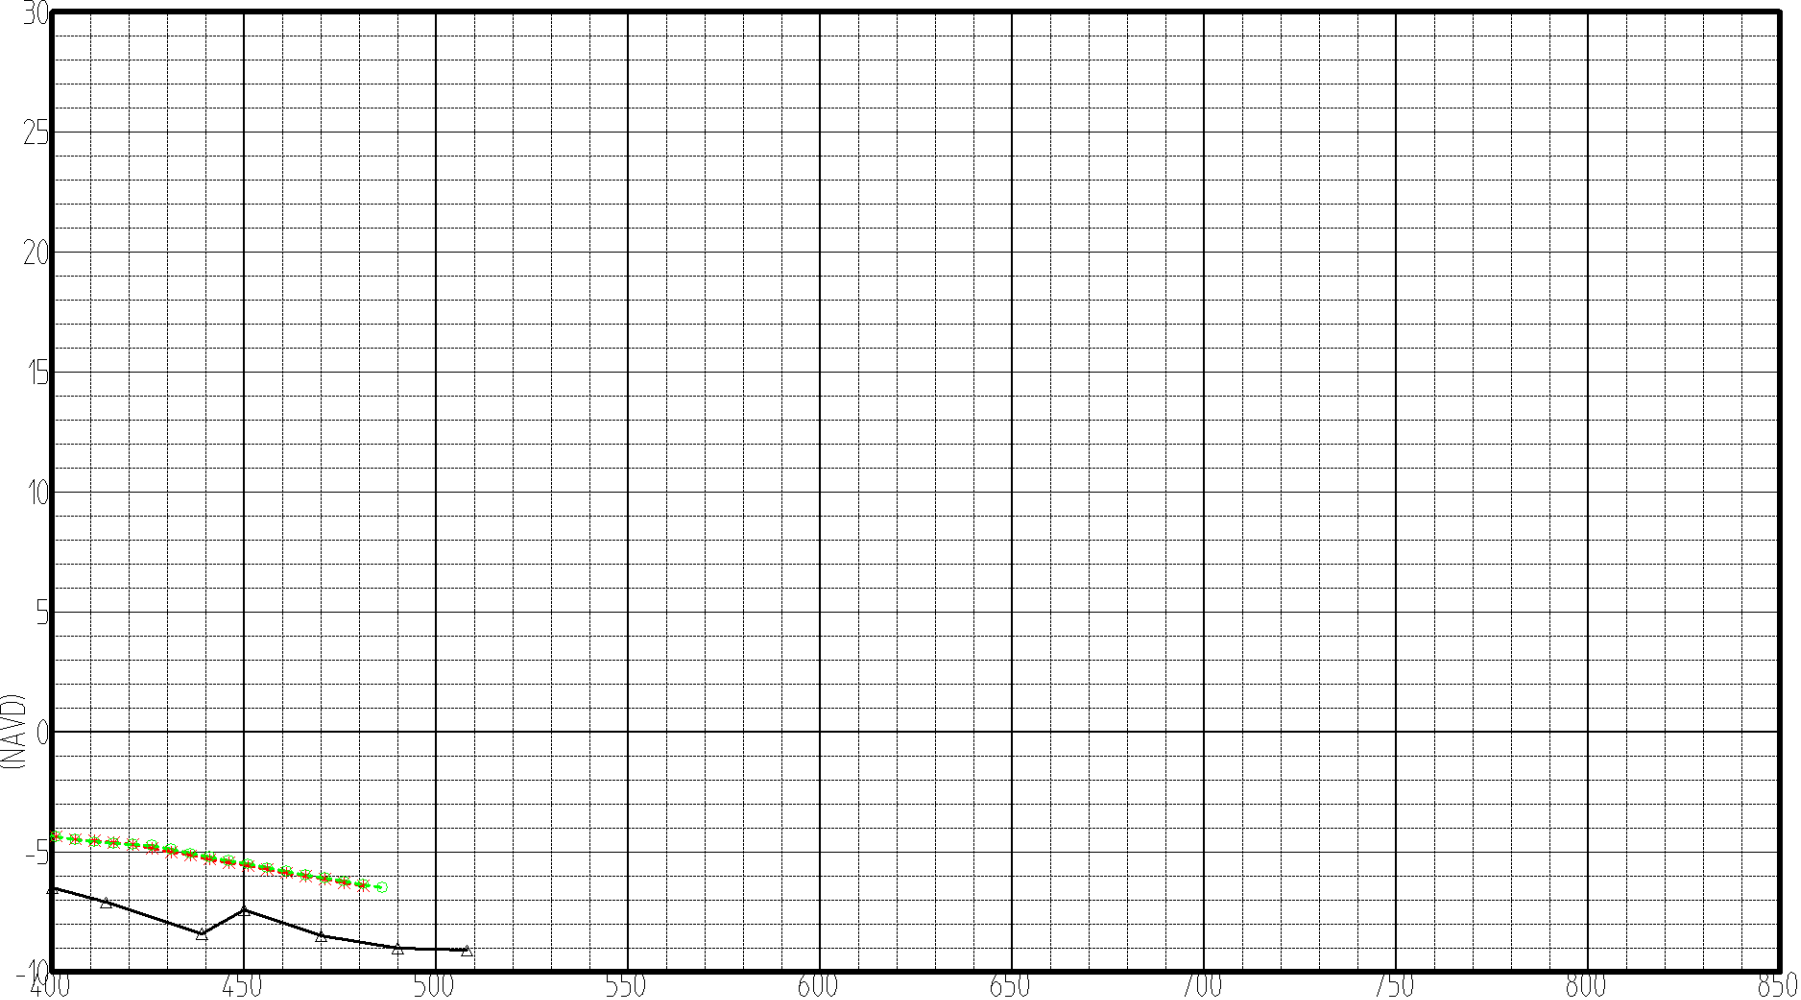
Range: R-125-T

—△—△— 2005-2008 INPUT PRF

- - - * - - - 15-YR SBEACH ERODED PRF

- - - o - - - 25-YR SBEACH ERODED PRF

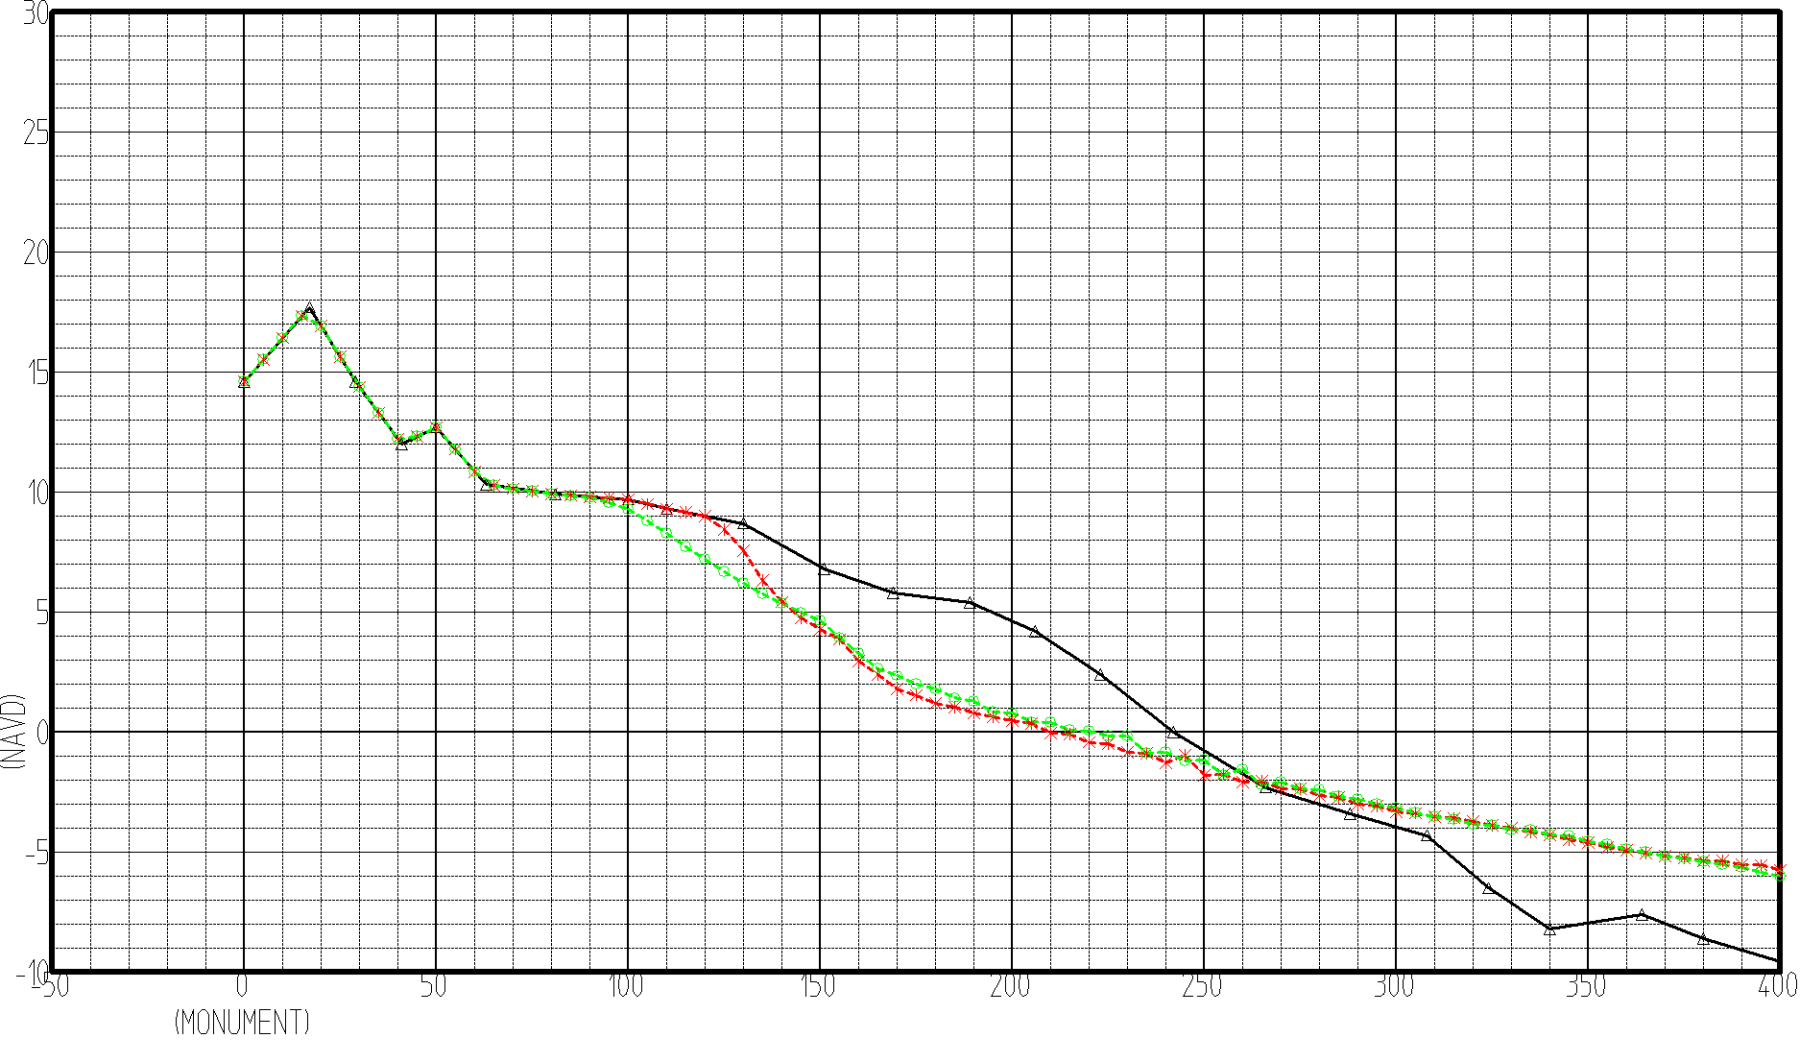
Range: R-126-T

—△—△— 2005-2008 INPUT PRF

- - - * - - - 15-YR SBEACH ERODED PRF

- - - o - - - 25-YR SBEACH ERODED PRF

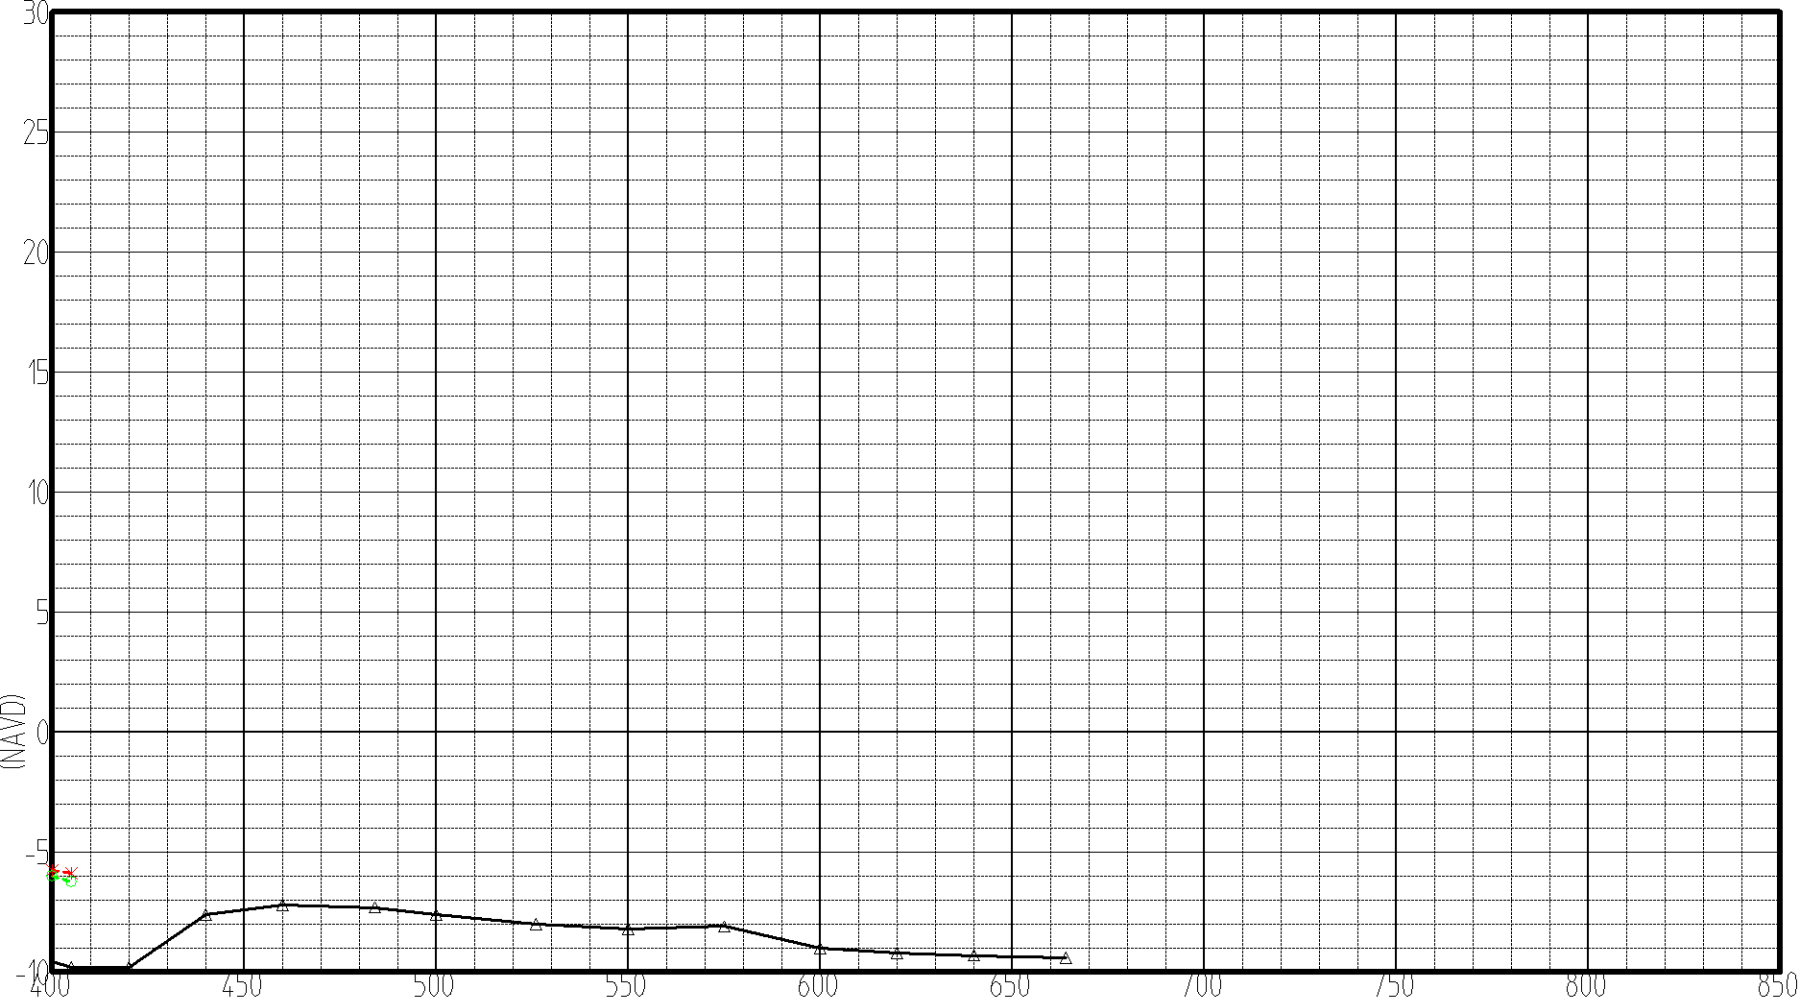
Range: R-126-T 2/2
 BEARING: 80.00

BEACH PROFILE
 —△—△— 2005-2008 INPUT PRF
 - - * - - * - - 15-YR SBEACH ERODED PRF
 - - o - - o - - 25-YR SBEACH ERODED PRF

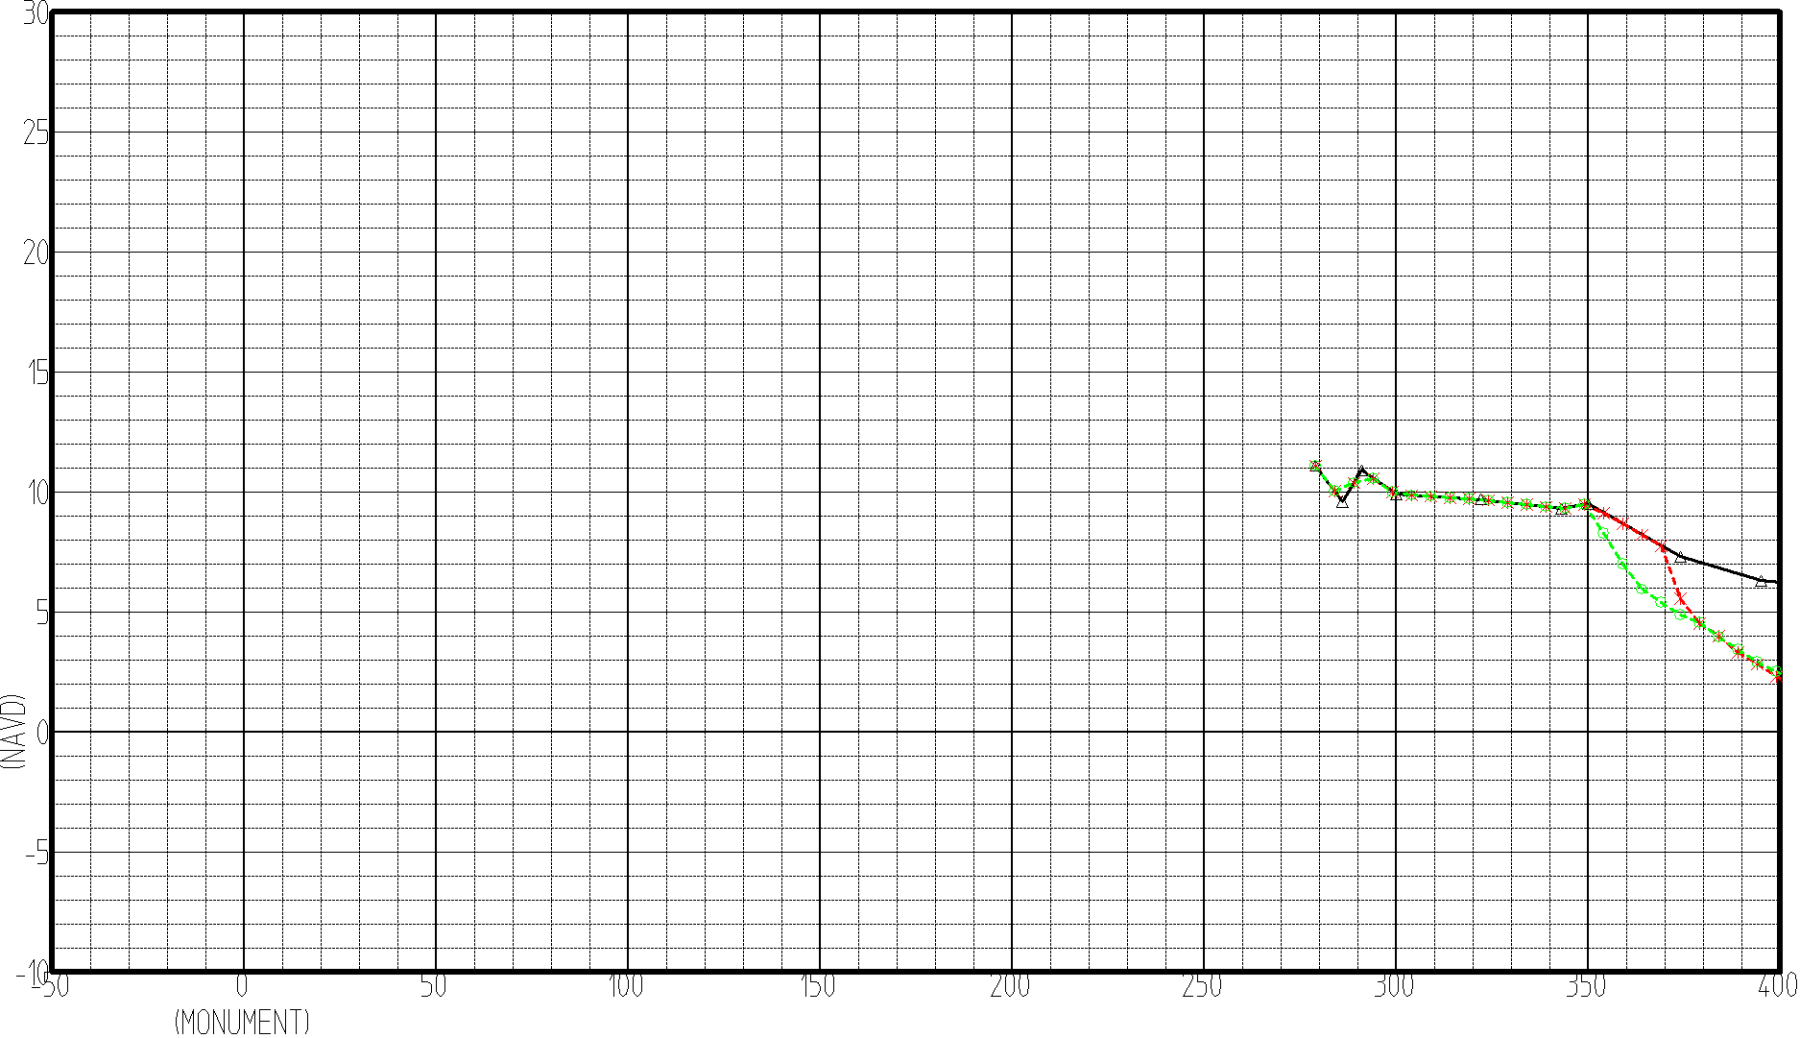
Range: R-127

—△—△— 2005-2008 INPUT PRF

- - - * - - - 15-YR SBEACH ERODED PRF

- - - o - - - 25-YR SBEACH ERODED PRF
