Appendix XI

SBEACH 15 and 25 yr. Storm Erosion Profiles

Brevard County

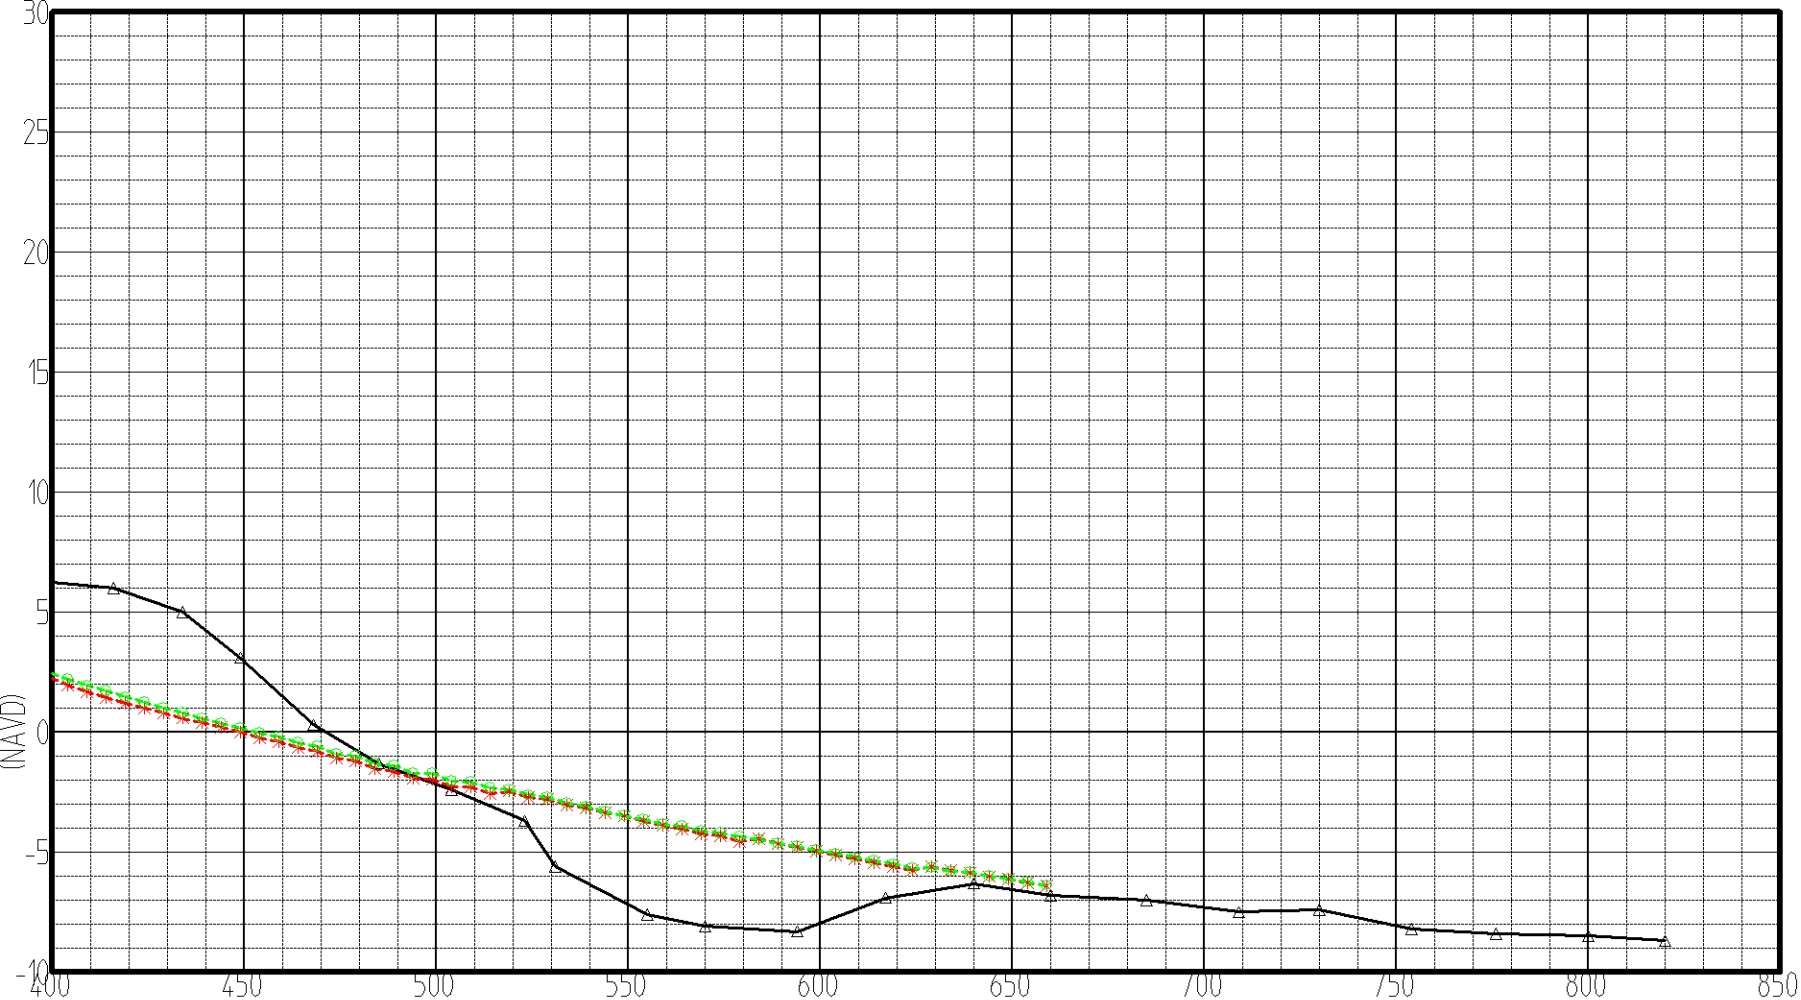
Range: R-127
 BEARING: 80.00
 2/2

BEACH PROFILE
 —△—△— 2005-2008 INPUT PRF
 - - * - - * - - 15-YR SBEACH ERODED PRF
 - - o - - o - - 25-YR SBEACH ERODED PRF

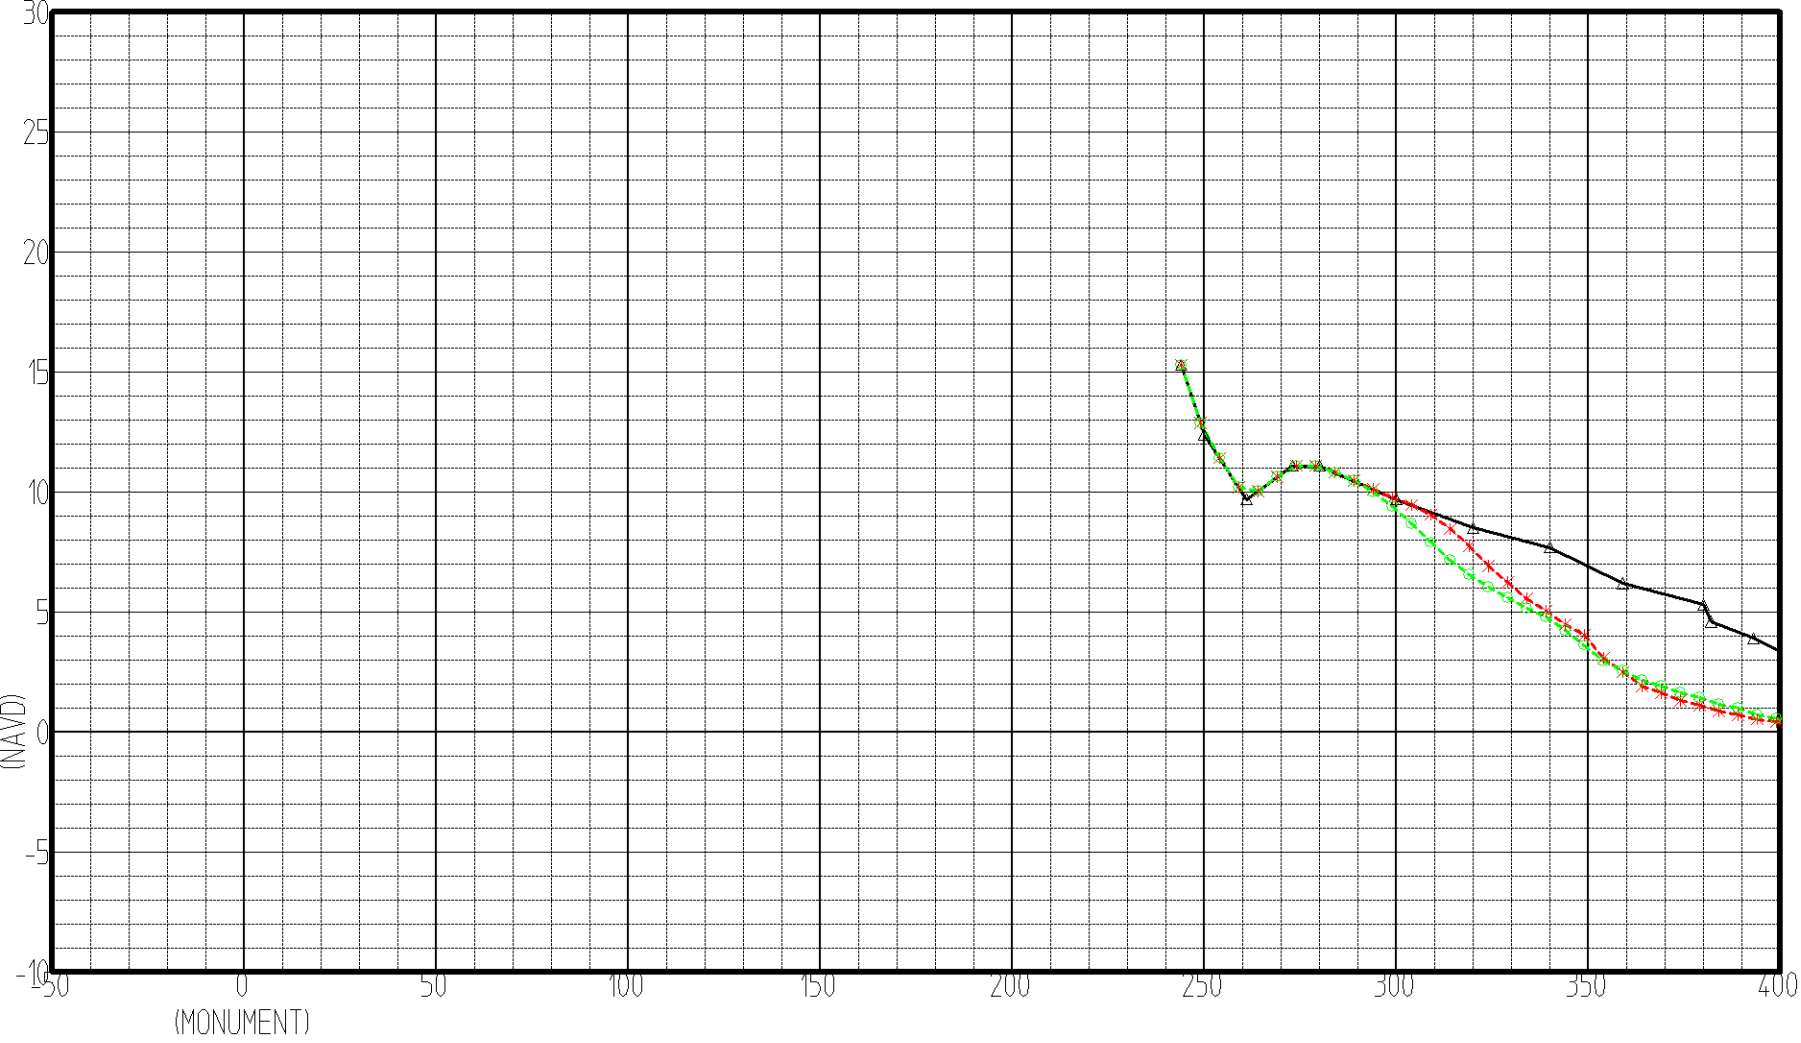
Range: R-128

—△—△— 2005-2008 INPUT PRF

- - * - - * - - 15-YR SBEACH ERODED PRF

- - o - - o - - 25-YR SBEACH ERODED PRF

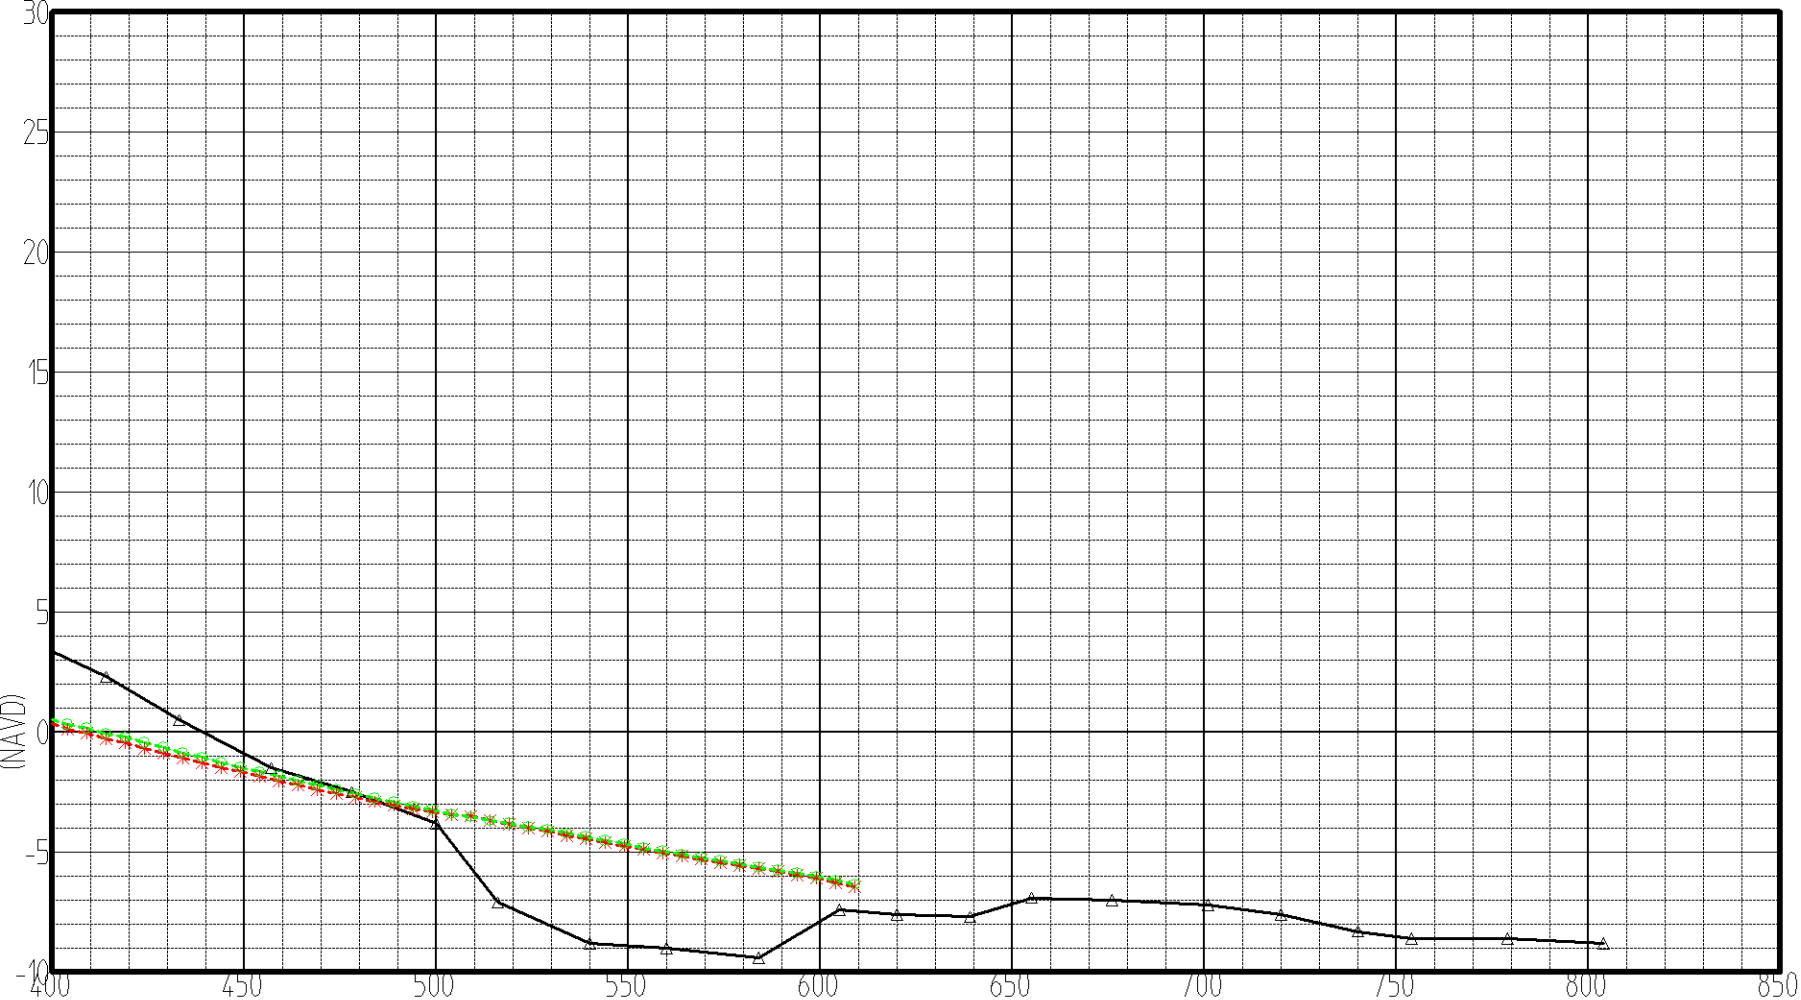
Range: R-128

—△—△— 2005-2008 INPUT PRF

- - - * - - - 15-YR SBEACH ERODED PRF

- - - o - - - 25-YR SBEACH ERODED PRF

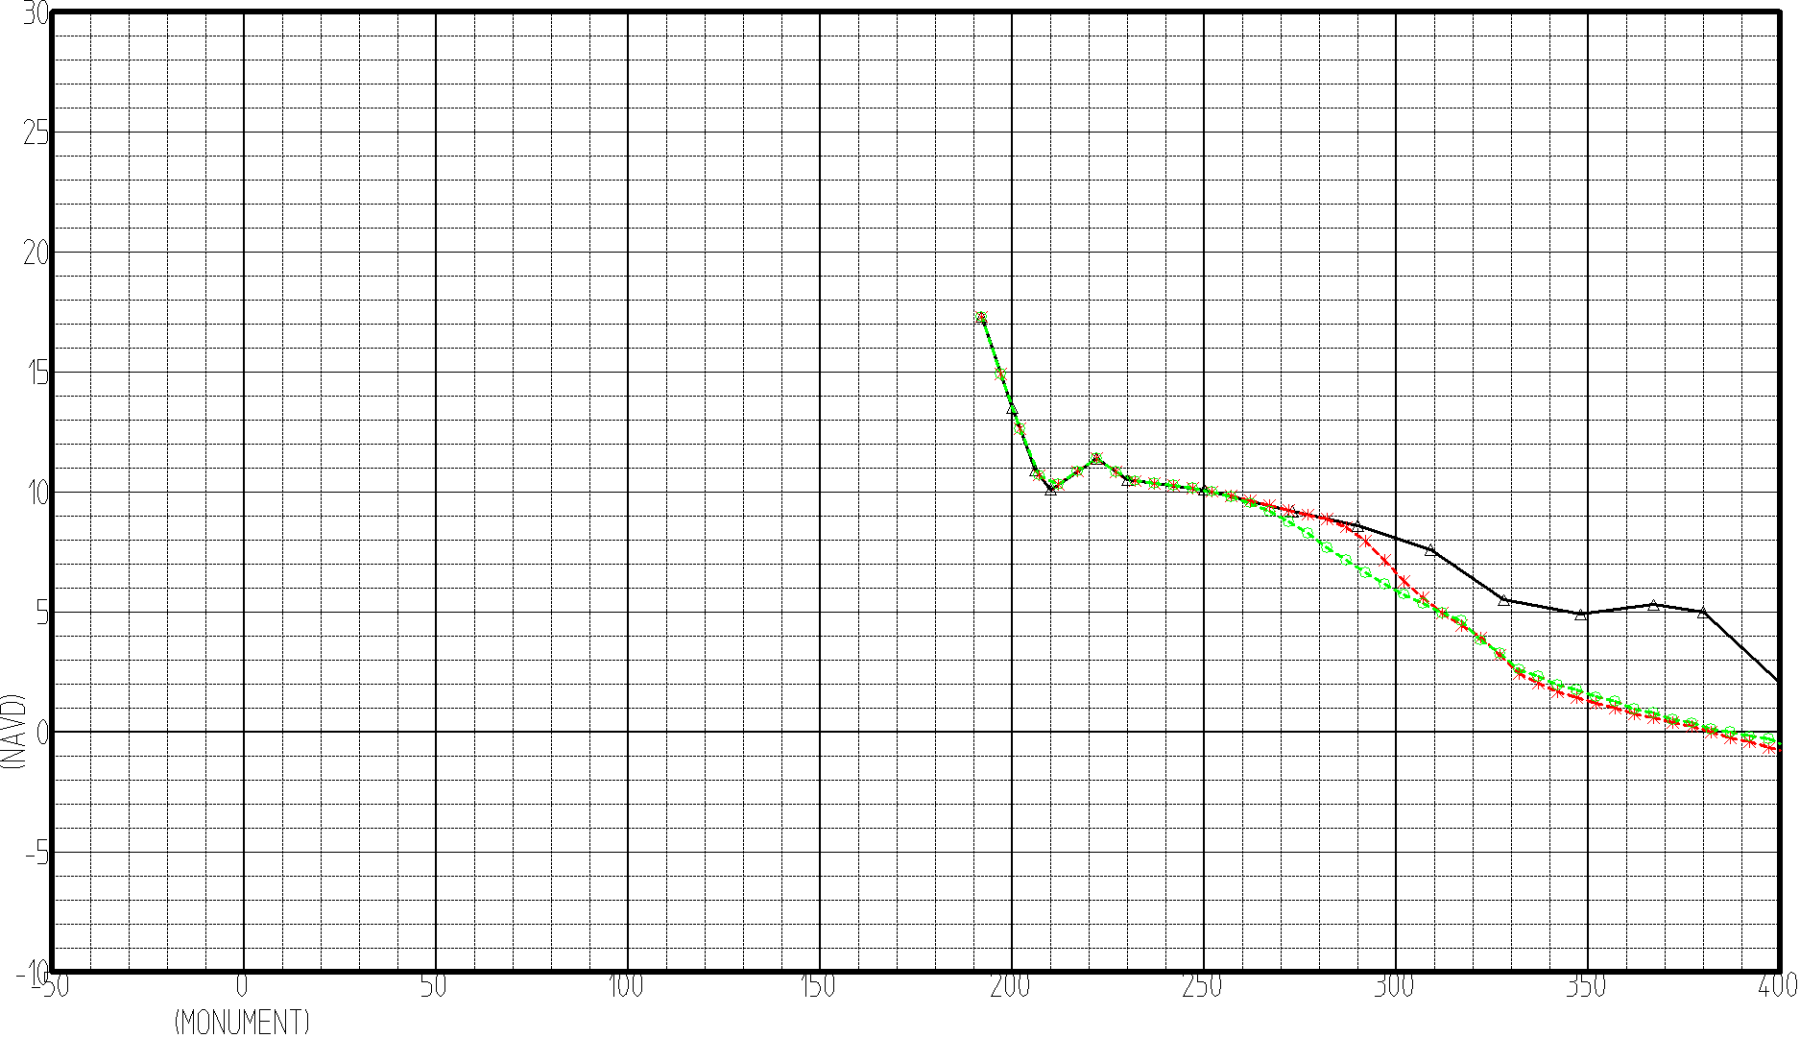
Range: R-129-T 1/2

- △—△— 2005-2008 INPUT PRF
- - * - - * - - 15-YR SBEACH ERODED PRF
- - o - - o - - 25-YR SBEACH ERODED PRF

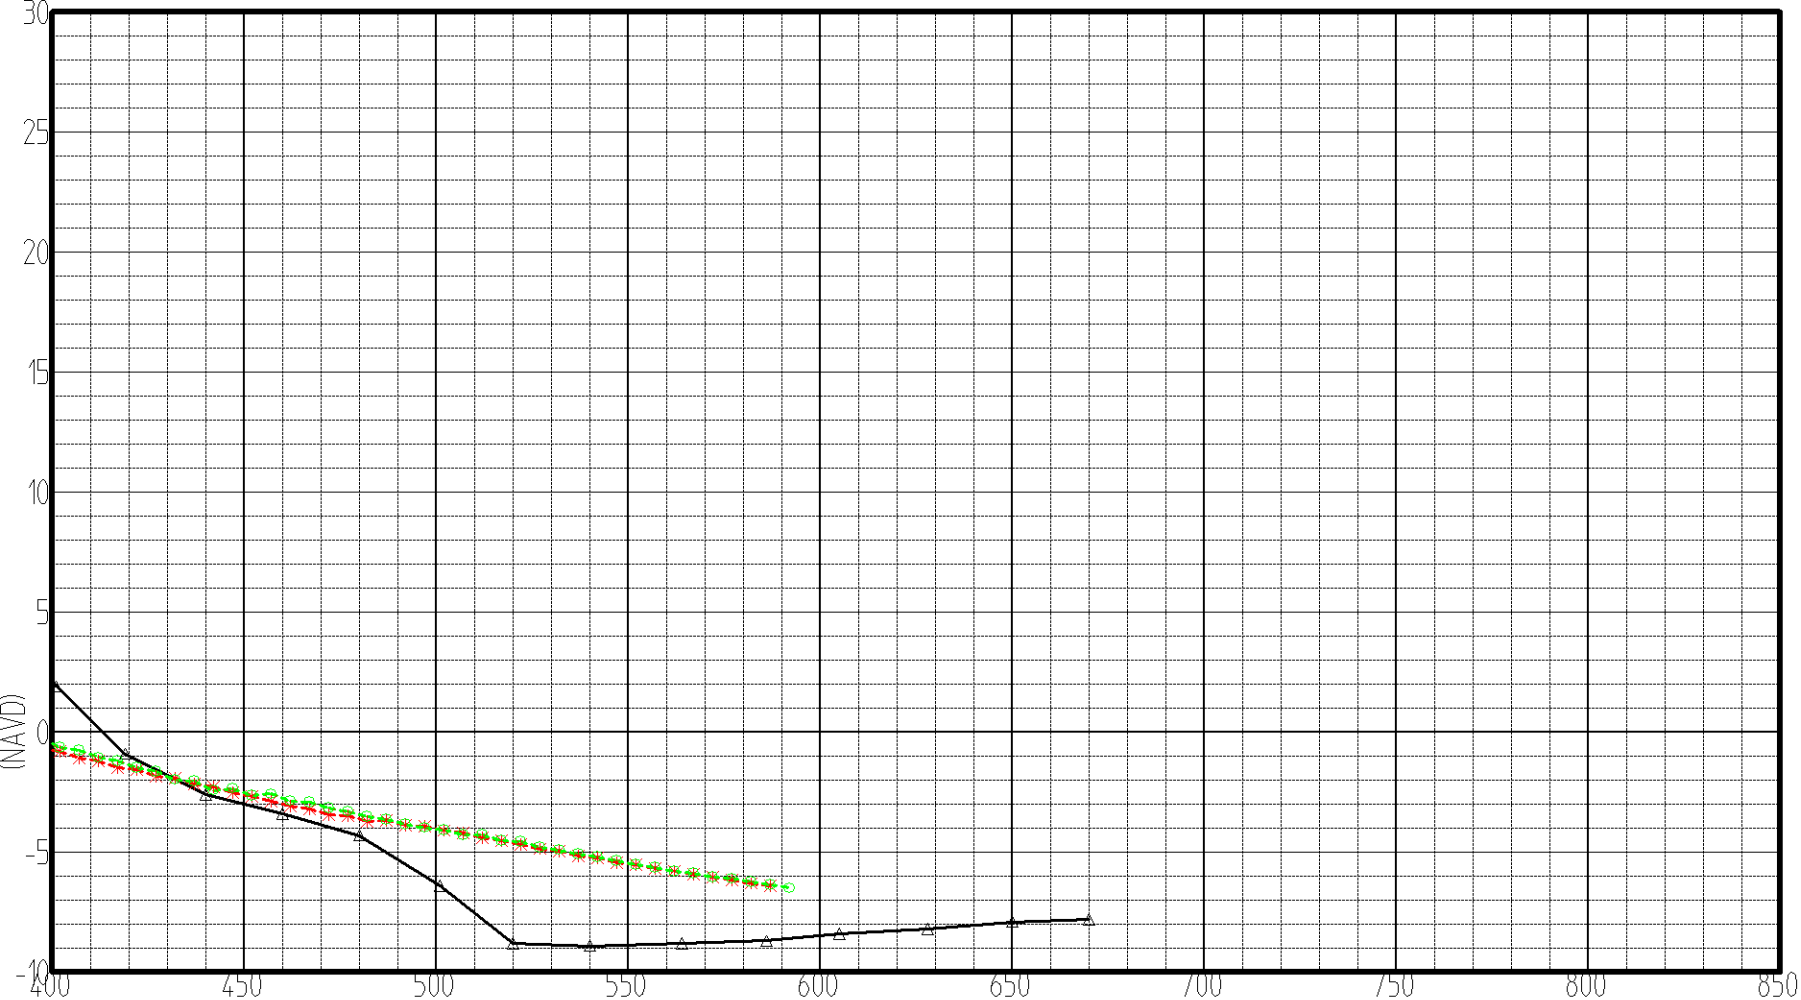
Range: R-129-T

—△—△— 2005-2008 INPUT PRF

- - - * - - - 15-YR SBEACH ERODED PRF

- - - o - - - 25-YR SBEACH ERODED PRF

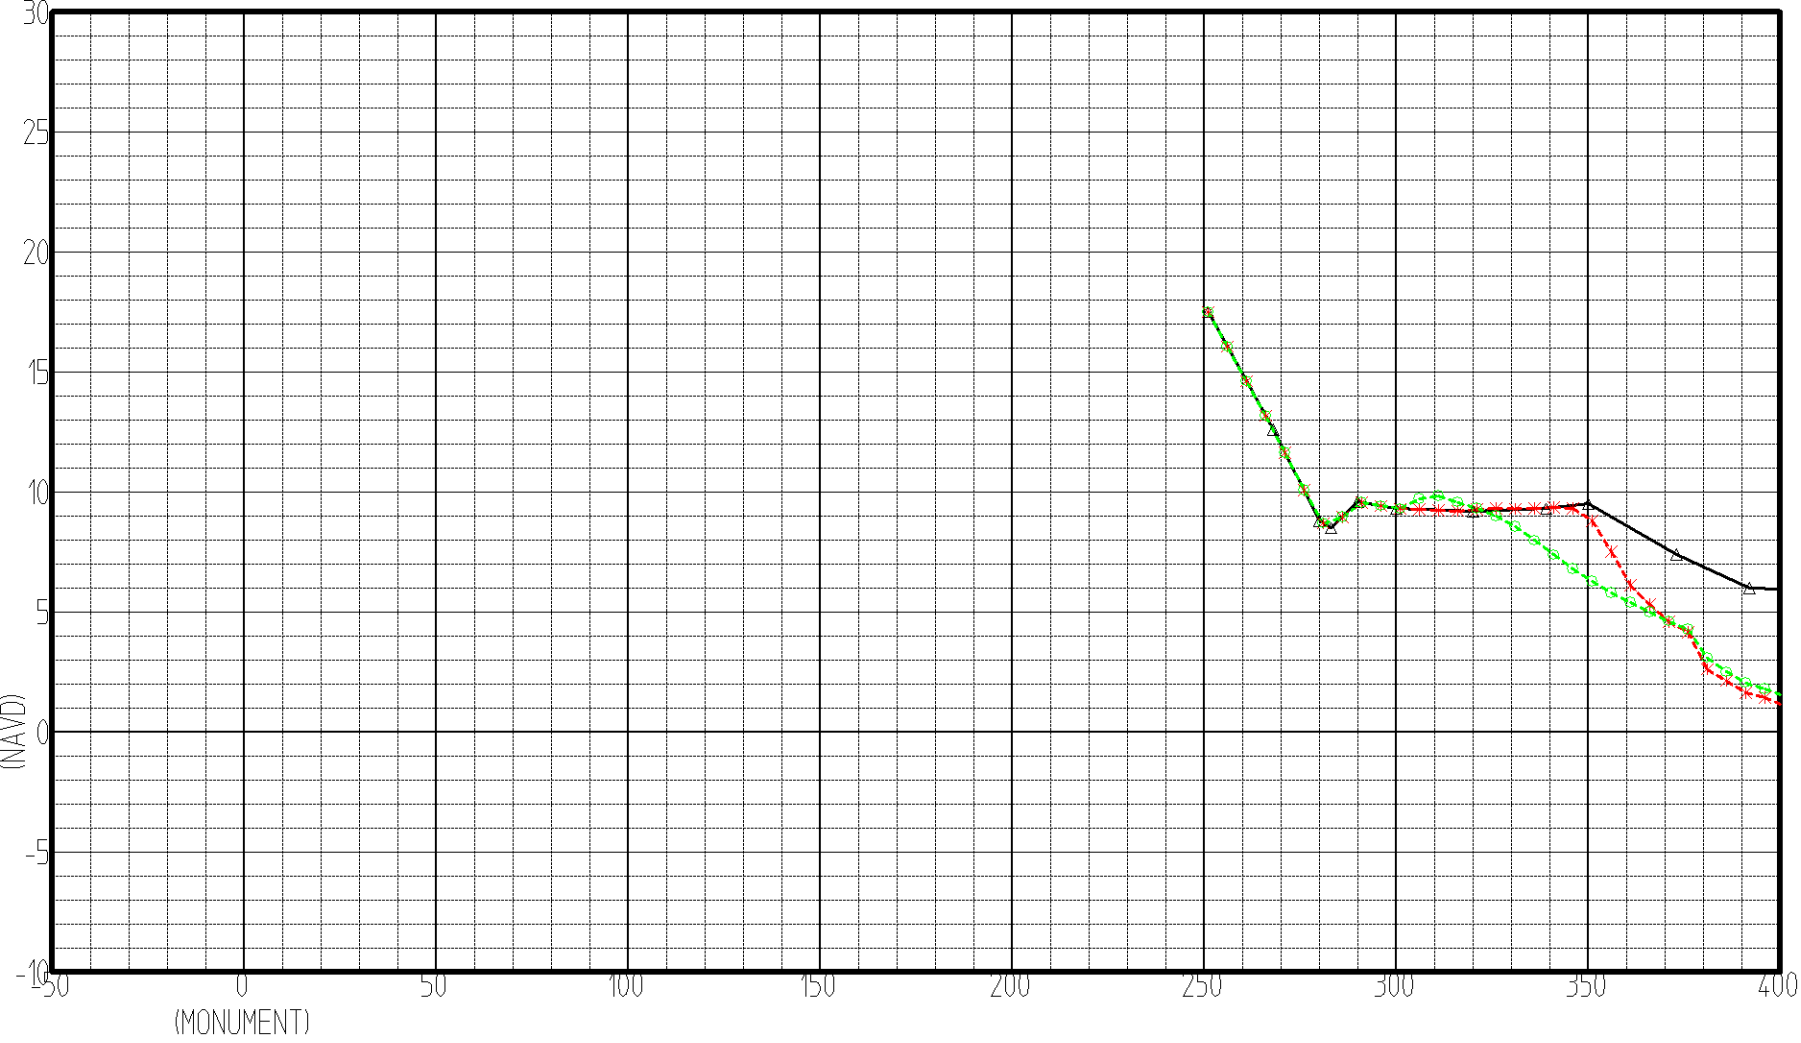
Range: R-130

—△—△— 2005-2008 INPUT PRF

- - * - - * - - 15-YR SBEACH ERODED PRF

- - ○ - - ○ - - 25-YR SBEACH ERODED PRF

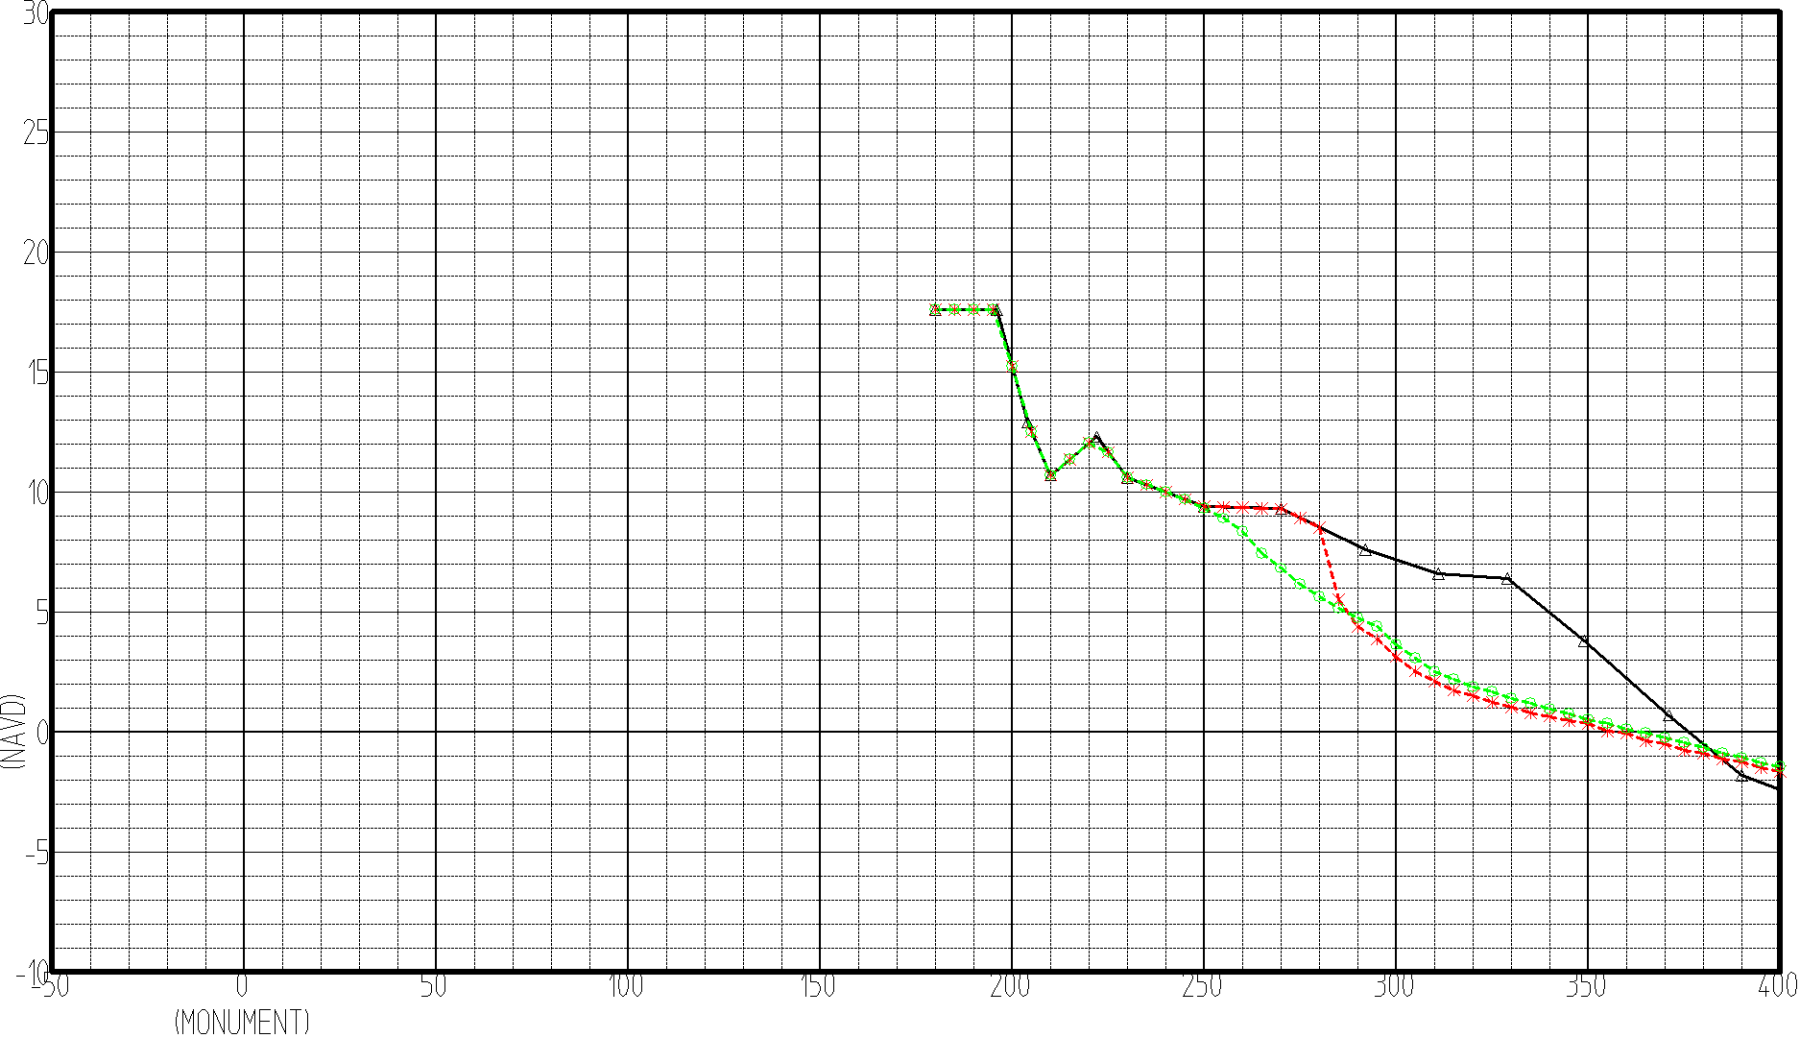
Range: R-131

BEACH PROFILE

—△—△— 2005-2008 INPUT PRF

- - - * - - - 15-YR SBEACH ERODED PRF

- - - o - - - 25-YR SBEACH ERODED PRF

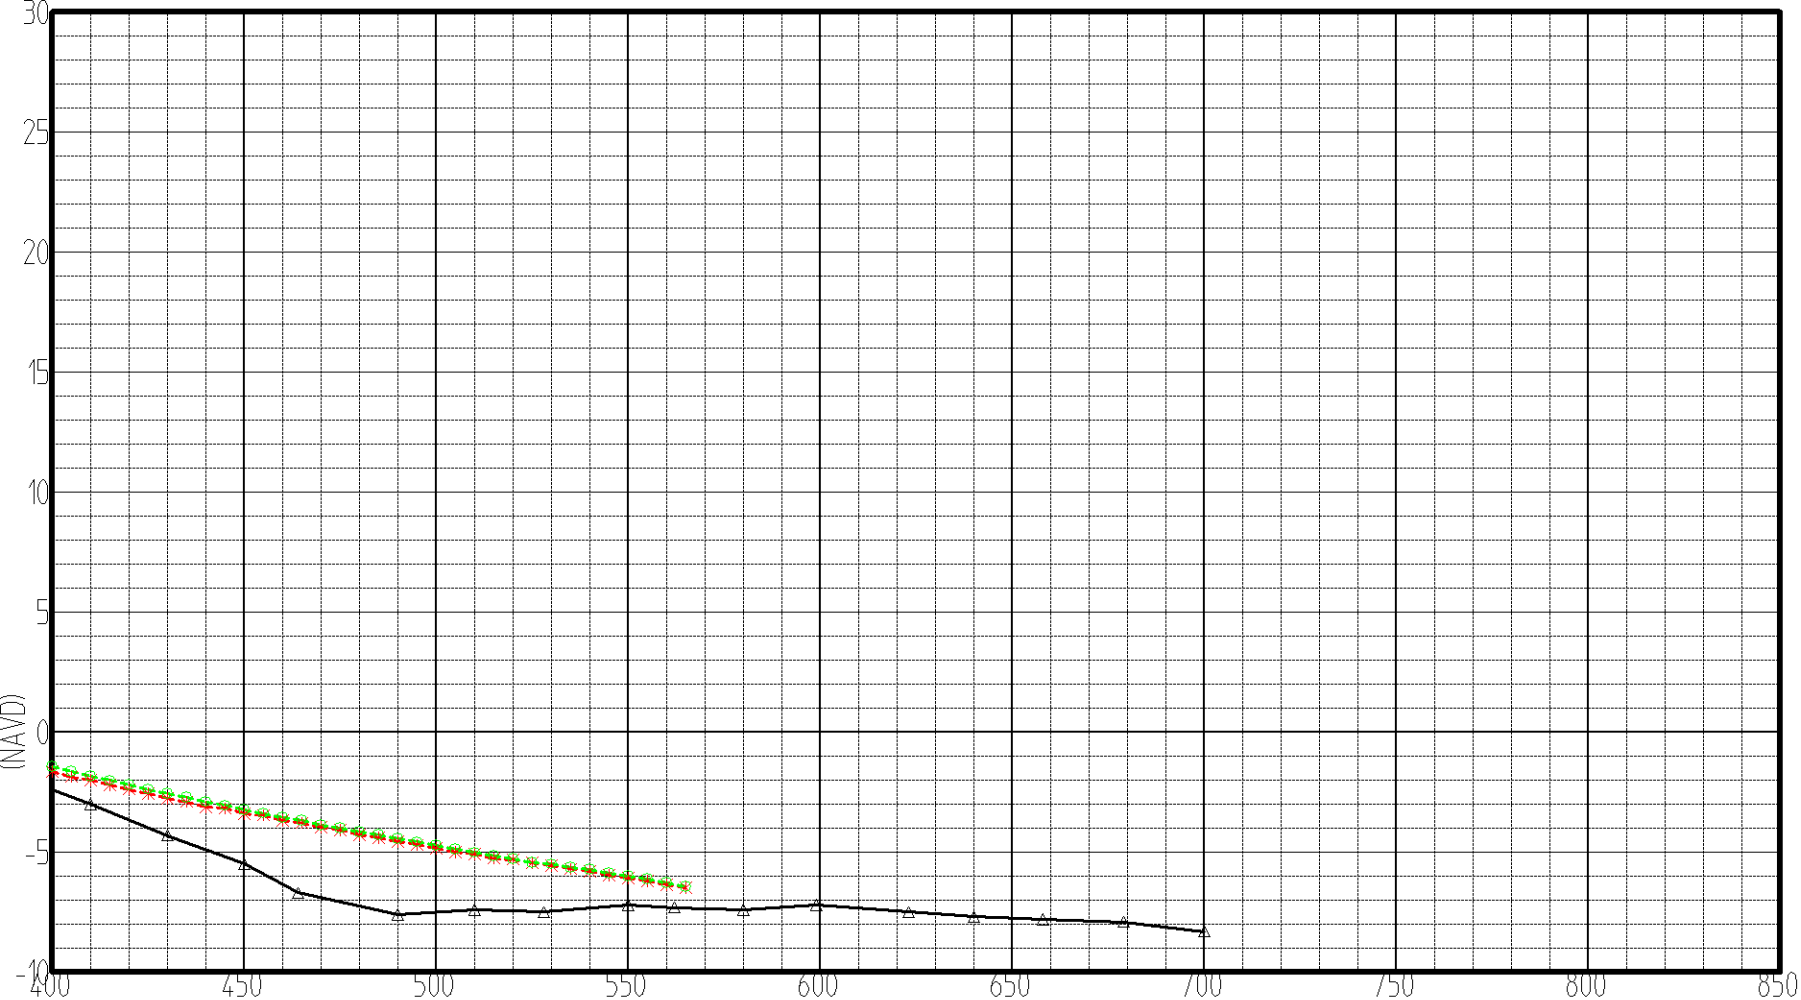
Range: R-131

BEACH PROFILE

—△—△— 2005-2008 INPUT PRF

- - - * - - - 15-YR SBEACH ERODED PRF

- - - o - - - 25-YR SBEACH ERODED PRF

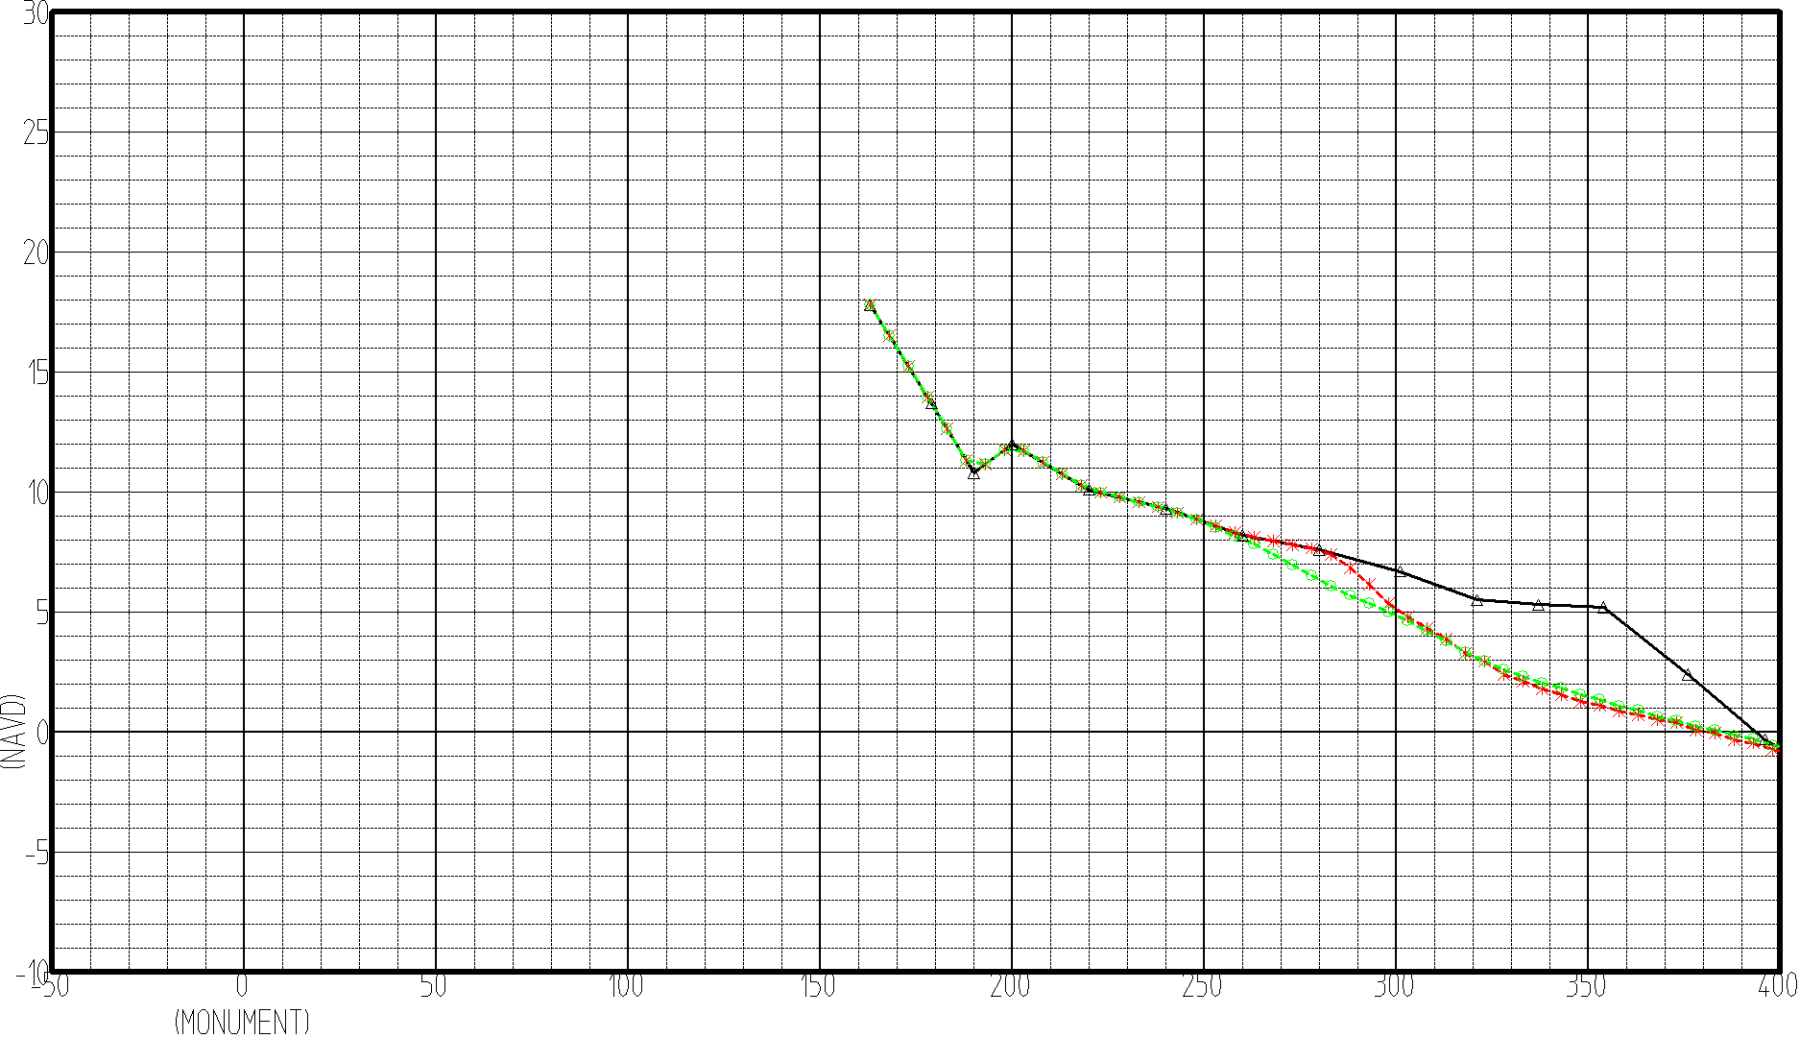
Range: R-132
 BEARING: 80.00
 1/3

BEACH PROFILE
 —△—△— 2005-2008 INPUT PRF
 - - * - - * - - 15-YR SBEACH ERODED PRF
 - - o - - o - - 25-YR SBEACH ERODED PRF

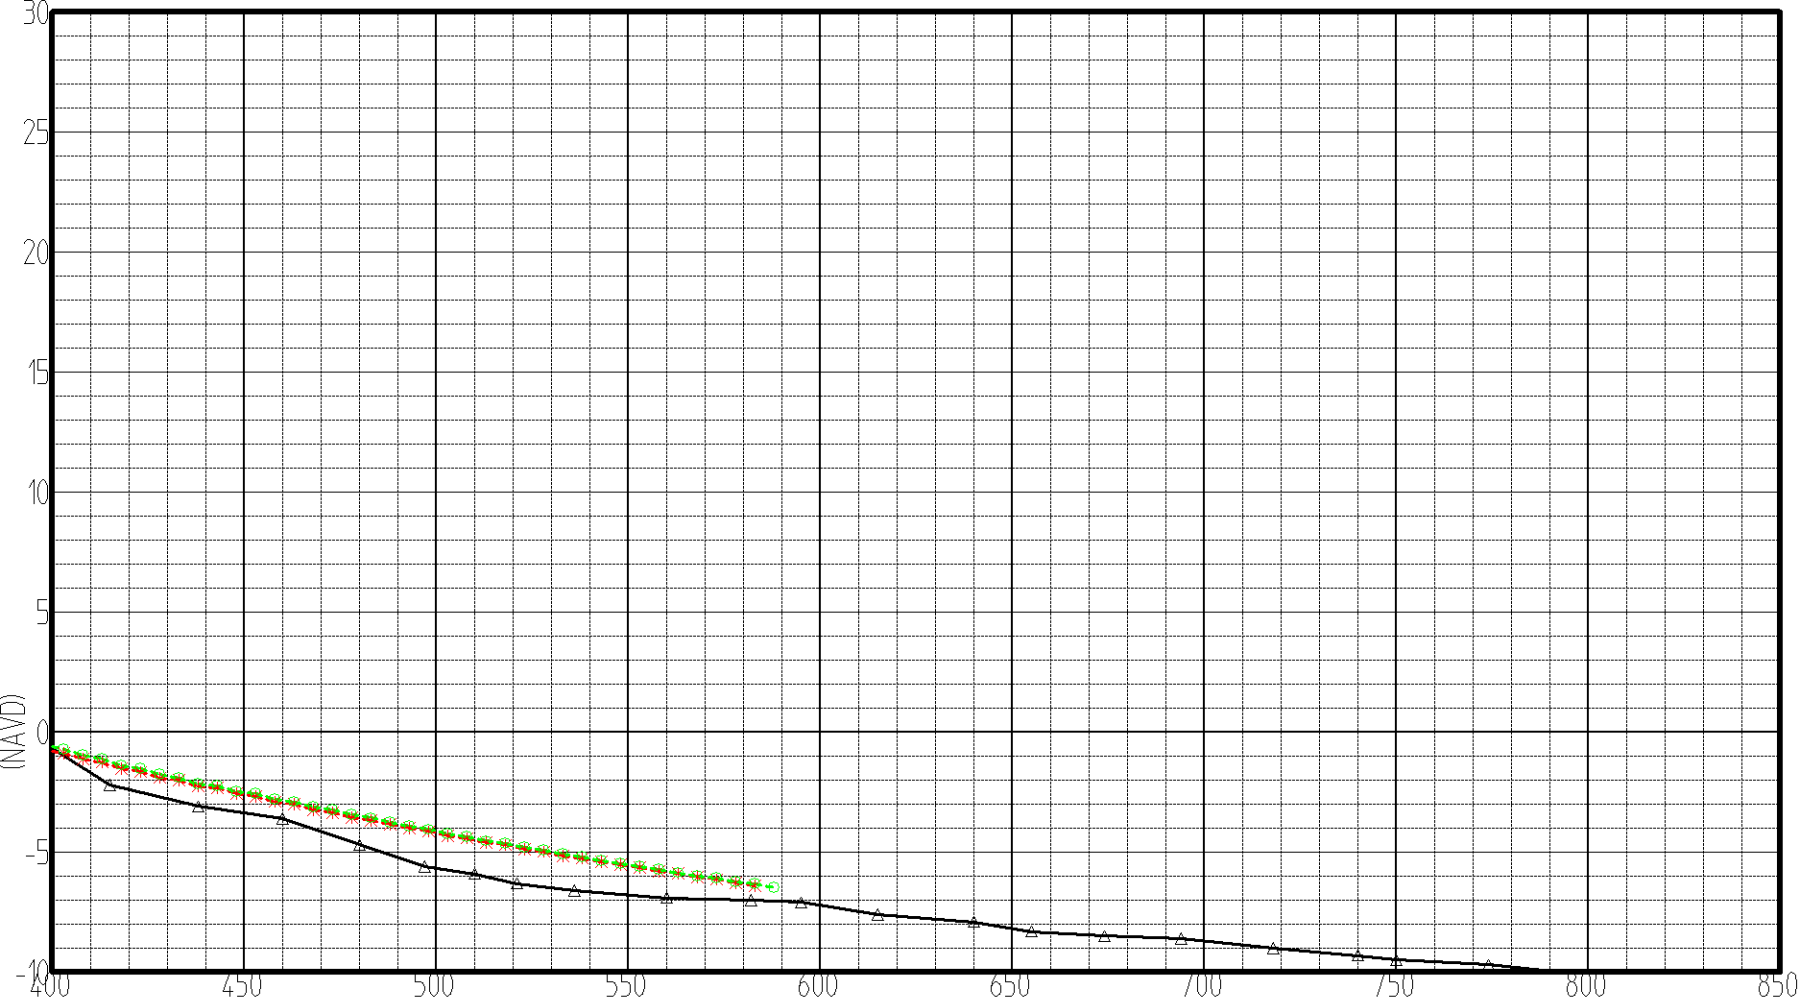
Range: R-132

BEACH PROFILE

—△—△— 2005-2008 INPUT PRF
 - - * - - * - - 15-YR SBEACH ERODED PRF
 - - o - - o - - 25-YR SBEACH ERODED PRF

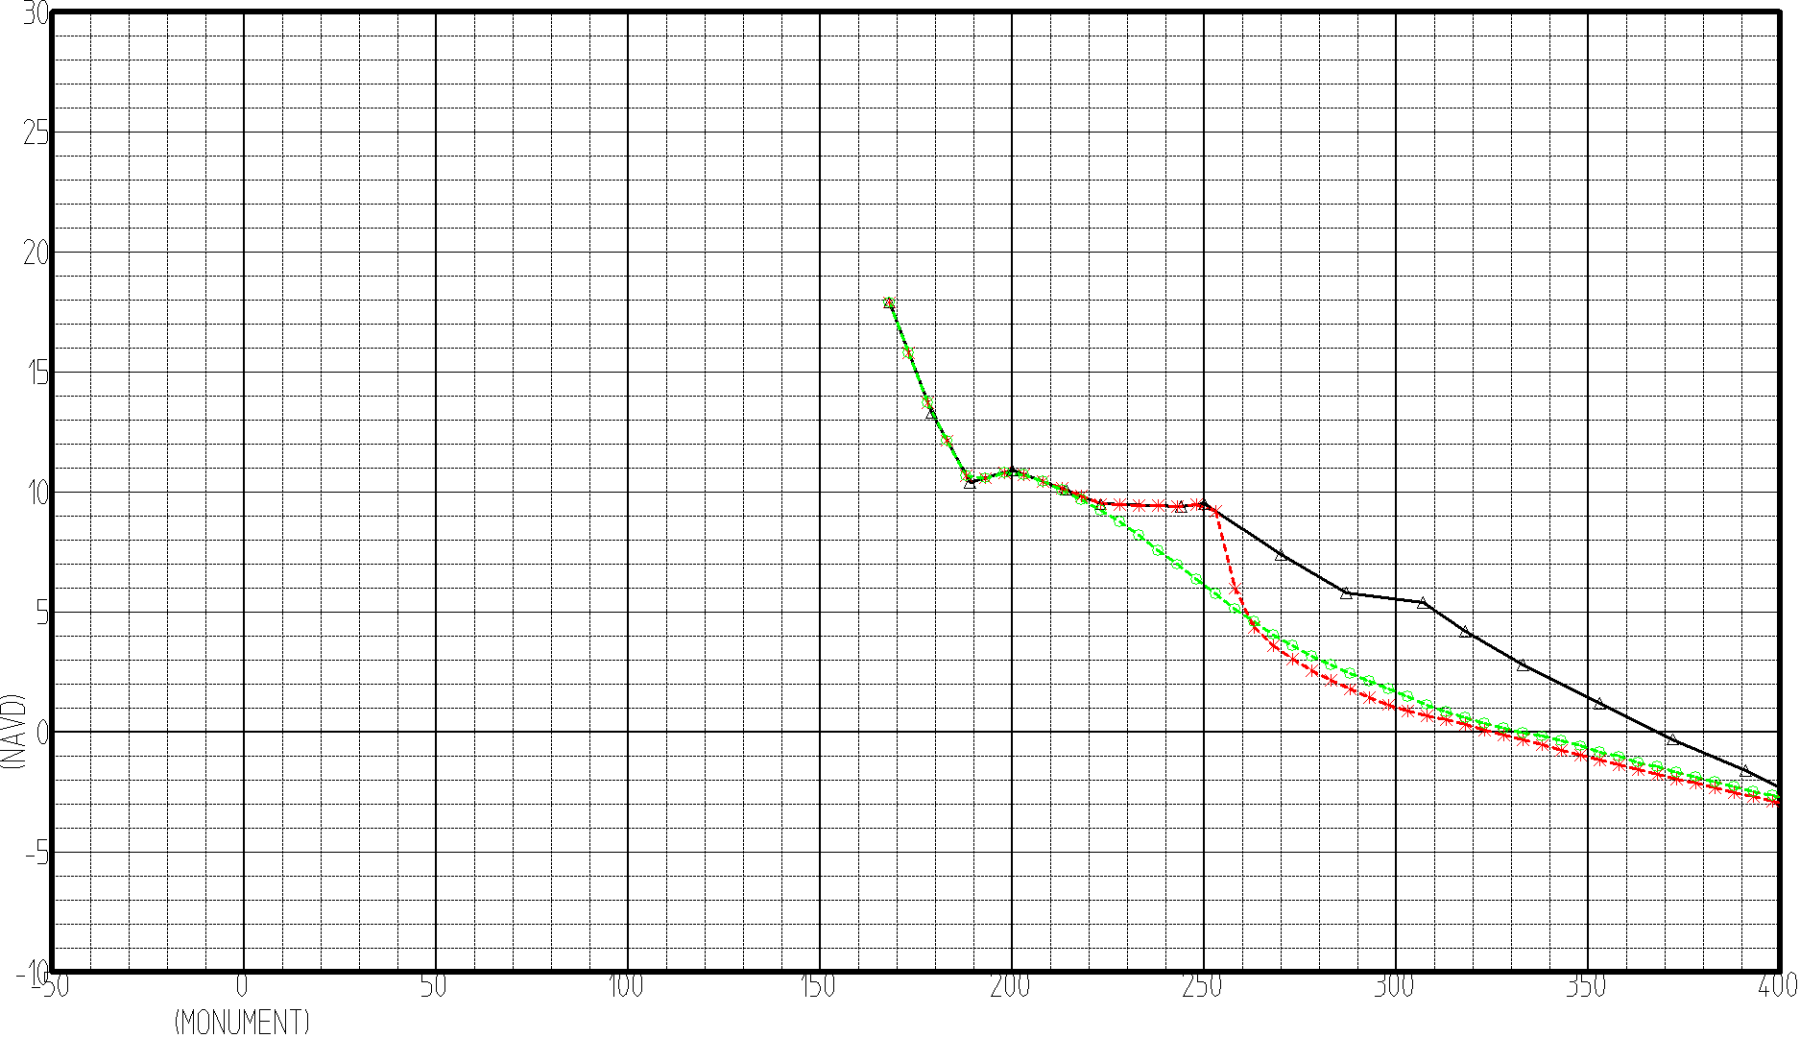
Range: R-133
 BEARING: 80.00
 1/2

BEACH PROFILE
 —△—△— 2005-2008 INPUT PRF
 - - * - - 15-YR SBEACH ERODED PRF
 - - o - - 25-YR SBEACH ERODED PRF

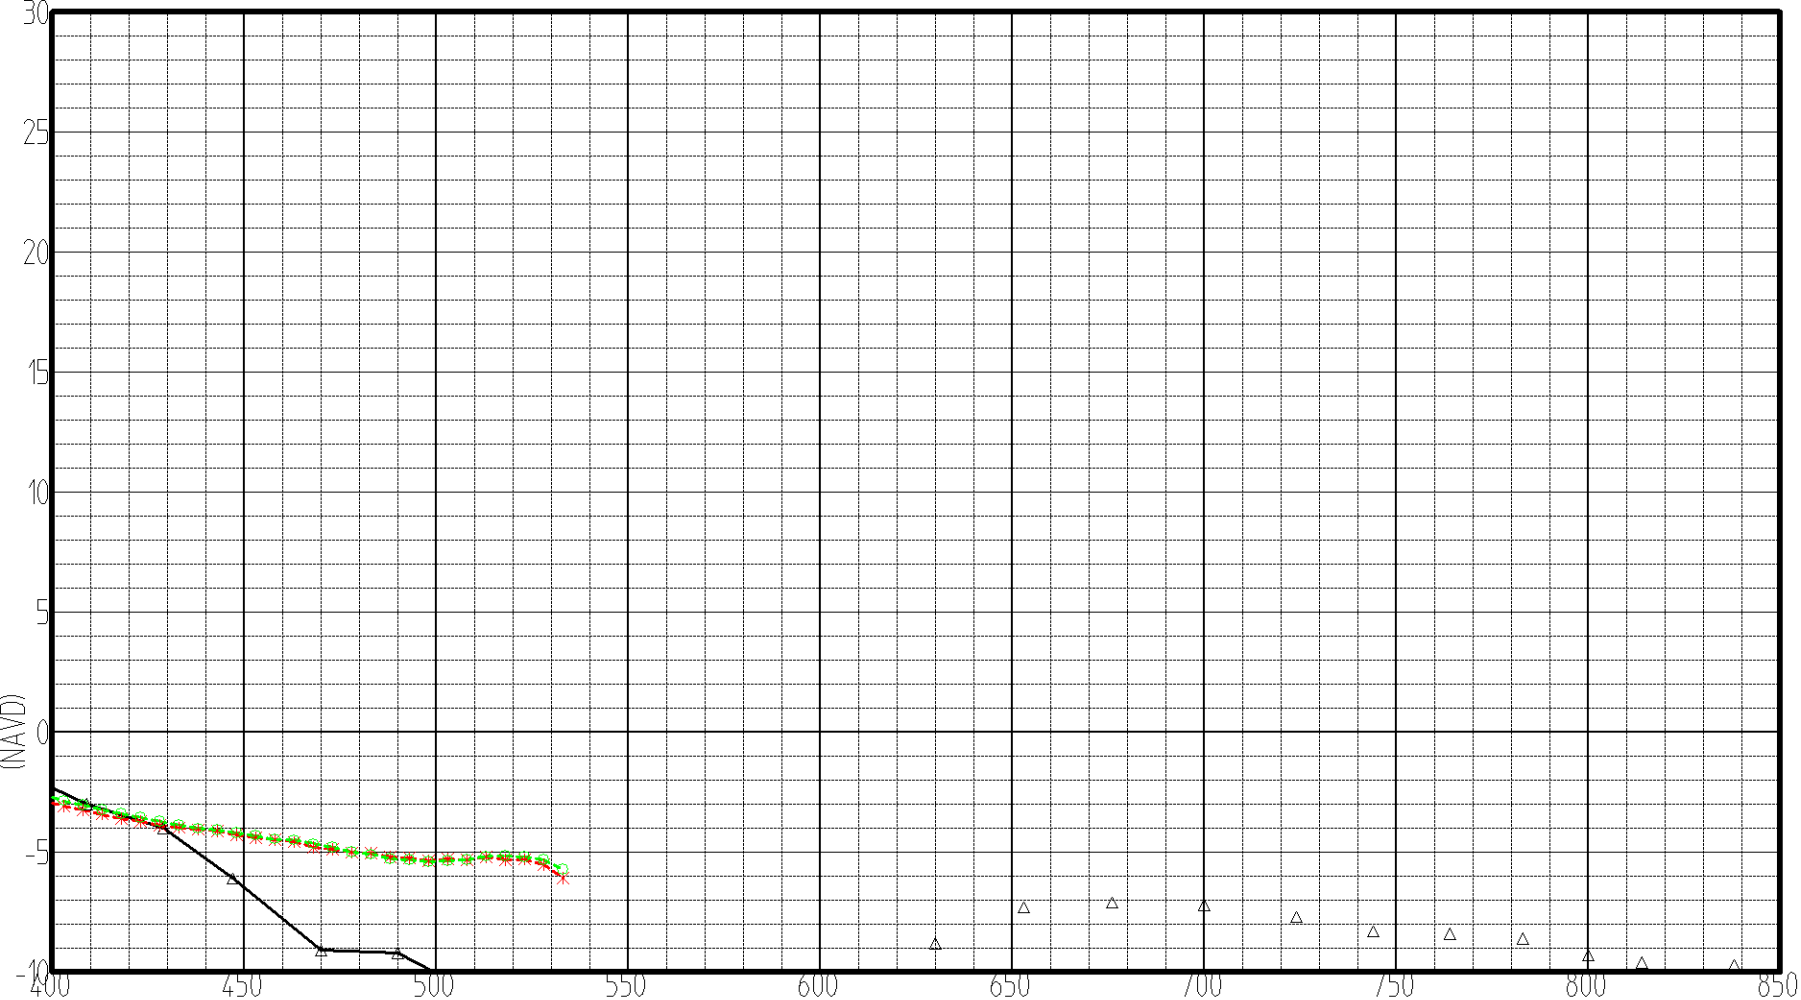
Range: R-133

BEACH PROFILE

—△—△— 2005-2008 INPUT PRF

- - - * - - - 15-YR SBEACH ERODED PRF

- - - o - - - 25-YR SBEACH ERODED PRF
