Appendix XI

SBEACH 15 and 25 yr. Storm Erosion Profiles

Brevard County

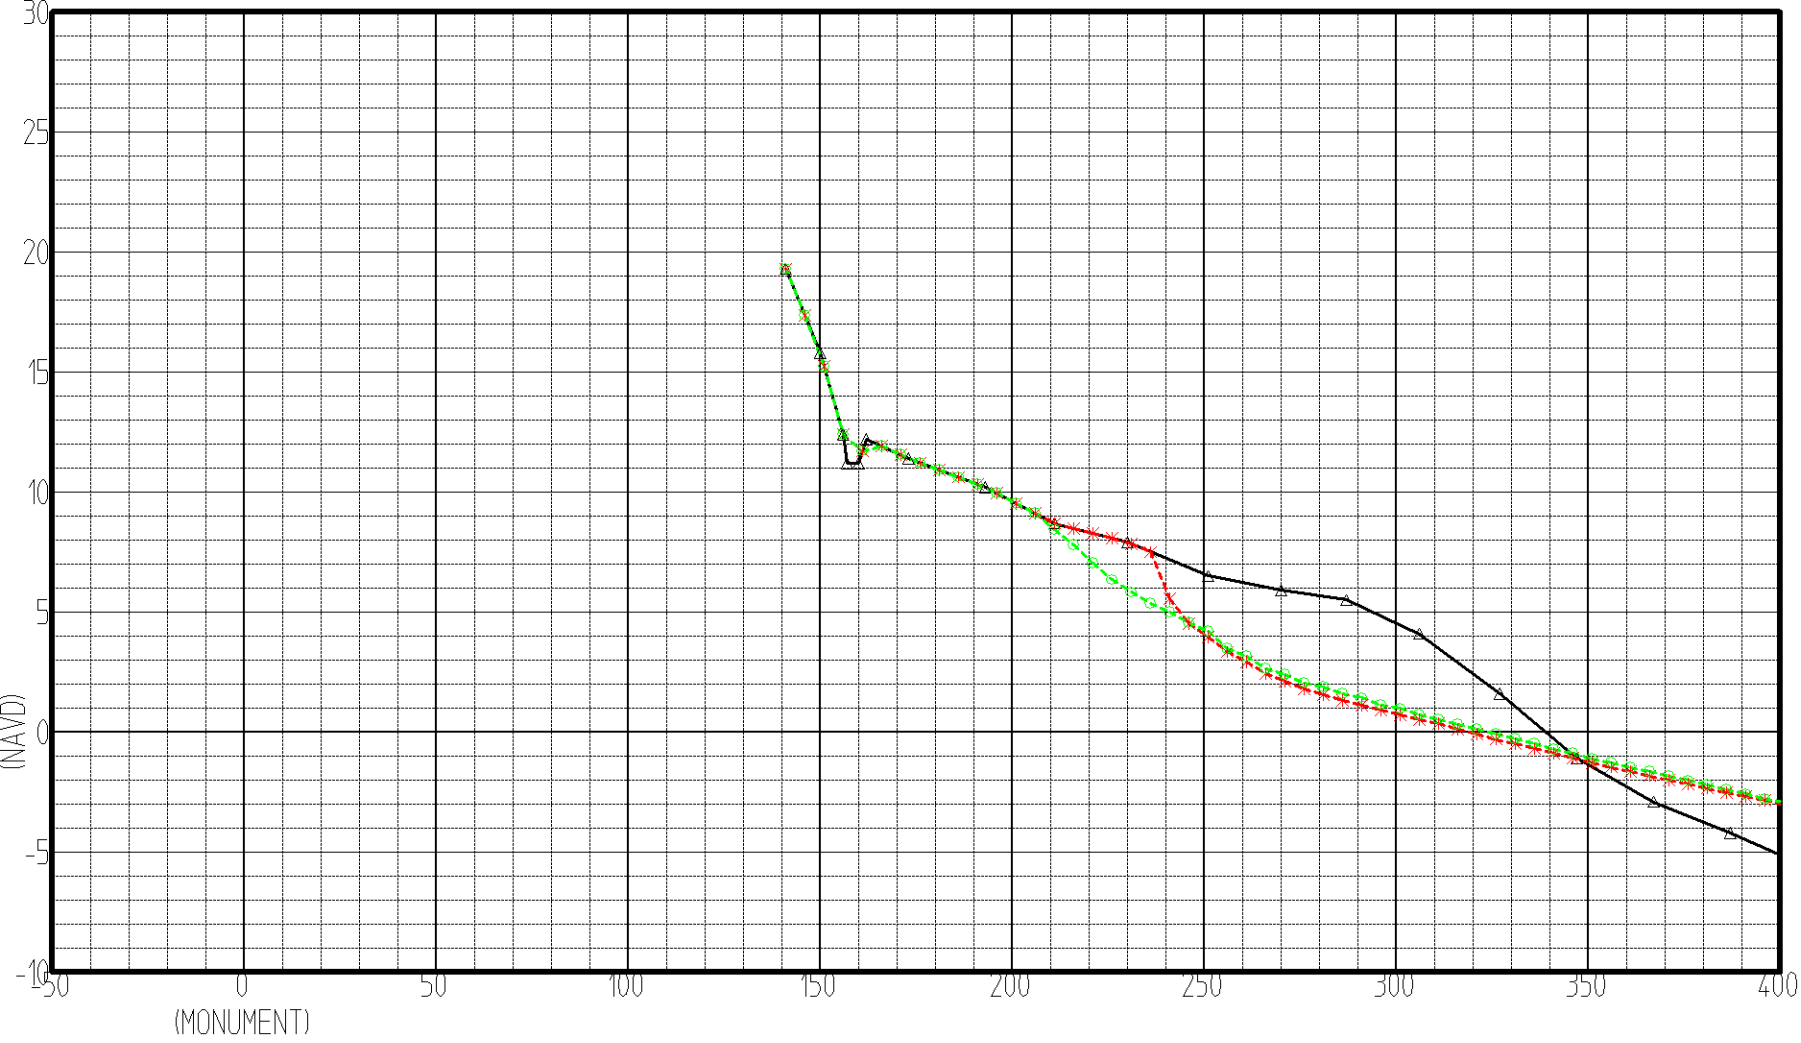
Range: R-134
 BEARING: 80.00
 1/2

BEACH PROFILE
 —△—△— 2005-2008 INPUT PRF
 - - * - - * - - 15-YR SBEACH ERODED PRF
 - - o - - o - - 25-YR SBEACH ERODED PRF

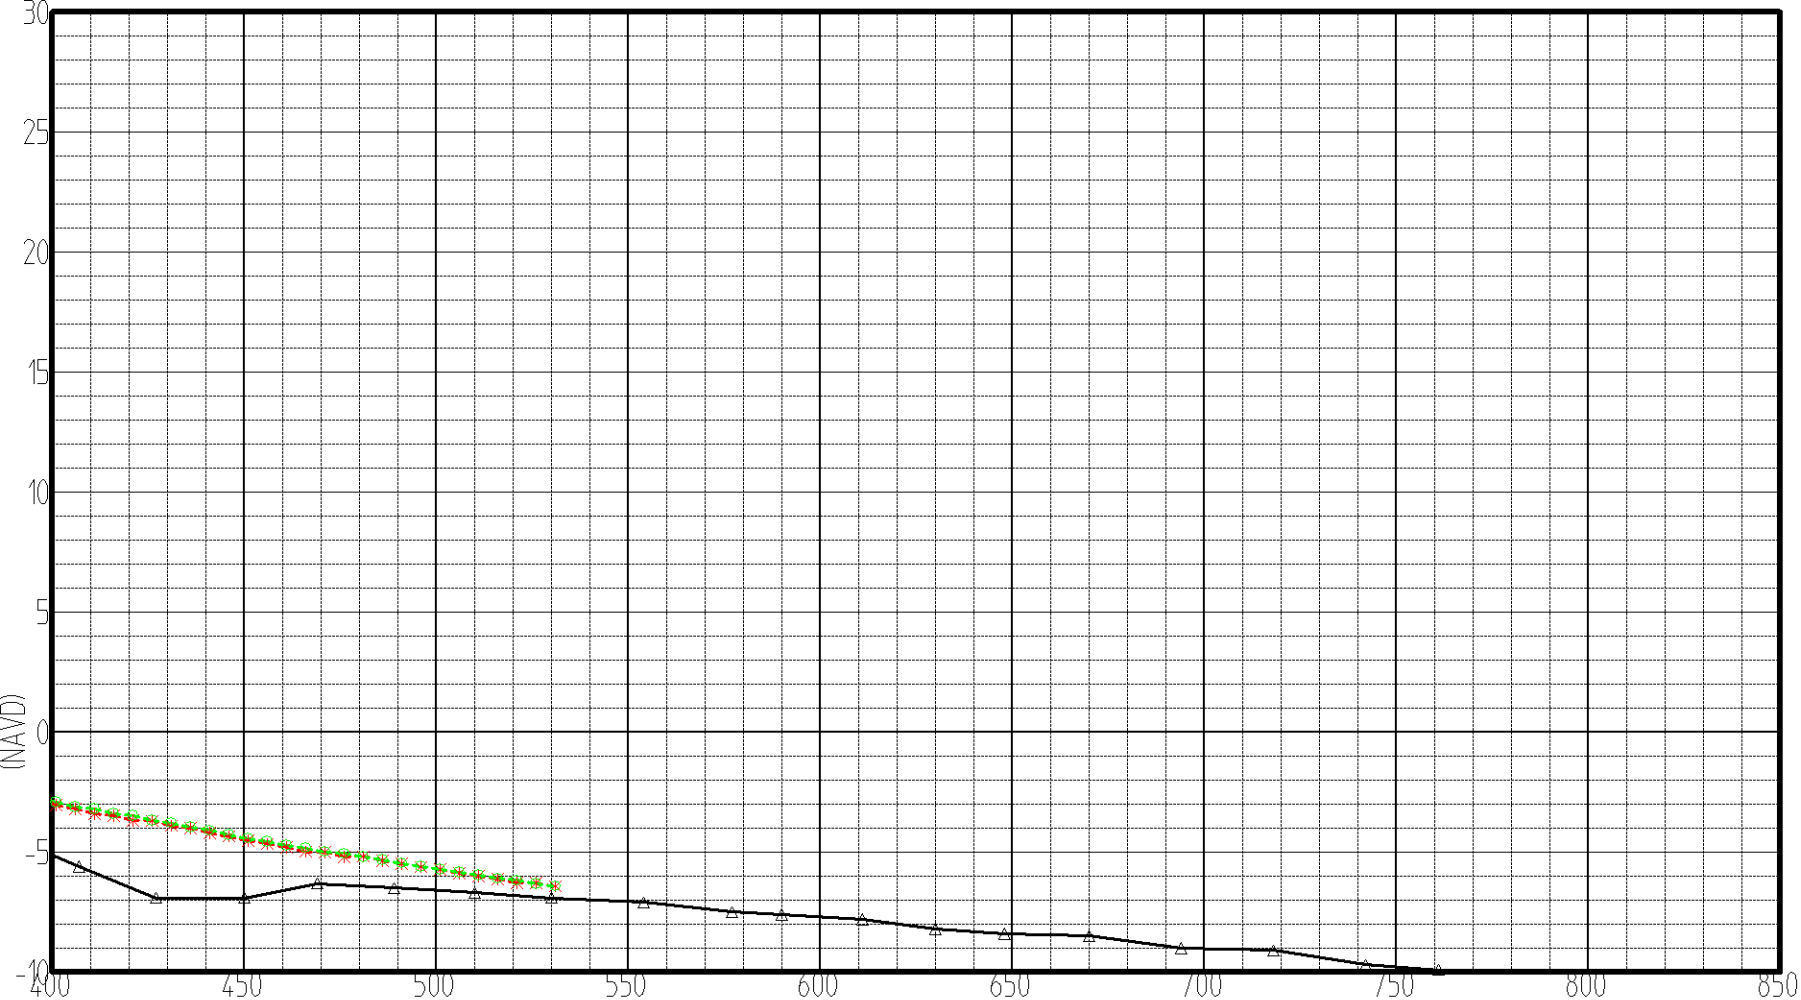
Range: R-134

BEACH PROFILE

—△—△— 2005-2008 INPUT PRF

- - - * - - - 15-YR SBEACH ERODED PRF

- - - o - - - 25-YR SBEACH ERODED PRF

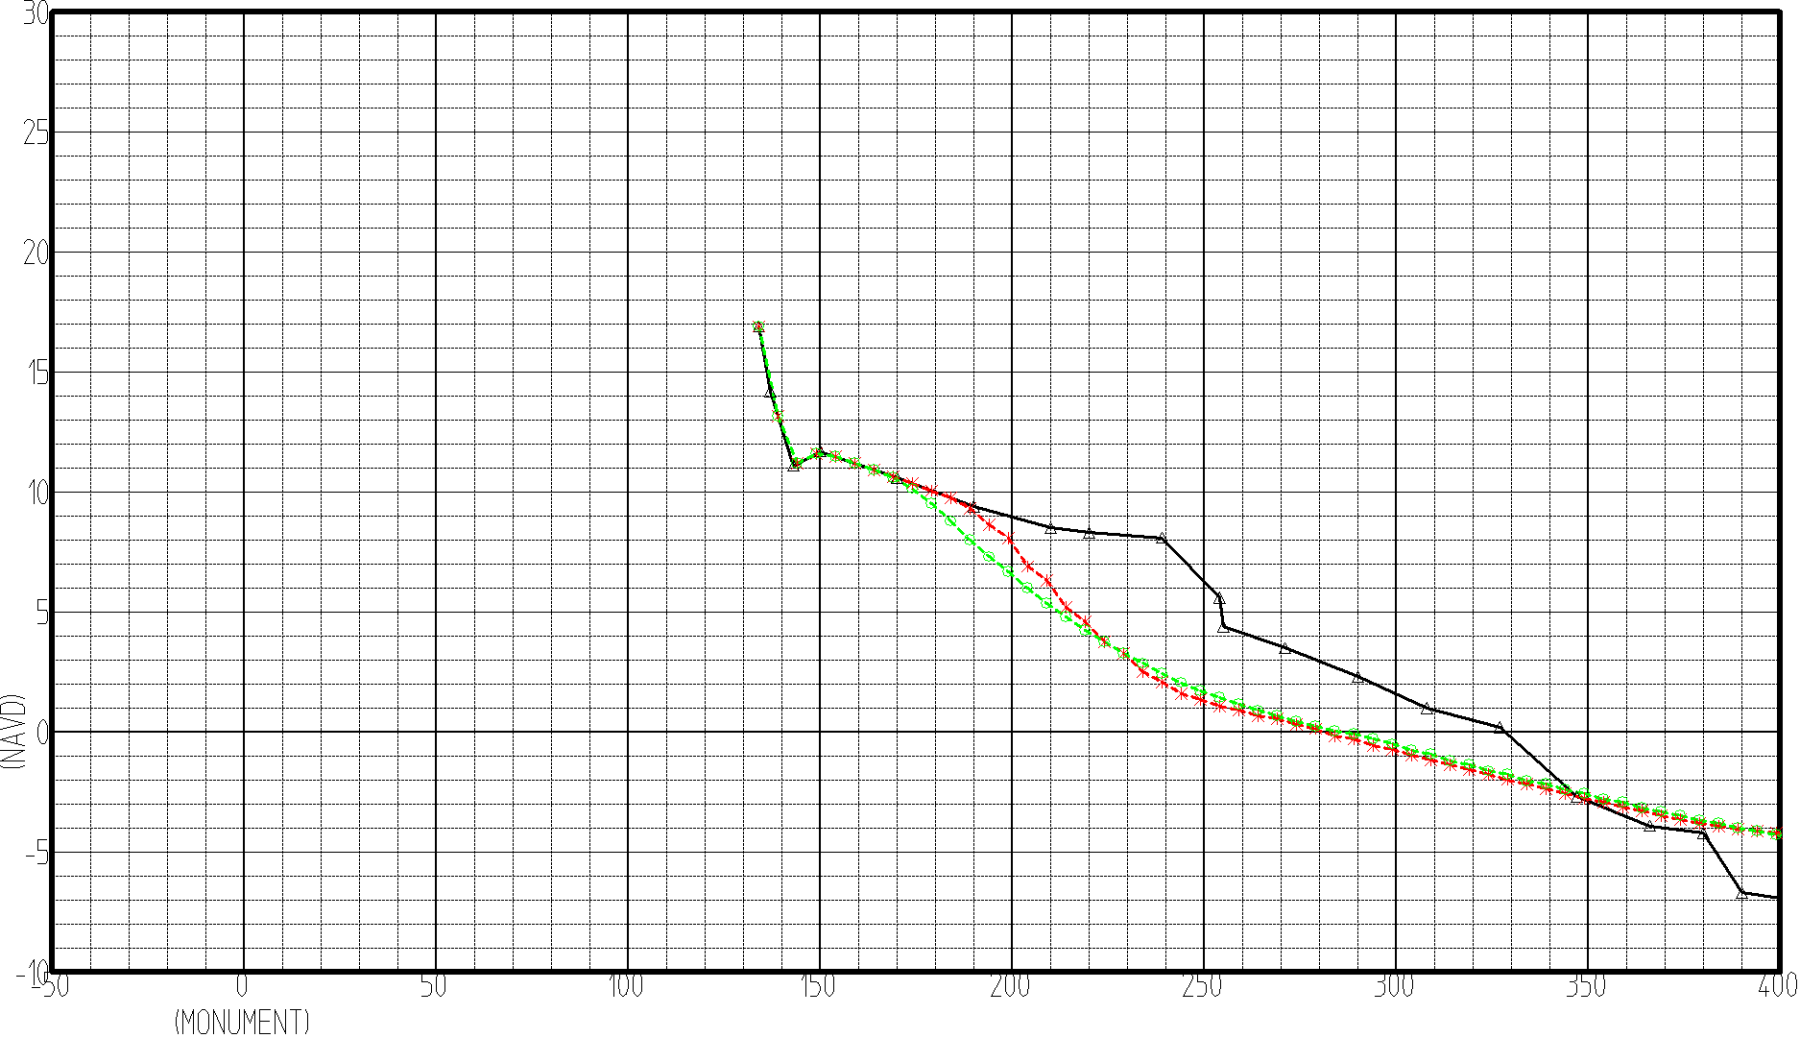
Range: R-135

BEACH PROFILE

—△—△— 2005-2008 INPUT PRF

- - - * - - - 15-YR SBEACH ERODED PRF

- - - o - - - 25-YR SBEACH ERODED PRF

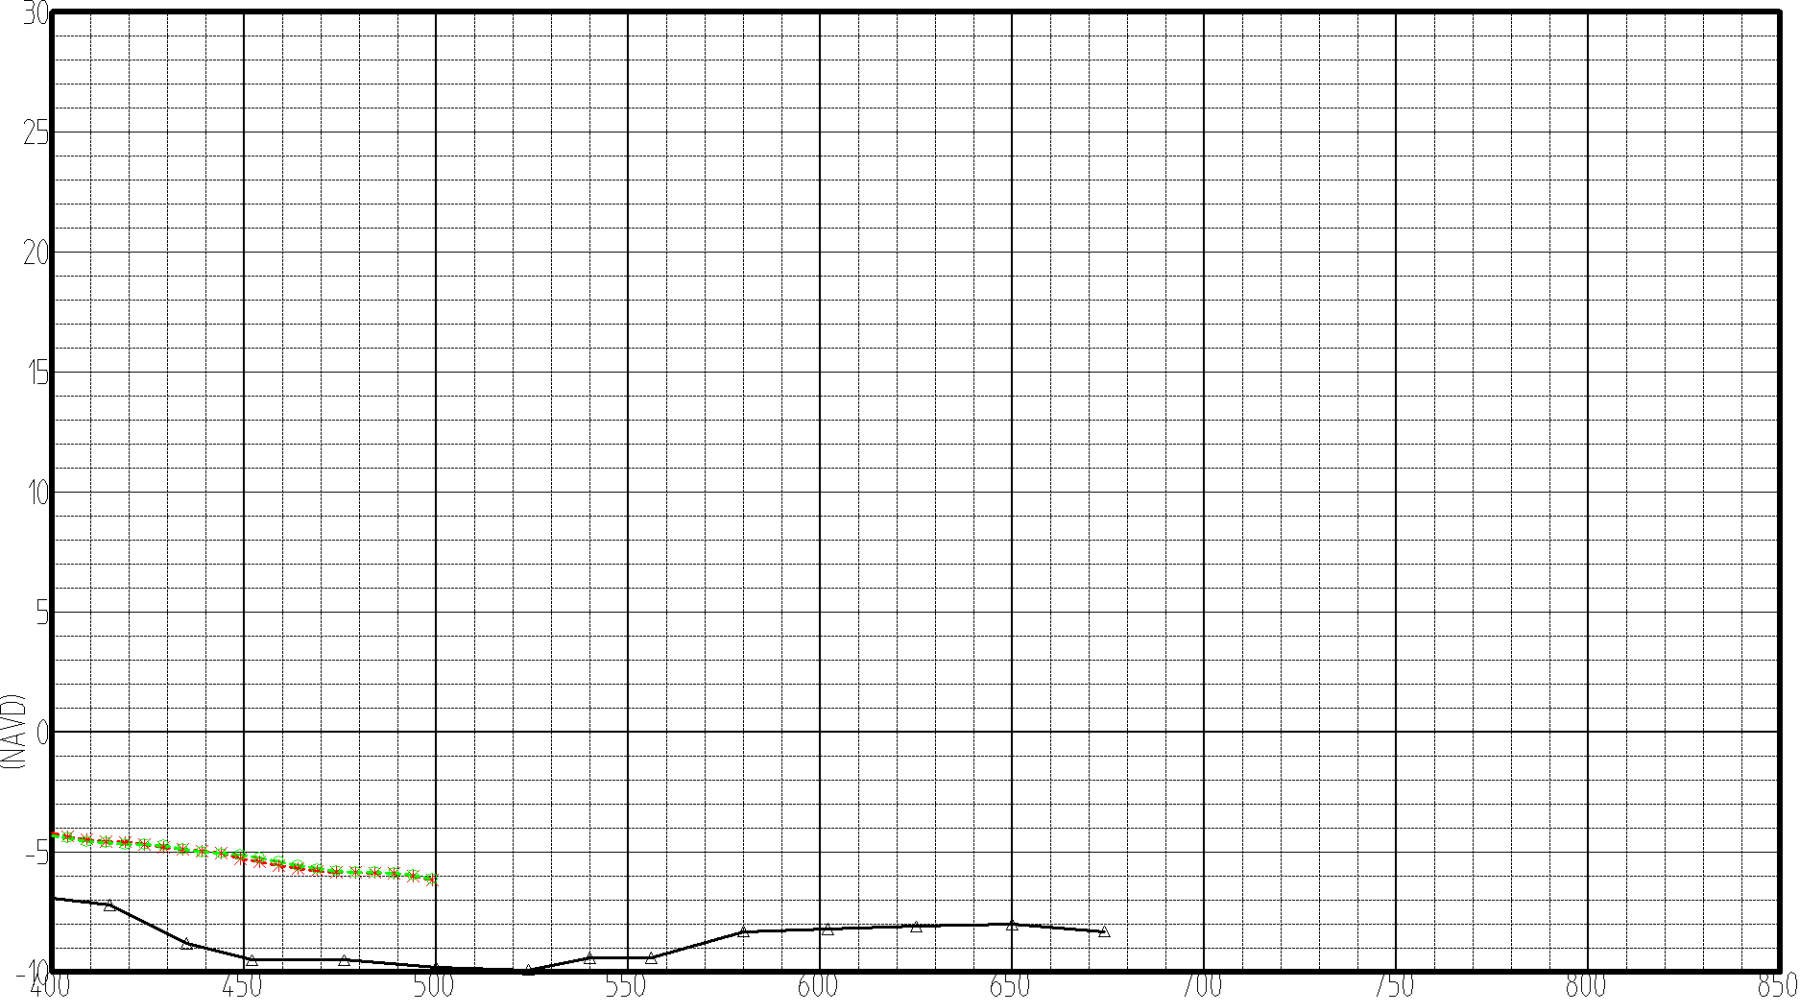
Range: R-135
 BEARING: 80.00
 2/2

BEACH PROFILE
 —△— 2005-2008 INPUT PRF
 - - * - - 15-YR SBEACH ERODED PRF
 - - o - - 25-YR SBEACH ERODED PRF

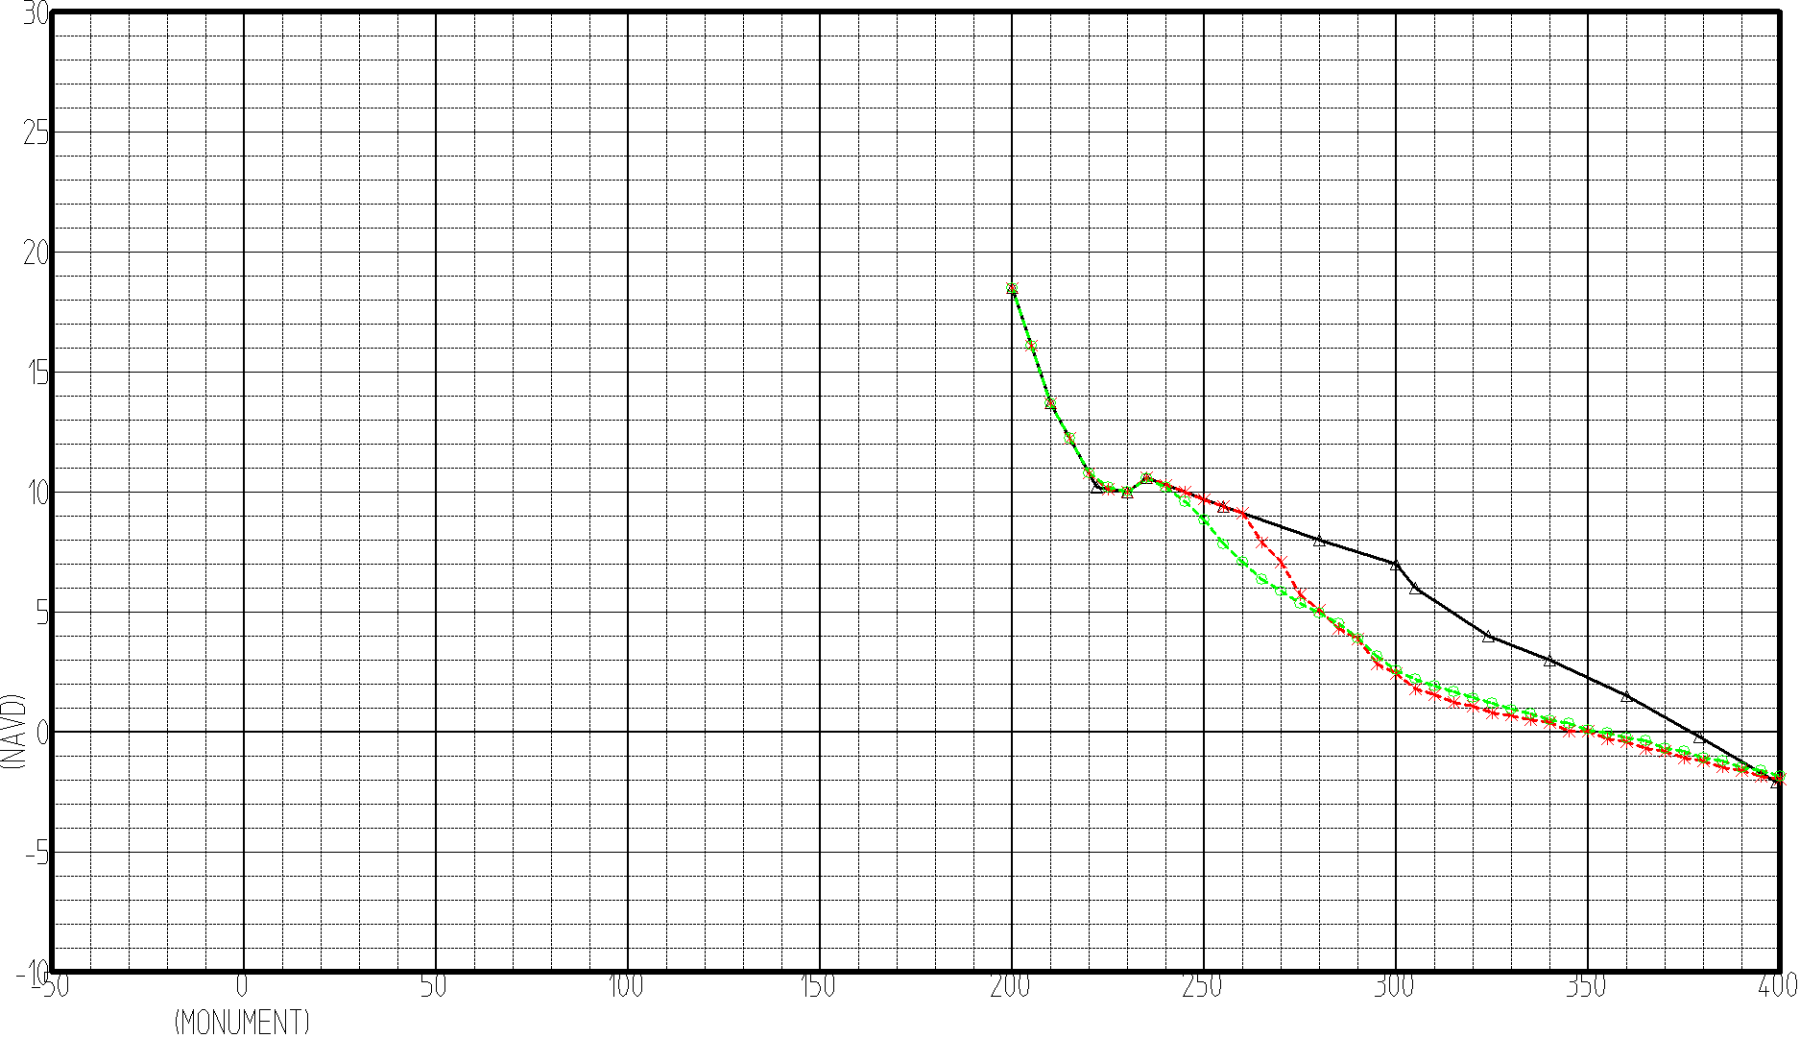
Range: R-136

BEACH PROFILE

—△—△— 2005-2008 INPUT PRF

- - * - - * - - 15-YR SBEACH ERODED PRF

- - o - - o - - 25-YR SBEACH ERODED PRF

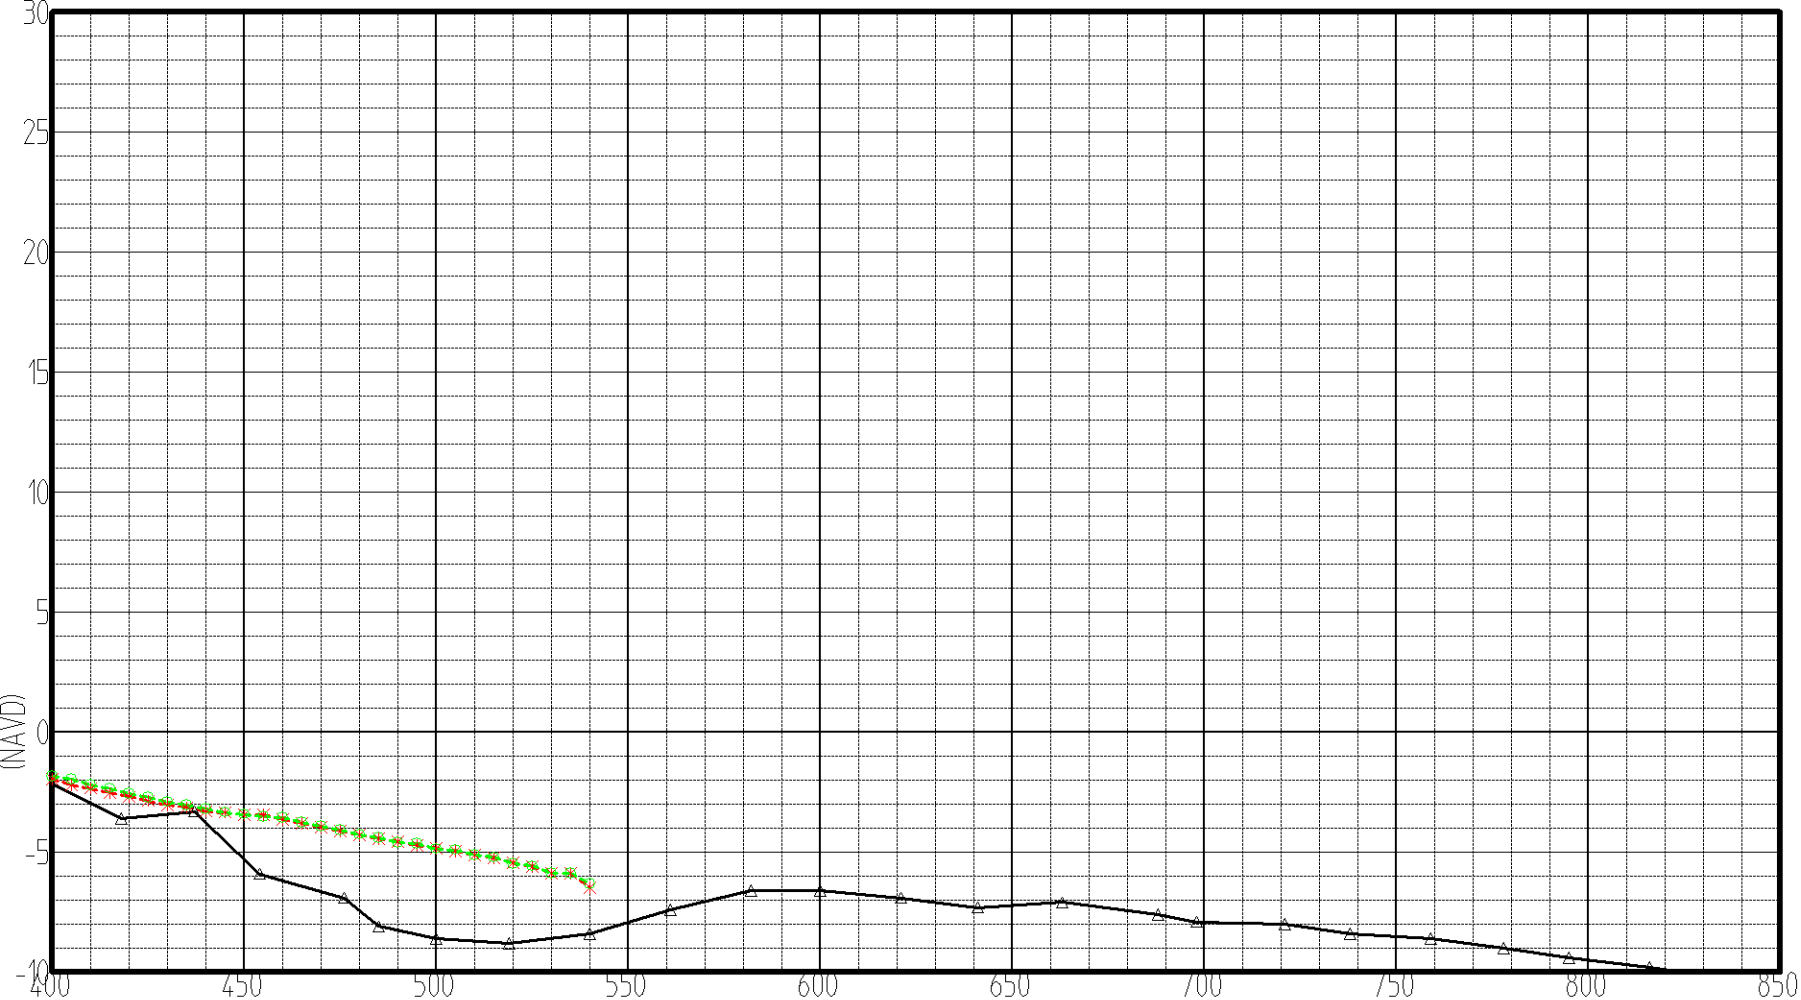
Range: R-136
 BEARING: 80.00
 2/3

BEACH PROFILE
 —△—△— 2005-2008 INPUT PRF
 - - * - - * - - 15-YR SBEACH ERODED PRF
 - - o - - o - - 25-YR SBEACH ERODED PRF

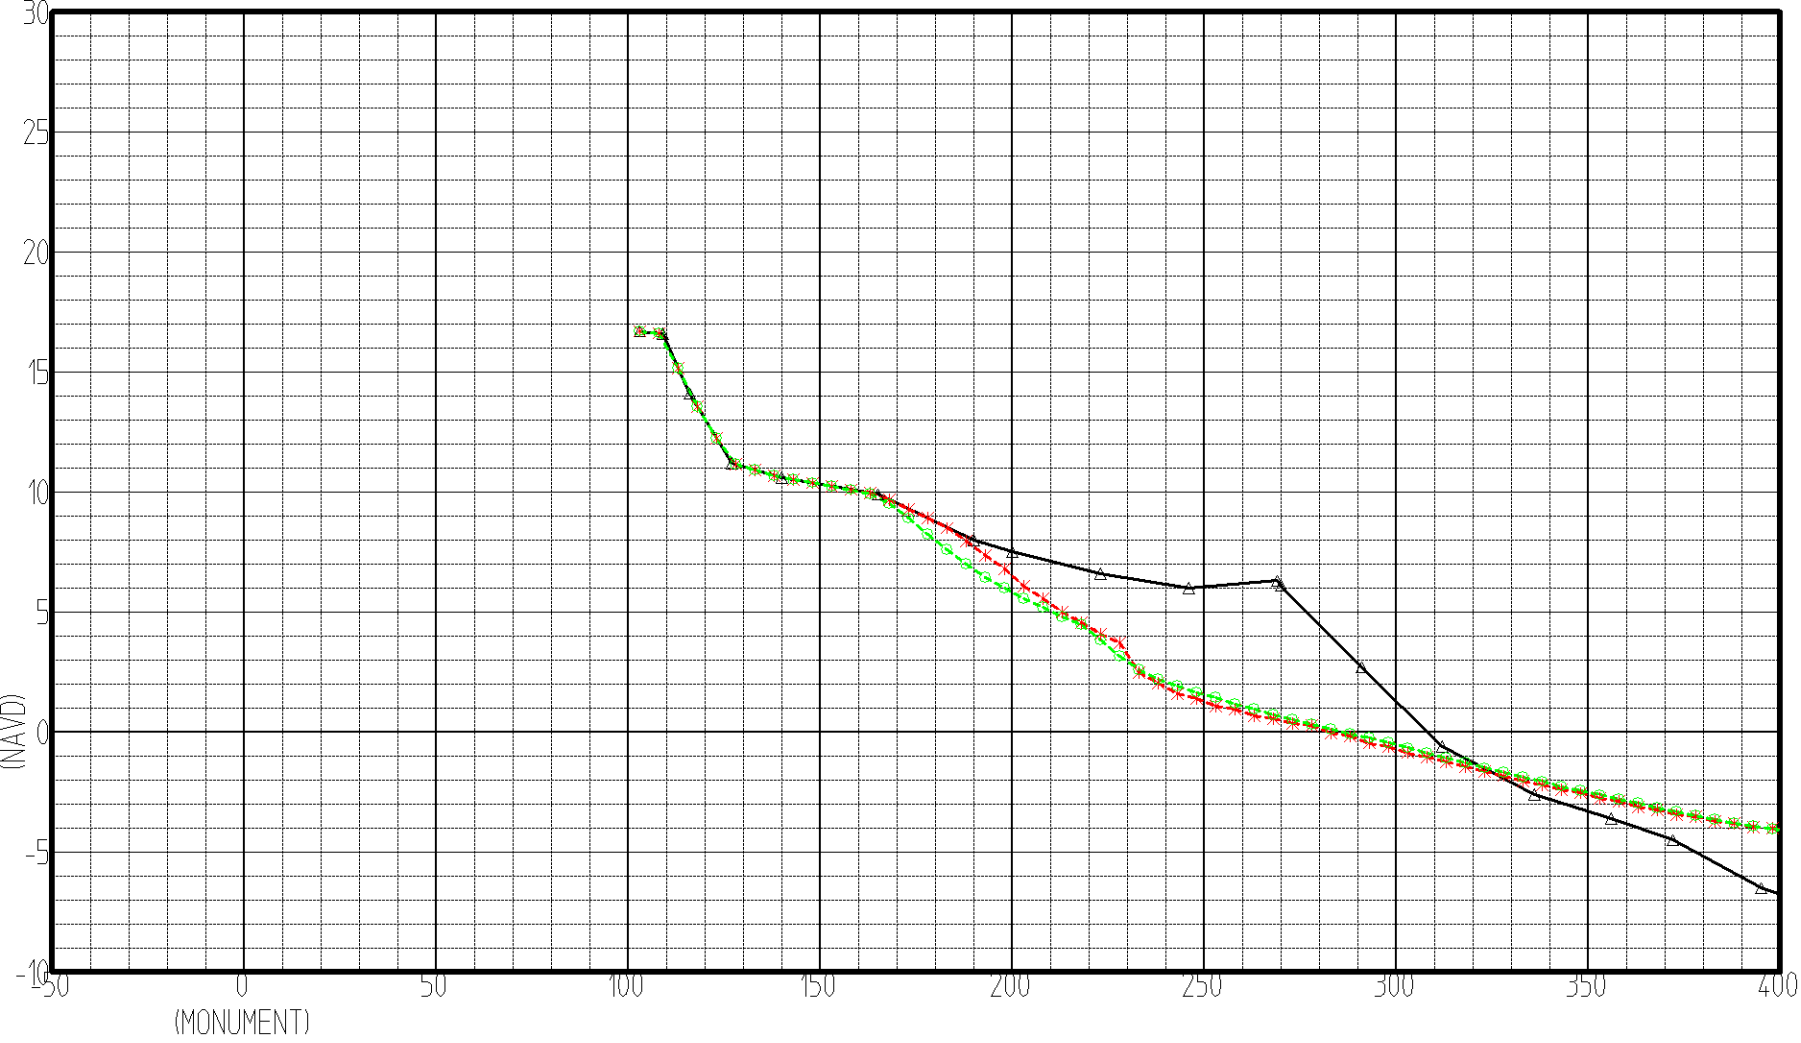
Range: R-137-T 1/2

BEACH PROFILE

- △—△— 2005-2008 INPUT PRF
- - * - - * - - 15-YR SBEACH ERODED PRF
- - o - - o - - 25-YR SBEACH ERODED PRF

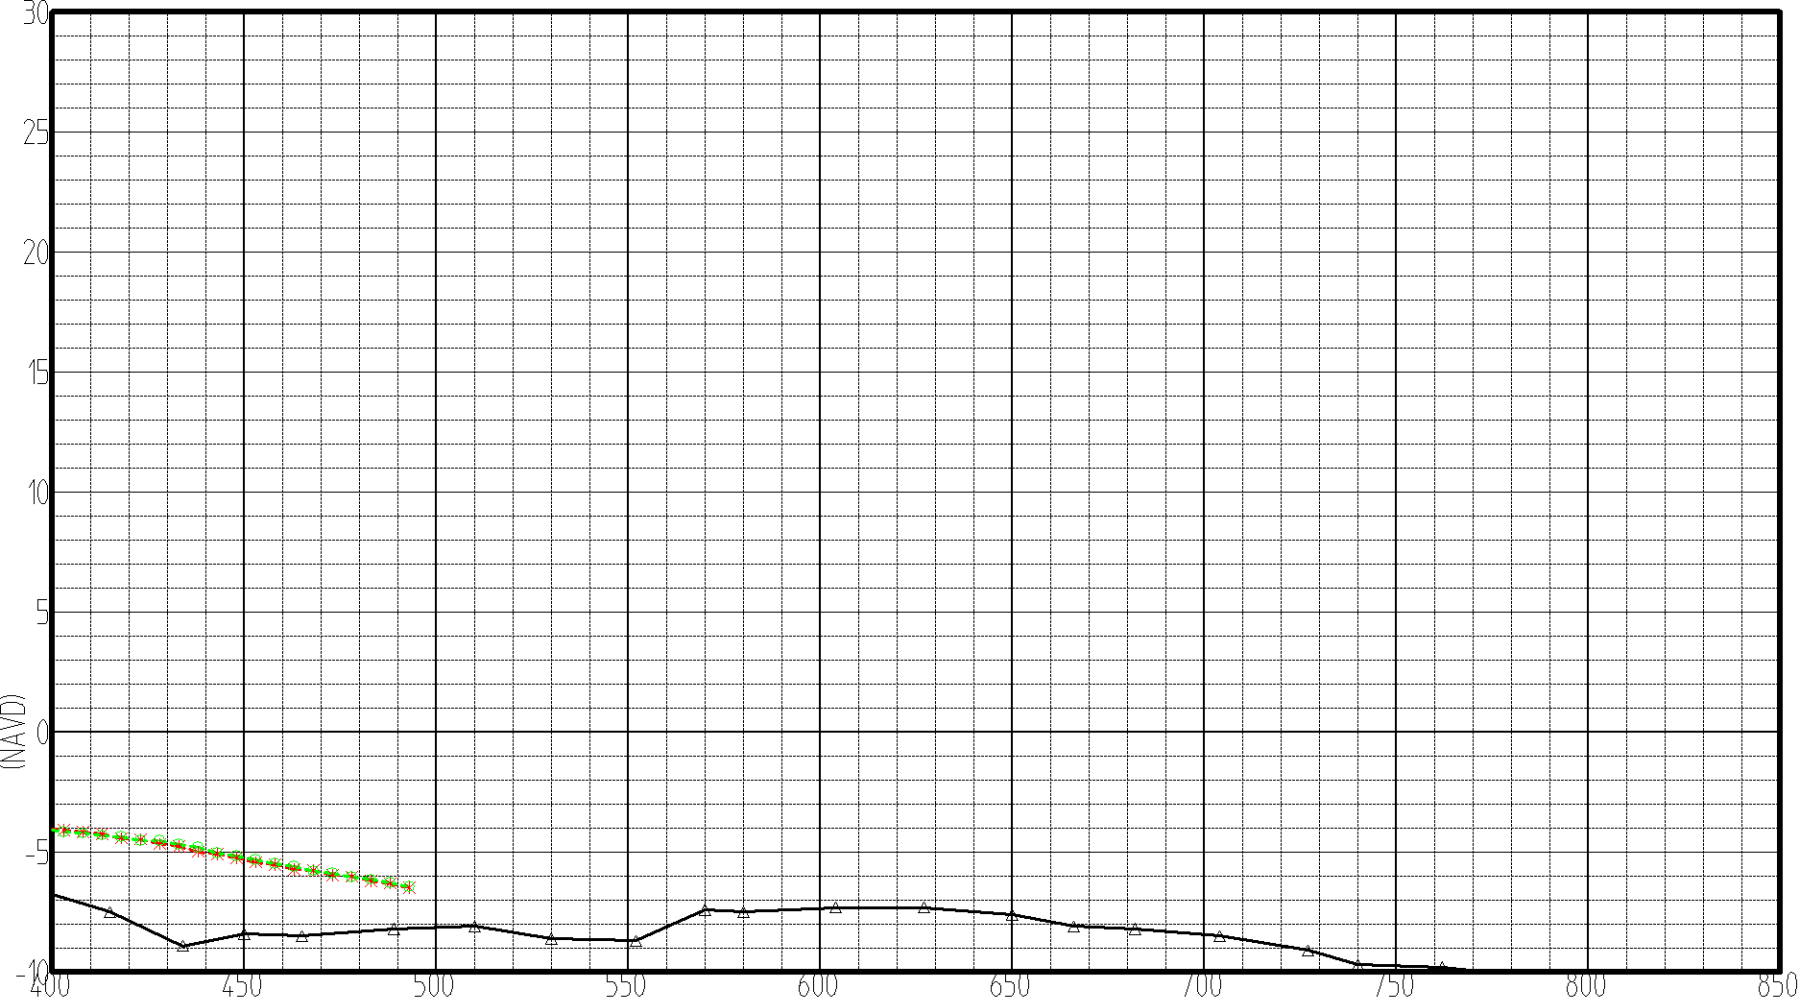
Range: R-137-T 2/2

BEACH PROFILE

- △—△— 2005-2008 INPUT PRF
- - - * - - - 15-YR SBEACH ERODED PRF
- - - o - - - 25-YR SBEACH ERODED PRF

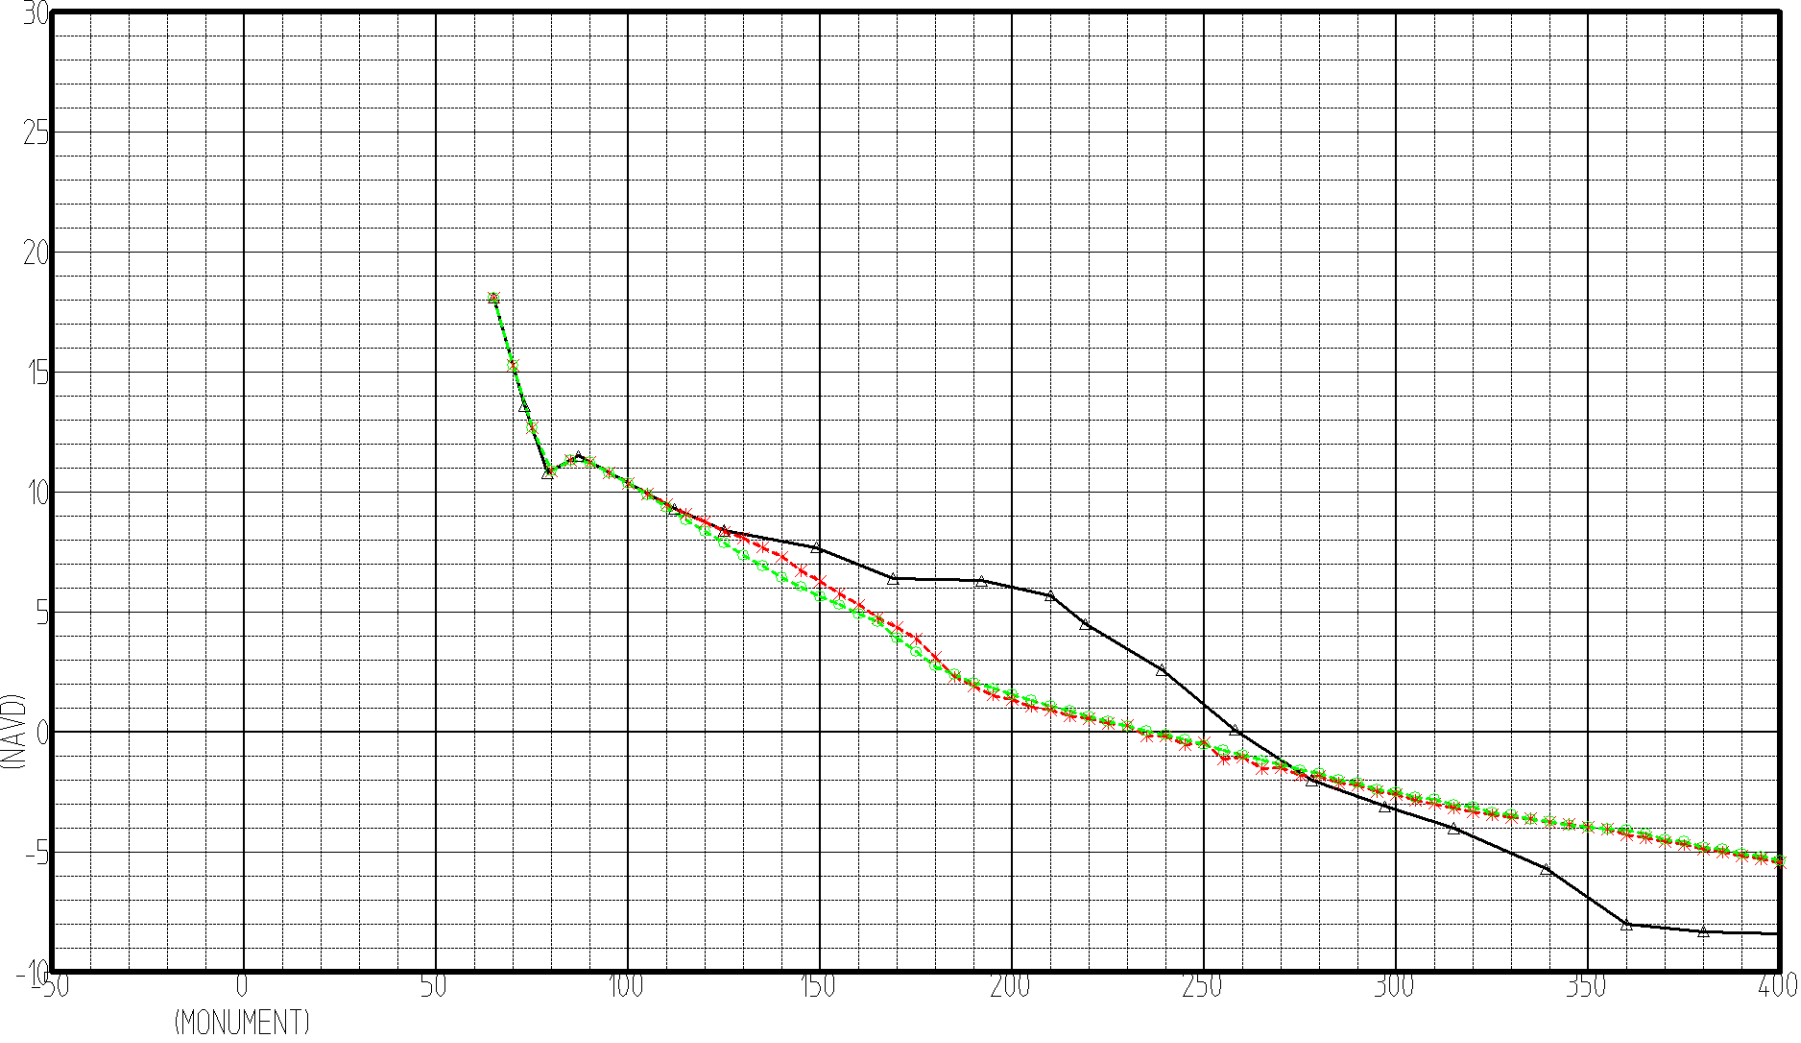
Range: R-138

BEACH PROFILE

—△—△— 2005-2008 INPUT PRF

- - - * - - - 15-YR SBEACH ERODED PRF

- - - o - - - 25-YR SBEACH ERODED PRF

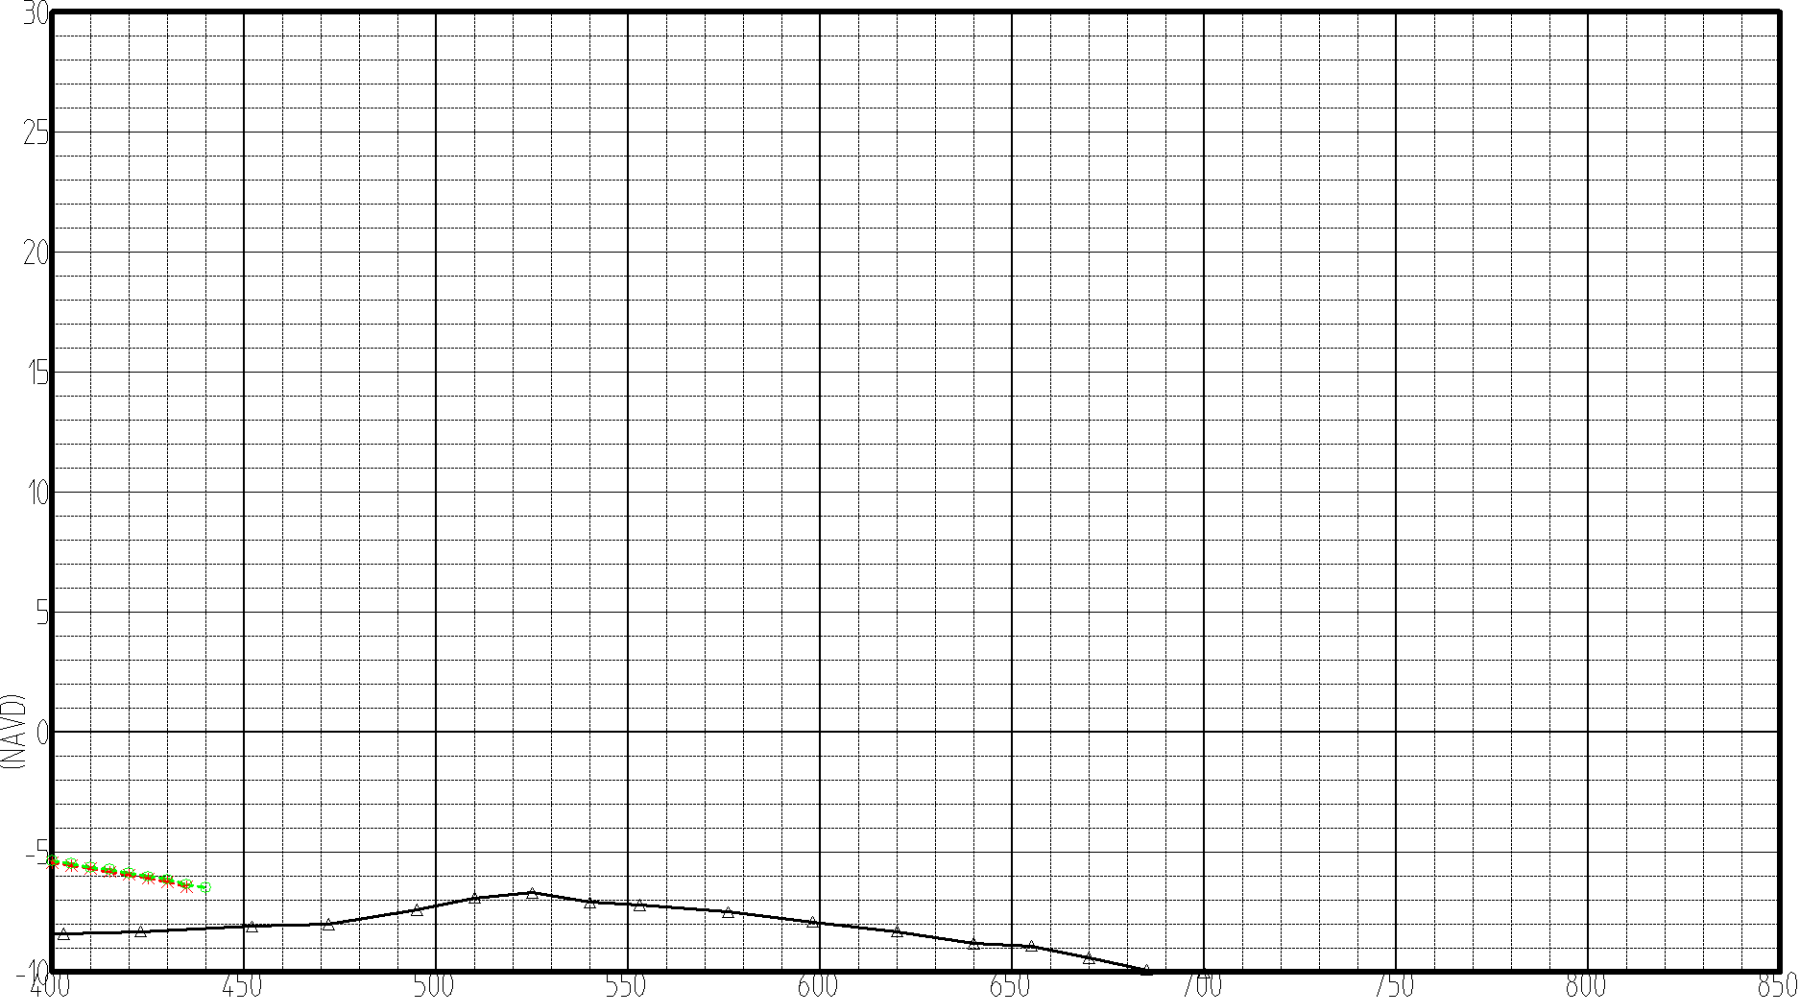
Range: R-138

BEACH PROFILE

—△—△— 2005-2008 INPUT PRF

- - - * - - - 15-YR SBEACH ERODED PRF

- - - o - - - 25-YR SBEACH ERODED PRF

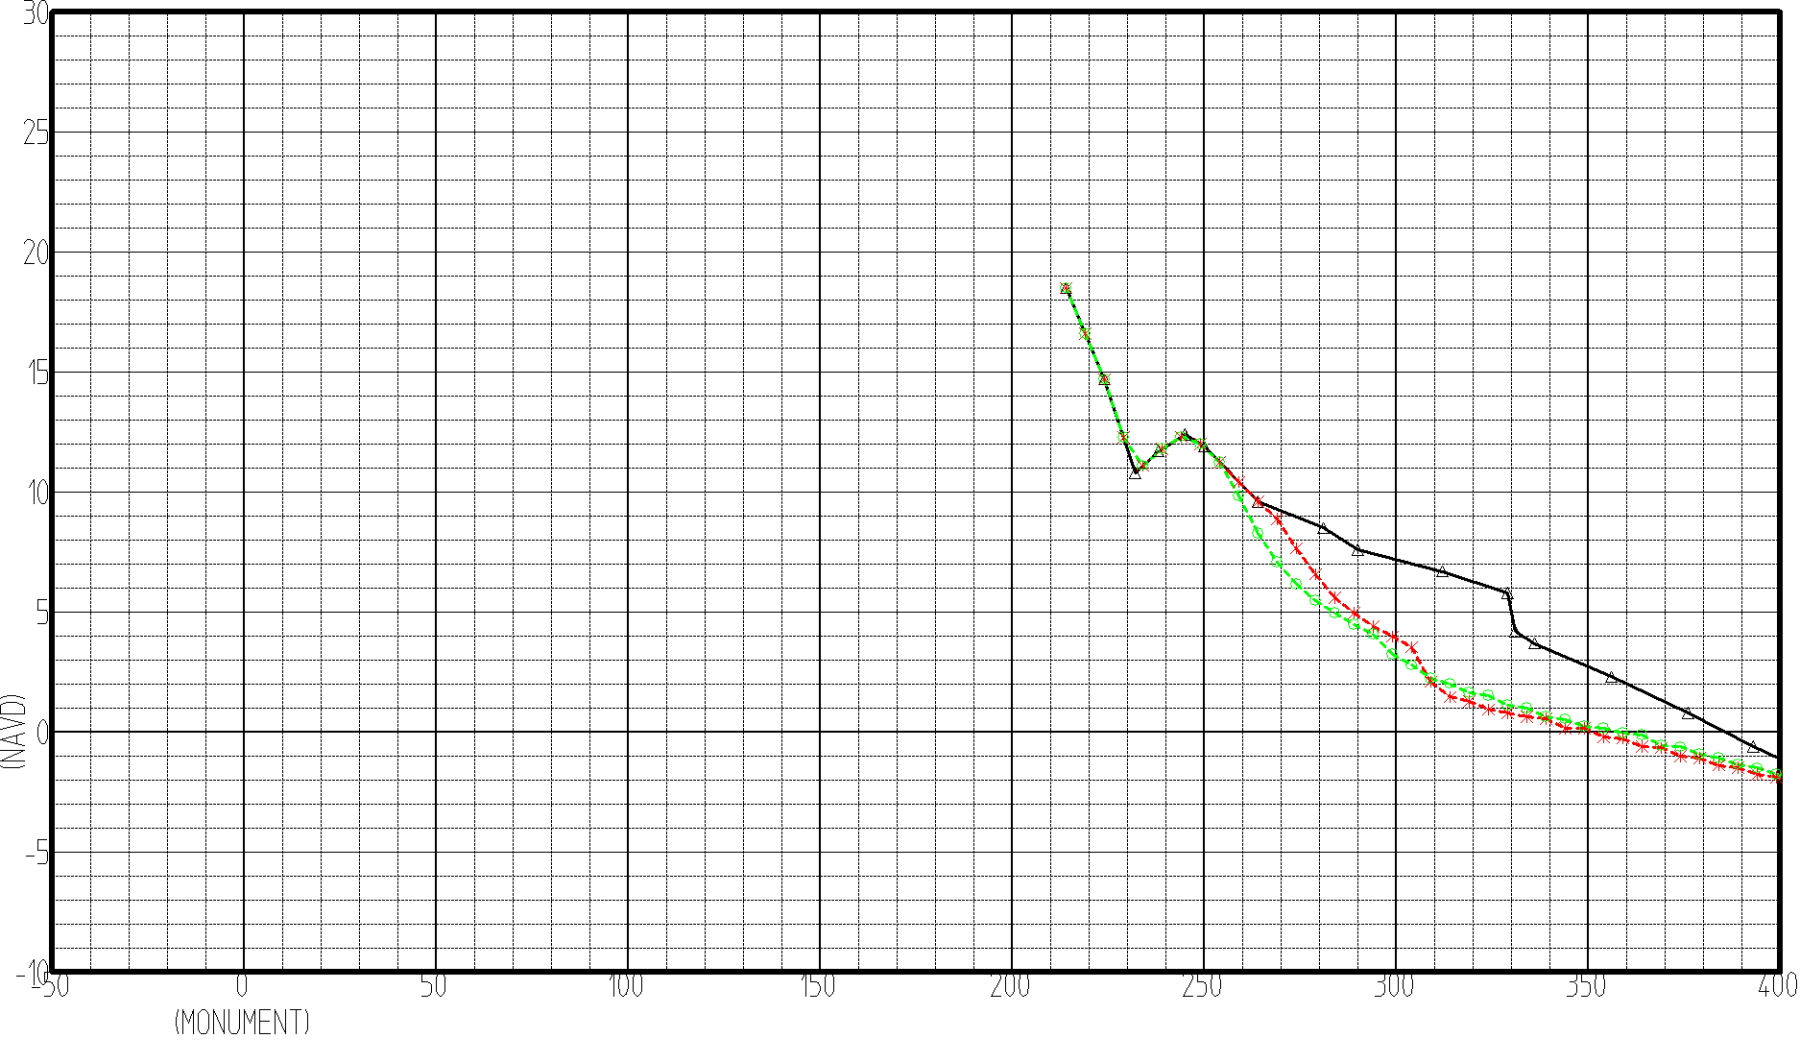
Range: R-139

BEACH PROFILE

—△—△— 2005-2008 INPUT PRF

- - - * - - - 15-YR SBEACH ERODED PRF

- - - o - - - 25-YR SBEACH ERODED PRF

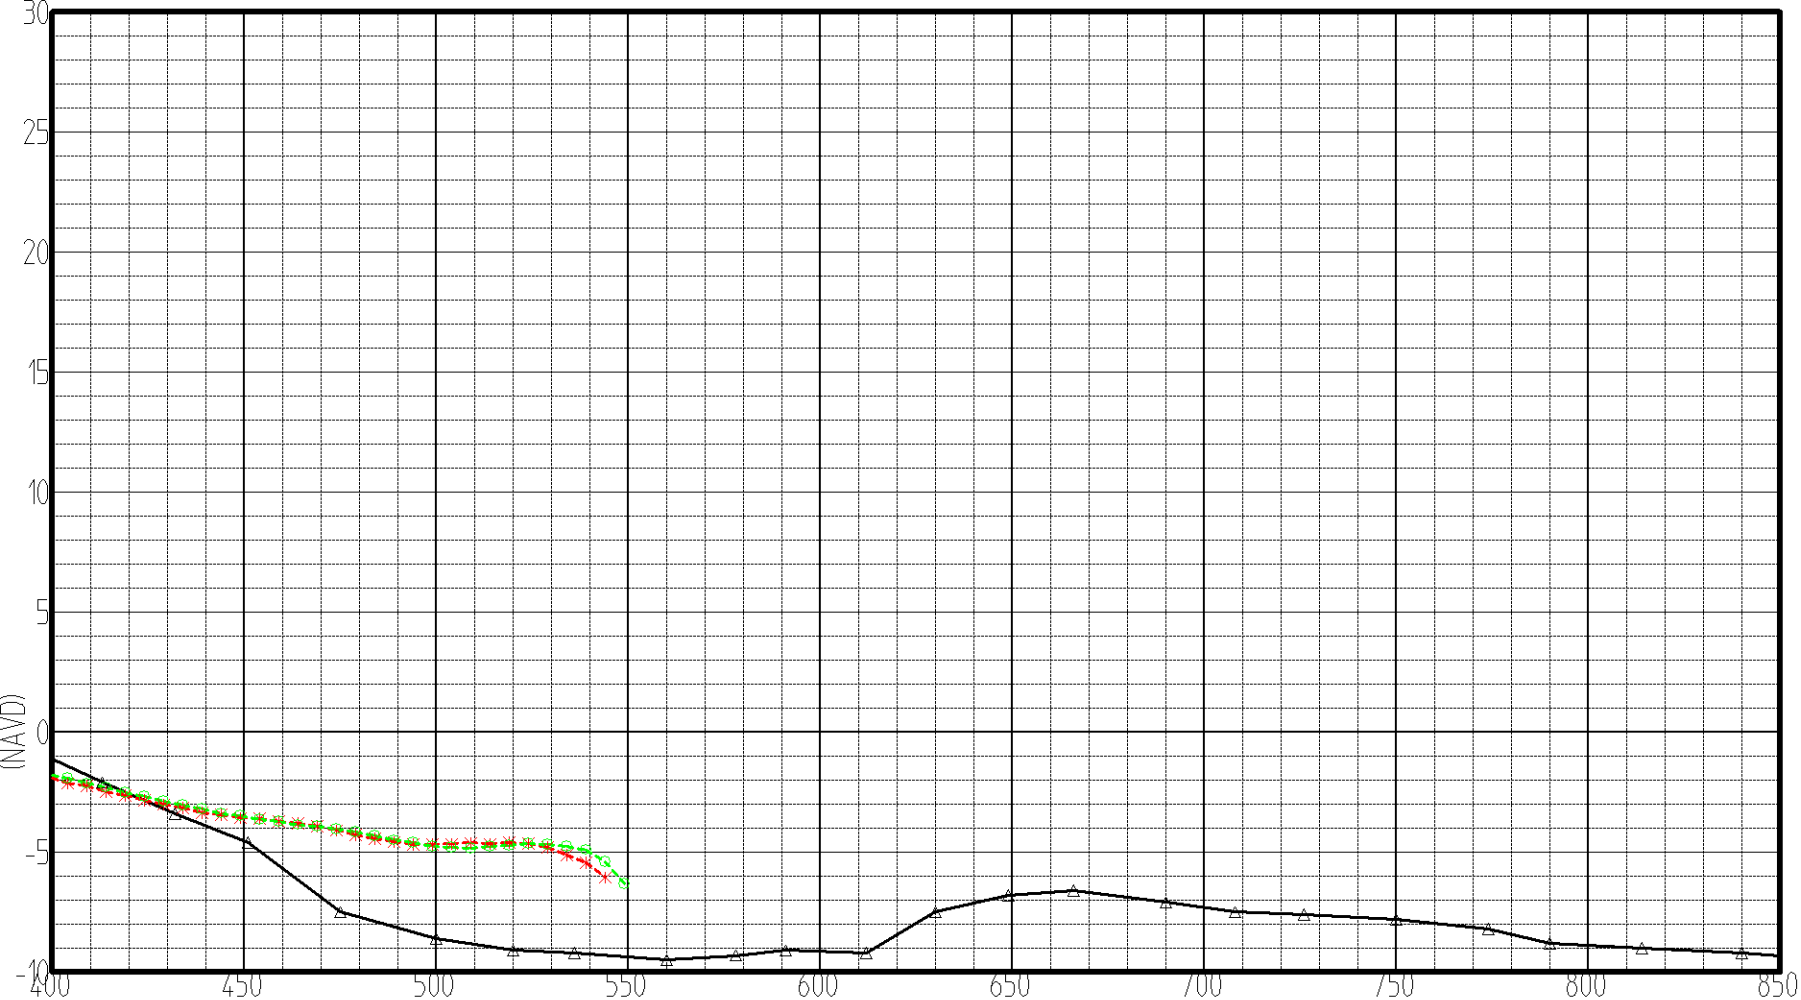
Range: R-139

BEACH PROFILE

—△—△— 2005-2008 INPUT PRF

- - - * - - - 15-YR SBEACH ERODED PRF

- - - o - - - 25-YR SBEACH ERODED PRF
